LESSONS LEARNED and RECENT SAFETY TRENDS

–Special Focus on OSHA/ESAMS Top Violations and Positive Trends

31 October 2012

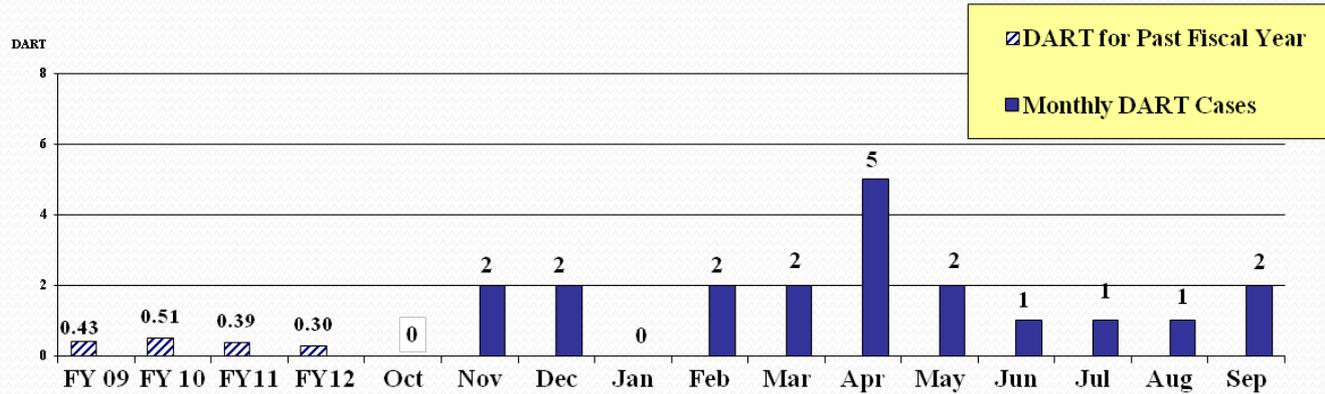
Contractor - Days-Away, Restricted Duty, or Transfer (DART) Rate

FY12 target dart rate is 0.37

FY12 end of year dart rate is 0.30

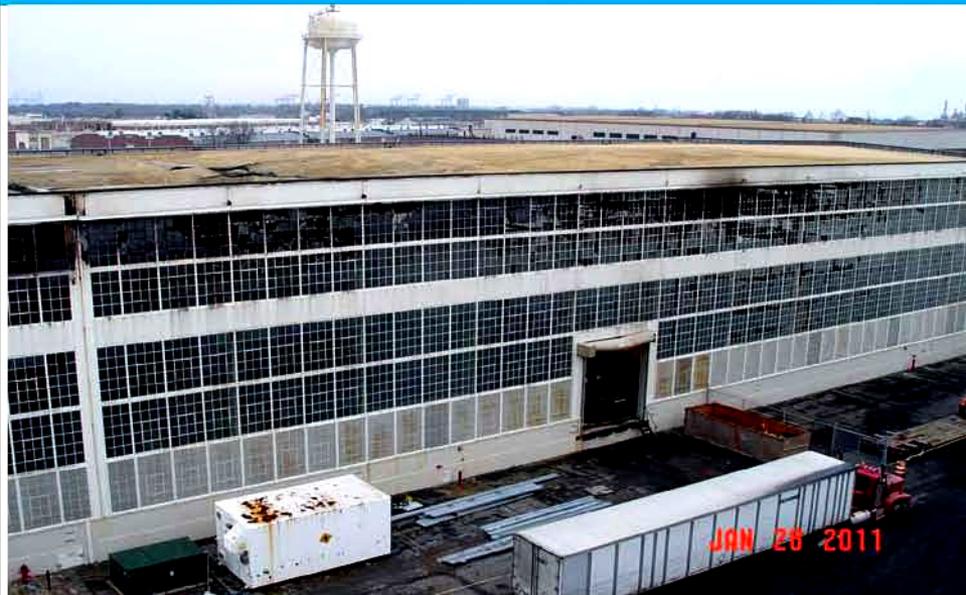
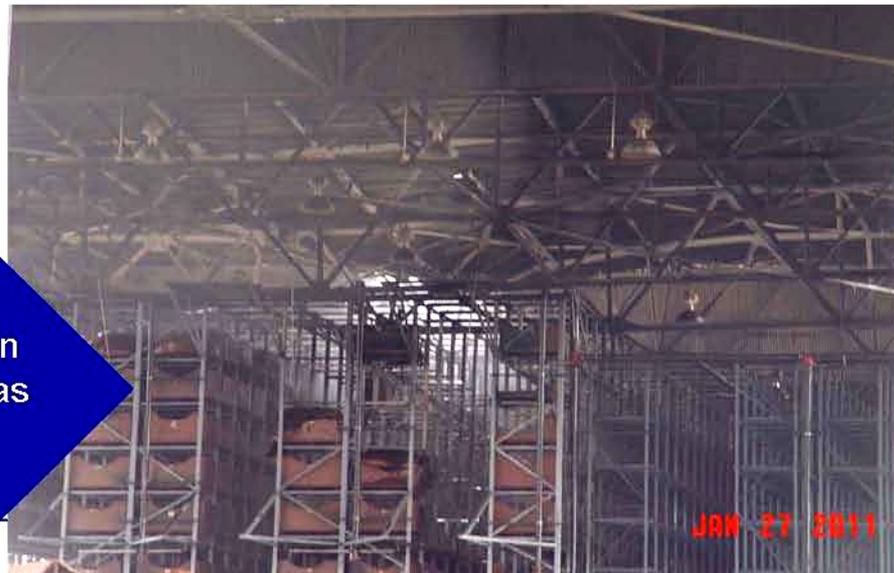
V-52 Warehouse Fire Damage

Storage racks with boxes in area where torch cutting was being performed

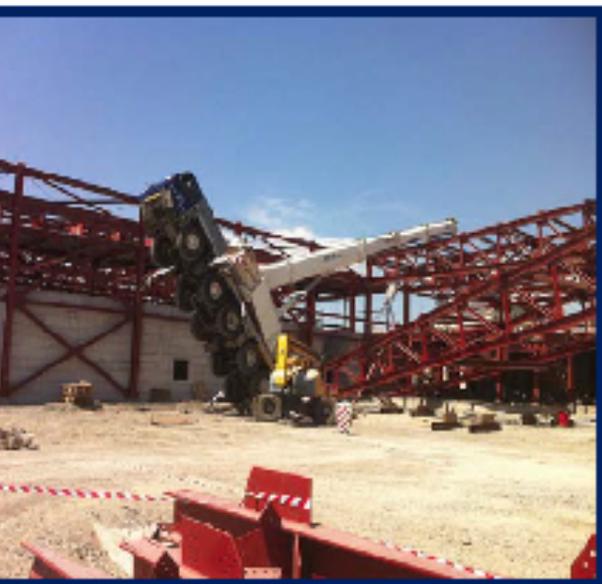
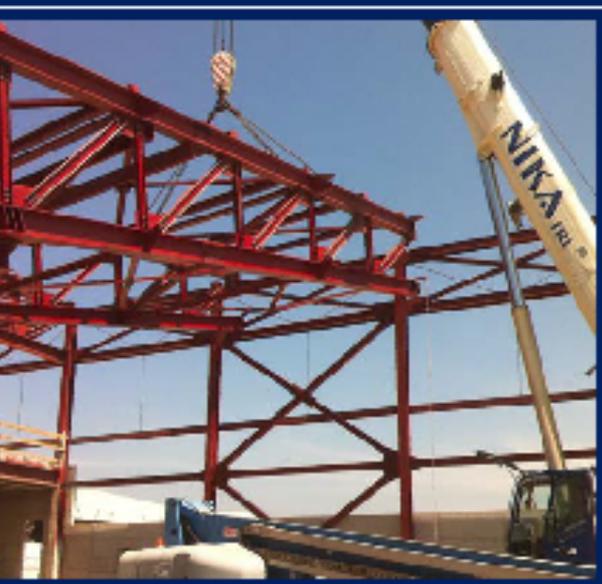
Tipped-over Crane

180-ton Crane Tipped Over; Crushed Elevated Work Platform; 3 Injured Employees with Total of 70 Lost Work Days

Activity: A contractor was conducting a critical lift of a 64 ton steel truss with a 180 ton and 200 ton hydraulic mobile crane rigged at opposite ends of the truss. The steel truss was raised in tandem by the cranes to the proper height. The fabricators were sent up on man-lifts to bolt the truss to the columns, but the man-lifts were improperly raised to extend underneath the boom of the crane. The steel truss on the right side was in alignment with the bolt plate while the left side of the truss was out of alignment and in touch with its bolt plate. The rigging lift supervisor signaled to the crane operator to move the load forward in order to align the left side with the bolt plate. The crane operator lowered the boom, but the truss was still in contact with the bolt plate, which restricted the truss' movement. The rigging lift supervisor did not tell the operator that the truss was caught by the bolt plate as the crane boom continued to be lowered. The load suddenly slipped from the bolt plate and swung forward of the crane, causing shock loading. As a result, the load fell and pulled the crane over, tipping the chassis to a 60 deg angle from the ground surface. As the crane boom fell, it struck the extended boom of the man lift that was positioned below.

- Communication failure between crane operator and rigging lift supervisor

- Adhere precisely to critical lift plan, which shall include proper crew communication
- Do not allow personnel or equipment to operate under a suspended load
- Verify contractor notification procedures for critical lifts are being followed
- Insure staff conducting pre-work meetings is fully qualified to conduct such meetings

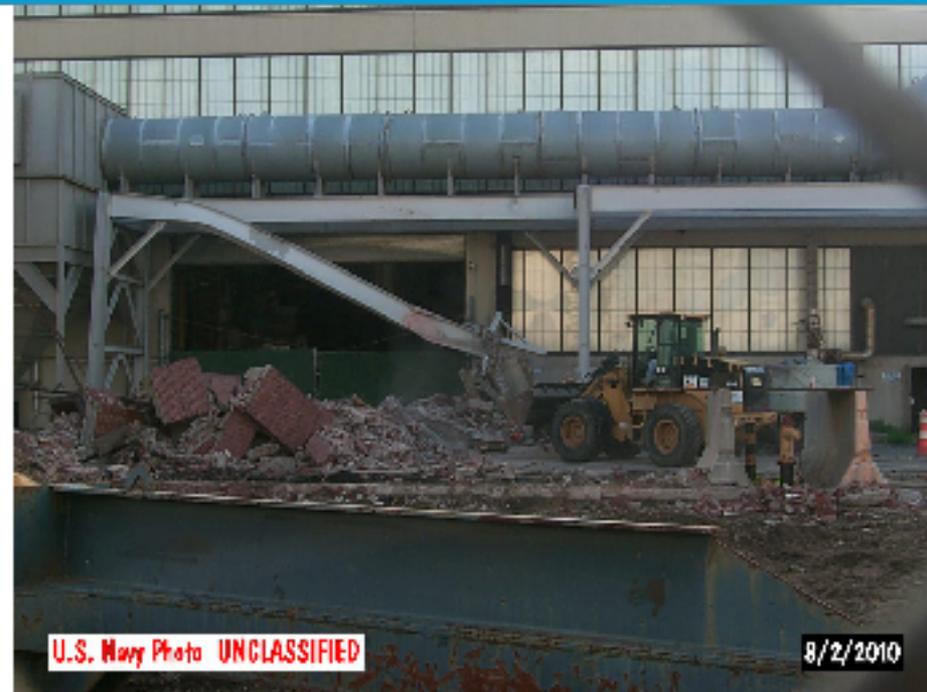
Property Damage Falling Brick Tower

A contractor was removing a 62ft. high brick tower of an old fire house. With the fire house portion of the demo complete, the contractor intended to demo the brick tower by removing several top sections by hand, then using a grappler to complete the demo. This changed when the contractor found the top section (Roof) was made of concrete. The contractor attempted to pull the top concrete section down with wire rope attached to an excavator when the base of the tower collapsed. The brick tower fell east striking and damaging a beam of another facility.

Failure to use proper equipment and approach for demolition.

- AHA did not detail the hazards.
- No FEAD notification before starting critical activity
- No EM-385-1-1 required Engineering and Demolition Plan signed by a Registered Professional Engineer
- No ORM adjustment made when conditions changed

- Ensure an Engineering and Demolition Plan is provided by a Registered Professional Engineer.
- AHA must be site specific for each definable feature of work, and all control measures must be followed.
- Ensure diligence in all three phases of QA / QC
