Naval Facilities Engineering Command, Atlantic

Safety Lessons Learned Accident Abstract

Accident Type: Load dropped while lifting
Injury: Not applicable near miss
Damage: Windshield and dash of a Cat IT28G Loader
Type of Work: Trenching for the installation of direct buried underground steam and condensate lines
Equipment: Catapillar IT28G Loader with fork attachment

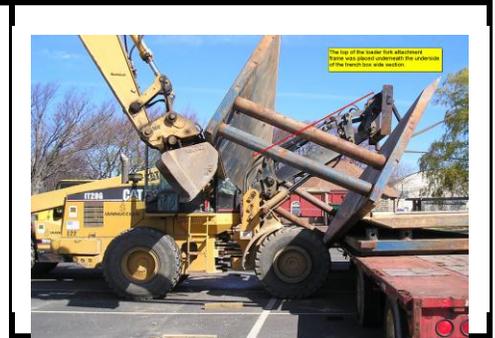
The excavating subcontractor in the demobilization phase of the project was lifting a large trench shield, 24'L x 8'H x 8'W, off of a flatbed truck with a Loader having a fork attachment when the trench shield hit a section of an already disassembled trench shield laying on the flatbed truck causing the trench shield to become unbalanced and slip off the top bracket of the fork attachment. At this time the trench shield came crashing down onto the front of the cab of the Loader shattering its windshield and dash. Due to the operator leaning forward enabling him to view the top of the load he was estimated to have been about six inches away from becoming seriously injured or possibly killed when the trench shield fell against the cab. This trench shield was one of the larger ones on site weighing 12,000 pounds.

- The Activity Hazard Analysis could have gone into more detail for every step of the trench shield disassembly procedure.
- A good communication chain of command has to be in place and followed.
- Employees are to confer with their supervisor if they feel they are about to use a piece of machinery as it is not intended.
- When a procedure is to be change by an employee they must get approval from their immediate supervisor.
- Anyone on the site can bring a safety concern to their immediate supervisor for review.
