# **CONTRACTOR FALL**

**Failure to Use Debris Chute**

**NAVFACHQ Abstract 98-1**

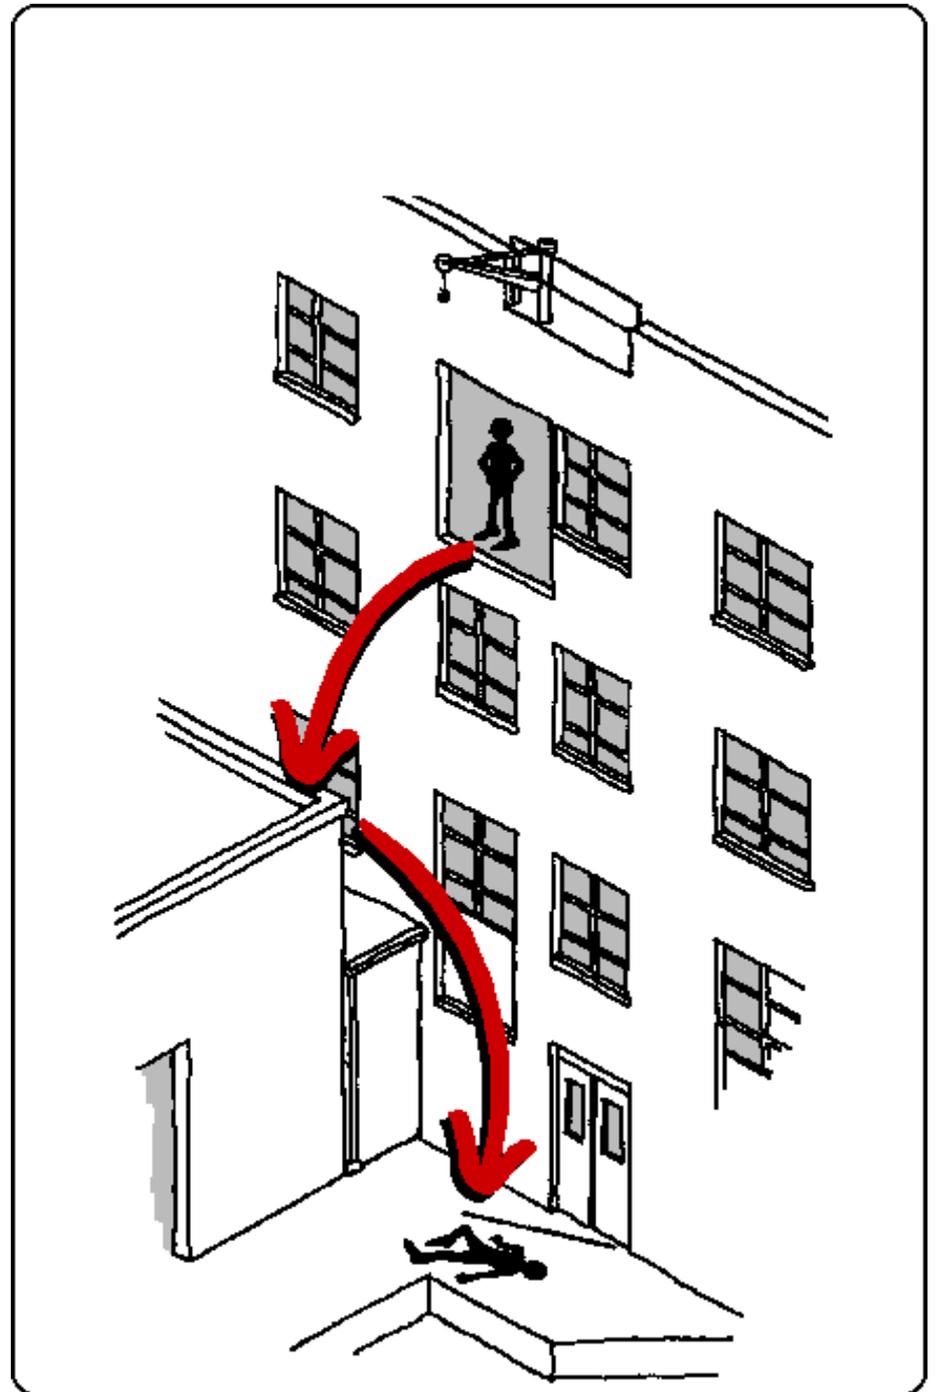
4th floor bldg, fell 30 feet

Electrical sub contractor fell  
out of unguarded wall  
opening

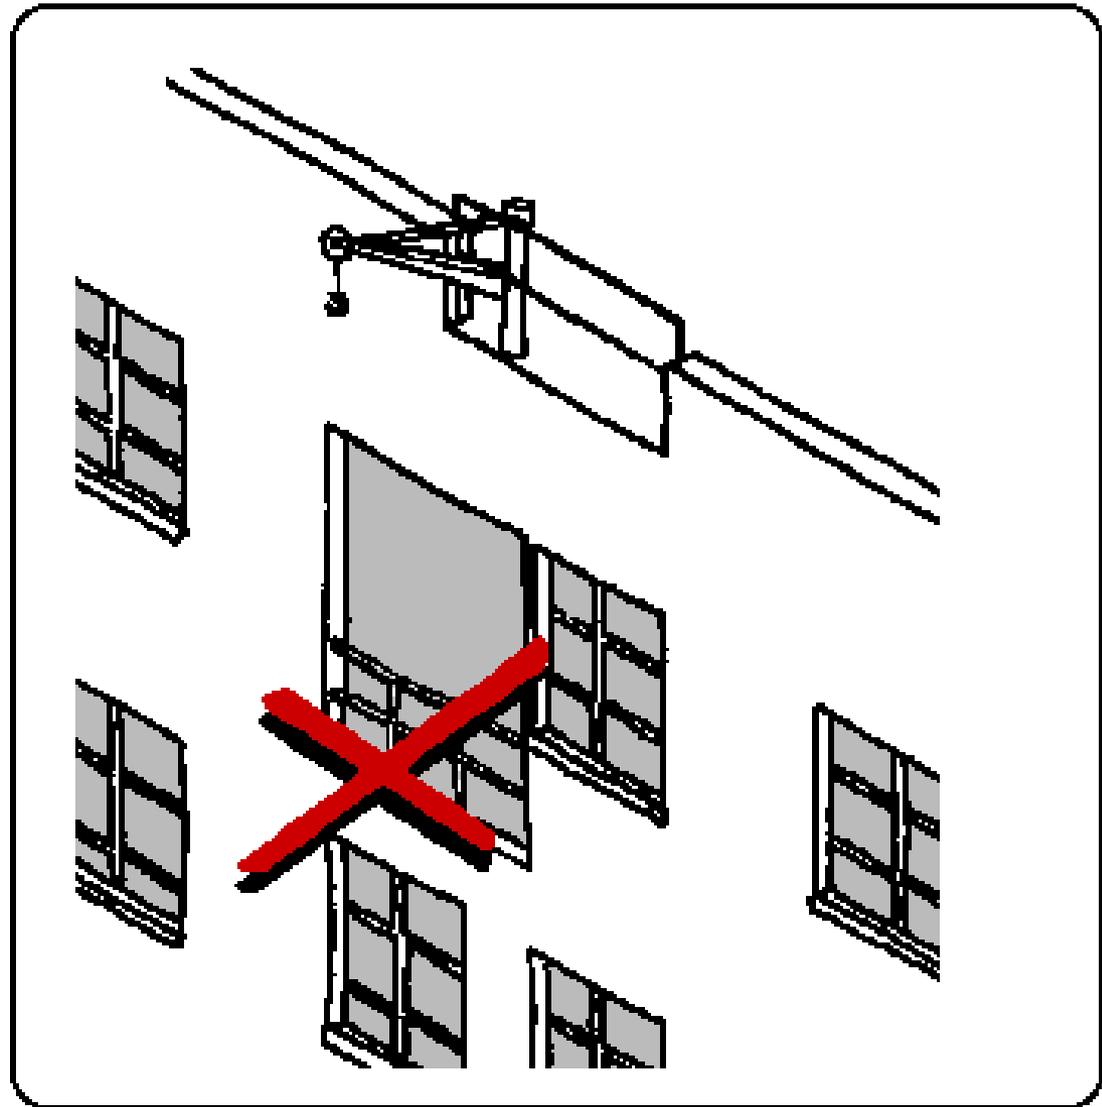
1. Guard rail removed by contractor.

Use existing building guardrail system

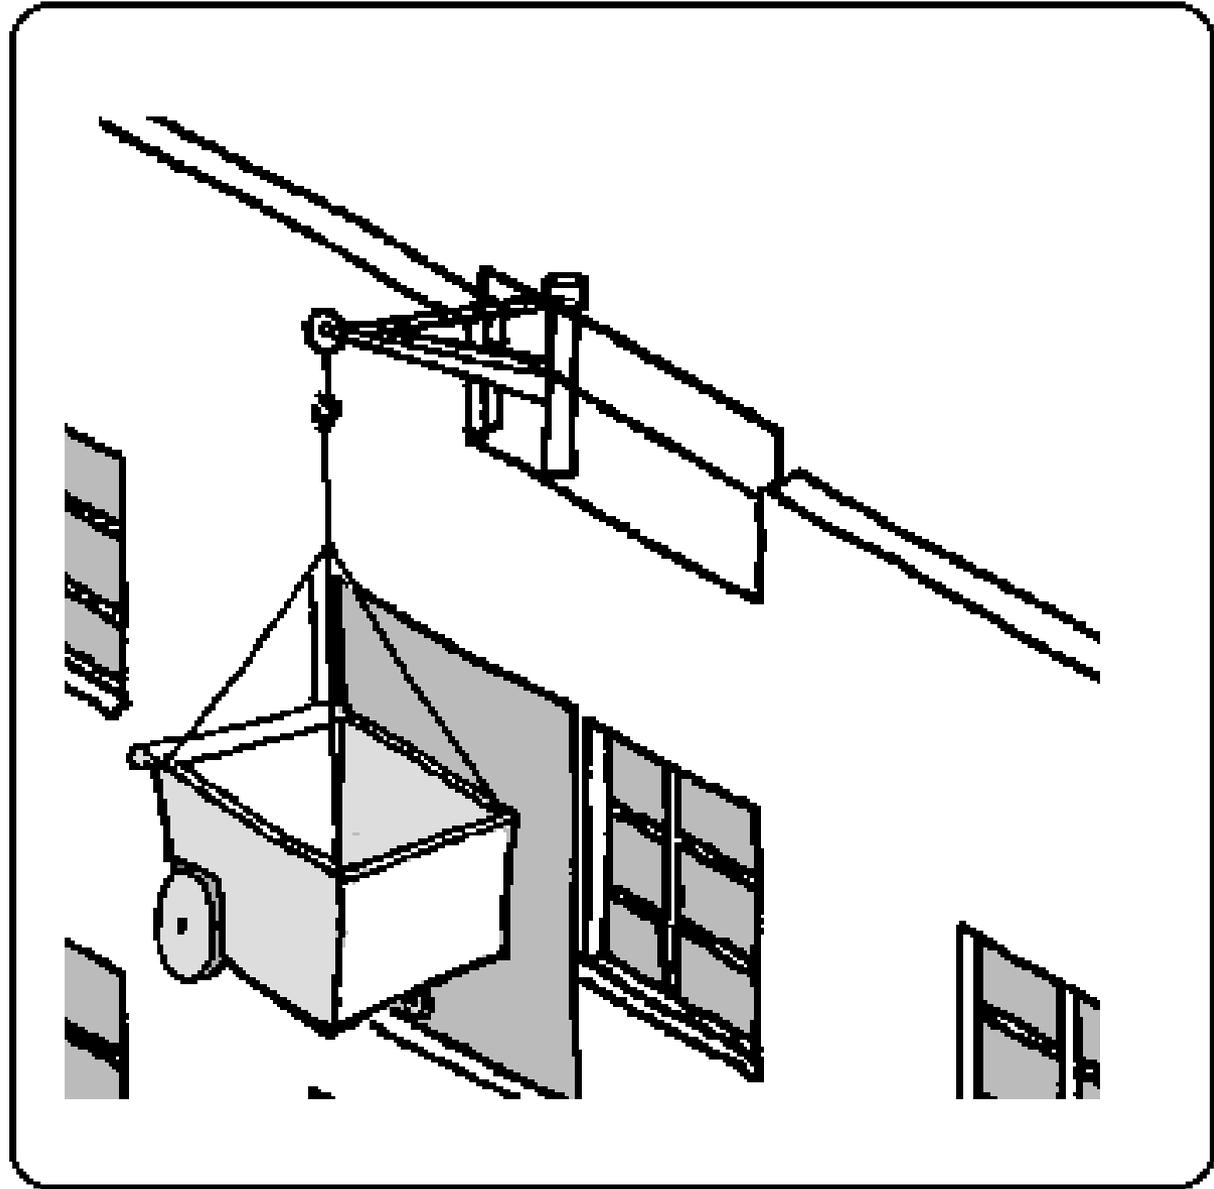
2. Tilt cart used instead of debris chute.

Contractor rigged winch to out-of-service pillar crane with wrong hoist.

Use debris chutes IAW Spec & Accident Prevention Plan

Ensure hoisting systems designed by an engineer.

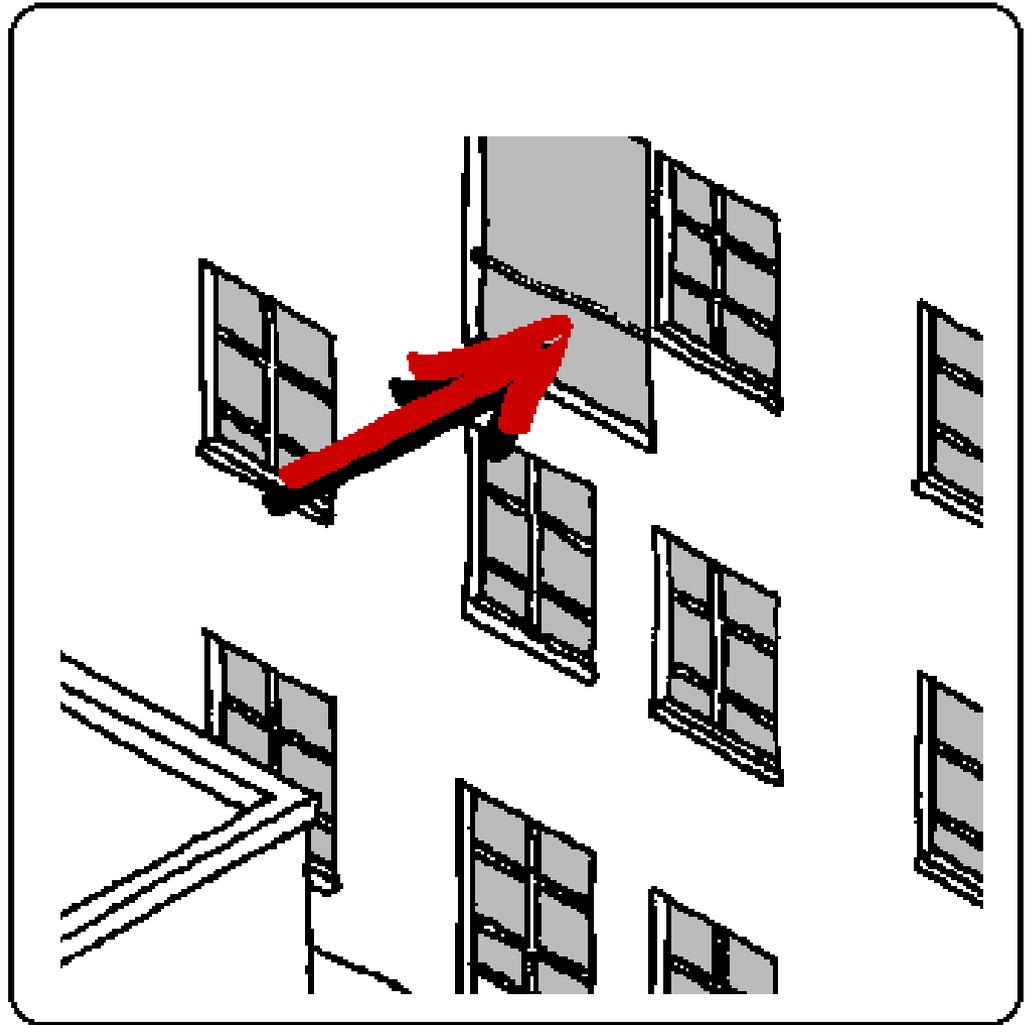
3. Copper pipe with crimped ends improperly substituted as a “guardrail”

-- Guardrail system was not used when hoisting operations were not taking place. Removable 'pipe' was used as guardrail system.(1926.502 b 10)

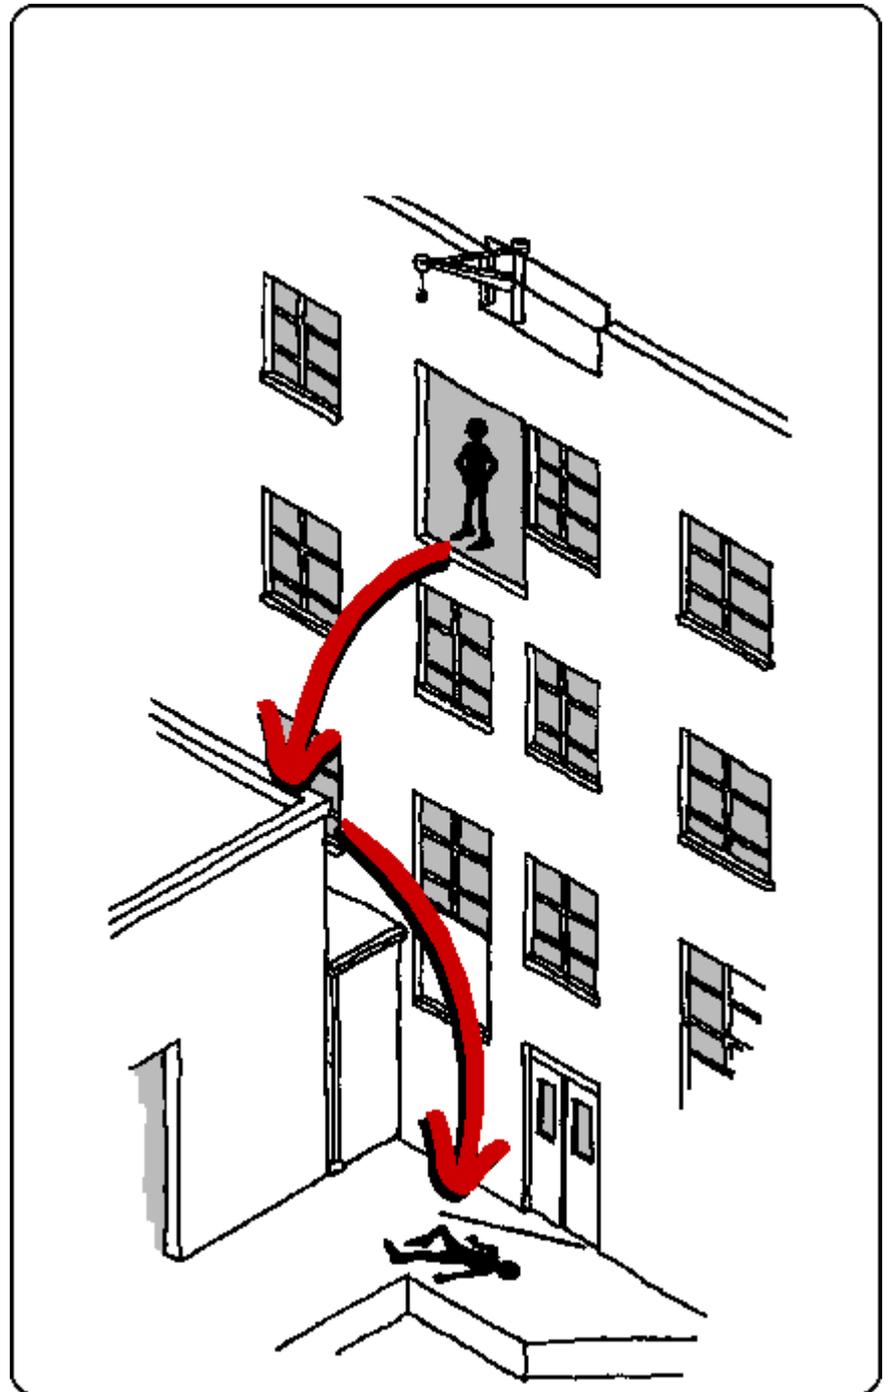
4. Worker leaned against copper pipe, which gave way, and he fell through the 4th floor opening to the loading dock below. (sketch shows pipe at bottom with victim)

Worker died from fractured C-1 vertebra.

Elapsed fall time:  
about 1.5 sec.

Use passive fall arrest system whenever fall hazard exists - as secondary system.
