Naval Facilities Engineering Command, Mid-Atlantic
Safety Lessons Learned Accident Abstract

Accident Type: Equipment Rollover
Injury: Operator Broken Leg
Damage: Equipment damaged
Type of Work: Compacting Spoils Pile
Equipment: Roller Compactor

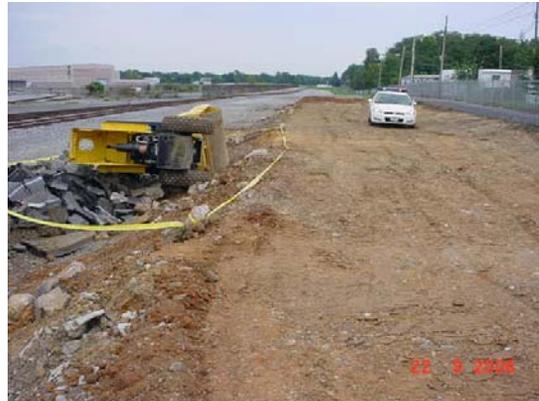
- ◆ Contractor Equipment Operator was compacting a spoils pile with a roller compactor. While backing, the operator maneuvered too close to a 4 foot embankment. The equipment began to slide down the embankment and as the weight shifted the equipment rolled over on its side. As the equipment rolled, the operator jumped from the roller. The jump resulted in the operator breaking his leg.
- ◆ The work activity was a field change. The change involved taking spoils from duct bank excavation to improve another area on the installation. No AHA was completed for this new work.

- Failure to mitigate rollover hazard associated with operating machinery on non-level surfaces.

- ◆ Failure to ensure EM-385-1-1 safety requirements were met
 - Failure to complete a AHA for field change that created a new job activity
 - No preparatory meeting held for this activity.
- ◆ Failure to implement proper controls to mitigate rollover hazard
- ◆ Operator failed to follow manufacturer equipment operating instructions

- ◆ Ineffective control of contractor site safety and implementation of EM-385-1-1 safety procedures.

- ◆ APPs and AHAs need to be reviewed for changing site conditions.
- ◆ Field changes resulting in new job activities require AHA and 3-phase QC.
- ◆ Equipment operators need to follow manufacturer operating instructions
 - Operator may not have broken leg if he took advantage of equipment safety features.
 - ROPS and seatbelt may have prevented broken leg.
- ◆ Visual markings of the embankment such as stakes and flags could have prevented operator from maneuvering too close to the embankment.
