Final
No Action Decision Document
PI-14 and PAOC FF
Former Vieques Naval Training Range (VNTR)
Vieques, Puerto Rico

Final

**No Action Decision Document
PI-14 and PAOC FF**

**Former Vieques Naval Training Range (VNTR)
Vieques, Puerto Rico**

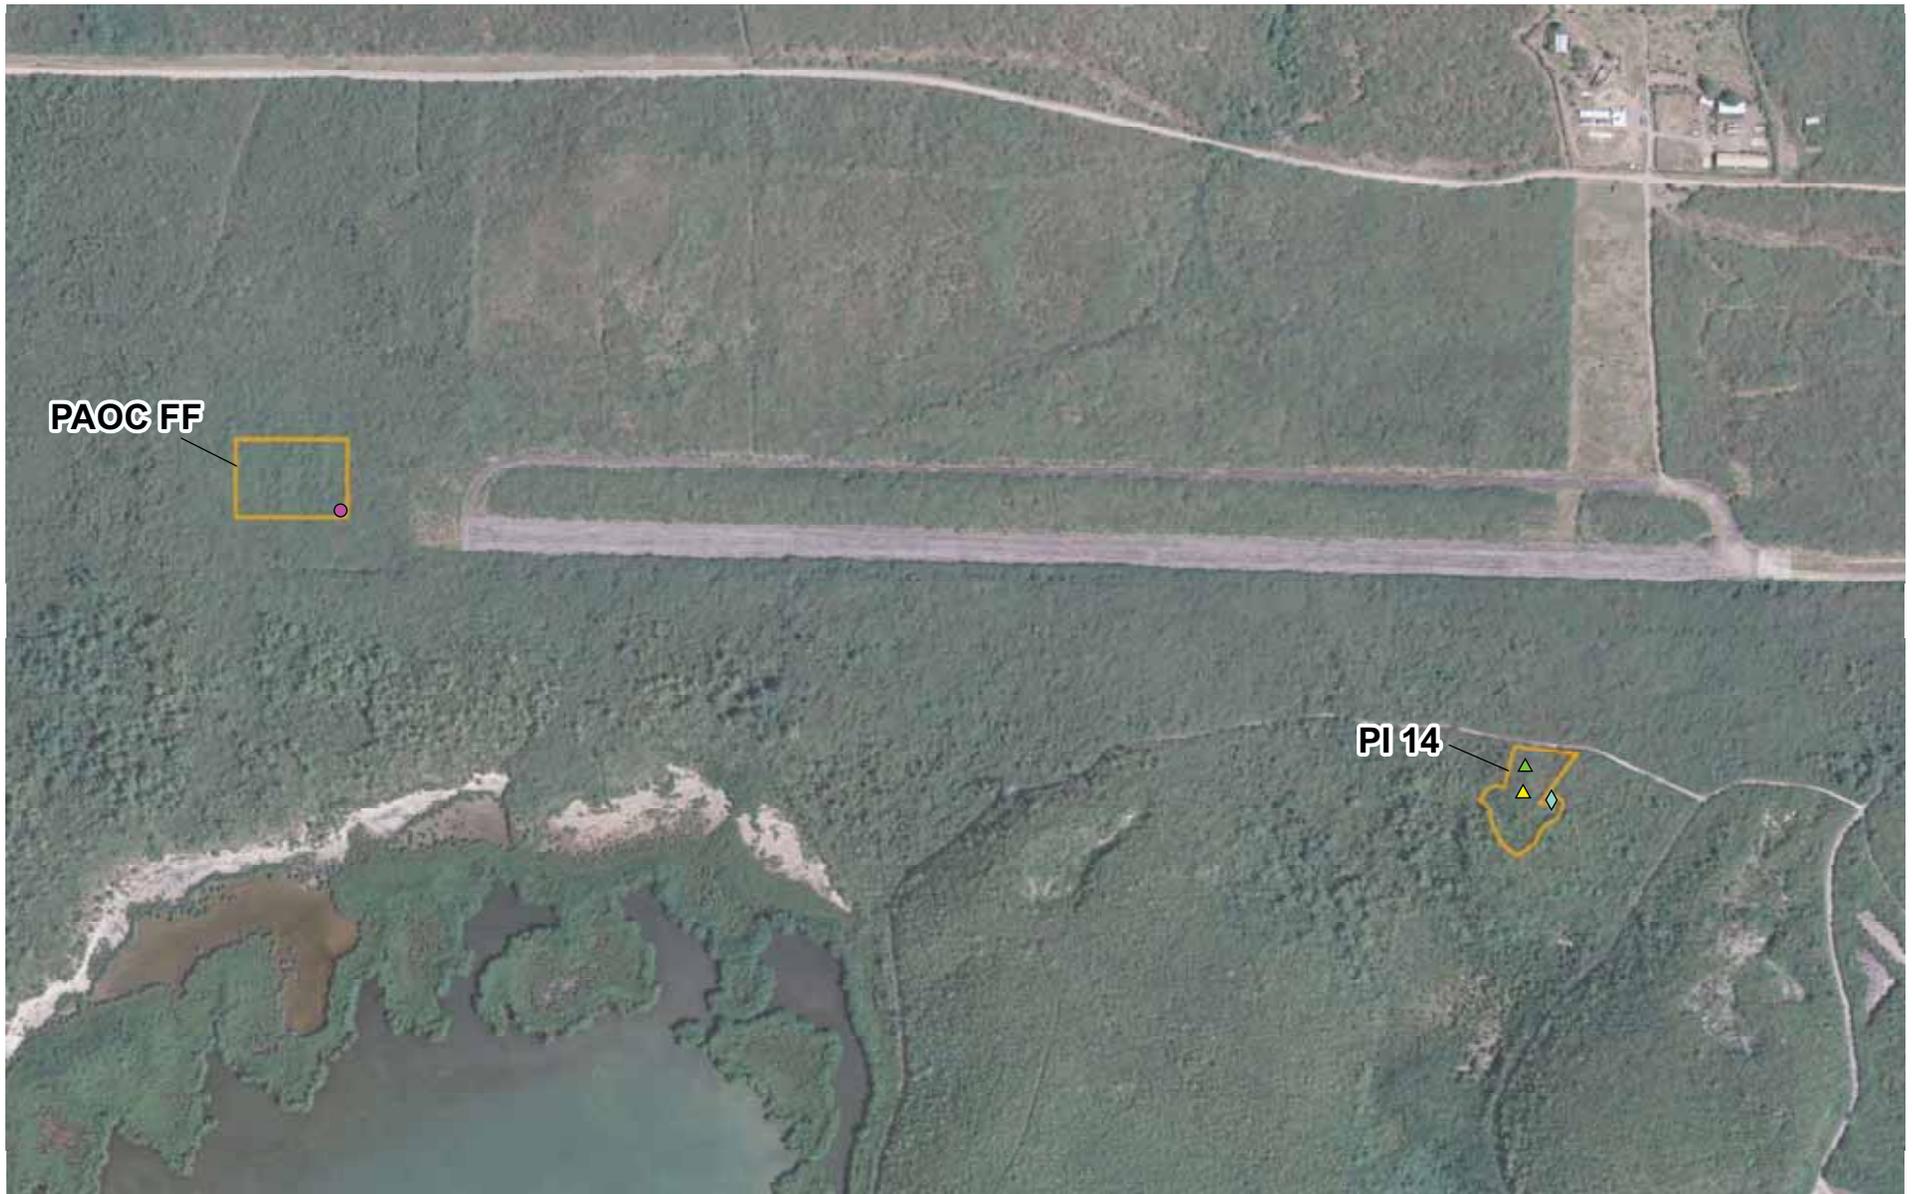
FIGURE ES-2
 PI 14 and PAOC FF
No Action Decision Document
 PI 14 and PAOC FF Sites
 Vieques, Puerto Rico

PAOC FF

PI 14

Communications wire and metal banding (removed)
-

Expended slap flares, removed, inspected, demilitarized and appropriately disposed
-

Unexpended slap flares, removed, demilitarized, and appropriately disposed
-

Fencing material
-

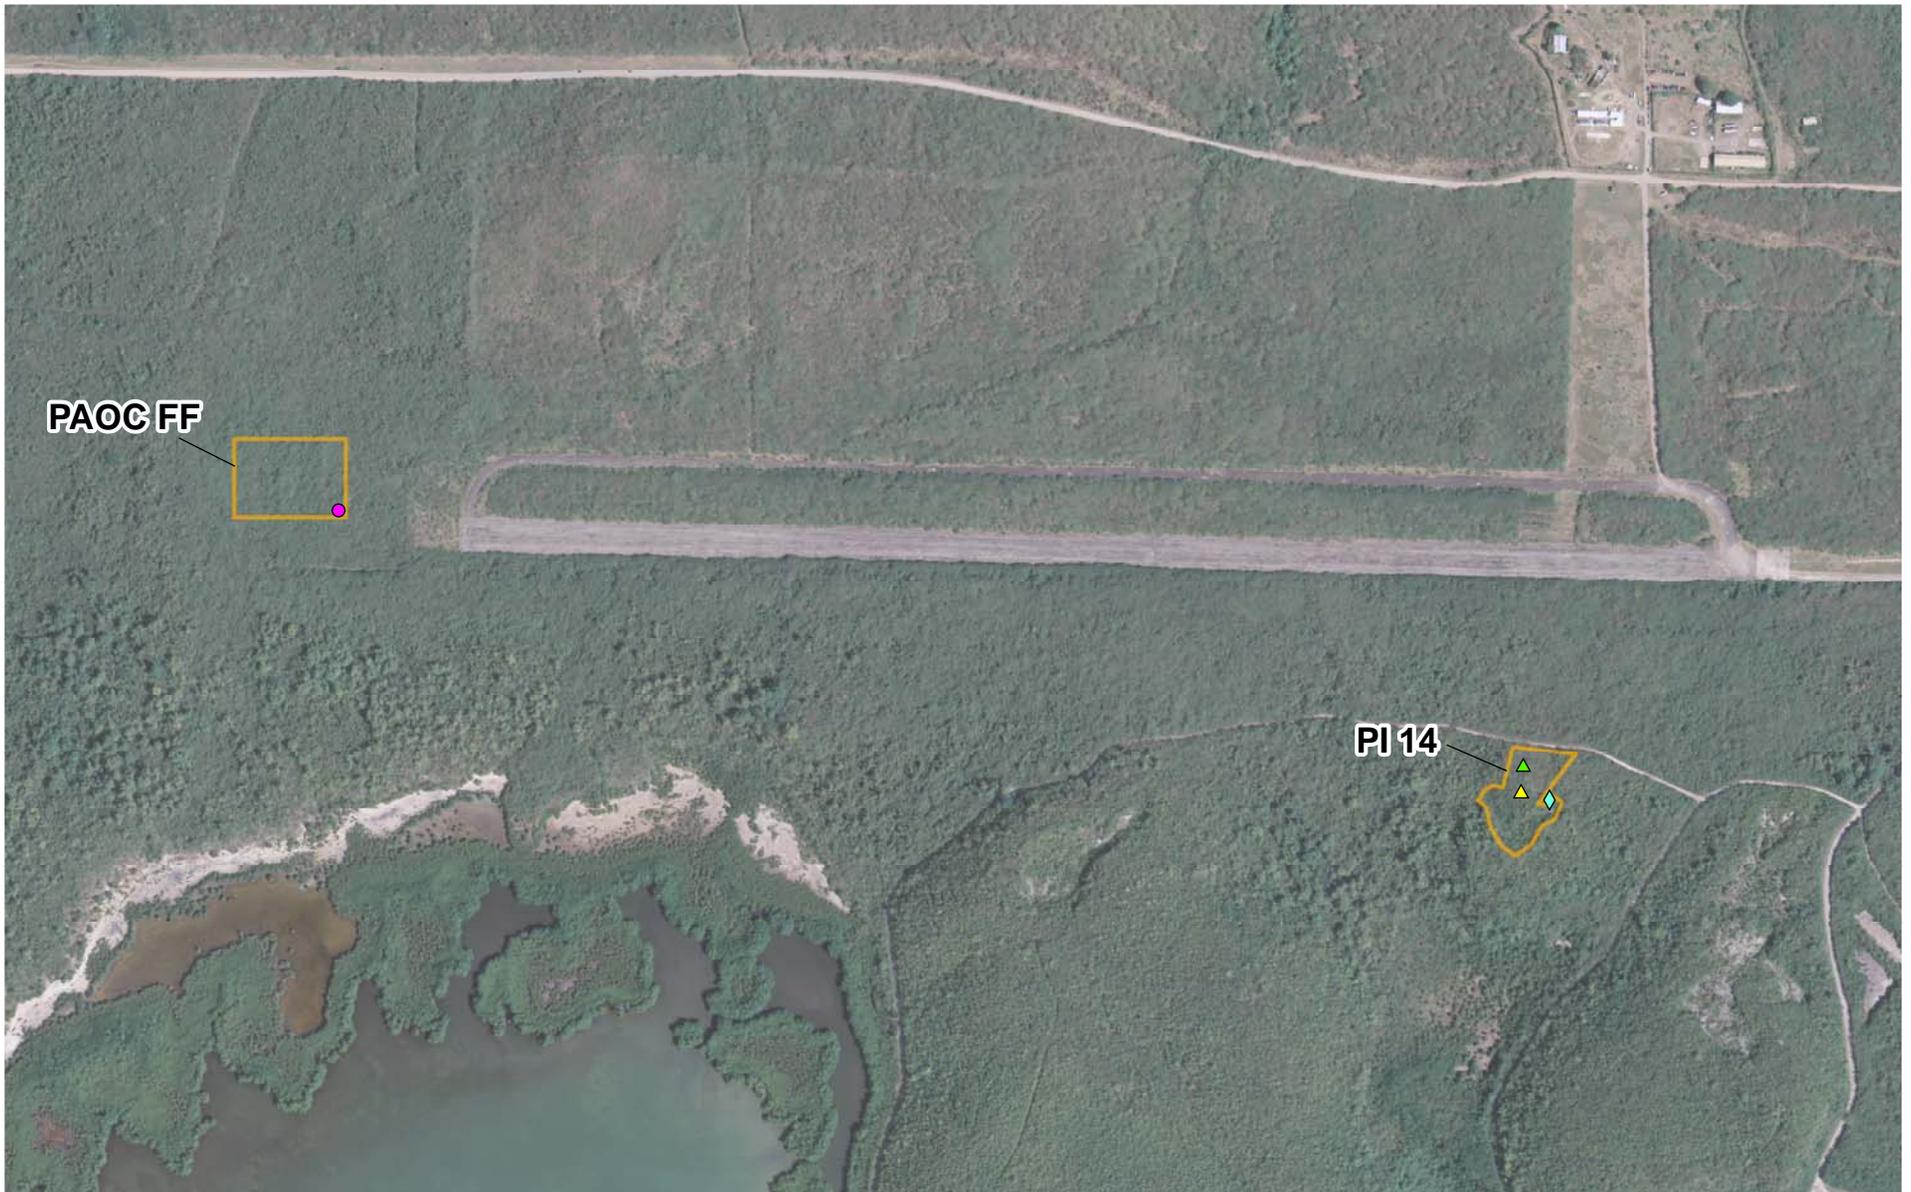
FIGURA ES-2
 PI 14 and PAOC FF
Documento de Decisión de Ninguna Acción
Sitios PI 14 y PAOC FF
Vieques, Puerto Rico

- ▲ Conexión de Comunicaciones y banda metálica (removidos)
- ▲ Vestigios de Bengala Usados, removidos, inspeccionados, desmilitarizados y dispuestos adecuadamente
- ◆ Vestigios de Bengala no Usados, removidos, inspeccionados, desmilitarizados y dispuestos adecuadamente
- Material para verjas
- Límite de PI/PAOC

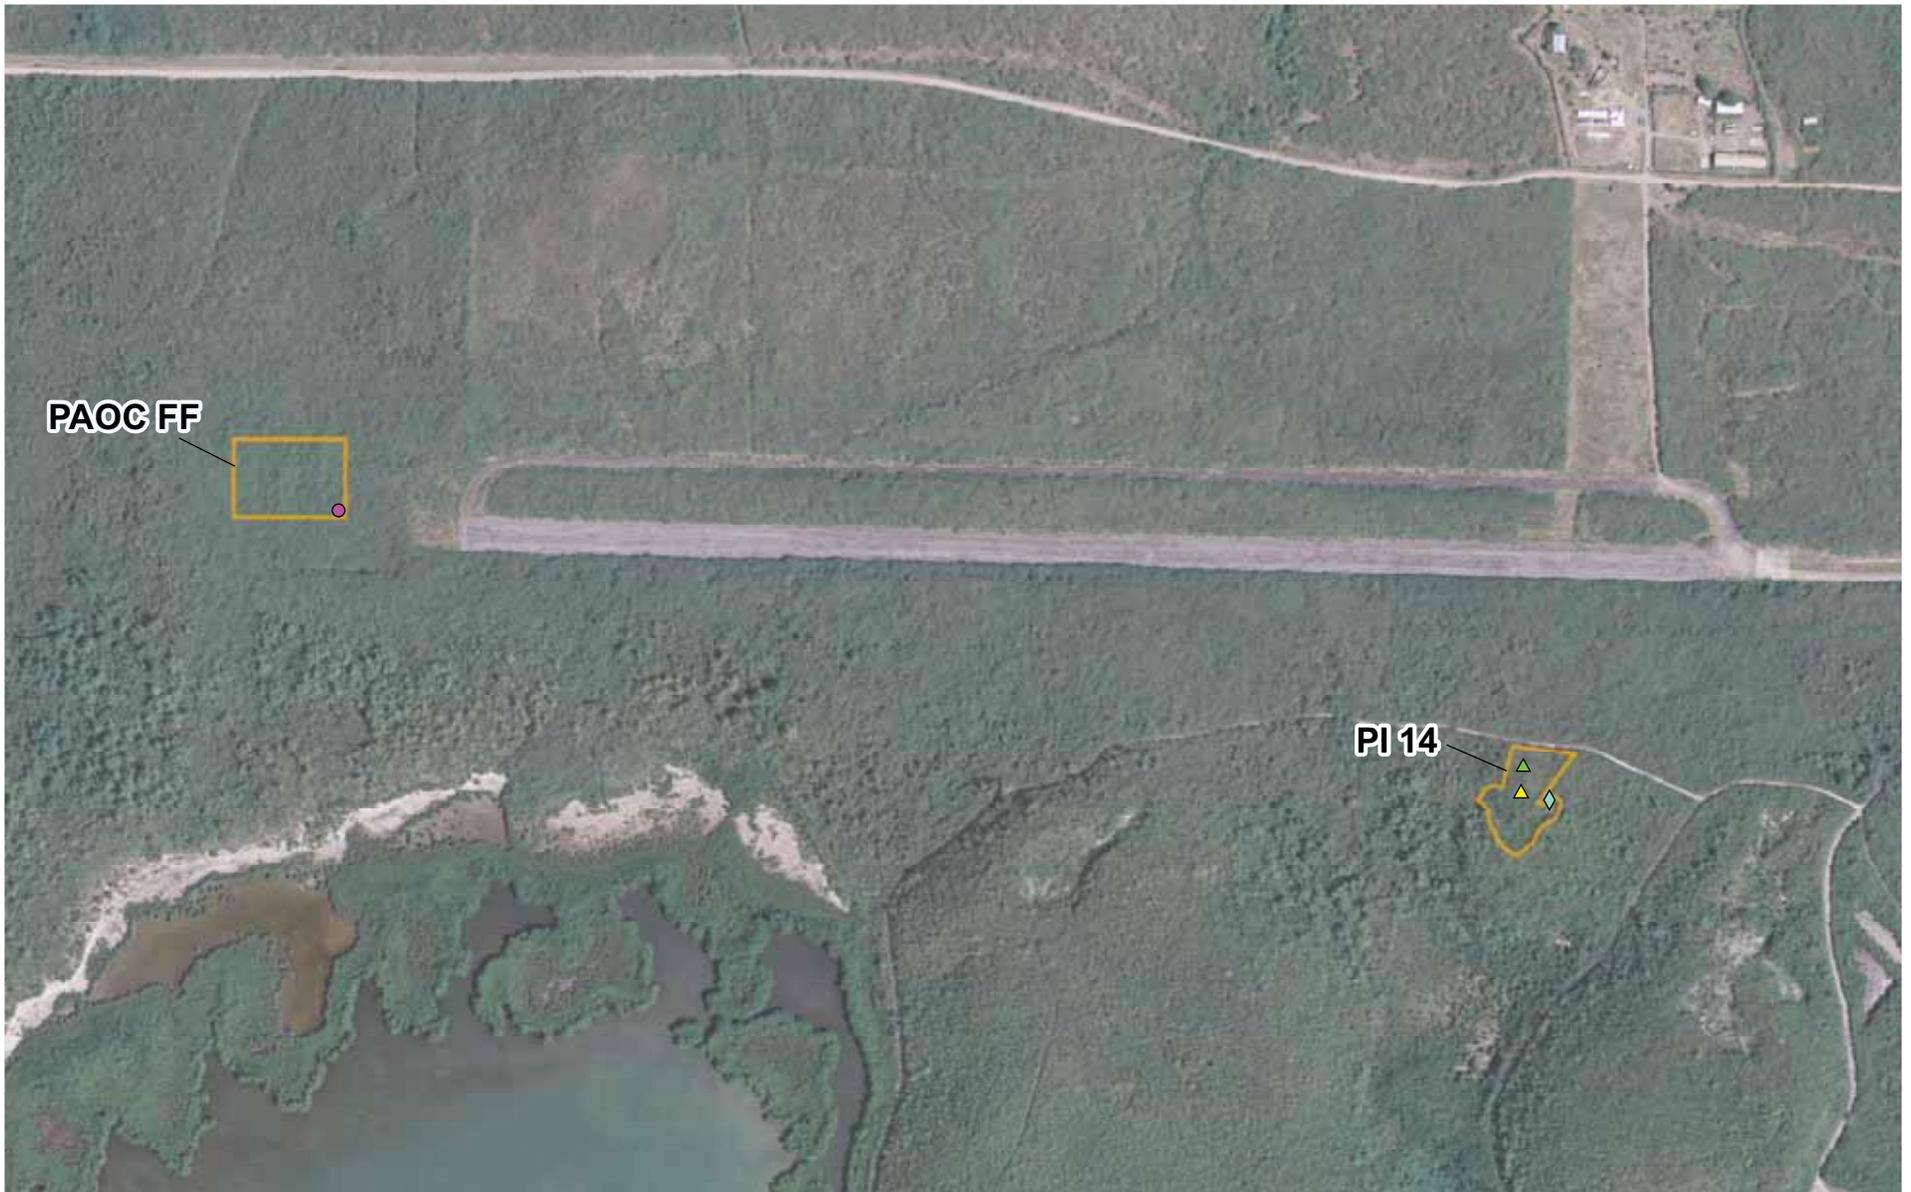
This Decision Document provides formal concurrence among the stakeholder agencies (Navy, USEPA Region 2, PREQB, and USFWS) that no action is necessary at PI 14 and PAOC FF, located within the former VNTR under the CERCLA. **Figure 1-1** shows the geographic location of Vieques, including the former VNTR, in relation to mainland Puerto Rico and the surrounding islands. The locations of PI 14 and PAOC FF are shown in **Figure 1-2**.

Communications wire and metal banding (removed)
-

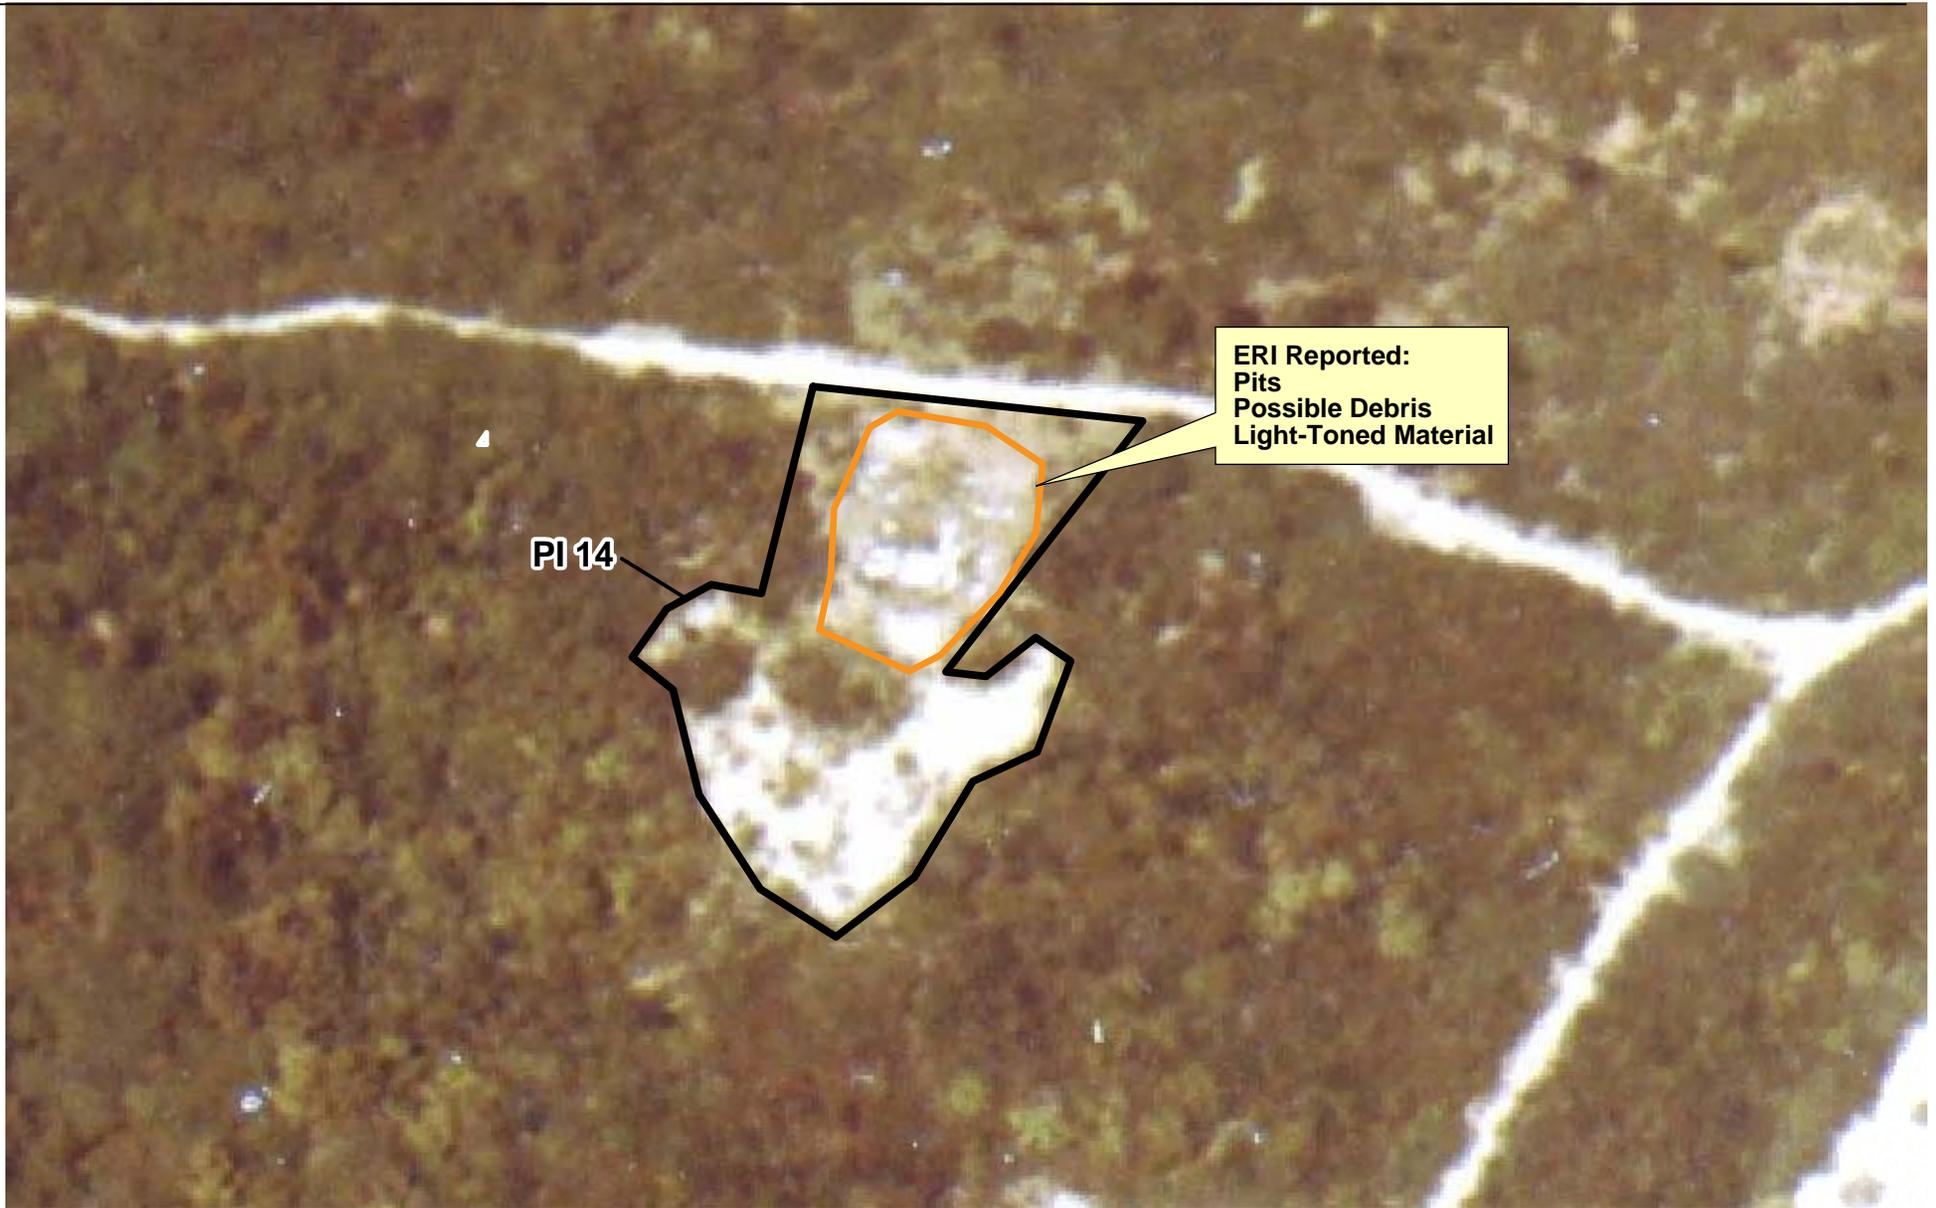
FIGURE 2-1
1970 Aerial Photograph of PI 14
No Action Decision Document
PI 14 and PAOC FF Sites
Vieques, Puerto Rico

PI 14 was identified in historical aerial photographic analysis as having two pits with light toned material and possible debris in the mid 1970s (**Figure 2-1**) (ERI, 2000). It is important to note that features identified by ERI on the aerial photographs are not necessarily accurate because ERI did not perform a site visit to substantiate the features they noted in the aerial photographs, and their photographic analysis was done many years after the aerial photographs were taken. During a visual site inspection by CH2M HILL in 2001, no evidence was found of human activities in the area and no environmental releases were observed. Interviews conducted during the VNTR EBS (NAVFACENGCOM, 2003) identified the possibility of PI 14 as being a disposal area for scrap metal, ammunition boxes, shell casings, and miscellaneous debris. Site visits conducted as part of the EBS observed a semi cleared area, with possible deposited material, but no evidence of metal debris or other waste. The EBS recommended no further action. Walking transects were conducted across PI 14 as part of the 2009 ERA/SI for visual inspection of the site (CH2M HILL 2009) (**Figure 2-2**). The survey identified slap flares, several pounds of metal banding and communications wire (**Figure 2-3**). These items have since been removed from the site. However, no evidence of buried debris was observed at the site. In fact, the site would not have been conducive for burial due to the steep grade leading off the road into area and because of the presence of rock at/near ground surface over much of the area.

ERI Reported:
Pits
Possible Debris
Light-Toned Material

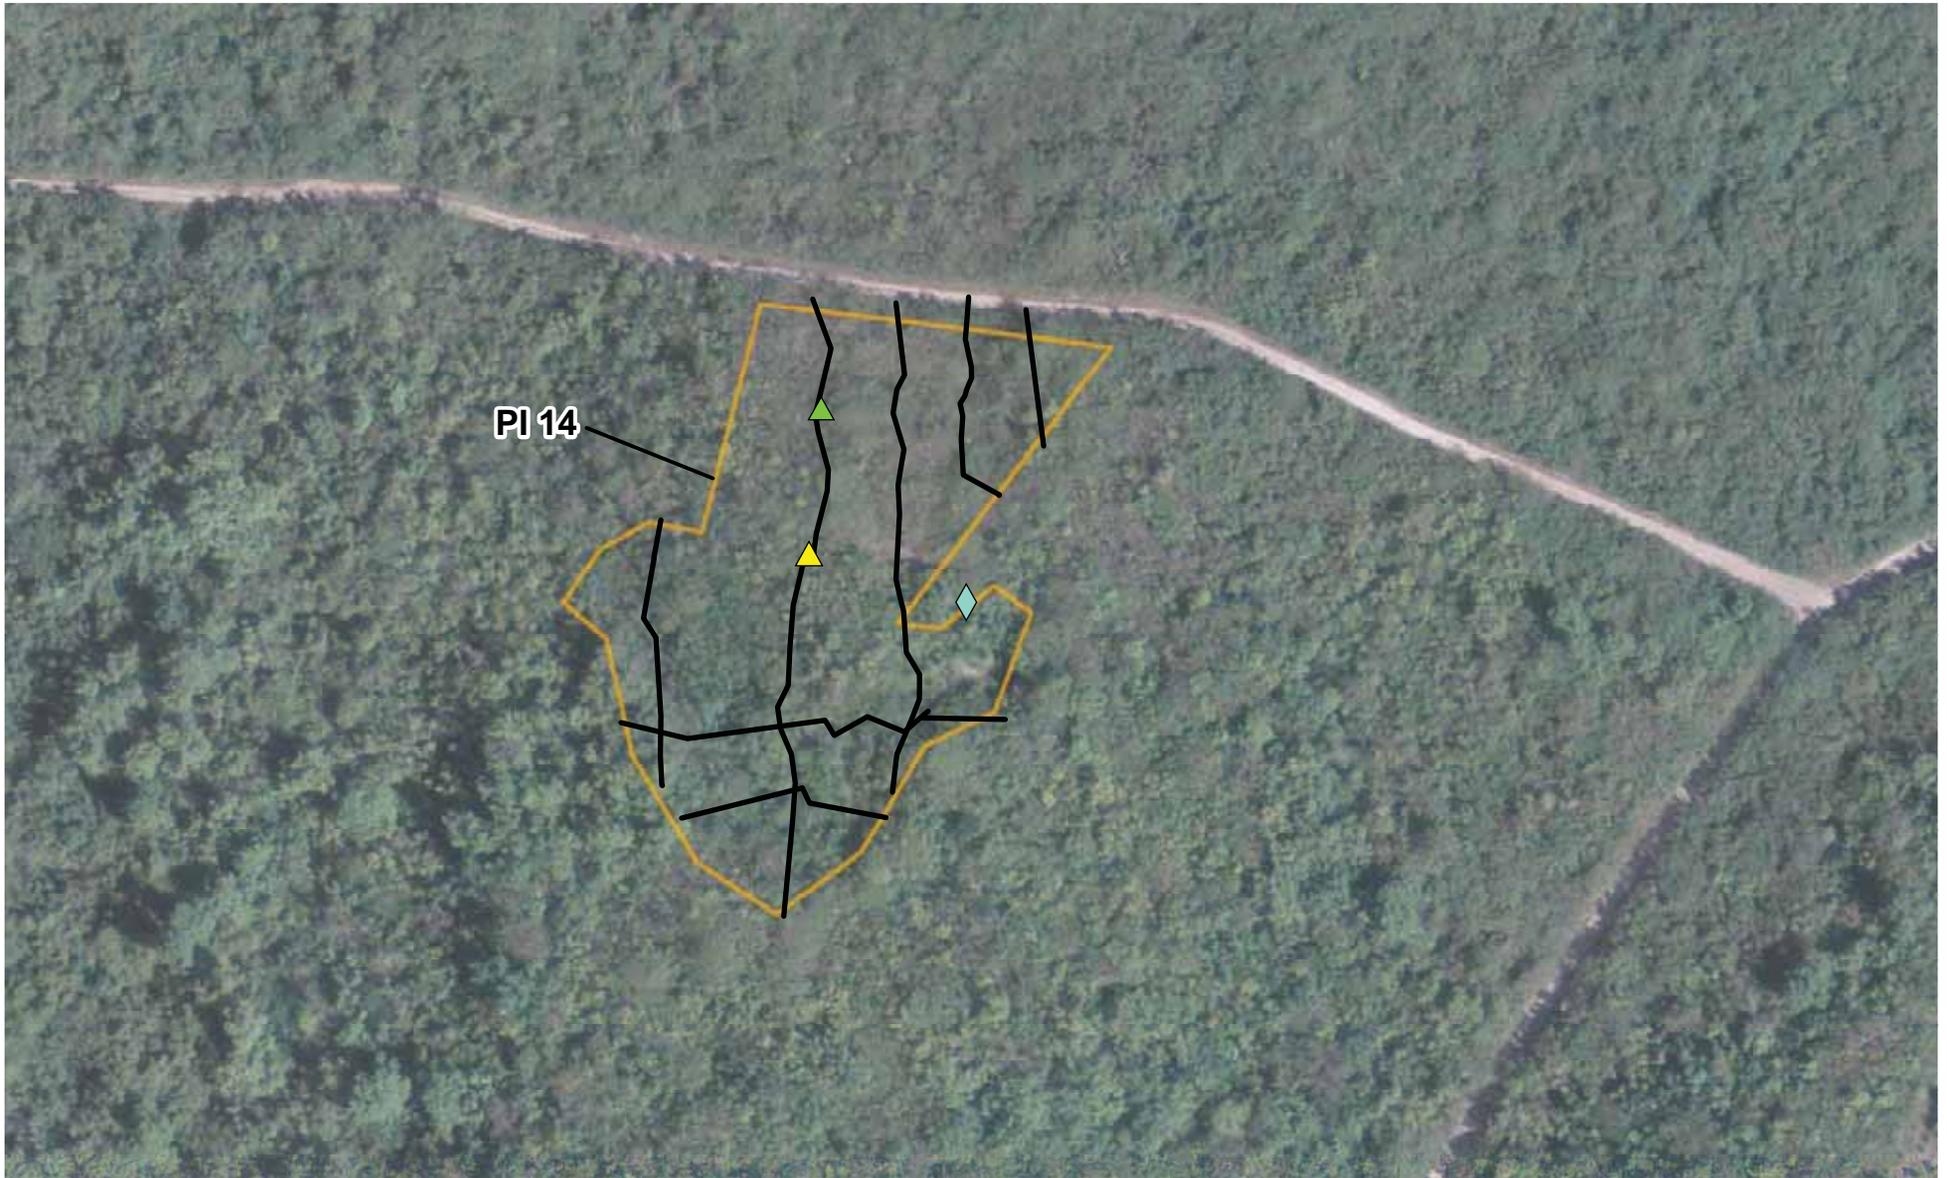
FIGURE 2-2
Location of Transects on PI 14
No Action Decision Document
PI 14 and PAOC FF Sites
Vieques, Puerto Rico

- ▲ Communications wire and metal banding (removed)
- ▲ Expended slap flares, removed, inspected, demilitarized, and appropriately disposed
- ◆ Unexpended slap flares, removed, demilitarized, and appropriately disposed

As noted previously, there is no evidence that the site was used for debris disposal and no evidence of a CERCLA-related release was observed at the site. In fact, the site's topography relative to access roads would not make it conducive for general disposal. Only a few innocuous items (several slap flares, several pounds of metal banding, and several spools of communications wire) indicative of incidental or accidental discarding were observed. These items have since been removed as part of general housekeeping at the site. Based on this information, no action is warranted for PI 14.

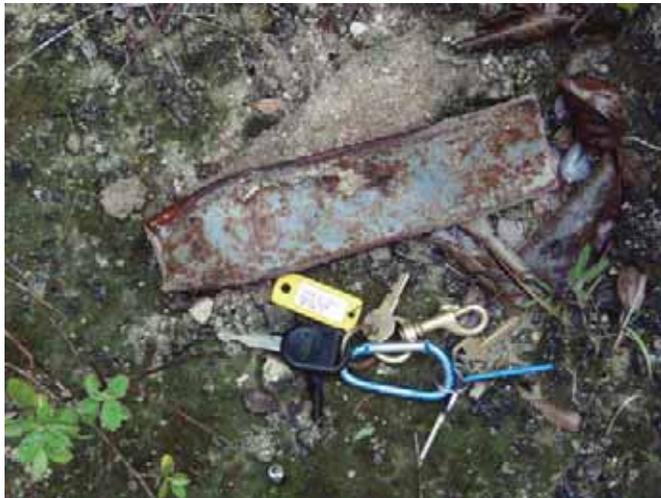
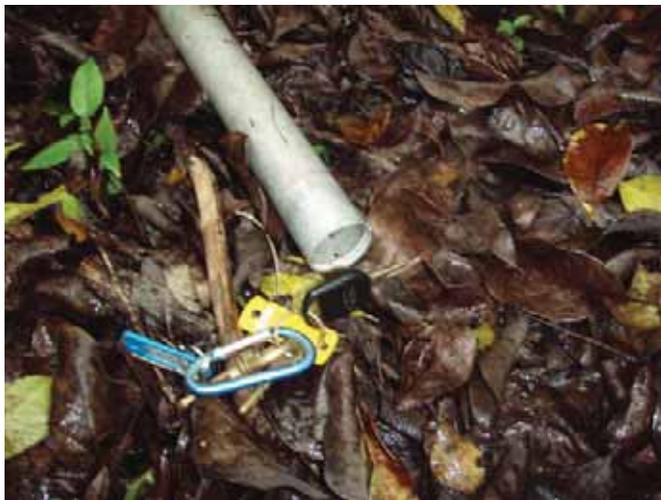
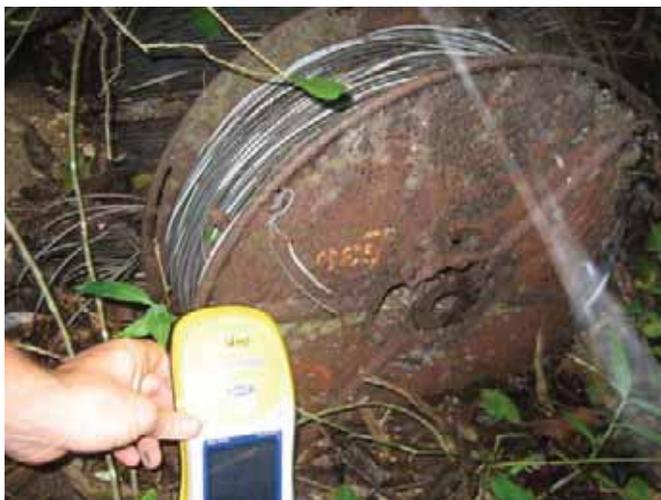
FIGURE 2-3
PI 14 Slap Flares and Communications Wire
No Action Decision Document
PI 14 and PAOC FF Sites
Vieques, Puerto Rico

Expended slap flare

Communications wire

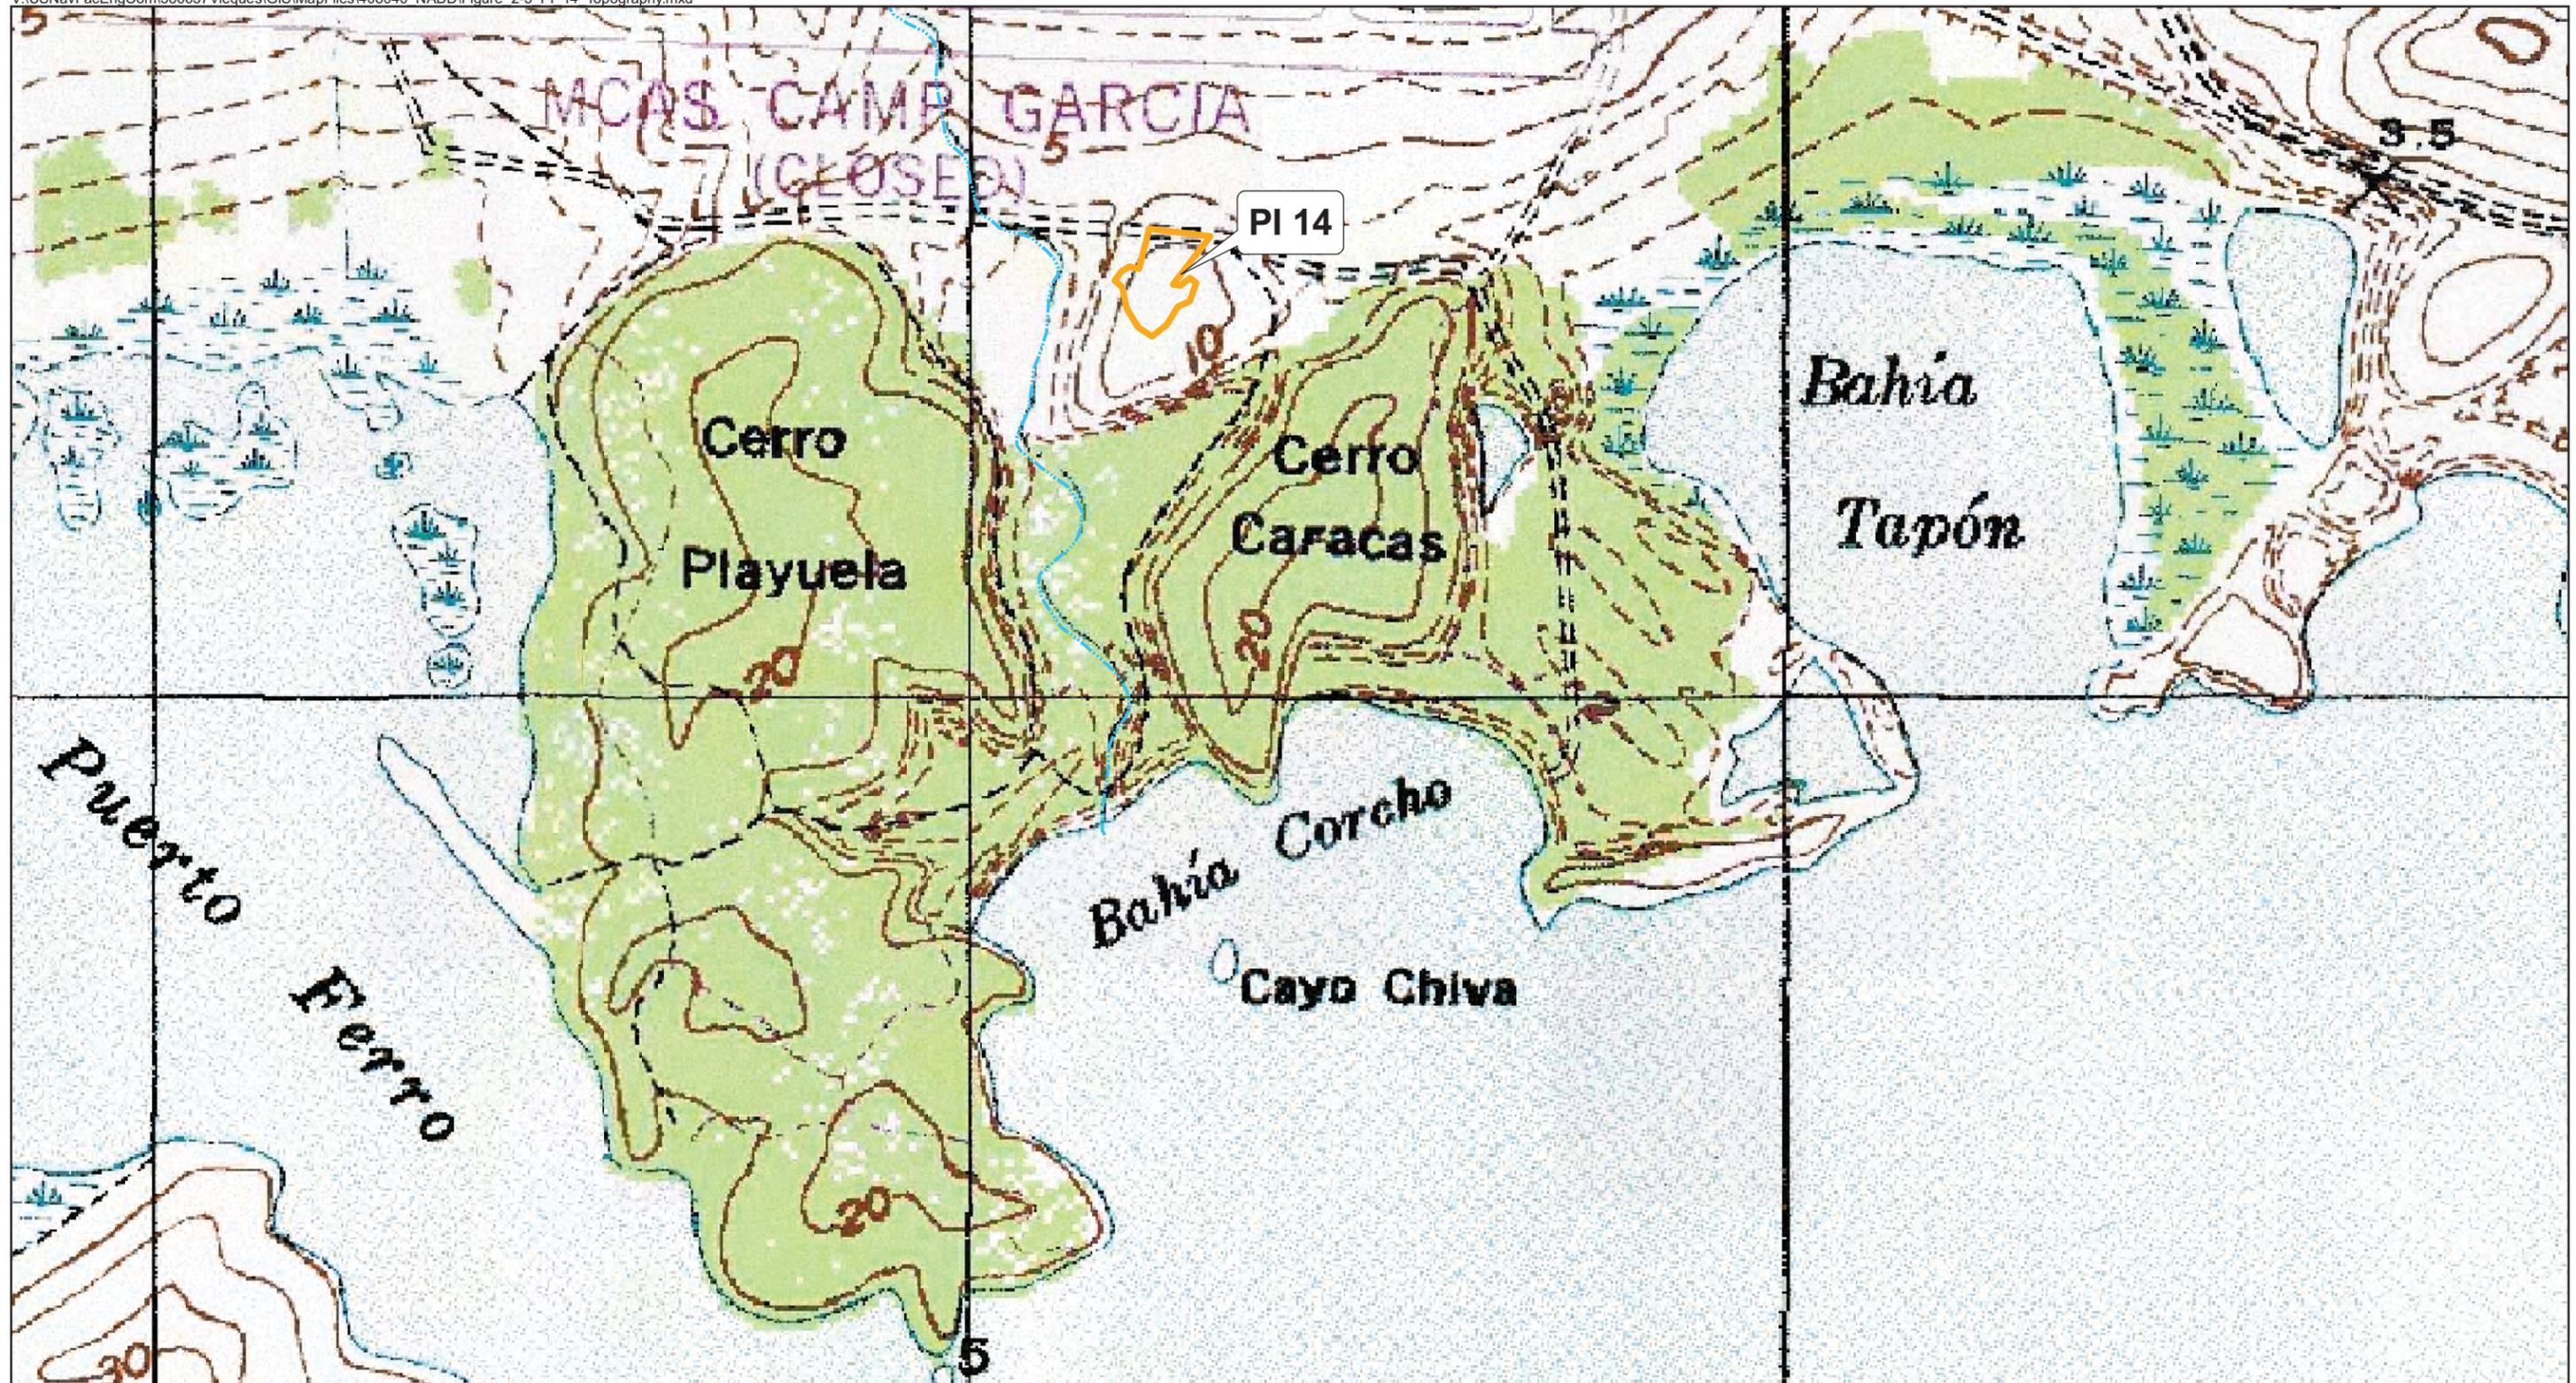
FIGURE 2-4
PI 14 Topography
No Action Decision Document
PI 14 and PAOC FF Sites
Vieques, Puerto Rico

PI 14 lies just north of Bahía Corcho (Cork bay) on a small hill between Cerro Playuela (Beach hill) to the west and Cerro Caracas (Caracas hill) to the east (**Figure 2-4**), with a maximum elevation of approximately 33 ft (foot/feet) above mean sea level (amsl). The land containing PI 14 is heavily vegetated and slopes upward to the south from the access road on the north side of the site. The hill crests in the center of the site where the site widens out, and then drops moderately steeply to Bahía Corcho. The topography also drops east and west of the site then raises into the aforementioned hills.

Note:
Elevation in meters above mean sea level
Contour interval is 10 meters where solid, 1 meter where dashed
