Final
No Action Decision Document
PI-14 and PAOC FF
Former Vieques Naval Training Range (VNTR)
Vieques, Puerto Rico

Final

**No Action Decision Document
PI-14 and PAOC FF**

**Former Vieques Naval Training Range (VNTR)
Vieques, Puerto Rico**

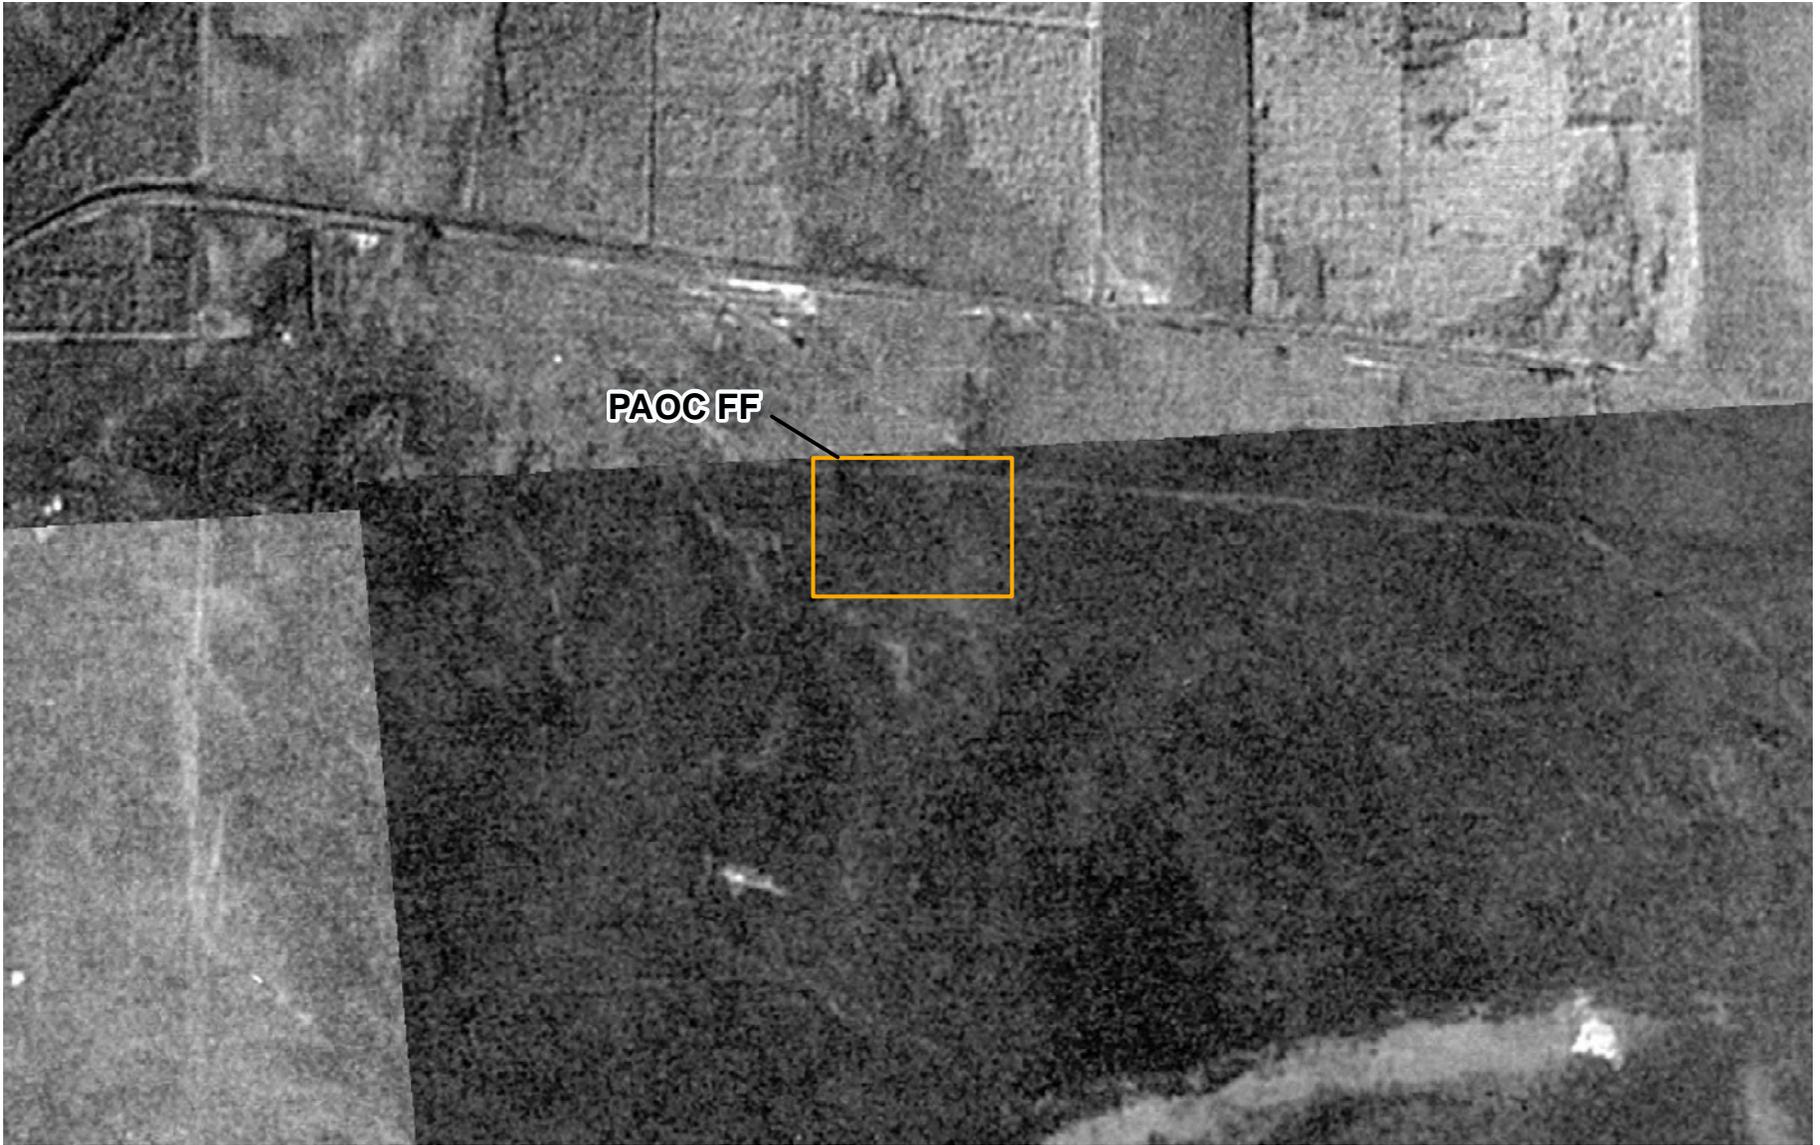
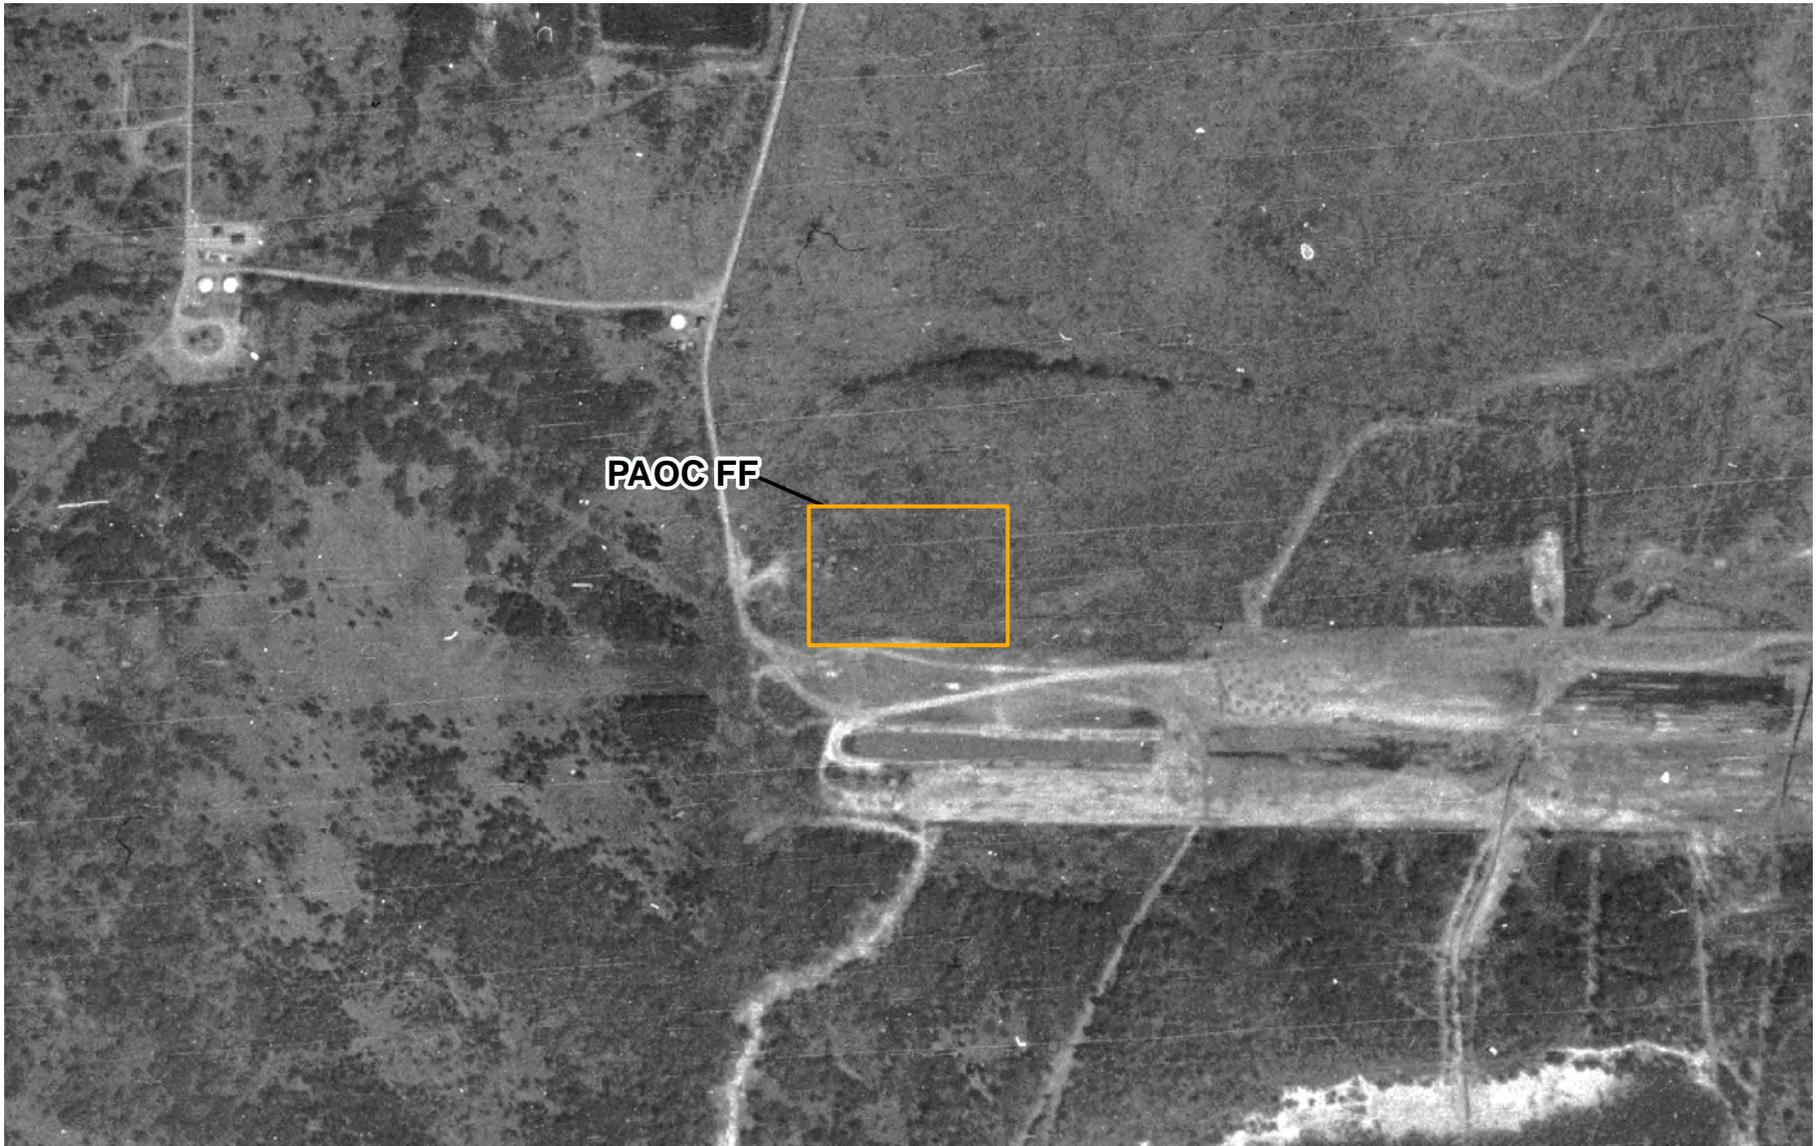
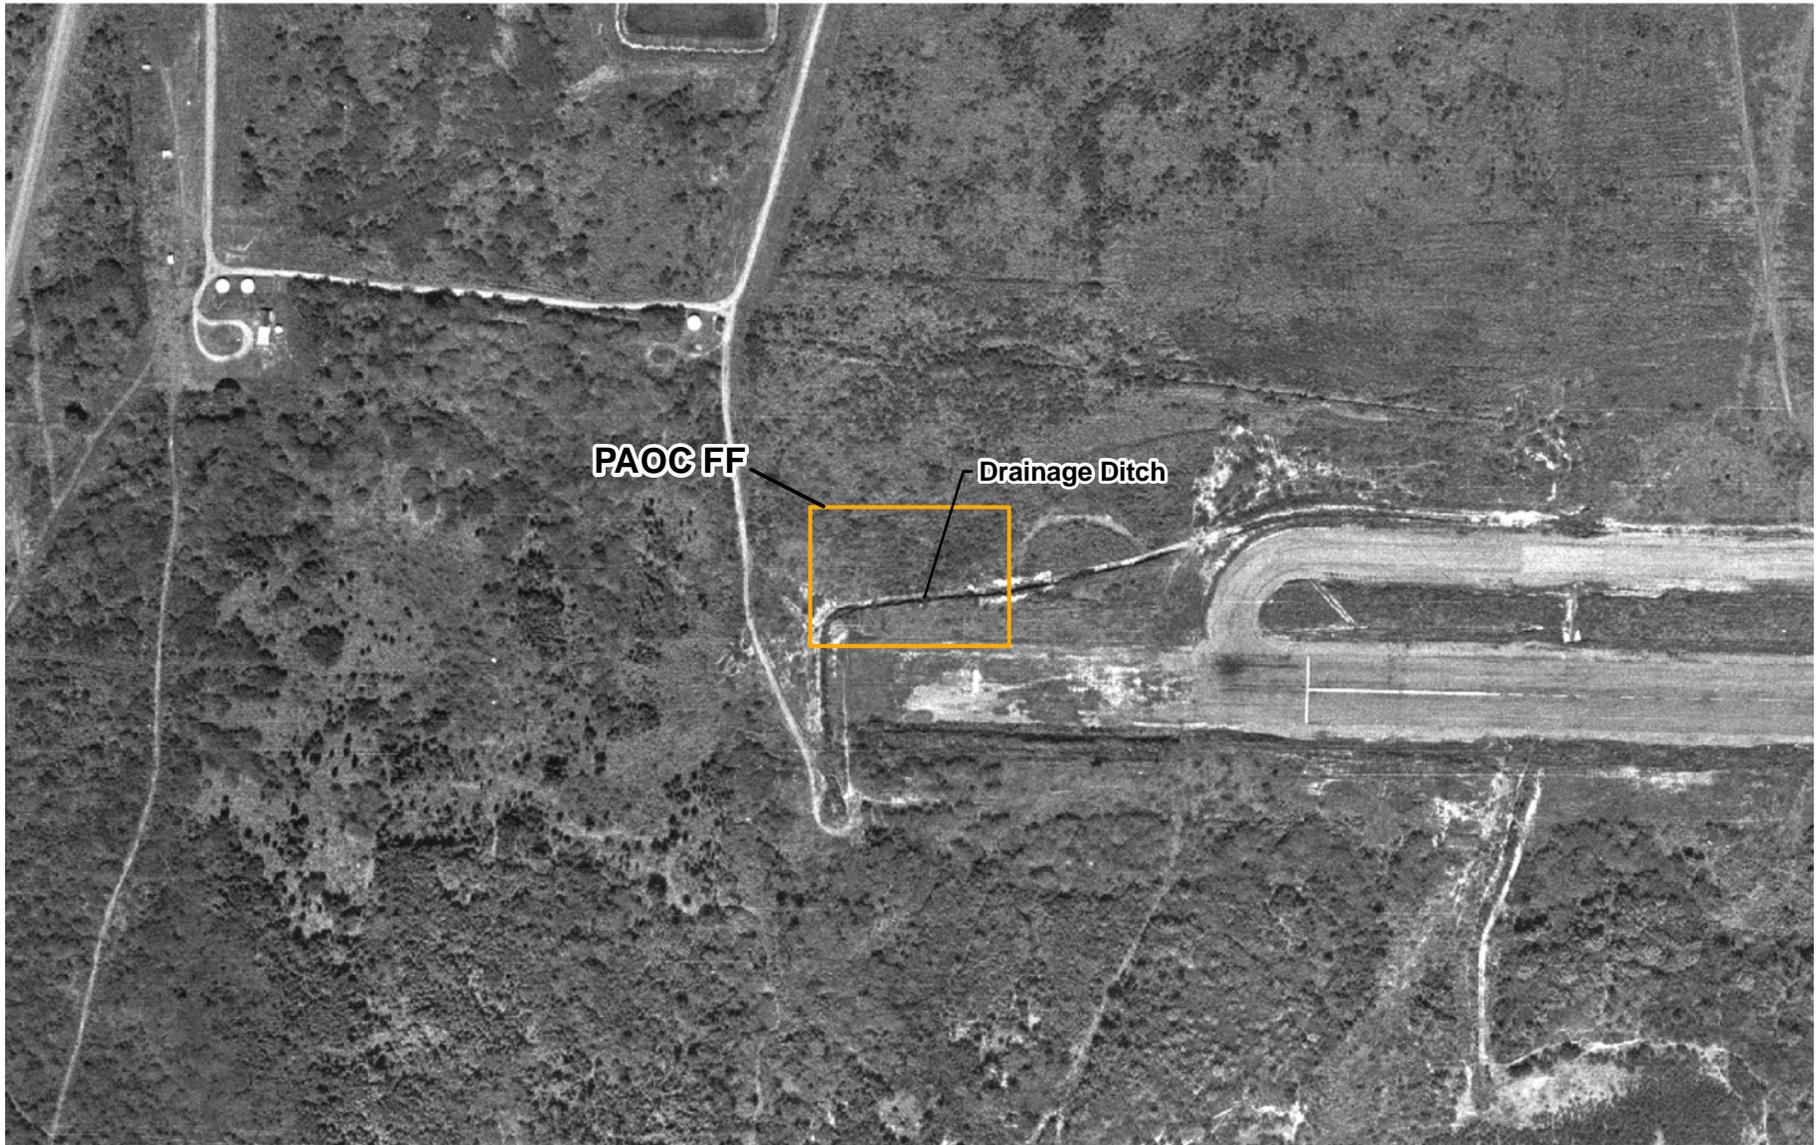
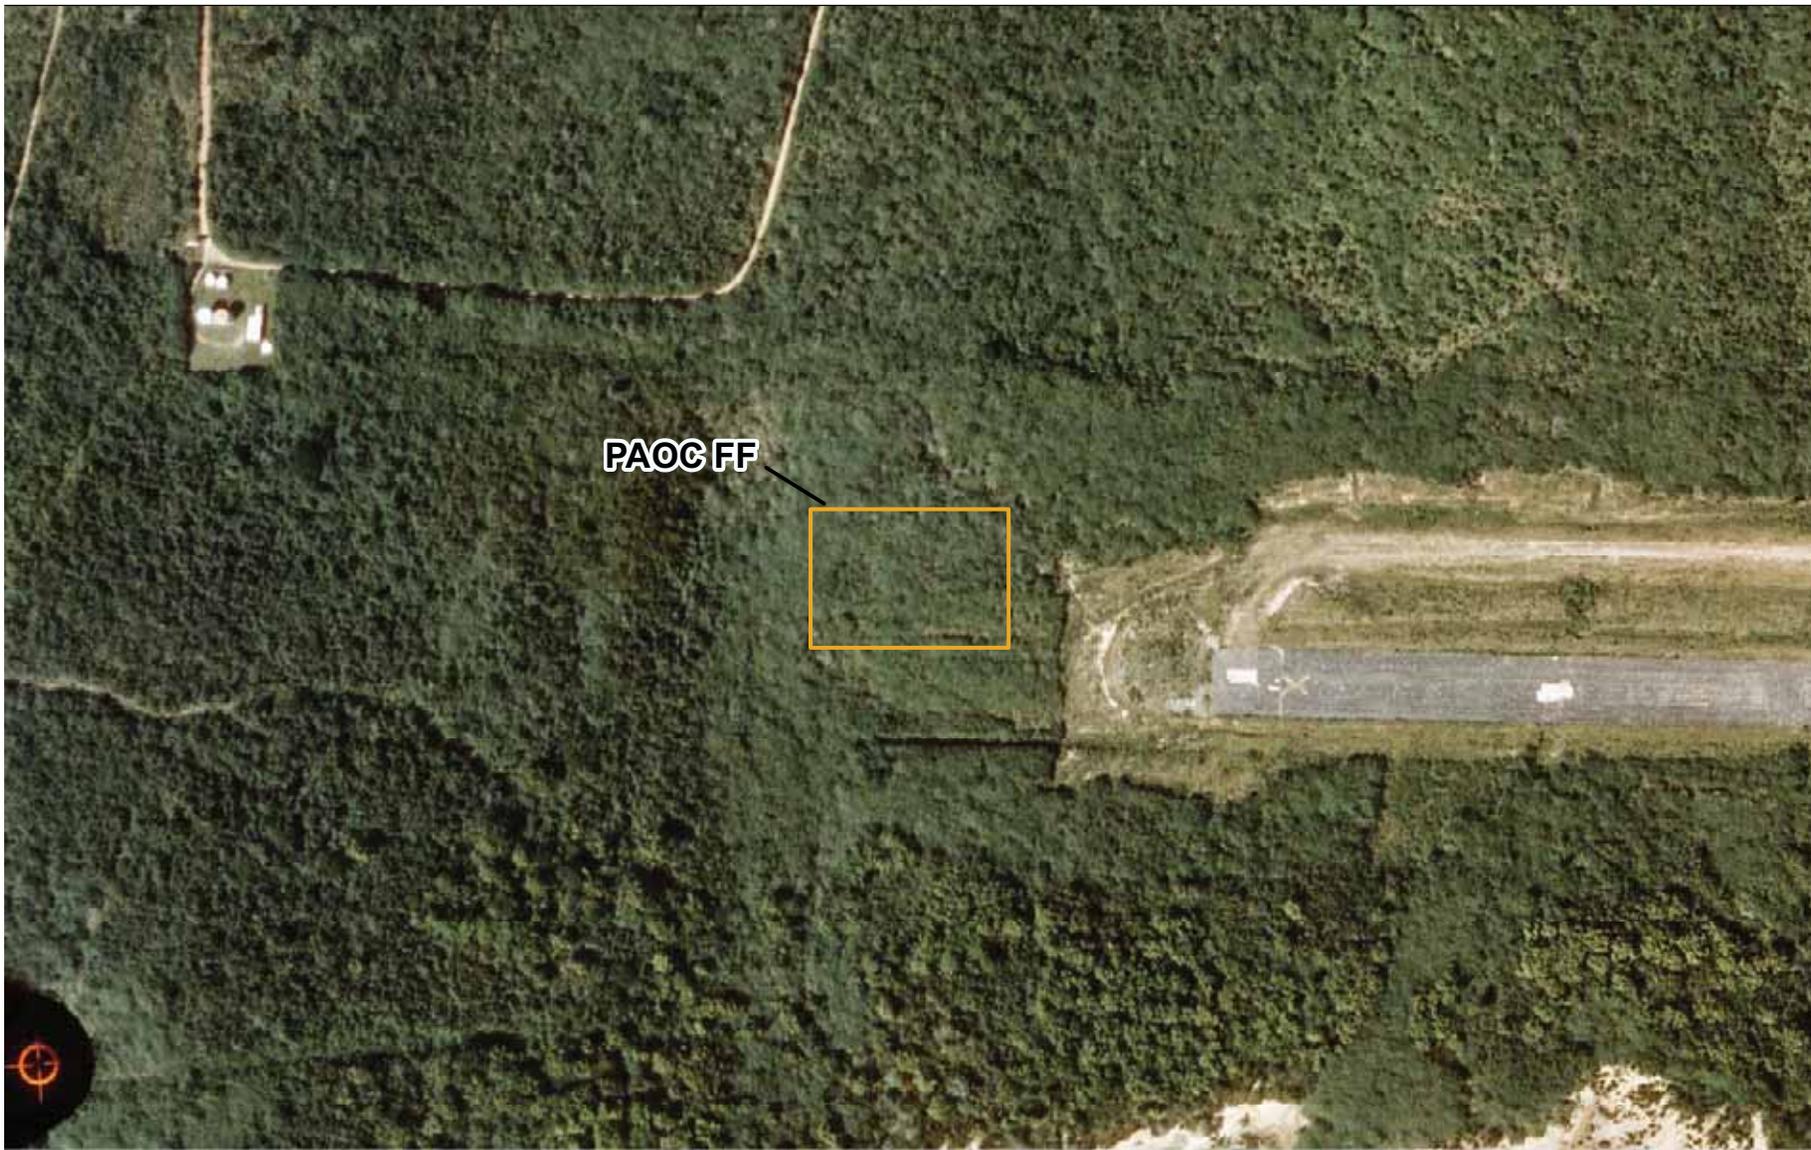
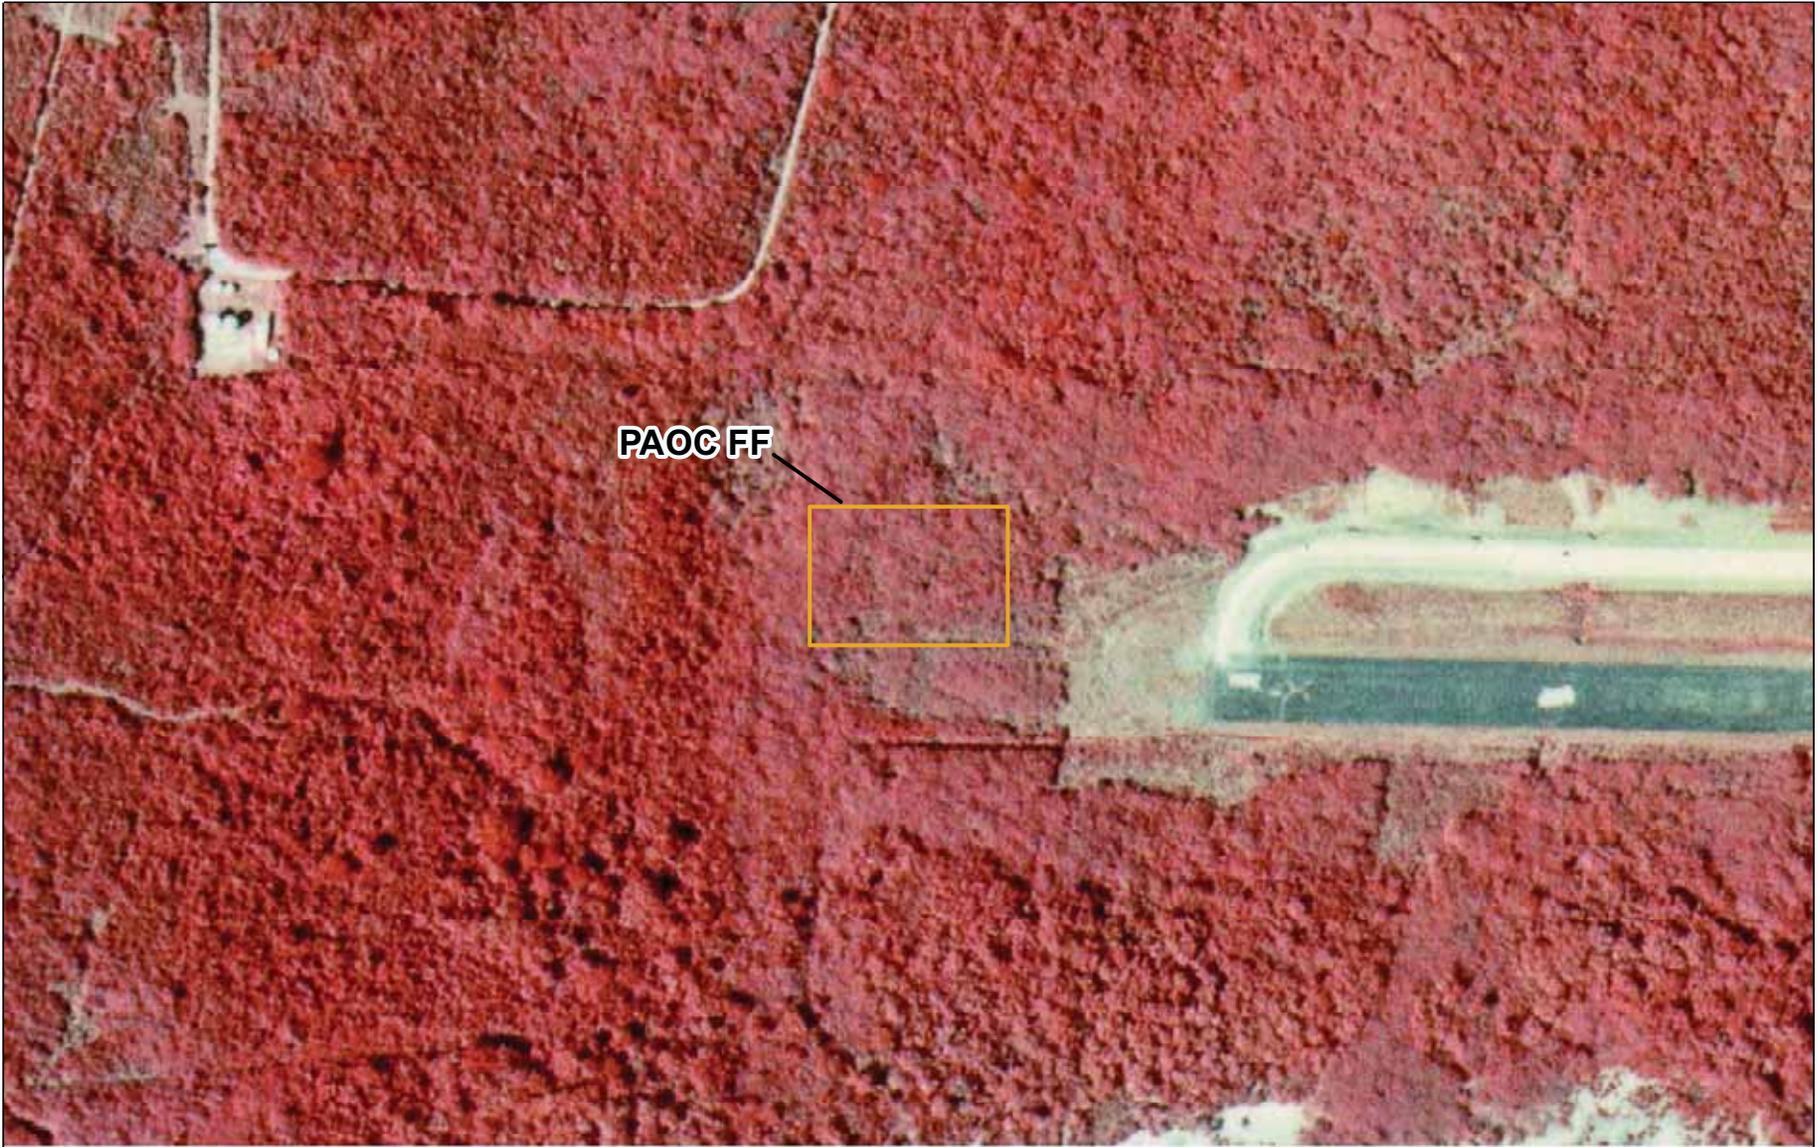
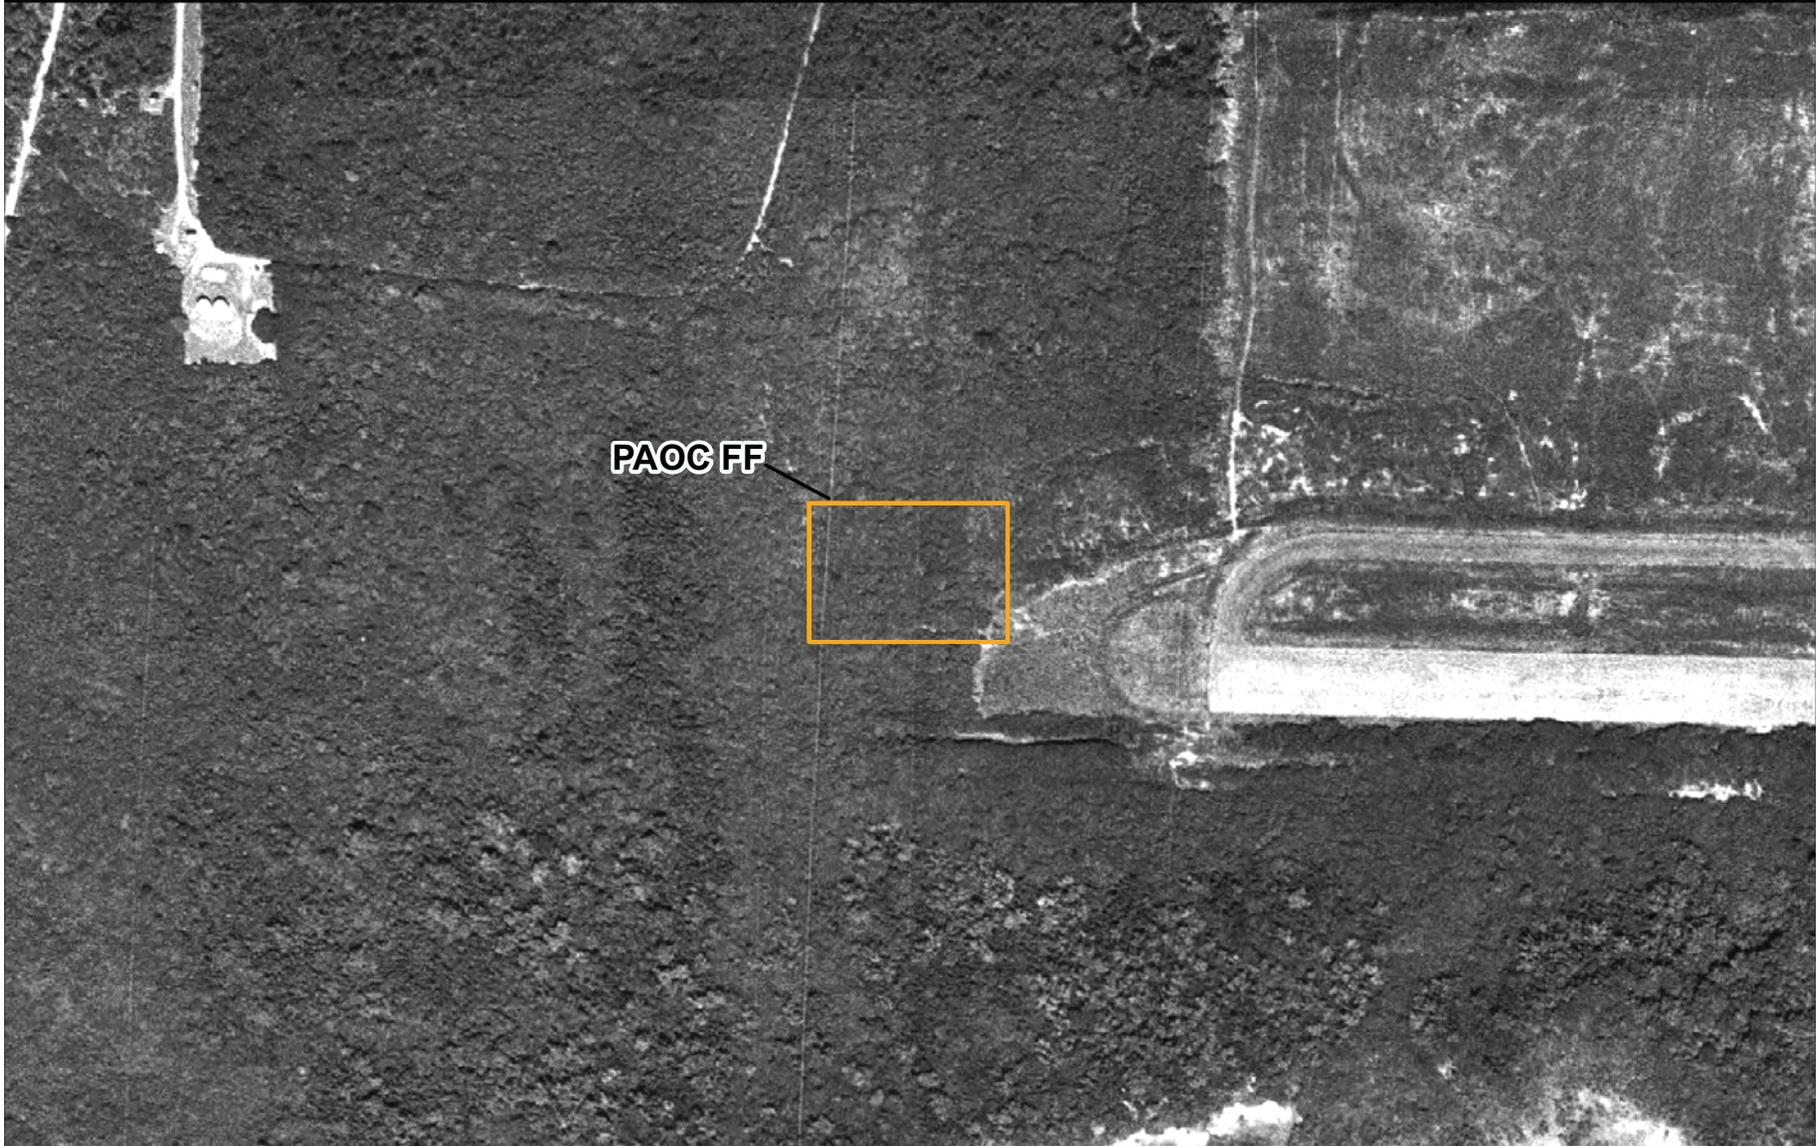
An interview conducted in October 2002 as part of the former VNTR EBS (NAVFACENCOM, 2003) indicated that a former artillery gun placement existed immediately north of the west end of the Camp Garcia runway at the location shown on **Figures 1-2 and 3-1** through **3-8**. A review of historical aerial photographs suggests there was no gun placement at PAOC FF. In fact, the aerial photographs show the only observable feature to be a drainage ditch that traversed the area and terminated in a small depression just to the south (**Figure 3-3**). In addition, the site's position at the end of the runway would not have been a reasonable location for a gun placement due to the takeoff and landing of aircraft. Further, a historical aerial photographic analysis conducted by ERI identified several artillery gun placements within the VNTR, but did not identify one at the location of PAOC FF (ERI, 2000).

As noted previously, there is no evidence that the site was used as a gun placement position and no evidence of a CERCLA-related release was observed at the site. Historical aerial photographs from the 1930s through 2004 show no artillery gun placement features and the site's proximity to the end of the runway indicates it would not have been used for artillery gun placement. Transects of the area identified only a few innocuous items (fencing material). Based on this information, no action is warranted for PAOC FF.

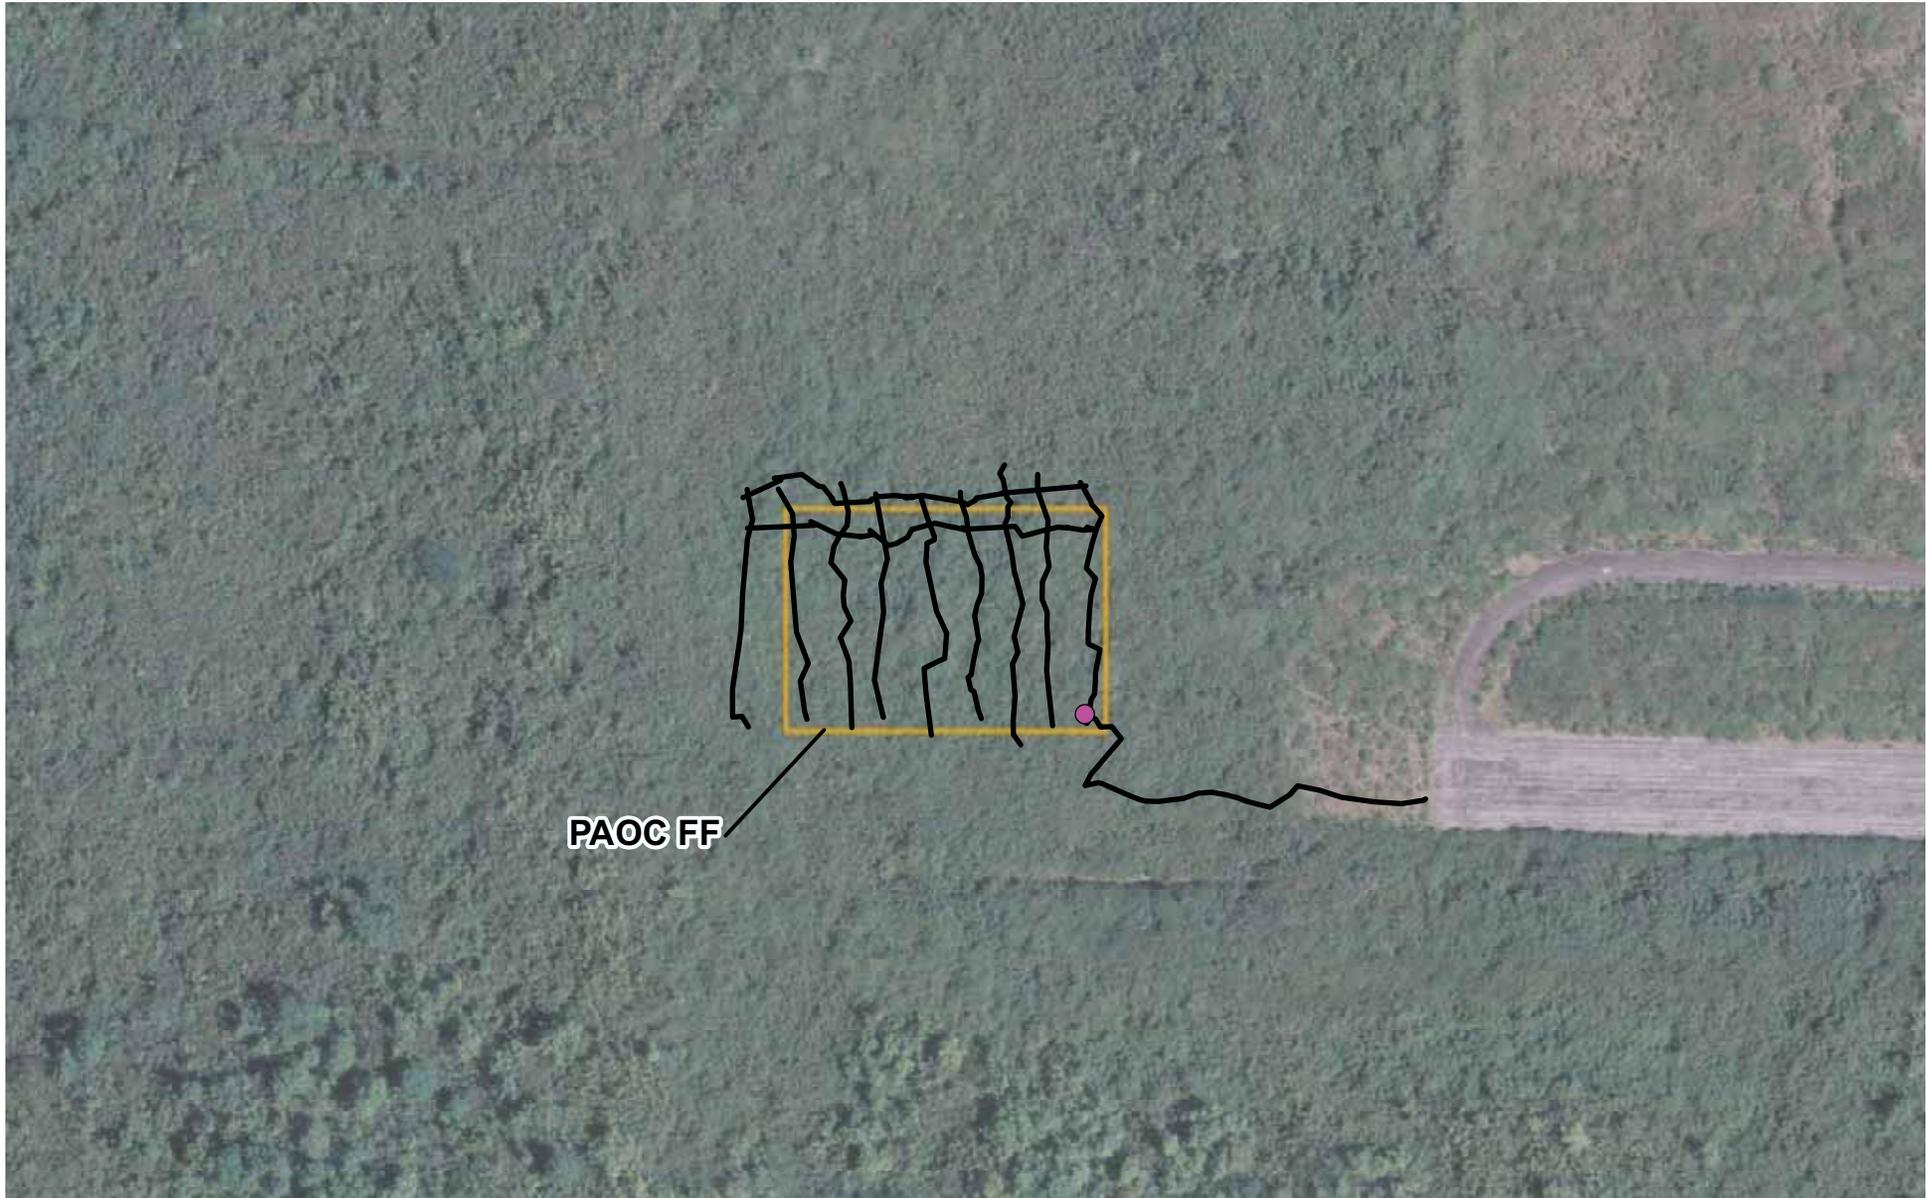
FIGURE 3-9
 Location of Transects on PAOC FF
No Action Decision Document
PI 14 and PAOC FF Sites
Vieques, Puerto Rico

During the ERA/SI conducted in 2009, transects through the site (**Figure 3-9**) encountered only rebar, fencing debris, and a partly intact fence, likely part of the fence surrounding the runway (**Figure 3-10**) (CH2M HILL, 2009).

- LEGEND**
Transect Items
- Fencing Material
 - Transect
 - PAOC boundary
