# No Action Decision Document for 4 Consent Order Sites and 6 PI/PAOC Sites

Former Vieques Naval Training Range  
Vieques, Puerto Rico

January 2009

Prepared by  
**CH2MHILL**

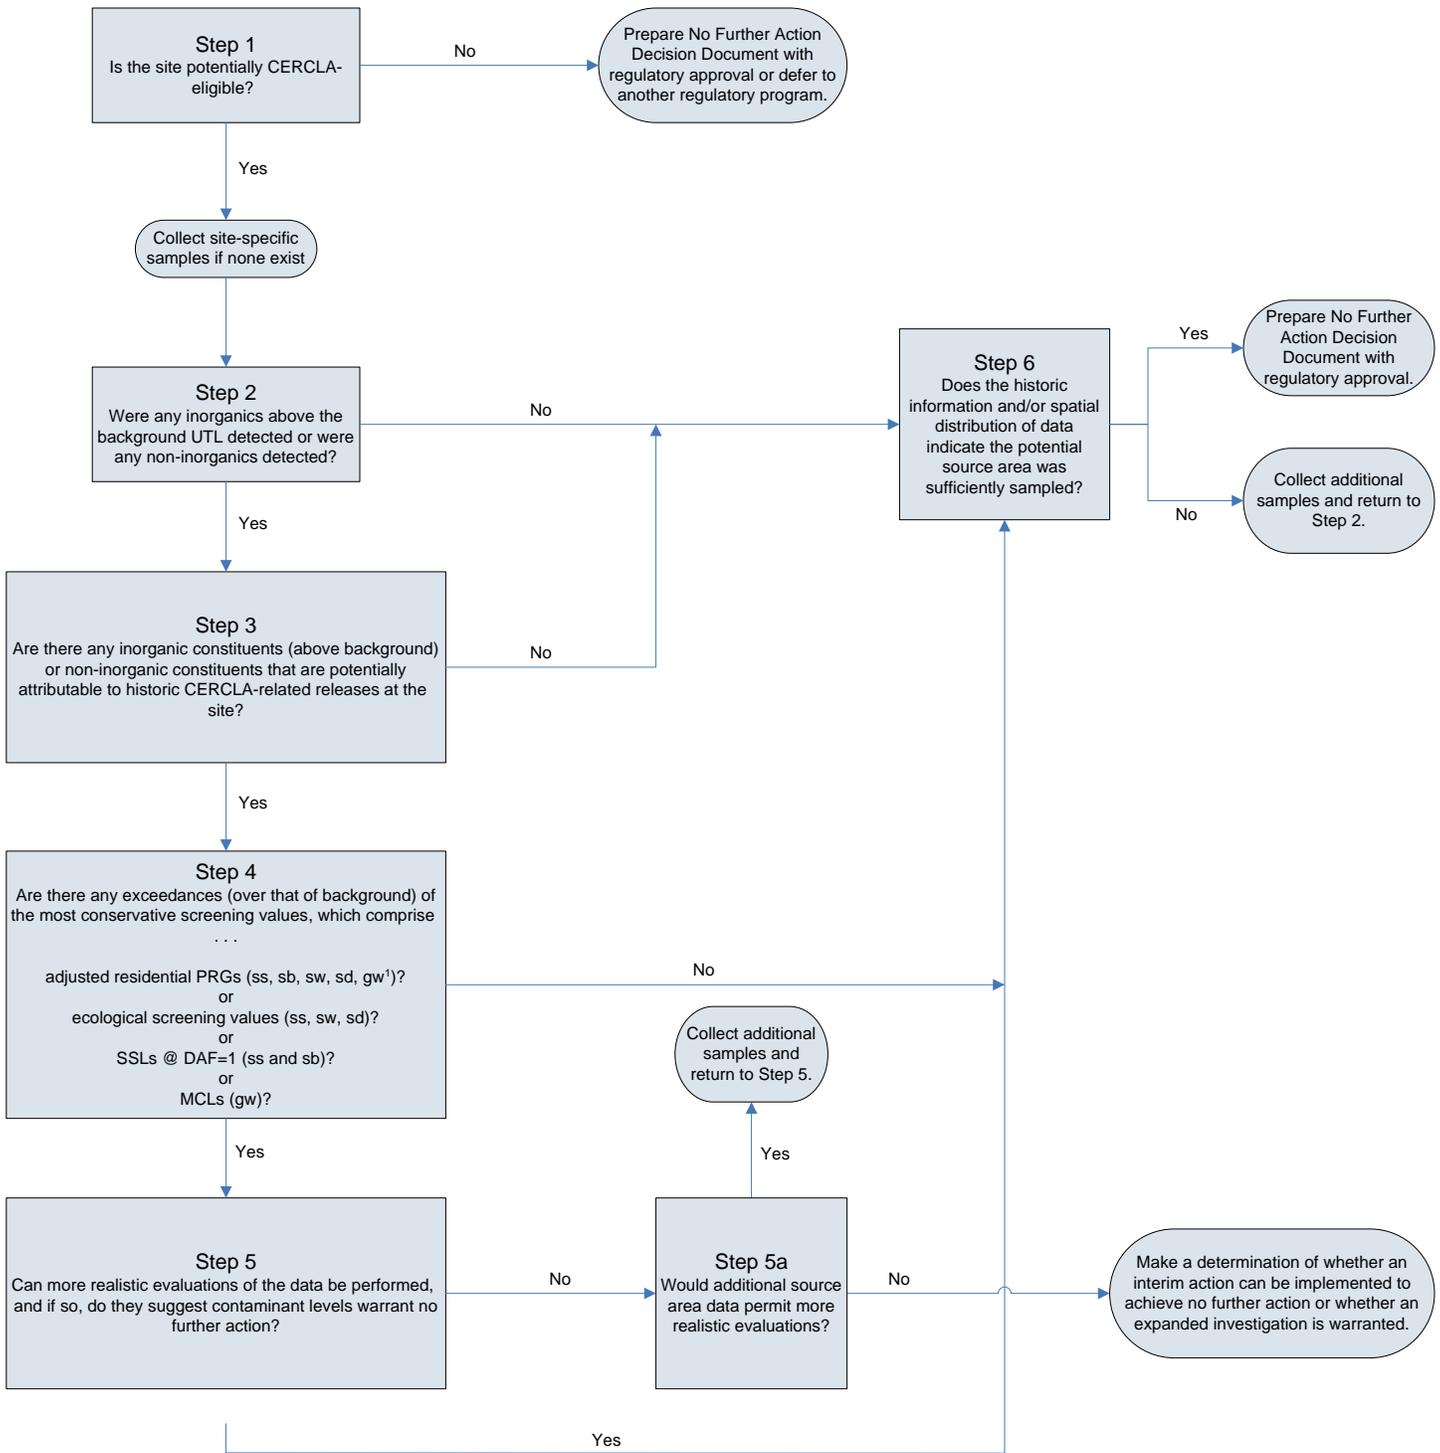
**Figure 1-3**  
**PA/SI Evaluation Decision Tree**  
*No Action Decision Document*  
*4 Consent Order Sites and 6 PI/PAOC Sites*  
*Vieques, Puerto Rico*

<sup>1</sup> ss = surface soil; sb = subsurface soil; sw = surface water; sd = sediment; gw = groundwater

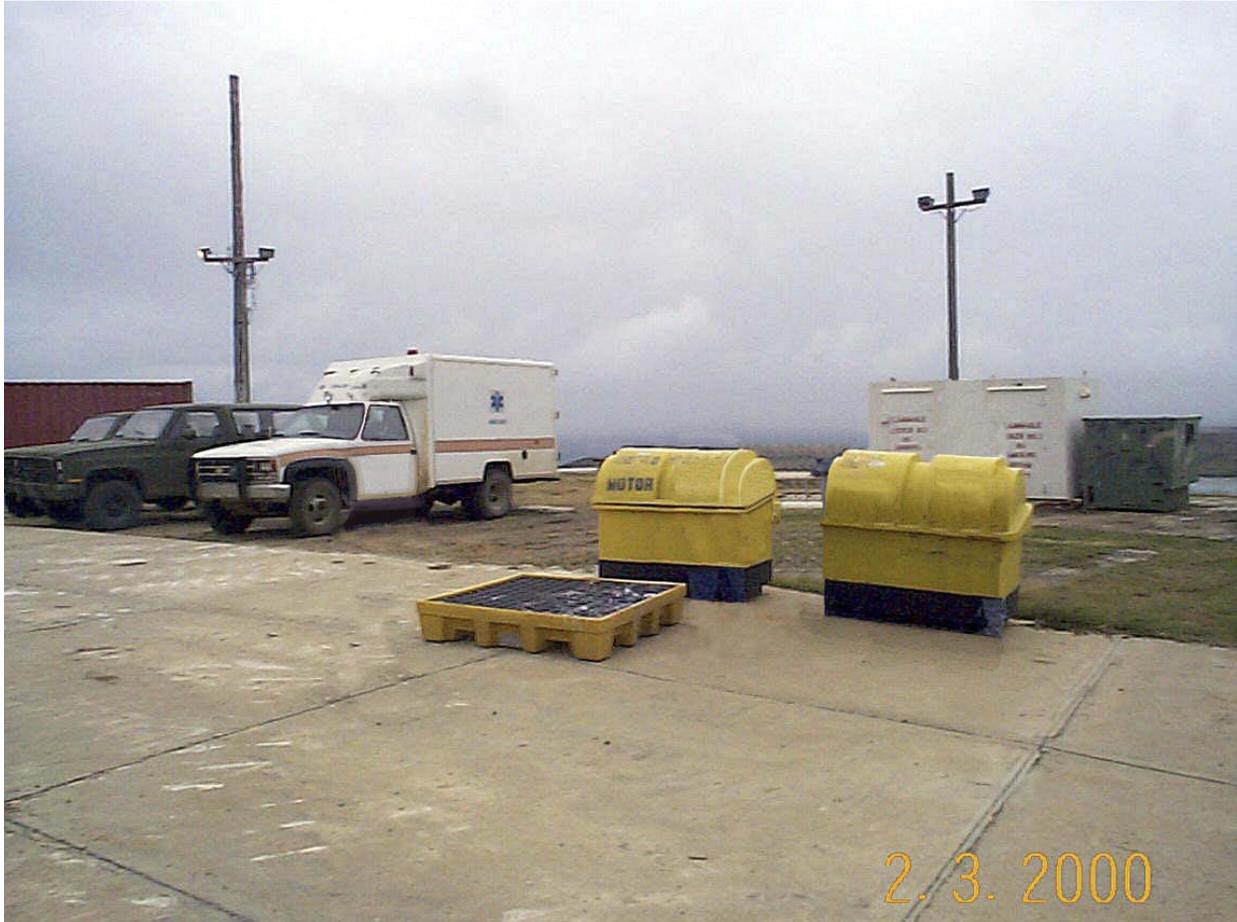
**Figure 2-2**  
**SWMU 5 Spent Battery Accumulation Area**  
**(Observation Post 1, former VNTR)**  
*No Action Decision Document*  
*4 Consent Order Sites and 6 PI/PAOC Sites*  
*Vieques, Puerto Rico*

Although the startup date for SWMU 5 is unknown, the SWMU remained active through May 2003. During the 1995 RFA, nine batteries were observed to be stored at this site on the gravel driveway. During the February 2000 site visit to all Consent Order sites, release controls (plastic storage trays) for battery storage were present, but no batteries were observed at the site. No signs of releases of battery acid were observed at that time. In addition, the storage containers were noted to be on concrete (Figure 2-2).

Photograph taken February 3, 2000

During the January 2004 PA/SI site visit, no signs of activity were evident at SWMU 5. No batteries were stored at the site. The plastic trays observed in 2000 had been removed as part of the closure of the former VNTR.

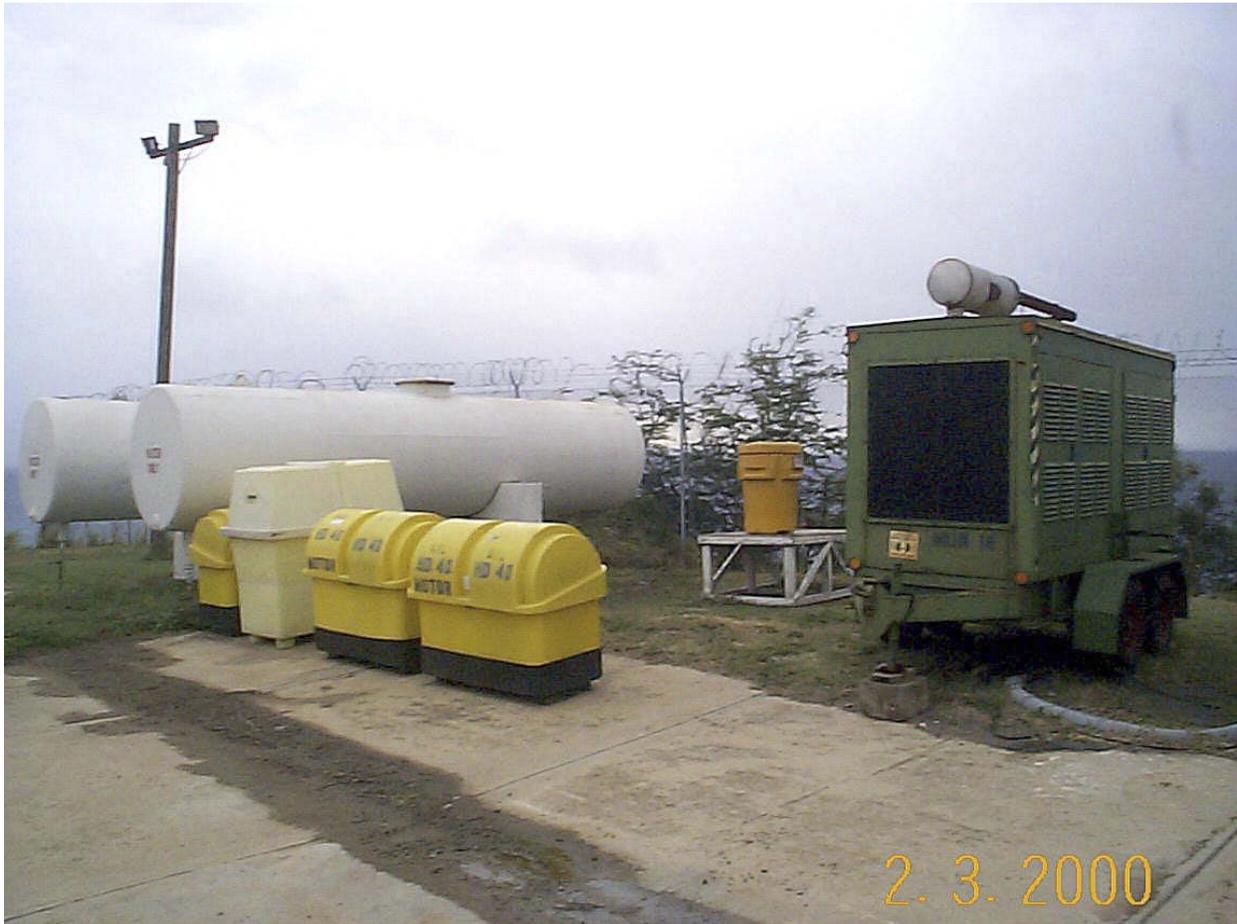
**Figure 3-2**  
**Waste Oil Accumulation Area, SWMU 8**  
*No Action Decision Document*  
*4 Consent Order Sites and 6 PI/PAOC Sites*  
*Vieques, Puerto Rico*

During the February 2000 site inspection in which the EPA and Navy inspected the consent order sites, no soil staining was evident in the accumulation area, and the drums were stored on concrete in plastic secondary containment trays for release control (Figure 3-2). Neither the containment trays nor any waste was present at the time of the 2004 site visit, conducted as part of the PA/SI. They had been removed as part of the closure of the former VNTR.

Photograph taken February 3, 2000

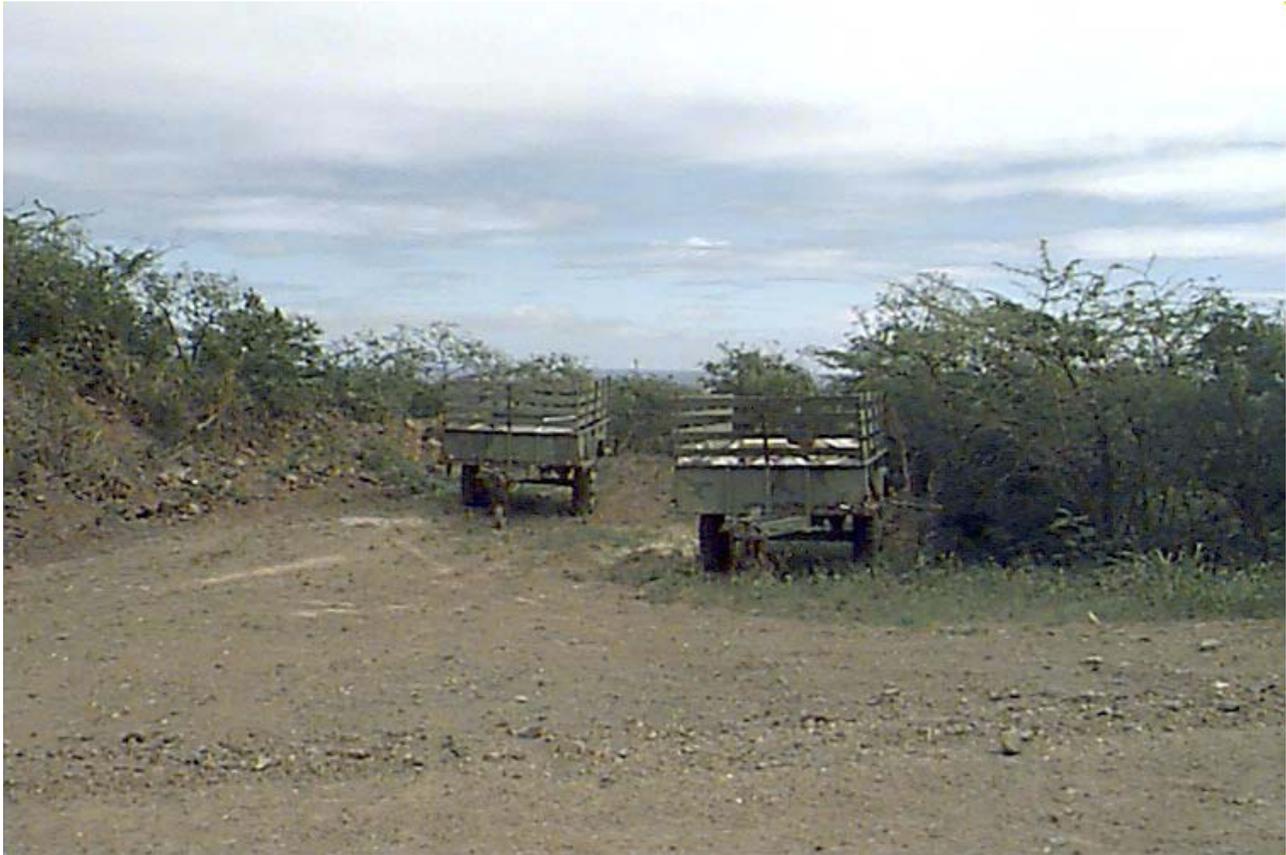
**Figure 4-2**  
**SWMU 12 Solid Waste Collection Unit Area**  
*No Action Decision Document*  
*4 Consent Order Sites and 6 PI/PAOC Sites*  
*Vieques, Puerto Rico*

The solid waste collection unit area served as a solid waste staging area, prior to pickup of the domestic solid waste (indicative of galley or barracks waste) for disposal at the Vieques Island landfill. Containers used to store solid wastes collected at the site included wooden boxes, wooden trailers, metal dumpsters, and metal cans. The two RFA reports (Kearney, 1988; PREQB, 1995) suggested no further action for this site was necessary because no known hazardous constituents were staged there, which is why the material could be disposed of at the Vieques Island landfill. The visual inspection in February 2000, when the EPA and Navy representatives visited the consent order sites, identified two trailers potentially used for staging of domestic waste from OP-1 prior to transport to the Vieques Island landfill. Figure 4-2 presents a photograph of SWMU 12 taken during the 2000 visual inspection. During the 2004 PA/SI sampling event, no trailers or any signs of waste were present at SWMU 12. The trailers had previously been removed as part of the Navy's closure of VNTR in 2003.

Photograph taken February 3, 2000

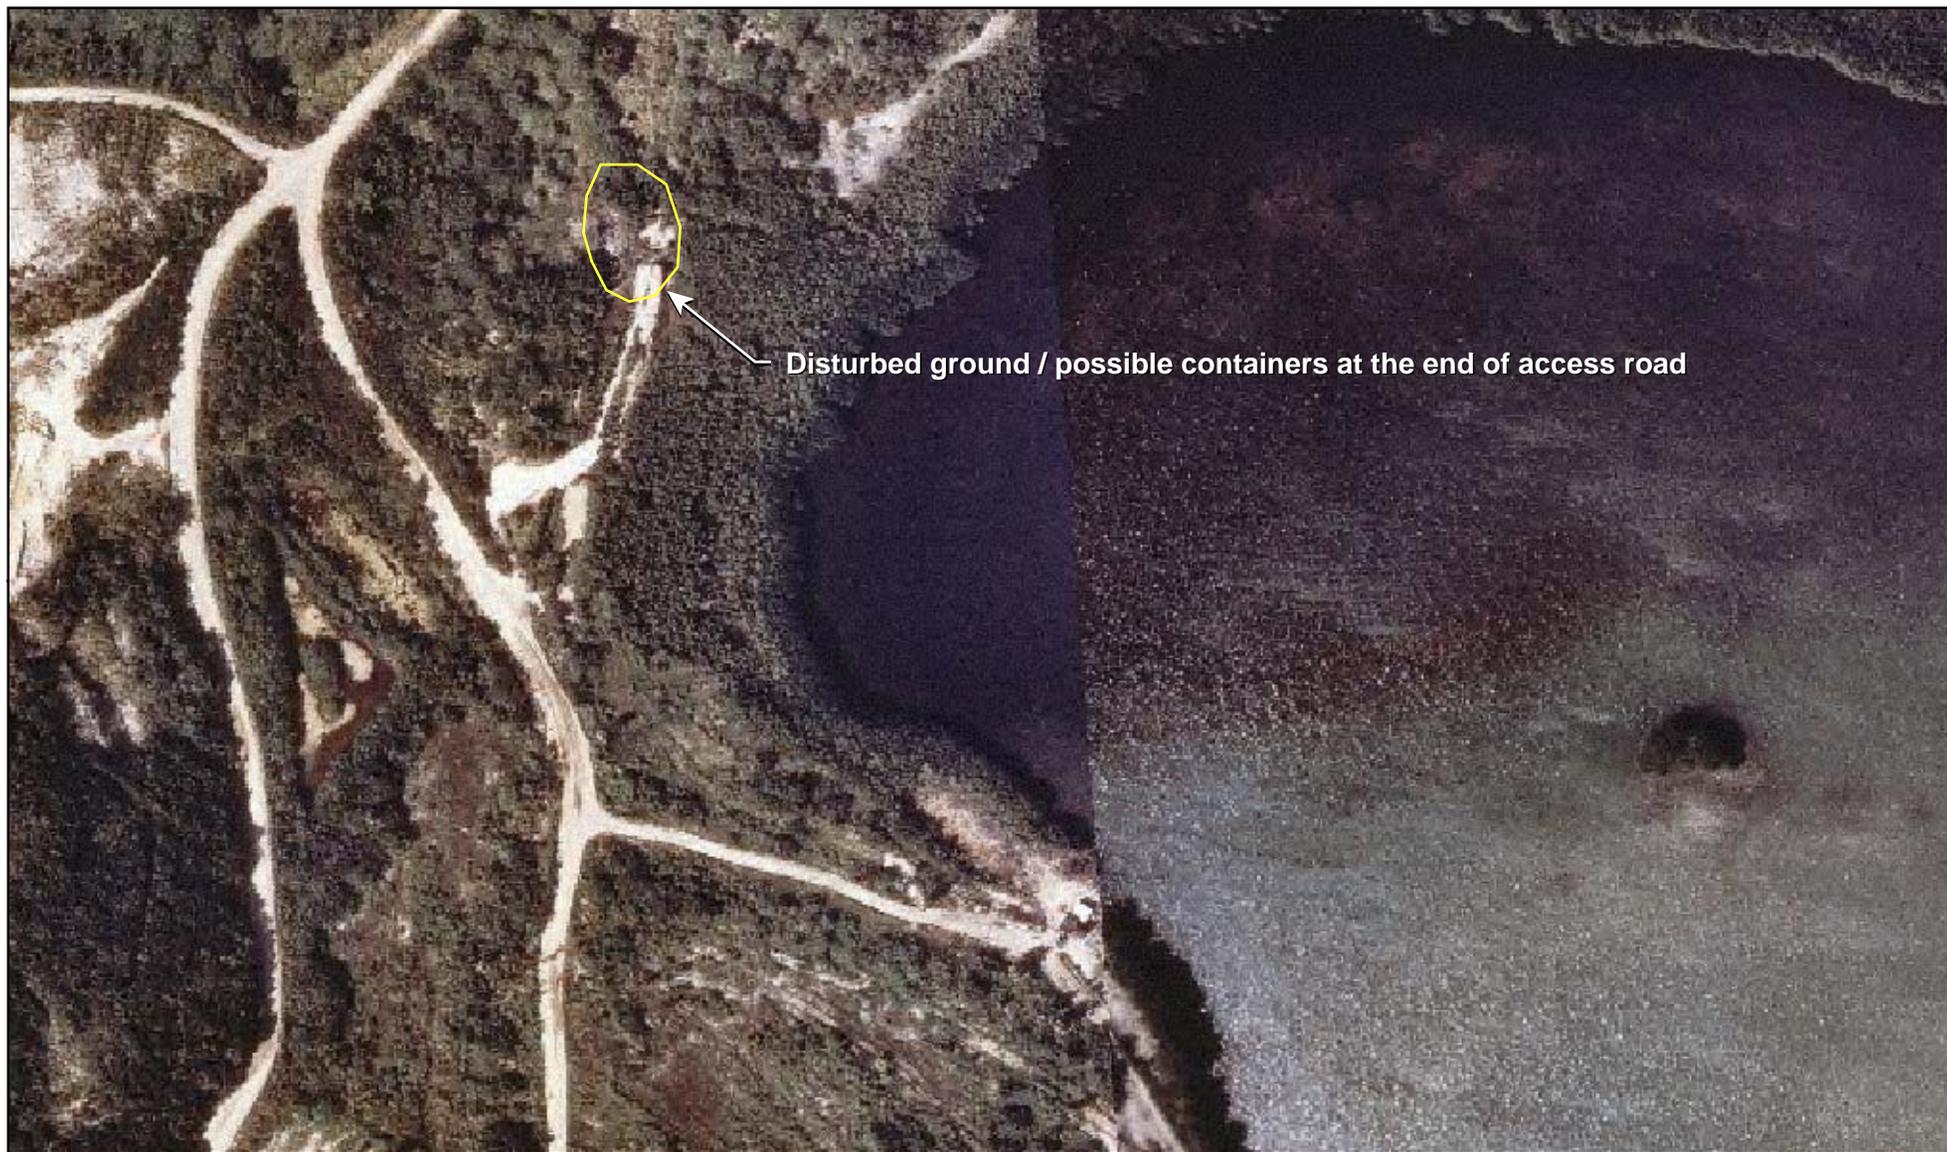
**Figure 6-1**  
**Observations from ERI Aerial Photographic Analysis**  
*No Action Decision Document*  
*4 Consent Order Sites and 6 PI/PAOC Sites*  
*Vieques, Puerto Rico*

Disturbed ground / possible containers at the end of access road

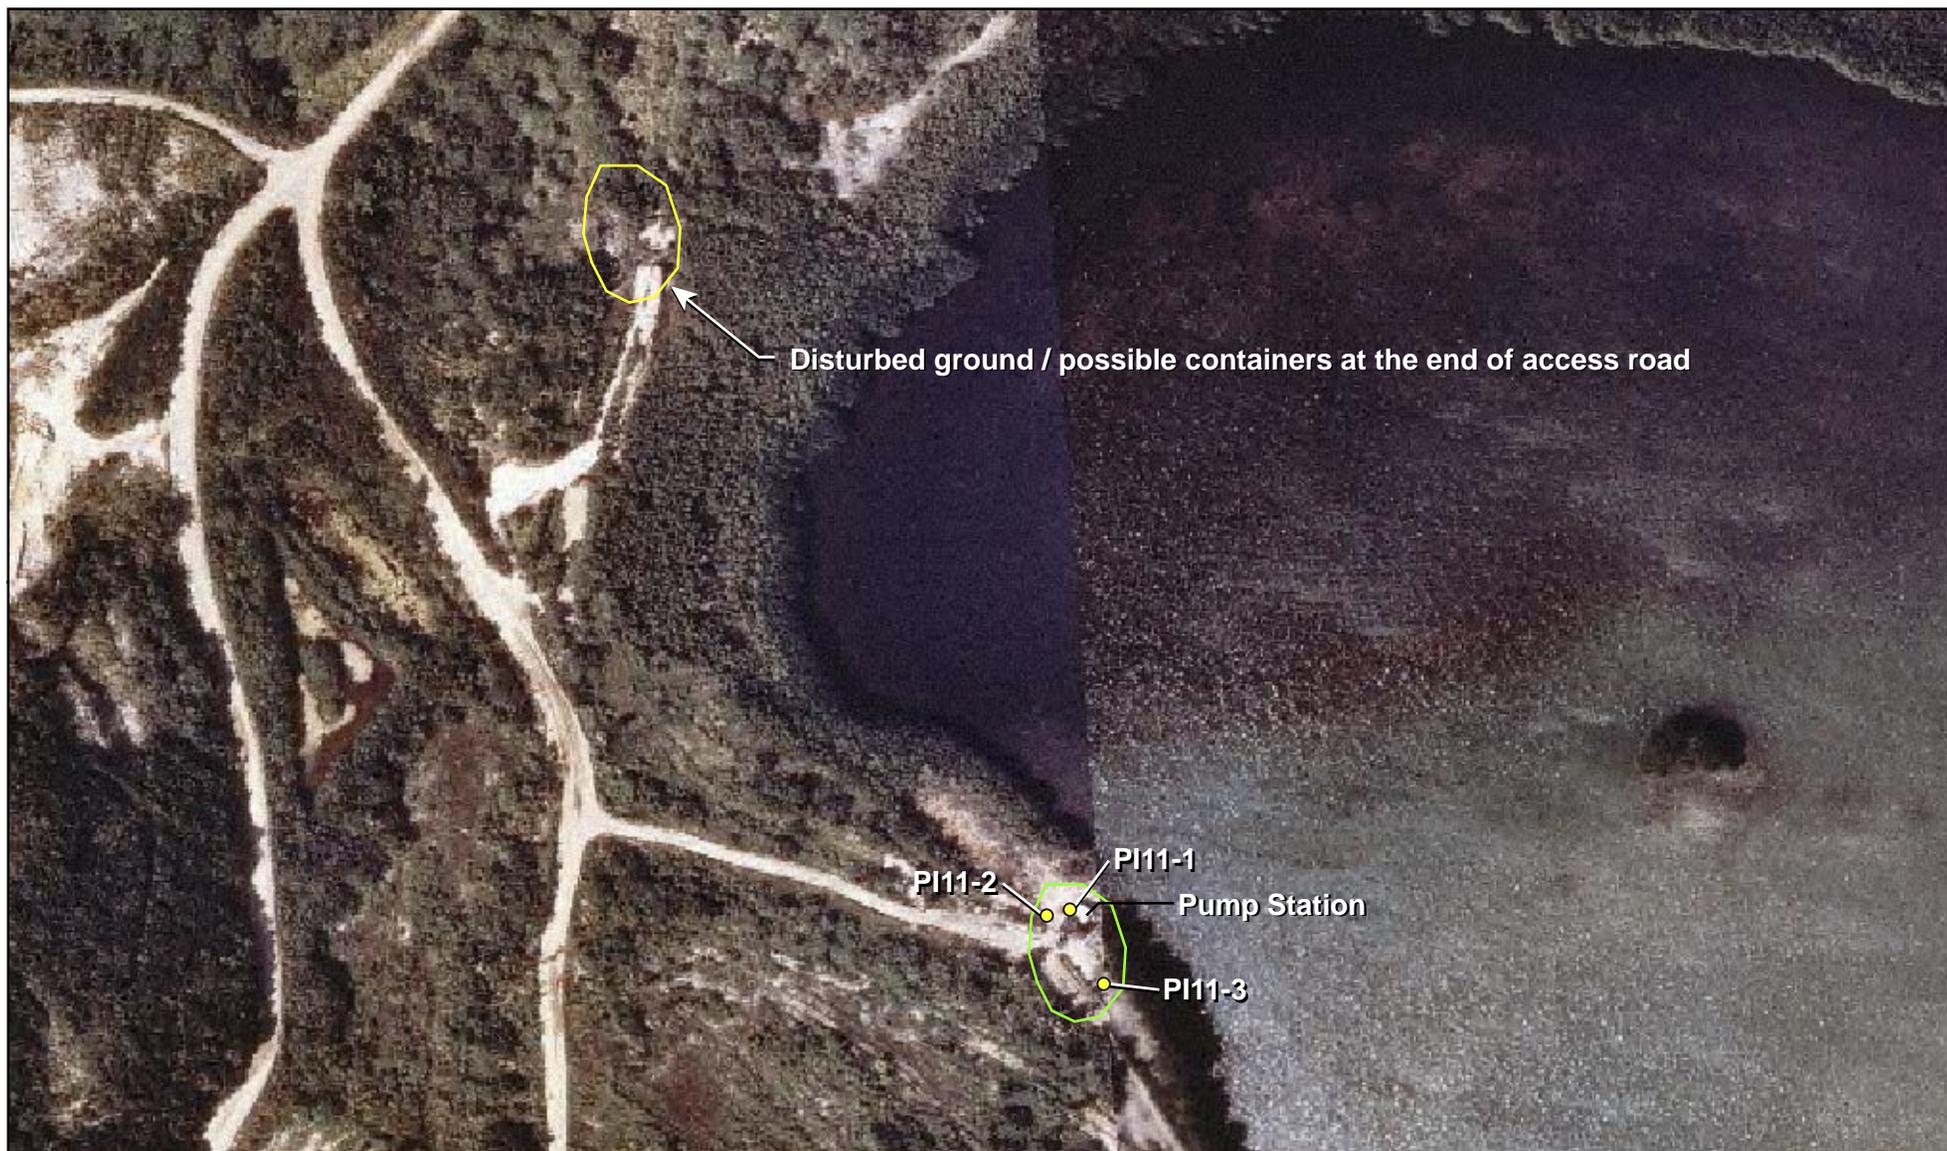
- 1962: Disturbed ground/possible containers at the end of access road (Figure 6-1)

Disturbed ground / possible containers at the end of access road

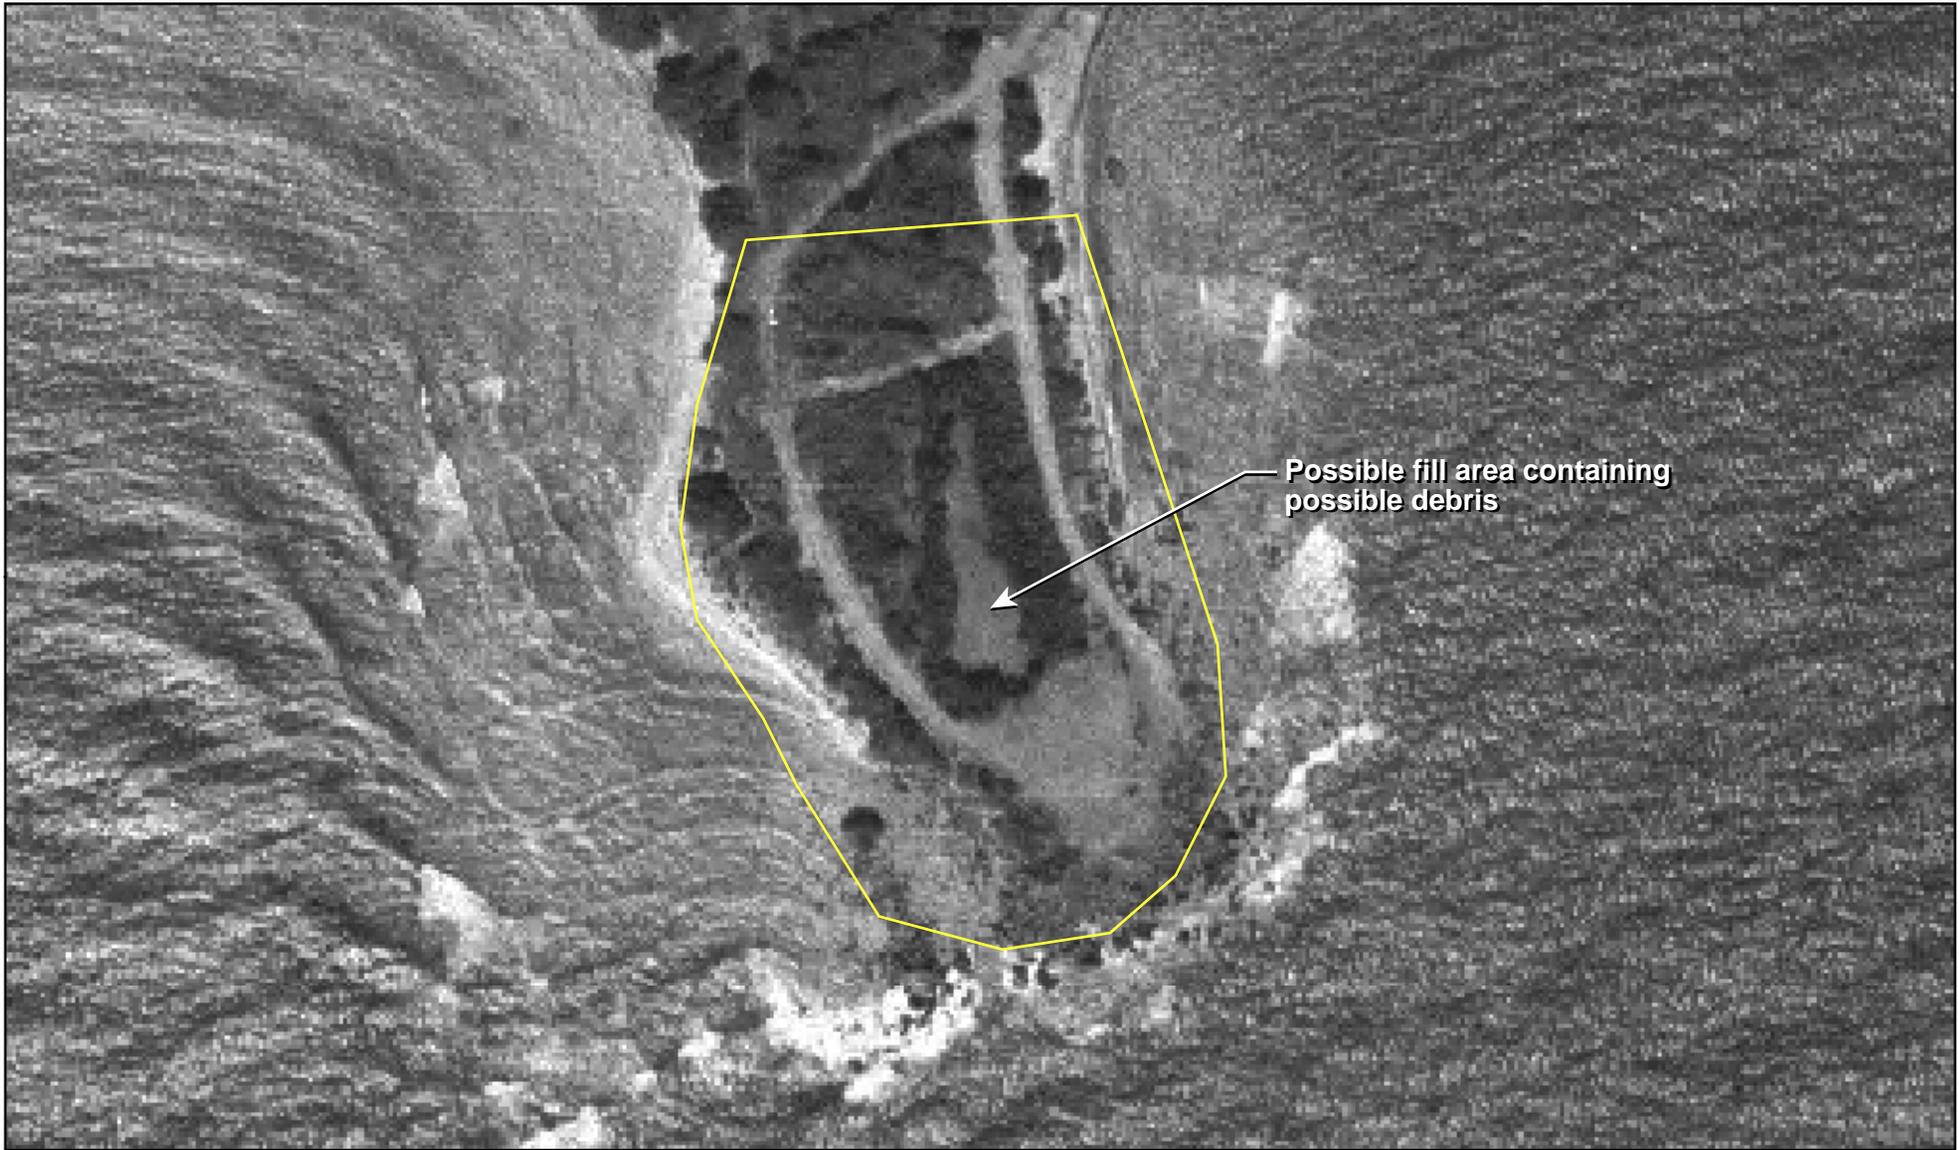
**Figure 7-1**  
**1964 Aerial Photograph**  
**of the PI-20 Area**  
*No Action Decision Document*  
*4 Consent Order Sites and 6 PI/PAOC Sites*  
*Vieques, Puerto Rico*

- 1964: Possible fill area containing possible debris (Figure 7-1)
- 1970: Possible fill area (Figure 7-2)
- 1985: Possible fill area (Figure 7-3)
- 1994: Fill area re-vegetating (Figure 7-4)

As noted above, historical information suggests the site was used as an observation point and potential quarry. Aerial photographic analysis incorrectly identified the site as a potential fill area. The site visits conducted in 2001 and 2007 observed the area identified in the aerial photographs to have become a lagoon, further supporting the historical information that suggested the site was used as a quarry, not as a fill area. The site visits observed no evidence of prior disposal or a release. Based on this information, the potential for the release of CERCLA hazardous substances can be confidently ruled out. Therefore, a no action determination is made for PI 20.

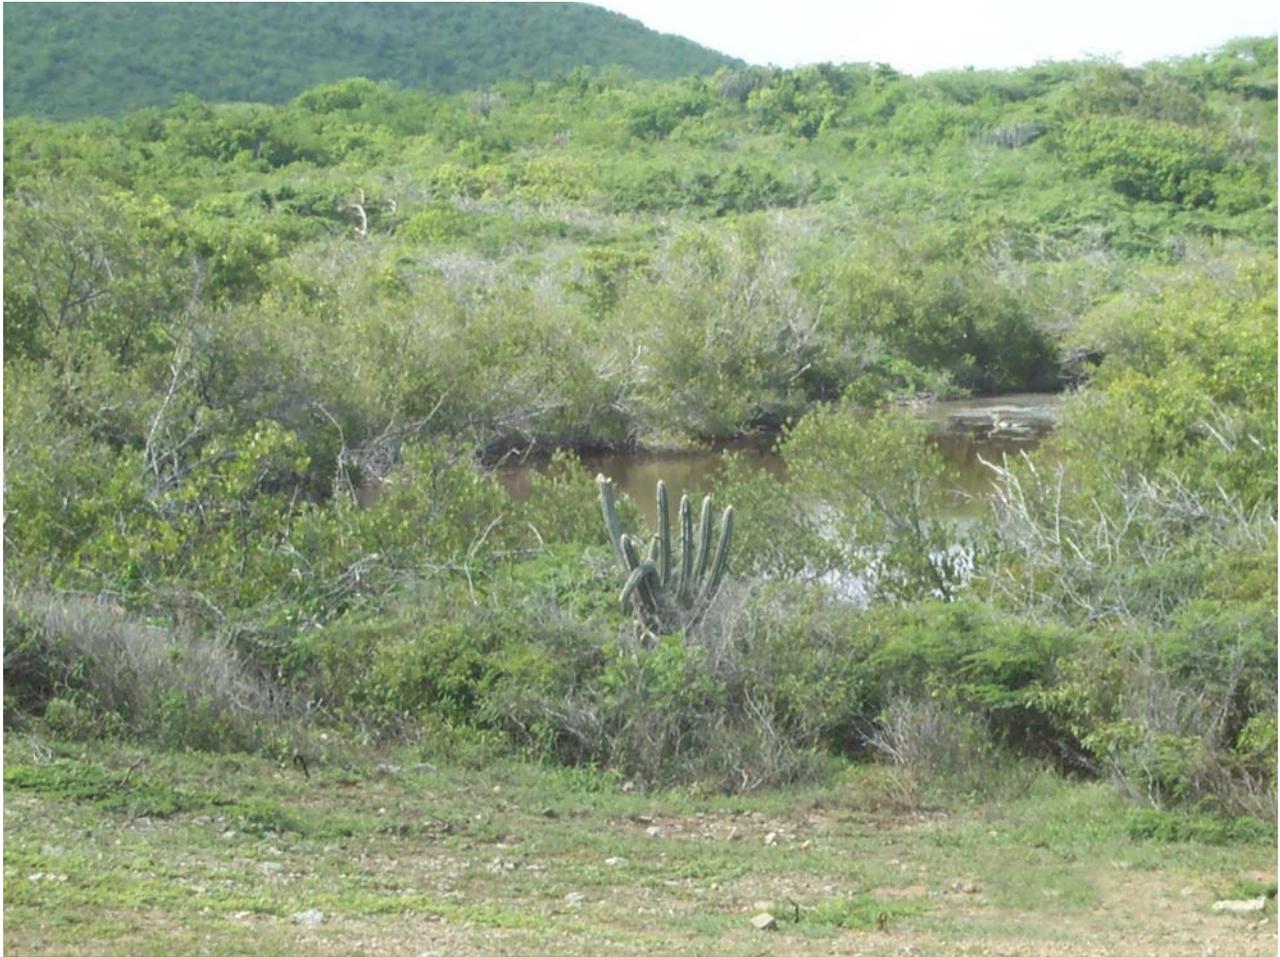
**Figure 7-6**  
**Photograph of the PI-20 Area**  
*No Action Decision Document*  
*4 Consent Order Sites and 6 PI/PAOC Sites*  
*Vieques, Puerto Rico*

Photograph taken during 2001 site visit

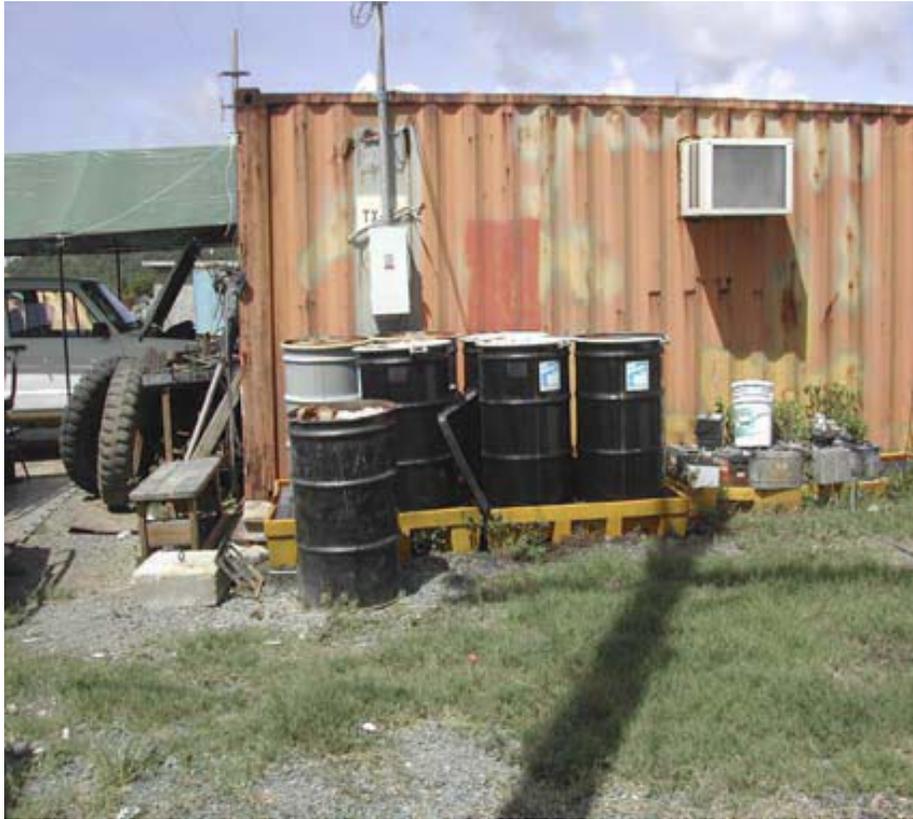
Photo 1 - Stained area at drum and battery area adjacent to automotive shop

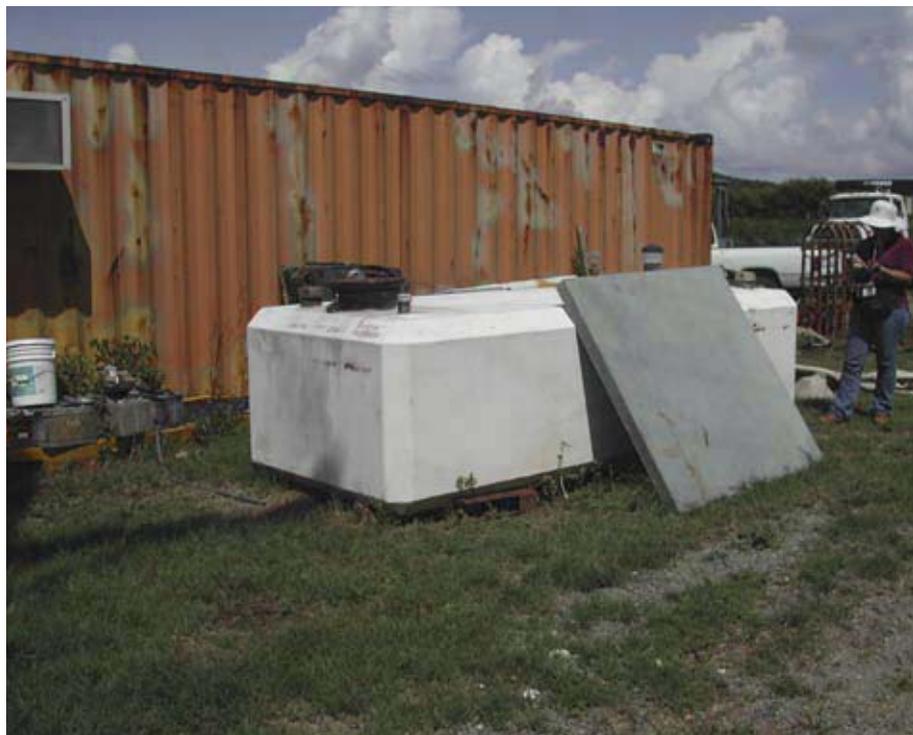
Photo 2 - AST adjacent to drum/battery storage
