FINAL AFTER ACTION REPORT NON-TIME CRITICAL INTERIM REMOVAL ACTION MAIN
ACCESS ROAD, LIGHTHOUSE AREA, TRAILS, AND BEACHES UNEXPLODED ORDNANCE
15 (UXO 15) ATLANTIC FLEET WEAPONS TRAINING AREA FORMER VIEQUES NAVAL
TRAINING RANGE VIEQUES ISLAND PUERTO RICO

**After Action Report
Non-Time Critical Interim Removal Action
Main Access Road, Lighthouse Area, Trails, and Beaches
UXO 15**

**Atlantic Fleet Weapons Training Area—Vieques
Former Vieques Naval Training Range
Vieques, Puerto Rico**

February 2015

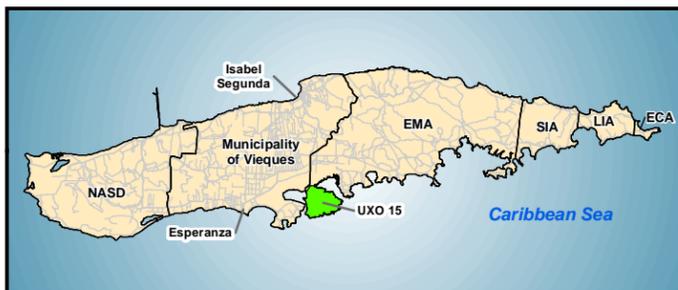
Figure ES-1
Areas Addressed by NTCRA
 UXO 15 After Action Report
 Former Vieques Naval Training Range
 Vieques, Puerto Rico

2007 Aerial Imagery

This After Action Report documents the completion of a Non-Time Critical Removal Action (NTCRA) conducted to reduce the explosive hazard associated with potential munitions and explosives of concern (MEC)/material potentially presenting an explosive hazard (MPPEH) at UXO 15, located at the former Vieques Naval Training Range (VNTR), Vieques, Puerto Rico. The NTCRA is intended to facilitate near-term public access via the main road to accessible areas around the historic Spanish lighthouse, including the adjacent parking area, trail, and beach. In addition, the NTCRA addressed two former trails and one sandy beach that are not planned for public access, but may be subject to wildlife management activities (**Figure ES-1**).

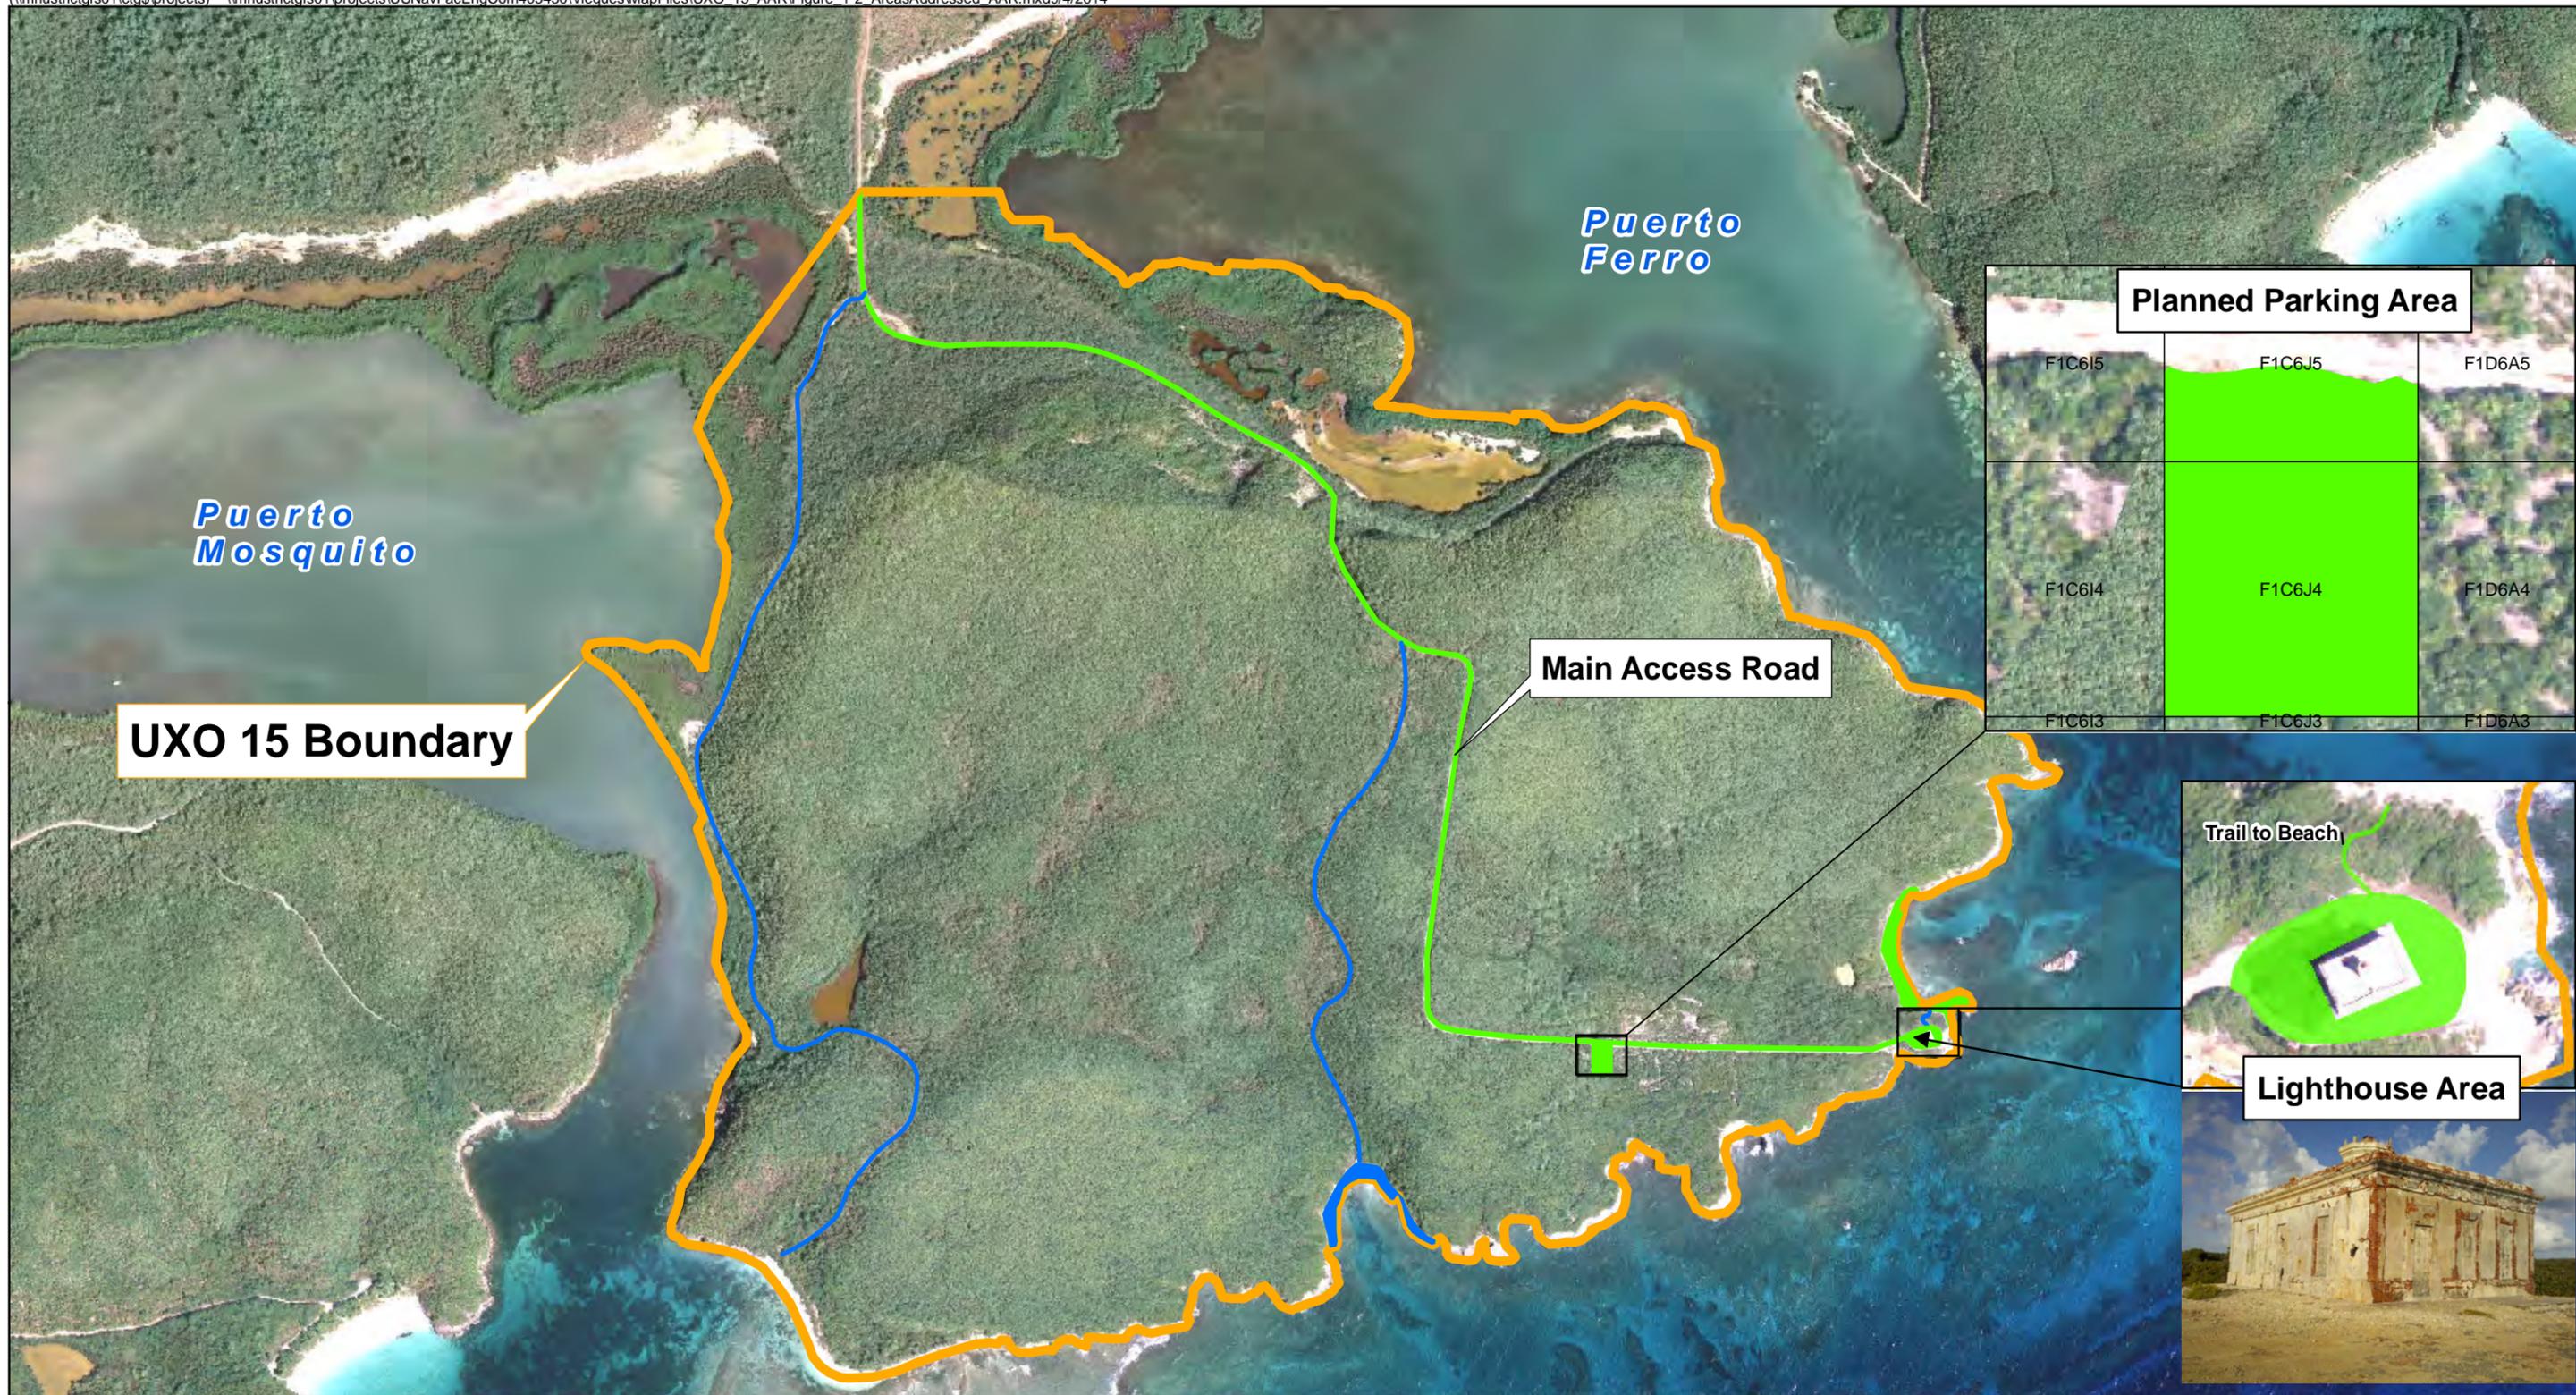
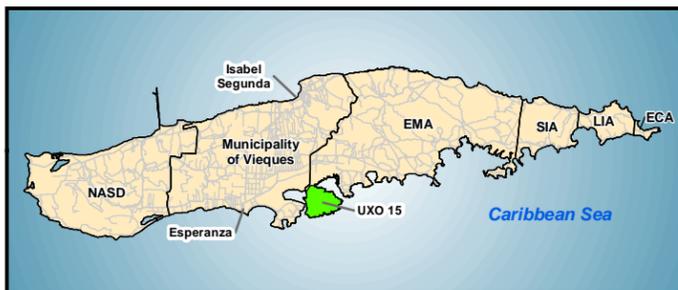
Figure 1-2
Areas Addressed by NTCRA
 UXO 15 After Action Report
 Former Vieques Naval Training Range
 Vieques, Puerto Rico

2007 Aerial Imagery

This After Action Report (AAR) documents the completion of a Non-Time Critical Removal Action (NTCRA) conducted to reduce the explosive hazard associated with potential munitions and explosives of concern (MEC)/material potentially presenting an explosive hazard (MPPEH) at UXO 15, located at the former Vieques Naval Training Range (VNTR), Vieques, Puerto Rico (**Figure 1-1** and **Figure 1-2**). The NTCRA is intended to facilitate near-term public access via the main site access road to the area immediately surrounding the historic Spanish lighthouse, including the adjacent parking area, trail, and beach. In addition, the NTCRA addressed two former trails and one sandy beach that may be subject to trespassing (shown as “Restricted Access” in **Figure 1-2**).

- The former VNTR is situated in the eastern half of Vieques, and is bordered on the west by the community of Isabel Segunda, to the north by Vieques Sound, and to the south by the Caribbean Sea. The former VNTR consists of approximately 14,500 acres that were divided operationally into four Munitions Response Areas (MRAs) that from west to east comprise: the 10,673-acre Eastern Maneuver Area (EMA); the 2,500-acre Surface Impact Area (SIA); the 900-acre Live Impact Area (LIA), and the 200-acre Eastern Conservation Area (ECA) on the easternmost tip of Vieques (CH2M HILL, 2006) (**Figure 1-2** bottom inset).

The goal of the NTCRA was to facilitate accelerated public access to the areas around the lighthouse desired by USFWS while the site as a whole continues through the full CERCLA process. To accomplish this, the approach to the interim removal action was to guide access along the main road to accessible areas around the lighthouse and adjacent beach, to deter access to the remaining (restricted) area of UXO 15, and to perform MEC/MPPEH clearance in areas planned for public access where clearance activities had not previously been performed. The areas intended for public access are shown in **Figure 1-2**.

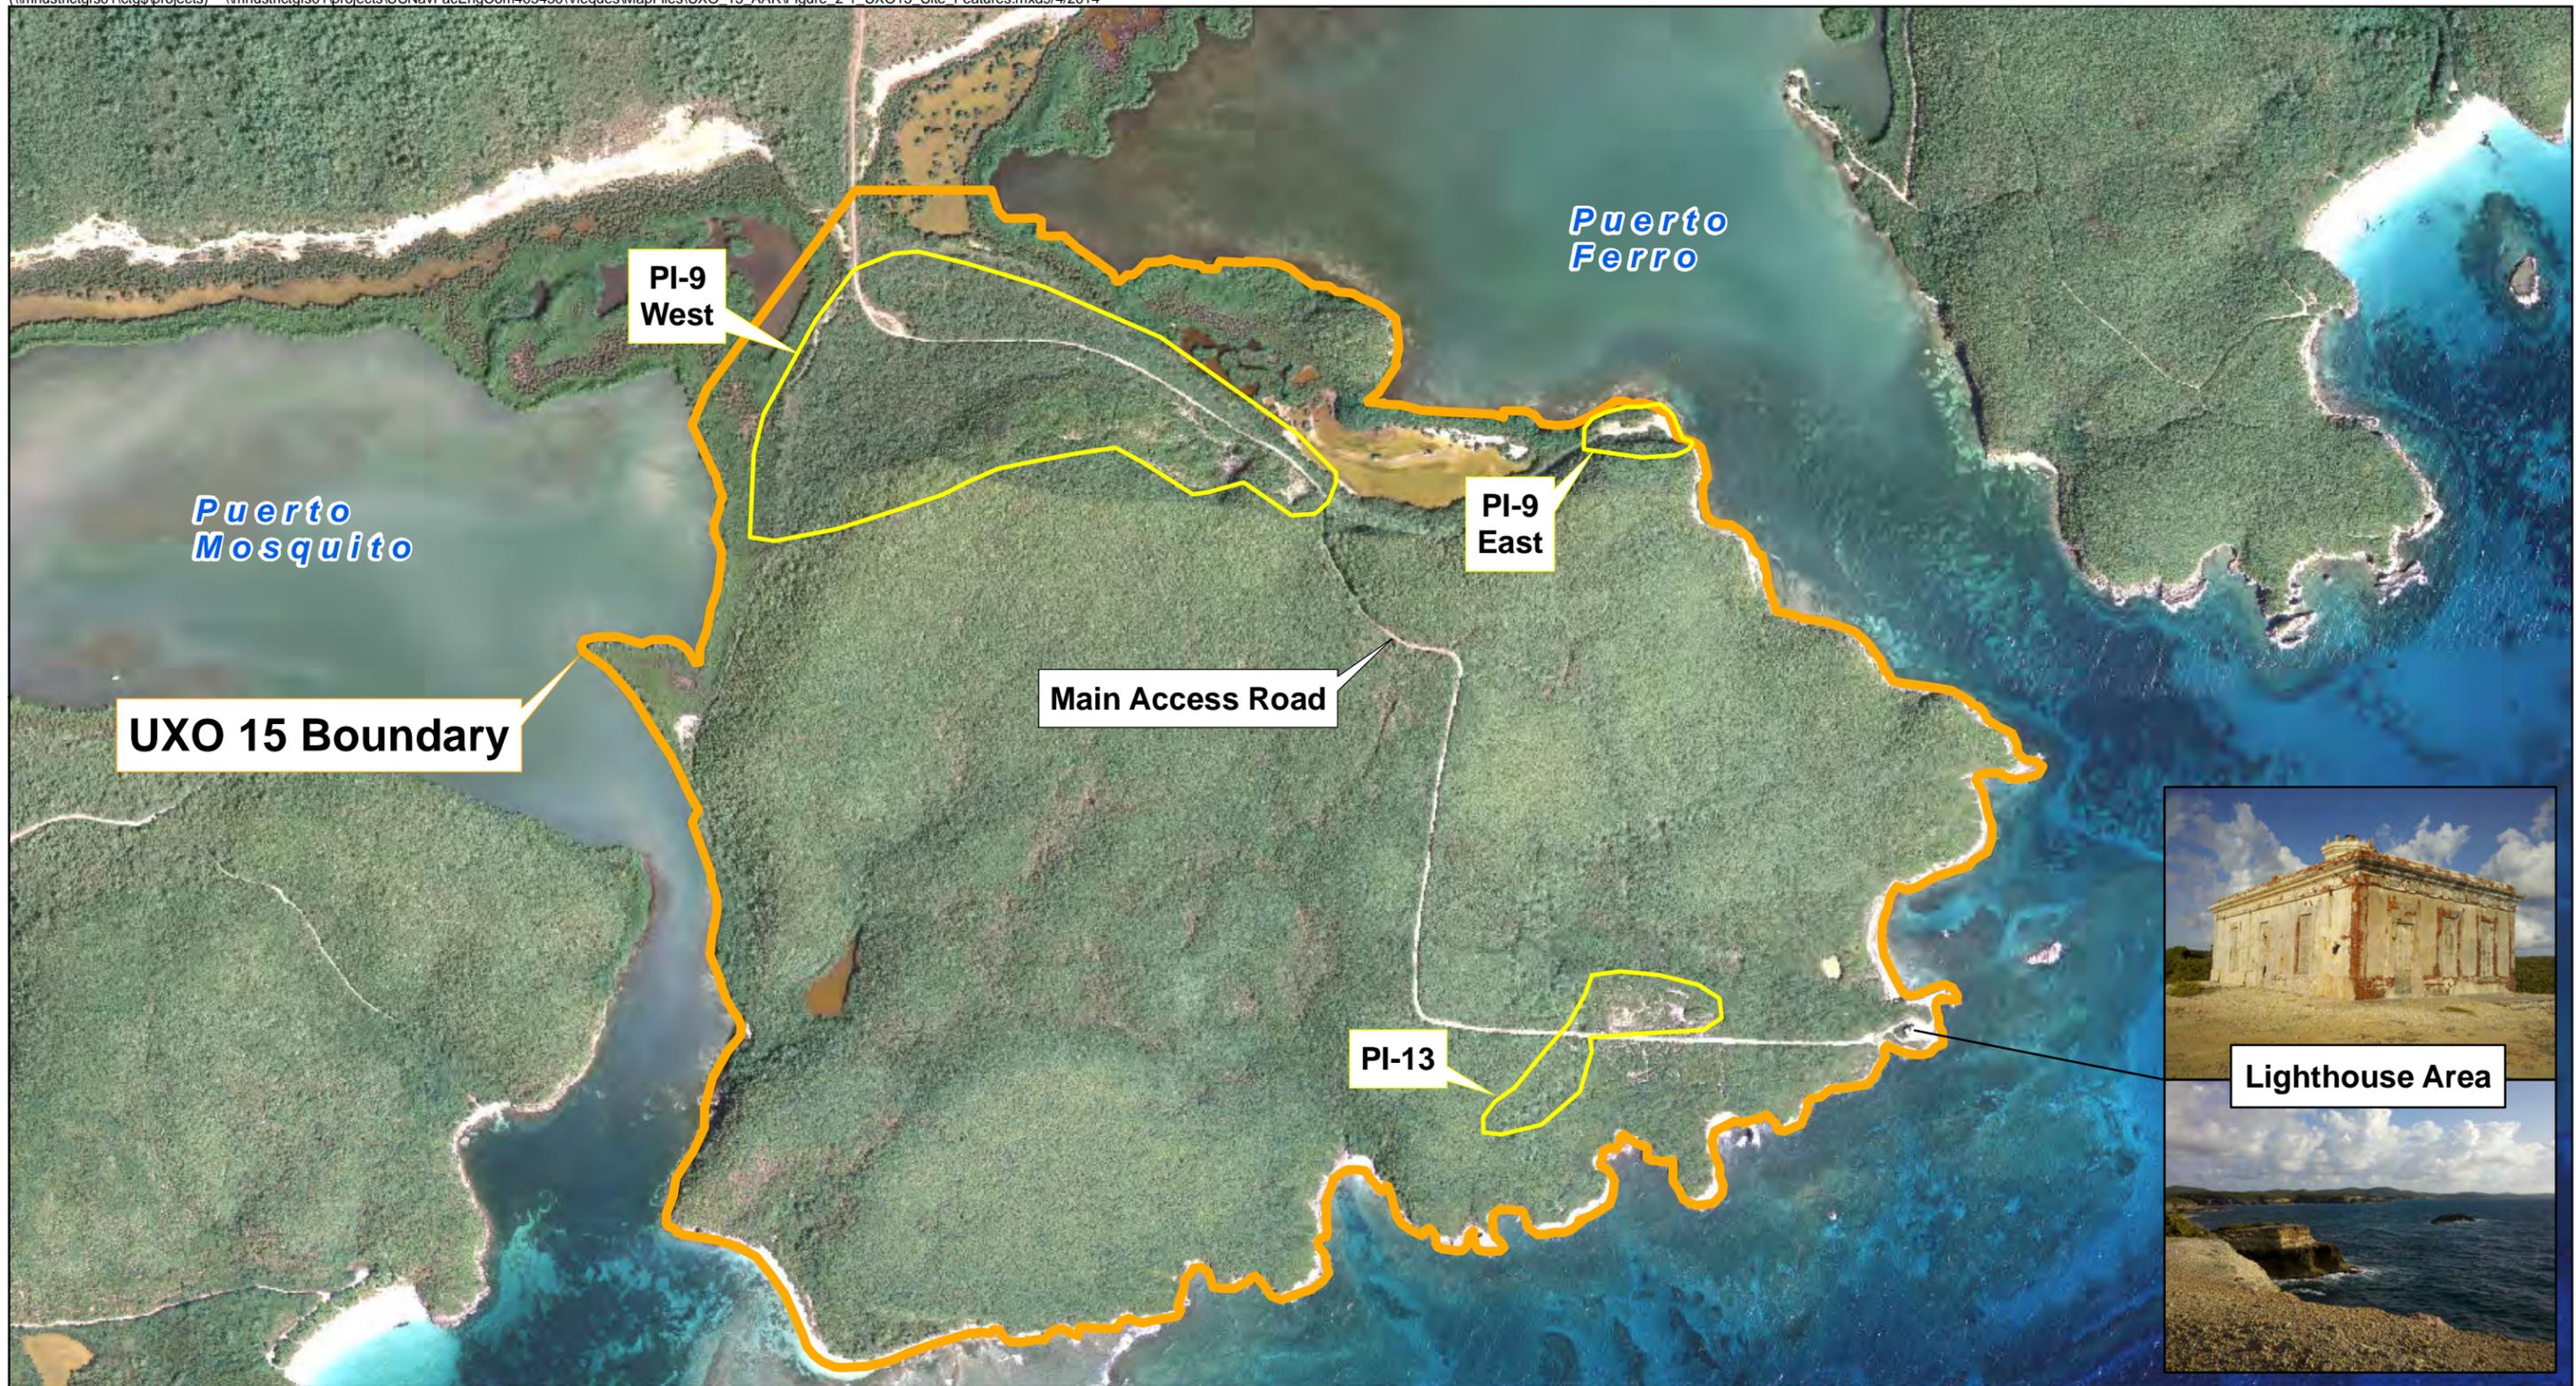
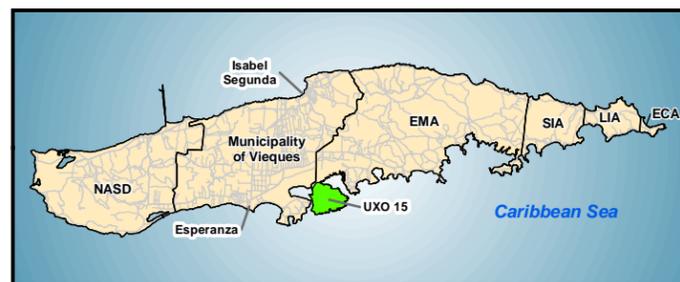
Figure 2-1
UXO 15 Site Features
 UXO 15 After Action Report
 Former Vieques Naval Training Range
 Vieques, Puerto Rico

2007 Aerial Imagery

- UXO 15 is approximately 535 acres, located in the southwestern portion of the EMA, and includes Photo Identified (PI) Sites PI 9 and PI 13 (**Figure 2-1**). PI 9 was likely used for ammunition storage based on historical information, aerial photographs, and recent investigation. PI 13 may have been the firing point from which long-range artillery was launched to the LIA/SIA; however, no evidence of this use has been found during investigations within the area. A summary of the investigations conducted within or including UXO 15 is presented in Section 2.2.

- The former VNTR was transferred to the Department of Interior (DOI) in 2003 to be operated and managed by the USFWS as a National Wildlife Refuge.
- In 2007, USFWS constructed the main access road to the lighthouse (**Figure 2-1**) to allow workers access to the lighthouse and surrounding area; the road was built with geotextile followed by a 6-inch-thick aggregate.

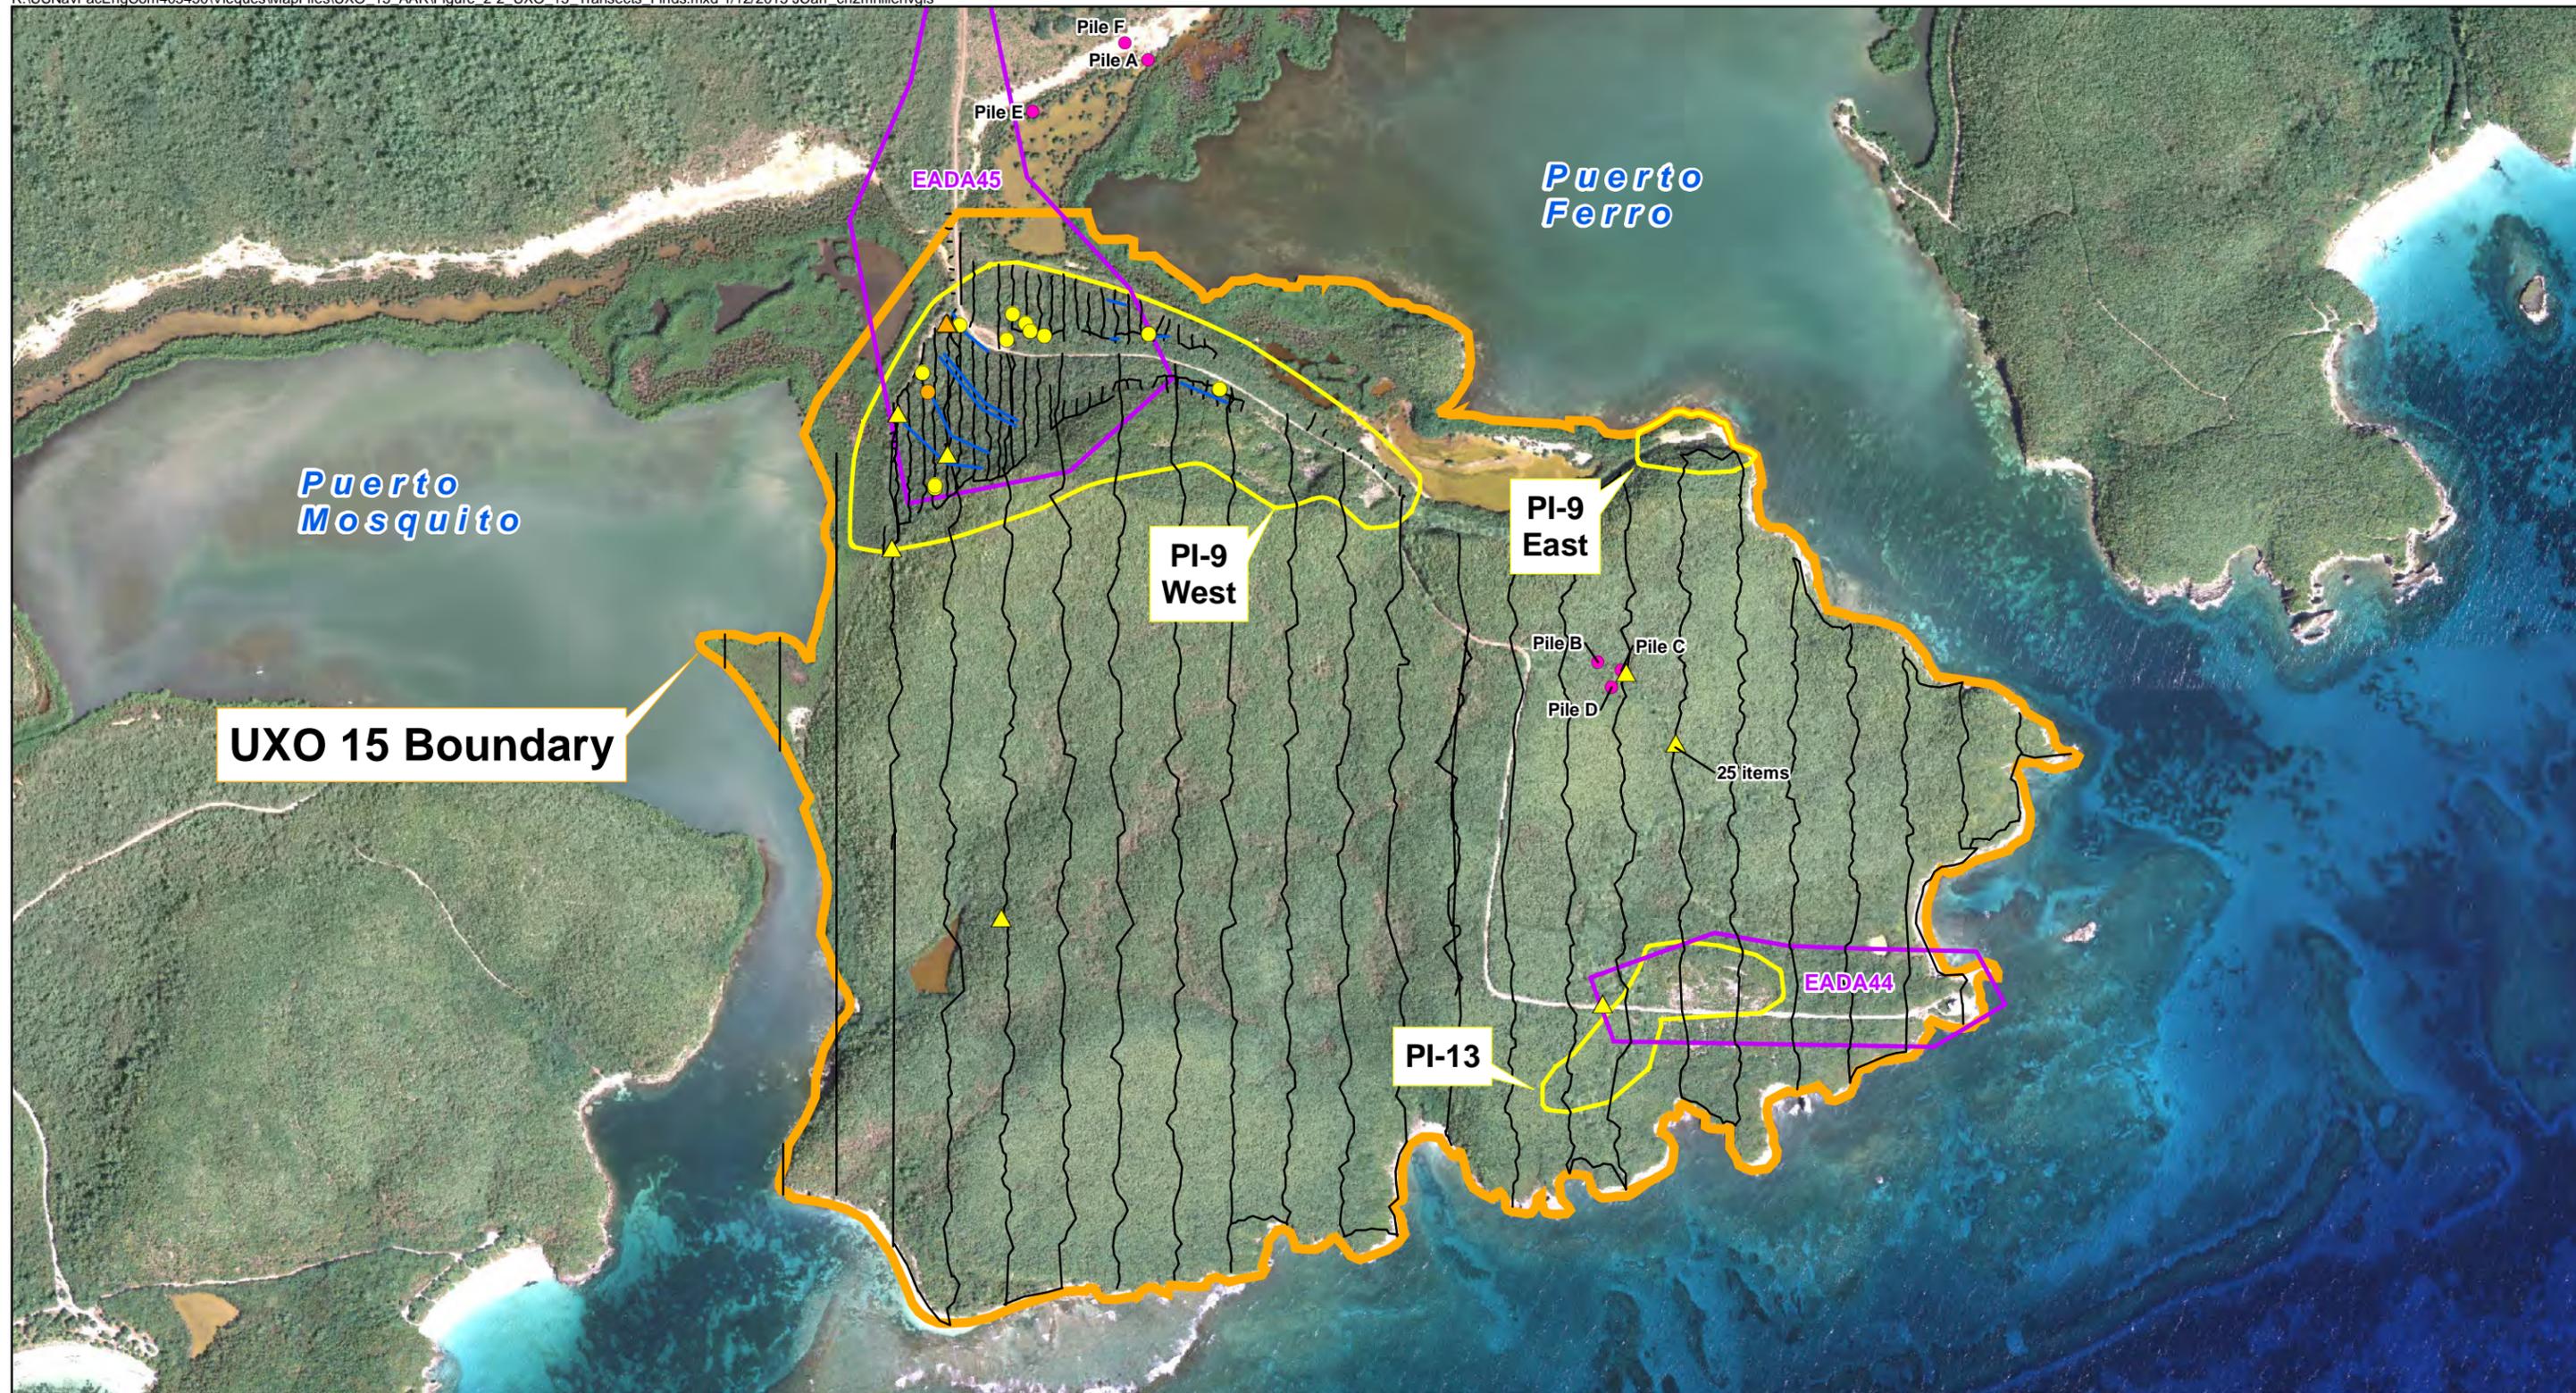
Figure 2-2
UXO 15 Transects and Finds
 UXO 15 After Action Report
 Former Vieques Naval Training Range
 Vieques, Puerto Rico

- The Expanded Range Assessment/Site Inspection (ERA/SI) identified 31 munitions debris (MD) items, one MPPEH item, and five debris piles (Piles A through E in **Figure 2-2**); munitions-related items encrusted in the rock in the eastern portion of PI 9; and two elevated anomaly density areas from an aerial magnetometer survey at UXO 15 (**Figure 2-2**); munitions were not identified along the main access road or areas around the lighthouse that are readily accessible. The ERA/SI recommended further investigation of the debris piles and encrusted munitions-related items and evaluation of the potential ecological and human health risks (CH2M HILL, 2010).

The yellow triangles shown have one MD item per location except for a single location which has 25 MD items as listed on the figure.

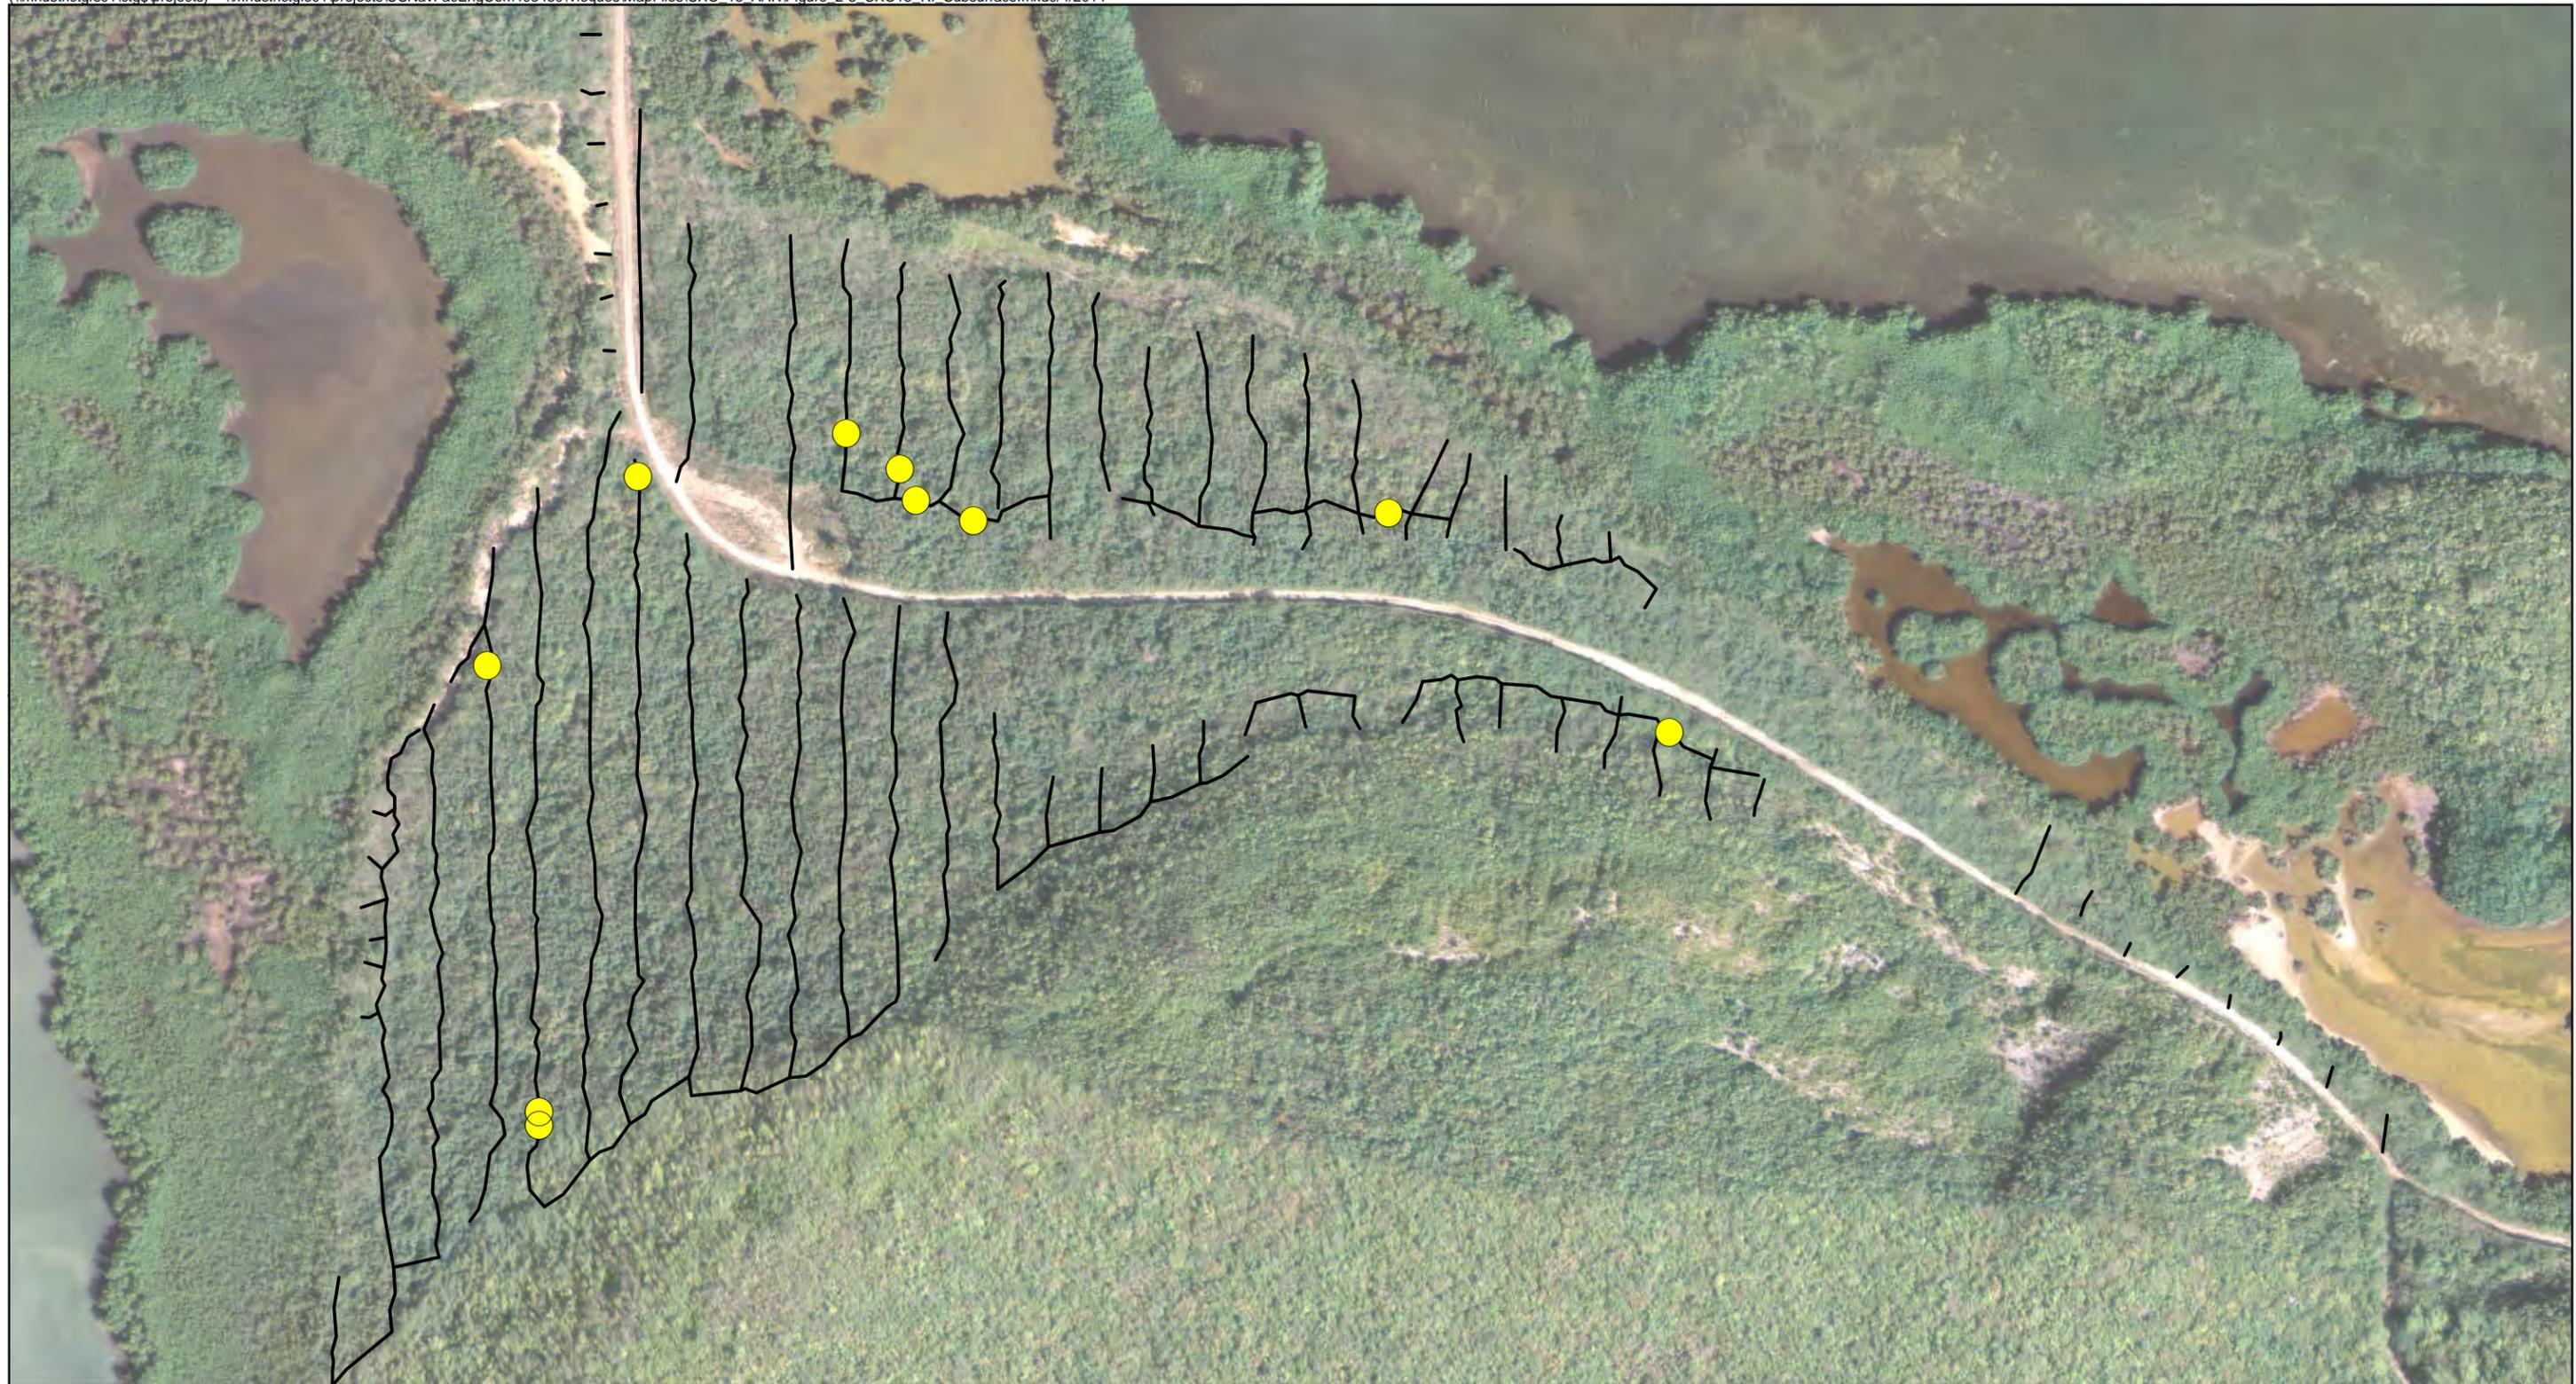
Figure 2-3
UXO 15 RI Subsurface Items
UXO 15 After Action Report
Former Vieques Naval Training Range
Vieques, Puerto Rico

- A Remedial Investigation (RI) was initiated in 2012 to characterize the potential presence of subsurface munitions; characterize the potential for a release of hazardous constituents to soil and sediment from subsurface munitions (if found) and from the surface debris piles; characterize the extent of the encrusted munitions-related items; and determine the appropriate path forward for UXO 15. As part of the RI activities Debris Piles A through E were investigated and removed; however during the removal activities an additional pile, Debris Pile F, was discovered and also addressed (as noted in the RI Status Report [CH2M HILL, 2013]). The RI is ongoing (CH2M HILL, 2013). During the investigation to date, only one MEC item (a teargas grenade classified as a discarded military munitions [DMM]) was found at the site on the ground surface and no MEC was found in the subsurface. Several berms were found throughout the northern portion of the site that will be the subject of future evaluation as part of the RI. The locations of the items found on the ground surface and the berms are presented in **Figure 2-2**. The locations of the subsurface items found during the intrusive investigation are shown on **Figure 2-3**.

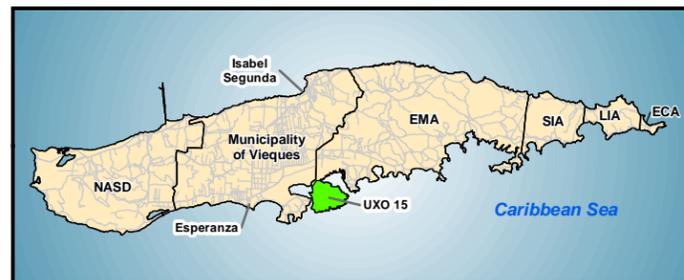
Legend
● MD Item
— Surveyed Transect

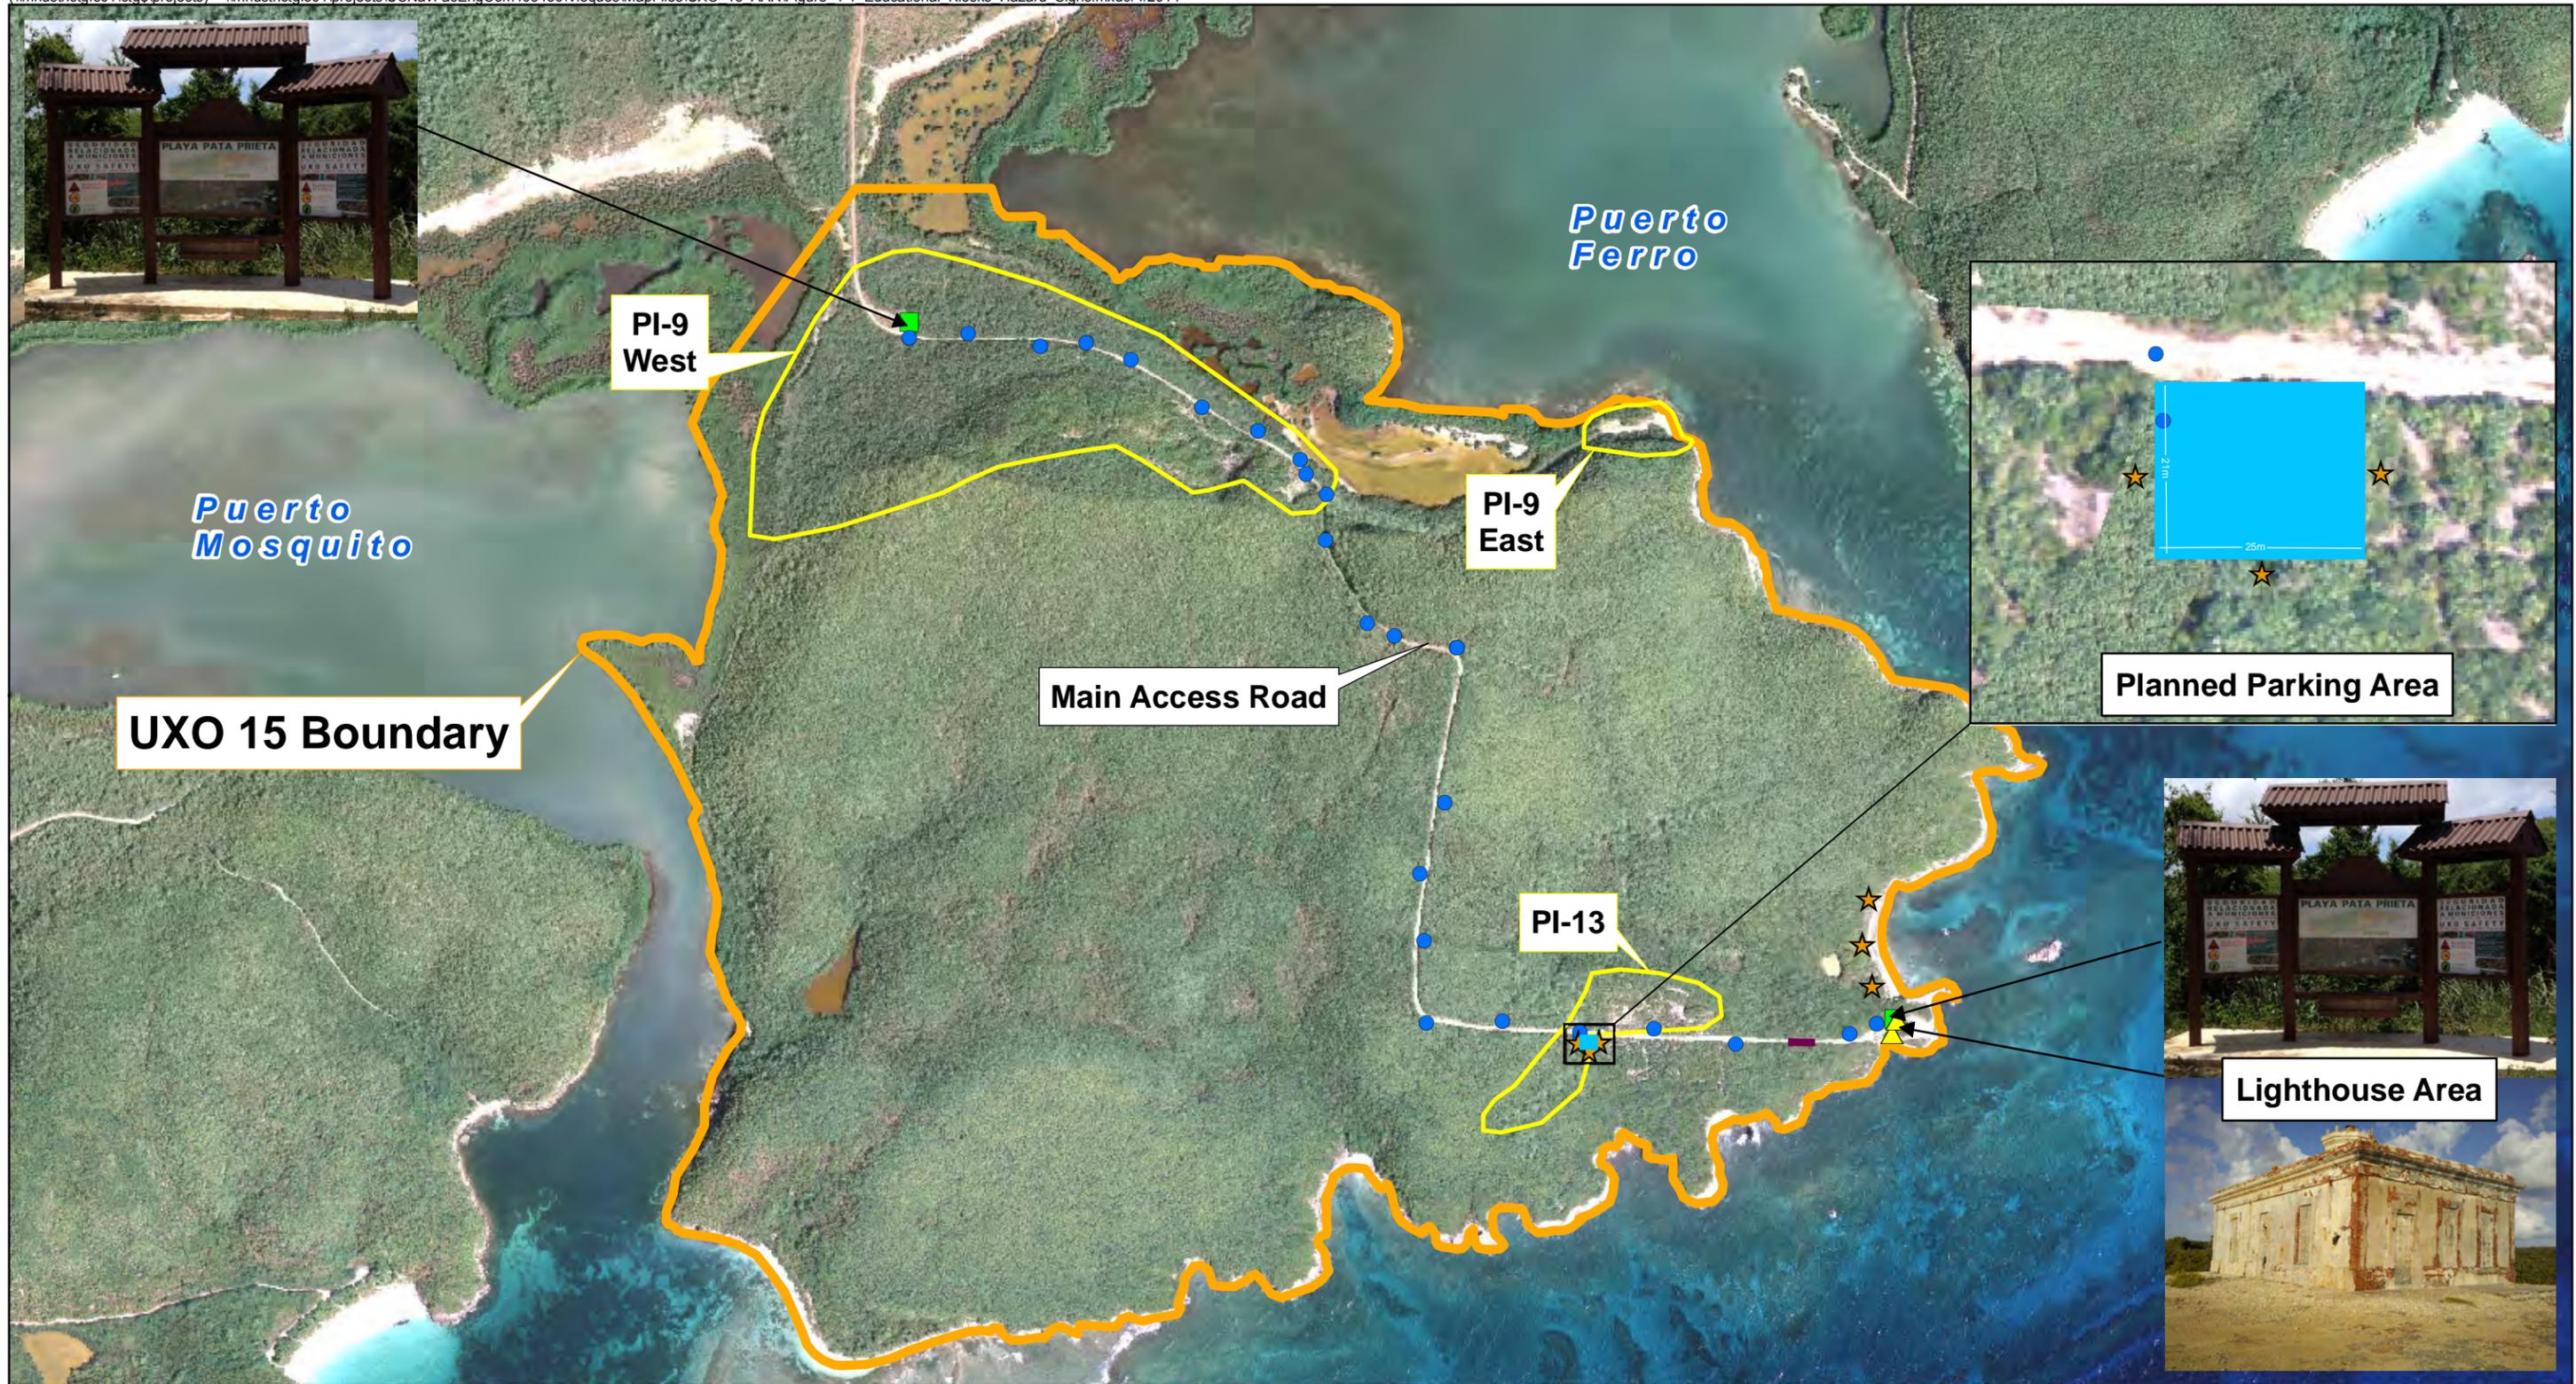
Figure 4-1
Location of Educational Kiosks and Hazard Warning Signs
 UXO 15 After Action Report
 Former Vieques Naval Training Range
 Vieques, Puerto Rico

- Thirty-three hazard warning signs were installed from August 27 through August 29, 2014 (**Figure 4-1** and **Appendix A**). The text of each sign was provided in both Spanish and English, as shown in **Appendix B**. Three different sign types were installed based on the location of the sign, as follows:

- “Explosive Hazard! Stay on Road, No Parking” – 25 signs
 - “Explosive Hazard! No Access Beyond This Point” – 6 signs
 - “Explosive Hazard! For Your Safety Stay on Marked Trail” – 2 signs

- Two wooden educational kiosks were installed from August 6 through August 13, 2014; one kiosk was installed near the location of the access gate along the main access road and one kiosk was installed adjacent to the lighthouse (**Figure 4-1**). UXO-qualified personnel provided MEC avoidance support during the kiosk installation activities.
- Each kiosk was constructed on 12-foot by 6-foot concrete pads and provides three display panels; each kiosk has two 3-foot by 3-foot panels for displaying MEC awareness and reporting procedures/USFWS-specific information and one 5-foot by 3-foot (width x height) panel for displaying the location of the access road, the historic lighthouse, the kiosks, the areas permitted for public access, and the restricted areas.

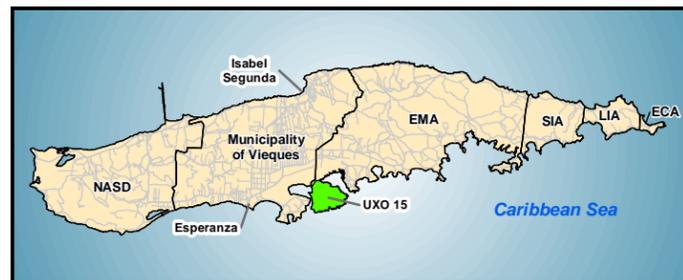
- Legend**
- ★ "No Access Beyond This Point" Warning Sign
 - "Stay On Road" Warning Sign
 - ▲ "Stay on Marked Trail" Warning Sign
 - Educational Kiosk
 - Planned Parking Area
 - Area Containing *Varronia rupicola*

- Prior to vegetation cutting to facilitate sign/kiosk installation and MEC clearance, USFWS was consulted to ensure that any protected plant species were identified and protected from being cut or damaged. USFWS identified a location along the southern edge of the road near the lighthouse where a protected species, *Varronia rupicola*, is present, and this area was avoided (**Figure 4-1**).

- All hazard warning sign and educational kiosk locations were selected in the field on July 23, 2014, by representatives from the Navy, EPA, PREQB, and USFWS (**Figure 4-1**). Sign and kiosk locations were selected to ensure visibility by the public accessing the lighthouse area and adjacent beach once opened by USFWS.
