FINAL AFTER ACTION REPORT NON-TIME CRITICAL INTERIM REMOVAL ACTION MAIN
ACCESS ROAD, LIGHTHOUSE AREA, TRAILS, AND BEACHES UNEXPLODED ORDNANCE
15 (UXO 15) ATLANTIC FLEET WEAPONS TRAINING AREA FORMER VIEQUES NAVAL
TRAINING RANGE VIEQUES ISLAND PUERTO RICO

**After Action Report
Non-Time Critical Interim Removal Action
Main Access Road, Lighthouse Area, Trails, and Beaches
UXO 15**

**Atlantic Fleet Weapons Training Area—Vieques
Former Vieques Naval Training Range
Vieques, Puerto Rico**

February 2015

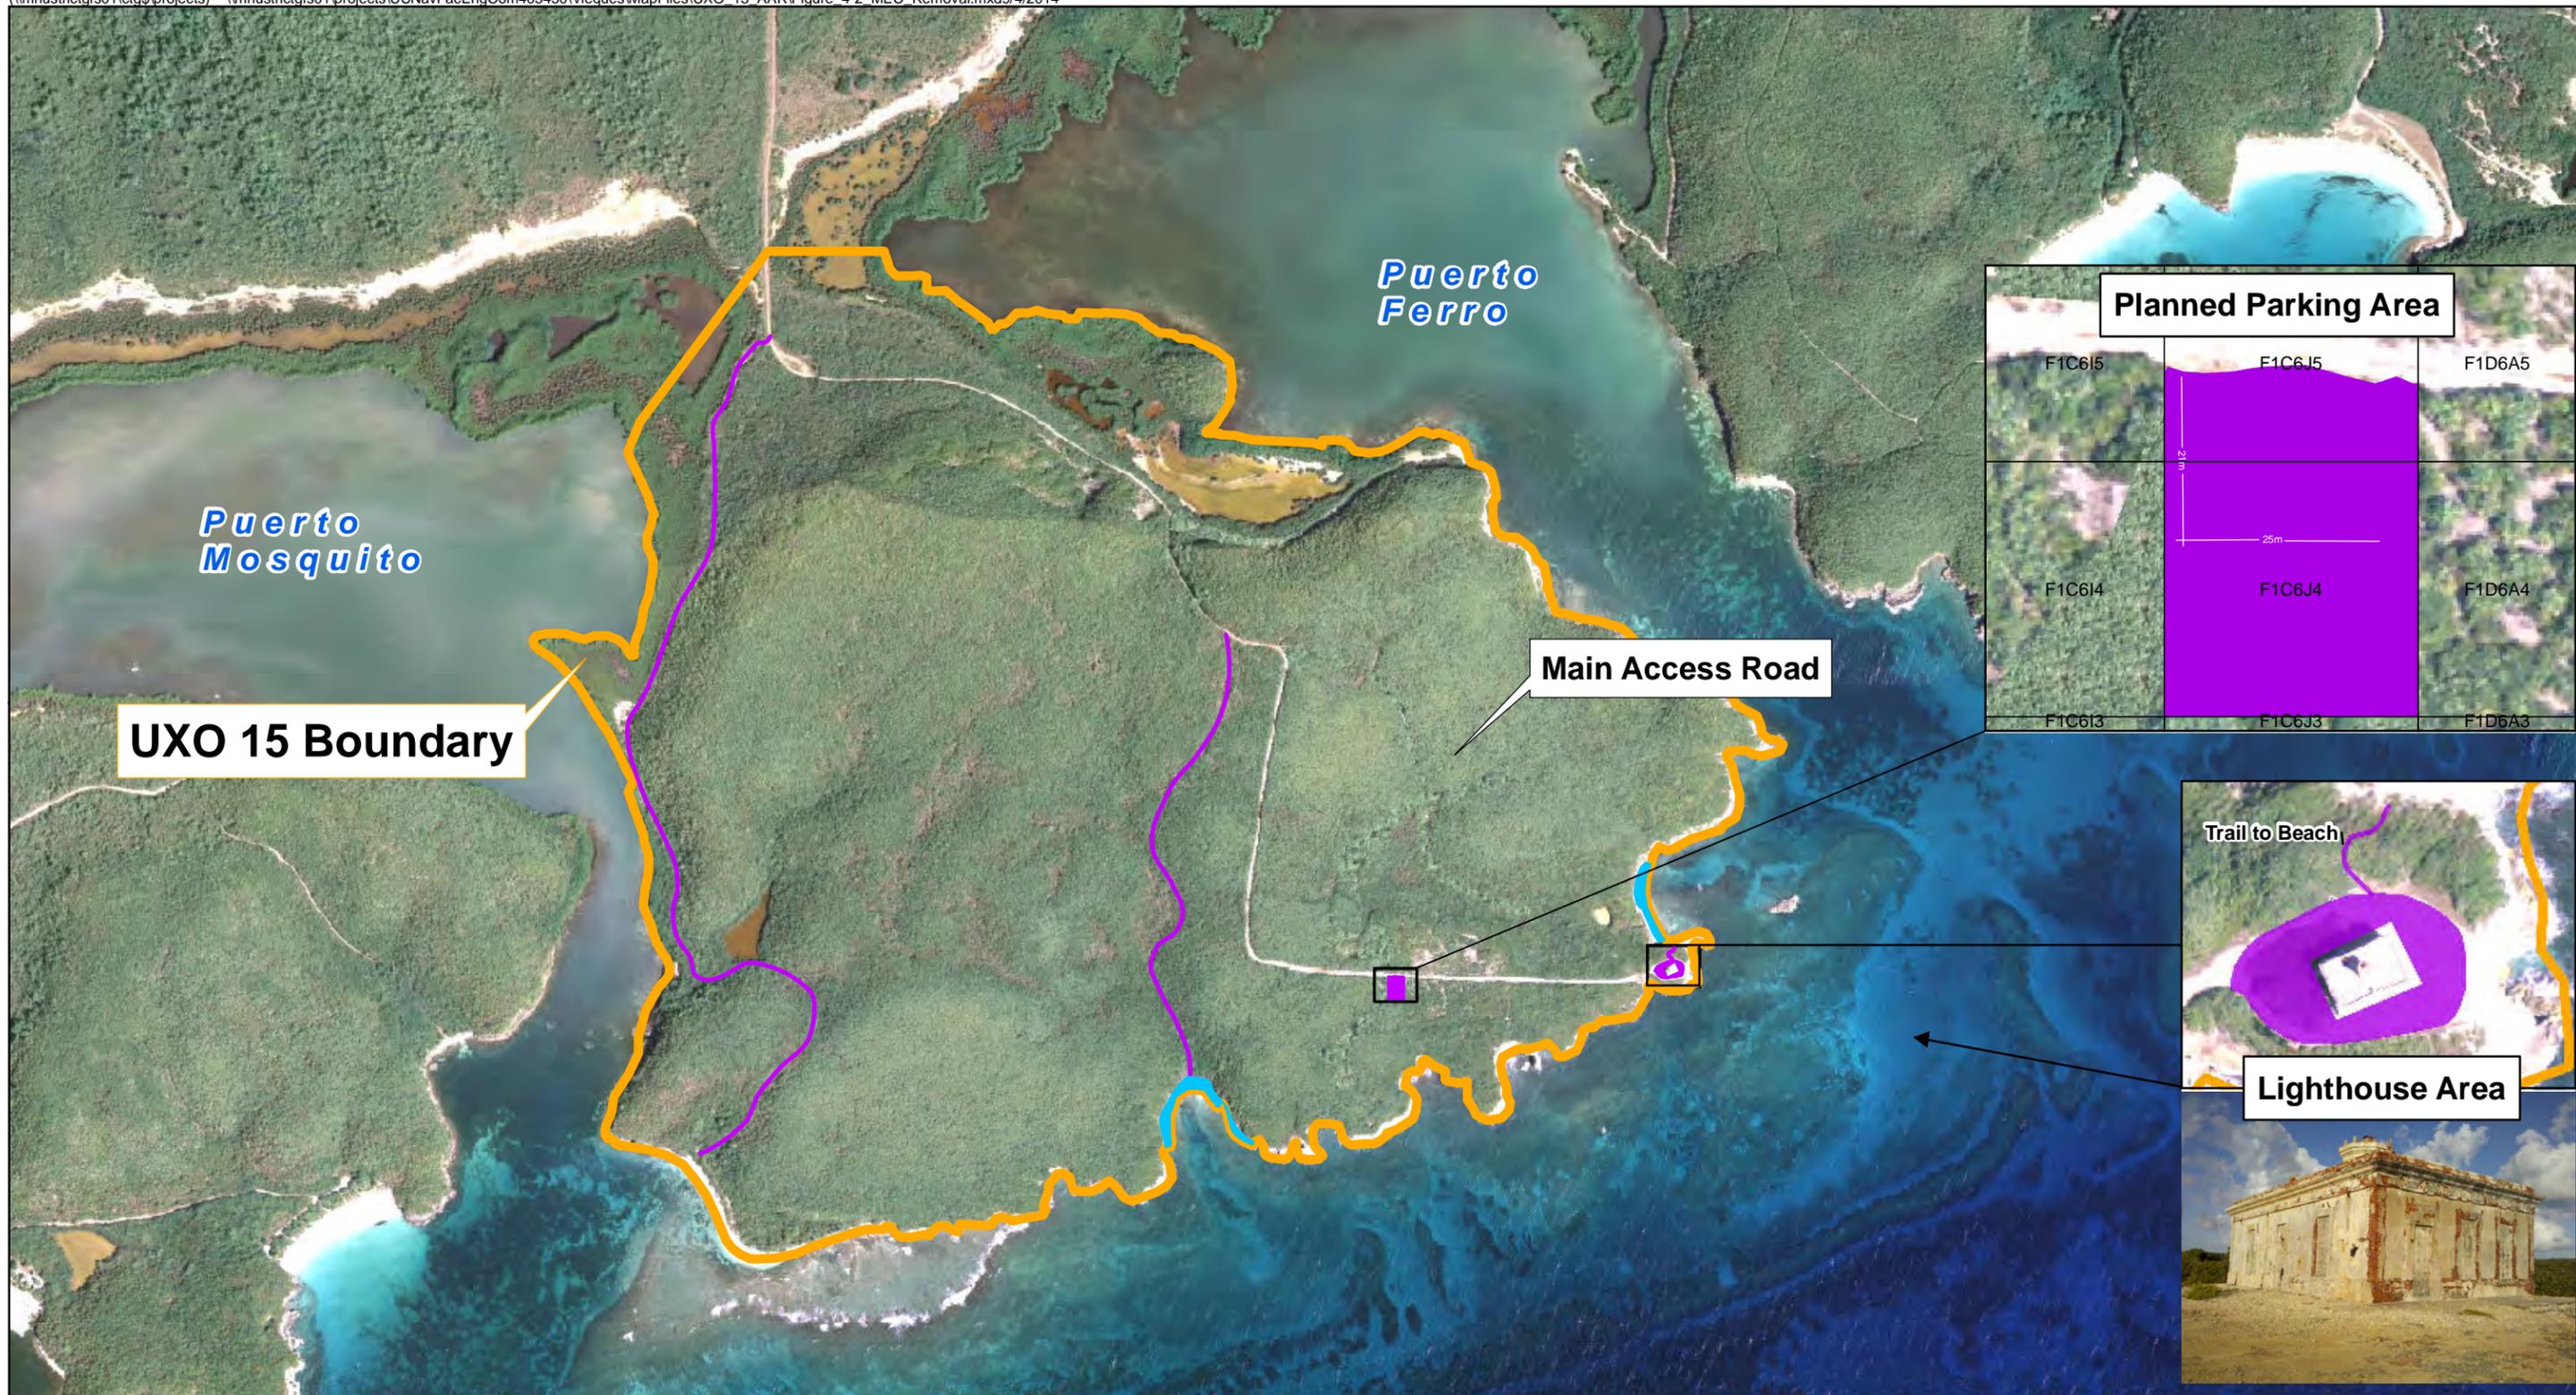
Figure 4-2
MEC Clearance Areas
 UXO 15 After Action Report
 Former Vieques Naval Training Range
 Vieques, Puerto Rico

MEC clearance was conducted at the two easternmost beaches (**Figure 4-2**) in accordance with the NTCRA for the roads and beaches (CH2M HILL, 2008a), modified via Field Change Request 2, which was approved by EPA and PREQB on January 14, 2014. The scope of this activity was to determine the presence of subsurface anomalies in the sandy beach areas between the existing vegetation line at the beaches and the edge of the water (using digital geophysical mapping [DGM]) and intrusively investigate all anomalies to a depth of 4 feet or until refusal/water was encountered.

MEC clearance at the lighthouse area, parking area, and trails (**Figure 4-2**) was conducted in accordance with the NTCRA for the roads and beaches (CH2M HILL, 2008a), modified via Field Change Request 3, which was approved by EPA and PREQB on July 6 and 7, 2014, respectively. Due to the historic use of the area and the shallow bedrock, "mag-and-dig" procedures were used for MEC surface and subsurface clearance (estimated to an approximate depth of 1 foot).

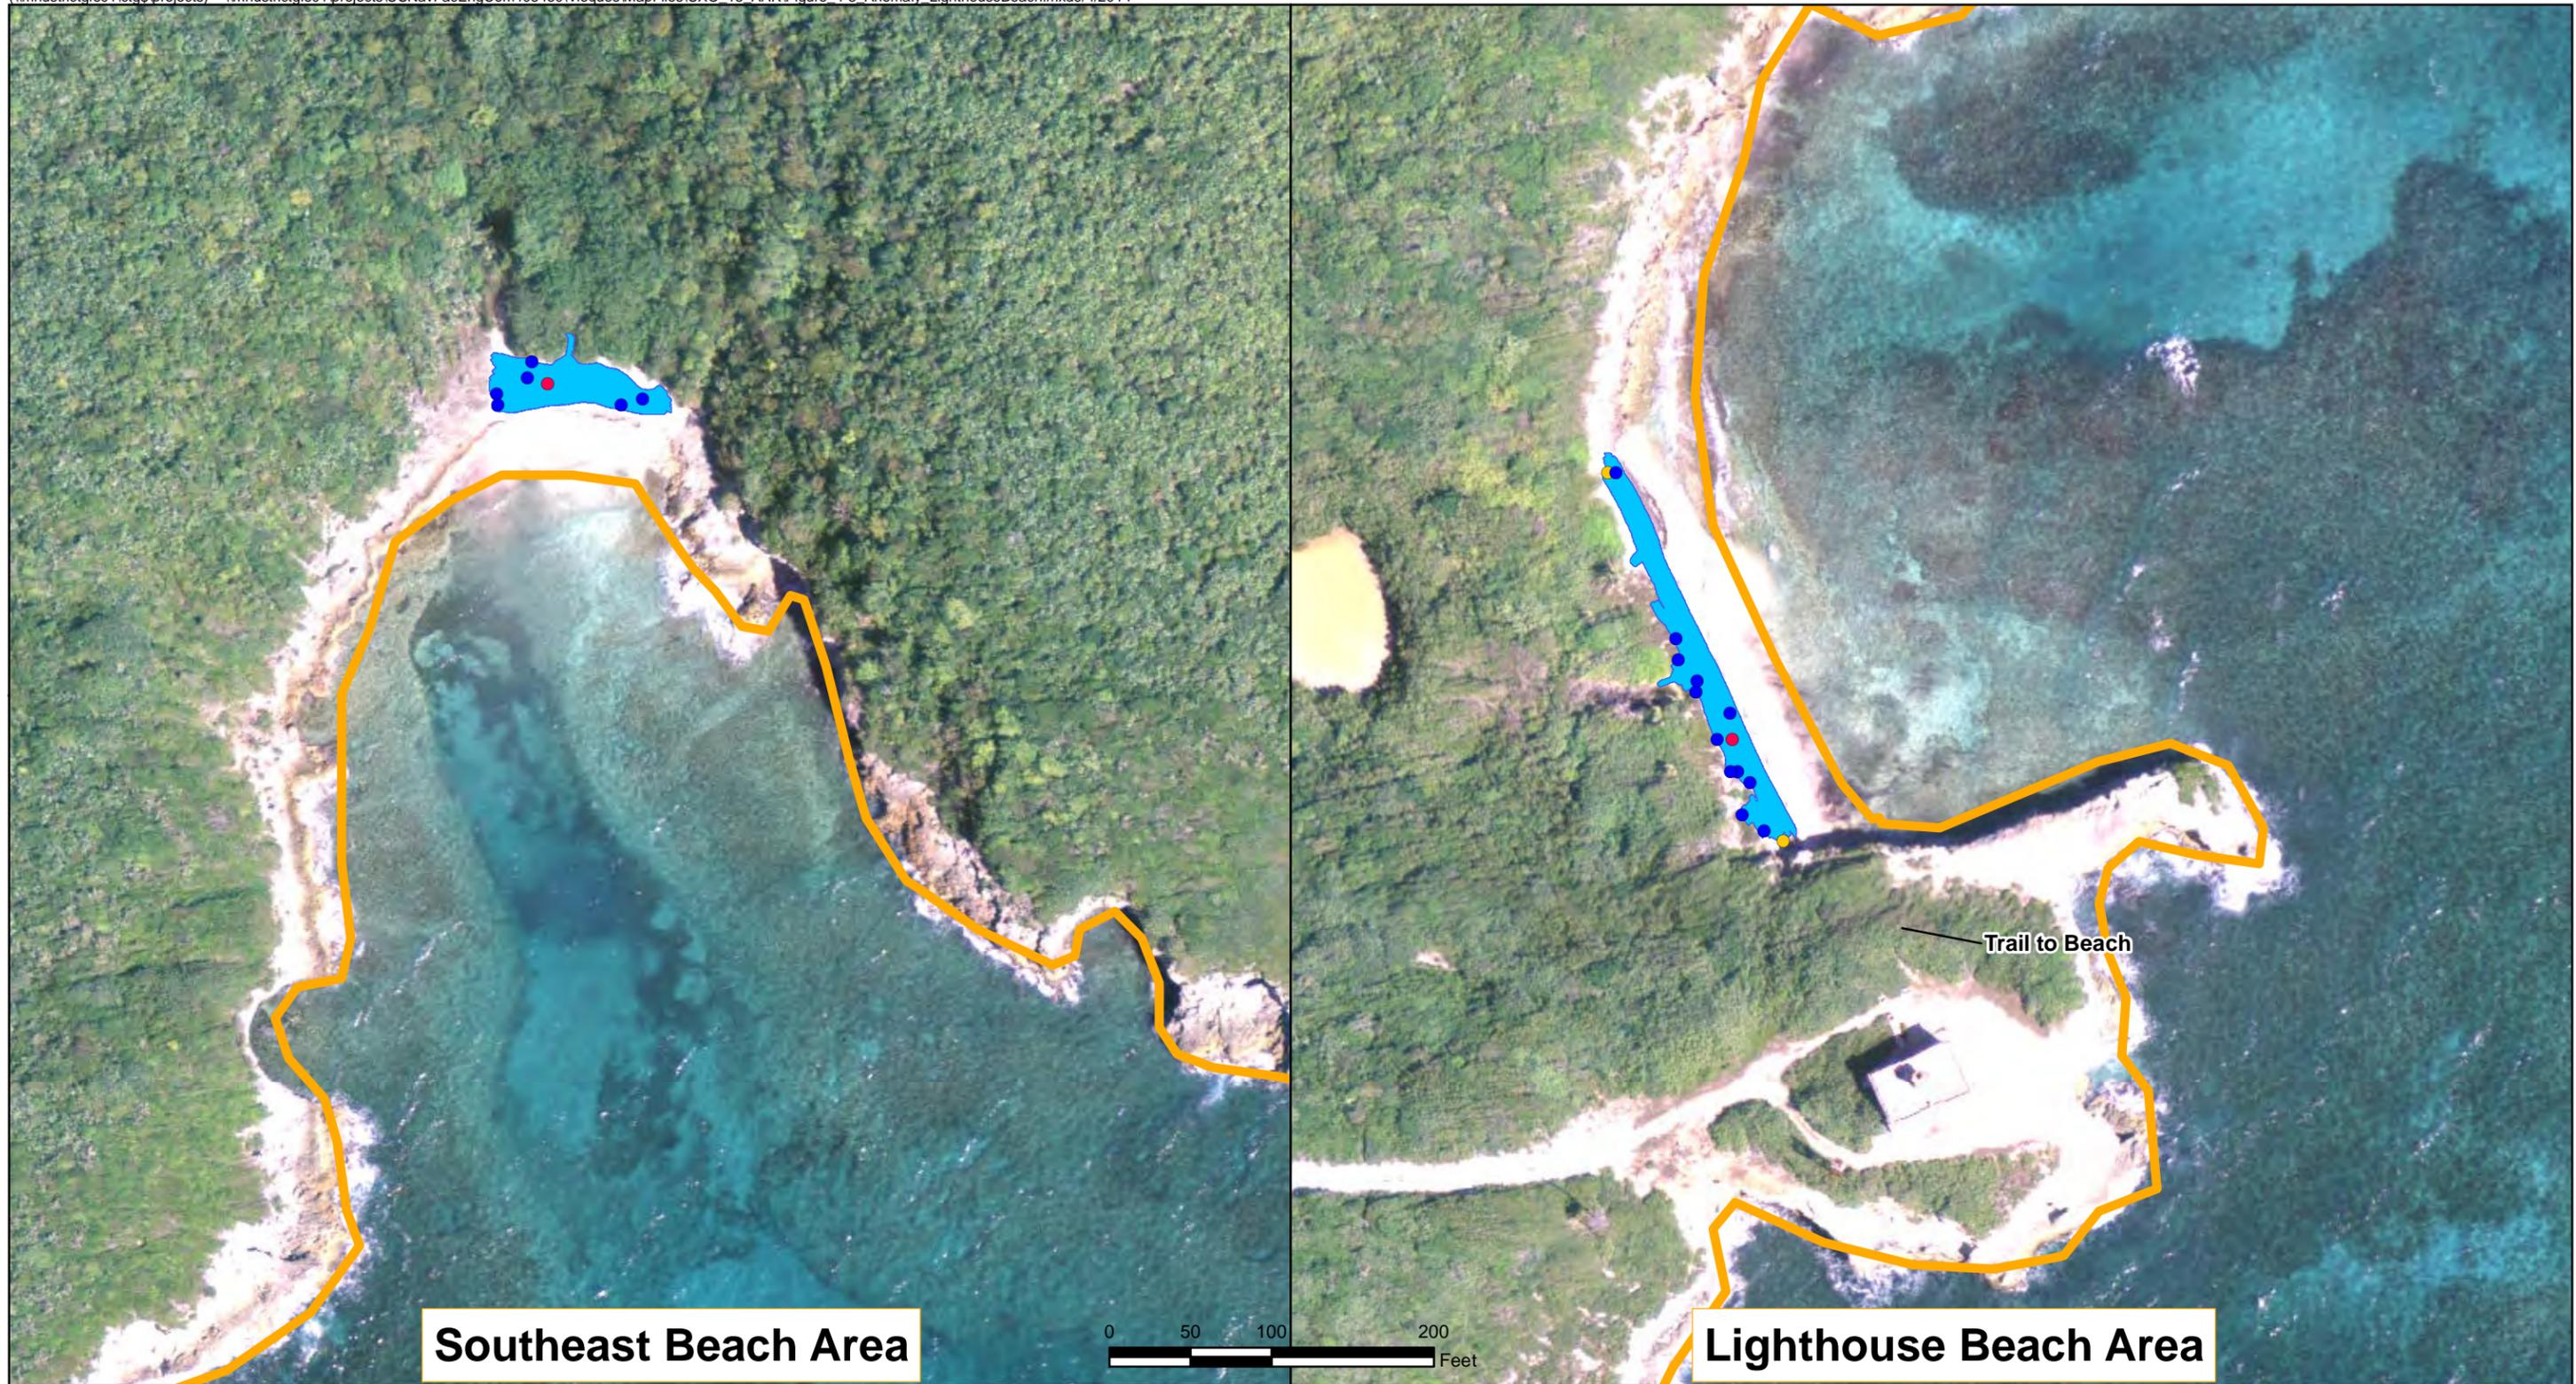
Figure 4-3
Southeast Beach and Lighthouse Beach
Anomaly Investigation Results
 UXO 15 After Action Report
 Former Vieques Naval Training Range
 Vieques, Puerto Rico

- A DGM survey was conducted using a Geonics EM-61 MK2 by CH2M HILL from June 5 through June 6, 2014; a total of 22 subsurface anomalies were identified at the two beaches that were subsequently intrusively investigated. The results of the anomaly investigation are presented below and shown in **Figure 4-3**. It should be noted that the entire sandy areas of the two beaches were surveyed and, due to the dynamic nature of the beaches, the existing footprint of the sandy beach area was smaller at the time of the NTCRA than it appears on the aerial photograph from 2007 that was used to create **Figure 4-3**.

- 18 cultural debris items identified as general trash.
 - 2 QC seeds placed prior to DGM activities to ensure the DGM equipment was capable of identifying anomalies at the site and to verify the positional accuracy of the DGM results.

- 2 "no finds" where the anomaly location was re-acquired and the millivolt (mV) reading for the reacquire was below the minimum anomaly threshold (2.5 mV) established in the work plan for the NTCRA for the roads and beaches (CH2M HILL, 2008a).

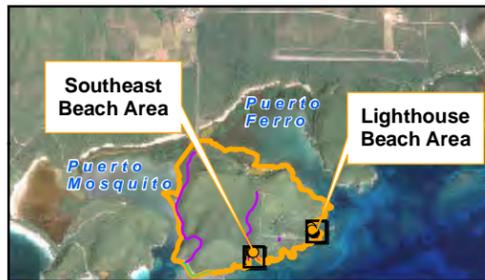
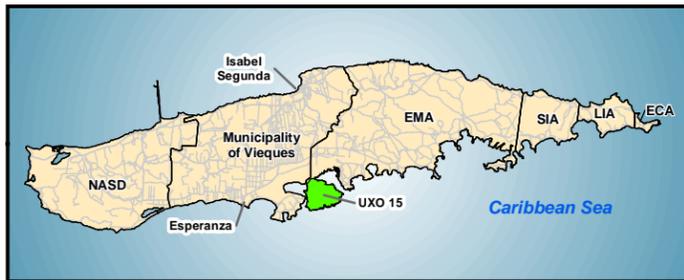
- Legend**
- Cultural Debris
 - No Find
 - QC Seed
 - UXO 15
 - DGM Area

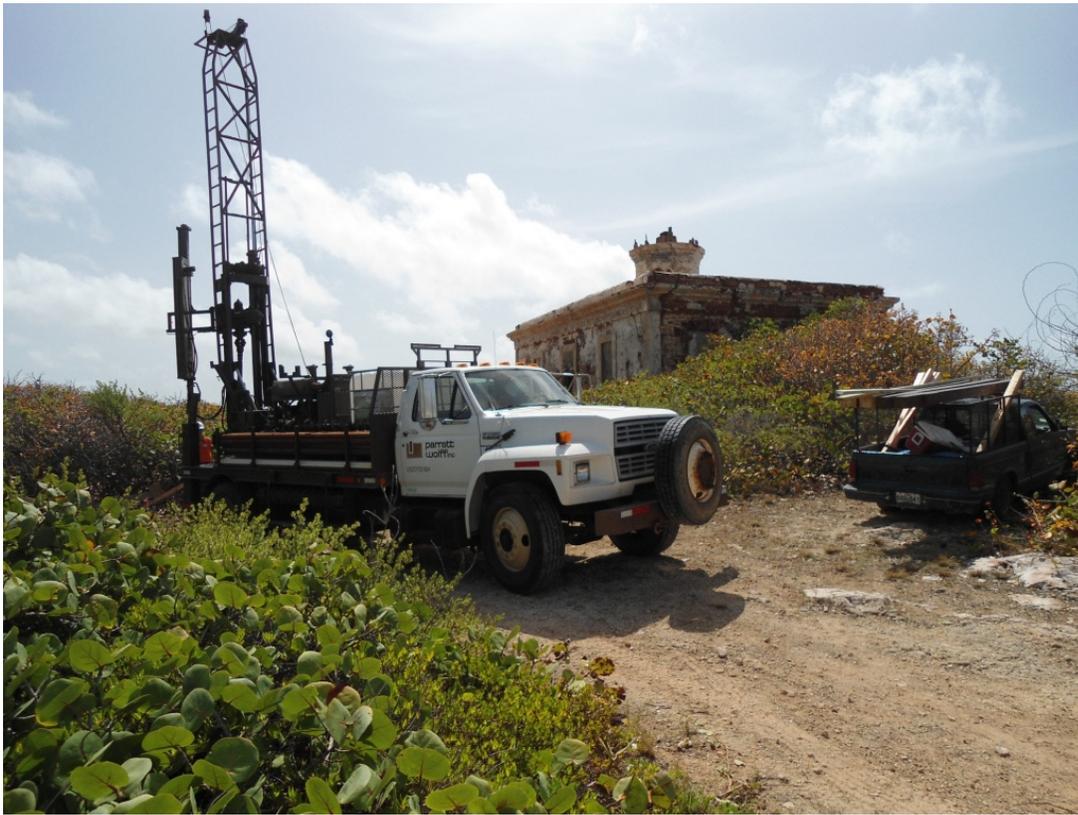
Photo 1 – Drilling boreholes for hazard warning signs along main access road

- Thirty-three hazard warning signs were installed from August 27 through August 29, 2014 (**Figure 4-1** and **Appendix A**). The text of each sign was provided in both Spanish and English, as shown in **Appendix B**. Three different sign types were installed based on the location of the sign, as follows:

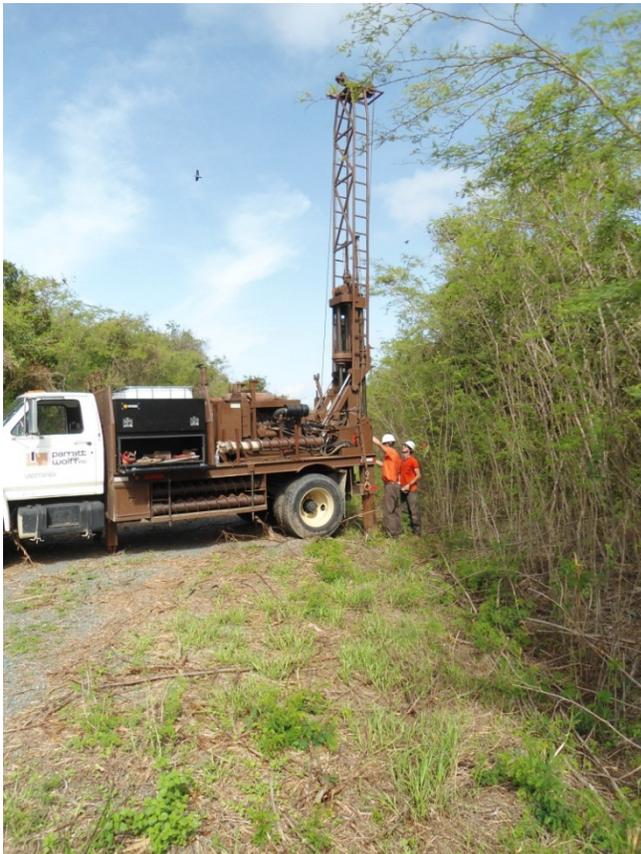
Photo 2 – Drilling boreholes for hazard warning signs along main access road

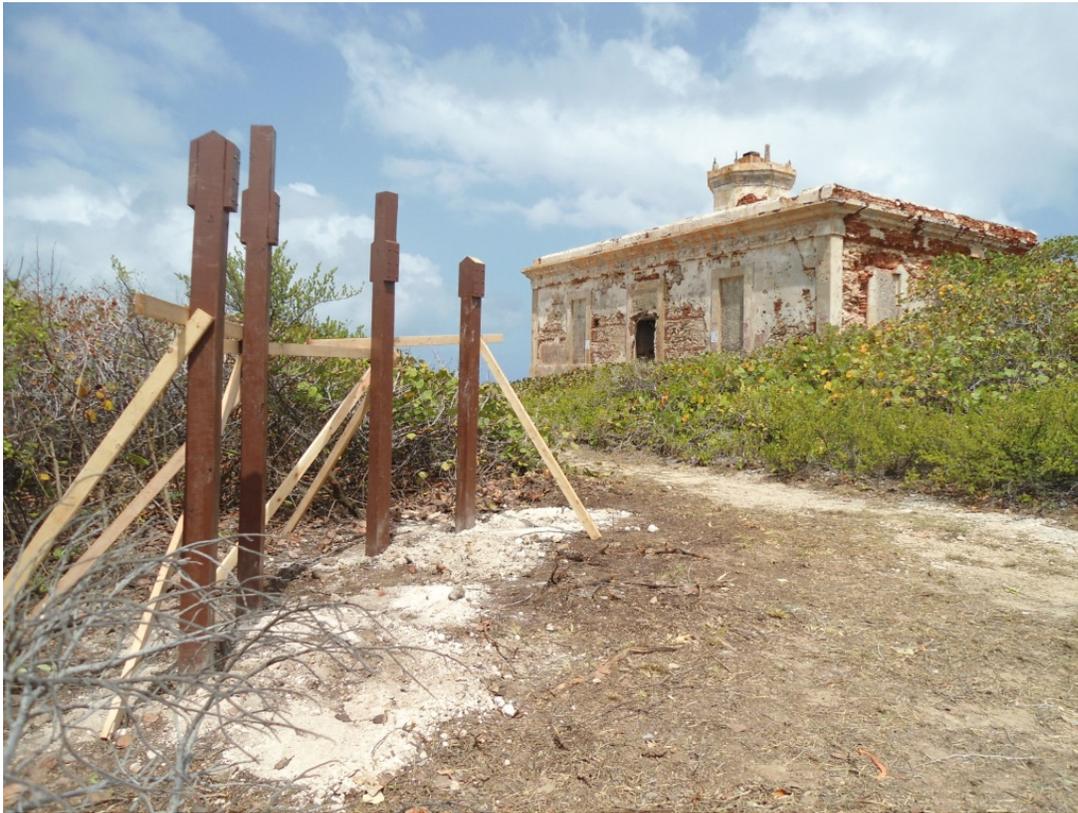
Photo 3 – Educational kiosk under construction near the historic lighthouse.

- Two wooden educational kiosks were installed from August 6 through August 13, 2014; one kiosk was installed near the location of the access gate along the main access road and one kiosk was installed adjacent to the lighthouse (**Figure 4-1**). UXO-qualified personnel provided MEC avoidance support during the kiosk installation activities.
- Each kiosk was constructed on 12-foot by 6-foot concrete pads and provides three display panels; each kiosk has two 3-foot by 3-foot panels for displaying MEC awareness and reporting procedures/USFWS-specific information and one 5-foot by 3-foot (width x height) panel for displaying the location of the access road, the historic lighthouse, the kiosks, the areas permitted for public access, and the restricted areas.

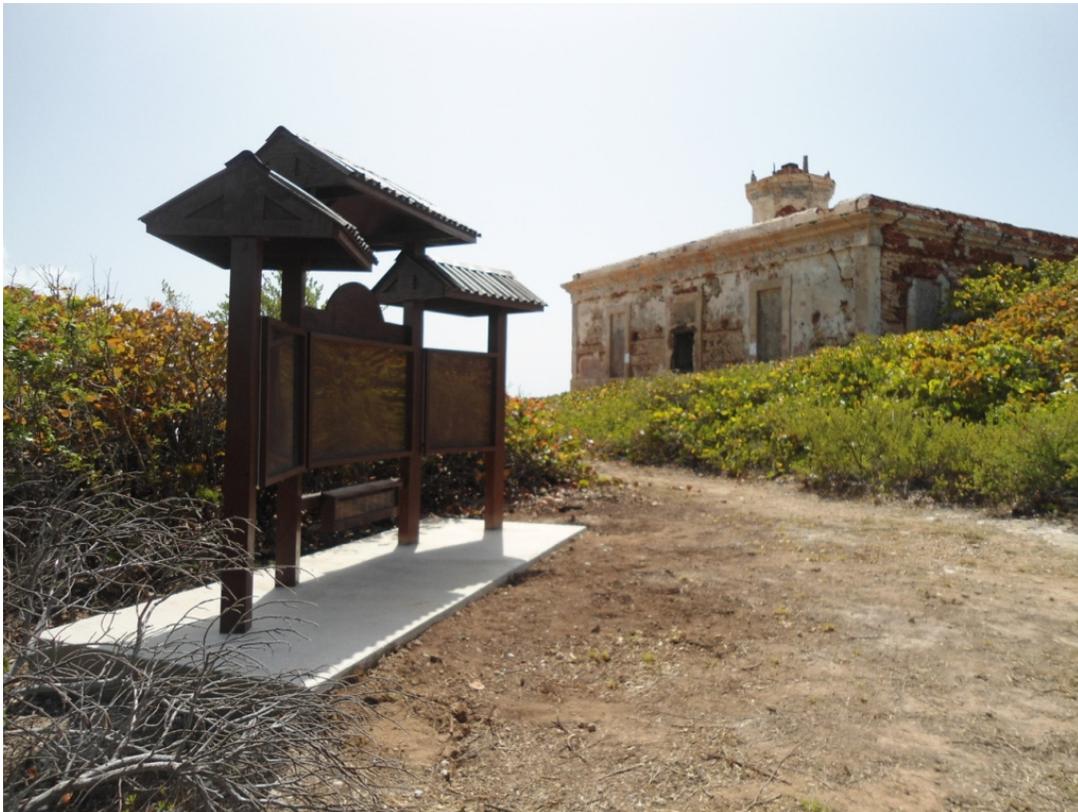
Photo 4 – Completed kiosk structure near the historic lighthouse.

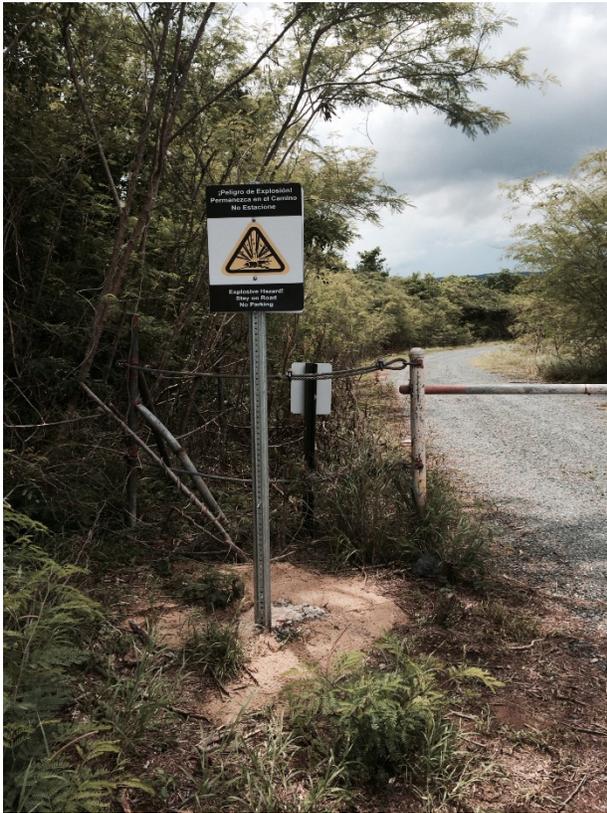
Photo 5 – Example warning sign along the main access road advising users to stay on the road and not to park.

- Each sign is approximately 17-inches by 22-inches (width x height). Other than on the beach, the tops of the signs are nominally 5 feet above the ground surface on 2-inch metal U-channel sign posts. Unexploded ordnance (UXO)-qualified personnel provided MEC avoidance support during the sign installation activities. The signs on the beach were constructed of concrete blocks that are approximately 18-inches high and 23-inches in diameter. The concrete blocks are painted yellow with the warning message and graphic stenciled on the block.

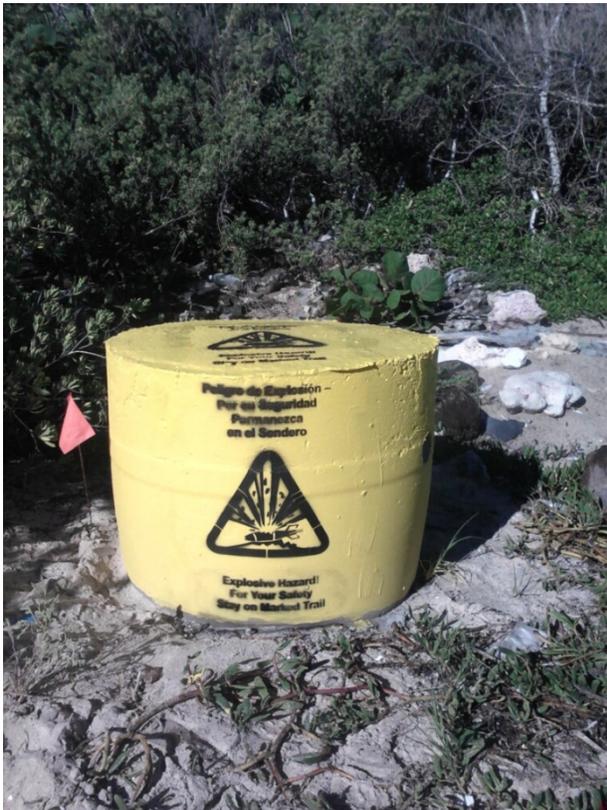
Photo 6 – Example warning “boulder” main access road near the entrance to one of the trails leading south. The sign was located in this position during the site visit to deter access to the trail.

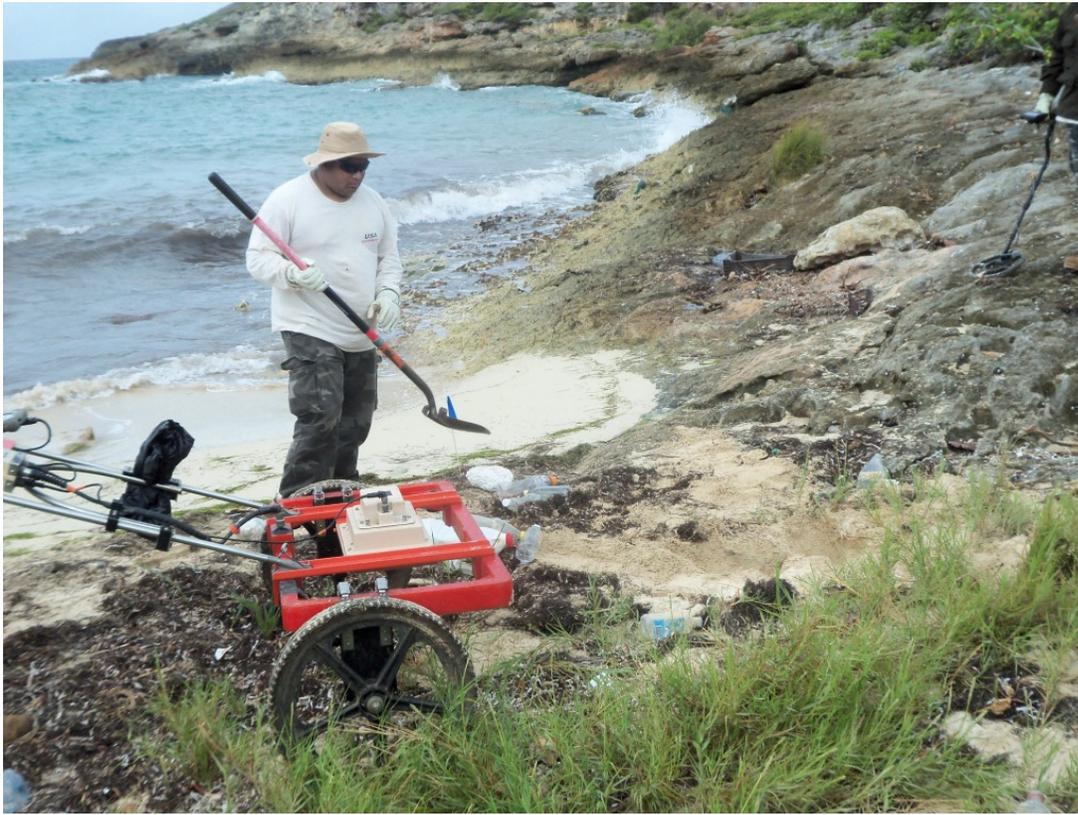
Photo 7 – Subsurface geophysical anomaly removal being performed on the beach adjacent to the historic lighthouse.

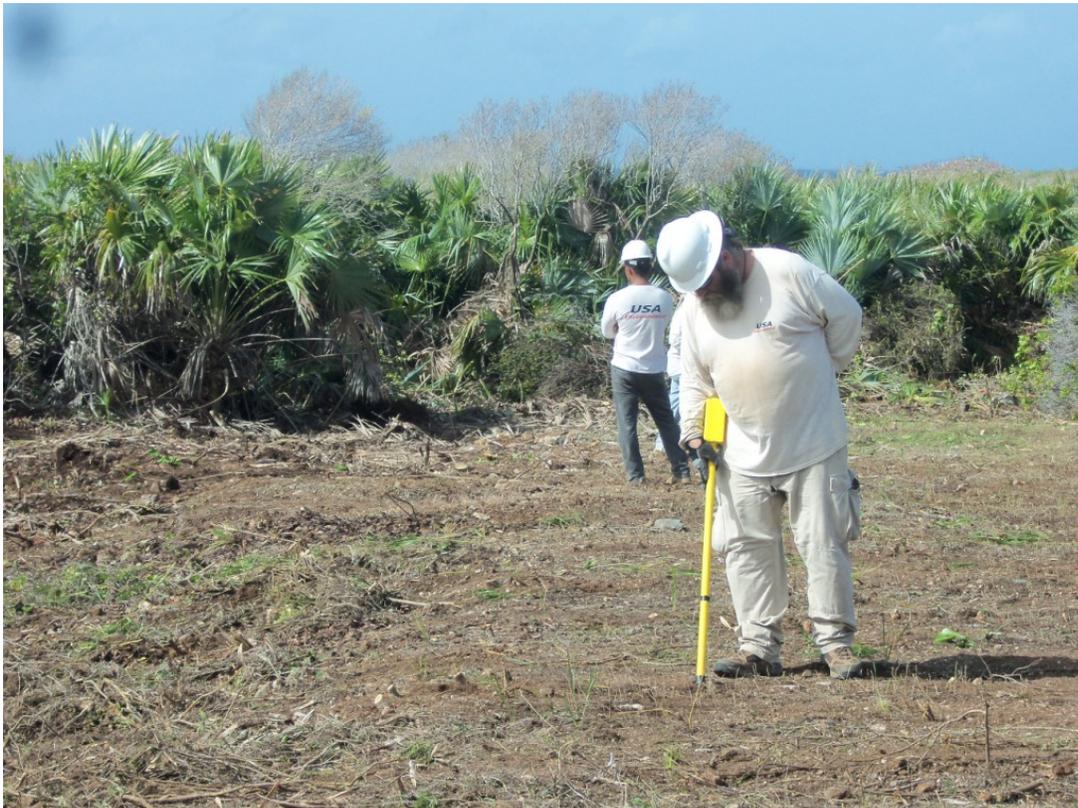
Photo 8 – “Mag-and-dig” MEC clearance at the parking area.

- Surface and subsurface MEC clearance was conducted using a “mag-and-dig” approach for the parking area on August 7, 2014. The parking area was divided into grids to allow for complete inspection by the UXO technicians using a geophysical instrument (magnetometer) to locate potential MEC.
- 236 pieces of RRD were removed; no MEC/MPPEH or MD was identified.
- The activity passed all QA inspections.

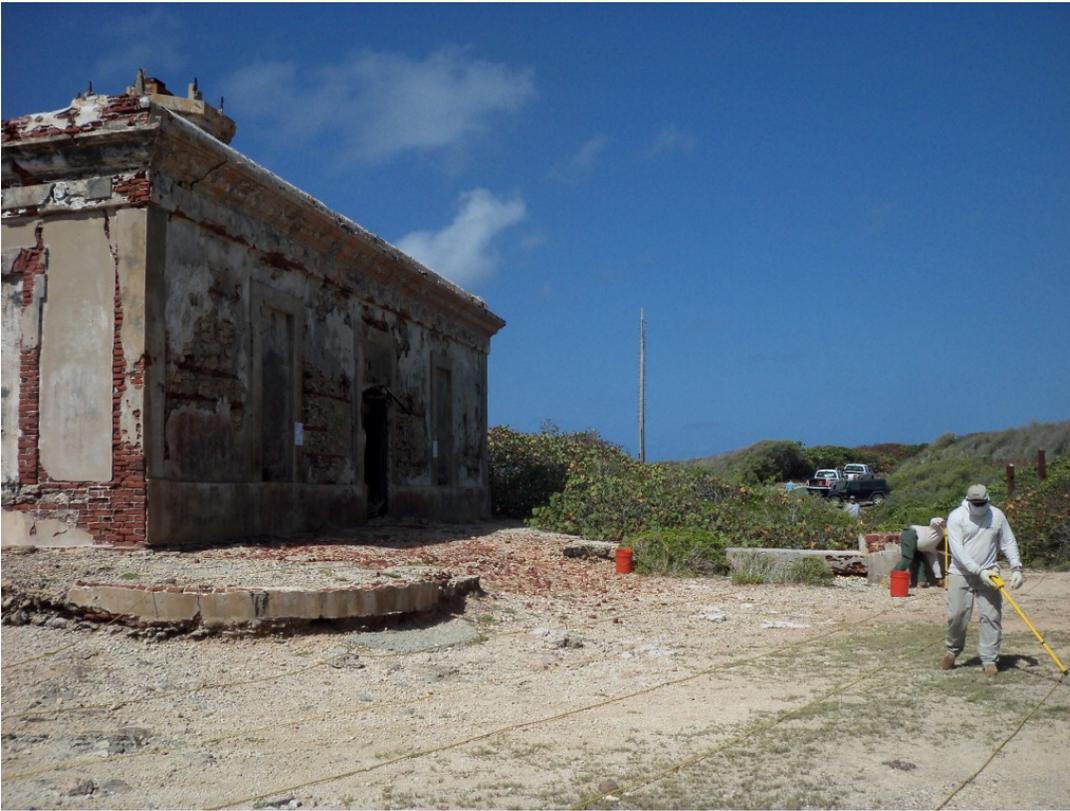
Photo 9 – “Mag-and-dig” MEC clearance around the historic lighthouse.

- Surface and subsurface MEC clearance was conducted using a "mag-and-dig" approach adjacent to the lighthouse (approximately 0.25 acre) from August 6 through August 8, 2014. The area adjacent to the lighthouse was divided into grids to allow for complete inspection by the UXO technicians using a geophysical instrument (magnetometer) to locate potential MEC.
- 460 pieces of scrap metal classified as range-related debris (RRD) were identified and removed; no MEC/MPPEH or MD was identified.
- The activity passed all QA inspections.

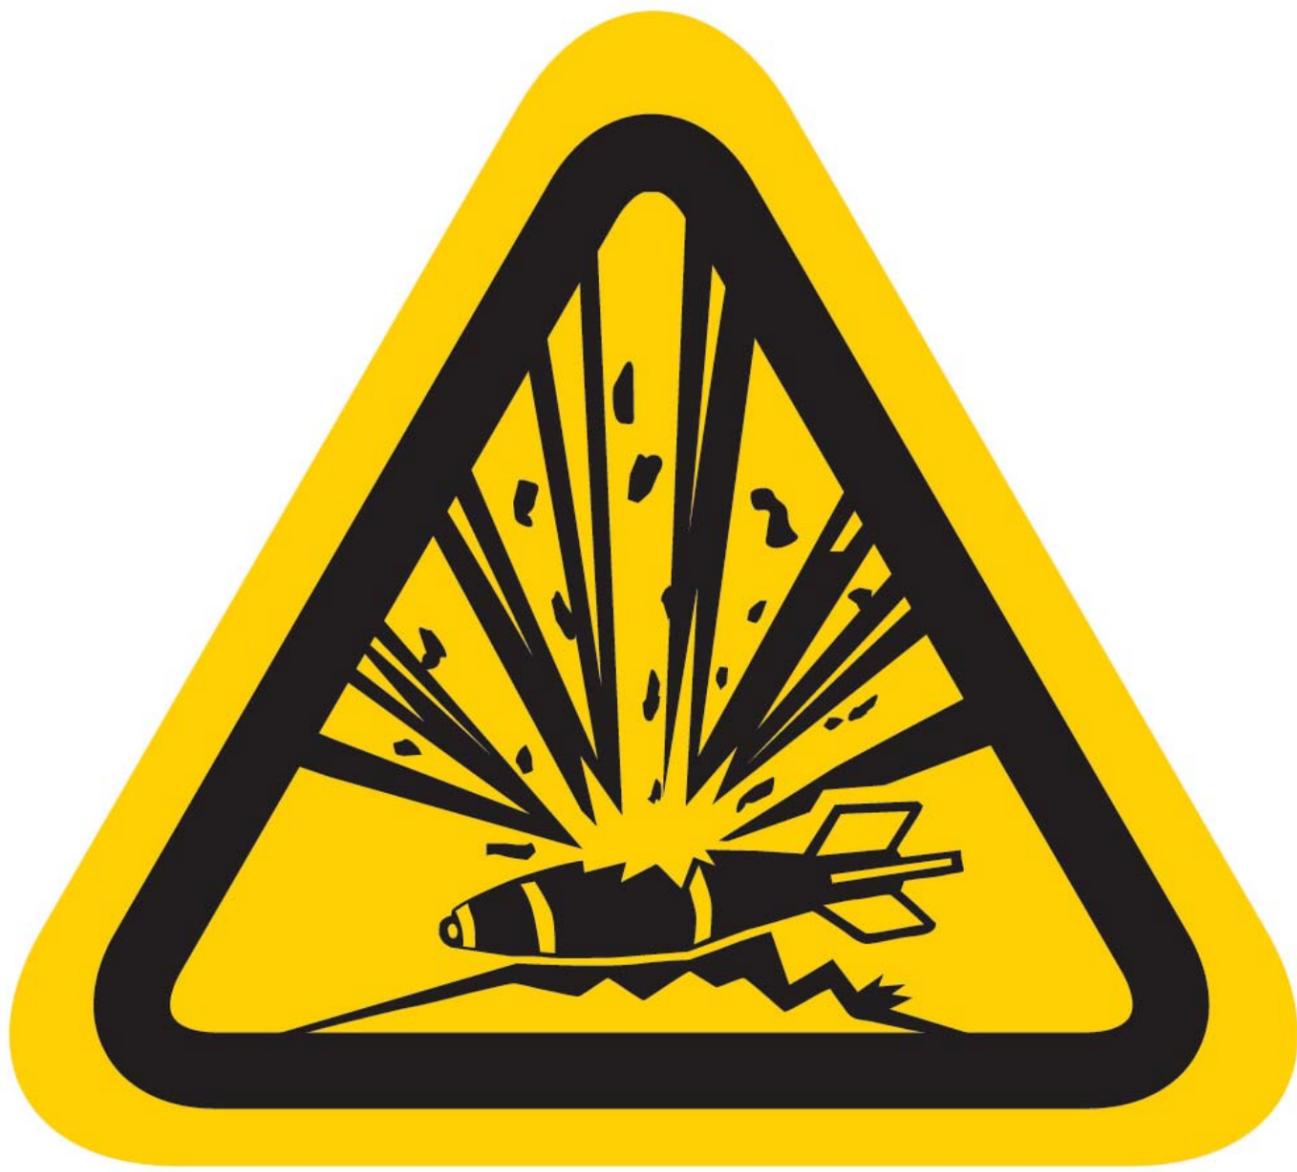
**¡Peligro de Explosión!
Por su Seguridad
Permanezca
en la Vereda**

**Explosive Hazard!
For Your Safety
Stay on Marked Trail**

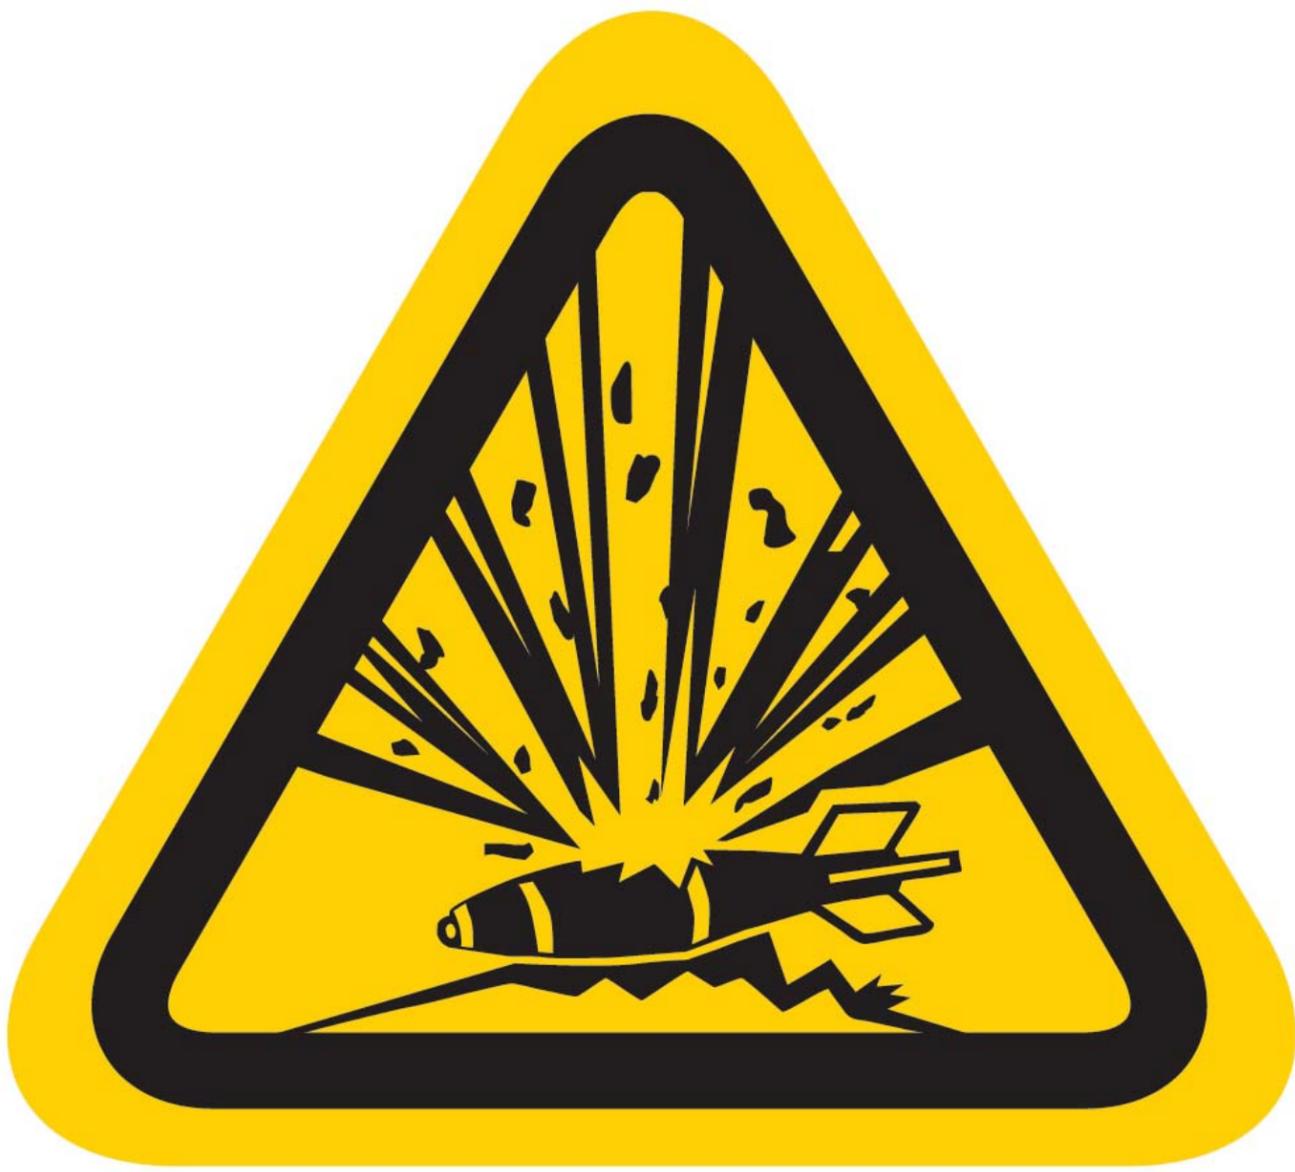
**¡Peligro de Explosión!
Permanezca en el Camino
No Estacione**

**Explosive Hazard!
Stay on Road
No Parking**
