Asbestos Abatement Completion Report
at
NWIRP Bethpage, New York

Contract No. N62472-03-D-0802
Contract Task Order# 0161

March 2008

Prepared By:
ECOR Solutions, Inc.
1075 Andrew Drive, Suite I
West Chester, PA 19380

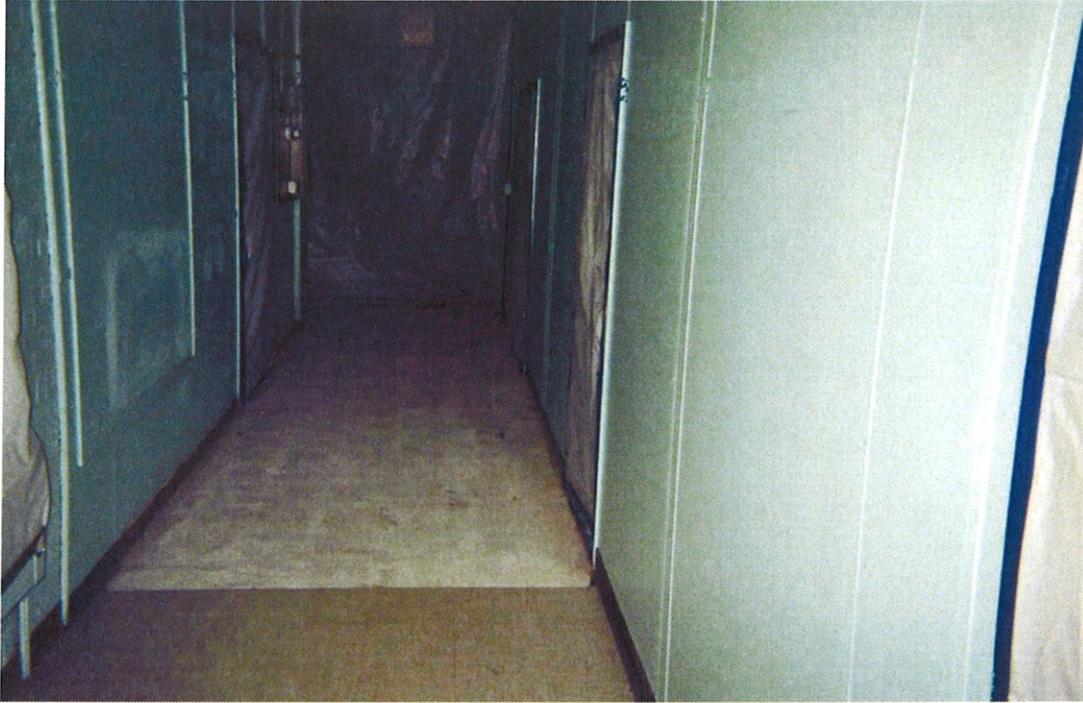
Building 10 Containment

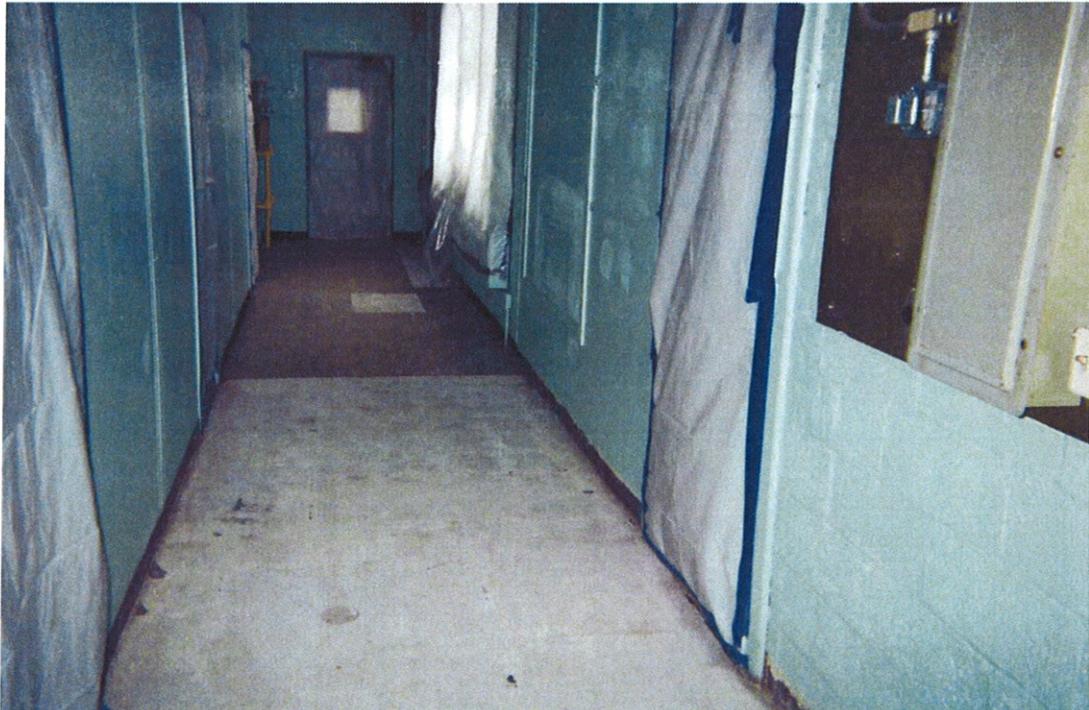
Building 10 Containment – Additional View

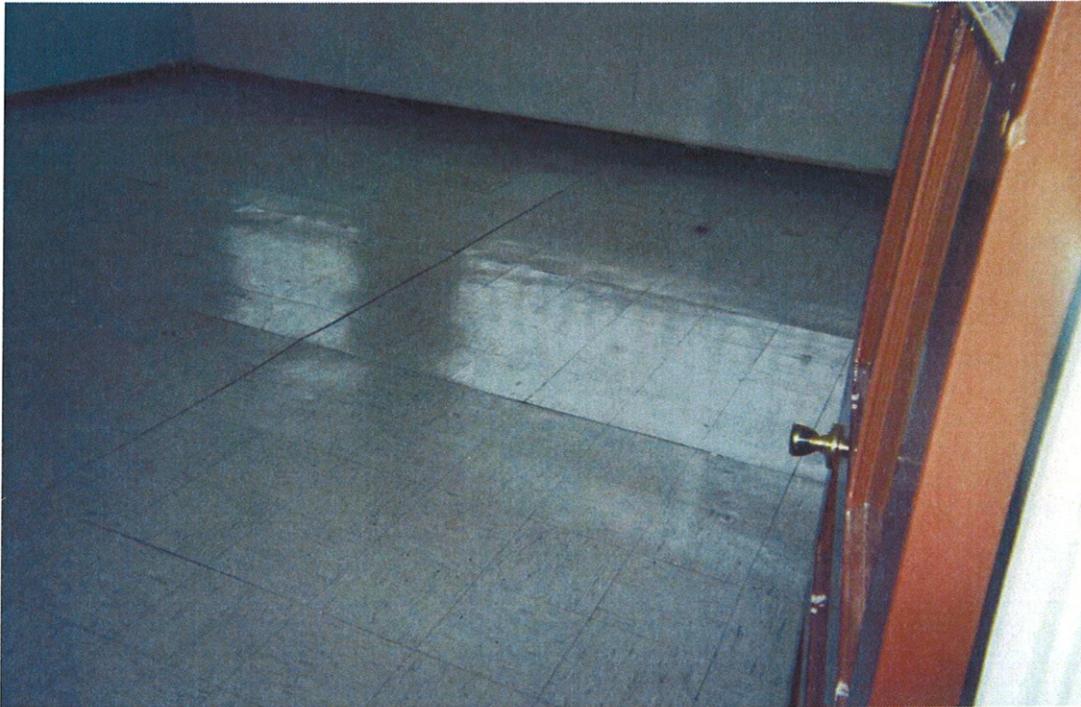
Building 10 – Damaged Floor Tile

CONTRACT CHANGES: More Damaged Flooring In 10-1 Than Projected

NOTES: Crews Finished 17-14, 15, 12, 13, 20
 Had Boyle Do More Refined Work In 17-14, 20, 13 Also Asked Them To Use White Encapsulant on All Floor Work Piece. Walk Through On Building 10, More Floor Damage Than Projected, Between (Ruff) 1200-1500 Sq Building & Fire Dept. Training Equipment All Over, Hard To Perform Proper Removal By Regs, Fire Dept Personnel Have Already Disturbed All Areas. Must Have More Defined Work Project or Variance. Front Guard Shak Roof Fallen In May Be Demolish 10.2 - 25 Sq Ft Tile To REMOVE.
 Approved and Accepted:

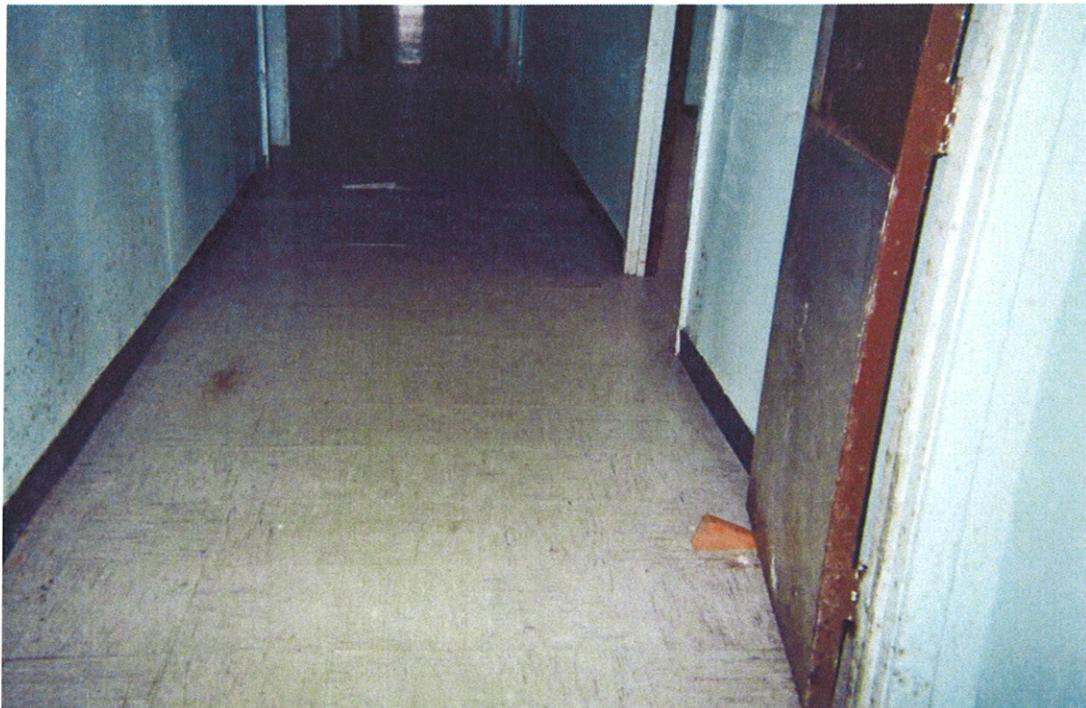
Building 10 – Damaged Floor Tile

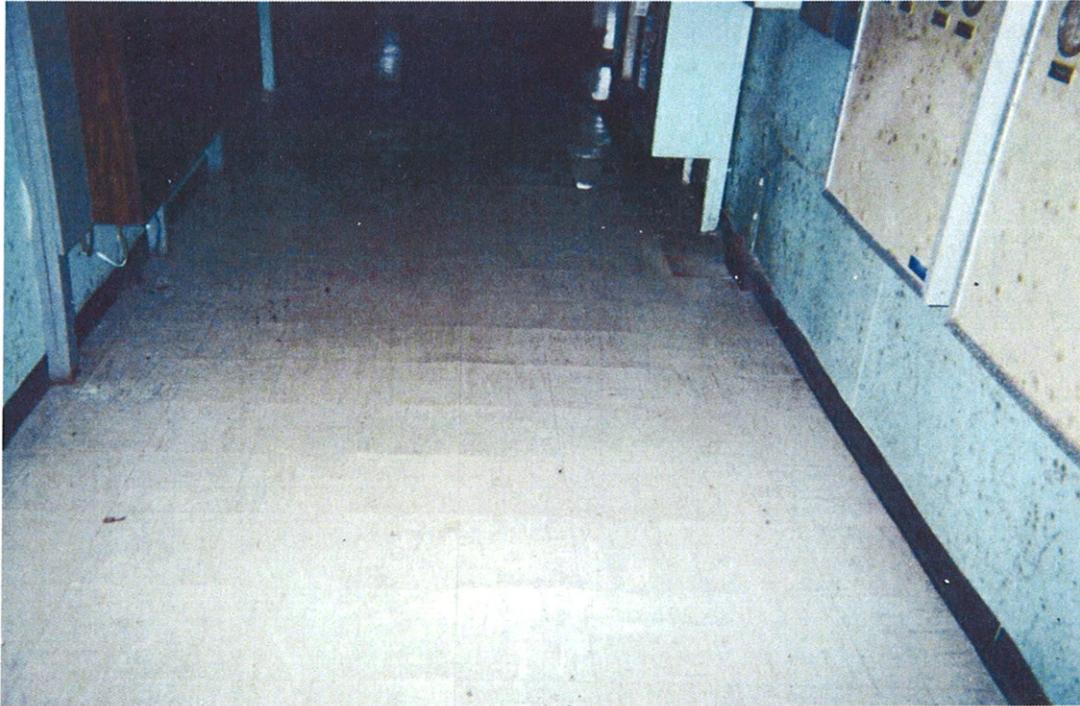
Building 10 – Out of Scope Floor Tile

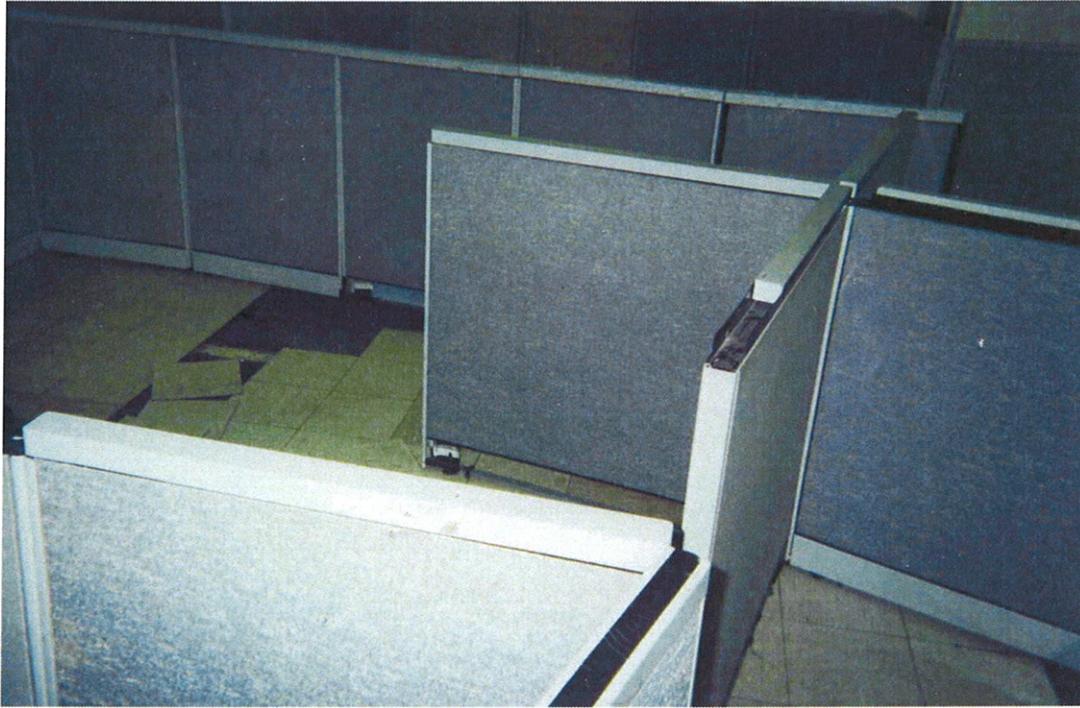
Building 8 Floor Tile to be Removed

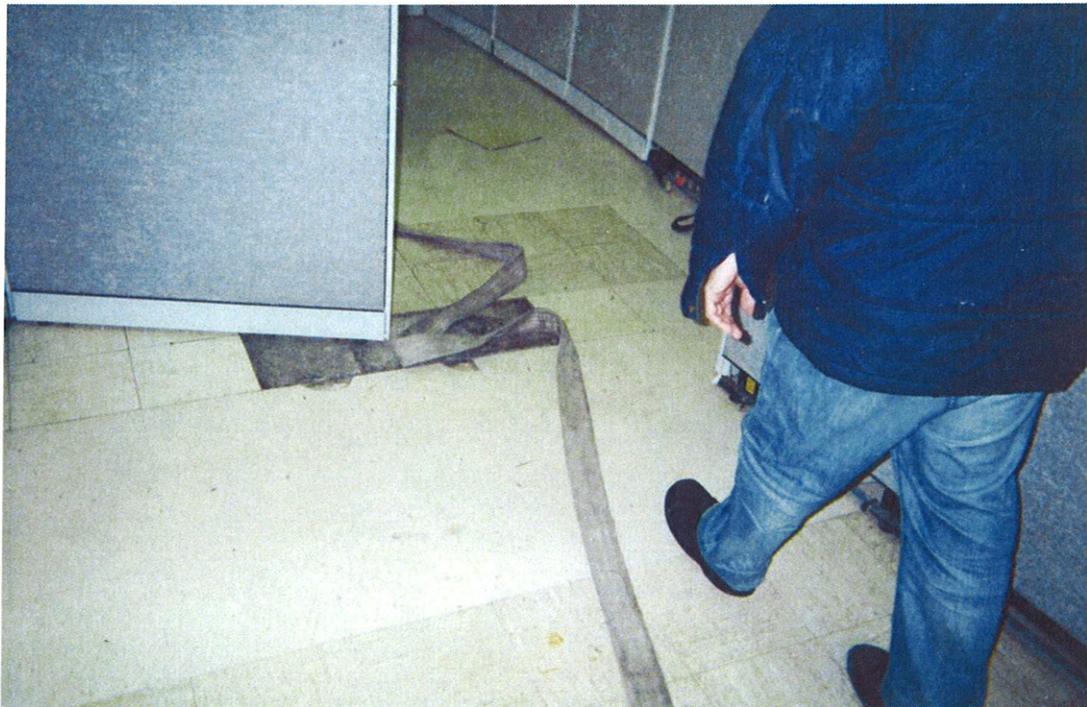
Building 8 Floor Tile to be Removed (2)

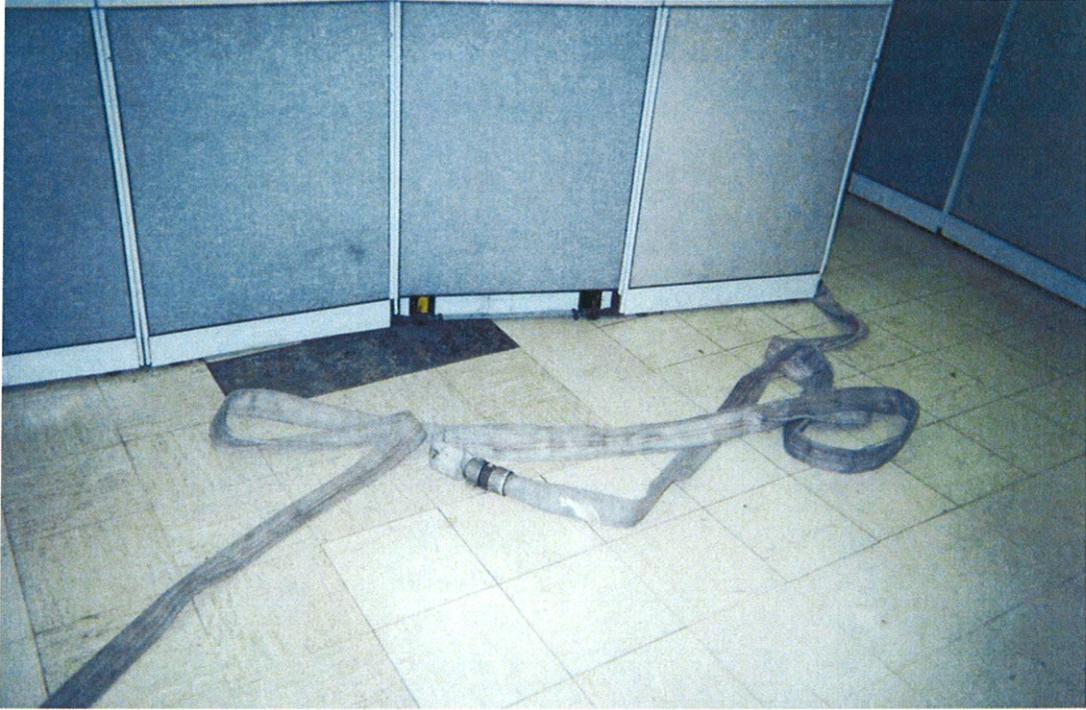
Building 8 Floor Tile to be Removed (3)

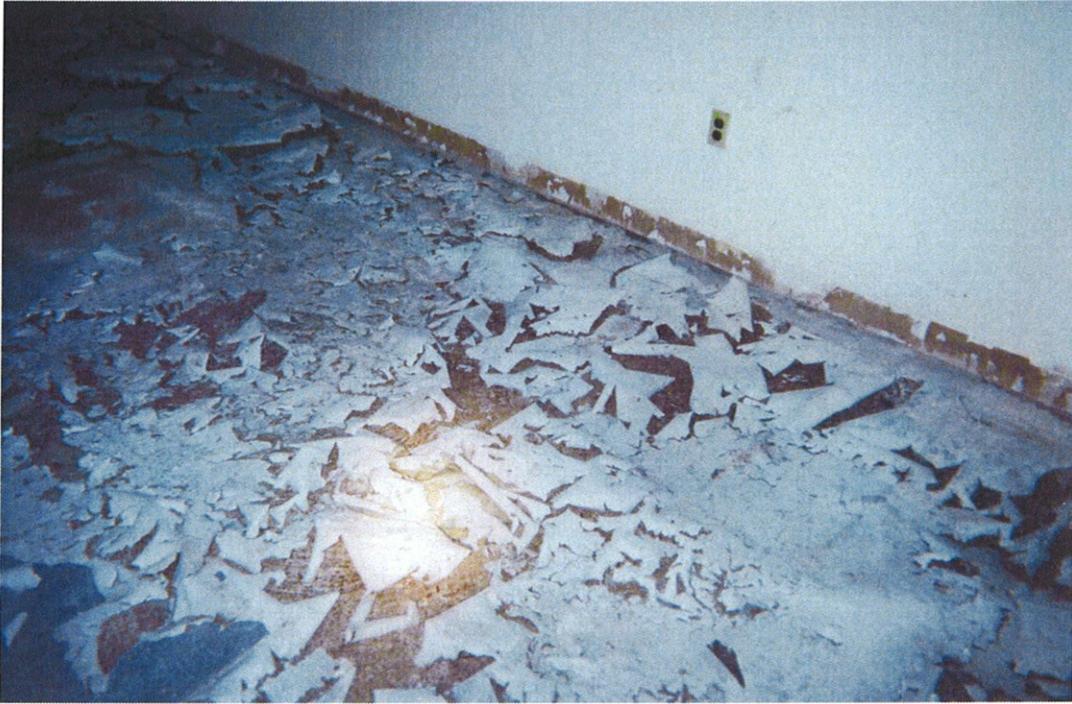
Building 17-20M Floor Encapsulant Peeling

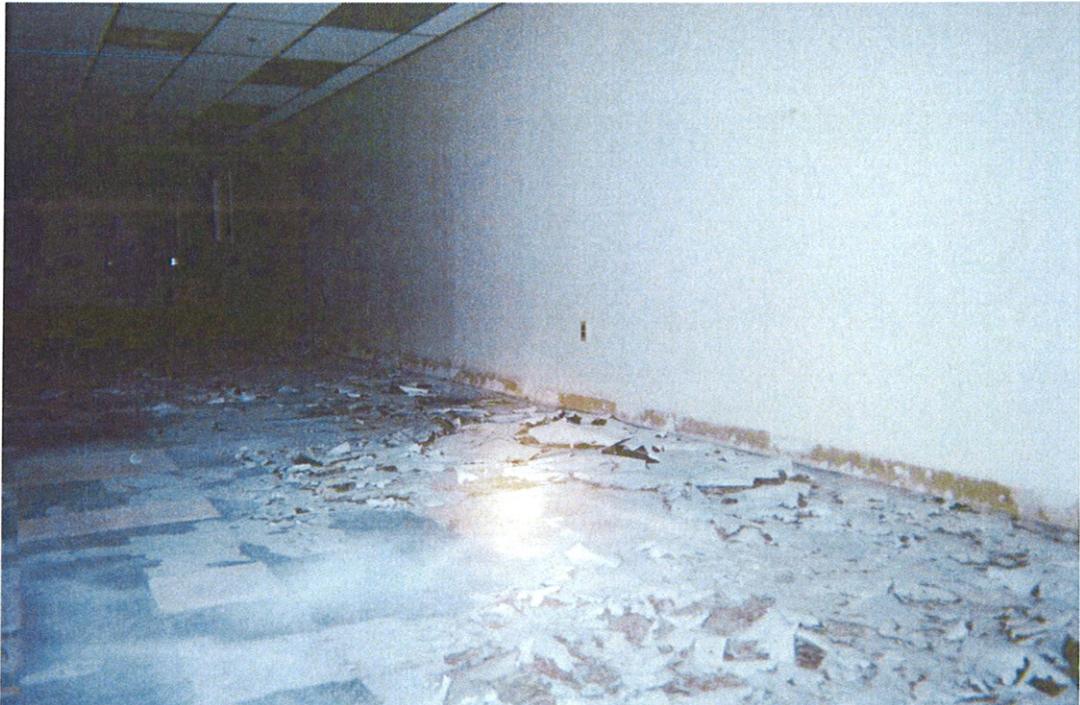
Building 17-20M Floor Encapsulant Peeling (2)

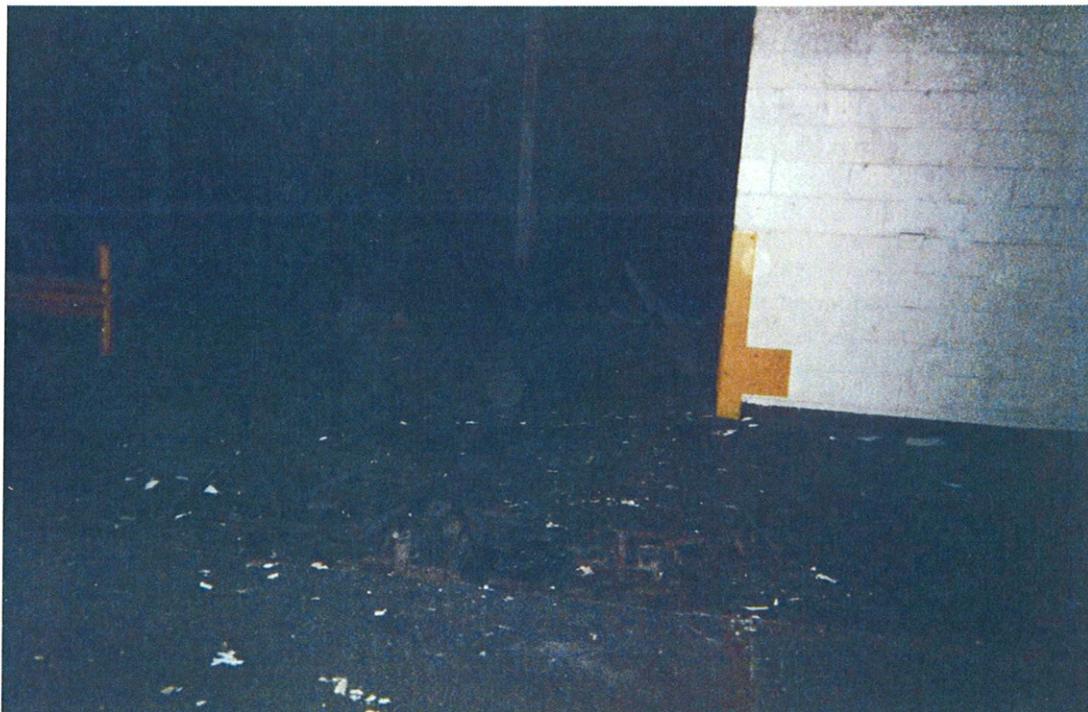
Building 3 – Heaved Wood Block to be Moved

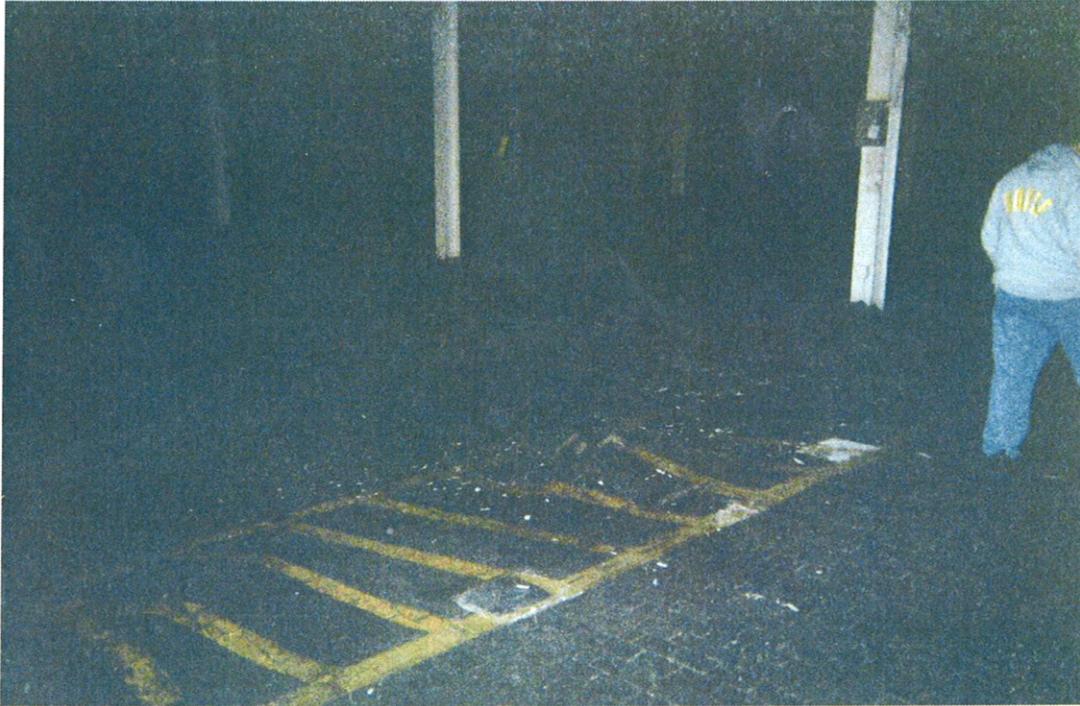
Building 3 – Heaved Wood Block to be Moved (2)

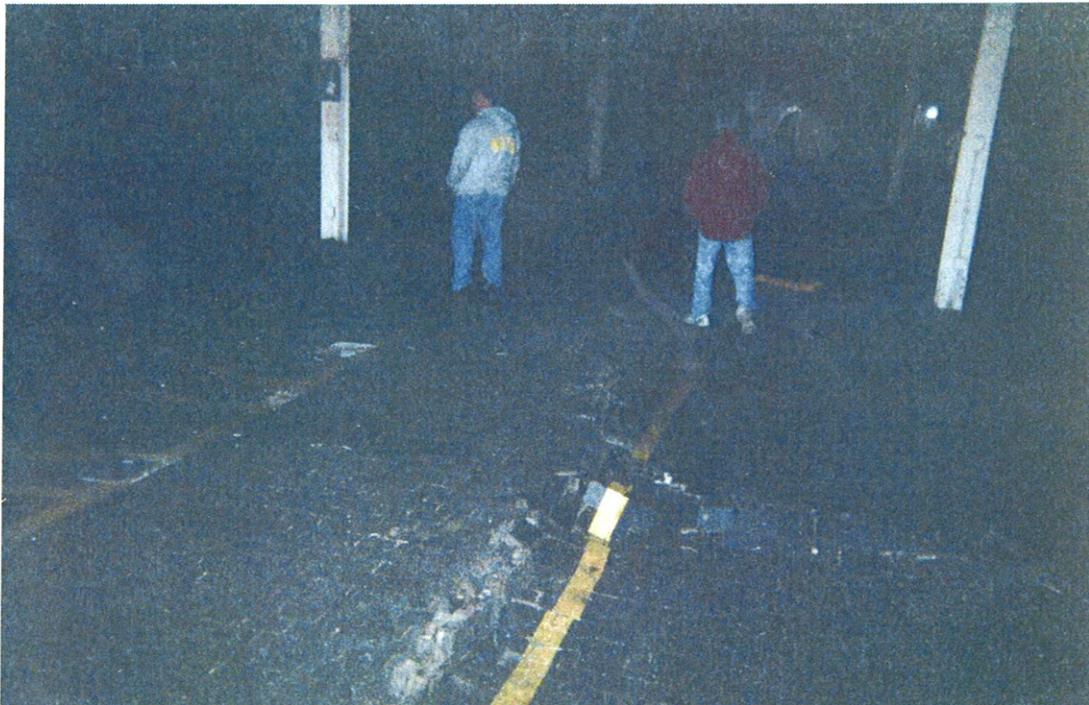
Building 3 – Heaved Wood Block to be Moved (3)

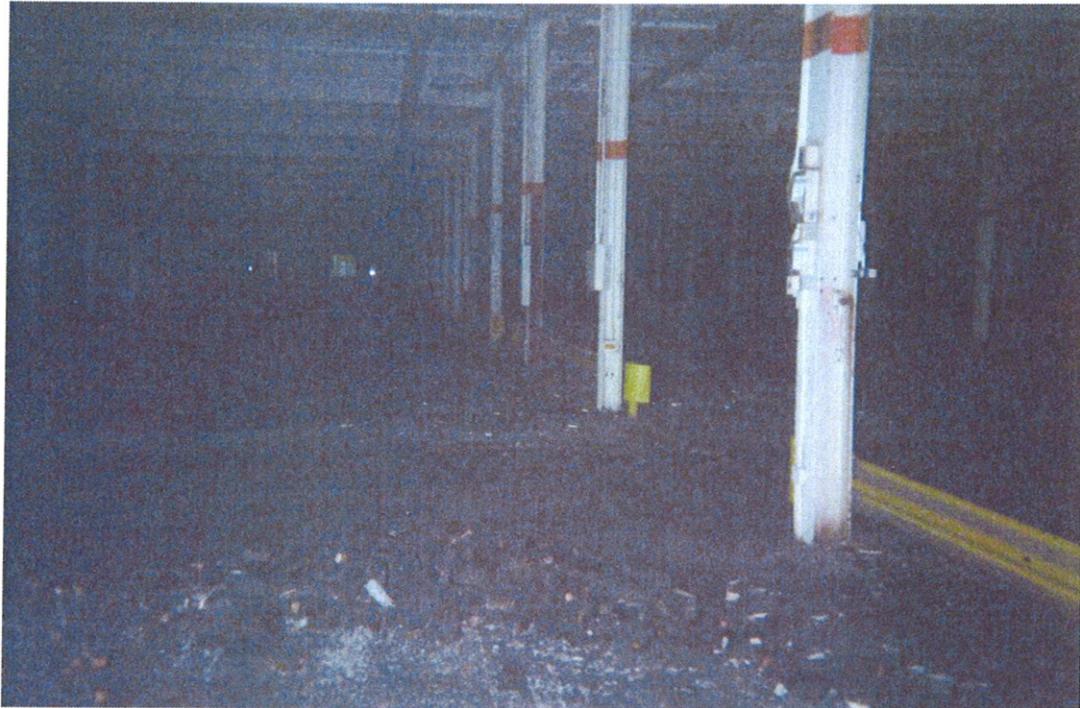
Building 3 Wood Block to be Moved (4)

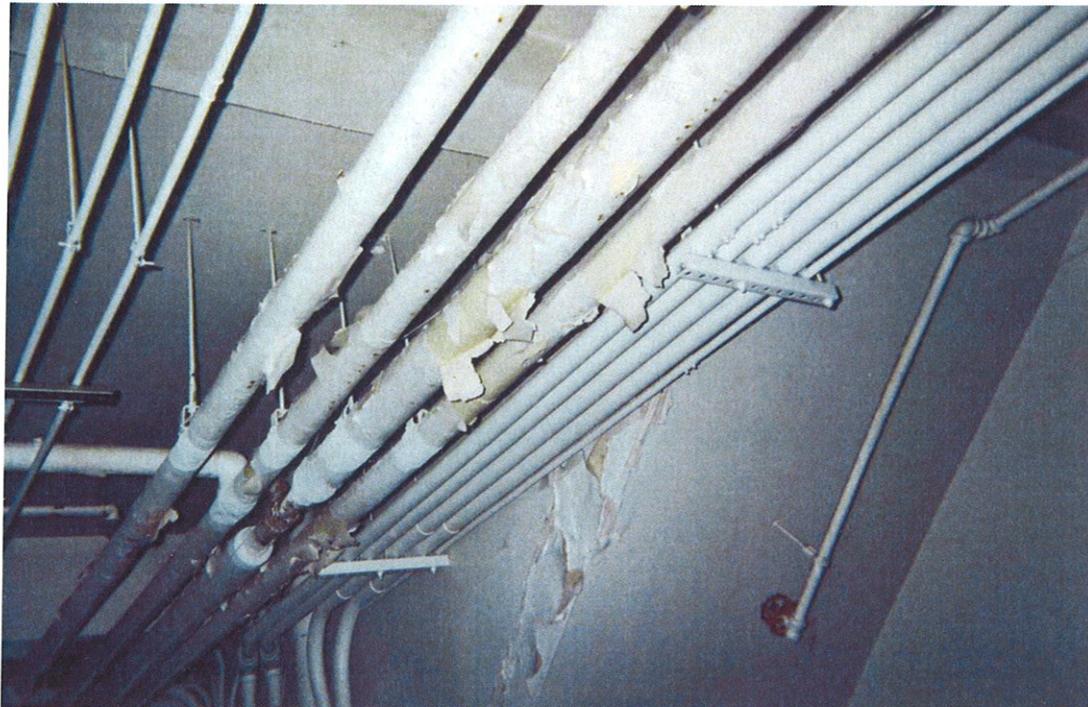
Building 3 Damaged Pipe Insulation to be Removed

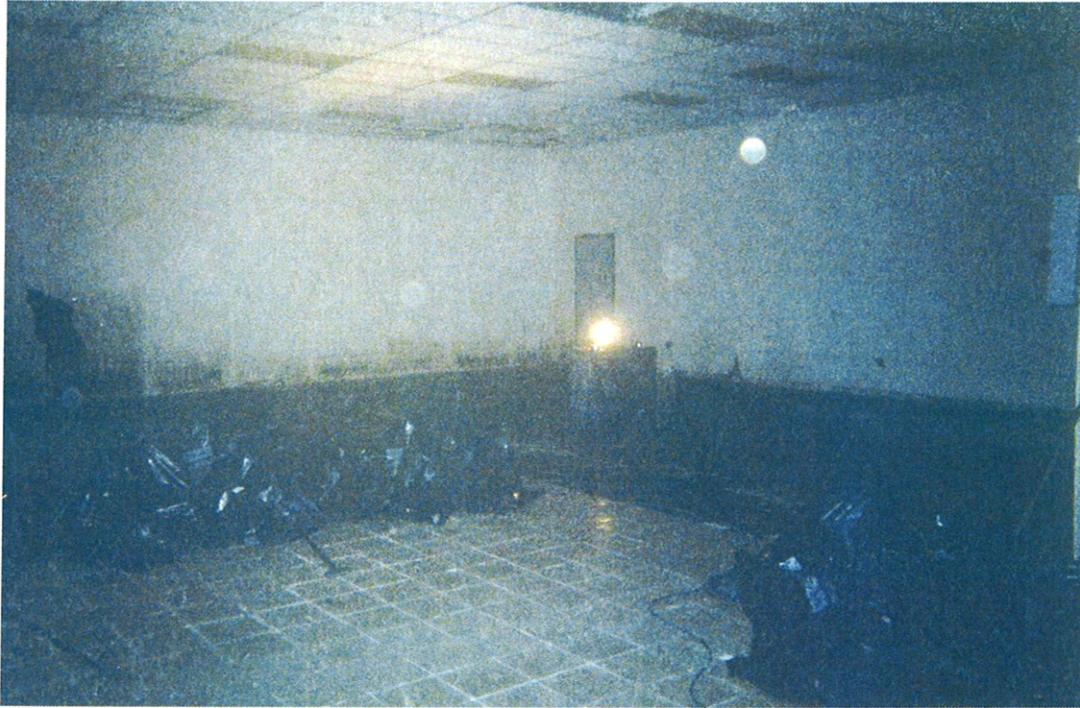
Building 3 – Section 1A Floor Tile Removal

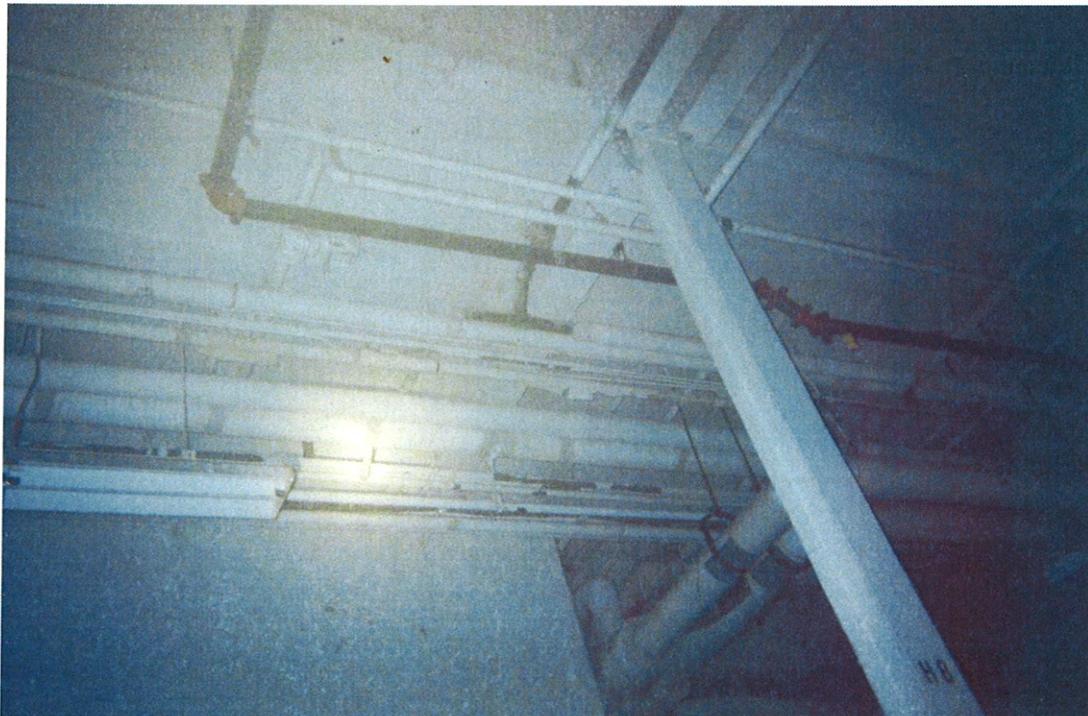
Building 3 – Piping to be Abated

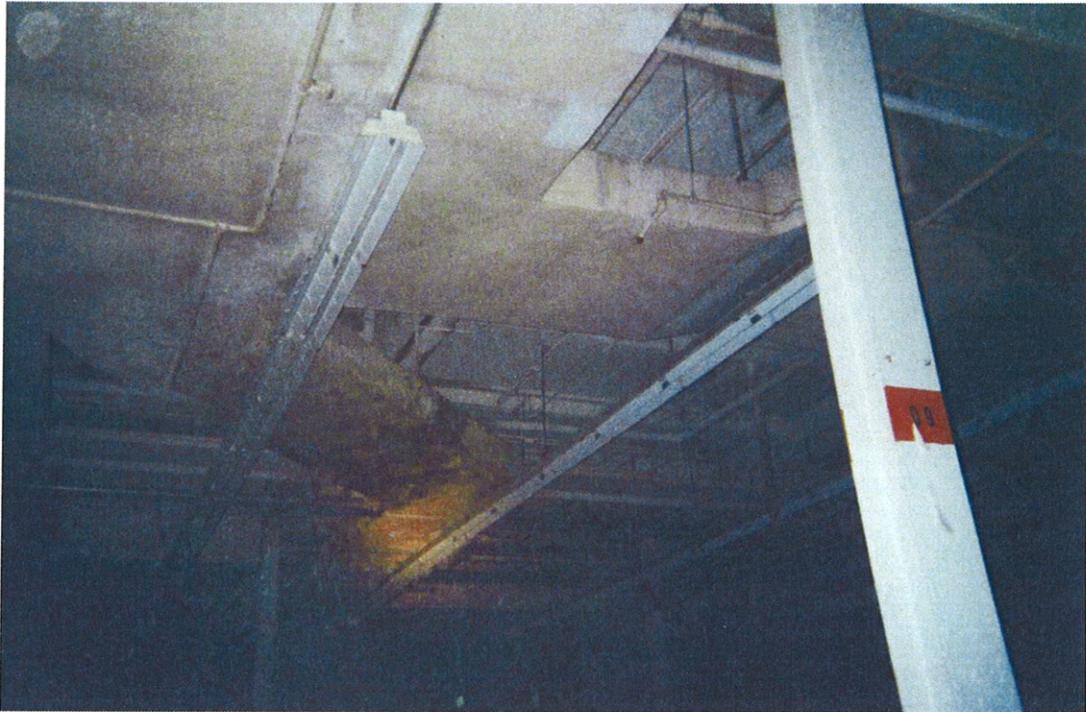
Building 3 – Section 2B Duct Insulation to be Abated

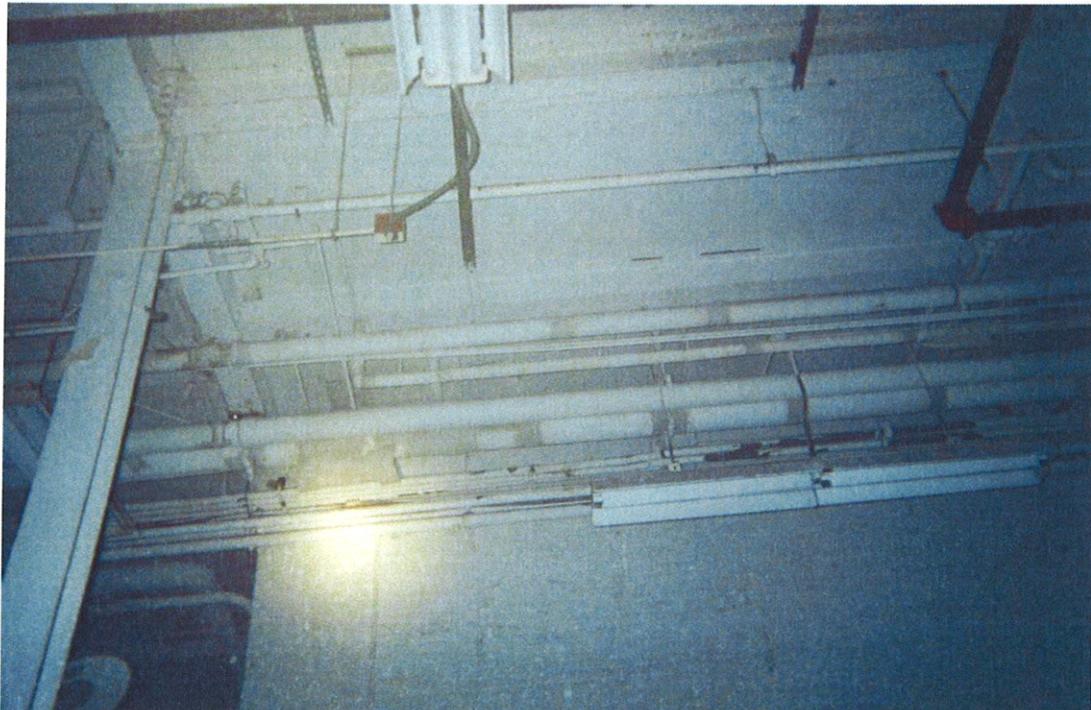
Building 3 - Section 2B Pipe Insulation to be Abated

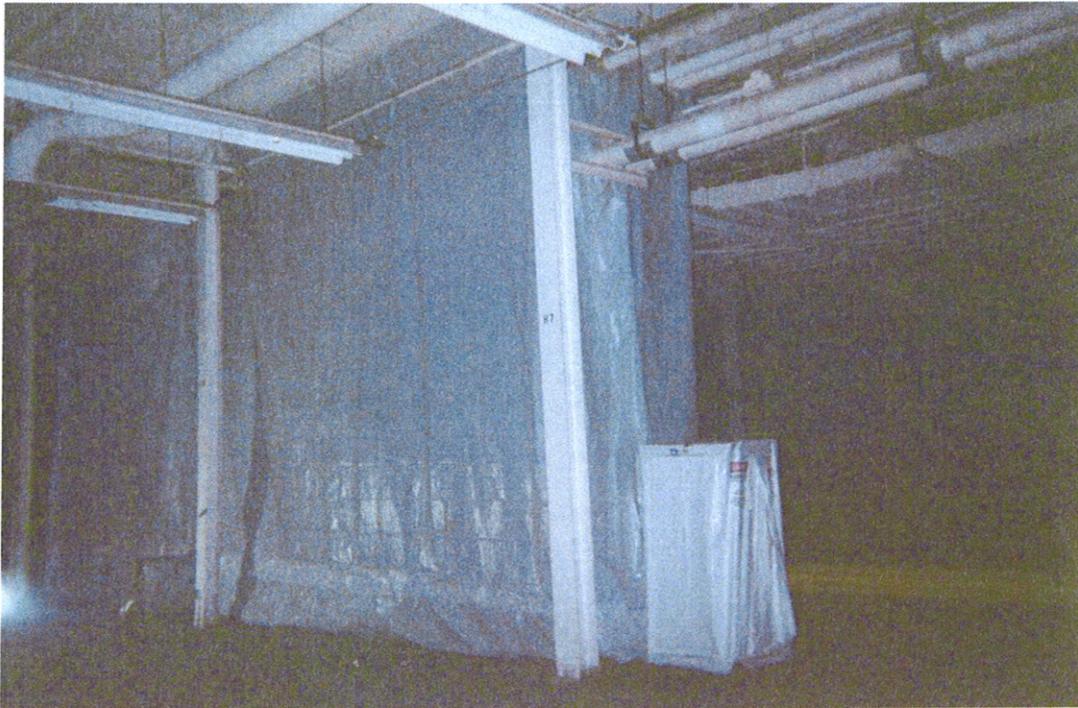
Building 3 – Section 2B Containment

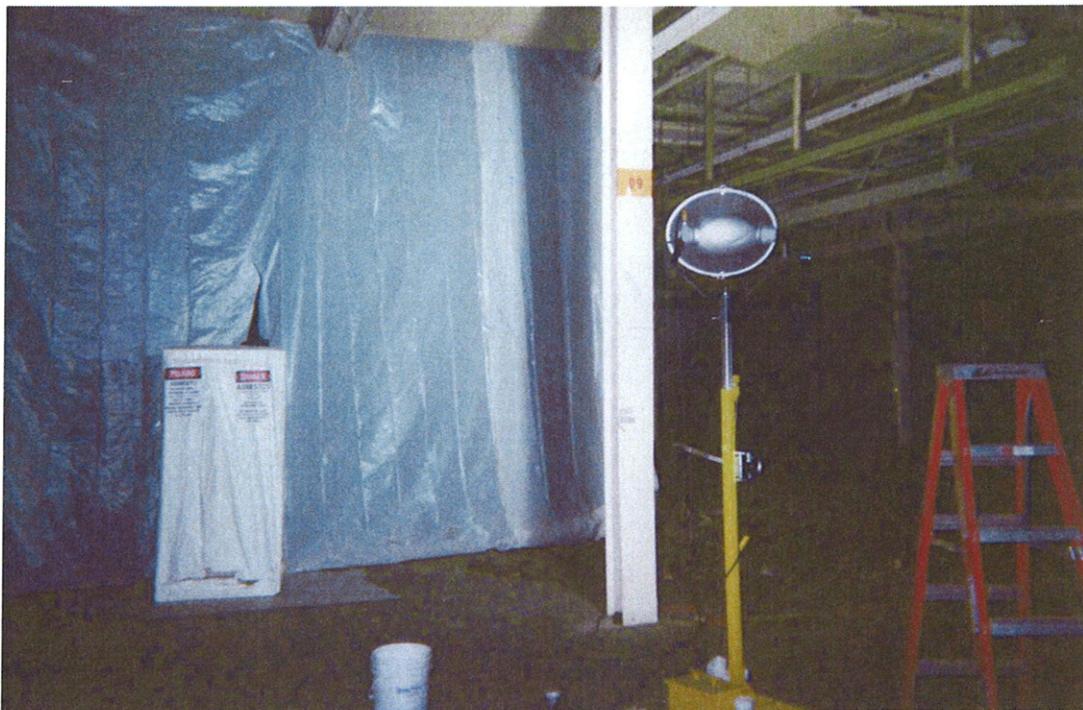
Building 3 Section 2B Containment (2)

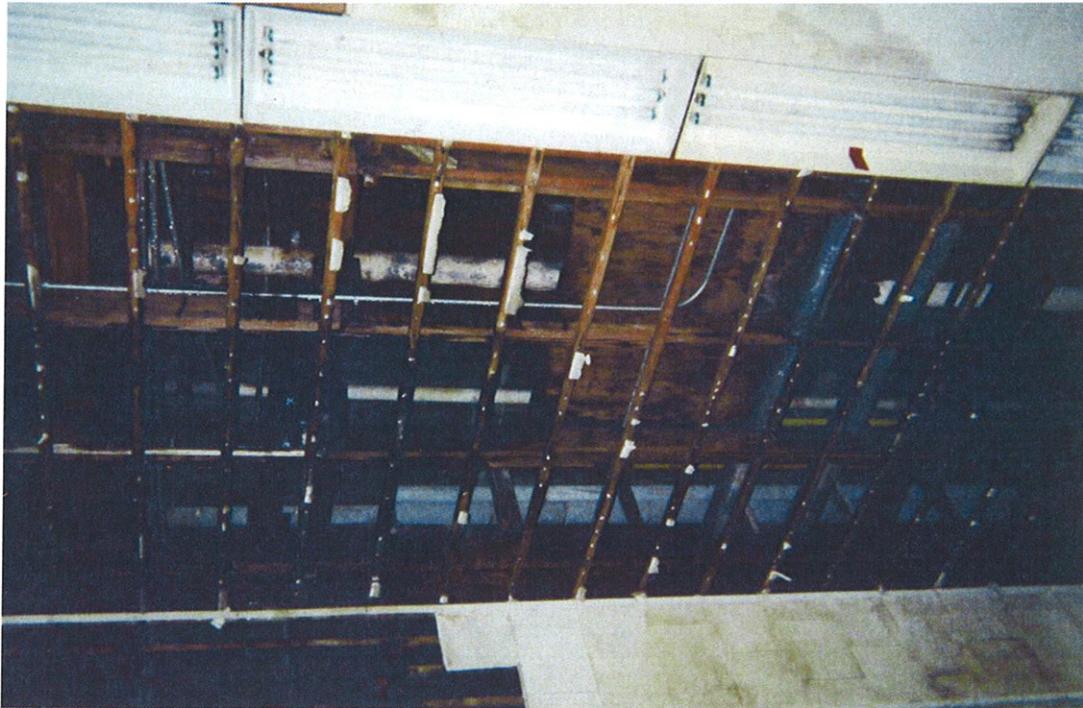
Building 3 – Section 2C1 Pipe and Duct Insulation to be Abated

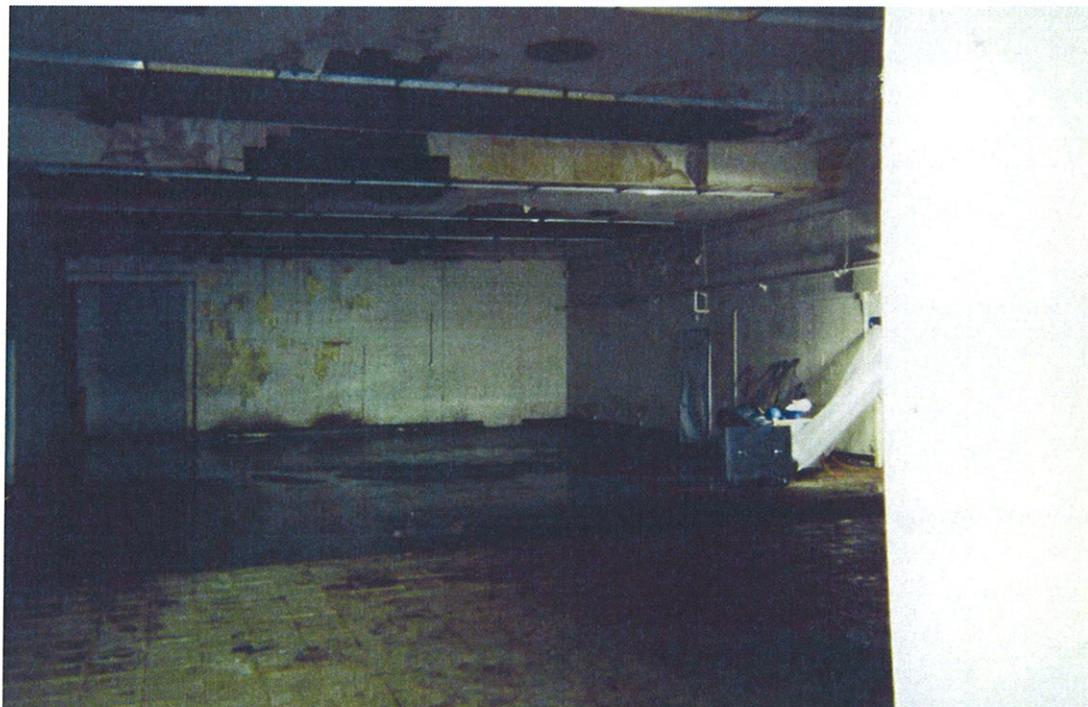
Building 3 – Section 2C1 Post Tile Abatement

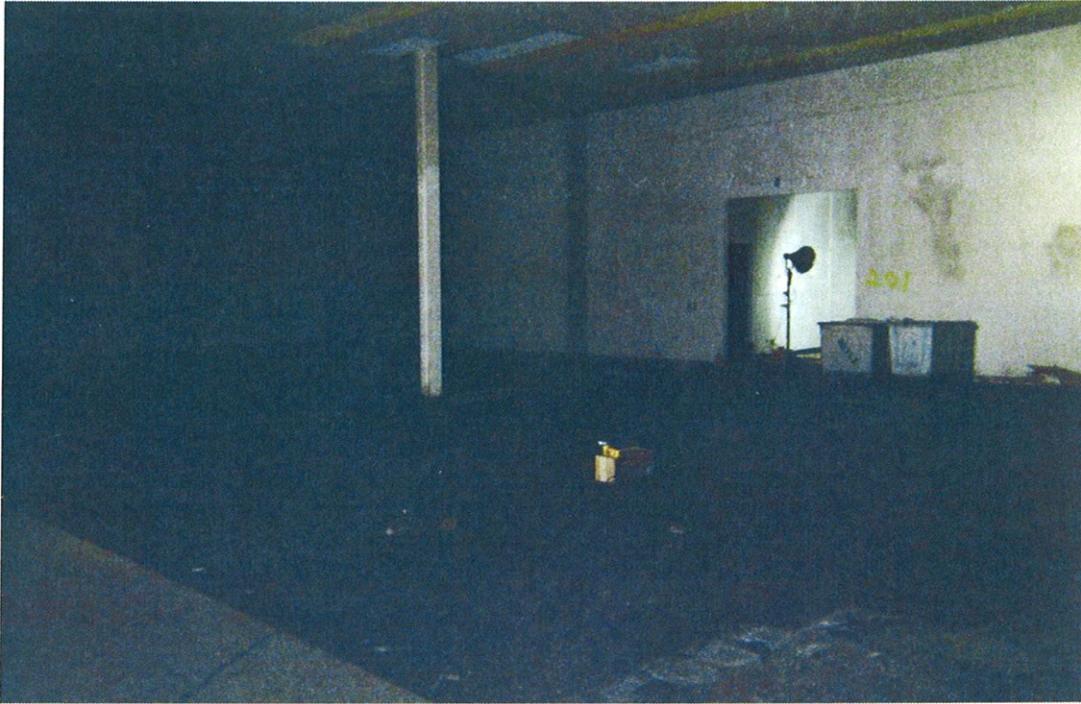
Building 3 – Section 2C2 Post Tile Abatement

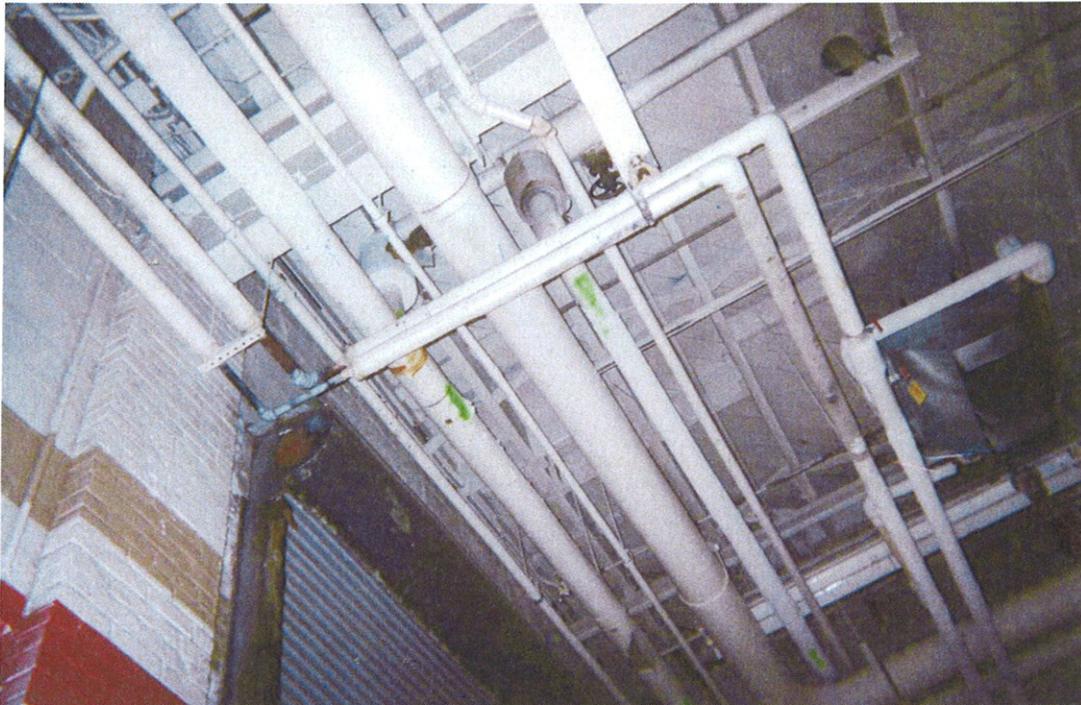
Building 3 – Section 4B Pipe Elbows to be Abated

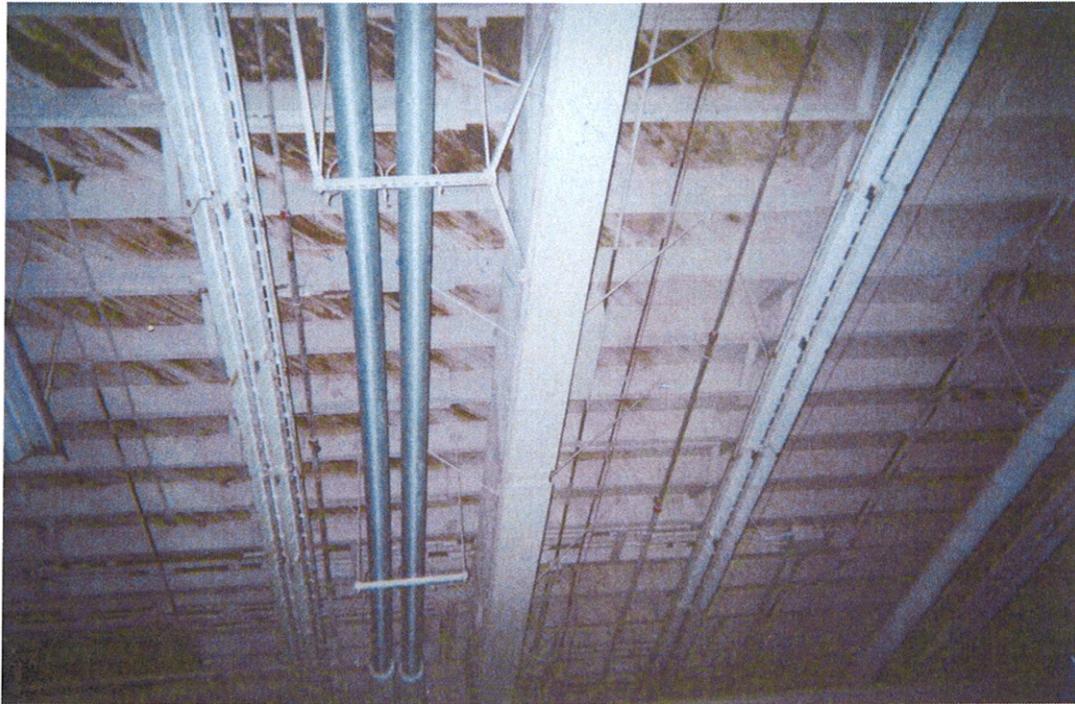
Building 3 – Section 4B Piping Post Abatement

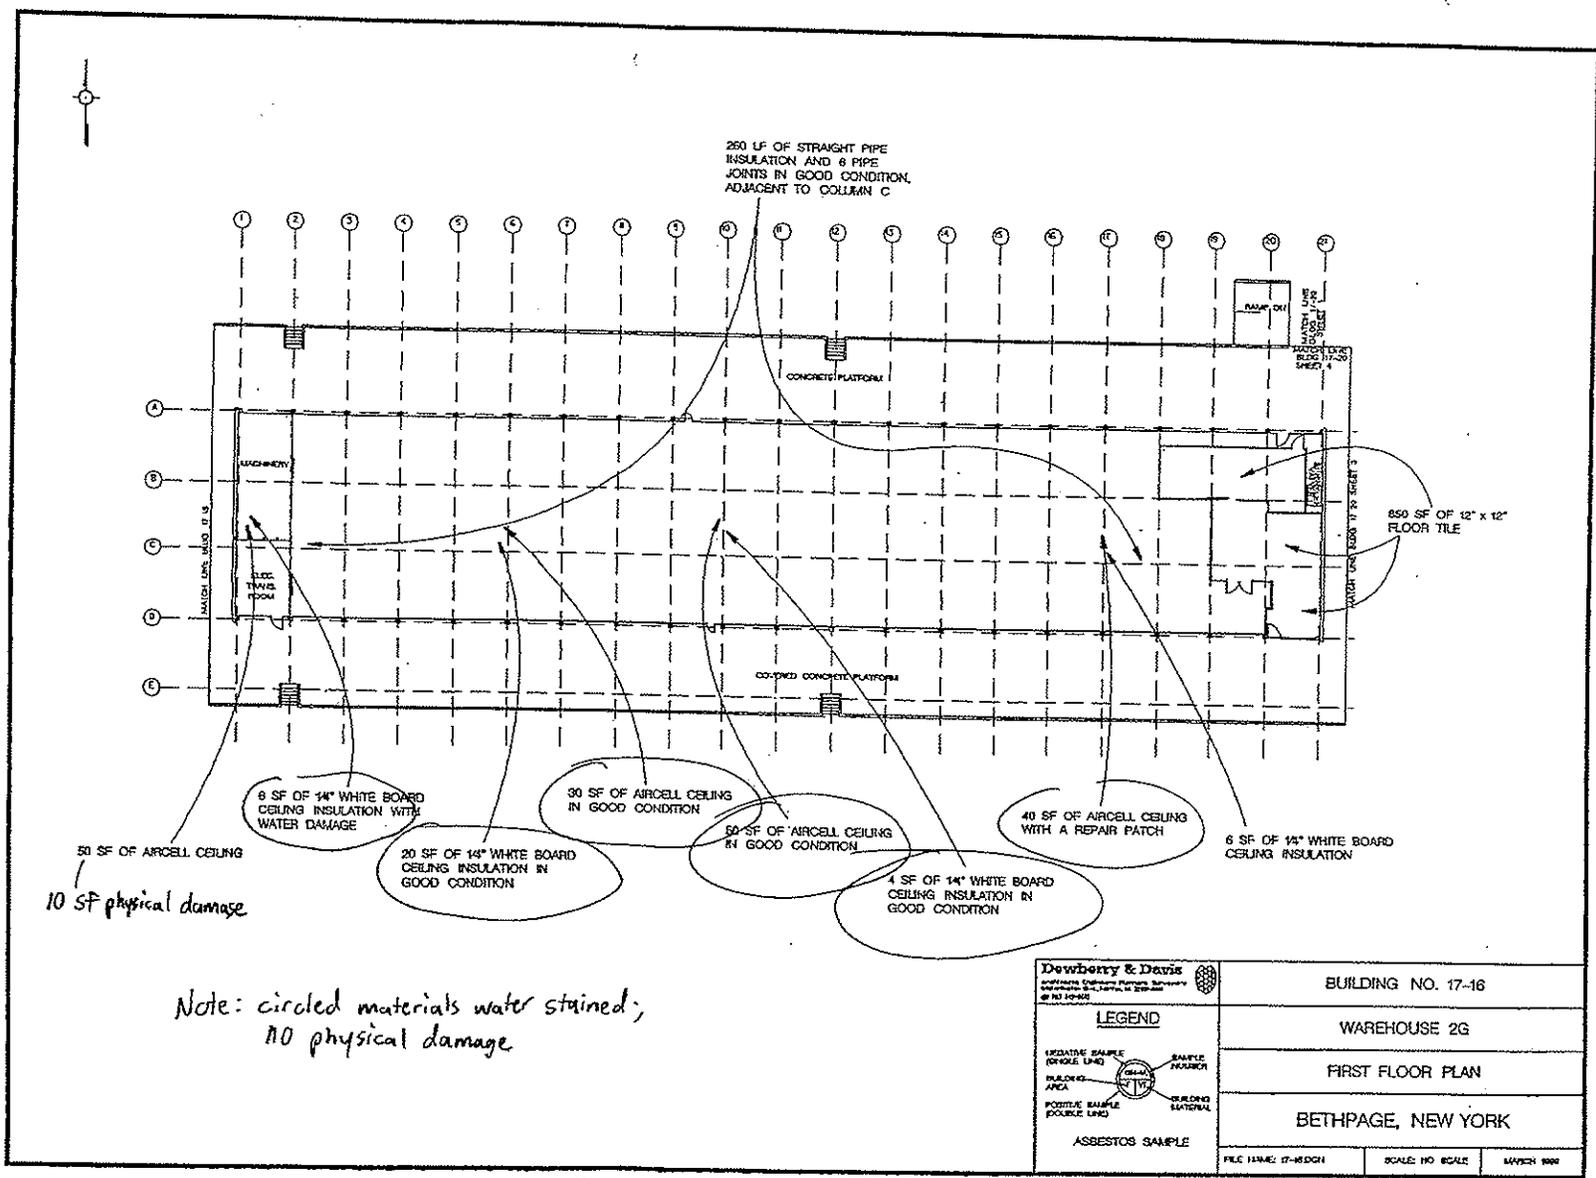
Note: circled materials water stained;
 NO physical damage

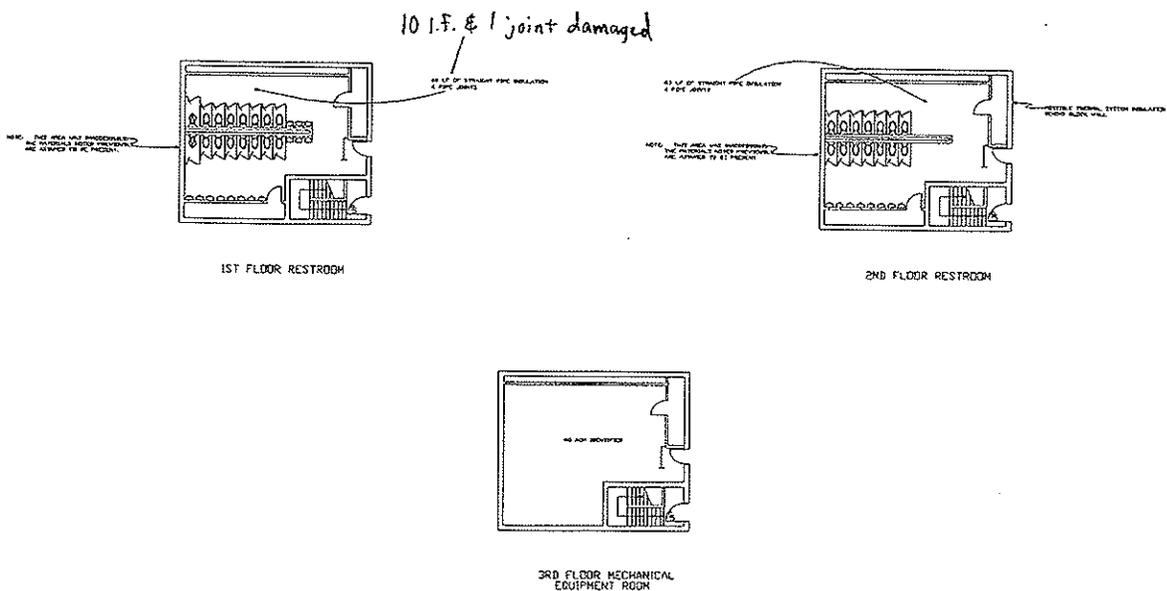
MECHANICAL EQUIPMENT / RESTROOM - BLDG. NO. 03-01
SCALE 1/4" = 1'-0"

2 I.F. damaged
in chase

3 I.F. damaged

10 I.F. damaged
above ceiling

2 joints damaged
