MINUTES FROM THE 27 OCTOBER 2015 RESTORATION ADVISORY BOARD MEETING
NWIRP CALVERTON NY
3/30/2016
RESOLUTION CONSULTANTS

RESTORATION ADVISORY BOARD MEETING
NAVAL WEAPONS INDUSTRIAL RESERVE PLANT (NWIRP), CALVERTON
CALVERTON COMMUNITY CENTER, CALVERTON, NEW YORK
TUESDAY, OCTOBER 27, 2015

**NAVAL WEAPONS INDUSTRIAL RESERVE
PLANT (NWIRP) CALVERTON, NEW YORK**

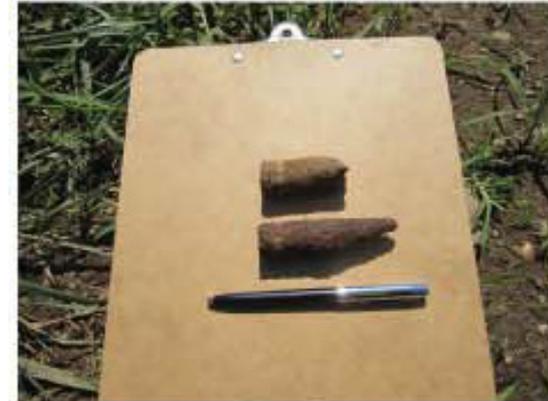
Site 2 Phase II and III Excavation Area

AREA = 2.07 ACRES
 SUBSURFACE MANUAL EXCAVATION OF ANOMALIES COMPLETED TO DEPTH OF NON-DETECTION. RISK CODE NEGLIGIBLE

AREA = 0.205 ACRES
 PHASE II AND PHASE III PLANNED EXCAVATION AREAS TO ADDRESS ENVIRONMENTAL COCs.

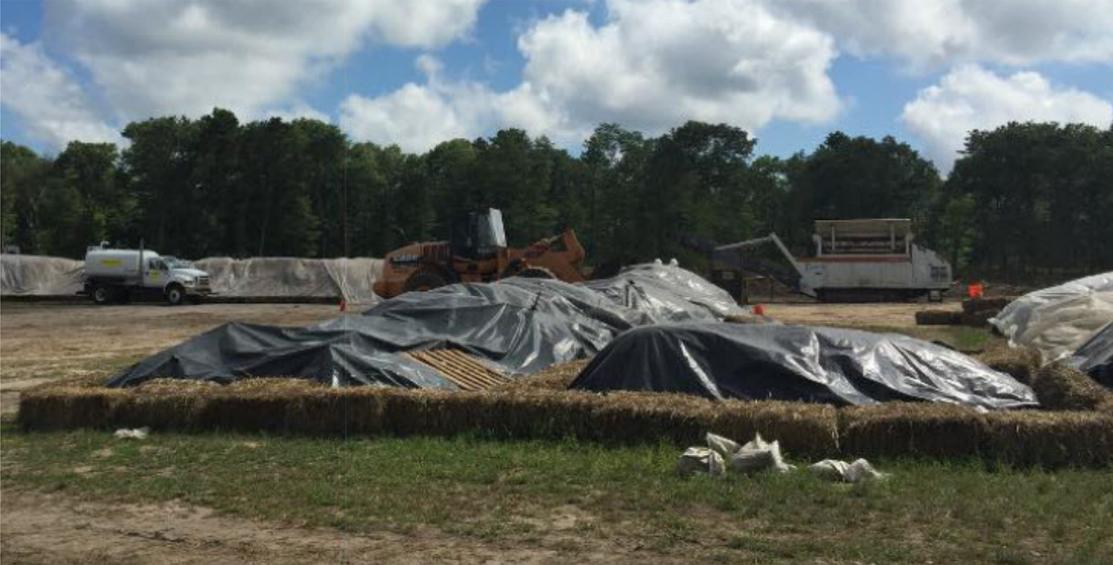
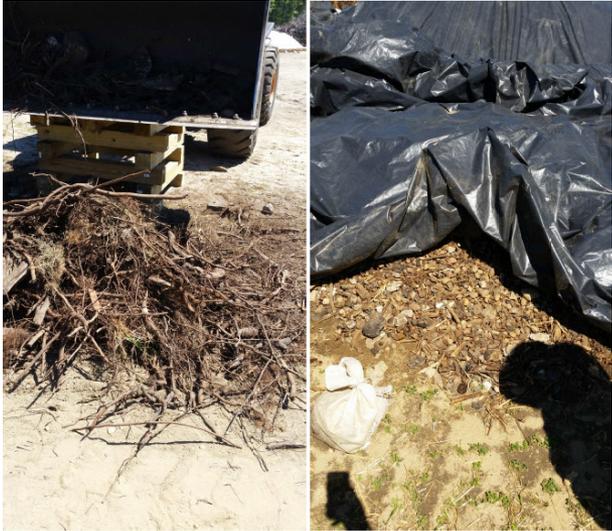
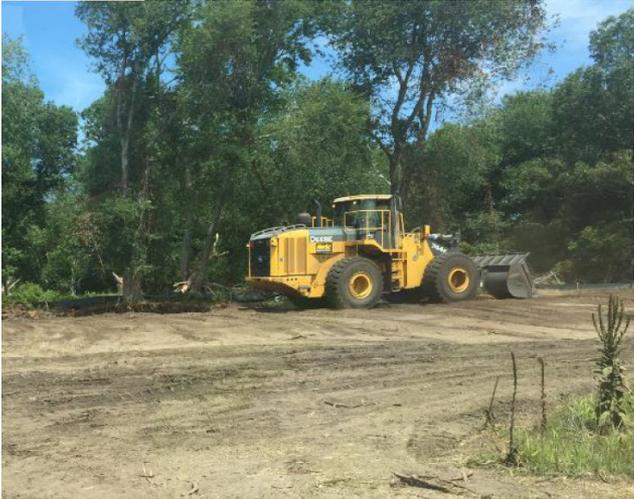
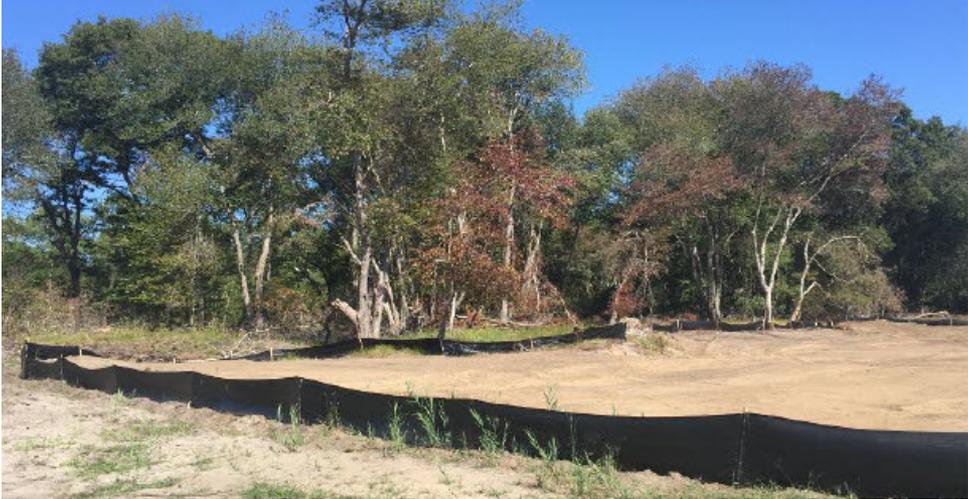
Site 2 Munitions Response (2015) Photo Log

Overs - Material > 3/4" spread and screened by UXO Tech

The overall schedule and a summary of the work completed during the 2015 response action and upcoming activities were then presented. Mobilization occurred in June 2015, and mechanical excavation, screening and backfill took place from July through September 2015. Transportation and disposal of overs, MEC and MPPEH was ongoing in October 2015, as was site restoration. A total of 4,152 CY of soil

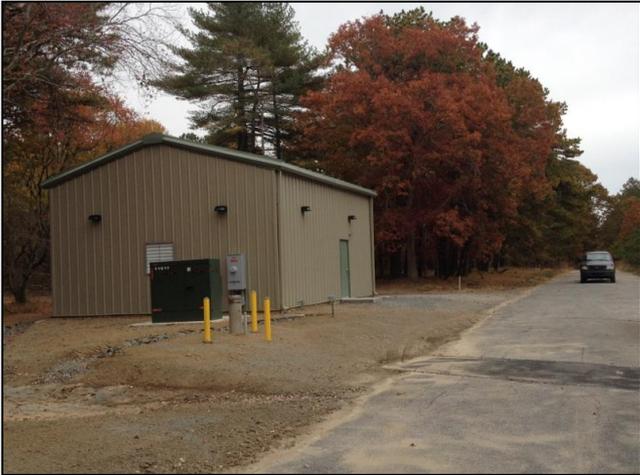
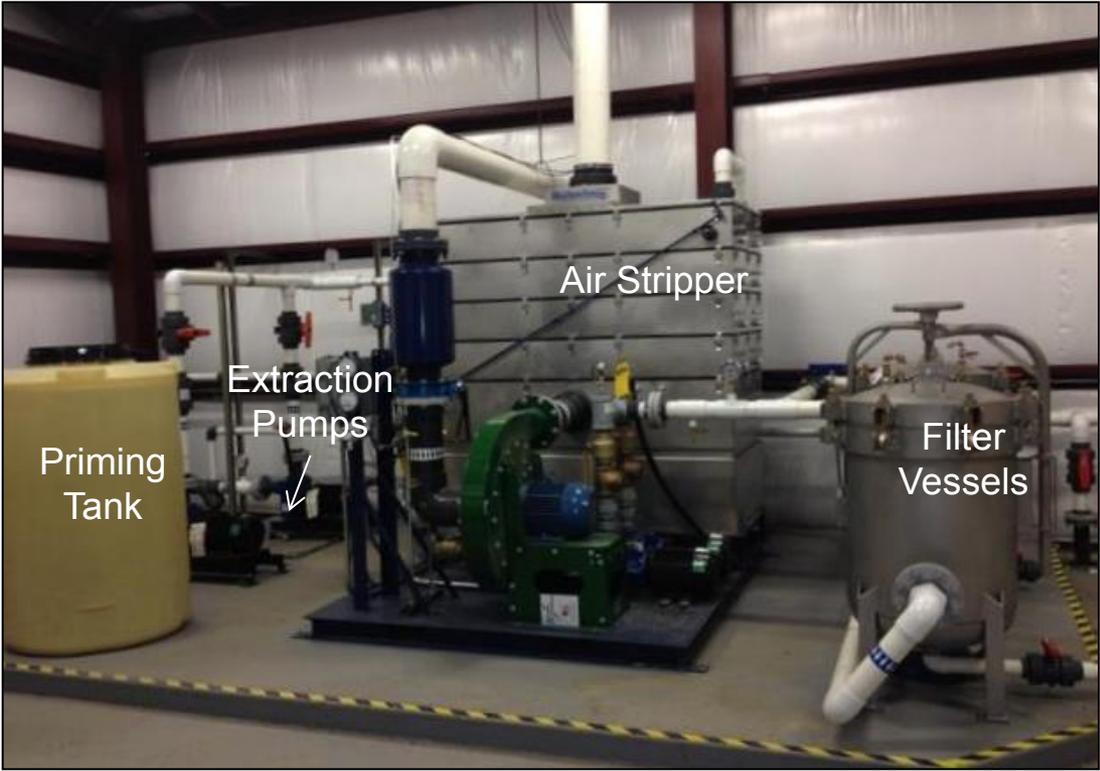
Treatment Plant Building

System Components

The FLTS system employs two extraction wells, air stripping equipment, and two infiltration galleries in order to control the VOC plume. Construction started in October 2012 and was completed in October 2013, and system start-up occurred on October 8, 2013.

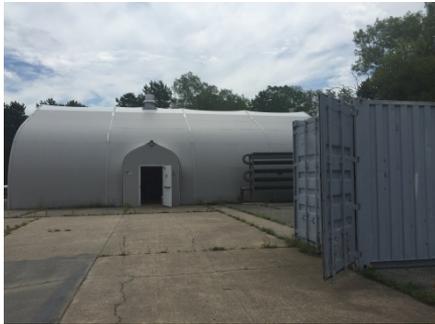
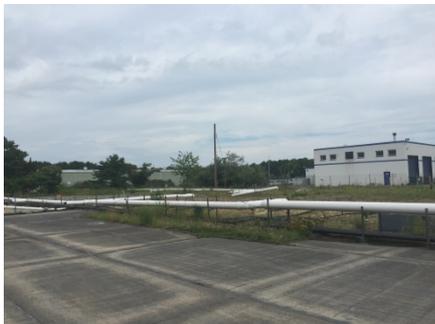
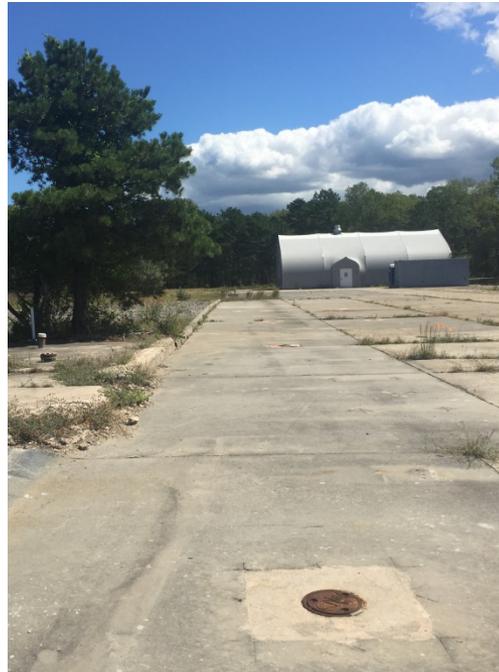
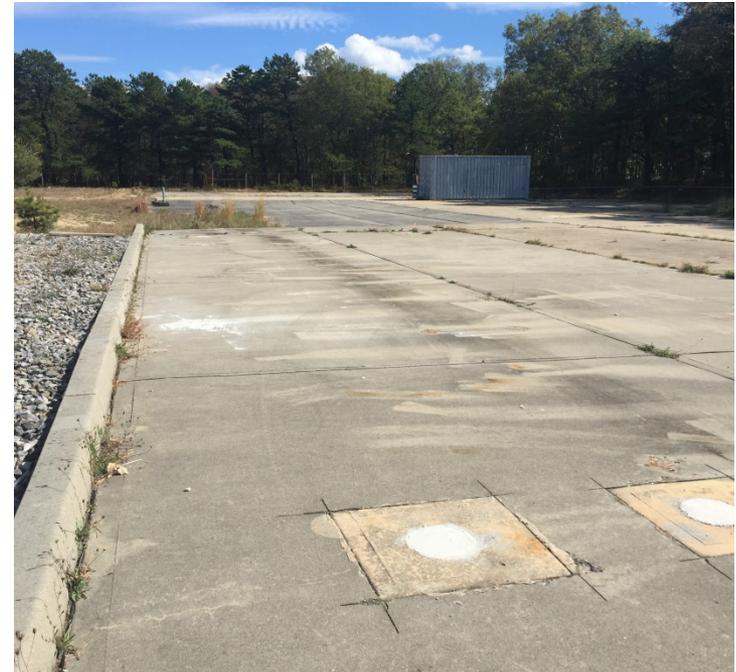
Decommissioning of Full-Scale AS/SVE System

- Contractor mobilized August 10, 2015
- Piping removed and wells decommissioned during first week
- Fabric structure repurposed for a museum
- All other material decontaminated and recycled or disposed

Mr. Robert Forstner (Resolution Consultants) then described the decommissioning of the AS/SVE system and the path forward for the site. The demolition contractor mobilized to the site on August 10, 2015, and completed removal of piping and abandonment of wells during the first week of site work. The equipment within the fabric structure was removed and all material was decontaminated and recycled or disposed. The fabric structure itself was repurposed by the manufacturer for reuse by a museum. Photographs indicating the progress of the work, including the final site condition, were shown. A construction completion report from the contractor was pending. Regarding future work, additional action in the form of in-situ remediation was considered likely. Further analysis of options and contracting were underway, with implementation targeted for 2016.

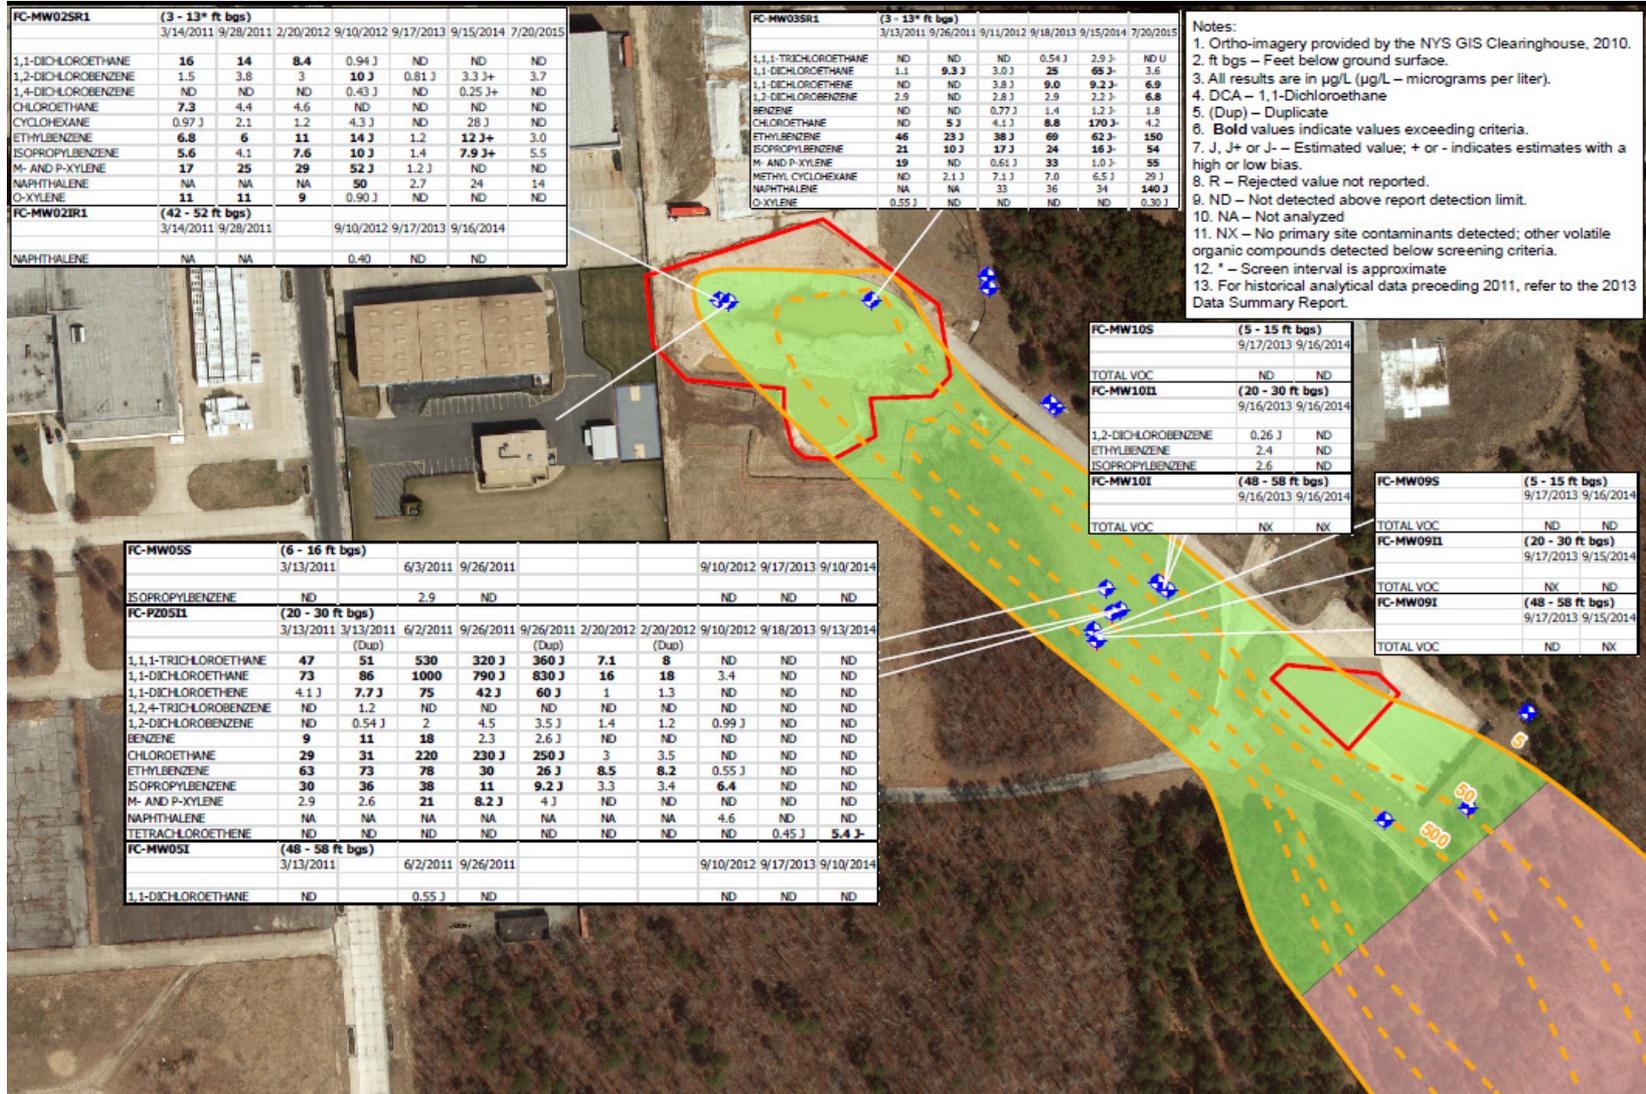
Fence Line Area Results

FC-PZ05I1	(20 - 30 ft bgs)									
	3/13/2011	3/13/2011	6/2/2011	9/26/2011	9/26/2011	2/20/2012	2/20/2012	9/10/2012	9/18/2013	9/13/2014
1,1,1-TRICHLOROETHANE	47	51	530	320 J	360 J	7.1	8	ND	ND	ND
1,1-DICHLOROETHANE	73	86	1000	790 J	830 J	16	18	3.4	ND	ND
1,1-DICHLOROBENZENE	4.1 J	7.7 J	75	42 J	60 J	1	1.3	ND	ND	ND
1,2,4-TRICHLOROBENZENE	ND	1.2	ND	ND	ND	ND	ND	ND	ND	ND
1,2-DICHLOROBENZENE	ND	0.54 J	2	4.5	3.5 J	1.4	1.2	0.99 J	ND	ND
BENZENE	9	11	18	2.3	2.6 J	ND	ND	ND	ND	ND
CHLOROETHANE	29	31	220	230 J	250 J	3	3.5	ND	ND	ND
ETHYLBENZENE	63	73	78	30	26 J	8.5	8.2	0.55 J	ND	ND
ISOPROPYLBENZENE	30	36	38	11	9.2 J	3.3	3.4	6.4	ND	ND
M- AND P-XYLENE	2.9	2.6	21	8.2 J	4 J	ND	ND	ND	ND	ND
NAPHTHALENE	NA	NA	NA	NA	NA	NA	NA	4.6	ND	ND
TETRACHLOROETHENE	ND	ND	ND	ND	ND	ND	ND	0.45 J	5.4 J+

FC-MW05I	(48 - 58 ft bgs)					
	3/13/2011	6/2/2011	9/26/2011	9/10/2012	9/17/2013	9/10/2014
1,1-DICHLOROETHANE	ND		0.55 J	ND		ND

- Results at SA-PZ179I through SA-PZ181I confirm plume still in this general area
- 1,1-DCA found at all three locations; exceeded MCL at two locations

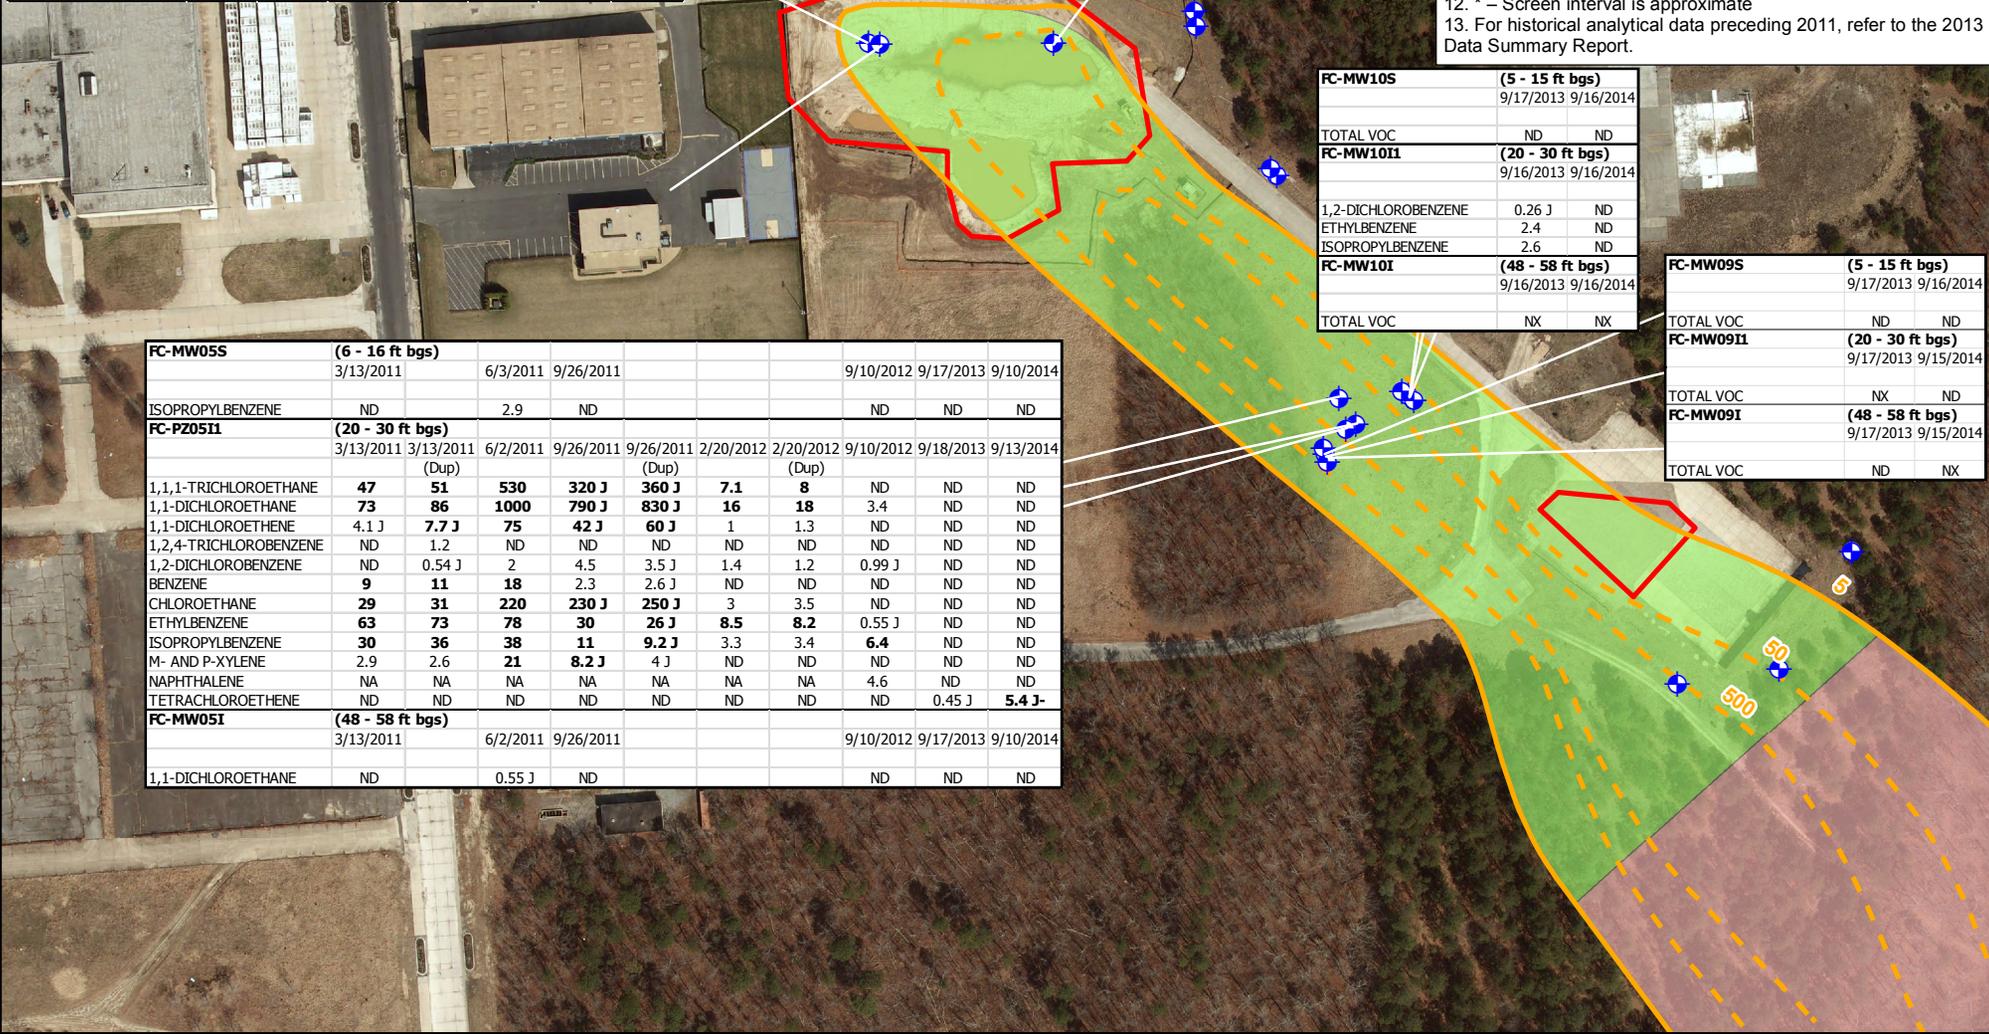
FC-MW03SR1 (3 - 13* ft bgs)							
	3/13/2011	9/26/2011	9/11/2012	9/18/2013	9/15/2014	7/20/2015	
1,1,1-TRICHLOROETHANE	ND	ND	ND	0.54 J	2.9 J-	ND U	
1,1-DICHLOROETHANE	1.1	9.3 J	3.0 J	25	65 J-	3.6	
1,1-DICHLOROETHENE	ND	ND	3.8 J	9.0	9.2 J-	6.9	
1,2-DICHLOROETHENE	2.9	ND	2.8 J	2.9	2.2 J-	6.8	
BENZENE	ND	ND	0.77 J	1.4	1.2 J-	1.8	
CHLOROETHANE	ND	5 J	4.1 J	8.8	170 J-	4.2	
ETHYLBENZENE	46	23 J	38 J	69	62 J-	150	
ISOPROPYLBENZENE	21	10 J	17 J	24	16 J-	54	
M- AND P-XYLENE	19	ND	0.61 J	33	1.0 J-	55	
METHYL CYCLOHEXANE	ND	2.1 J	7.1 J	7.0	6.5 J	29 J	
NAPHTHALENE	NA	NA	33	36	34	140 J	
O-XYLENE	0.55 J	ND	ND	ND	ND	0.30 J

- Notes:
1. Ortho-imagery provided by the NYS GIS Clearinghouse, 2010.
 2. ft bgs – Feet below ground surface.
 3. All results are in µg/L (µg/L – micrograms per liter).
 4. DCA – 1,1-Dichloroethane
 5. (Dup) – Duplicate
 6. Bold values indicate values exceeding criteria.
 7. J, J+ or J- – Estimated value; + or - indicates estimates with a high or low bias.
 8. R – Rejected value not reported.
 9. ND – Not detected above report detection limit.
 10. NA – Not analyzed
 11. NX – No primary site contaminants detected; other volatile organic compounds detected below screening criteria.
 12. * – Screen interval is approximate
 13. For historical analytical data preceding 2011, refer to the 2013 Data Summary Report.

FC-MW05S (6 - 16 ft bgs)							
	3/13/2011	6/3/2011	9/26/2011	9/10/2012	9/17/2013	9/10/2014	
ISOPROPYLBENZENE	ND	2.9	ND	ND	ND	ND

FC-PZ05I (20 - 30 ft bgs)										
	3/13/2011	3/13/2011 (Dup)	6/2/2011	9/26/2011	9/26/2011 (Dup)	2/20/2012	2/20/2012 (Dup)	9/10/2012	9/18/2013	9/13/2014
1,1,1-TRICHLOROETHANE	47	51	530	320 J	360 J	7.1	8	ND	ND	ND
1,1-DICHLOROETHANE	73	86	1000	790 J	830 J	16	18	3.4	ND	ND
1,1-DICHLOROETHENE	4.1 J	7.7 J	75	42 J	60 J	1	1.3	ND	ND	ND
1,2,4-TRICHLOROETHENE	ND	1.2	ND	ND	ND	ND	ND	ND	ND	ND
1,2-DICHLOROETHENE	ND	0.54 J	2	4.5	3.5 J	1.4	1.2	0.99 J	ND	ND
BENZENE	9	11	18	2.3	2.6 J	ND	ND	ND	ND	ND
CHLOROETHANE	29	31	220	230 J	250 J	3	3.5	ND	ND	ND
ETHYLBENZENE	63	73	78	30	26 J	8.5	8.2	0.55 J	ND	ND
ISOPROPYLBENZENE	30	36	38	11	9.2 J	3.3	3.4	6.4	ND	ND
M- AND P-XYLENE	2.9	2.6	21	8.2 J	4 J	ND	ND	ND	ND	ND
NAPHTHALENE	NA	NA	NA	NA	NA	NA	NA	4.6	ND	ND
TETRACHLOROETHENE	ND	ND	ND	ND	ND	ND	ND	0.45 J	5.4 J-
