FINAL PRELIMINARY ASSESSMENT/SITE INSPECTION REPORT SITE UXO-12 NEW
RIVER 1,000 INCH RANGE AND UXO-18 - 50 FOOT SMALL BORE RANGE MCB CAMP
LEJEUNE NC
04/01/2011
CH2M HILL

**Preliminary Assessment/Site Inspection Report
Site UXO-12 - New River 1,000-inch Range (ASR #2.5)
and UXO-18 - 50-foot Small Bore Range (ASR #2.44)**

Marine Corps Base Camp Lejeune
Jacksonville, North Carolina

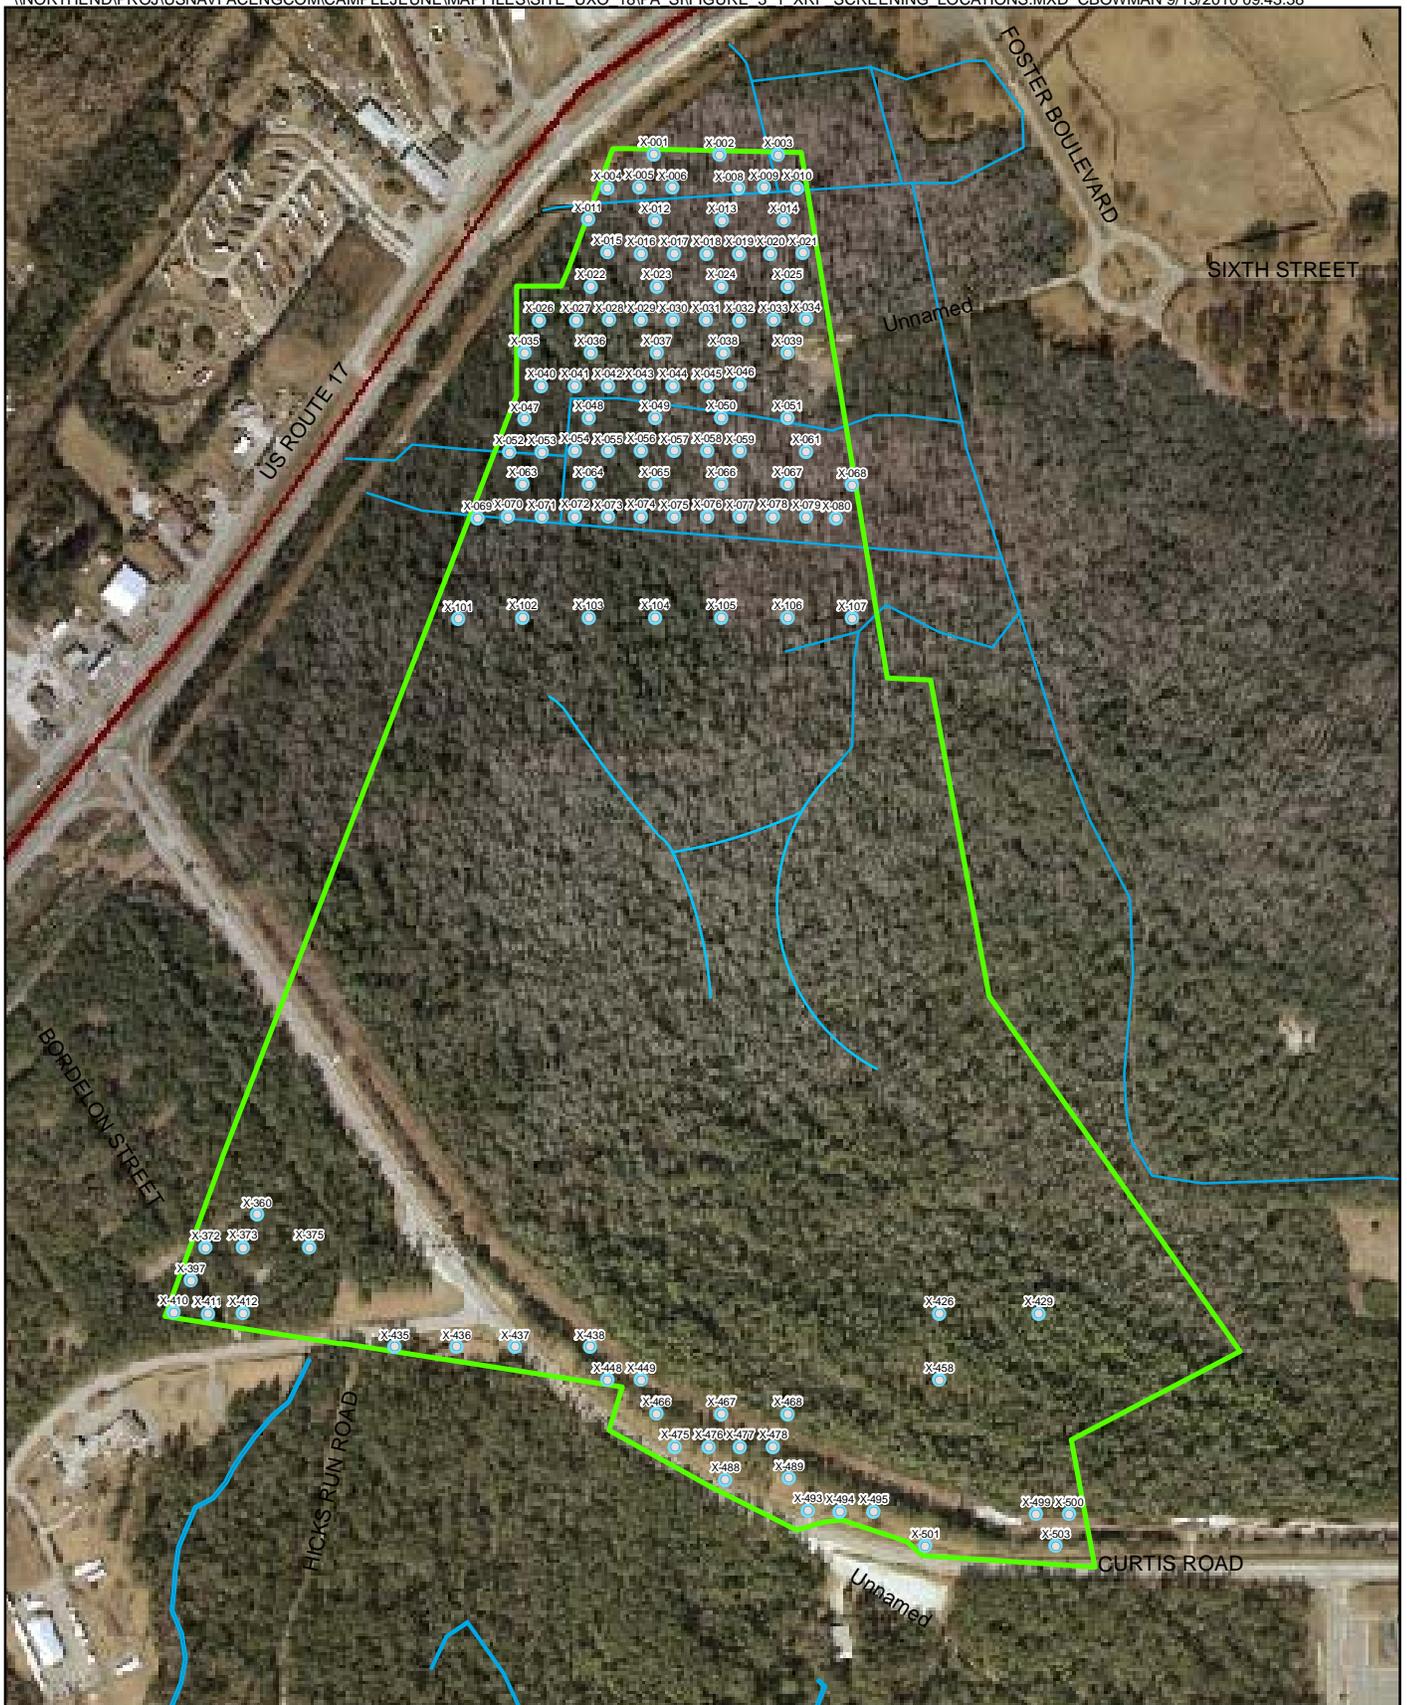
Figure 3-1
 XRF Screening Locations
 Site UXO-12/UXO-18
 Preliminary Assessment/Site Inspection
 MCB CamLej
 North Carolina

The majority of the surface soil metals concentrations were less than the detection limits of the XRF instrument, as presented in **Table 4-1**. For this reason, a correlation between the XRF results and the fixed-base laboratory results could not be drawn. Additionally, XRF screening is inaccurate for soils with moisture contents greater than 20% therefore XRF screening could not be performed under the saturated soil conditions at the site. As metals concentrations in site soils are for the most part less than the XRF instrument detection limits and saturated soils were present throughout much of the site, it was concluded that XRF screening is not an appropriate tool for soil screening at Site UXO-12/UXO-18.

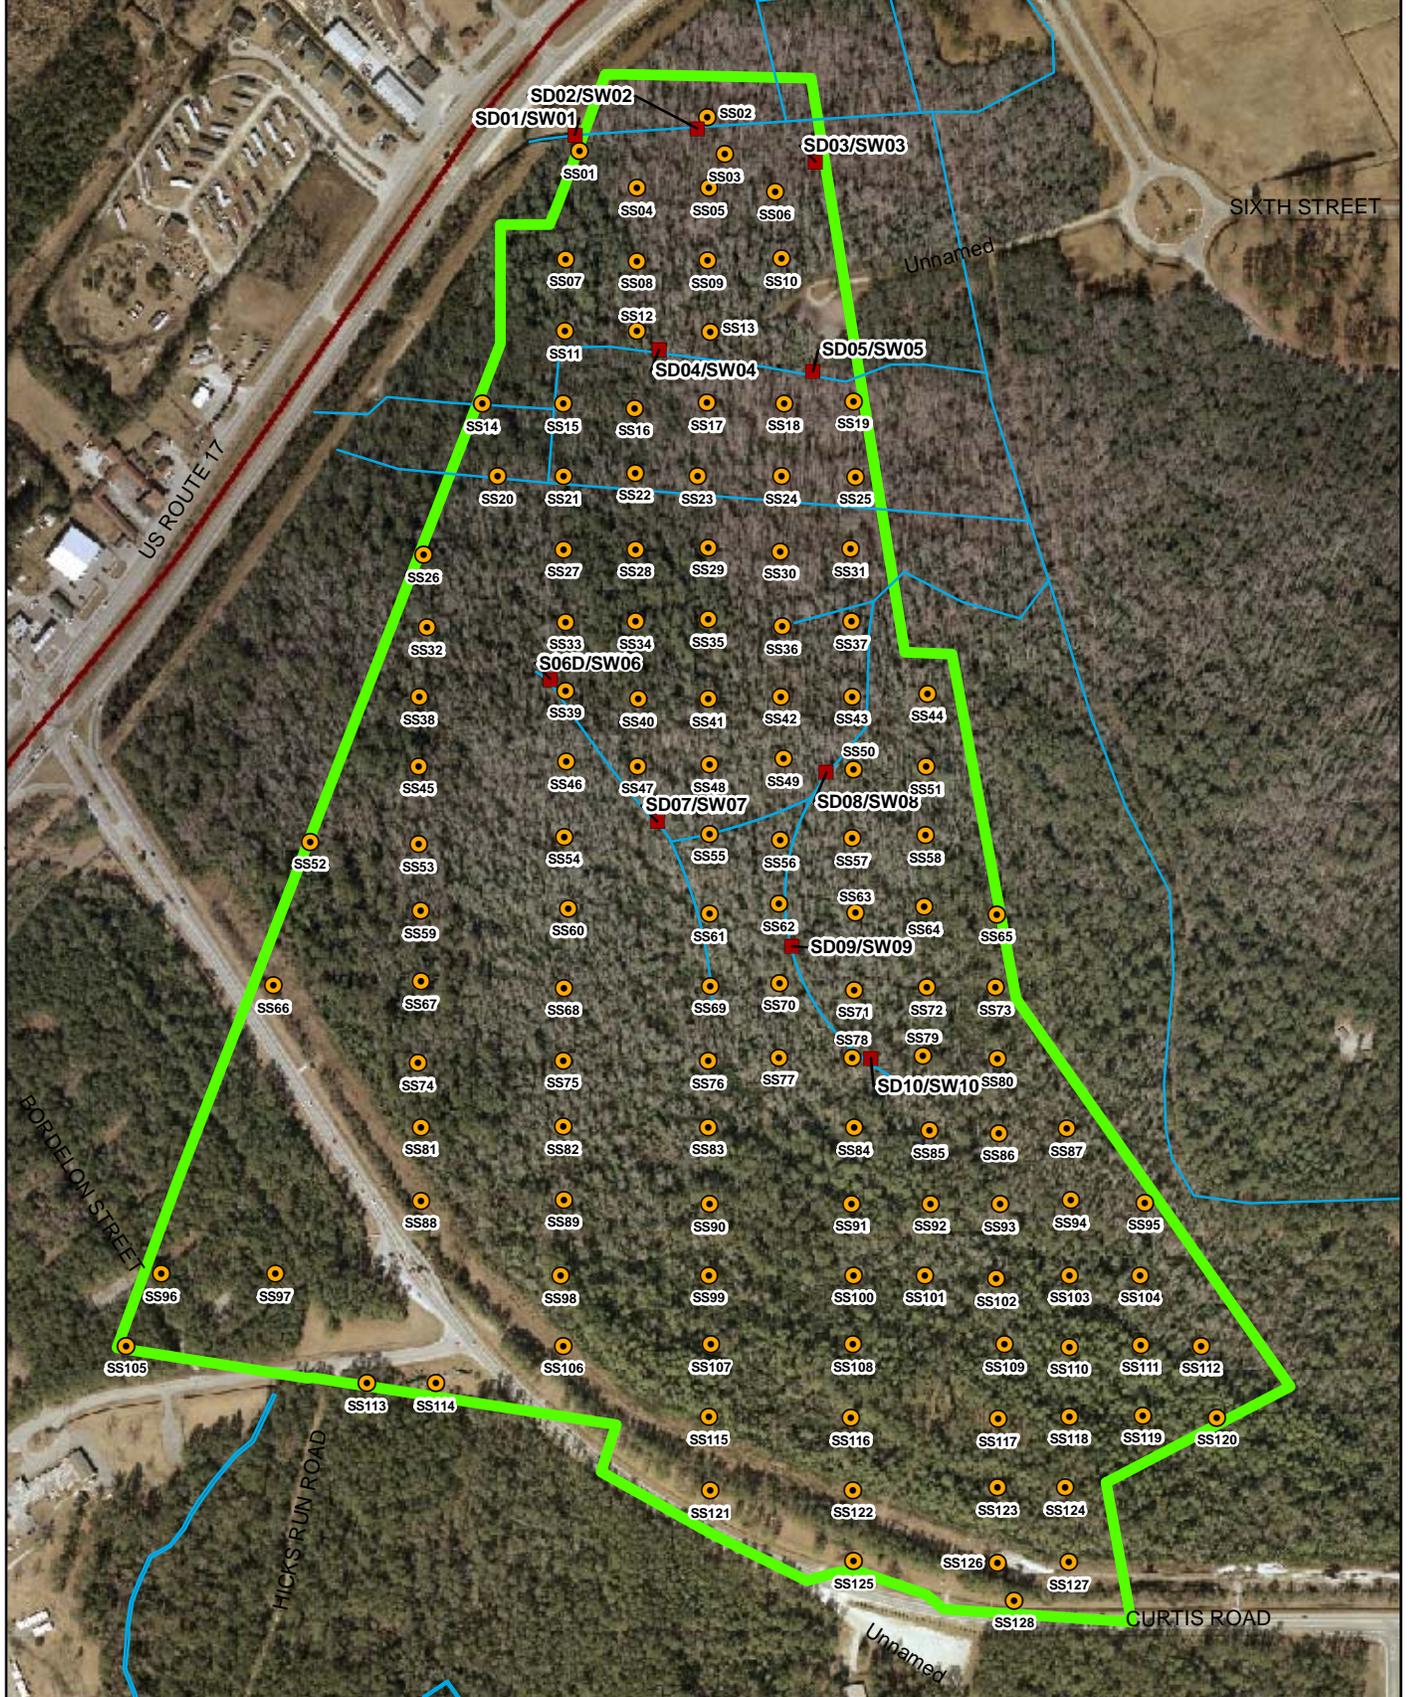
During the initial phase of field investigation, conducted in November 2009, surface soil from 118 of the proposed 536 screening locations was screened using a XL3T 600 XRF device. The XRF screening focused upon 5 metals commonly associated with small arms ranges, antimony, arsenic, copper, lead and zinc. The screening process was used to identify the presence of elevated metals concentrations (compared to site-specific background) and facilitate the selection of samples for fixed-base laboratory analysis. Surface soil samples were collected from a depth interval of 0 to 1 feet below ground surface (bgs), as described in Section 3.2.2. XRF surface soil screening locations are shown on **Figure 3-1**.

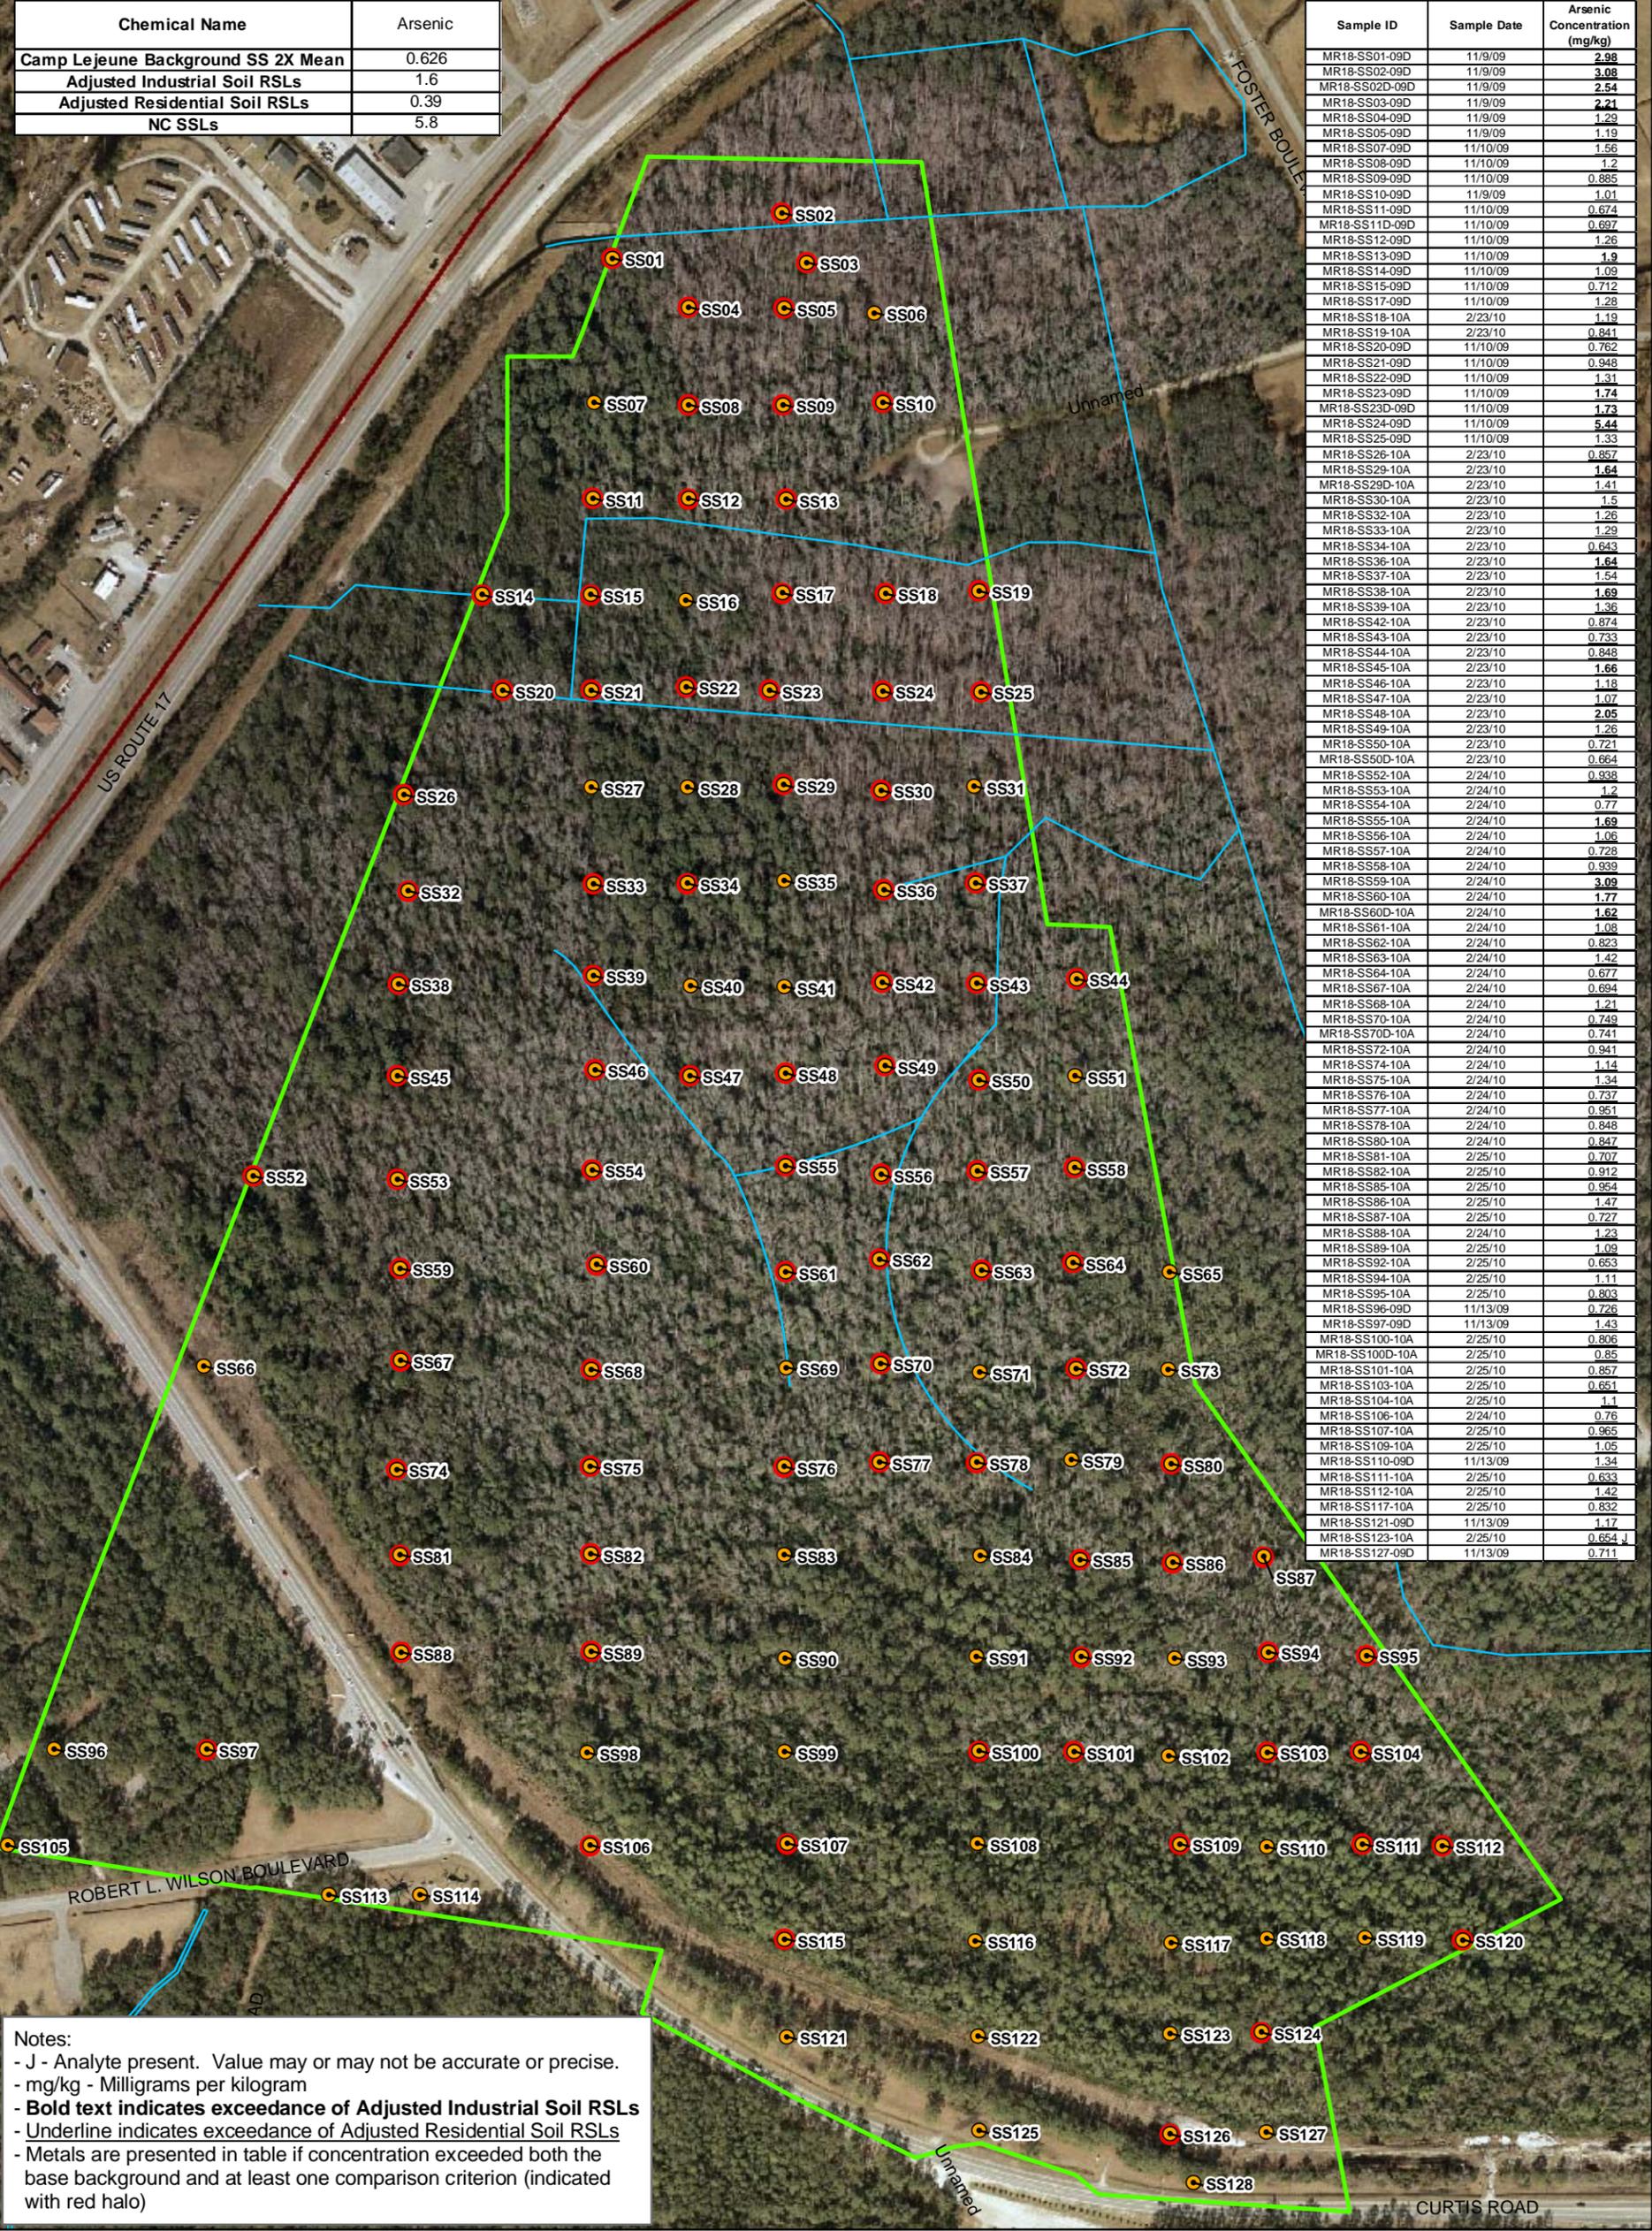
Figure 4-1
 Surface Soil Exceedances
 Site UXO-12/UXO-18
 Preliminary Assessment/Site Inspection
 MCB CamLej
 North Carolina

A total of 128 surface soil samples were collected for fixed-base laboratory analysis of antimony, arsenic, copper, lead, and zinc in November 2009 and February 2010 (**Figure 3-2**). Surface soil concentrations were screened against the North Carolina Hazardous Waste Site Soil Screening Levels (NC SSLs) (NCDENR, 2010) and the adjusted USEPA residential and industrial soil risk-based screen levels (RSLs) (USEPA, 2010)), and MCB CamLej background soil data from the *Final Base Background Soil Study Report* (Baker, 2001).

Notes:
 - J - Analyte present. Value may or may not be accurate or precise.
 - mg/kg - Milligrams per kilogram
 - **Bold text indicates exceedance of Adjusted Industrial Soil RSLs**
 - Underline indicates exceedance of Adjusted Residential Soil RSLs
 - Metals are presented in table if concentration exceeded both the base background and at least one comparison criterion (indicated with red halo)

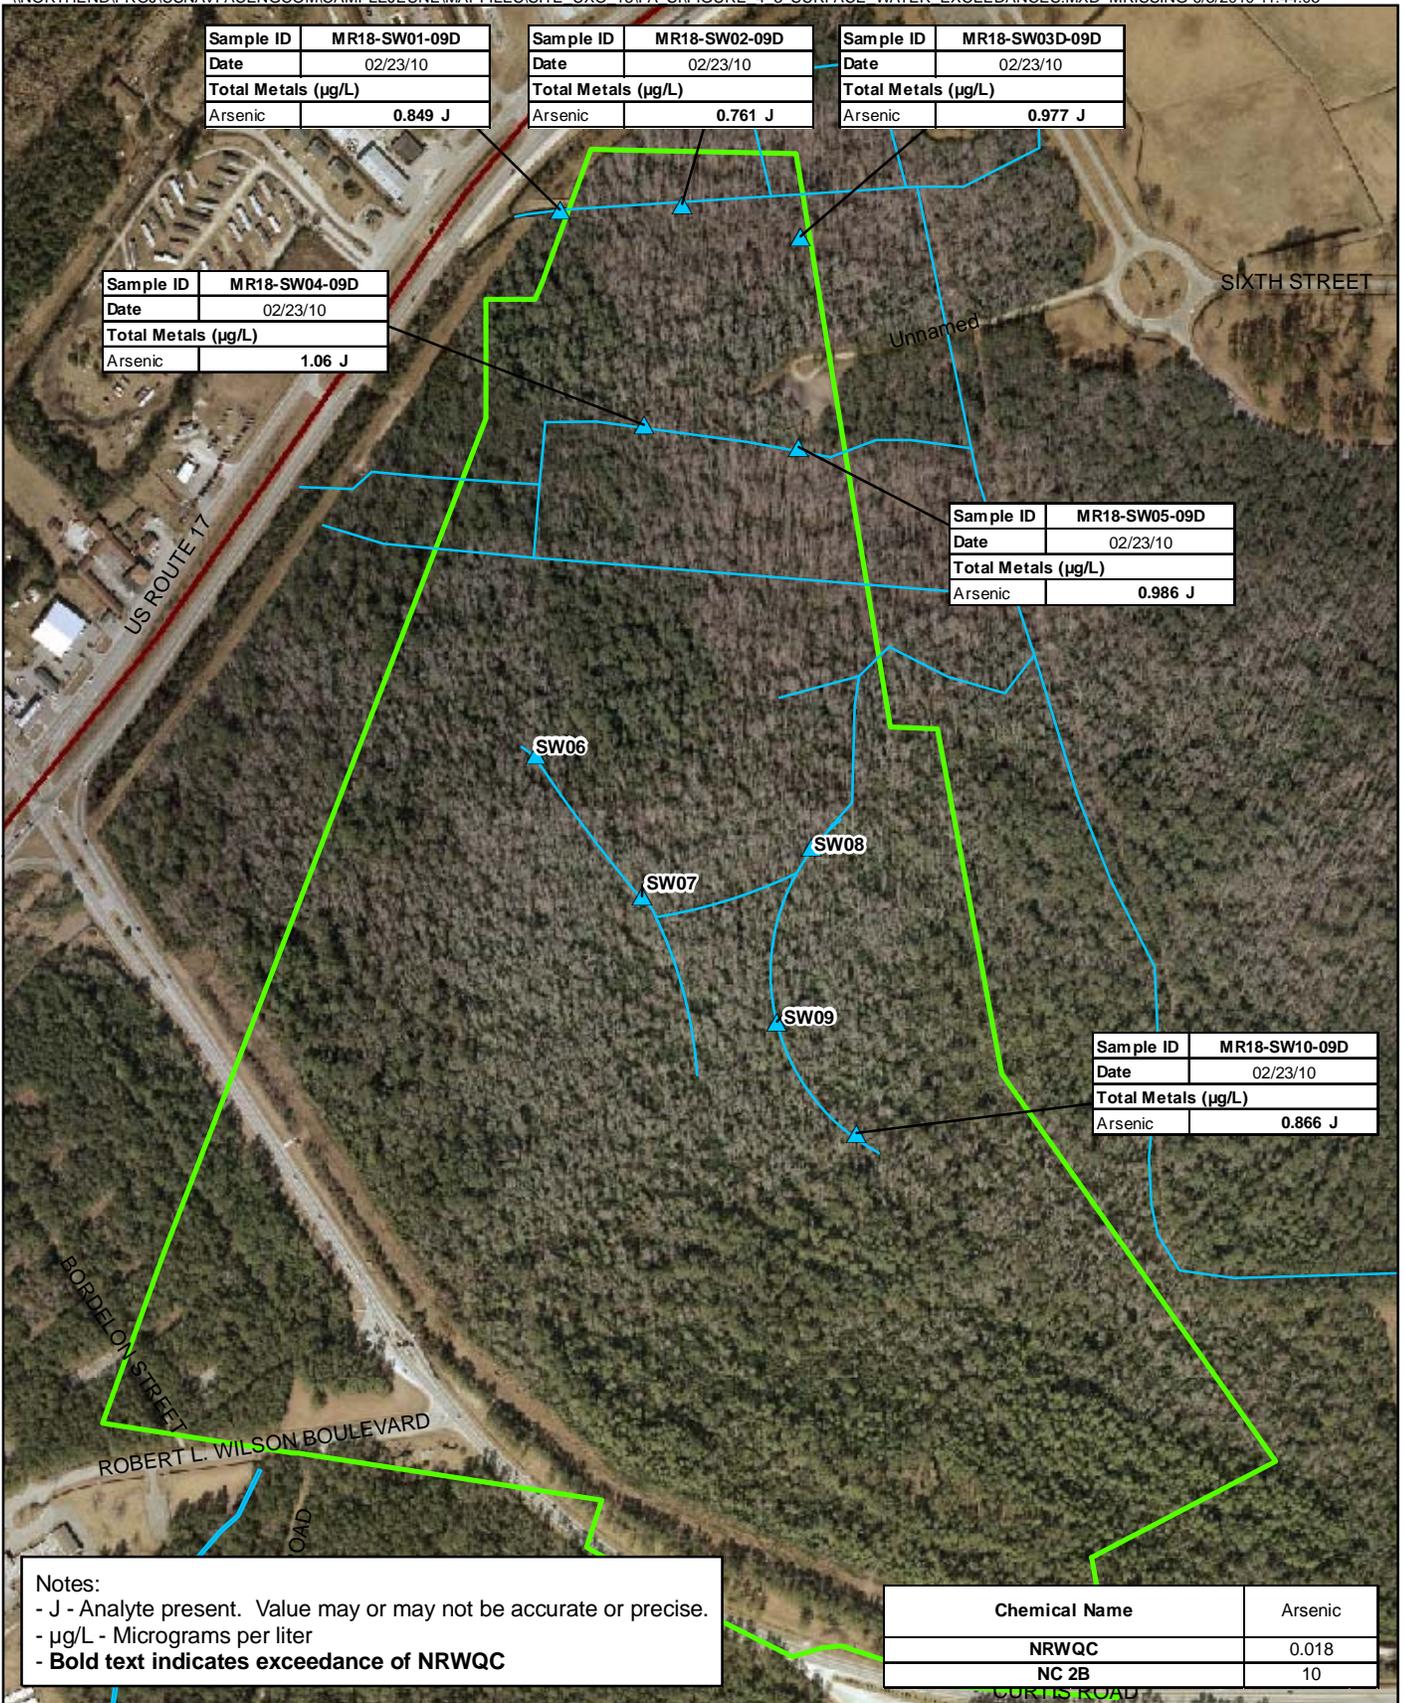
Figure 4-3
 Surface Water Exceedances
 Site UXO-12/UXO-18
 Preliminary Assessment/Site Inspection
 MCB CamLej
 North Carolina

In February 2010, ten surface water samples (MR18-SW01 through MR18-SW10) were collected for fixed-base laboratory analysis of antimony, arsenic, copper, lead, and zinc. Surface water samples were analyzed for total and dissolved metals. Target analyte concentrations were screened against North Carolina 2B (NC 2B) surface water standards (NCDENR, 2007) and USEPA National Recommended Water Quality Criteria (NRWQC) (USEPA, 2009a). Surface water analytical results for total metals were as follows:

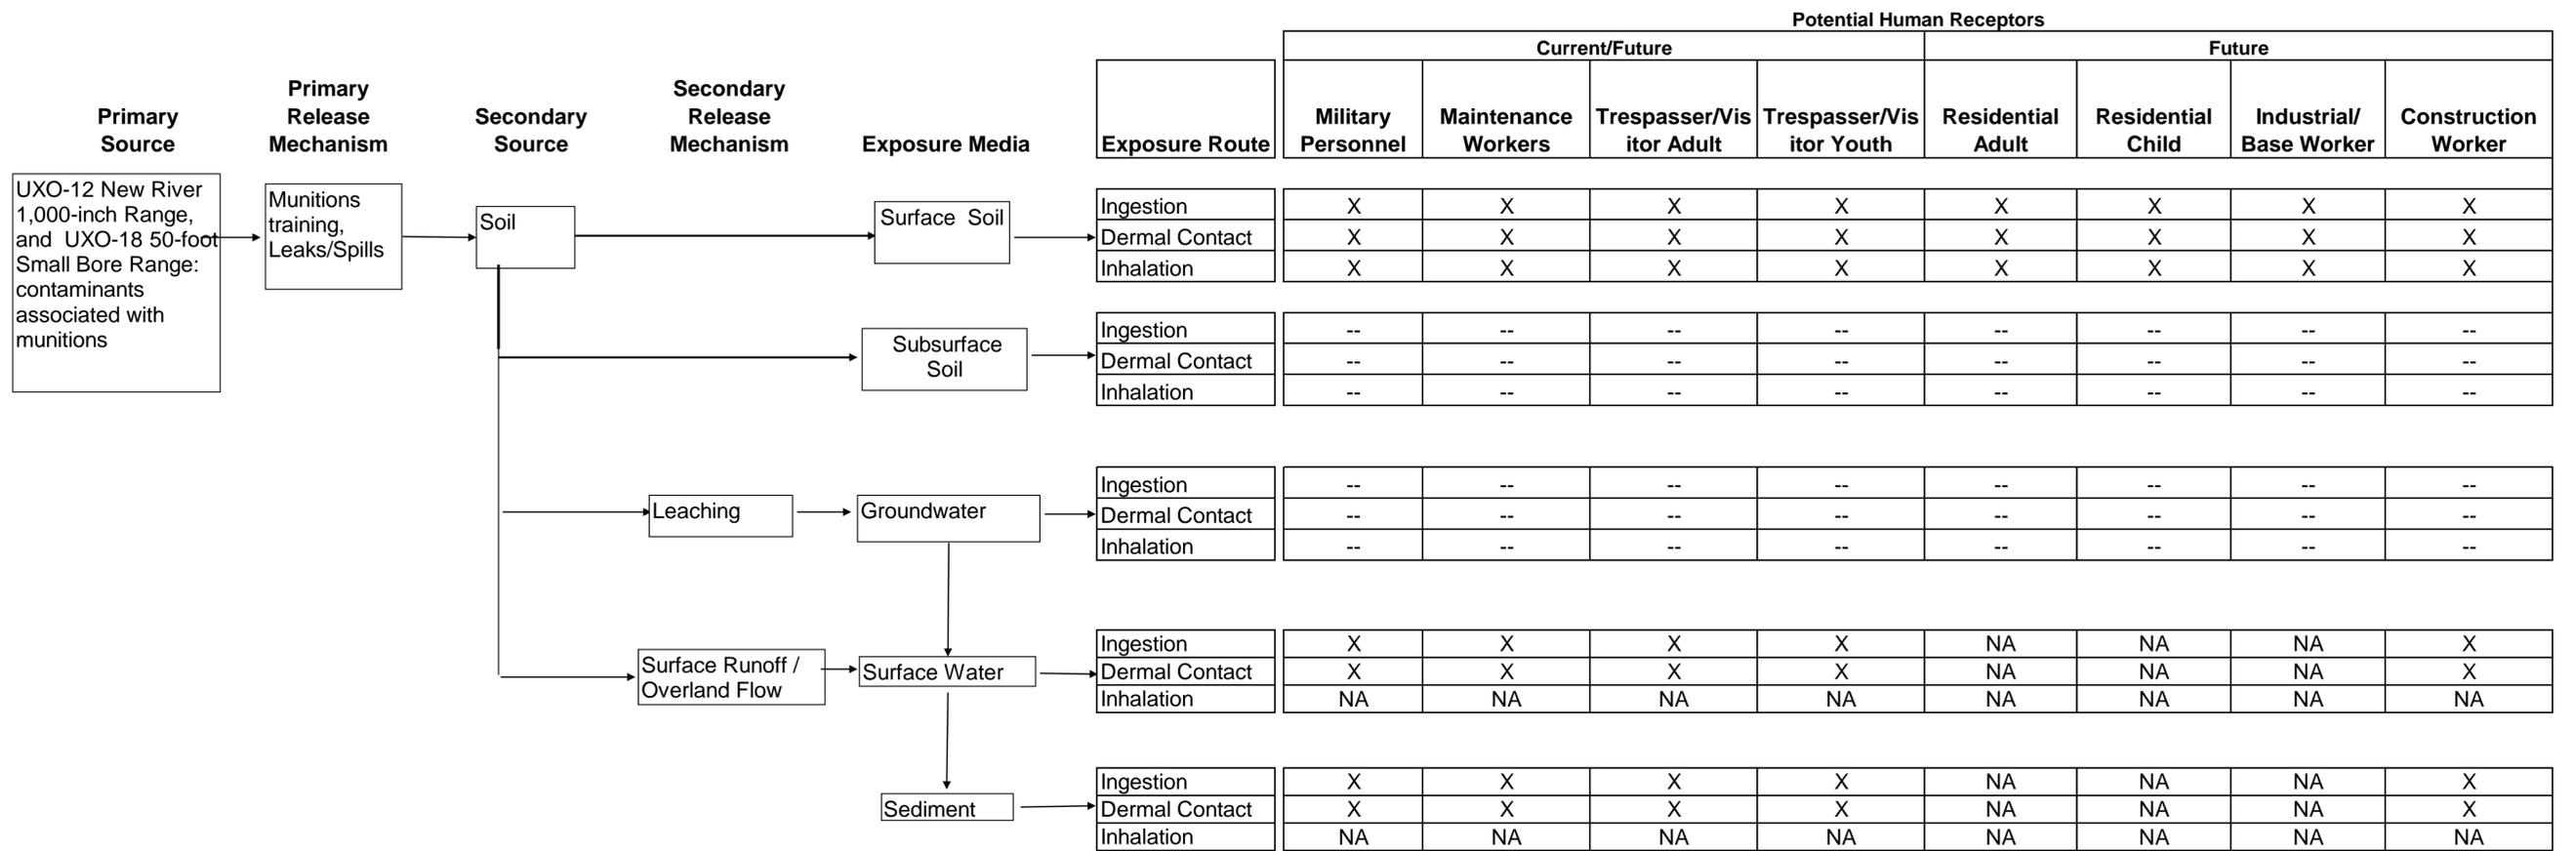
The human health conceptual site model (CSM) presents an overview of site conditions, potential contaminant migration pathways, and exposure pathways to potential receptors. The human health CSM for surface soil, surface water, and sediment is presented on **Figure 5-1**. **Section 2** presents the site history and setting.

NA - Not Applicable or pathway is incomplete
 X - Potentially complete exposure pathways
 -- = Exposure media is present, however samples not collected from this media since low surface soil contamination found. Therefore, pathway not evaluated in risk assessment.

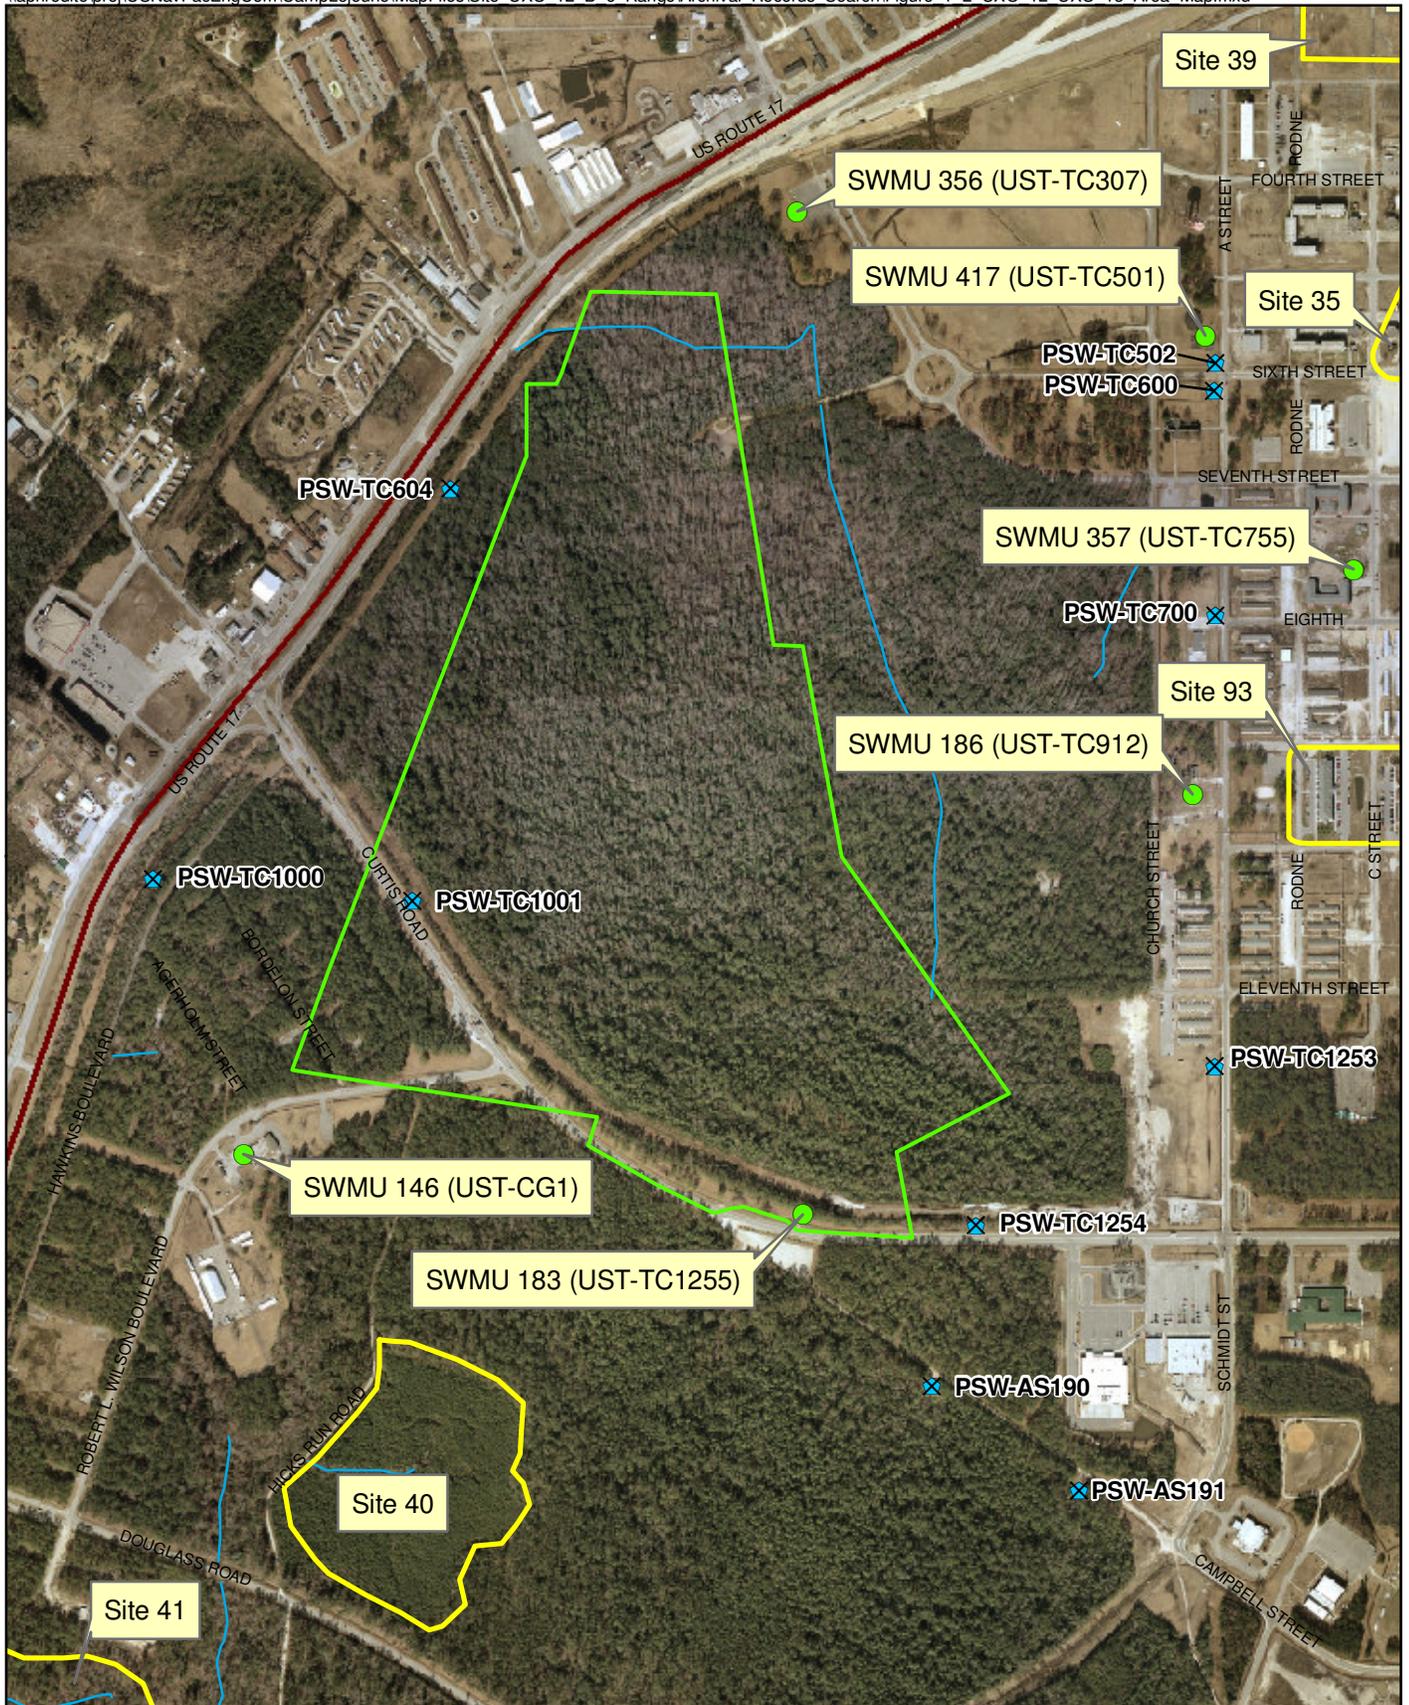
Figure 1-1
Site Map
UXO-12/UXO-18 Archival Records Search Report
MCB Camp Lejeune
North Carolina

The UXO-12/UXO-18 investigation area is currently densely vegetated over most of the site. A road loop is located in the northern portion of the site, Curtis Road runs through the southern portion of the site and the roads for the PHS Trailer Park are visible, **Figure 1-1**.

The site currently appears to be densely vegetated, with evidence of one stream, one road, one utility line access, and no buildings, **Figure 1-1**.

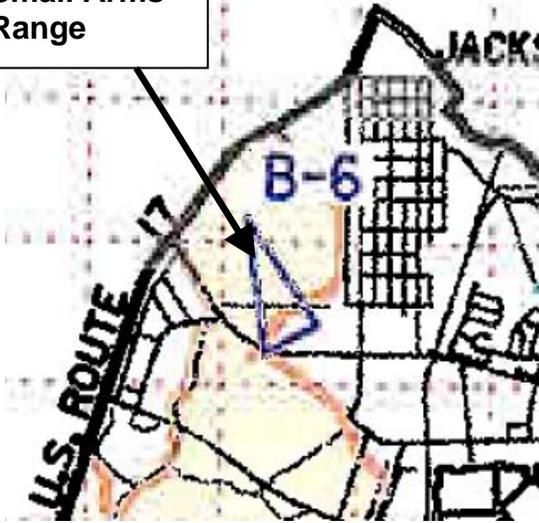
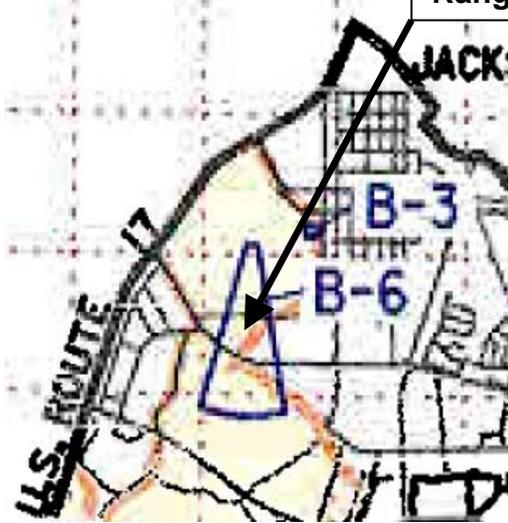
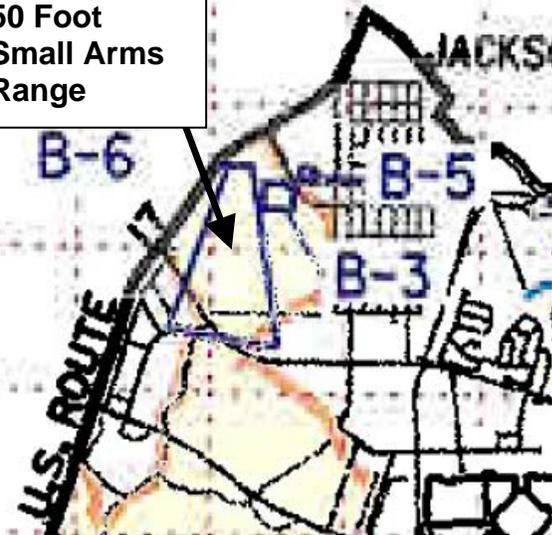
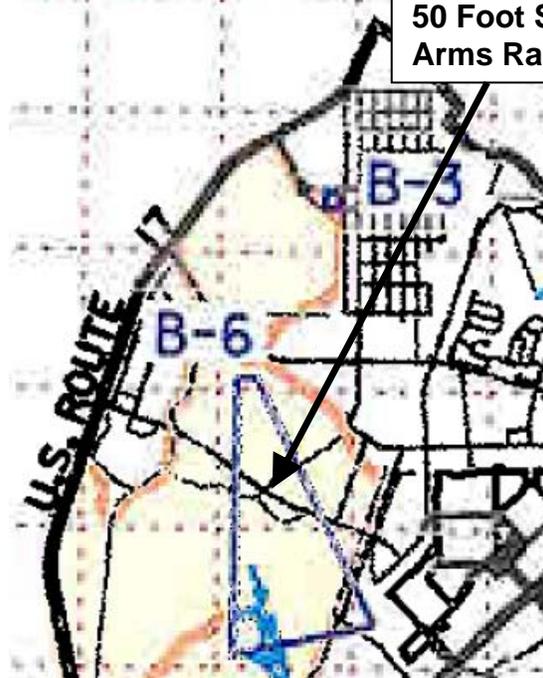
The UXO-18 site boundary encompasses the B-6 50-Foot Small Arms Range (ASR #2.44). Four different range fans appear around the Camp Geiger area from 1951 to 1958 and are identified as B-6 50-Foot Small Arms Range (ASR #2.44) (USACE, 2001). The UXO-12/UXO-18 site boundary was delineated by plotting three of the historical range fans and incorporating Site UXO-12. It should be noted that the southernmost range from Plate 10, (USACE, 2001) located south of Curtis Road, was not used in the delineation of the UXO-12/UXO-18 investigation area site boundary (**Figure 2-3**). The reason for this is that another former military range, the B-12 range complex, is located in this area.

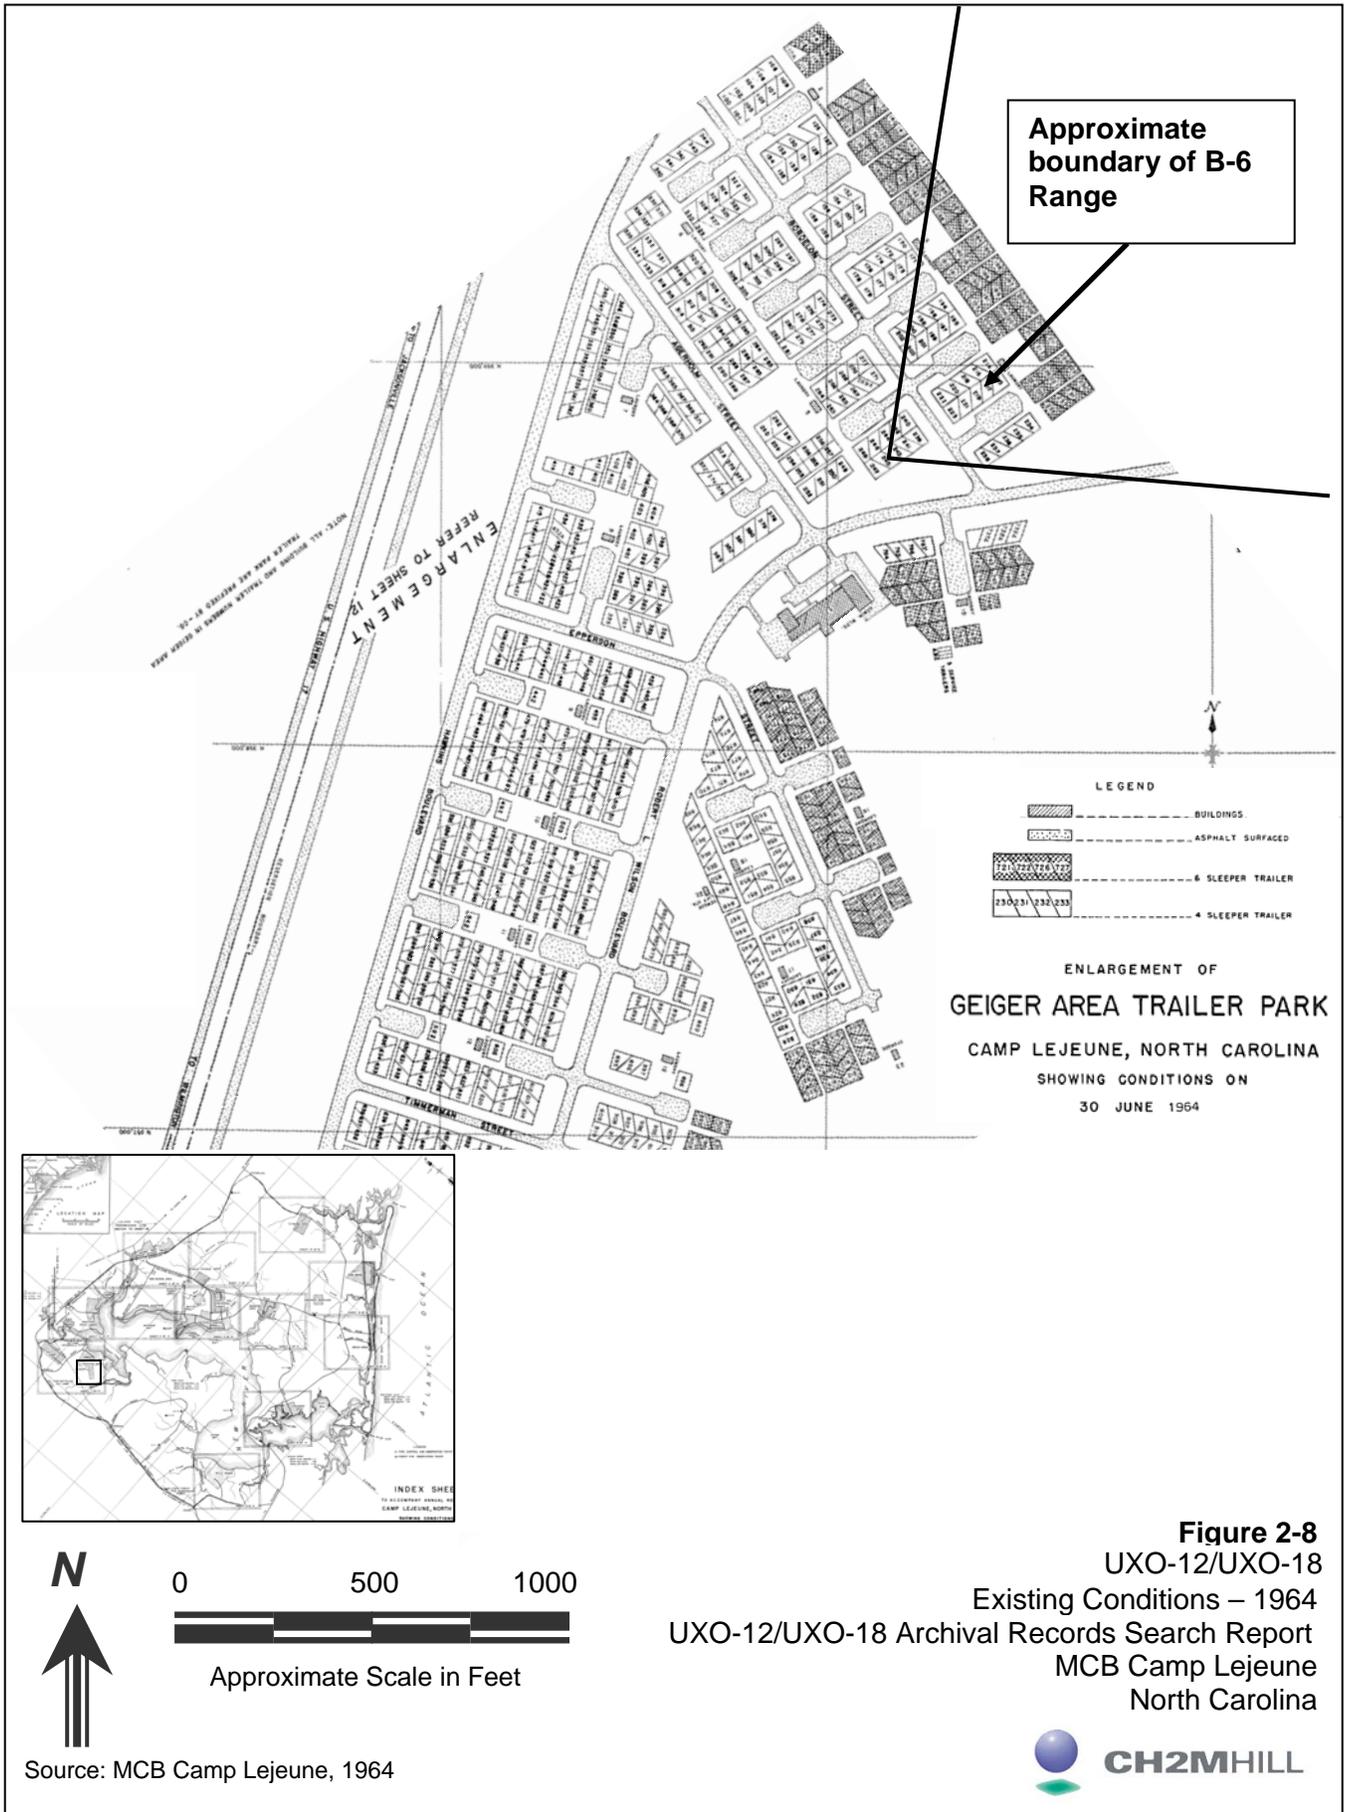
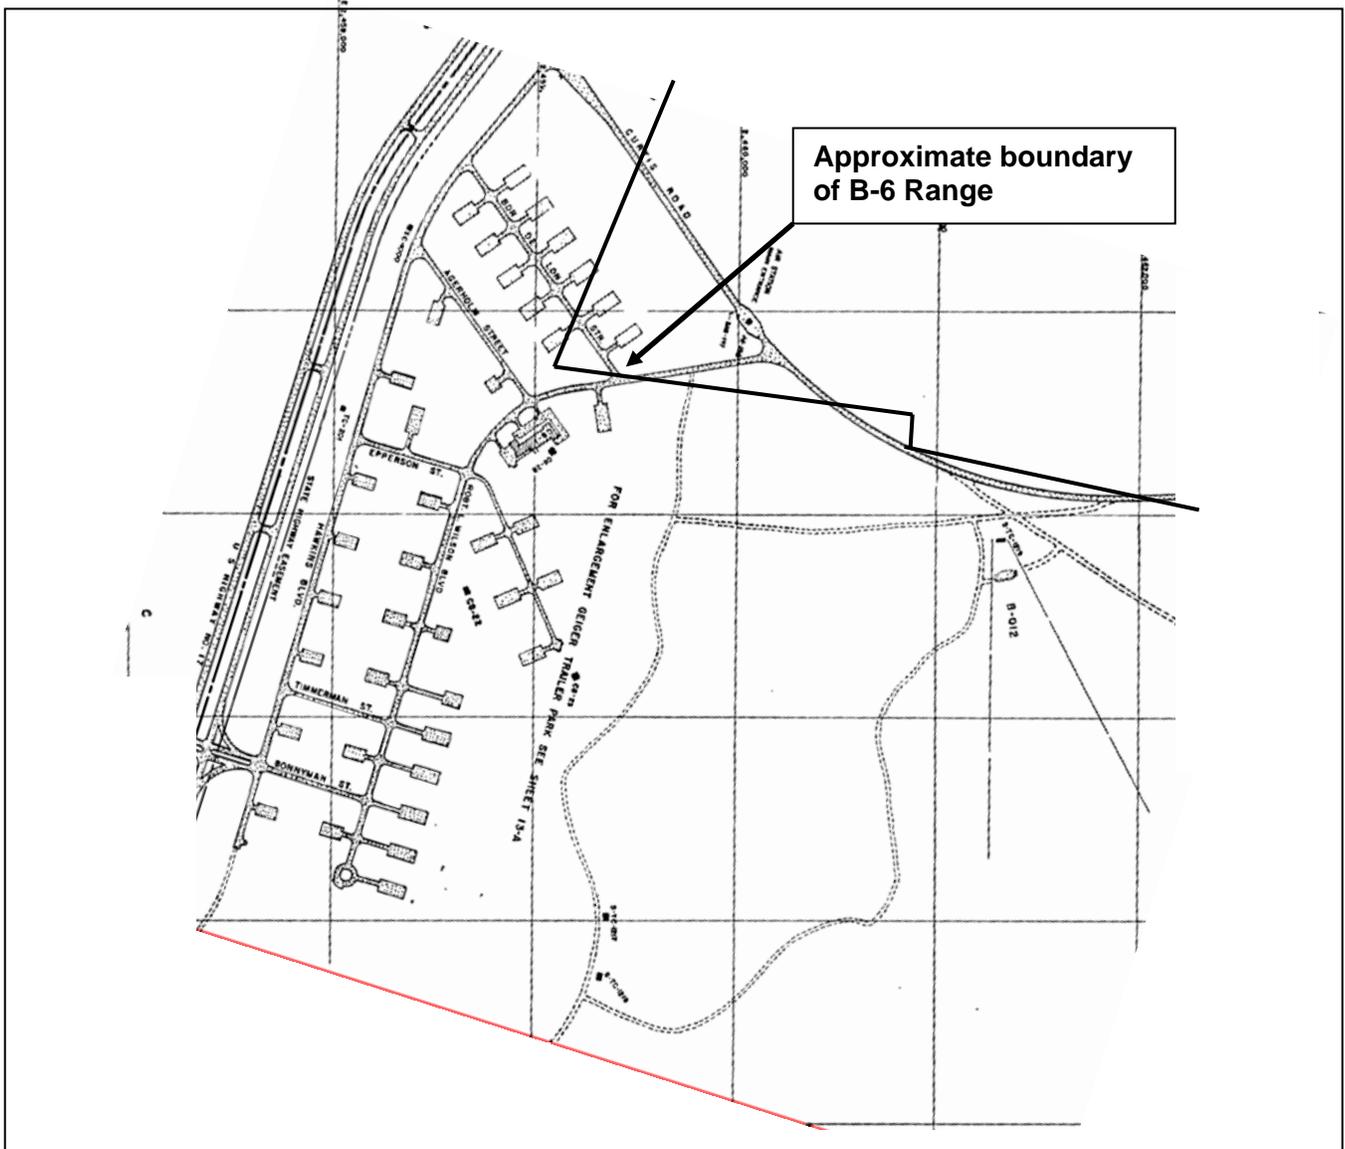
Figure 2-9
 UXO-12/UXO-18 Existing Conditions –1979
 UXO-12/UXO-18 Archival Records Search Report
 MCB Camp Lejeune
 North Carolina

From 1953 until 1985, there are no changes in the infrastructure near or within the UXO-12/UXO-18 investigation area site boundary according to available existing condition maps. The 1979 Camp Lejeune existing conditions map shows the footprint of the former trailer park in the area of UXO-05 and various small buildings on the site that were/are used for classrooms, storage, a sewer pump station and pump houses for wells (**Figure 2-9**).

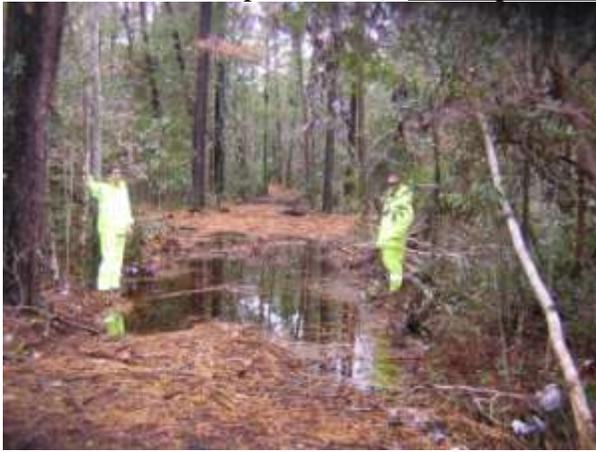
1. Estimate the approximate size of the wooded area 170 acres
Please identify what information was used to determine the wooded area of the site (e.g., direct observation, photos, etc). Aerial photos available through Google earth and site photos.

2. Indicate the dominant type of vegetation in the wooded area. Provide photographs, if available.

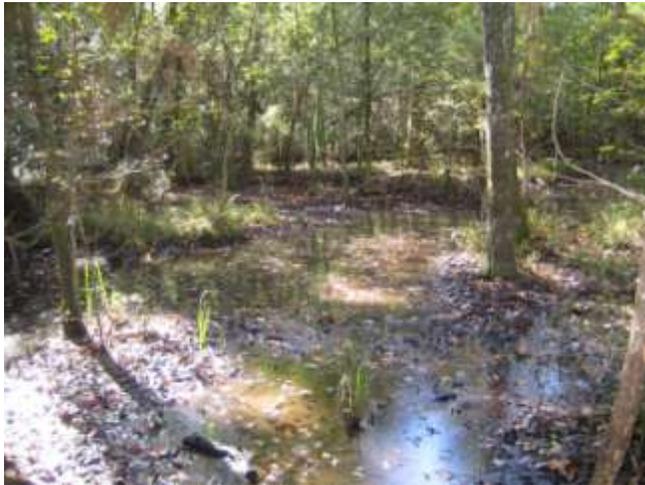
3. Provide a general description of the vegetation present in and around the wetland (height, color, etc). Provide a photograph of the known or suspected wetlands, if available.
Forested, palustrine wetlands with some emergent vegetation.
