FINAL EXPANDED SITE INVESTIGATION REPORT MILITARY MUNITIONS RESPONSE  
PROGRAM (MMRP) SITE UXO-01 (ASR 2.23) FORMER LIVE HAND GRENADE COURSE  
MCB CAMP LEJEUNE NC  
3/1/2012  
CH2M HILL

**Expanded Site Investigation Report  
Military Munitions Response Program Site UXO-01 (ASR #2.23) -  
Former Live Hand Grenade Course**

**Marine Corps Base Camp Lejeune  
Jacksonville, North Carolina**

**March 2012**

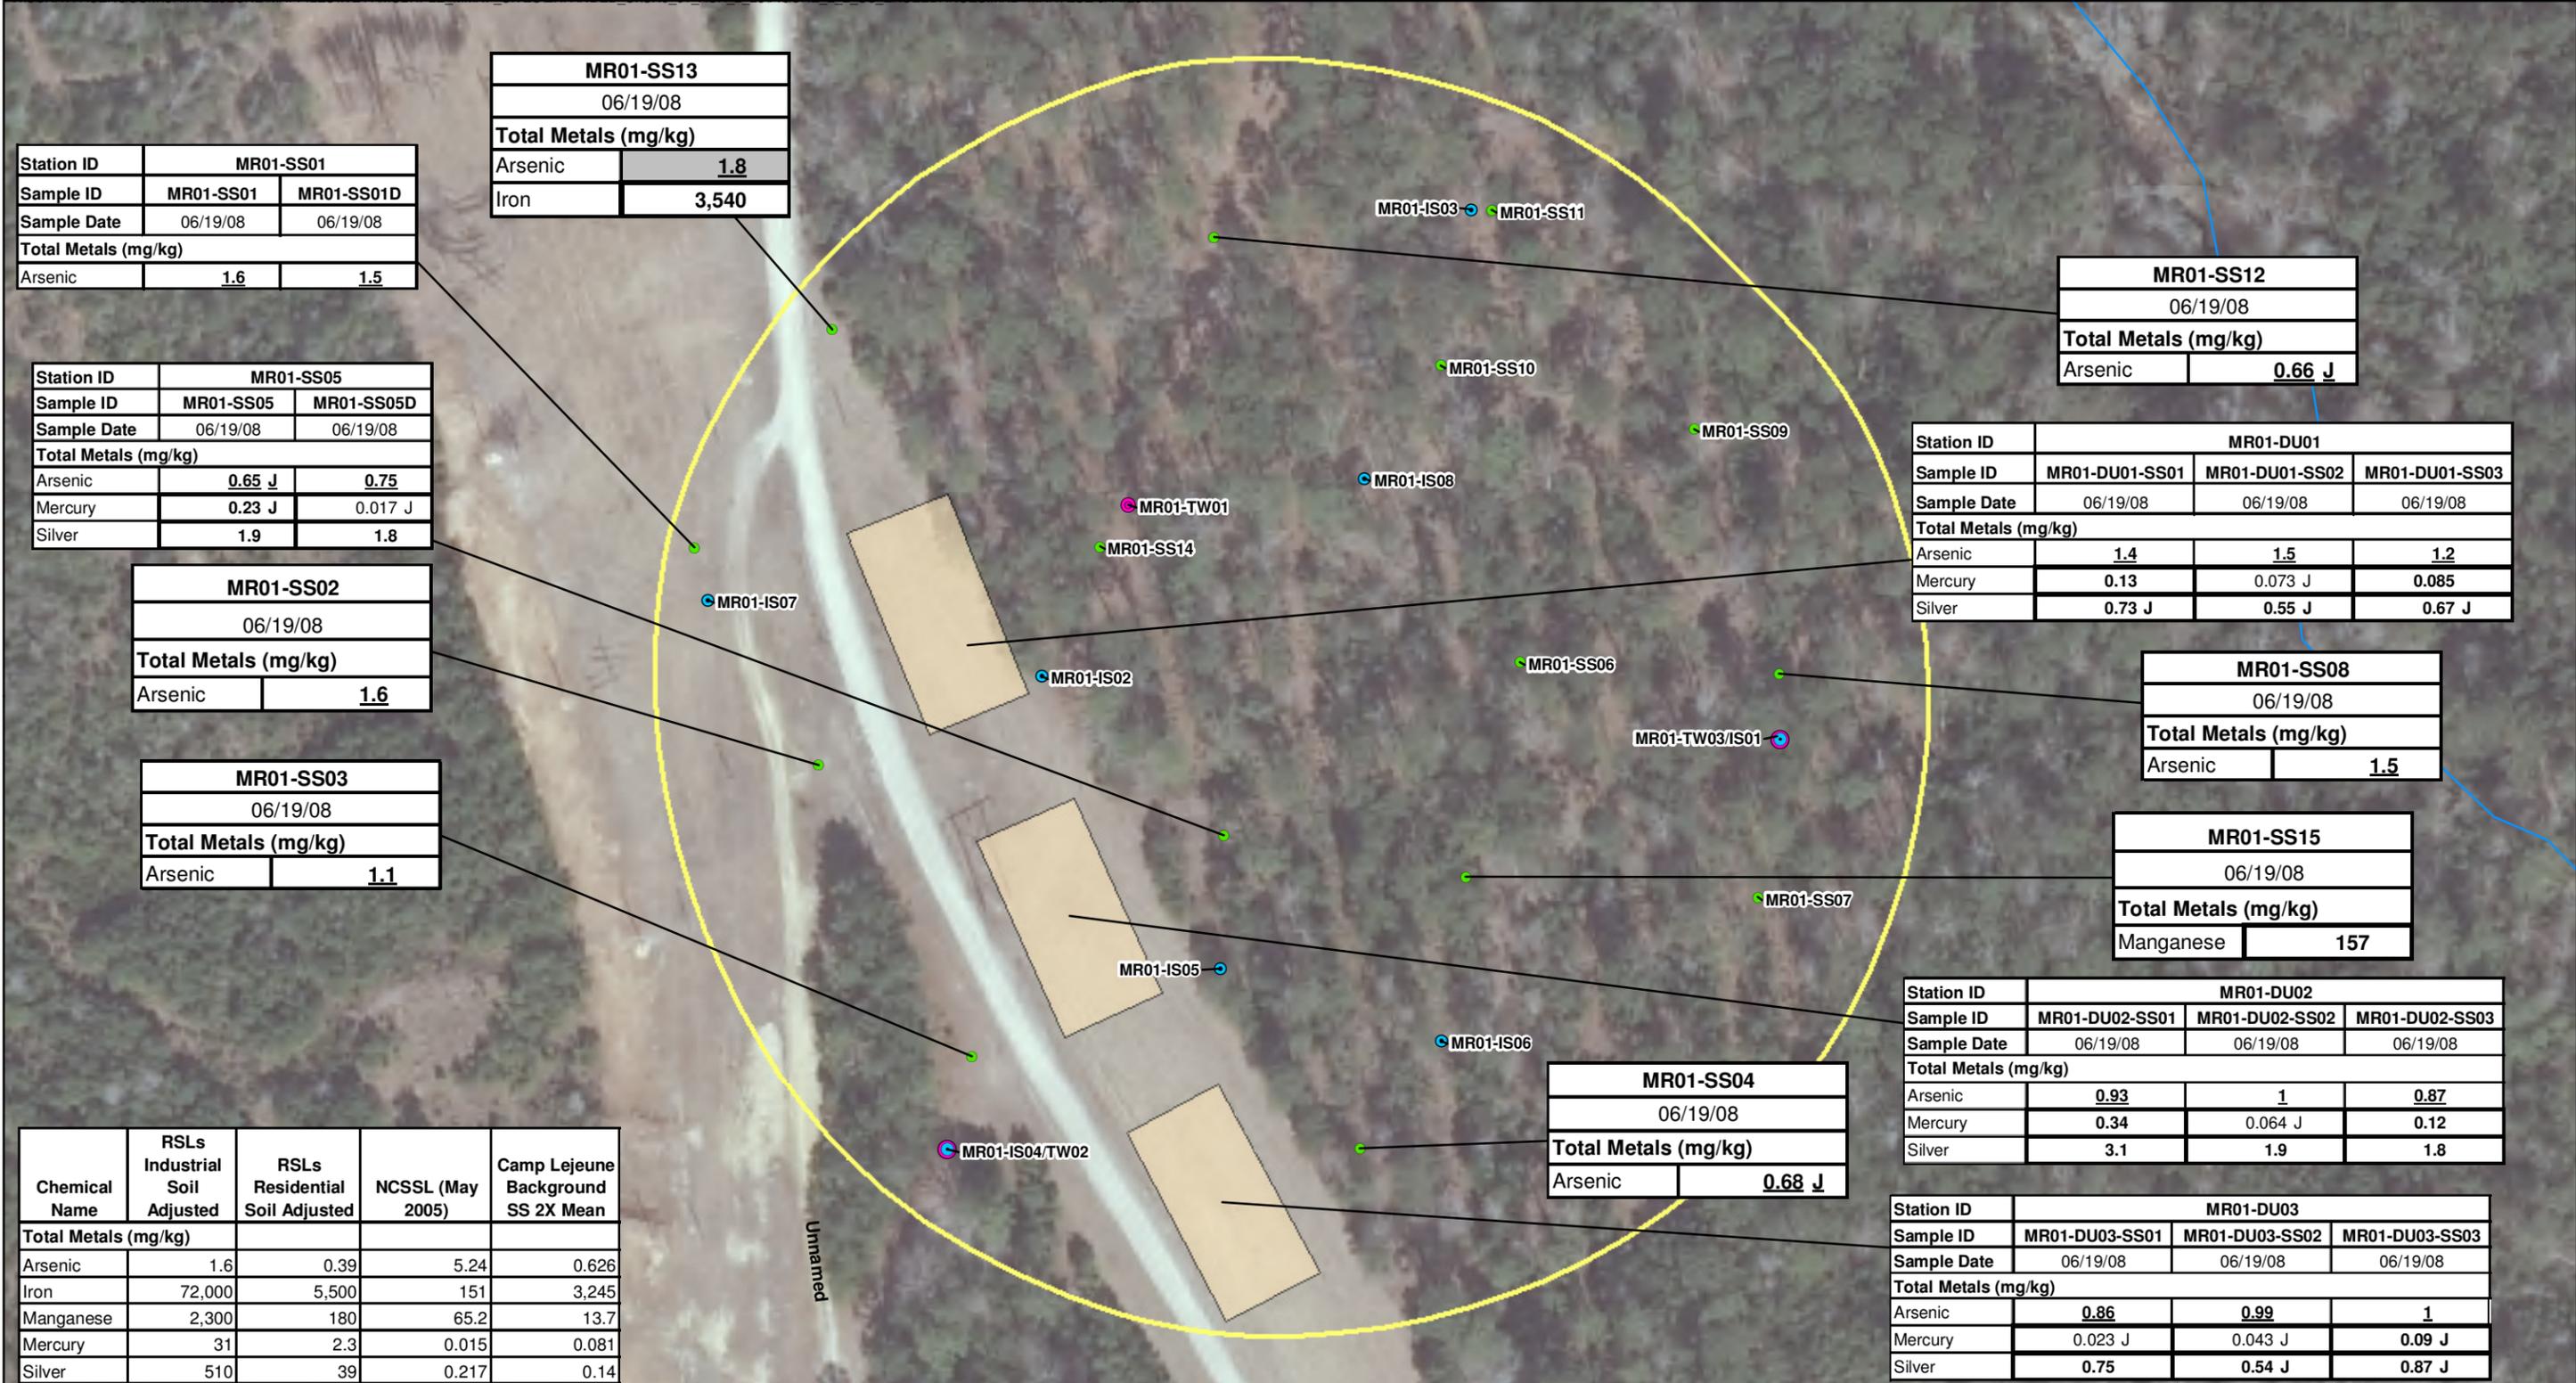
Figure 2-2  
 Surface Soil Exceedances  
 Site UXO-01 (ASR # 2.23) Expanded SI Report  
 MCB CamLej  
 North Carolina

**Figure 2-2** shows the locations of the Site UXO-01 surface soil screening criteria exceedances, and the surface soil screening levels are summarized in **Table 2-1**.

Station ID	MR01-SS01	
Sample ID	MR01-SS01	MR01-SS01D
Sample Date	06/19/08	06/19/08
Total Metals (mg/kg)		
Arsenic	<u>1.6</u>	<u>1.5</u>

<b>MR01-SS13</b>	
06/19/08	
Total Metals (mg/kg)	
Arsenic	<u>1.8</u>
Iron	<b>3,540</b>

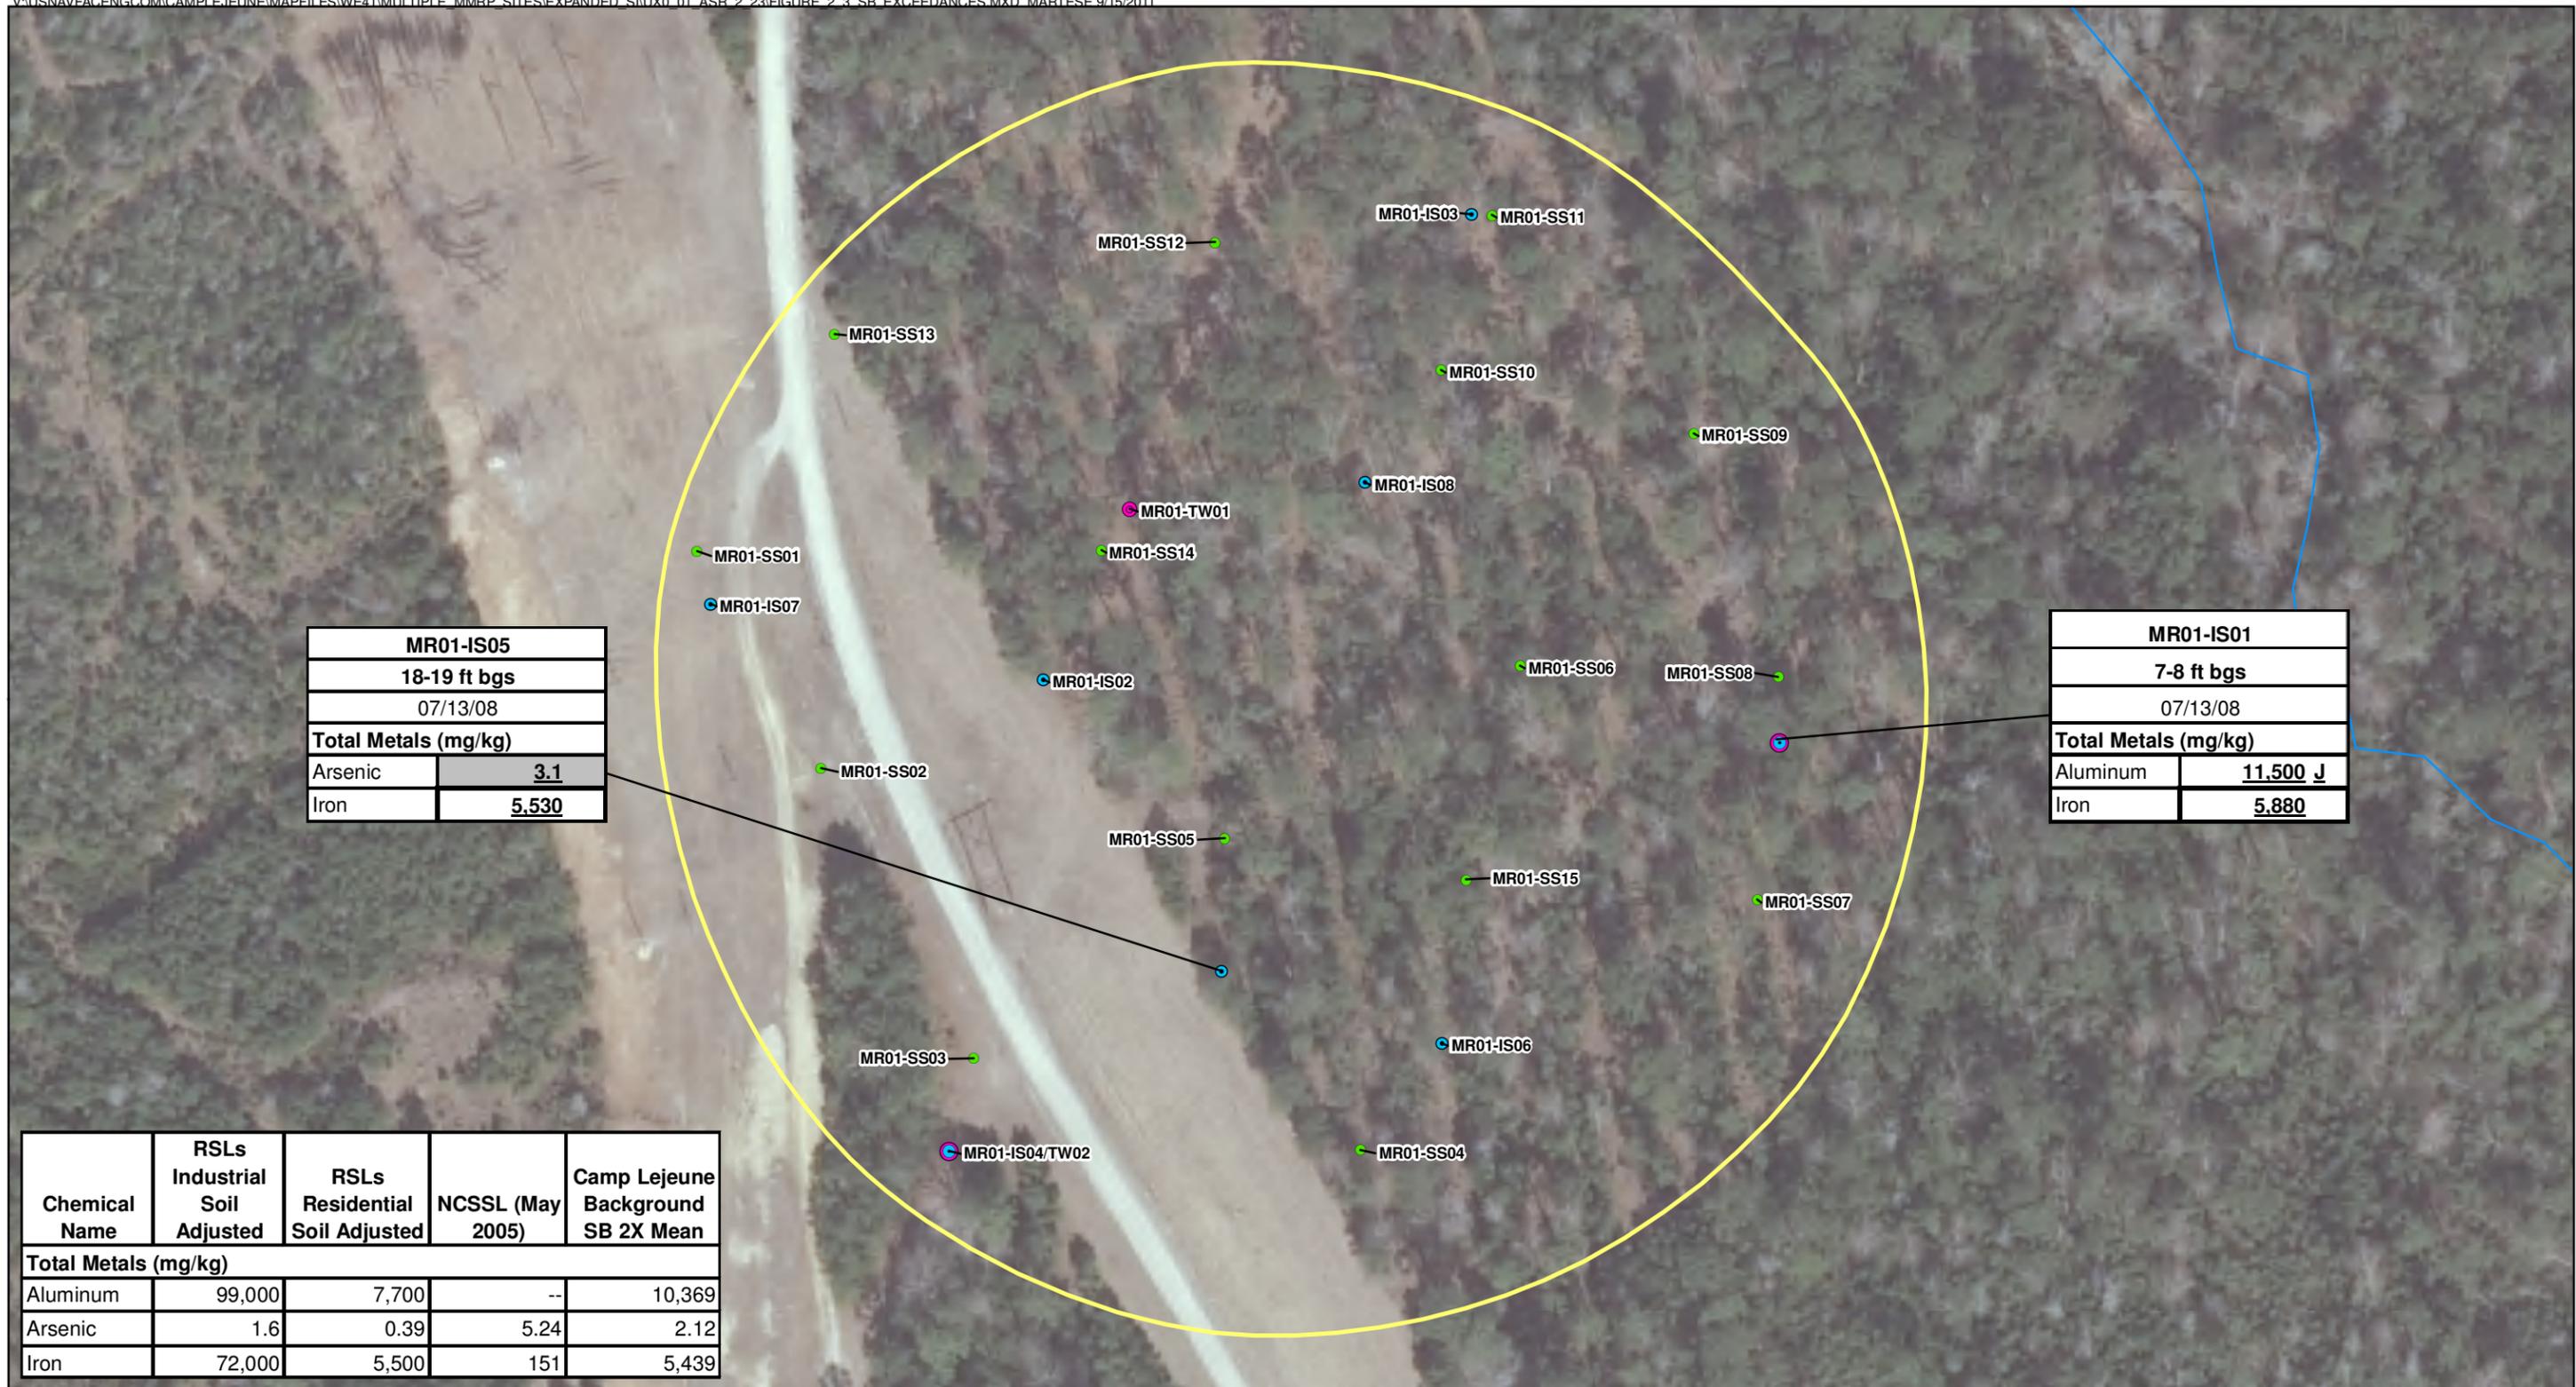
Figure 2-3  
 Subsurface Soil Exceedances  
 Site UXO-01 (ASR # 2.23) Expanded SI Report  
 MCB CamLej  
 North Carolina

Figure 2-3 presents the locations of the Site UXO-01 subsurface soil screening criteria exceedances, and the subsurface soil screening levels are summarized in Table 2-2.

MR01-IS05	
18-19 ft bgs	
07/13/08	
Total Metals (mg/kg)	
Arsenic	<u>3.1</u>
Iron	<b>5,530</b>

MR01-IS01	
7-8 ft bgs	
07/13/08	
Total Metals (mg/kg)	
Aluminum	<u>11,500 J</u>
Iron	<u>5,880</u>

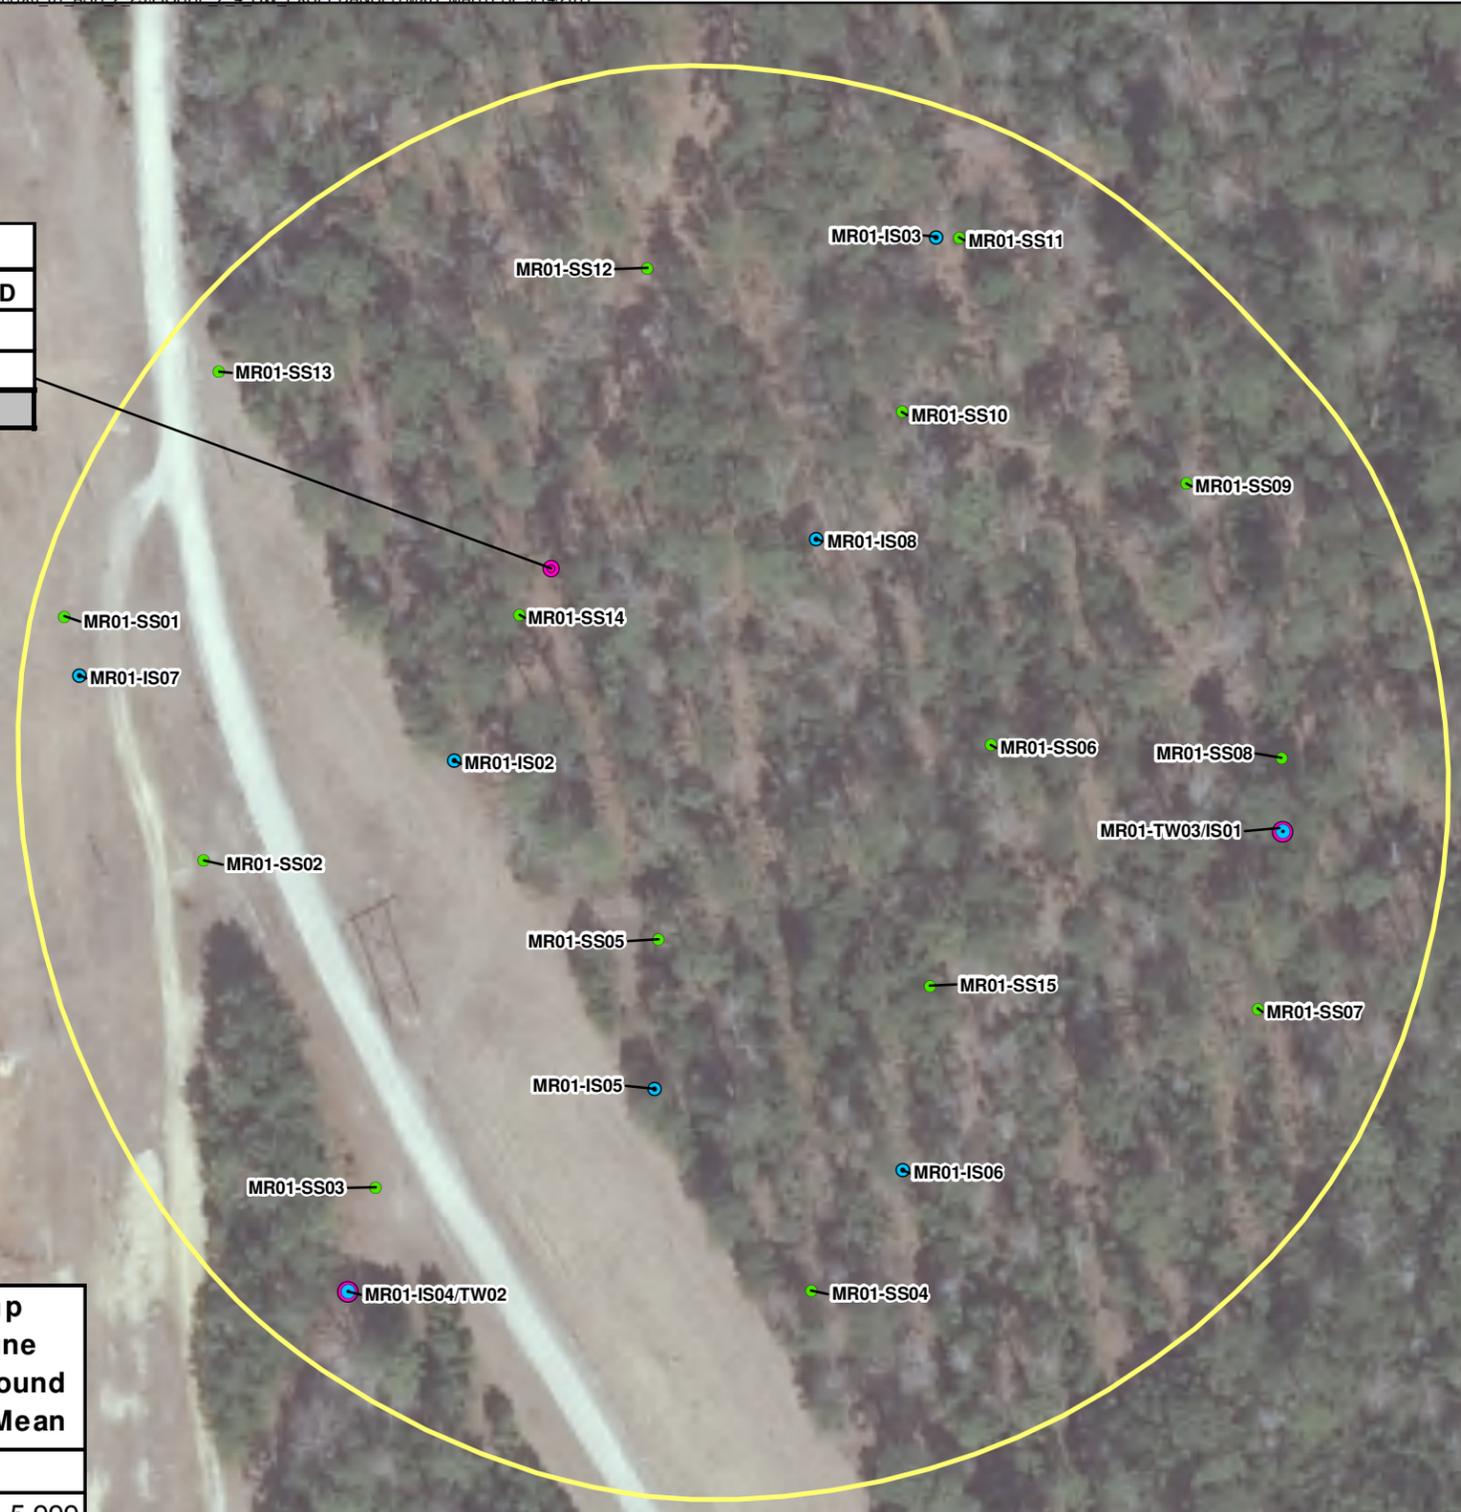
Figure 2-4  
 Groundwater Exceedances  
 Site UXO-01 (ASR # 2.23) Expanded SI Report  
 MCB CamLej  
 North Carolina

Station ID	MR01-TW01	
Sample ID	MR01-TW01	MR01-TW01D
Sample Date	07/30/08	07/30/08
Total Metals (µg/L)		
Iron	7,370	6,720

Chemical Name	Adjusted Tap Water RSLs	NCGWQS (December 2005)	Camp Lejeune Background GW 2X Mean
<b>Total Metals (µg/L)</b>			
Iron	2,600	300	5,999

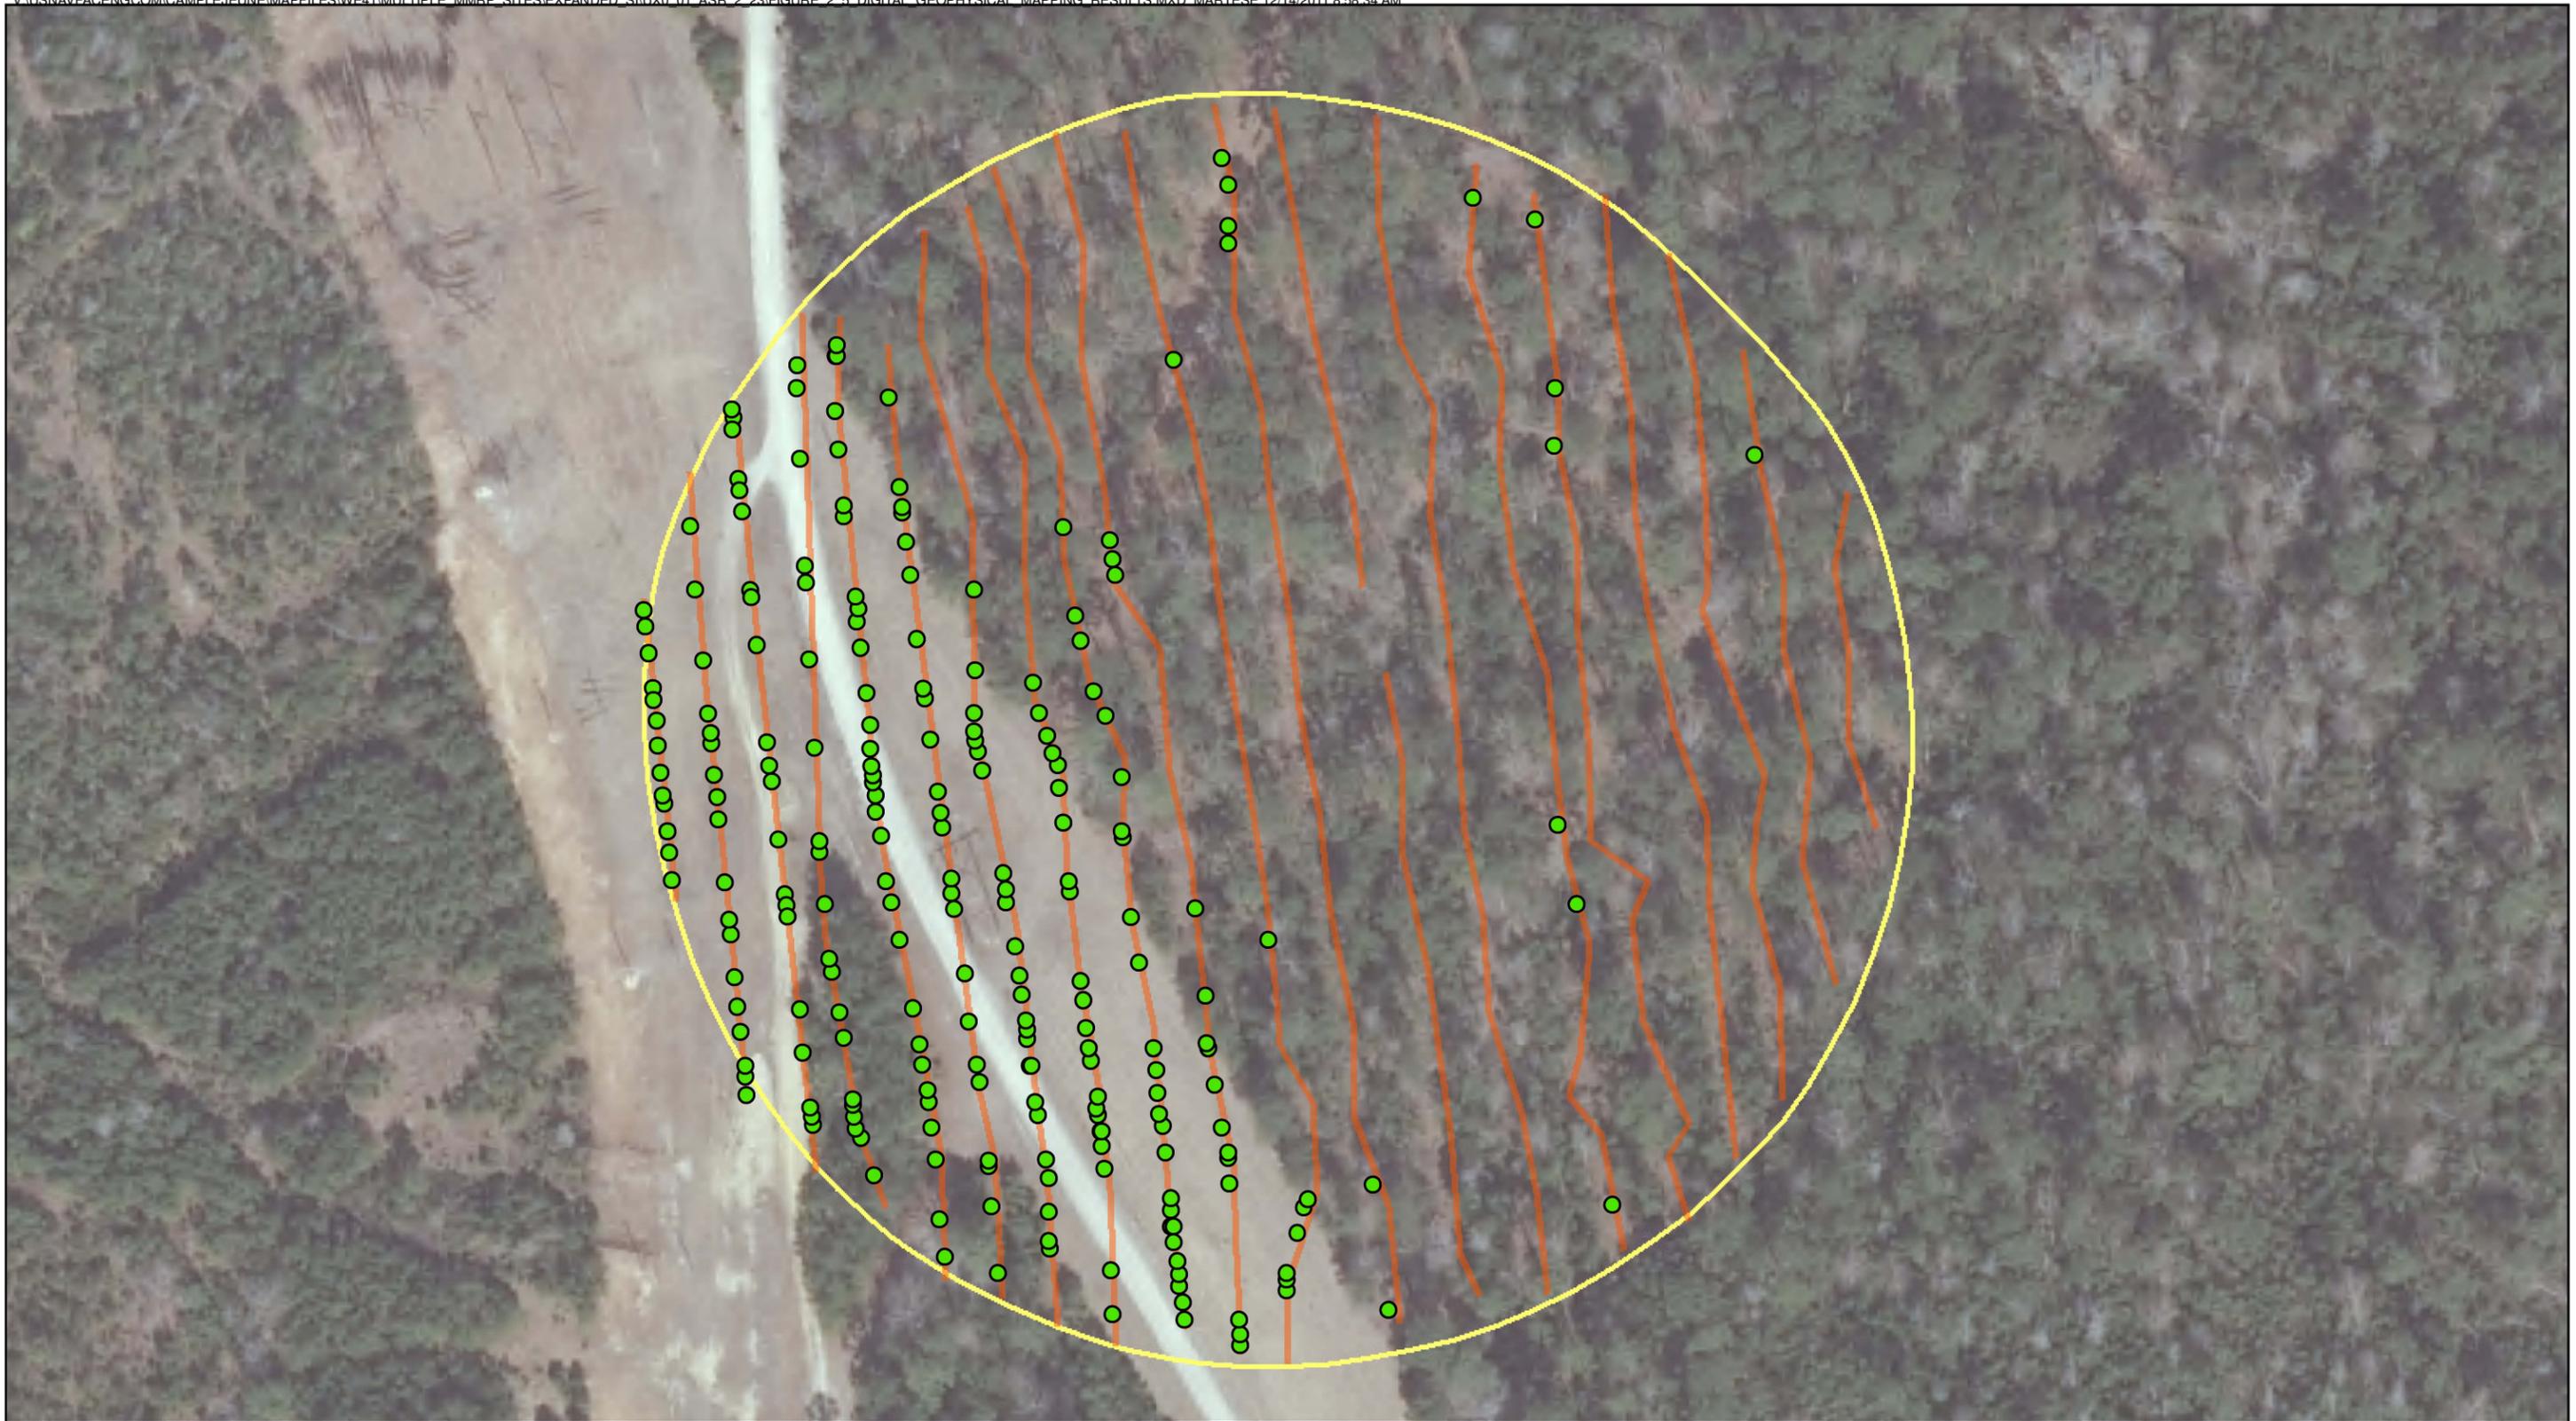
Figure 2-5  
Digital Geophysical Mapping Results  
Site UXO-01 (ASR # 2.23) Expanded SI Report  
MCB CamLej  
North Carolina

A DGM survey was conducted over approximately 10 percent of Site UXO-01 (ASR #2.23) using a single-coil EM61-MK2 electromagnetic system (EM61). The DGM survey was conducted along 3-foot wide parallel transects every 30 feet across the site, totaling approximately 1 acre, and yielded a total of 249 geophysical anomalies representing potential subsurface MEC (**Figure 2-5**). The PA/SI report recommended an intrusive investigation be conducted to assess the nature of the geophysical anomalies.

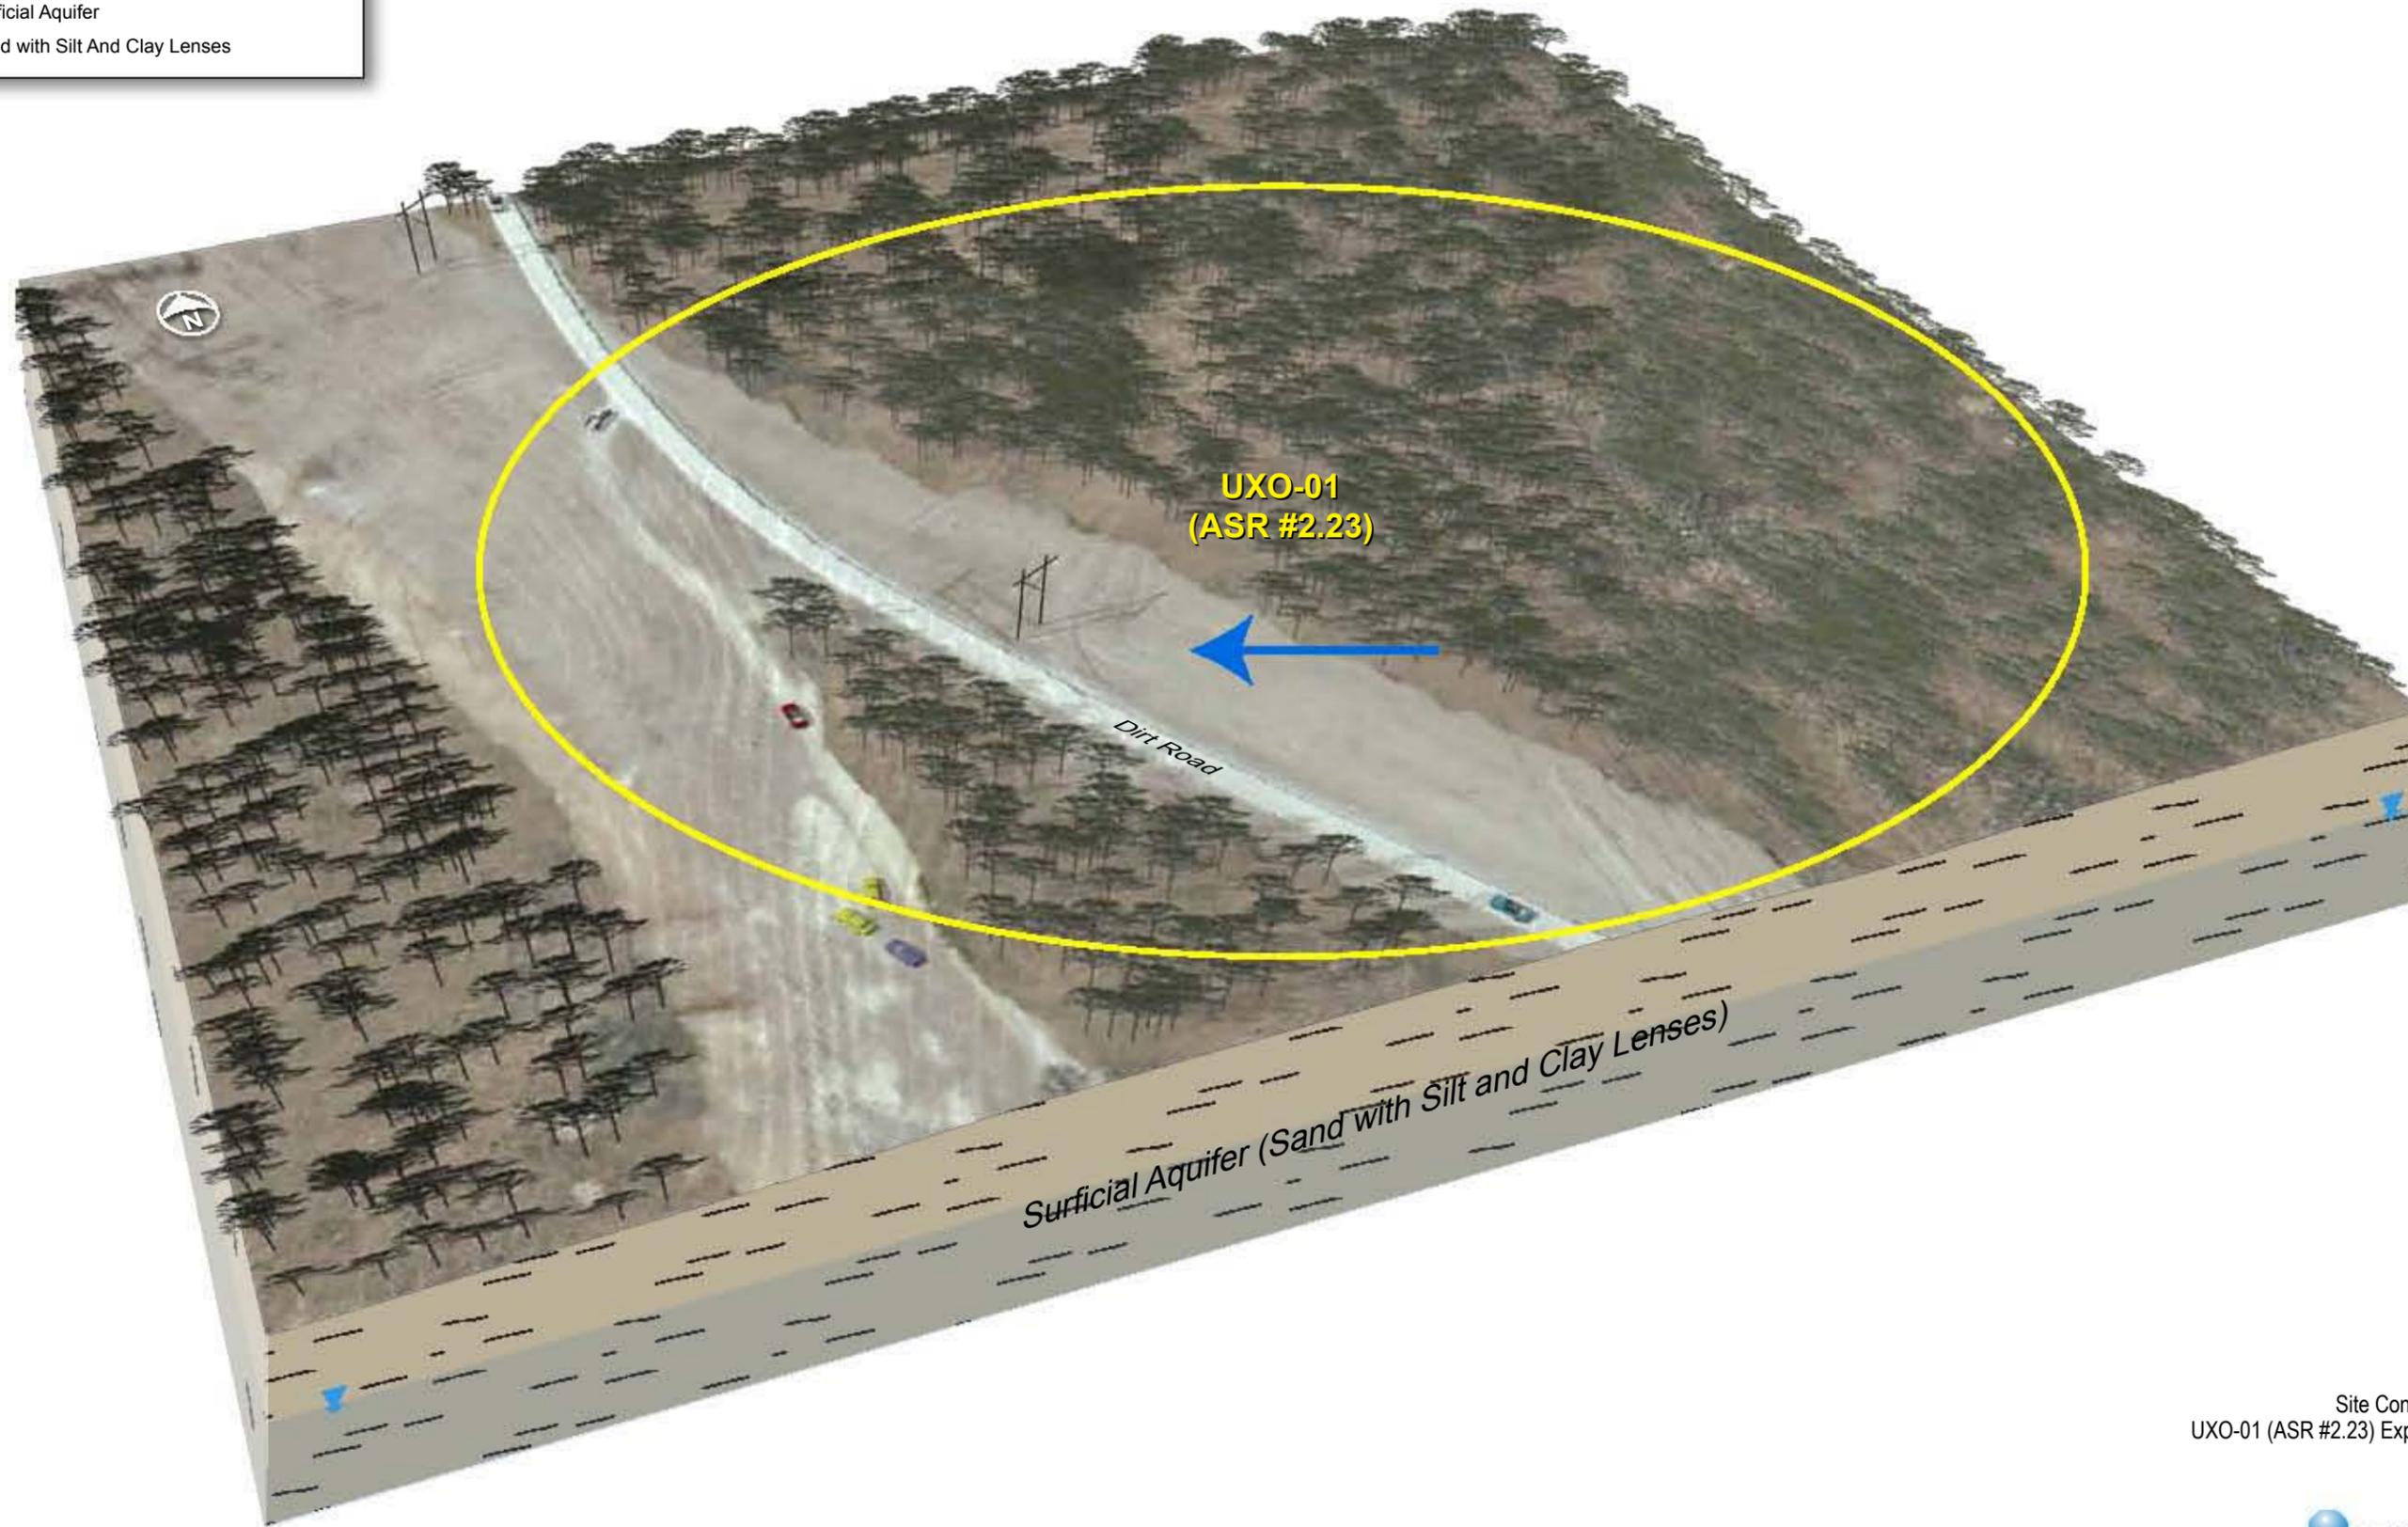
**FIGURE 2-6**  
Site Conditions Summary  
UXO-01 (ASR #2.23) Expanded SI Report  
MCB CamLej  
North Carolina

The water table of the surficial aquifer occurs in the undifferentiated formation at this site. Site-specific hydrogeologic information was derived from the installation of three shallow temporary monitoring wells in the surficial aquifer during the PA/SI. In July 2008, shallow groundwater flow was northwest towards Northeast Creek, a tributary of the New River. The horizontal hydraulic gradient was 0.0006 foot per foot (ft/ft), based upon the July 30, 2008, potentiometric surface map of the water table (CH2M HILL, 2009).

**Figure 2-6** provides a summary of the Site UXO-01 (ASR #2.23) physical conditions.

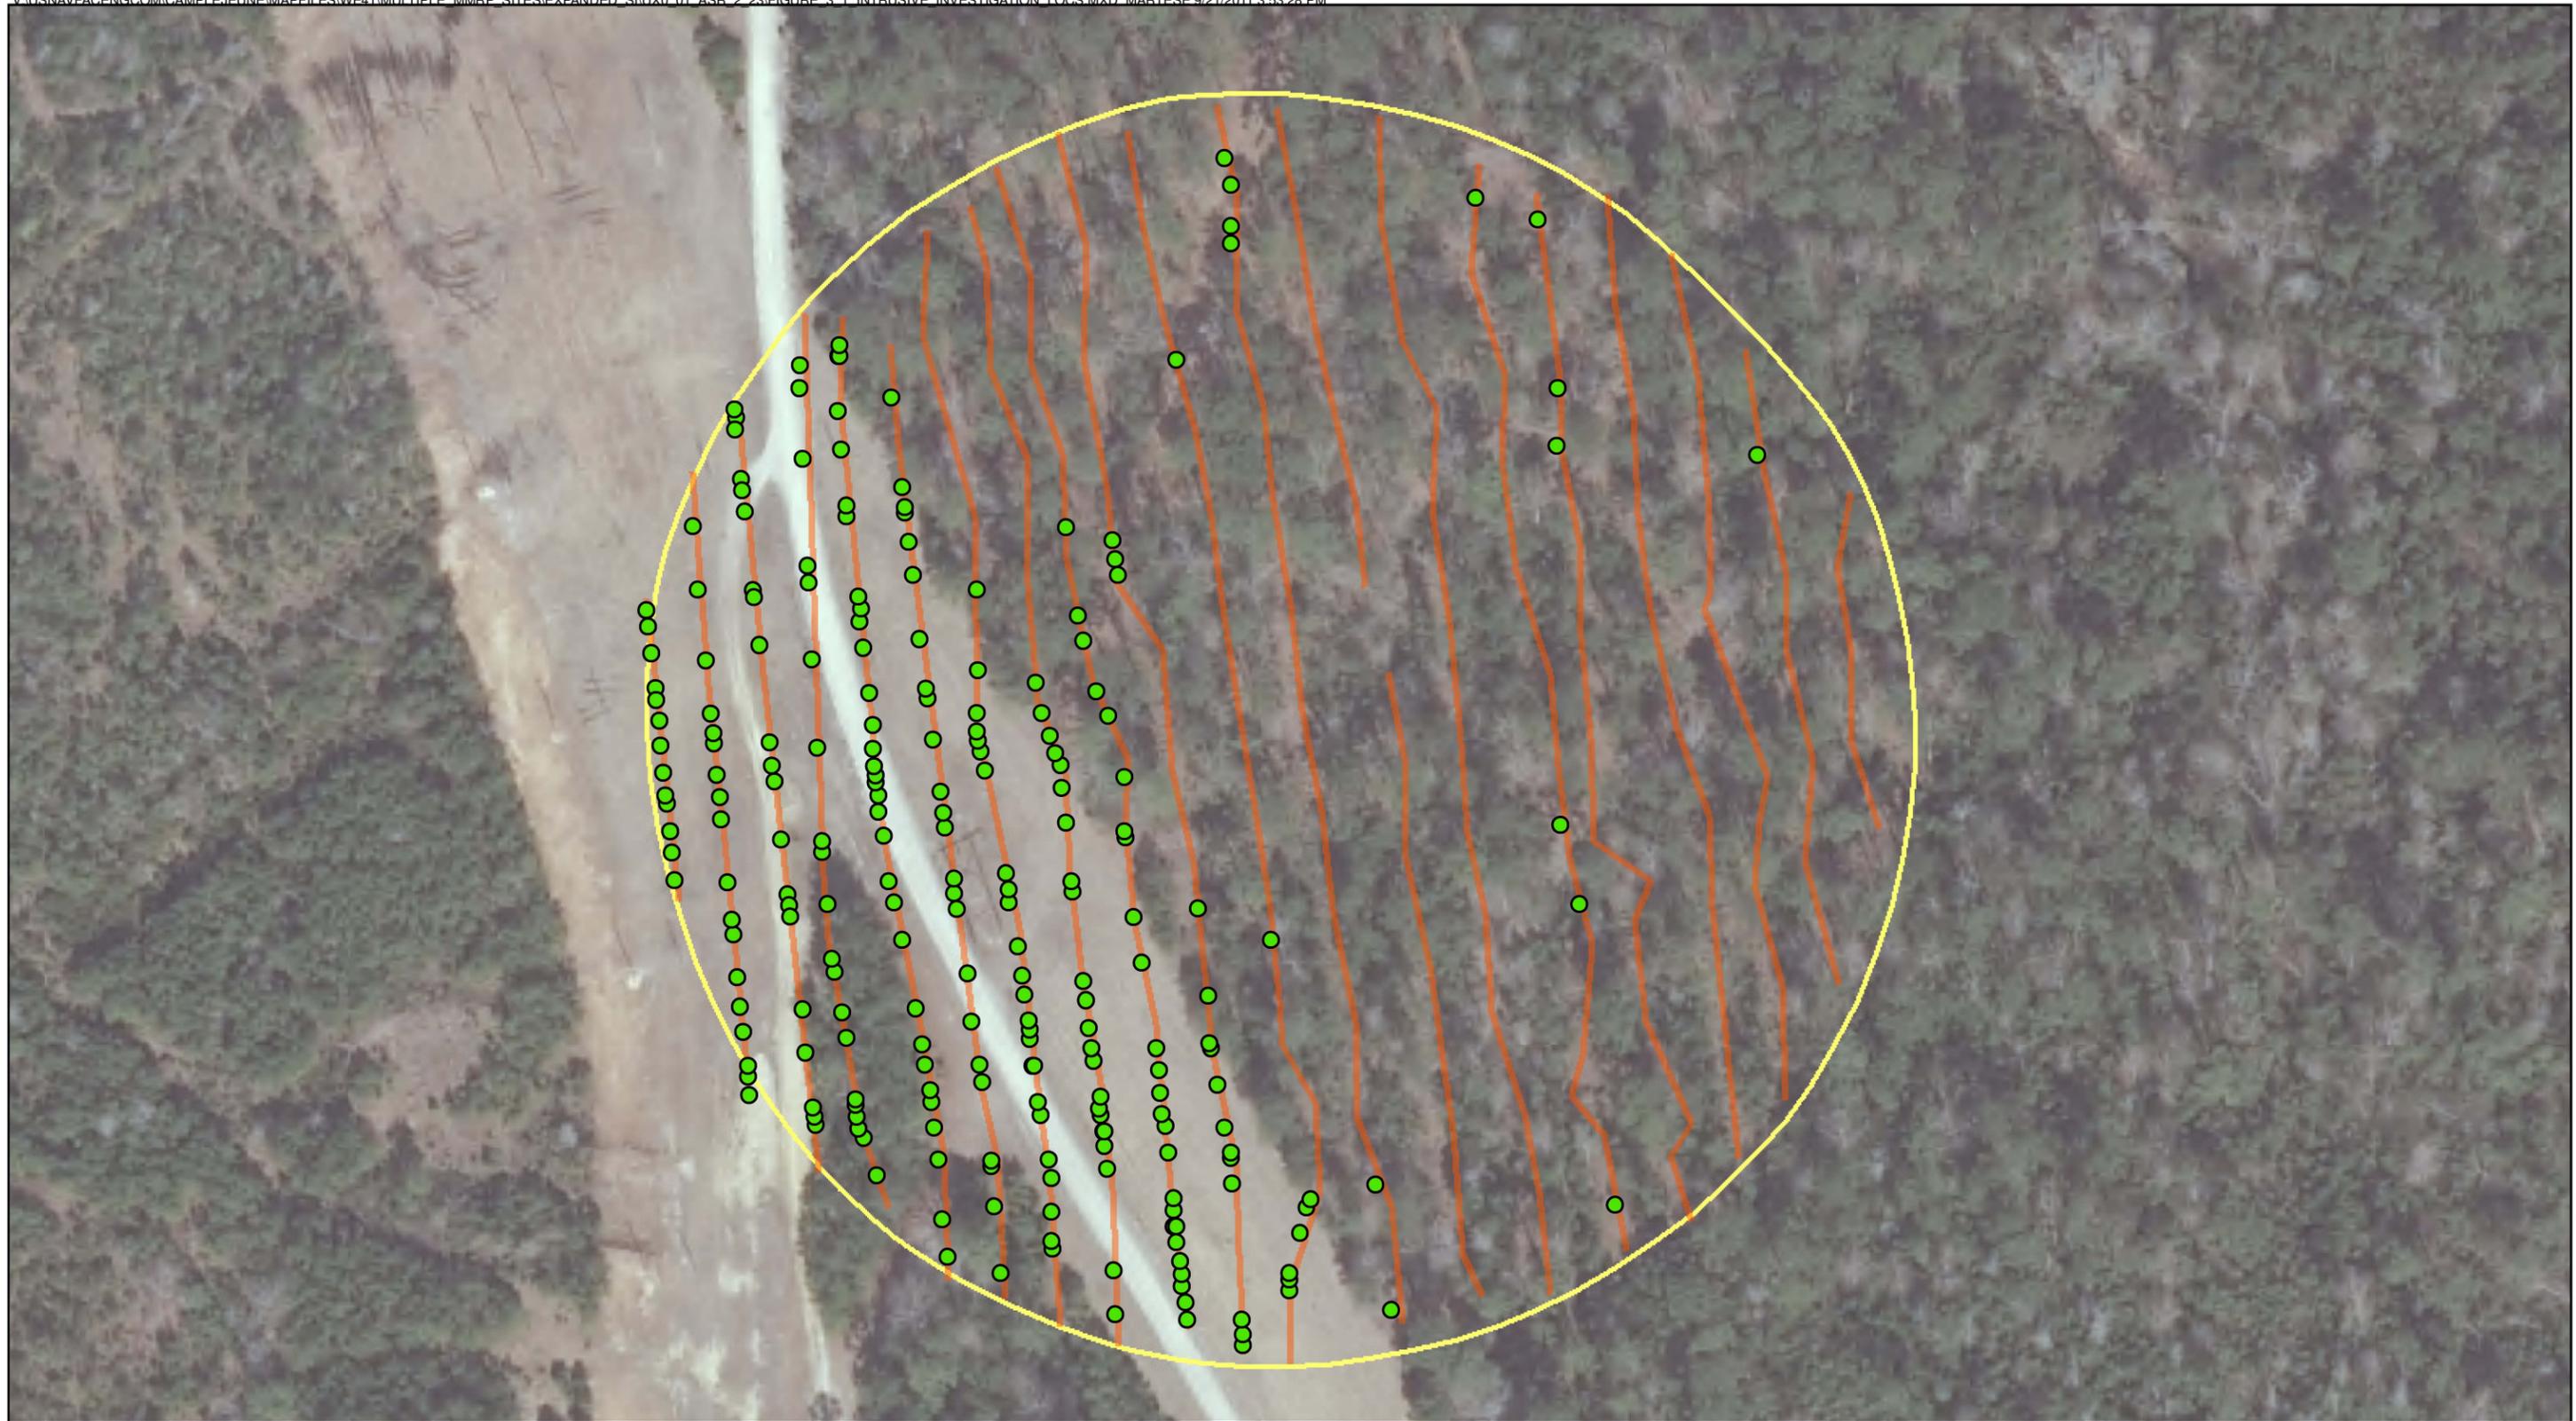
Figure 3-1  
Intrusive Investigation Locations  
Site UXO-01 (ASR # 2.23) Expanded SI Report  
MCB CamLej  
North Carolina

Excavation of all anomalies was performed by USAE, to a depth of 2 feet bgs. The UXO teams were composed of at least one UXO Technician III, one UXO Technician II, and additional UXO technicians. Small hand tools, such as shovels, spades, trowels, and pry bars, were used to access the source anomaly. If the item did not appear to be ordnance related (such as scrap metal or other debris), it was moved to the non-MPPEH collection point. Once the item was removed, the excavation area was rechecked with the EM61 to ensure all anomaly source material had been removed. No MEC or MPPEH was found during the intrusive investigation.

The data collected during the investigation of each anomaly is documented in **Appendix B**. Approximately 50 pounds of non-MPPEH metallic debris (such as scrap metal or other debris) were collected during the intrusive investigation. No MEC or MPPEH were found during the intrusive investigation.
