FINAL VAPOR INTRUSION MITIGATION SYSTEM DIAGNOSTIC TESTING WORK PLAN
MCB CAMP LEJEUNE NC
1/1/2011
CH2M HILL

Vapor Intrusion Mitigation System Diagnostic Testing Work Plan

Marine Corps Base Camp Lejeune
Jacksonville, North Carolina

January 2011

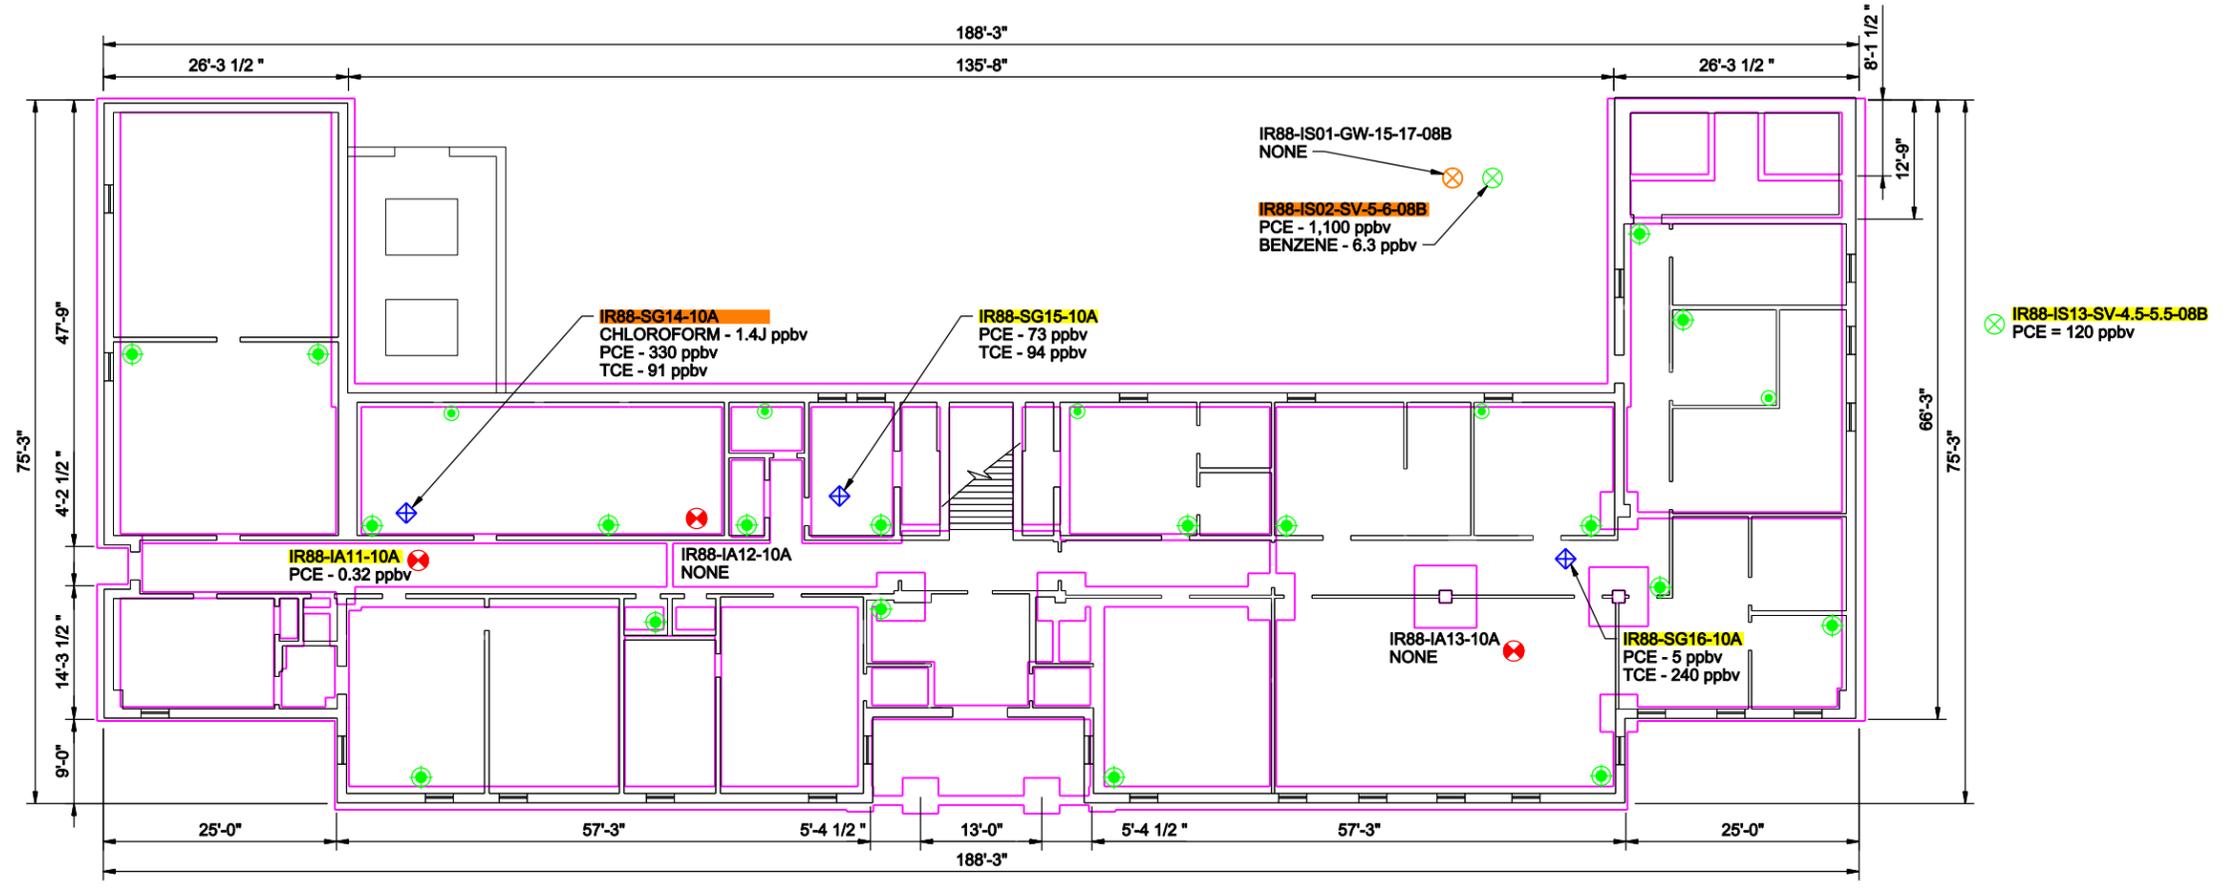
Figure 2-2
Building 3 Floor and Foundation Plan
with Sample Locations
MCB CamLej
North Carolina

The foundation for Building 3 was constructed in the 1940s. According to drawing # 228877 (**Attachment A**), the subslab of the building was built from 1 to 2 feet above present grade and the approximately 4-inch thick concrete slab floors (unless otherwise noted) were reinforced with a 6 x 6-inch wire mesh and the concrete was poured over a sand asphalt base. The slab thickness was measured in the field to be approximately 8 inches, suggesting that the slab was built up from the original 1940s thickness of 4 inches. The exterior foundation walls (14 inches thick) extend a minimum of 10 inches below grade; the footings range from 18 to 30 inches in thickness and extend to a total depth of 18 inches below grade. The interior foundation walls (ranging from 8 to 14 inches in thickness) extend a minimum of 10 inches below grade; the footings range from 12 to 32.5 inches in thickness and extend to a total depth of 18 inches below grade. The foundation plans include the construction of a sump; however, the exact location of the sump was not noted on the building surveys completed during the VI investigation.

The present floor plan and foundation outline are shown on **Figure 2-2**.

Building No.	No. Suction Locations	No. Test Locations	Comments
3	5	18	Building has multiple rooms and offices and carpeted areas that will limit the PFE test locations. These two buildings also have subslab foundation walls that sub-divide the subslab area and block the PFE from extending beyond the dividing foundation walls. See Figure 2-2 for proposed test locations.
3B	2	10	Building has limited interior walls, which will allow adequate PFE measurements to be made. See Figure 2-4 for proposed test locations.
37	2	10	Building has multiple rooms and offices and carpeted areas that will limit the PFE test locations. These two buildings also have subslab foundation walls that sub-divide the subslab area and block the PFE from extending beyond the dividing foundation walls. See Figure 2-6 for proposed test locations.
43	3	8	Building has limited interior walls, which will allow adequate PFE measurements to be made. See Figure 2-8 for proposed test locations.

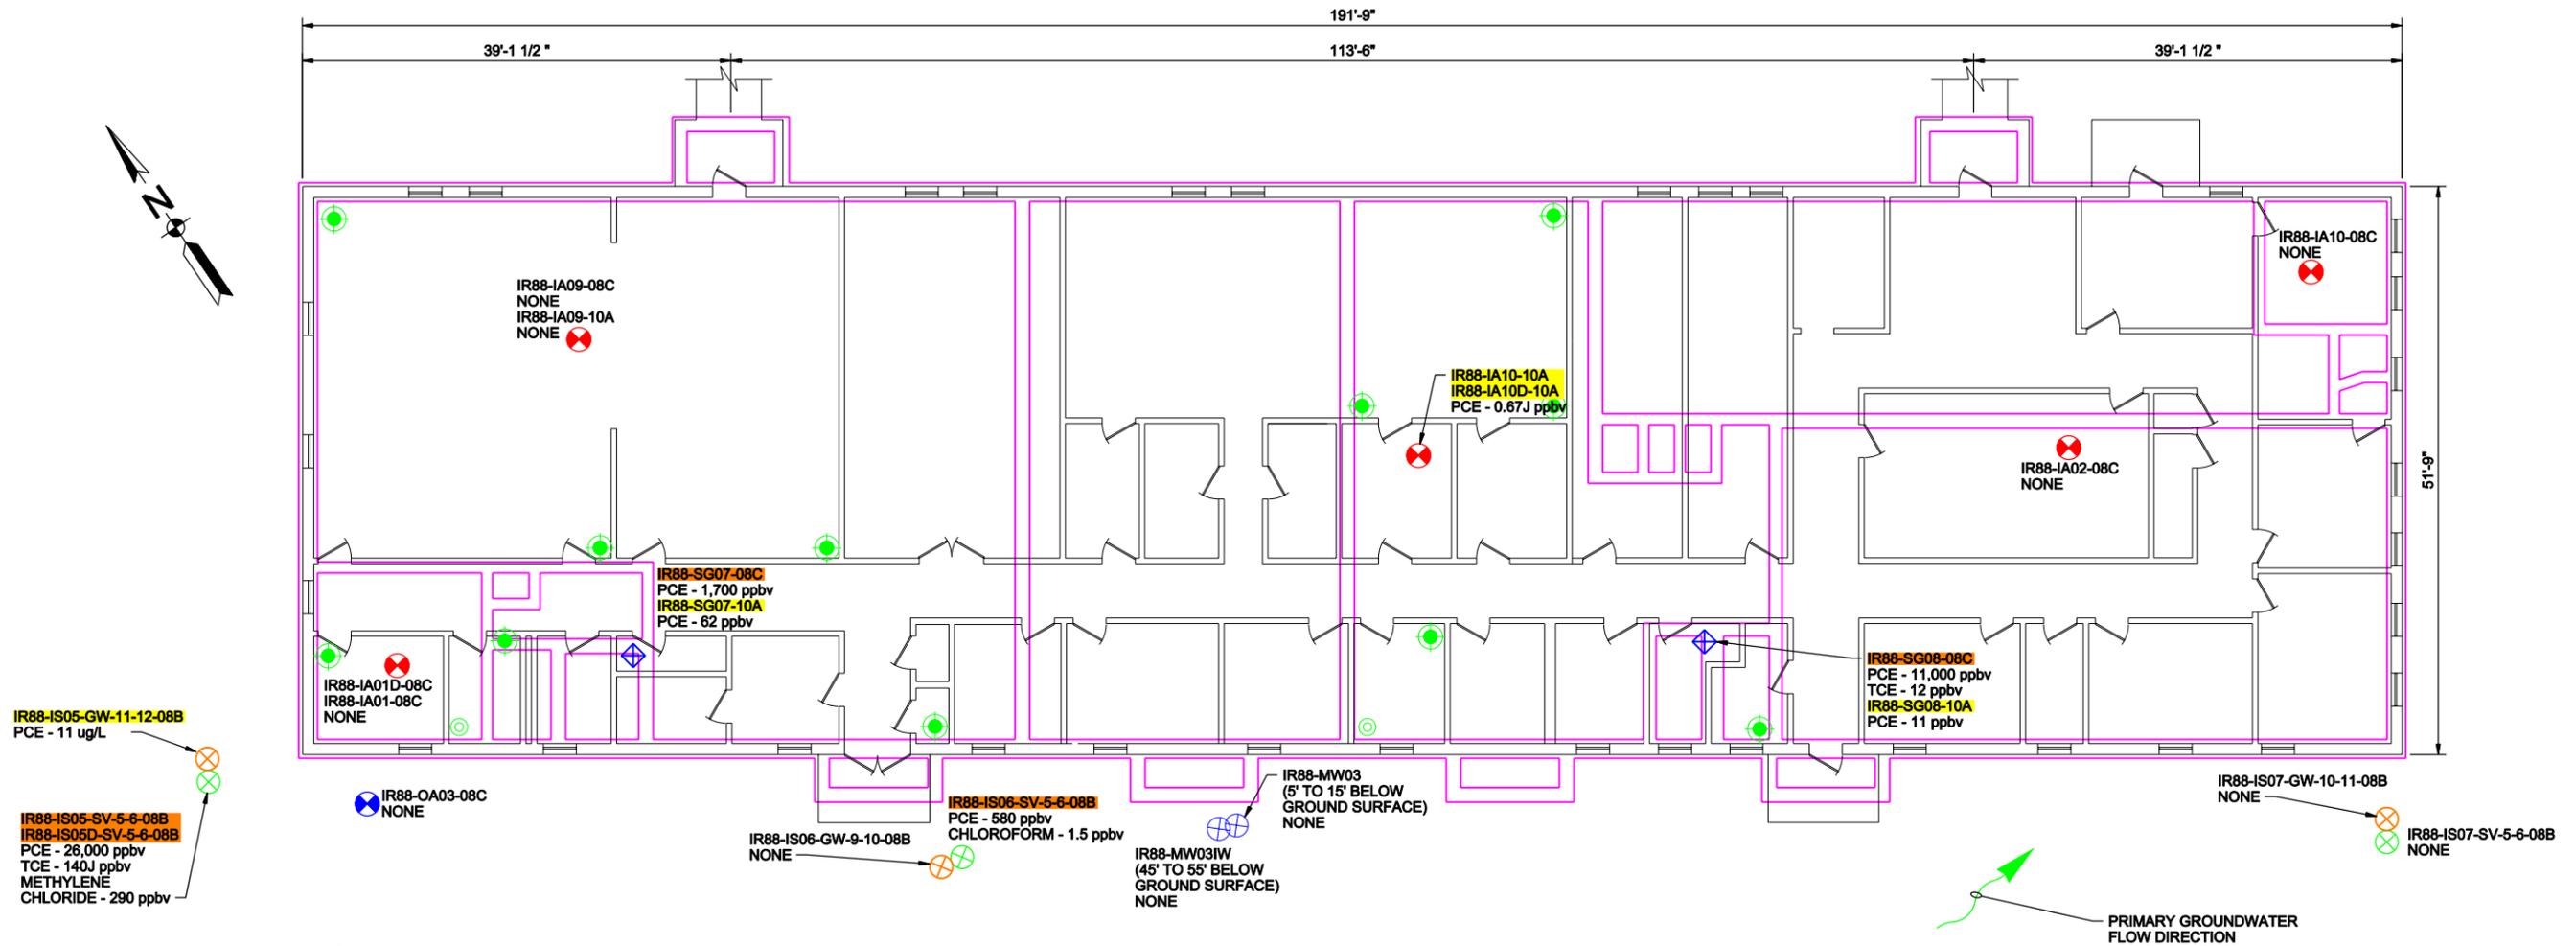
Figure 2-6
Building 37 Floor and Foundation Plan
with Sample Locations
MCB CamLej
North Carolina

Building 37 is a one-story brick and mortar building. The building is approximately 175 feet long by 50 feet wide (based on the figure scale) by 8 feet high. The interior walls are constructed of cinderblock. There are multiple offices, a kitchen, a classroom, and separate male and female restrooms within the building. The concrete slab is covered with ceramic tile in the restrooms, vinyl tile in the hallways, and carpet in the office spaces. Floor drains were observed in the restrooms and kitchen area. Windows and doors are typically kept closed, although one door on the south side of the building was propped open during the Phase III survey. Building 37 has two HVAC units (with evaporator/condenser units), which are located on the south side of the building. The building has approximately 35 windows and 6 doors that typically remain closed. The number of workers who occupy the building during working hours, from 7AM to 3PM on weekdays, is approximately 25.

The foundation for Building 37 was constructed in the 1940s. According to drawing # 267600 (**Attachment A**), the subslab of the building is approximately 4 inches thick and reinforced with 6 x 6-inch wire mesh. The slab thickness was measured in the field to be approximately 6 inches, suggesting that the slab was built up from the original 1940s thickness of 4 inches. The exterior foundation walls (14 to 16 inches thick) extend a minimum of 8 inches below grade; the footings are approximately 10 inches in thickness and extend to a minimal total depth of 18 inches below grade. The interior foundation walls (4 to 8 inches in thickness) extend below grade and the footings are approximately 14 inches thick. The foundation plans include the construction of a mechanical pit which extends greater than 8 feet below the slab surface; however, the exact location of the sump was not noted on the building surveys completed during the VI investigation.

The present floor plan and foundation outline are shown on **Figure 2-6**.

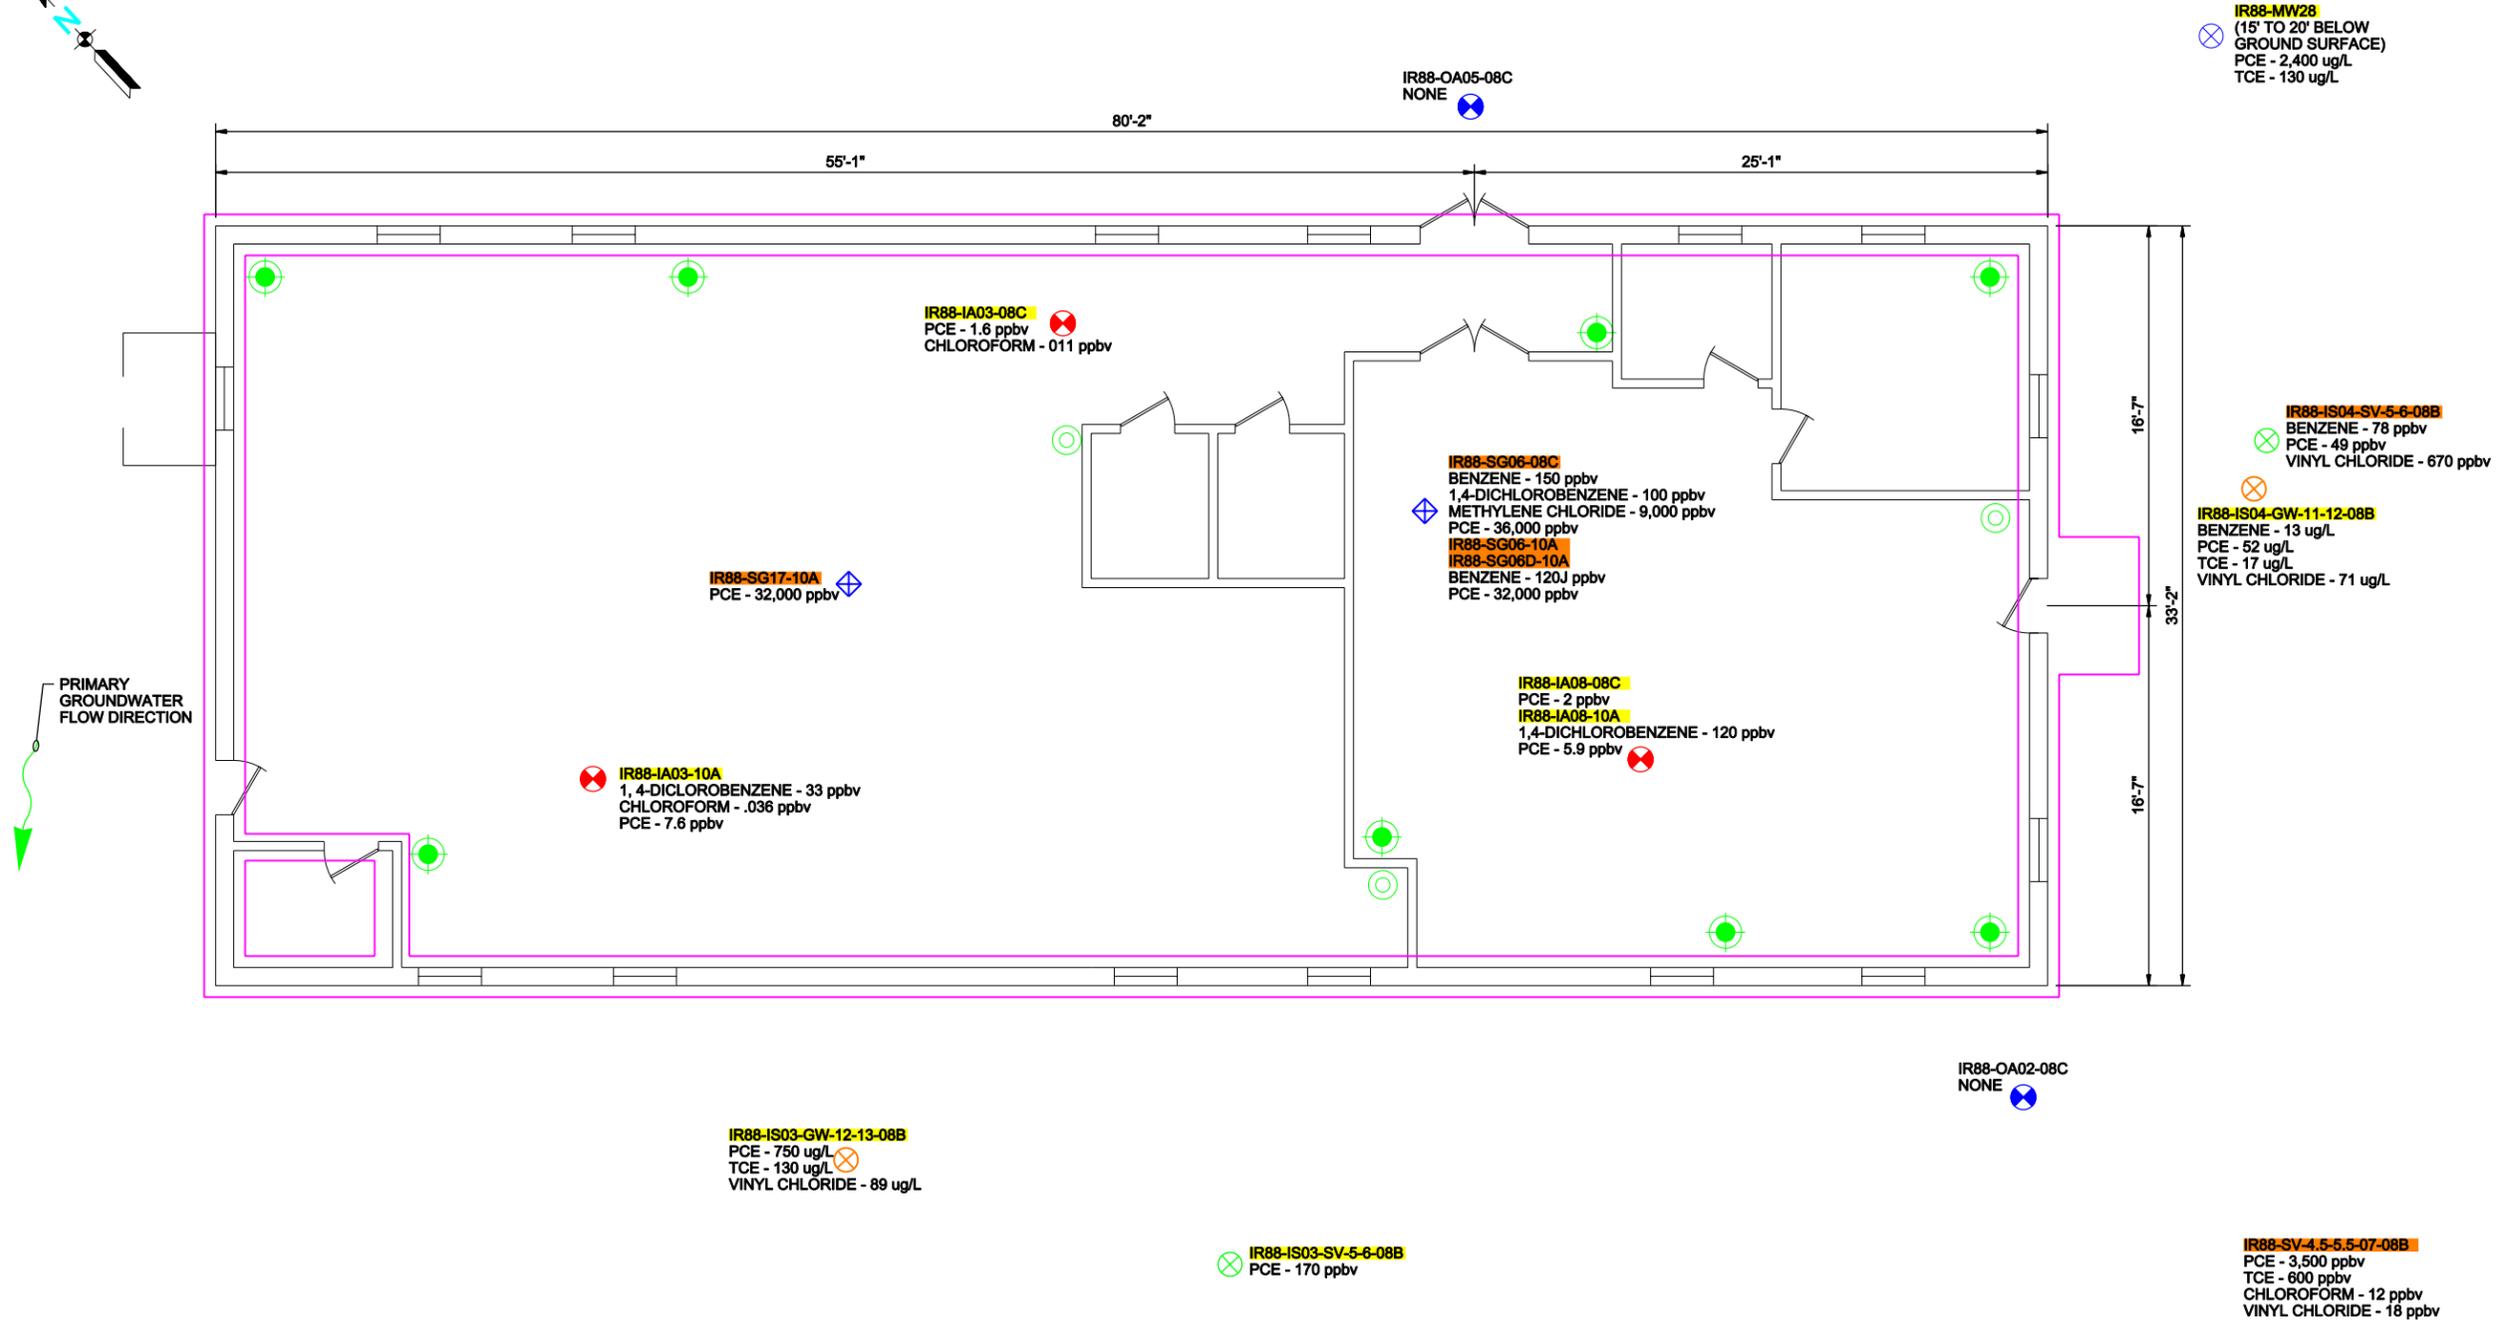
Figure 2-8
Building 43 Floor and Foundation Plan
with Sample Locations
MCB CamLej
North Carolina

The foundation for Building 43 was constructed in the 1940s. According to drawing # 228589 (**Attachment A**), the subslab of the building is approximately 4 inch and reinforced with a 6 x 6-inch wire mesh. The slab thickness was measured in the field to be approximately 6 inches, suggesting that the slab was built up from the original 1940s thickness of 4 inches. The exterior foundation walls (9.5 inches thick) extend a minimum of 6 inches below grade; the footings are 21.5 inches thick and extend to a minimal total depth of 18 inches below grade. The interior foundation walls (approximately 4.5 to 5 inches in thickness) extend below grade and the footings are approximately 6 inches thick. The foundation plans include the construction of a sump; however, the exact location of the sump was not noted on the building surveys completed during the VI investigation.

The present floor plan and foundation outline are shown on **Figure 2-8**.

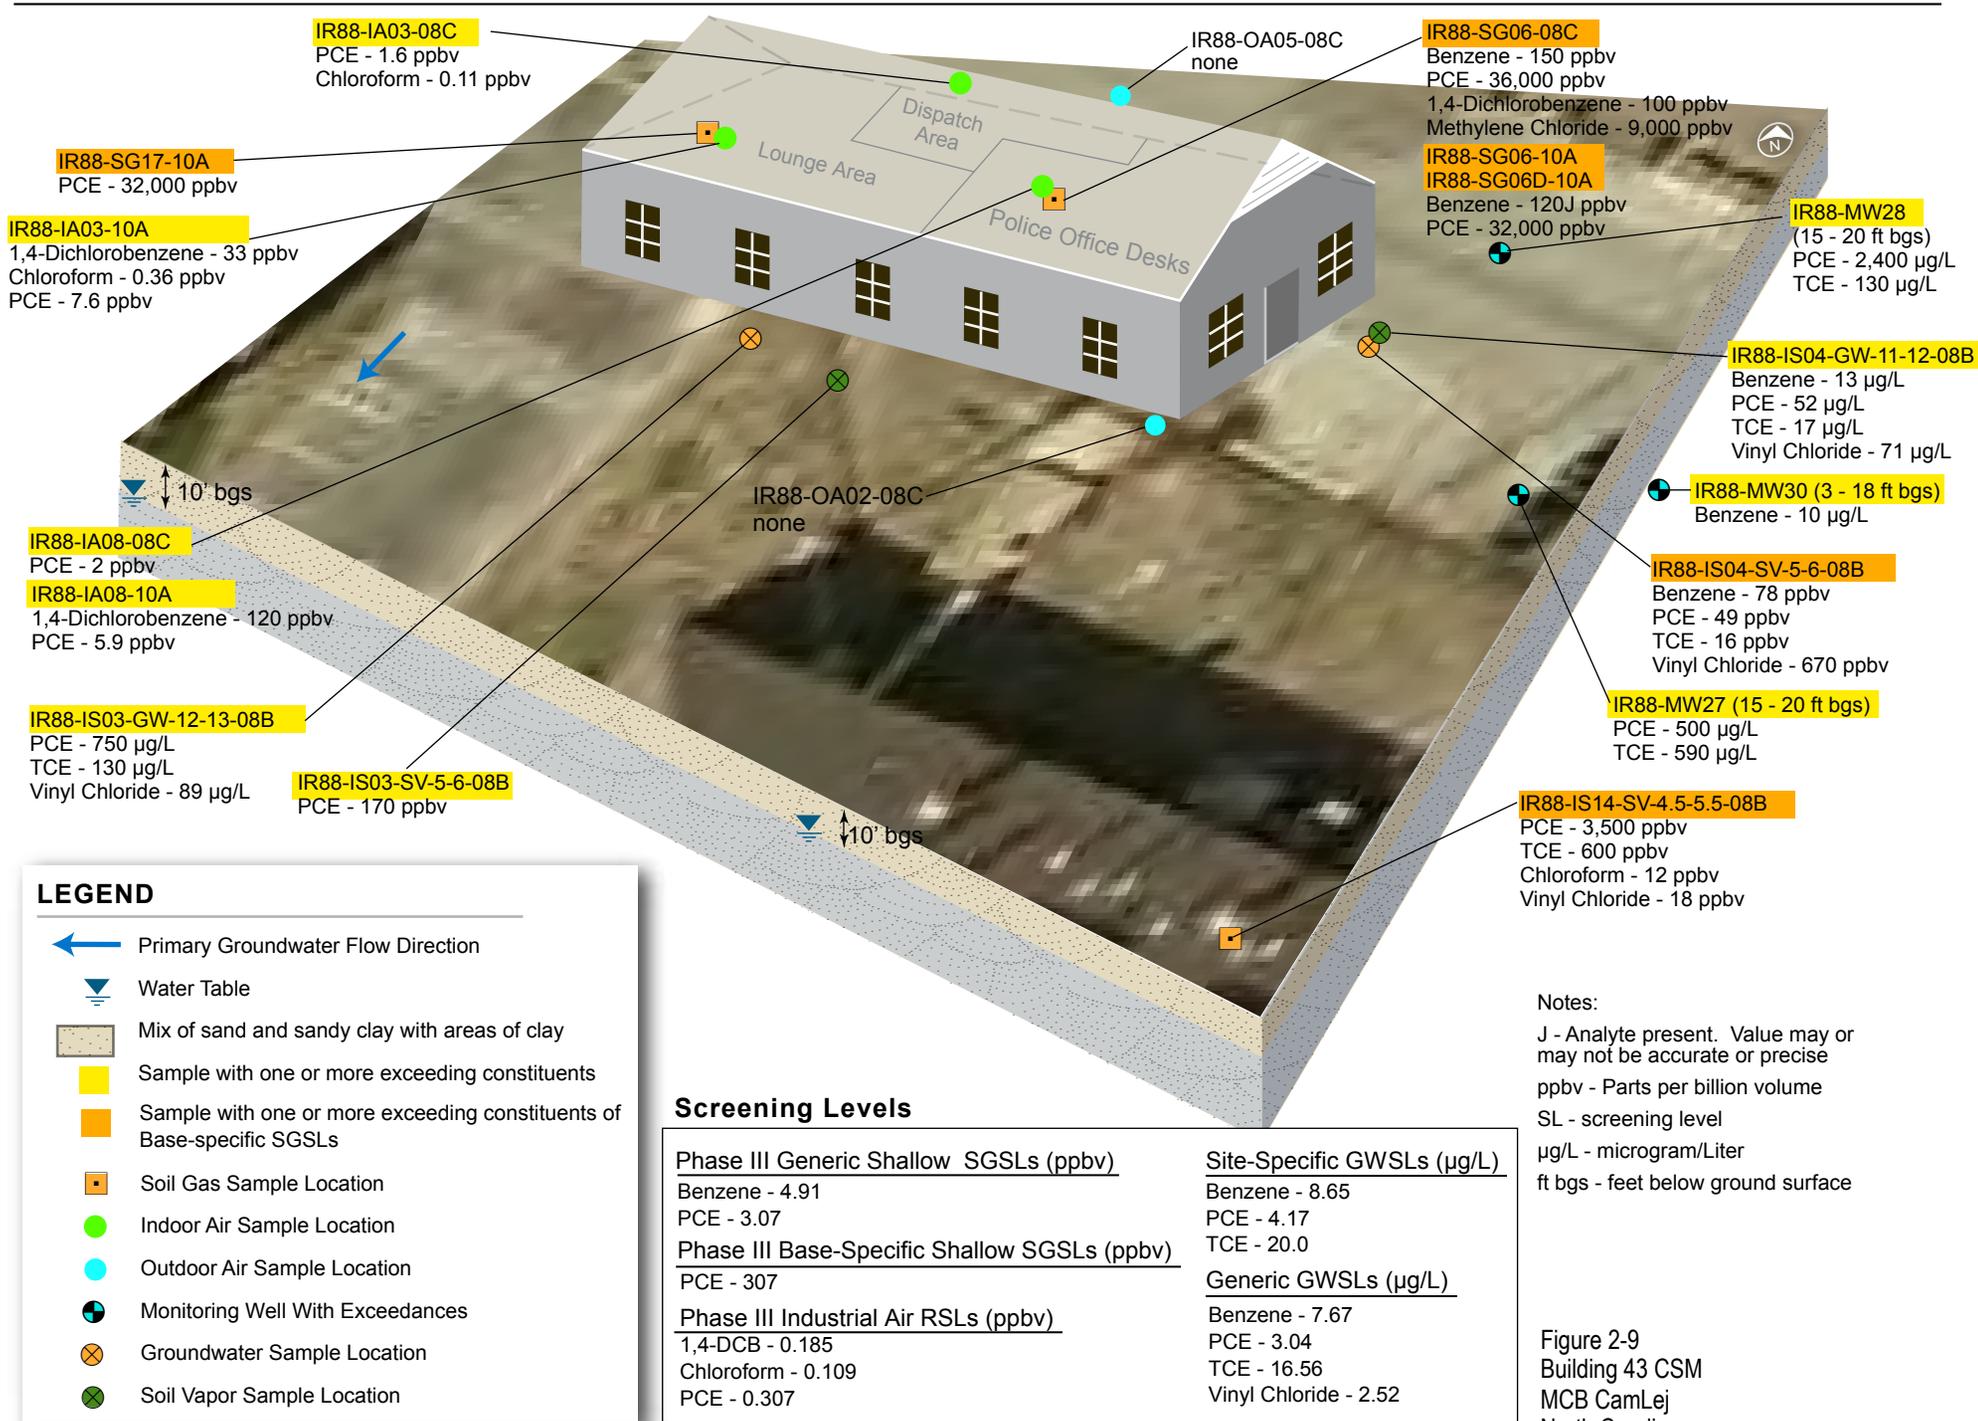
Figure 2-9
Building 43 CSM
MCB CamLej
North Carolina

Groundwater, exterior soil gas, subslab soil gas, and/or indoor air samples were collected during Phase I, Phase II, and Phase III VI evaluations at Building 43. A 3-D CSM was created and refined based on the information collected throughout the investigations (**Figure 2-9**). The Phase I, II, and III sample locations and results for VOCs with previous or current screening level exceedances for Building 43 are shown on **Figures 2-8 and 2-9**.

gas and subslab soil gas, and the layout of the building, which is not conducive to enhanced outdoor air exchange (**Figure 2-9**). Due to this uncertainty, the Base has elected to conduct a VIMS pilot study at Building 43. The VIMS is expected to depressurize the building subslab, thus mitigating potential intrusion of vapors into the building.

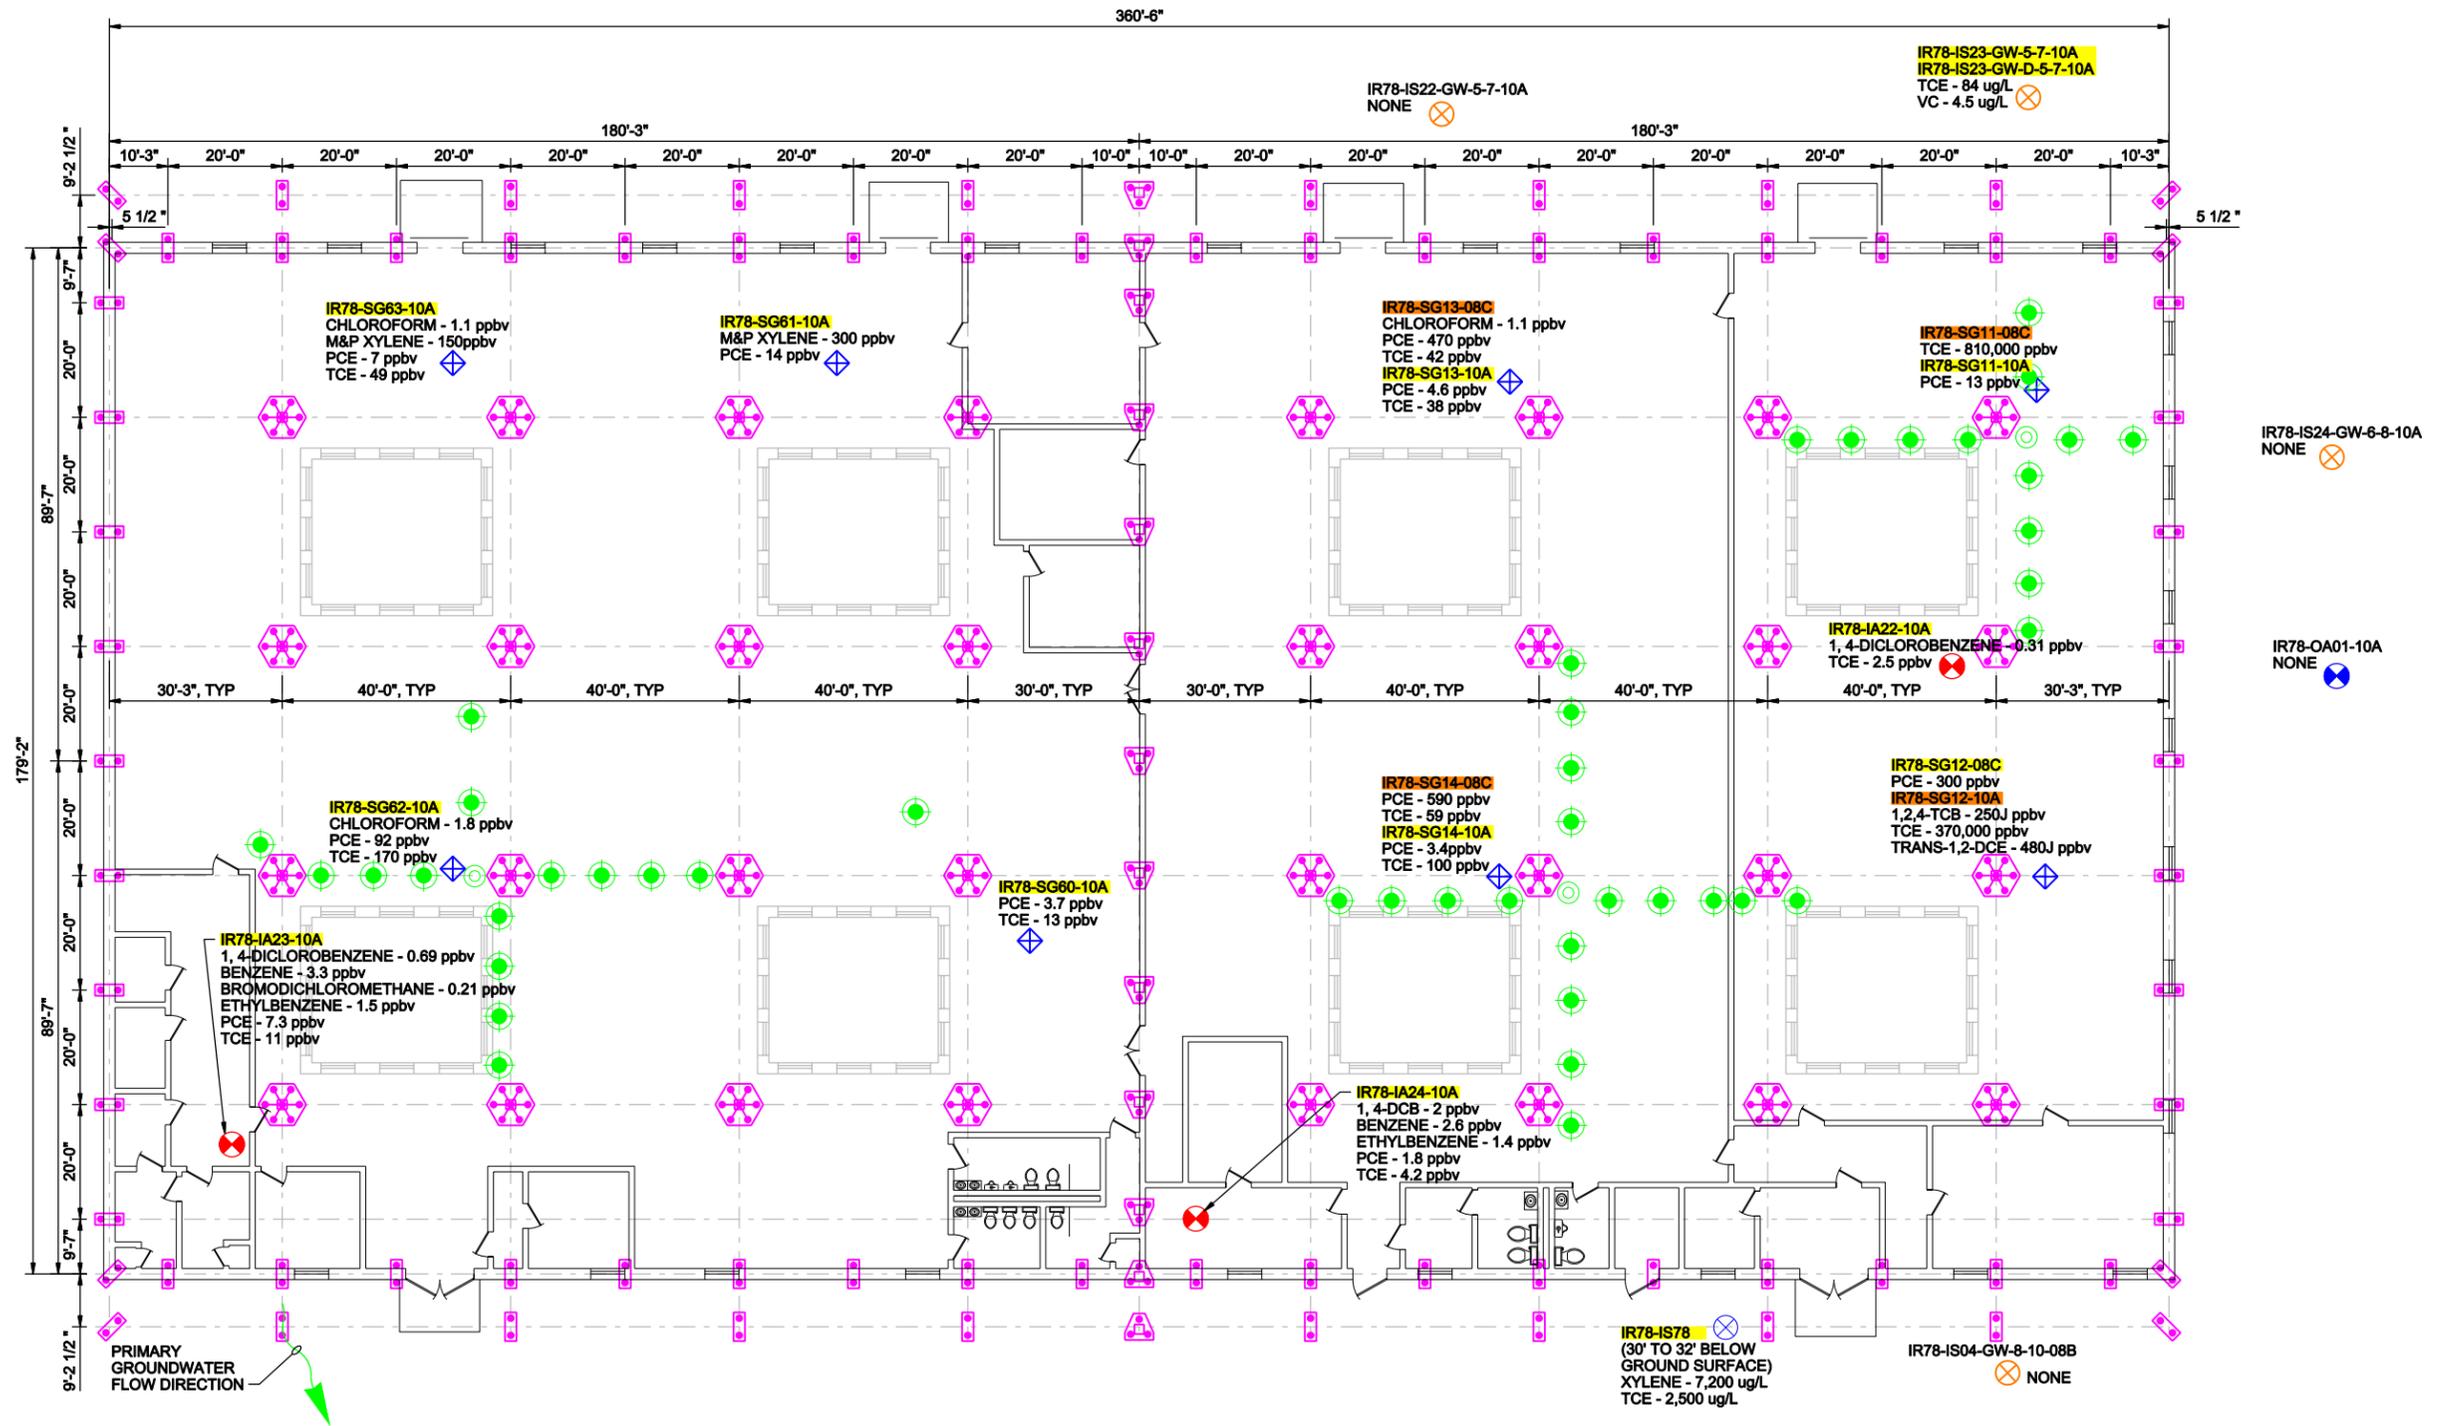
Figure 2-11
Building 902 Floor and Foundation Plan
with Sample Locations
MCB CamLej
North Carolina

Building 902 is a one-story brick and mortar building with a half-story attic. It is approximately 360 feet long by 200 feet wide (based on the figure scale) by 35 feet high. The building is divided into three separate sections by concrete block walls; the northern section is an auto repair shop, the center section is used for tent storage, and the southern section is a storage area that is not often accessed. There are several small office spaces in the northern and center sections of the building (equaling approximately one-tenth the entire building area). During the Phase III building survey, it was noted that the southern section of the building was being used to teach combat scenarios.

The office portions of the building have raised wooden floors with carpet. The warehouse areas have exposed concrete floors. There are floor drains in both the bathrooms and the auto repair side of the building. During the Phase III building survey it was also noted that the sealant on the concrete slab is degrading.

The building foundation was constructed in the 1940s and is a pile type formation (drawing #387332, **Attachment A**) over a concrete slab, which is level with the exterior ground surface. The concrete slab is approximately 7 inches thick and contains wire mesh. The slab thickness was confirmed when measured in the field. The piling plan indicates that the footings are approximately 26 inches thick and are installed a minimum of 56 inches below the slab surface. Interior columns are spaced approximately 40 feet from one another except along the perimeter and central portions of the building.

The present floor plan and foundation outline are shown on **Figure 2-11**.

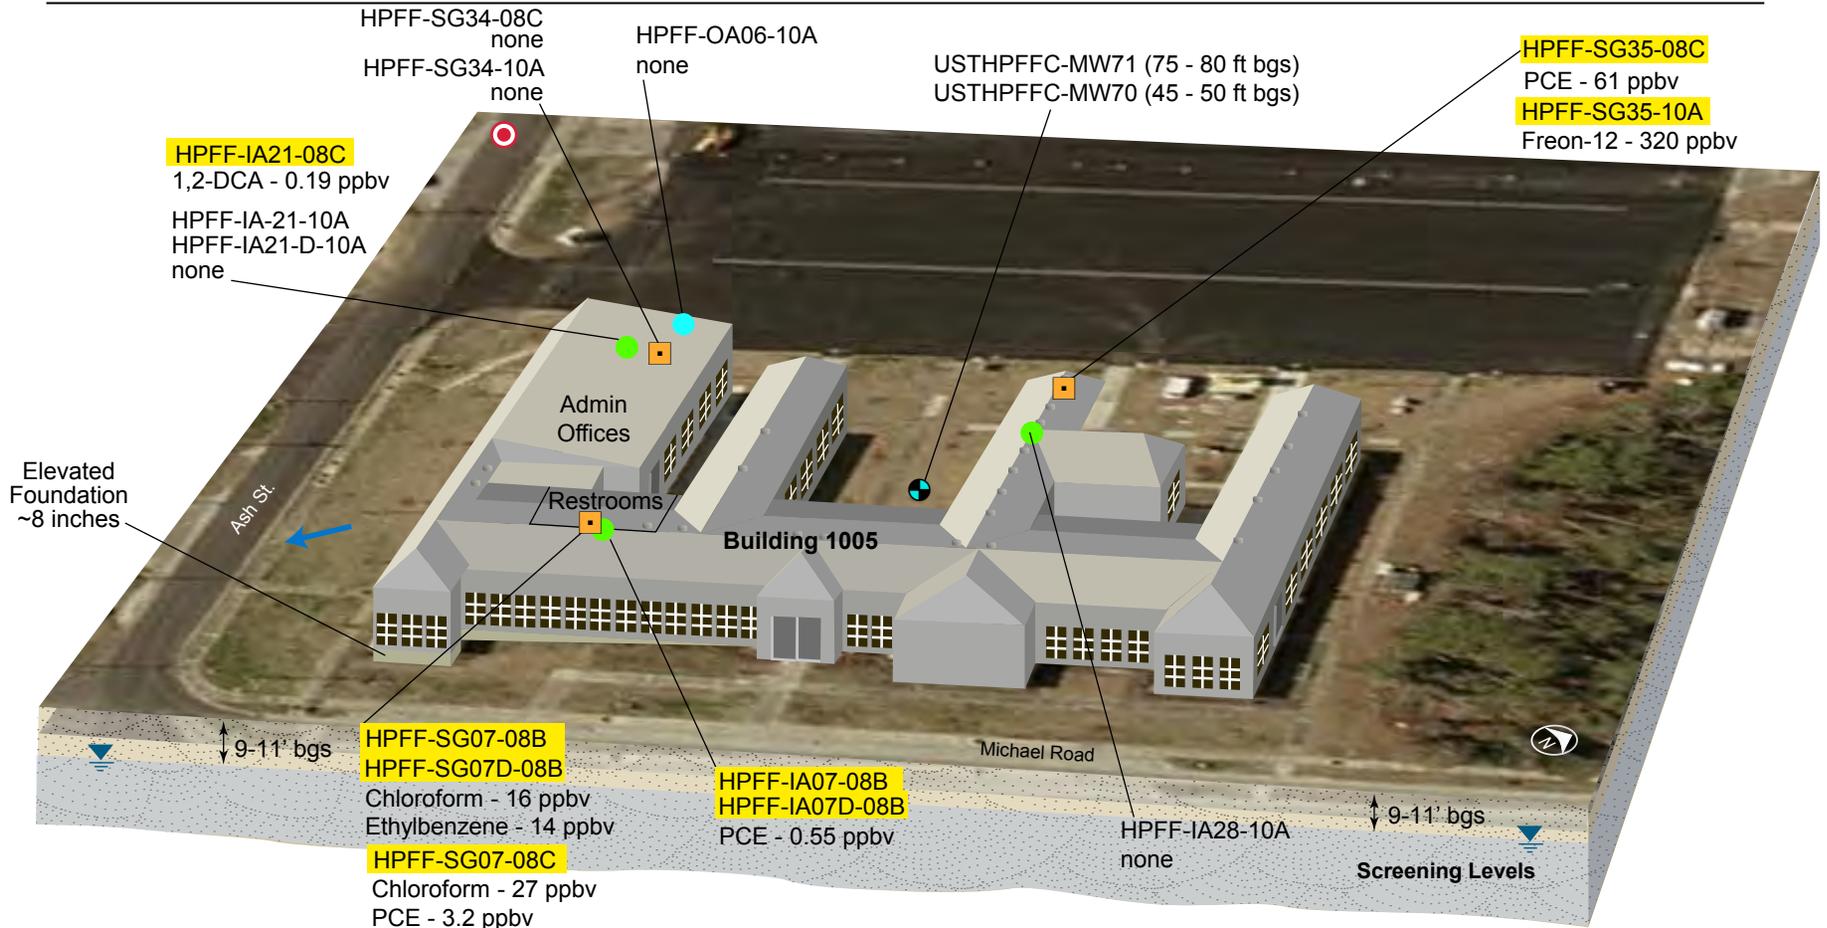
Figure 2-15
Building 1005 Vapor Intrusion CSM
MCB CamLej
North Carolina

Building 1005 has five separate air handlers to provide HVAC for the entire building (**Figure 2-15**). Outdoor air is supplied to each of the HVAC units. All of the HVAC outdoor air supplies have dampers that can be adjusted. The site visit, conducted in October 2010, indicated that one HVAC unit has an access panel adjacent to the outdoor air damper; the remaining HVAC units will require installation of access panels adjacent to the outdoor damper locations in the existing ductwork of these units. The outdoor damper that was visible was rusted and one of the damper wings was open, while the other was closed at the time of the site visit. All dampers for HVAC units servicing Building 1005 will be tested to determine whether the dampers are operating correctly; each of the control heads for each HVAC unit has a gauge that specifies the damper position.

The occupancy rate and the outdoor air presently being supplied to each of the five HVAC zones within Building 1005 will be measured by a qualified HVAC technician. It is recommended that the minimum amount of outdoor air being supplied to each of these zones matches the recommended current ASHRAE ventilation rate. If the existing system can achieve 20 CFM per building occupant, it will be assumed that the HVAC system can create a positive pressure compared to subslab pressure.

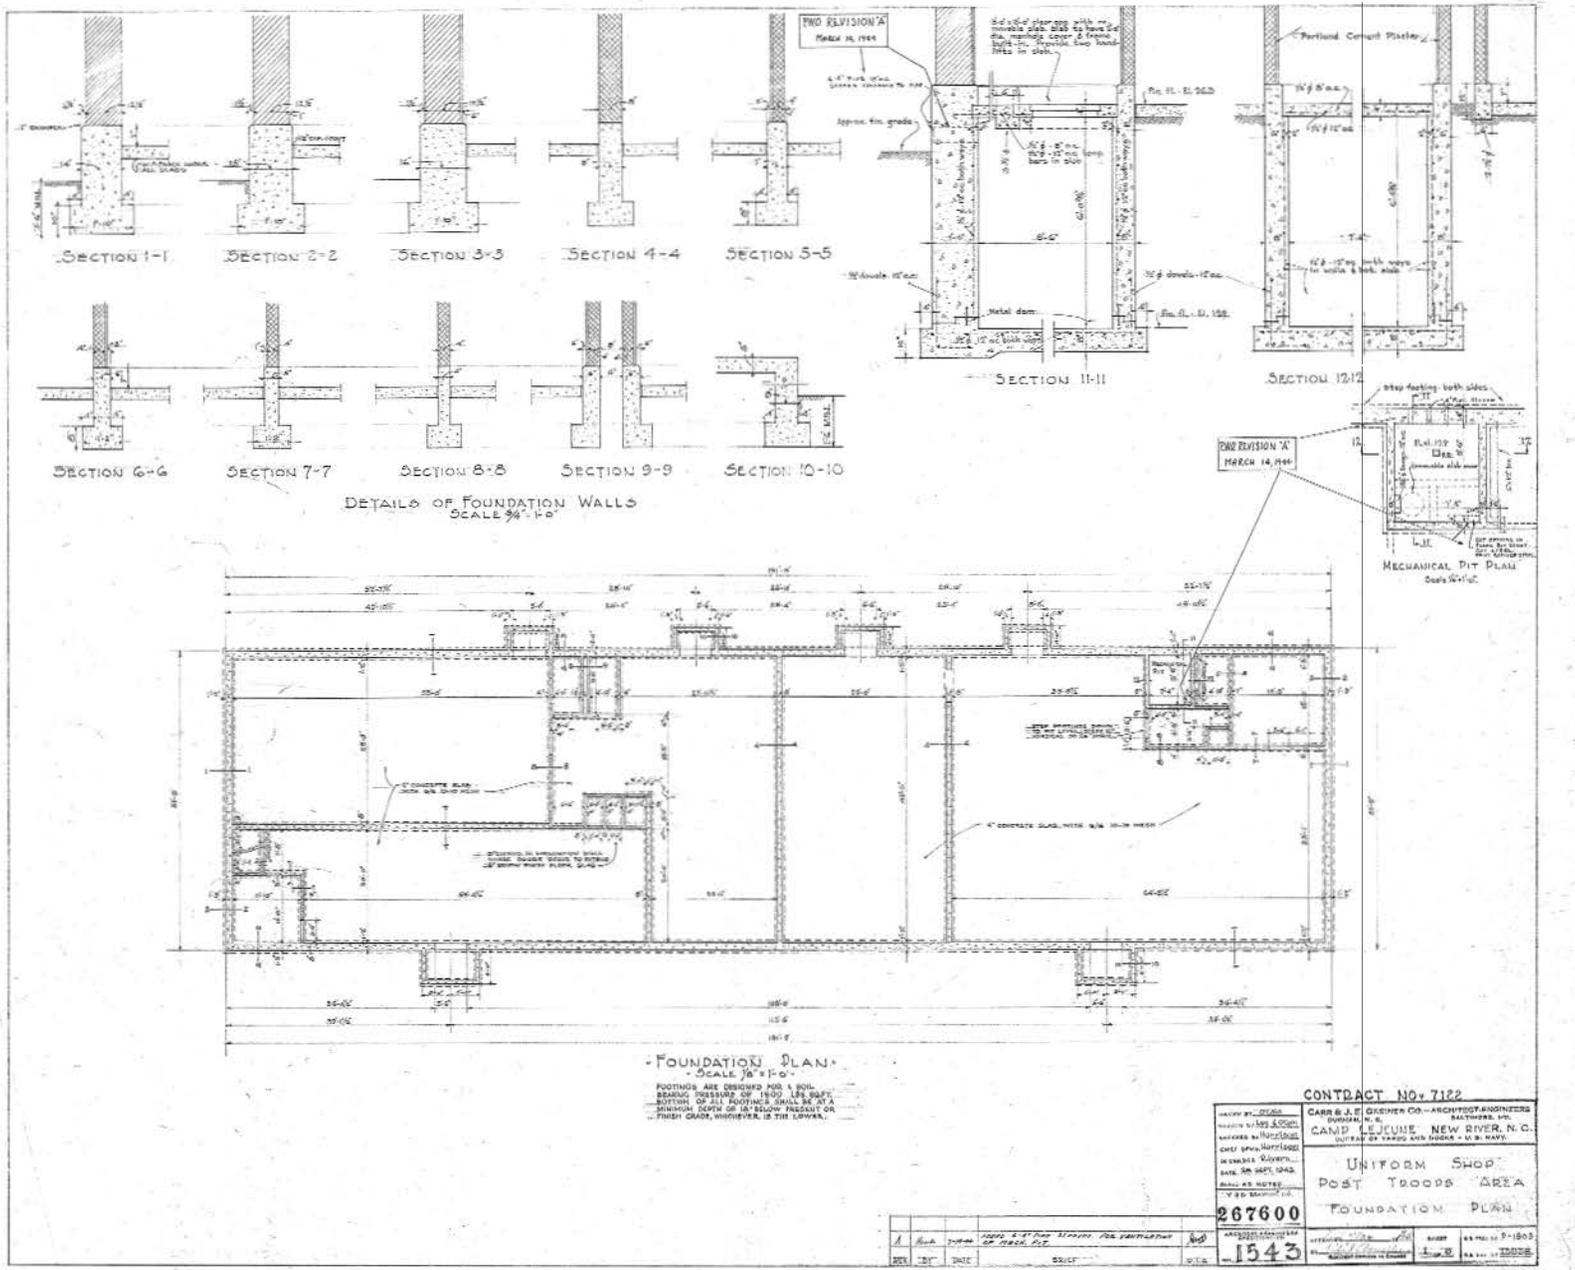
267600

FOOTINGS ARE DESIGNED FOR A SOIL BEARING CAPACITY OF 1500 LBS. PER SQ. FT. BOTTOM OF ALL FOOTINGS SHALL BE AT A FINISH GRADE (COPY OF A BELOW FINISH GRADE) UNLESS OTHERWISE NOTED.

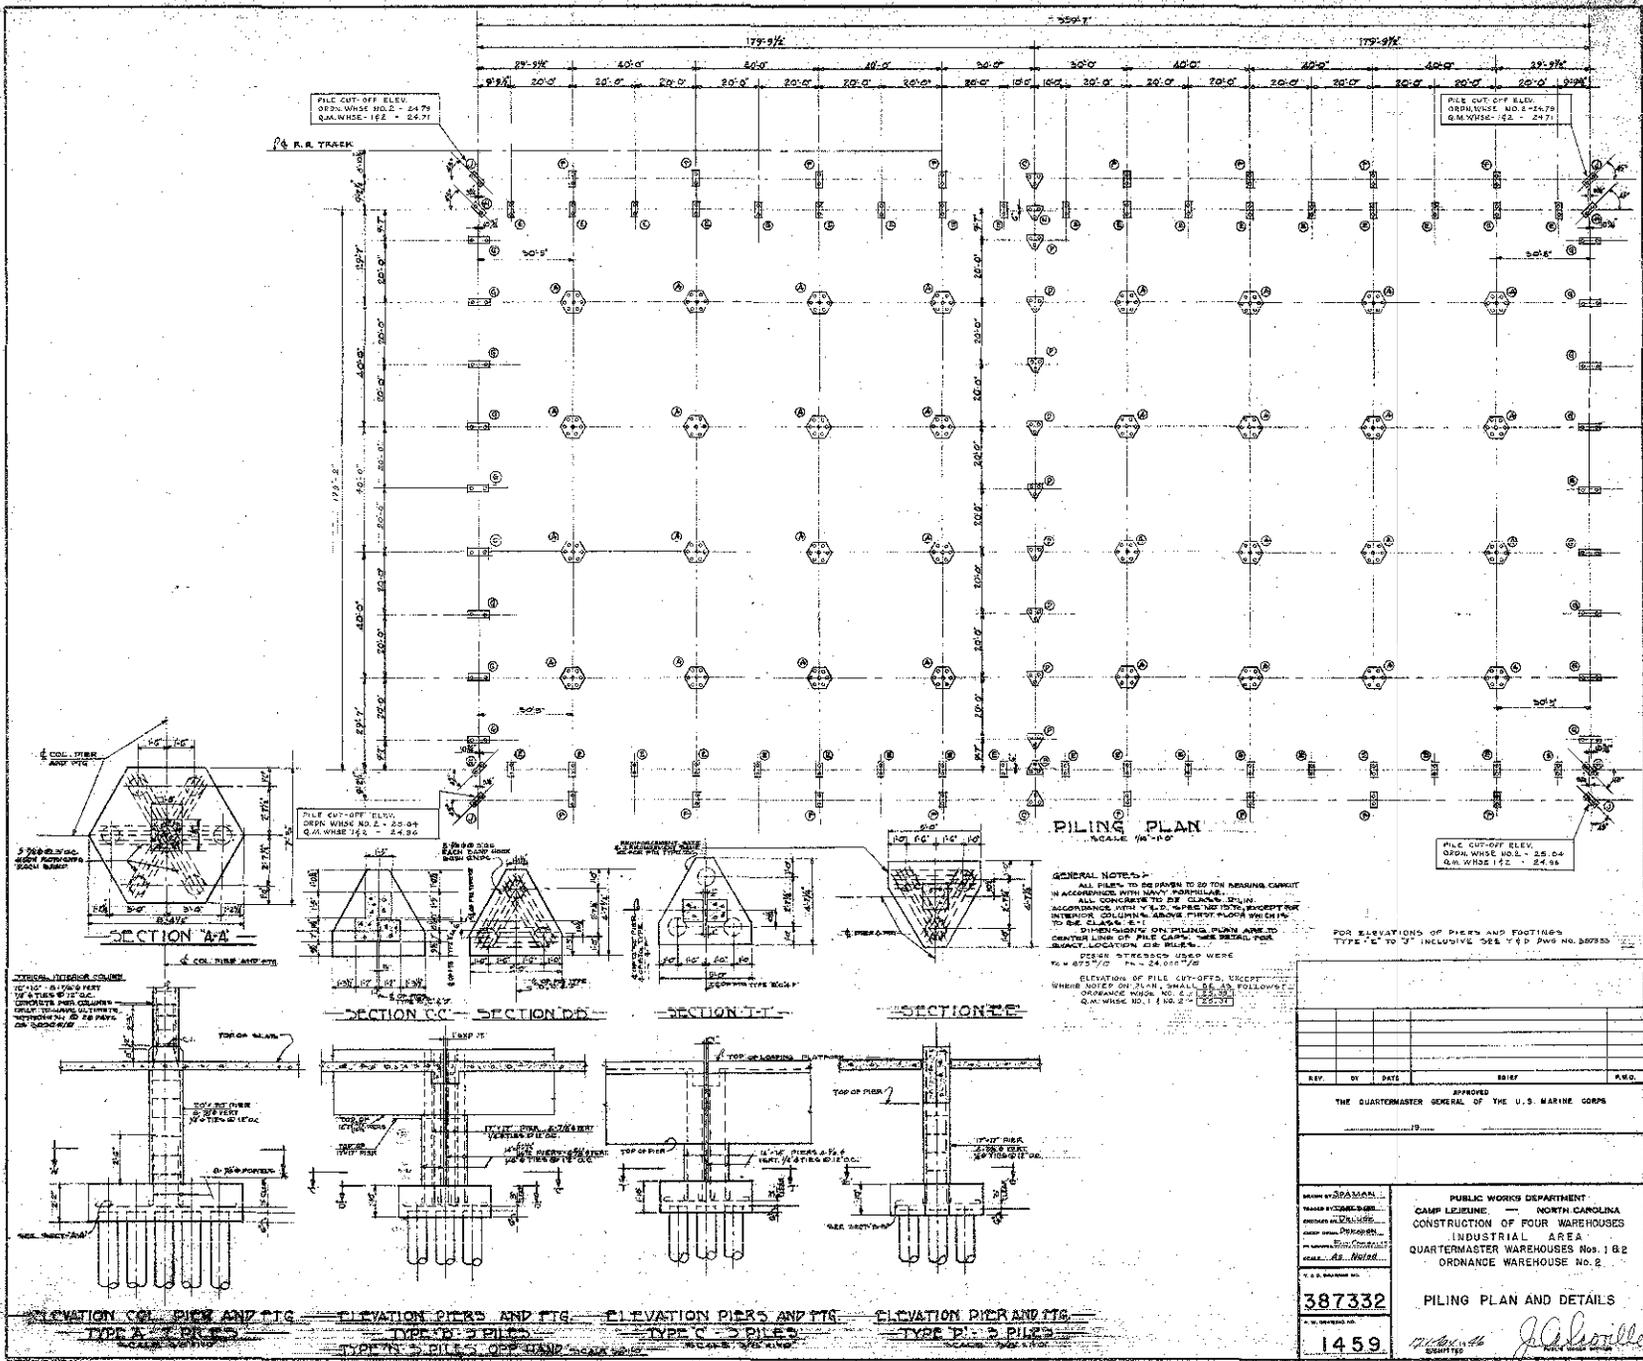
GENERAL NOTES:
 ALL PILES TO BE DRIVEN TO 20 TON TESTING CAPACITY IN ACCORDANCE WITH NAVY SPECIFICATIONS.
 ALL CONCRETE TO BE CLASS "B" CONCRETE IN ACCORDANCE WITH V.L.P. SPEC. 10170, EXCEPT FOR INTERIOR COLUMNS ABOVE FIRST FLOOR LEVEL.
 TO BE CLASS "B".
 DIMENSIONS ON PILING PLAN ARE TO CENTER LINE OF PILE CAPS. SEE DETAIL FOR EXACT LOCATION OF PILES.
 PILES STRESSED USED WERE 16" x 22" TYPE No. 24,000-TYPE.
 ELEVATION OF PILE CUT-OFF, EXCEPT WHERE NOTED ON PLAN, SHALL BE AS FOLLOWS:
 DECK WARE NO. 1 - 24.71
 Q.M. WARE NO. 1 - 24.96
