DRAFT FINAL INTERIM MEASURES REPORT FOR SOLID WASTE MANAGEMENT UNIT 27
(SWMU 27) SETTLING TANK AND SUMP REMOVALS AND FORMER BUILDING 181 AREA
BASIN, CISTERN, AND UNDERGROUND STORAGE TANK REMOVALS NSA CRANE
(DRAFT FINAL ACTING AS FINAL)

02/01/2014
TETRA TECH

**Naval Support Activity Crane
Crane, Indiana**

**Contract Number N62470-08-D-1001
Contract Task Order F276**

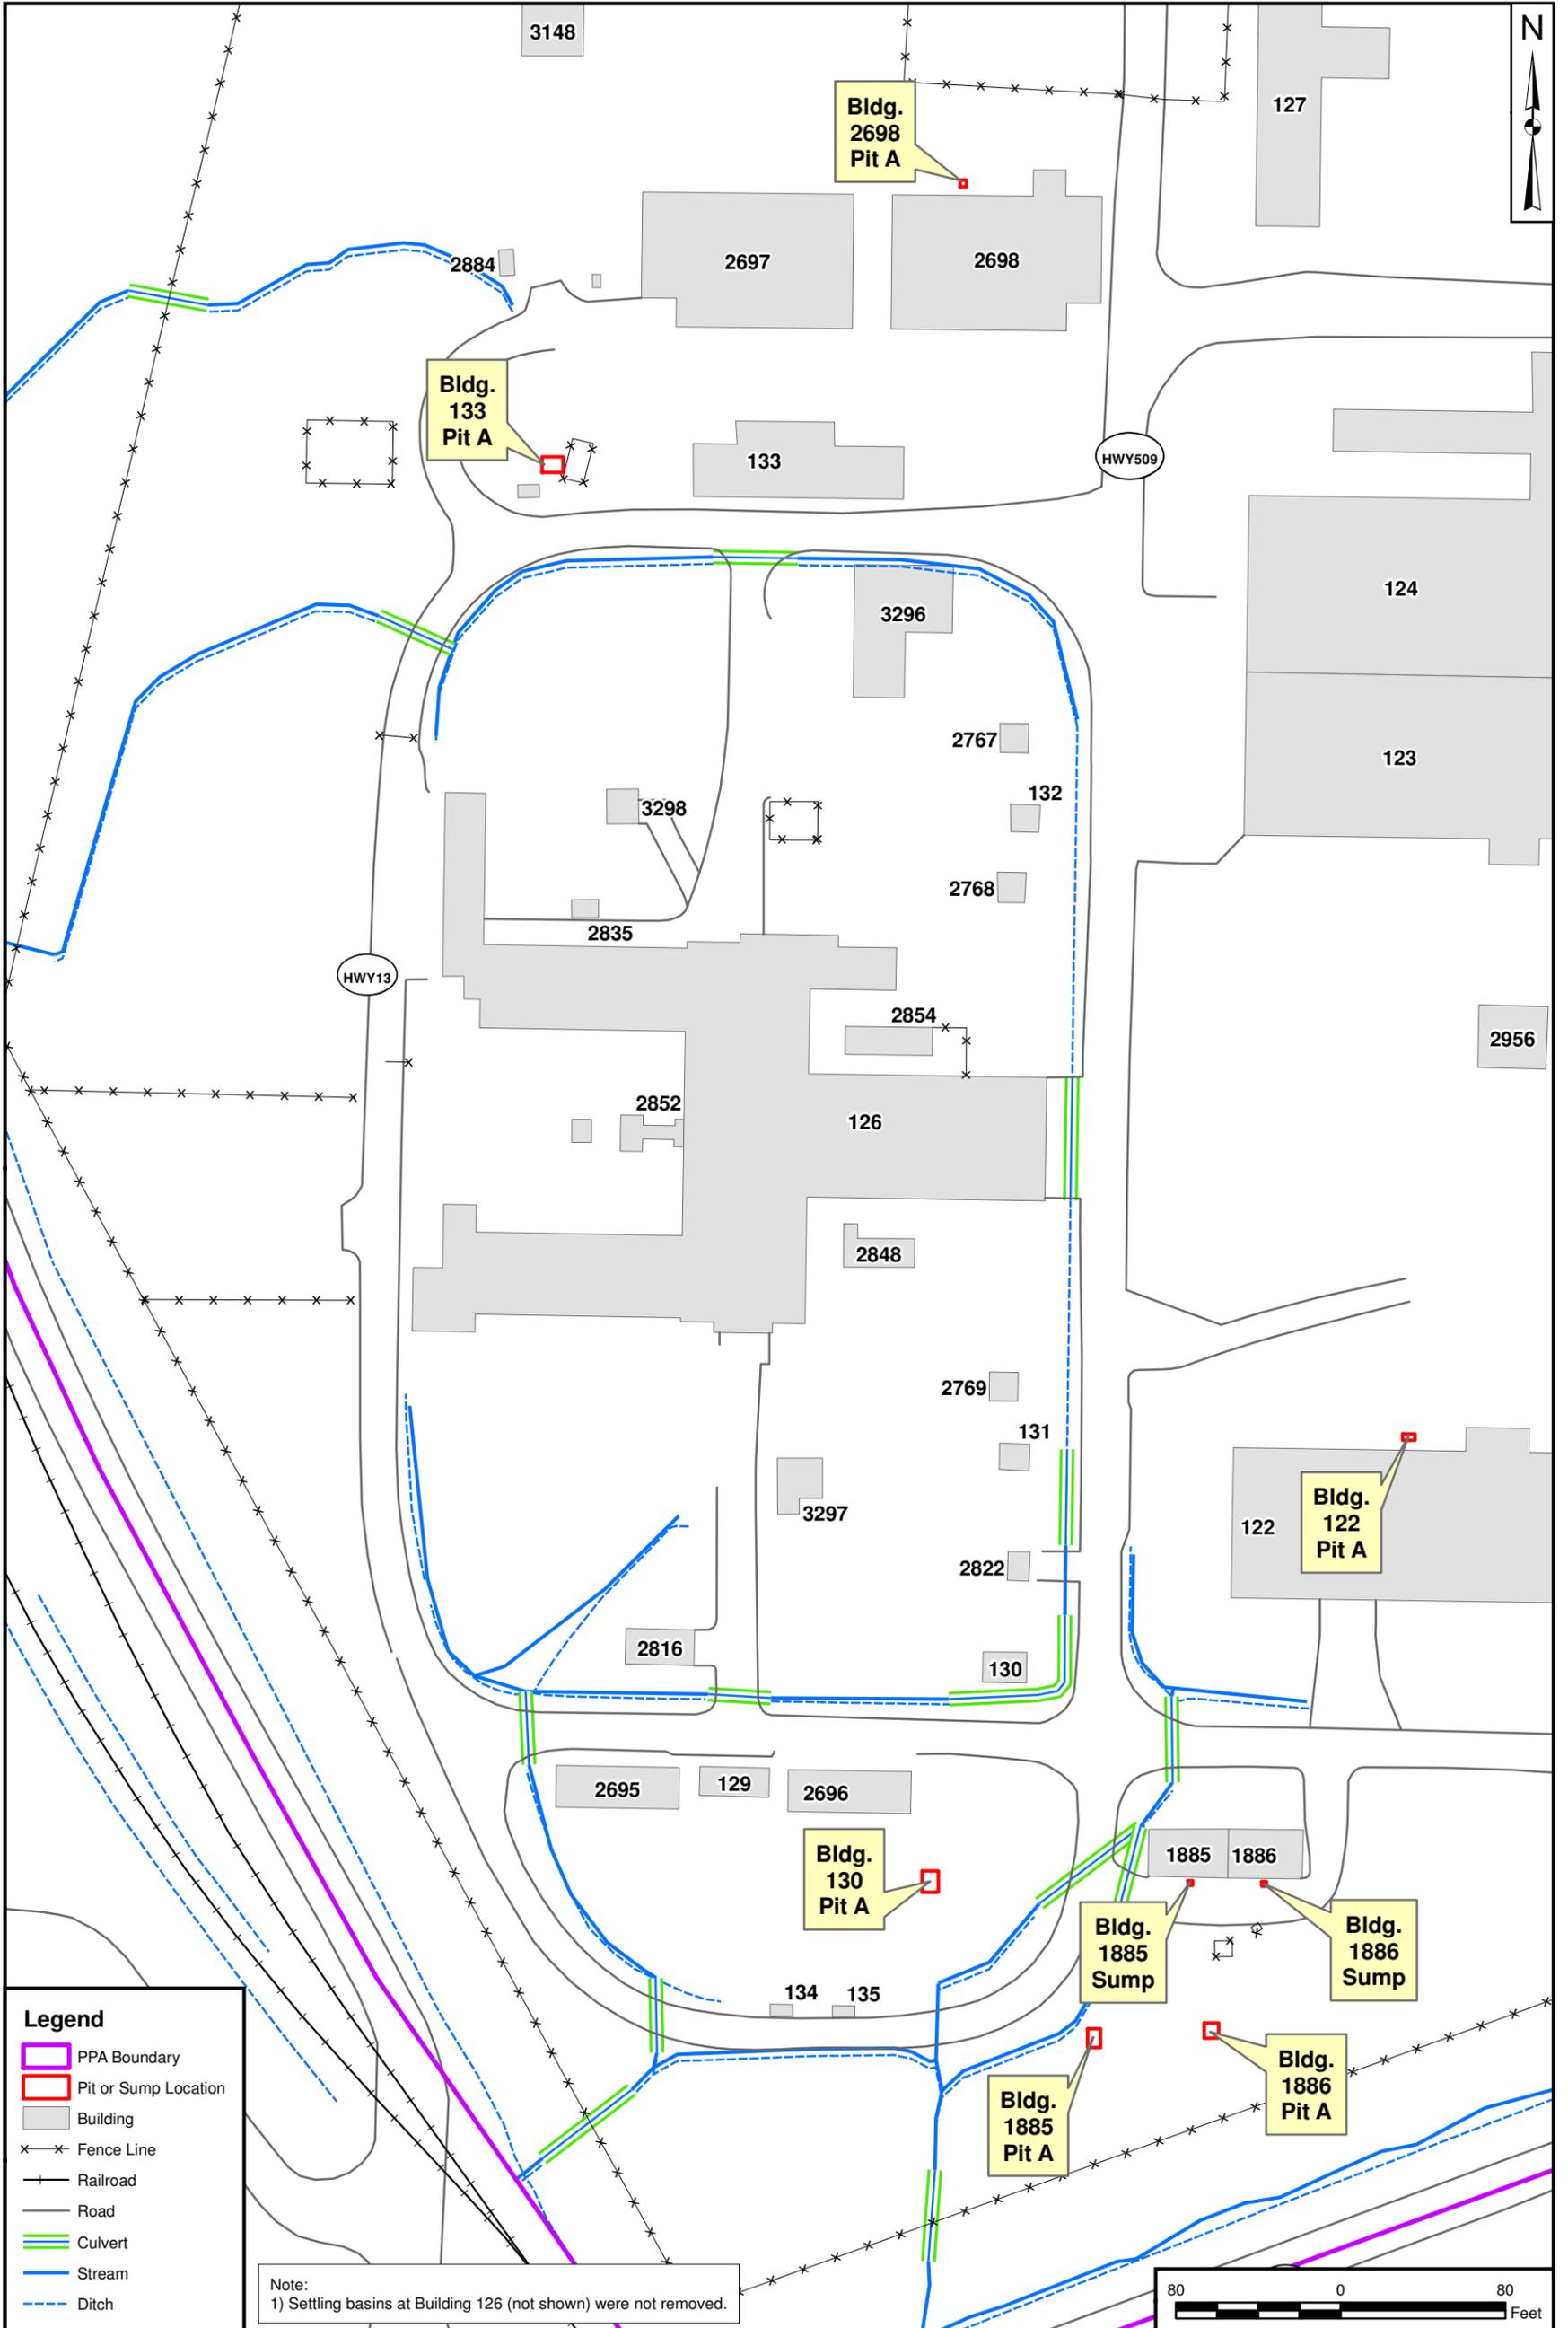
CONTRACT NUMBER 2126	CTO NUMBER F276
APPROVED BY	DATE
APPROVED BY	DATE
FIGURE NO. FIGURE 2	REV 0

Note:
1) Settling basins at Building 126 (not shown) were not removed.

**LOCATIONS OF SUMPS AND SETTLING BASINS REMOVED DURING
INTERIM MEASURE REMOVAL ACTION
SWMU 27 - PYROTECHNICS PRODUCTION AREA
NSA CRANE
CRANE, INDIANA**

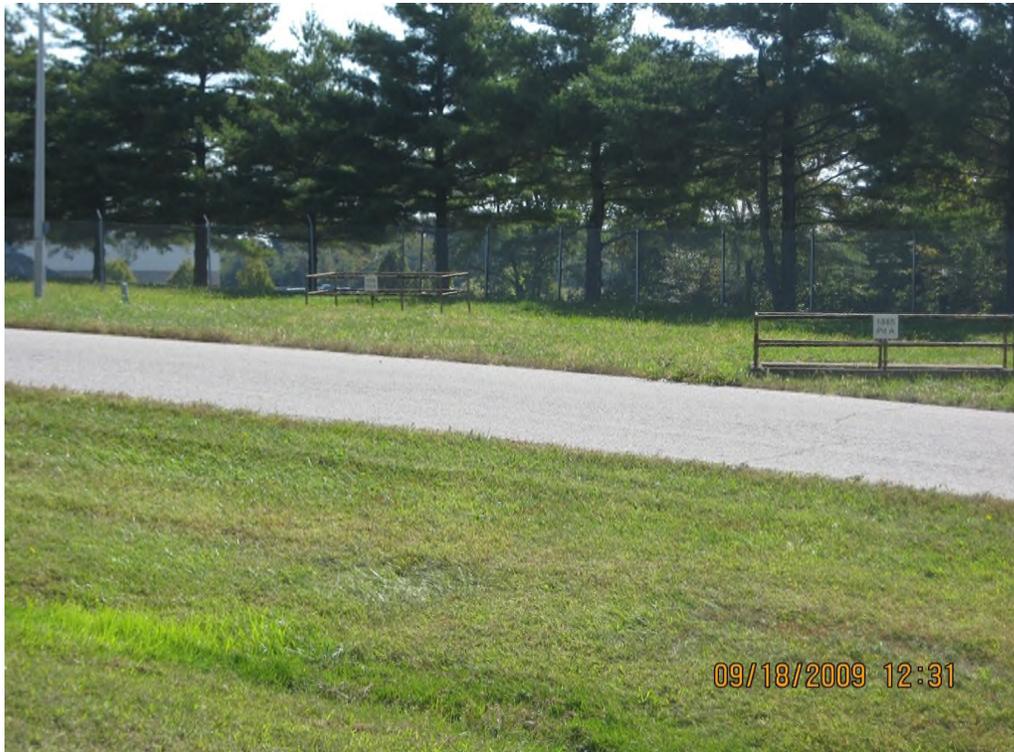
Bldg. 1885 Pit A (center right) and Bldg. 1886 Pit A (left center background)

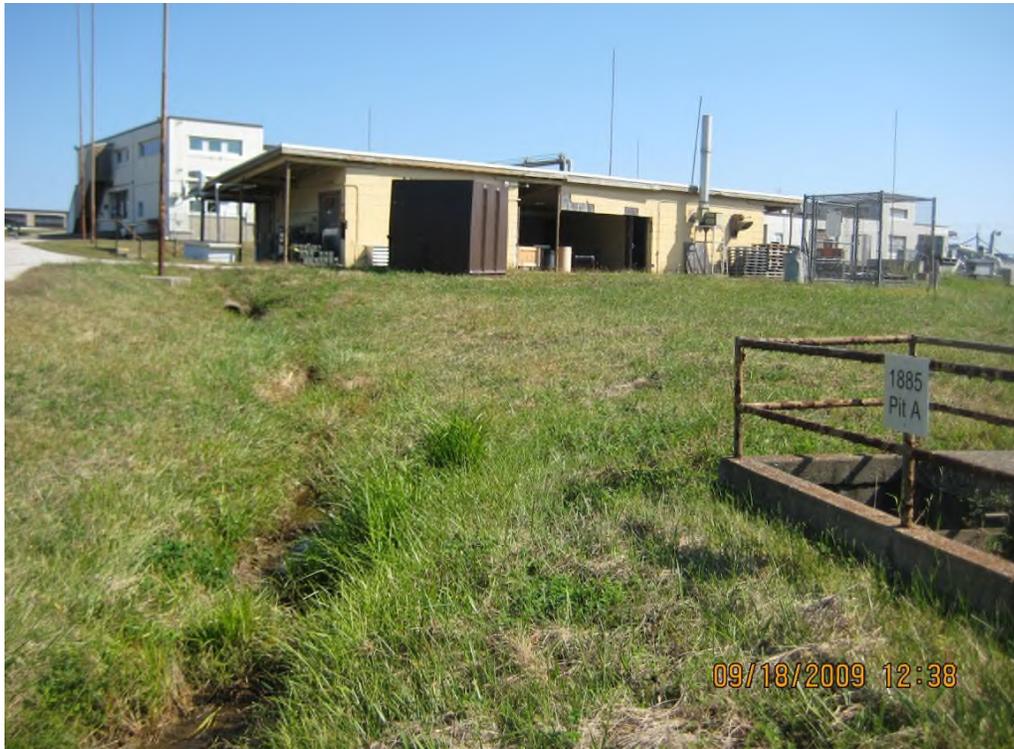
Bldg. 1885 Pit A

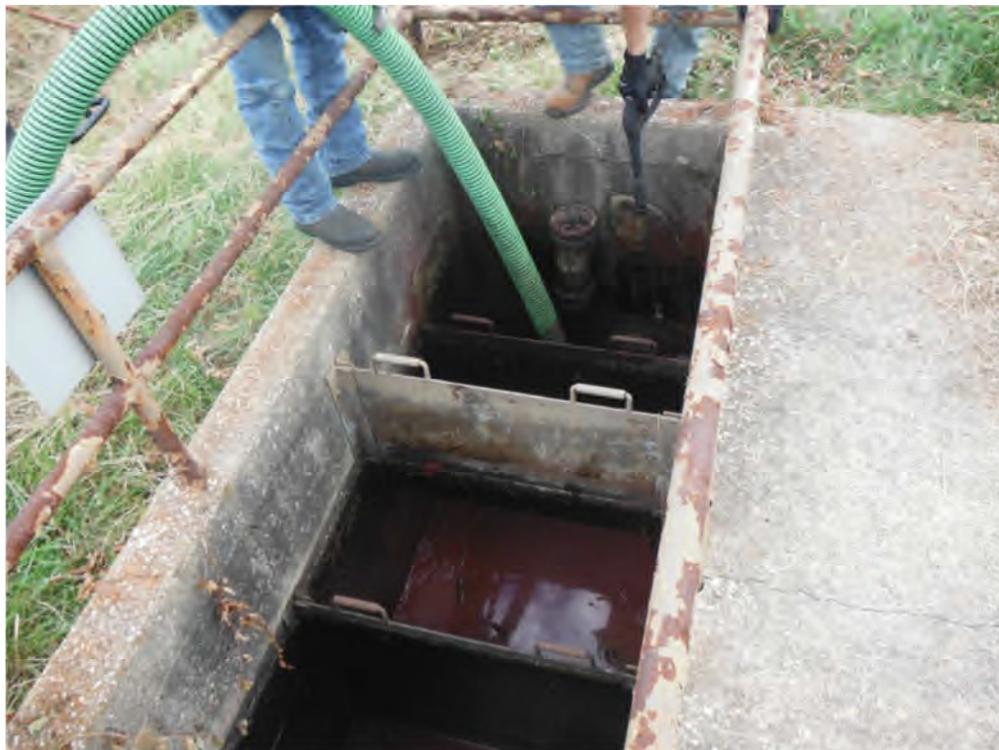
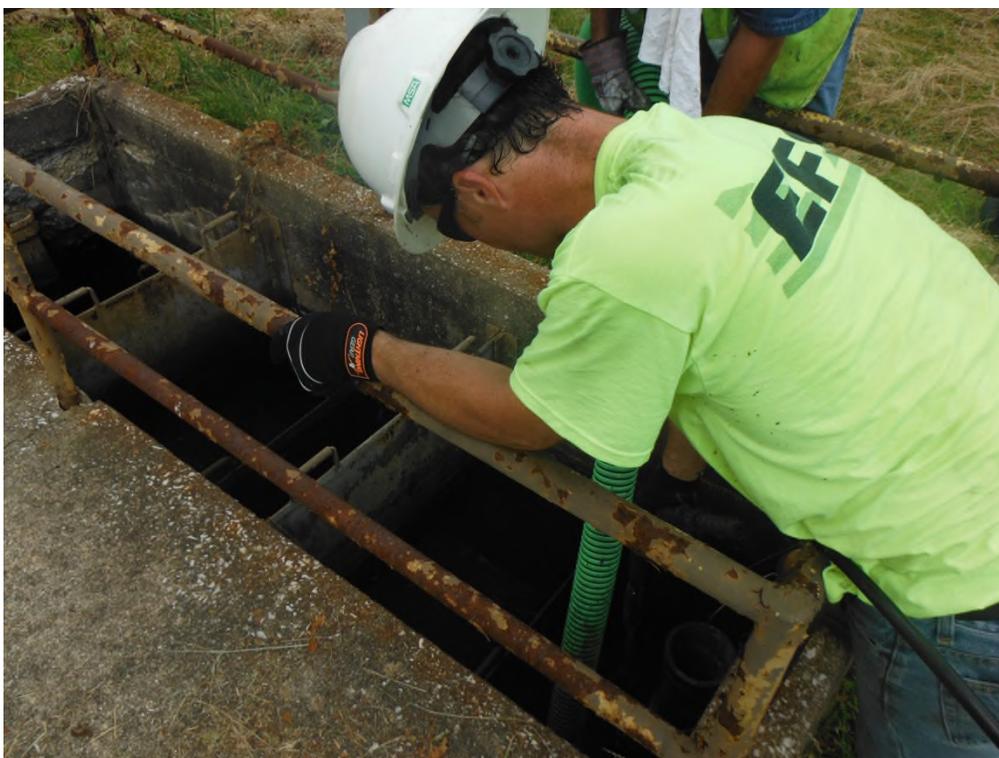
Bldg. 1885 Pit A Cleaning

After the settling tanks and pits were cleaned and the residues were pumped out, the basins were visually inspected and certified clean by the QCM. To increase access to the settling tanks, the hand rails (when present) were removed and placed on polyethylene sheeting. Loose lead-based paint was scraped and

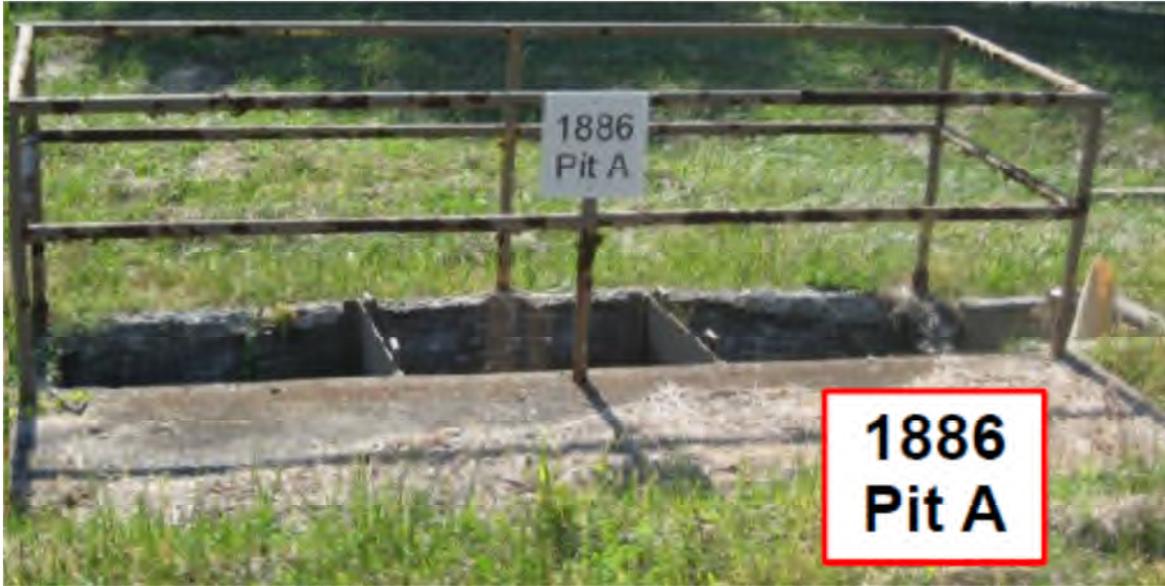
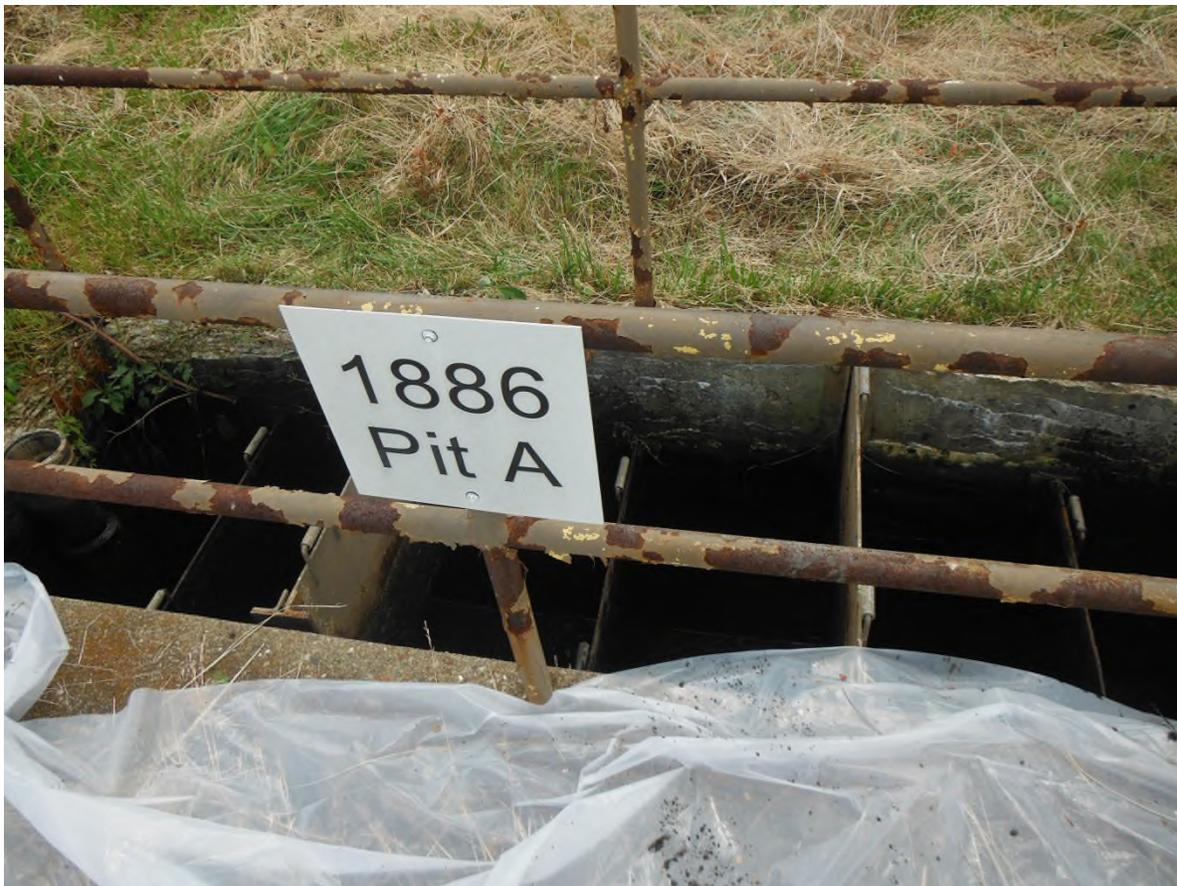
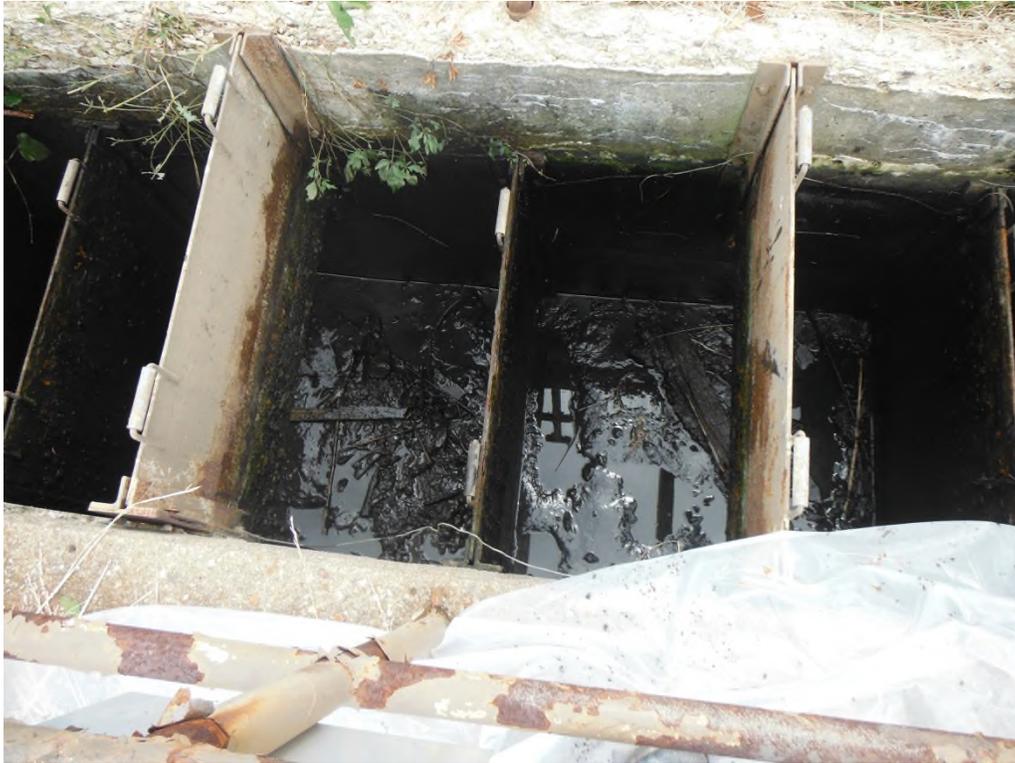
Bldg. 1886 Pit A

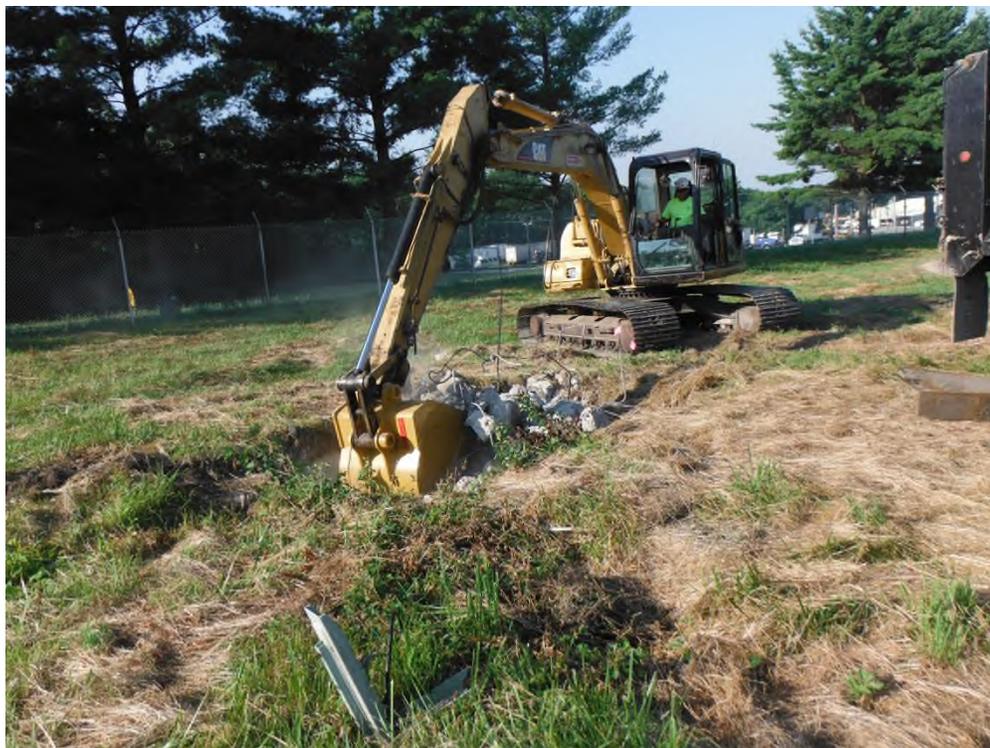
Bldg. 1886 Pit A Concrete Debris Being Removed

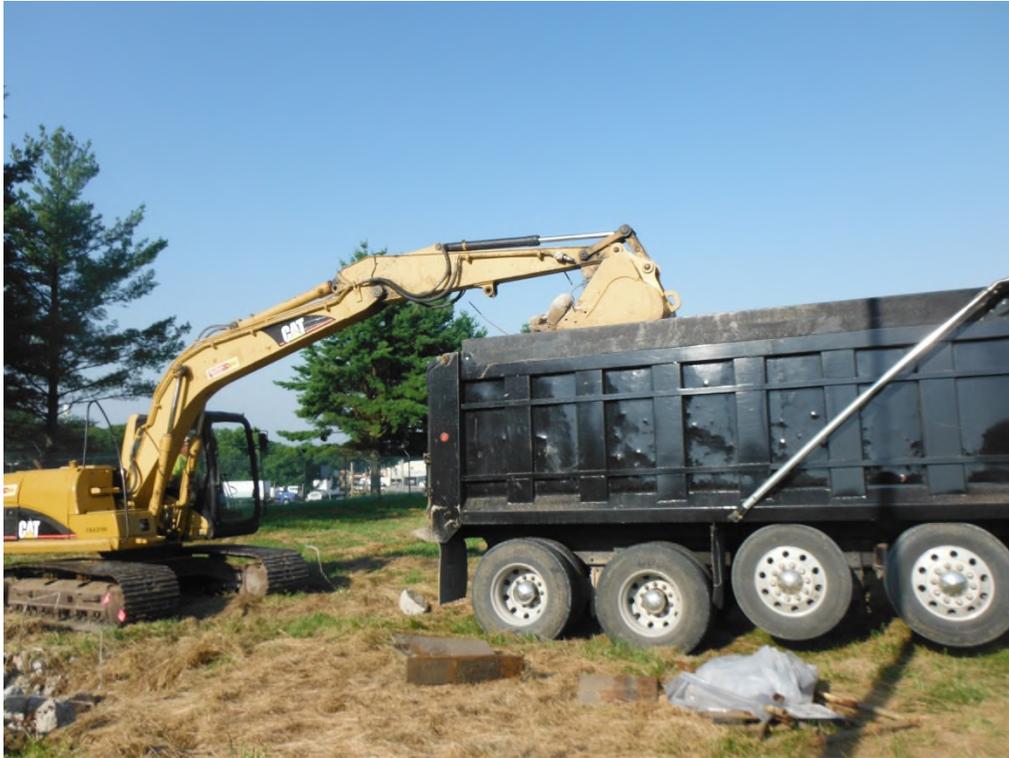
Bldg. 1886 Pit A Concrete Debris Being Loaded into Truck for Transport

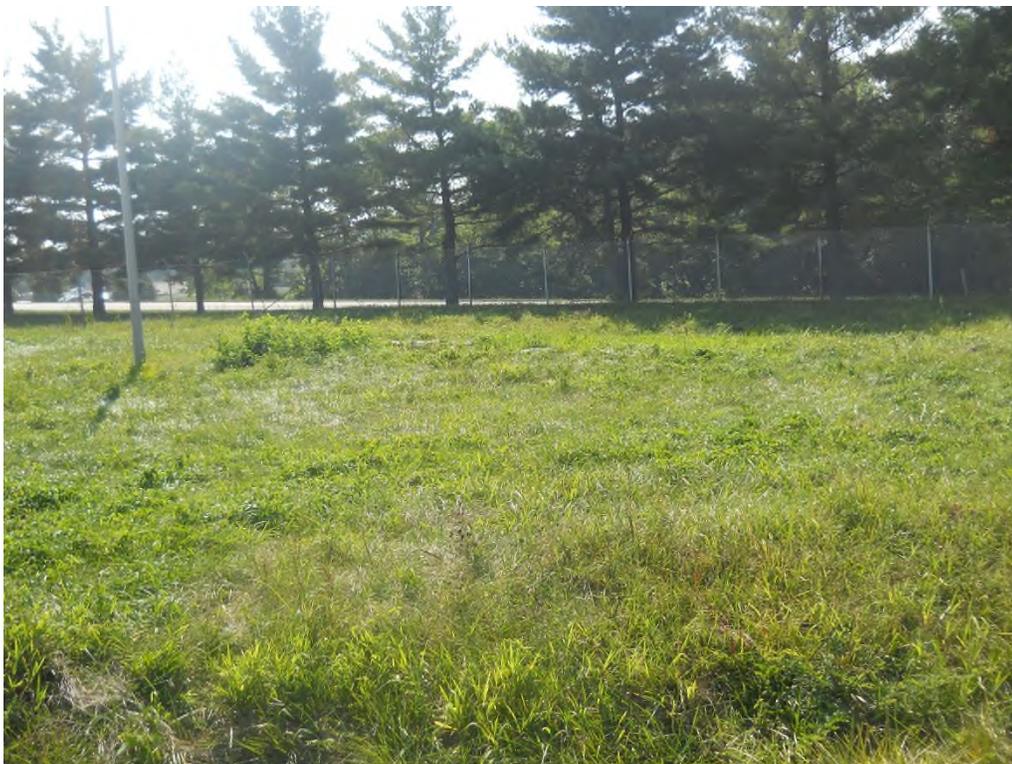
Bldg. 1886 Pit A After Site Restoration

When backfilling was complete, 4 inches of topsoil were placed over the excavation areas and additional areas that were impacted by IM activities. The site was then restored with a mix of winter wheat and annual ryegrass temporary cover and Kentucky 32 fescue permanent cover. The topsoil was fertilized and amended according to the seed supplier's recommendation with 5 pounds of crushed limestone and a 13-0-13 fertilizer. Erosion control mattresses and straw were then placed over the seeded areas as temporary cover. Backfill and restoration was completed on July 25, 2013, for the basins and completed on August 29, 2013, for the supplemental pipe installation.

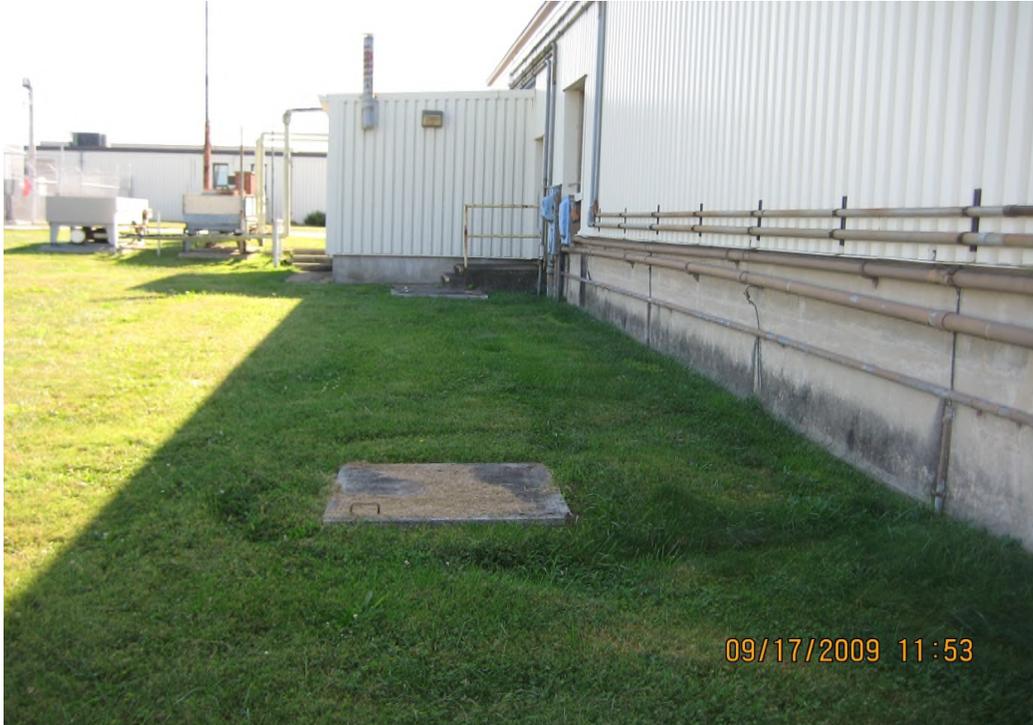
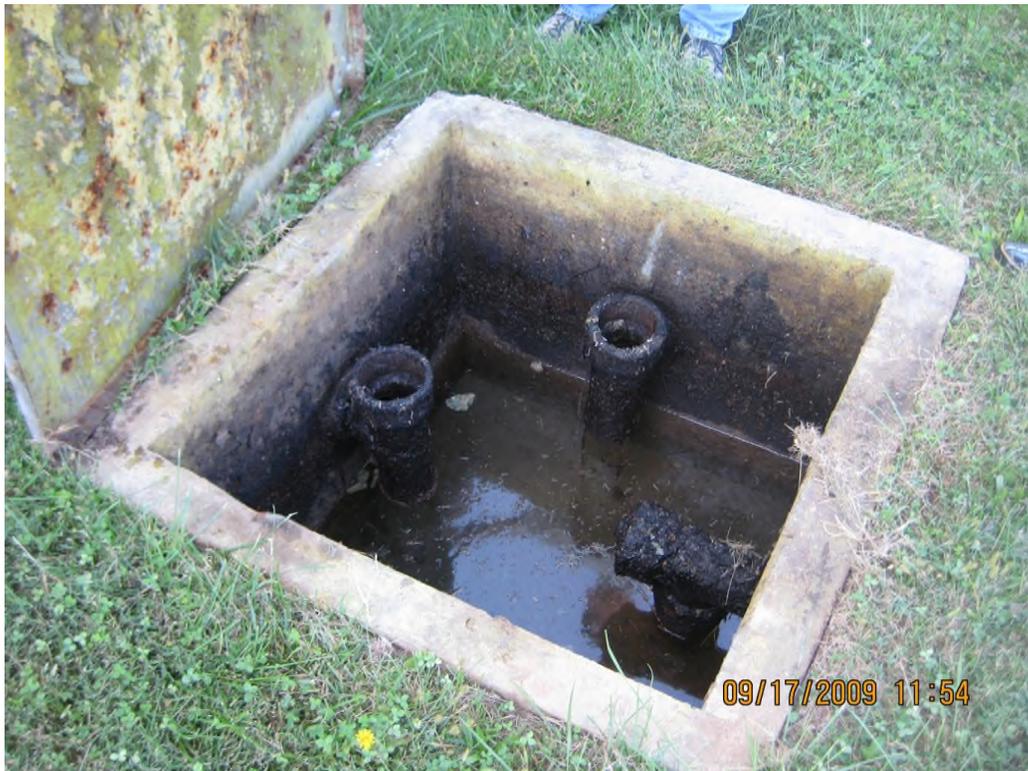
Bldg. 2698 Pit A

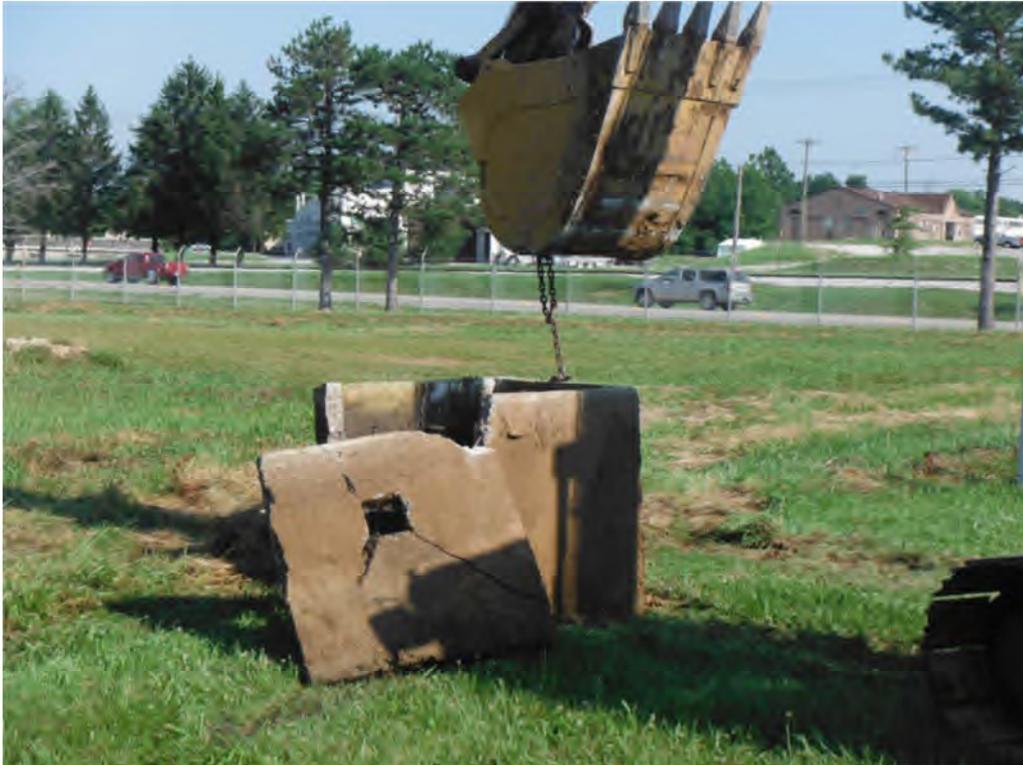
Bldg. 2698 Pit A Removal

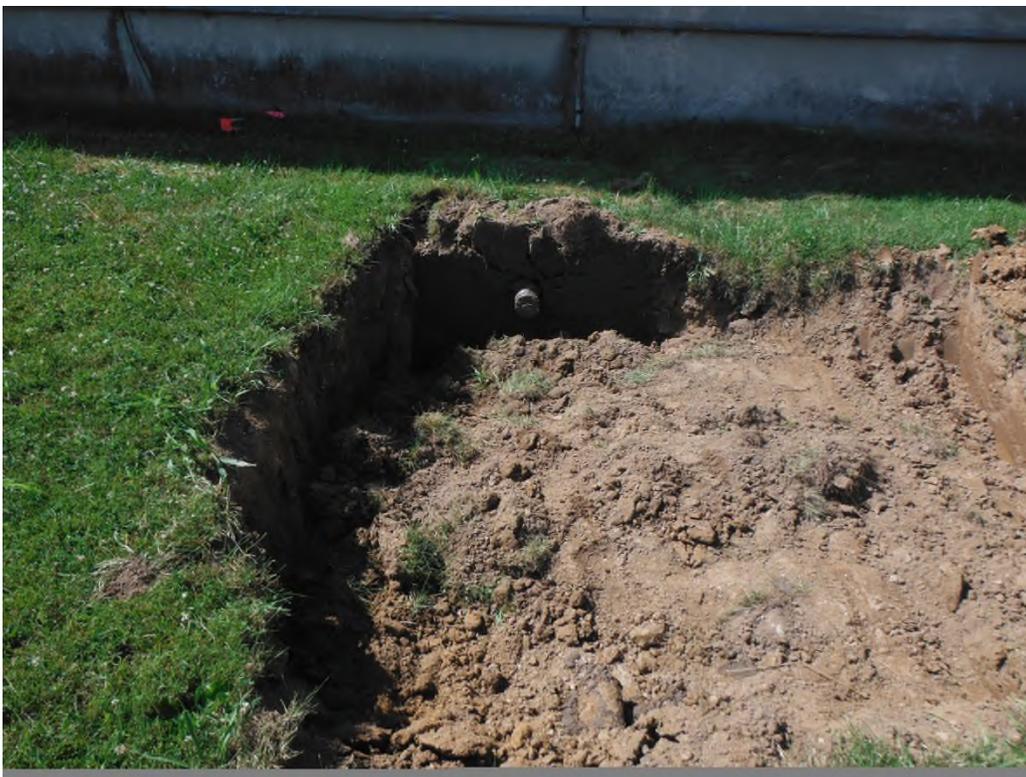
Bldg. 2698 Pit A Removal Area Showing Plugged Pipe

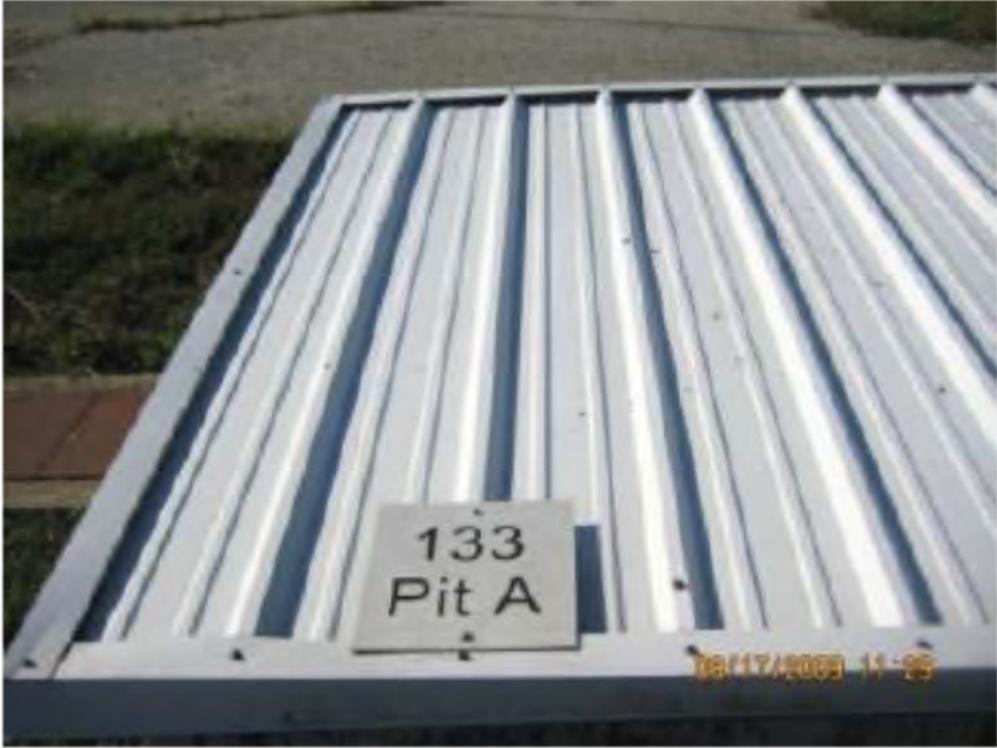
Bldg. 133 Pit A with Metal Cover

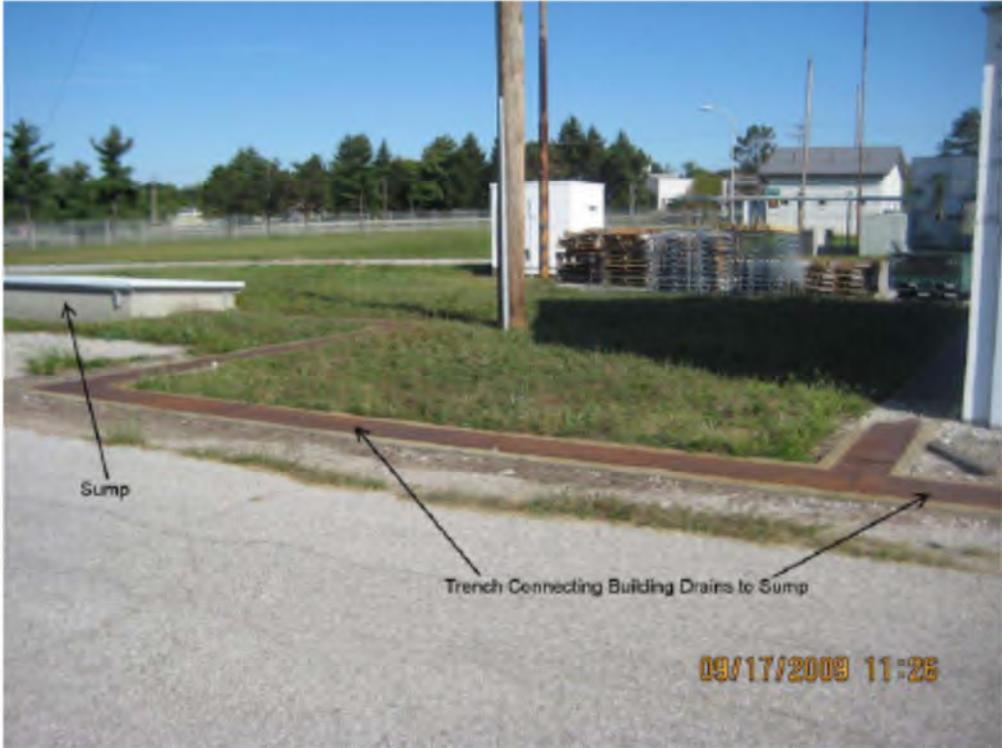
Bldg. 133 Trench Drain System to Settling Tank

- Repairs to Building 126 Pit B – Clean interior settling basin, apply epoxy surface coating, power jet influent drain line, replace settling tank control valves, replace safety hand railing
- Modification 1 – Fabricate and install aluminum settling tank covers for Building 126 Pit B.
- Modification 2 – Install new drain pipes at Building 126 and Building 133 and fill former drainage trench at Building 133 with flowable fill.

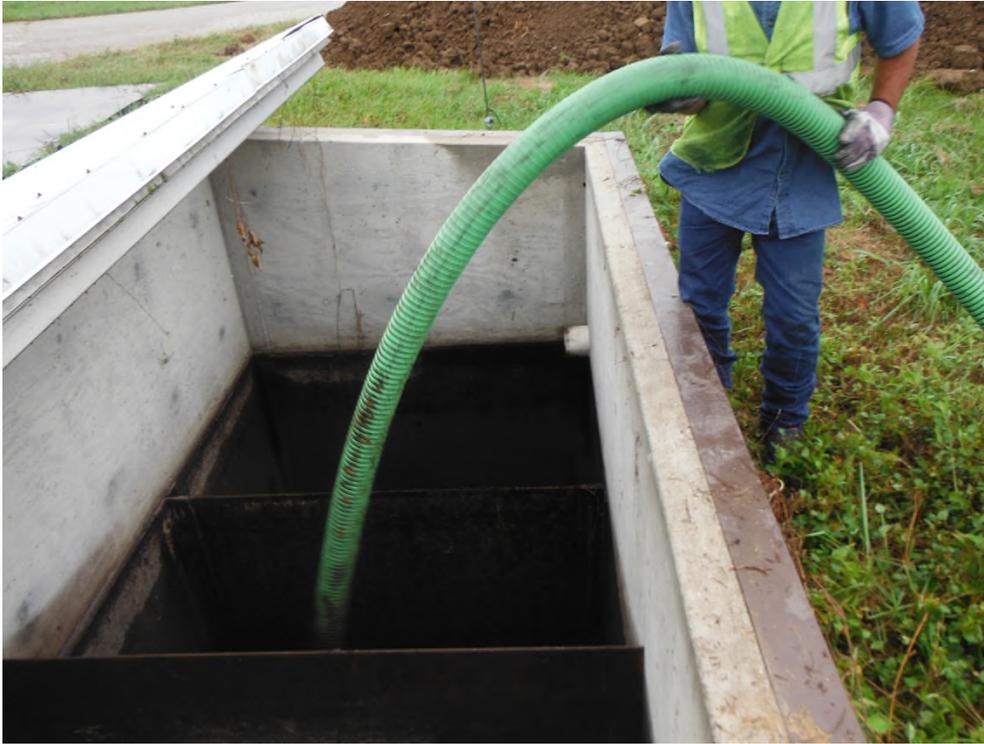
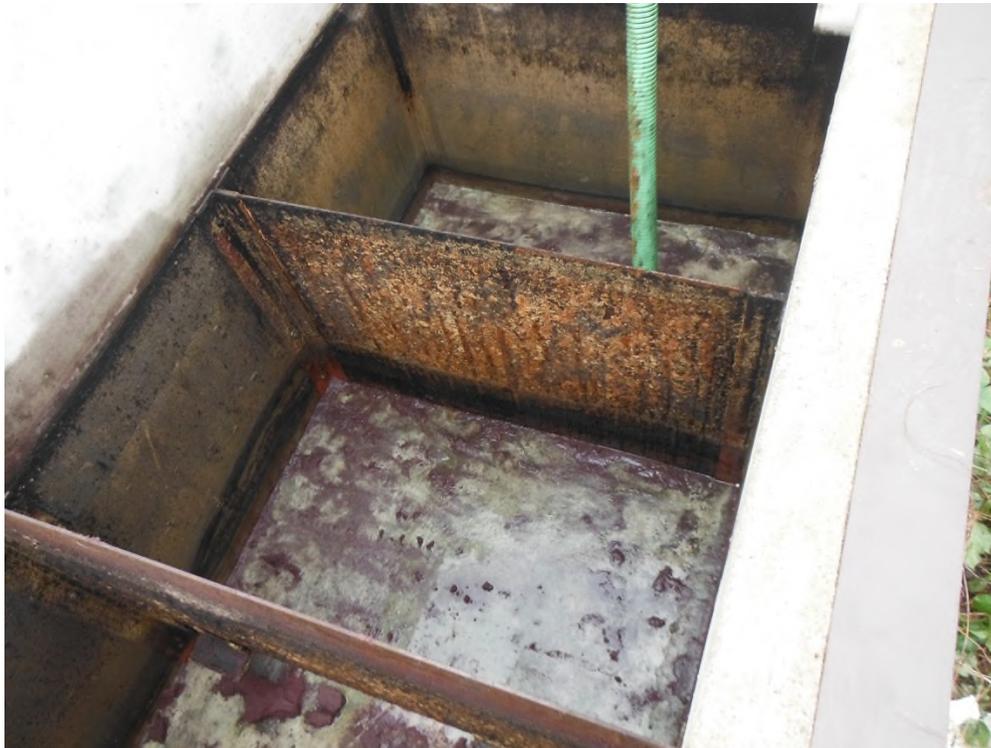
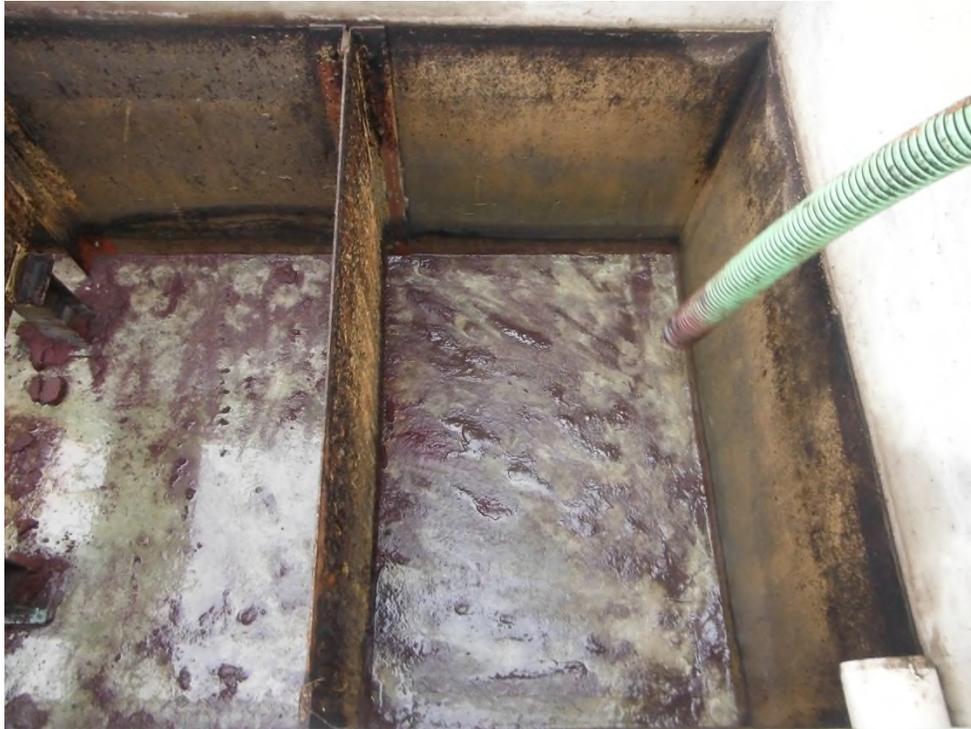
Bldg. 133 Pit A Cleaning

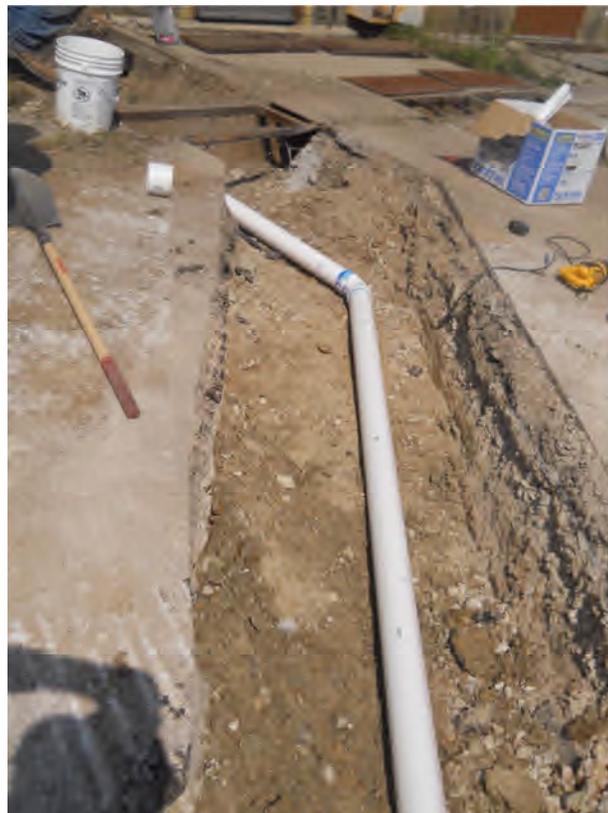
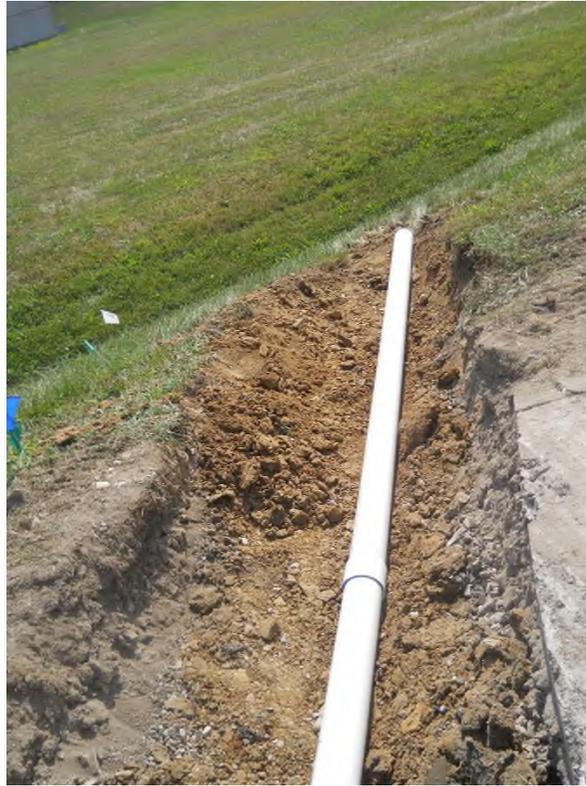
Bldg. 133 Installed Drainage Pipe

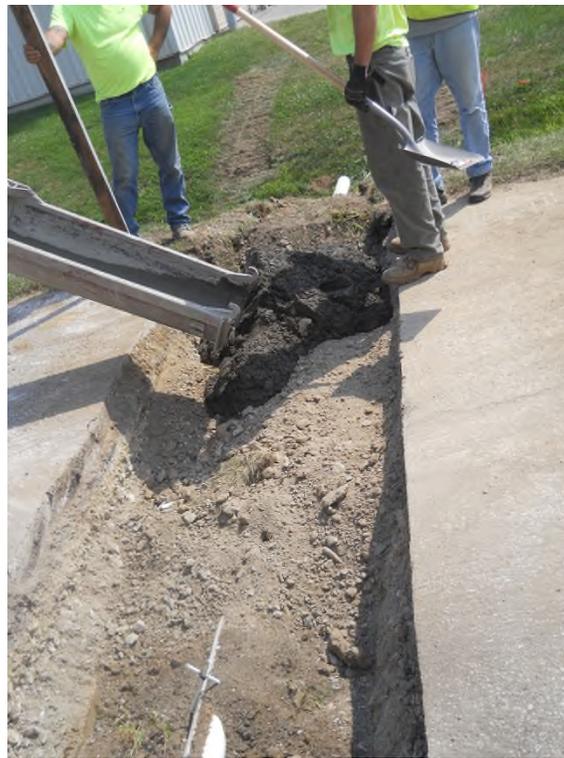
Filling/Covering Bldg. 133 Installed Drainage Pipe

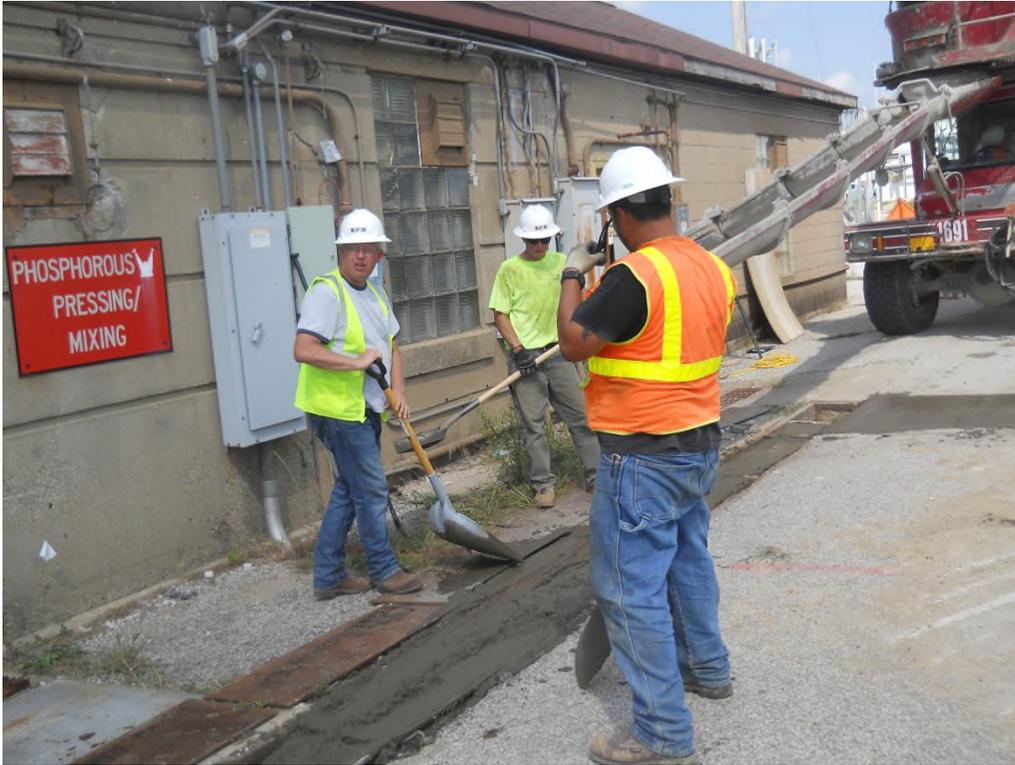
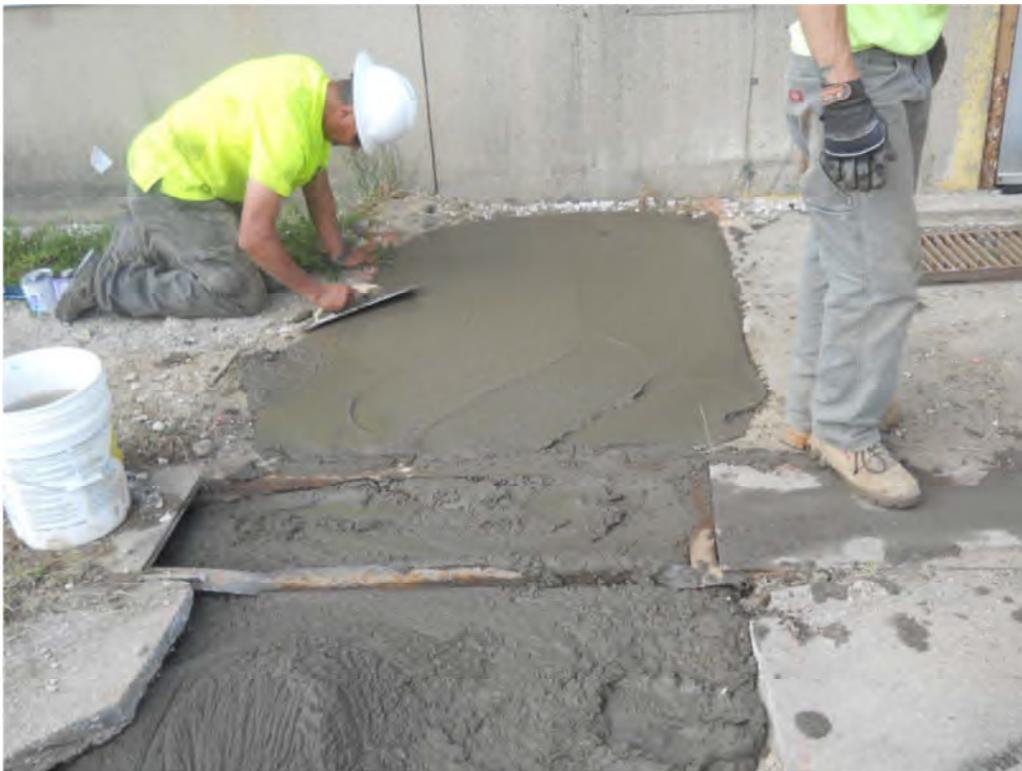
Bldg. 133 Filling Drainage Trench

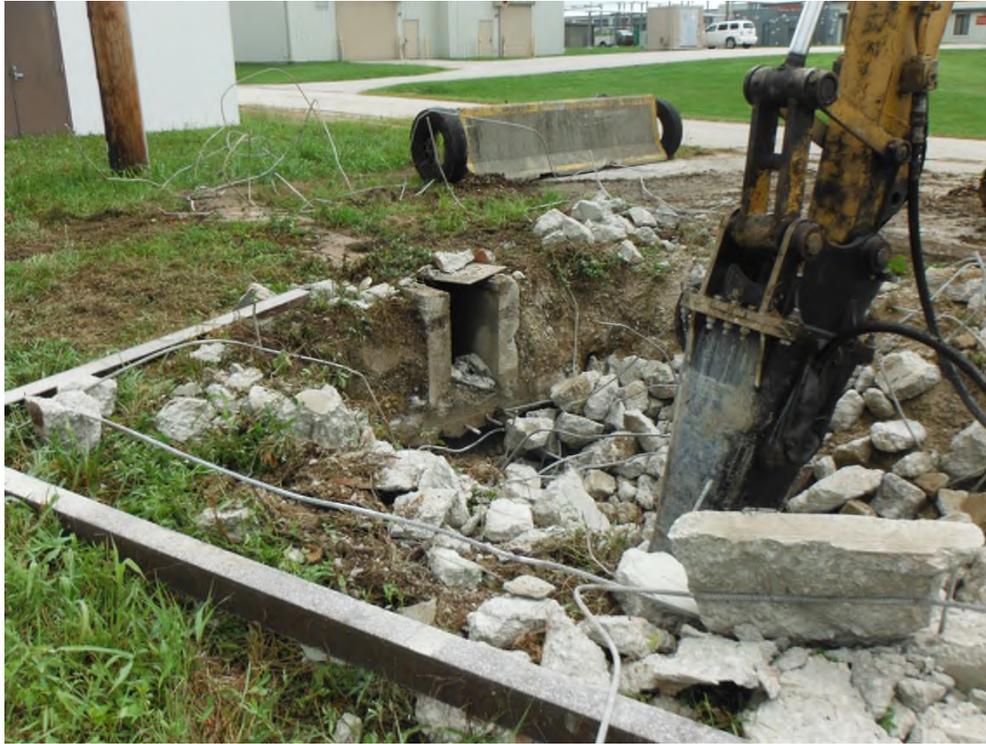
Removal of Bldg. 133 Pit A Concrete and Debris
