DRAFT FINAL INTERIM MEASURES REPORT FOR SOLID WASTE MANAGEMENT UNIT 27
(SWMU 27) SETTLING TANK AND SUMP REMOVALS AND FORMER BUILDING 181 AREA
BASIN, CISTERN, AND UNDERGROUND STORAGE TANK REMOVALS NSA CRANE
(DRAFT FINAL ACTING AS FINAL)

02/01/2014
TETRA TECH

**Naval Support Activity Crane
Crane, Indiana**

**Contract Number N62470-08-D-1001
Contract Task Order F276**

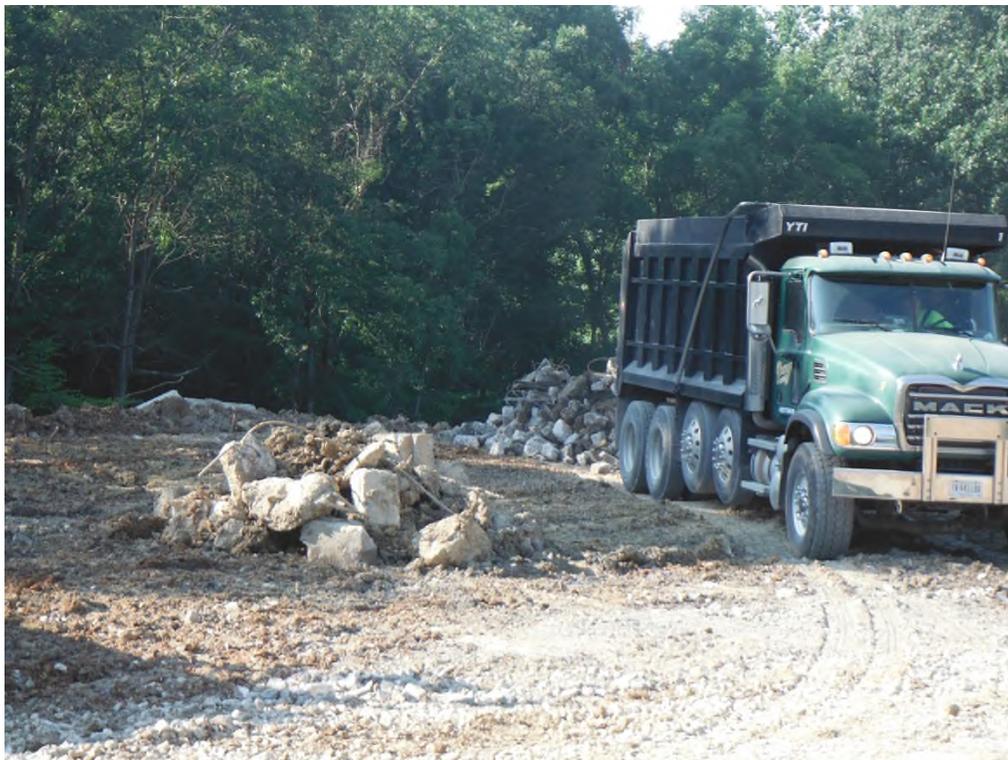
Concrete Debris Being Unloaded at Concrete Staging Area for Recycling

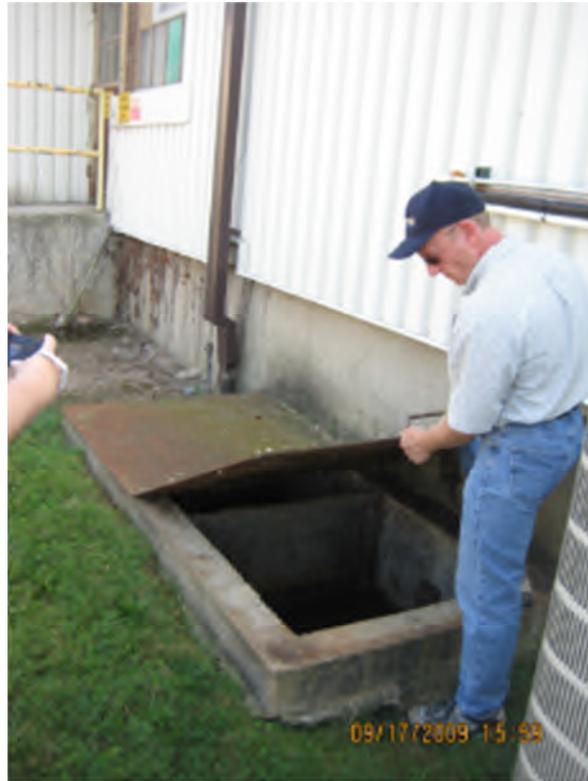
- Building 122 Pit A was physically attached to the foundation of the building. During removal activities, saw cutting of the structure disrupted sensitive operations within Building 122. The IM work was stopped, and the structure was abandoned in place with flowable fill.

Bldg. 122 Pit A

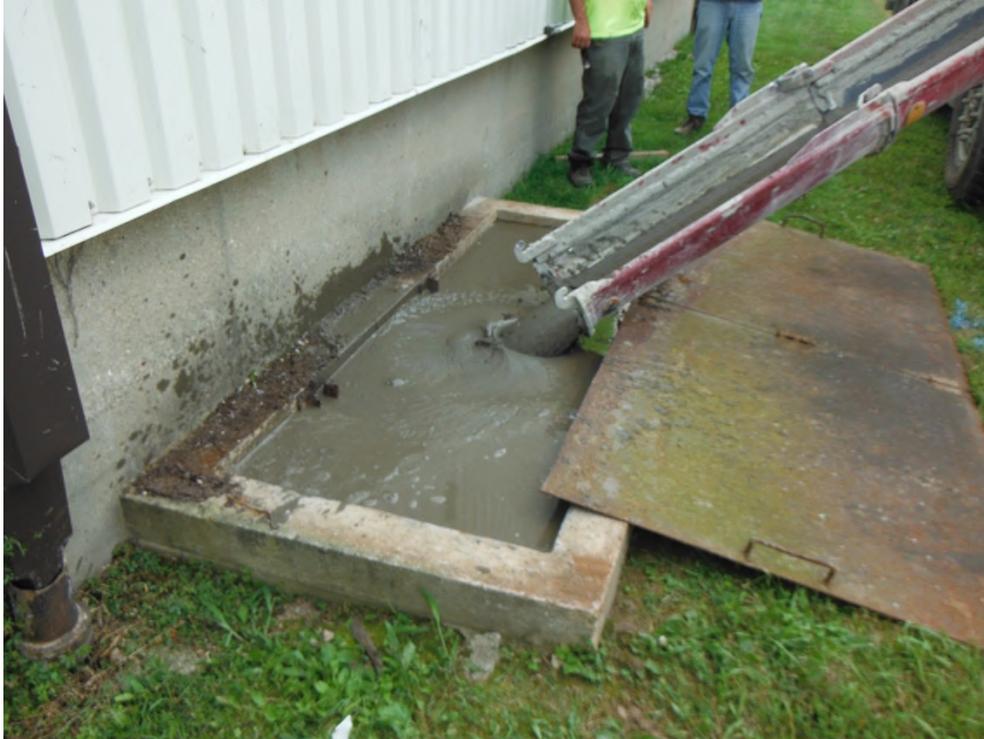
Bldg. 122 Pit A Closed in Place with Fill

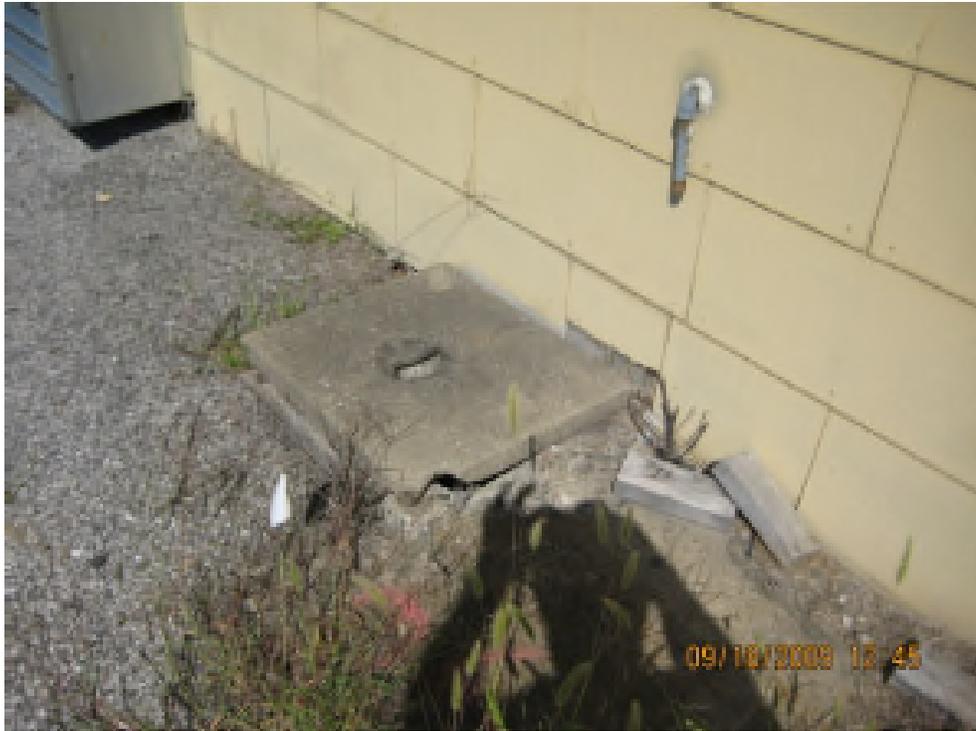
Bldg. 1885 Sump

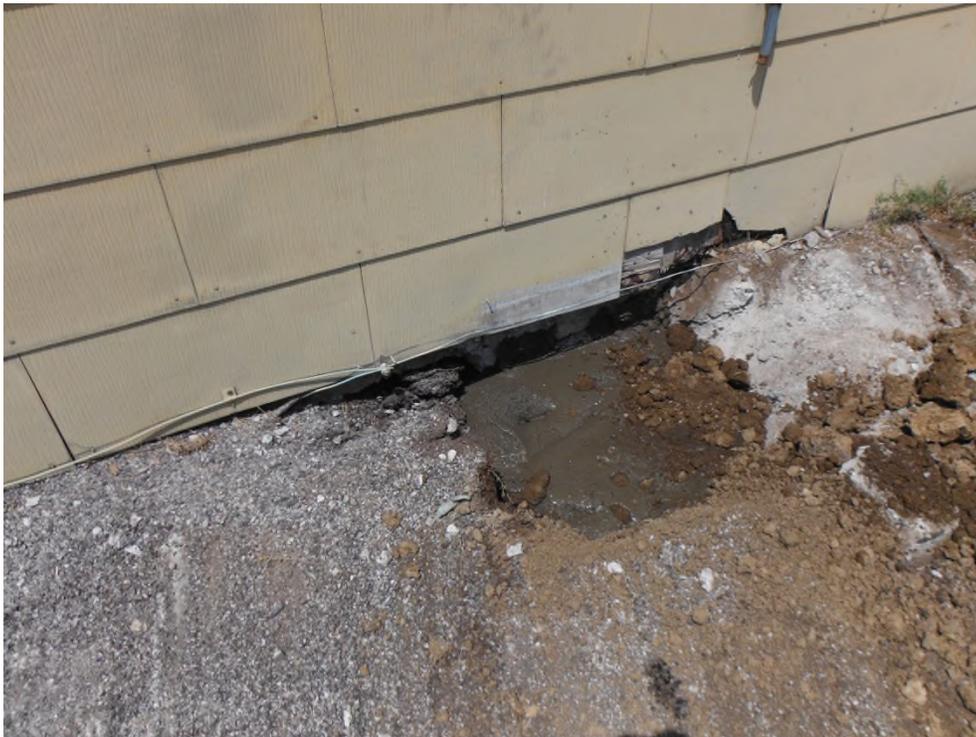
Bldg. 1885 Sump after Removal

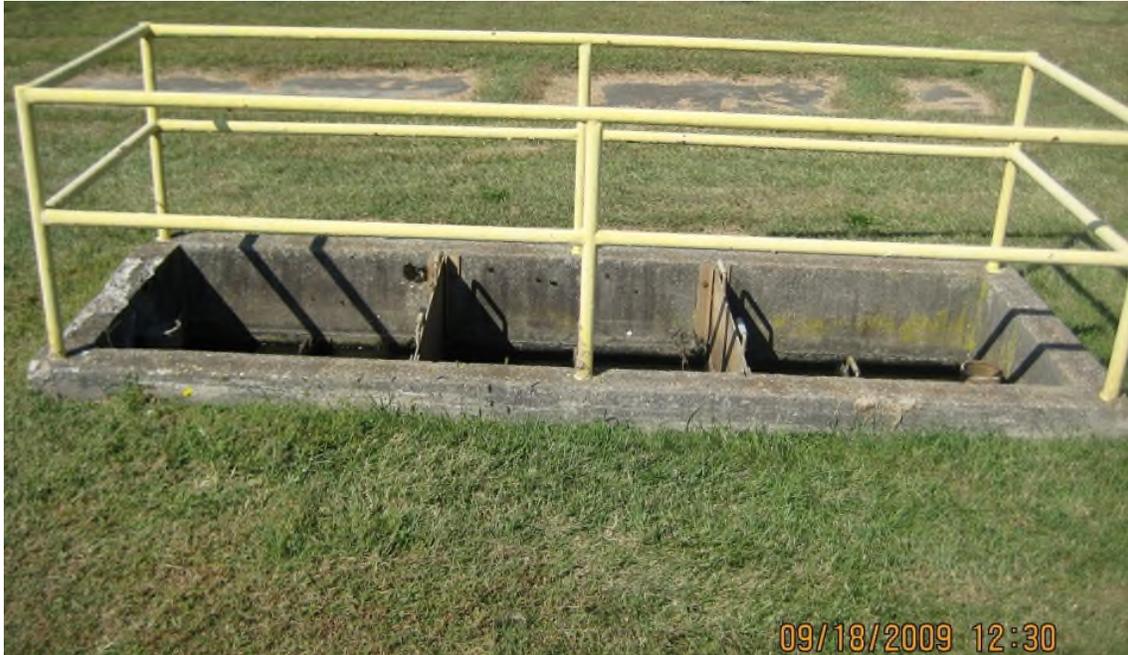
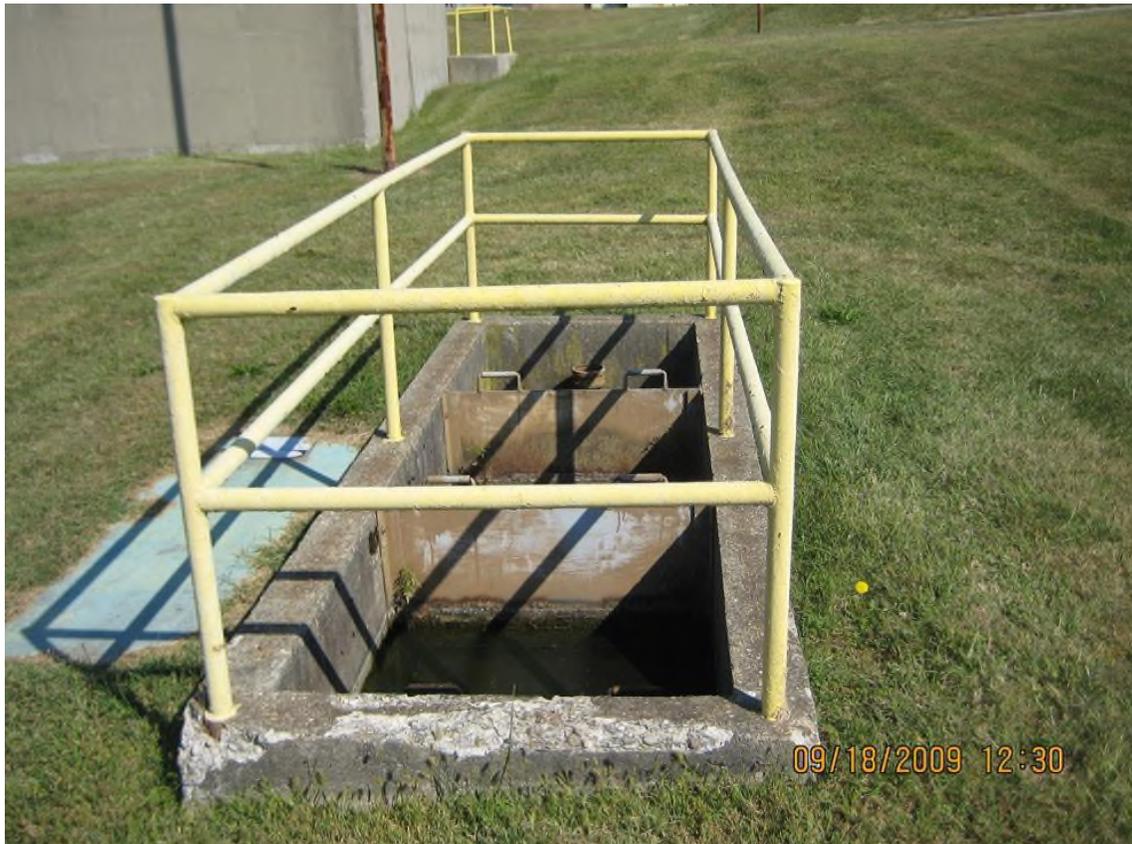
Bldg. 130 Pit A

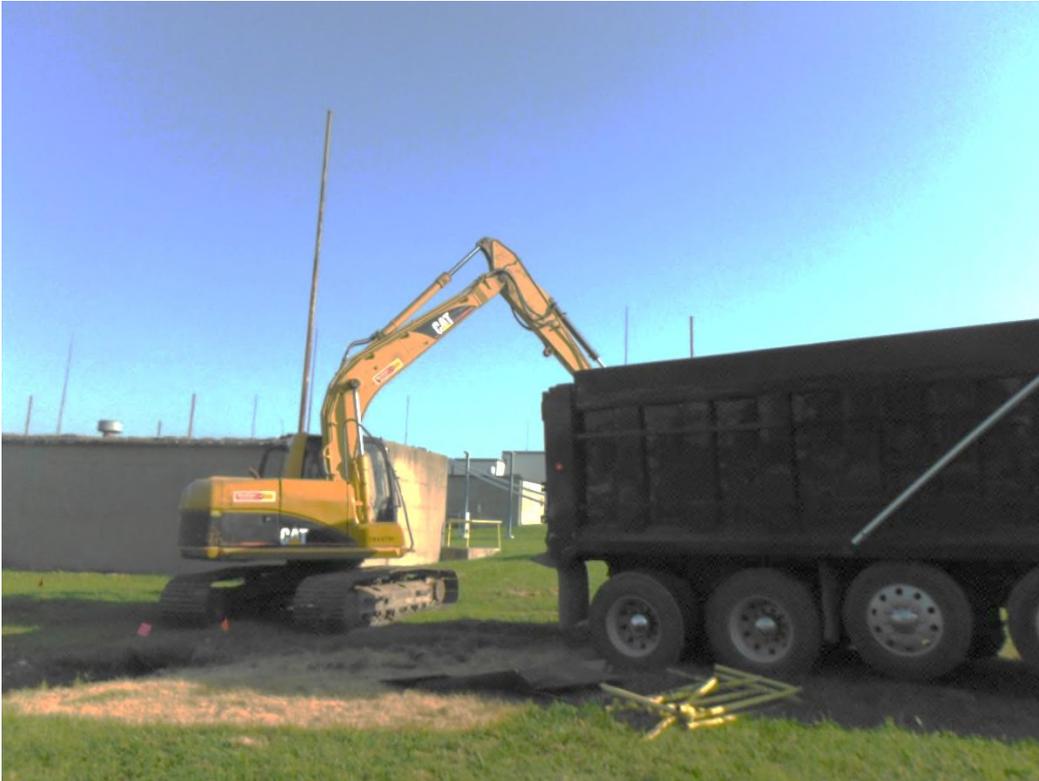
Bldg. 130 Pit A Area After Cleaning and Concrete Debris Loading to Truck

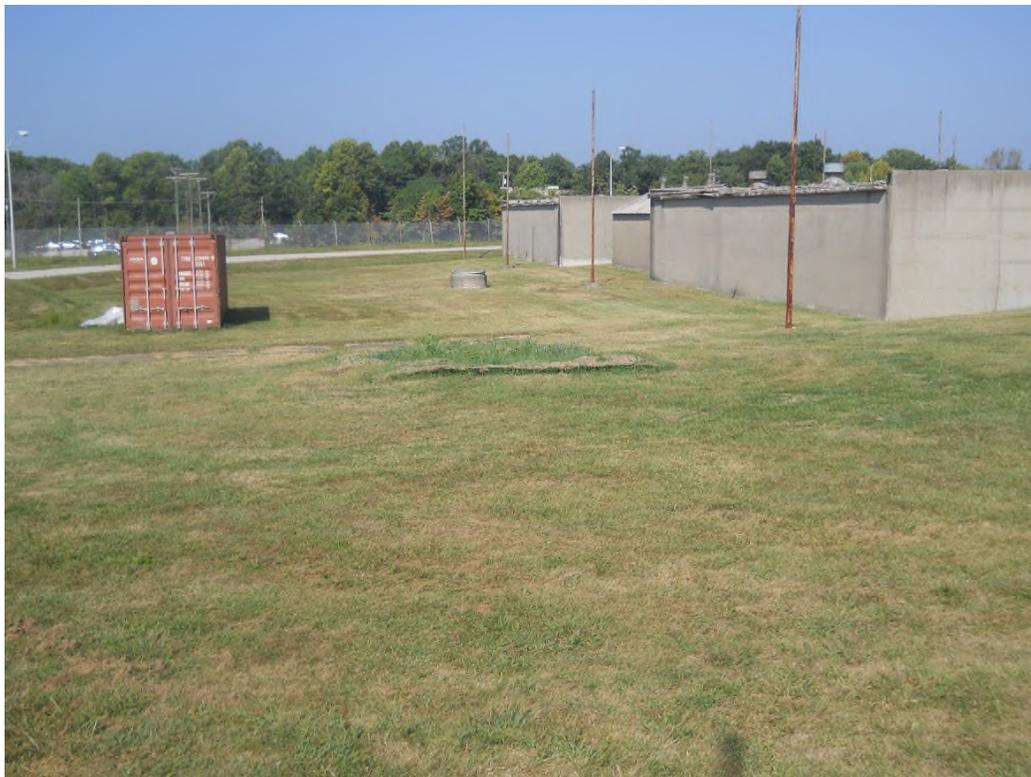
Bldg. 130 Pit A After Backfilling and Site Restoration

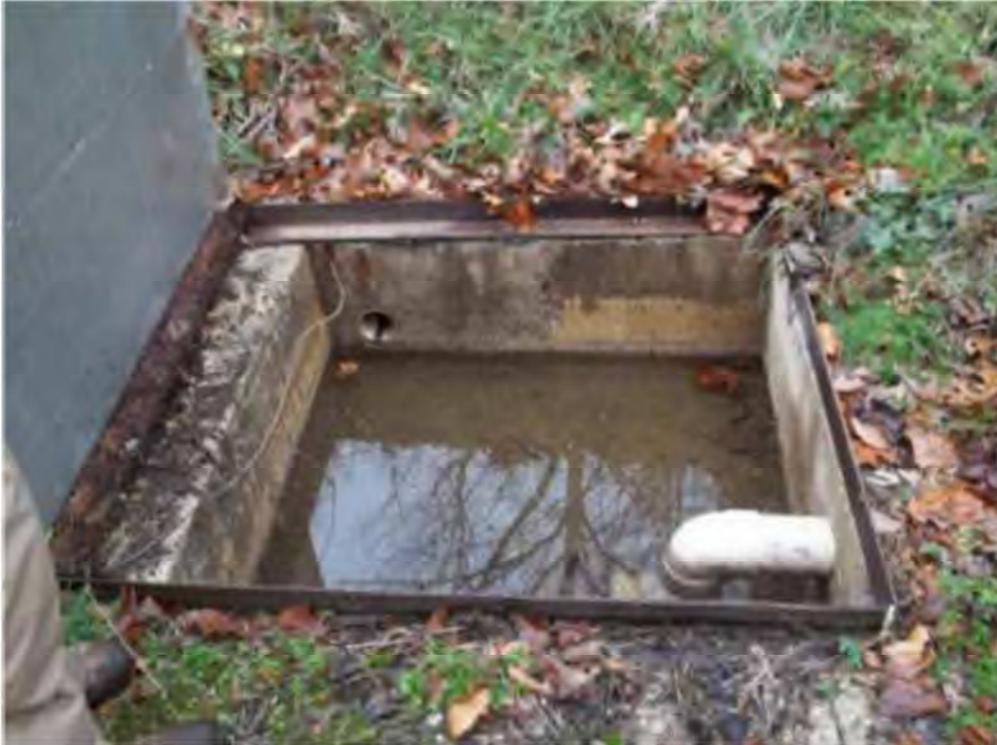
- Concrete settling tank - a concrete settling basin located in the northern portion of the site measuring approximately 5 feet by 4 feet and 2 feet deep. Approximately 4 inches of water and 1 inch of sediment were observed in the basin during a site walk conducted by Tetra Tech on November 21, 2011. The settling tank was cleaned and removed.

View of Bldg. 181 Area Settling Tank

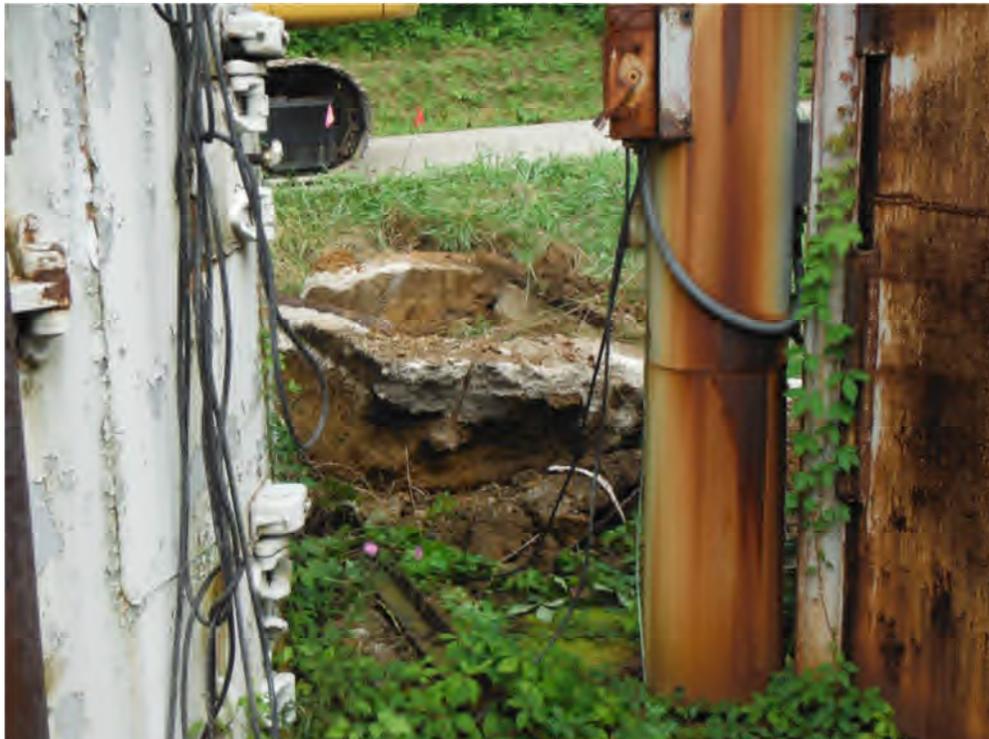
View of Bldg. 181 Settling Tank Removal During Interim Measure

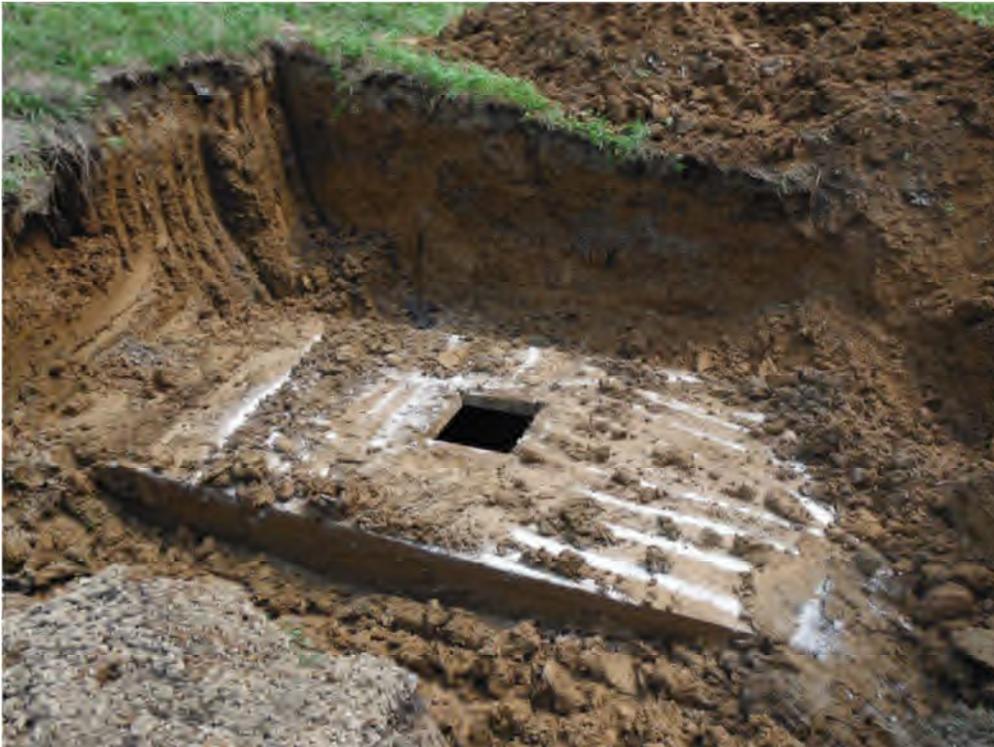
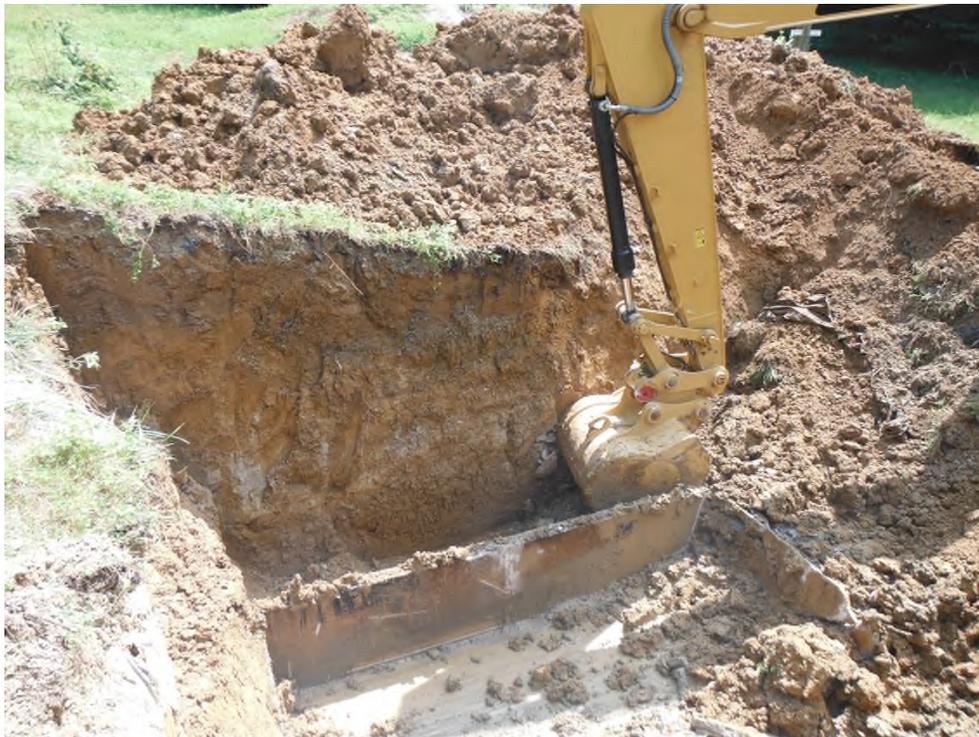
- Concrete UST - a steel UST (non-petroleum) was originally planned for removal under the IMWP; however, during performance of the IM, the UST structure was observed to be a concrete vault. The UST was cleaned and removed. The concrete debris from the UST was removed and disposed of at the NSA Crane concrete demolition waste staging area.

View of Bldg. 181 Area Underground Storage Tank Removal During Interim Measure

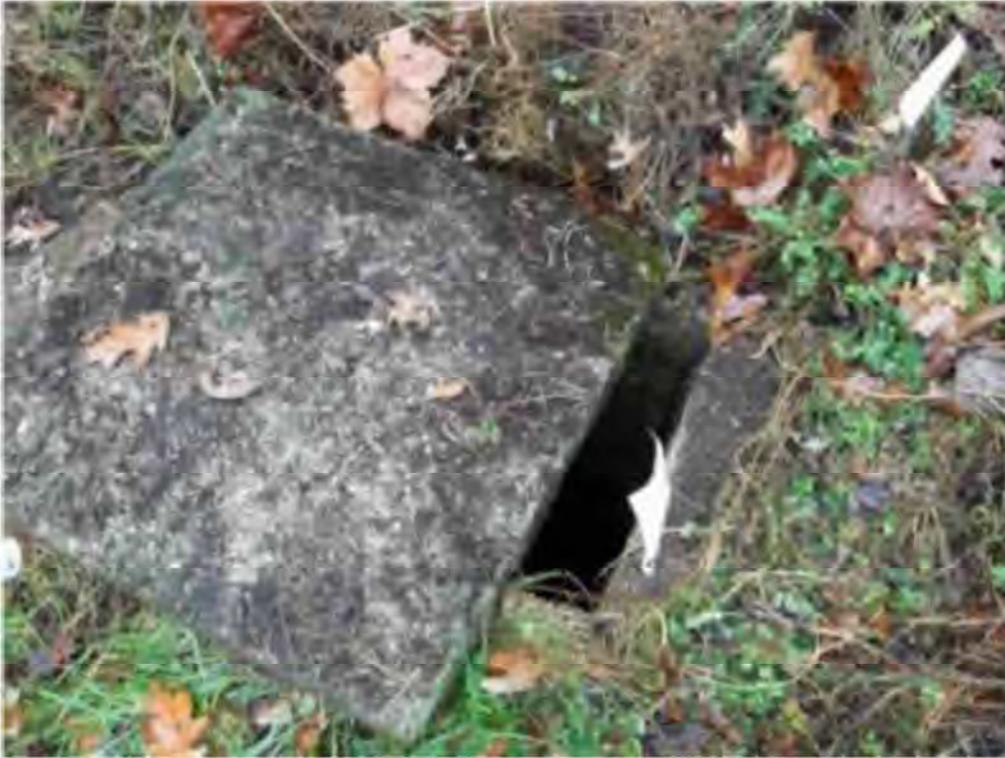
- Concrete cistern - a square concrete cistern structure with dimensions of approximately 2 feet by 2 feet and 9.4 feet deep located in the western portion of the site near the tree line. Several inches of water and an unknown amount of sediment were observed in the cistern during a site walk conducted by Tetra Tech on November 21, 2011. The cistern was cleaned and removed.

View of Bldg. 181 Area Cistern Structure

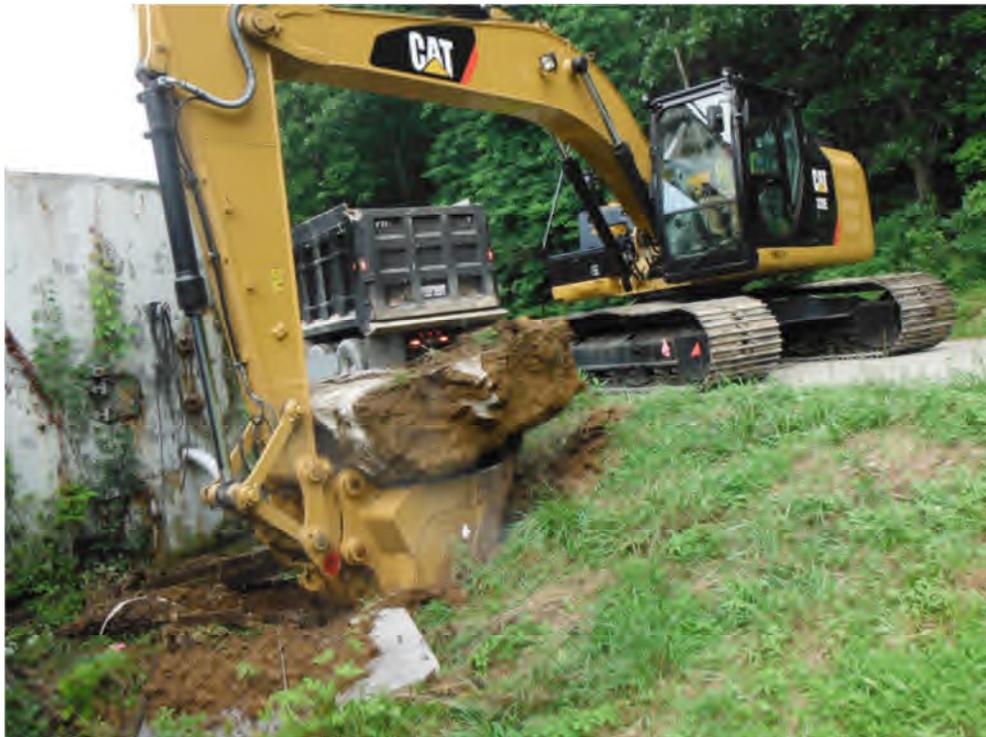
View of Bldg. 181 Cistern Structure Removal During Interim Measure

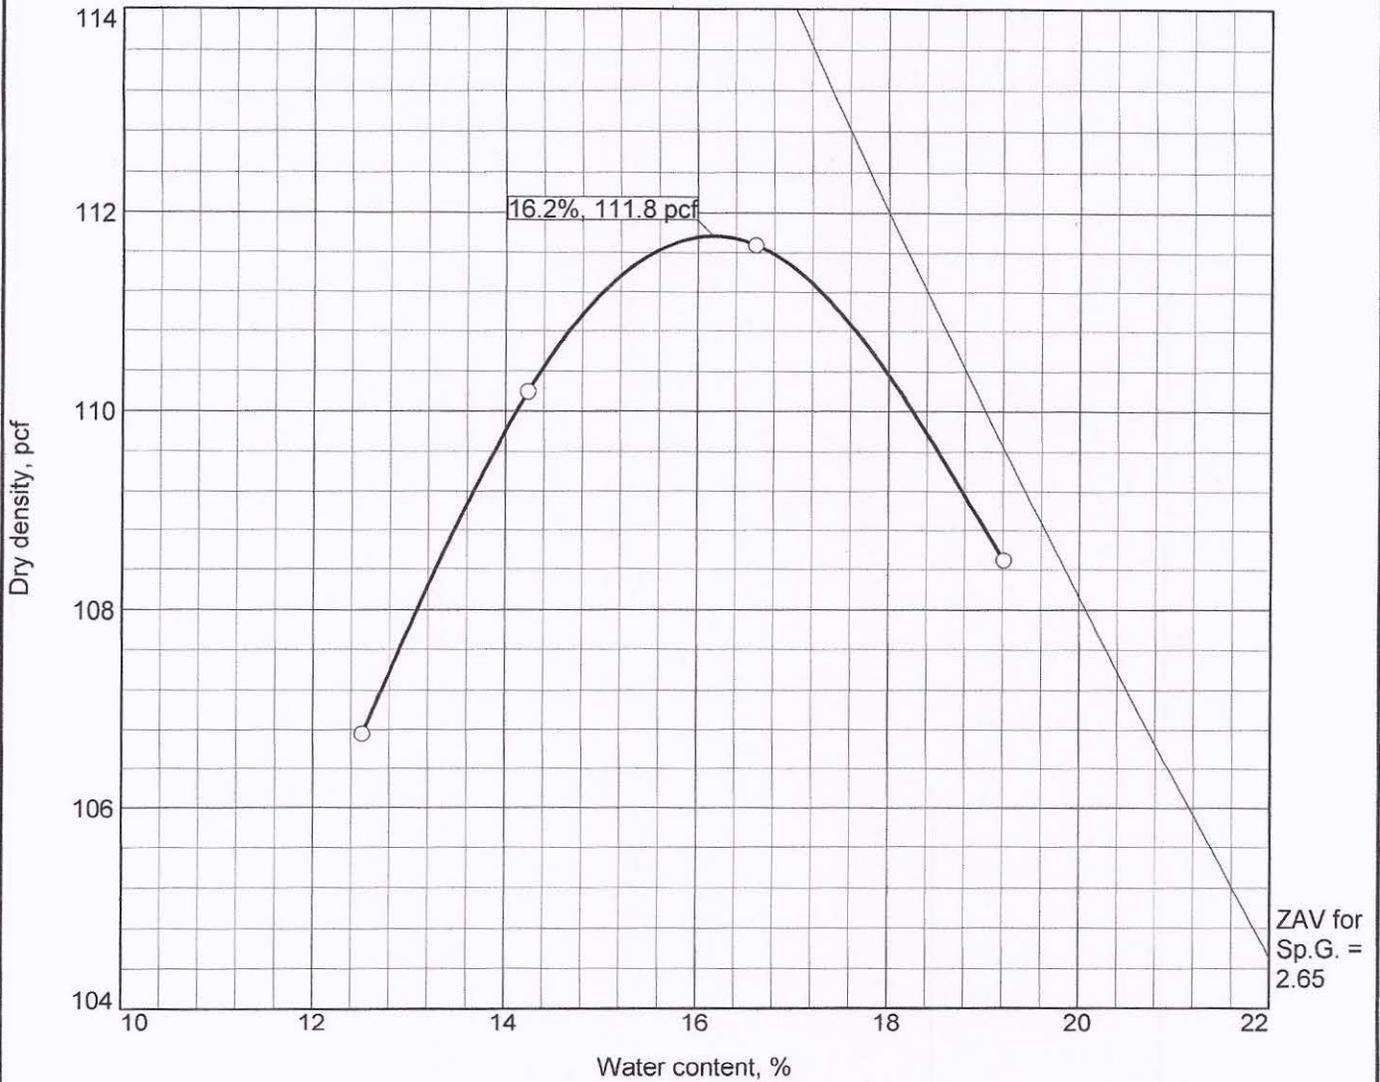
STANDARD PROCTOR TEST REPORT

Test specification: ASTM D 698-07 Method A Standard

TEST RESULTS	MATERIAL DESCRIPTION
Maximum dry density = 111.8 pcf Optimum moisture = 16.2 %	Gray Brown, LEAN CLAY WITH SAND with CLAY SHALE and SANDSTONE Fragments
Project No. 6300 Client: Mr. Craig Hoby Env. Quality Mgmt. Project: CRANE NSA - SWMU 17 Bloomington, Indiana Date: 3-13-12 ○ Location: US AGGREGATE - SMITHVILLE QUARRY	Remarks:
WHITNEY & ASSOCIATES PEORIA, ILLINOIS www.whitneyassociates.com

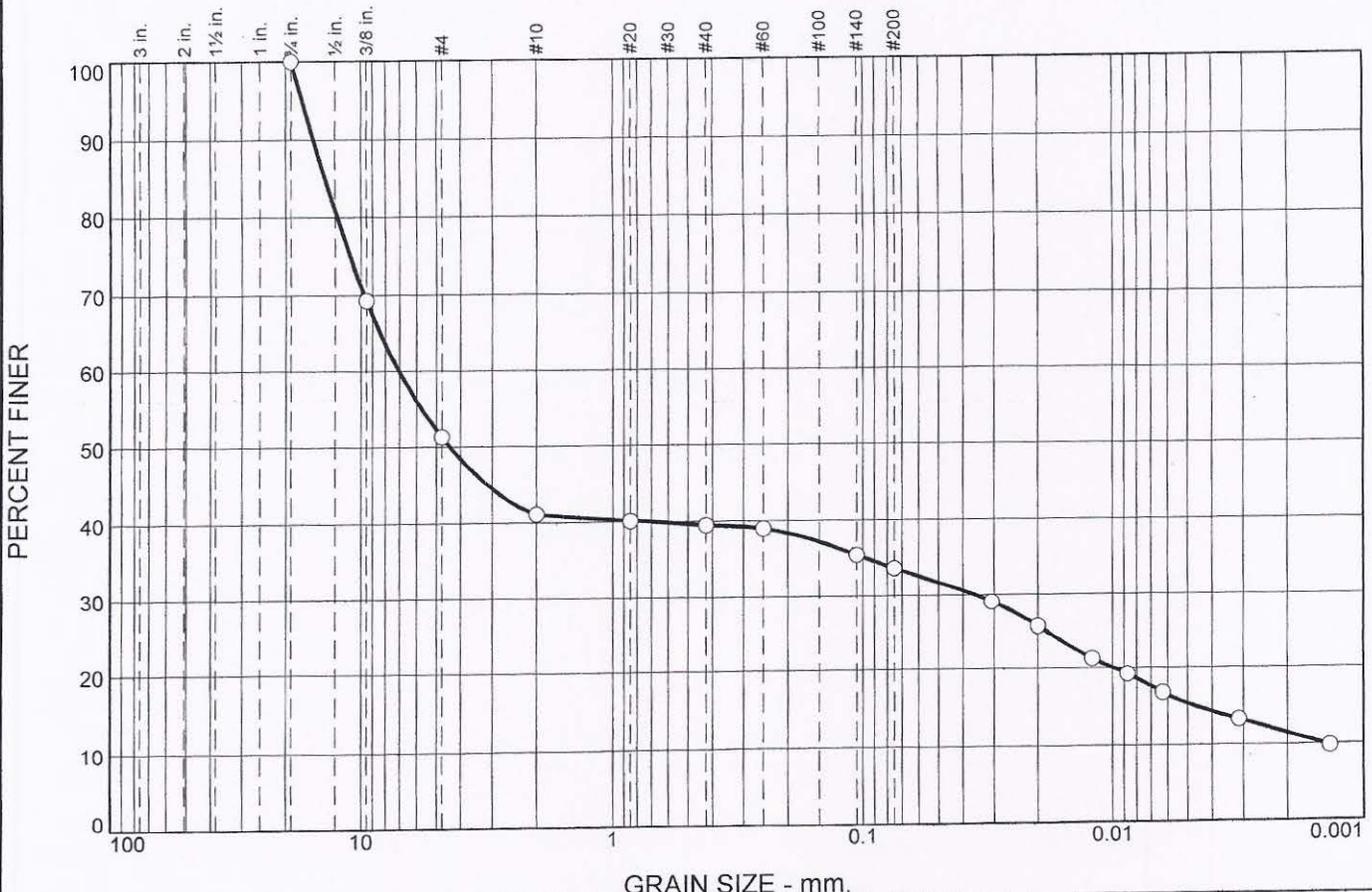
GRAIN SIZE ANALYSIS REPORT

% +3"	% Gravel		% Sand			% Fines	
	Coarse	Fine	Coarse	Medium	Fine	Silt	Clay
0.0	0.0	48.7	10.2	1.6	5.8	18.4	15.3

SIEVE SIZE	PERCENT FINER	SPEC.* PERCENT	PASS? (X=NO)
3/4"	100.0		
3/8"	69.3		
#4	51.3		
#10	41.1		
#20	40.1		
#40	39.5		
#60	39.0		
#140	35.5		
#200	33.7

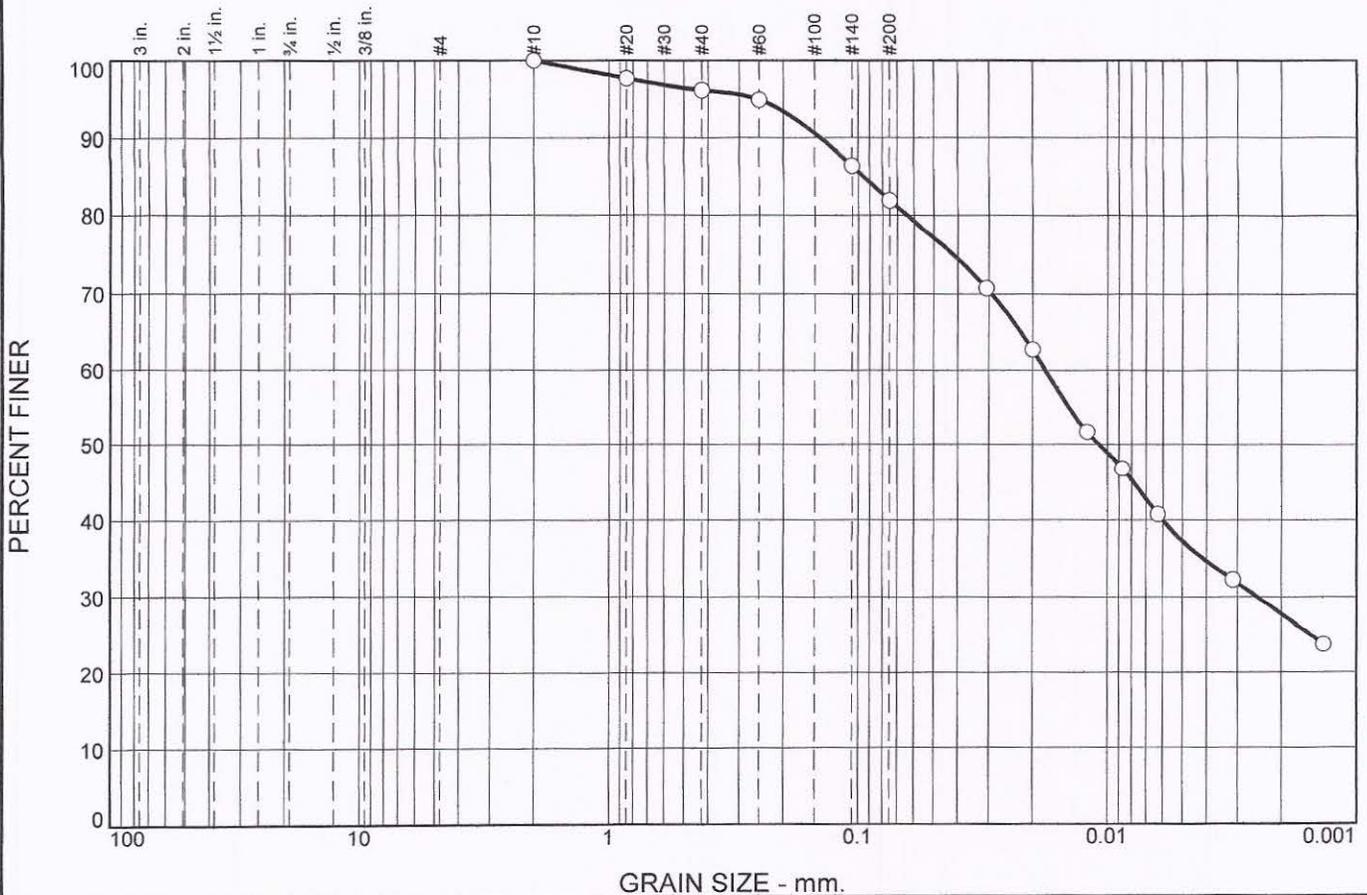
GRAIN SIZE ANALYSIS REPORT

% +3"	% Gravel		% Sand			% Fines	
	Coarse	Fine	Coarse	Medium	Fine	Silt	Clay
0.0	0.0	0.0	0.0	3.9	14.2	44.6	37.3

SIEVE SIZE	PERCENT FINER	SPEC.* PERCENT	PASS? (X=NO)
#10	100.0		
#20	97.7		
#40	96.1		
#60	94.9		
#140	86.4		
#200	81.9
