TECHNICAL MEMORANDUM REGARDING CONCRETE AND SOIL SAMPLING AND
ANALYSIS RESULTS SOLID WASTE MANAGEMENT UNIT 9 (SWMU 9) PESTICIDE
CONTROL AREA CONCRETE WASH RACK NSA CRANE IN

07/14/2011
TETRA TECH

SUBJECT: NSA Crane – SWMU 9 Pesticide Control Area – Concrete Wash Rack

- Concrete and Soil Sampling and Analysis Results

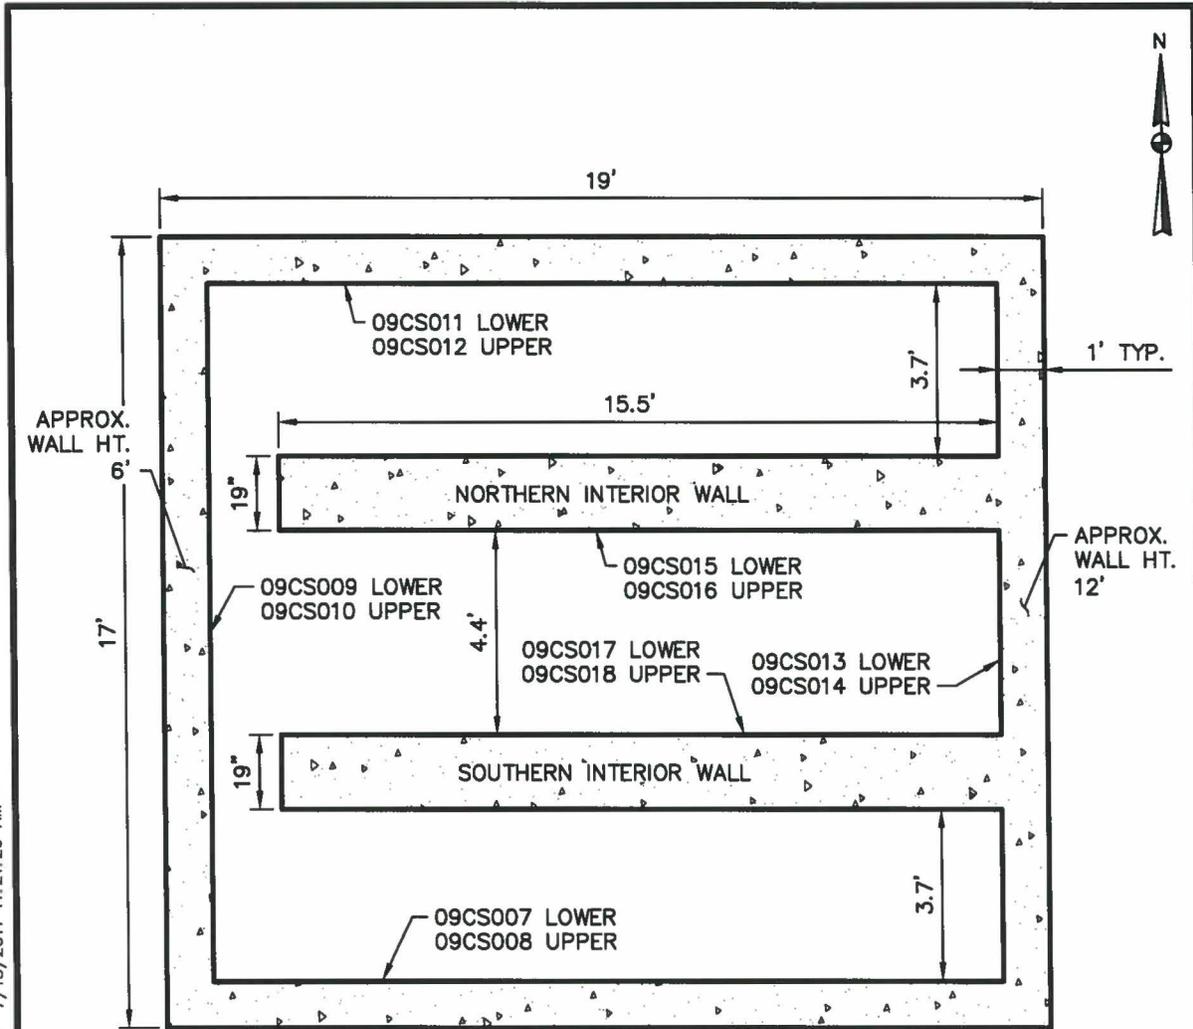
CONTRACT NO. 2111	
OWNER NO. 0000	
APPROVED BY	DATE
DRAWING NO. FIGURE 1	REV. 0

SAMPLING LOCATION NOTES:

1. ALL CONCRETE SAMPLES WERE COMPOSITES.
2. FOUR (4) DISCRETE SAMPLES (ALIQUOT) WERE COLLECTED FOR EACH COMPOSITE SAMPLE.
3. SEE FIGURE 2 & 3 FOR VIEW OF WALLS.

**CONCRETE SAMPLING AT
WASH RACK - PLAN
SWMU 9 VIEW
NSA CRANE, CRANE, IN**

As shown on the Figures and Photographs in Attachment A, the concrete wash rack is a below ground structure that is approximately 17 feet wide by 19 feet long. The top of the wash rack has been partially demolished; it is approximately 12 feet deep on the east side and 6 feet deep on the west side. The wash rack consists of six concrete walls, four outer walls (north, south, east, and west) and two interior walls (northern interior wall and southern interior wall) that divide the wash rack into three cells. There is a concrete floor covering the middle cell, the north and south cells have a gravel/soil floor.

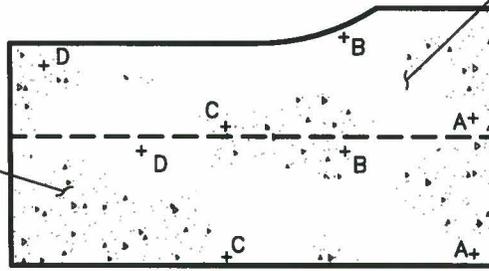
NORTH WALL

09CS011		
4,4'-DDD	2.75	J
4,4'-DDE	9.83	J
4,4'-DDT	12.1	J
ALPHA-CHLORDANE	2.58	U
DIELDRIN	0.897	UJ
GAMMA-CHLORDANE	5.9	J
HEPTACHLOR	0.897	UJ

09CS012		
4,4'-DDD	12.1	
4,4'-DDE	814	
4,4'-DDT	358	J
ALPHA-CHLORDANE	30.6	
DIELDRIN	18.1	
GAMMA-CHLORDANE	29.7	
HEPTACHLOR	2.32

A total of twelve (12) concrete samples (09CS007 to 09CS018) were collected on May 10 and 11, 2011. Two samples were collected from each of the wash rack walls; one sample was collected from the lower area and one from the upper area of each wall. All concrete samples were composites. As shown on Figures 2 and 3, four discrete aliquots (A, B, C, and D) were collected from each upper and lower area. The four aliquots from each area were then composited to create a sample to represent that area.

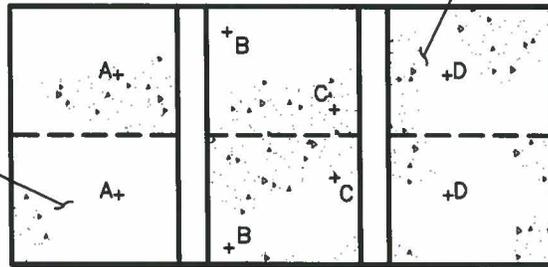
EAST WALL

09CS014		
4,4'-DDD	464	
4,4'-DDE	12100	
4,4'-DDT	4480	J
ALPHA-CHLORDANE	823	J
DIELDRIN	85.8	J
GAMMA-CHLORDANE	984	J
HEPTACHLOR	136

09CS013		
4,4'-DDD	4.49	J
4,4'-DDE	15.3	J
4,4'-DDT	20.9	J
ALPHA-CHLORDANE	2.95	U
DIELDRIN	0.221	UJ
GAMMA-CHLORDANE	3.4	J
HEPTACHLOR	0.702	UJ

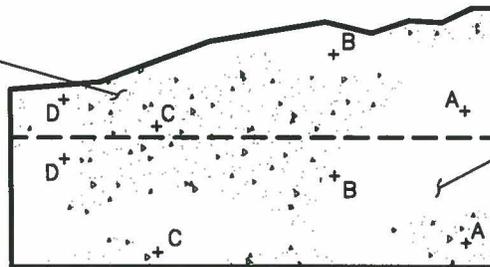
NORTHERN INTERIOR WALL

09CS016		
4,4'-DDD	1270	J
4,4'-DDE	10500	
4,4'-DDT	2350	J
ALPHA-CHLORDANE	243	J
DIELDRIN	61	J
GAMMA-CHLORDANE	381	J
HEPTACHLOR	17.4

09CS015		
4,4'-DDD	6.75	J
4,4'-DDE	18.6	J
4,4'-DDT	19.7	J
ALPHA-CHLORDANE	2.4	U
DIELDRIN	0.263	UJ
GAMMA-CHLORDANE	3.38	J
HEPTACHLOR	0.711	UJ

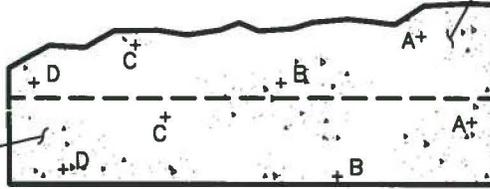
SOUTHERN INTERIOR WALL

09CS017		
4,4'-DDD	4.83	J
4,4'-DDE	15	J
4,4'-DDT	18.8	J
ALPHA-CHLORDANE	4.98	J
DIELDRIN	0.604	J
GAMMA-CHLORDANE	7.35	J
HEPTACHLOR	0.301	J

09CS018		
4,4'-DDD	235	J
4,4'-DDE	10300	J
4,4'-DDT	1830	J
ALPHA-CHLORDANE	376	J
DIELDRIN	22.7	J
GAMMA-CHLORDANE	277	J
HEPTACHLOR	44.8	J

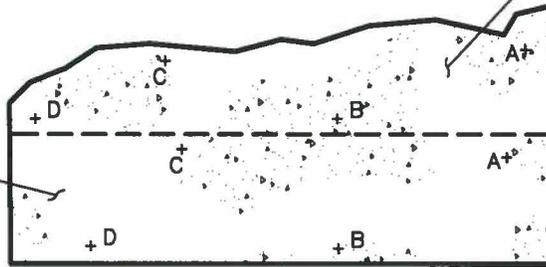
SOUTH WALL

09CS007		
4,4'-DDD	5.12	J
4,4'-DDE	7.5	J
4,4'-DDT	16.5	J
ALPHA-CHLORDANE	2.08	U
DIELDRIN	0.19	J
GAMMA-CHLORDANE	2.11	J
HEPTACHLOR	0.736	UJ

09CS008		
4,4'-DDD	5.72	
4,4'-DDE	86	
4,4'-DDT	58.1	
ALPHA-CHLORDANE	17.5	
DIELDRIN	0.667	
GAMMA-CHLORDANE	17.1	
HEPTACHLOR	0.799

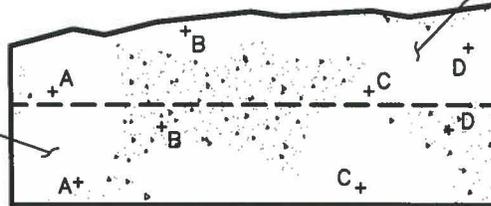
WEST WALL

09CS009		
4,4'-DDD	13.35	J
4,4'-DDE	8.69	J
4,4'-DDT	10.7	J
ALPHA-CHLORDANE	7.4	J
DIELDRIN	0.218	J
GAMMA-CHLORDANE	7.7	J
HEPTACHLOR	0.709	UJ

09CS010		
4,4'-DDD	5.98	J
4,4'-DDE	33.7	J
4,4'-DDT	55.4	J
ALPHA-CHLORDANE	18.8	J
DIELDRIN	0.556	J
GAMMA-CHLORDANE	18	J
HEPTACHLOR	0.285	J

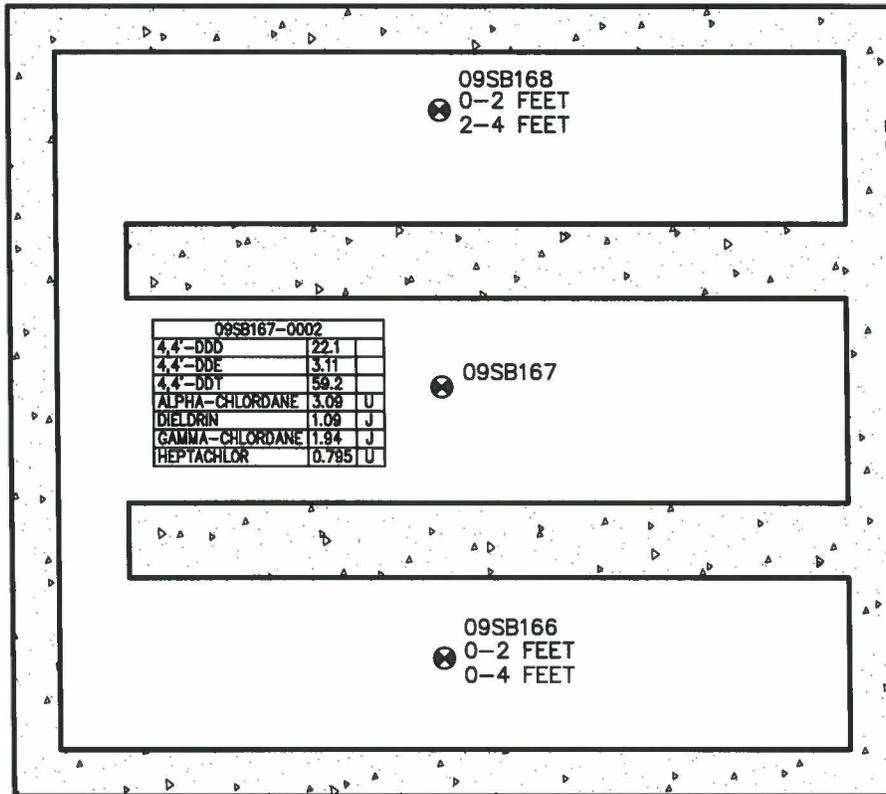
CONTRACT NO. 2111	
OWNER NO. 0000	
APPROVED BY	DATE
DRAWING NO. FIGURE 4	REV. 0

09SB168-0002		
4,4'-DDD	18.1	
4,4'-DDE	3.18	
4,4'-DDT	16	
ALPHA-CHLORDANE	0.816	UJ
DIELDRIN	0.211	J
GAMMA-CHLORDANE	6.58	J
HEPTACHLOR	0.816	U

09SB168-0204		
4,4'-DDD	25.9	
4,4'-DDE	4.2	
4,4'-DDT	57.6	
ALPHA-CHLORDANE	4.99	J
DIELDRIN	0.788	U
GAMMA-CHLORDANE	0.913	J
HEPTACHLOR	0.368	J

09SB167-0002		
4,4'-DDD	22.1	
4,4'-DDE	3.11	
4,4'-DDT	59.2	
ALPHA-CHLORDANE	3.09	U
DIELDRIN	1.09	J
GAMMA-CHLORDANE	1.94	J
HEPTACHLOR	0.795	U

09SB166-0002		
4,4'-DDD	106	J
4,4'-DDE	18.9	J
4,4'-DDT	99.9	J
ALPHA-CHLORDANE	11	J
DIELDRIN	1	J
GAMMA-CHLORDANE	10.4	J
HEPTACHLOR	0.84	UJ

09SB166-0204		
4,4'-DDD	248	J
4,4'-DDE	36.2	J
4,4'-DDT	410	J
ALPHA-CHLORDANE	20.5	J
DIELDRIN	1.61	J
GAMMA-CHLORDANE	22.6	J
HEPTACHLOR	0.82	UJ

1. SOIL SAMPLES 09SB166 AND 09SB168 COLLECTED USING HAND AUGER FROM MATERIAL BELOW THE WASH RACK FLOOR
2. SAMPLE 09SB167 COLLECTED FROM MATERIAL ON CONCRETE FLOOR OF CENTER CELL
3. TAGS SHOW ANALYTICAL RESULTS IN ug/kg (ppb)

SOIL SAMPLING AT
WASH RACK - PLAN
SWMU 9 VIEW
NSA CRANE, CRANE, IN

A total of five soil samples were collected from three locations (166 to 168); from at or below the wash rack floor as shown on Figure 4. Two soil samples were collected from below the wash rack floor in the south and north cell (09SB166 and 09SB168 respectively) using a hand auger; at each location one sample was collected from 0 to 2 feet below ground surface (bgs) and 2 feet to 4 feet bgs. Approximately 6 inches of gravel was on the floor of the north and south cells; the soil below the wash rack was very wet brown and gray clay. Because the middle cell has a concrete floor, soil sample 09SB167 was collected from material on the floor (see Figure 5 photos).

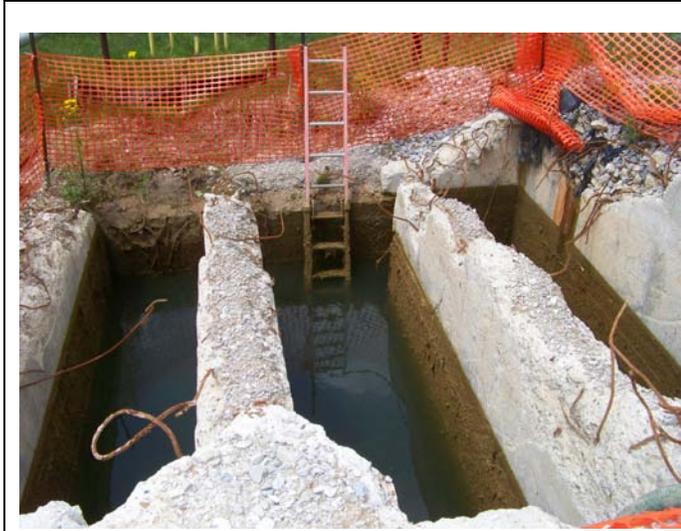
View of:
Wash rack during pump down operation on first day on site.

Because the wash rack is a below ground structure, it was filled with water (see Photos in Attachment A). Therefore, on May 9, water was pumped from the wash rack and transferred to the wastewater treatment plant via a nearby manhole. At the end of pumping, approximately 6" of mud and water remained on the wash rack floor.

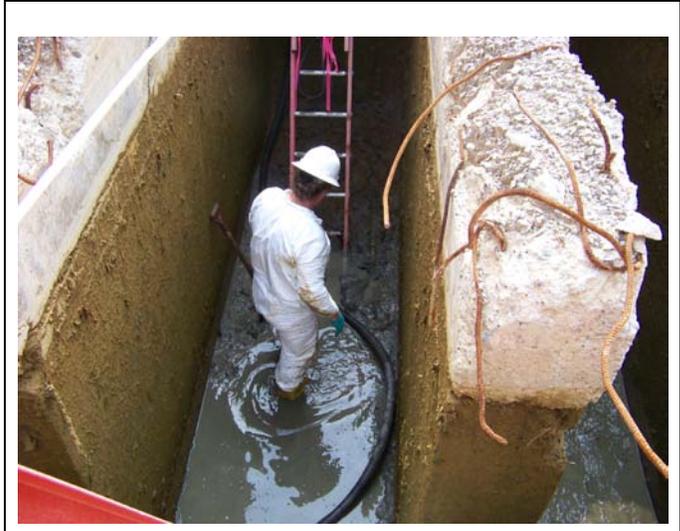
View of:
Wash rack in the final stages of pump down during the second day on site.

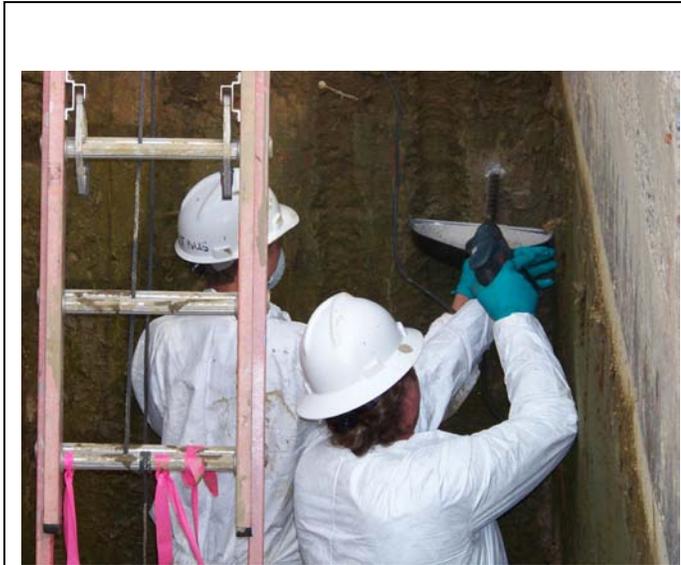
View of :
Collecting concrete sample from east wall.

The concrete samples were collected using a demolition hammer drill with a one inch diameter drill bit in accordance with the US Environmental Protection Agency (EPA) Region 1 Standard Operating Procedure for Sampling Concrete in the Field. Samples were collected by drilling holes into the concrete wall to a depth of one inch. The concrete cuttings were collected as the holes were drilled. An average of five holes was drilled per aliquot to obtain sufficient quantity (5 ounces) of material; sampling equipment (drill bit) was decontaminated between collection of each aliquot sample. Each composite sample was comprised of equal parts of each aliquot and consisted of approximately 4 ounces. The remaining aliquot sample quantity is sufficient for individual aliquot analysis, if requested.

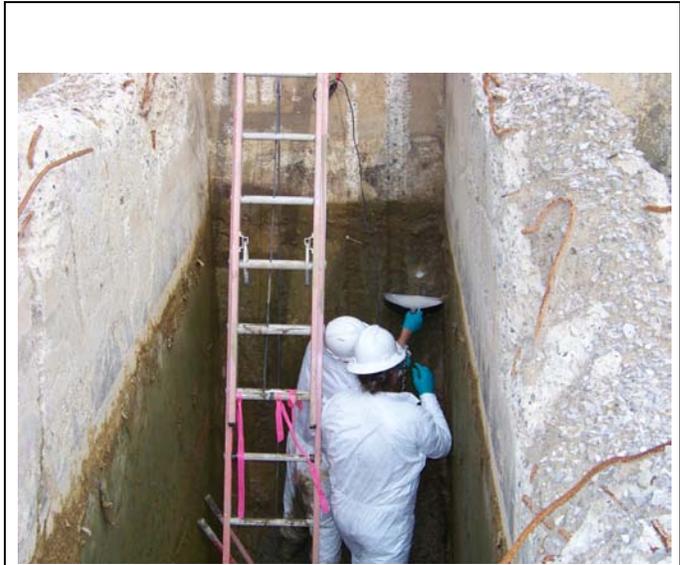
View of:
Collecting concrete sample from east wall.

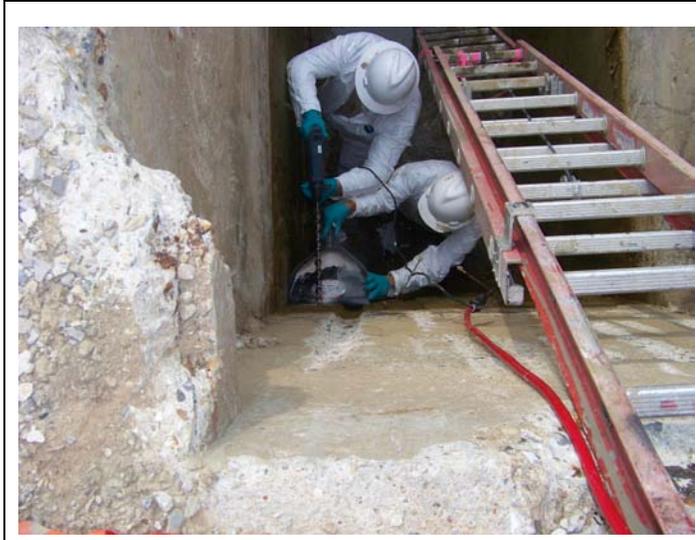
Date: 05/10/11	View: E	Photographer: M. Reising
View of: Collecting concrete sample from east wall.

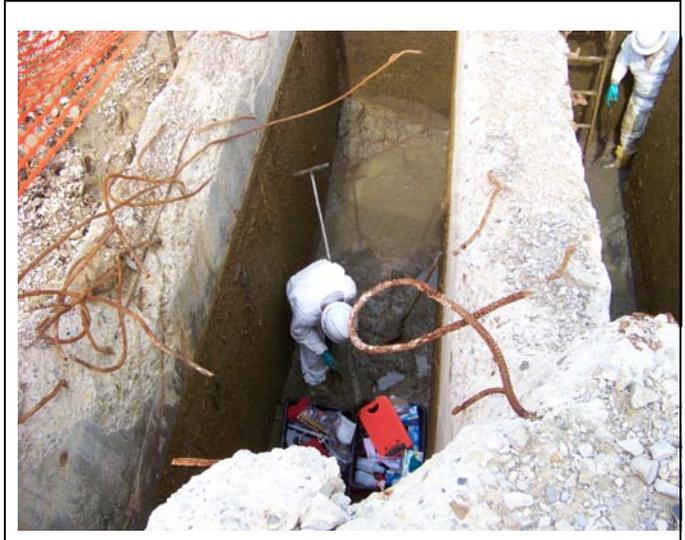
Date: 05/10/11	View: W	Photographer: M. Reising
View of: Collecting soil sample from below wash rack floor at location SB166.

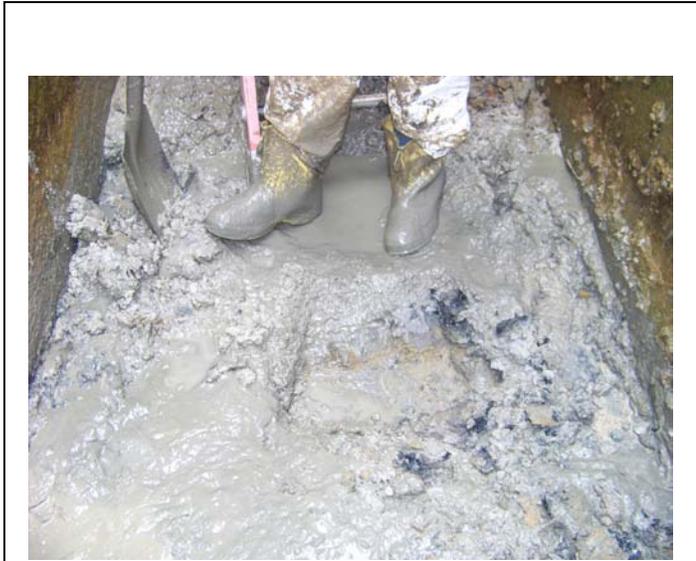
Date: 05/10/11	View: E	Photographer: M. Reising
View of: Floor of center section of concrete wash rack. There was approximately 6 inches of material on the concrete floor. Soil sample SB167 was collected from this material.

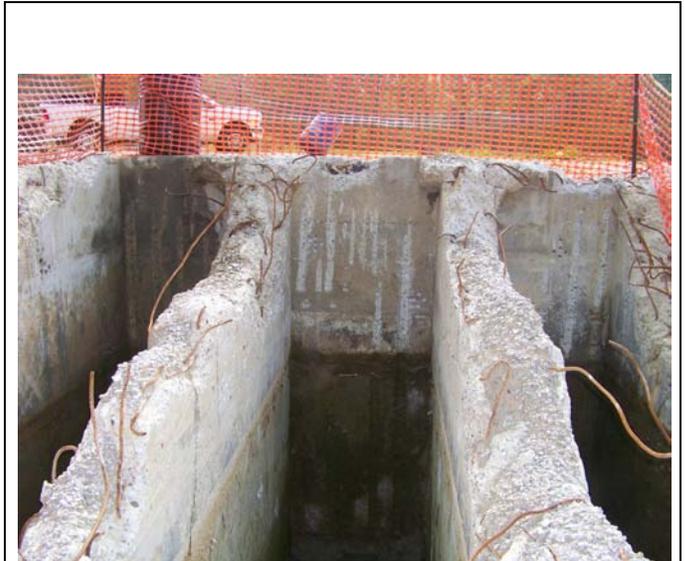
Date: 05/12/11	View: E	Photographer: K. Losekamp
View of: East wall of wash rack at completion of sampling activities. Sample aliquot locations 0014 B, C and D are visible on the east wall.
