**ENVIRONMENTAL EVALUATION
OF "WAYSIDE" NAVAL WEAPONS
STATION EARLE
COLTS NECK, NEW JERSEY**

**COMPREHENSIVE LONG-TERM
ENVIRONMENTAL ACTION NAVY (CLEAN)
PROGRAM**

**CONTRACT NO. N62472-90-D-1298
CONTRACT TASK ORDER
NUMBER (CTO) - 010**

NOVEMBER 7, 1991

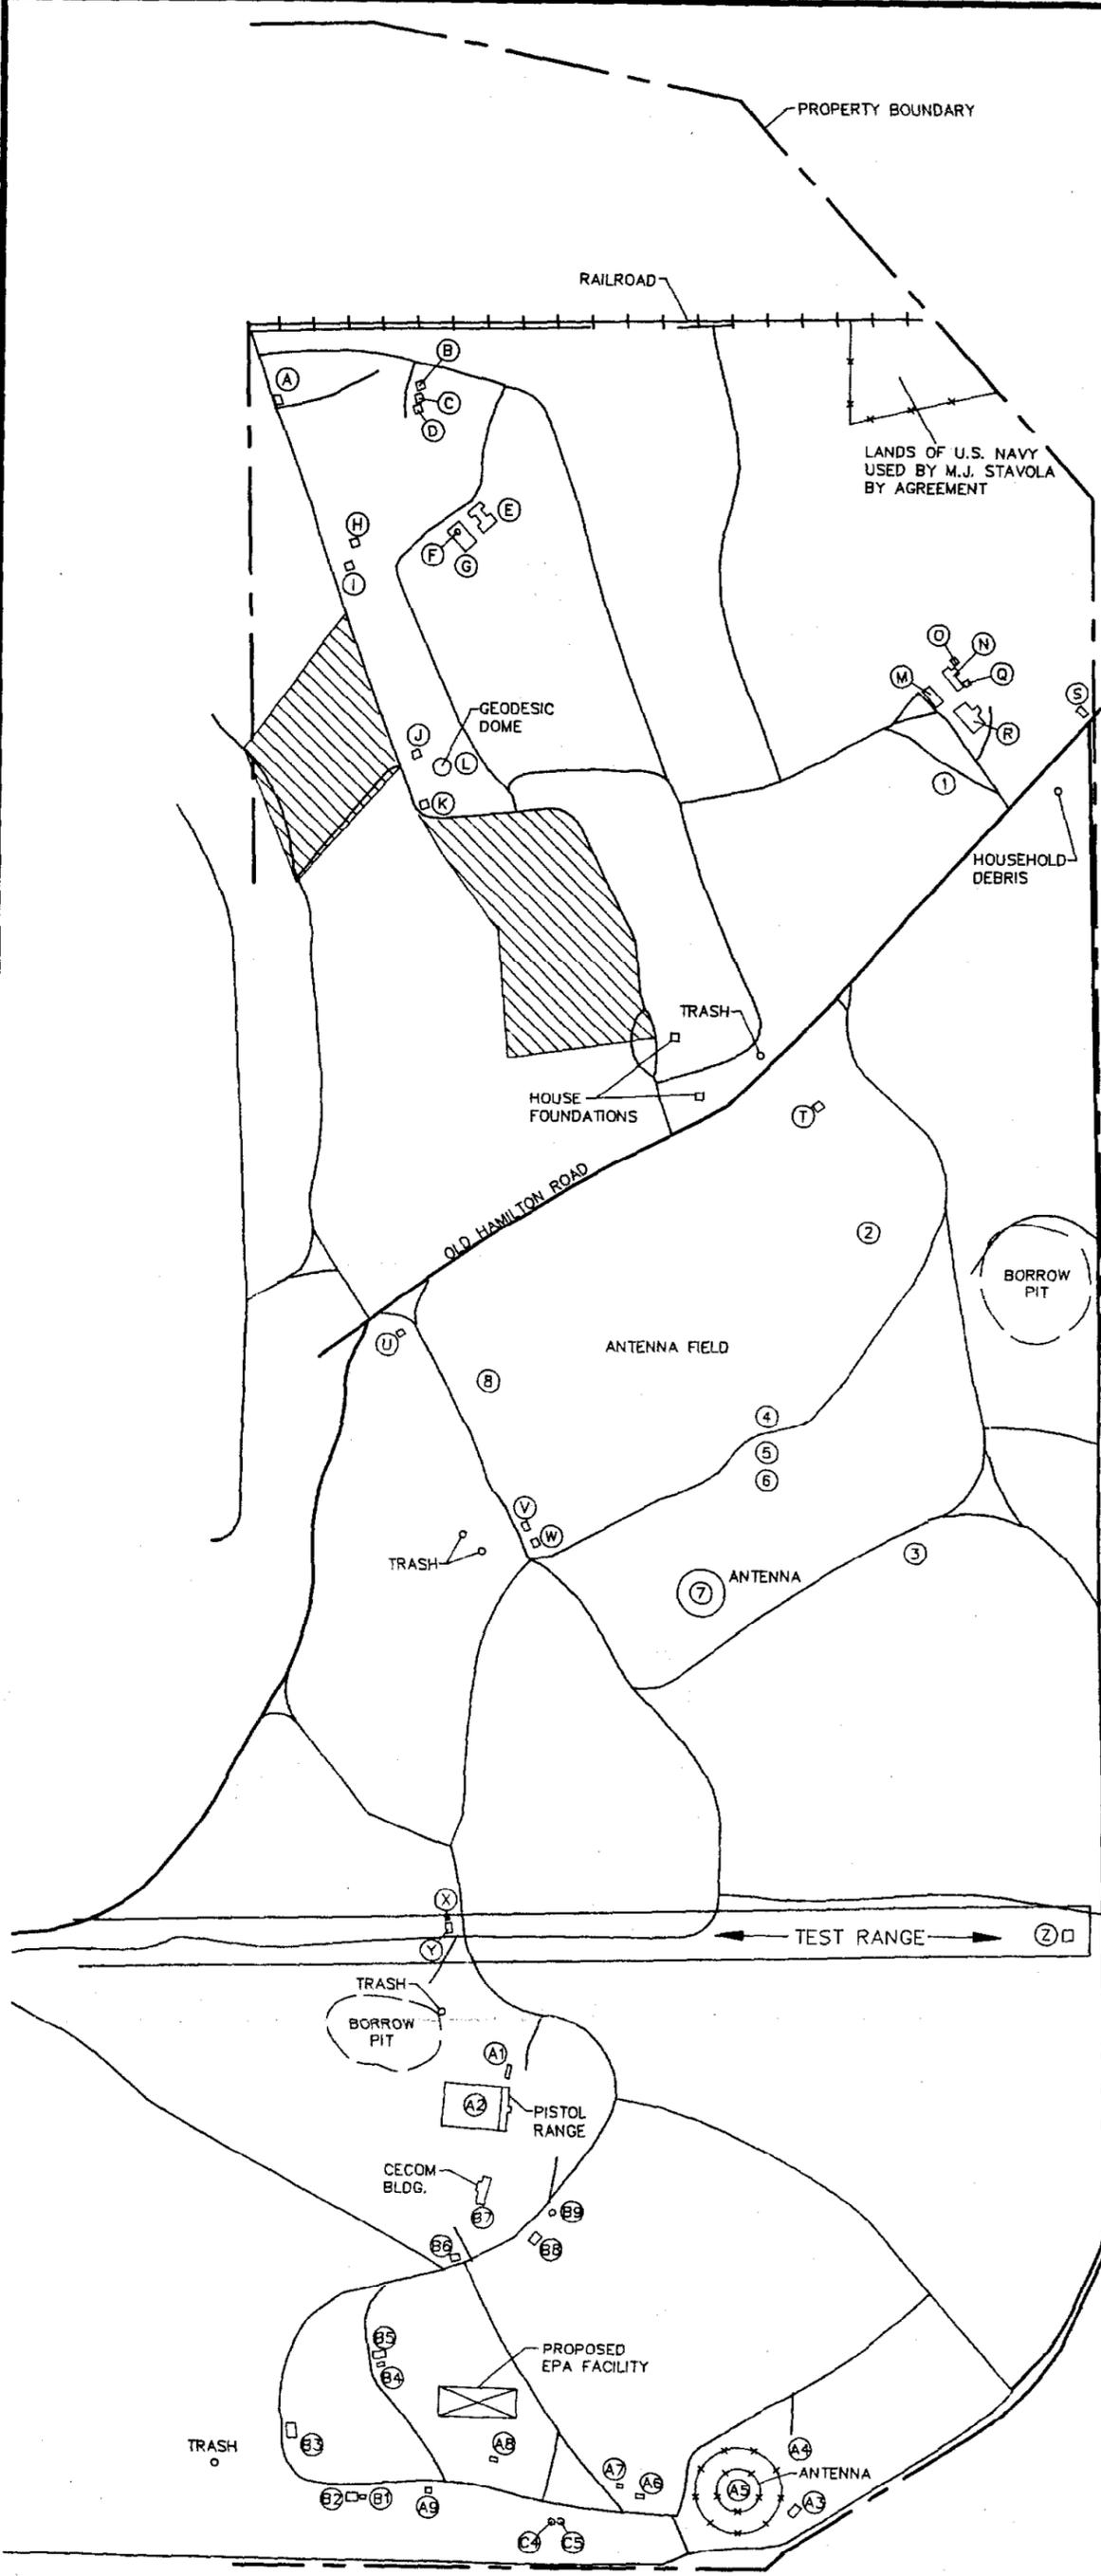
FIGURE 2-2
GENERAL SITE MAP
WAYSIDE AREA
NAVAL WEAPONS STATION, EARLE
MONMOUTH COUNTY, NJ

KEY TO STRUCTURES

- A METAL BLDG.
 - B METAL SHED
 - C WOOD SHED W/OBSERVATION DECK ROOF & SMALL SHED IN BACK
 - D SMALL ROUND METAL BLDG.
 - E LARGE WOOD ROOF HELICOPTER HANGER

- R CONCRETE FOUNDATION OF BLDG. DESTROYED BY FIRE
 - S WOOD GUARD HOUSE
 - T WOOD OBSERVATION PLATFORM APPROX. 25' HIGH
 - U SMALL WOOD STORAGE SHED
 - V METAL TRAILER BOX (ELECTRICAL)

- A3 BLDG. FOUNDATION
 - A4 CAMP SITE W/S PORTA-JOHN
 - A5 ABANDONED ANTENNA
 - A6 SMALL WOOD SHED
 - A7 METAL TOWER
 - A8 METAL TOWER W/METAL TRUCK BOX
 - A9 METAL BOX SHED

- B8 PAD OR OLD BLDG. FOUNDATION
 - B9 SMALL ROUND BLDG.
 - C4 SMALL ROUND BLDG.
 - C5 SMALL ROUND BLDG.

Several small trash disposal areas were found throughout the Wayside Area, although most of them were small (less than 10x10 ft) and contained miscellaneous trash such as lumber, discarded electrical wire, and household debris. The approximate locations of these small disposal areas are shown on Figure 2-1.

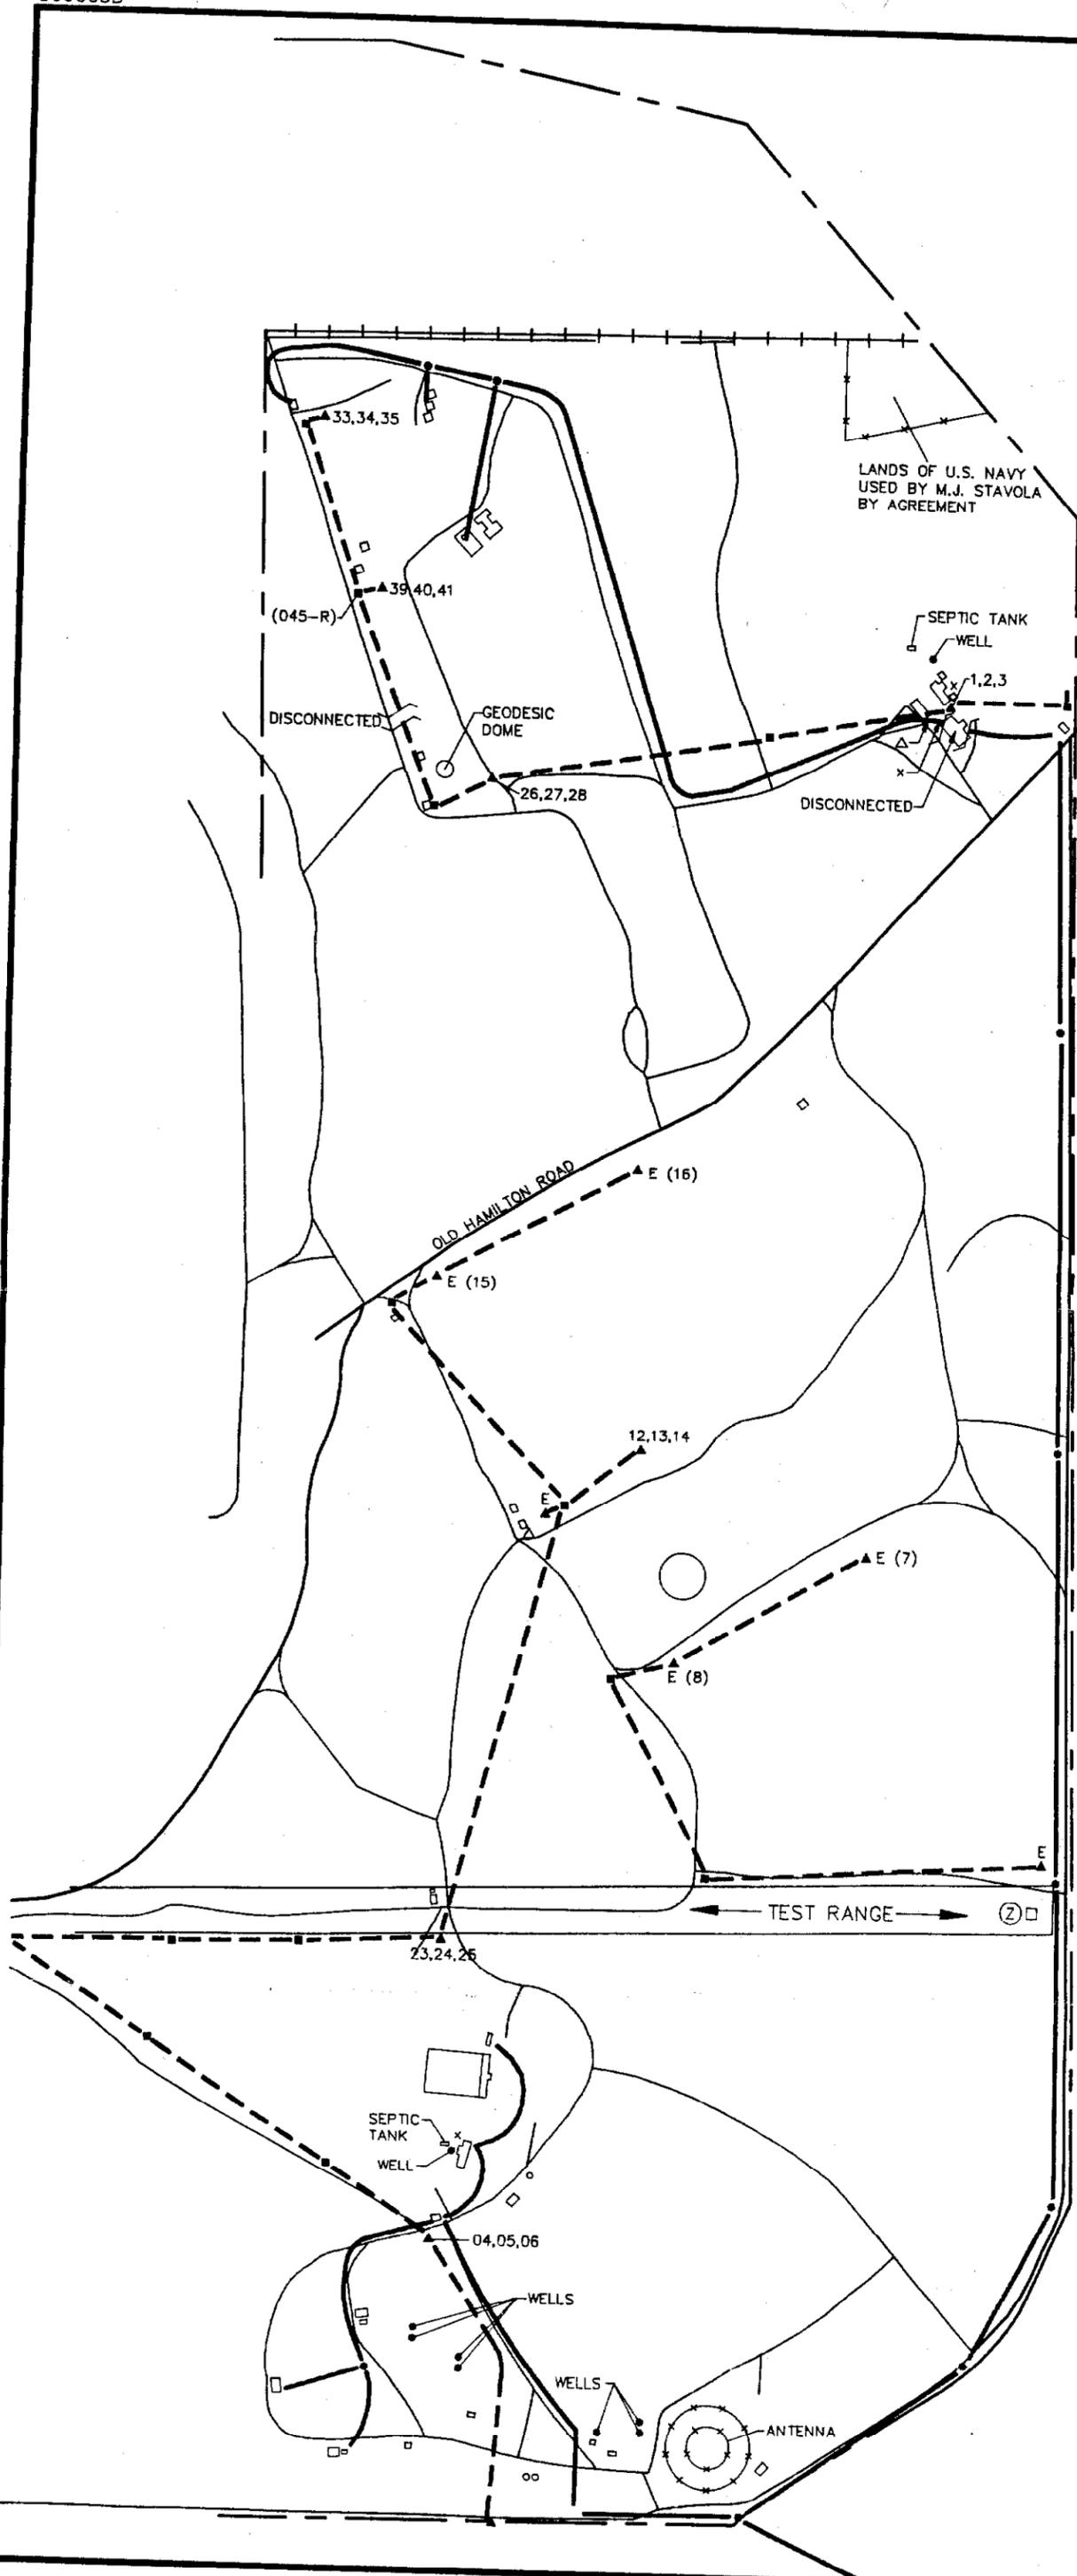
**FIGURE 3-1
UTILITIES MAP
WAYSIDE AREA
NAVAL WEAPONS STATION, EARLE
MONMOUTH COUNTY, NJ**

No transformers or empty transformer pads located by ENSR on the site showed any evidence of leaks or staining. The inventory of transformers in the Wayside Area (prepared by Fort Monmouth) is summarized on Table 3-2. Transformers located by ENSR during the site visit are denoted with an "F" for Found. The location of the transformer is given by a) the notation on the handwritten inventory done by Fort Monmouth, and b) a description of where it is, if known. The table gives the PCB test result of each transformer tested, as well as any reference to PCB concentration noted on the transformer itself. Figure 3-1 shows the approximate locations of the transformers.

- ▲ TRANSFORMER (E - EMPTY PAD)
- MANHOLE, 4'x4'x6' DEEP
- POLE
- WELL
- SEPTIC TANK
- △ ABOVE GROUND TANK
- X UNDERGROUND TANK
- TELEPHONE
- - - ELECTRICITY

Several drinking water wells are located in the Wayside Area. The approximate locations of these wells are shown on Figure 3-1. One drinking water well is located near building R, in the northwest section of the Site. A second well is located next to the CECOM-EMI building, in the southeast section of the Wayside Area. Three wells were found in the northeast section of the Wayside Area. One of these wells is located in a partially collapsed building (A7) and is

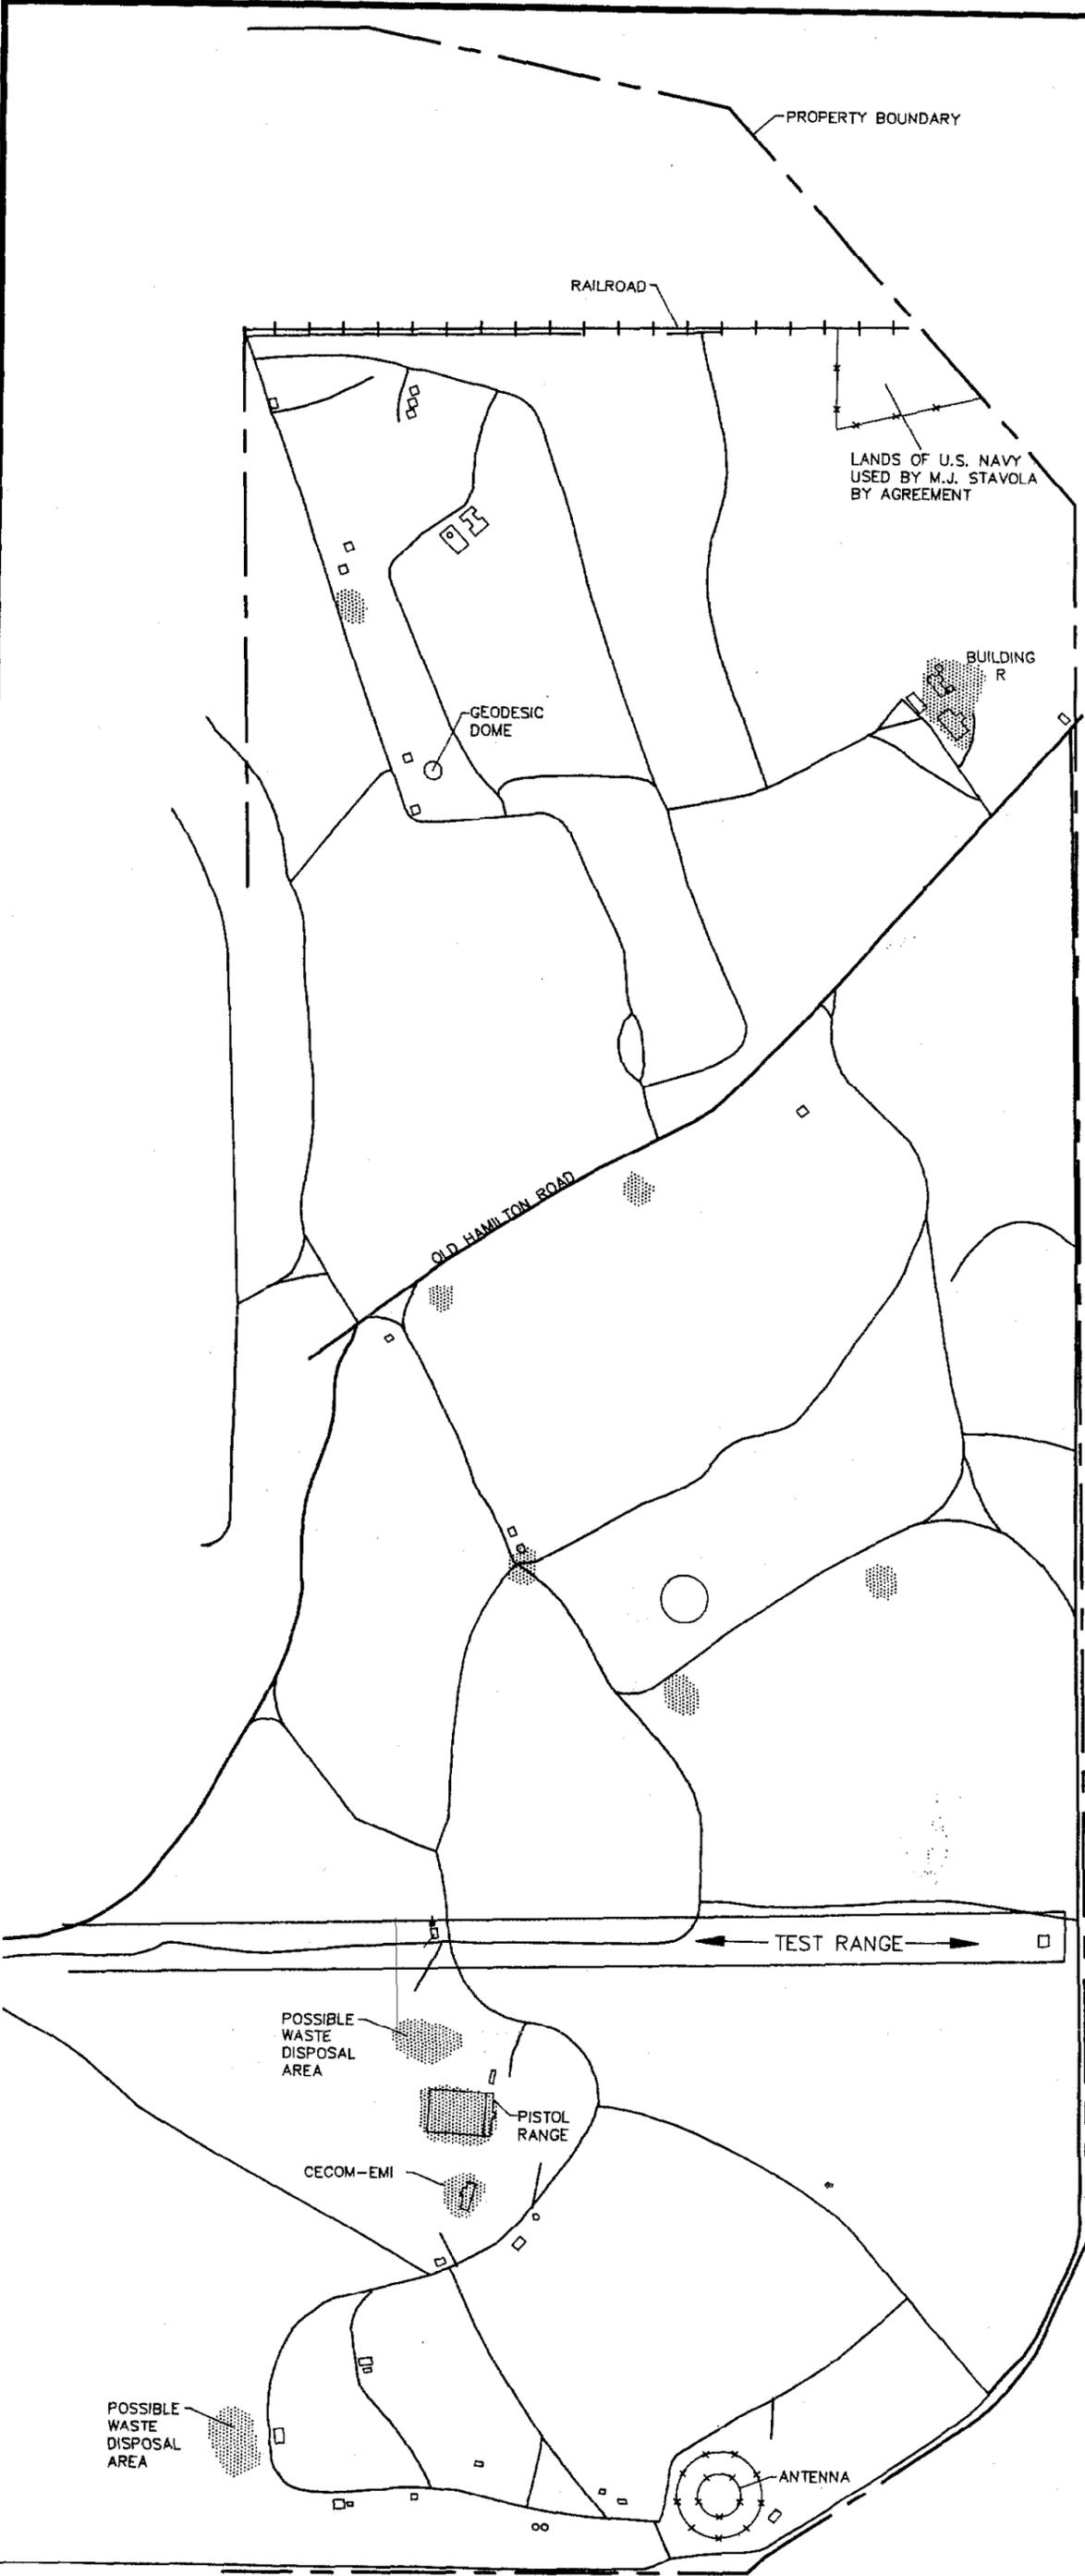
FIGURE 4-1
AREAS RECOMMENDED FOR
ADDITIONAL INVESTIGATION
WAYSIDE AREA
NAVAL WEAPONS STATION, EARLE
MONMOUTH COUNTY, NJ

However, the areas listed below are recommended for further investigation and may subsequently warrant remediation prior to development. The locations of these areas are shown on Figure 4-1.

- Pistol Range - The embankment is covered with bullets and shells that may contain lead and other heavy metals.
- Underground storage tanks - Two USTs remain on the site. One of these tanks, storing No. 2 fuel oil, is known to be at least 36 years old. It is recommended that soil around these tanks should also be sampled at the time the tanks are removed. Soil and/or ground water samples should also be collected in the vicinity of the tank which was removed. If contamination is identified in any of these areas, they should be remediated.

- Creosote staining was noted on the ground around the base of nearly all poles used to construct the observation towers and decks. Although the staining is very localized, children could be potentially be exposed to the hardened material at the base of the posts.
- The building insulation in several buildings may contain asbestos, given the age of the buildings, and the fact that some of the insulation was marked "Johns-Manville", a known manufacturer of asbestos insulation.
- Peeling paint was observed on the interior and exterior of many of the buildings. Given the age of these buildings, it is possible that lead paint was used.

- The septic tank adjacent to the CECOM-EMI building and also the septic system behind building T-8003 (near the main gate) may warrant sampling. These septic systems appear to have been used for sanitary wastewater, however, since the past uses of these buildings have not been fully determined, the potential exists that unknown chemicals were also disposed of through the septic system.
- Some minor soil staining was observed near several buildings throughout the Wayside Area. All of the areas appear to be associated with incidental petroleum releases from leaking vehicles.
- Two above ground fuel storage tanks are located near building N and at the south edge of the antenna field, respectively.
- Five of the empty transformer pads once held PCB-contaminated transformers (50-500 ppm PCBs).

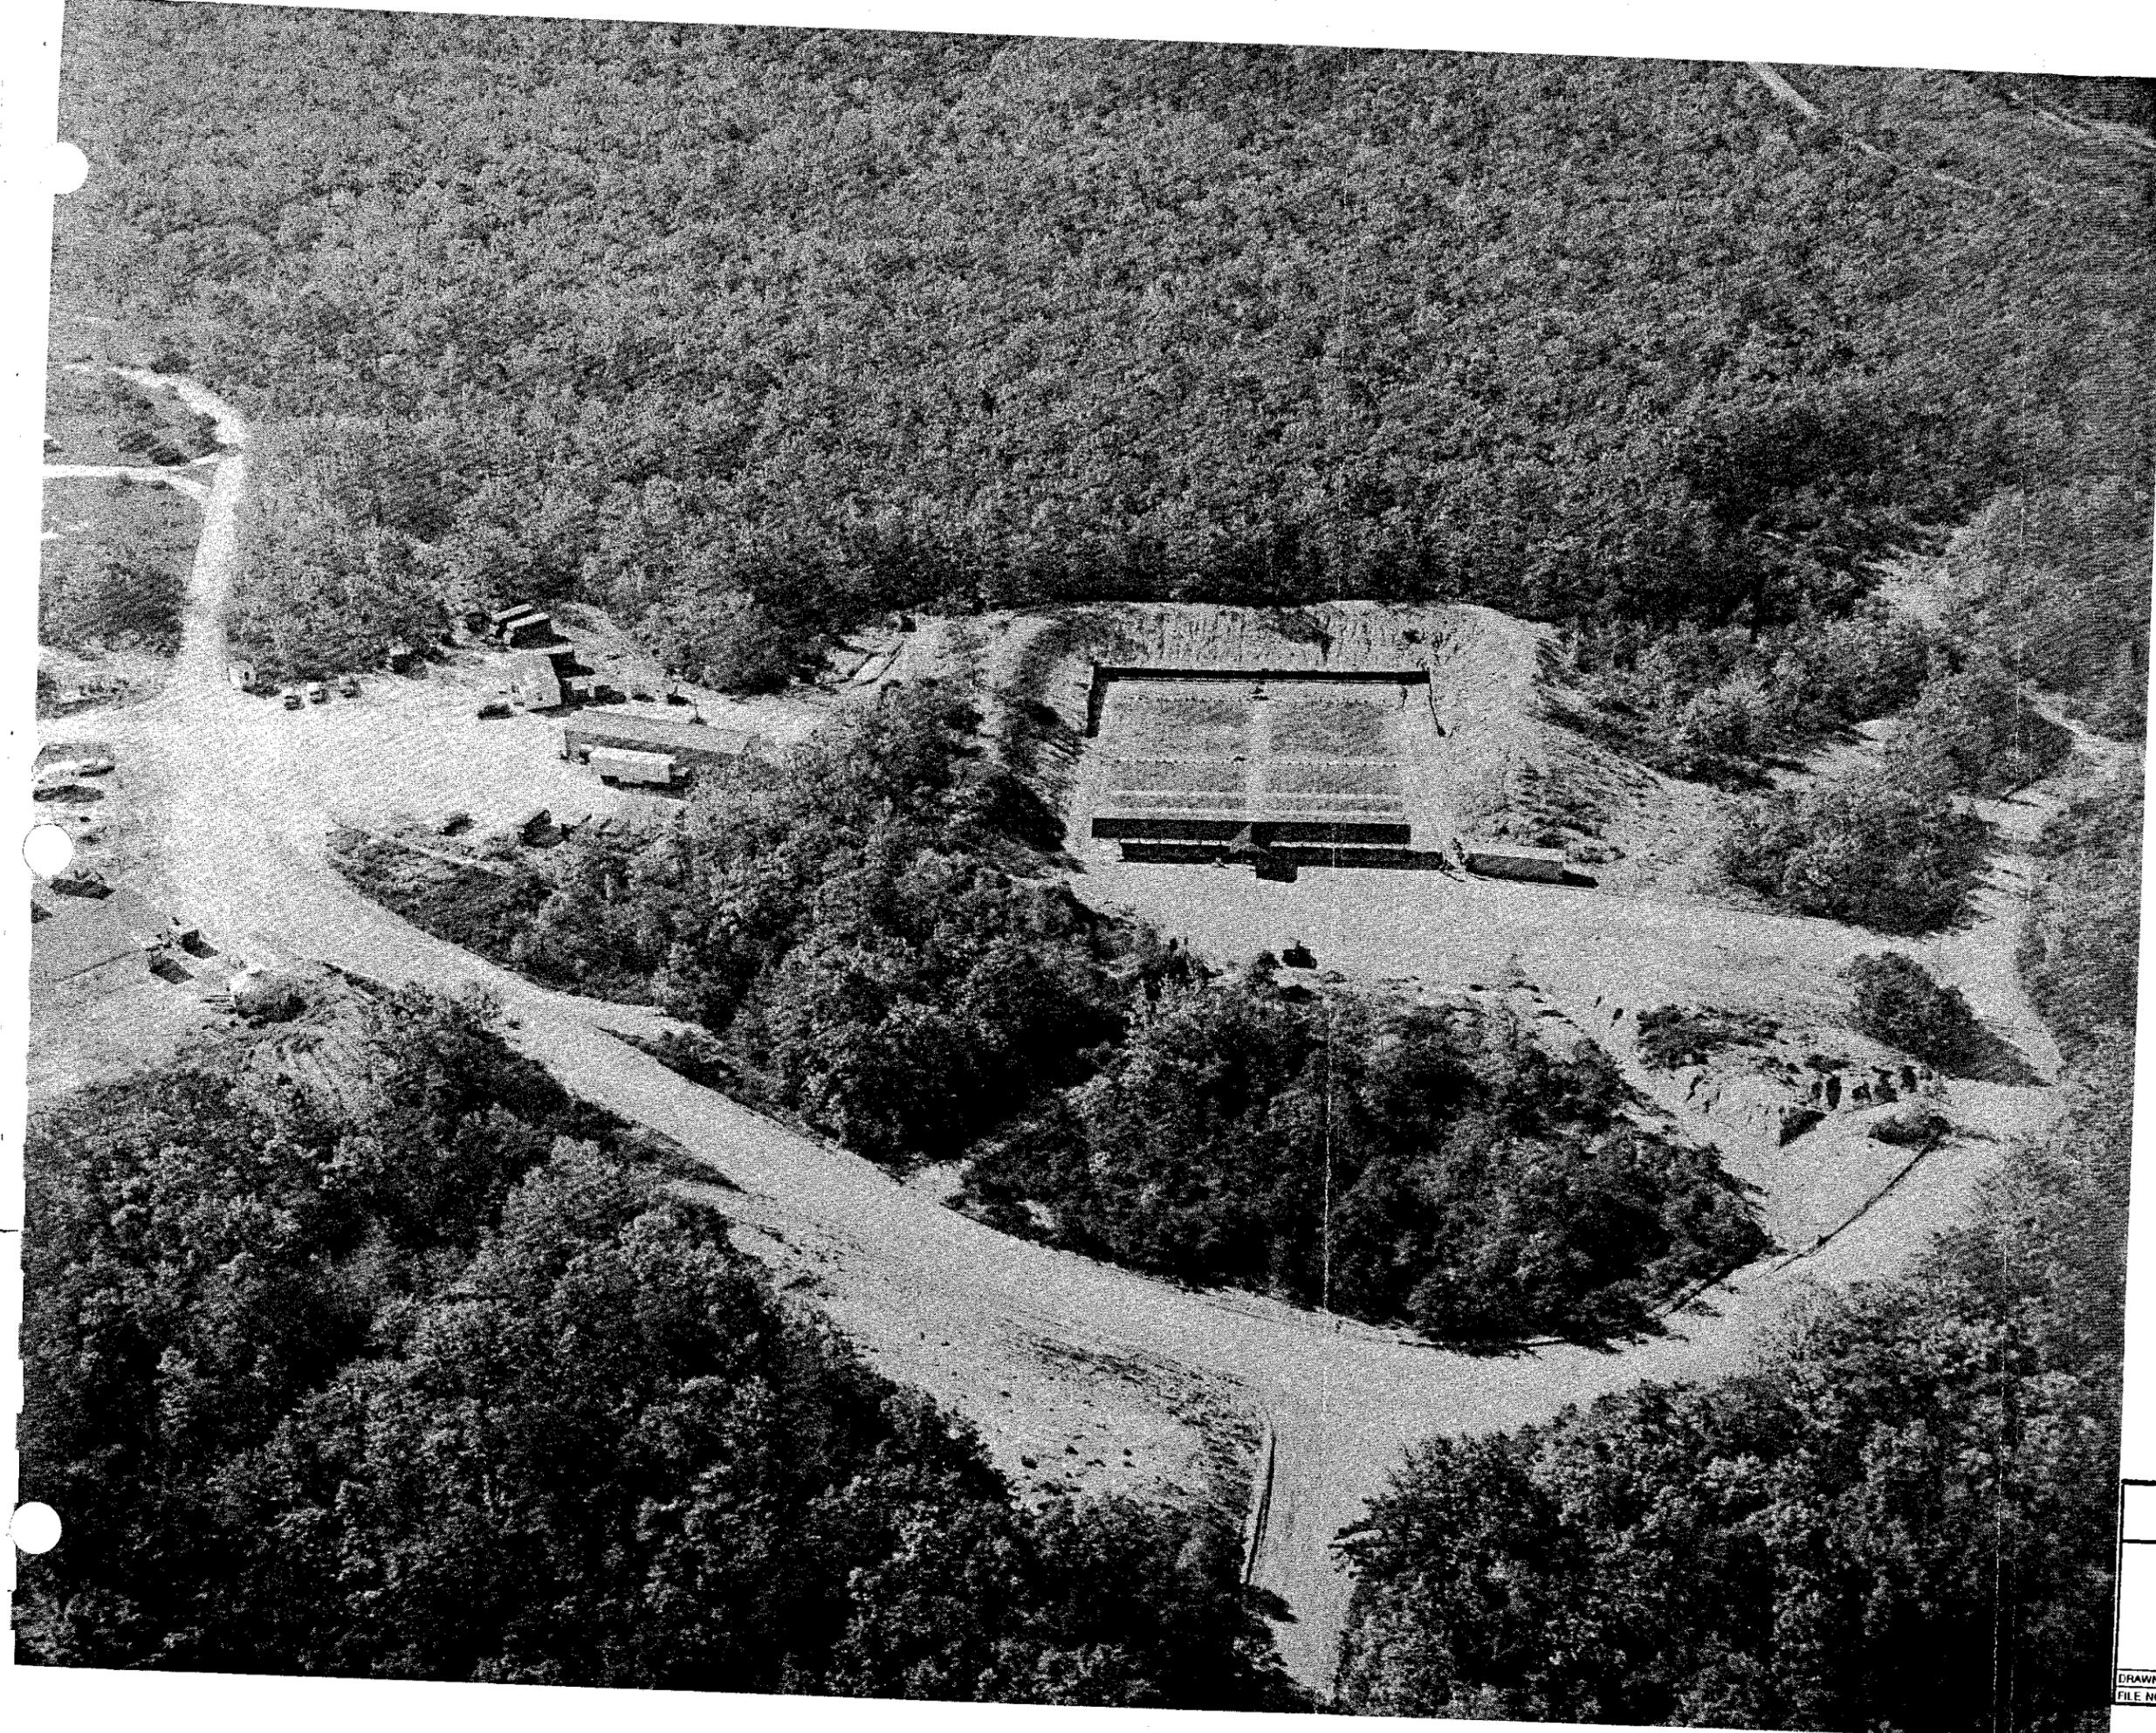
AERIAL VIEW OF WAYSIDE AREA PISTOL RANGE AND CECOM-EMI BUILDING LOOKING EAST (CORNER OF WAYSIDE AND SHAFTO ROAD NEAR TOP OF PHOTO, POSSIBLE WASTE DISPOSAL AREA NEAR BOTTOM CENTER)

Aerial photographs from 1969 to 1990 show a circular cleared area in the southern corner of the site, southwest of the dirt road, and just to the northwest of observation tower B3. On a 1978 photograph, something resembling a rectangular structure was located at the edge of this clearing next to the woods. This area was labelled as a helicopter pad on a 1978 Army map. A minor trash disposal area was found in the woods at the edge of this clearing. Although no other visual evidence of a disposal area was found during the site reconnaissance, the morphology of this area and the fact that it appears that it has been bulldozed suggests that this area could have been used for waste disposal.

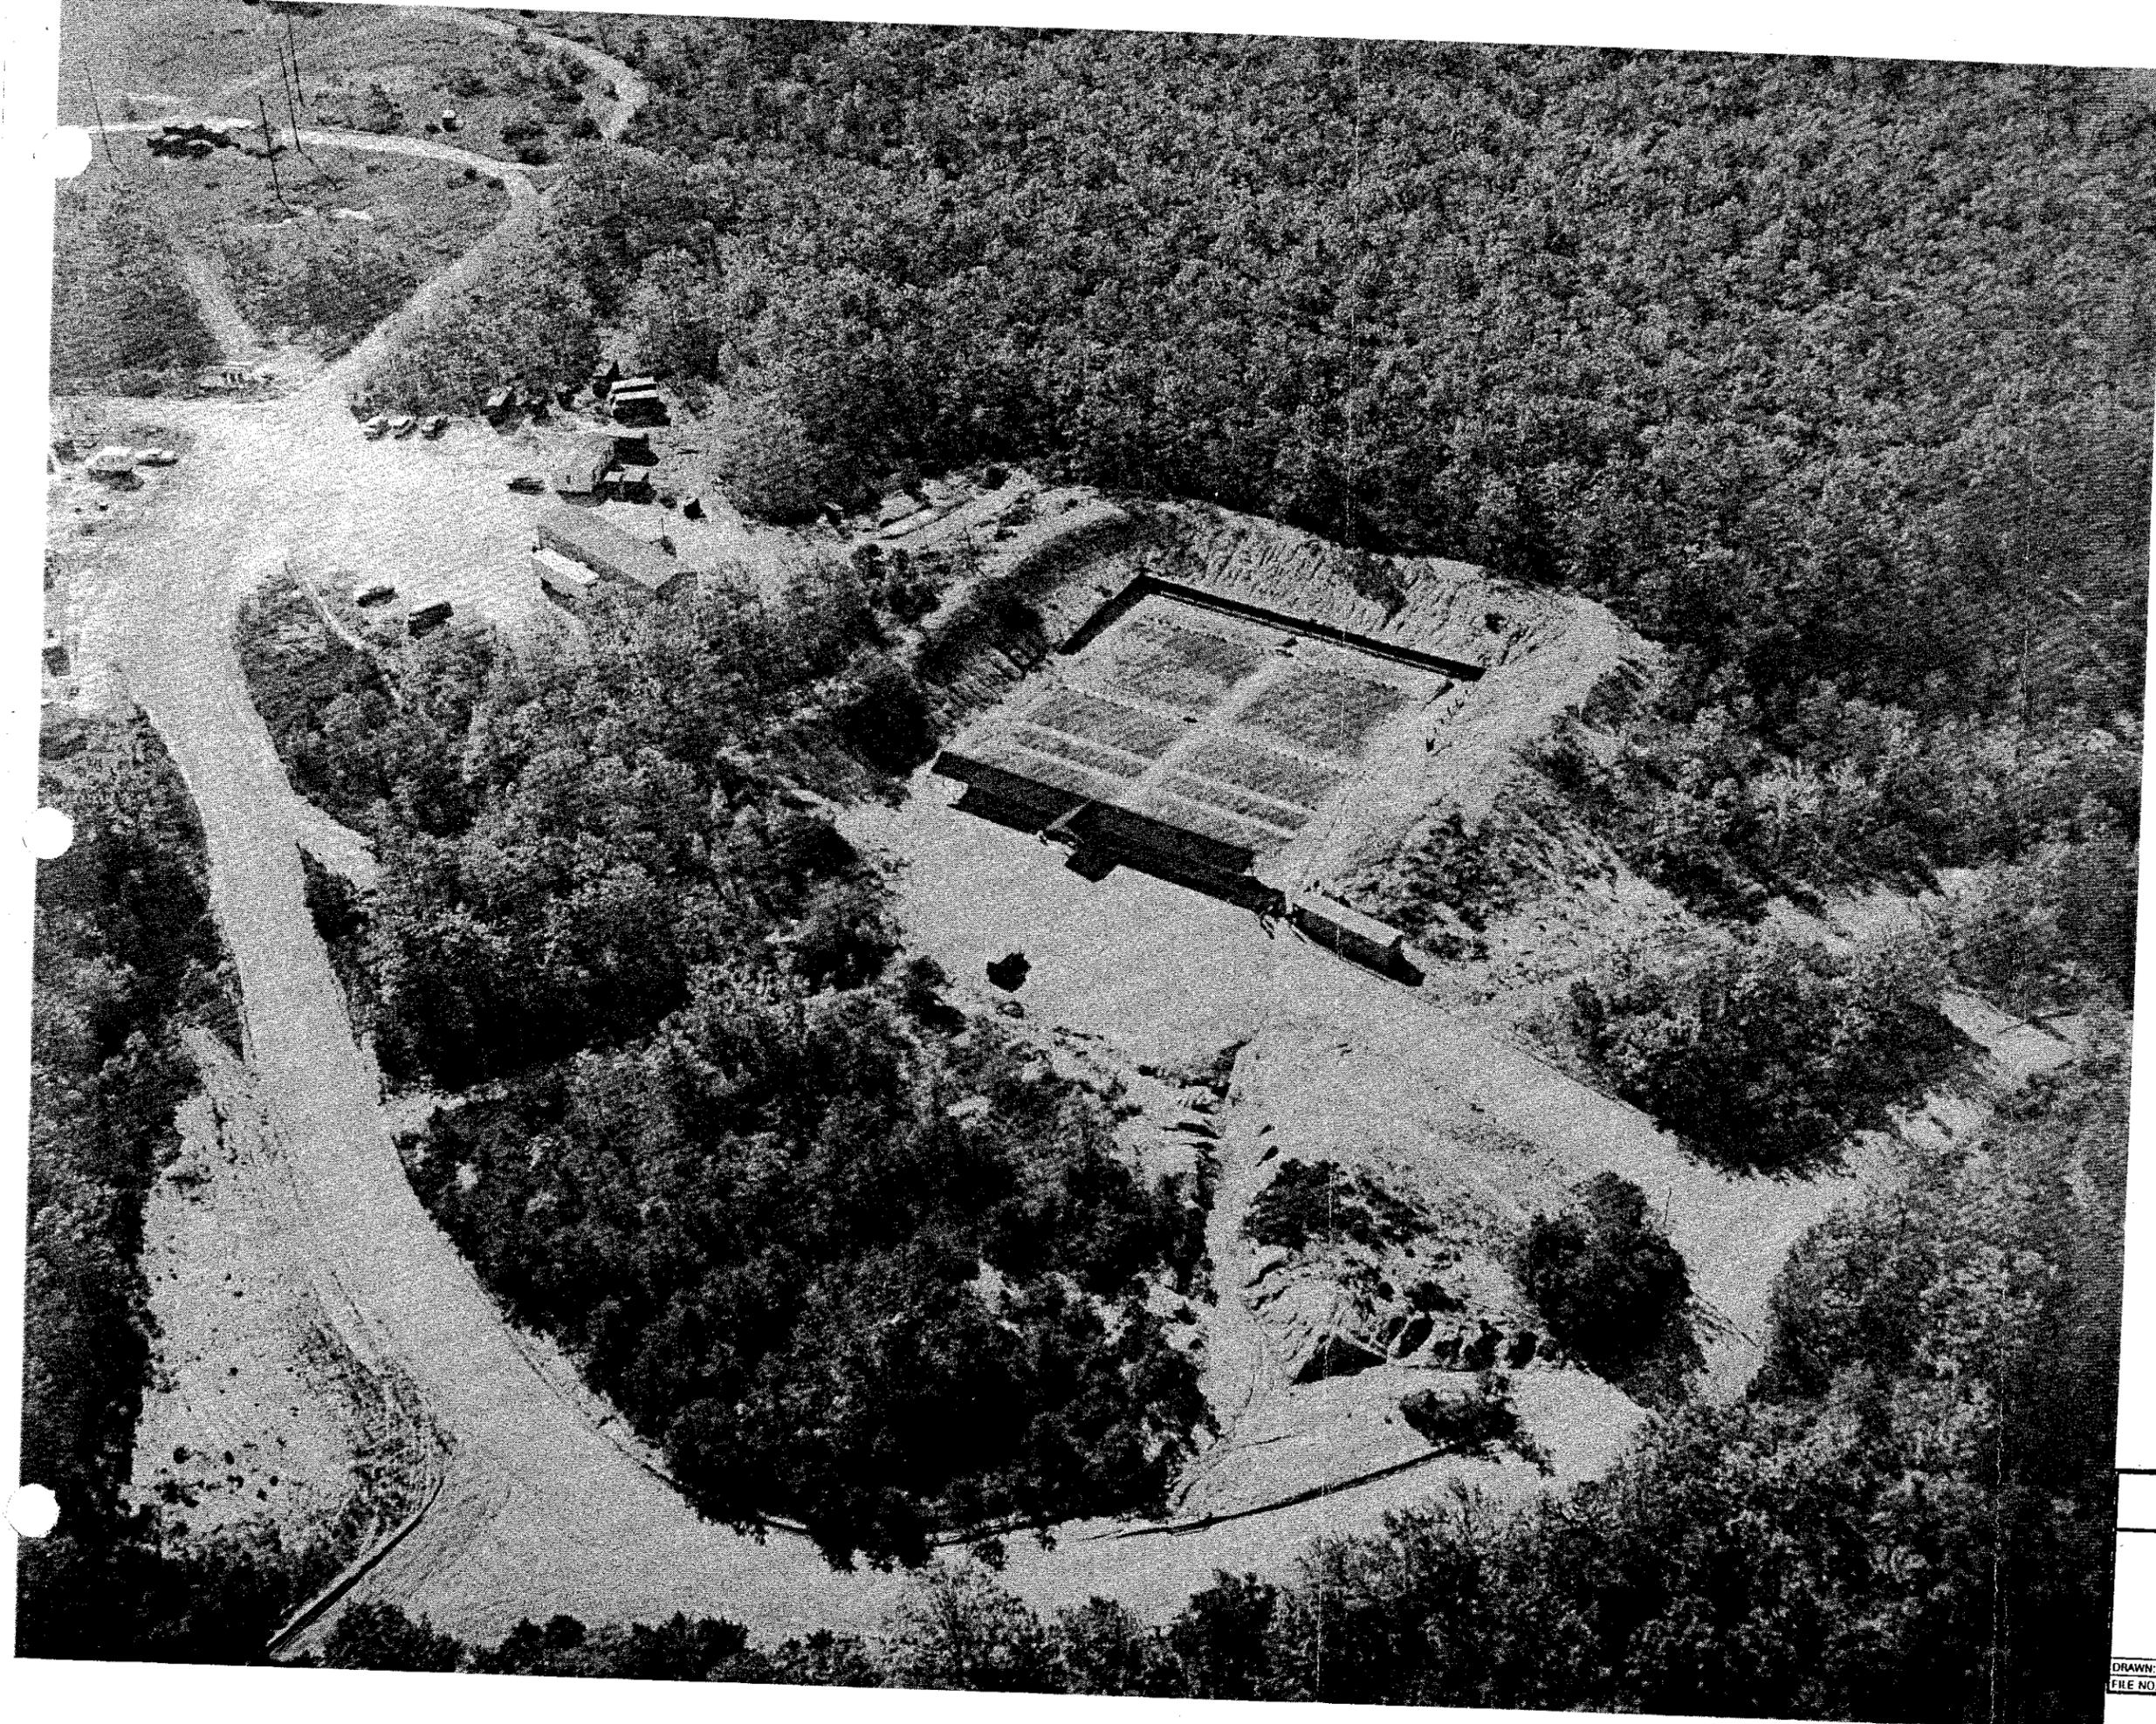
AERIAL VIEW OF WAYSIDE AREA PISTOL RANGE
AND CECOM-EMI BUILDING LOOKING SOUTH
