**ADDENDUM TO THE  
PRELIMINARY ASSESSMENT  
(INITIAL ASSESSMENT STUDY)  
OF  
NAVAL WEAPONS STATION EARLE  
COLTS NECK, NEW JERSEY**

**NEESA 13-020A**

**31 July 1992**

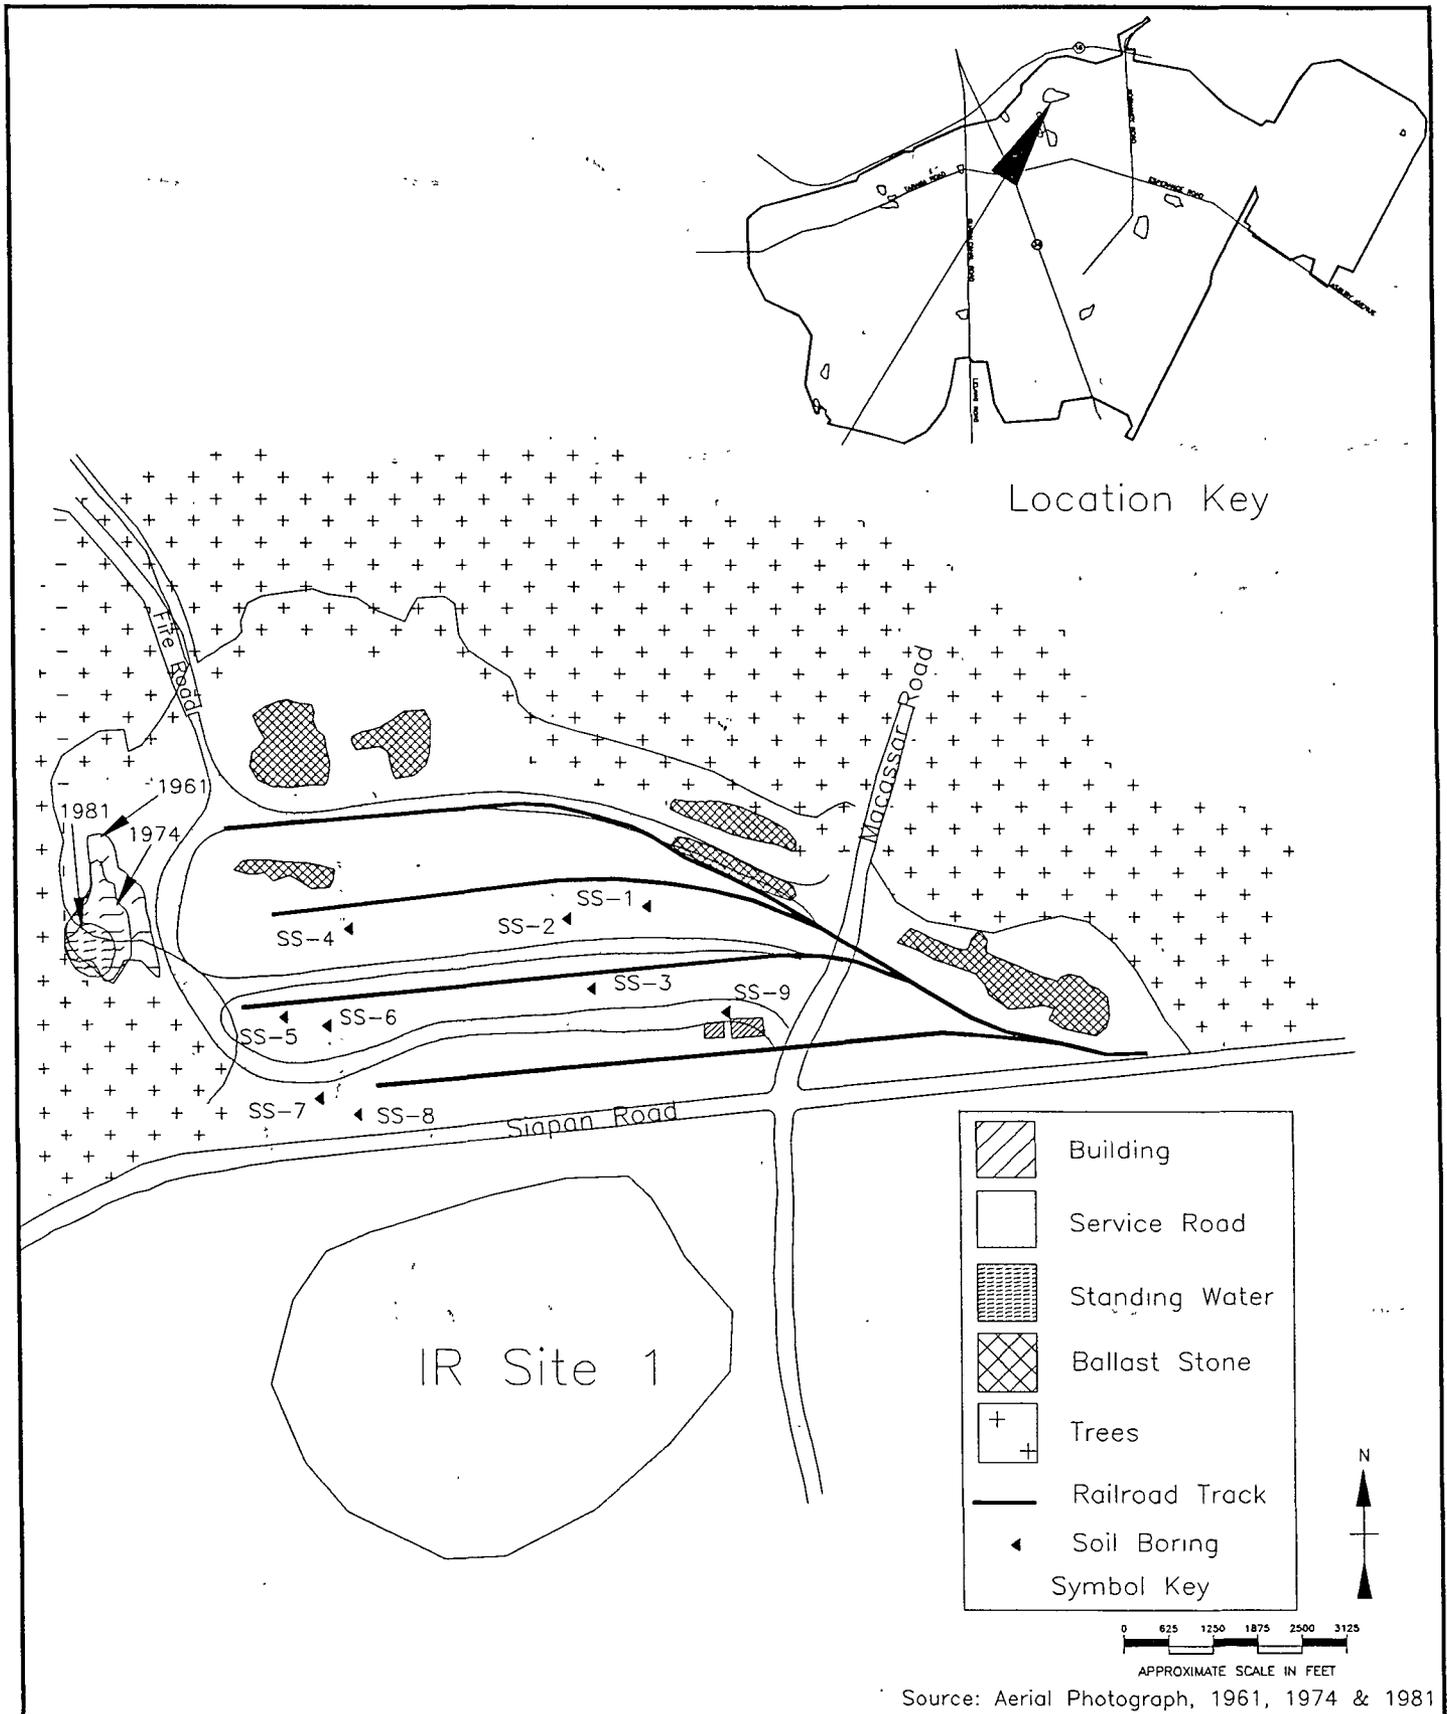
Figure 1 -  
Site A - Railroad Storage Yard

- ♦ March 1974: "Railroad classification yard; buildings; open storage; dark-toned objects; impoundment; light- and medium-toned mounded material." *The yard appears much the same as in the 1961 photograph, approximately 25 railroad cars and engines are parked along the spurs. A second building has been added adjacent to the building noted in the 1961 photograph. The dark objects on the ground between the middle two spurs are reported to be railroad ties. The ground between the southern two spurs appears to contain more than telephone poles, possibly scrap wood or piles of ballast stone. The ground surface between*

- ♦ January 1981: "Railroad classification yard; buildings; open storage; dark-toned objects; impoundment; medium-toned mounded material; probable dark-toned stain." *The yard appears much the same as in the 1961 and 1974 photographs. The two buildings of unknown use remain. Approximately 15 railroad cars and engines are parked on the spurs. The dark objects on the ground between the middle two spurs are reported to be railroad ties. The ground between the southern two tracks appears to contain more than telephone poles, possibly scrap wood or piles of ballast rock. The ground surface between the northern two tracks appears dark in color probably because of the slag or cinders used as railroad track bedding. The surface water to the west appears dry and a building or connex box is located in the area. Some of the mounds of ballast stone have been removed.*

Recommendations: Because there are no reports of hazardous material storage or disposal and because soil samples did not reveal contaminant levels of concern, no further work is recommended under the Installation Restoration program.

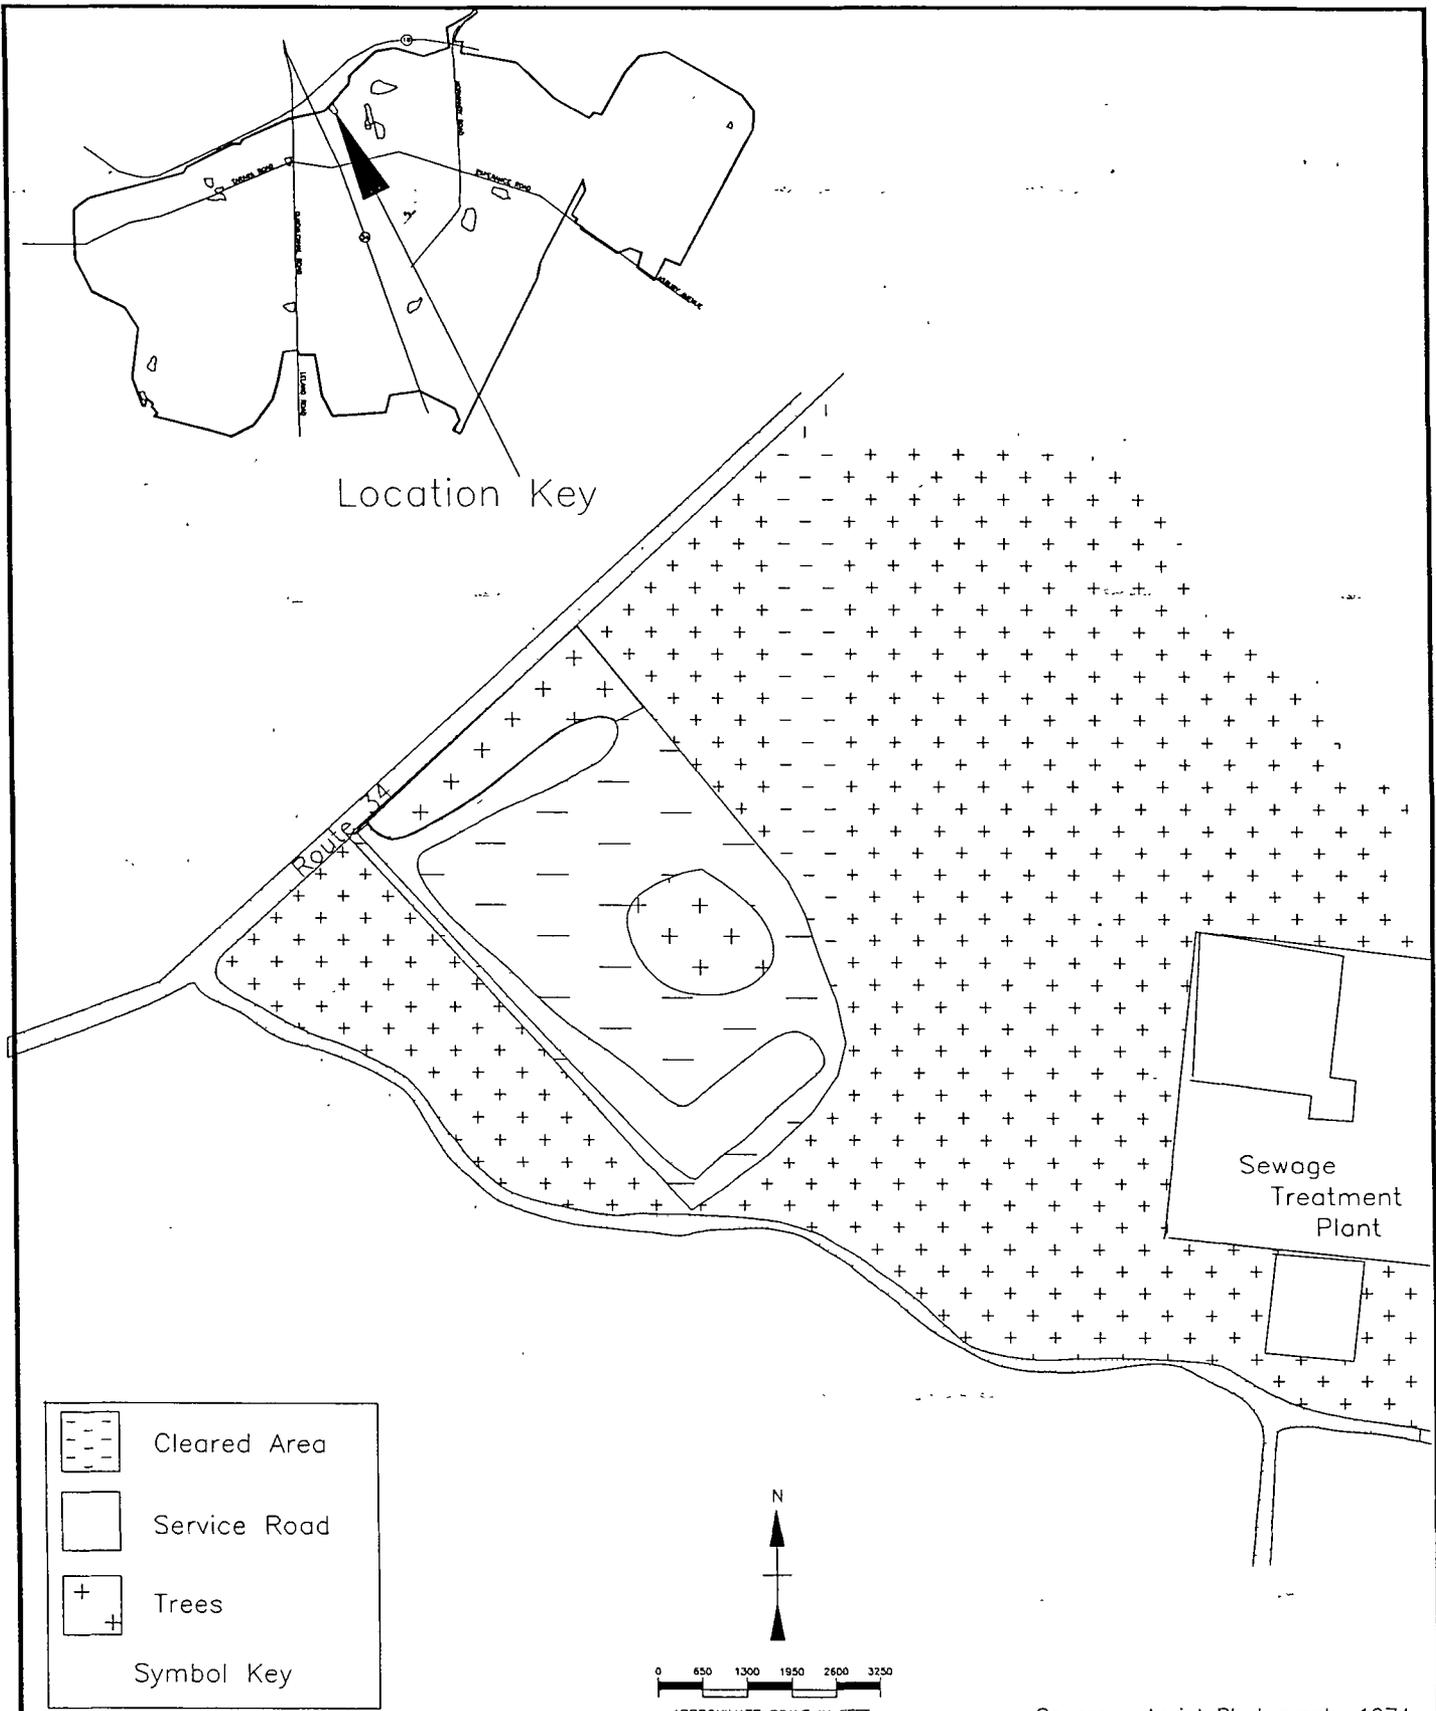
Figure 2 —  
 Site B — Colts Neck  
 Garage Area of 1974

- ♦ 1953/1961: Pre-site.
- ♦ March 1974: "Disposal area; mounded material; debris." *The area was in the process of being cleared. The mounded debris evident in the photograph was from clearing and burial of tree stumps. There were no reports of disposal of trash or other types of debris.*
- ♦ 1981: "Building; trailers; mounded materials." *The area appears as an unpaved storage yard, with some piles of dirt in the center of the area.*
- ♦ 1987: "Building; vehicle and equipment storage; dark-toned stain; light- and medium-toned mounded material." *The area is a paved storage yard for the Colts Neck Township vehicles.*

Recommendations. Because there are no reports of hazardous material storage disposal on the southern half of this area, no further work is recommended under the Installation Restoration program. However, some effort should be made by NWS Earle to ensure that the local township is complying with standard hazardous materials handling techniques.

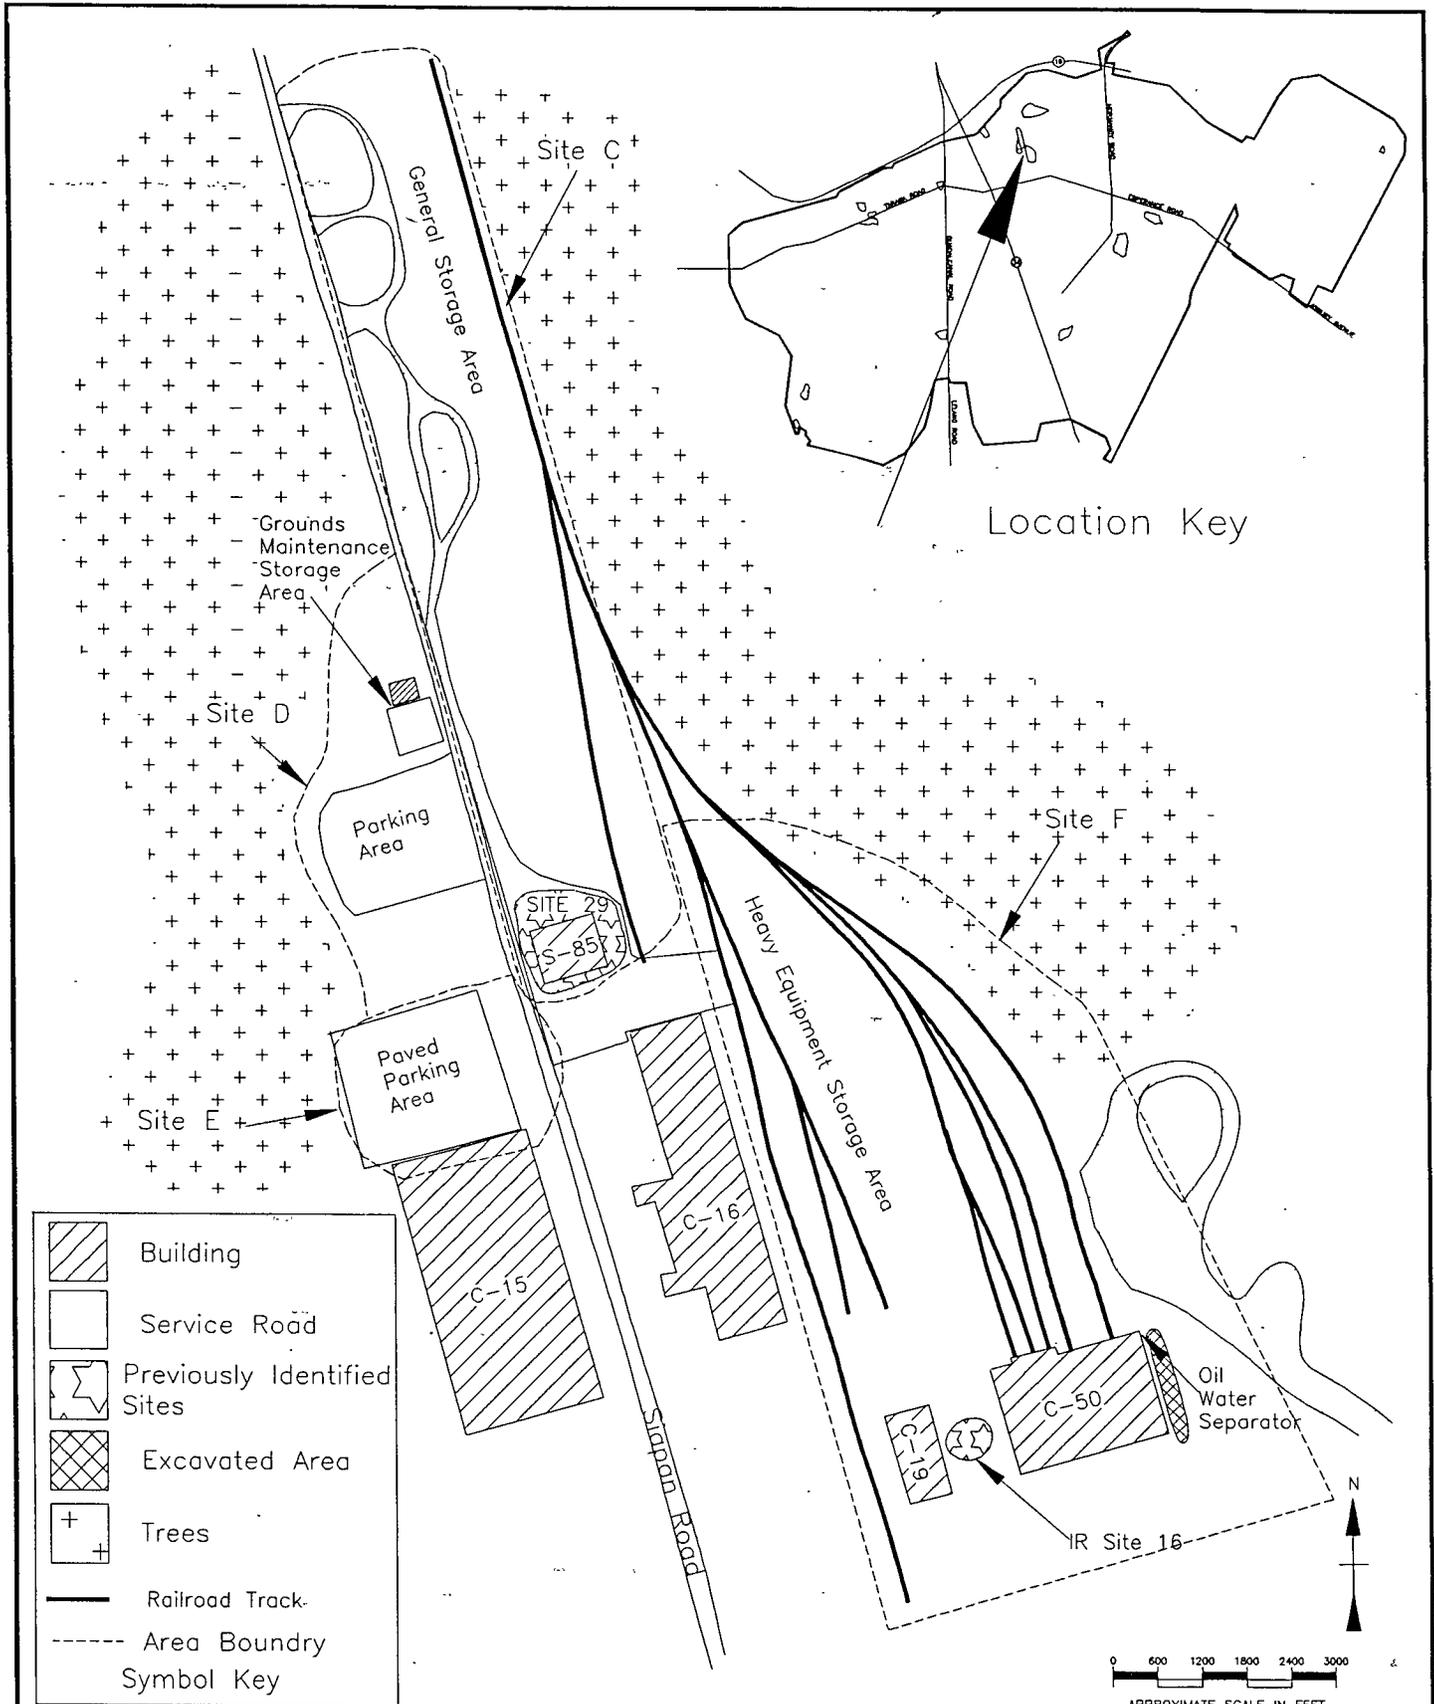
Figure 3 –  
Sites C, D, E, and F

- ♦ March 1974: "Open storage; variety of objects; light- and dark-toned mounded material; probable dark-toned stain." *The mounded materials are reportedly sand. The dark ground surface is probably cinders used as ground cover near railroad tracks.*

- ♦ January 1981: "Open storage; variety of objects; mounded materials; debris; probable dark-toned stain." *The objects appear to be telephone poles in the center of the turn-around, overseas or connex boxes, and various metal scrap. The mounded material is probably sand. The dark-toned ground surface is probably telephone poles or cinders.*

Conclusions. This area has been used for Public Works storage. IAS Site 29 has been identified and is currently being investigated. The scale and quality of the aerial photographs do not allow a conclusion regarding any disposal areas or the exact identity of the items stored. There were no reports of hazardous material storage or disposal.

Recommendation. Because there is no clear indication that hazardous materials were either stored or disposed of in this area, no further work under the Installation Restoration program is recommended.

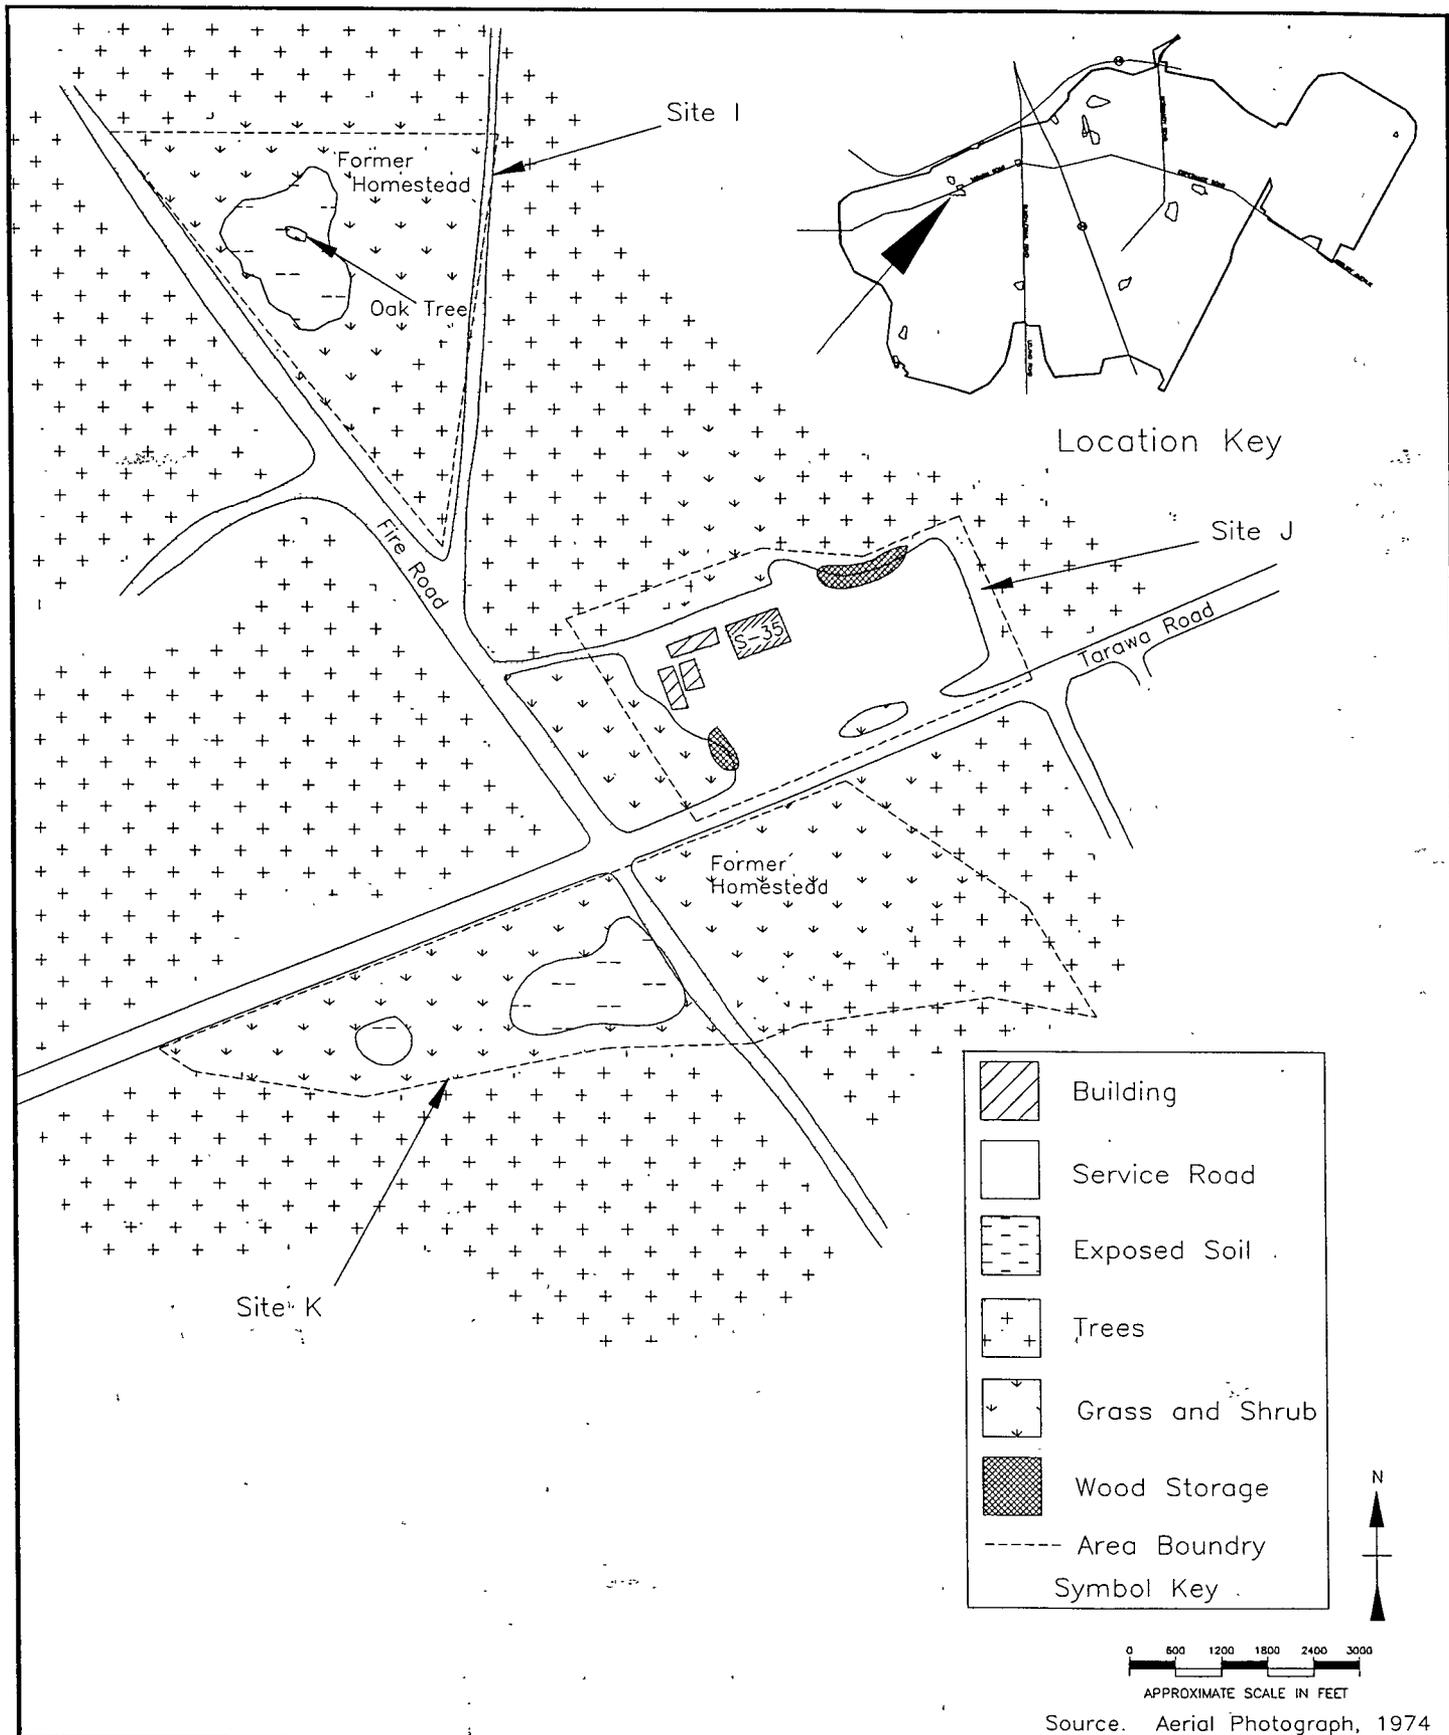
Figure 6 —  
Sites I, J, and K

- ♦ 1953: "Disturbed ground." *No photograph available.*
- ♦ 1961: "Cleared area; center remains disturbed." *No photograph available.*
- ♦ 1963: *Stereo view reveals that the vegetation in this area is undergrown. A blackjack oak in the center of an area of white soil is evident.*
- ♦ 1974: "Burn area; disturbed ground surface; dark-toned feature near center of the site." *Area was burned for agricultural reasons. Area appears disturbed because of poor soil conditions. Dark toned feature is a blackjack oak which remains.*
- ♦ 1981: "Cleared area; disturbed ground." *No photograph available.*
- ♦ 1987: "Cleared area; disturbed ground surface; graded area; dark-toned stains." *Photograph reveals that the area has been plowed in preparation for planting.*

The ordnance carpenter shop has been a wood working facility providing pallets, boxes, etc. in support of ordnance transfer and storage operations from the early 1940's until the present. Aside from the generation of sawdust and trash waste, the shop produces empty cans which may contain hazardous waste, e.g. lacquer, polyurethane, varnish, wood stain, toluene, plastic resin glue, rubber

Conclusions. From the property records, this area first had a building that was used as a lunchroom, then converted to rework small caliber ammunition, then converted to the carpenter shop. Facility personnel have no knowledge of any hazardous material operations occurring in this area. There

Recommendations. Because there are no reports or evidence of hazardous material release or problems with the drinking water wells, no further work is recommended under the Installation Restoration program.

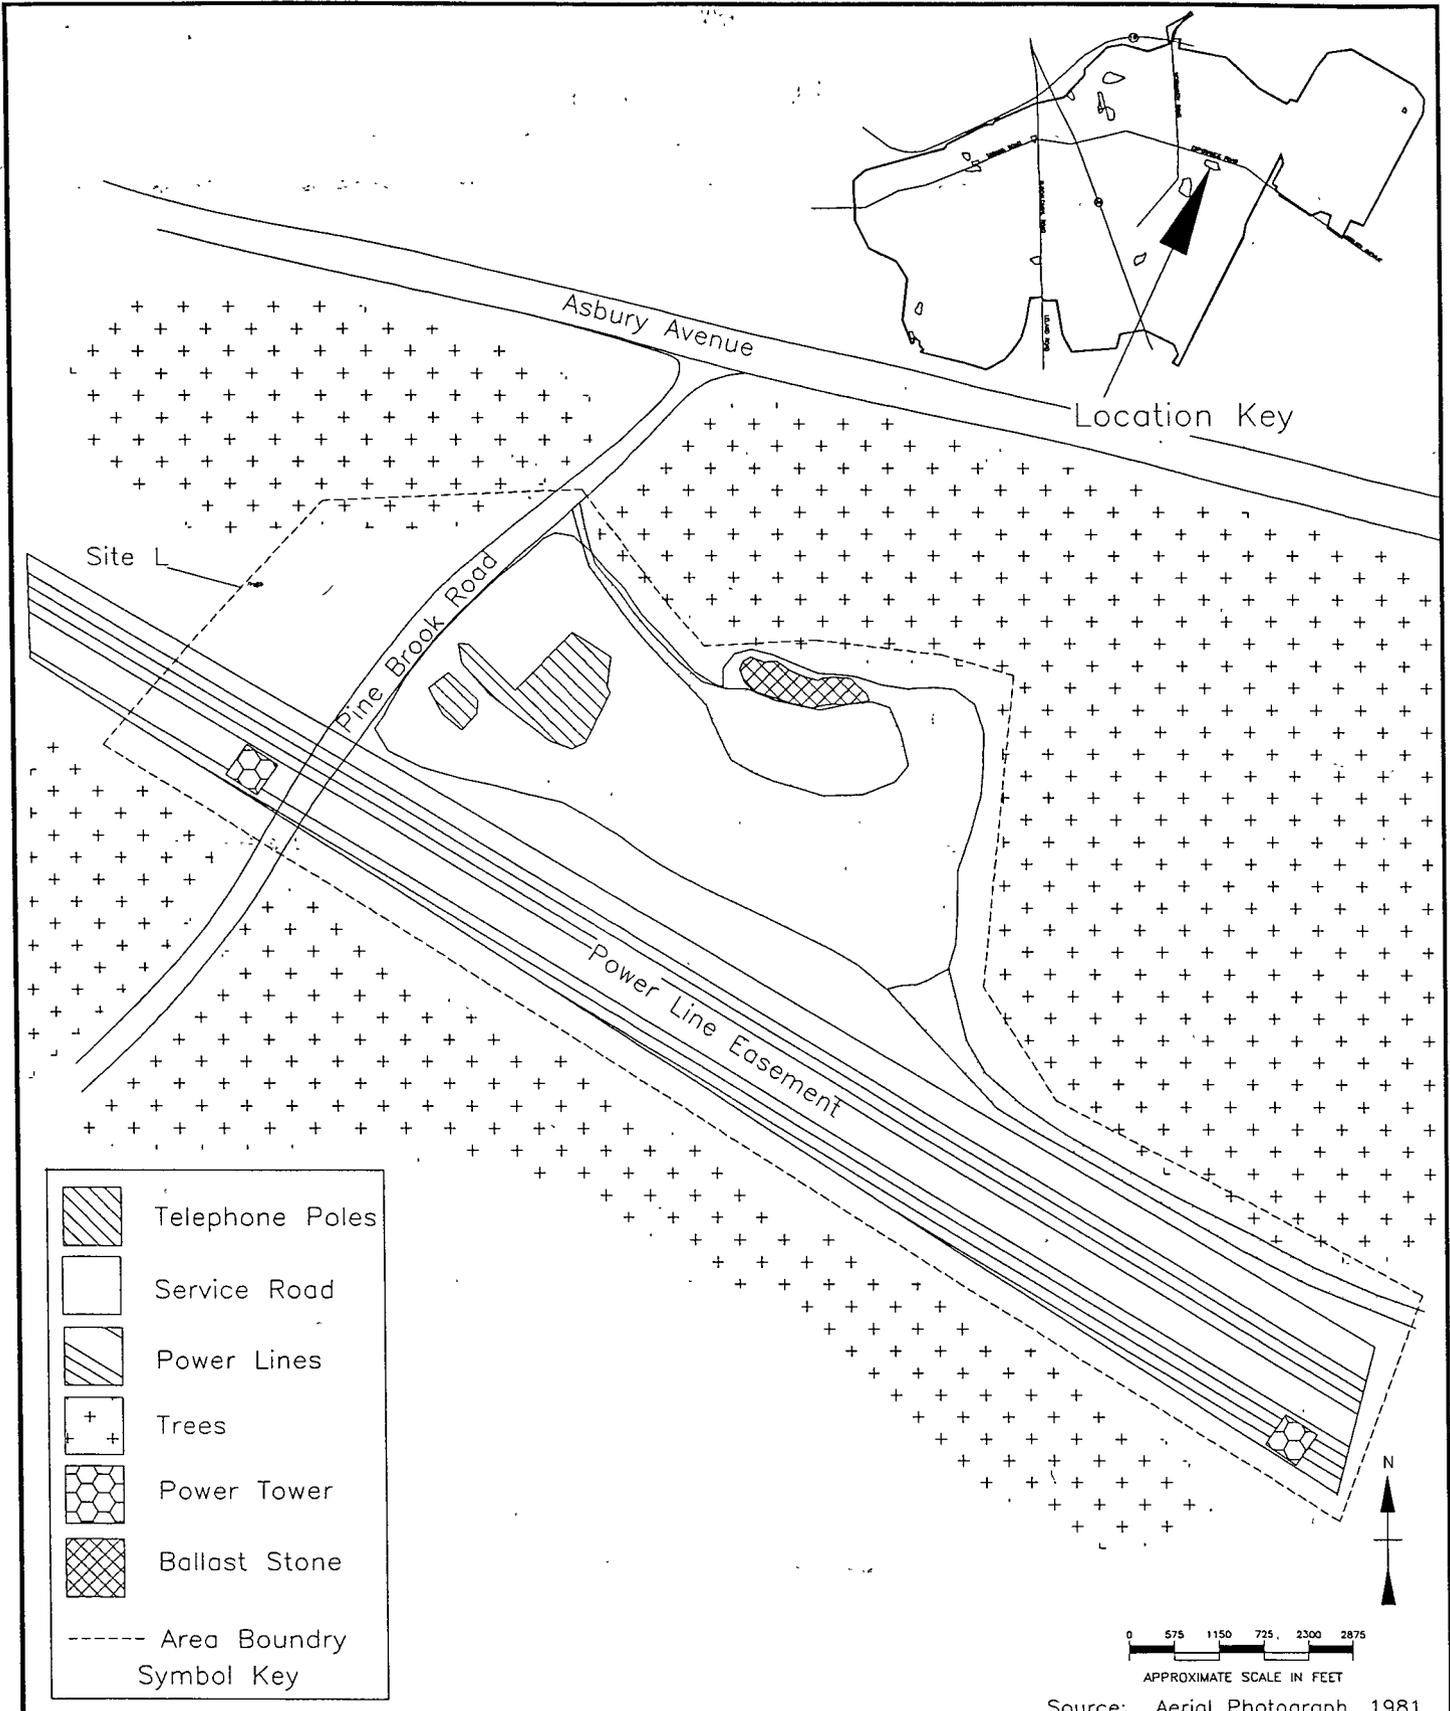
Figure 7 -  
Site L - MSC Van Parking Lot

- ◆ 1961: "Disturbed ground; dark-toned linear objects; probable dark-toned stains; light-toned mounded material." *No photograph available.*
- ◆ 1963: *General storage, telephone poles are obvious.*
- ◆ 1974: "Light-through dark-toned material." *No photograph available.*
- ◆ 1981: "Open storage: linear objects; medium- and dark-toned mounded material; graded area; probable debris." *Linear objects are clearly telephone poles. Mounded materials are railroad ballast stone. The northeast section of the area appears cleared because it has been accessed by heavy equipment; no debris noted.*
- ◆ 1987: "Open storage with linear objects; ground scars; possible dark stains." *No photograph available.*

Recommendations. Because there are no reports or visual evidence of hazardous material operations, no further work under the Installation Restoration program is recommended.

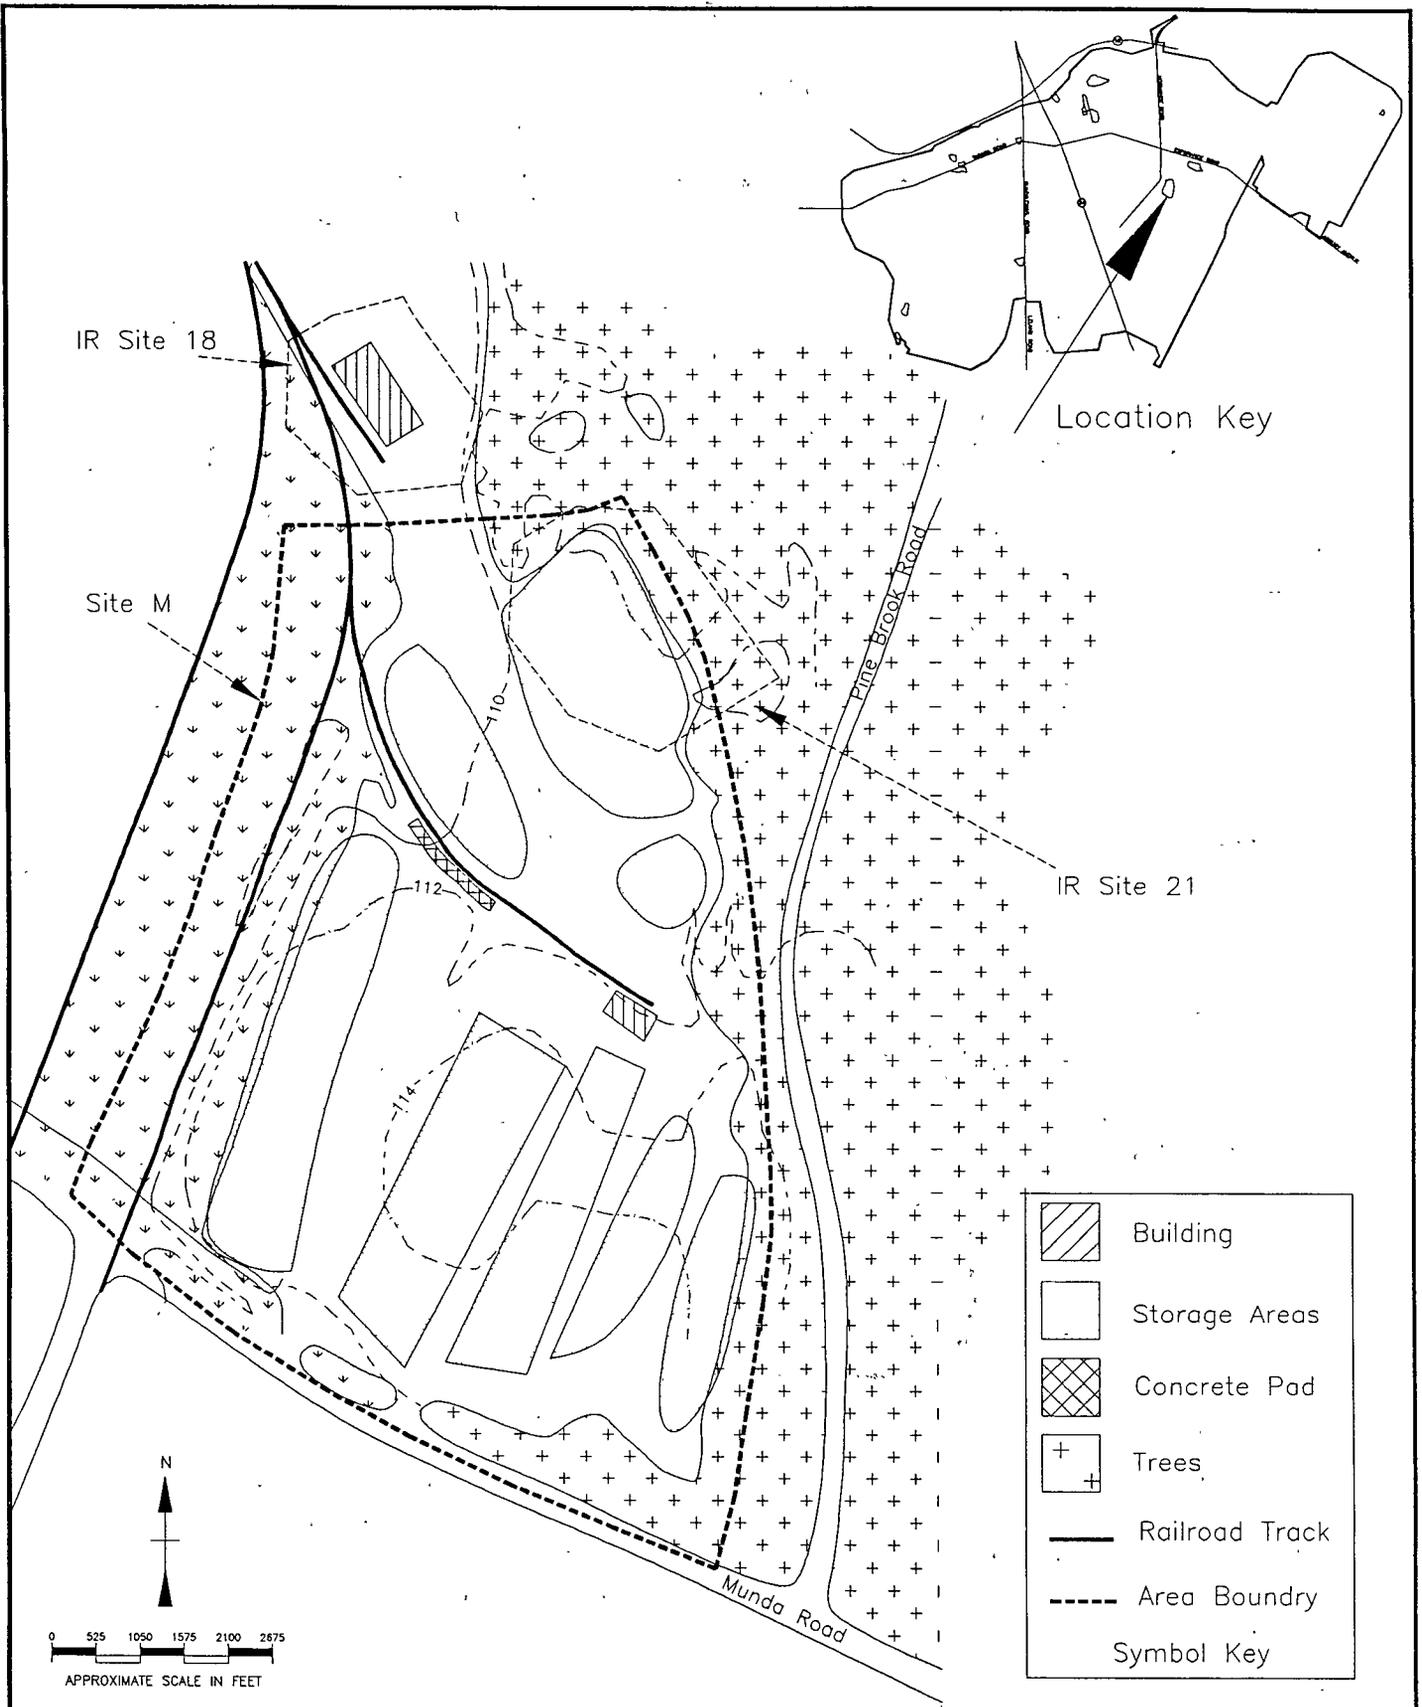
Figure 8 -  
Site M - Demil Furnace Area

- ◆ 1981: "Buildings; open storage; variety of objects; stacked material; crates; probable drums." *It appears that most of the stored items have been removed; a few containers remain along the east edge and in the center of the area. Vegetation replaces stored items along the west edge of the area. Drums used to store baghouse material appear in the upper northeast section of the area; this area is designated as IR Site 21.*

Currently the area is used for extensive storage of ordnance-related storage containers. A permitted hazardous waste storage area is located within this area. The storage facility was permitted by the state of New Jersey September 6, 1990.

Recommendations. This area was reported to store empty ordnance related items, therefore no further work under the Installation Restoration program is recommended.

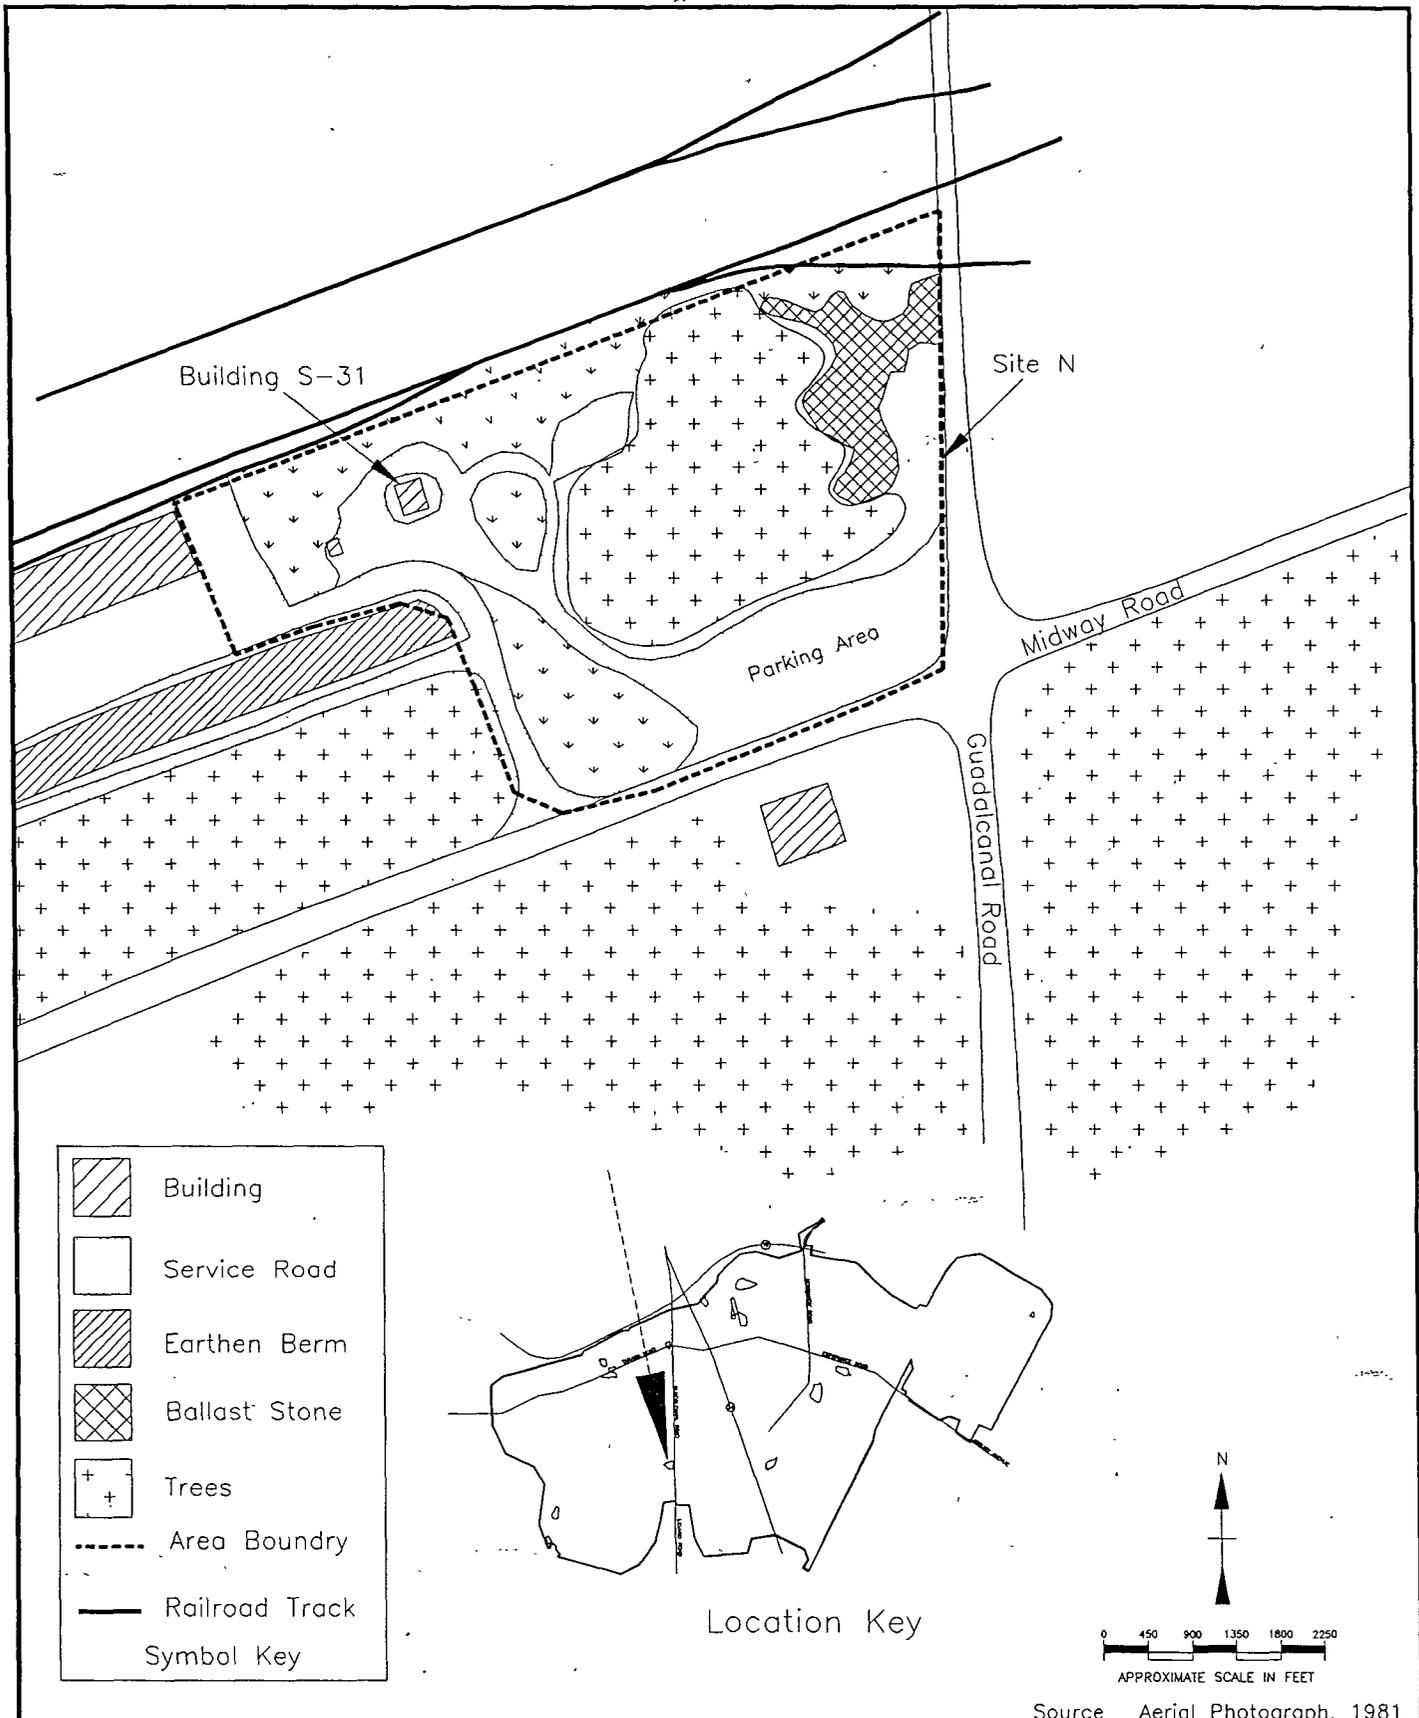
Figure 9 -  
Site N - Storage Area

- ◆ 1953: "Buildings; possible dark-toned stain; drainage ditch; cleared area." *No photograph available.*
- ◆ 1961: "Buildings; fill area; dark-toned areas; standing liquid." *The foundation for Building HA-3 appears near the center of the area. Dark areas are probably from stone fill laid down to provide support for vehicles. The standing liquid appears to be vegetation.*

- ◆ 1974: "Buildings; ground scarring; open storage; medium- and dark-toned stacked objects; revegetation." *No photograph available.*
- ◆ 1981: "Buildings; probable disposal; light-toned mounded material; trailers; open storage; dark-toned objects." *Part of the area is cleared, probably by heavy vehicles that transport ordnance. The light-toned mounded material is soil from the construction of M-group bunkers to the east. Trailers are flatbeds used in the transportation of ordnance. No open storage is noted; the dark-toned objects appear to be trees.*

Recommendations. Because there is no evidence or reports of hazardous material operations in this area, no further work under the Installation Restoration program is recommended.

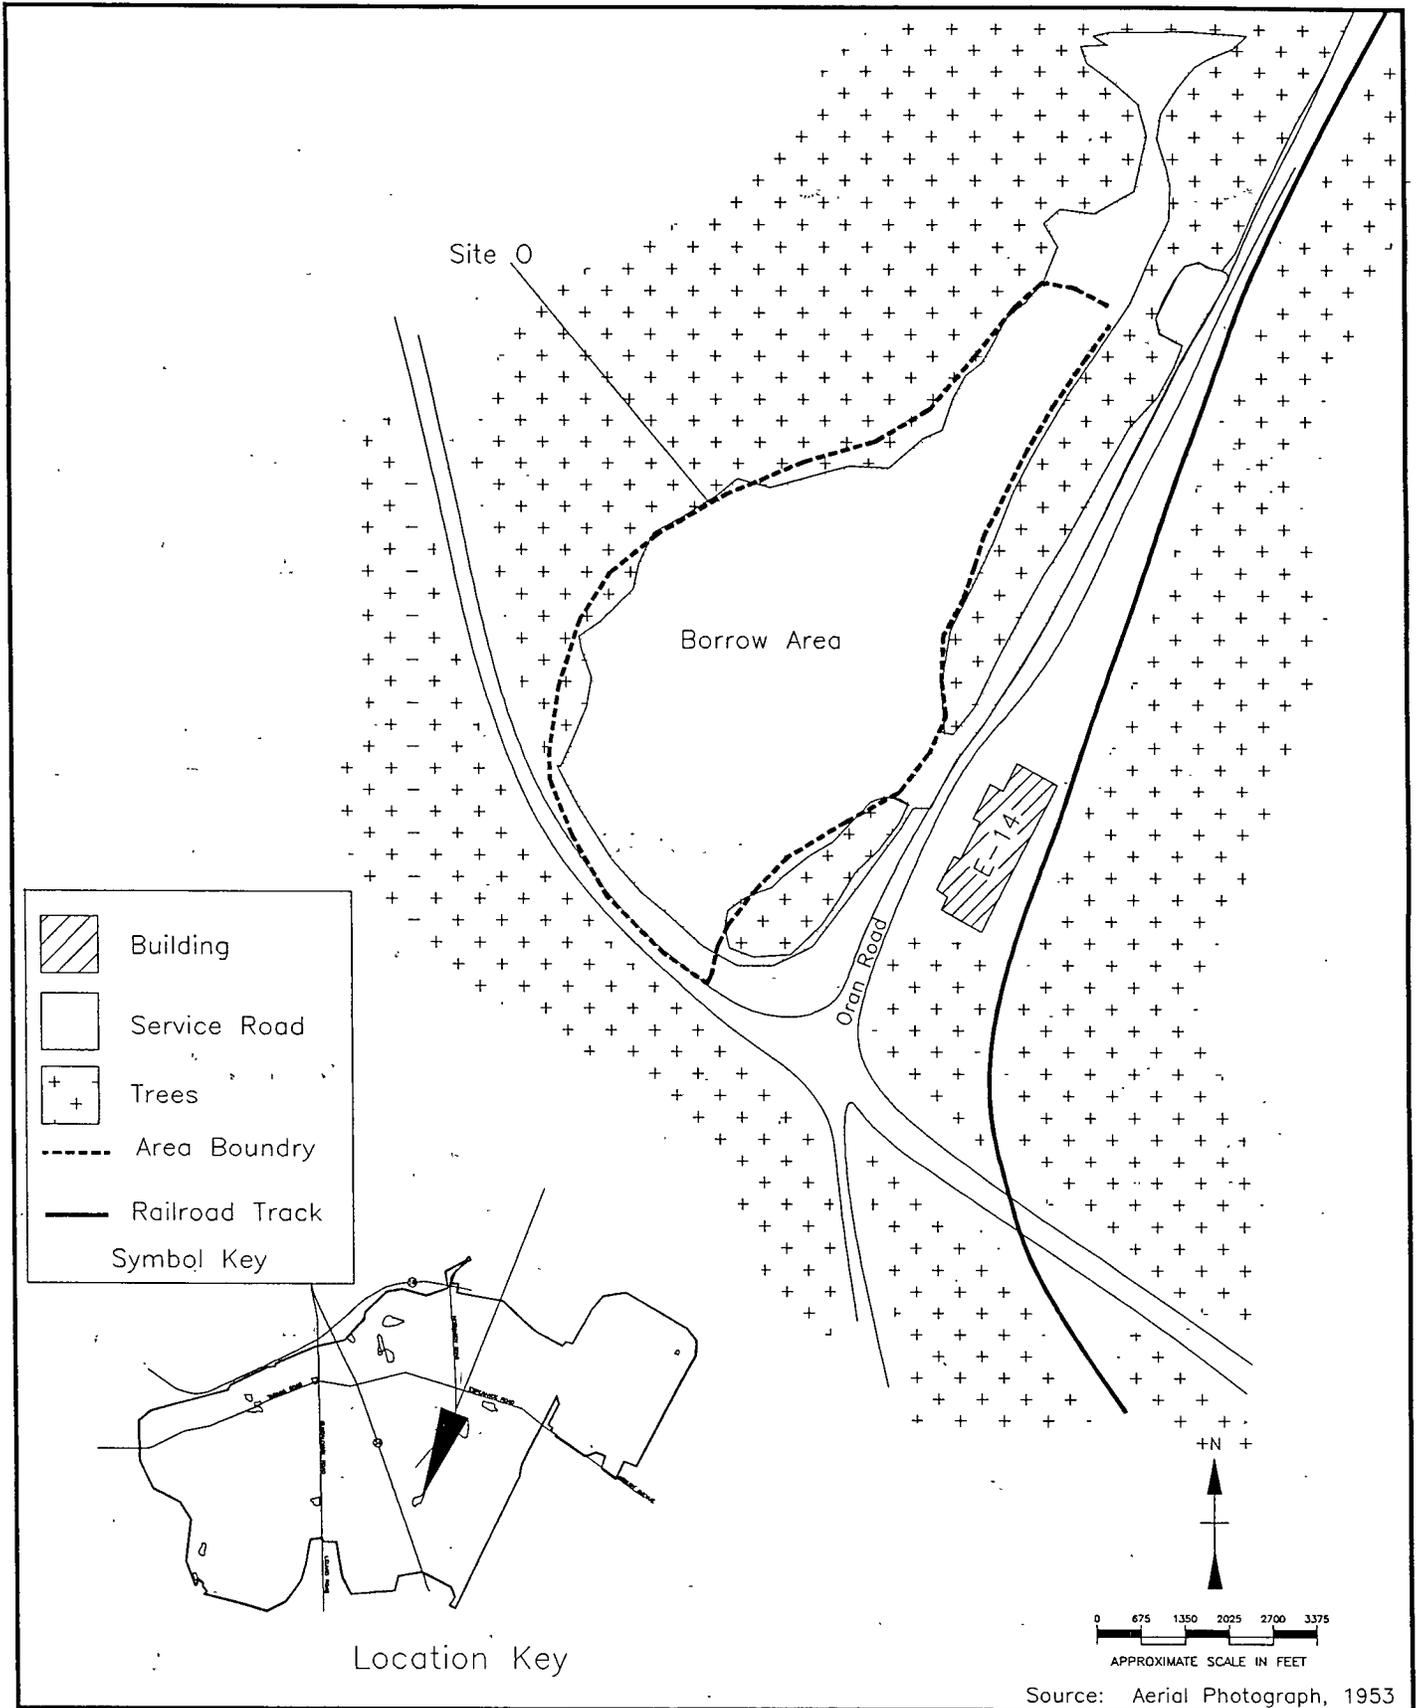
Figure 10 -  
Site 0 - Borrow Pit

This area is approximately 6.2 acres and is located just west of Oran Road opposite Building E-14 as shown in Figure 10. Reportedly this area was originally cleared in 1947. At that time material was excavated and used in the construction of roads and railroad track. Reportedly because of poor soil conditions, this area remained undervegetated until the late 1960s when varieties of grasses were planted to feed local wildlife. This area currently has a full stand of trees.

Conclusions. This area was reportedly used for borrow material during construction of NWS Earle in 1947. It was planted in the late 1960s to provide food for local wildlife. There are no reports or evidence of hazardous material disposal.

Recommendations. No further work under the Installation Restoration program is recommended.
