**ADDENDUM TO THE  
PRELIMINARY ASSESSMENT  
(INITIAL ASSESSMENT STUDY)  
OF  
NAVAL WEAPONS STATION EARLE  
COLTS NECK, NEW JERSEY**

**NEESA 13-020A**

**31 July 1992**

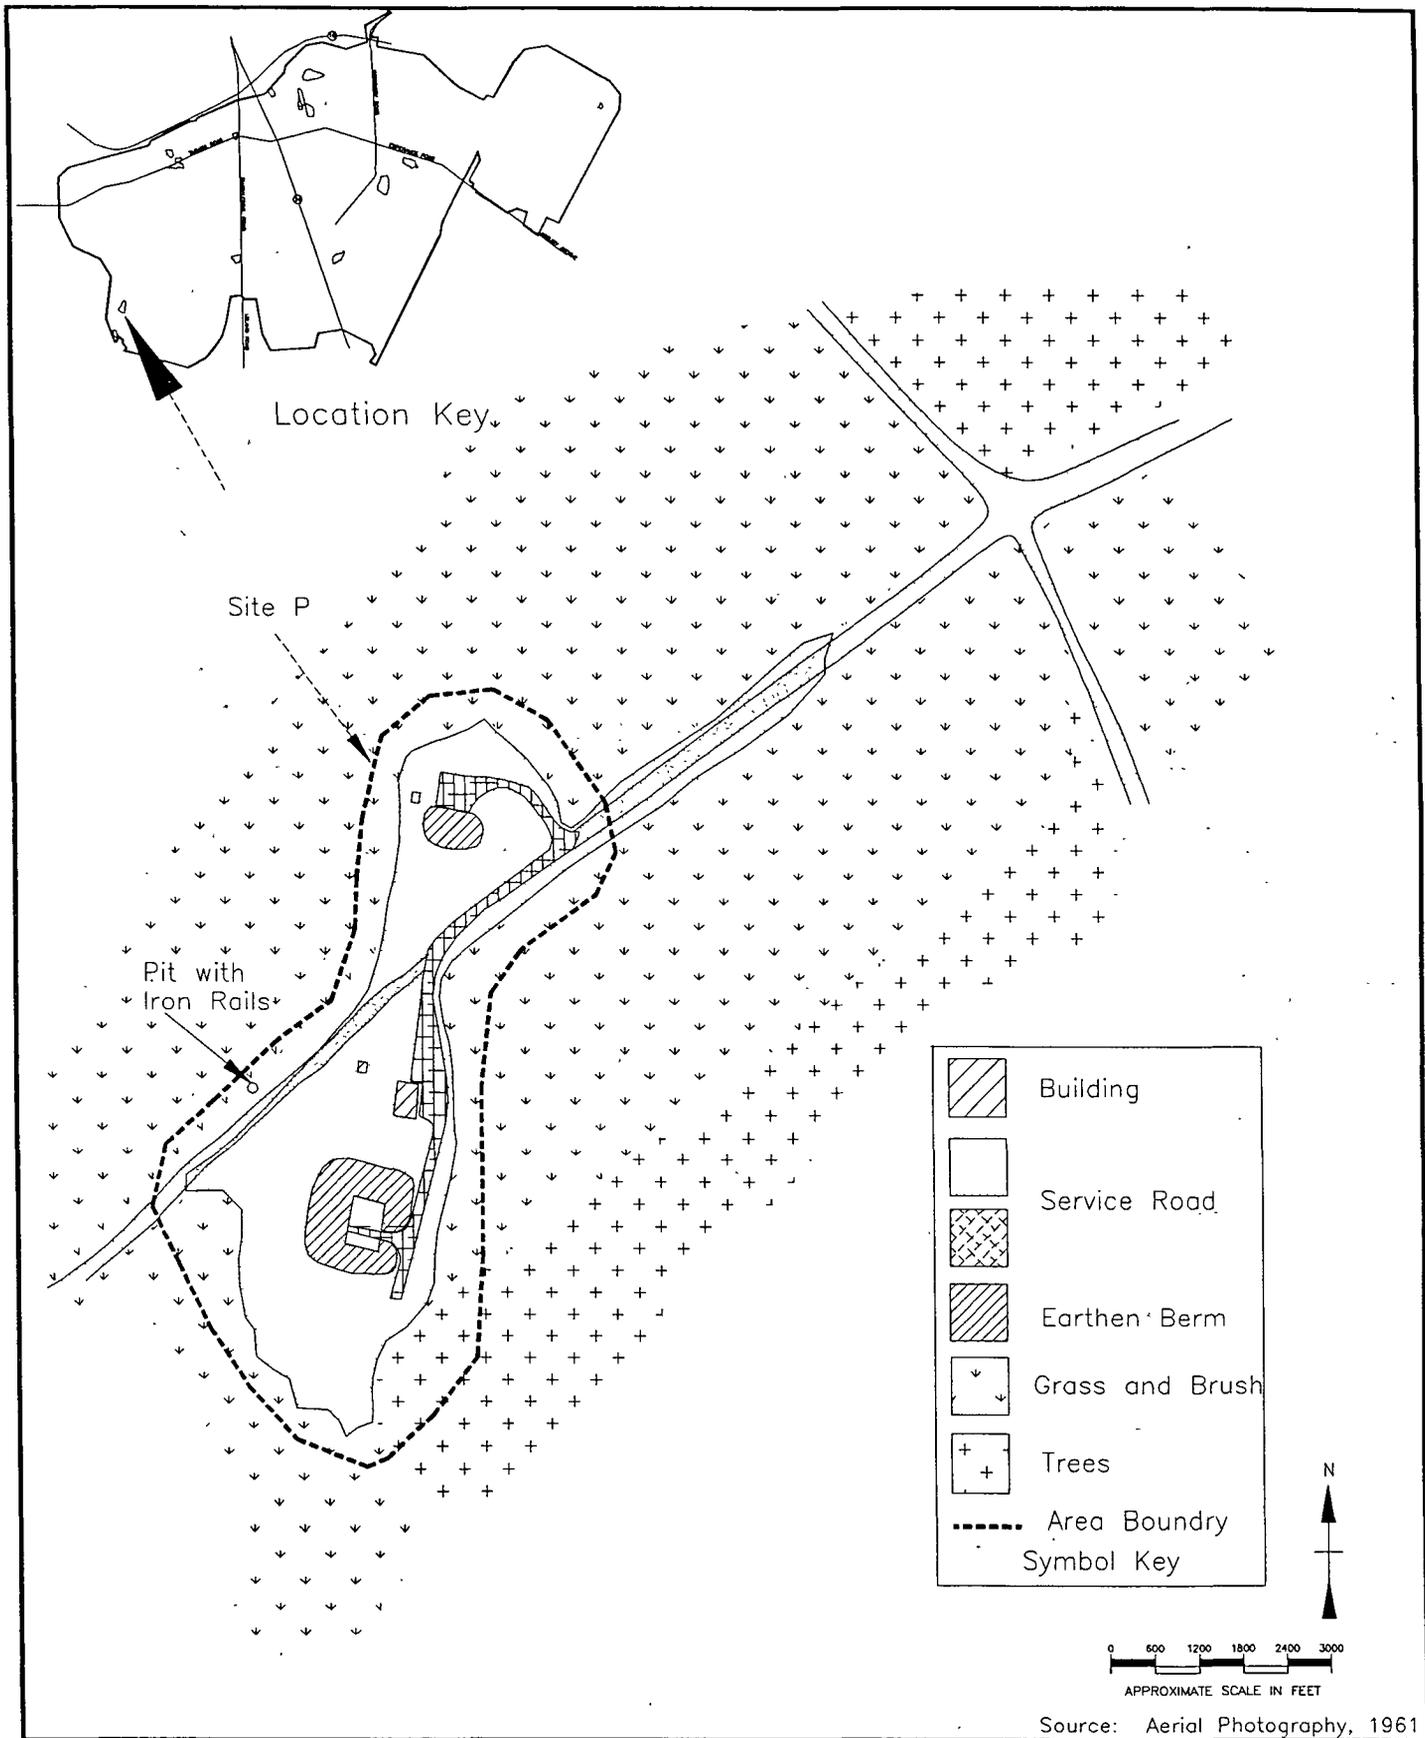
Figure 11 —  
Site P — Abandoned Bunkers

- 1) These structures were reported built in 1961 and abandoned in 1965, but the trees growing through the southern bunker are approximately 25 to 30 years old according to the station forester. Which indicates that the structure may have been abandoned between 1962 and 1967.
- 2) The layout of the southern bunker is not typical for EOD purposes; the walls of the bunker are designed to focus a blast upward, not protect personnel from a blast outside of the bunker.
- 3) If the southern bunker was used for ordnance disposal, some type physical damage to the interior of the bunker should be evident; none was observed.

The pit with the railroad rails possibly appears in the 1947 aerial photograph as the center of a large circular cleared area. This pit was probably not associated with the bunkers because the White Pines planted in rows in 1961 appear all around the pit, suggesting that it was not used at the time the bunkers were constructed.

Conclusions. The structures in this area were built to contain an ordnance blast, but it appears from inspection that no blast or demolition ever occurred. These structures were probably used for a short period of time for the disassembly of live ordnance. This would explain the lack of damage to the bunkers.

Recommendations. Because there was no evidence that ordnance demolition occurred in this area, no further work under the Installation Restoration program is recommended.

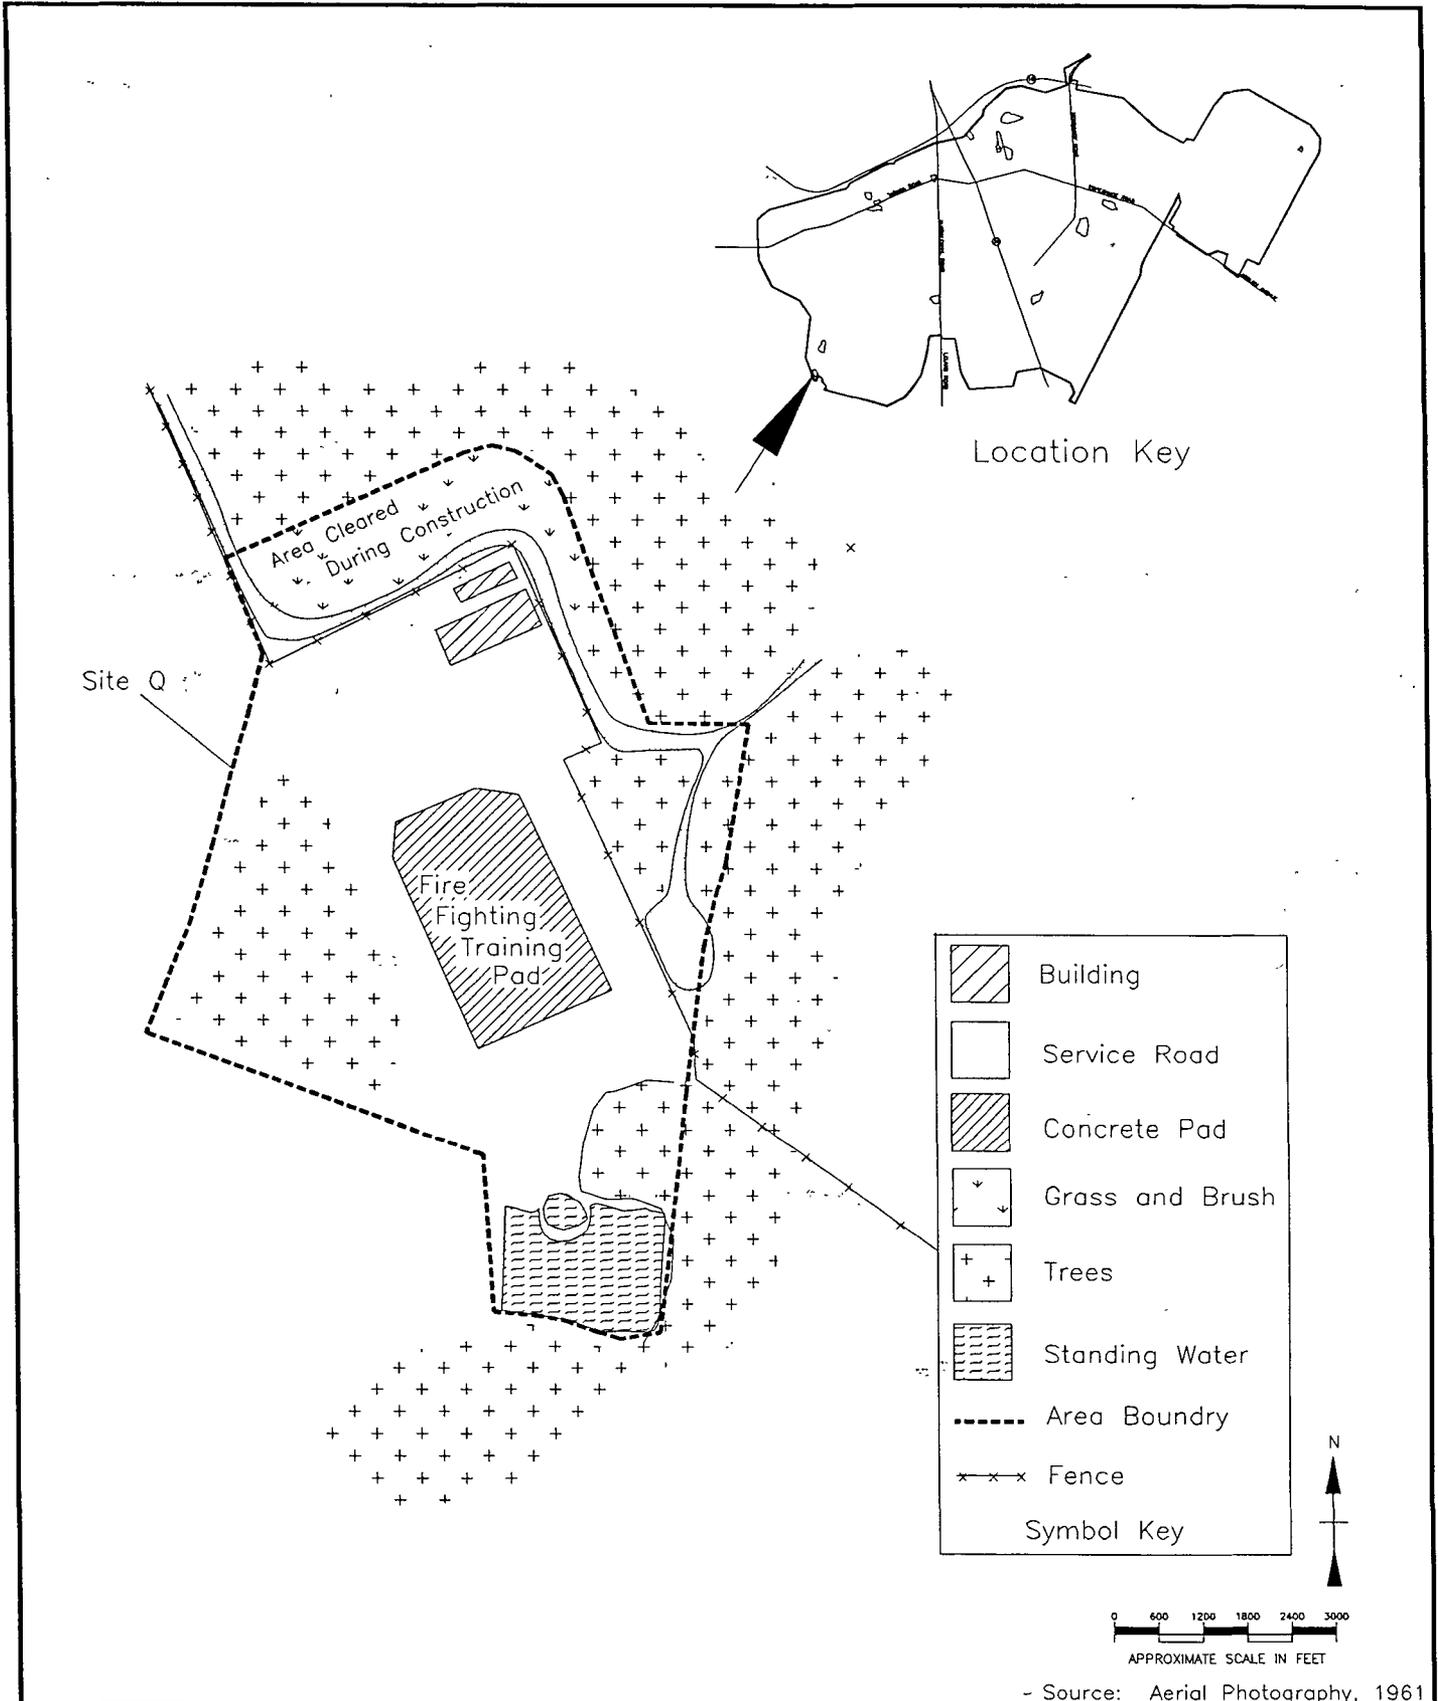
Figure 12 -  
Site Q - Fire Training

- ◆ 1953/1961/1974: *"Pre-site; wooded area." No photographs available.*
- ◆ 1981: *"Horizontal tanks; open storage; dark stains; impoundment; structure centrally located on a concrete pad." The tanks were used in fire fighting training; the dark stains appear to be shadows cast by the training structure which is over 100 feet tall.*
- ◆ 1987: No coverage.

Conclusions. This area was developed in 1975 by the Military Sealift Command as a fire training facility.

Recommendations. No further work under the Installation Restoration program is recommended. However, because the area is located on station property, NWS Earle personnel should ensure that the Military Sealift Command is complying with state and federal regulations.
