Five Year Review Report

**Naval Station Newport
(Formerly NETC Newport)**

Newport, Rhode Island

**FIVE YEAR REVIEW REPORT
FOR
NAVAL STATION NEWPORT
(FORMERLY NETC NEWPORT)
NEWPORT, RHODE ISLAND
COMPREHENSIVE LONG-TERM
ENVIRONMENTAL ACTION NAVY (CLEAN) CONTRACT**

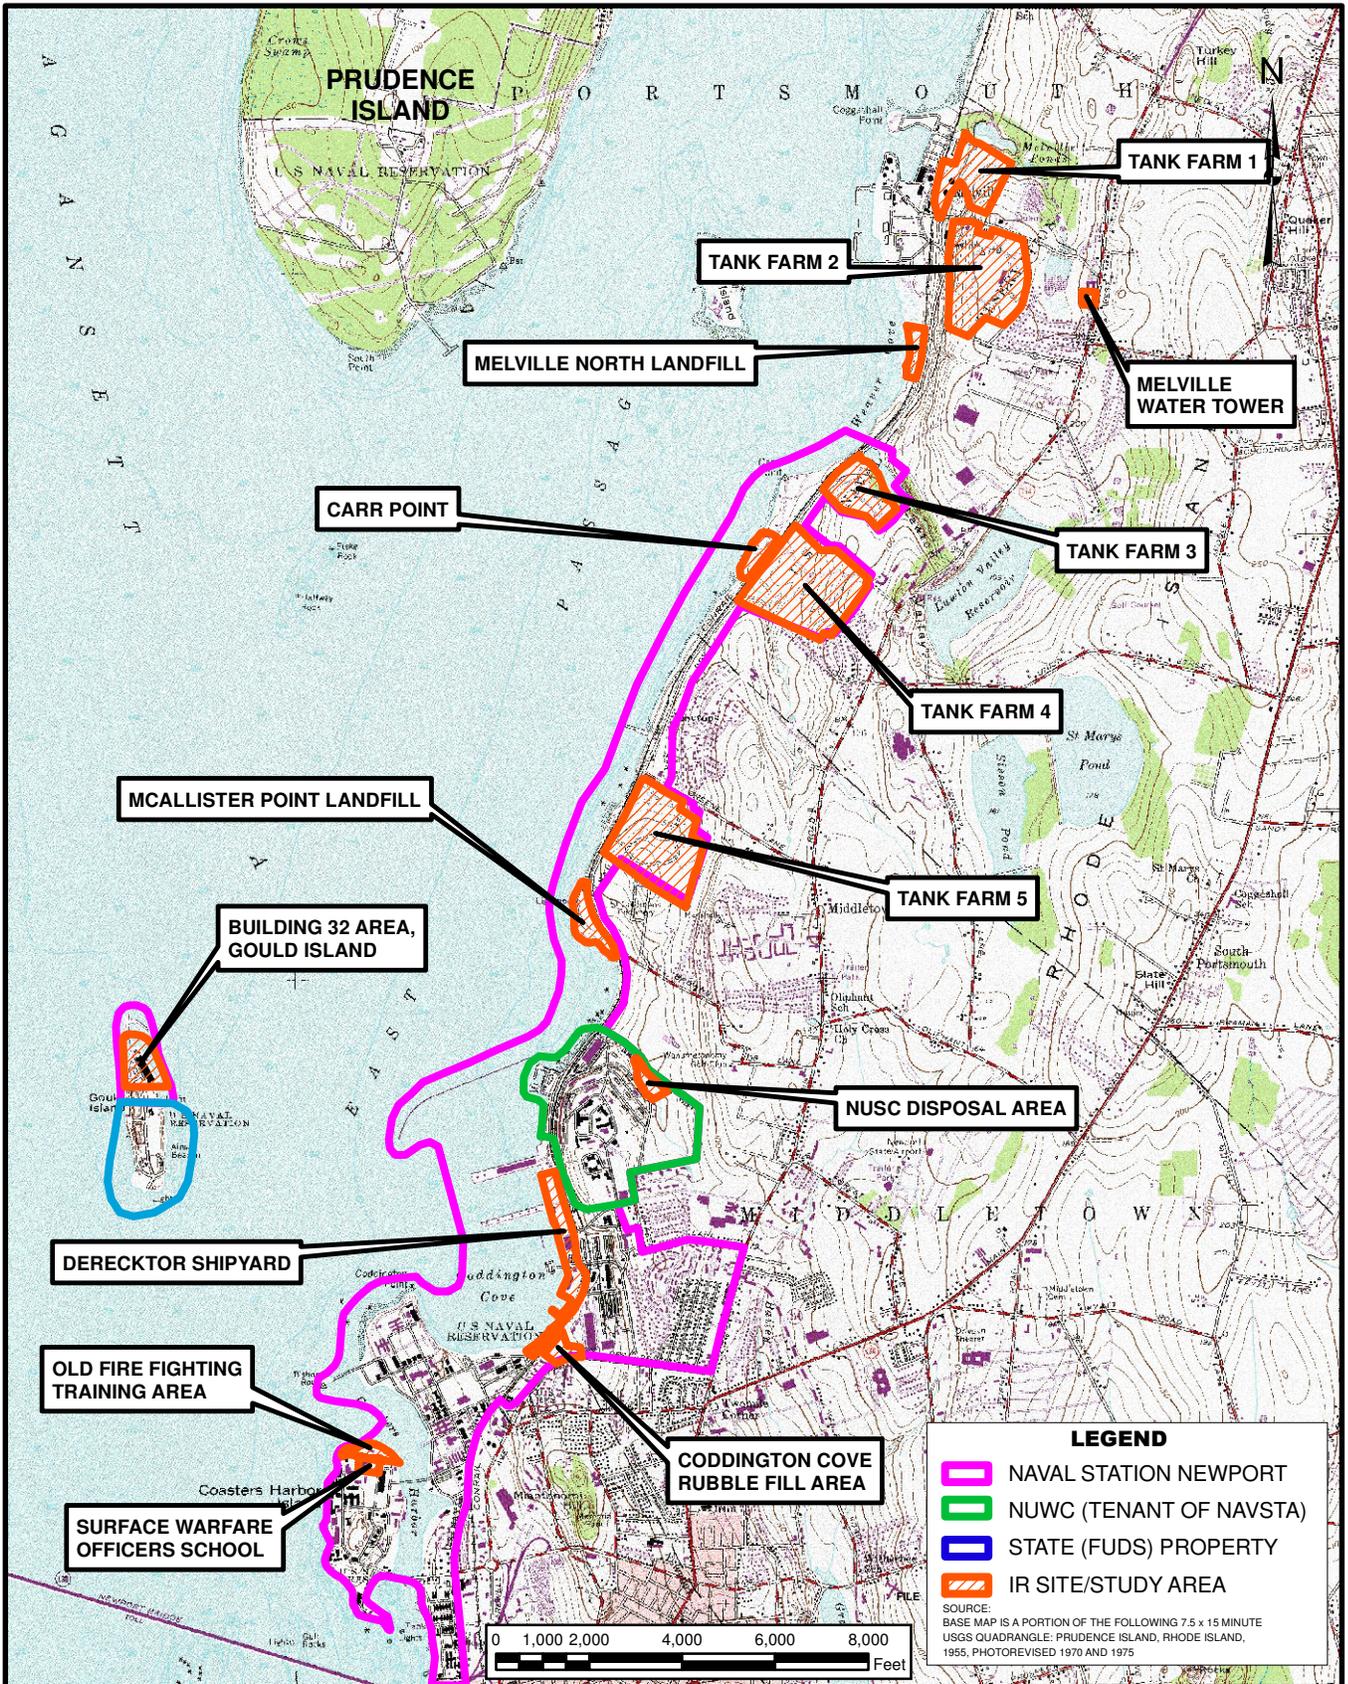
SCALE AS NOTED	
FILE	
\\..15YrRev_LOCUS.MXD	
REV	DATE
0	04/23/09
FIGURE NUMBER	
FIGURE NO. 1-1

SITE LOCUS (SITE STUDY AREAS)
 FIVE-YEAR REVIEW REPORT
 NAVAL STATION NEWPORT
 NEWPORT, RHODE ISLAND

These two sites (see Figure 1-1) were included in the first and second five-year reviews of NAVSTA Newport, as appropriate for their progress in remediation, pursuant to the U.S. Environmental Protection Agency's (USEPA) five-year review guidance. The other NAVSTA Newport sites and study areas (defined in the Federal Interagency Facility Agreement 1992, FFA), are in various stages of pre-remedial investigation and are therefore not included in detail in this five-year review. The locations of the sites and study areas listed below are shown on Figure 1-1. Each of the listed sites is briefly discussed in Section 4 of this document along with the progress of the various investigations underway. These sites and study areas include:

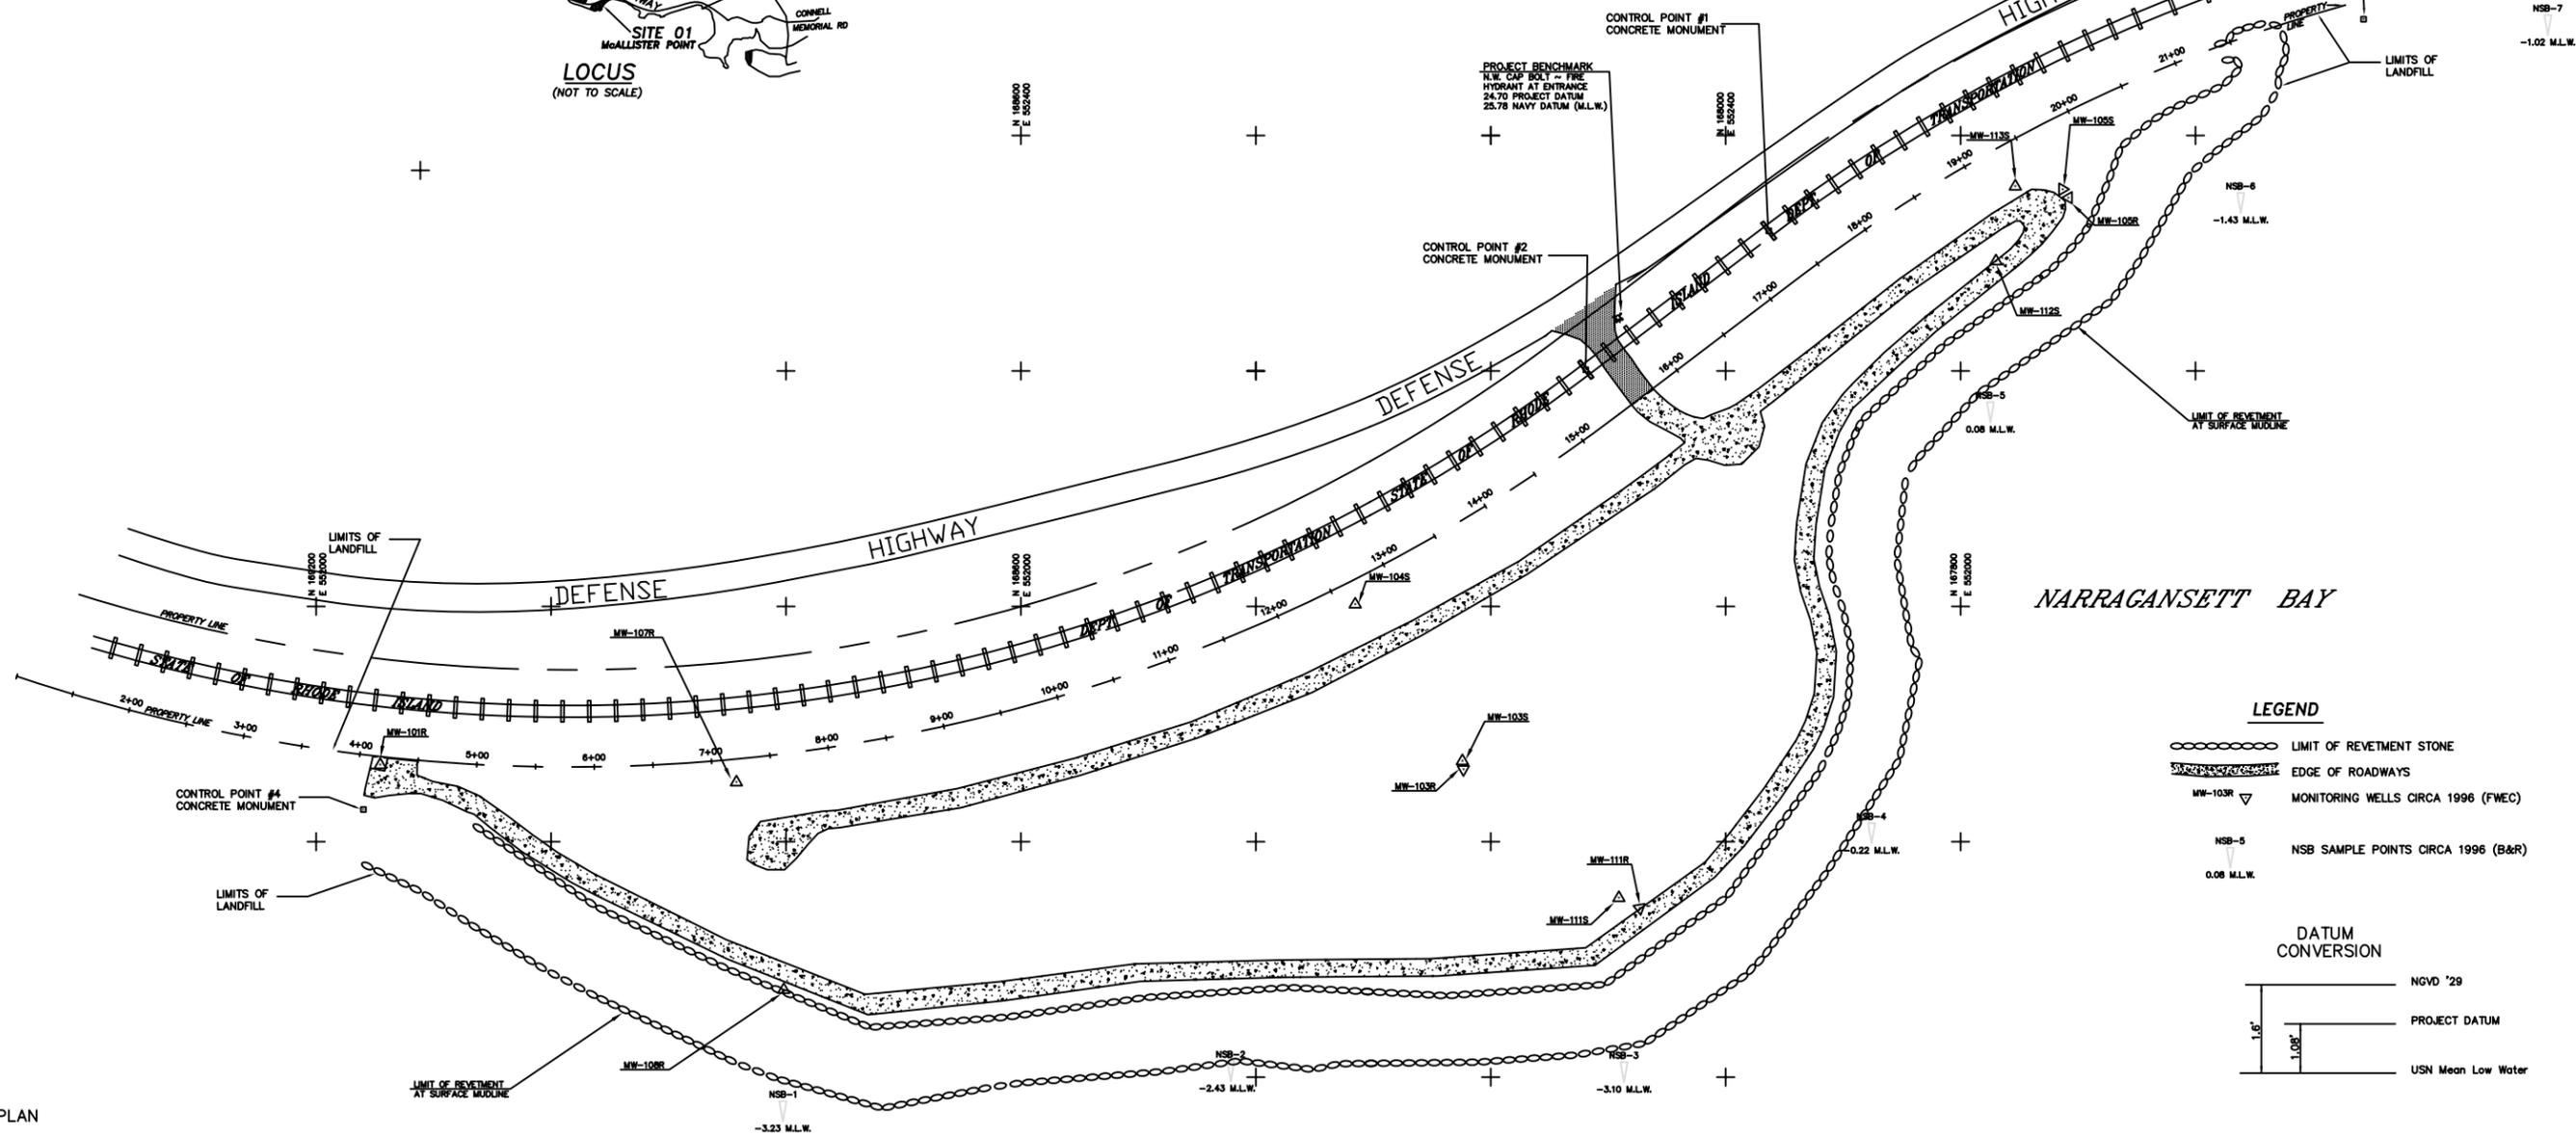
MCALLISTER POINT LANDFILL	
NAVSTA NEWPORT - FIVE-YEAR REVIEW	
NEWPORT, RHODE ISLAND	
DRAWN BY:	D.W. MACDOUGALL
CHECKED BY:	S. PARKER
SCALE:	AS NOTED
REV.:	0
DATE:	APRIL 20, 2009
FILE NO.:	\01636\0210\FIG_2-1.DWG

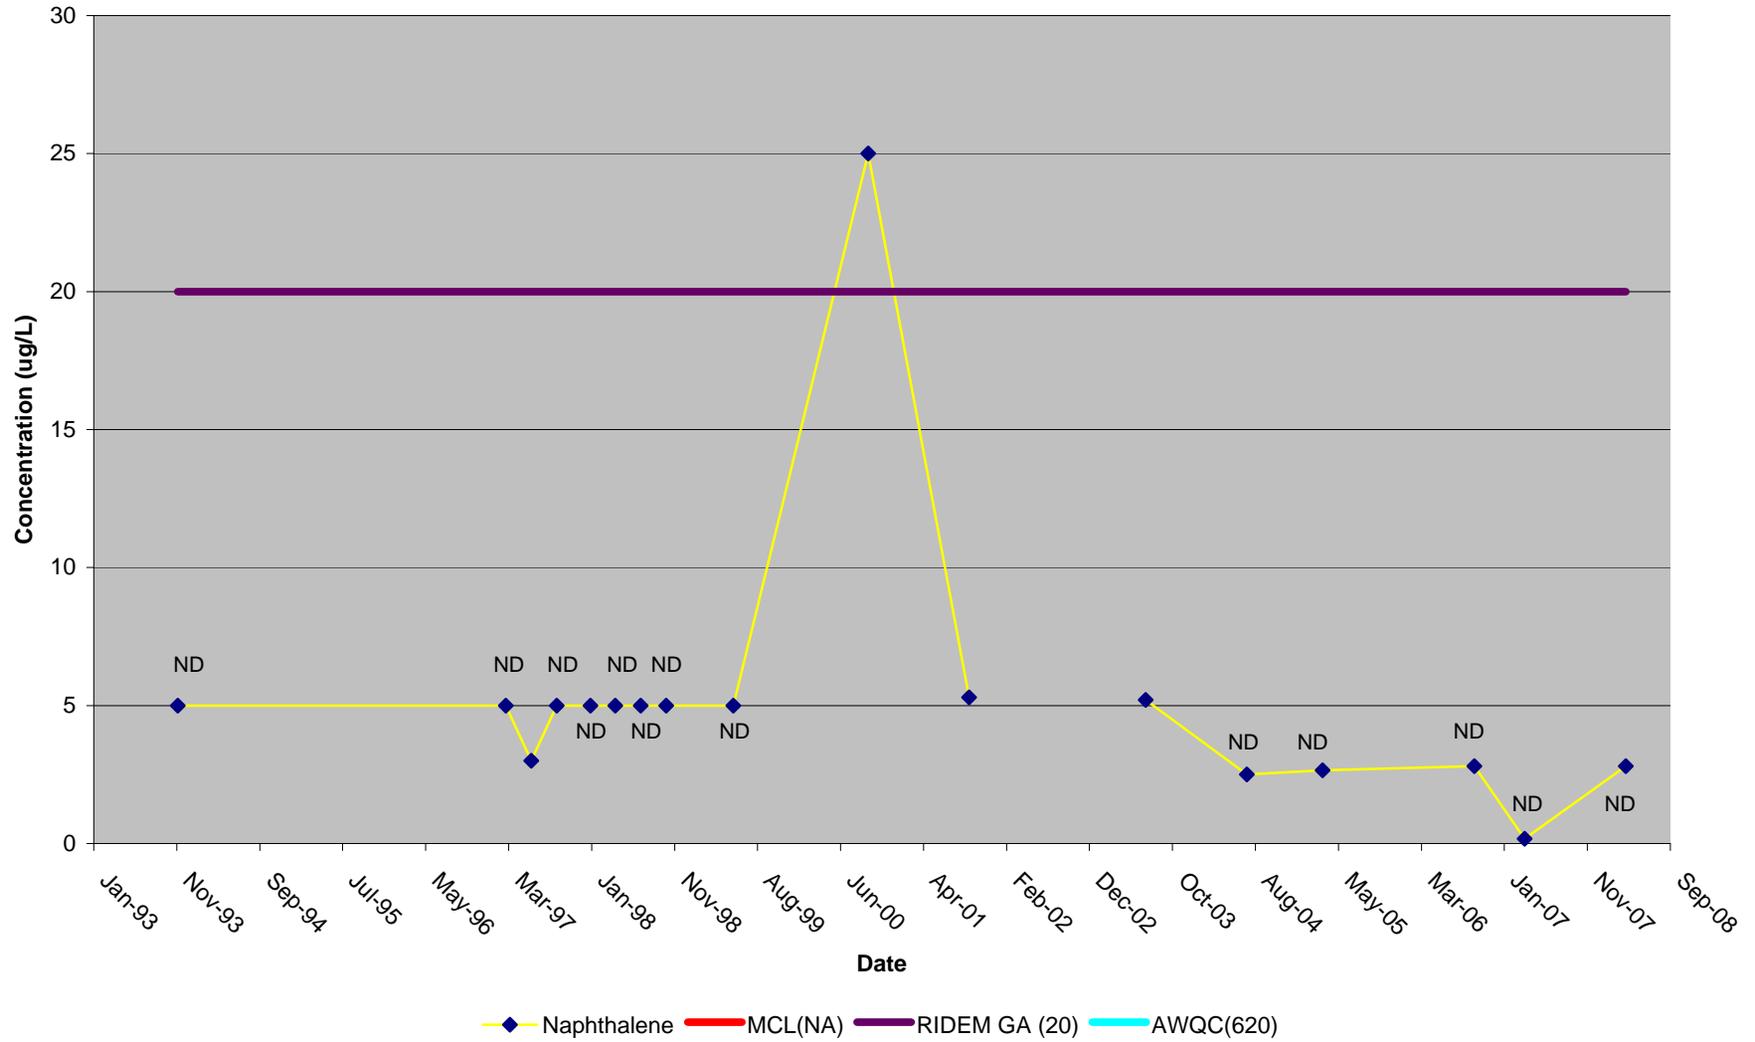
NAPHTHALENE IN GROUNDWATER, MW101R
SITE 01 McALLISTER POINT LANDFILL
NAVAL STATION NEWPORT
FIVE YEAR REVIEW REPORT

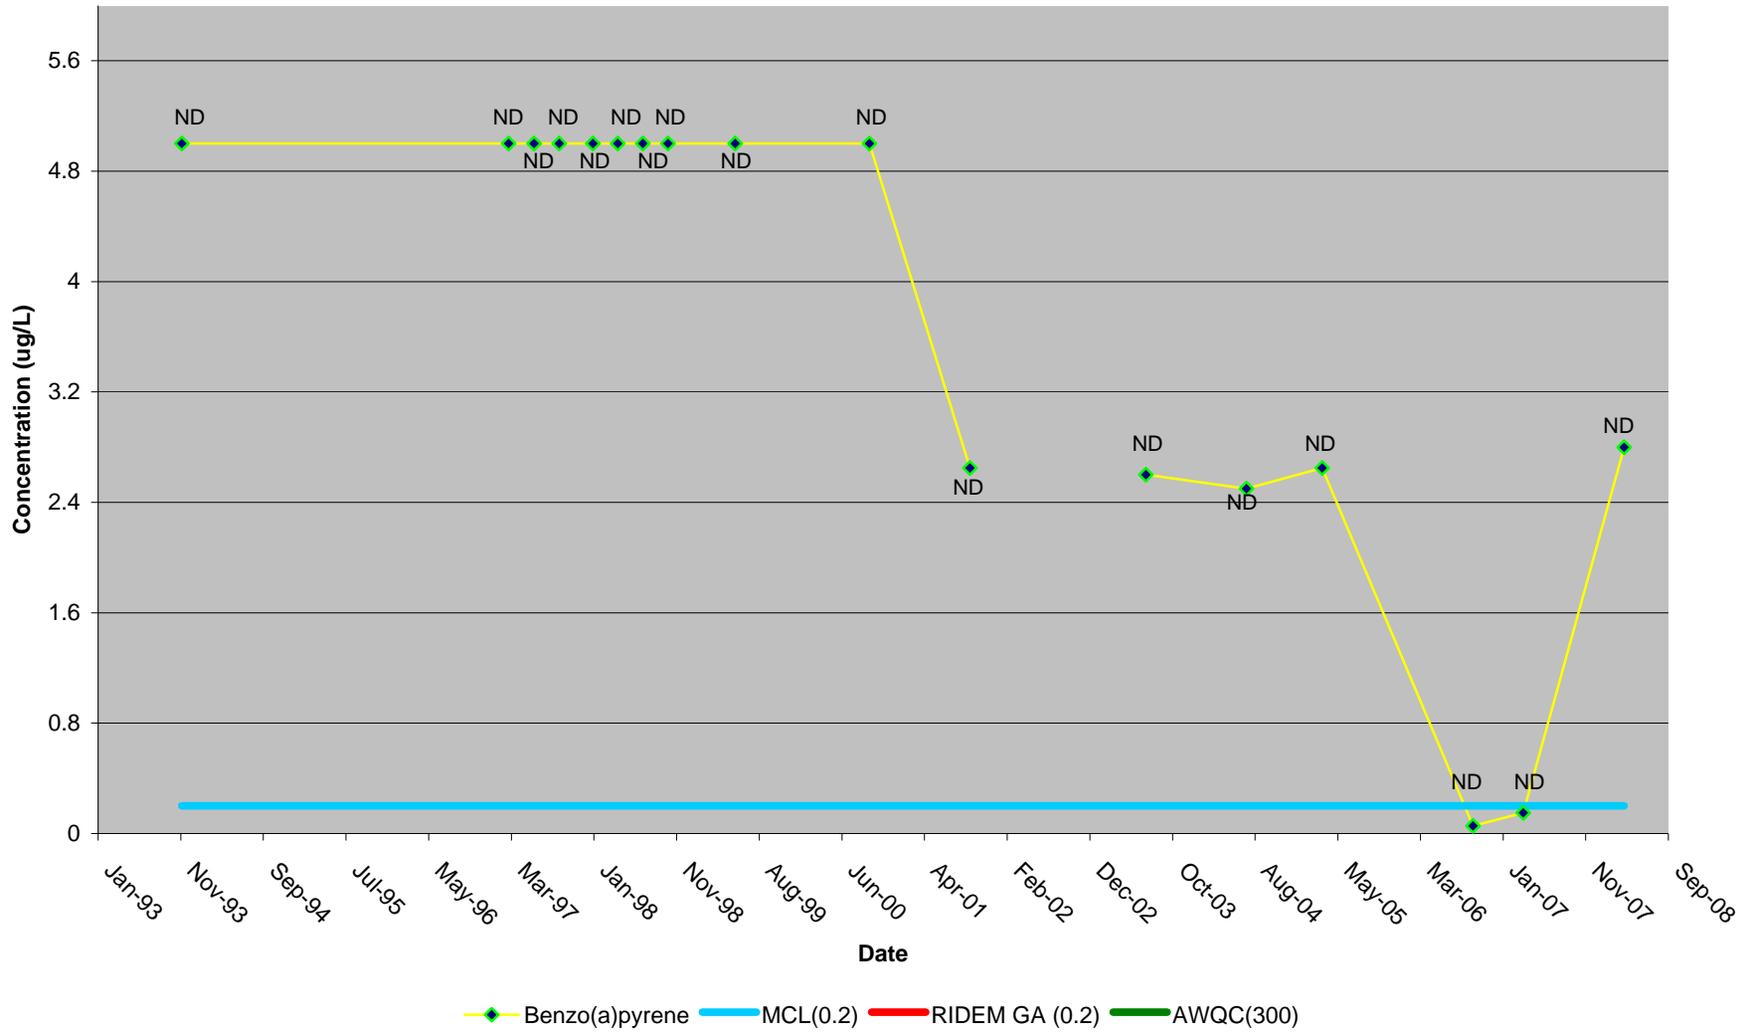
APPENDIX F-1: GROUNDWATER
FIGURE F-1.1-11

BENZO(A)PYRENE IN GROUNDWATER, MW101R
SITE 01 McALLISTER POINT LANDFILL
NAVAL STATION NEWPORT
FIVE YEAR REVIEW REPORT

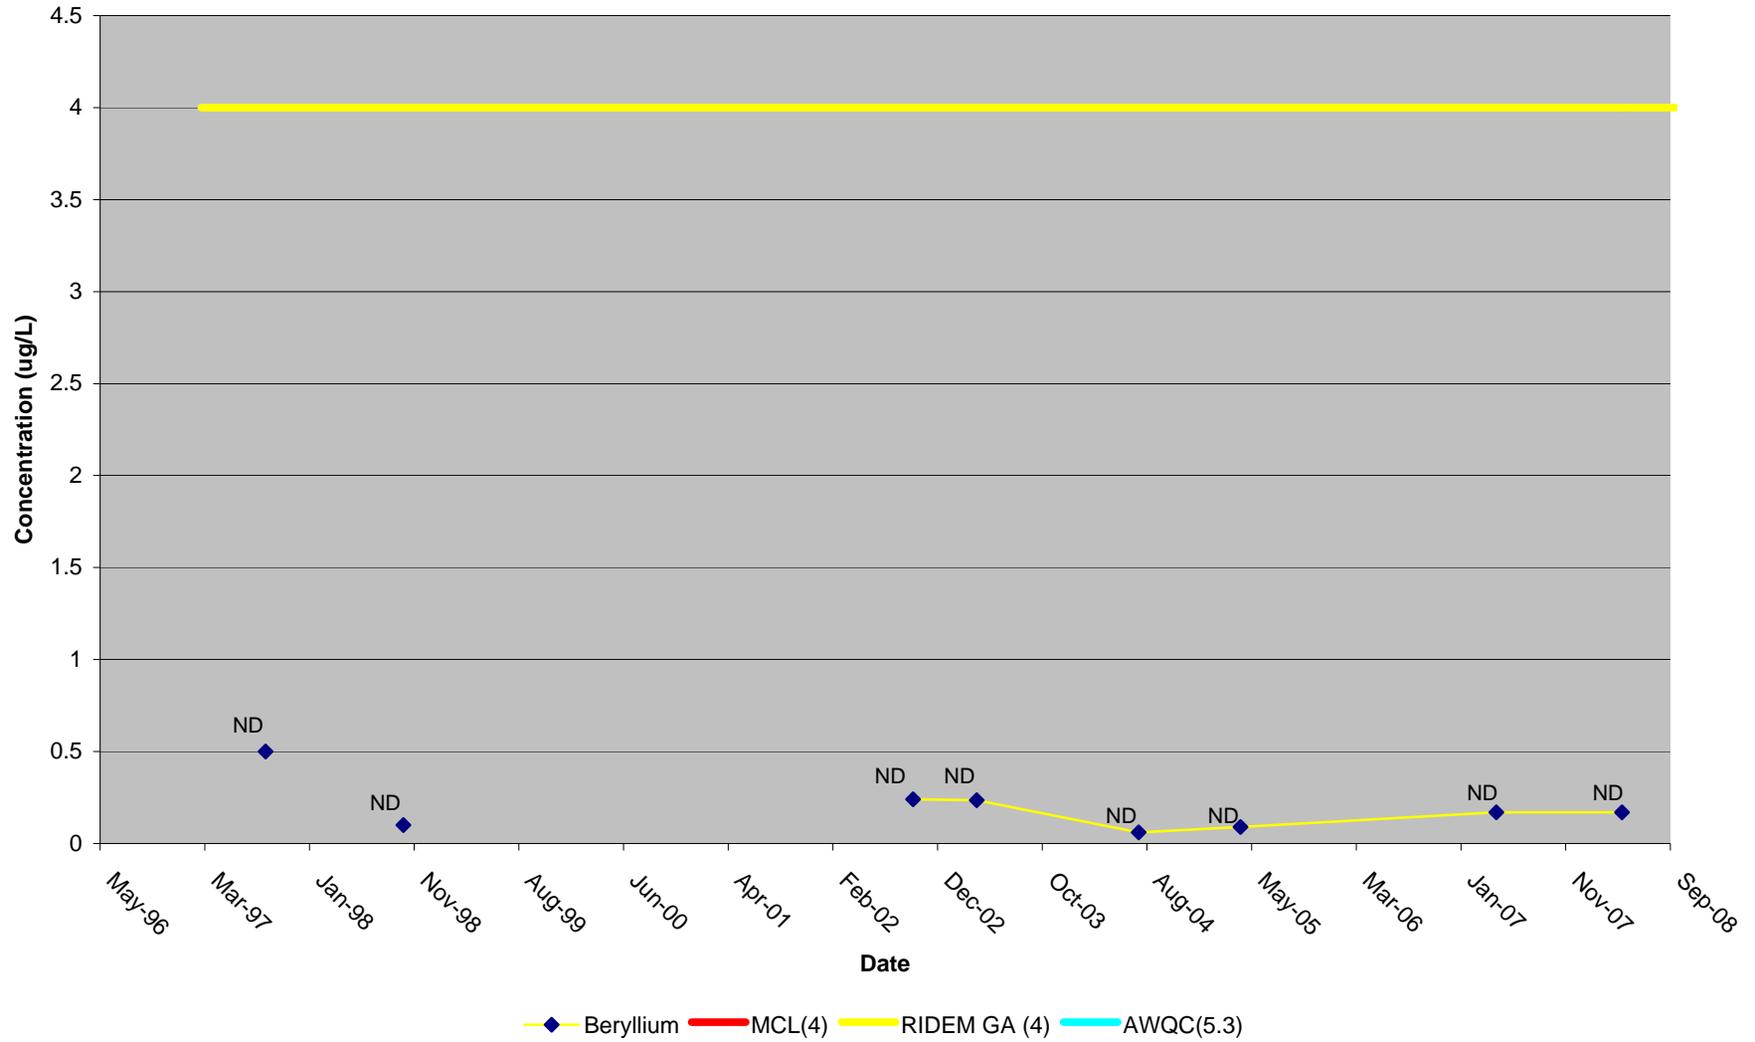
BERYLLIUM IN GROUNDWATER, MW103R
SITE 01 McALLISTER POINT LANDFILL
NAVAL STATION NEWPORT
FIVE YEAR REVIEW REPORT

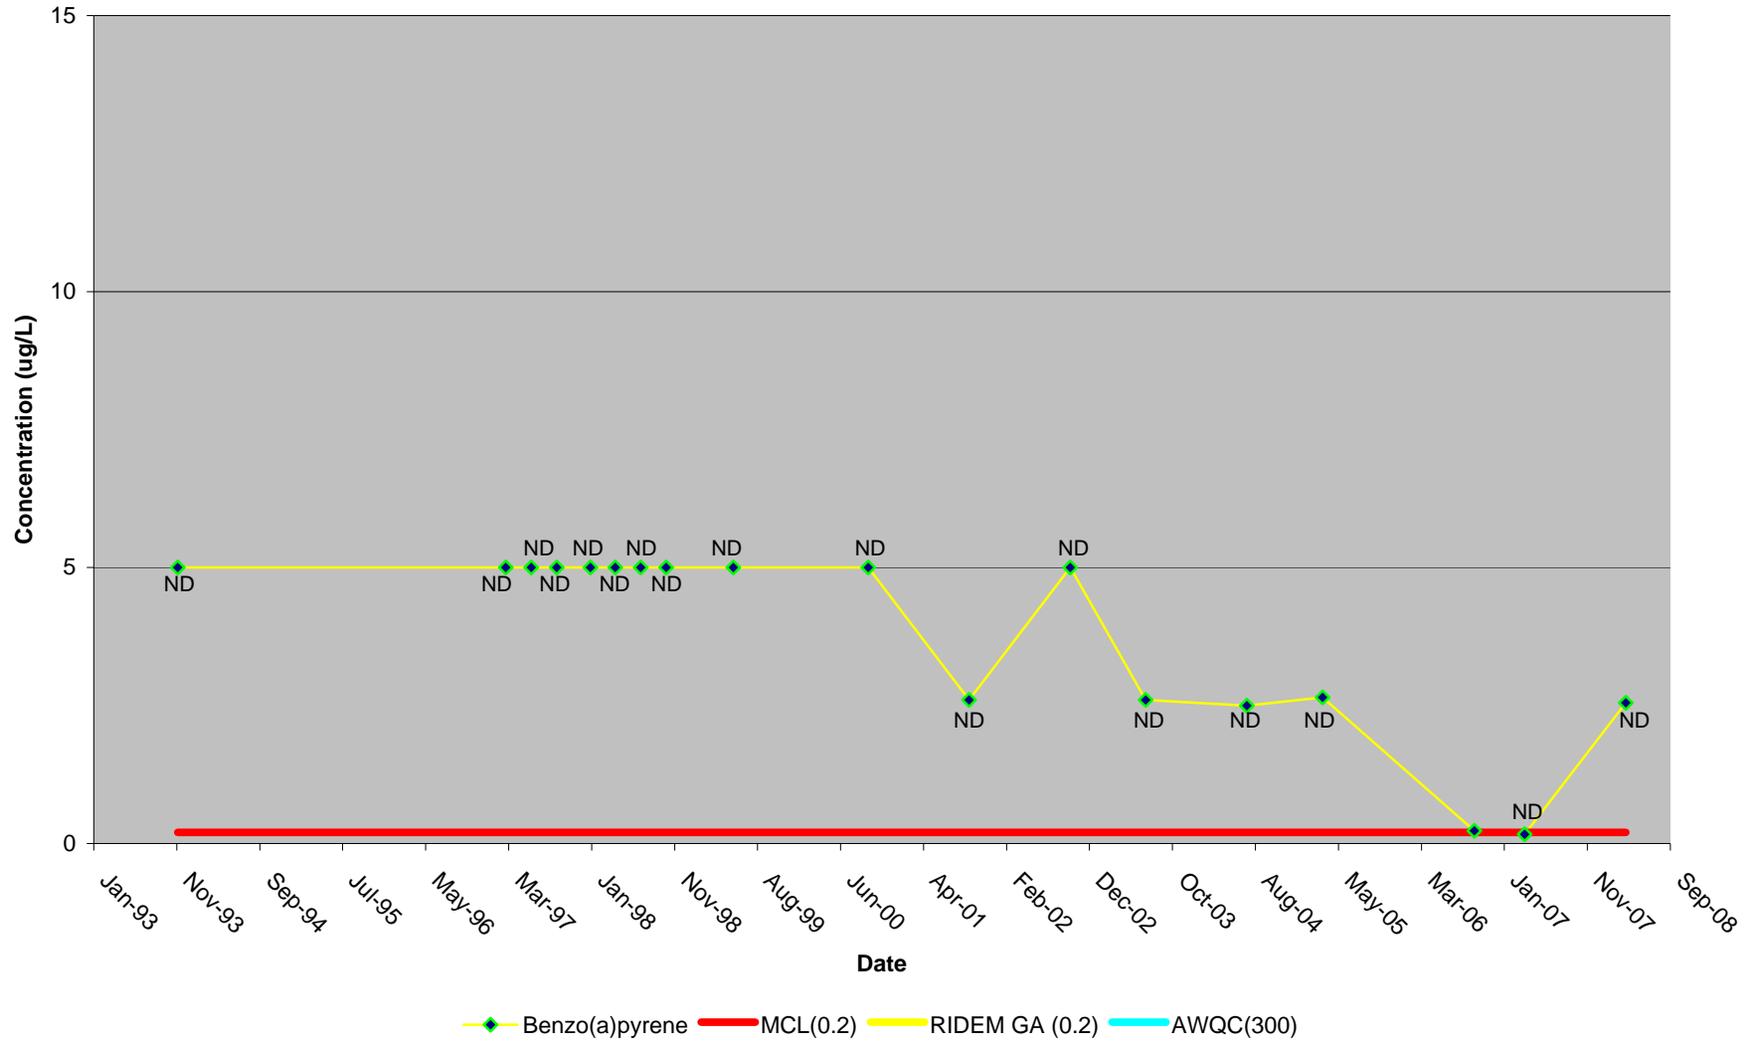
BENZO(A)PYRENE IN GROUNDWATER, MW103R
SITE 01 McALLISTER POINT LANDFILL
NAVAL STATION NEWPORT
FIVE YEAR REVIEW REPORT

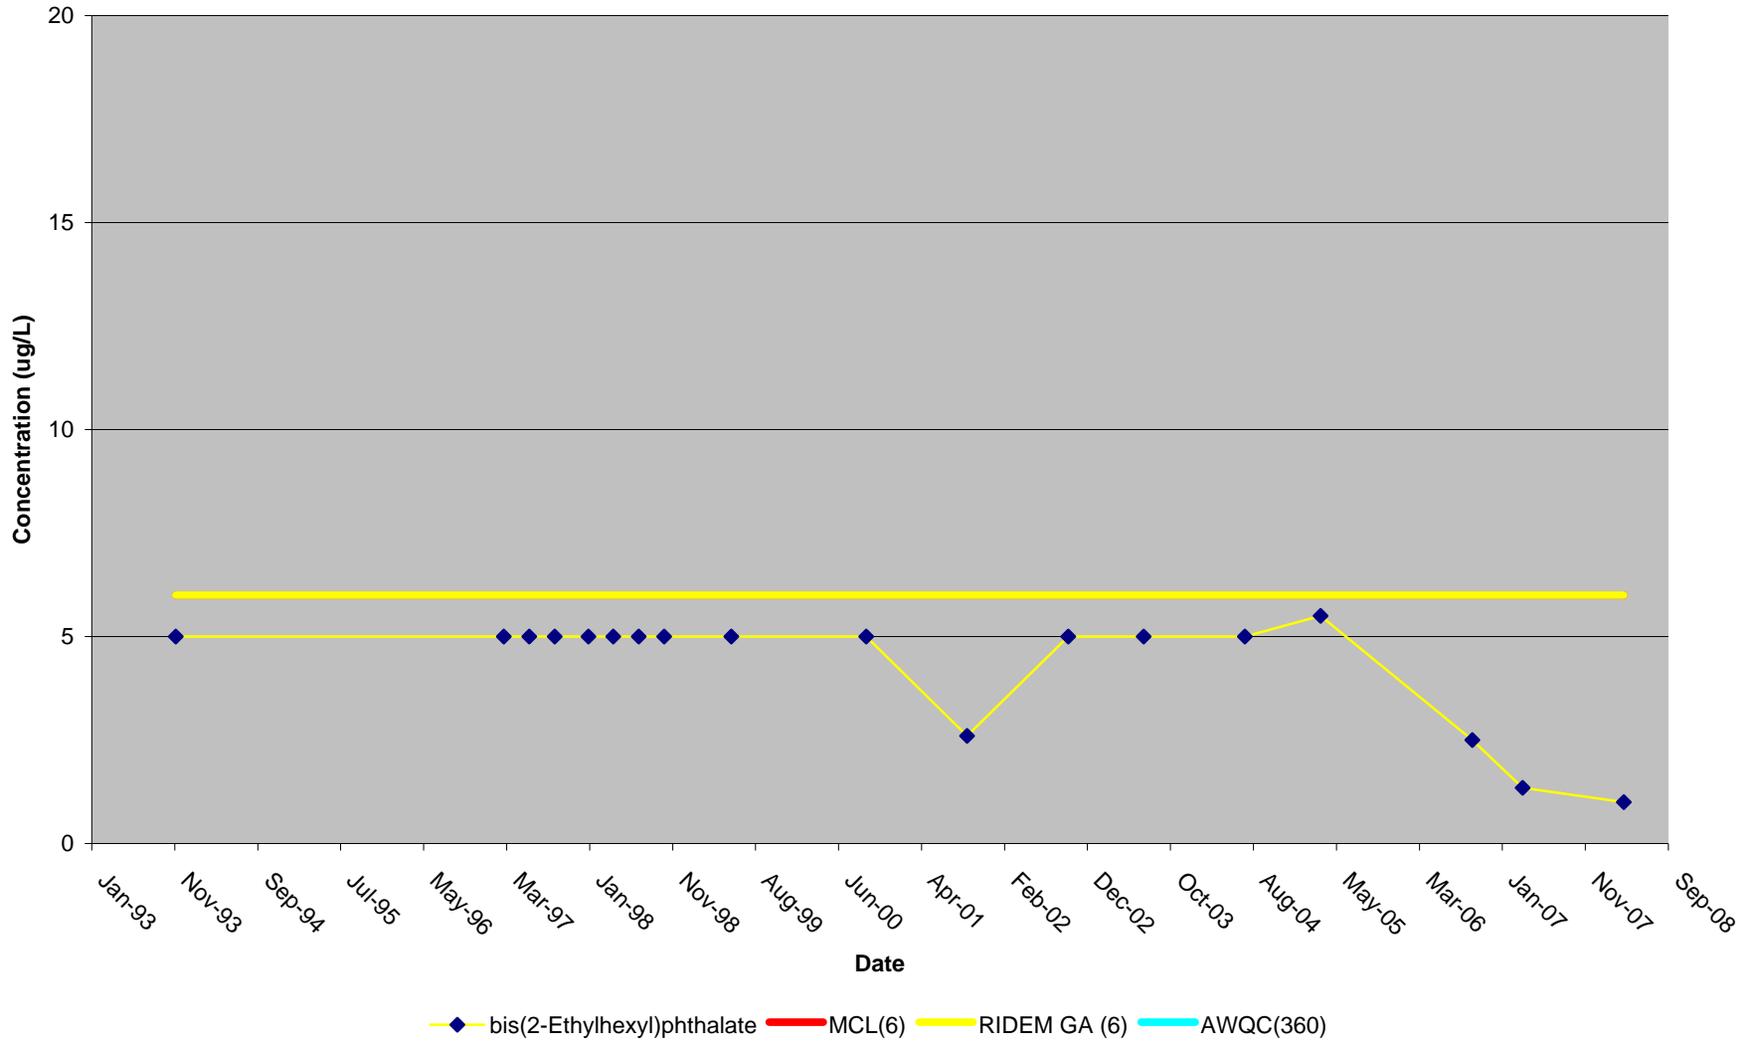
APPENDIX F-1: GROUNDWATER
FIGURE F-1.2-12

BIS(2-ETHYLHEXYL)PHTHALATE IN GROUNDWATER, MW103R
SITE 01 McALLISTER POINT LANDFILL
NAVAL STATION NEWPORT
FIVE YEAR REVIEW REPORT

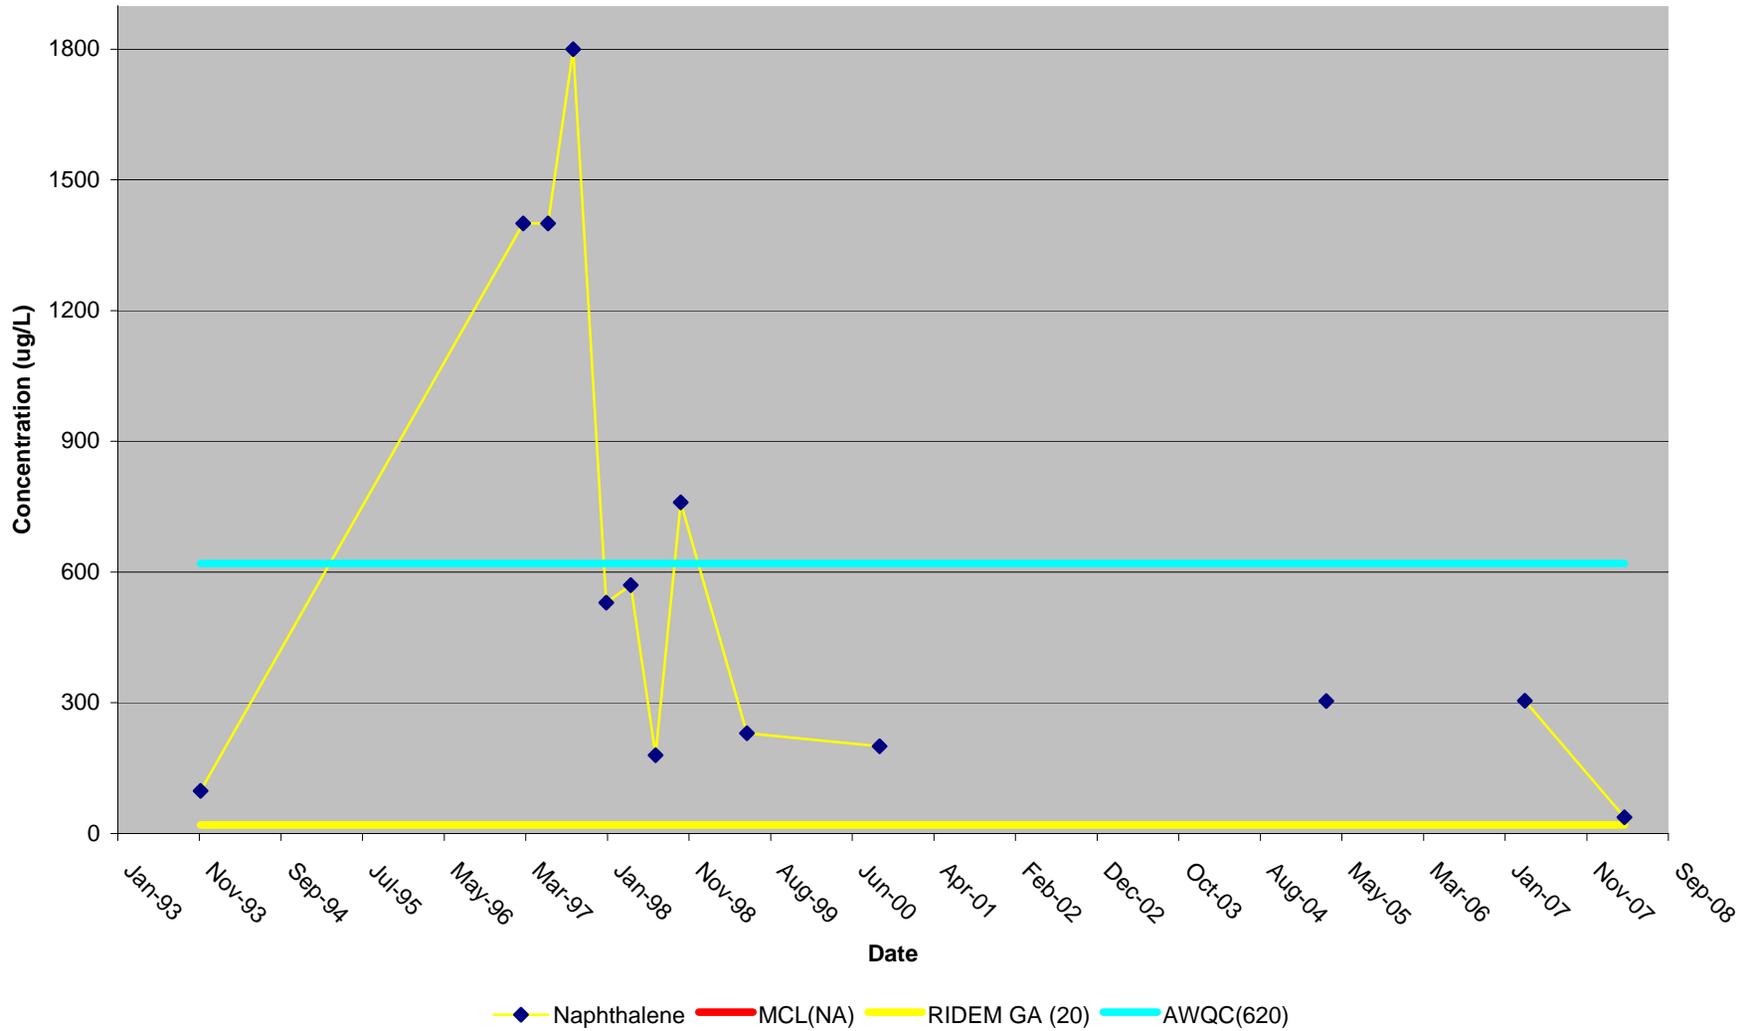
NAPHTHALENE IN GROUNDWATER, MW103S
SITE 01 McALLISTER POINT LANDFILL
NAVAL STATION NEWPORT
FIVE YEAR REVIEW REPORT

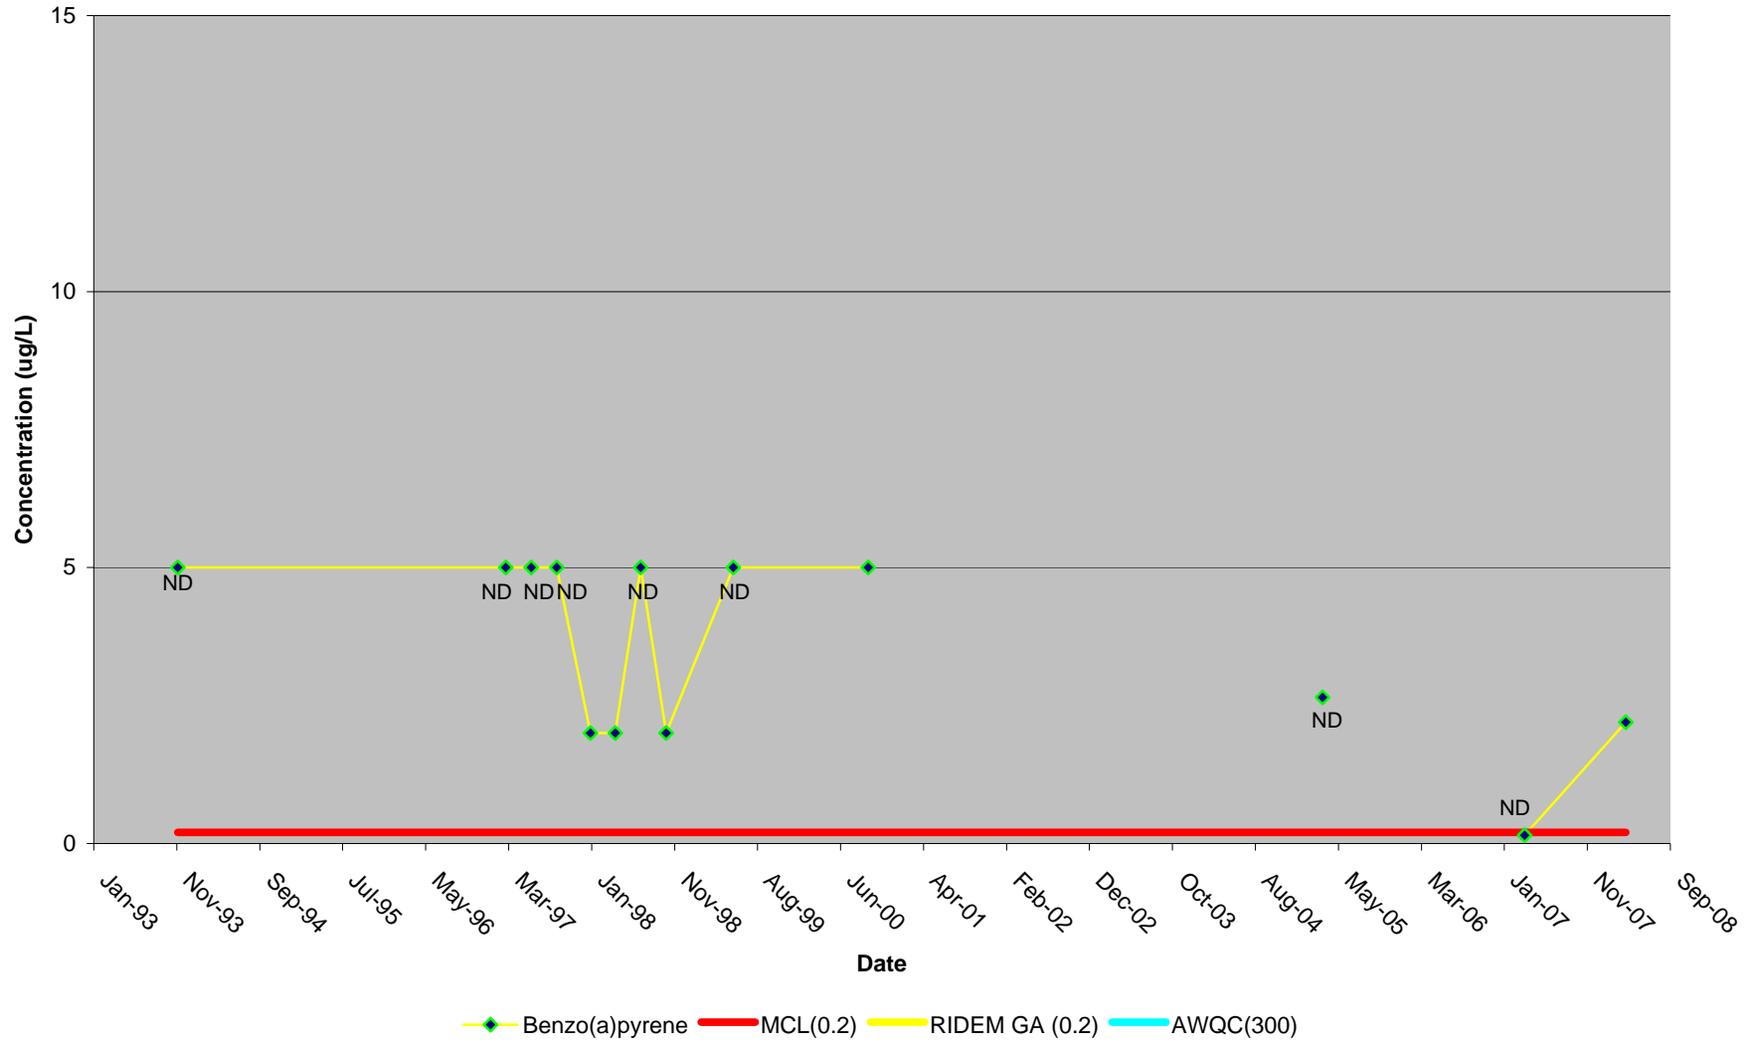
APPENDIX F-1: GROUNDWATER
FIGURE F-1.3-11

BENZO(A)PYRENE IN GROUNDWATER, MW103S
SITE 01 McALLISTER POINT LANDFILL
NAVAL STATION NEWPORT
FIVE YEAR REVIEW REPORT

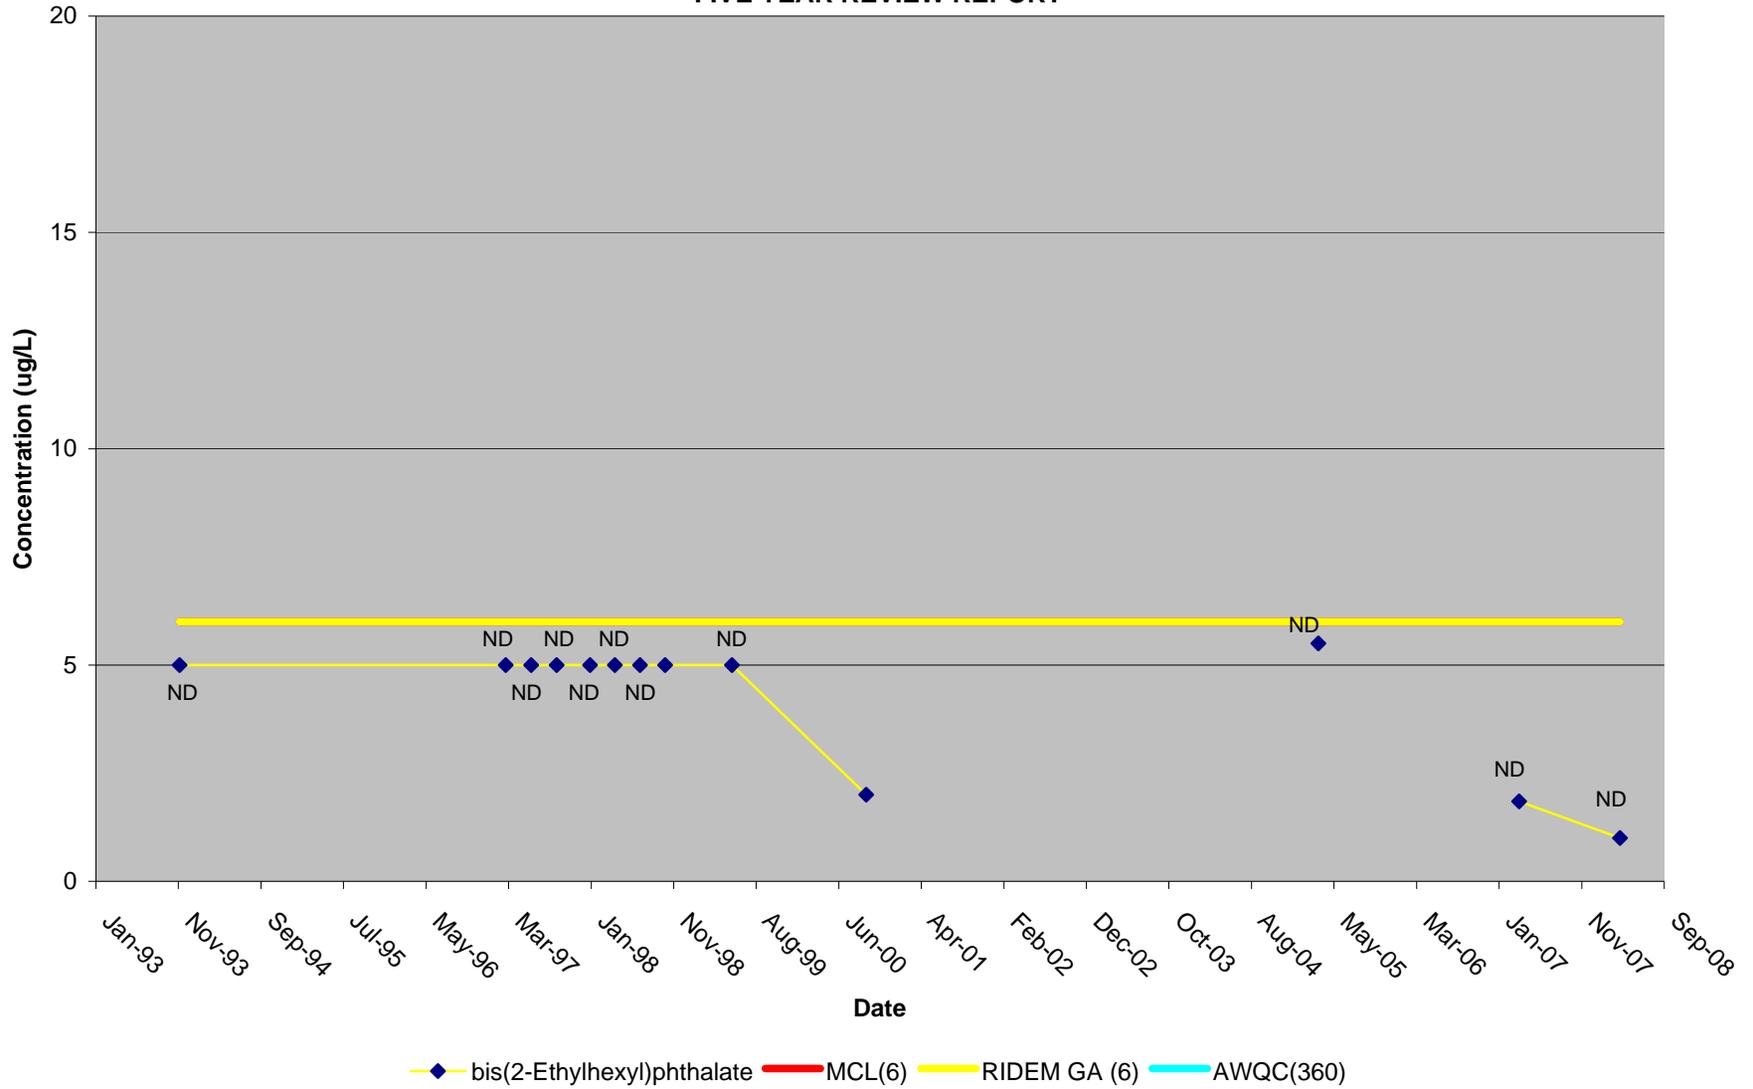
APPENDIX F-1: GROUNDWATER
FIGURE F-1.3-12

BIS(2-ETHYLHEXYL)PHTHALATE IN GROUNDWATER, MW103S
SITE 01 McALLISTER POINT LANDFILL
NAVAL STATION NEWPORT
FIVE YEAR REVIEW REPORT

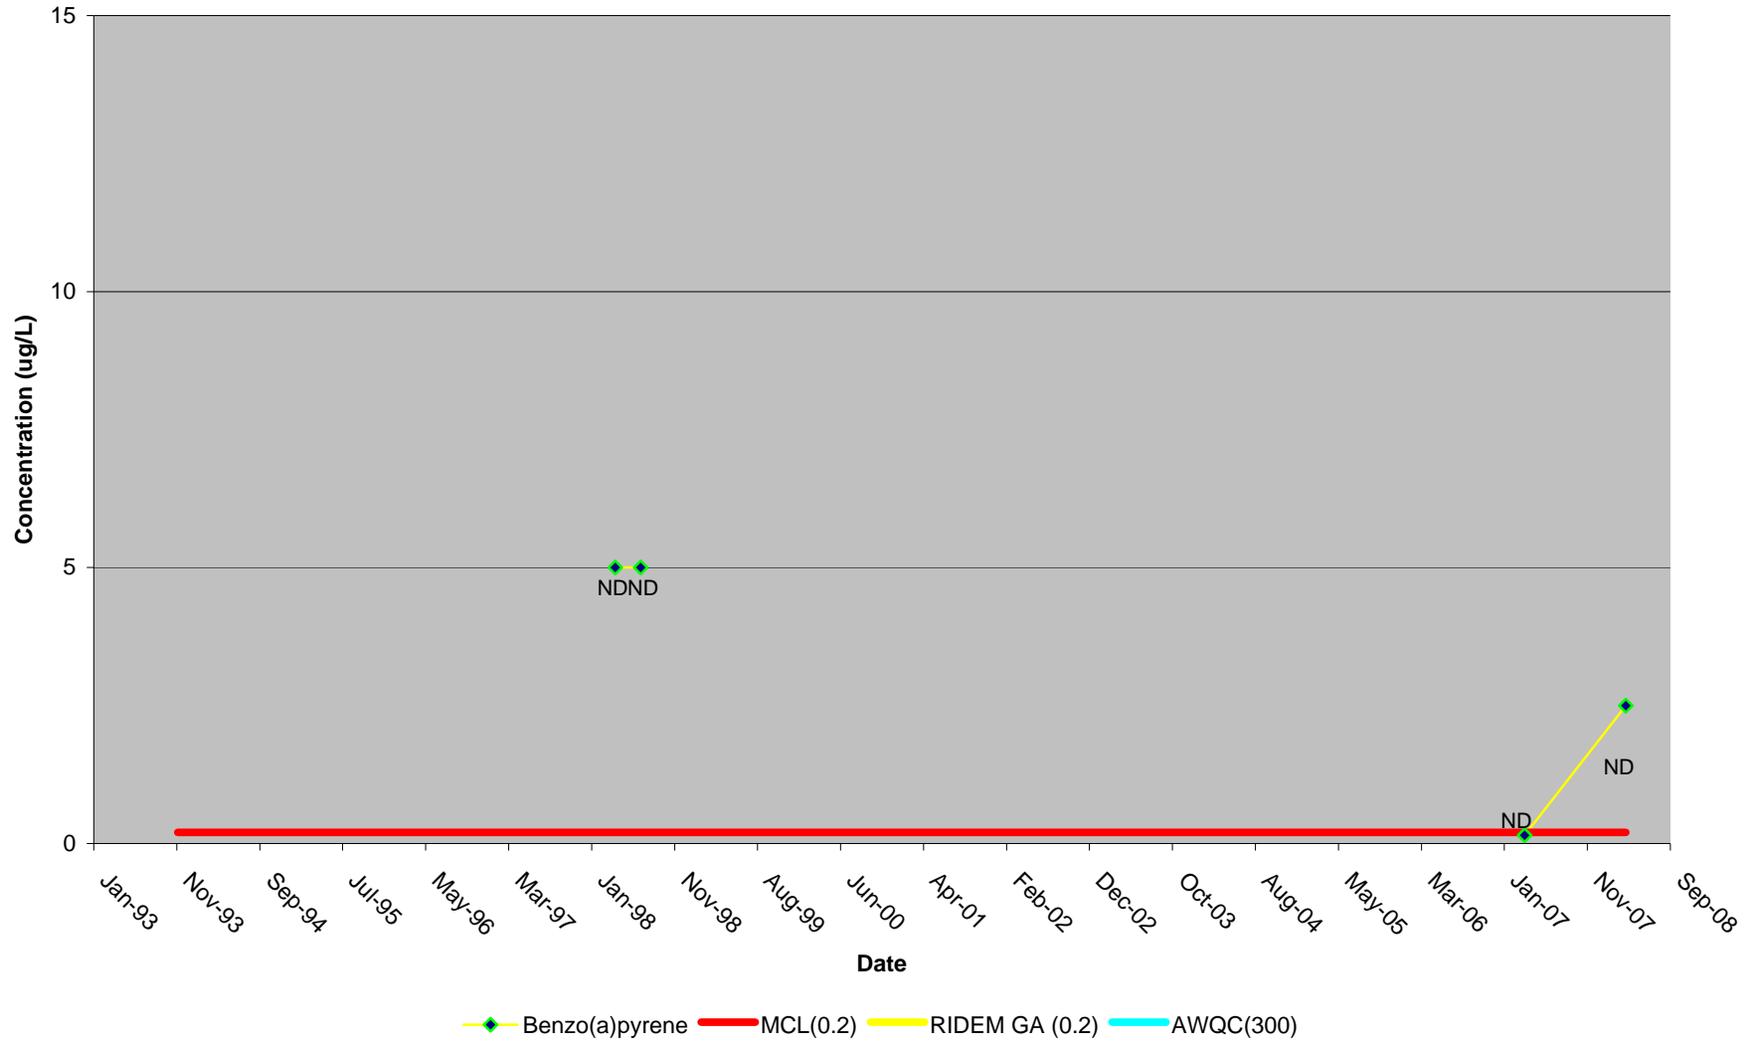
BENZO(A)PYRENE IN GROUNDWATER, MW104S
SITE 01 McALLISTER POINT LANDFILL
NAVAL STATION NEWPORT
FIVE YEAR REVIEW REPORT
