Five Year Review Report

**Naval Station Newport
(Formerly NETC Newport)**

Newport, Rhode Island

**FIVE YEAR REVIEW REPORT
FOR
NAVAL STATION NEWPORT
(FORMERLY NETC NEWPORT)
NEWPORT, RHODE ISLAND
COMPREHENSIVE LONG-TERM
ENVIRONMENTAL ACTION NAVY (CLEAN) CONTRACT**

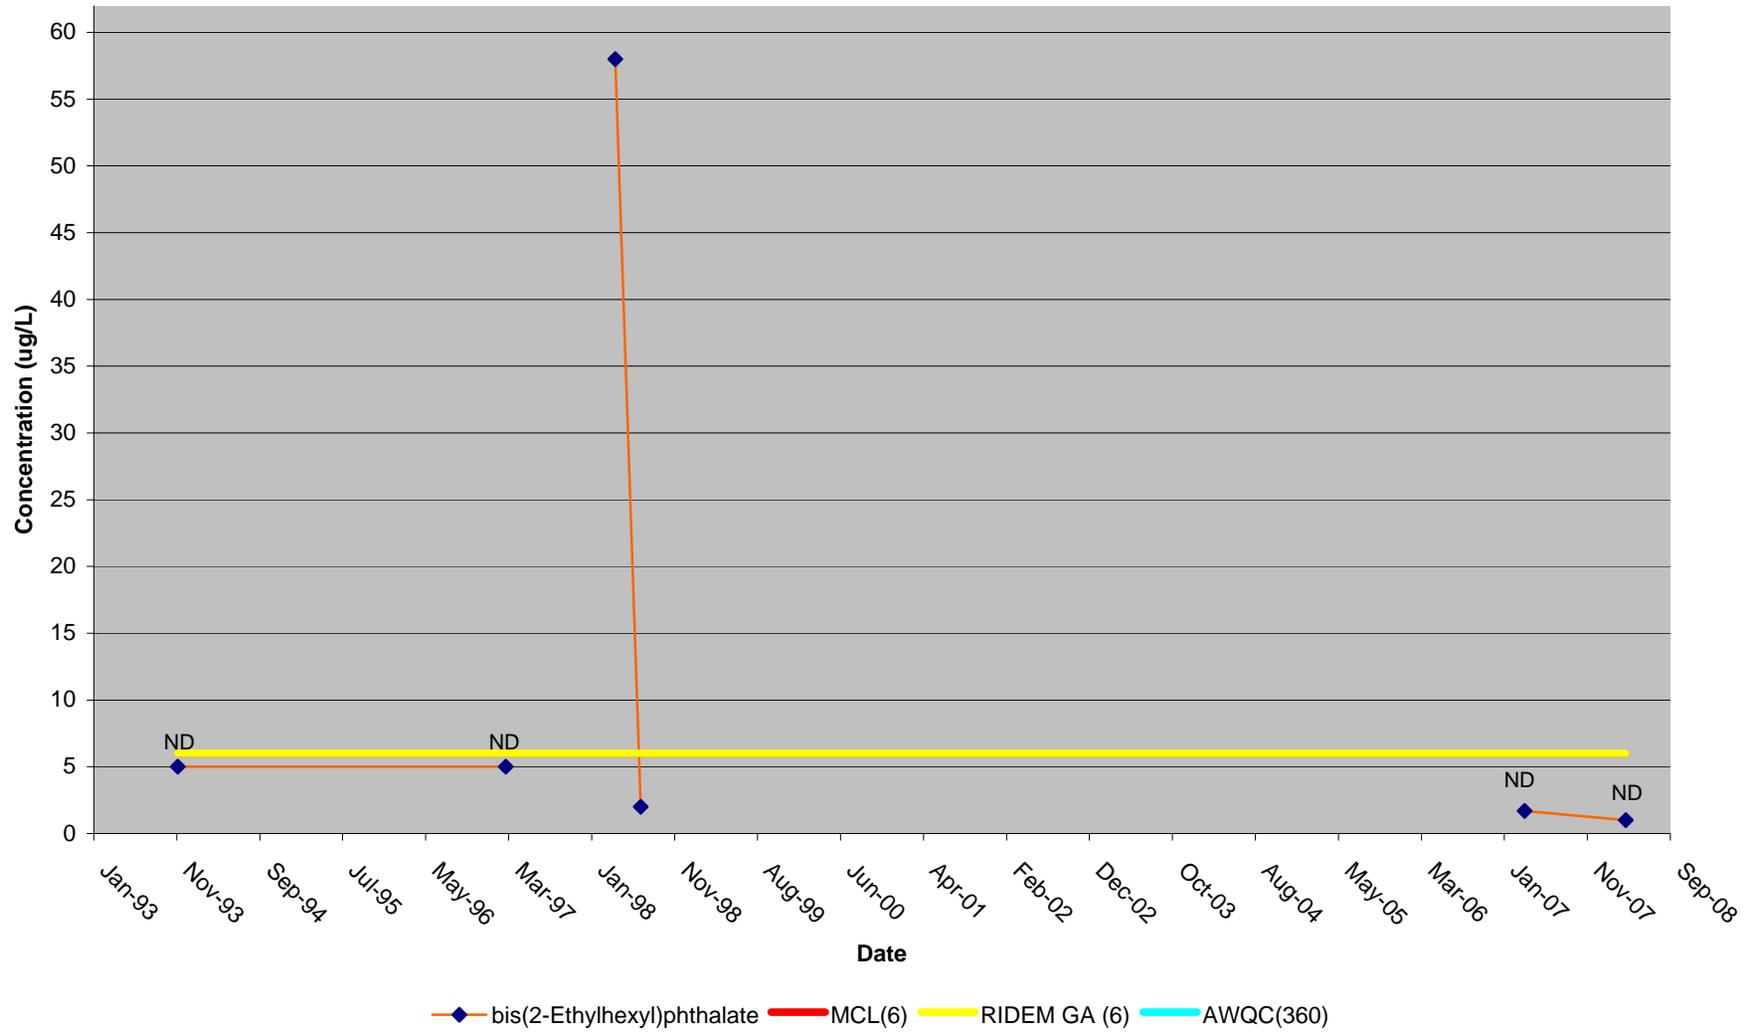
APPENDIX F-1: GROUNDWATER
FIGURE F-1.4-12

BIS(2-ETHYLHEXYL)PHTHALATE IN GROUNDWATER, MW104S
SITE 01 McALLISTER POINT LANDFILL
NAVAL STATION NEWPORT
FIVE YEAR REVIEW REPORT

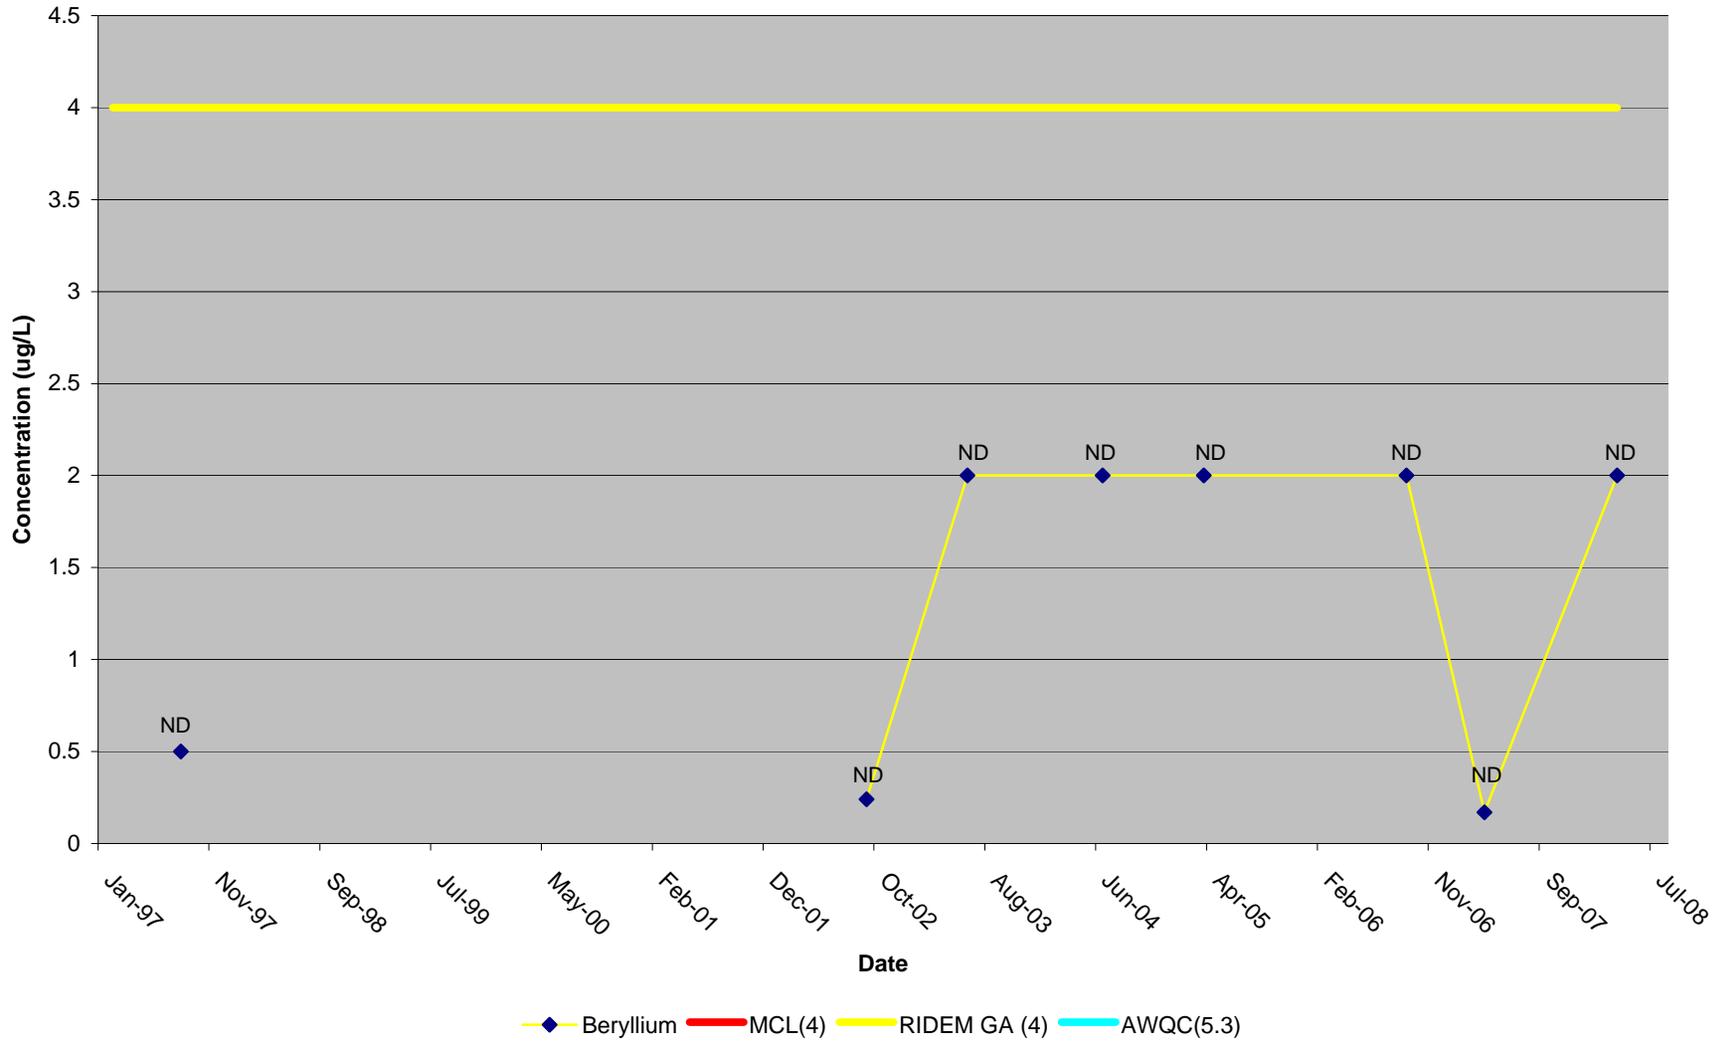
BERYLLIUM IN GROUNDWATER, MW105R
SITE 01 McALLISTER POINT LANDFILL
NAVAL STATION NEWPORT
FIVE YEAR REVIEW REPORT

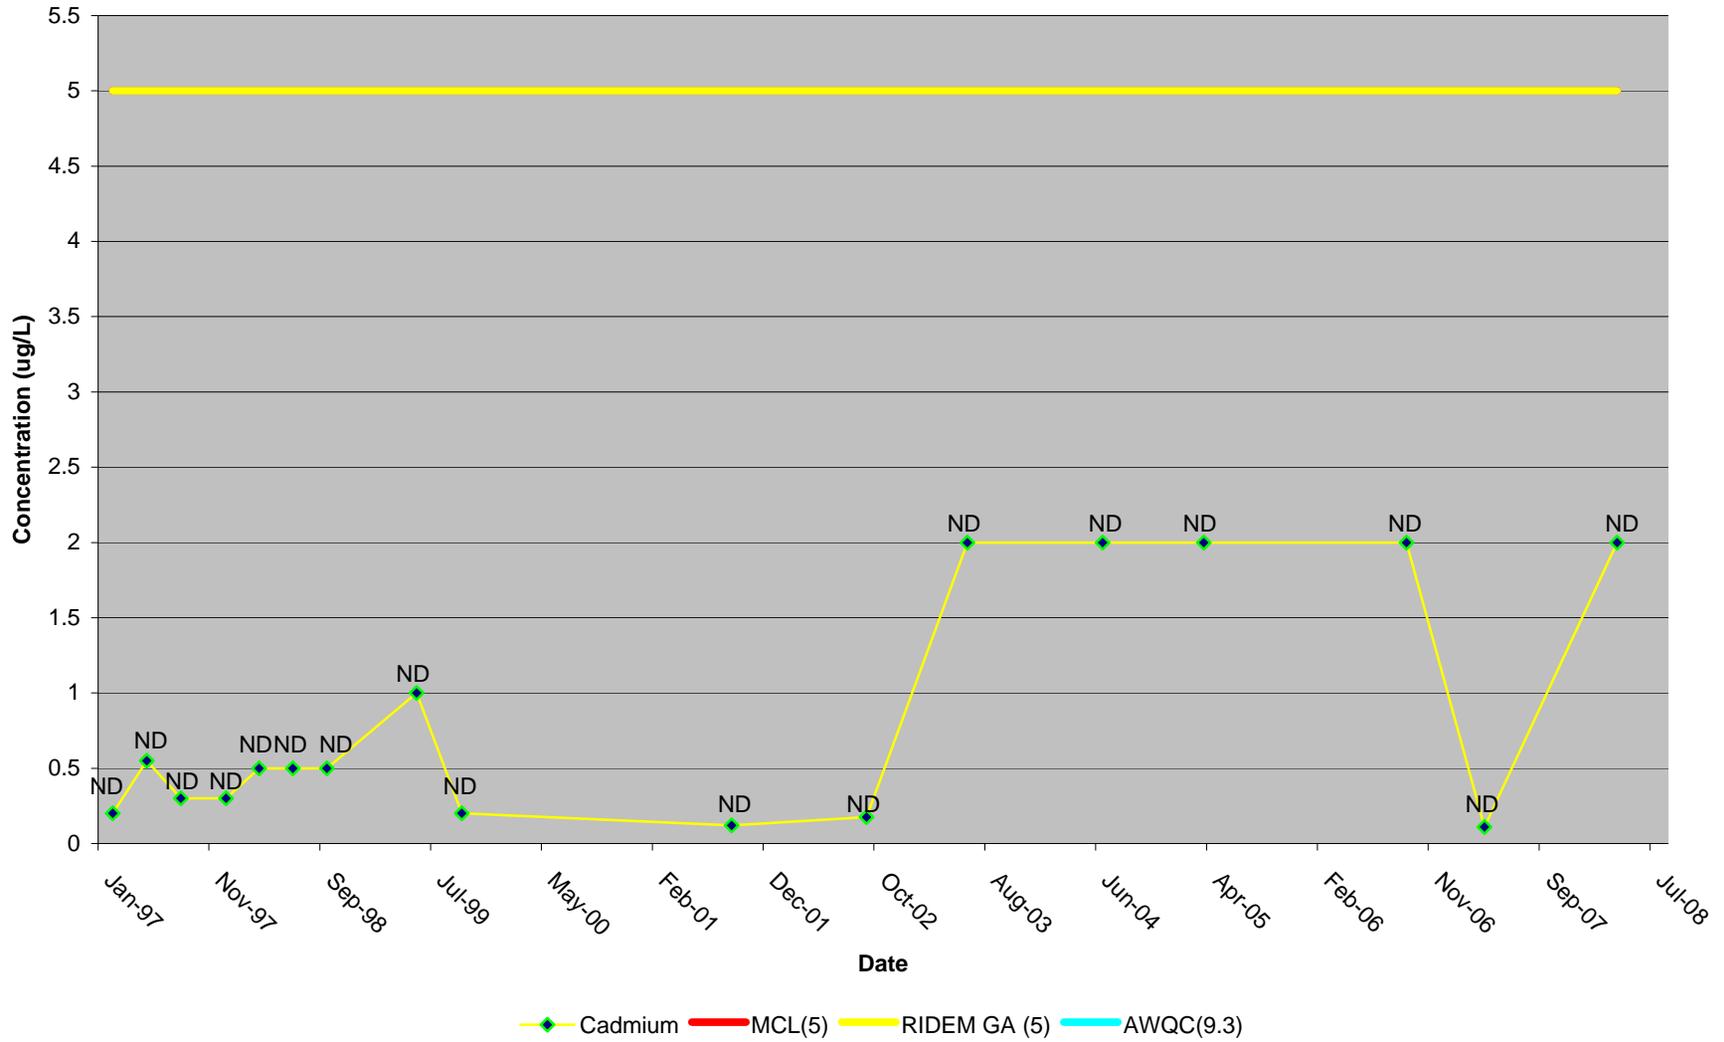
APPENDIX F-1: GROUNDWATER
FIGURE F-1.5-4

CADMIUM IN GROUNDWATER, MW105R
SITE 01 McALLISTER POINT LANDFILL
NAVAL STATION NEWPORT
FIVE YEAR REVIEW REPORT

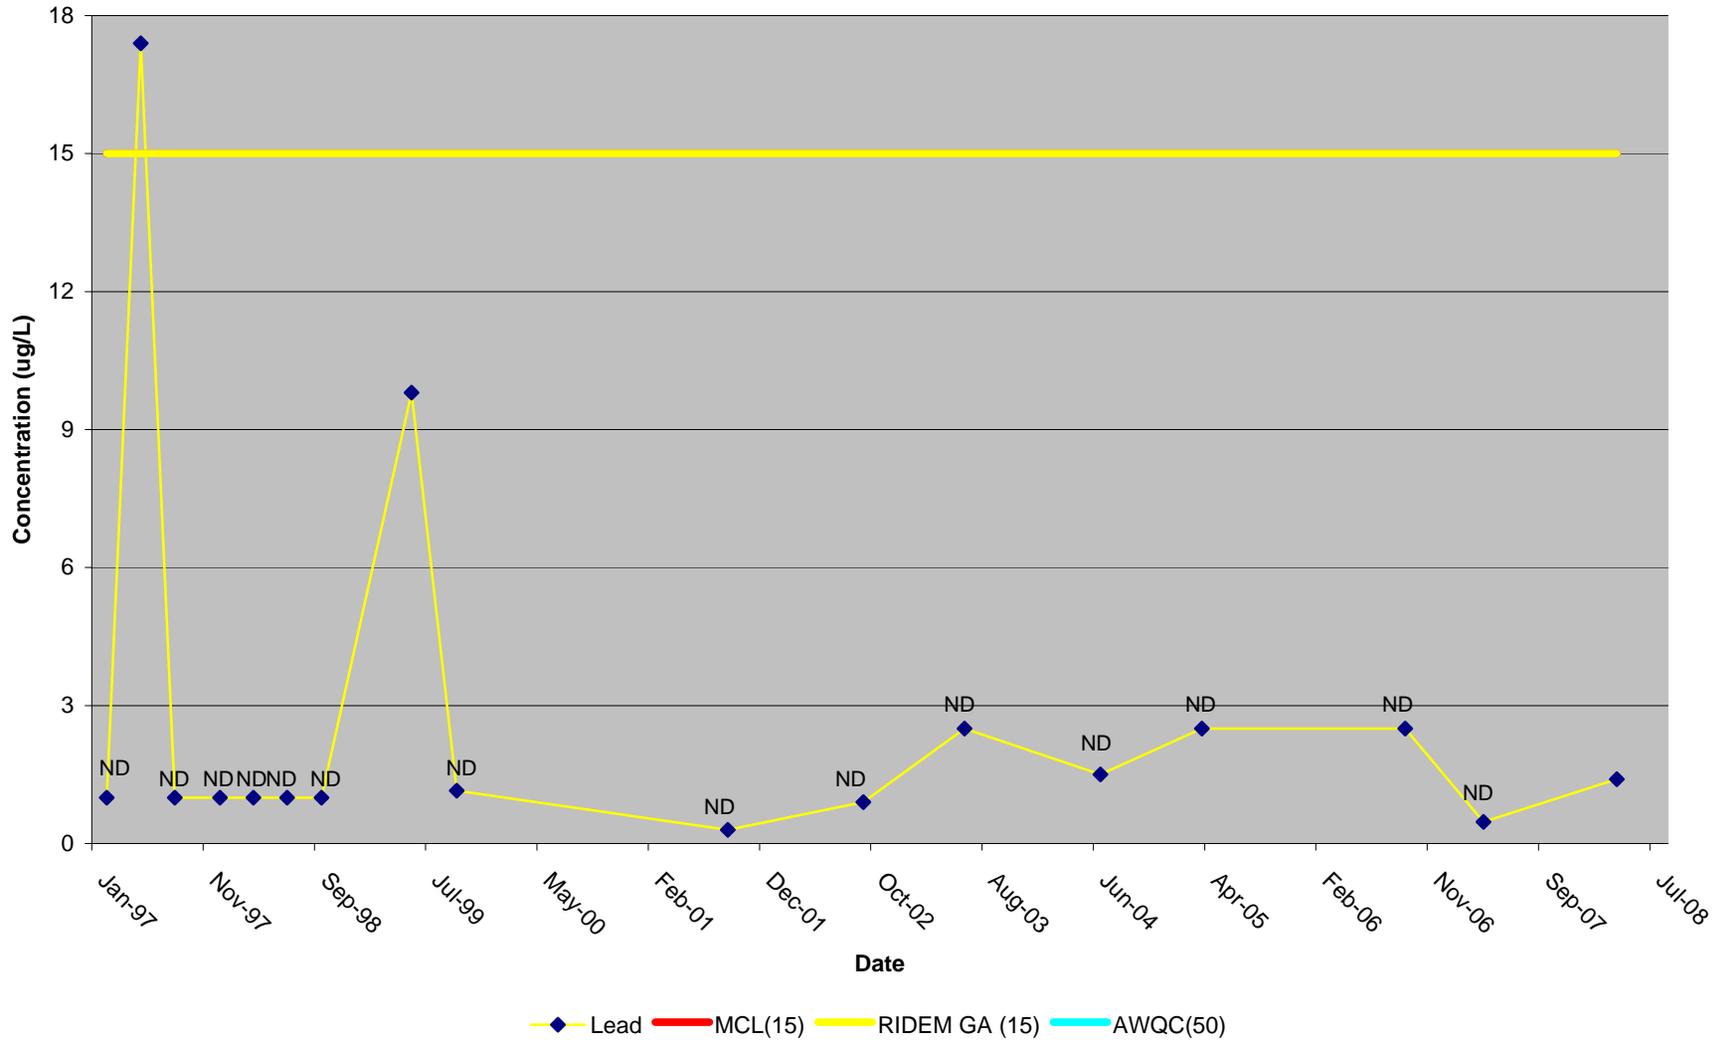
LEAD IN GROUNDWATER, MW105R
SITE 01 McALLISTER POINT LANDFILL
NAVAL STATION NEWPORT
FIVE YEAR REVIEW REPORT

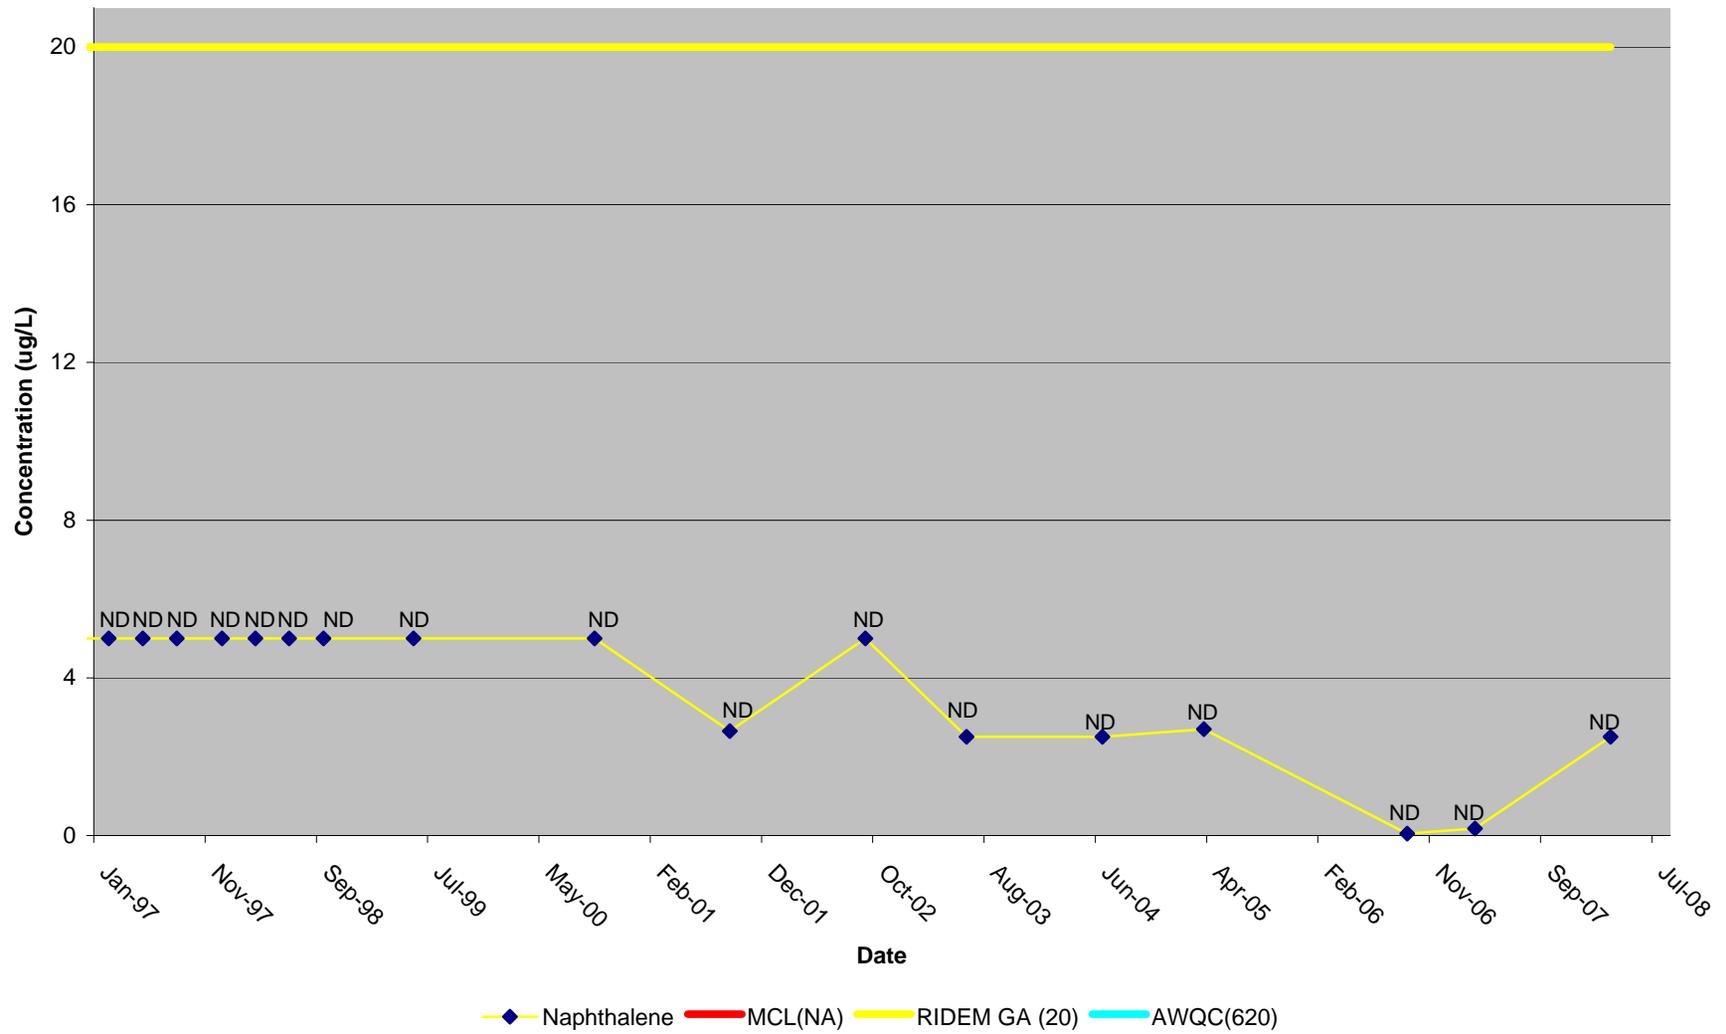
NAPHTHALENE IN GROUNDWATER, MW105R
SITE 01 McALLISTER POINT LANDFILL
NAVAL STATION NEWPORT
FIVE YEAR REVIEW REPORT

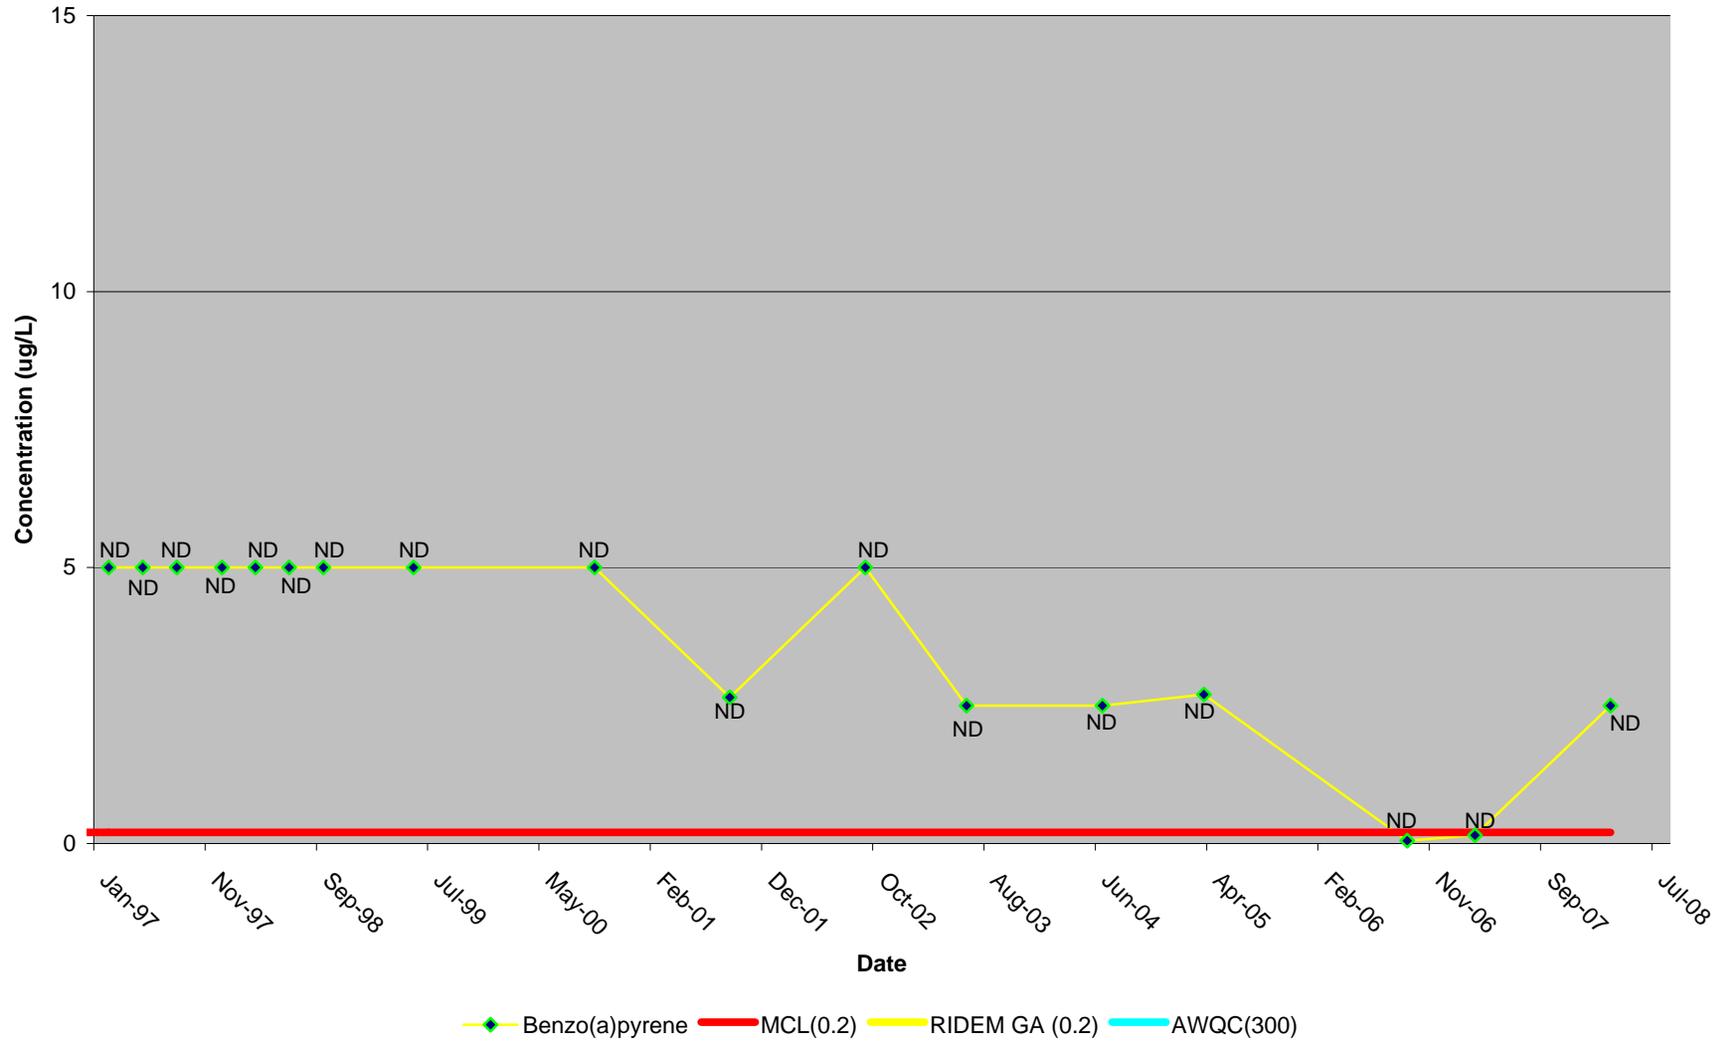
APPENDIX F-1: GROUNDWATER
FIGURE F-1.5-11

BENZO(A)PYRENE IN GROUNDWATER, MW105R
SITE 01 McALLISTER POINT LANDFILL
NAVAL STATION NEWPORT
FIVE YEAR REVIEW REPORT

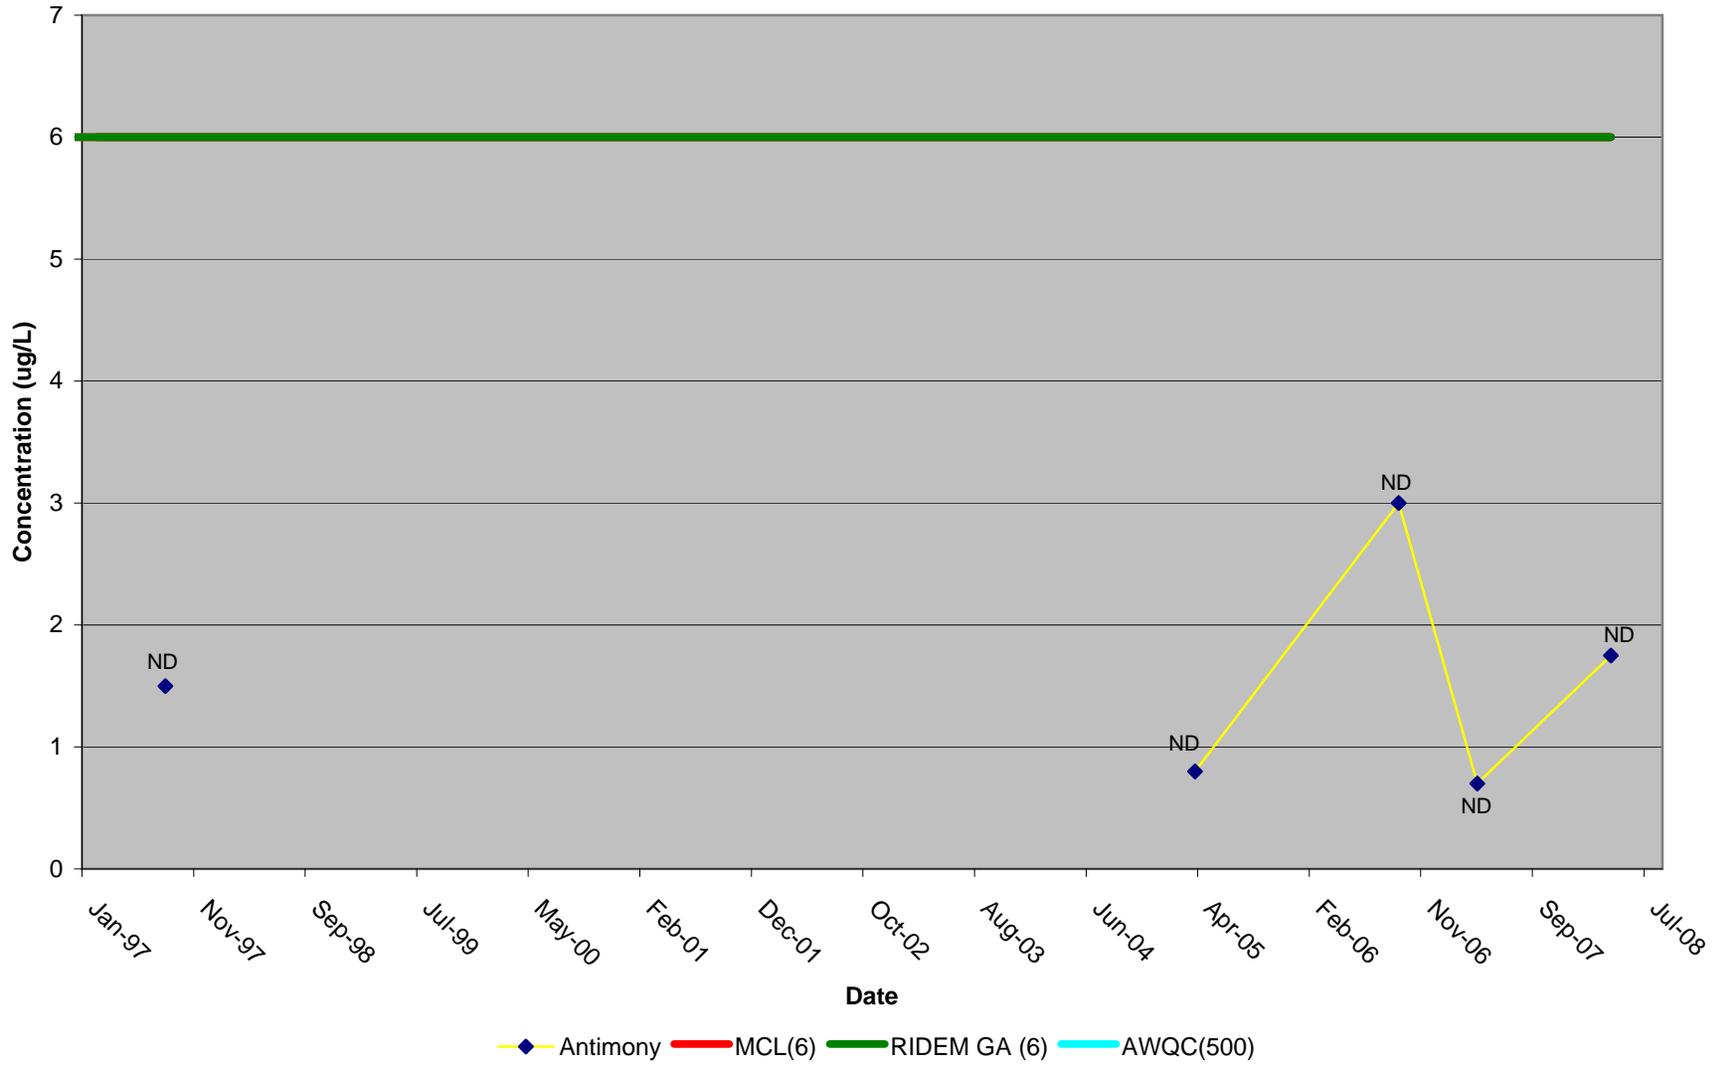
APPENDIX F-1: GROUNDWATER
FIGURE F-1.6-1

ANTIMONY IN GROUNDWATER, MW105S
SITE 01 McALLISTER POINT LANDFILL
NAVAL STATION NEWPORT
FIVE YEAR REVIEW REPORT

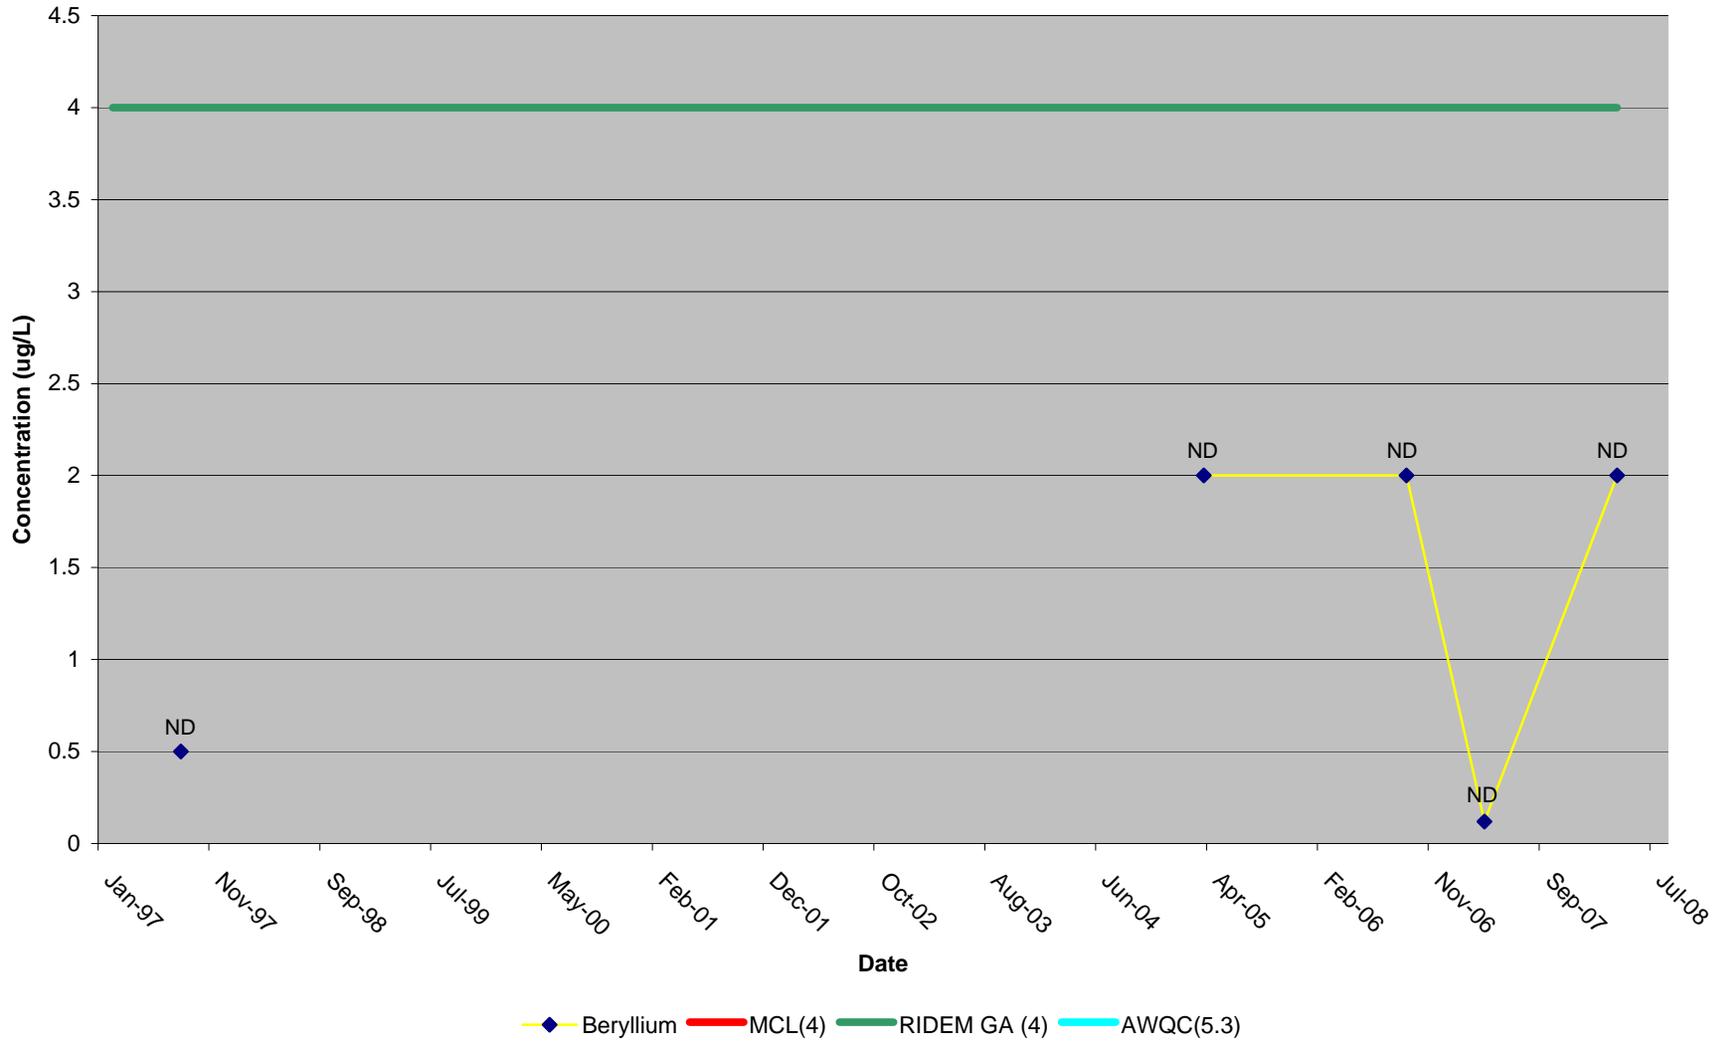
BERYLLIUM IN GROUNDWATER, MW105S
SITE 01 McALLISTER POINT LANDFILL
NAVAL STATION NEWPORT
FIVE YEAR REVIEW REPORT

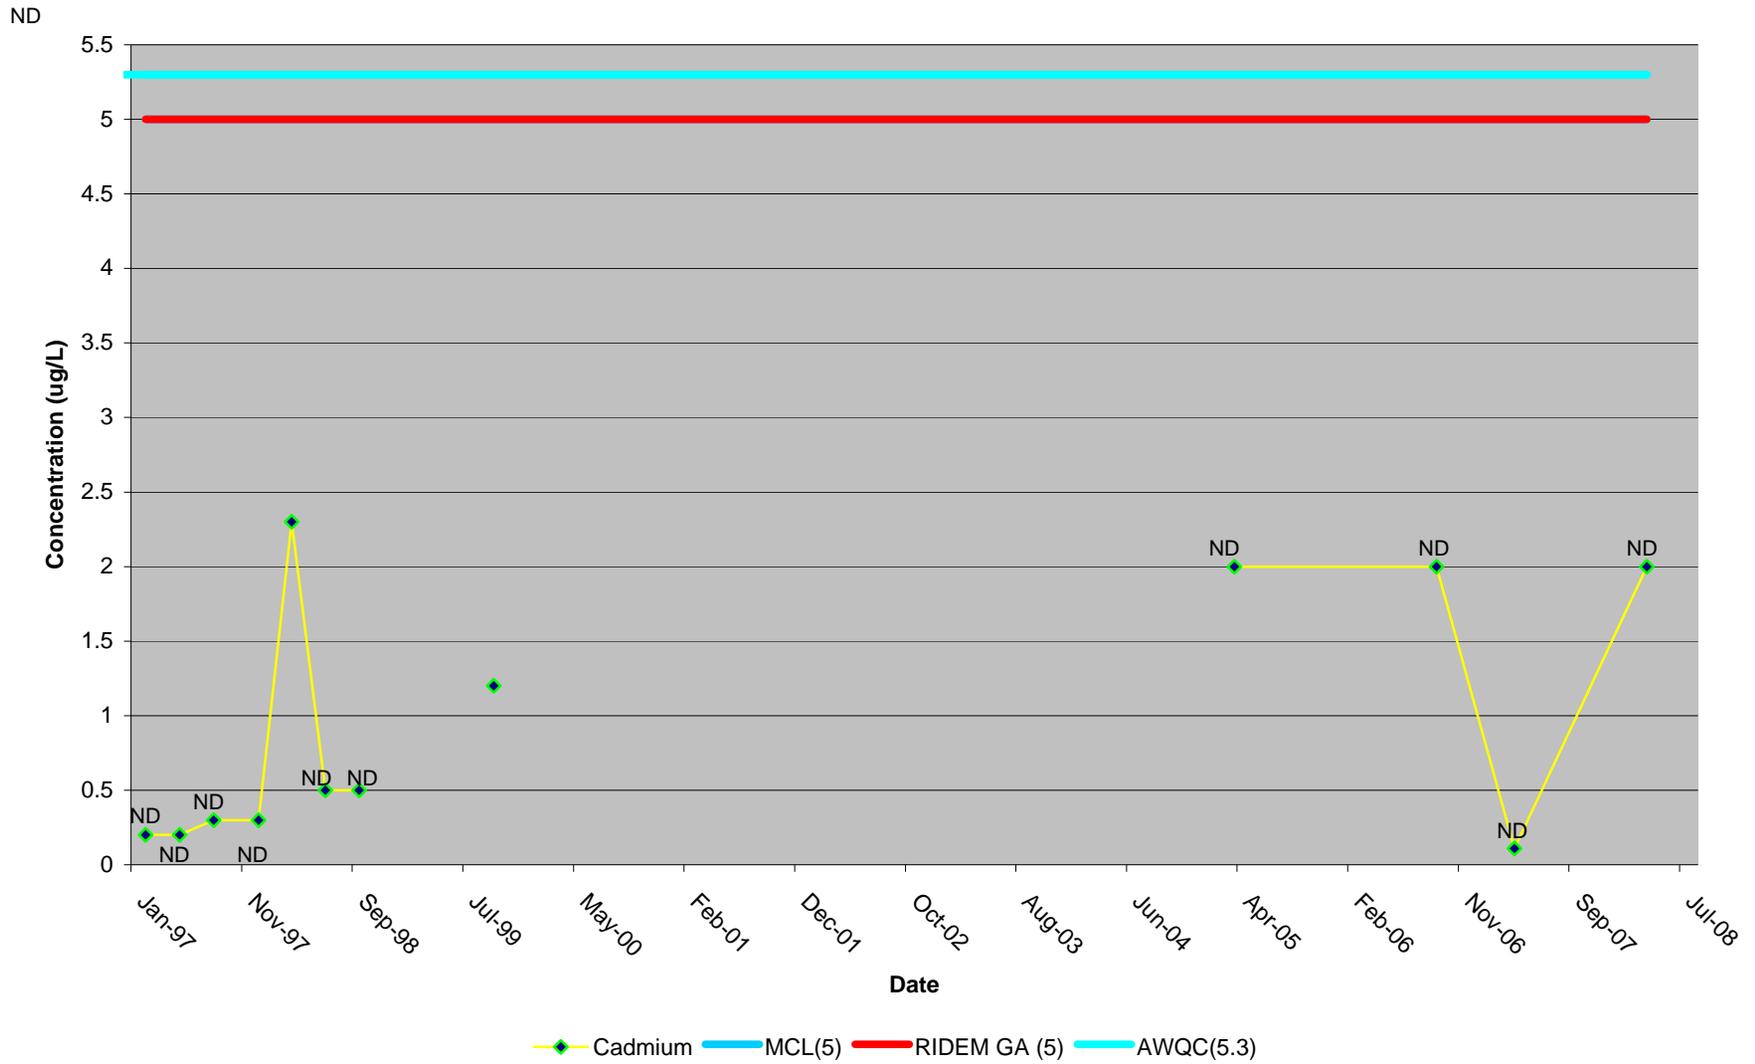
APPENDIX F-1: GROUNDWATER
FIGURE F-1.6-4

CADMIUM IN GROUNDWATER, MW105S
SITE 01 McALLISTER POINT LANDFILL
NAVAL STATION NEWPORT
FIVE YEAR REVIEW REPORT

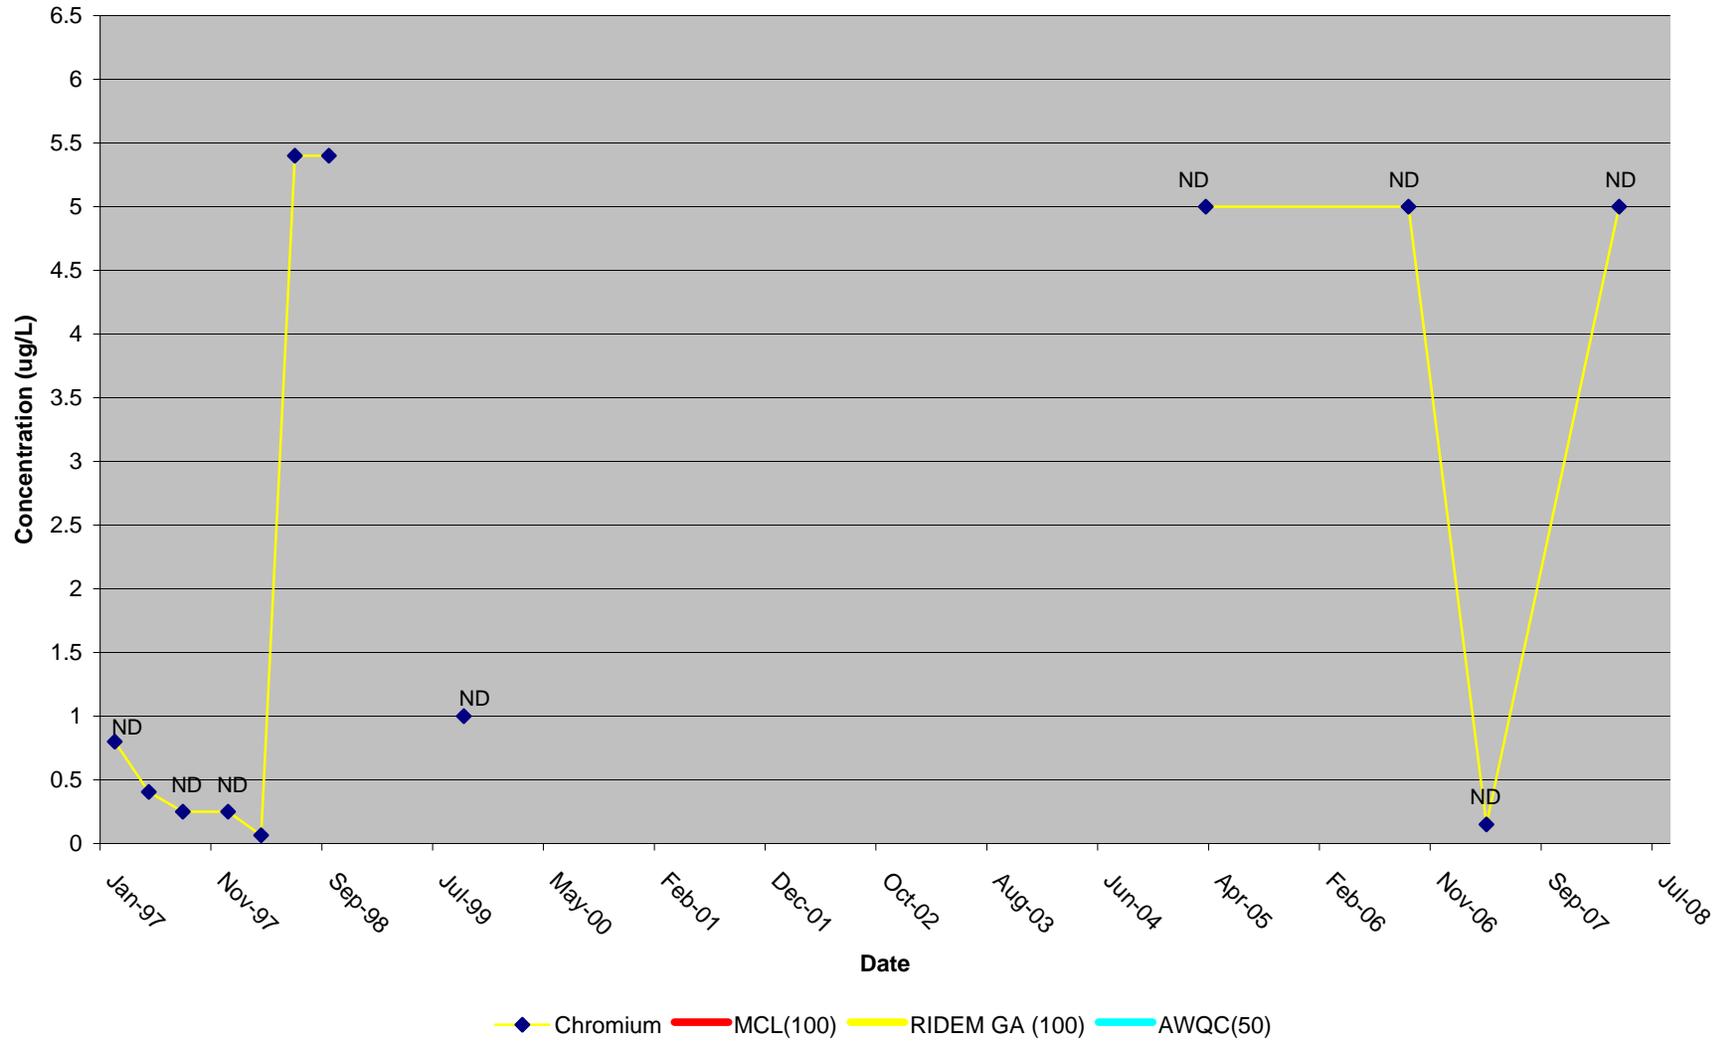
APPENDIX F-1: GROUNDWATER
FIGURE F-1.6-5

CHROMIUM IN GROUNDWATER, MW105S
SITE 01 McALLISTER POINT LANDFILL
NAVAL STATION NEWPORT
FIVE YEAR REVIEW REPORT

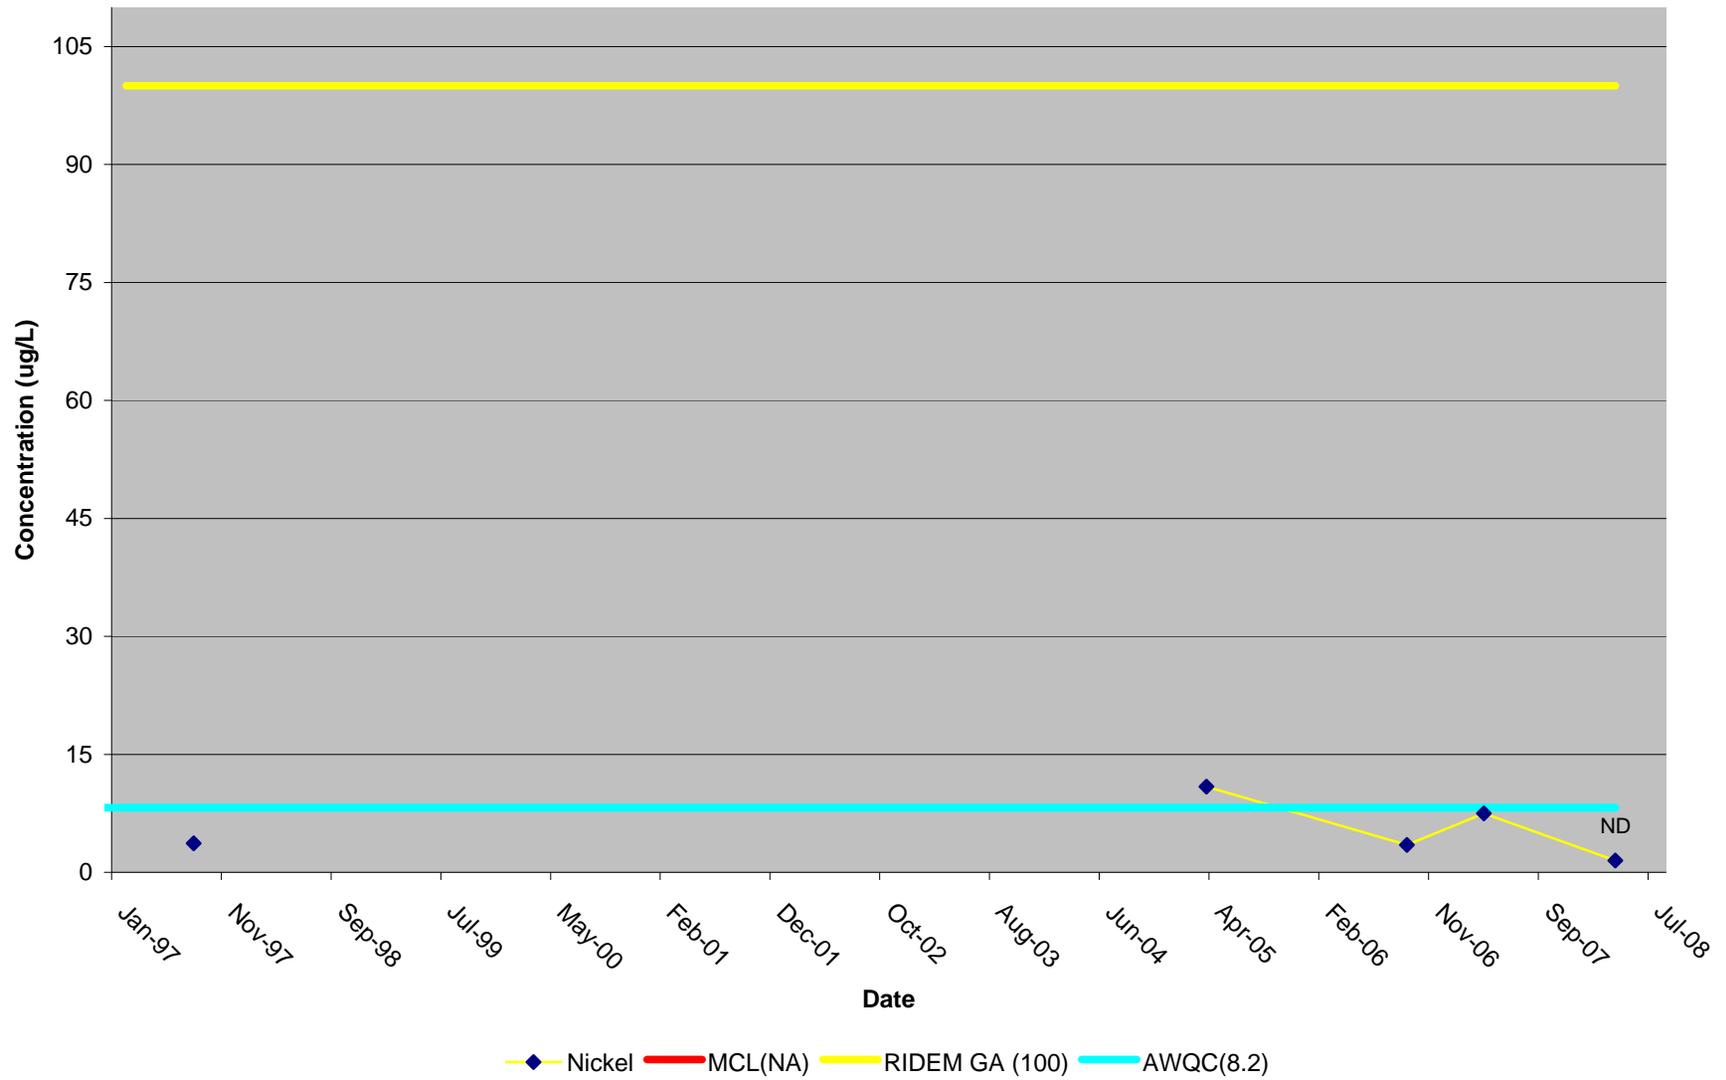
NICKEL IN GROUNDWATER, MW105S
SITE 01 McALLISTER POINT LANDFILL
NAVAL STATION NEWPORT
FIVE YEAR REVIEW REPORT

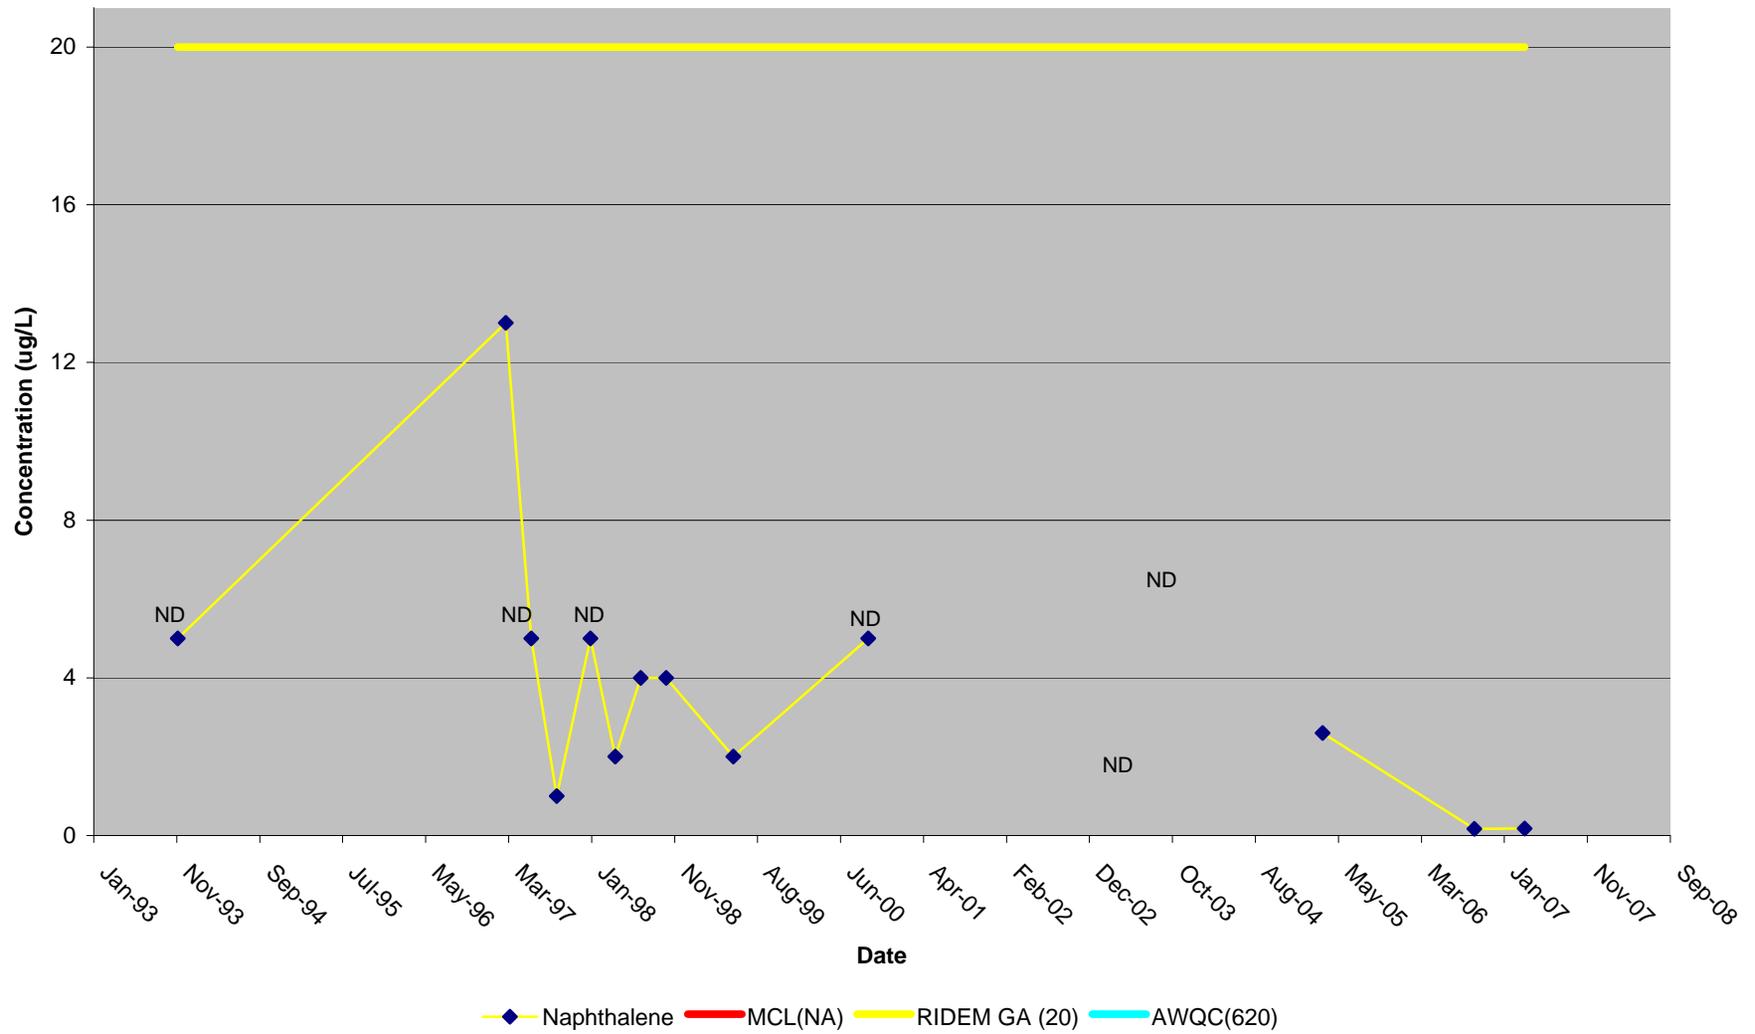
NAPHTHALENE IN GROUNDWATER, MW105S
SITE 01 McALLISTER POINT LANDFILL
NAVAL STATION NEWPORT
FIVE YEAR REVIEW REPORT
