Five Year Review Report

**Naval Station Newport
(Formerly NETC Newport)**

Newport, Rhode Island

**FIVE YEAR REVIEW REPORT
FOR
NAVAL STATION NEWPORT
(FORMERLY NETC NEWPORT)
NEWPORT, RHODE ISLAND
COMPREHENSIVE LONG-TERM
ENVIRONMENTAL ACTION NAVY (CLEAN) CONTRACT**

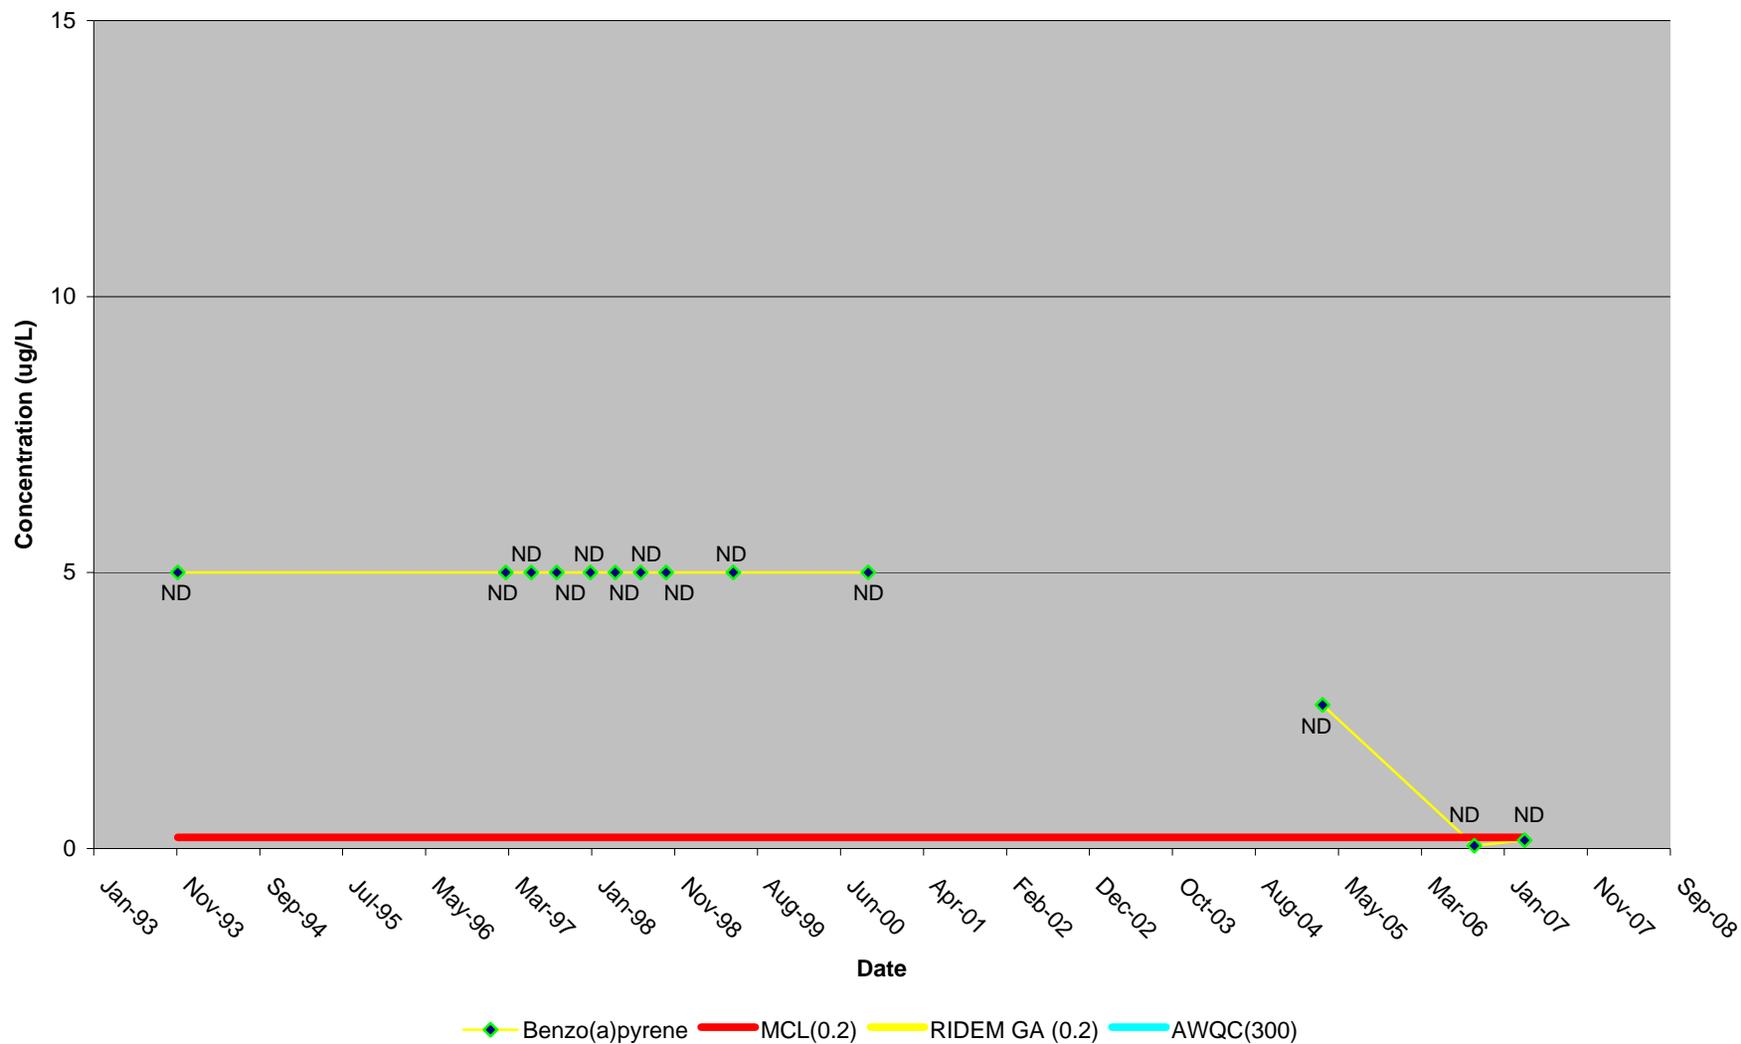
APPENDIX F-1: GROUNDWATER
FIGURE F-1.6-11

BENZO(A)PYRENE IN GROUNDWATER, MW105S
SITE 01 McALLISTER POINT LANDFILL
NAVAL STATION NEWPORT
FIVE YEAR REVIEW REPORT

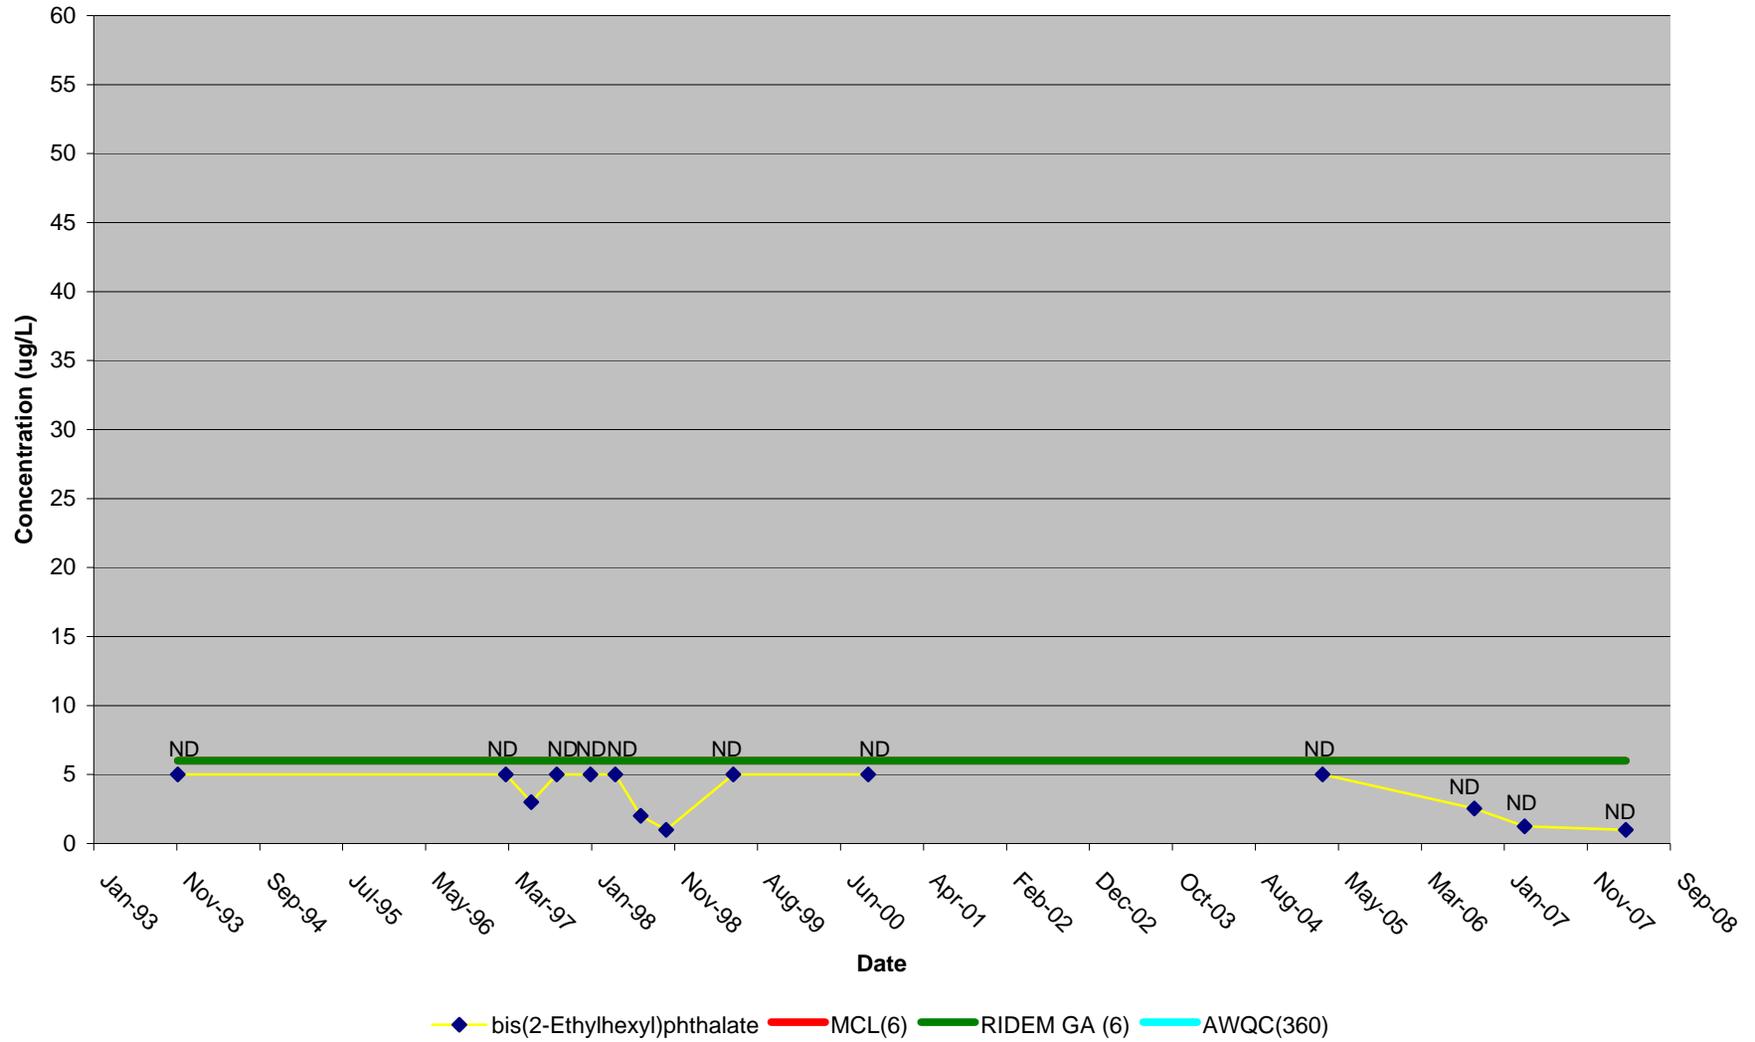
APPENDIX F-1: GROUNDWATER
FIGURE F-1.6-12

BIS(2-ETHYLHEXYL)PHTHALATE IN GROUNDWATER, MW105S
SITE 01 McALLISTER POINT LANDFILL
NAVAL STATION NEWPORT
FIVE YEAR REVIEW REPORT

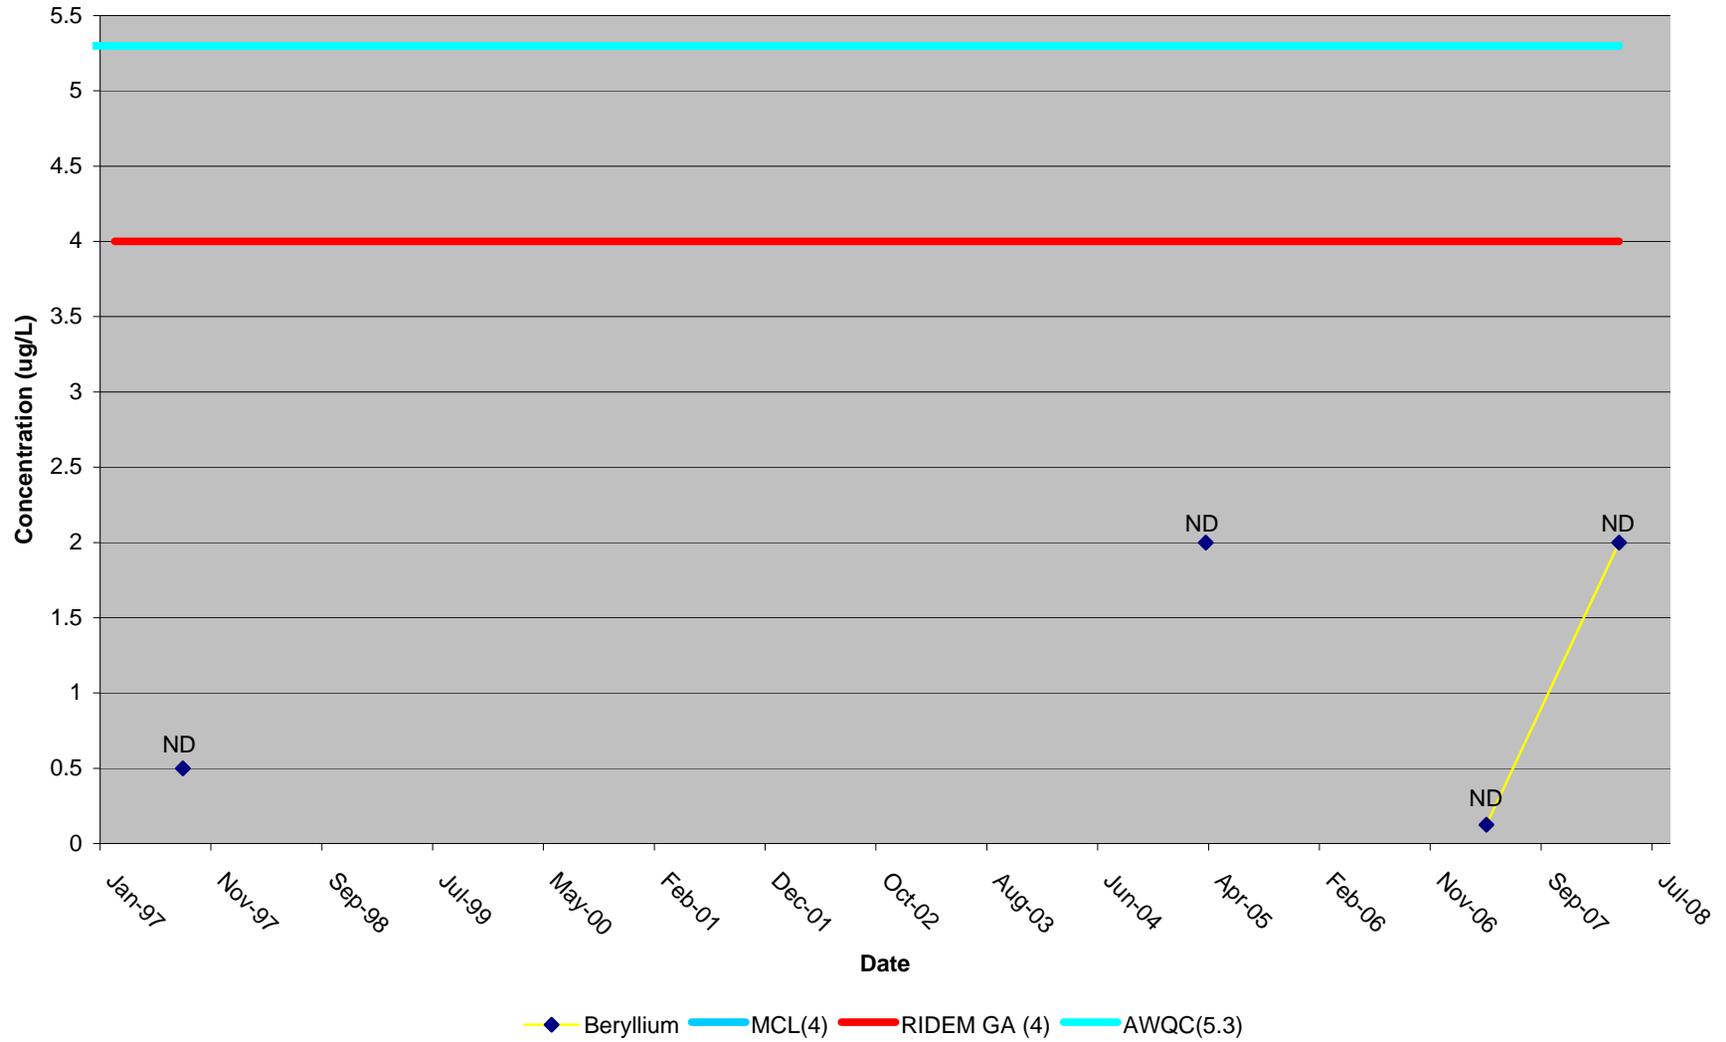
BERYLLIUM IN GROUNDWATER, MW107R
SITE 01 McALLISTER POINT LANDFILL
NAVAL STATION NEWPORT
FIVE YEAR REVIEW REPORT

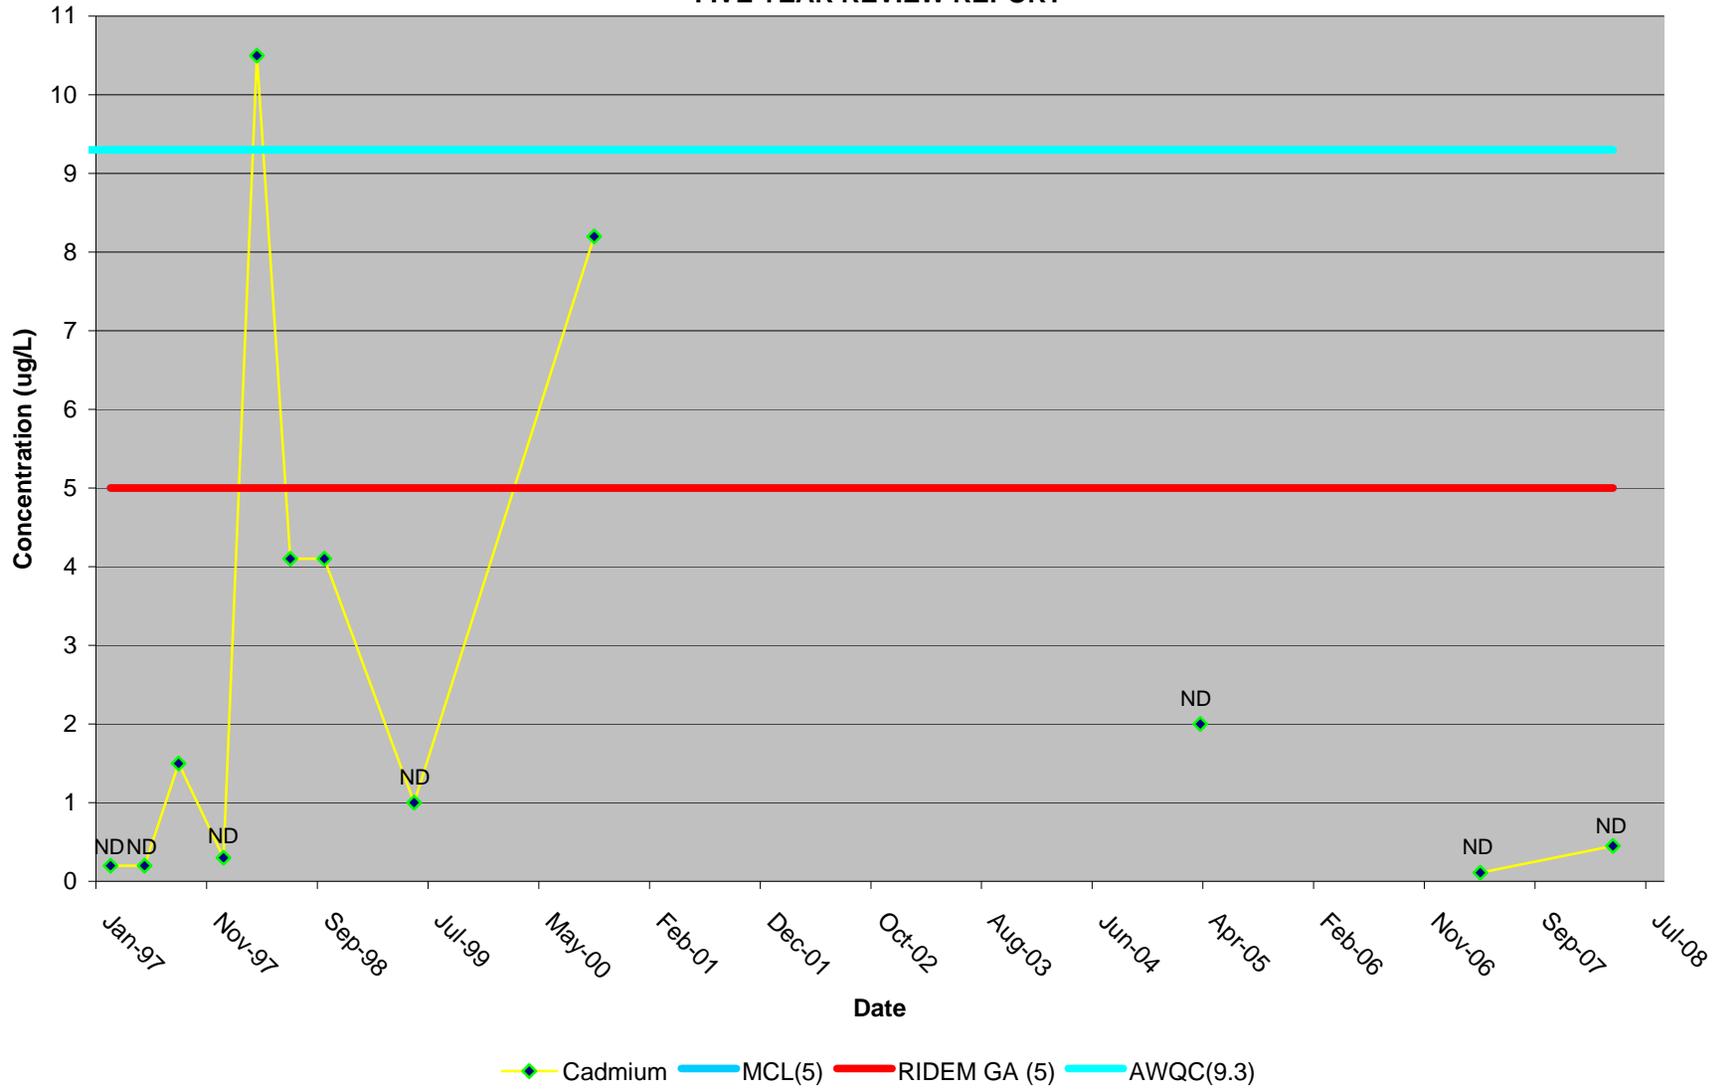
APPENDIX F-1: GROUNDWATER
FIGURE F-1.7-4

CADMIUM IN GROUNDWATER, MW107R
SITE 01 McALLISTER POINT LANDFILL
NAVAL STATION NEWPORT
FIVE YEAR REVIEW REPORT

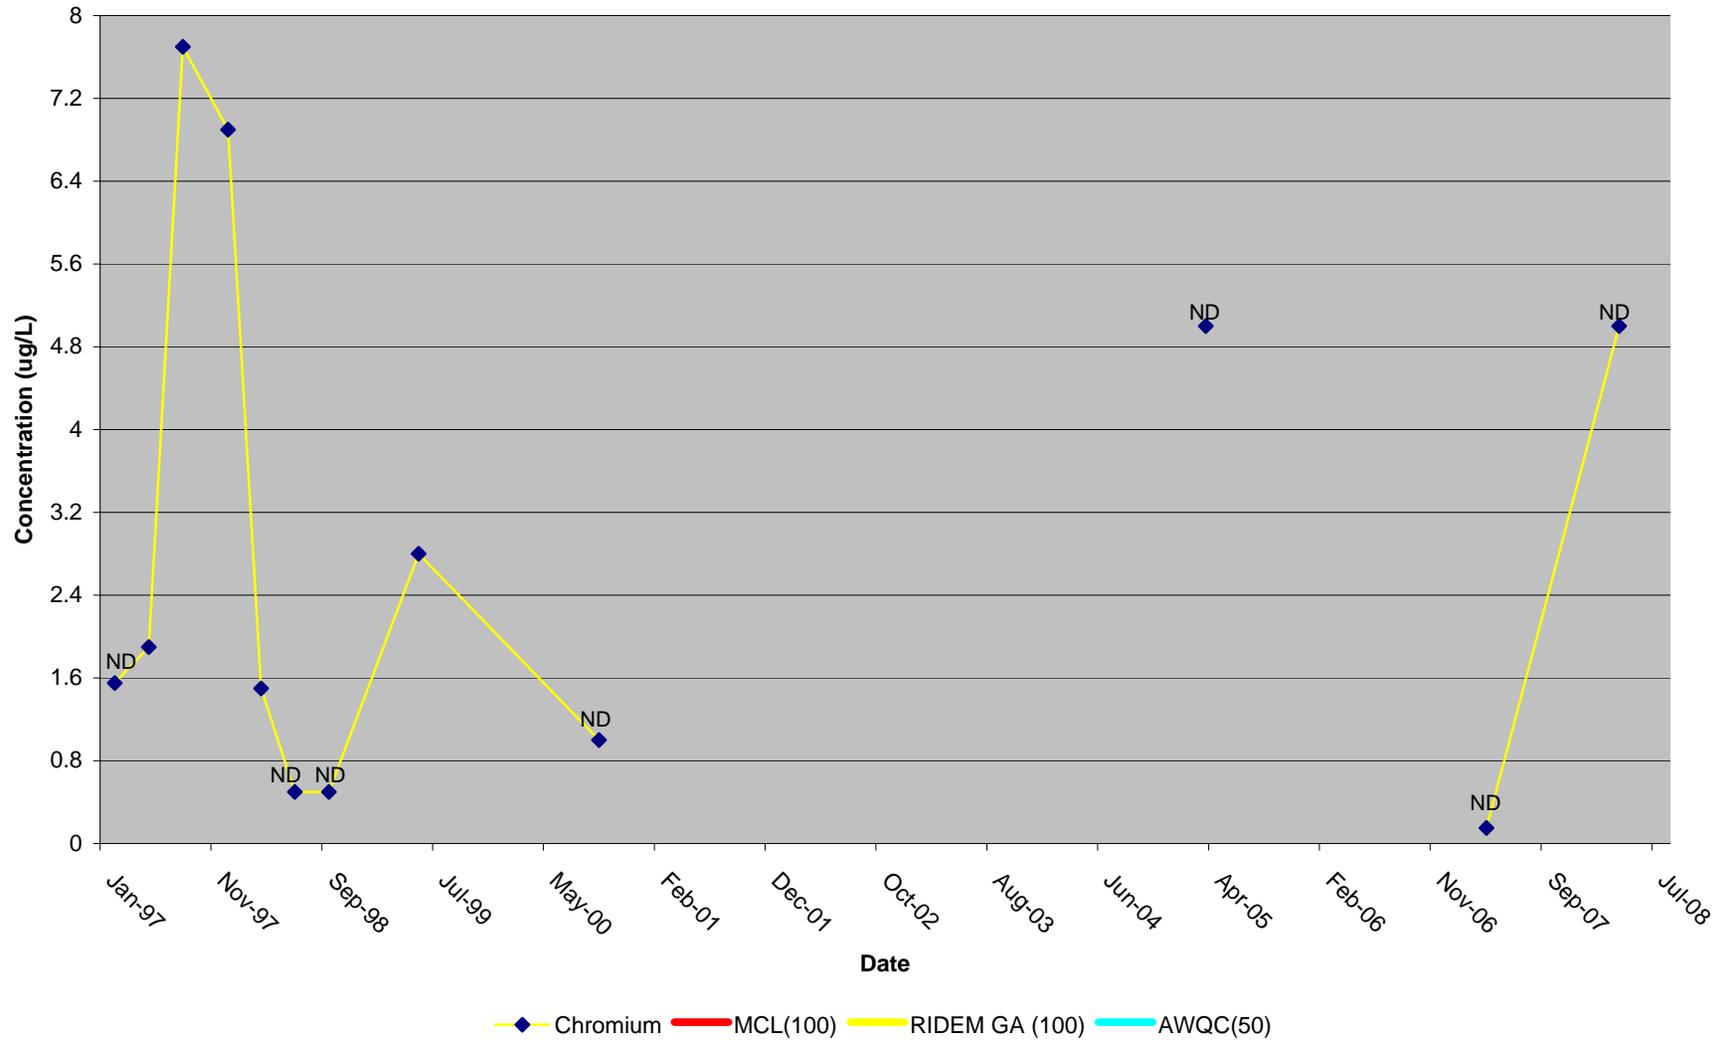
APPENDIX F-1: GROUNDWATER
FIGURE F-1.7-5

CHROMIUM IN GROUNDWATER, MW107R
SITE 01 McALLISTER POINT LANDFILL
NAVAL STATION NEWPORT
FIVE YEAR REVIEW REPORT

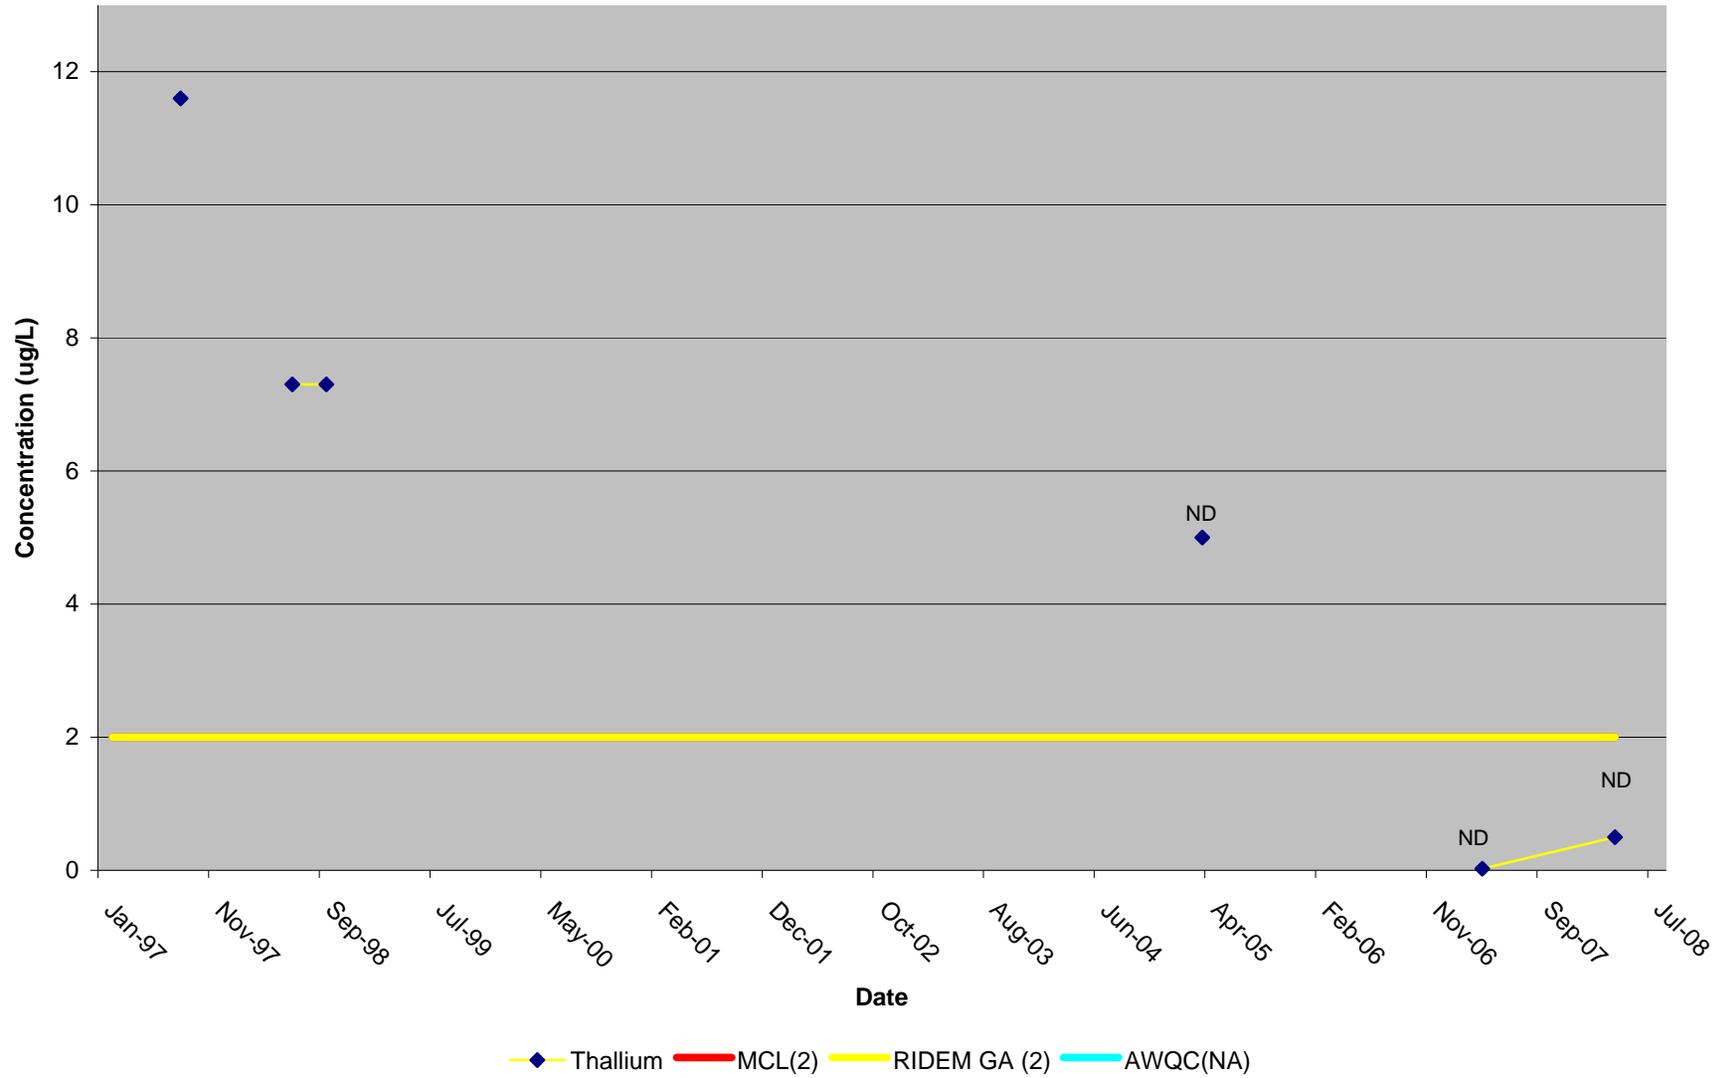
THALLIUM IN GROUNDWATER, MW107R
SITE 01 McALLISTER POINT LANDFILL
NAVAL STATION NEWPORT
FIVE YEAR REVIEW REPORT

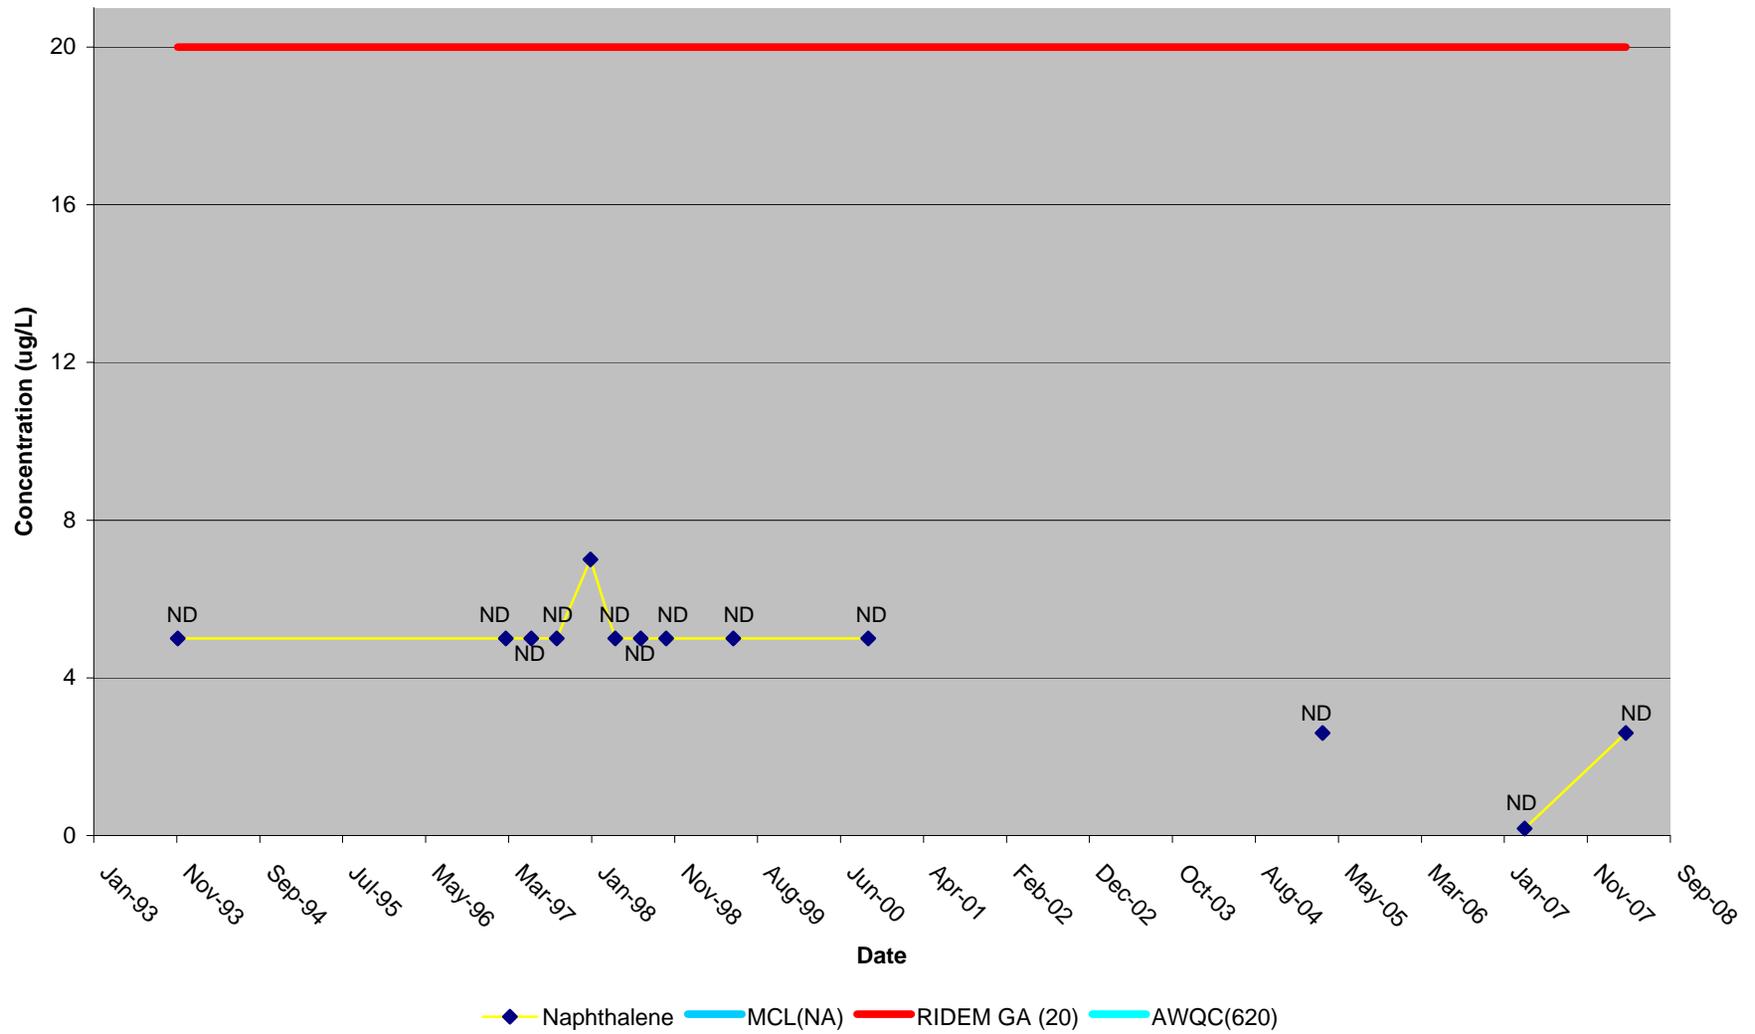
APPENDIX F-1: GROUNDWATER
FIGURE F-1.7-10

NAPHTHALENE IN GROUNDWATER, MW107R
SITE 01 McALLISTER POINT LANDFILL
NAVAL STATION NEWPORT
FIVE YEAR REVIEW REPORT

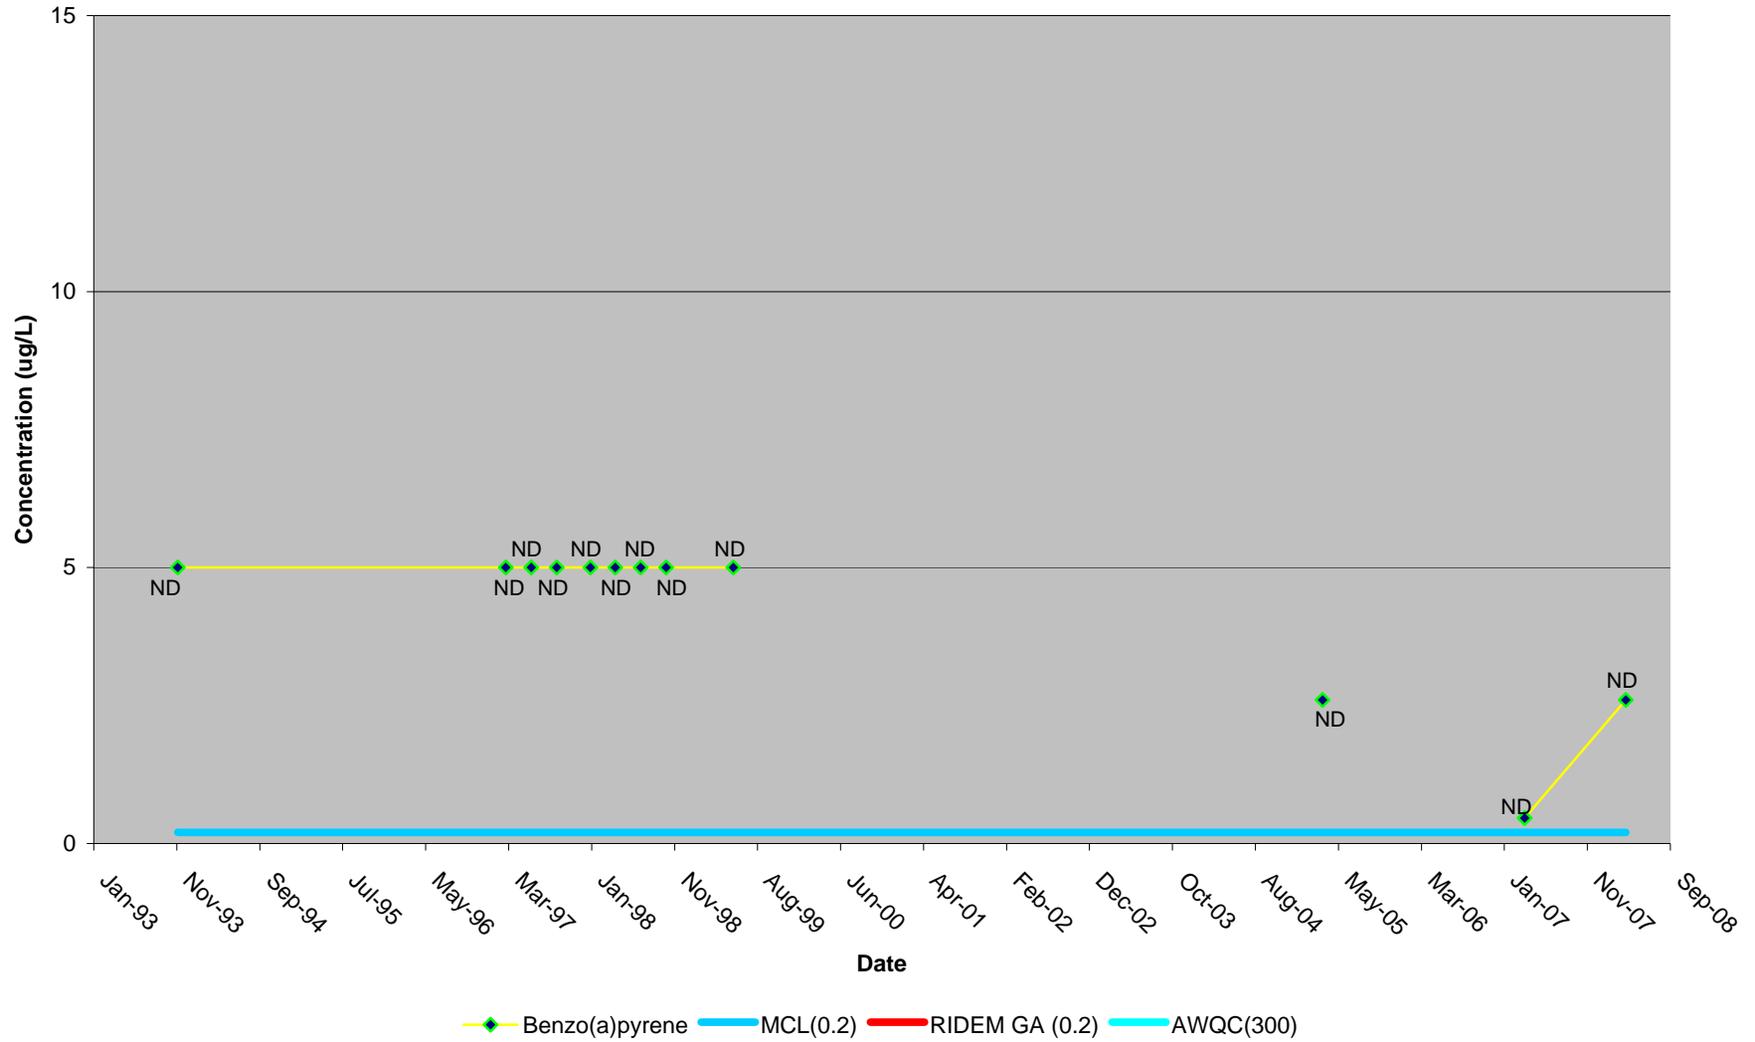
APPENDIX F-1: GROUNDWATER
FIGURE F-1.7-11

BENZO(A)PYRENE IN GROUNDWATER, MW107R
SITE 01 McALLISTER POINT LANDFILL
NAVAL STATION NEWPORT
FIVE YEAR REVIEW REPORT

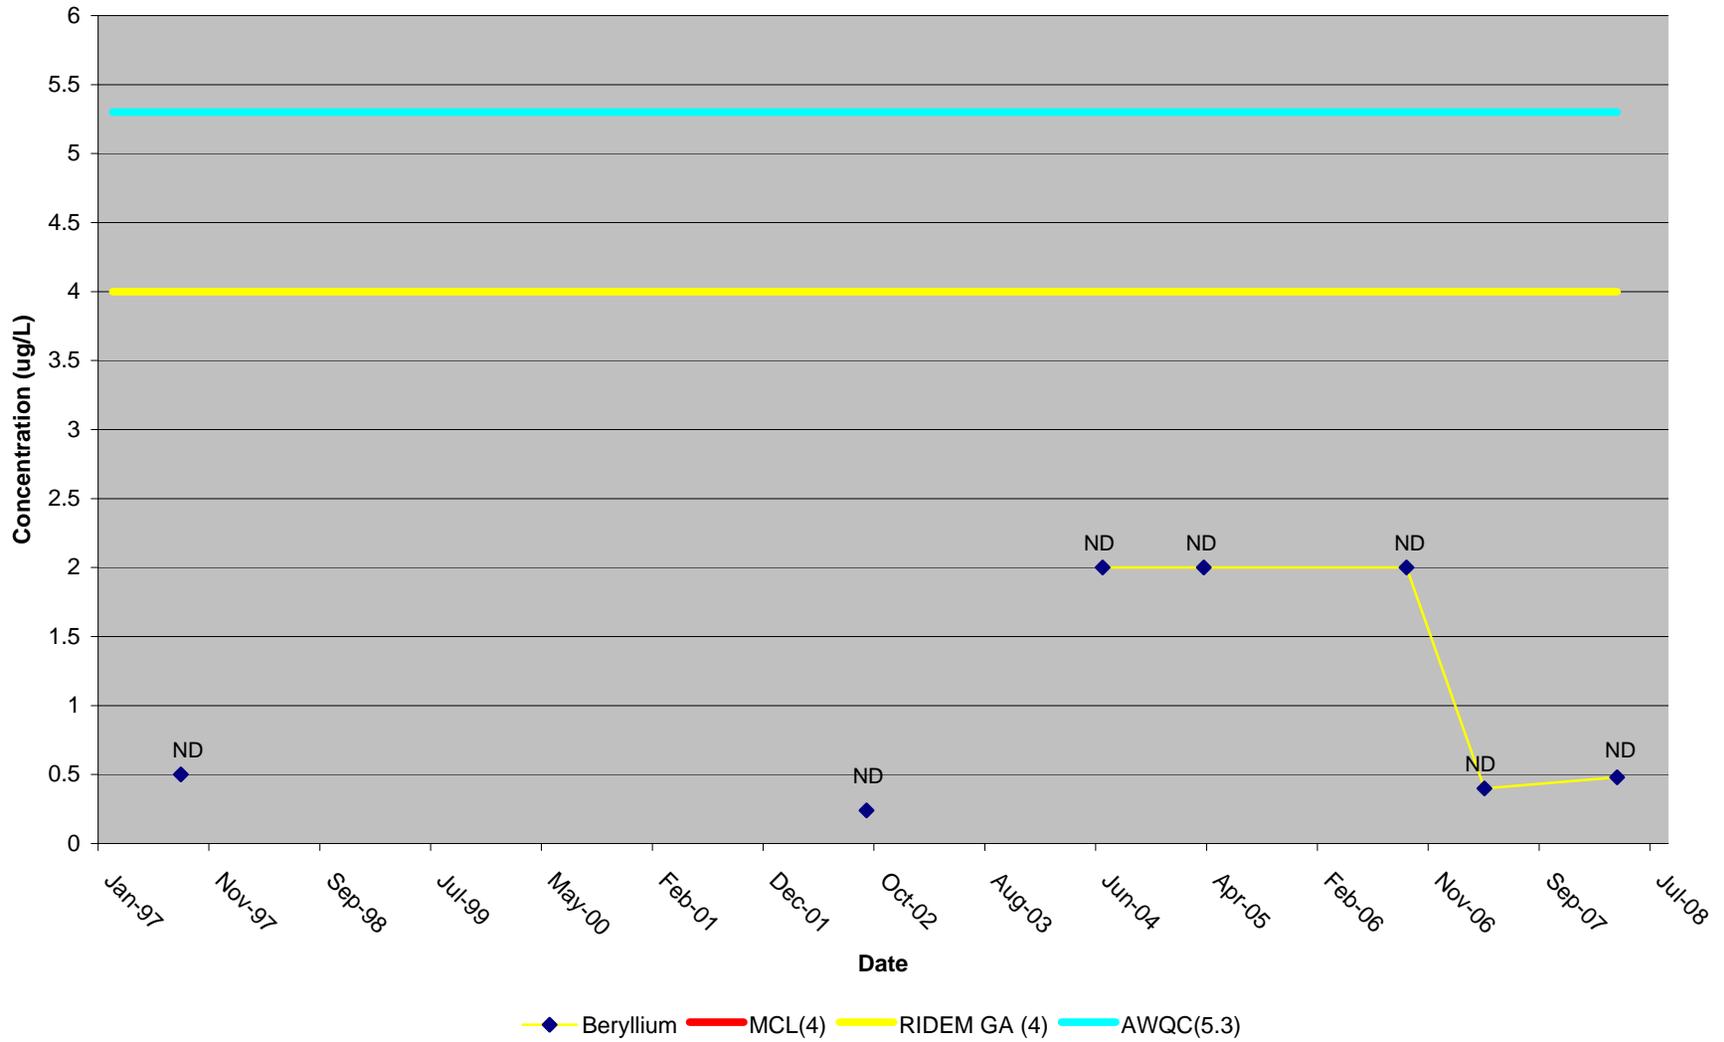
BERYLLIUM IN GROUNDWATER, MW108R
SITE 01 McALLISTER POINT LANDFILL
NAVAL STATION NEWPORT
FIVE YEAR REVIEW REPORT

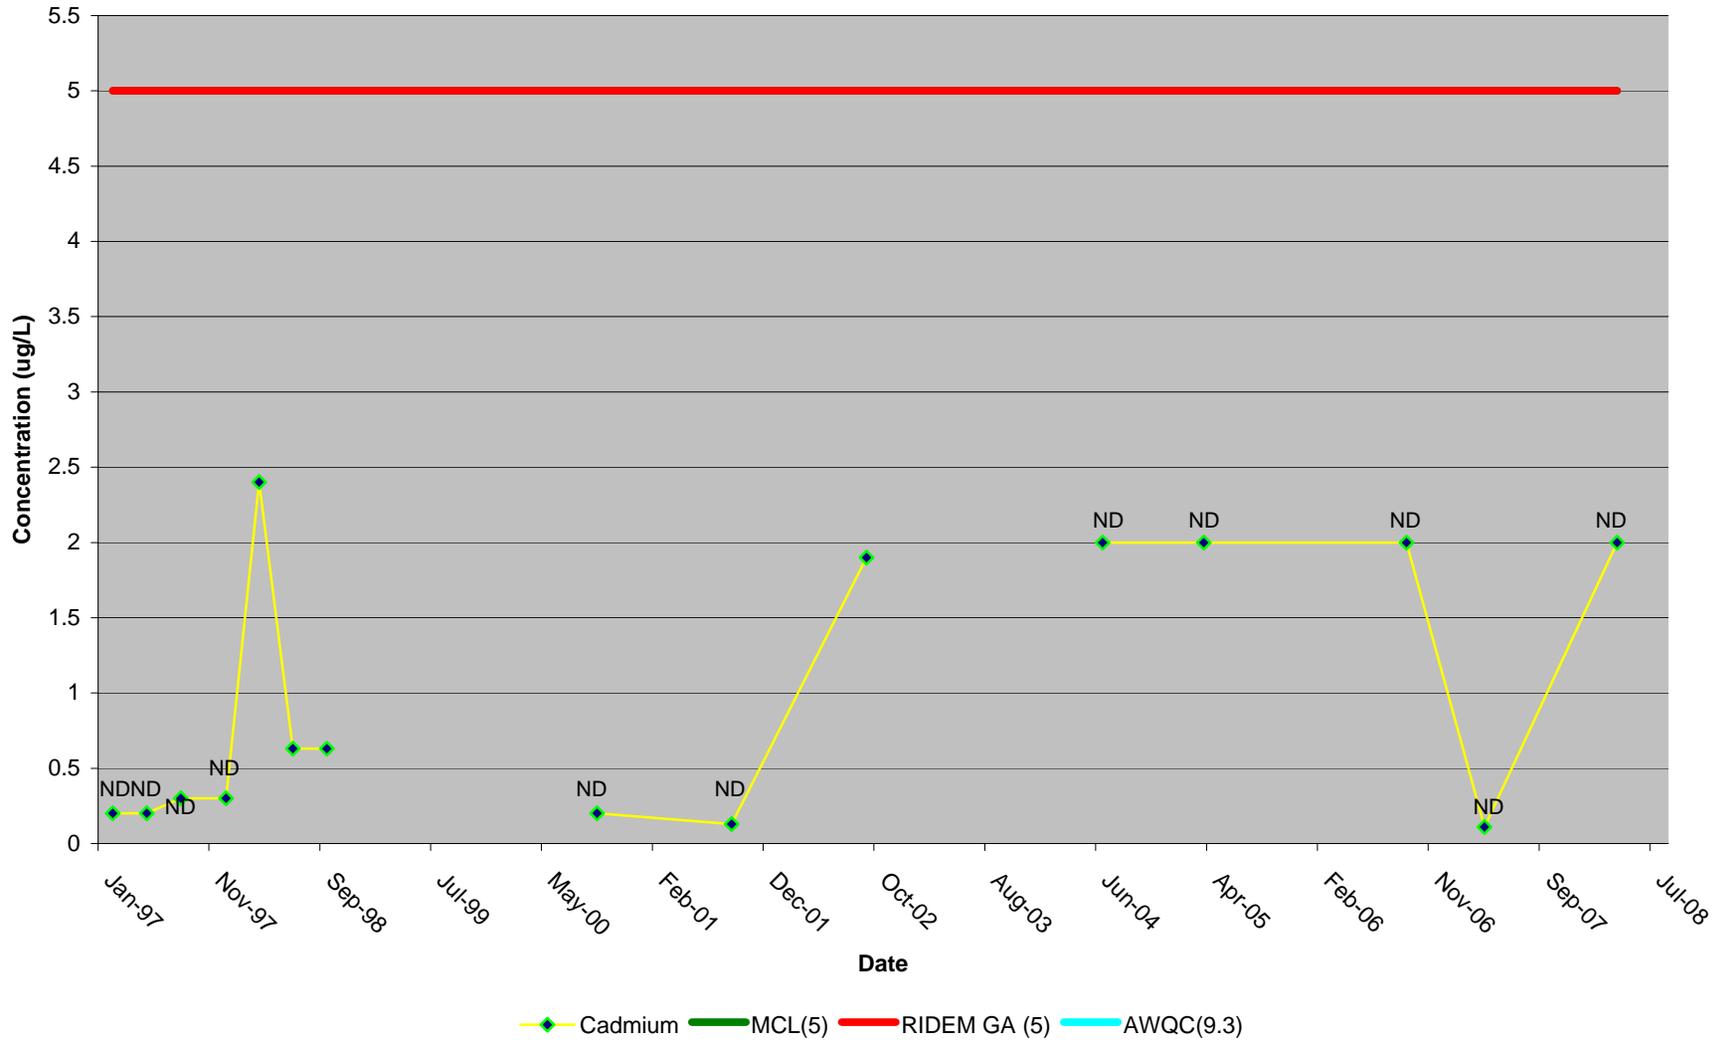
APPENDIX F-1: GROUNDWATER
FIGURE F-1.8-4

CADMIUM IN GROUNDWATER, MW108R
SITE 01 McALLISTER POINT LANDFILL
NAVAL STATION NEWPORT
FIVE YEAR REVIEW REPORT

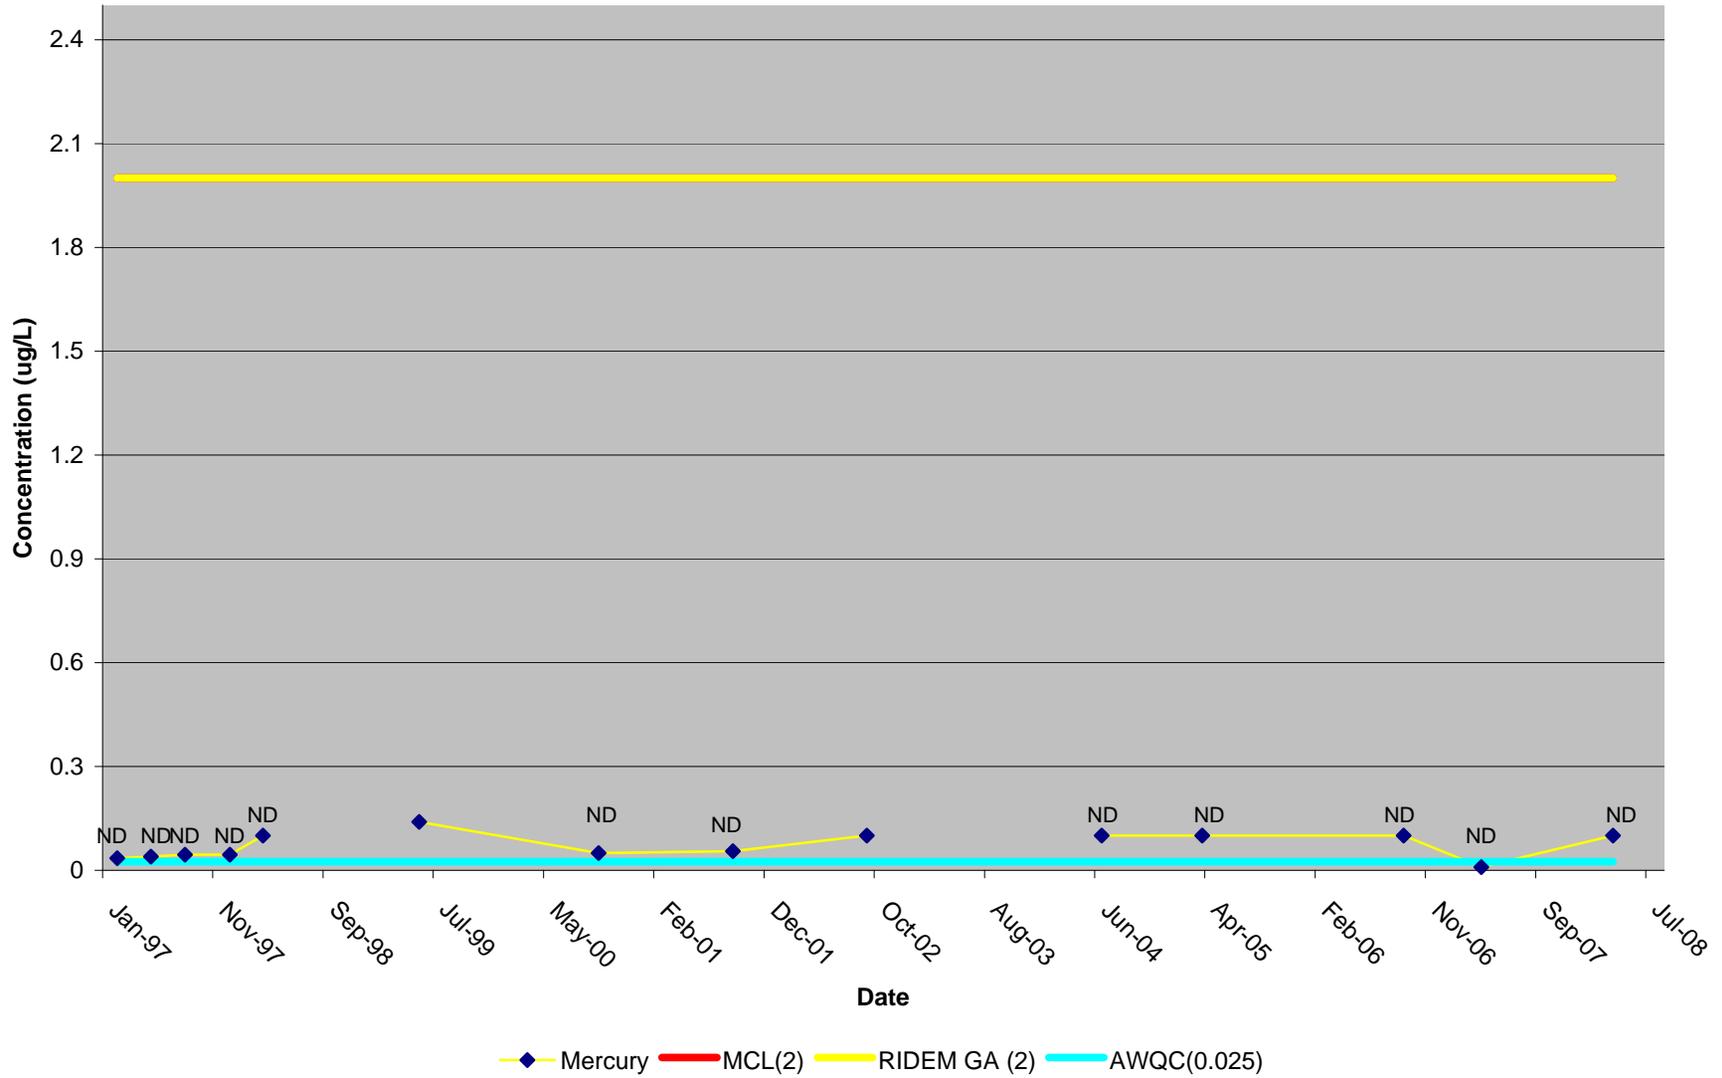
MERCURY IN GROUNDWATER, MW108R
SITE 01 McALLISTER POINT LANDFILL
NAVAL STATION NEWPORT
FIVE YEAR REVIEW REPORT

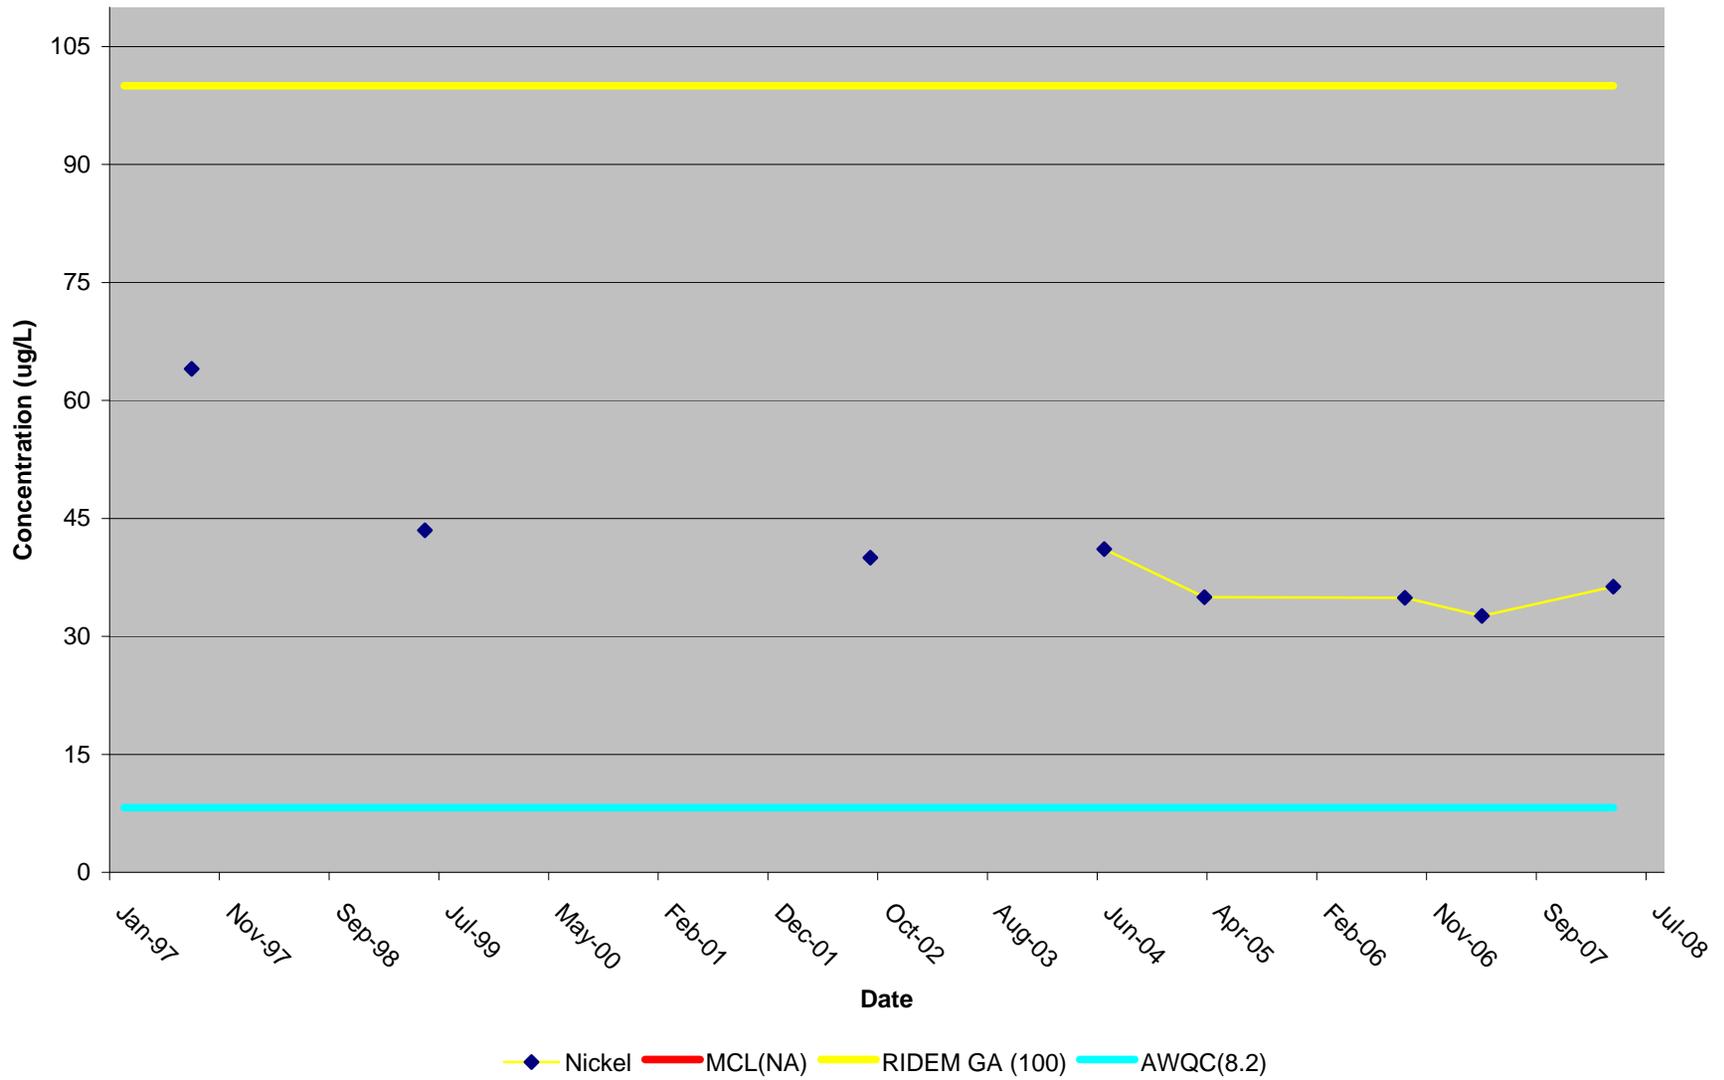
APPENDIX F-1: GROUNDWATER
FIGURE F-1.8-8

NICKEL IN GROUNDWATER, MW108R
SITE 01 McALLISTER POINT LANDFILL
NAVAL STATION NEWPORT
FIVE YEAR REVIEW REPORT
