Five Year Review Report

**Naval Station Newport
(Formerly NETC Newport)**

Newport, Rhode Island

**FIVE YEAR REVIEW REPORT
FOR
NAVAL STATION NEWPORT
(FORMERLY NETC NEWPORT)
NEWPORT, RHODE ISLAND
COMPREHENSIVE LONG-TERM
ENVIRONMENTAL ACTION NAVY (CLEAN) CONTRACT**

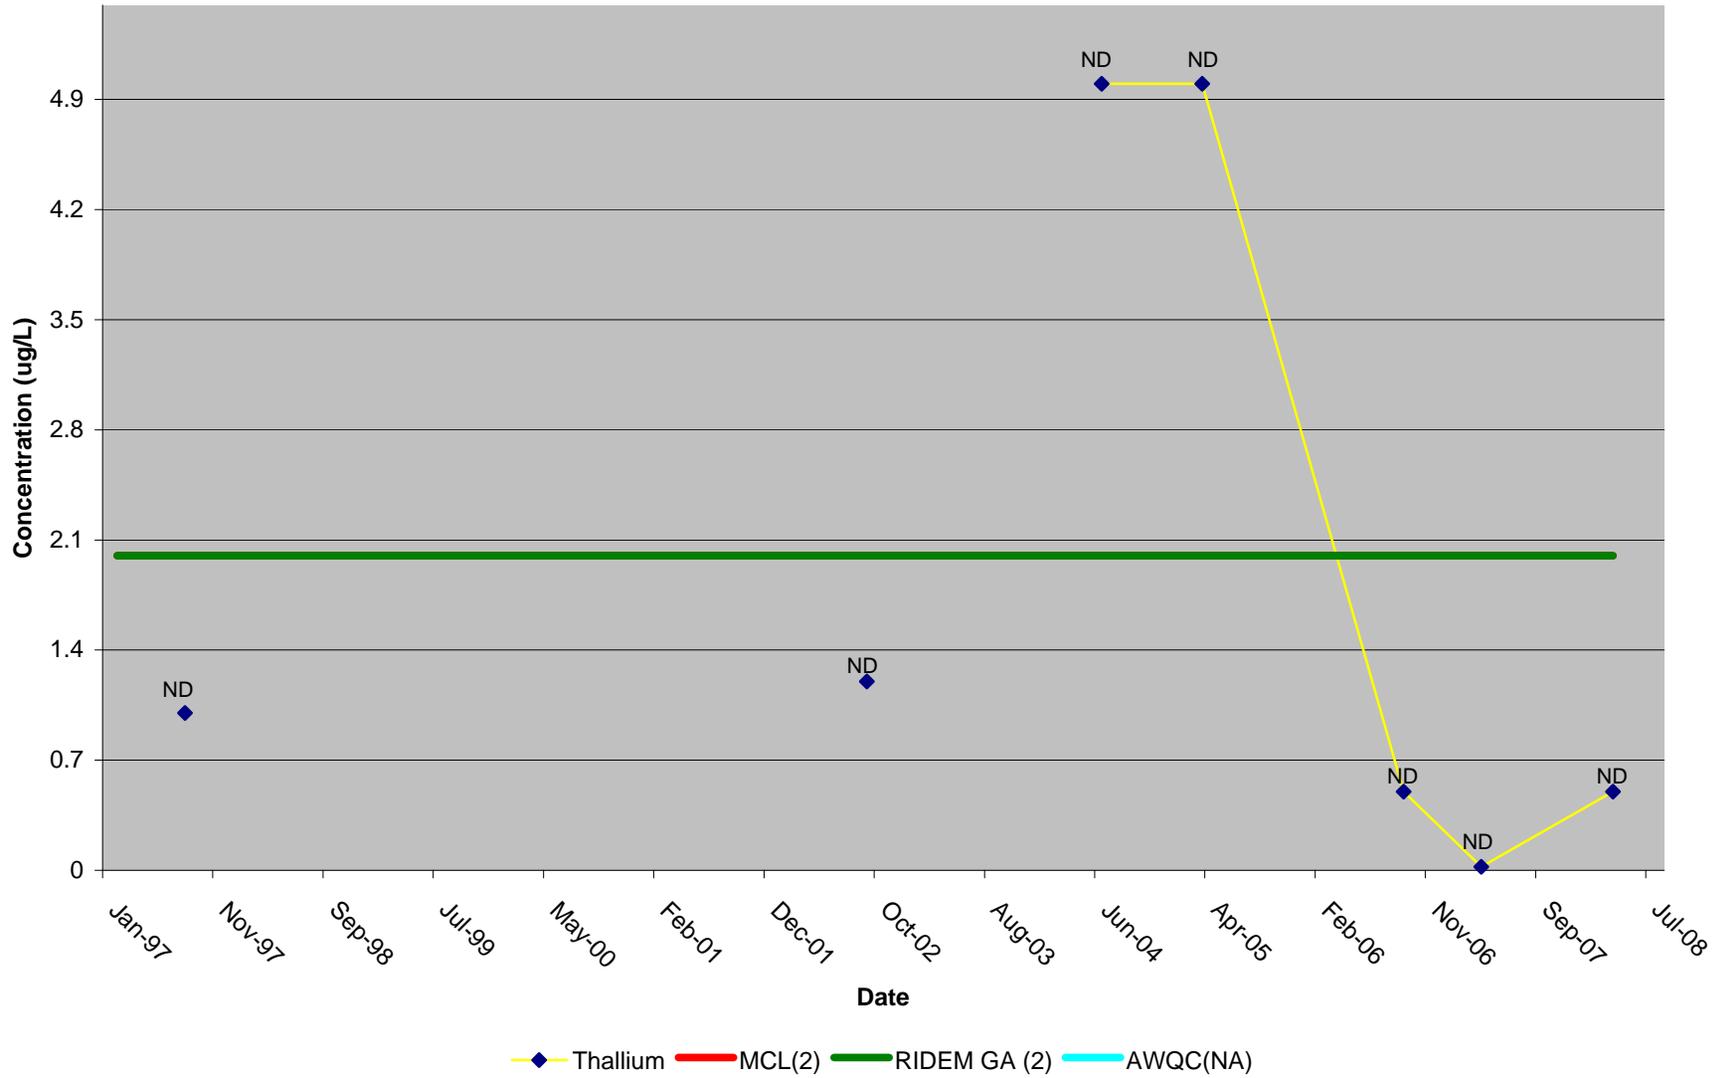
APPENDIX F-1: GROUNDWATER
FIGURE F-1.8-9

THALLIUM IN GROUNDWATER, MW108R
SITE 01 McALLISTER POINT LANDFILL
NAVAL STATION NEWPORT
FIVE YEAR REVIEW REPORT

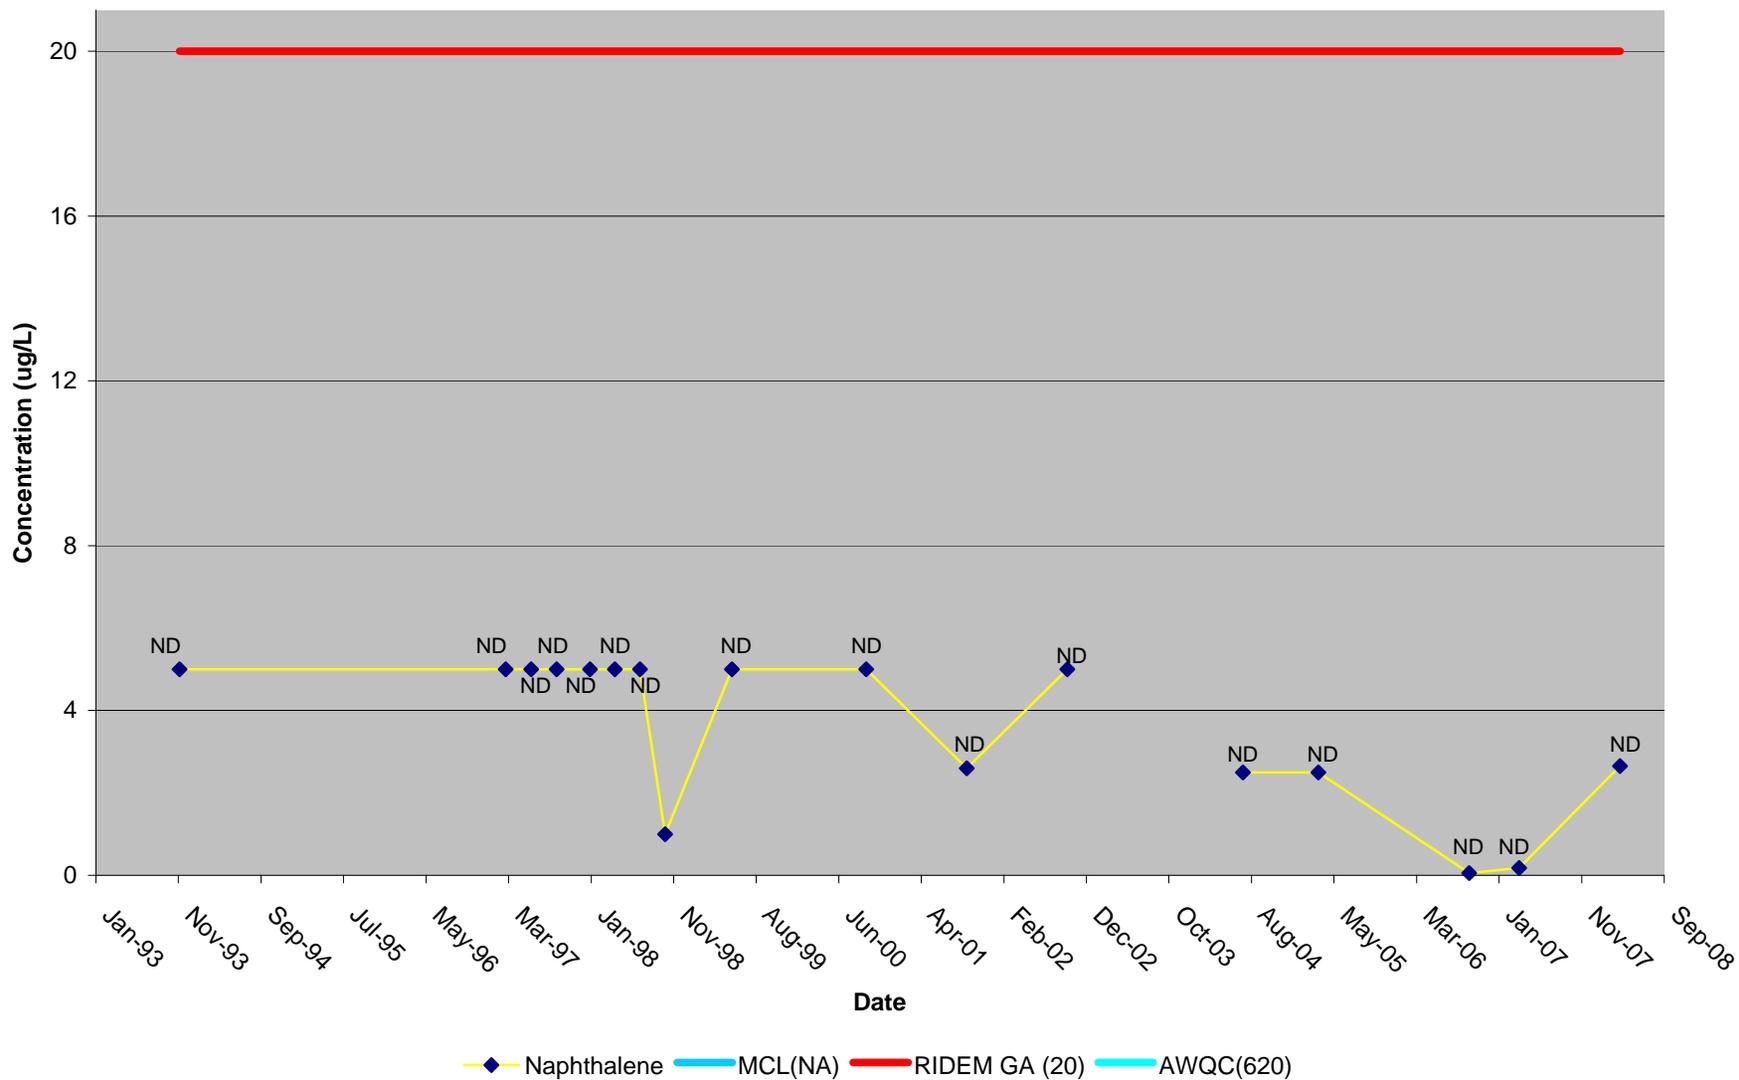
APPENDIX F-1: GROUNDWATER
FIGURE F-1.8-10

NAPHTHALENE IN GROUNDWATER, MW108R
SITE 01 McALLISTER POINT LANDFILL
NAVAL STATION NEWPORT
FIVE YEAR REVIEW REPORT

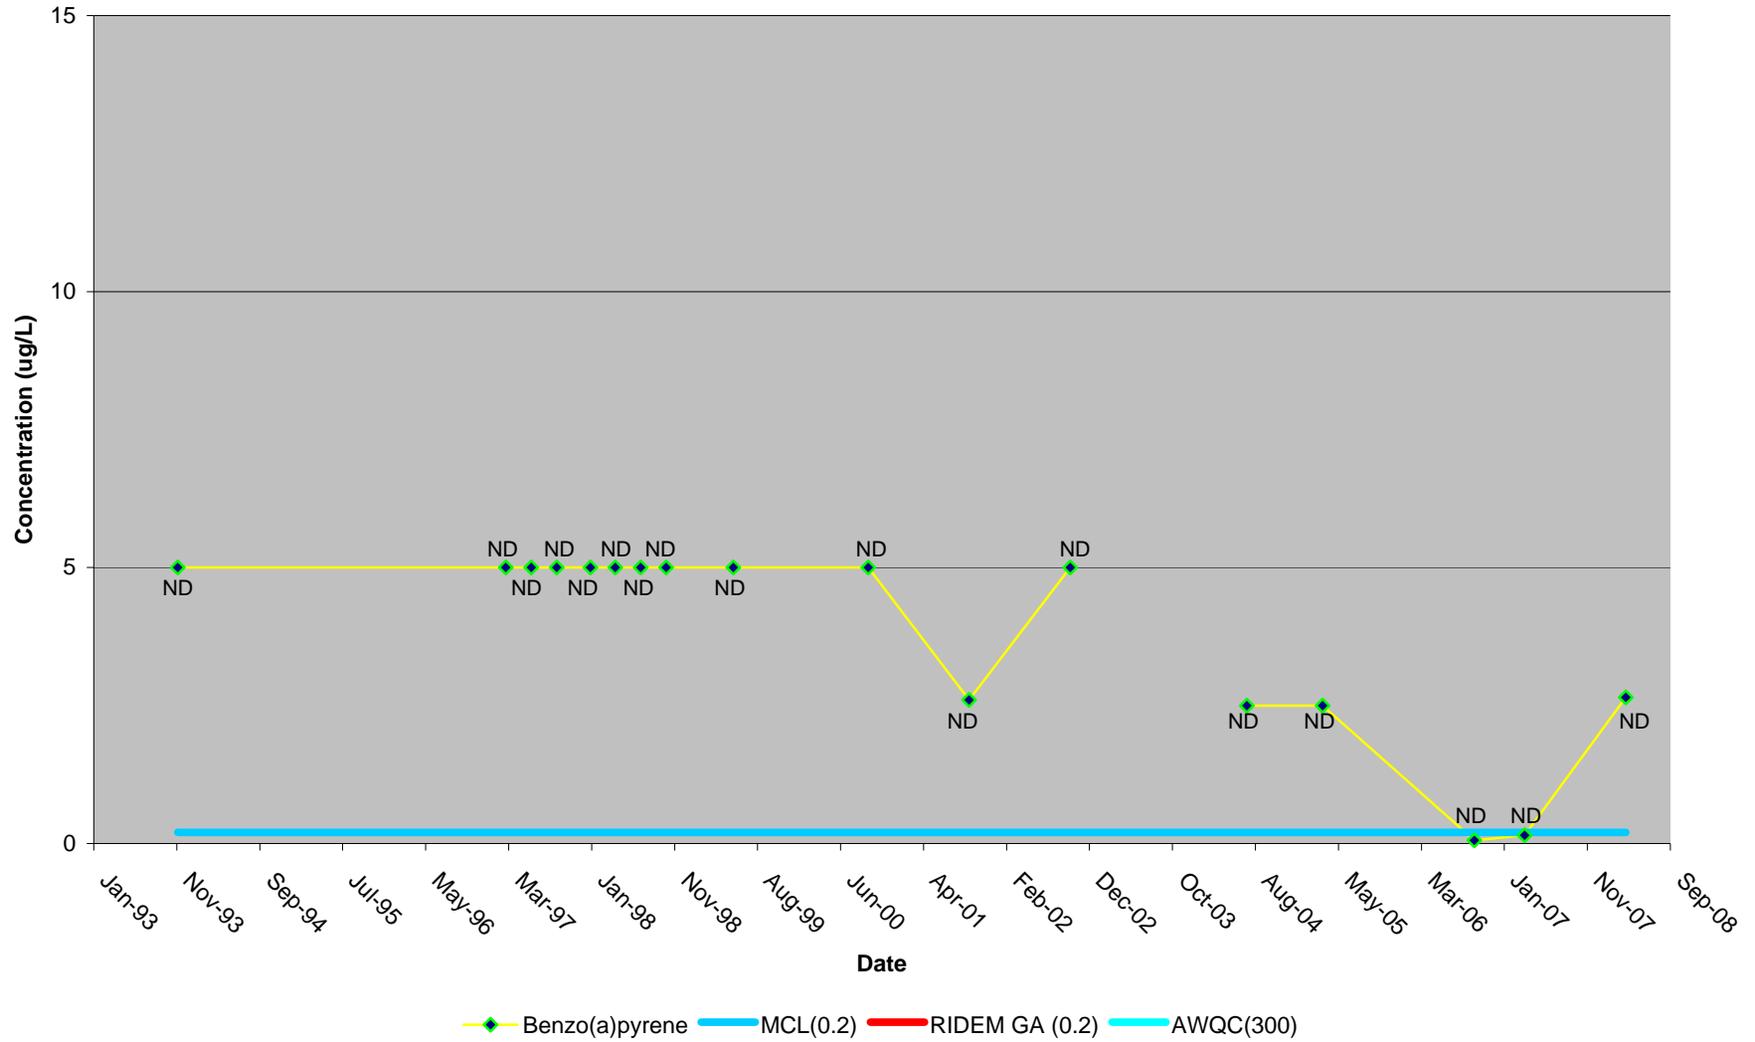
APPENDIX F-1: GROUNDWATER
FIGURE F-1.8-11

BENZO(A)PYRENE IN GROUNDWATER, MW108R
SITE 01 McALLISTER POINT LANDFILL
NAVAL STATION NEWPORT
FIVE YEAR REVIEW REPORT

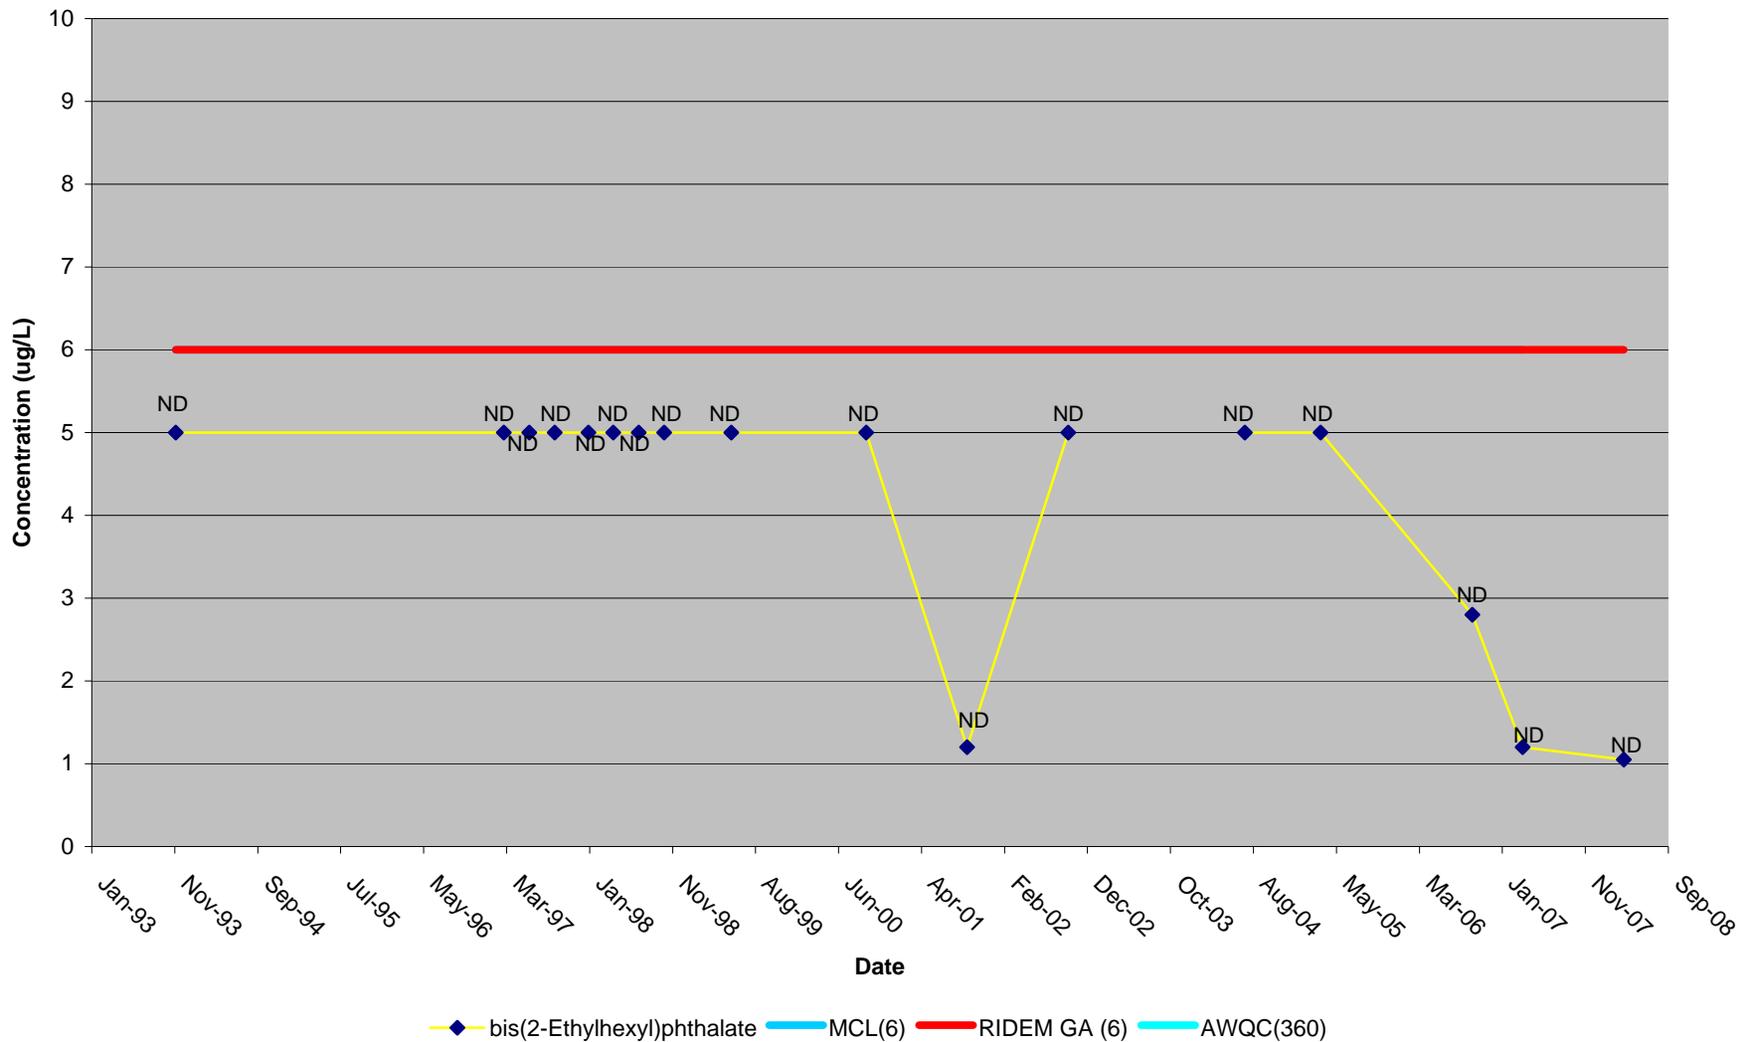
APPENDIX F-1: GROUNDWATER
FIGURE F-1.8-12

BIS(2-ETHYLHEXYL)PHTHALATE IN GROUNDWATER, MW108R
SITE 01 McALLISTER POINT LANDFILL
NAVAL STATION NEWPORT
FIVE YEAR REVIEW REPORT

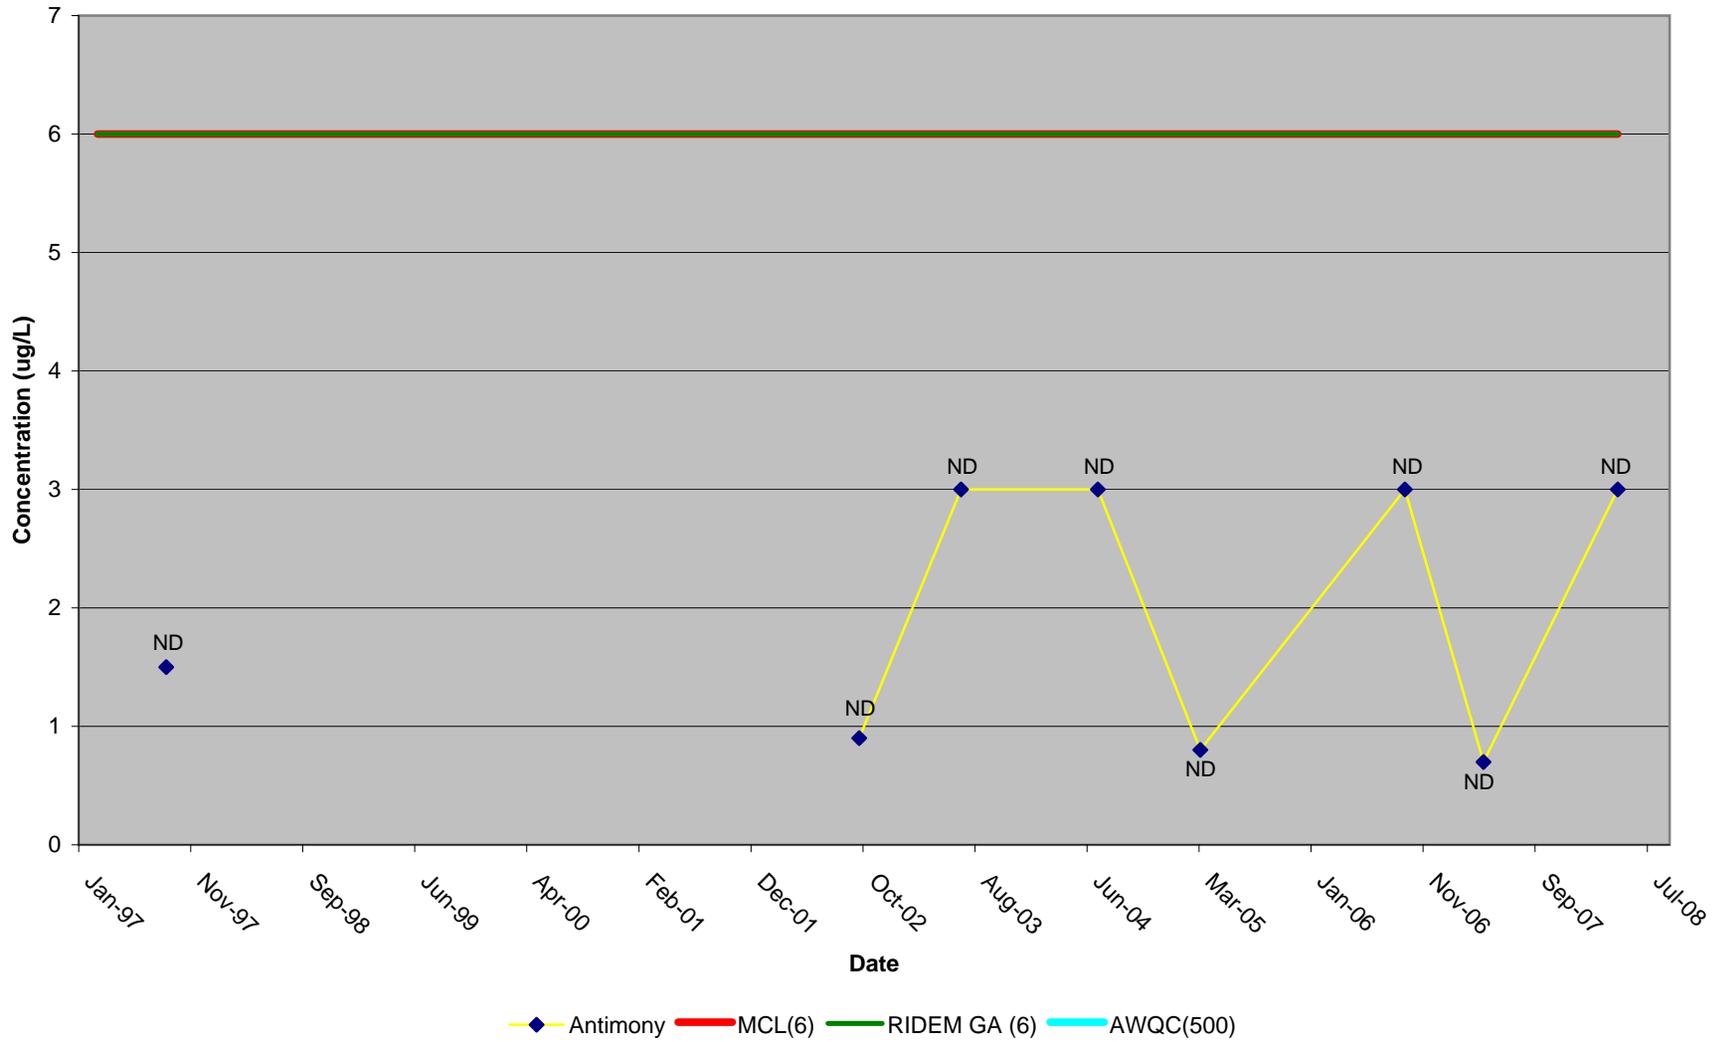
APPENDIX F-1: GROUNDWATER
FIGURE F-1.9-1

ANTIMONY IN GROUNDWATER, MW111R
SITE 01 McALLISTER POINT LANDFILL
NAVAL STATION NEWPORT
FIVE YEAR REVIEW REPORT

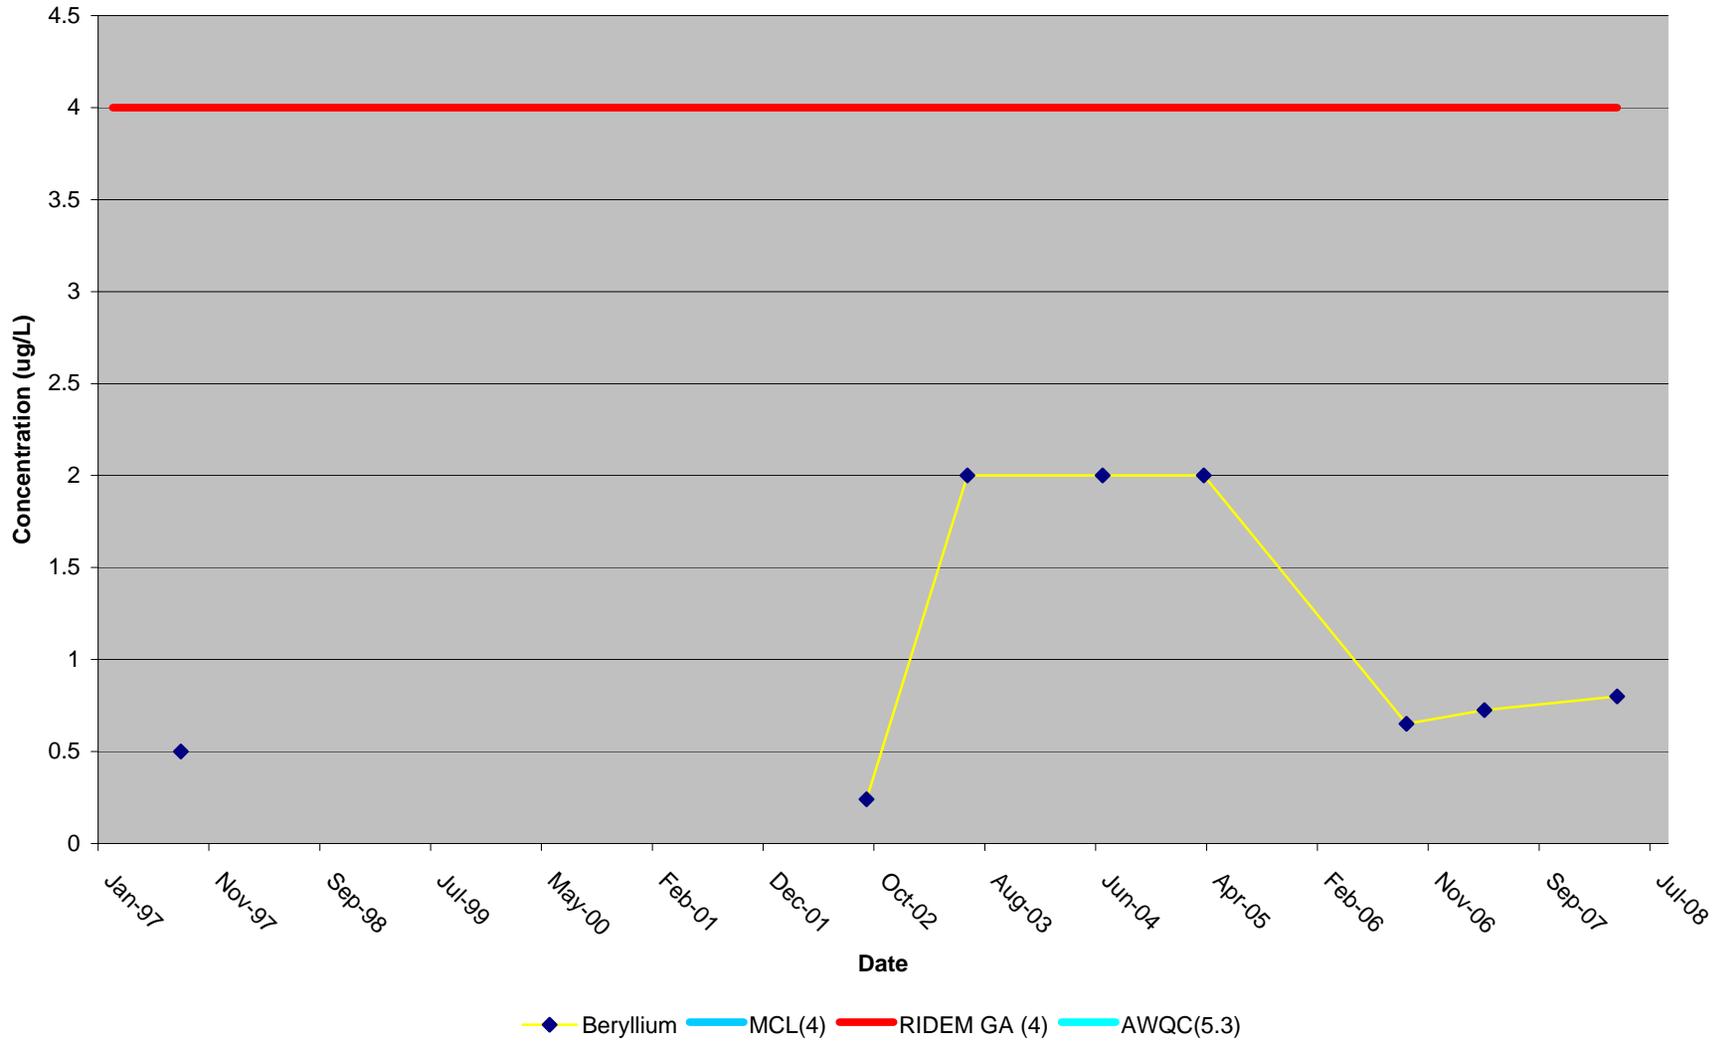
BERYLLIUM IN GROUNDWATER, MW111R
SITE 01 McALLISTER POINT LANDFILL
NAVAL STATION NEWPORT
FIVE YEAR REVIEW REPORT

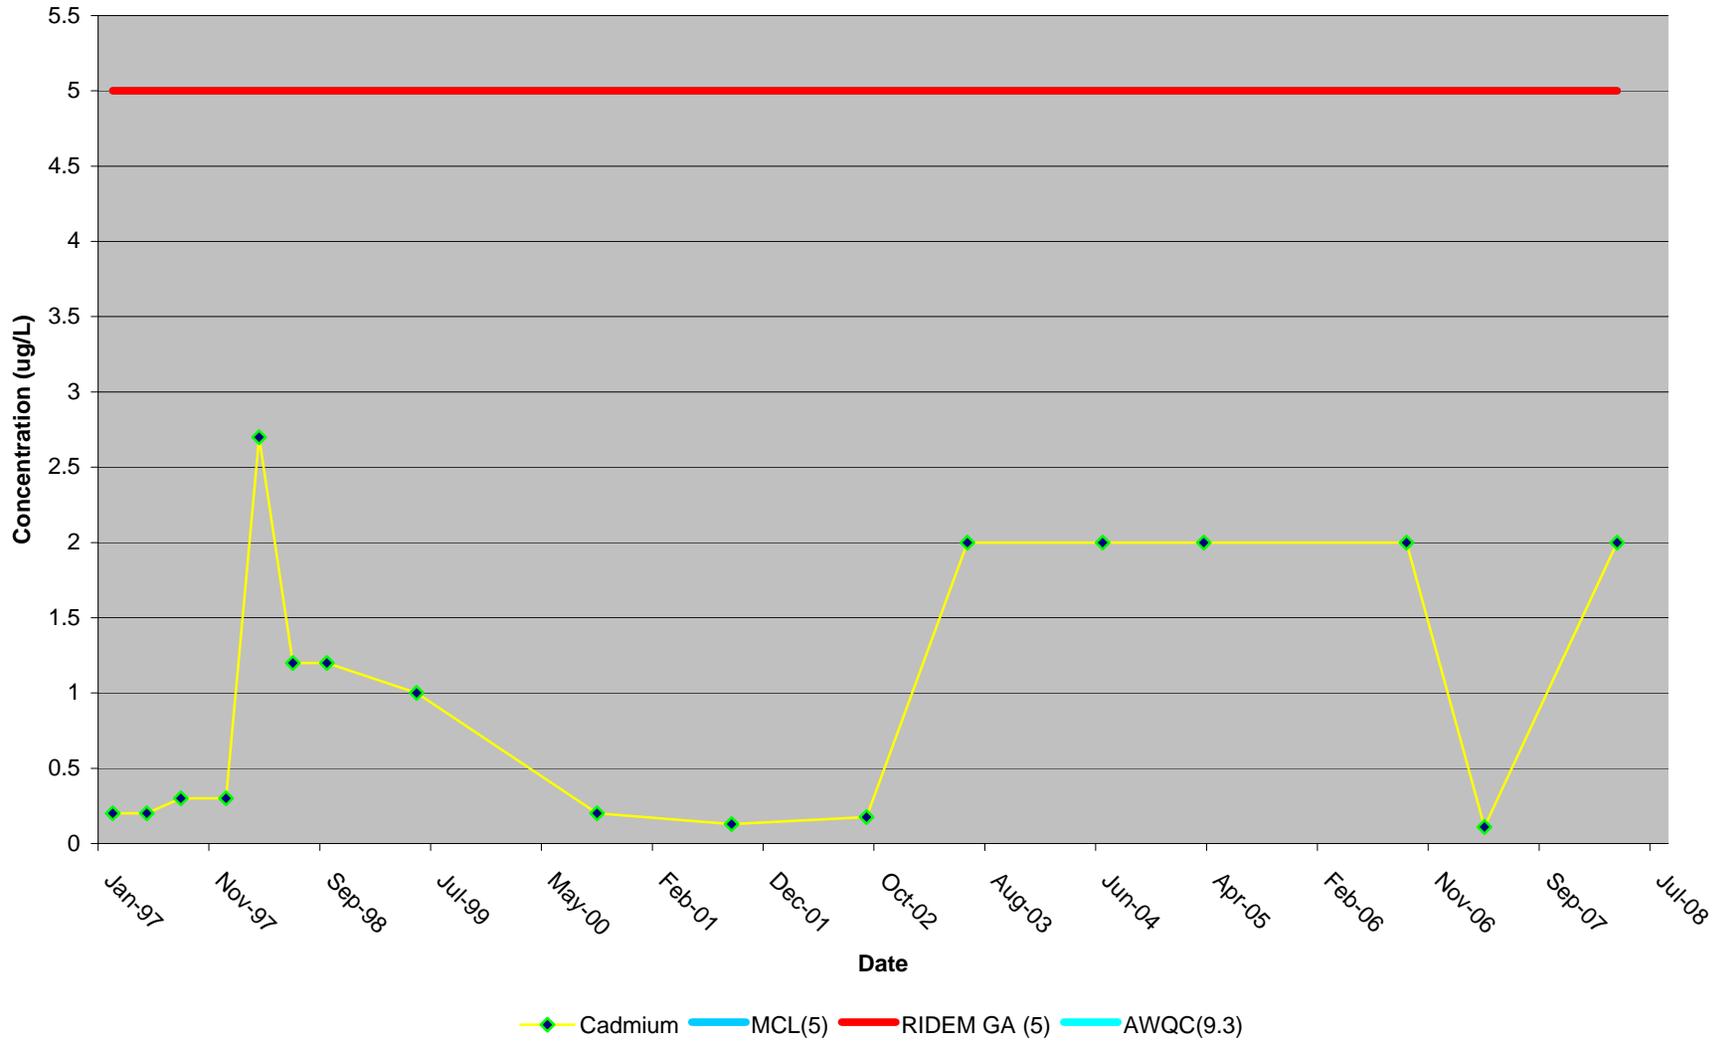
APPENDIX F-1: GROUNDWATER
FIGURE F-1.9-4

CADMIUM IN GROUNDWATER, MW111R
SITE 01 McALLISTER POINT LANDFILL
NAVAL STATION NEWPORT
FIVE YEAR REVIEW REPORT

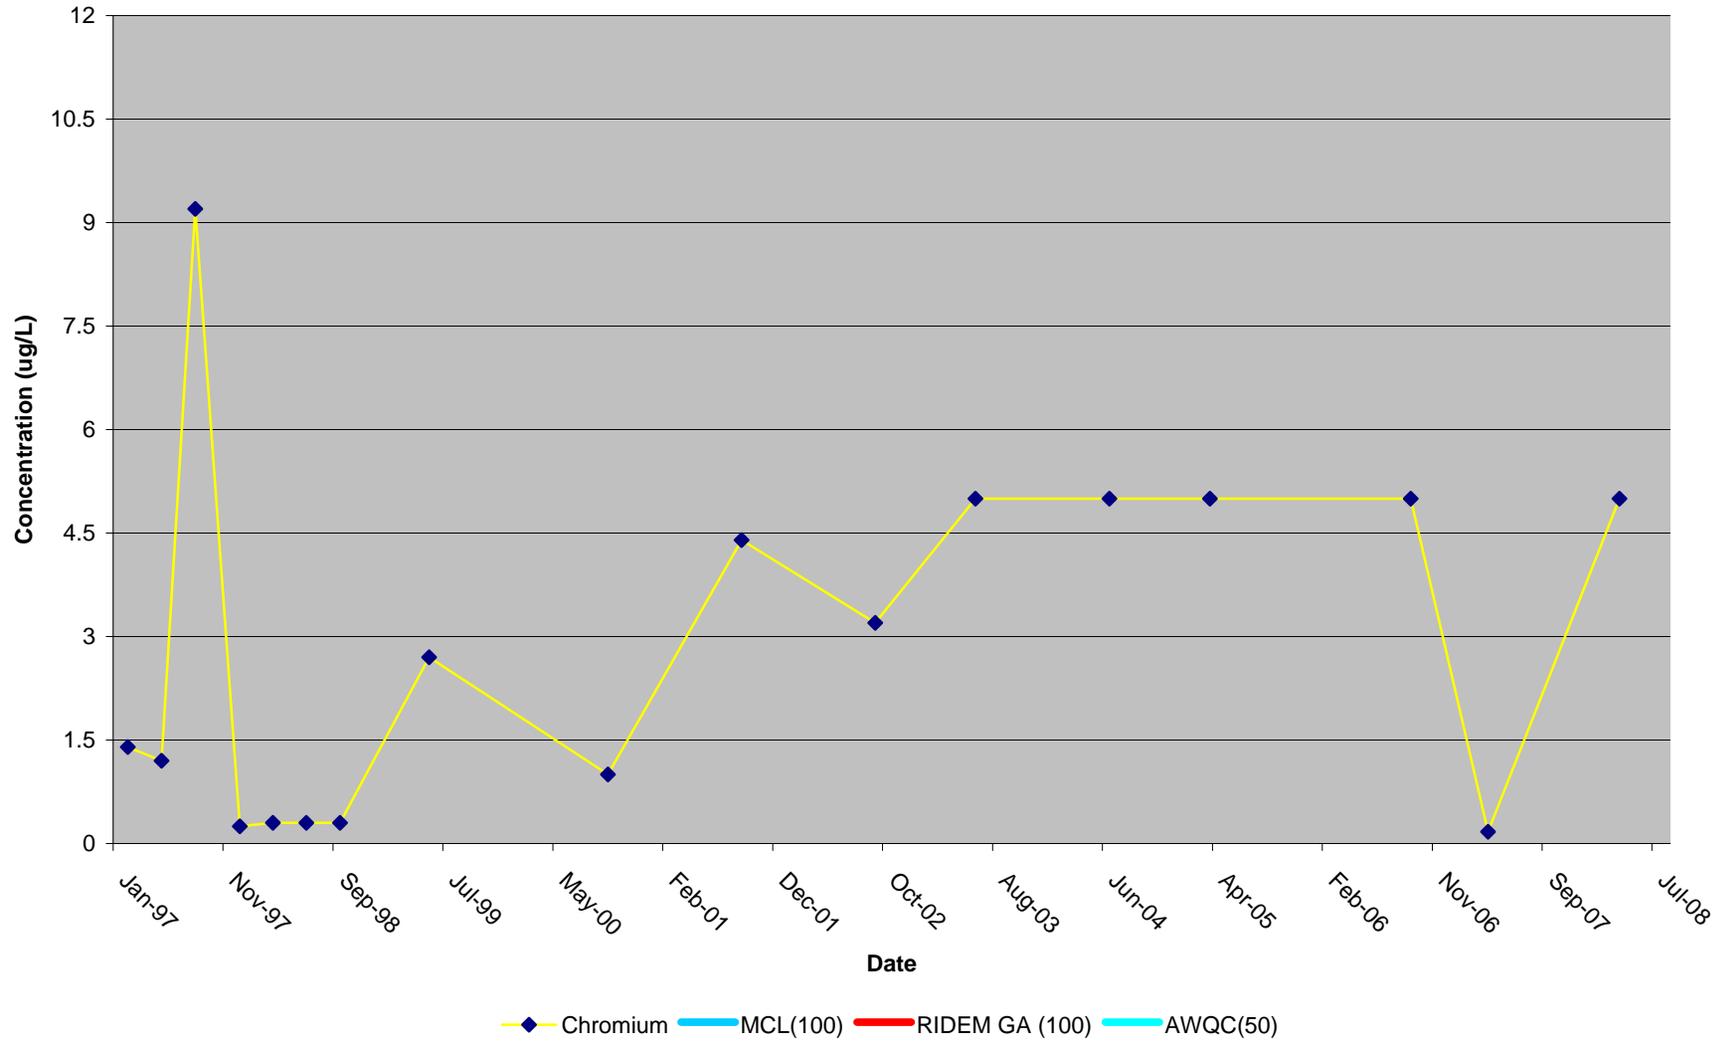
APPENDIX F-1: GROUNDWATER
FIGURE F-1.9-5

CHROMIUM IN GROUNDWATER, MW111R
SITE 01 McALLISTER POINT LANDFILL
NAVAL STATION NEWPORT
FIVE YEAR REVIEW REPORT

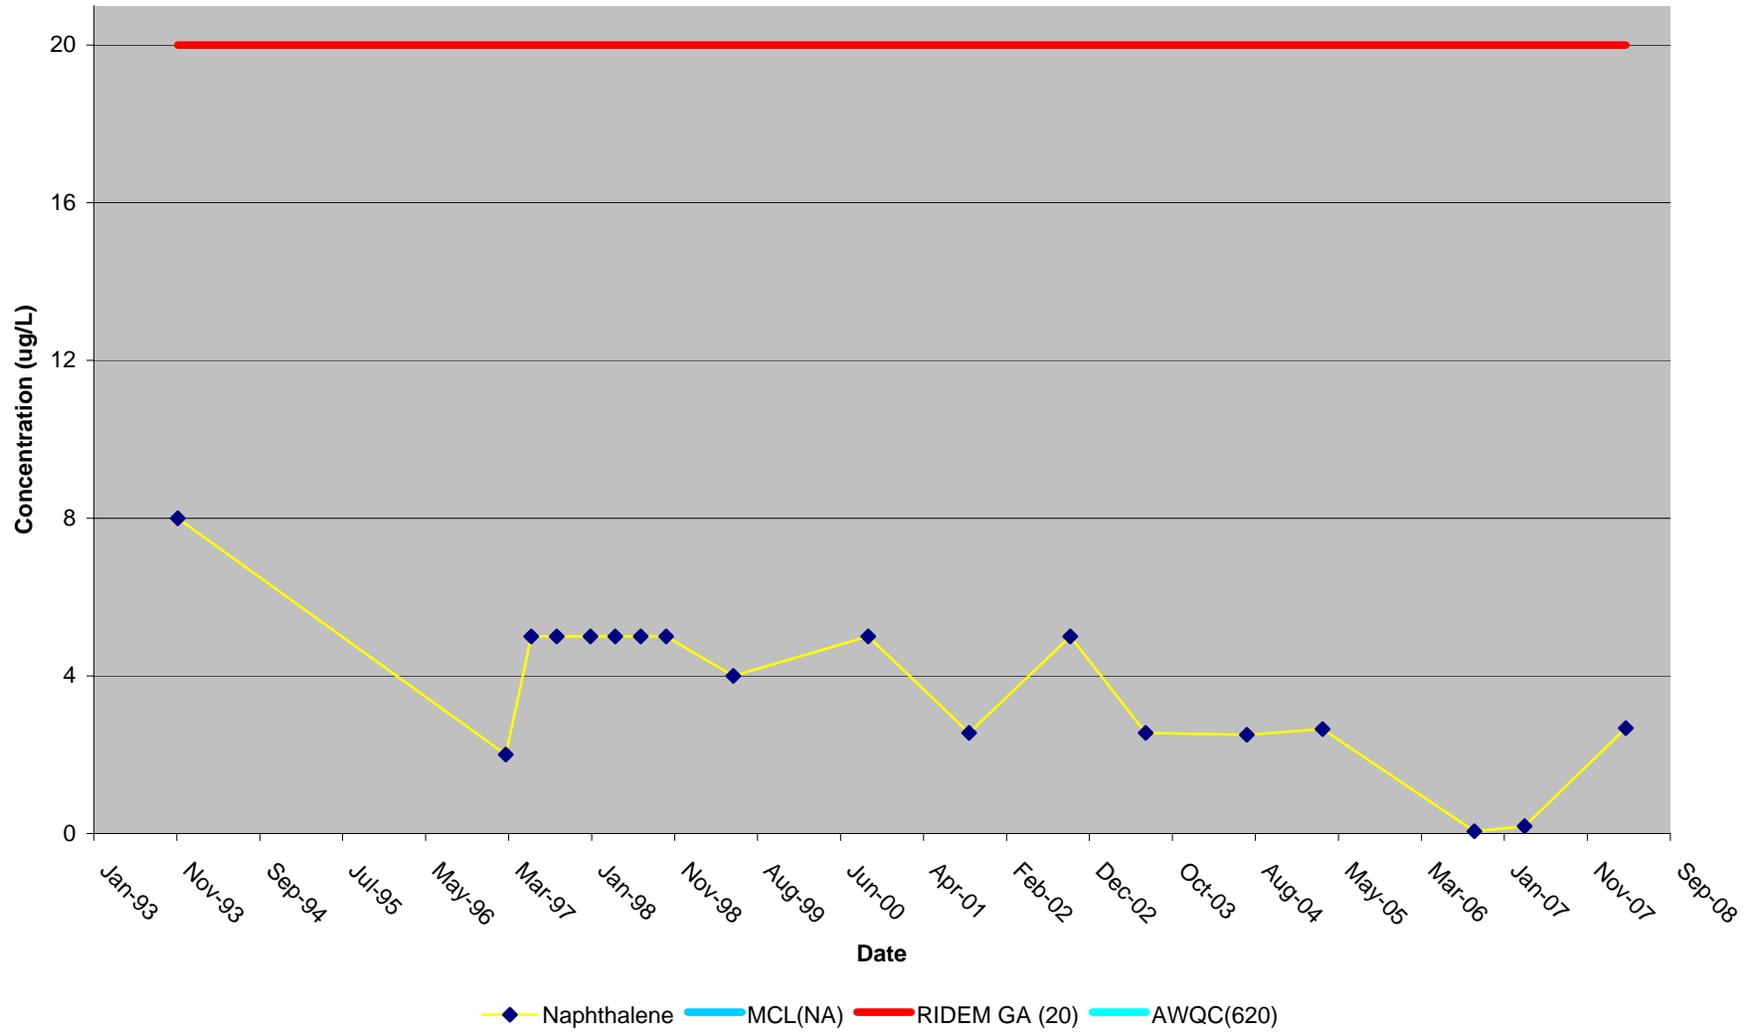
NAPHTHALENE IN GROUNDWATER, MW111R
SITE 01 McALLISTER POINT LANDFILL
NAVAL STATION NEWPORT
FIVE YEAR REVIEW REPORT

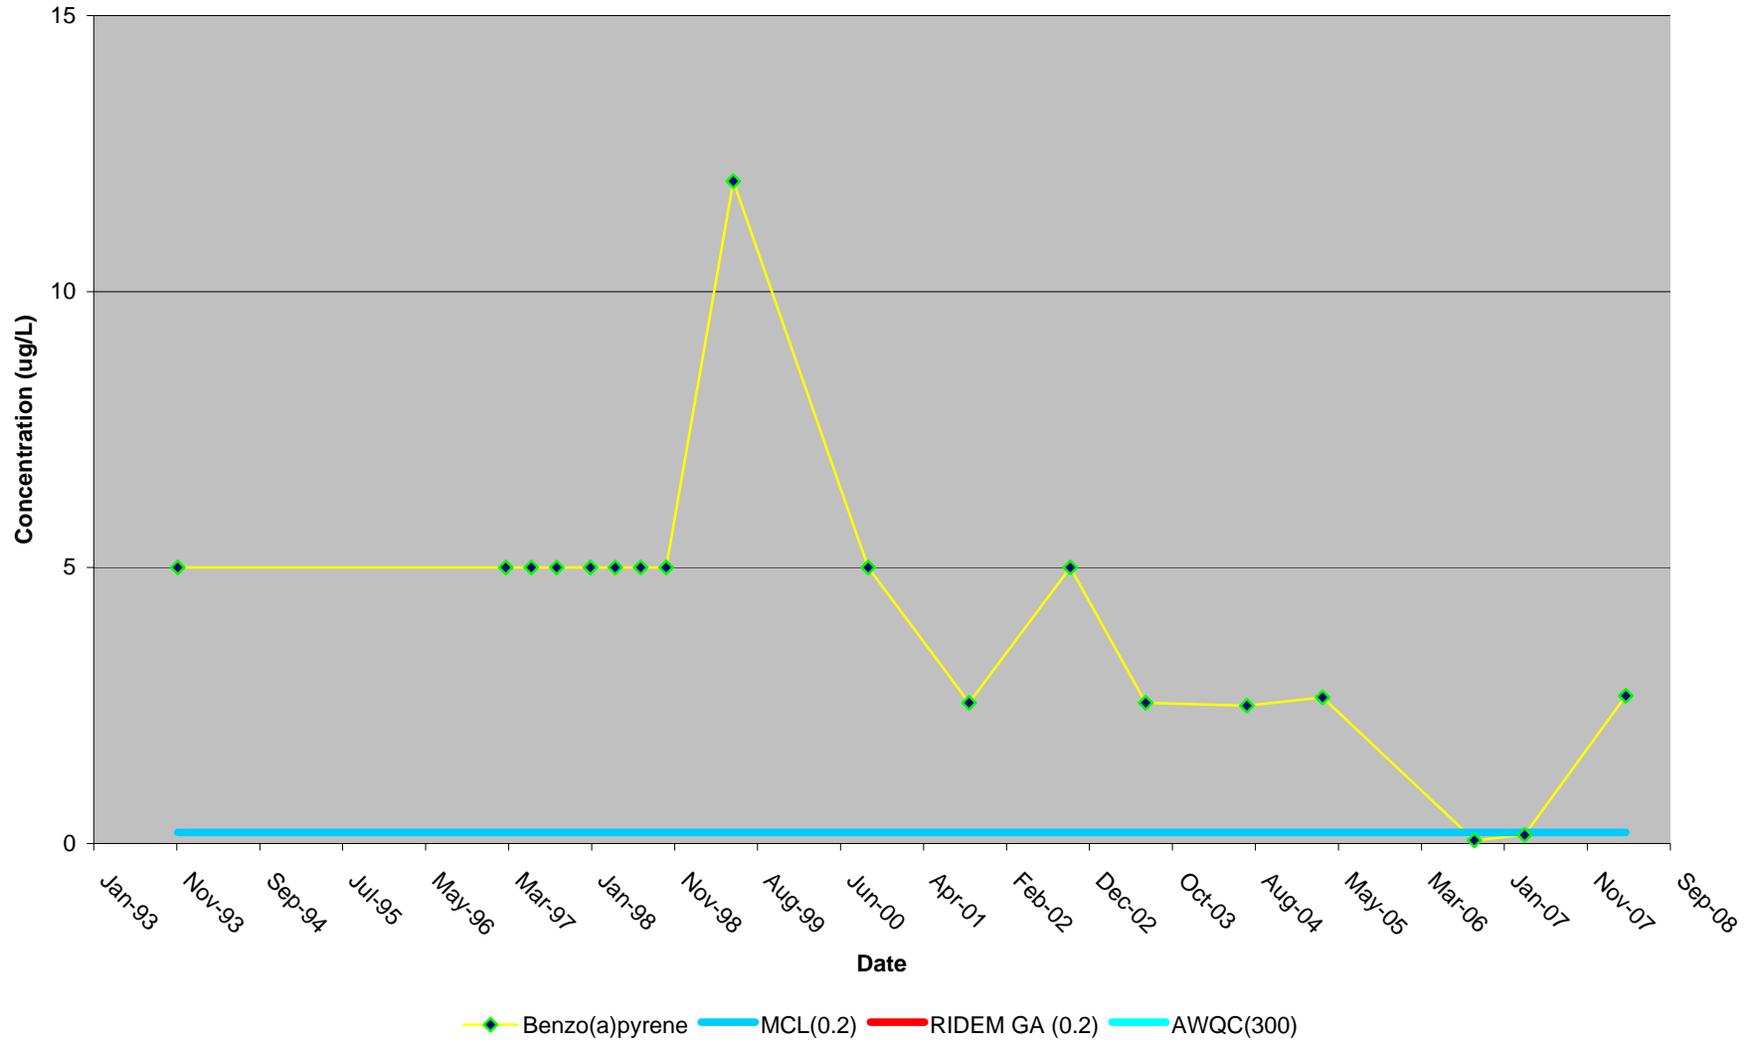
APPENDIX F-1: GROUNDWATER
FIGURE F-1.9-11

BENZO(A)PYRENE IN GROUNDWATER, MW111R
SITE 01 McALLISTER POINT LANDFILL
NAVAL STATION NEWPORT
FIVE YEAR REVIEW REPORT

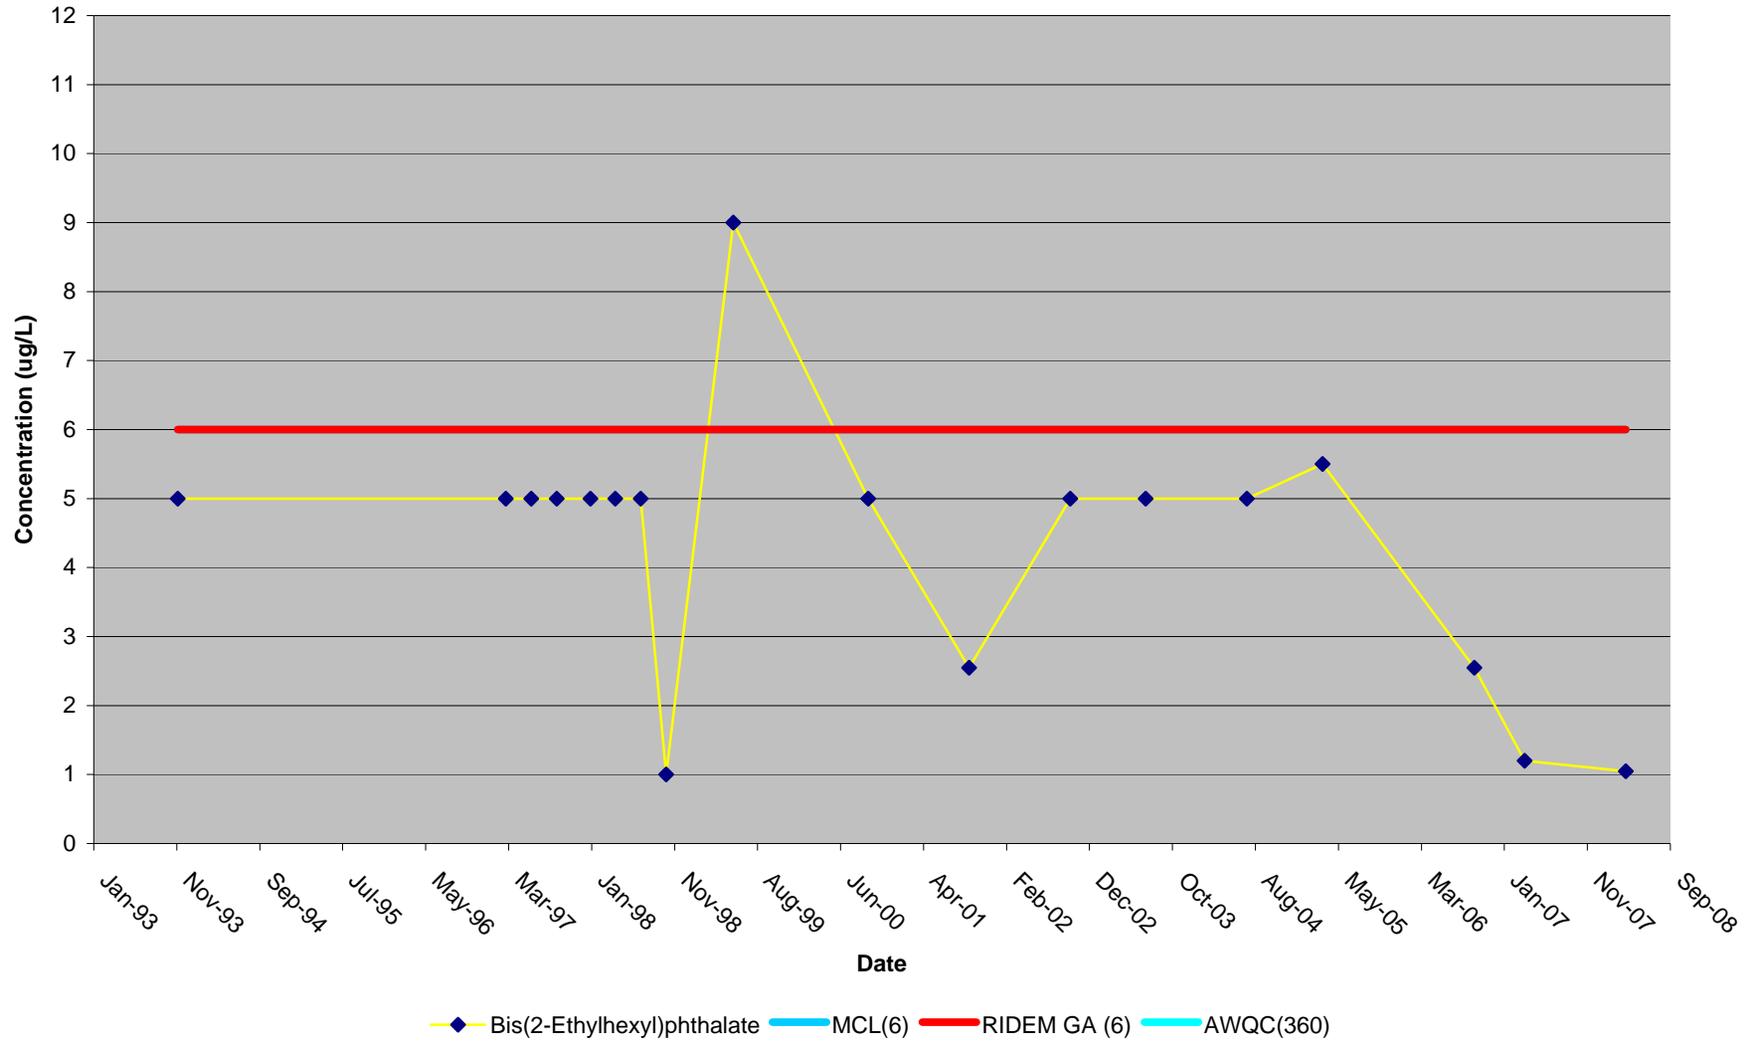
APPENDIX F-1: GROUNDWATER
FIGURE F-1.9-12

BIS(2-ETHYLHEXYL)PHTHALATE IN GROUNDWATER, MW111R
SITE 01 McALLISTER POINT LANDFILL
NAVAL STATION NEWPORT
FIVE YEAR REVIEW REPORT

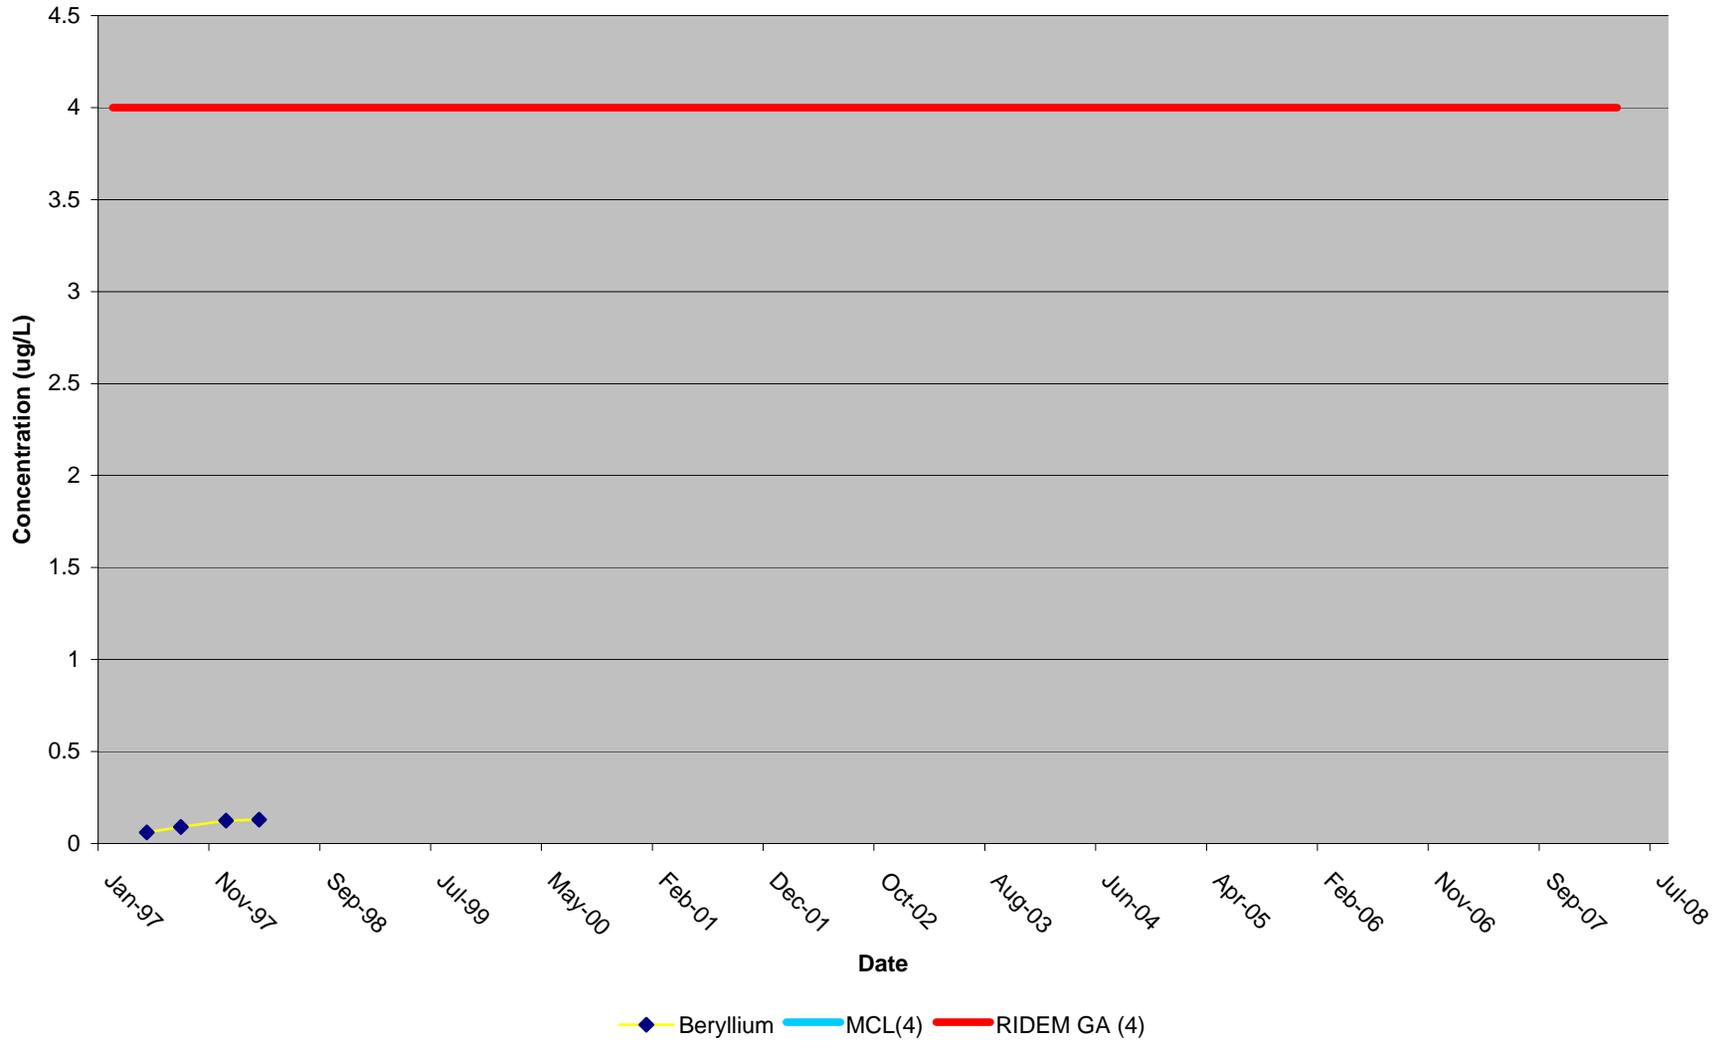
BERYLLIUM IN GROUNDWATER, MW112S
SITE 01 McALLISTER POINT LANDFILL
NAVAL STATION NEWPORT
FIVE YEAR REVIEW REPORT
