Five Year Review Report

**Naval Station Newport
(Formerly NETC Newport)**

Newport, Rhode Island

**FIVE YEAR REVIEW REPORT
FOR
NAVAL STATION NEWPORT
(FORMERLY NETC NEWPORT)
NEWPORT, RHODE ISLAND
COMPREHENSIVE LONG-TERM
ENVIRONMENTAL ACTION NAVY (CLEAN) CONTRACT**

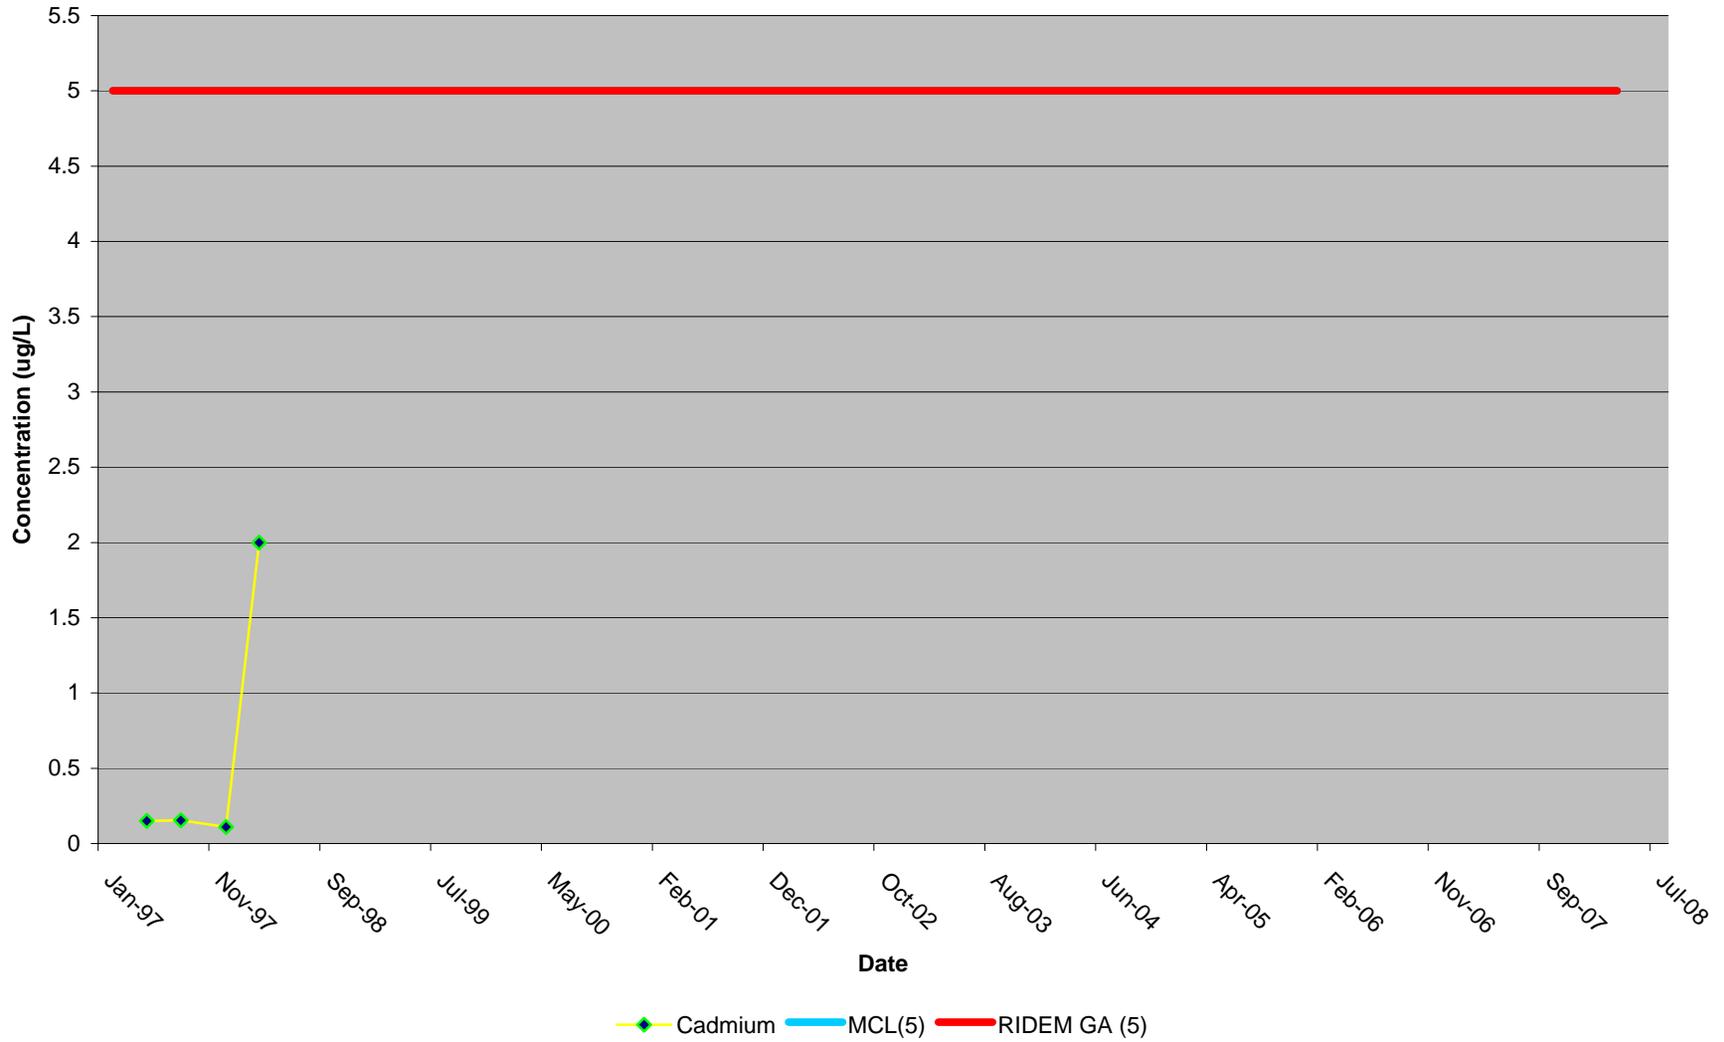
APPENDIX F-1: GROUNDWATER
FIGURE F-1.10-4

CADMIUM IN GROUNDWATER, MW112S
SITE 01 McALLISTER POINT LANDFILL
NAVAL STATION NEWPORT
FIVE YEAR REVIEW REPORT

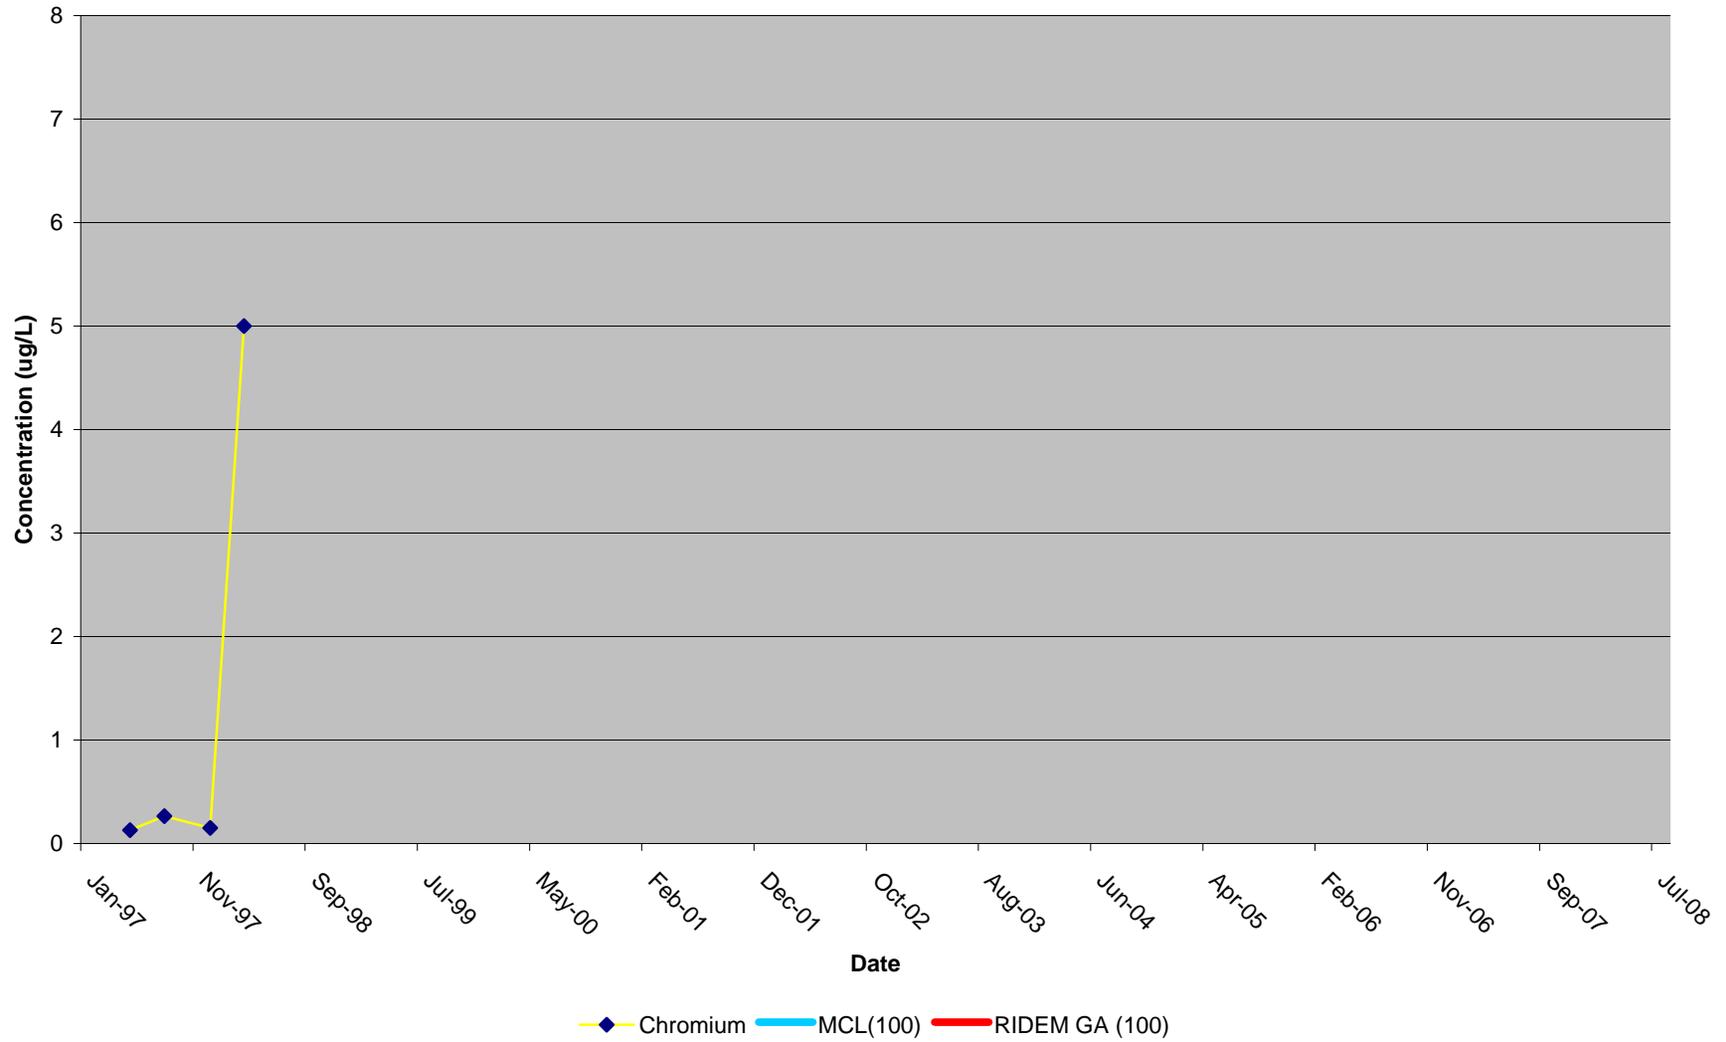
APPENDIX F-1: GROUNDWATER
FIGURE F-1.10-5

CHROMIUM IN GROUNDWATER, MW112S
SITE 01 McALLISTER POINT LANDFILL
NAVAL STATION NEWPORT
FIVE YEAR REVIEW REPORT

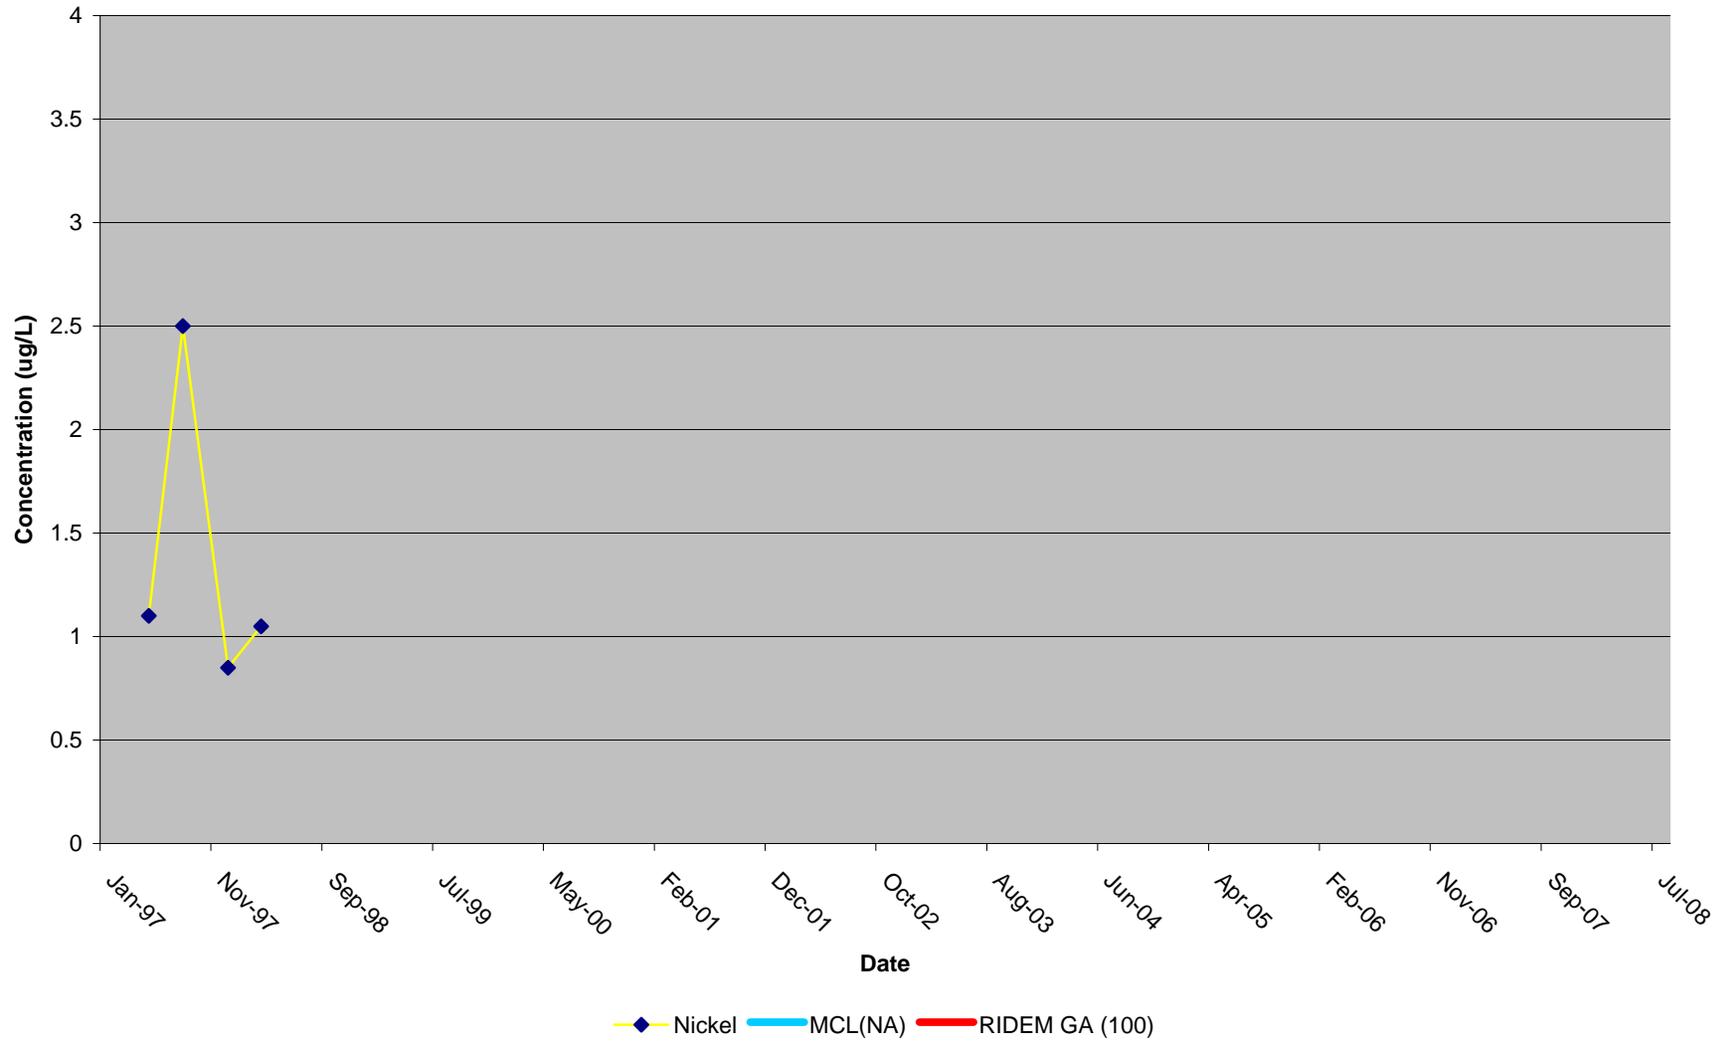
NICKEL IN GROUNDWATER, MW112S
SITE 01 McALLISTER POINT LANDFILL
NAVAL STATION NEWPORT
FIVE YEAR REVIEW REPORT

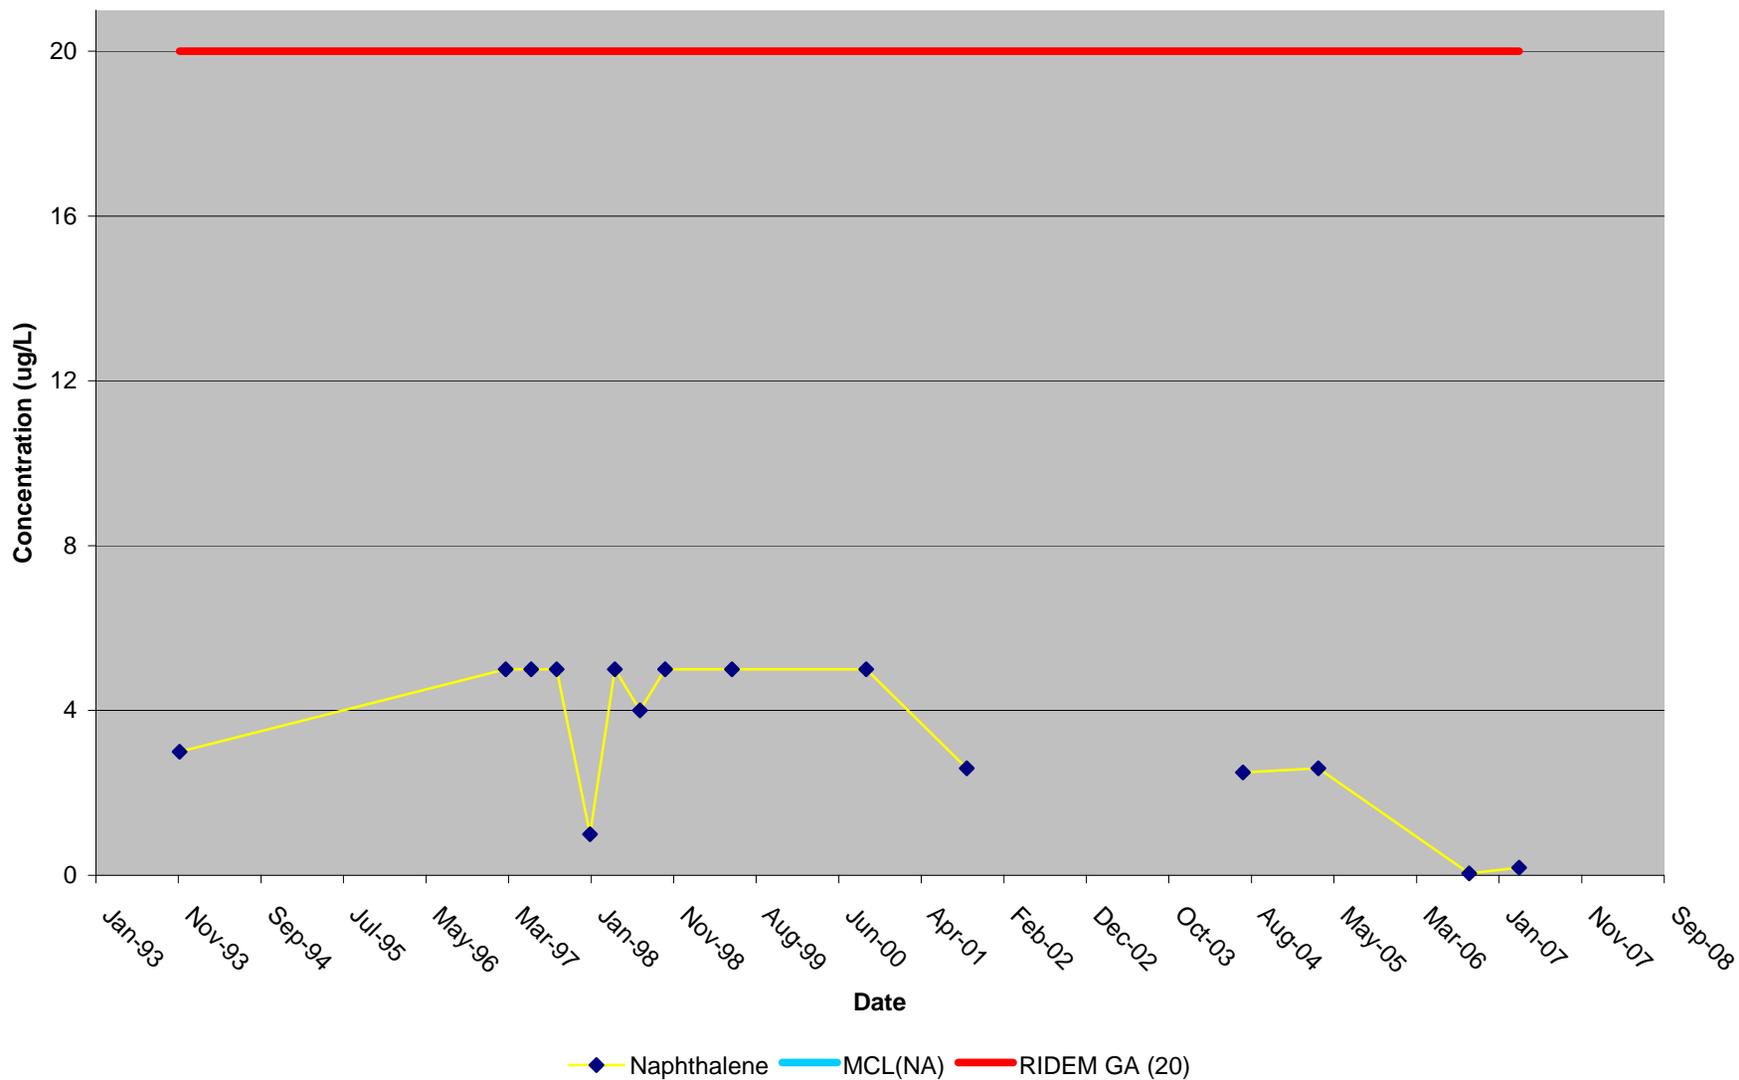
NAPHTHALENE IN GROUNDWATER MW-112S
SITE 01 - MCALLISTER POINT LANDFILL, NAVAL STATION NEWPORT
FIVE YEAR REVIEW REPORT

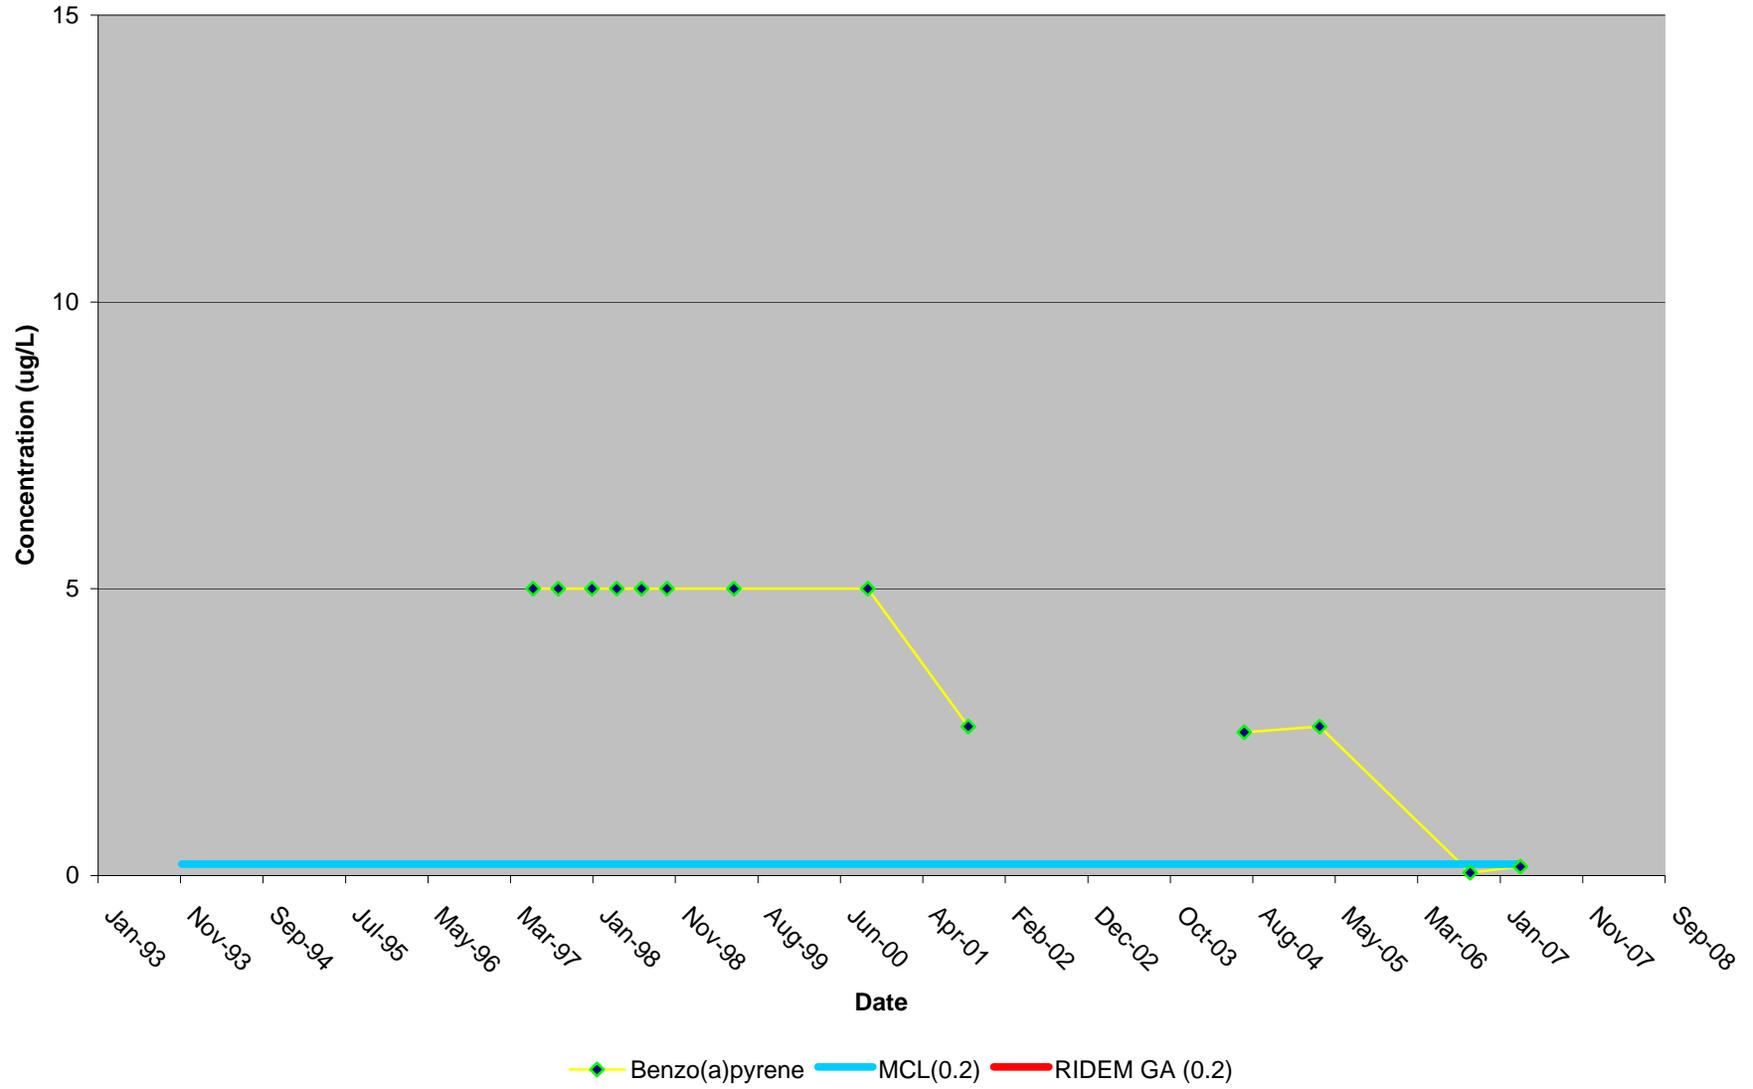
APPENDIX F-1: GROUNDWATER
FIGURE F-1.10-11

BENZO(A)PYRENE IN GROUNDWATER, MW-112S
SITE 01 - MCALLISTER POINT LANDFILL, NAVAL STATION NEWPORT
FIVE YEAR REVIEW REPORT

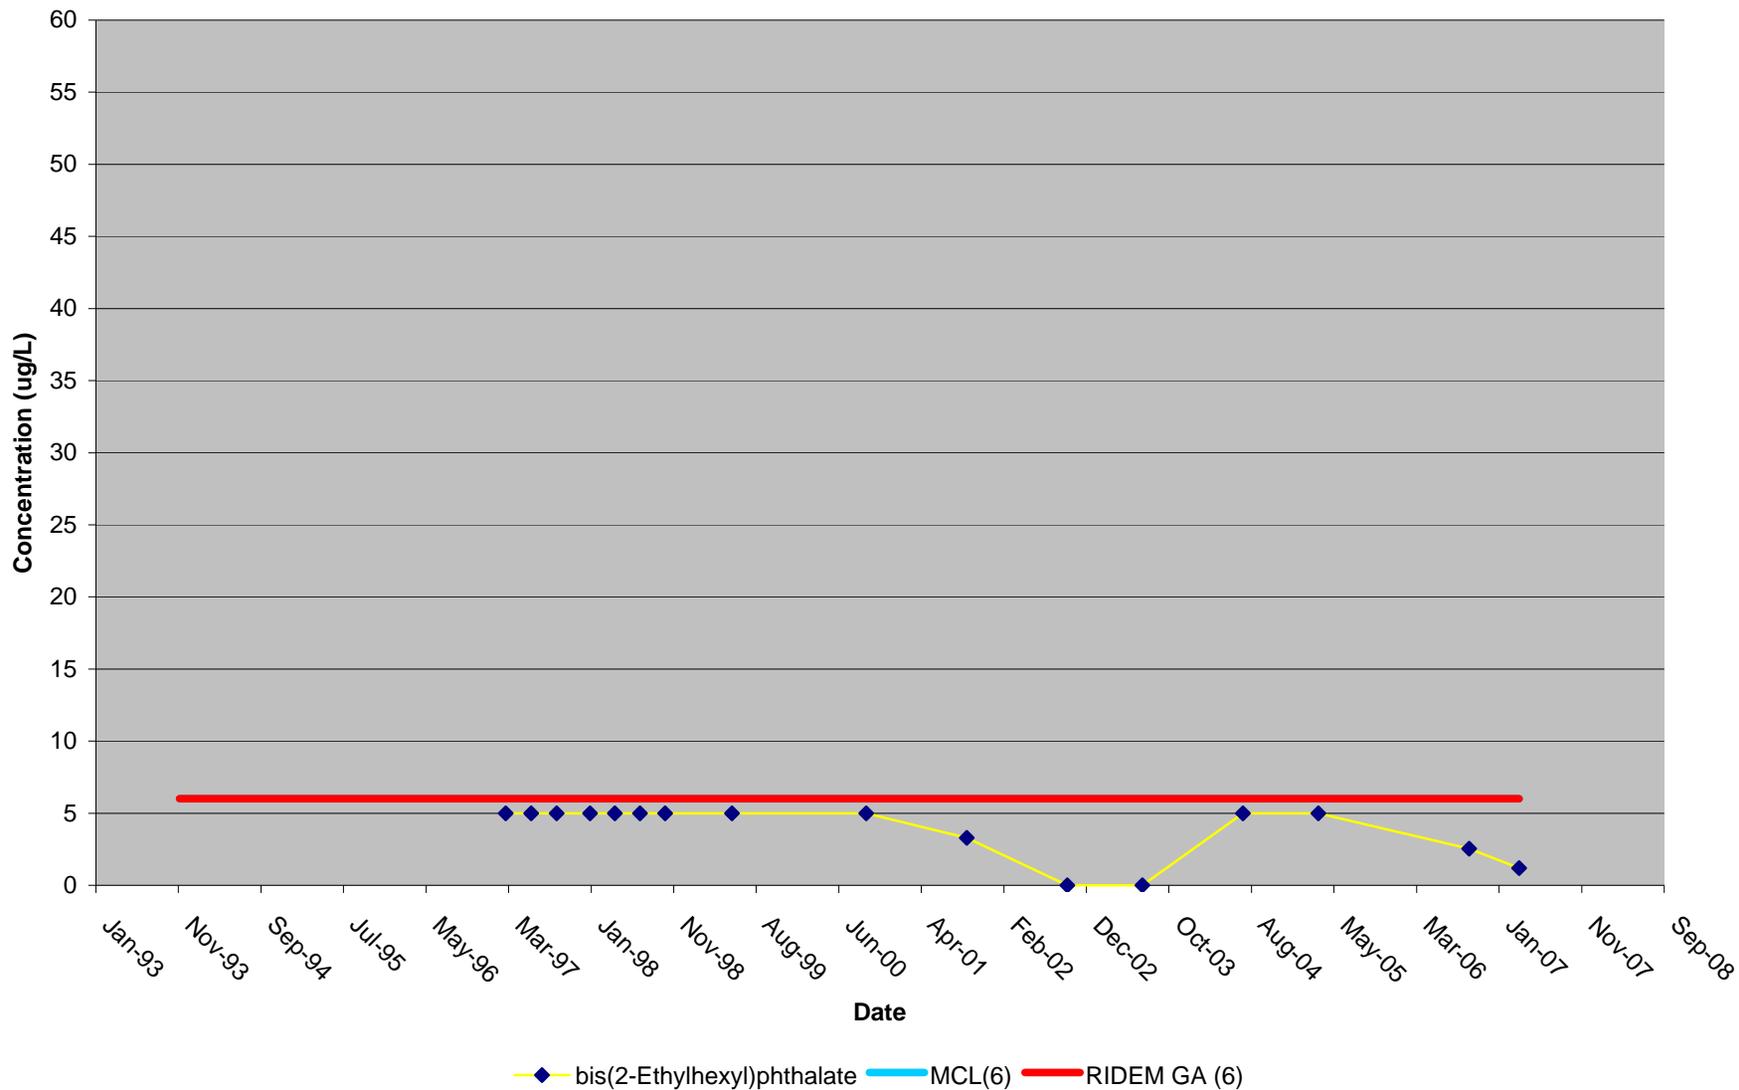
BIS(2-ETHYLHEXYL)PHTHALATE IN GROUNDWATER, MW-112S
SITE 01 - MCALLISTER POINT LANDFILL NAVAL STATION NEWPORT
FIVE YEAR REVIEW REPORT

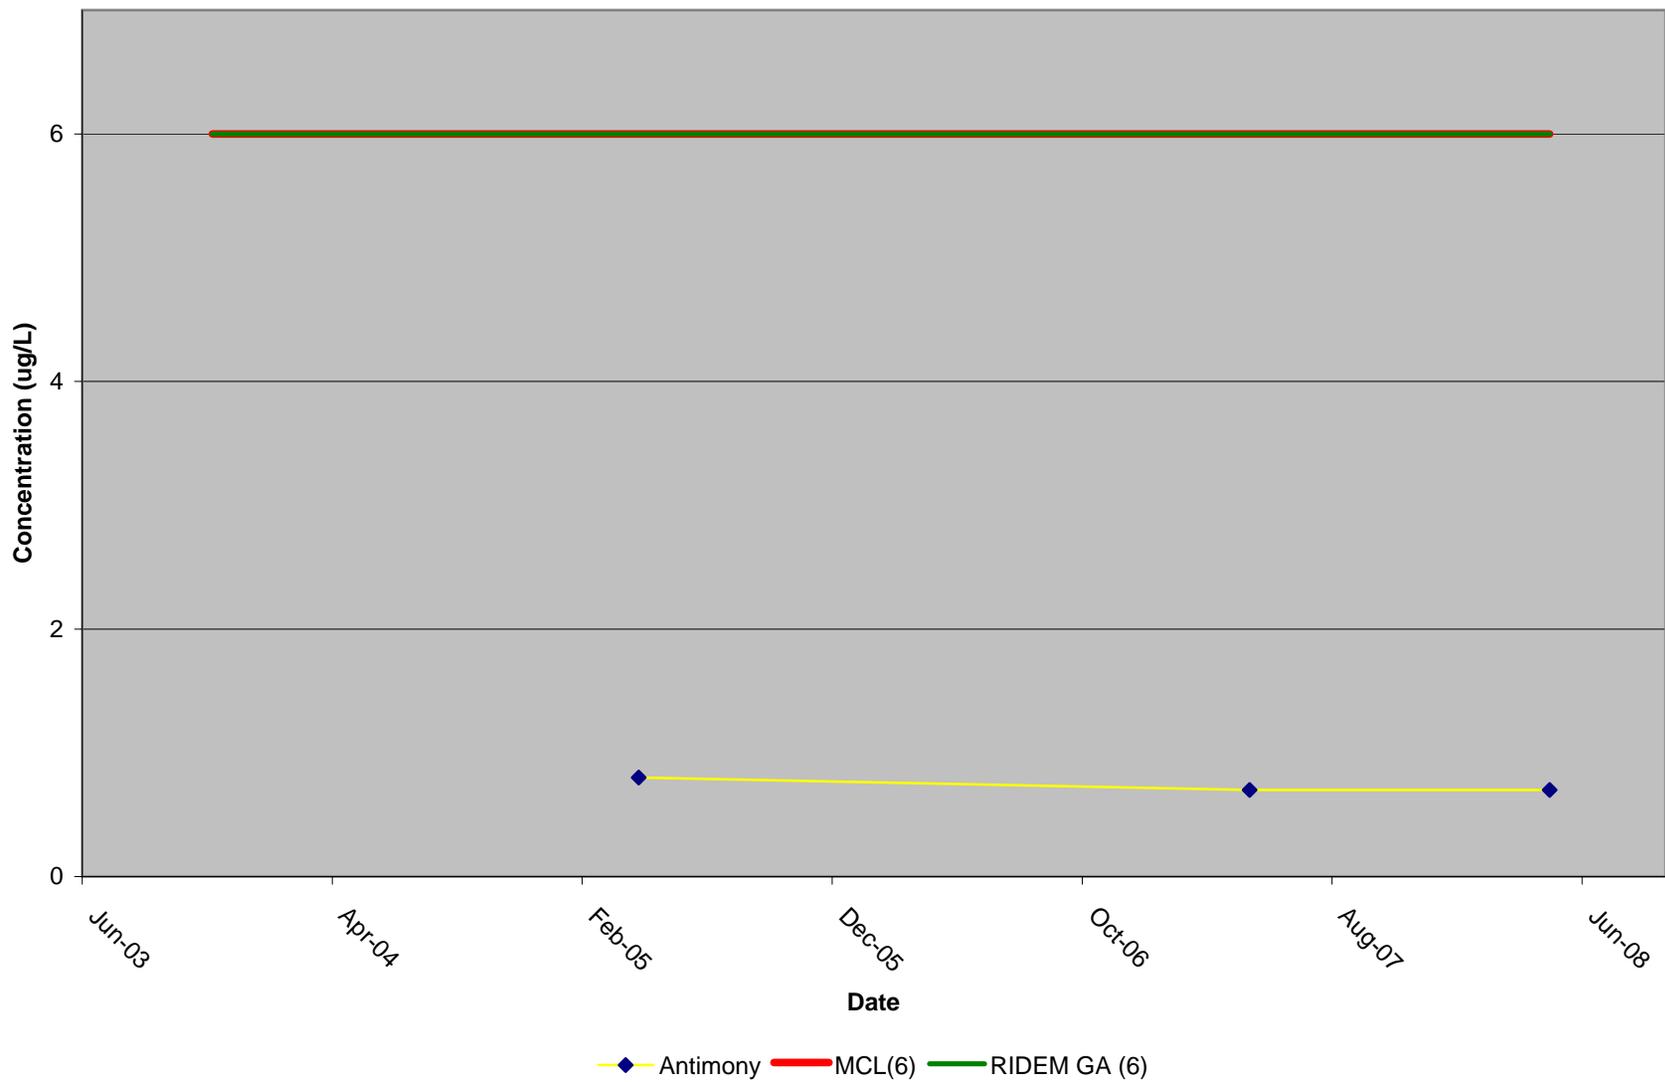
ANTIMONY IN GROUNDWATER, MW-113S
SITE 01 McALLISTER POINT LANDFILL, NAVAL STATION NEWPORT
FIVE YEAR REVIEW REPORT

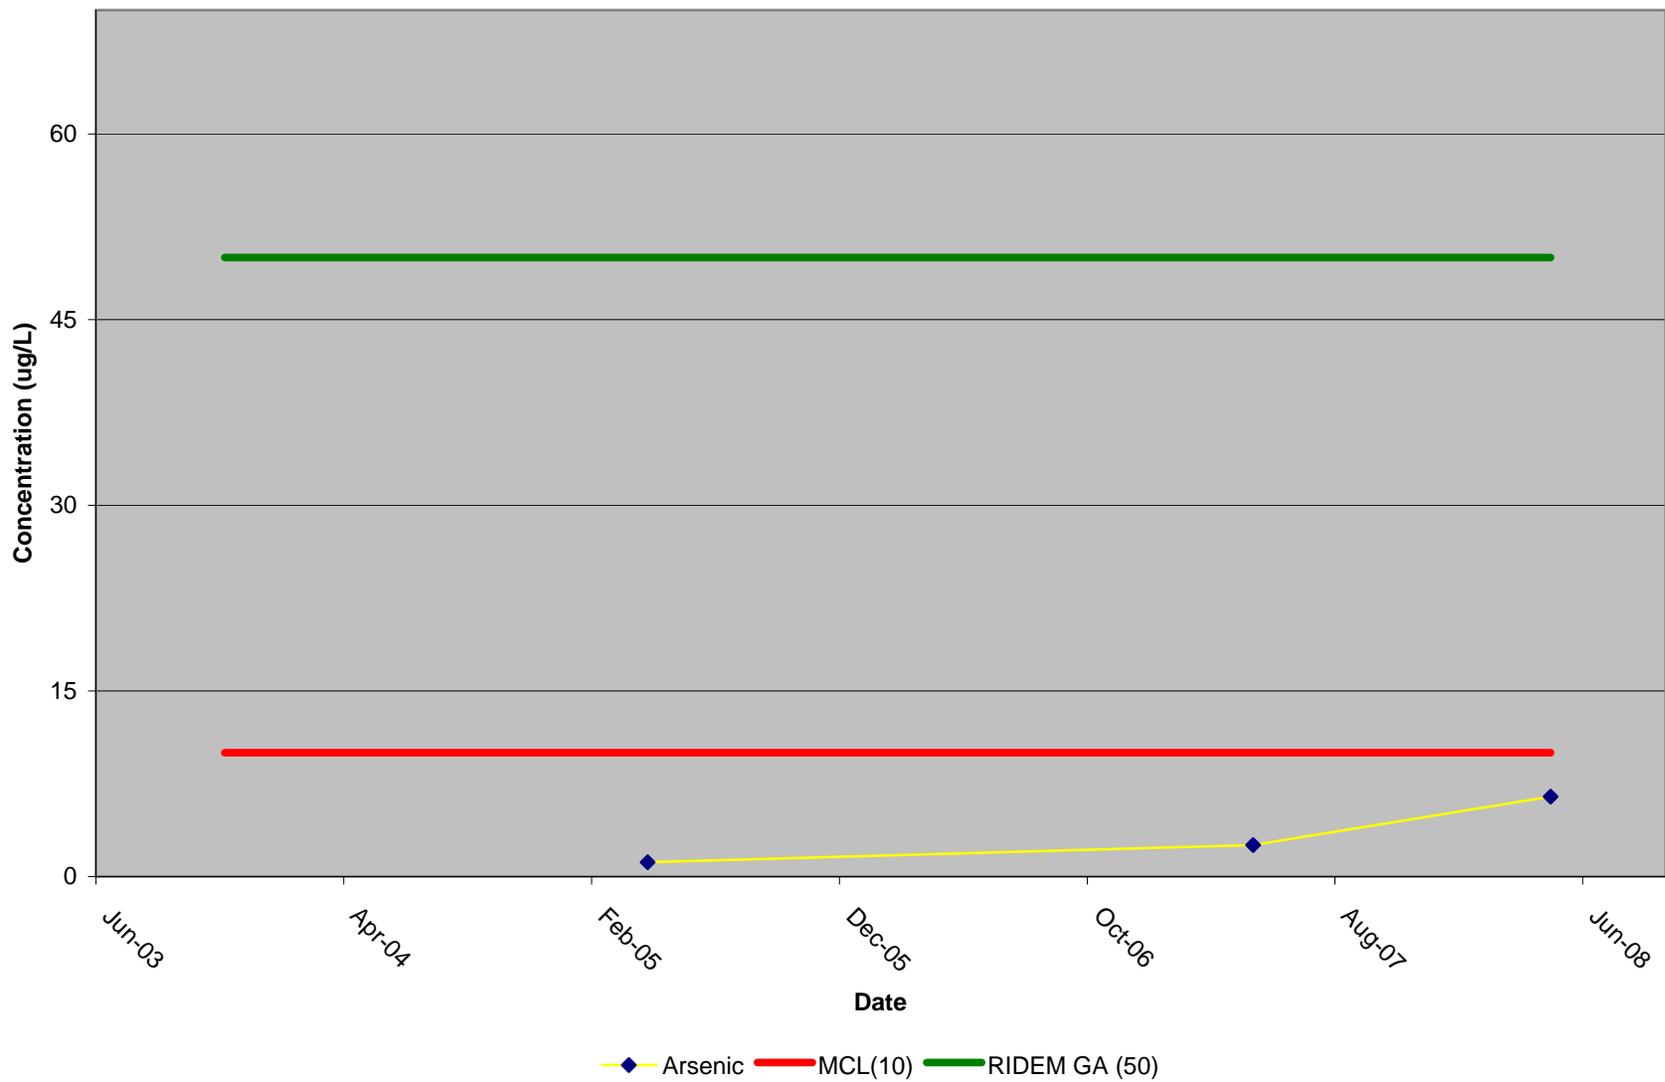
ARSENIC IN GROUNDWATER MW-113S
SITE 01, McALLISTER POINT LANDFILL, NAVAL STATION NEWPORT
FIVE YEAR REVIEW REPORT

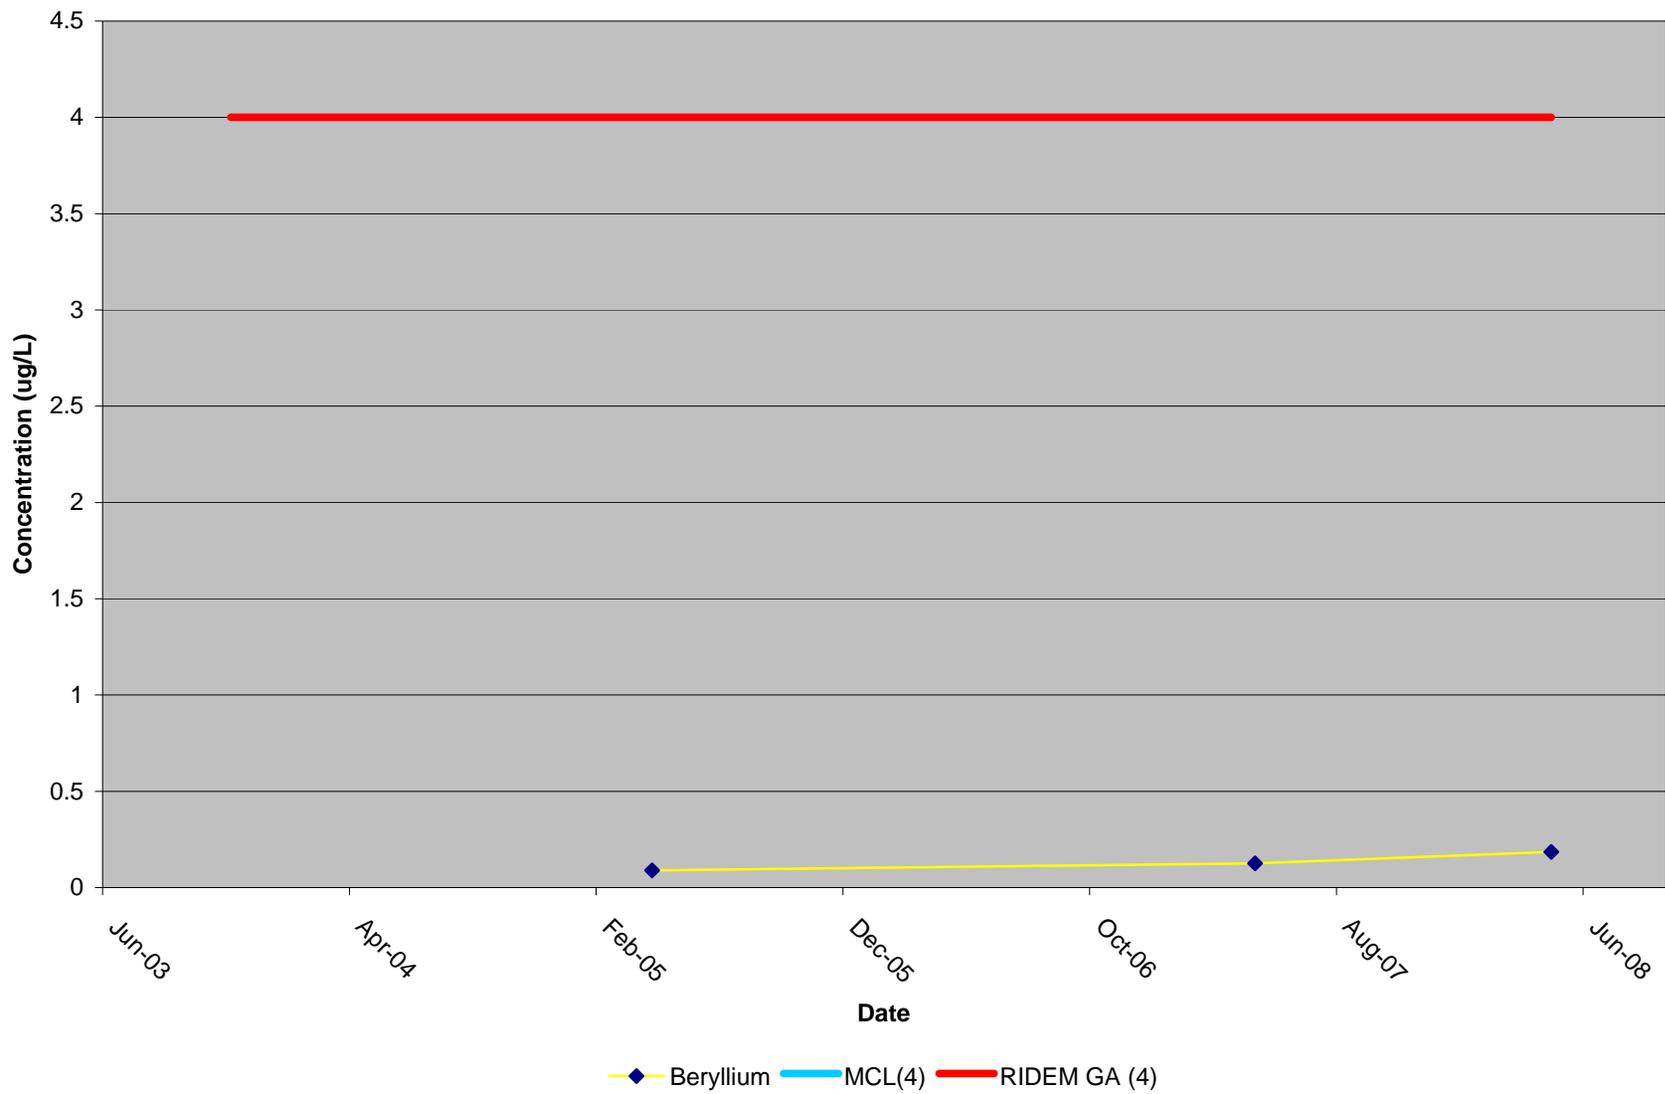
BERYLLIUM IN GROUNDWATER, MW-113S
SITE 01 McALLISTER POINT LANDFILL, NAVAL STATION NEWPORT
FIVE YEAR REVIEW REPORT

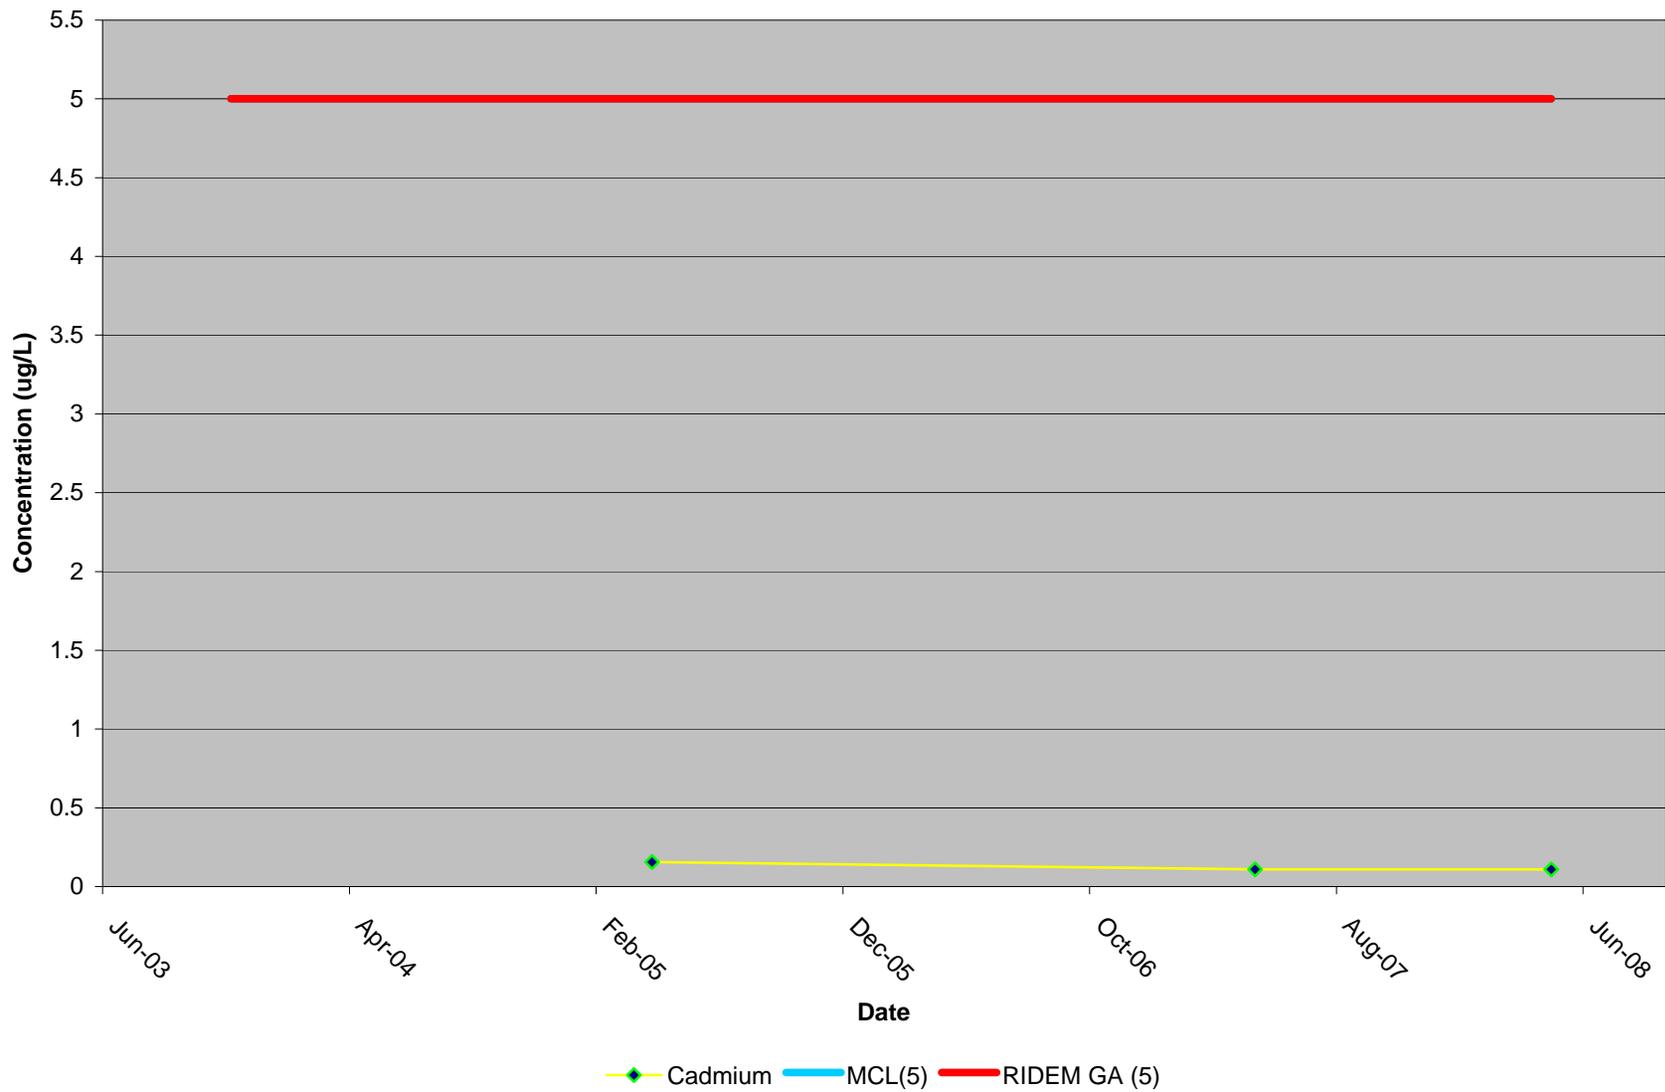
CADMIUM IN GROUNDWATER, MW-113S
SITE 01 McALLISTER POINT LANDFILL, NAVAL STATION NEWPORT
FIVE YEAR REVIEW REPORT

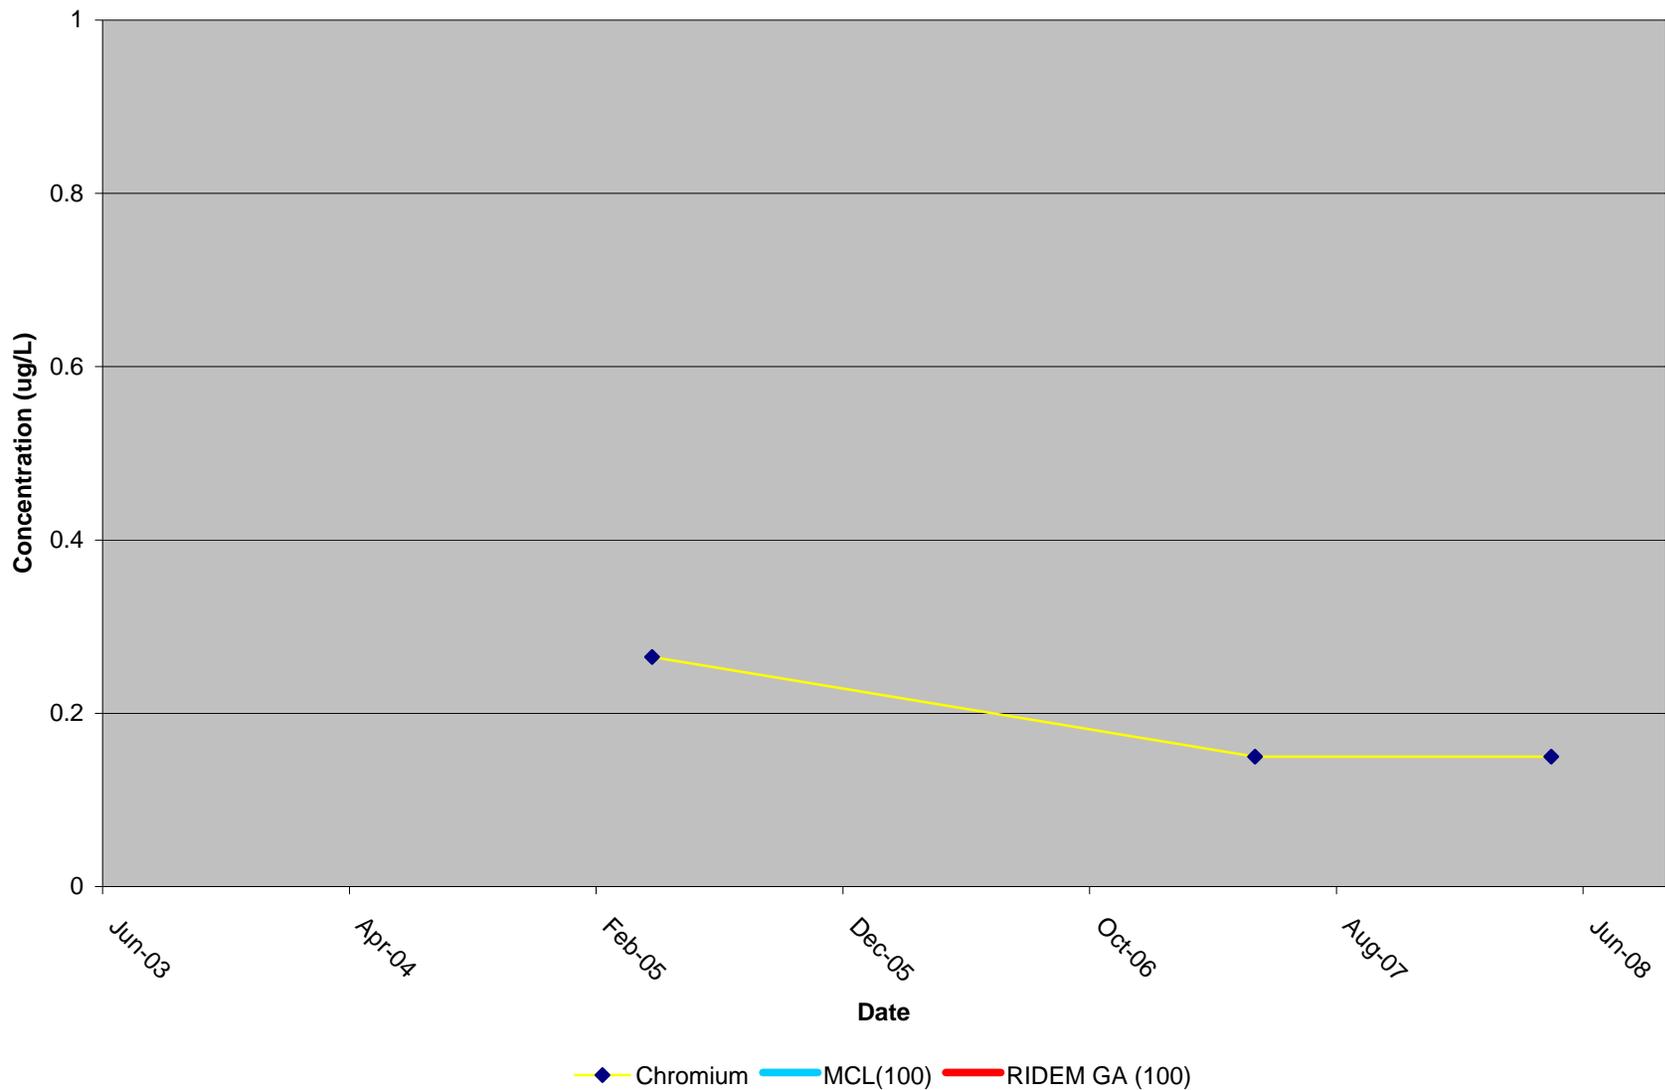
CHROMIUM IN GROUNDWATER MW-113S
SITE 01, McALLISTER POINT LANDFILL, NAVAL STATION NEWPORT
FIVE YEAR REVIEW REPORT

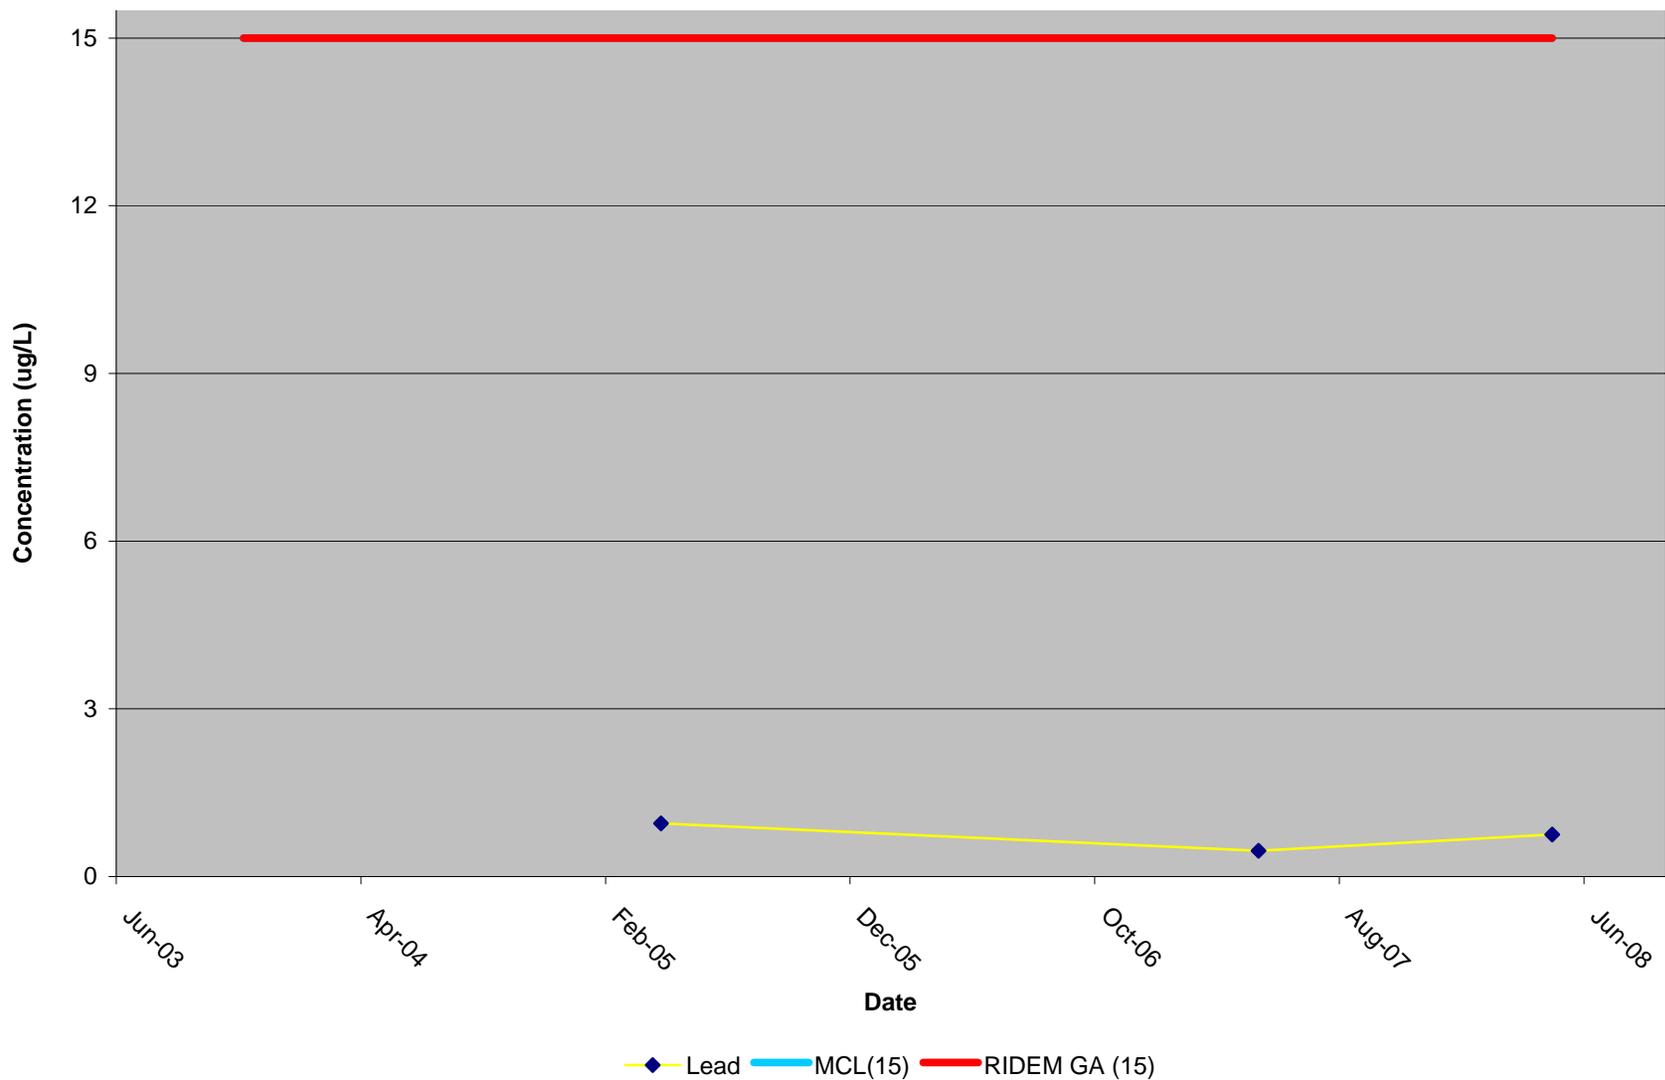
LEAD IN GROUNDWATER, MW-113S
SITE 01 McALLISTER POINT LANDFILL, NAVAL STATION NEWPORT
FIVE YEAR REVIEW REPORT
