Five Year Review Report

**Naval Station Newport
(Formerly NETC Newport)**

Newport, Rhode Island

**FIVE YEAR REVIEW REPORT
FOR
NAVAL STATION NEWPORT
(FORMERLY NETC NEWPORT)
NEWPORT, RHODE ISLAND
COMPREHENSIVE LONG-TERM
ENVIRONMENTAL ACTION NAVY (CLEAN) CONTRACT**

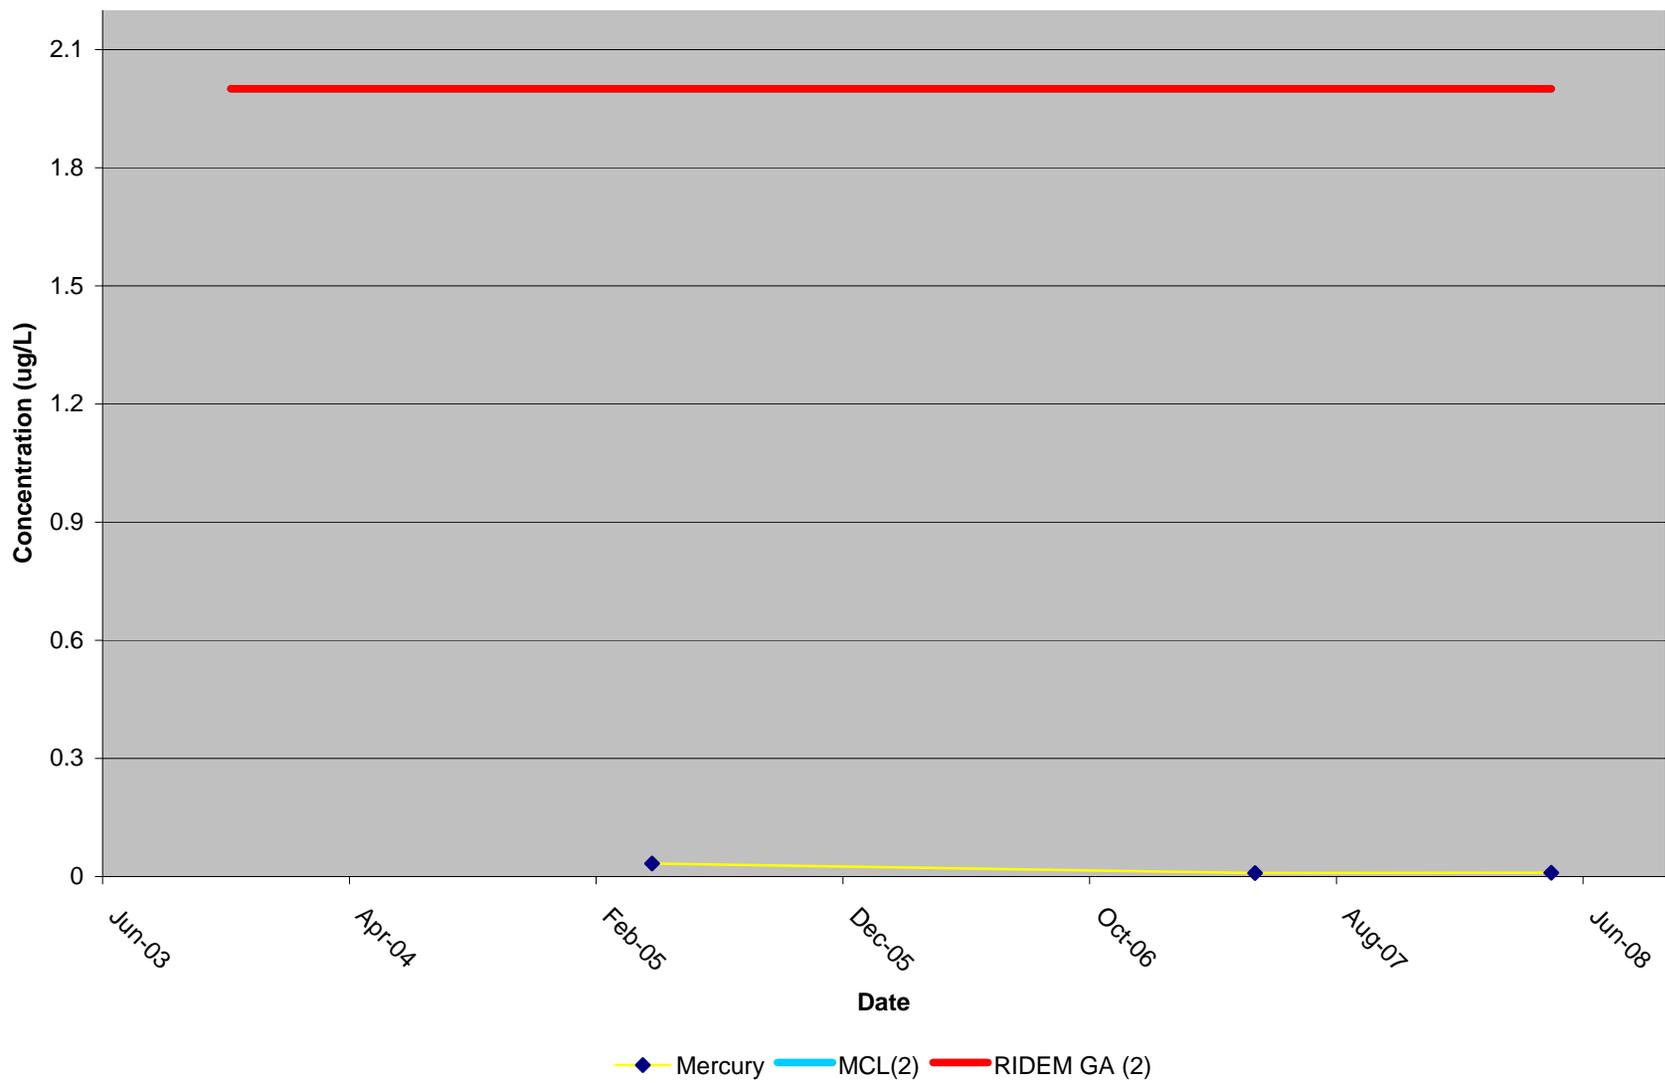
MERCURY IN GROUNDWATER MW-113S
SITE 01, McALLISTER POINT LANDFILL, NAVAL STATION NEWPORT
FIVE YEAR REVIEW REPORT

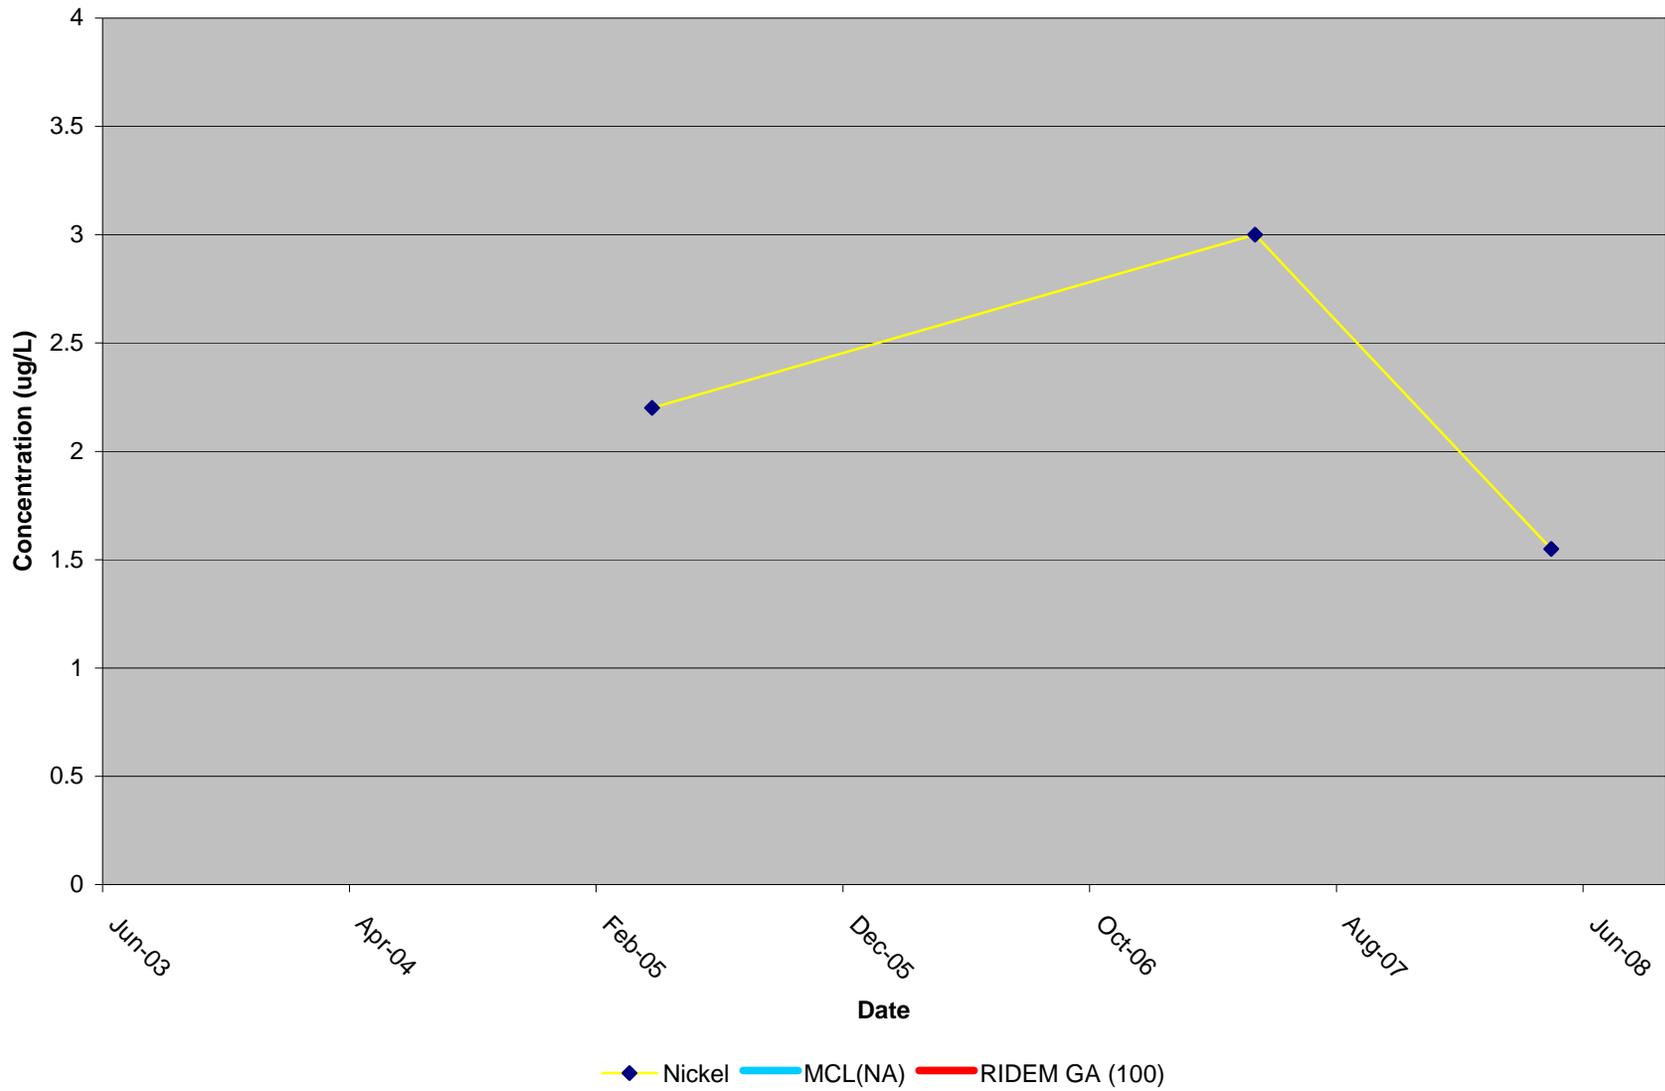
APPENDIX F-1, GROUNDWATER
FIGURE F-1.11-8

NICKEL IN GROUNDWATER, MW-113S
SITE 01, McALLISTER POINT LANDFILL, NAVAL STATION NEWPORT
FIVE YEAR REVIEW REPORT

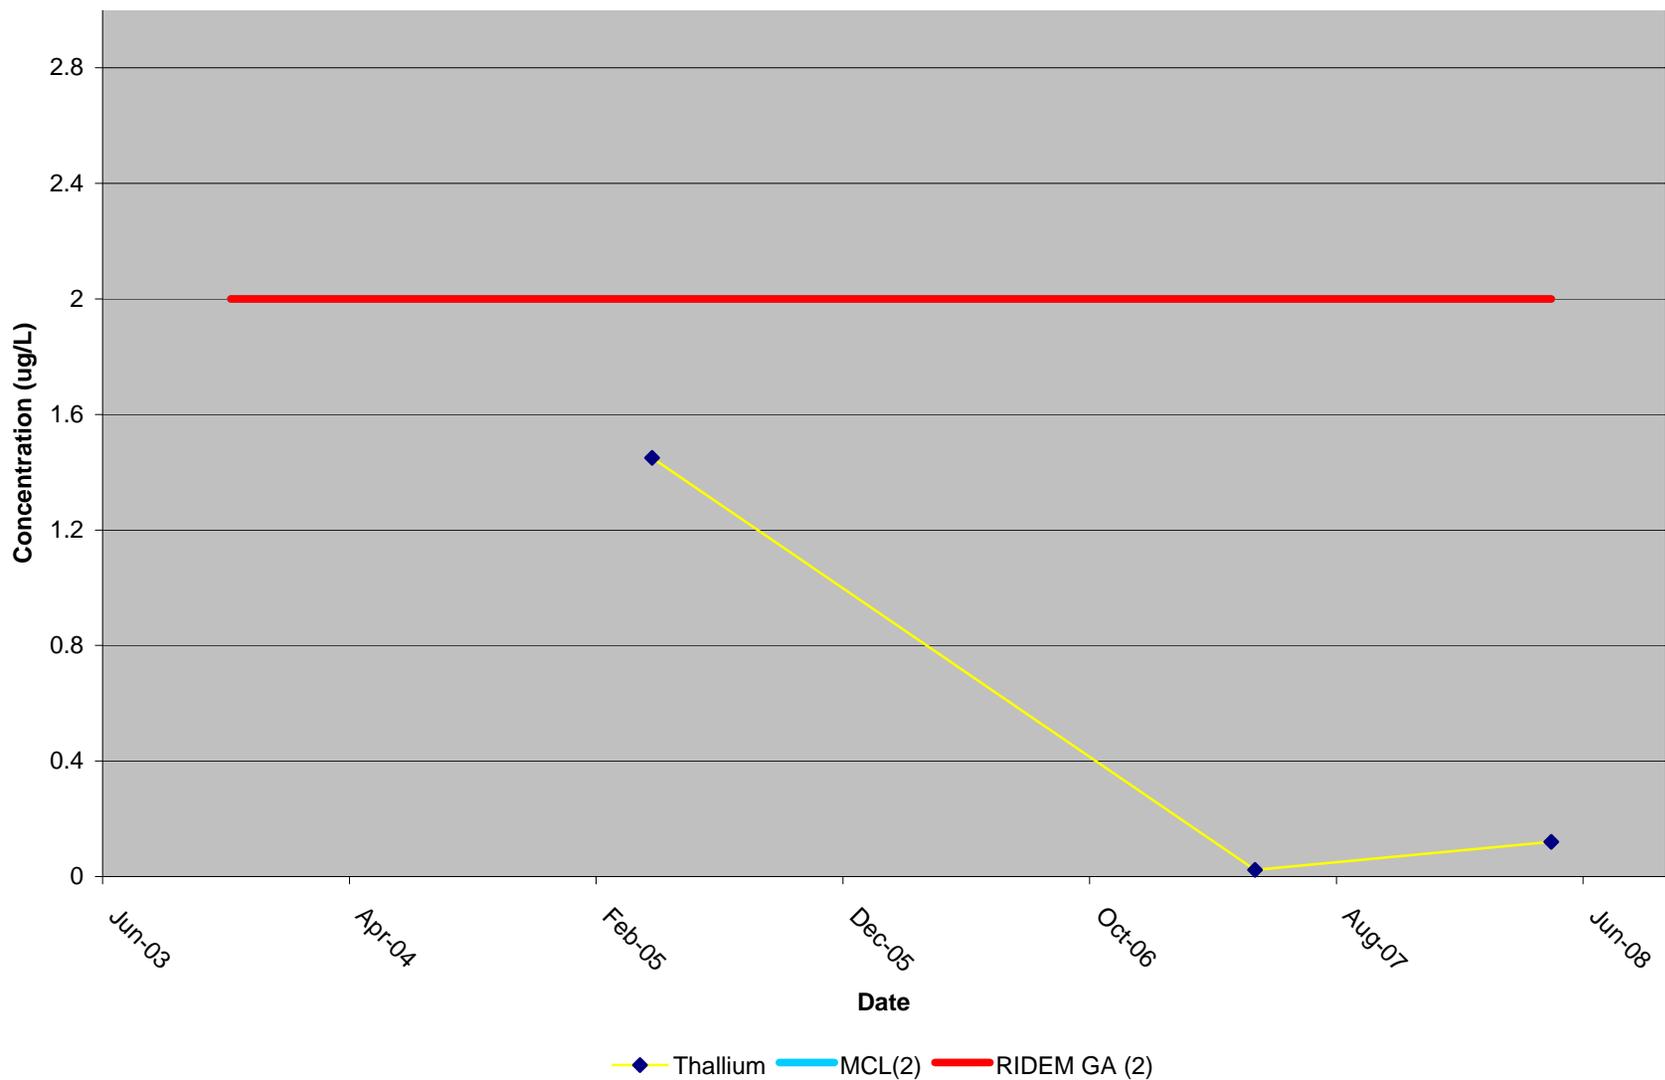
THALLIUM IN GROUNDWATER, MW-113S
SITE 01, McALLISTER POINT LANDFILL, NAVAL STATION NEWPORT
FIVE YEAR REVIEW REPORT

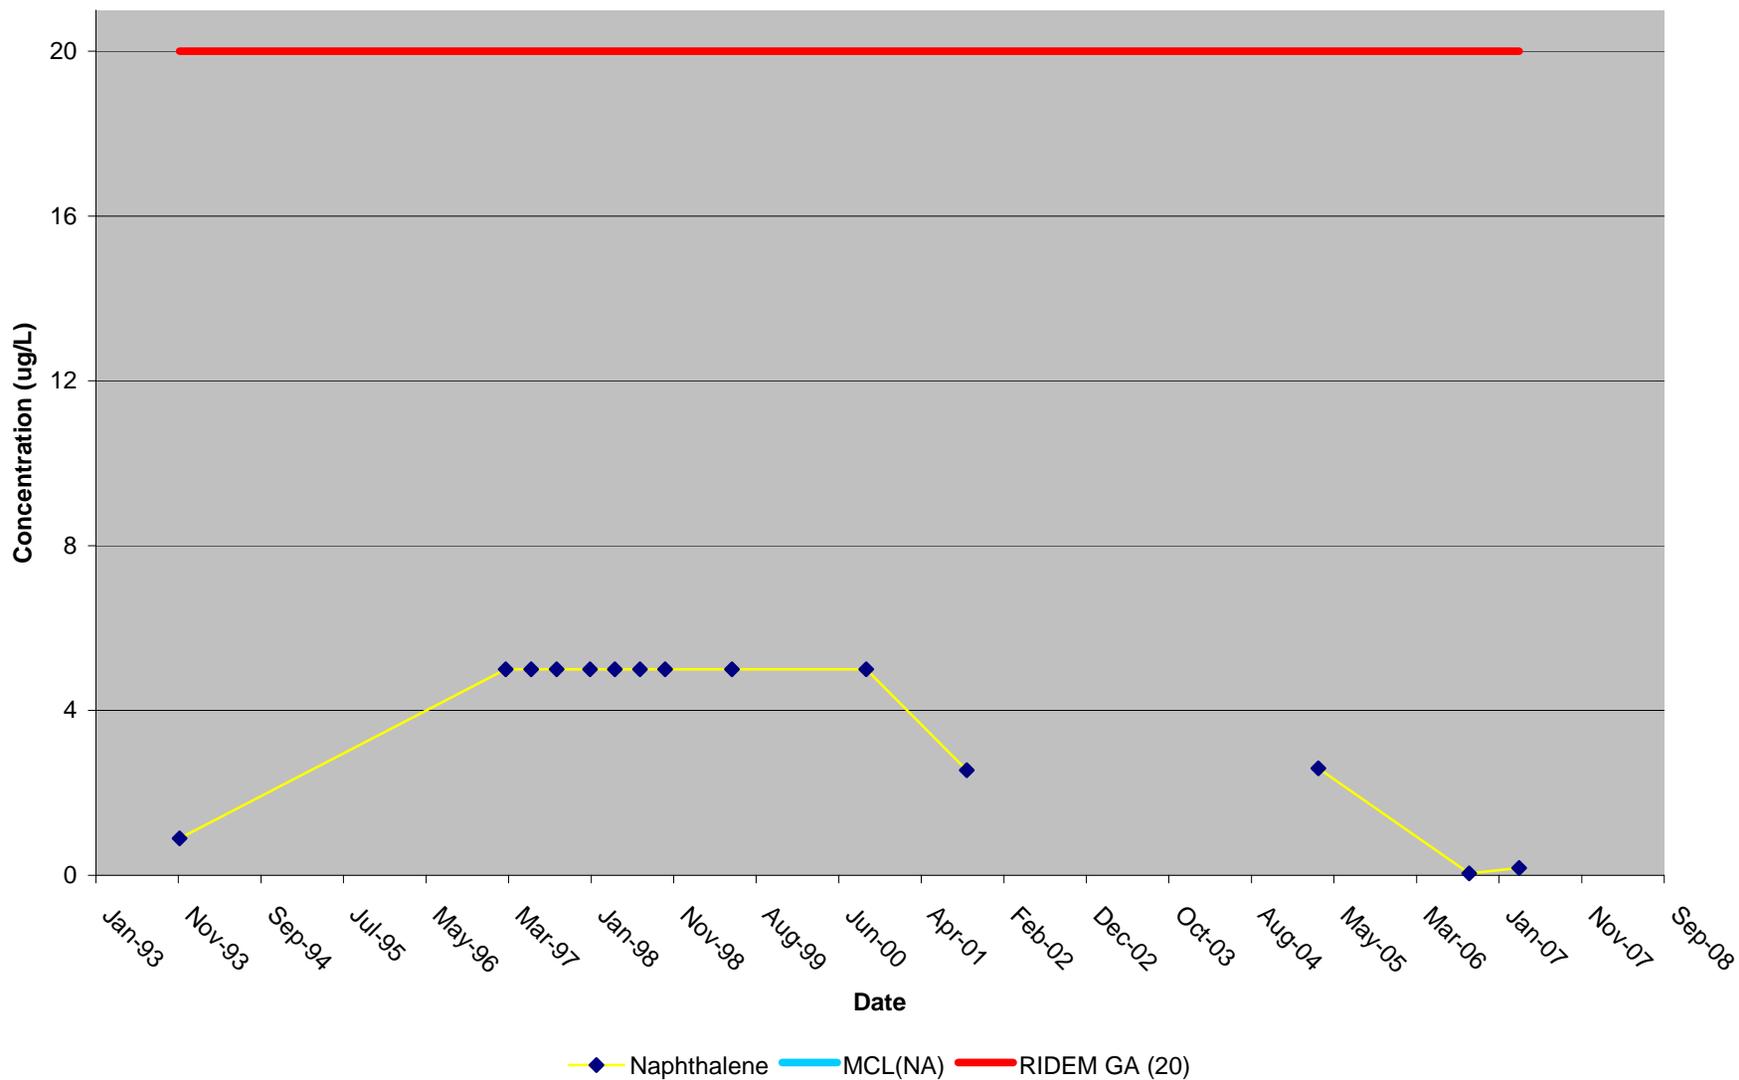
NAPHTHALENE IN GROUNDWATER, MW 113S
SITE 01 - MCALLISTER POINT LANDFILL NAVAL STATION NEWPORT
FIVE YEAR REVIEW REPORT

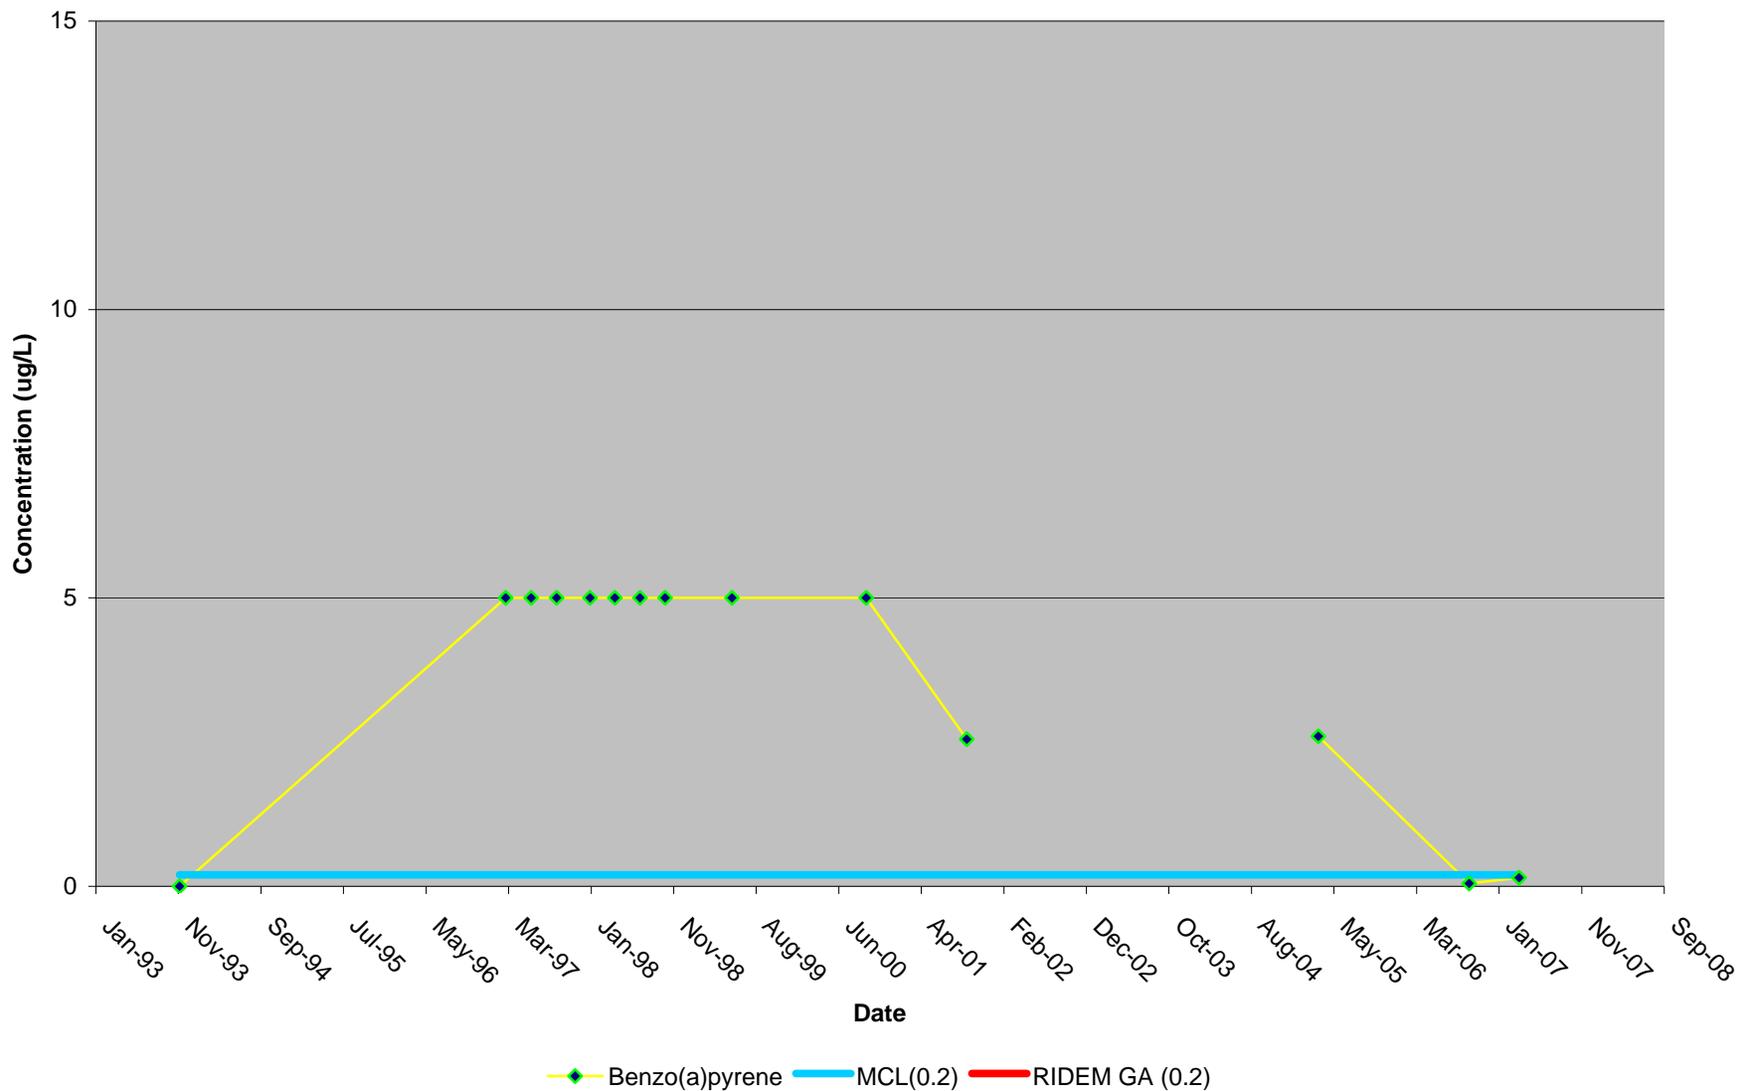
BENZO(A)PYRENE IN GROUNDWATER, MW-113S
SITE 01 - MCALLISTER POINT LANDFILL NAVAL STATION NEWPORT
FIVE YEAR REVIEW REPORT
