FINAL SOIL INVESTIGATION LETTER REPORT MELVILLE WATER TOWER SITE NS  
NEWPORT RI  
2/14/2007  
NAVFAC MIDLANT

Subject: FINAL SOIL INVESTIGATION LETTER REPORT,  
MELVILLE WATER TOWER SITE, PORTSMOUTH, RHODE ISLAND

Subject: Results from Soil Sampling, Former Melville Water Tower  
Portsmouth, Rhode Island

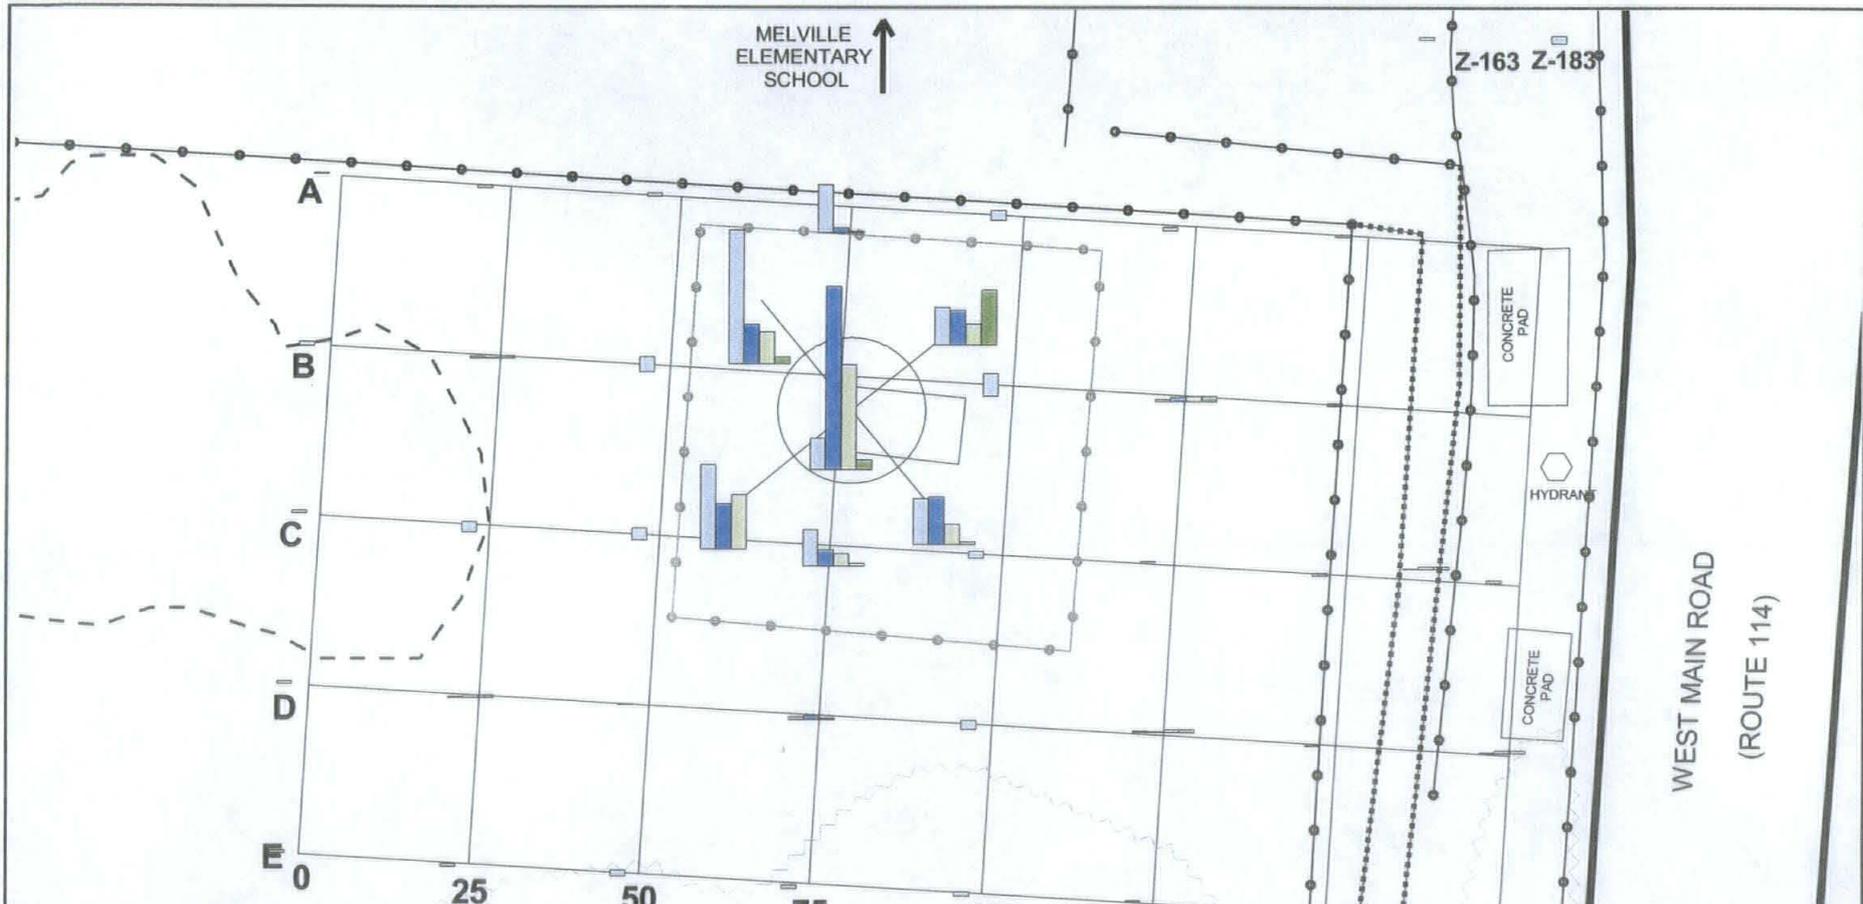
FILE G:\Gis_arc\PROJECTS\CLEAN\CTO 008\ Melville Water Tower\mwt_grid.apr	SCALE <b>AS NOTED</b>
FIGURE NUMBER <b>FIGURE 6</b>	REV 0 DATE 11/10/06

**RELATIVE CONCENTRATIONS  
OF LEAD BY DEPTH  
FORMER MELVILLE WATER TOWER  
SOIL INVESTIGATION REPORT  
PORTSMOUTH, RHODE ISLAND**

It is recommended that a remediation plan be developed for the affected area as shown on the attached Figures 2 through 6. A conservative approach for prompt, effective and permanent remediation would involve removal of soil exceeding 150 mg/kg lead in soil due to the proximity to the school and residential properties to the south, and disposal of this material in accordance with local, state, and federal regulations. Effective removal of this material will require removal of the former water tower footings, and the boiler house foundation as well. Finally, the gravel area used for lay-down during demolition of the water tower should also be removed to approximately 3 inches to assure any paint chips lost in this area are removed from the site. In the meantime, the site should remain fenced to prevent access to the affected area.

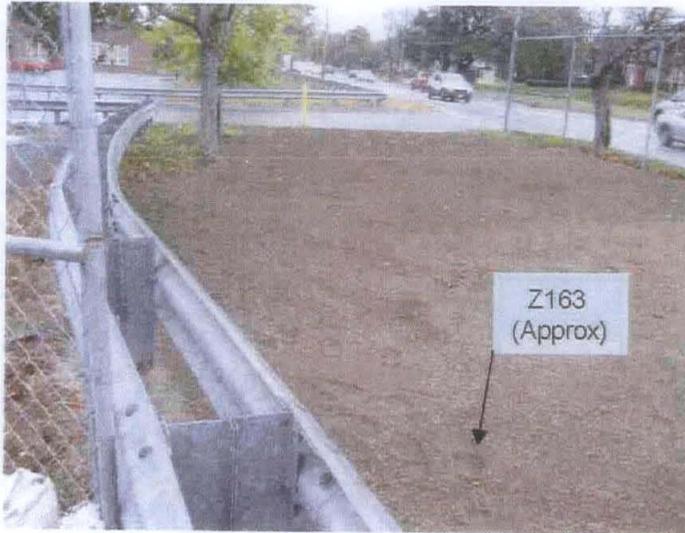
Photo1  
General Area of Station Z163  
Area has been landscaped after installation of temporary water connection  
View is to the north
