DRAFT WORK PLAN FOR SITE CLOSURE AT TANK FARM 2 NS NEWPORT RI (DRAFT
ACTING AS FINAL)
5/1/2005
FOSTER WHEELER

**DRAFT
WORK PLAN FOR SITE CLOSURE
TANK FARM 2**

**DEFENSE FUEL SUPPORT POINT – MELVILLE
PORTSMOUTH, RHODE ISLAND**

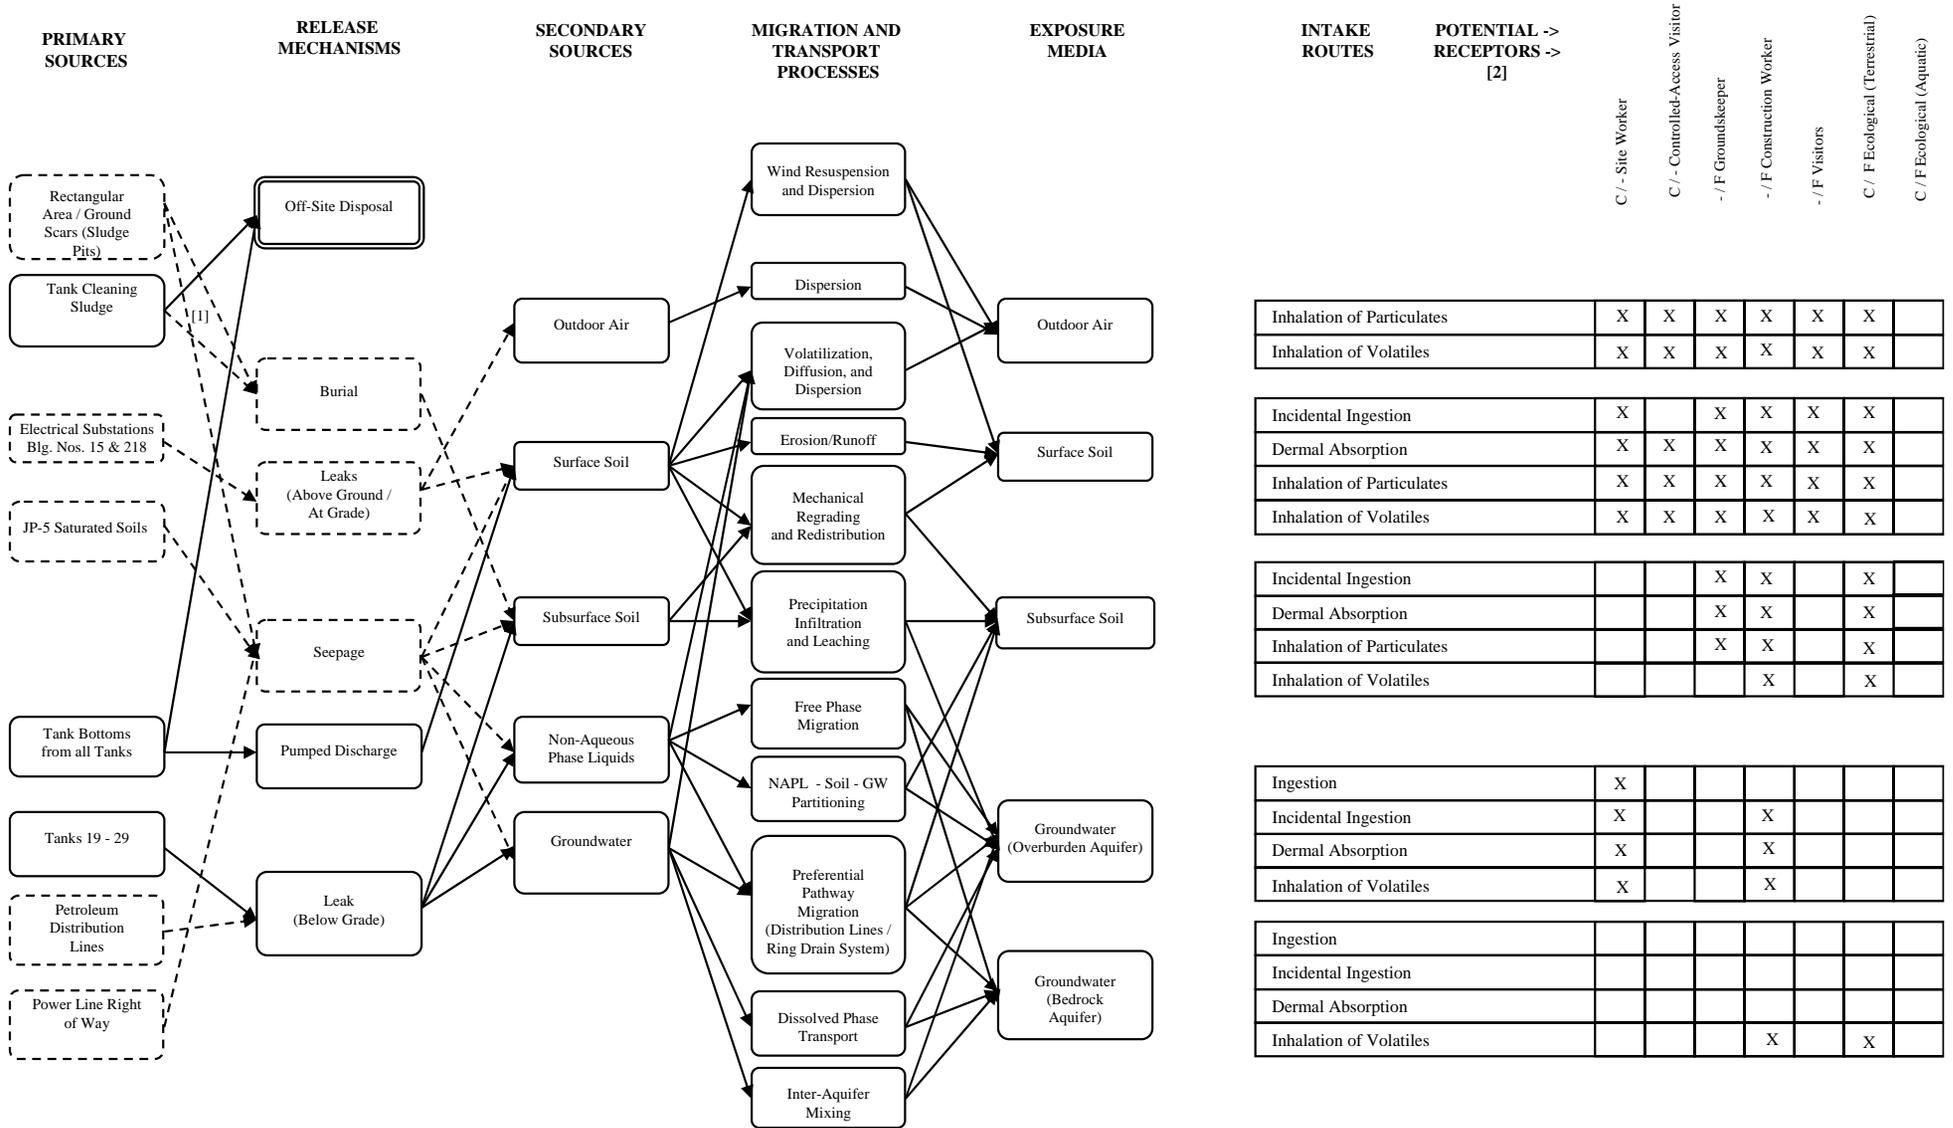
FIGURE 4-1 CONCEPTUAL SITE MODEL FOR THE TANK FARM 2 PROPERTY

NOTES:
 [1] Dashed lines indicate possible sources or processes that have not been conclusively proved or disproved.
 [2] C = Current Land Use; F = Possible Future Land Use

Releases from the primary sources may enter the surrounding soil or groundwater that may then serve as secondary sources of the constituents. Releases from the primary sources are possible due to leaks, seepage, and other activities that occurred as part of routine tank farm operations. Also, a few known releases have been documented. These releases include the disposal and seepage of tank bottoms and sludge from the USTs. Possible secondary sources at Tank Farm 2 are shown in Figure 4-1 and are discussed below.

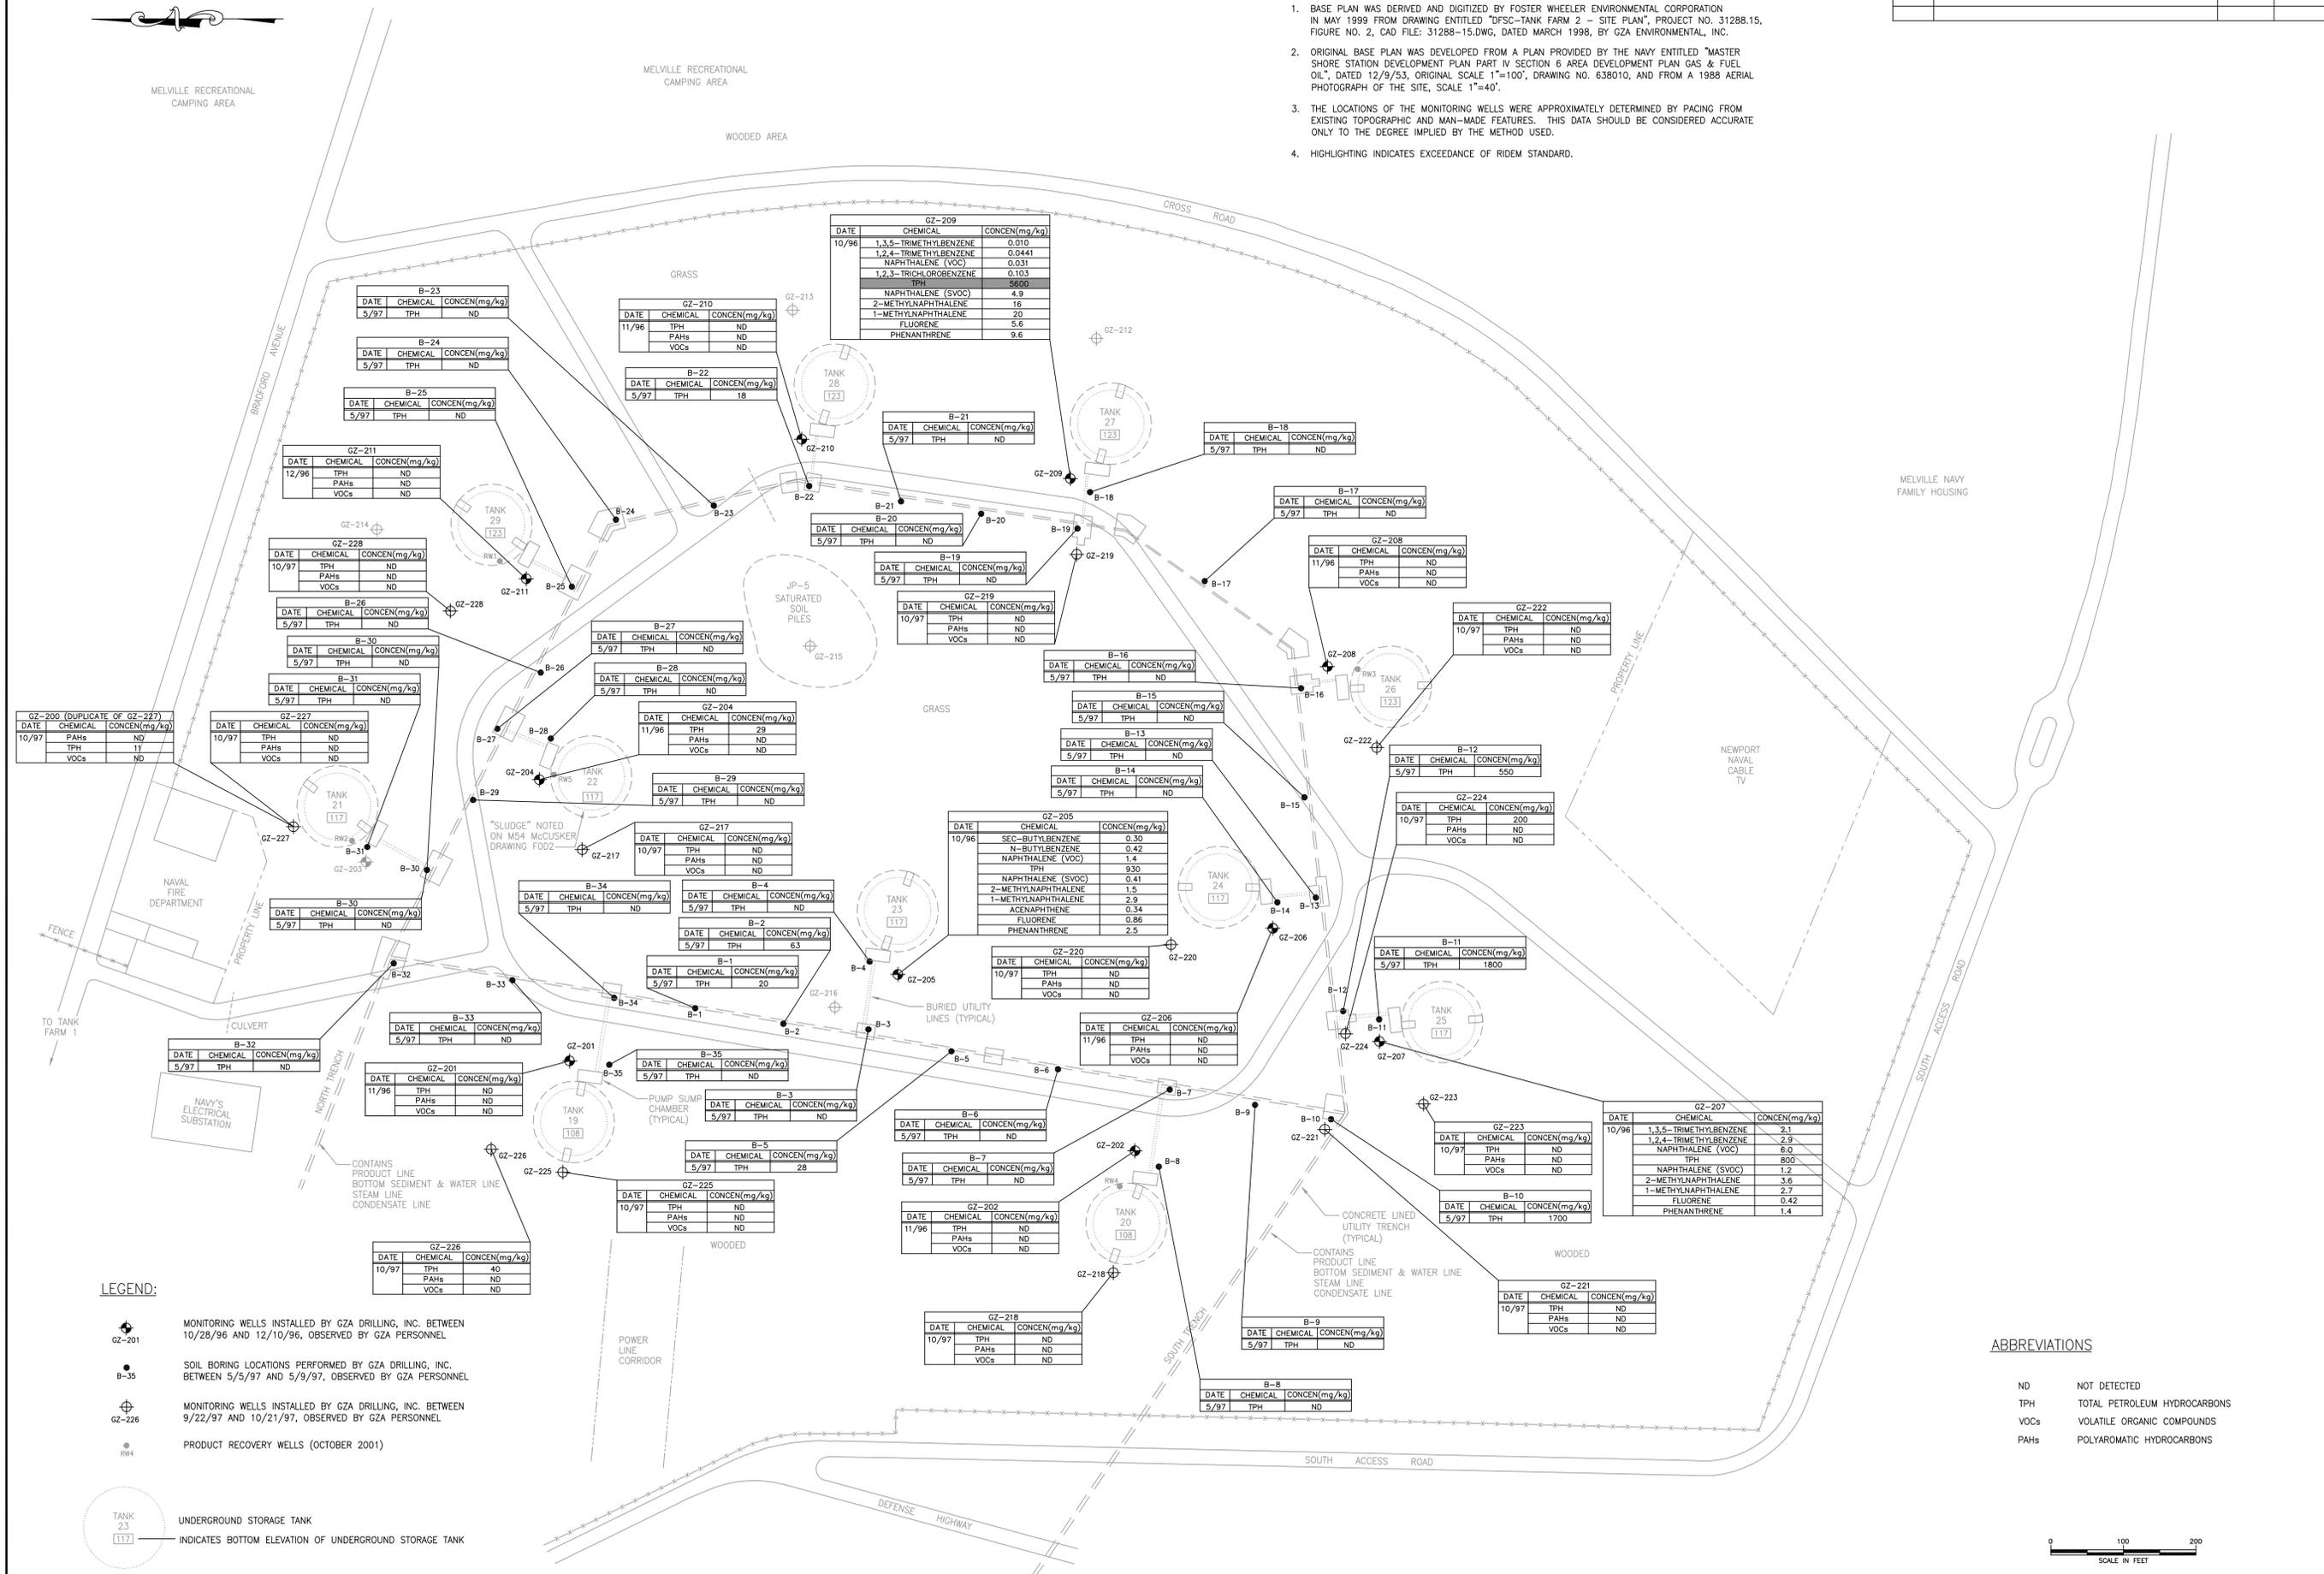
1. BASE PLAN WAS DERIVED AND DIGITIZED BY FOSTER WHEELER ENVIRONMENTAL CORPORATION IN MAY 1999 FROM DRAWING ENTITLED "DFSC-TANK FARM 2 - SITE PLAN", PROJECT NO. 31288.15, FIGURE NO. 2, CAD FILE: 31288-15.DWG, DATED MARCH 1998, BY GZA ENVIRONMENTAL, INC.
2. ORIGINAL BASE PLAN WAS DEVELOPED FROM A PLAN PROVIDED BY THE NAVY ENTITLED "MASTER SHORE STATION DEVELOPMENT PLAN PART IV SECTION 6 AREA DEVELOPMENT PLAN GAS & FUEL OIL", DATED 12/9/53, ORIGINAL SCALE 1"=100', DRAWING NO. 638010, AND FROM A 1988 AERIAL PHOTOGRAPH OF THE SITE, SCALE 1"=40'.
3. THE LOCATIONS OF THE MONITORING WELLS WERE APPROXIMATELY DETERMINED BY PACING FROM EXISTING TOPOGRAPHIC AND MAN-MADE FEATURES. THIS DATA SHOULD BE CONSIDERED ACCURATE ONLY TO THE DEGREE IMPLIED BY THE METHOD USED.
4. HIGHLIGHTING INDICATES EXCEEDANCE OF RIDEW STANDARD.

The most recent data from each soil boring were compared to the RIDEM Method 1 Industrial/Commercial Direct Exposure and GB Leachability Criteria. Historical soil sampling summarized on Figure 5-1 does not indicate a widespread problem with contamination at Tank Farm 2. Only soil sample GZ-209 exceeded the TPH Industrial/Commercial Direct Contact and Leachability Criteria of 2,500 ppm with a concentration of 5,600 mg/kg. This sample was taken between 15 and 17 feet bgs. No other exceedances were noted. Figure 5-1 depicts the location of all soil samples taken at Tank Farm 2 and this exceedance. With the exception of the area immediately surrounding the GZ-209 soil boring location, no further action is recommended for the remainder of soils on site.

As discussed in Section 5.1.1, GZ-209 exceeded the TPH Industrial/Commercial Direct Contact and Leachability Criteria of 2,500 ppm with a concentration of 5,600 mg/kg at a depth of 15-17 feet bgs. This area of soil represents the only exceedance of the RIDEM Method 1 Industrial/Commercial Direct Exposure and GB Leachability Criteria found on the site. In order to better assess the source of this contamination, a test pit investigation is recommended. If the soil contamination is found to be localized an attempt will be made to remove the contaminated soils and provide closure samples from the four sides and bottom of the excavation area. A bottom hole grab sample will be taken at 17 feet and sidewall samples will be collected two feet off the bottom of the excavation from each wall and then composited. The two samples will be analyzed for TPH. Any soils exhibiting staining or petroleum odors will be sampled for waste characterization parameters and staged on 6-millimeter poly sheeting and covered. See Figure 5-1 for test pit location.
