FINAL THIRD FIVE YEAR REVIEW REPORT NB NORFOLK VA  
02/01/2014  
CH2M HILL

# Third Five-Year Review Report

**Naval Station Norfolk  
Norfolk, Virginia**

### Naval Station Norfolk Norfolk, Virginia

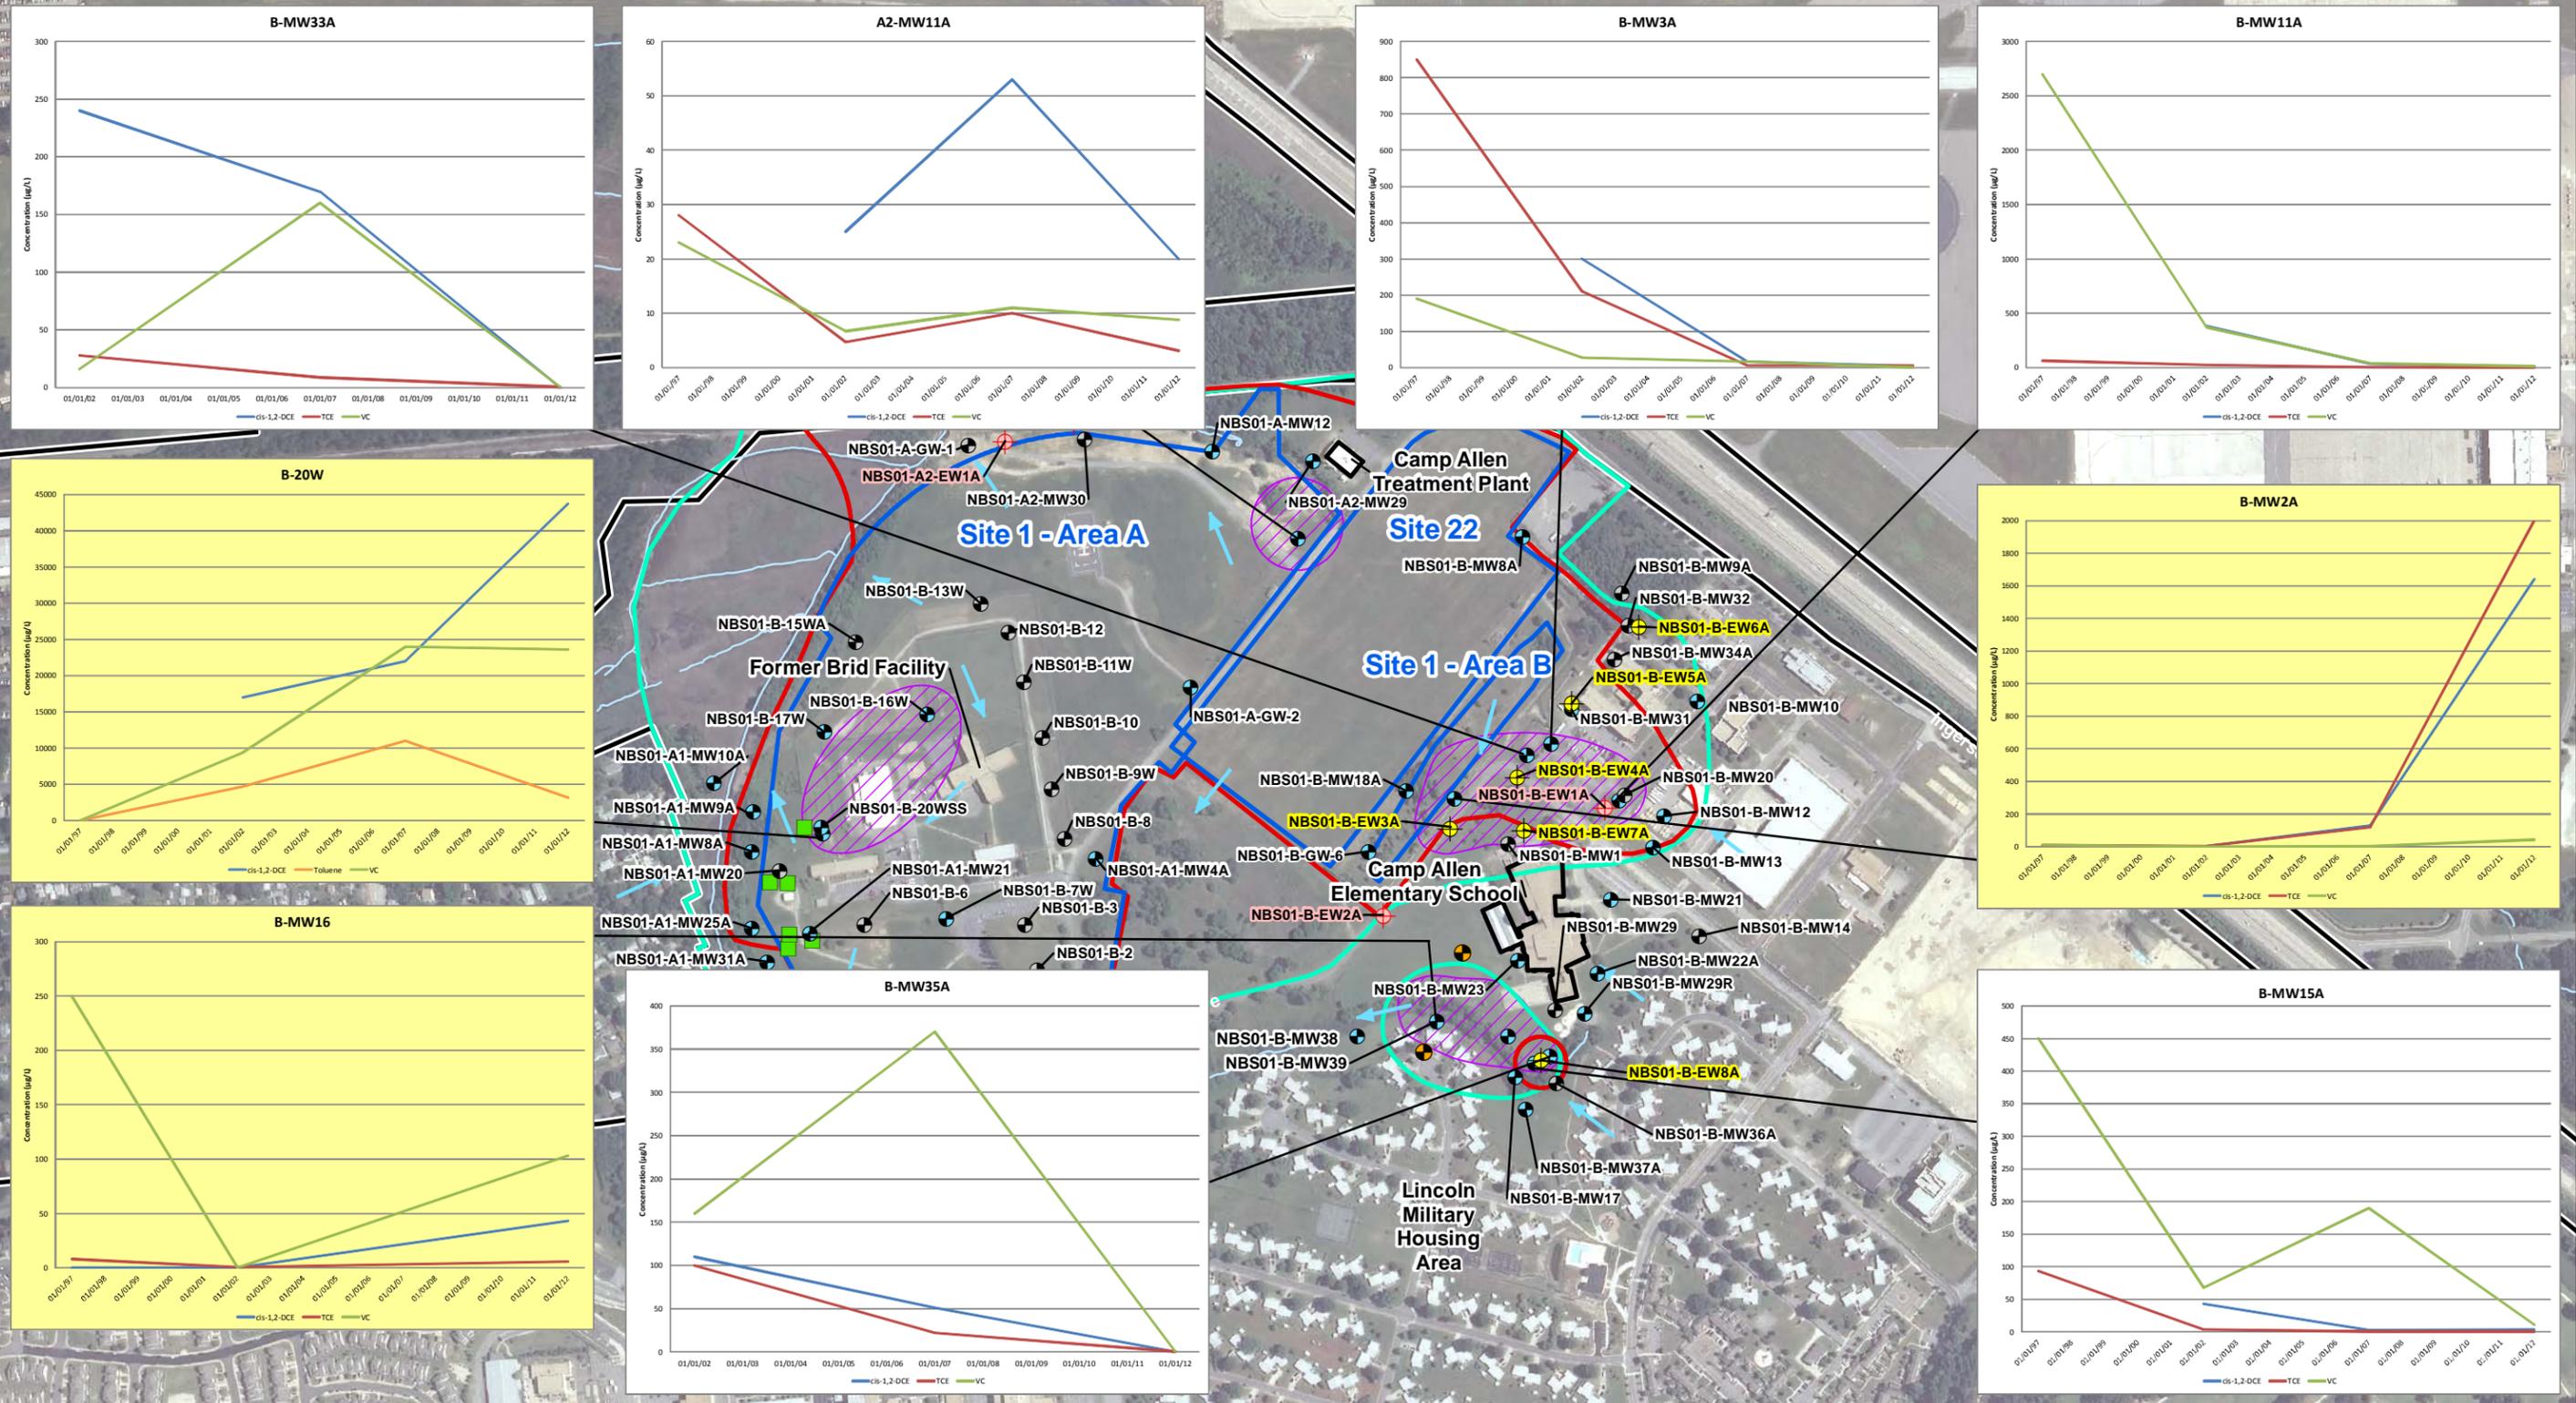
**Figure 4-5**  
**COC Temporal Concentration Trends for Select Shallow Monitoring Wells**  
 Naval Station Norfolk  
 Norfolk, Virginia

**Notes:**  
 -Highlighted graph indicates an increasing trend in COC concentrations.  
 -Graphs not highlighted indicate little to no change in COC concentrations or a decreasing trend in COC concentrations.  
 -Vertical scales on graphs are not consistent  
 COC - Contaminant of Concern  
 DPVE - Dual Phase Vapor Extraction

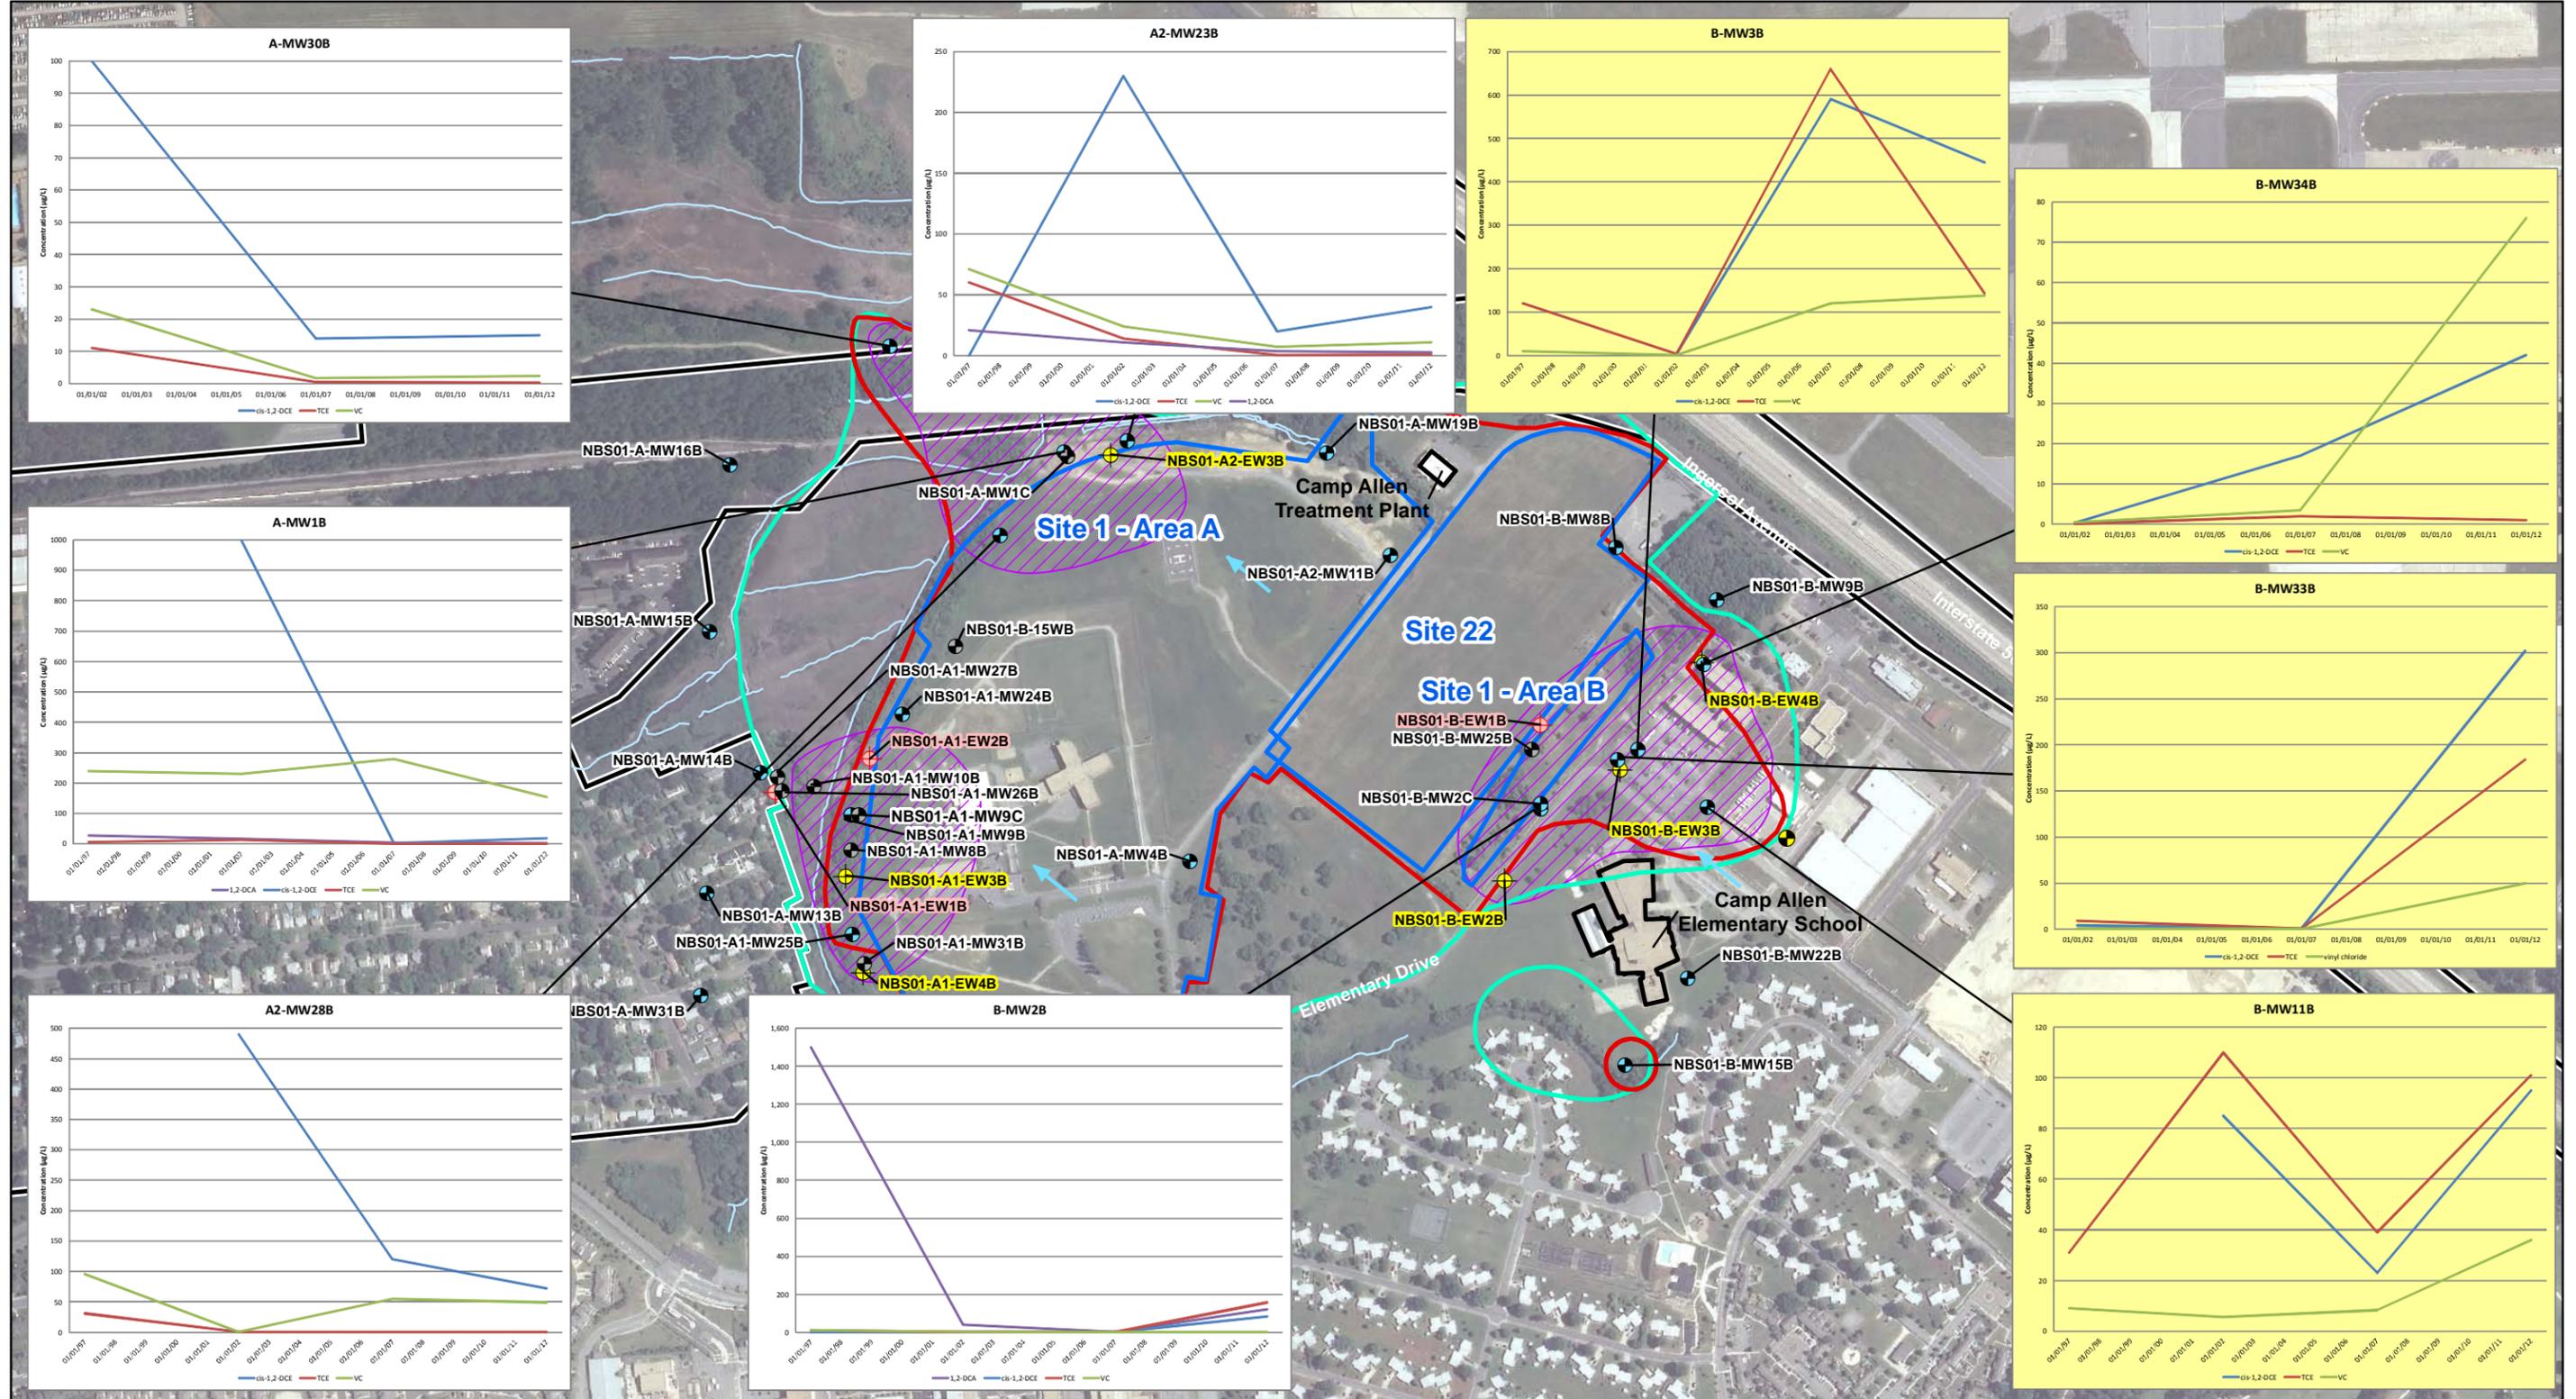
**Figure 4-6**  
 COC Temporal Concentration Trends for Select Deep Monitoring Wells  
 Naval Station Norfolk  
 Norfolk, Virginia

**Notes:**  
 Highlighted graph indicates an increasing trend in COC concentrations.  
 Graphs not highlighted indicate little to no change in COC concentrations or a decreasing trend in COC concentrations.  
 Scales on graphs are not consistent.  
 COC - Contaminant of Concern  
 LTM - Long-Term Monitoring

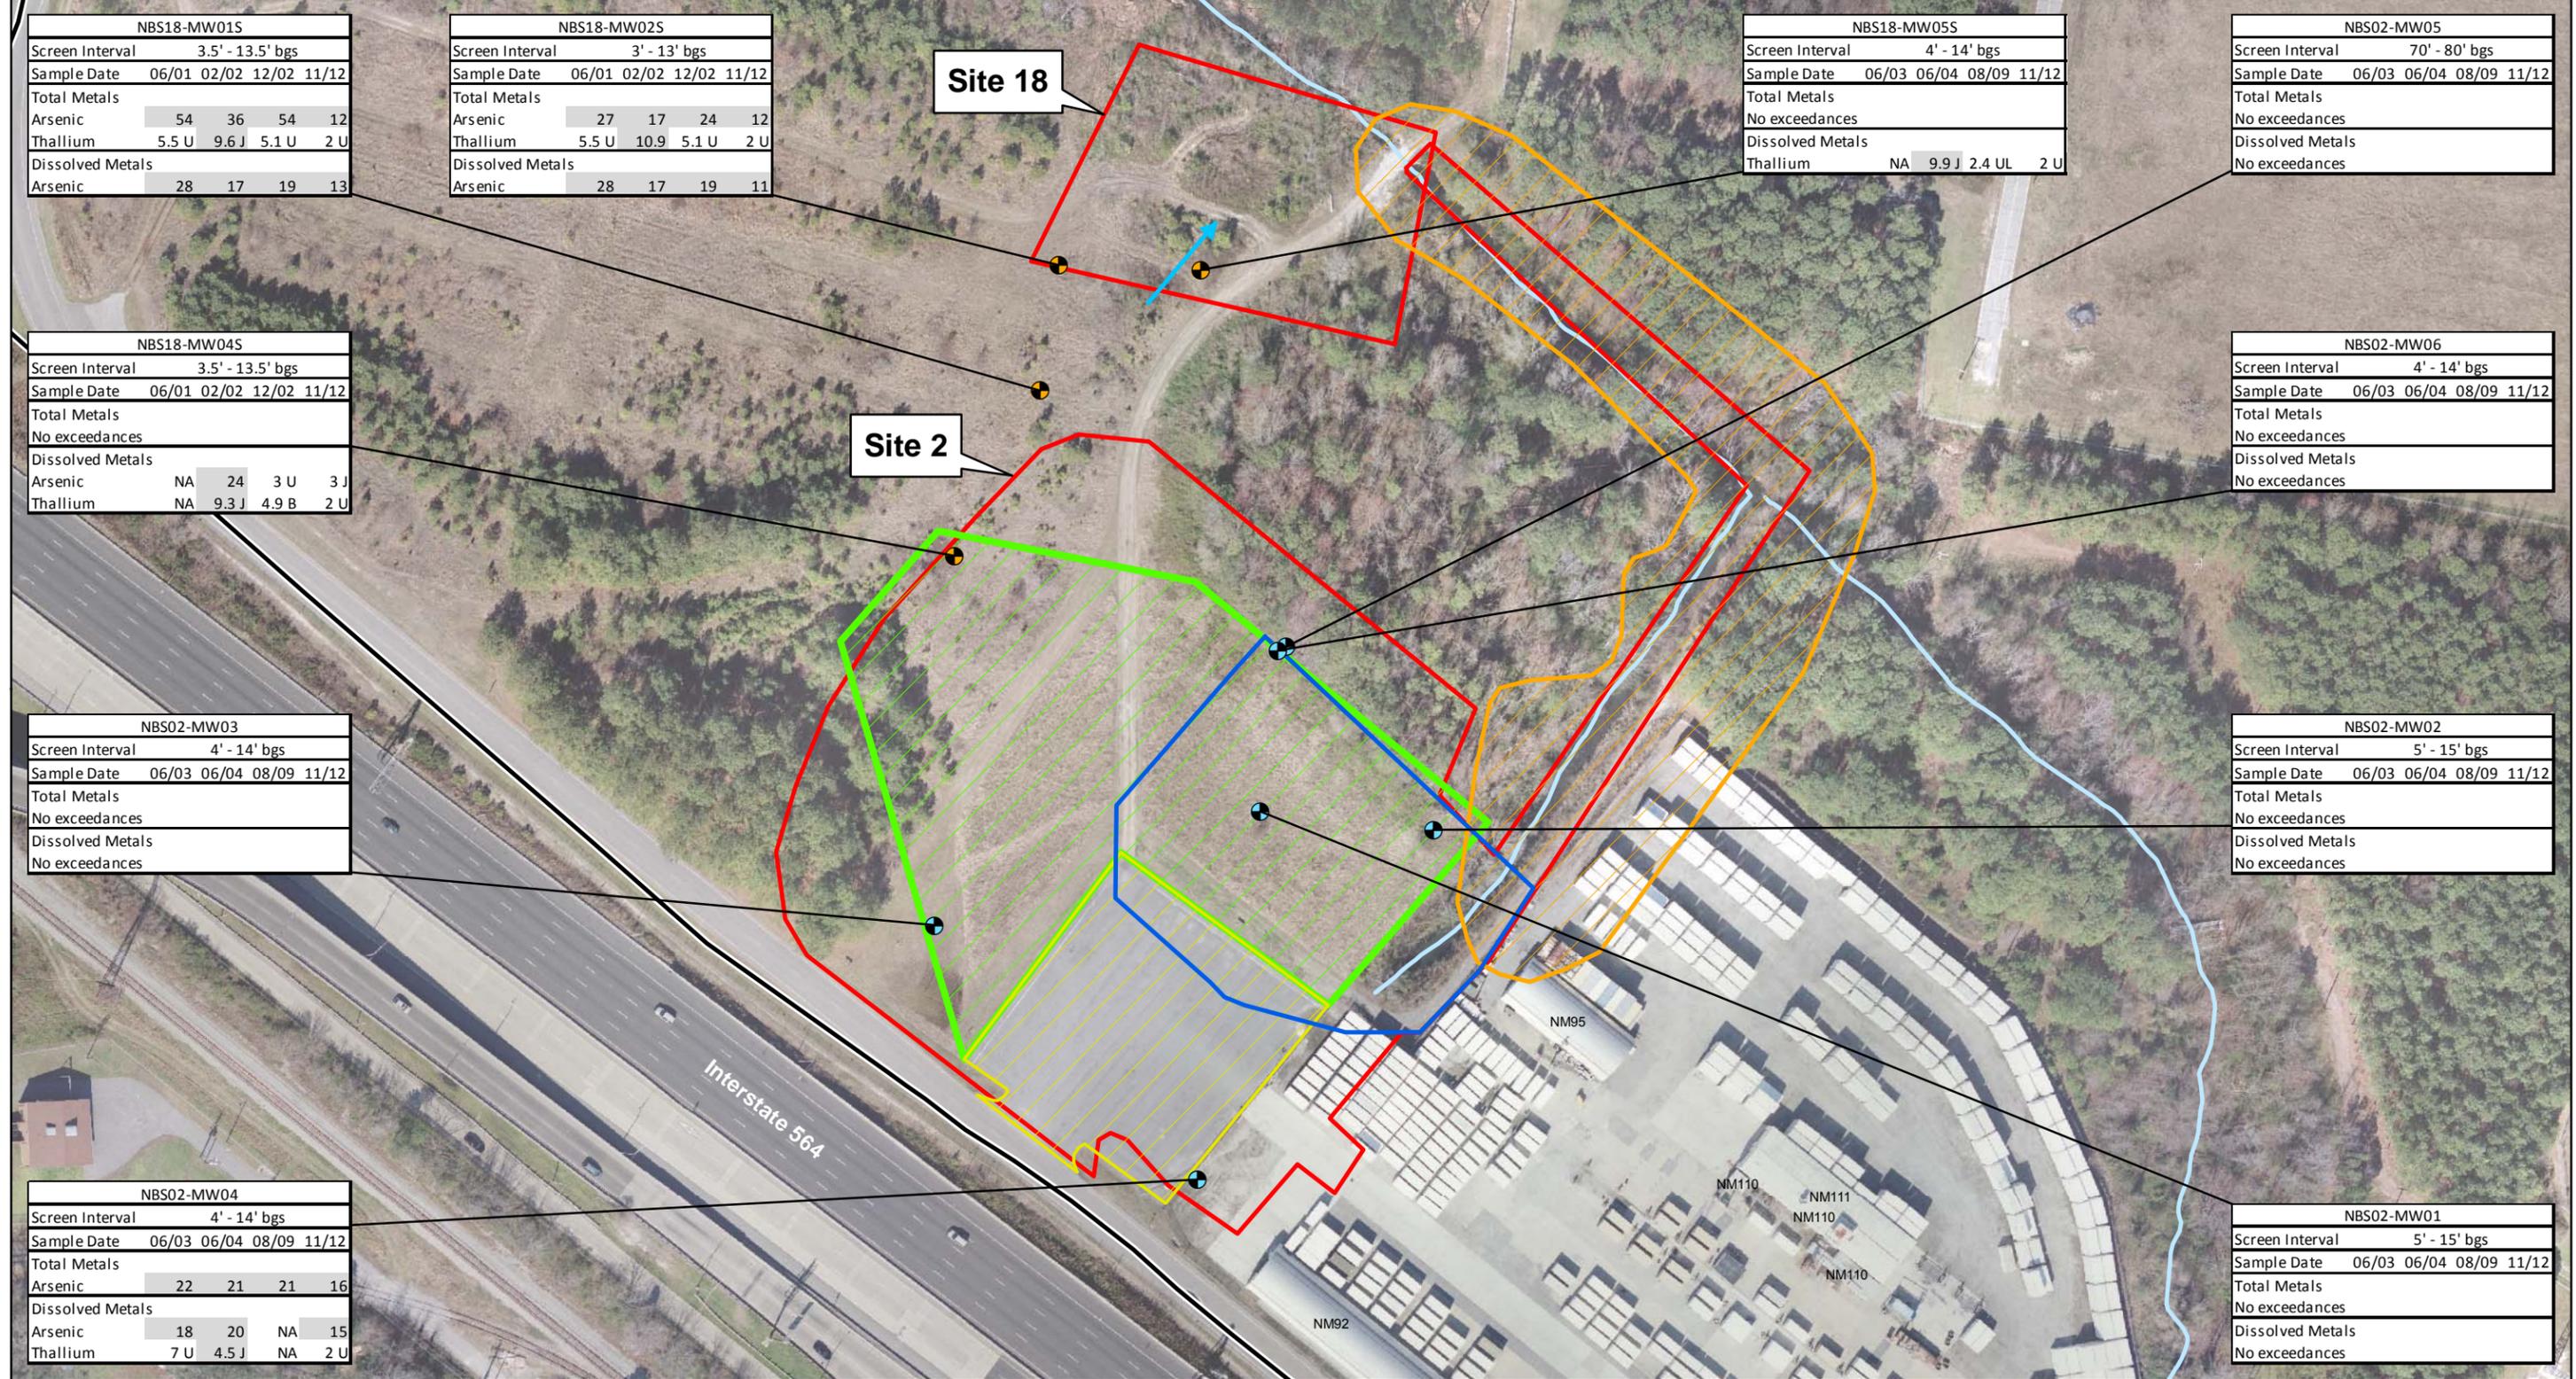
**Figure 5-3**  
**Total and Dissolved Metals in Groundwater**  
 Naval Station Norfolk  
 Norfolk, Virginia

NBS18-MW01S				
Screen Interval	3.5' - 13.5' bgs			
Sample Date	06/01	02/02	12/02	11/12
Total Metals				
Arsenic	54	36	54	12
Thallium	5.5 U	9.6 J	5.1 U	2 U
Dissolved Metals				
Arsenic	28	17	19	13

Chemical	Screening Criteria (MCLs)
Arsenic	10 µg/L
Thallium	4 µg/L

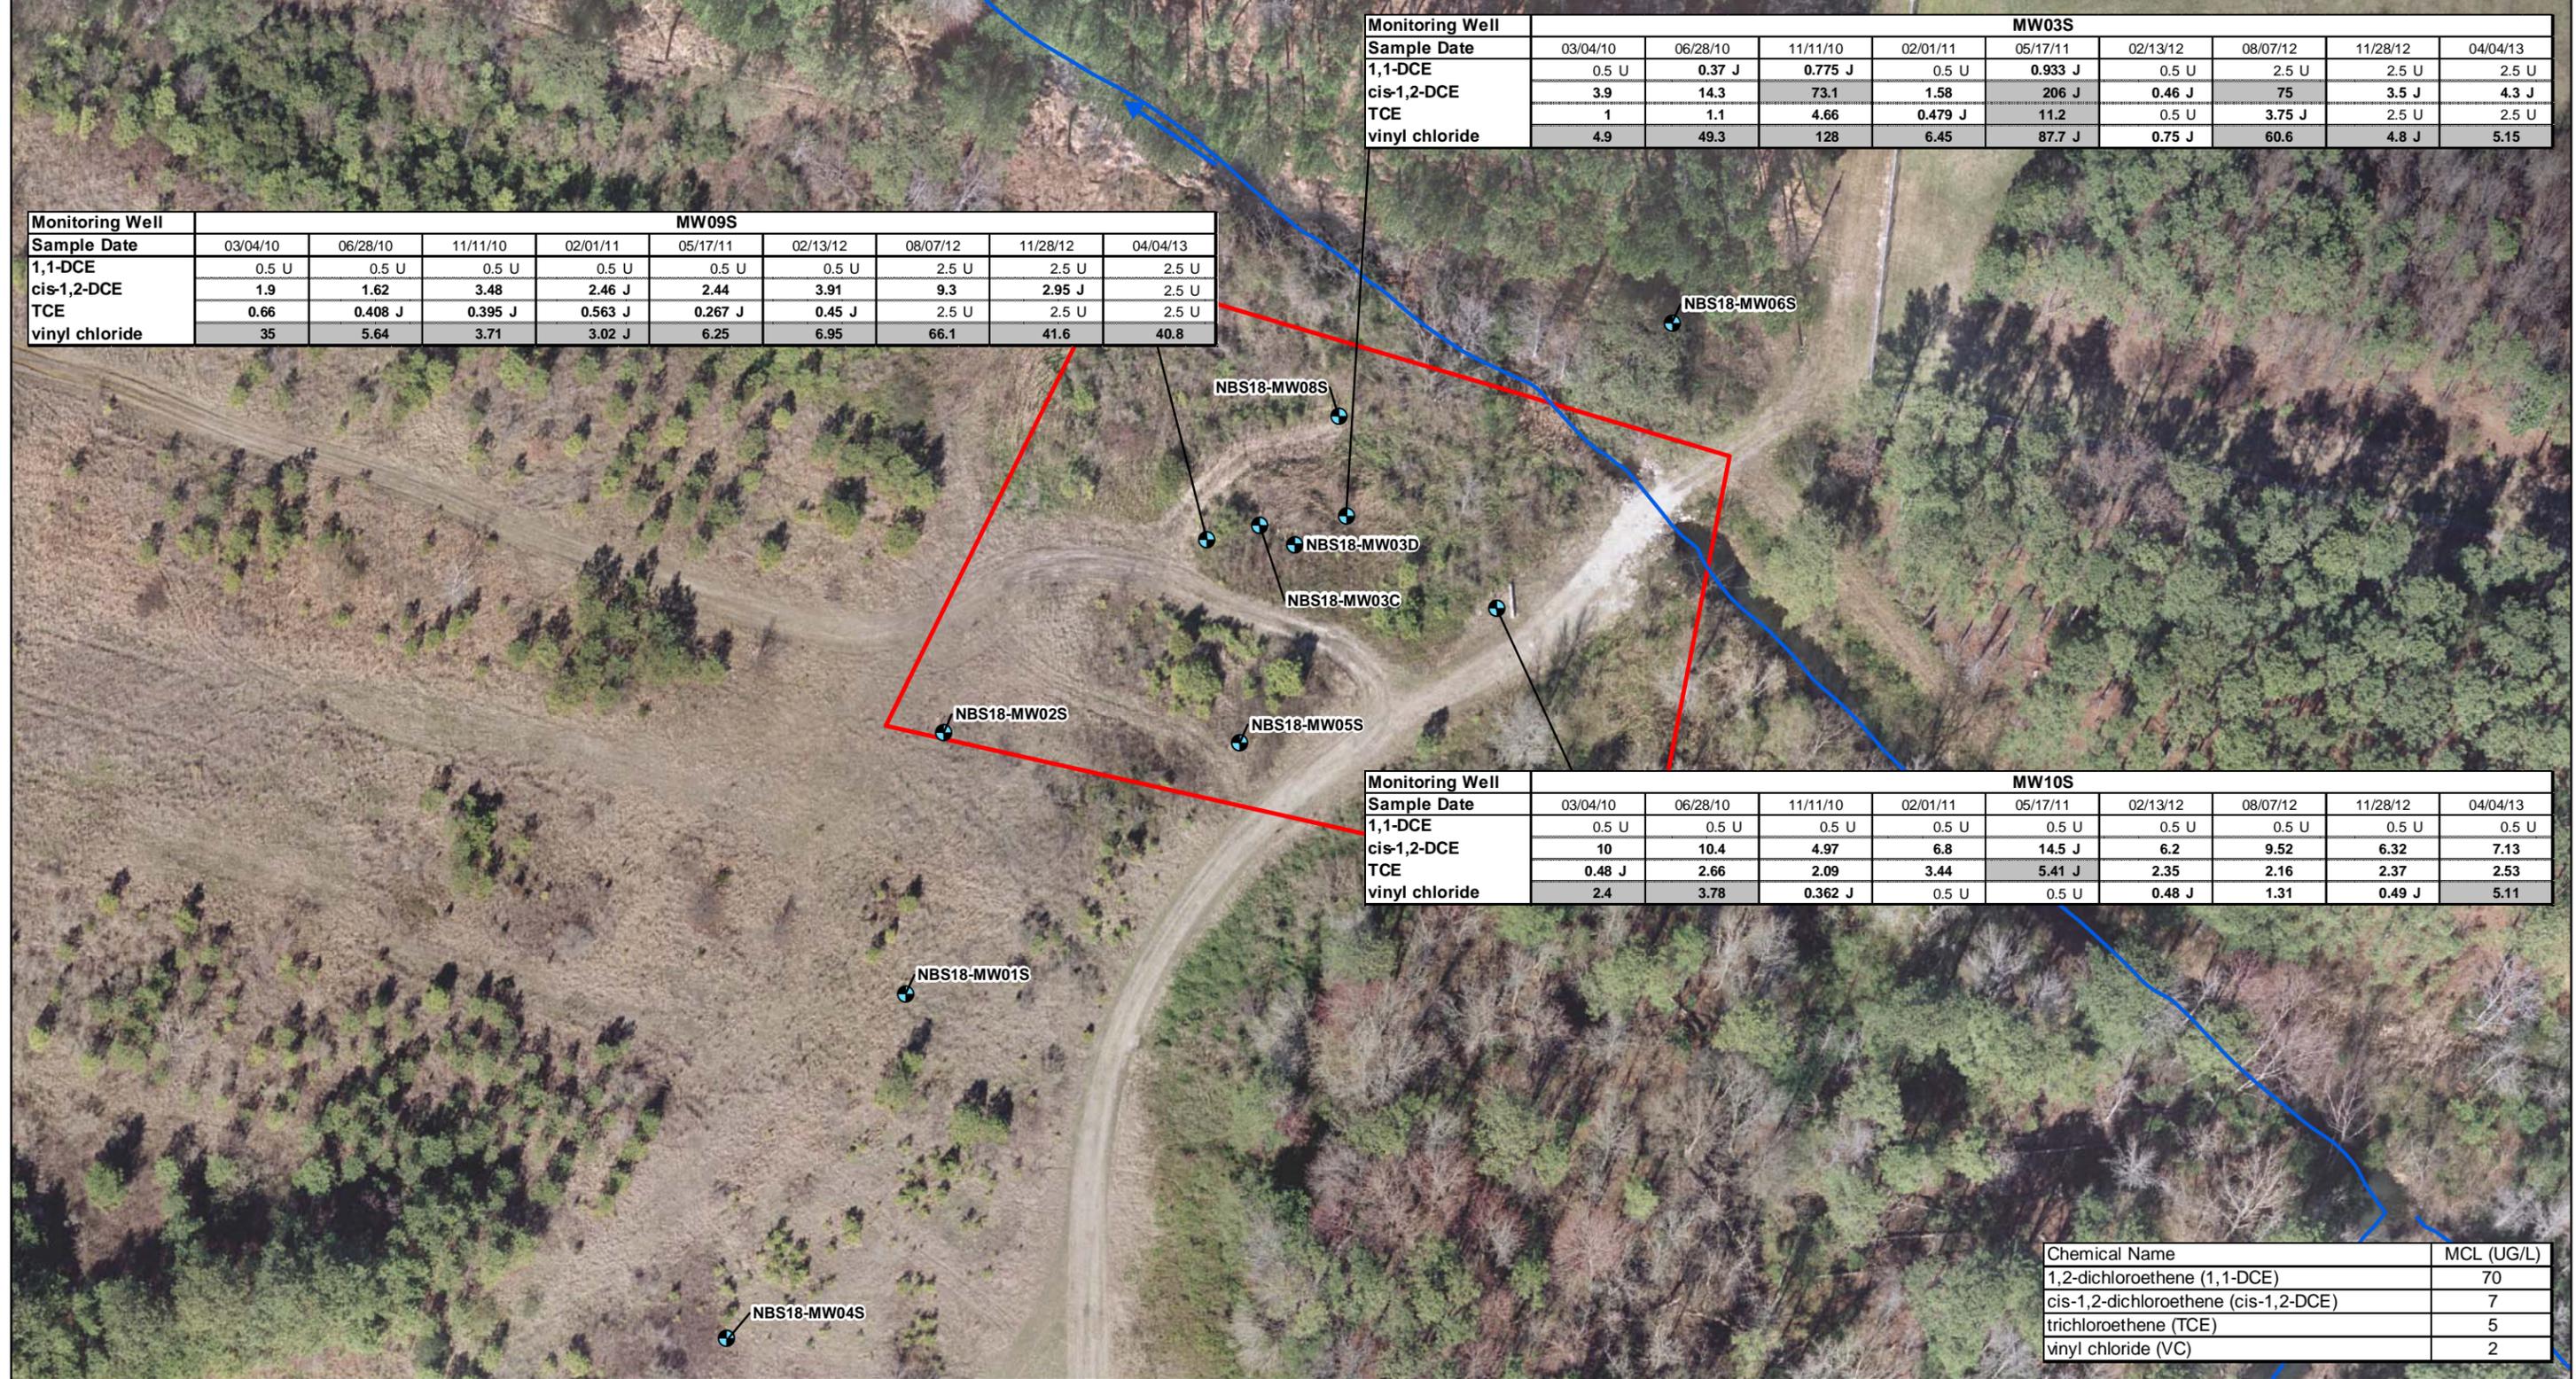
**Figure 8-3**  
**Site 18 -Performance Monitoring Cleanup Goal Exceedances, 2010-2013**  
 Naval Station Norfolk  
 Norfolk, Virginia

Monitoring Well	MW03S									
Sample Date	03/04/10	06/28/10	11/11/10	02/01/11	05/17/11	02/13/12	08/07/12	11/28/12	04/04/13	
1,1-DCE	0.5 U	0.37 J	0.775 J	0.5 U	0.933 J	0.5 U	2.5 U	2.5 U	2.5 U	
cis-1,2-DCE	3.9	14.3	73.1	1.58	206 J	0.46 J	75	3.5 J	4.3 J	
TCE	1	1.1	4.66	0.479 J	11.2	0.5 U	3.75 J	2.5 U	2.5 U	
vinyl chloride	4.9	49.3	128	6.45	87.7 J	0.75 J	60.6	4.8 J	5.15

**Notes:**  
 Shading indicates exceedance of MCLs  
**Bold indicates detections**  
 J - Analyte present, value may or may not be accurate or precise  
 U - The material was analyzed for, but not detected  
 All results are reported in UG/L - Micrograms per liter

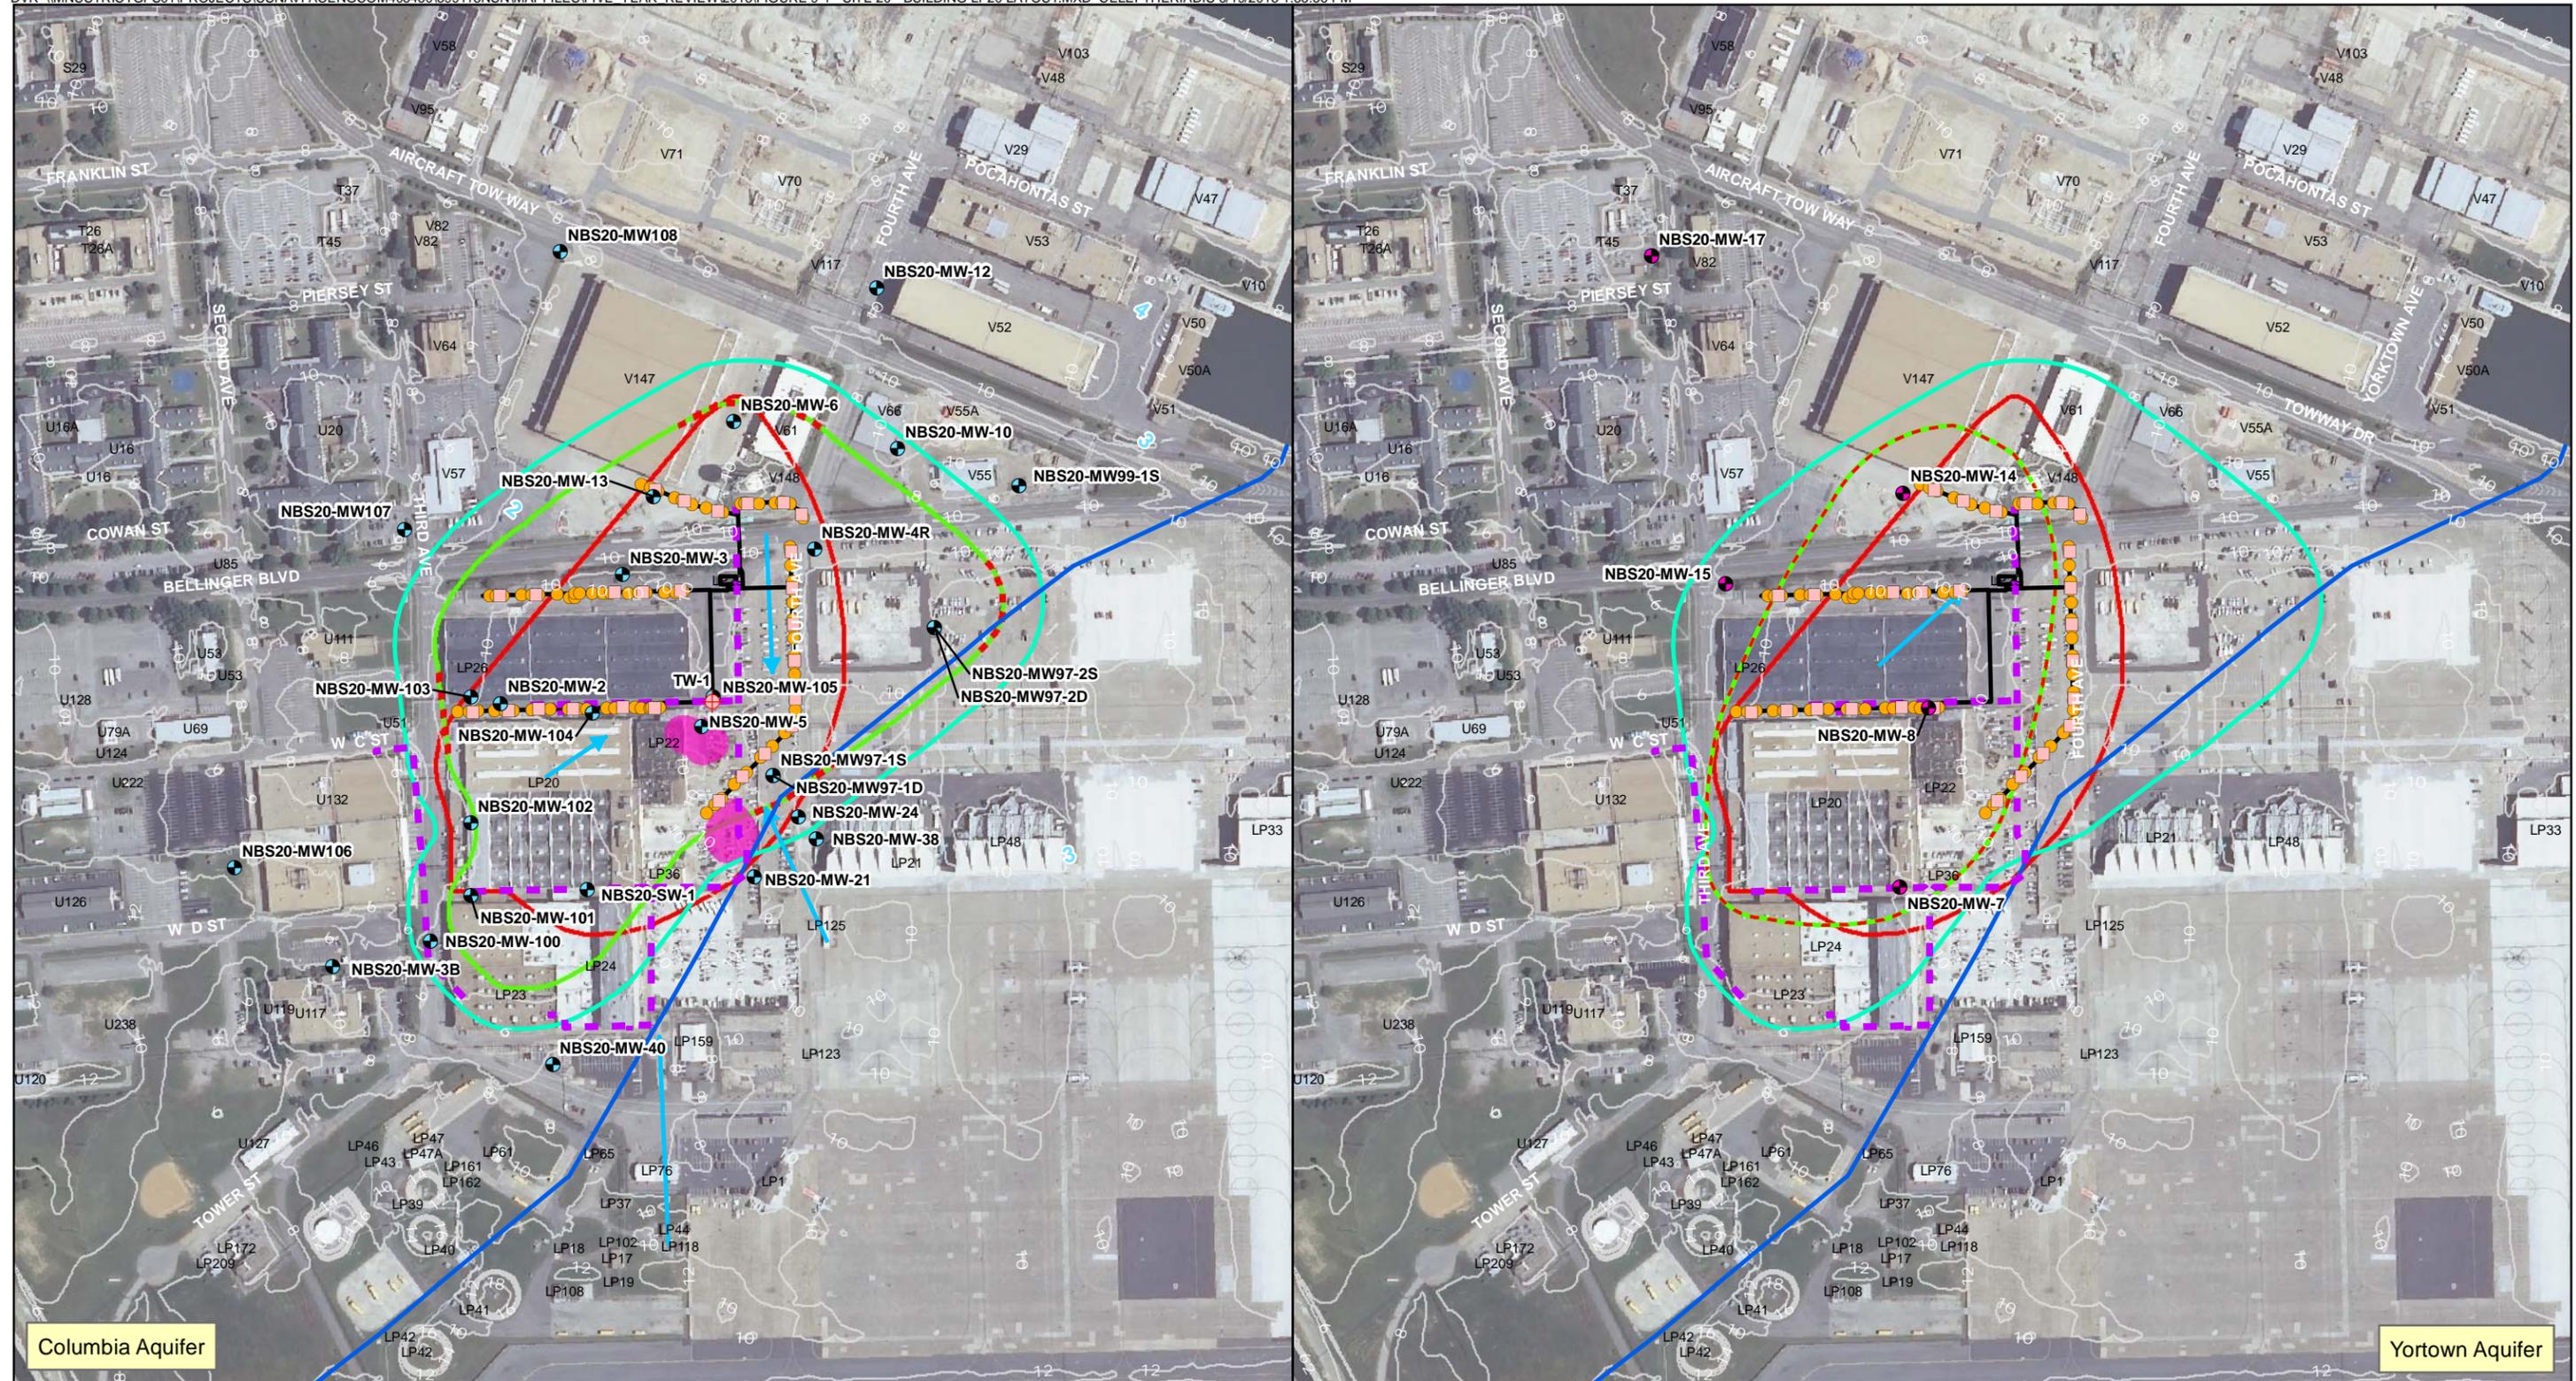
**Figure 9-1**  
**Site 20 - Building LP-20 Layout**  
 Naval Station Norfolk  
 Norfolk, Virginia

**Notes:**  
 TW-1 is the current extraction well for the remedy enhancement for Site 20  
 AS - Air Sparge  
 COC - Contaminant of Concern  
 POL - Petroleum, Oil, and Lubricant  
 SVE - Soil Vapor Extraction

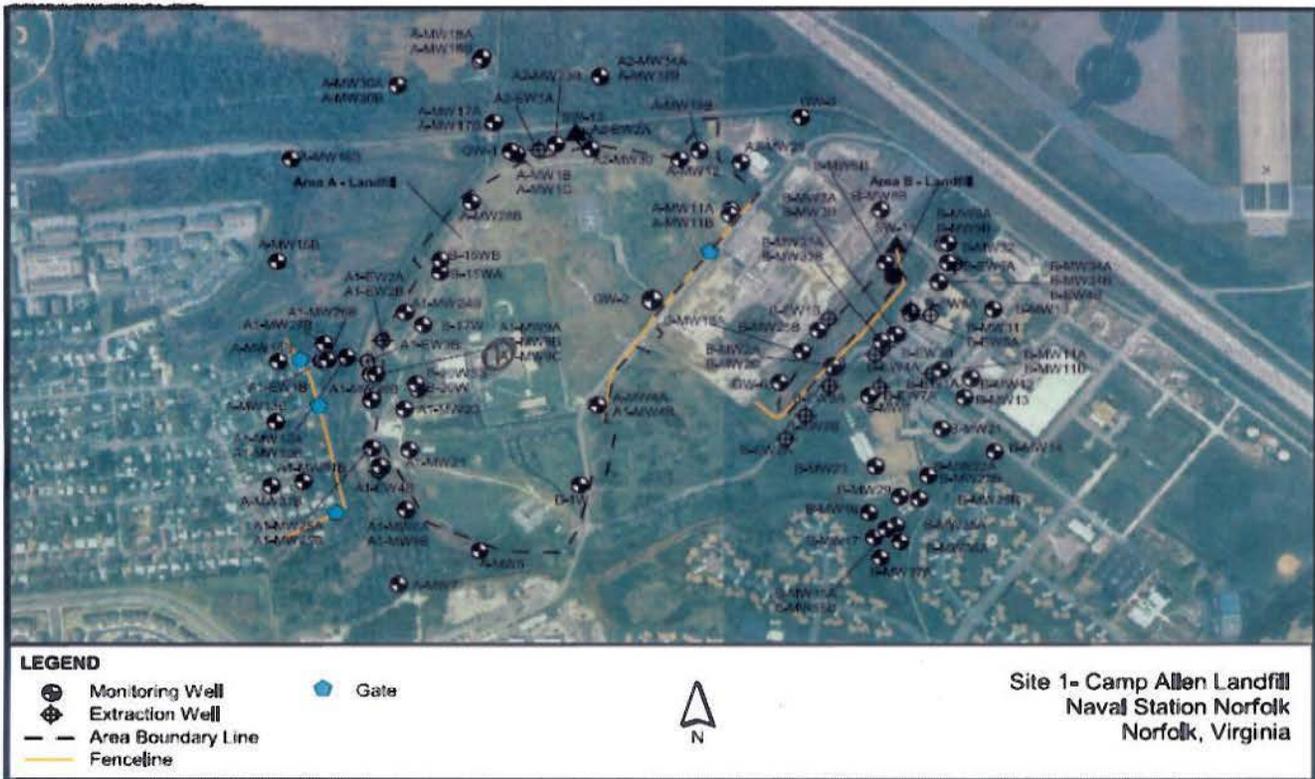
Description: Site 1 - Camp Allen Landfill is located adjacent southwest of I-564 and consists of two distinct areas (Area A, the 45 acre landfill, and Area B, the 2 acre fire disposal landfill). The Area A landfill operated from the 1940s to 1974 and was used for the disposal of metal plating solution, paint strippers, solvents, chemicals, pesticides, asbestos, ash, and debris. The Area B landfill was used to dispose of drums of waste from a fire at Site 22 - Camp Allen Salvage Yard.

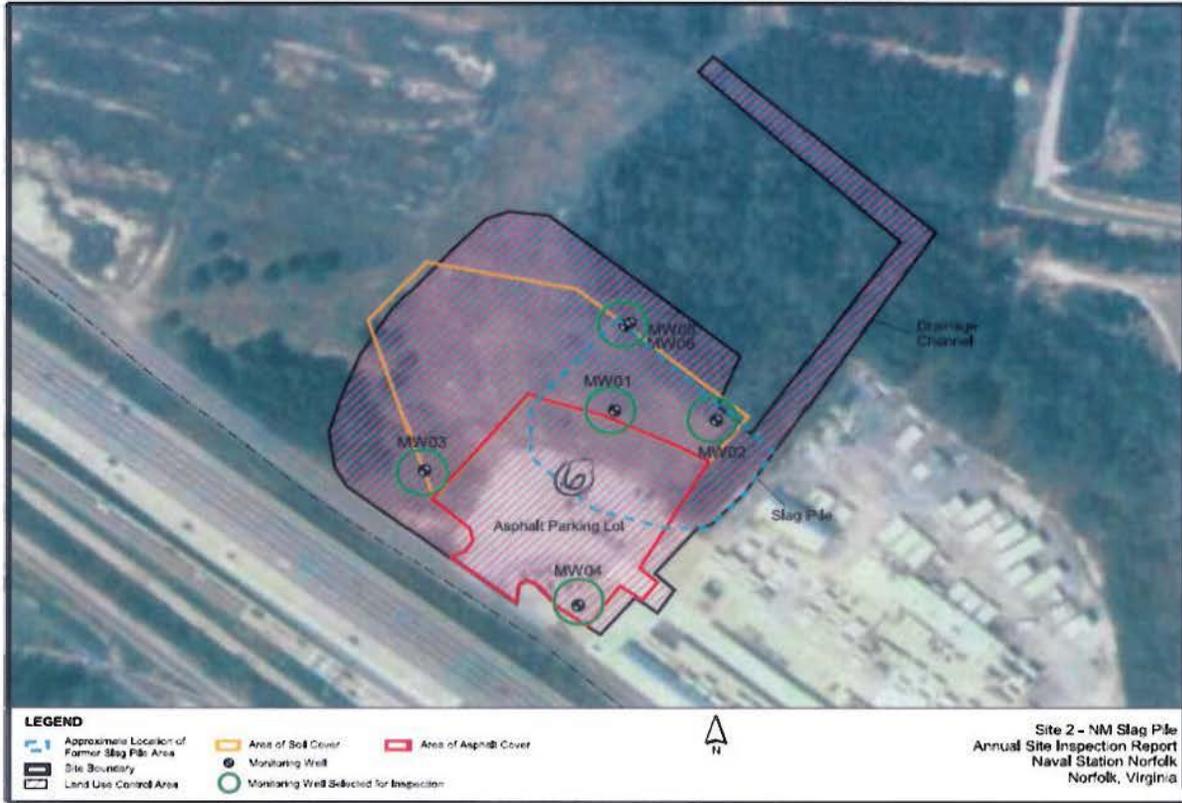
Description: Site 2 - NM Slag Pile is located adjacent to the Naval Magazine. The site covers an area of approximately 2 acres and was used in the 1950s and 1960s for the disposal of slag generated by an aluminum smelting process.

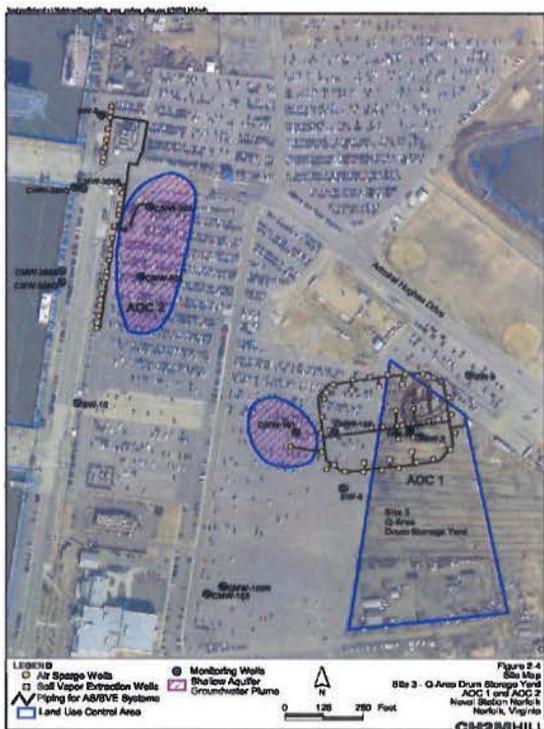
Description: Site 3 - Q Area Drum Storage Yard is located adjacent to Piers 10 and 11. The site was used to store tens of thousands of drums containing petroleum products, chlorinated organic solvents, and paint thinners.

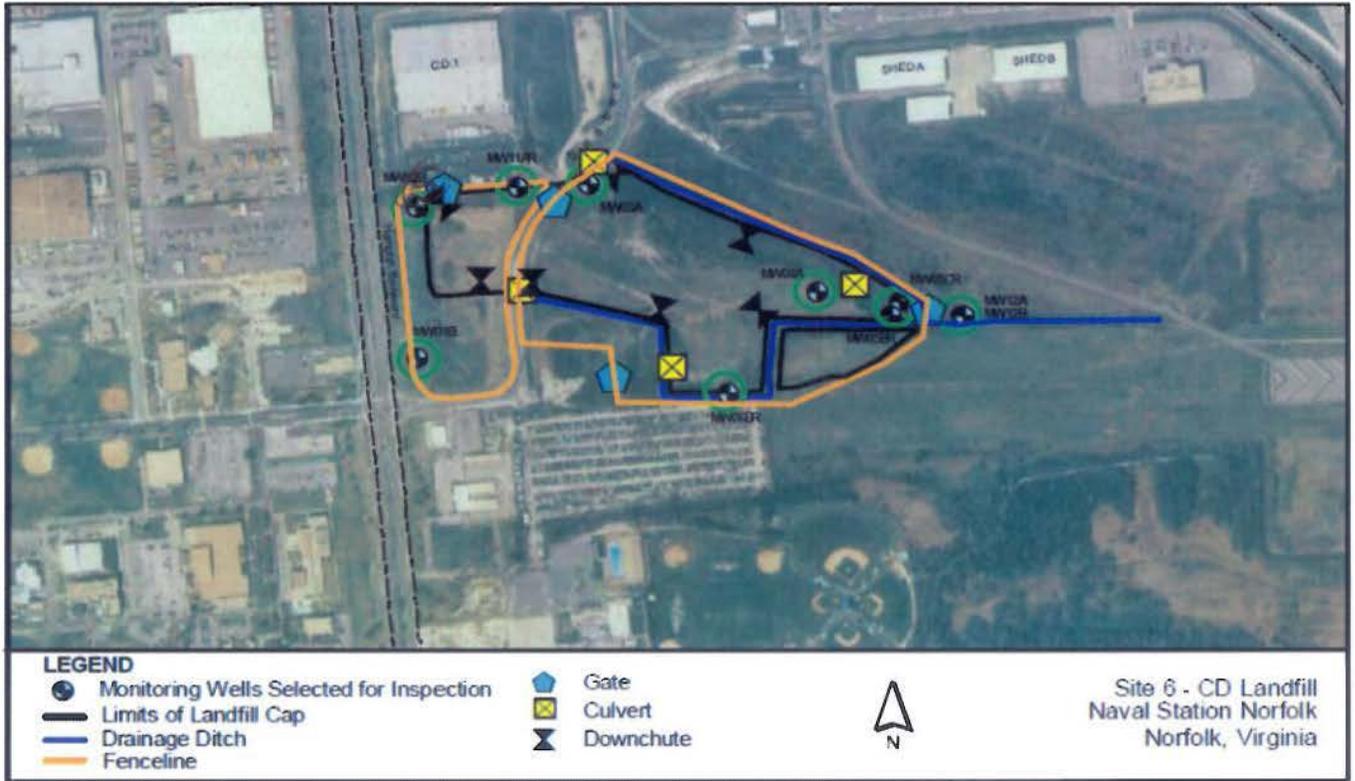
Description: Site 6 - CD Landfill is located adjacent to the Naval Station Norfolk Pass Office along Seebee Rd (see attached figure). The site covers approximately 22 acres and from 1974 to 1979 eastern half of the landfill was used for the disposal of demolition debris, inert waste, fly ash, and incinerator residue. From 1979 to 1987 the western half of the landfill site was used for the disposal of demolition debris and other inert solid wastes.

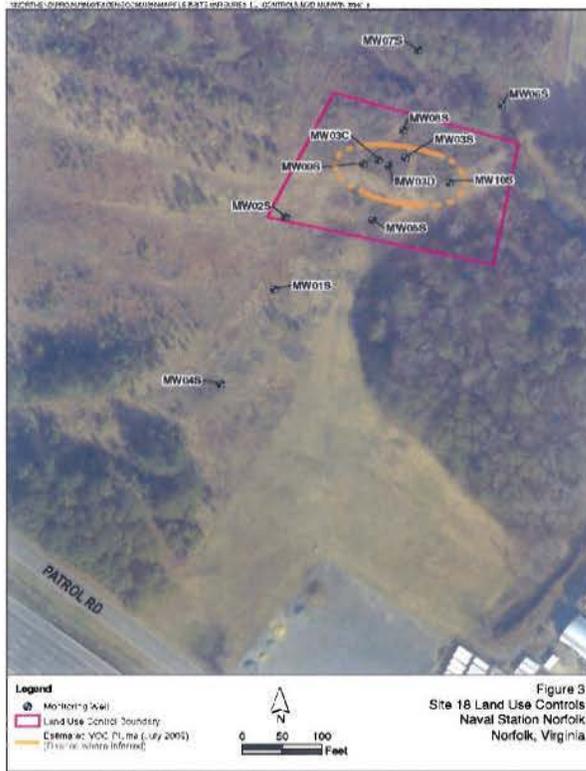
Description: Site 18 - Former NM Hazardous Waste Storage Area is located adjacent to the Naval Magazine. The site was used from 1975 to 1979 to store drums of hazardous waste including - waste oil, metal plating solutions, organic acids, and paint stripping solutions. Spillage of hazardous wastes is documented in this area.
