FINAL THIRD FIVE YEAR REVIEW REPORT NB NORFOLK VA  
02/01/2014  
CH2M HILL

# Third Five-Year Review Report

**Naval Station Norfolk  
Norfolk, Virginia**

### Naval Station Norfolk Norfolk, Virginia

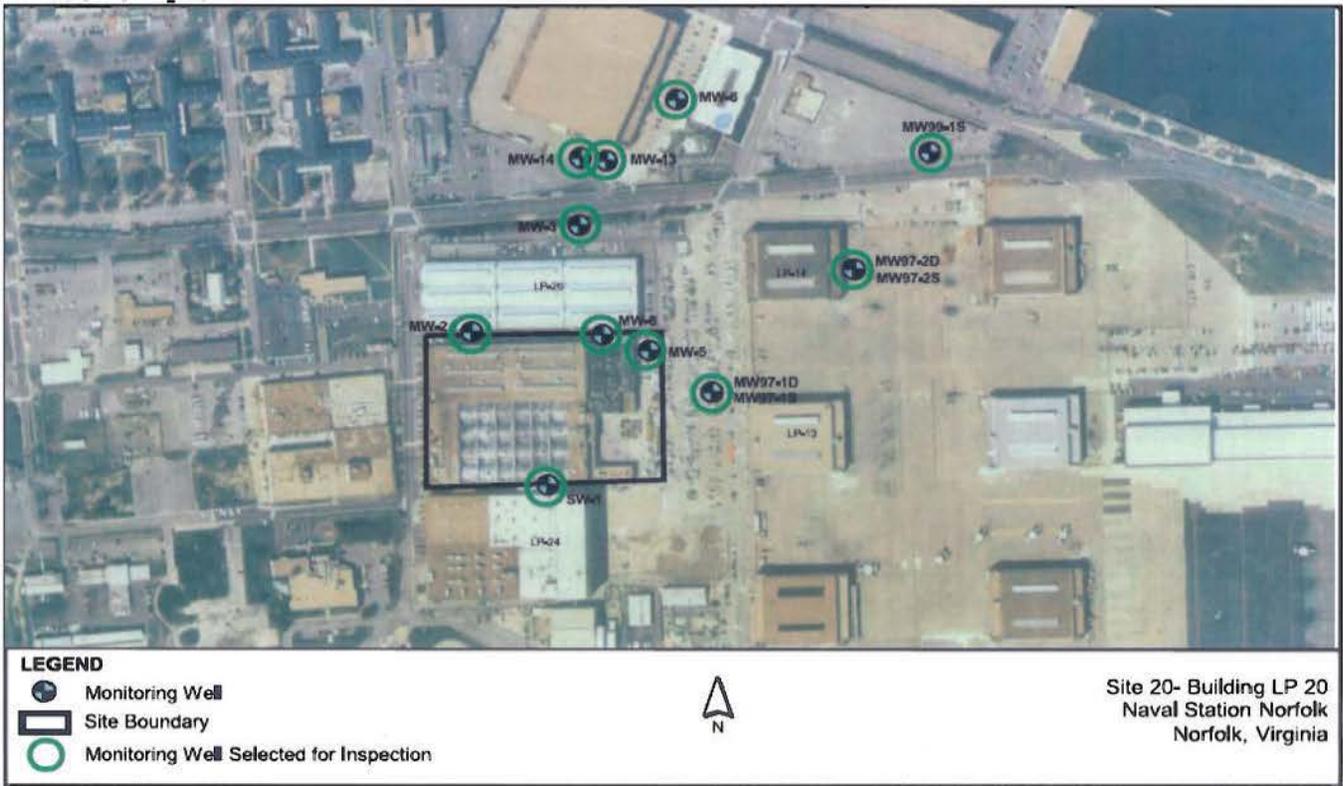
Description: Site 20 - Building LP-20 is located northwest of the main runway at Naval Station Norfolk. Building LP-20 was previously used for engine overhaul and maintenance. Wastewater from these processes as well as a large fuel storage area located south of the building are likely sources of contamination in this area.

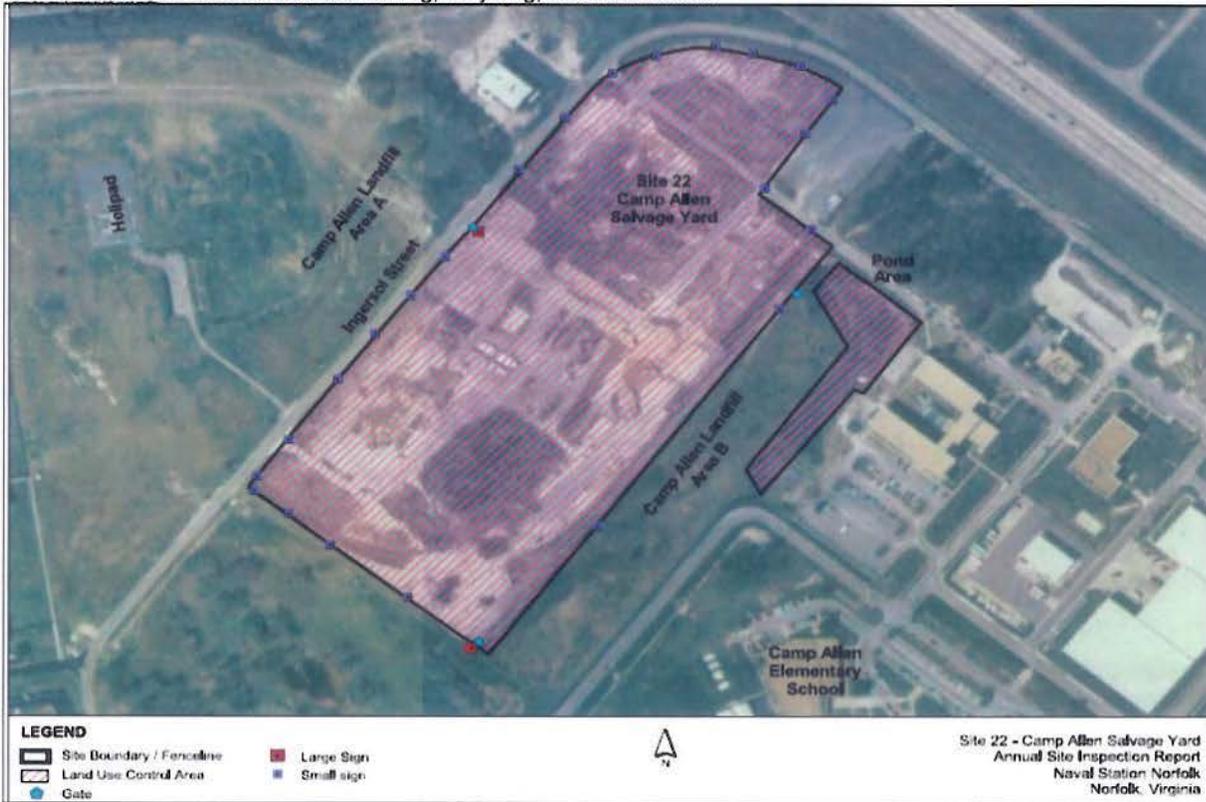
Description: Site 22 - Camp Allen Salvage Yard is located between Area A and Area B of the Camp Allen Landfill. The site was used from the 1940s to 1995 to salvage and process scrap materials. Site activities included storage and management of waste oils, used chemical, acids, paint thinners, solvents, pesticides, transformers, and scrap industrial/commercial equipment. Site activities also included metal smelting, recycling, and incineration.

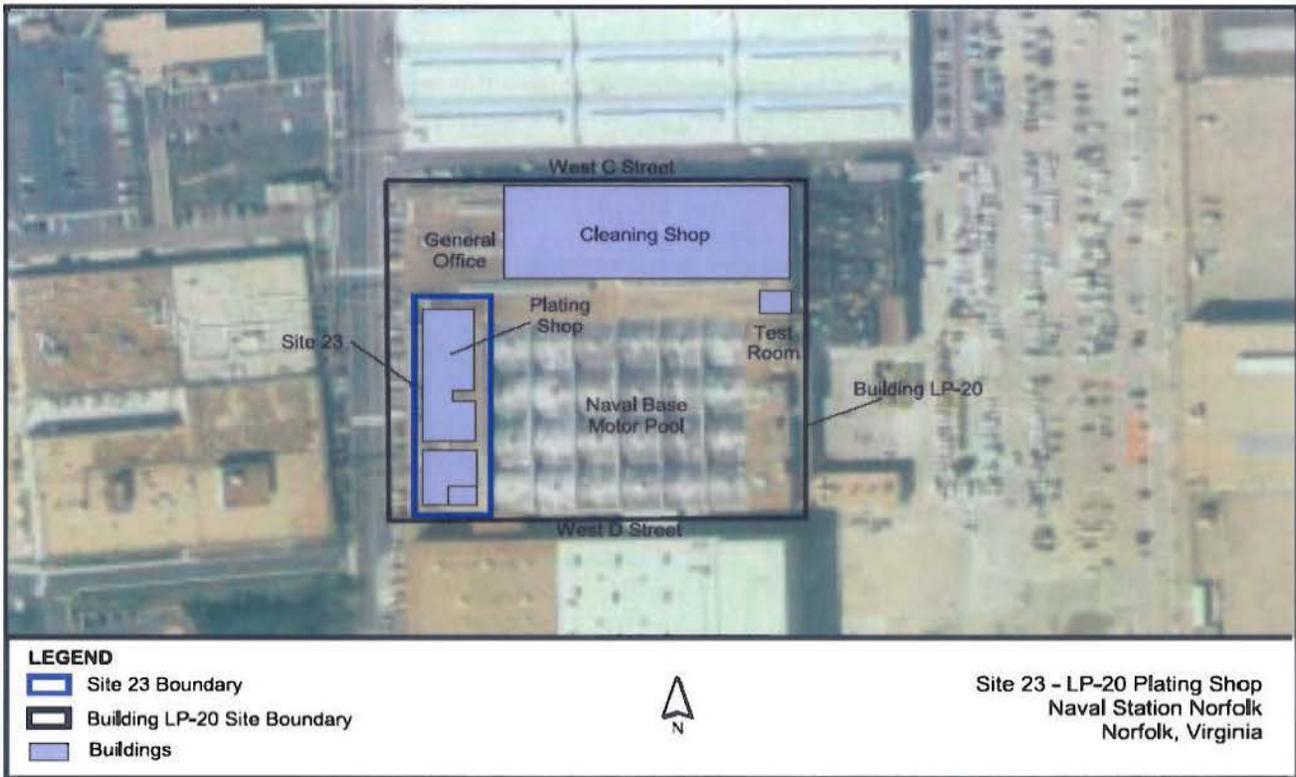
Description: Site 23 - LP-20 Plating shop is located northwest of the main runway at Naval Station Norfolk. The building LP-20 Plating Shop was previously used as an engine overhaul facility where metal parts were stripped and re-plated. The shop contains 7 process pits for cleaning, stripping, and plating parts as well as a drainage system for collection of wastewater from the pits.

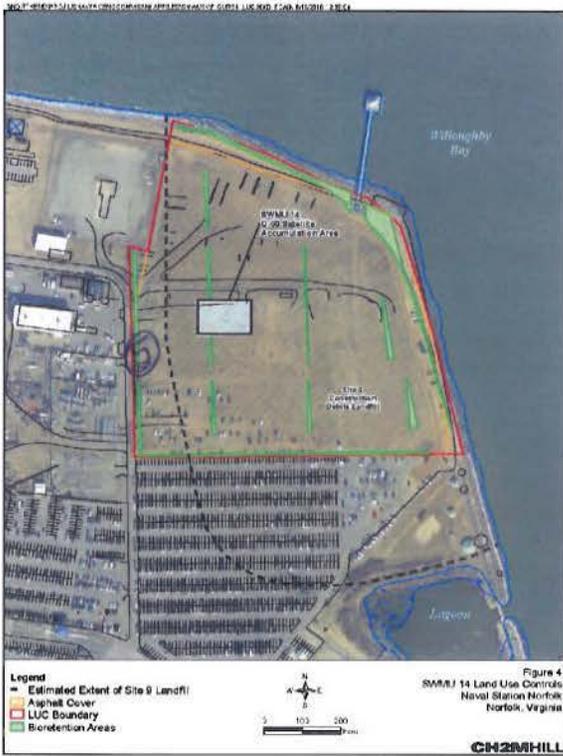
Description: SWMU 14 - Q-50 Satellite Accumulation Area is located in the northeast corner of Naval Station Norfolk and consisted of a concrete pad that served as a 90-day hazardous waste accumulation pad. This pad has since been demolished and replaced with a new pad located west of the original location. Site 9 - Q Area Landfill forms approximately half of the peninsula located at Sewell's Point and was utilized for the disposal of construction debris from 1974 to 1978. These sites also encompass the drainage lagoon located to the southeast.
