FINAL SITE INSPECTION REPORT MUNITIONS RESPONSE PROGRAM TANGIER ISLAND
TARGET SITE NAS OCEANA VA
02/01/2011
CH2M HILL

Final
Site Inspection Report
Munitions Response Program
Tangier Island Target Site, Virginia
Naval Air Station Oceana
Virginia Beach, Virginia

**Site Inspection Report
Munitions Response Program
Tangier Island Target Site, Virginia**

**Naval Air Station Oceana
Virginia Beach, Virginia**

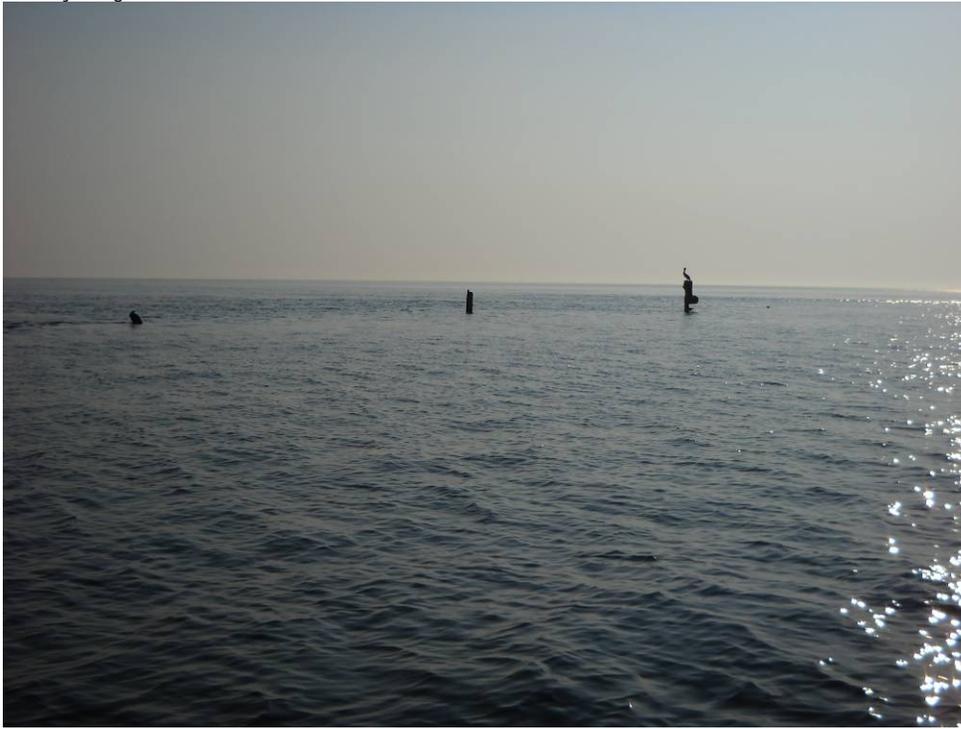
PHOTOGRAPH 2-1
Primary Target Current Conditions

The site is located approximately 2,800 yards southwest of Tangier Island (in Restricted Air Space R-6609) and approximately 65 miles north of Norfolk, Virginia (**Figure 2-1**). The range is located in the lower portion of the Chesapeake Bay in relatively shallow waters, ranging from 10 to over 30 feet deep. The Primary target is located just below the water surface and portions of the target are visible at low tide (**Photograph 2-1**) and may be a possible hazard to navigation. The depth of water in the vicinity of this target area is approximately 11 to 20 feet (**Figure 2-3**). Navy Targets 1 and 2 are located northeast of the primary target, between the primary target and Tangier Island. They are located within the 3-mile restricted area around the Primary Target. The depth of water around these targets is approximately 10 to 22 feet (**Figure 2-4**). Portions of these targets are visible above the water surface (**Photographs 2-2** and **2-3**) and may be a possible hazard to navigation. The San Marcos Target is located approximately 5.5 miles south of the Primary Target. The depth of water at this location is approximately 26 to 32 feet (**Figure 2-5**). NOAA Nautical Charts indicate that the San Marcos Target is at a depth of greater than 20 feet below water surface.

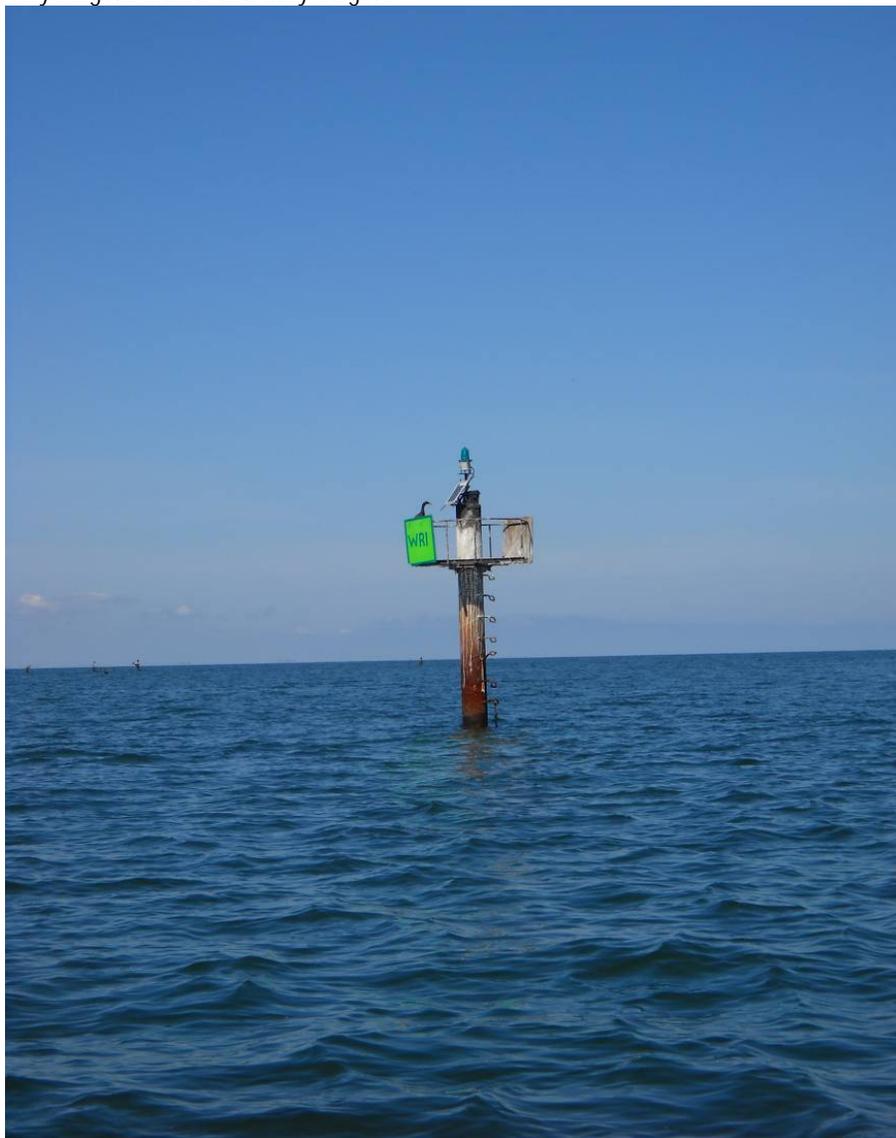
PHOTOGRAPH 2-3

Navy Target 2 Marker and Navy Target 1

[Note: Navy Target 1 in background.]

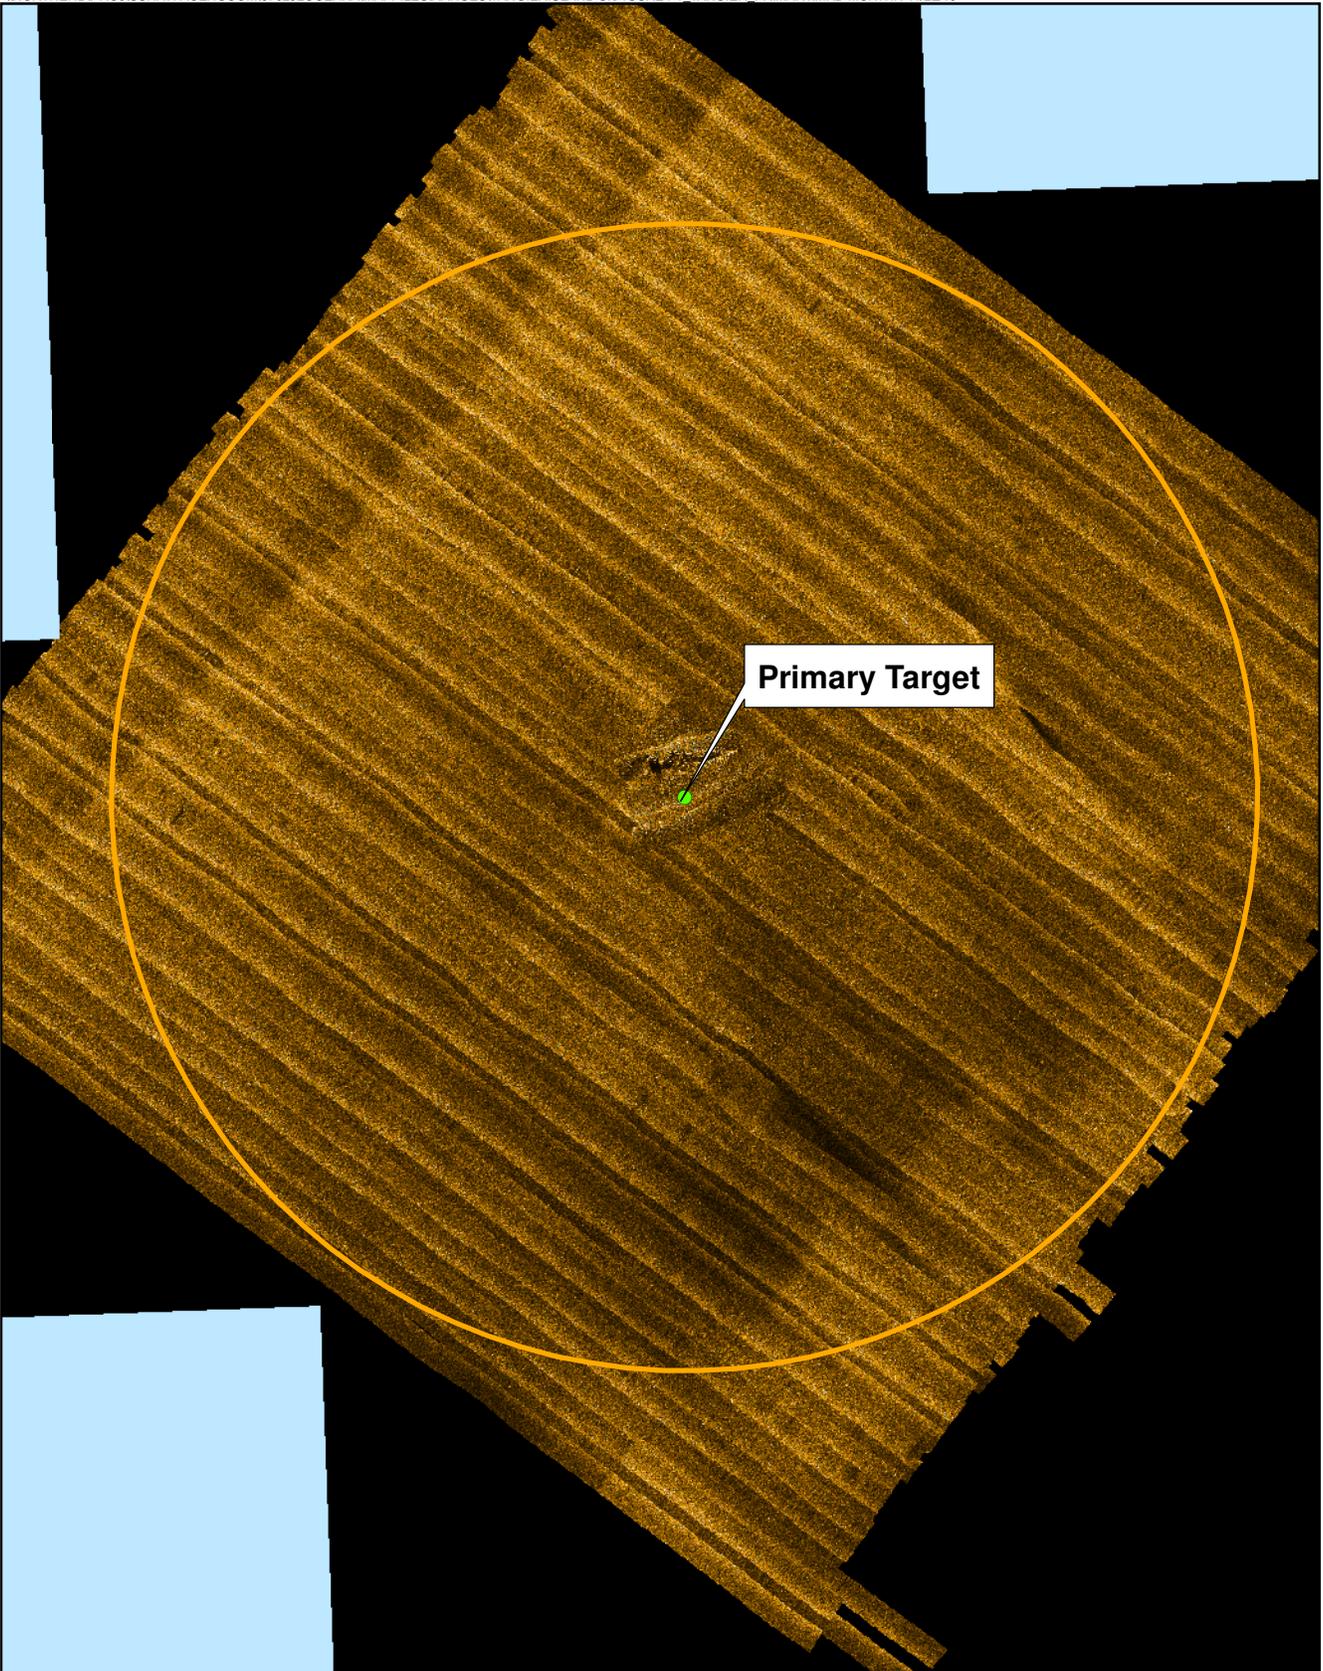
Figure 4-1
Primary Target Investigation Area
NAS Oceana
Virginia Beach, Virginia

The data collection approach was outlined in the Work Plan (CH2M HILL, 2010), and included a focused investigation of each of the known target locations. The investigation areas for the Primary Target, Navy Targets 1 and 2, and San Marcos Target locations are presented in **Figures 4-1, 4-2, and 4-3**, respectively. Side-scan sonar imaging from the side-scan investigation are also included on these figures. This information was used to confirm the target locations and identify any potential navigational hazards. The DGM survey focused on the target locations (an approximate radius of 1,000 yards around each target) as these areas are the most likely to show evidence of range activities. At all the target locations, transects were spaced 100 feet apart for the first 500 yards from the presumed target location. The spacing of the transects was increased to 250 feet for the remaining 500 yards, up to a total distance of 1,000 yards from the presumed target location. The interior lines (the first 500 yards) were collected first at each target location, so that the data could be assessed to determine whether it was necessary to collect the remaining data (from 500 to 1,000 yards). During the survey, the sensors were towed just above the seafloor surface, but no higher than 5 feet above the sediment; to prevent inadvertent contact with MEC and to prevent damage to aquatic habitats while obtaining quality DGM data. The average depth above the seafloor was estimated to be approximately 3 feet.

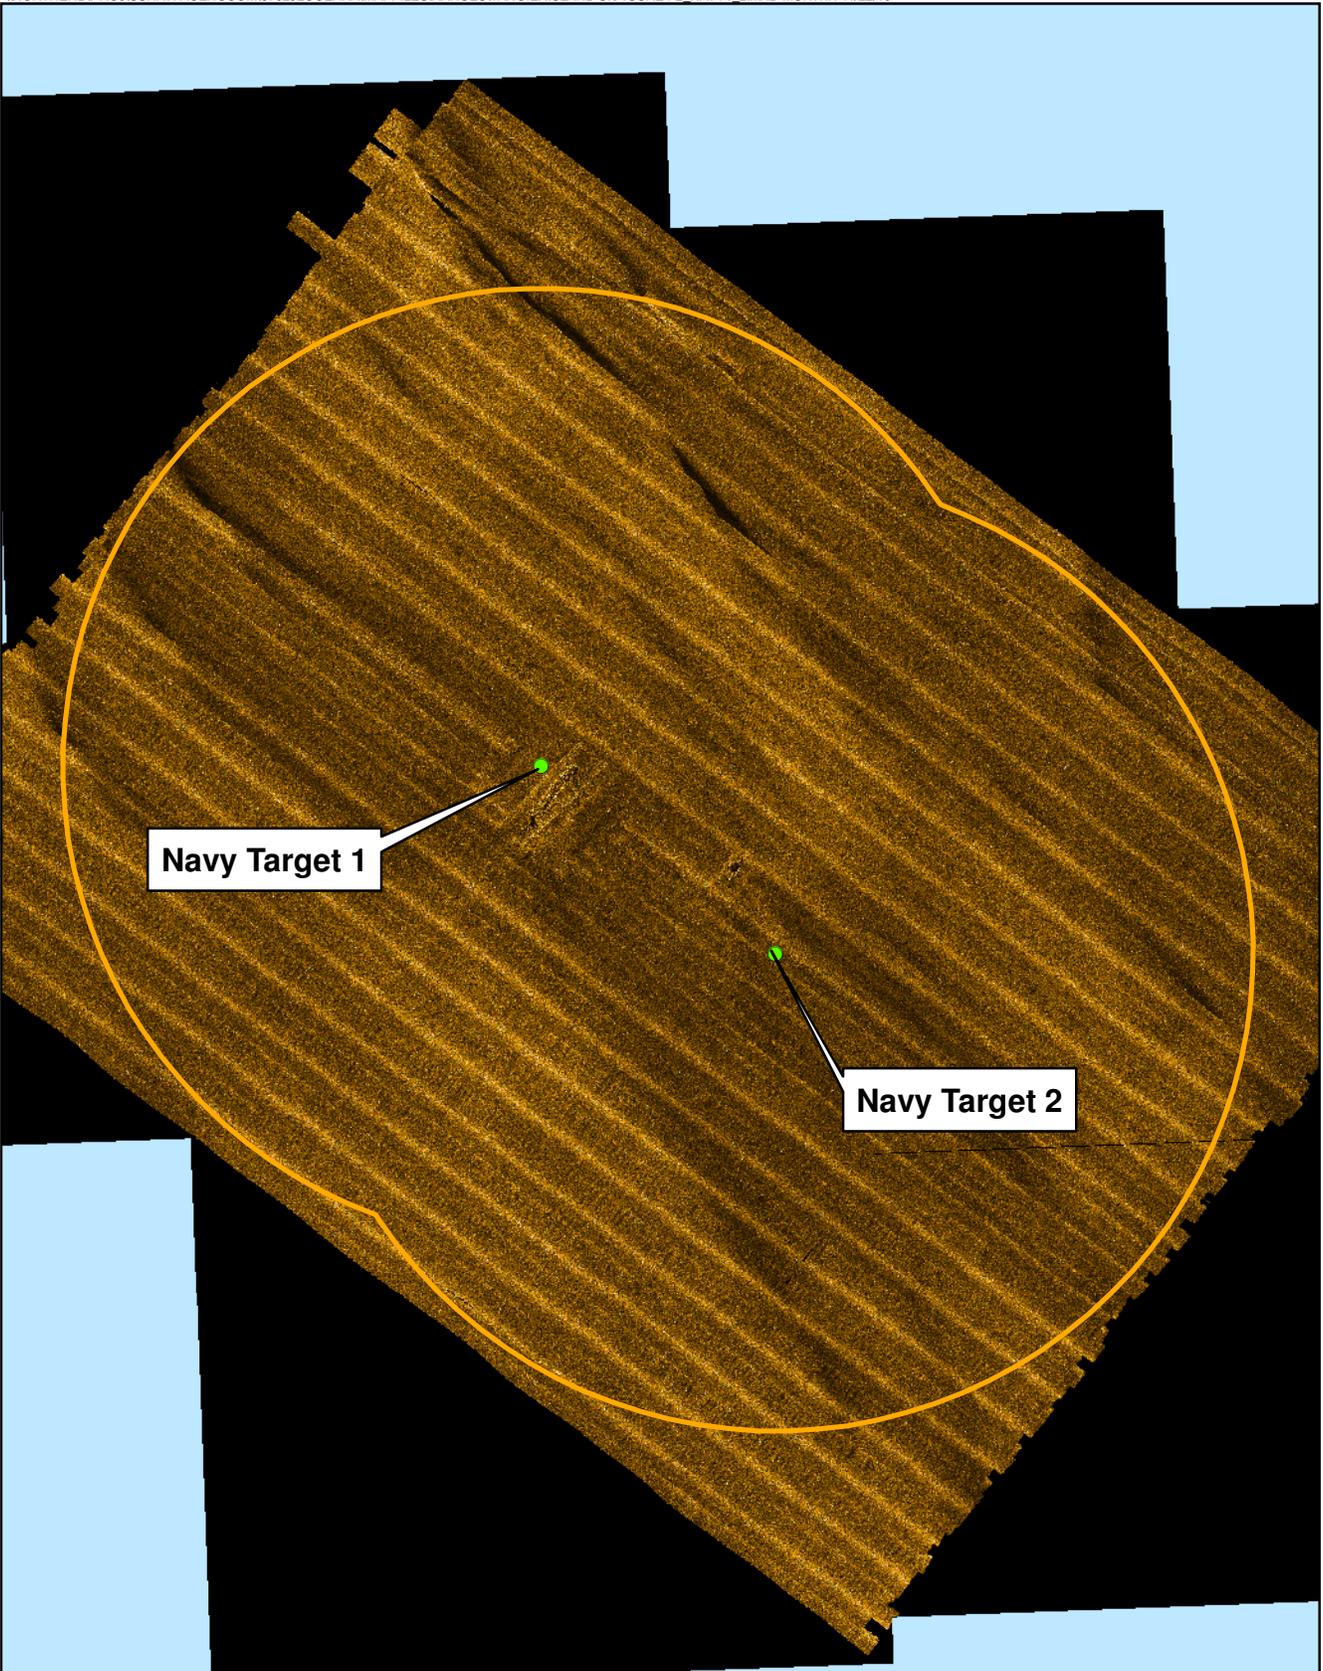
Figure 4-2
Navy Targets 1 and 2 Investigation Area
NAS Oceana
Virginia Beach, Virginia

- At the Navy Targets 1 and 2, the DGM survey was not conducted as originally detailed in the Work Plan. As a result of hazards associated with navigating the DGM equipment between the two hard targets (Navy Targets 1 and 2) data were not collected from between the hard targets.

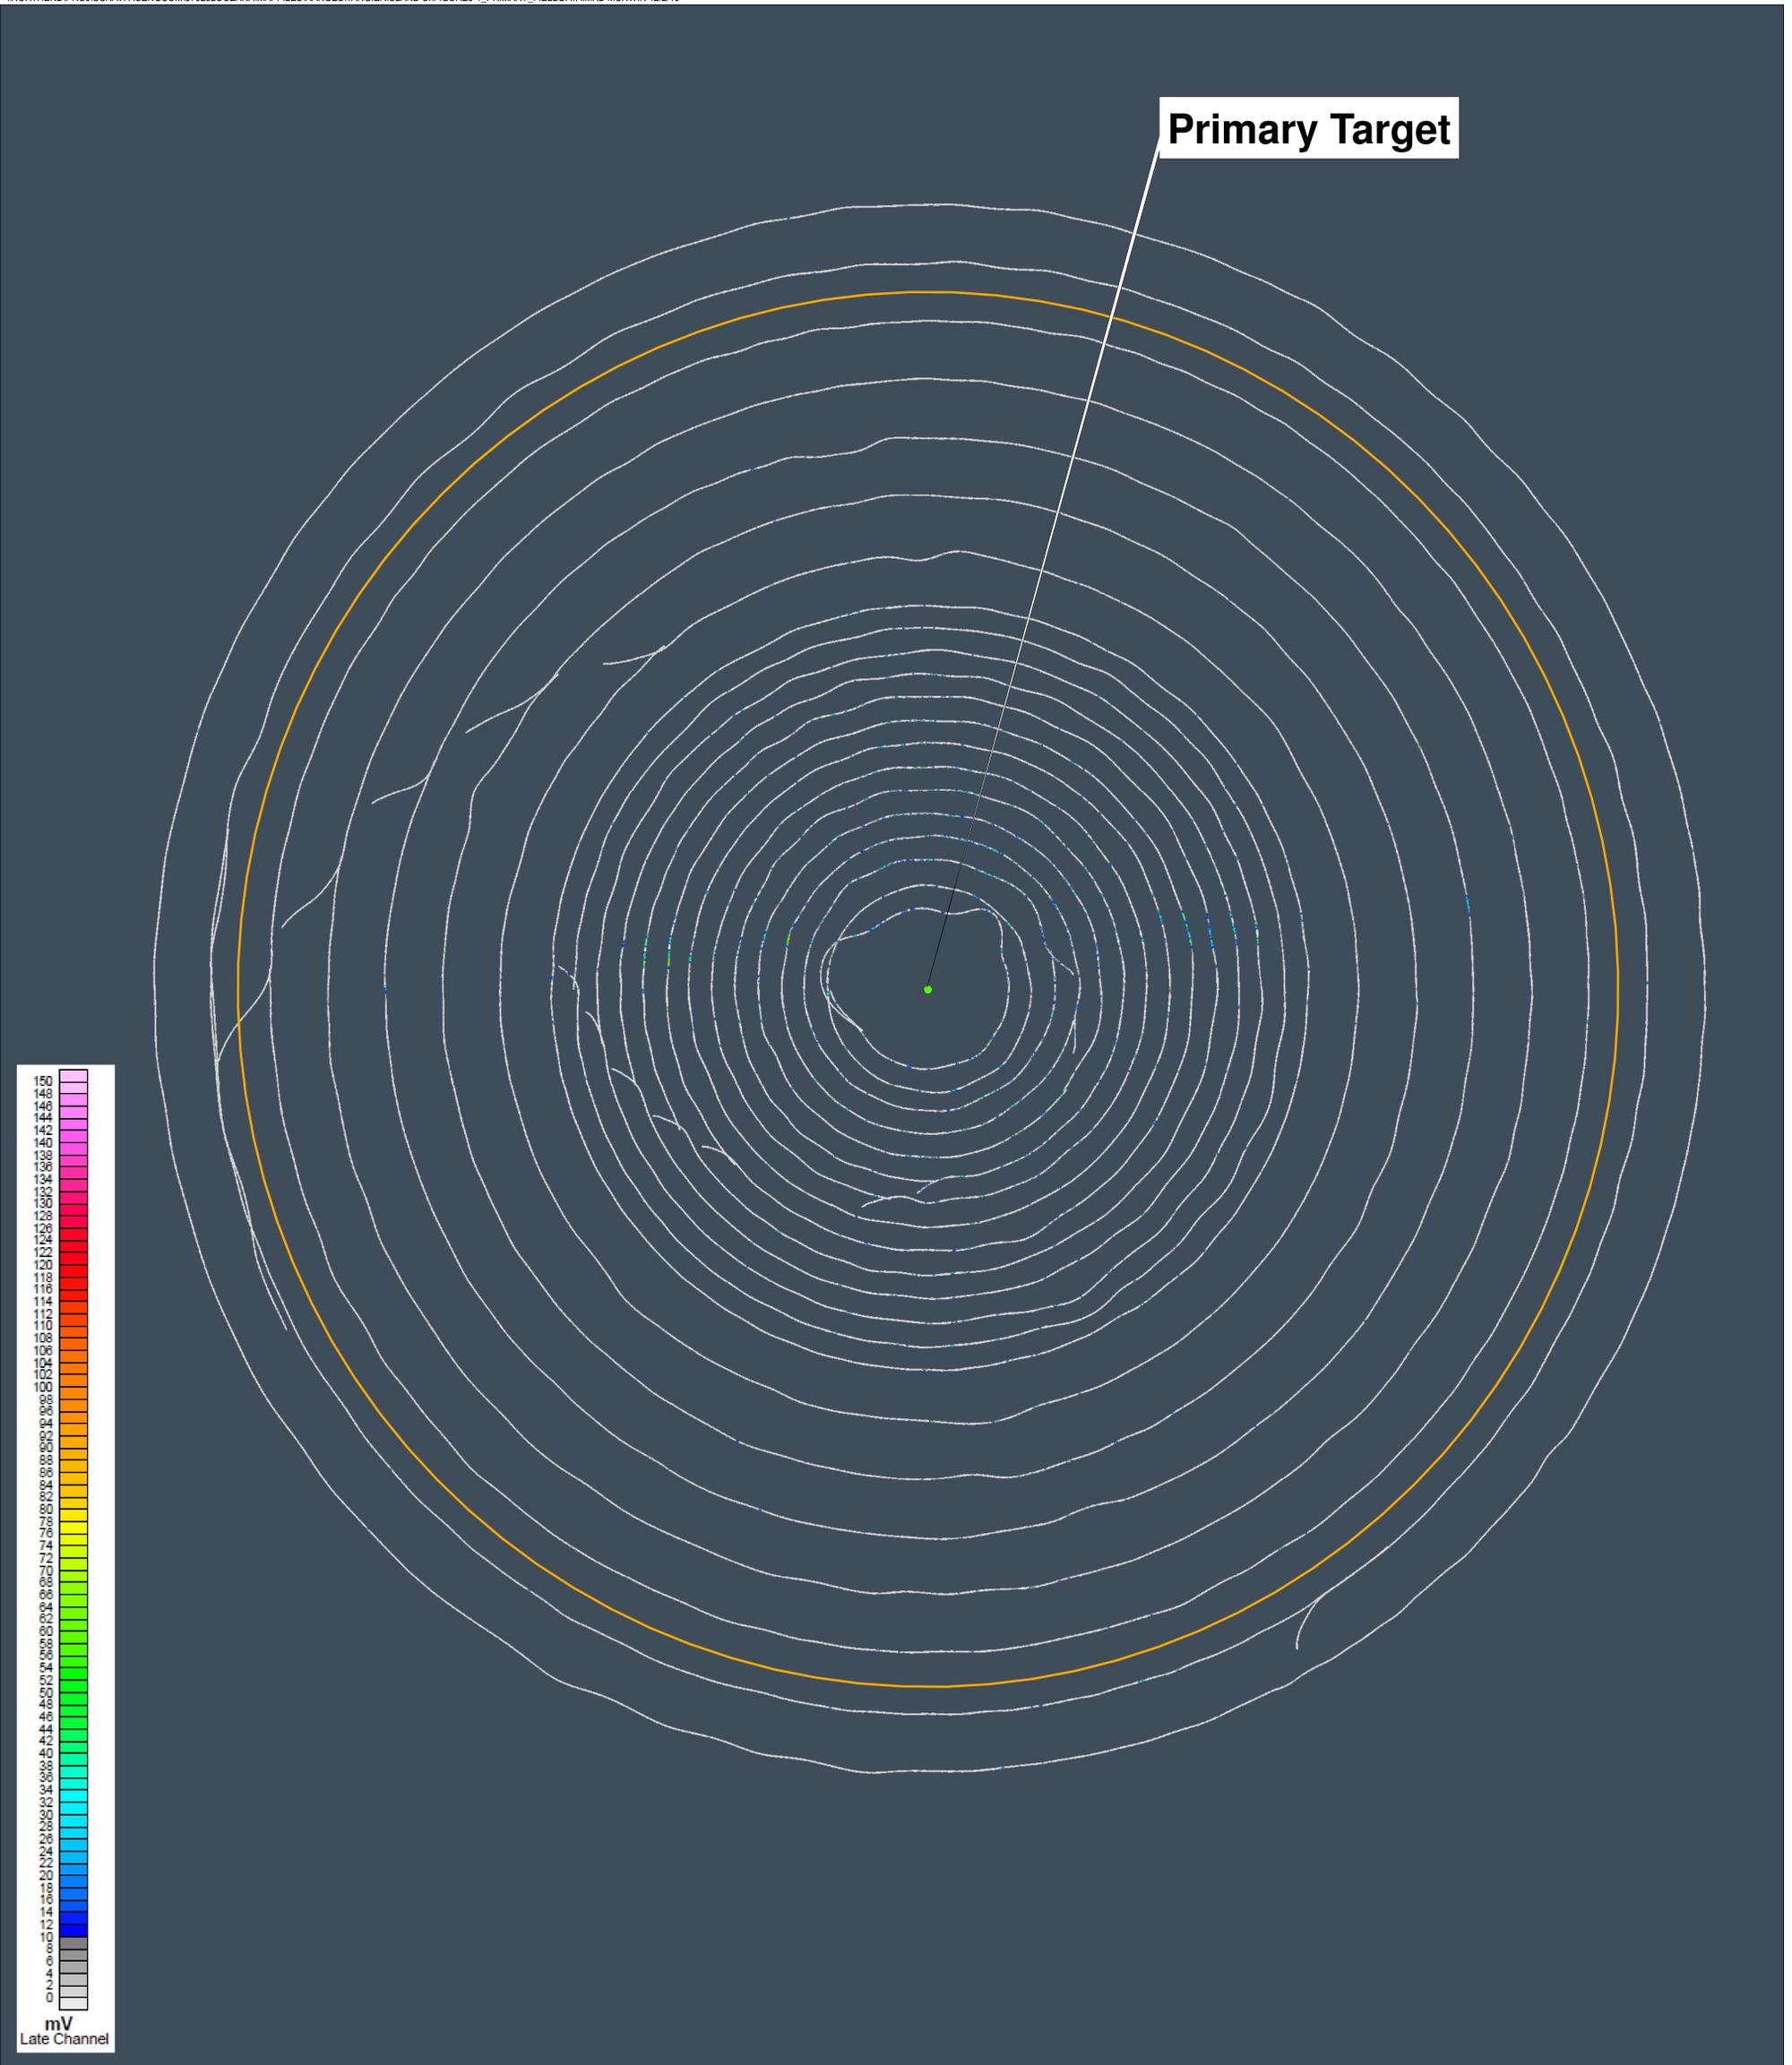
Figure 5-1
Primary Target Field Data
NAS Oceana
Virginia Beach, Virginia

At the Tangier Island Target Site, 112.6 miles of transects (with an instrument detection footprint of 6.56 feet wide) were surveyed with 4,148 anomalies detected. This corresponds to 89.6 acres (approximately 4 percent of the total investigation area acreage) of data collected with an average of 46.3 anomalies per acre. **Table 5-1** outlines the distance, acreage, and number of anomalies found at each target area. The total acreage of the site is approximately 25,000 acres (which includes the 3-mile restricted area surrounding the Primary Target and the 1,000-yard radius around the San Marcos Target). However, for the purposes of this SI, the investigation focused only on the areas most likely to contain MEC (the areas surrounding the proposed target locations). Therefore the acreage of each investigation area was 650, 904, and 650 acres for the Primary Target, Navy Targets 1 and 2, and the San Marcos Target, respectively.

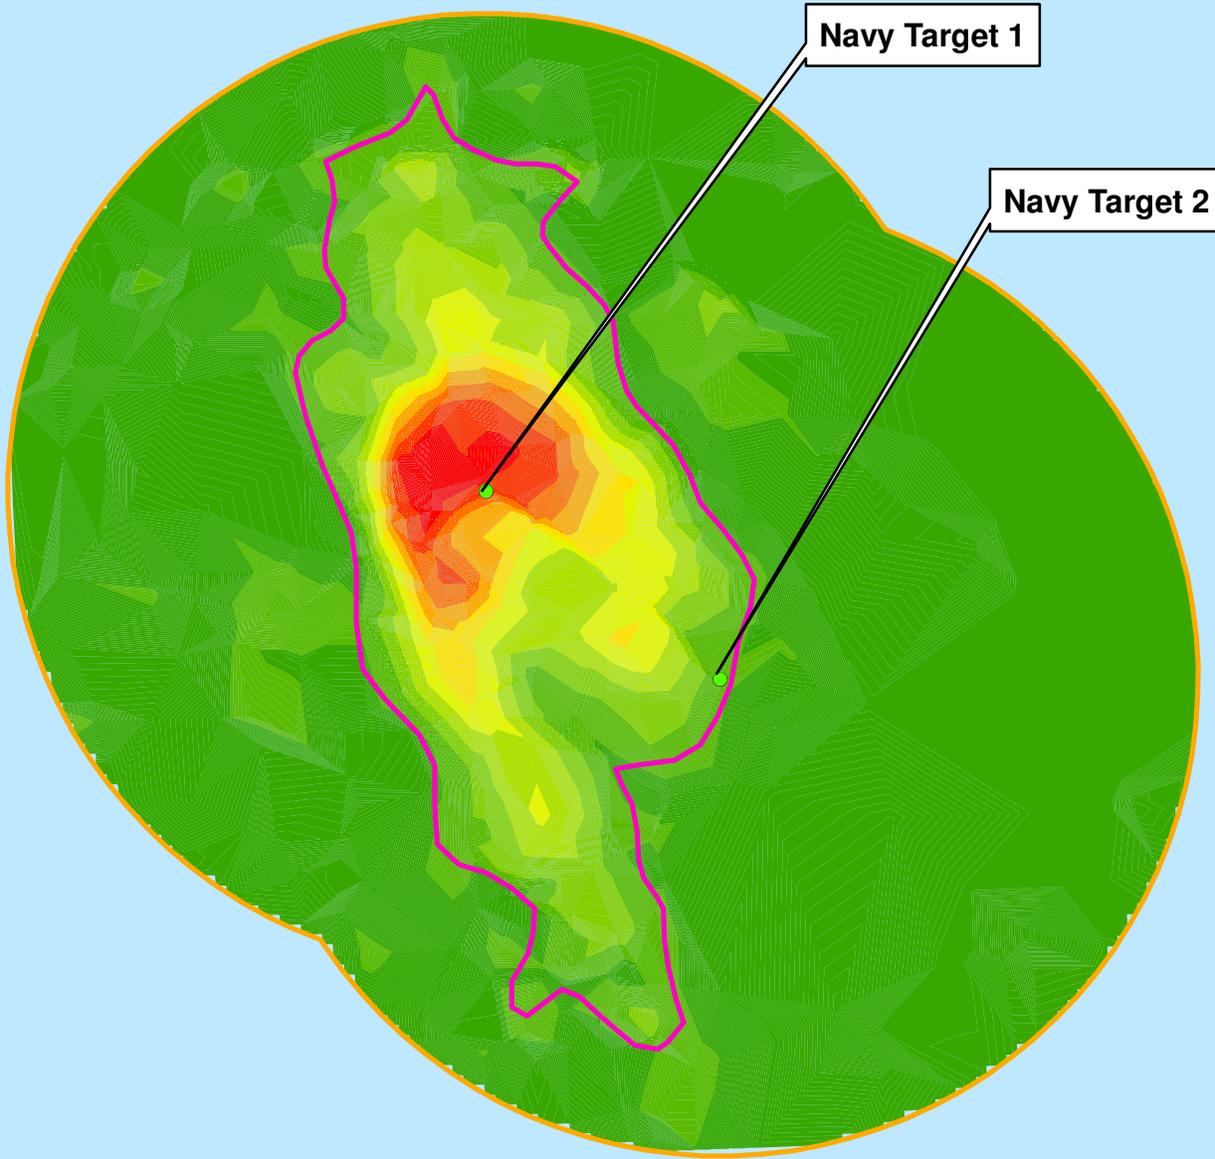
Figure 5-4
Navy Targets 1 and 2
Anomaly Density Map
NAS Oceana
Virginia Beach, Virginia

Based upon the results of the DGM investigation, a significant number of anomalies were detected at each of the target locations within the range. The lowest anomaly densities were observed at the San Marcos Target location and the highest anomaly densities were observed surrounding Navy Target 1.

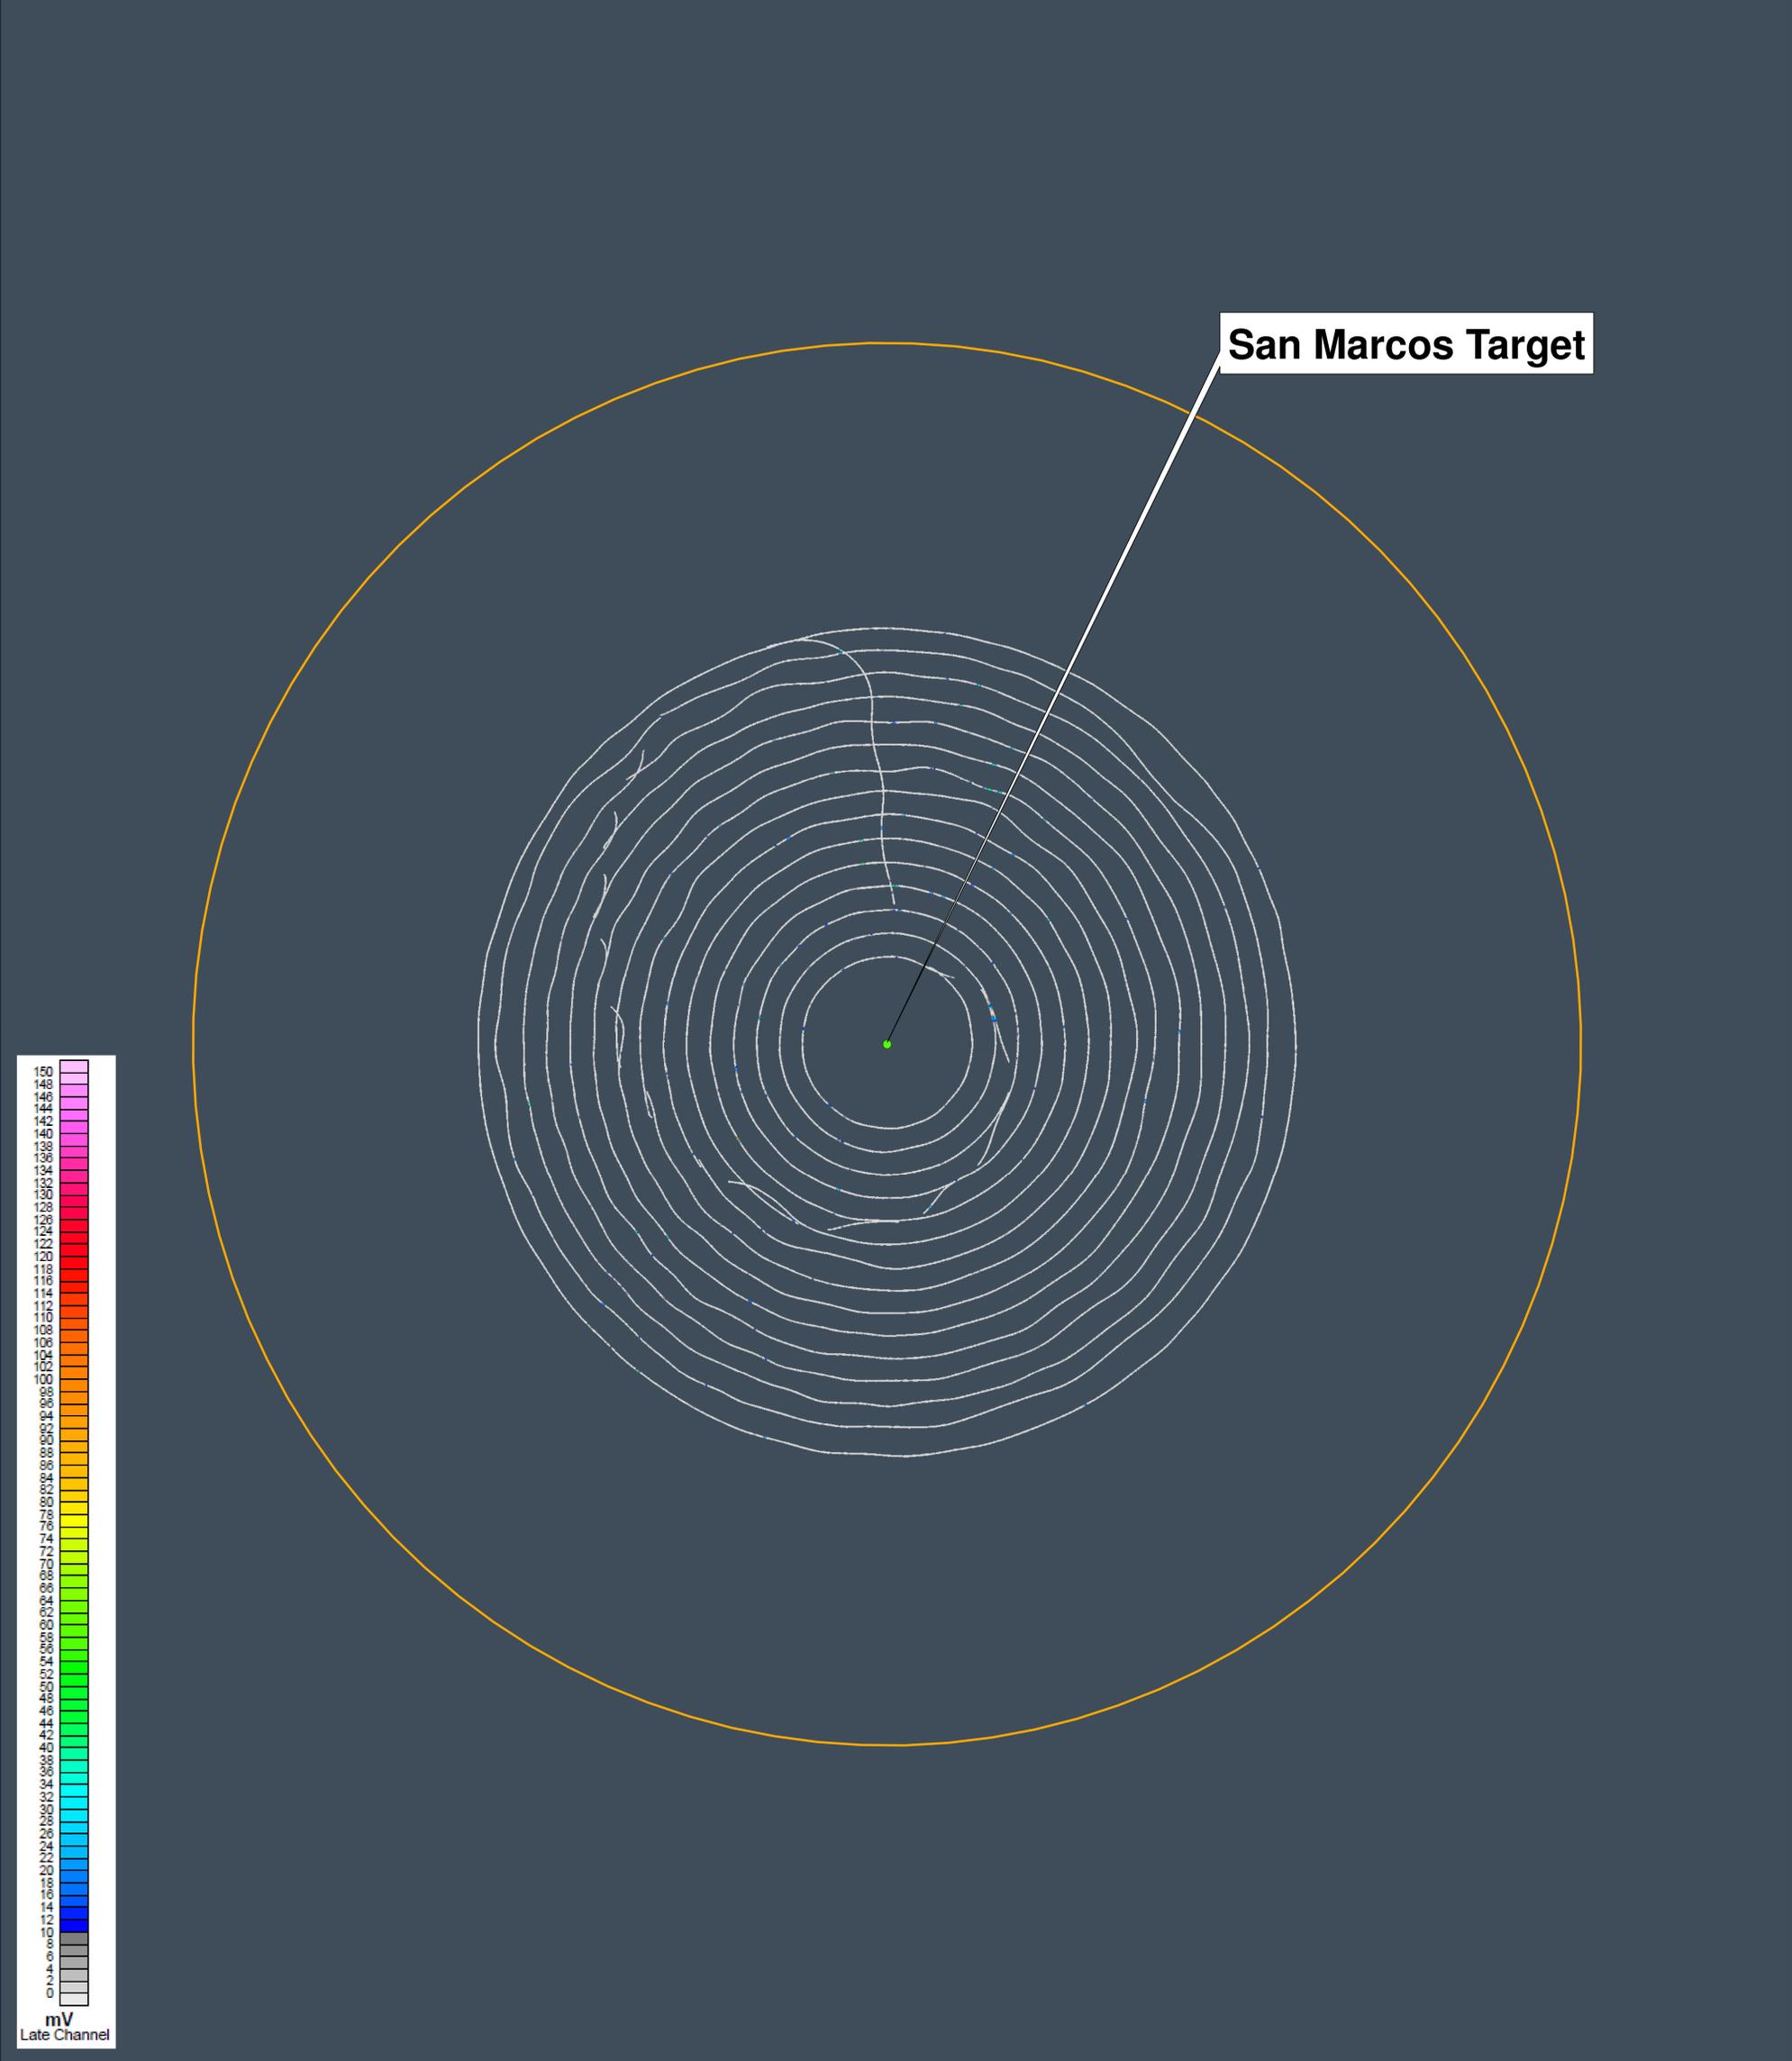
Figure 5-5
San Marcos Target Field Data
NAS Oceana
Virginia Beach, Virginia

- The DGM survey from 500 to 1,000 yards at the San Marcos Target could not be conducted as originally detailed in the Work Plan. As a result of poor weather, adverse sea conditions, and limited anomalies detected from the inner transects, the Navy, CH2M HILL and NAEVA determined that adequate data had been collected and data collection from the outer transects at the San Marcos Target would not be performed.

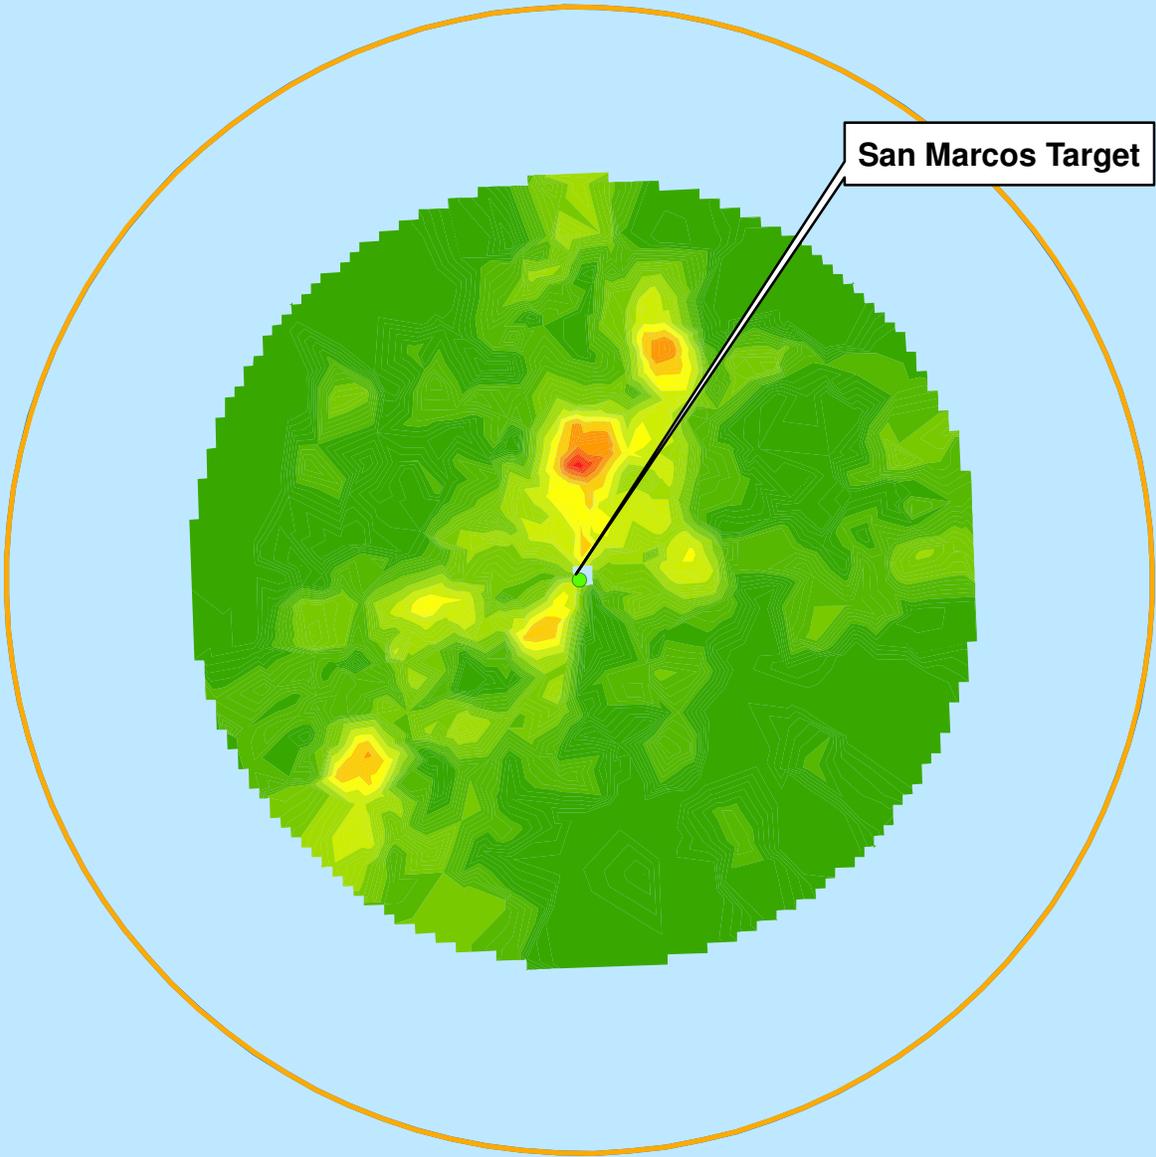
Figure 5-6
San Marcos Target
Anomaly Density Map
NAS Oceana
Virginia Beach, Virginia

Investigation Area	Anomalies Per Acre	26 - 30
Target Location	0 - 5	31 - 35
	6 - 10	36 - 40
	11 - 15	41 - 45
	16 - 20	46 - 50
	21 - 25	51 - 54

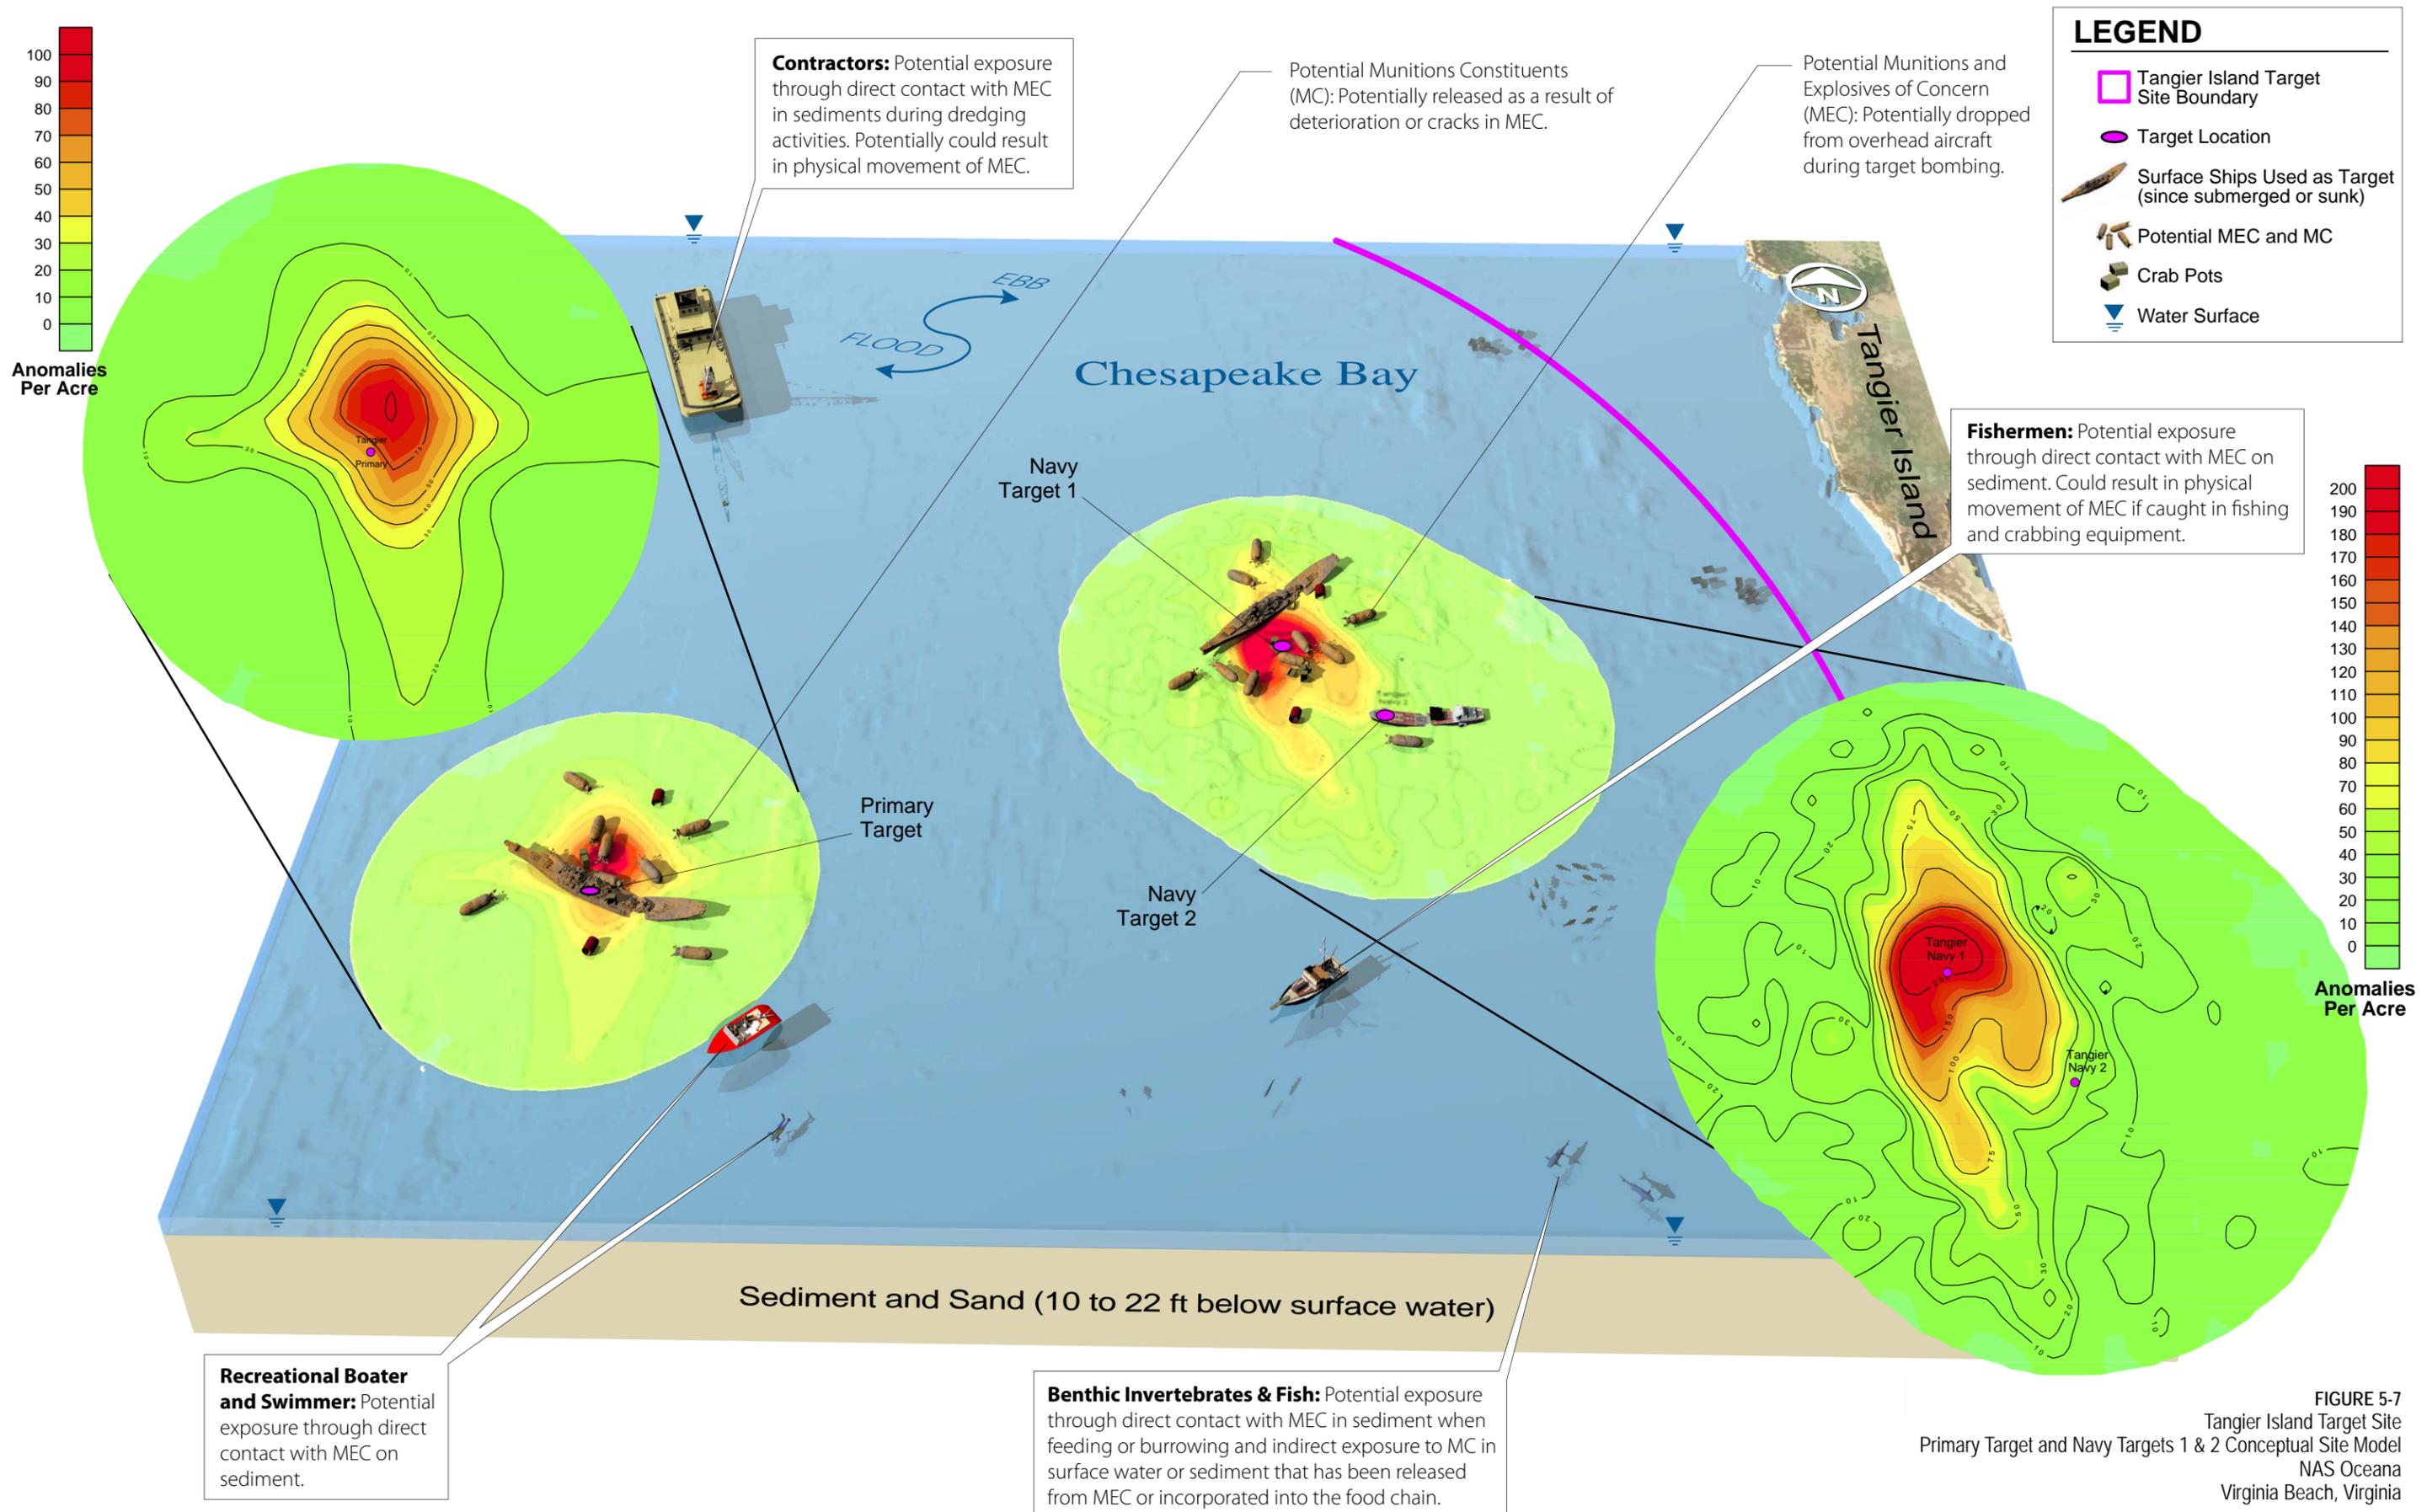
FIGURE 5-7
Tangier Island Target Site
Primary Target and Navy Targets 1 & 2 Conceptual Site Model
NAS Oceana
Virginia Beach, Virginia

The data presented in the previous sections, along with the results of the SI, were used to update the conceptual site model (CSM) profile presented in the PA Report and to develop a graphical CSM. The CSM is a useful engineering management tool that helps to manage site information and guide decision making throughout the environmental restoration process. CSMs are used to scope investigations, support potential risk management decisions, and aid in defining the effectiveness of potential remedial alternatives. Each CSM summarizes the site conditions, the distribution of potential MEC and MC, potential receptors and exposure pathways, and land use data for the site.

exposure pathways include direct contact with MEC during commercial and recreational activities that could result in unintentional detonation of the item, contact with MC that has leached from MEC into the sediment and surface water, and ingestion of fish, shell fish, and other edible items from the Bay environment. Similarly, marine organisms may be impacted if an item detonates or they are exposed to MC through ingestion of the Bay water and sediment, which can bioaccumulate through the food chain as they are eaten by higher level species feeding in or on the Bay.
