FINAL SITE INSPECTION REPORT MUNITIONS RESPONSE PROGRAM TANGIER ISLAND
TARGET SITE NAS OCEANA VA
02/01/2011
CH2M HILL

Final
Site Inspection Report
Munitions Response Program
Tangier Island Target Site, Virginia
Naval Air Station Oceana
Virginia Beach, Virginia

**Site Inspection Report
Munitions Response Program
Tangier Island Target Site, Virginia**

**Naval Air Station Oceana
Virginia Beach, Virginia**

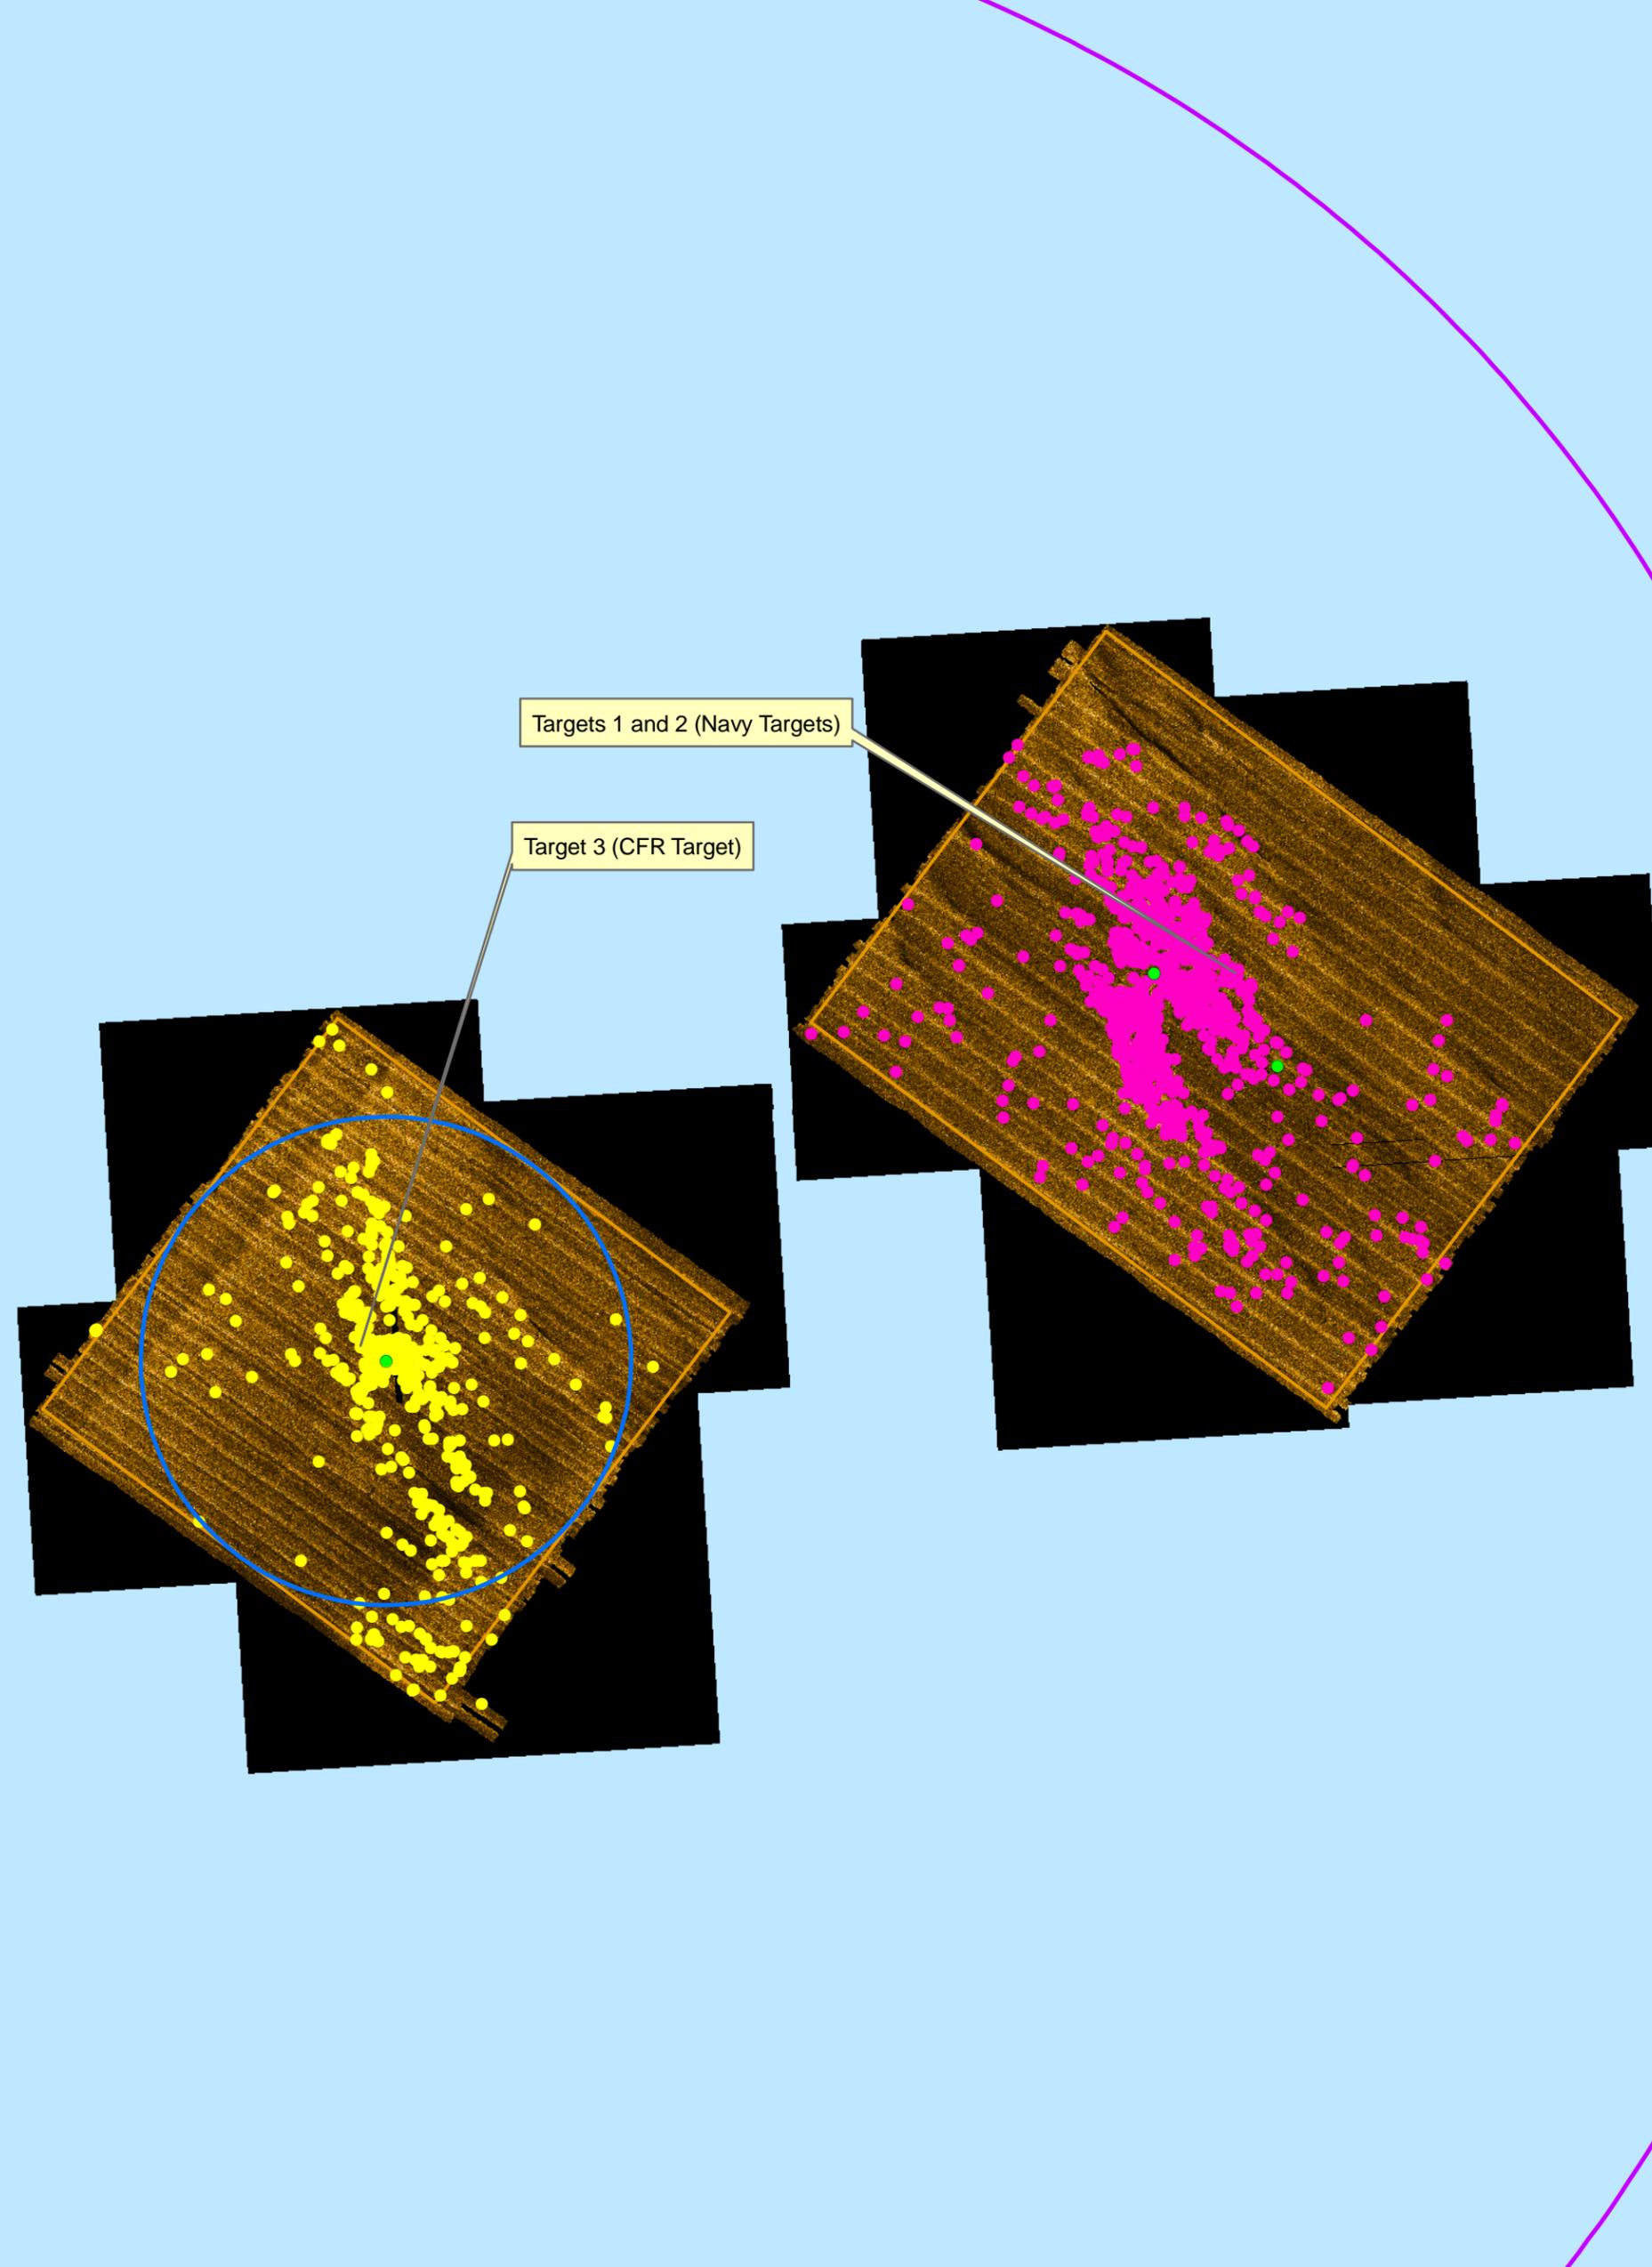
Figure 3
Tangier Island Side-Scan Sonar Area
with Contacts
Tangier Island Target Site
NAS Oceana
Virginia Beach, Virginia

There are a significant number of contacts that were identified in the vicinity of each of the identified hard targets. The pattern of the majority of contacts identified around the targets indicate that, if they are related to the bombing range activities, the bombers flew primarily in a north-south orientation, which is perpendicular to the east-west alignment of the targets. Based on the results of the investigation, these targets are considered navigational hazards to vessels that have impaired or lacking navigational skills or tools. While the two larger targets (the CFR Target and Navy Target West), are still exposed at the surface in a few places, they are difficult to see and could be easily missed, especially in bad weather. All three targets, as well as the San Marcos wreck to the south, will be included in the upcoming DGM investigation.

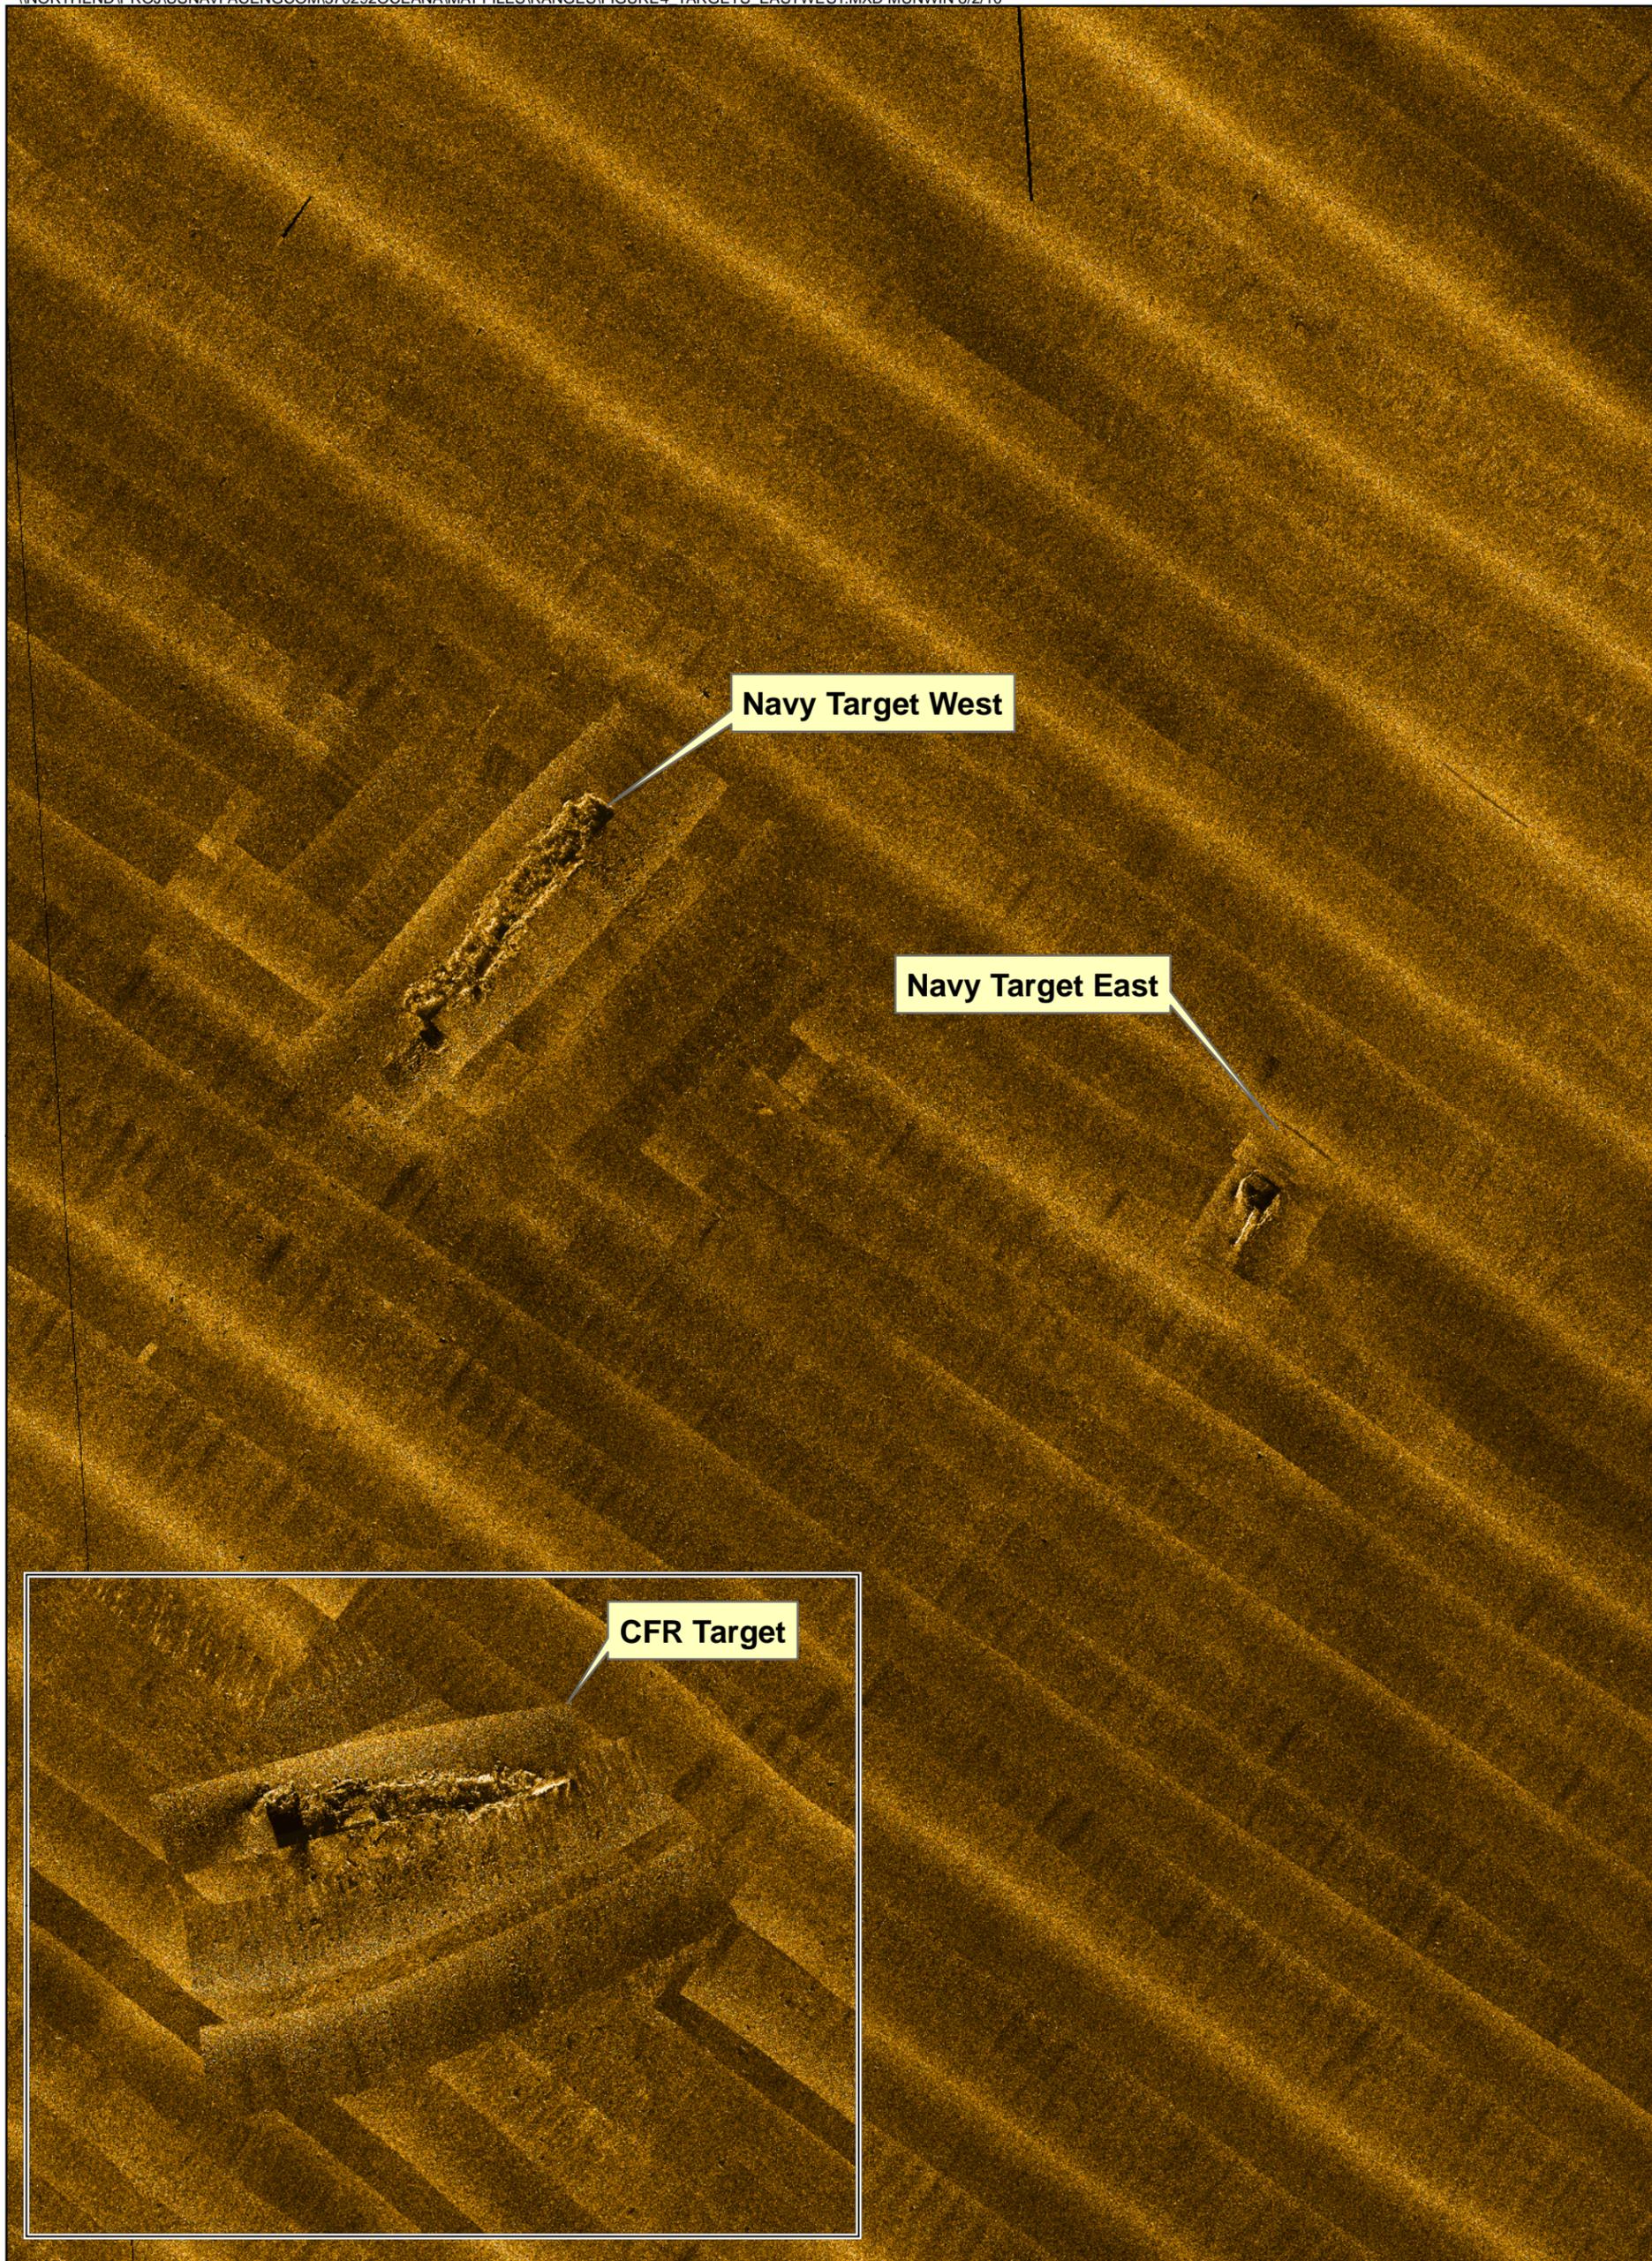
Side-scan sonar imagery and data collected during the site investigation has been used to identify hard target locations and potential obstructions that may interfere with future DGM operations. Objects detected that were larger than 24-inches cubed were identified as contacts (**Figure 3**). Three known potential hard target locations were investigated, including the two “Navy Targets” and CFR identified target (**Figure 4**). The coordinates, dimensions, and descriptions are listed below and summarized in **Table 1**.

The side-scan activities included 200 percent bottom coverage of the identified areas of concern (1,920 acres). Objects identified as equal as or greater than the size of a crab pot (assumed dimensions of 24 inches cubed) were considered a contact. In summary, 528 contacts were identified in the vicinity of the Navy Targets (Target Area 2), while 1,099 contacts were identified in the vicinity of the CFR cited target (Target Area 1). The side-scan sonar imagery of the contacts identified in Target Areas 1 and 2 is presented in **Figure 3**. The majority of contacts are believed to show evidence that they are related to the bombing range due to the north and south patterns concentrated throughout the wreck sites.

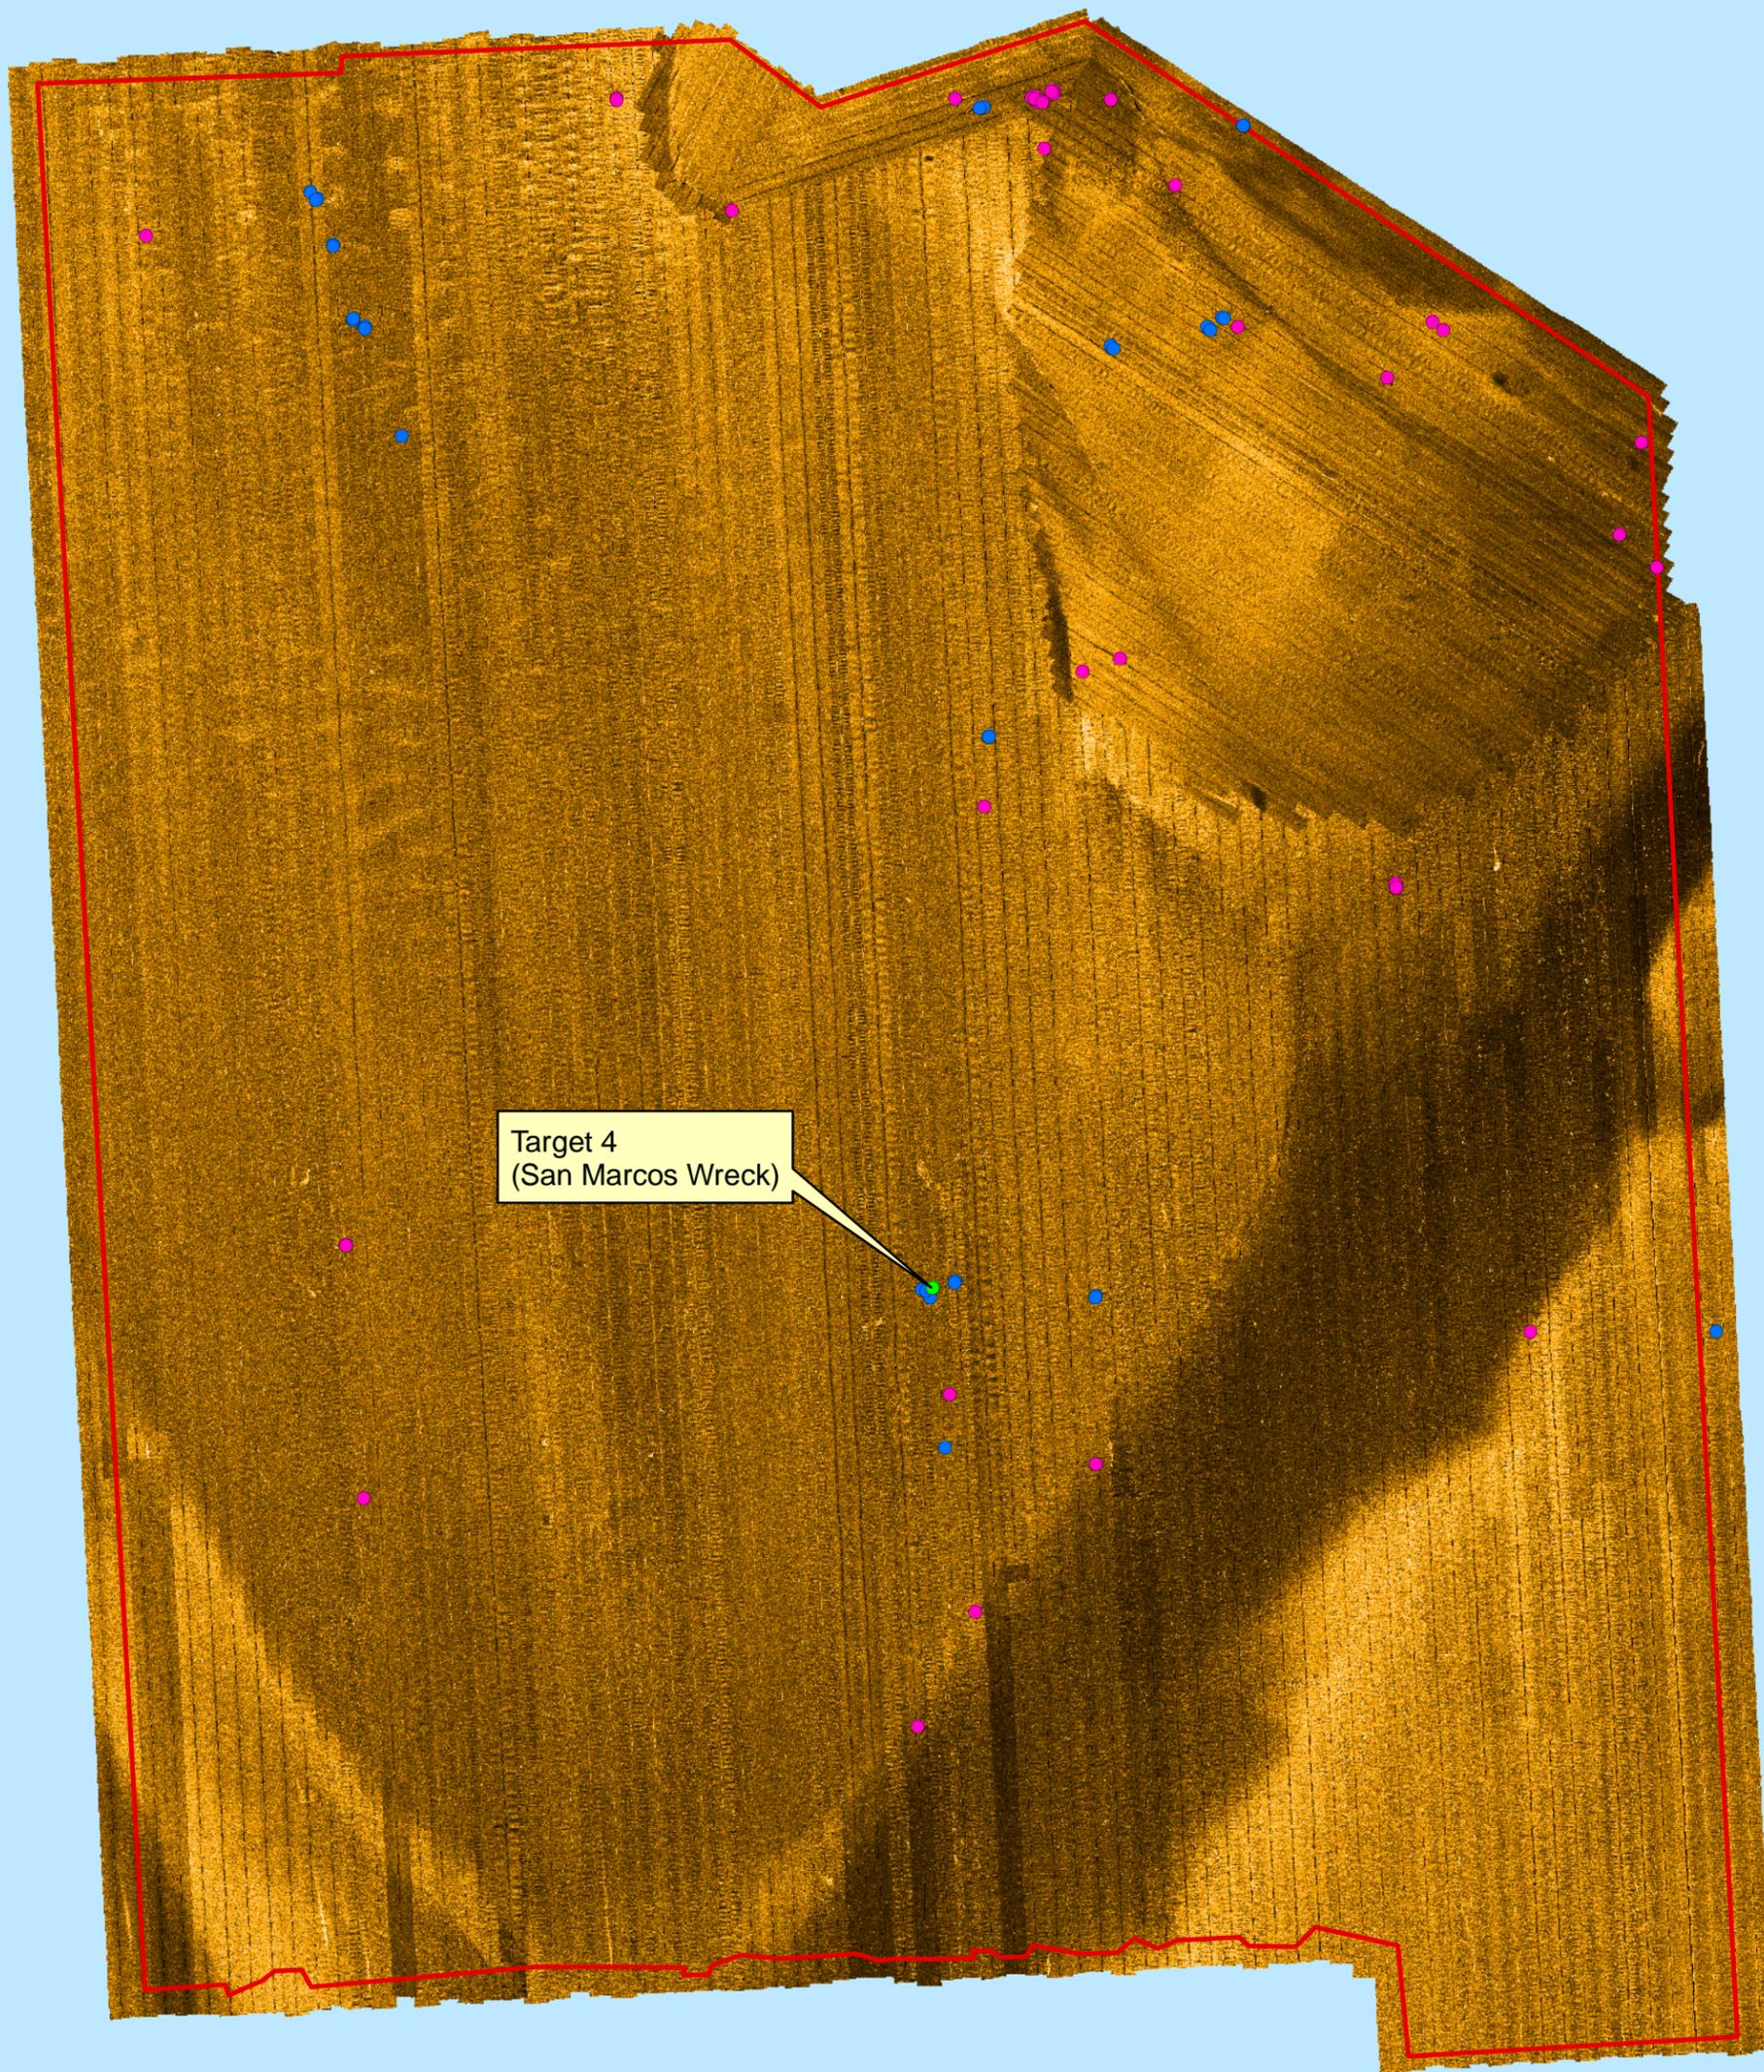
Figure 8
NOAA Side-Scan Sonar Area Contacts
Tangier Island Target Site
NAS Oceana
Virginia Beach, Virginia

It was noted during the side-scan investigation of the CFR target that additional contacts were identified further south outside the Primary Target 1 search box. Some of these contacts are also identified in the NOAA reports as shown in **Figure 8**.

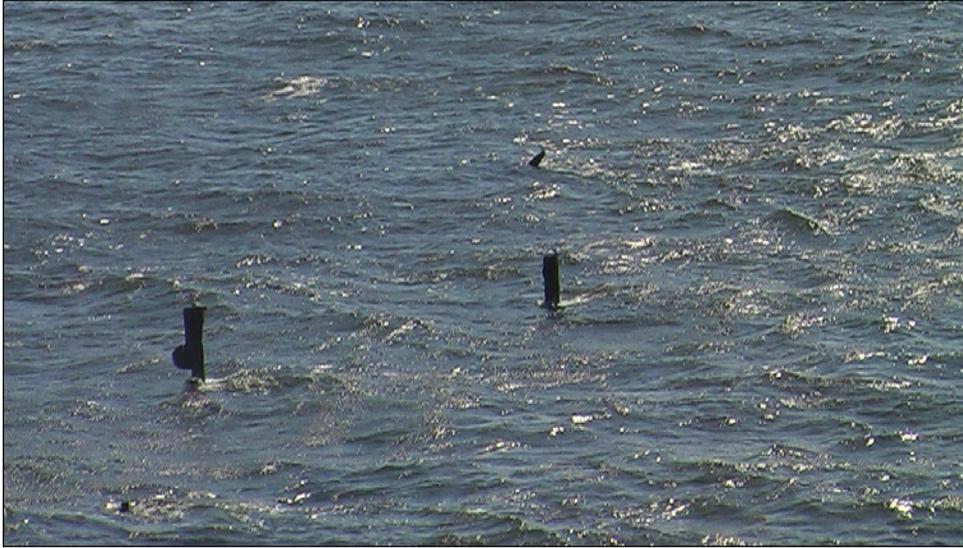
PHOTOGRAPH 1

Target Remnants, Helicopter Tour May 12, 2009

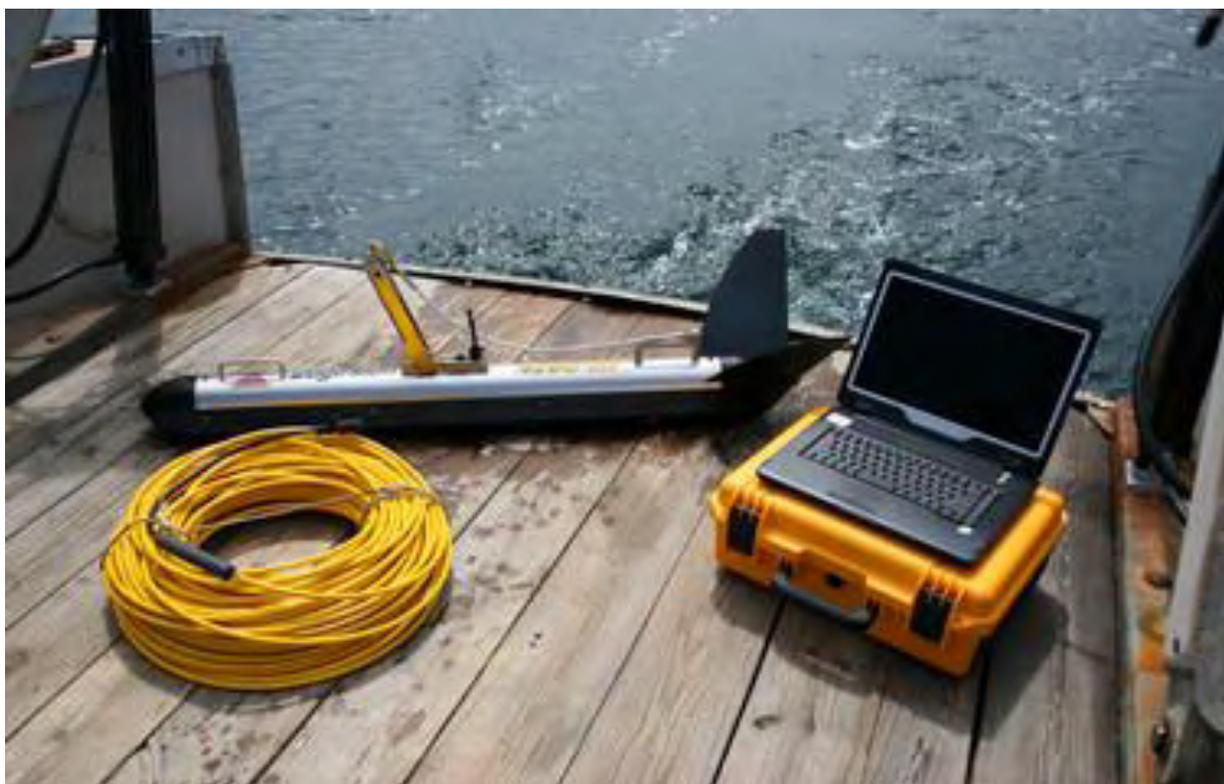
EdgeTech 4200-FS Side-Scan Sonar System

The Side-Scan Sonar System employed on this survey was the EdgeTech 4200-FS digital "chirp" simultaneous dual frequency unit. This unit is the stainless steel model and employs the 300 kHz and 600 kHz frequencies. The survey was conducted using the HDM (High Definition Mode). The brochure for the 4200-FS is included in Attachment E.

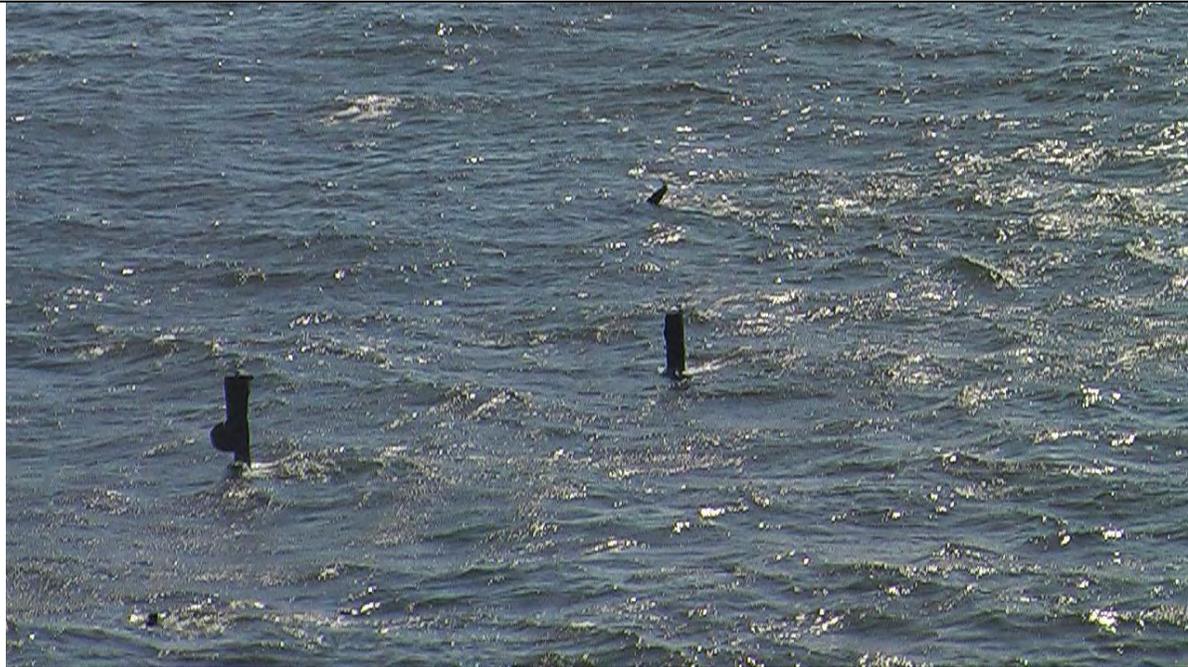
Photograph 1 - Target Remnants, Helicopter Tour May 12, 2009

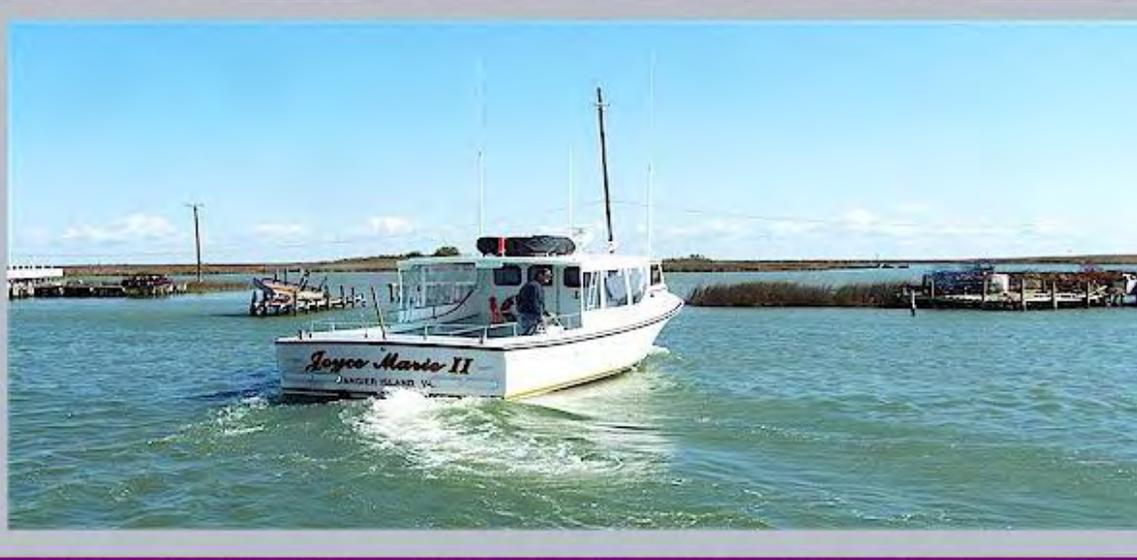
6.1. Attachment A: Vessel Joyce Marie II

**This boat was originally built in Maine in 1988.
A Fiberglass - Lobster Boat, similar to a Chesapeake Bay Deadrise.
36 ' Long with a 4' Draft
Captain and Boat - Coast Guard Certified
25 Passenger Boat**

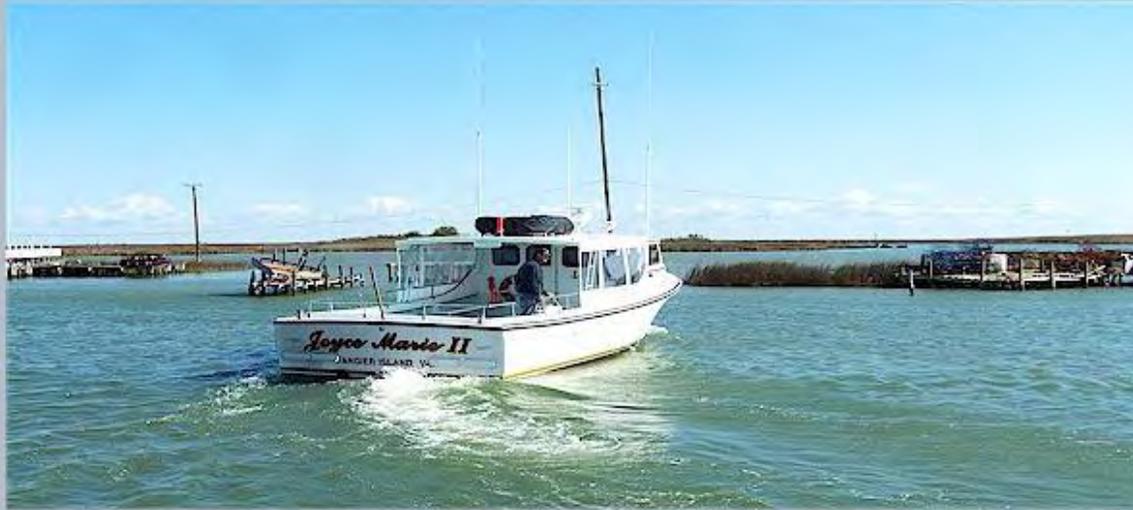
Attachment F: Vessel Joyce Marie II

**This boat was originally built in Maine in 1988.
A Fiberglass - Lobster Boat, similiar to a Chesapeake Bay Deadrise.
36 ' Long with a 4' Draft
Captain and Boat - Coast Guard Certified
25 Passenger Boat**

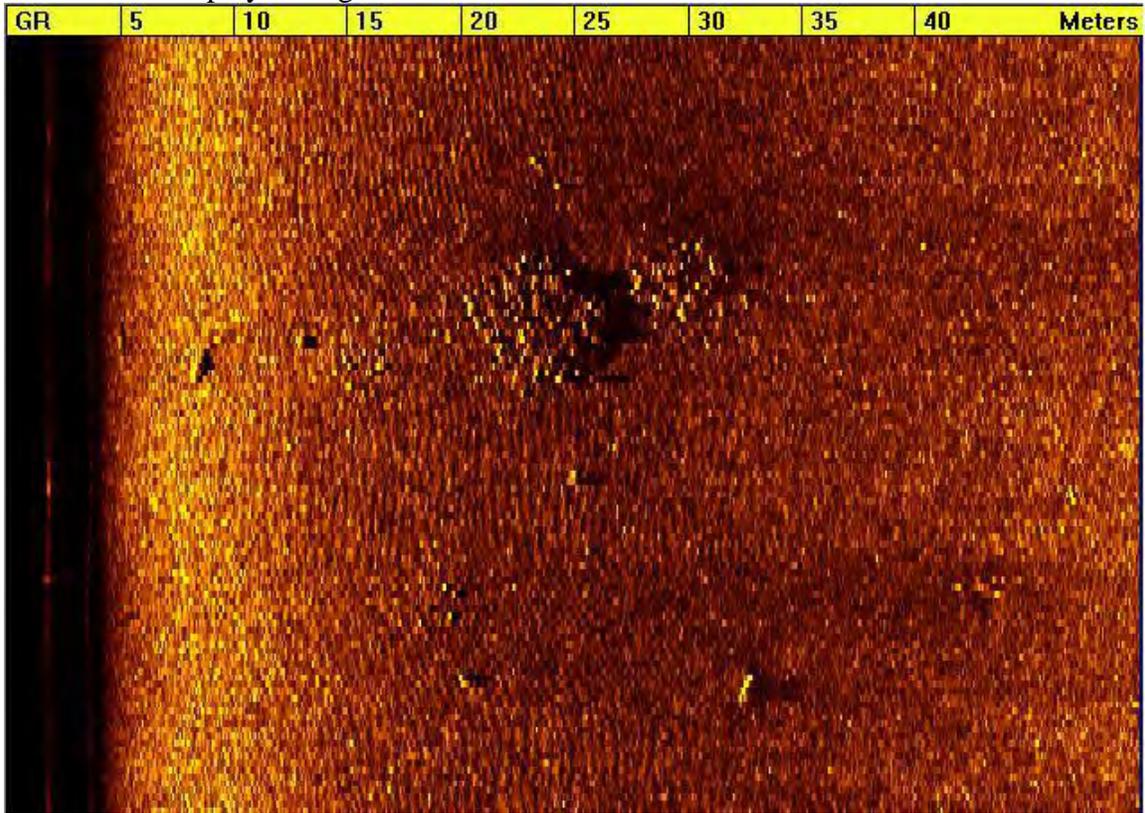
Full channel display of target 1-6.

Target 1-11 is a small target with acoustic shadow marked on the port side of line A1-57SE.

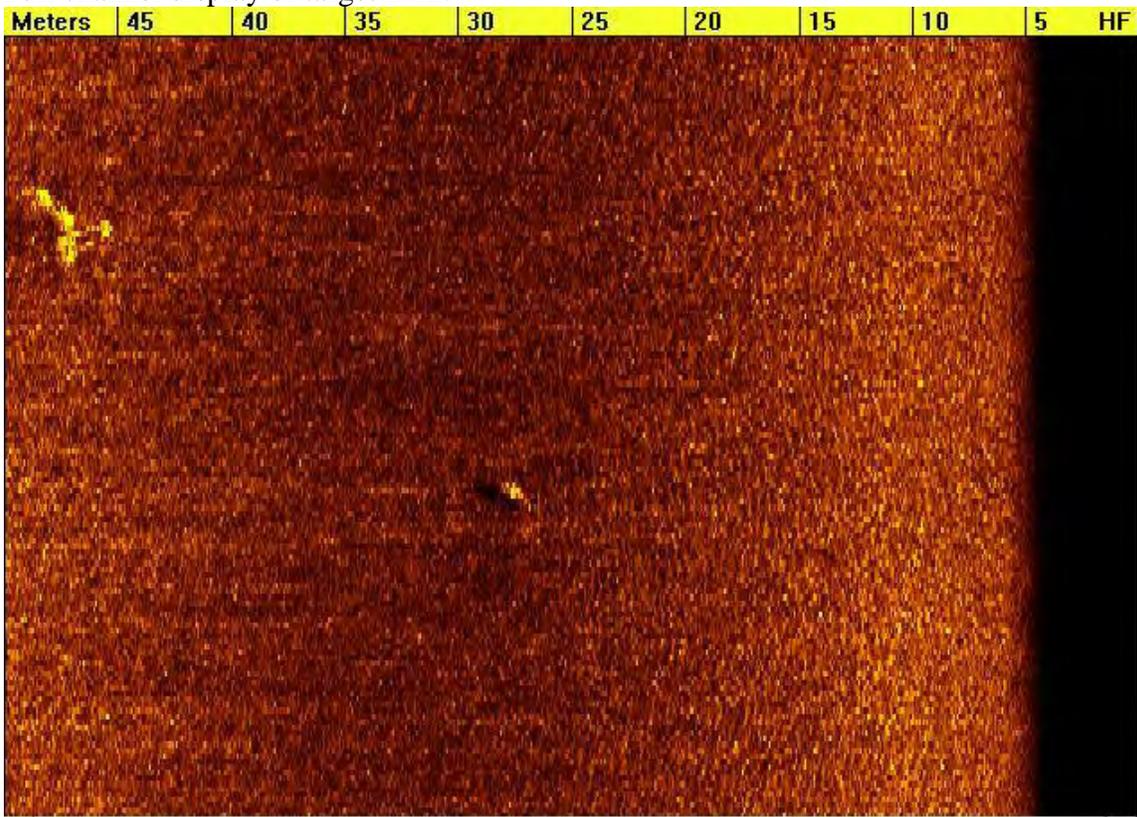
Full channel display of target 1-12.

Target 1-13 is a target with shadow marked on the port side of line A1-1NW.

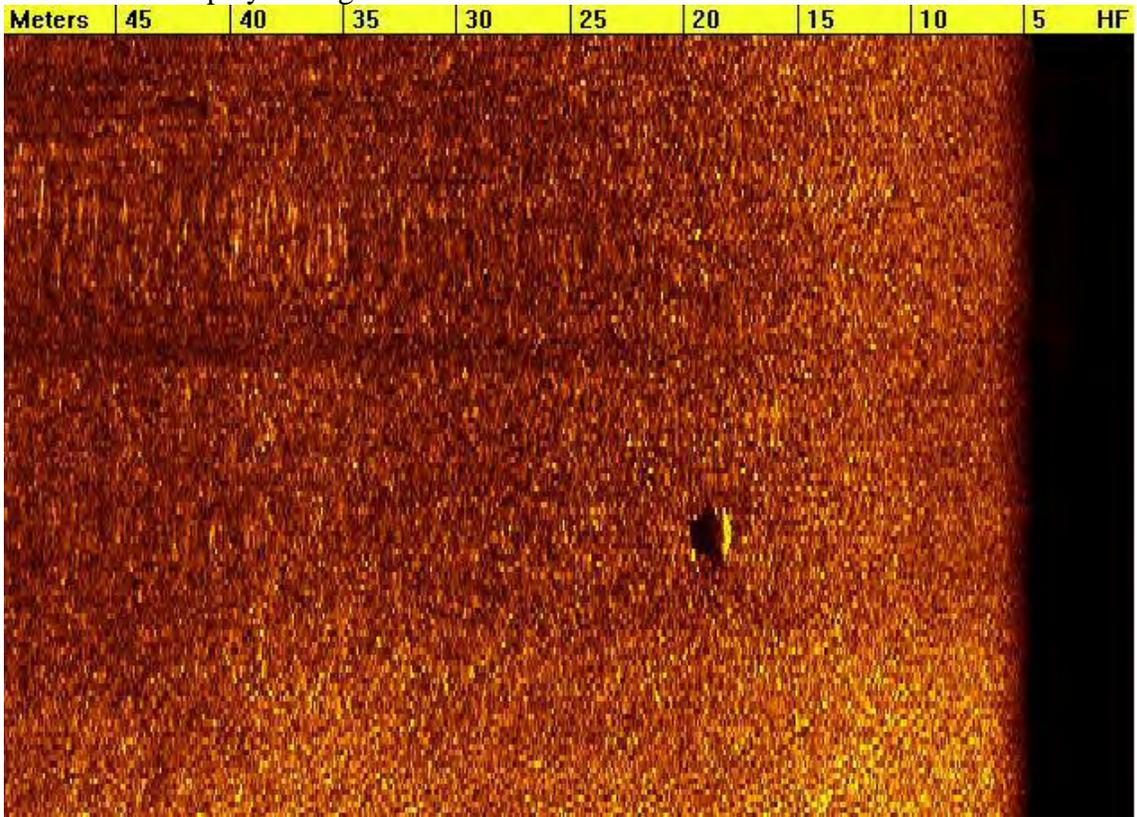
Full channel display of target 1-13.

Target 1-14 is the same target with shadow as Target 1-13 and marked again here on the starboard side of Line A1-2SE.

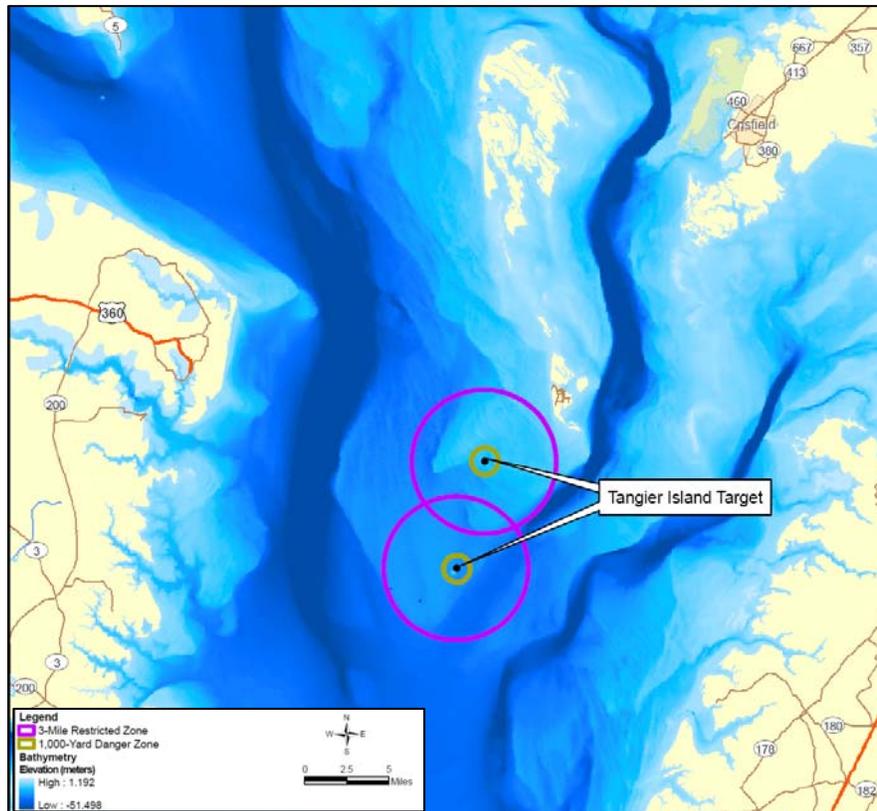
FIGURE 1
Bathymetric Map of the Chesapeake Bay in the Vicinity of the Tangier Island Target

The southern target is consistent with the location of what is identified as the “San Marcos Wreck” on National Oceanic and Atmospheric Administration (NOAA) nautical charts. The coordinates of the southern target are latitude 37° 43' 17"N, longitude 76° 4' 34"W. The locations of the northern and southern targets are shown on Figure 1.

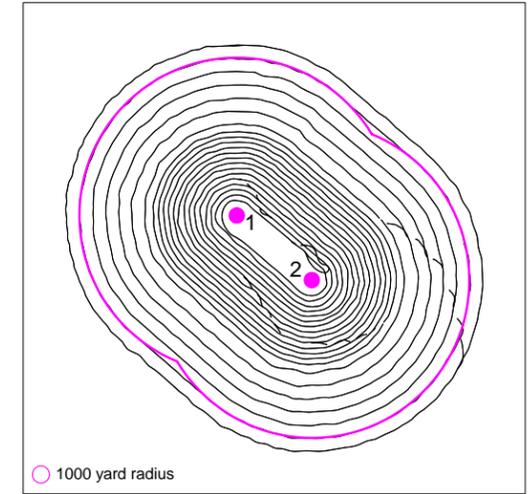
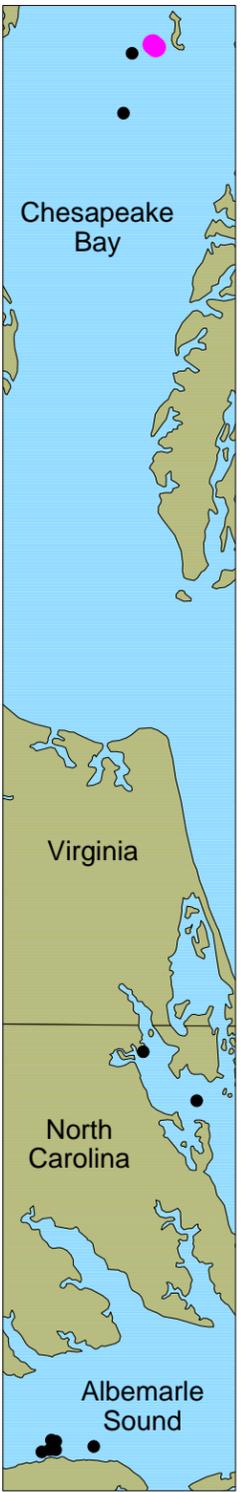
Figure 13

ft, which was greater than the reported depths of 10 to 15 ft (**Figure 13**). The system maintained an average height above seafloor of 2.6 ft.

Client: CH2M HILL
Humminbird 997c SI Combo Bathymetric Mosaic Tangier Primary Target Site Other-Than-Operational Ranges - NAS Oceana Virginia Beach, Virginia
Date of Survey: 09/13/2010 - 09/23/2010 Date of Map Creation: 09/27/2010
Map Approver: J. Guillard
