SEDIMENT SAMPLING AND ANALYSIS SUMMARY REPORT FOR SITE 3 CAUSEWAY  
LANDFILL SEDIMENT AREA 4 MCRD PARRIS ISLAND SC

5/1/2003  
TECHLAW

## **SEDIMENT SAMPLING AND ANALYSIS SUMMARY REPORT SITE 3, SEDIMENT AREA 4, MCRD PARRIS ISLAND**

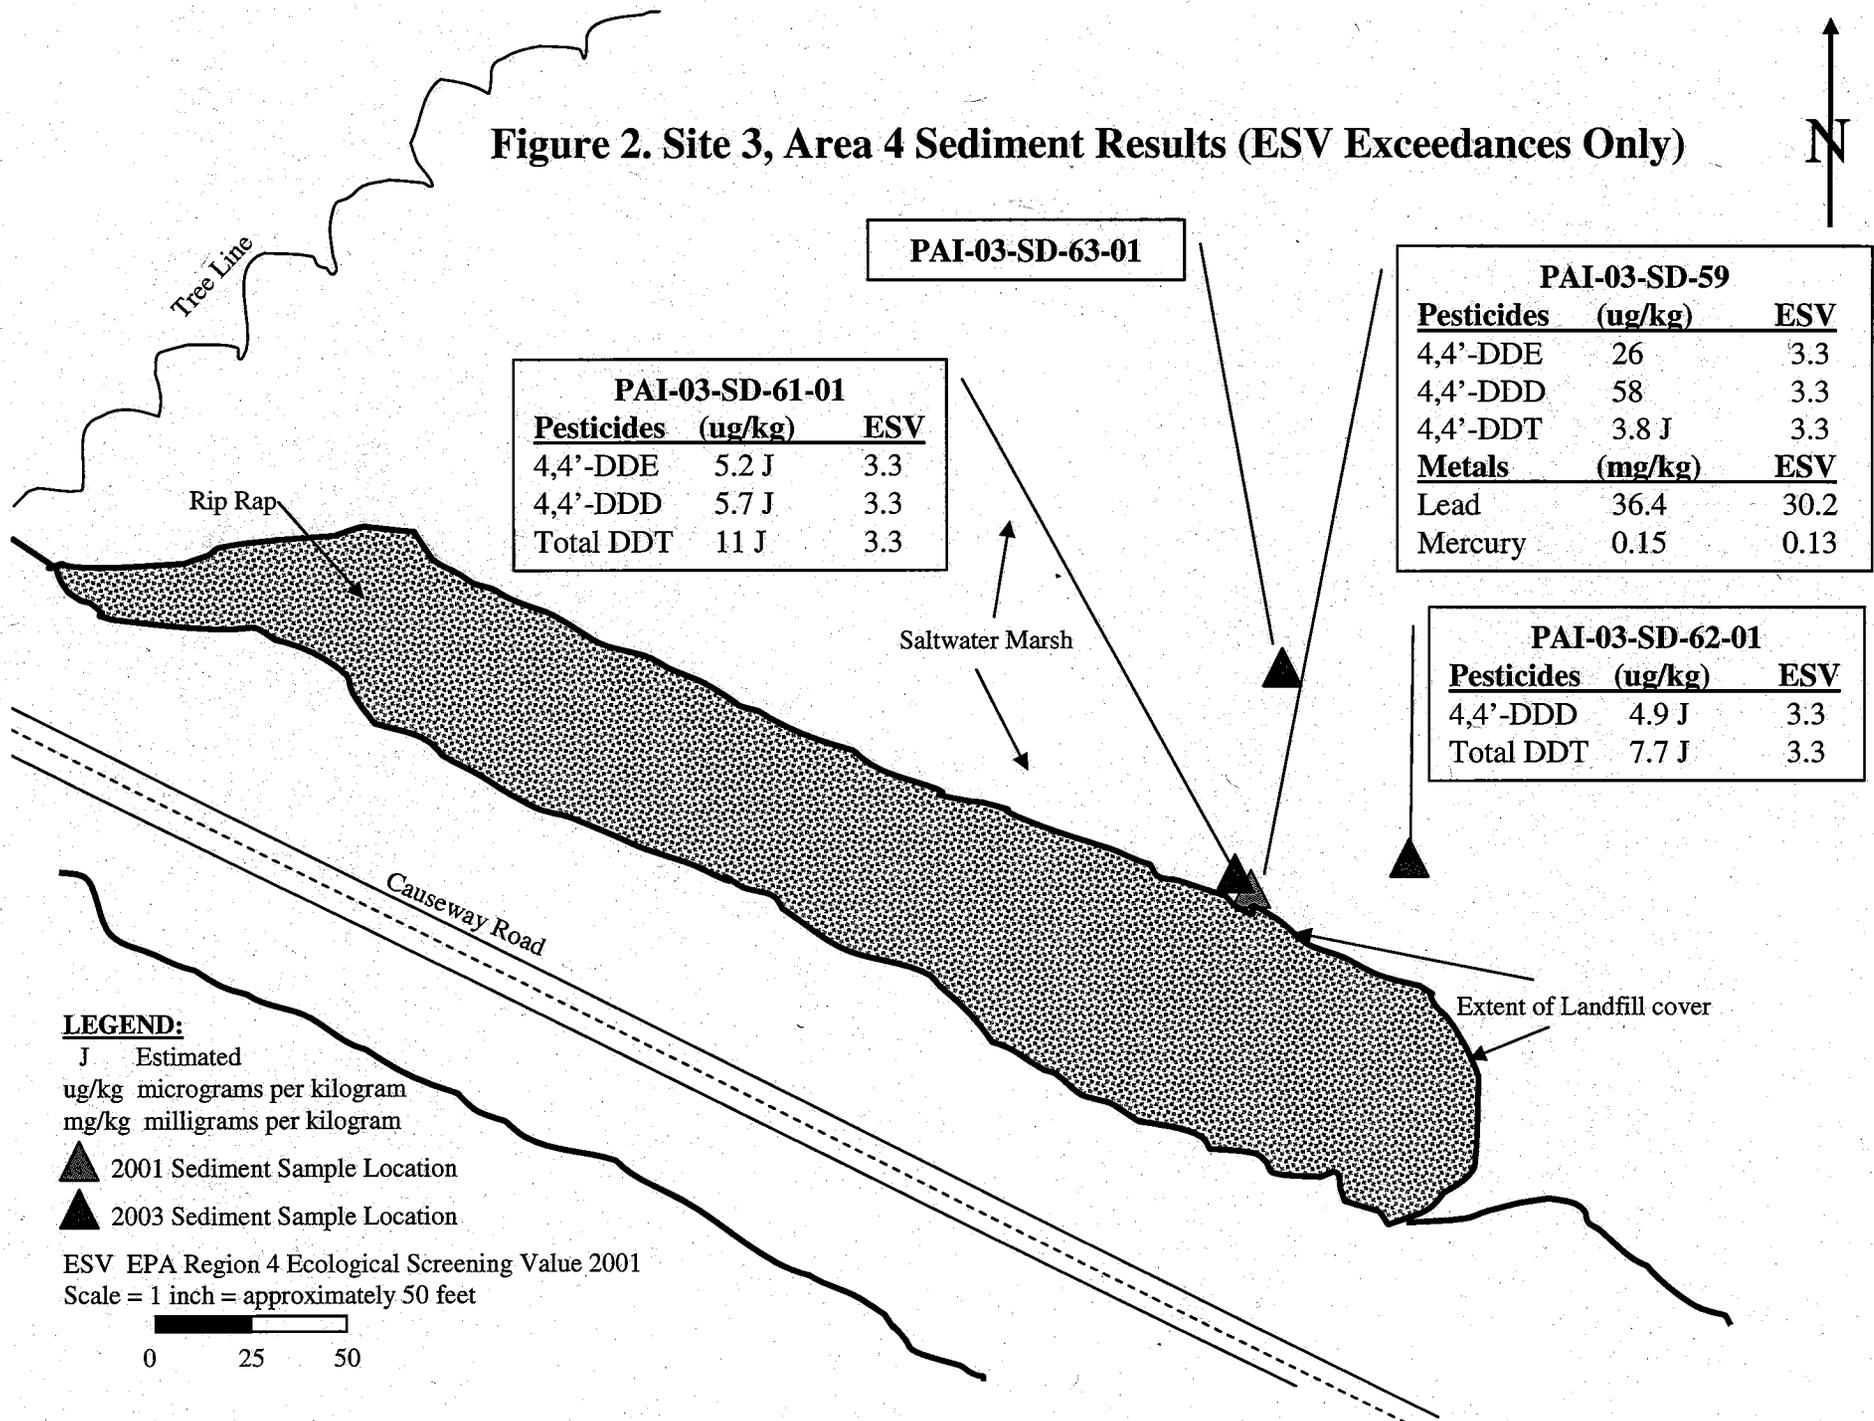
**Figure 2. Site 3, Area 4 Sediment Results (ESV Exceedances Only)**

Three (3) samples were collected within tidal rivulets located in the marsh on the pond side of Site 3, Sediment Area 4. The first sample designated PAI-03-SD-61-01 was co-located with sample PAI-03-SD-59. The second sample designated PAI-03-SD-62-01 was collected at a location approximately 47.8-ft due east of the first sample location. The third sample designated PAI-03-SD-63-01 was located approximately North 25-degrees East and 59-ft from the first sample location. The sediment sample locations are shown in Figure 2, attached.

Analytical test results indicate that samples PAI-03-SD-61-01 and PAI-03-SD-62-01 were in excess of EPA Region 4 Sediment Ecological Screening Values (ESVs) for the pesticides DDE, DDD and Total DDT residues. Sample PAI-03-SD-63-01, which is located approximately 59-ft northeast of the rip-rap bank, measured below sediment ESVs for DDE, DDD and Total DDT residues. Mercury, lead and arsenic analysis of the three sediment samples indicates no exceedances above applicable sediment ESVs. A Sediment Results Summary is presented in Table 2, attached.
