RESTORATION ADVISORY BOARD (RAB) MEETING MINUTES AND AGENDA 6
DECEMBER 2011 NSY PORTSMOUTH ME
12/6/2011
RESTORATION ADVISORY BOARD (RAB)

**RESTORATION ADVISORY BOARD MEETING
PORTSMOUTH NAVAL SHIPYARD
KITTERY TOWN HALL, KITTERY, MAINE
December 6, 2011**

Site 30, Former Galvanizing Tank Vault Construction Completion Update

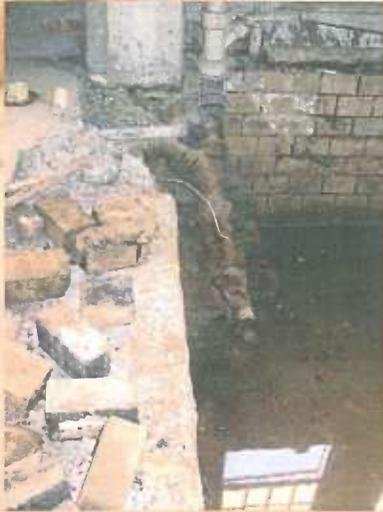
Existing piping from bathroom tied into floor drain in tank vault via cast iron pipe. Drain was functioning correctly at time of removal, and was sealed during demolition activities.

Floor drain connection and remaining cast iron piping

- Asbestos Removal-
 - Mill City Environmental, Inc – Mobilized to site on 30 August, 2011;
 - Removed floor tile and mastic on 30 August and 31 August, 2011;
 - Received Certification of Clean, and Clearance for Occupancy from 3rd Party Certified Industrial Hygienist on 31 August, 2011.
- Office Demolition-
 - Removed Electrical and Mechanical connections to office structure;
 - Removed office;
 - Disposed of materials as construction debris.
- Bathroom Demolition-
 - Removed existing bathroom in Northeast Corner of Tank Vault;
 - Drain piping was plumbed into drain within tank vault area.

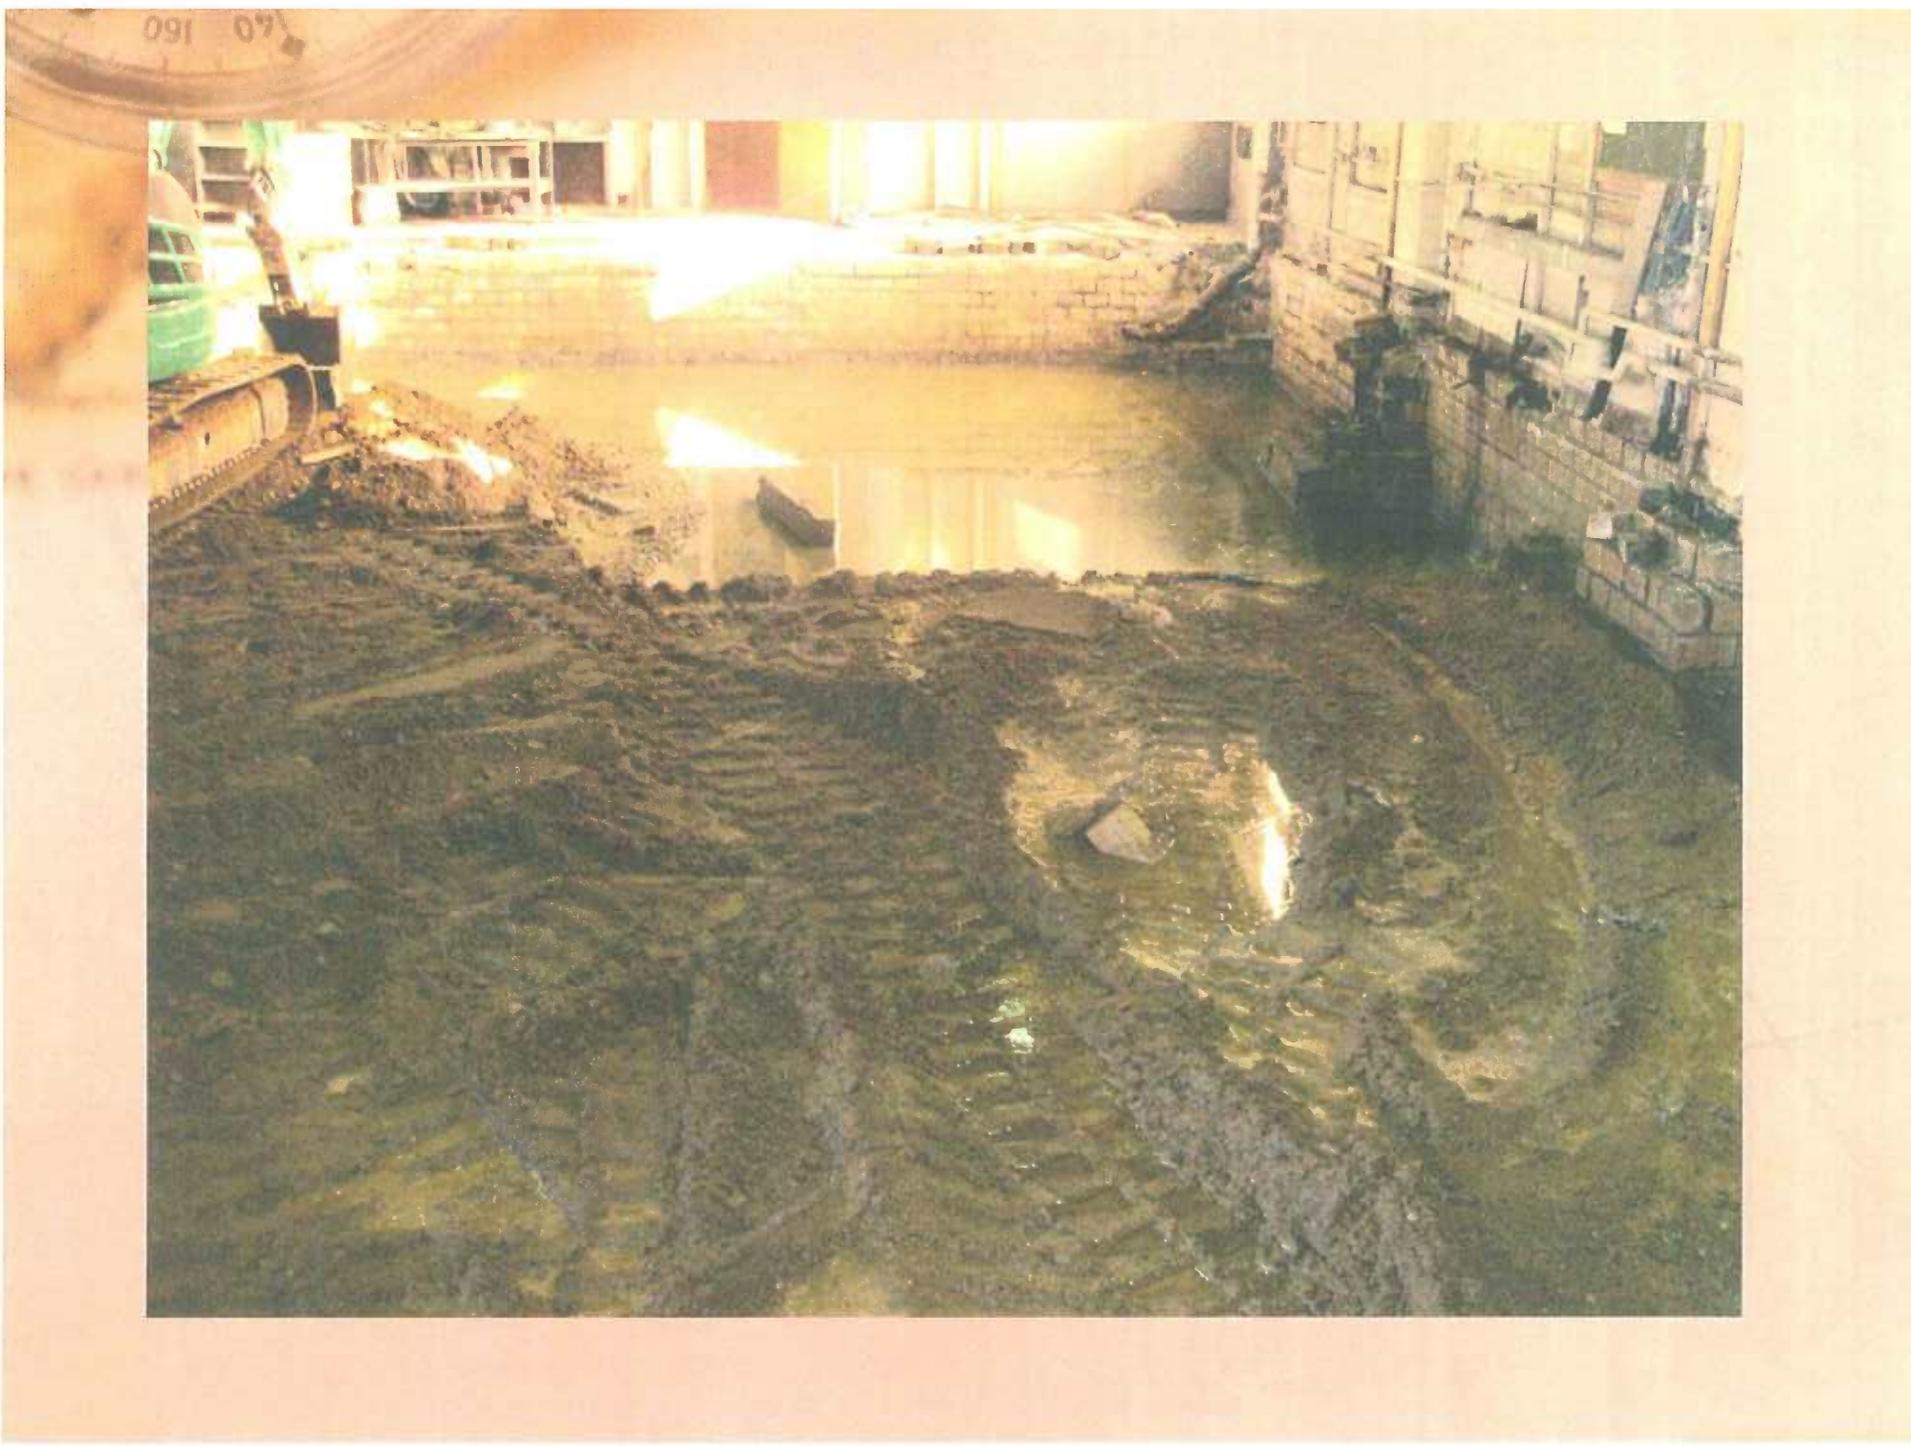
091 09

Excavation

- Material Excavated consisted of fine and coarse sands and silt.
- Material exhibited no visible staining, odors, or other sensory indications of contamination.
- Miscellaneous Acid Bricks located within the excavation were segregated and placed within a separate lined stockpile at the former DRMO Storage Yard.
- Soil was transported to the DRMO Storage Yard utilizing a covered wheeled loader bucket. Soil was placed in a lined cell.
- 150 Cubic Yards of Soil were excavated
- Minimal amounts of water were recovered from excavation
 - Approximately 500 Gallons recovered and disposed of by PNS Hazardous Waste Facility (Building 357)
 - Source of water appears to be surficial run-on

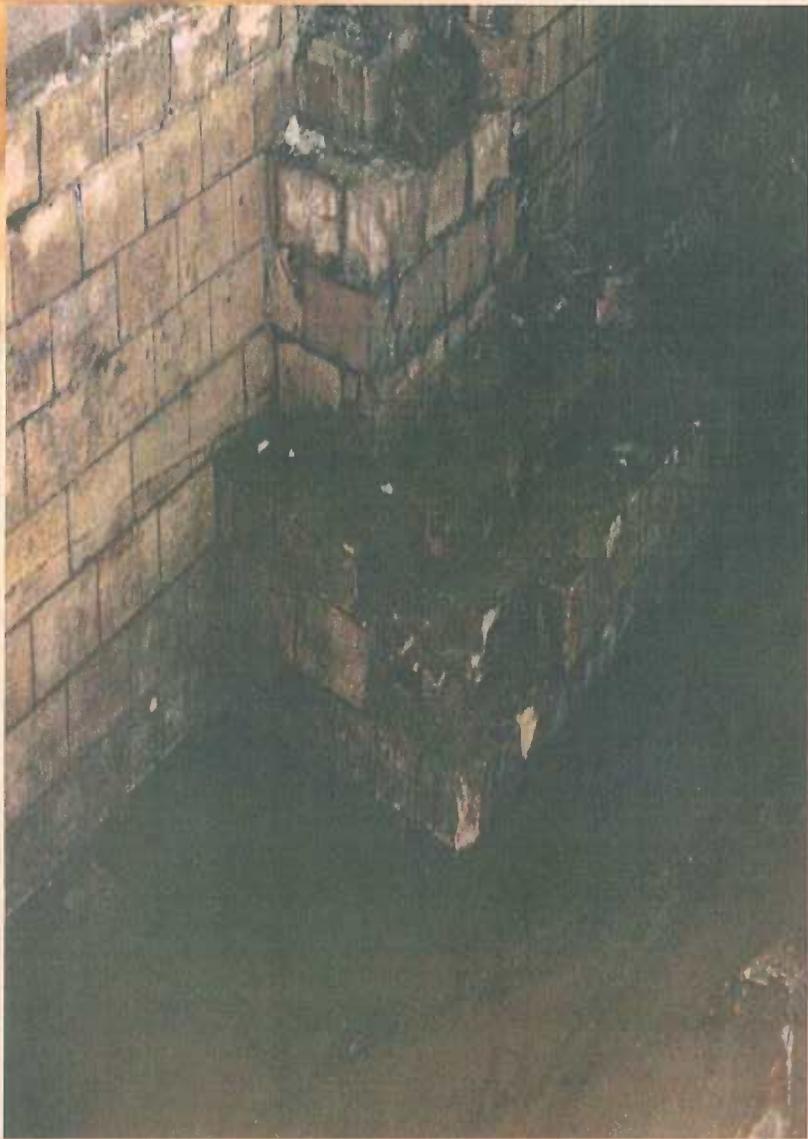
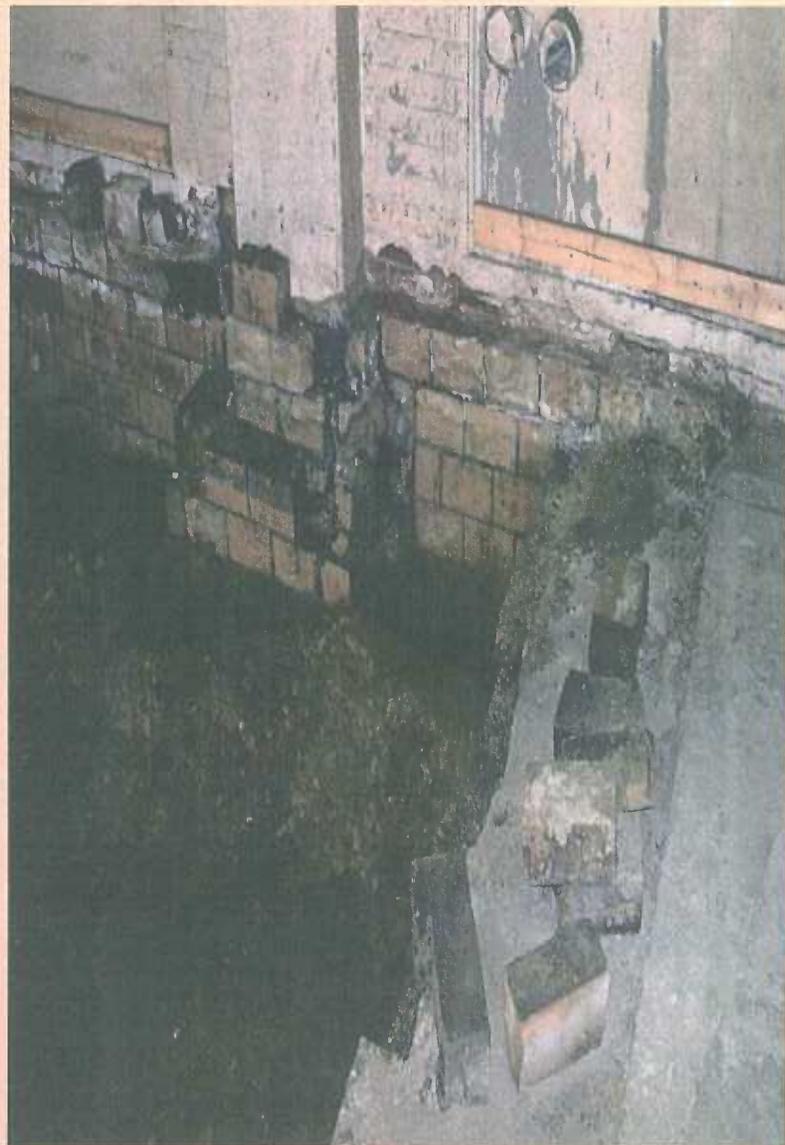
Tank Vault Acid Brick Liner Inspection, Wall Washing

- Acid Brick Lining Material was cleaned utilizing push brooms and low pressure water streams.
- Water was captured and containerized for disposal.
- Vault was air dried utilizing industrial fans.
- No visible staining was evident on the acid bricks.
- No penetrations or visible pathways to the underlying concrete vault were evident.

acid brick lining of the tank vault was cleaned with push brooms and low pressure water streams. No staining was evident on the bricks lining the vault and no penetrations or visible pathways to the underlying concrete vault were found. PNS is performing a historical recordation of Building 184 including pictures taken in accordance with the National Historic Register Photo Policy Factsheet and Maine State Historic Preservation Office (SHPO) Guidelines.
