MINUTES AND AGENDA REGARDING THE FINAL JUNE 2015 RESTORATION ADVISORY
BOARD (RAB) MEETING HELD ON 16 JUNE 2015 AT KITTELY TOWN HALL NSY
PORTSMOUTH ME (PUBLIC DOCUMENT)
06/16/2015
RESOLUTION CONSULTANTS

**Portsmouth Naval Shipyard
Restoration Advisory Board Meeting
Kittery Town Hall, Kittery, Maine
June 16, 2015**

**Operable Unit (OU) #4
Status Update
Portsmouth Naval Shipyard
Restoration Advisory Board
June 16, 2015**

**Operable Unit (OU) #7
Site 32
Status Update
Portsmouth Naval Shipyard
Restoration Advisory Board
June 16, 2014**

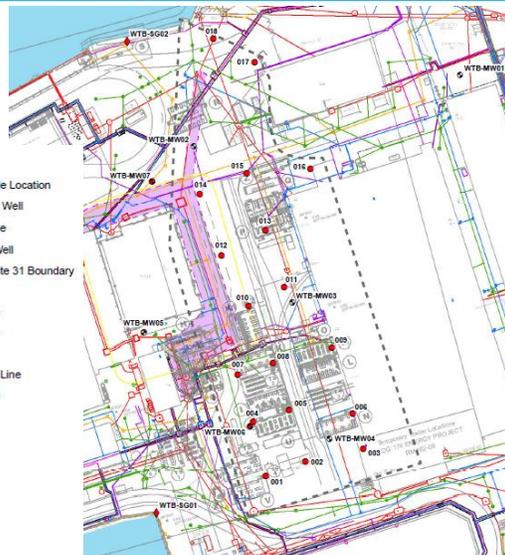
OPERABLE UNIT 8
Site 31 (Former West Timber Basin)

• Remedial Investigation

- OU8 (Site 31) Former West Timber Basin: OU8 is currently in the Remedial Investigation (RI) phase. The Sampling and Analysis Plan (SAP) was finalized in May 2015. RI activities were completed in early June 2015, which included soil sampling, groundwater monitoring well installation, and groundwater sampling. The Draft Remedial Investigation Report will be submitted Fall 2015, and results of the sampling at OU8 can be presented at the next RAB meeting. This area is within the Controlled Industrial Area (CIA), and the entire site is covered in asphalt, concrete, or buildings. The soils below OU8 are comprised of mostly fill material that was placed in the early 1900s. An earlier Site Screening Investigation indicated limited lead and polycyclic aromatic hydrocarbon (PAH) impacts in the fill that are generally shallow in depth. An old quay wall is located in this area that may serve as a boundary between impacted fill material and clean material based on the preliminary analytical results and historical records. Some of the contaminated fill material was removed during construction of a utility trench across the area. OU8 is the last site to be investigated at PNSY under CERCLA. Once a remedy is in place at OU8, the Navy can move forward with having the Shipyard delisted from the National Priorities List (NPL).

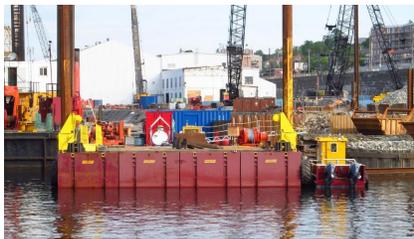
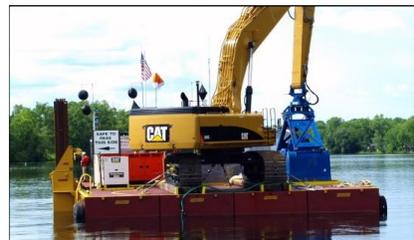
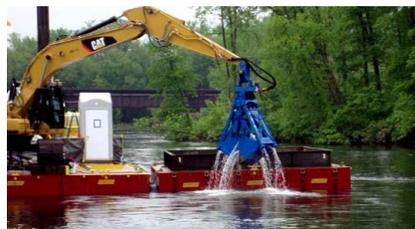
Dredging Assembly

Dredging at OU4 began on December 20, 2015 and continued through April 20, 2015. An overview was presented on the equipment set-up for dredging submerged sediment, including a constructed barge with a mounted excavator, a barge to transport dredged sediment that used jersey barriers and filter fabric to keep sediment in and allow water to drain out, and spud posts that extend into the sediment to keep the barges in place. GPS technology mounted to the dredge bucket was used to ensure accuracy of the vertical and horizontal limits of the dredge areas. Prior to and during dredging activities, water quality buoys surrounding the dredge areas monitored turbidity, temperature and dissolved oxygen. No turbidity issues were observed throughout the duration of the project, with one exception when a turbidity spike was observed as a result of a tug boat that was helping to mobilize the dredge barge.

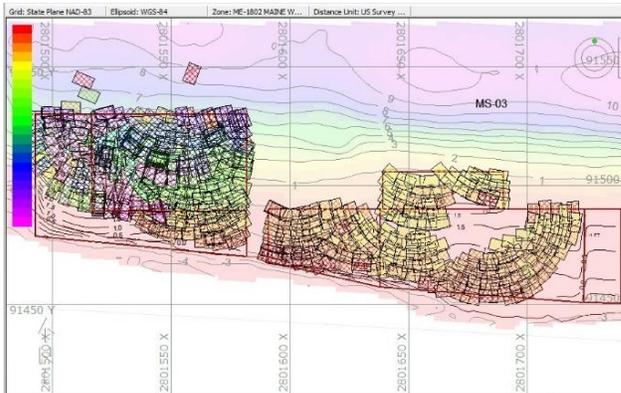
Tracking Progress of Dredging

- The location of the dredge bucket was tracked using GPS
- A record of the where the bucket had dredged was recorded to track the progress made and ensure that the entire area was covered.

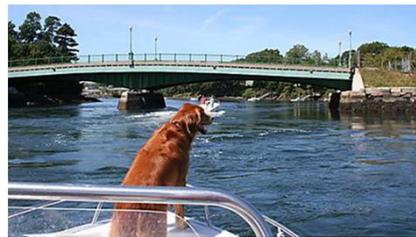
Challenges Encountered at MS-01

- **MS-01 Access**
 - Gate 1 bridge construction blocked access from the west
 - Low bridge limits access to only low tide
 - Strong currents limit movement of barges
- **Currents prohibited the safe use of the turbidity curtain**
 - When partially deployed the curtain moved the dredge barge with the spuds set

Numerous challenges were encountered during dredging. MS-01, MS-03, MS-04 were exposed at low tide, which made it difficult for the barge to reach these areas. Due to the strong currents barges could only be moved during slack tide, which made coordination of field activities difficult. There is limited height clearance under the bridge to the Shipyard, equipment had to be moved through at low tide, and it required two tug boats to move the barge under

the bridge. Movement of equipment was also limited to one direction by construction on the Gate 1 Bridge. The heavy snow fall and very cold conditions added an additional level of challenge. Work was delayed in order to remove snow on a somewhat regular basis. Ice buildup, cloudy weather, and short daylight hours caused problems with the solar powered battery chargers on the water quality buoys. Due to the strong currents in the river, turbidity curtains were not deployed during dredging in some areas where unsafe conditions were created, and only water quality monitoring was performed as discussed with USEPA and MEDEP.
