St. Juliens Creek Annex Restoration Advisory Board Meeting Summary: May 18, 2010 Meeting

Fiscal Year 2010 Goals

Site 21 Interim Remedial Design/Remedial Action

Area UXO 1

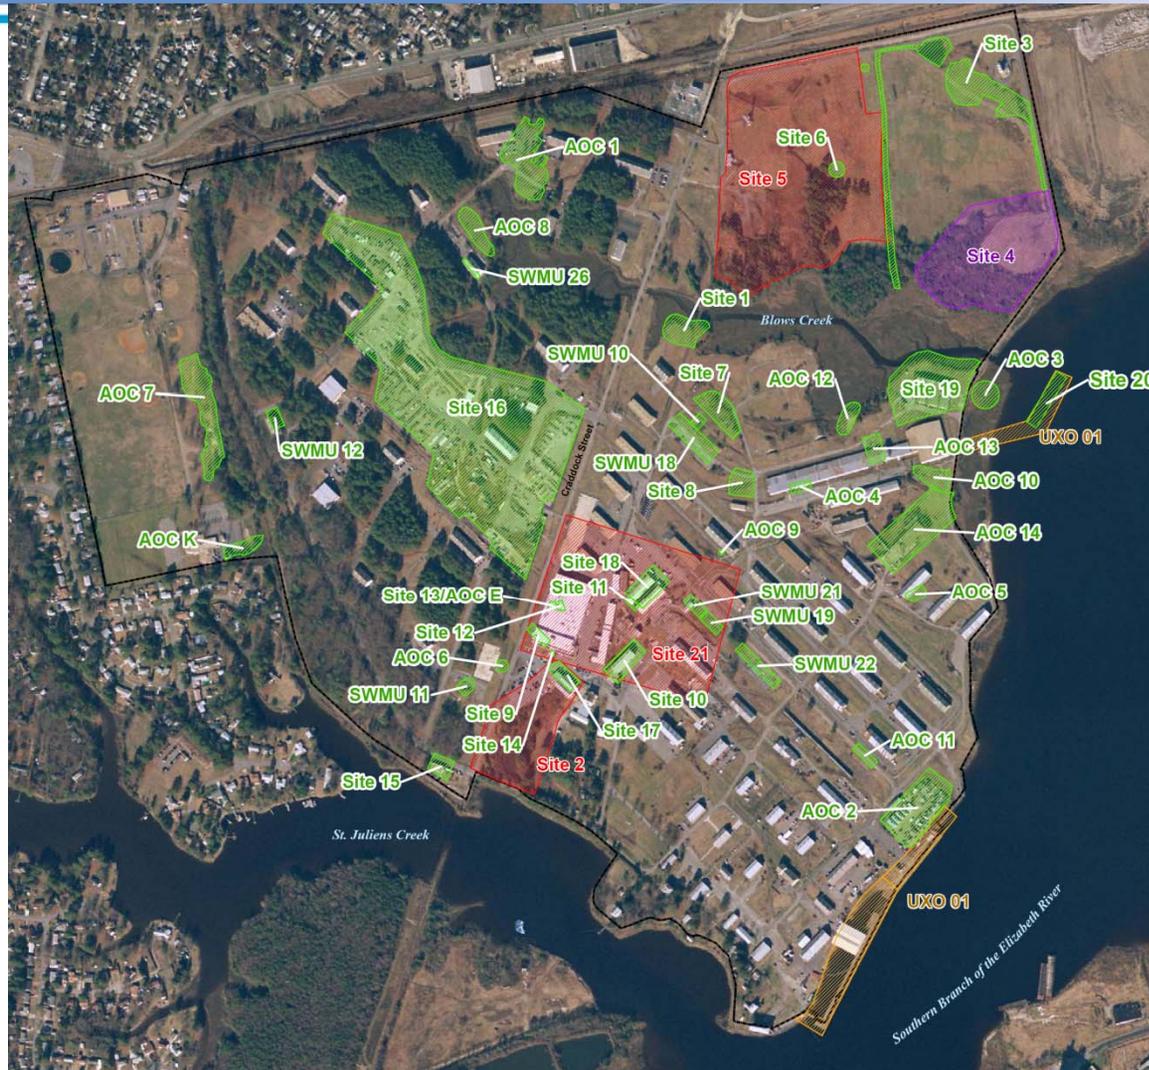
5 ERP Sites Currently Active:

- IRP Sites - Further Action
- IRP Sites - No Further Action
- Response Complete - Sites with LUCs
- MRP Areas

To-date 54 sites determined no further action

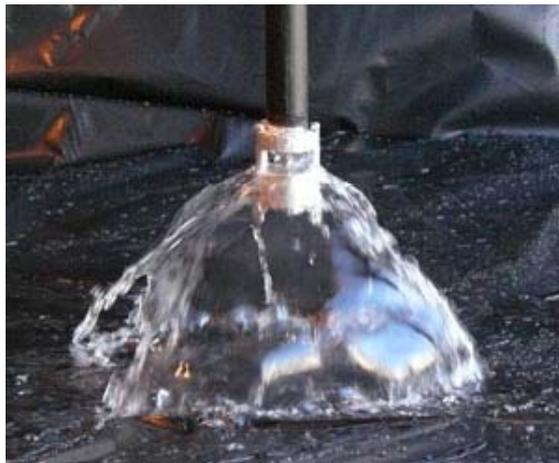
Standard Hydraulic Injection

- **Zero valent iron (ZVI) will be injected into 202 locations to chemically destroy CVOCs in the highest concentration areas**
- **Process is estimated to take 55 days to complete**
- **Liquid Atomized Injection (LAI®) process will be used**
 - **creates a liquid-like mixture of iron particles, gas and water that can be sprayed at high pressure into the subsurface**

Ms. Staszak explained the ISCR portion of the remedy. Zero valent iron (ZVI) will be injected into 202 locations to chemically destroy the CVOCs in the highest concentration areas of the site. The process is estimated to take 55 days to complete. The Liquid Atomized Injection (LAI®) process will be used to perform the injections. This process creates a liquid-like mixture of iron particles, gas and water that can be sprayed at high pressure into the subsurface. A figure depicting the layout of the injection points was displayed. The injection points will be placed in the highest concentration areas a minimum of 10 feet from utilities. Although the activity looks relatively intrusive, only small areas of the site will be impacted at a time and those areas will be delineated with fencing and signs. The injection equipment consists of a direct push drilling rig, mixing equipment, and a compressed gas source.

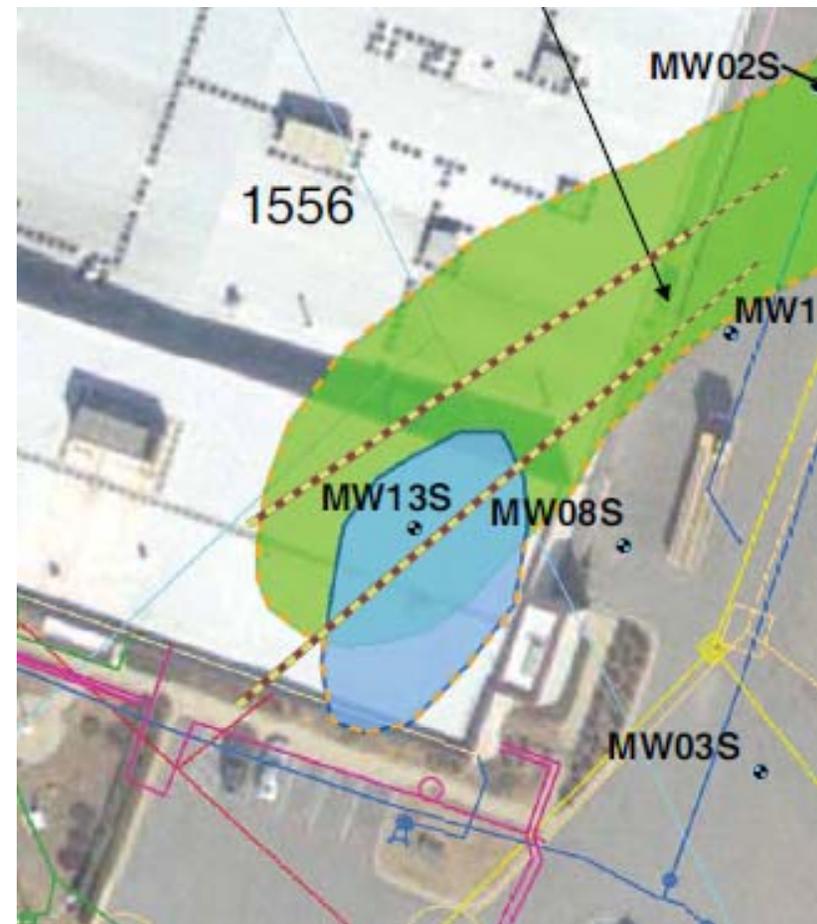
- High-concentration areas under Building 1556 that cannot be accessed by ZVI injection equipment will be treated through enhanced biological processes
- Emulsified vegetable oil (EVO) will be injected into two horizontal wells drilled under the foundation of Building 1556
- EVO will stimulate the degradation of CVOCs by naturally-occurring microbes

Ms. Staszak explained the first phase of the ERD portion of the remedy. The high-concentration areas under Building 1556 that cannot be accessed by ZVI injection equipment will be treated through enhanced biological processes. Emulsified vegetable oil (EVO) will be injected into two horizontal wells drilled under the foundation of Building 1556. EVO will stimulate the degradation of CVOCs by naturally-occurring microbes. A figure depicting a cross section of a horizontal well was displayed.

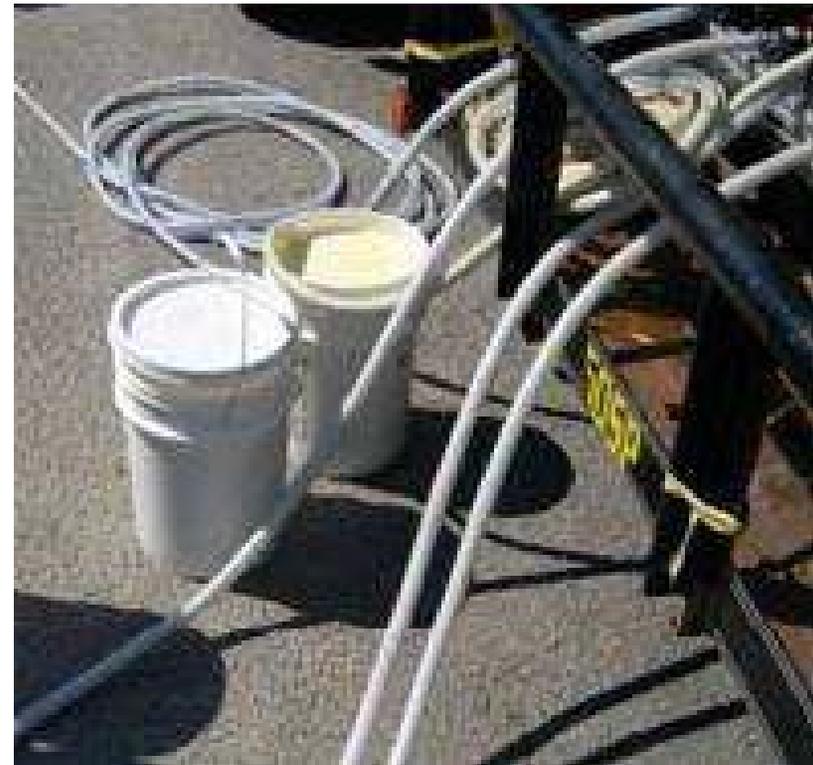
- **Low-concentration areas will be treated by injecting EVO into temporary injection points across the site**
- **EVO will stimulate the degradation of CVOCs by naturally-occurring microbes**
- **Injection layout consists of a series of rows placed perpendicular to groundwater flow**
- **Groundwater is expected to flow through these rows and be treated**

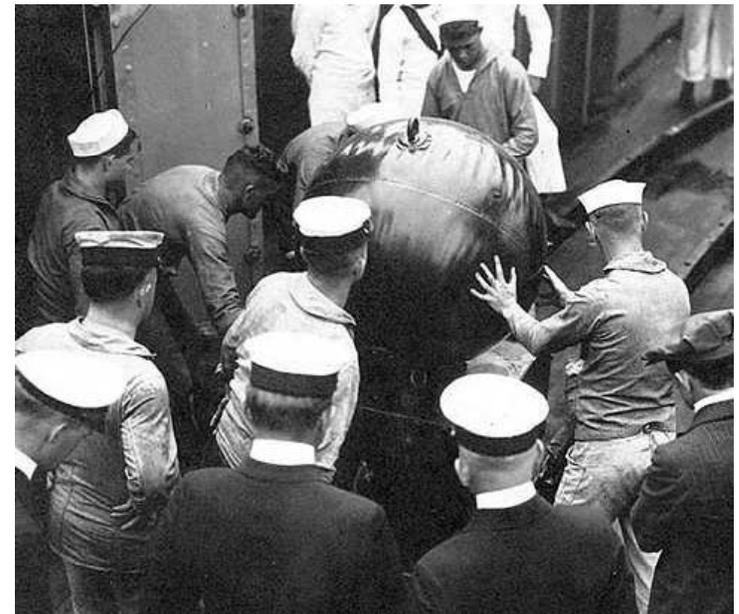
- Approximately 2,230 linear feet of current and former wharf areas along the Southern Branch of the Elizabeth River
- Northern Wharf Area
 - Constructed in 1917
 - Used for loading/unloading ordnance, particularly Mark VI mines
 - No longer present with the exception of pilings
- Southern Wharf Area
 - Constructed in 1898
 - Used for loading/unloading various ordnance
 - Damaged when two ships struck it in 1975
 - Still in use, but not for ordnance loading/unloading

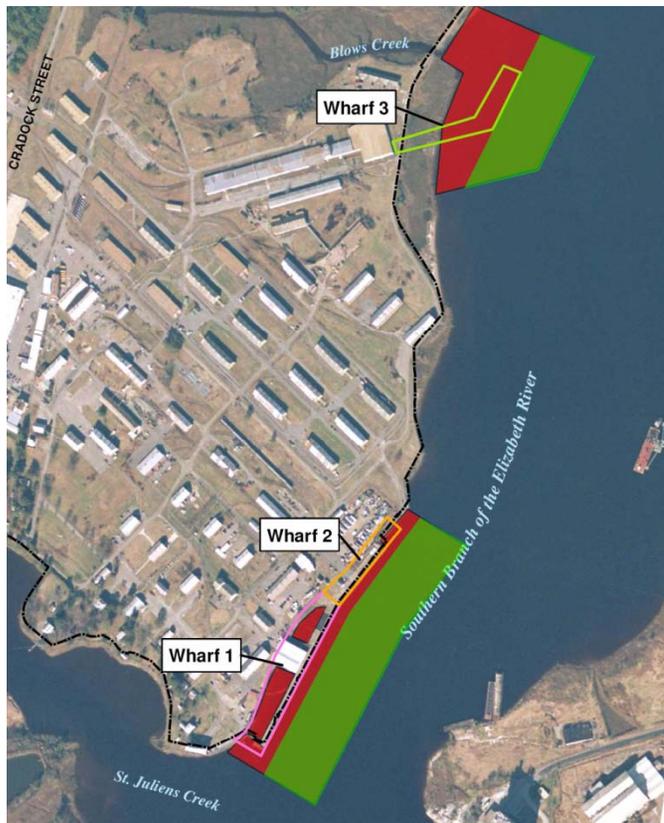
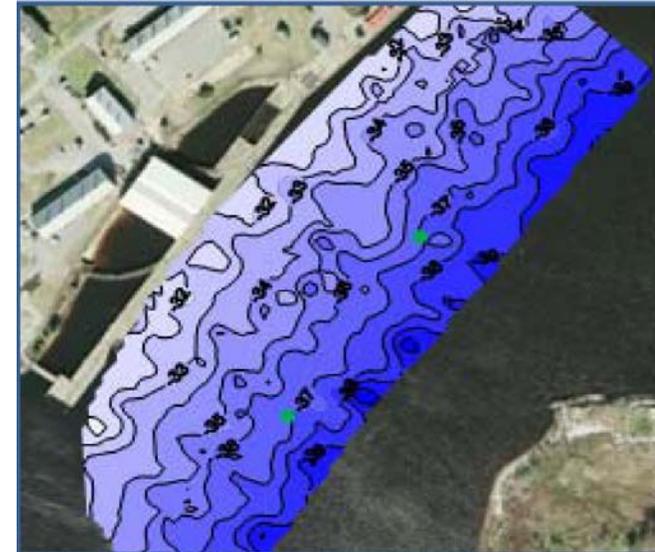
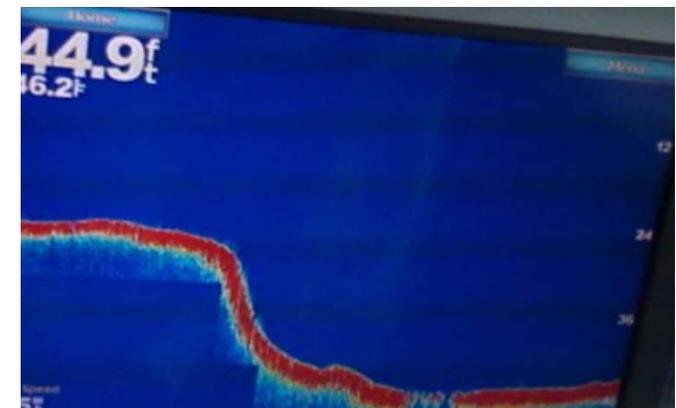
- Side scan and bathymetry surveys
- Digital geophysical mapping survey

An SI, consisting of side scan and bathymetry surveys and a digital geophysical mapping survey, was conducted in 2010. A figure showing the areas of the site included in the investigation was projected. Ms. Staszak explained that the area of the figure shown in red represent the portions of the site that could not be included due to access restrictions (i.e., the water was too shallow or the damaged wharf presented safety concerns). The areas shown in green represent the areas of the site that were able to be investigated. The digital geophysical mapping was conducted by pulling boat-towed sensors with magnetometers spaced at 1.5 meters, resulting in surveyed lines 1 meter apart to give complete coverage of the area. Figures depicting the results of the geophysical mapping were displayed. The geophysical mapping identified 1,386 metallic anomalies at the bottom of the river in the southern area and 265 anomalies in the northern area. Because metallic anomalies are present but it is unknown whether they represent DMM, an additional investigation will be conducted to inspect metallic anomalies. Divers cannot be used for the inspection because the river water is too murky and poses safety concerns; therefore, metallic anomalies will be dredged from select areas of the river bottom for inspection and identification. If DMM presence is positively confirmed, an RI or Removal Action will be conducted.

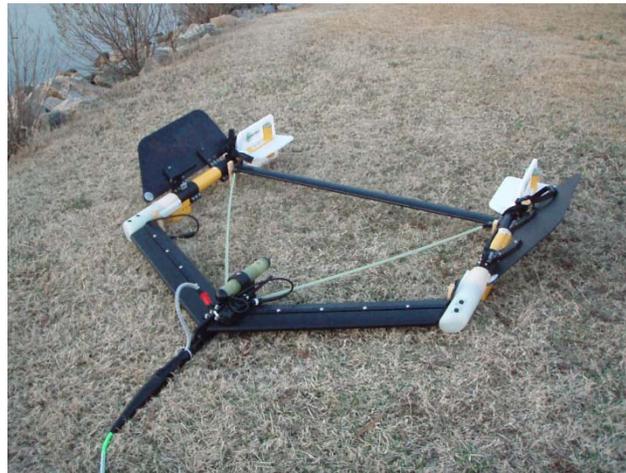
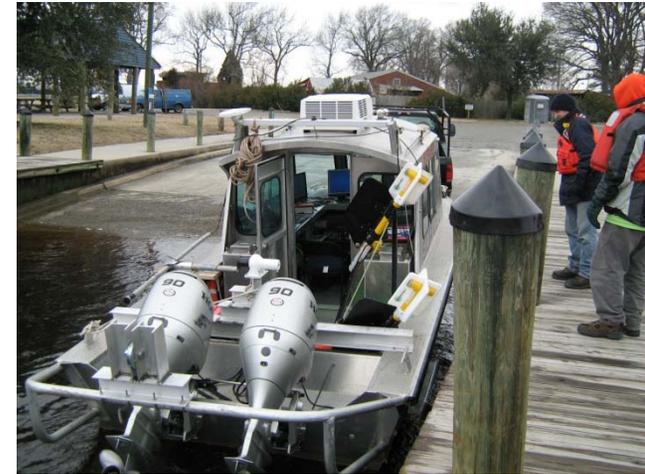
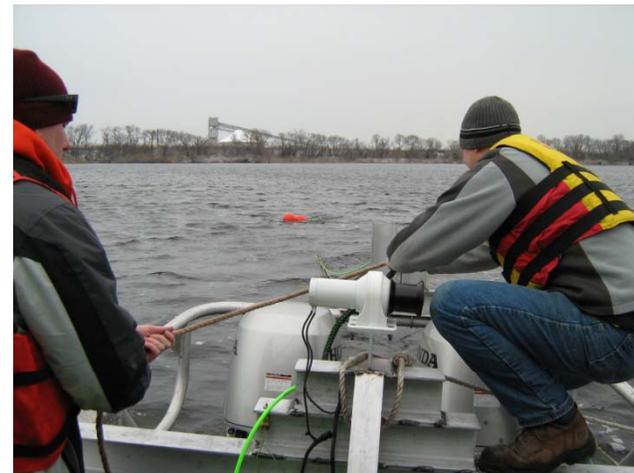
MRP Site Inspection Digital Geophysical Mapping

- Boat-towed sensors
 - 2 magnetometers spaced at 1.5 meets
 - Surveyed lines 1 meter apart

Mr. Costello asked to what depth magnetometers can detect metallic anomalies in the silt. Ms. Staszak responded that it depends on the size and orientation of the anomaly, but that the rule of thumb is that an anomaly can be detected at a depth of 11 times its diameter. Mr.

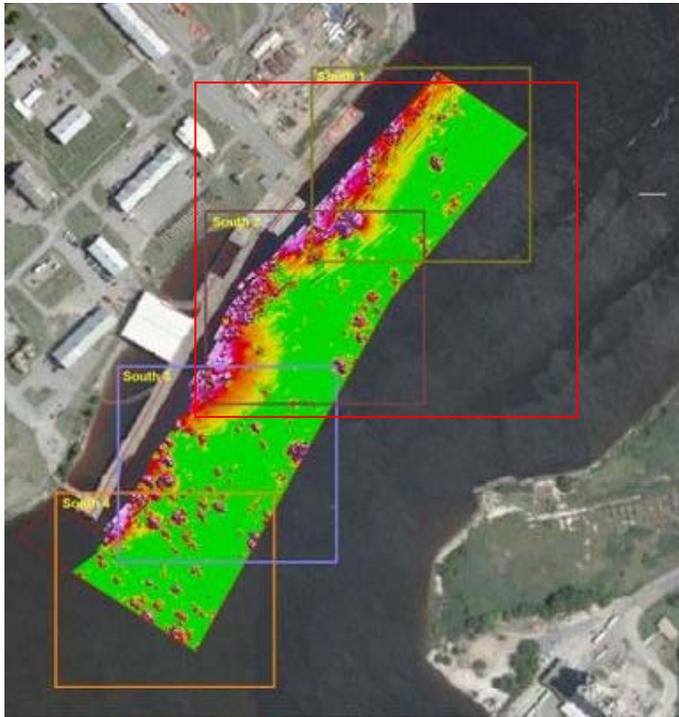
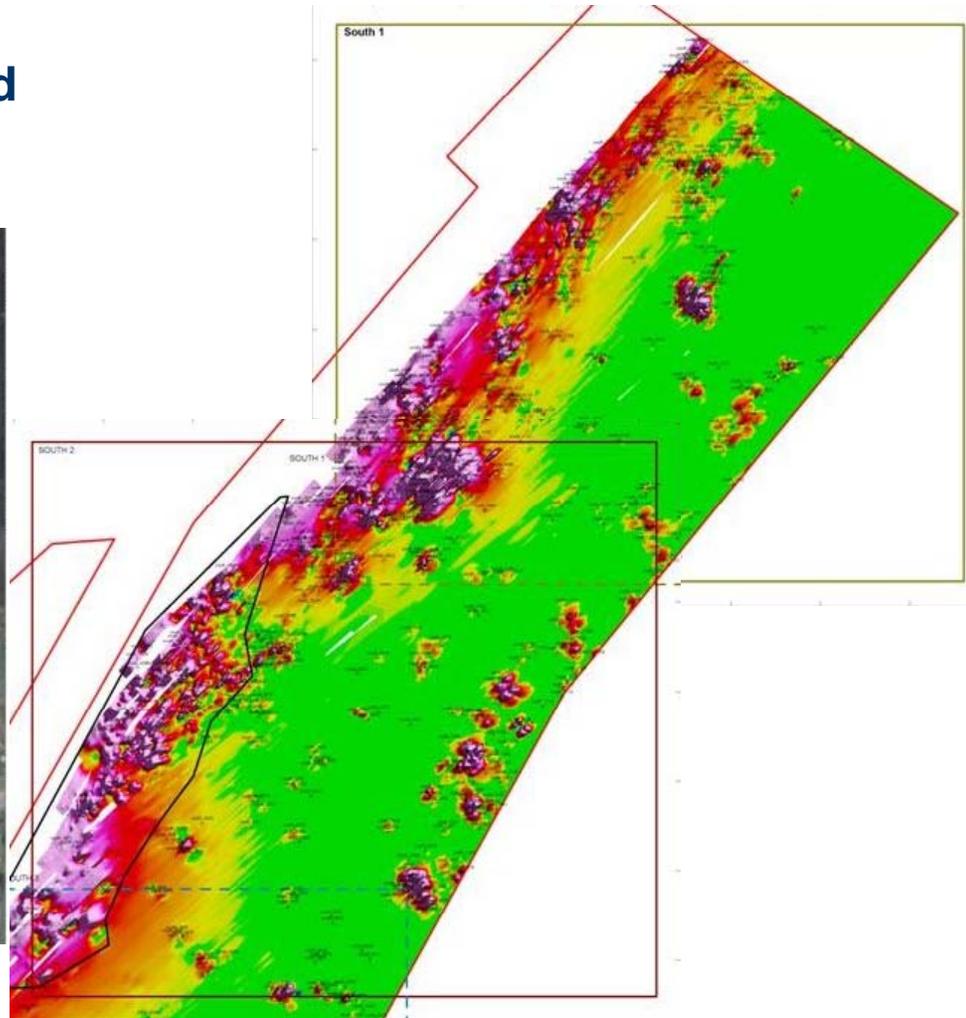
- Southern Area DGM
–1,386 anomalies identified

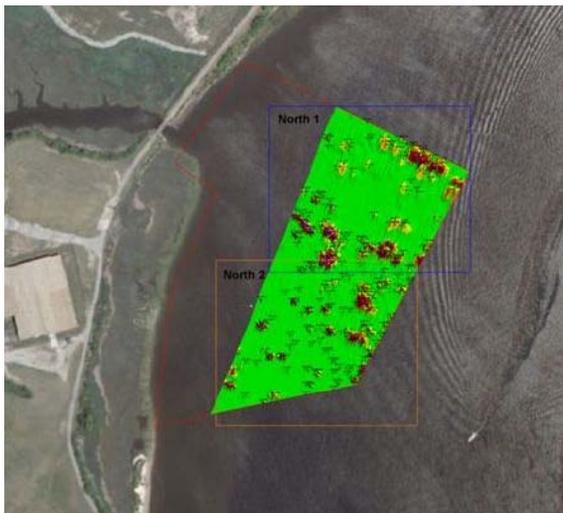
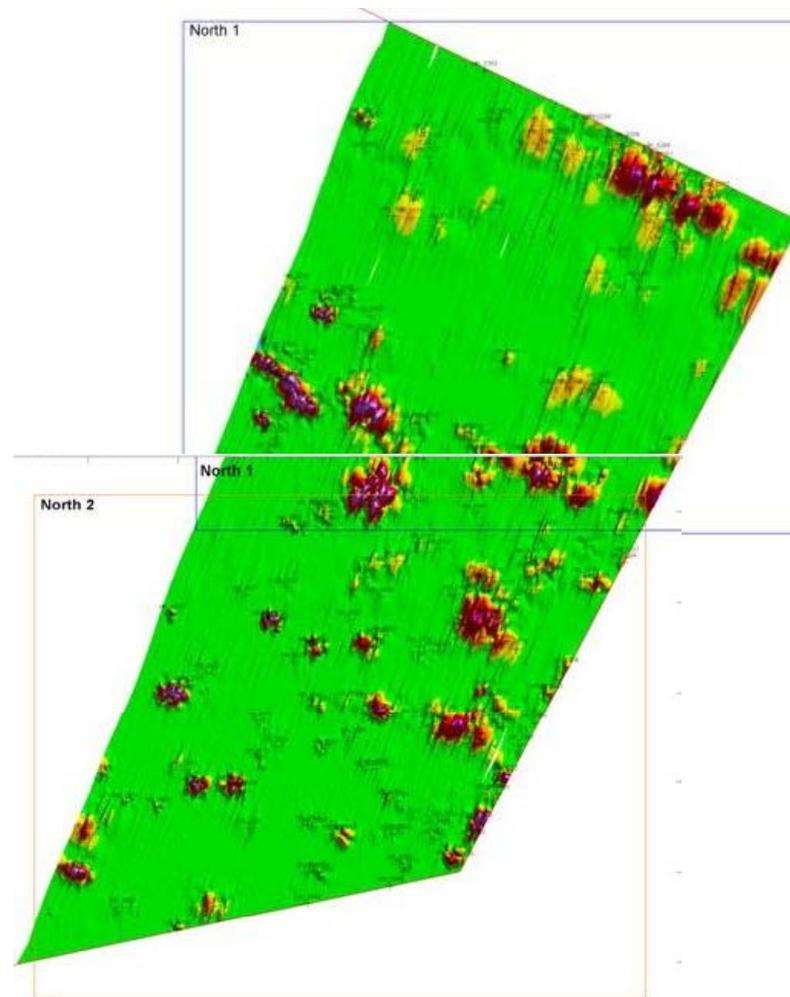
- Northern Area DGM
–265 anomalies identified

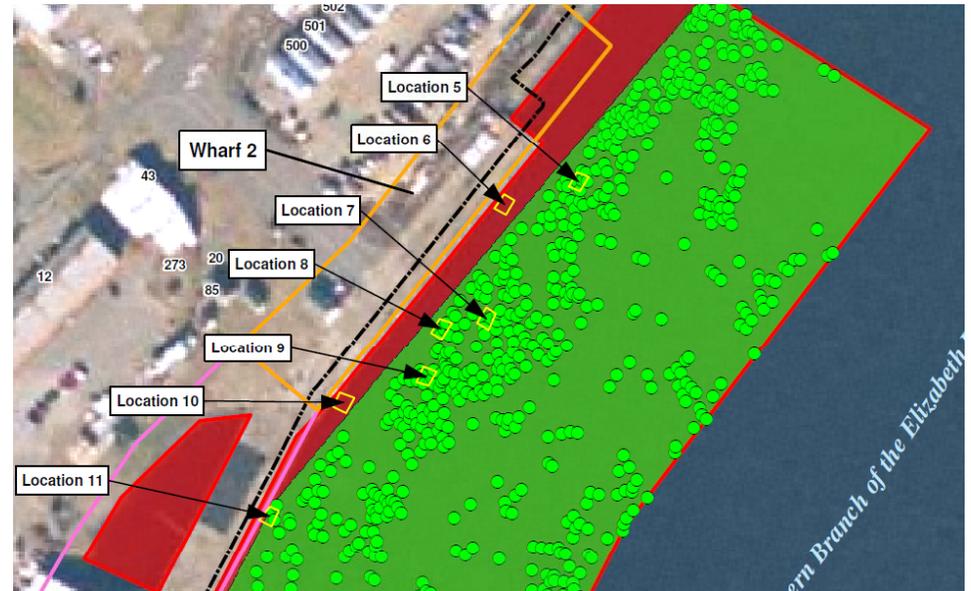
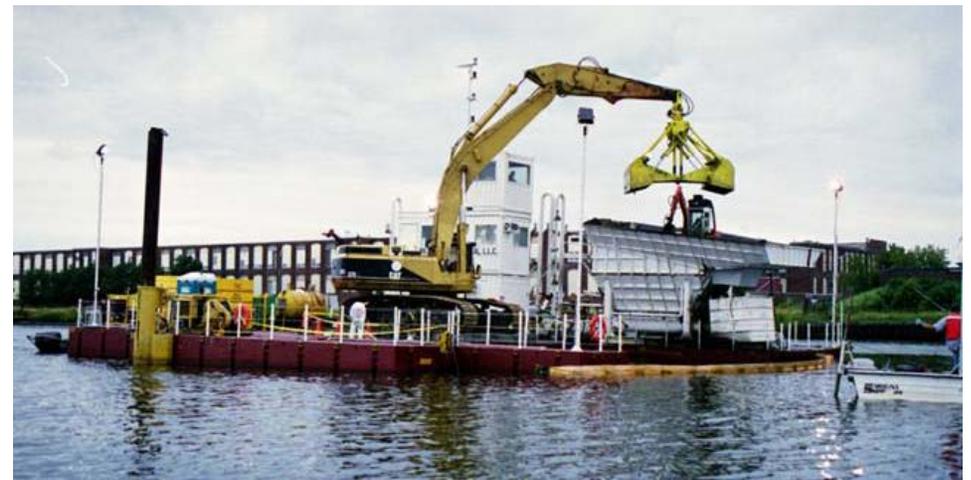
- **Metallic anomalies are present in the southern and northern wharf areas**
 - However, metallic may or may not represent DMM
- **Intrusive investigation will be conducted**
 - Metallic anomalies from select areas will be dredged from the river bottom for inspection and identification
- **If DMM presence is positively confirmed, a Remedial Investigation or Removal Action will be conducted**
