Final Technical Memorandum

# Summary of Well Abandonment and Repair Activities

St. Juliens Creek Annex  
Chesapeake Virginia

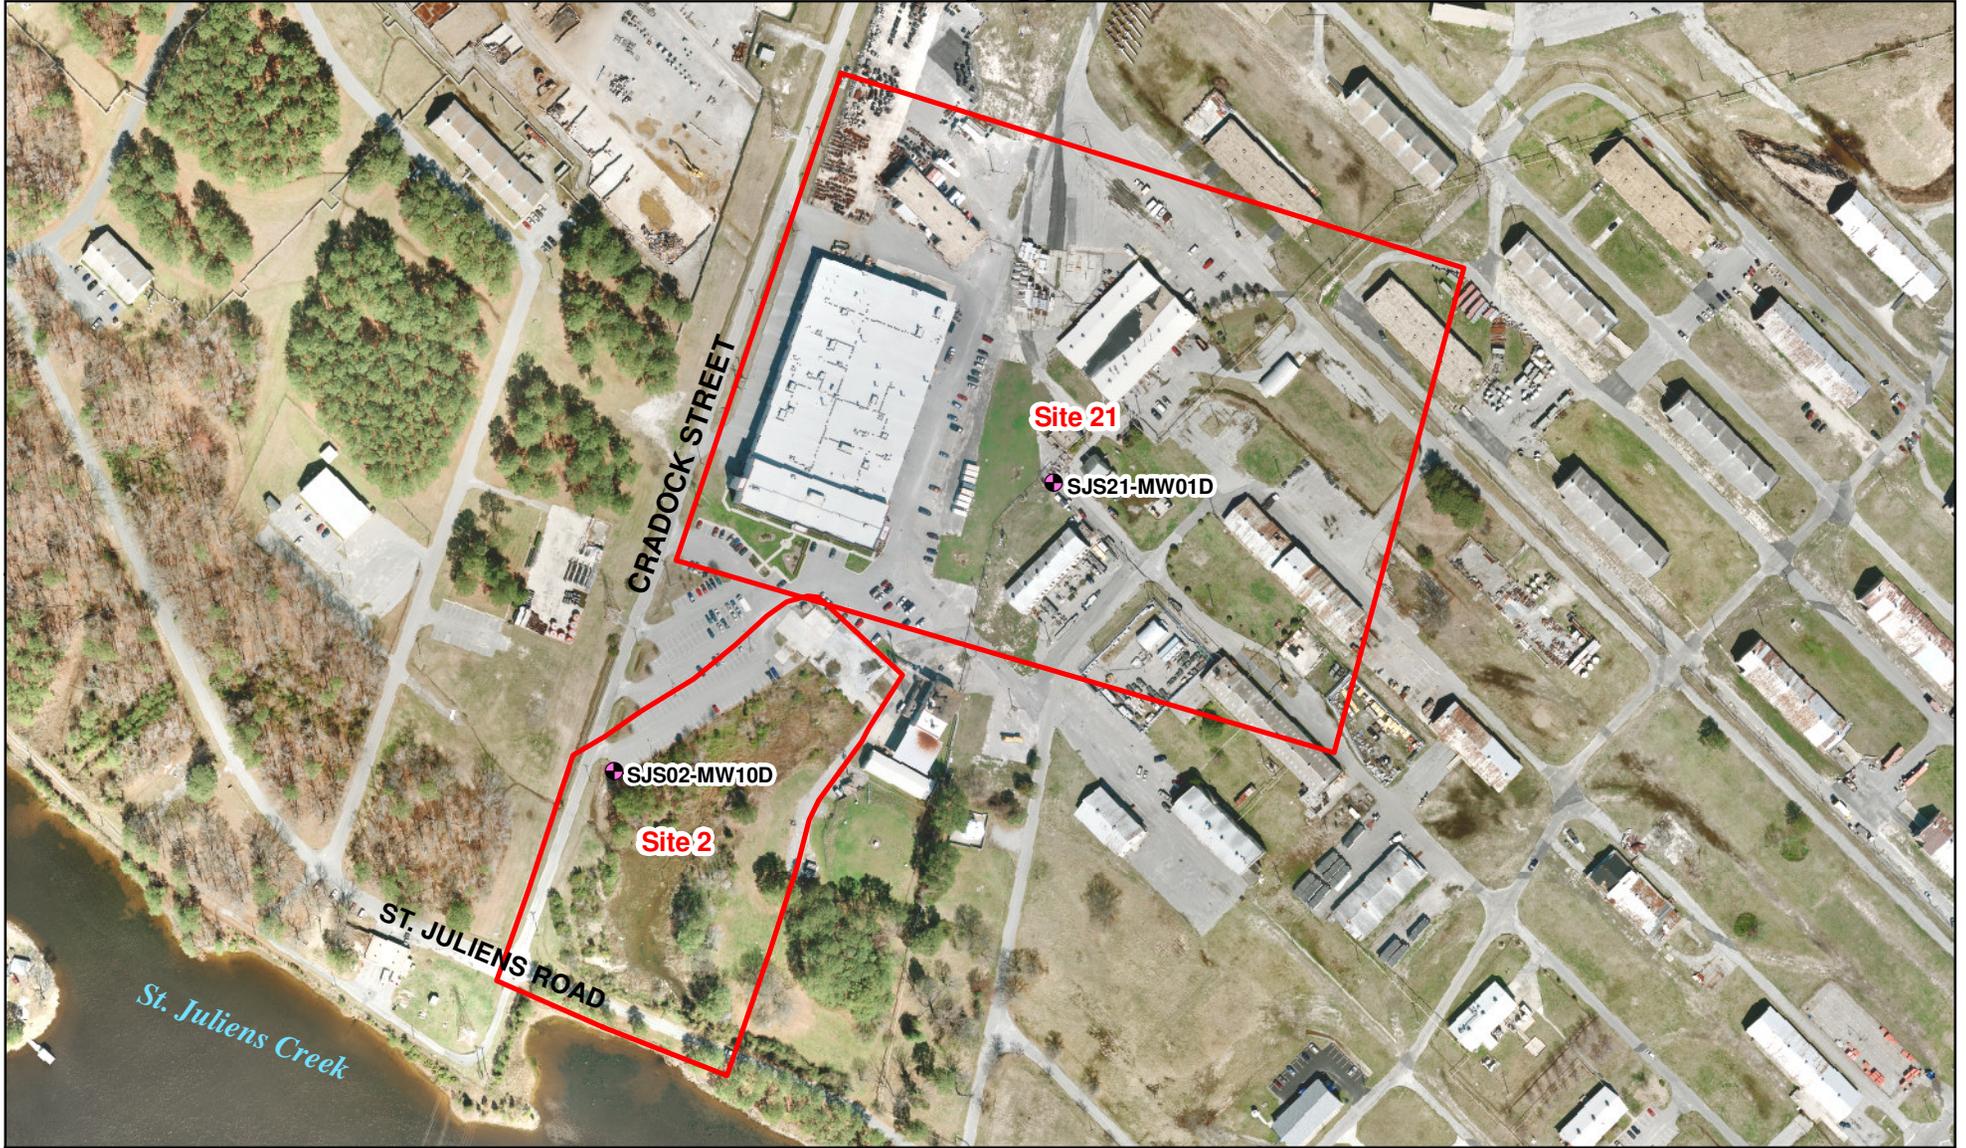
Figure 2  
Monitoring Well Locations  
St. Juliens Creek Annex  
Chesapeake, Virginia

This technical memorandum summarizes well abandonment and repair activities conducted at Sites 2 and 21 at St. Juliens Creek Annex (SJCA) from November 17 through 19, 2009 (Figure 1). Deep groundwater monitoring wells SJS02-MW10D and SJS21-MW01D at Sites 2 and 21, respectively (Figure 2), were abandoned based on the decision to do so by the SJCA Partnering Team during the November 2008 partnering meeting. Shallow groundwater monitoring well SJS02-MW12S at Site 2 was repaired based on the observation during Quarterly Installation Restoration site inspections that the well was not locking properly. The well abandonment and repair was conducted by Parratt-Wolff under the oversight of a CH2M HILL geologist. Field notes are provided as an attachment.

The abandonment of deep monitoring well SJS02-MW10D was initiated on November 17, 2009. The total depth of SJS02MW10D was measured to be approximately 69 feet below ground surface (bgs), consistent with the well construction record (68 feet bgs), prior to abandonment. The concrete pad around the stick-up protective casing was then broken with a jack hammer and removed. Bollards were pulled from the ground, and the stick-up protective casing and polyvinyl chloride (PVC) well riser were saw-cut off approximately 1.5 feet bgs. All debris from well abandonment was placed in the Parratt-Wolff vehicle for offsite disposal at a Subtitle D landfill. A tremmie pipe was then lowered to the bottom of the well, and a bentonite slurry of 1 to 2 pounds bentonite per gallon water was mixed and pumped in the well via the tremmie pipe until the bentonite slurry mixture came out the top of the well casing. The tremmie pipe remained submerged in the bentonite slurry mixture during the entire filling process. Following filling, the tremmie pipe was removed, the slurry was topped off, the well was capped, and the ground surface was restored to match the surrounding conditions. Two days later, on November 19, 2009, the area around the abandoned well was excavated to reveal the well casing, and the bentonite slurry was measured to have subsided approximately 3.5 feet below the top of casing. The slurry in the well was topped off with bentonite chips and recapped. The surrounding area was restored with topsoil and compacted to grade.

The abandonment of deep monitoring well SJS21-MW01D was initiated on November 17, 2009. The total depth of SJS21MW01D was measured to be approximately 44 feet bgs, which was consistent with the well construction record (43 feet bgs), prior to abandonment. A jack hammer was used to break up the concrete around the flush mount steel vault and both the concrete and steel vault were removed. The PVC casing was broken off at approximately 1 foot bgs. All well abandonment debris was placed in the Parratt Wolff vehicle for disposal at a subtitle D landfill. A tremmie pipe was then lowered to the bottom of the well, and a bentonite slurry of 1 to 2 pounds bentonite per gallon water was mixed and pumped in the well via the tremmie pipe until the slurry came out the top of the well casing. The tremmie pipe remained submerged in the bentonite slurry mixture during the entire filling process. Following filling, the tremmie pipe was removed and the slurry was topped off. The slurry was topped off a second time before leaving the site, and the well was capped and covered temporarily with sand bags and barricaded. Two days later, on November 19, 2009, the abandoned well was uncovered and uncapped, and the bentonite slurry was measured to have subsided approximately 2 feet below the top of casing. The slurry in the well was topped off with bentonite chips and recapped. The hole left by the removal of the vault was then backfilled with filter pack sand to about an inch below the bottom of the adjacent asphalt surface. The hole was then patched with cold patch asphalt in two thin lifts, with each lift being individually compacted.
