FINAL TECHNICAL MEMORANDUM FOR RESULTS OF THE STEP 1 POLYCHLORINATED  
BIPHENYLS SITE INSPECTION AT PENNIMAN LAKE CHEATHAM ANNEX FISC  
WILLIAMSBURG VA  
2/29/2012  
CH2MHILL

## Results of the Step 1 Polychlorinated Biphenyls Site Inspection at Penniman Lake, Cheatham Annex, Williamsburg, Virginia

PREPARED FOR: Cheatham Annex Partnering Team  
PREPARED BY: CH2M HILL  
DATE: February 29, 2012

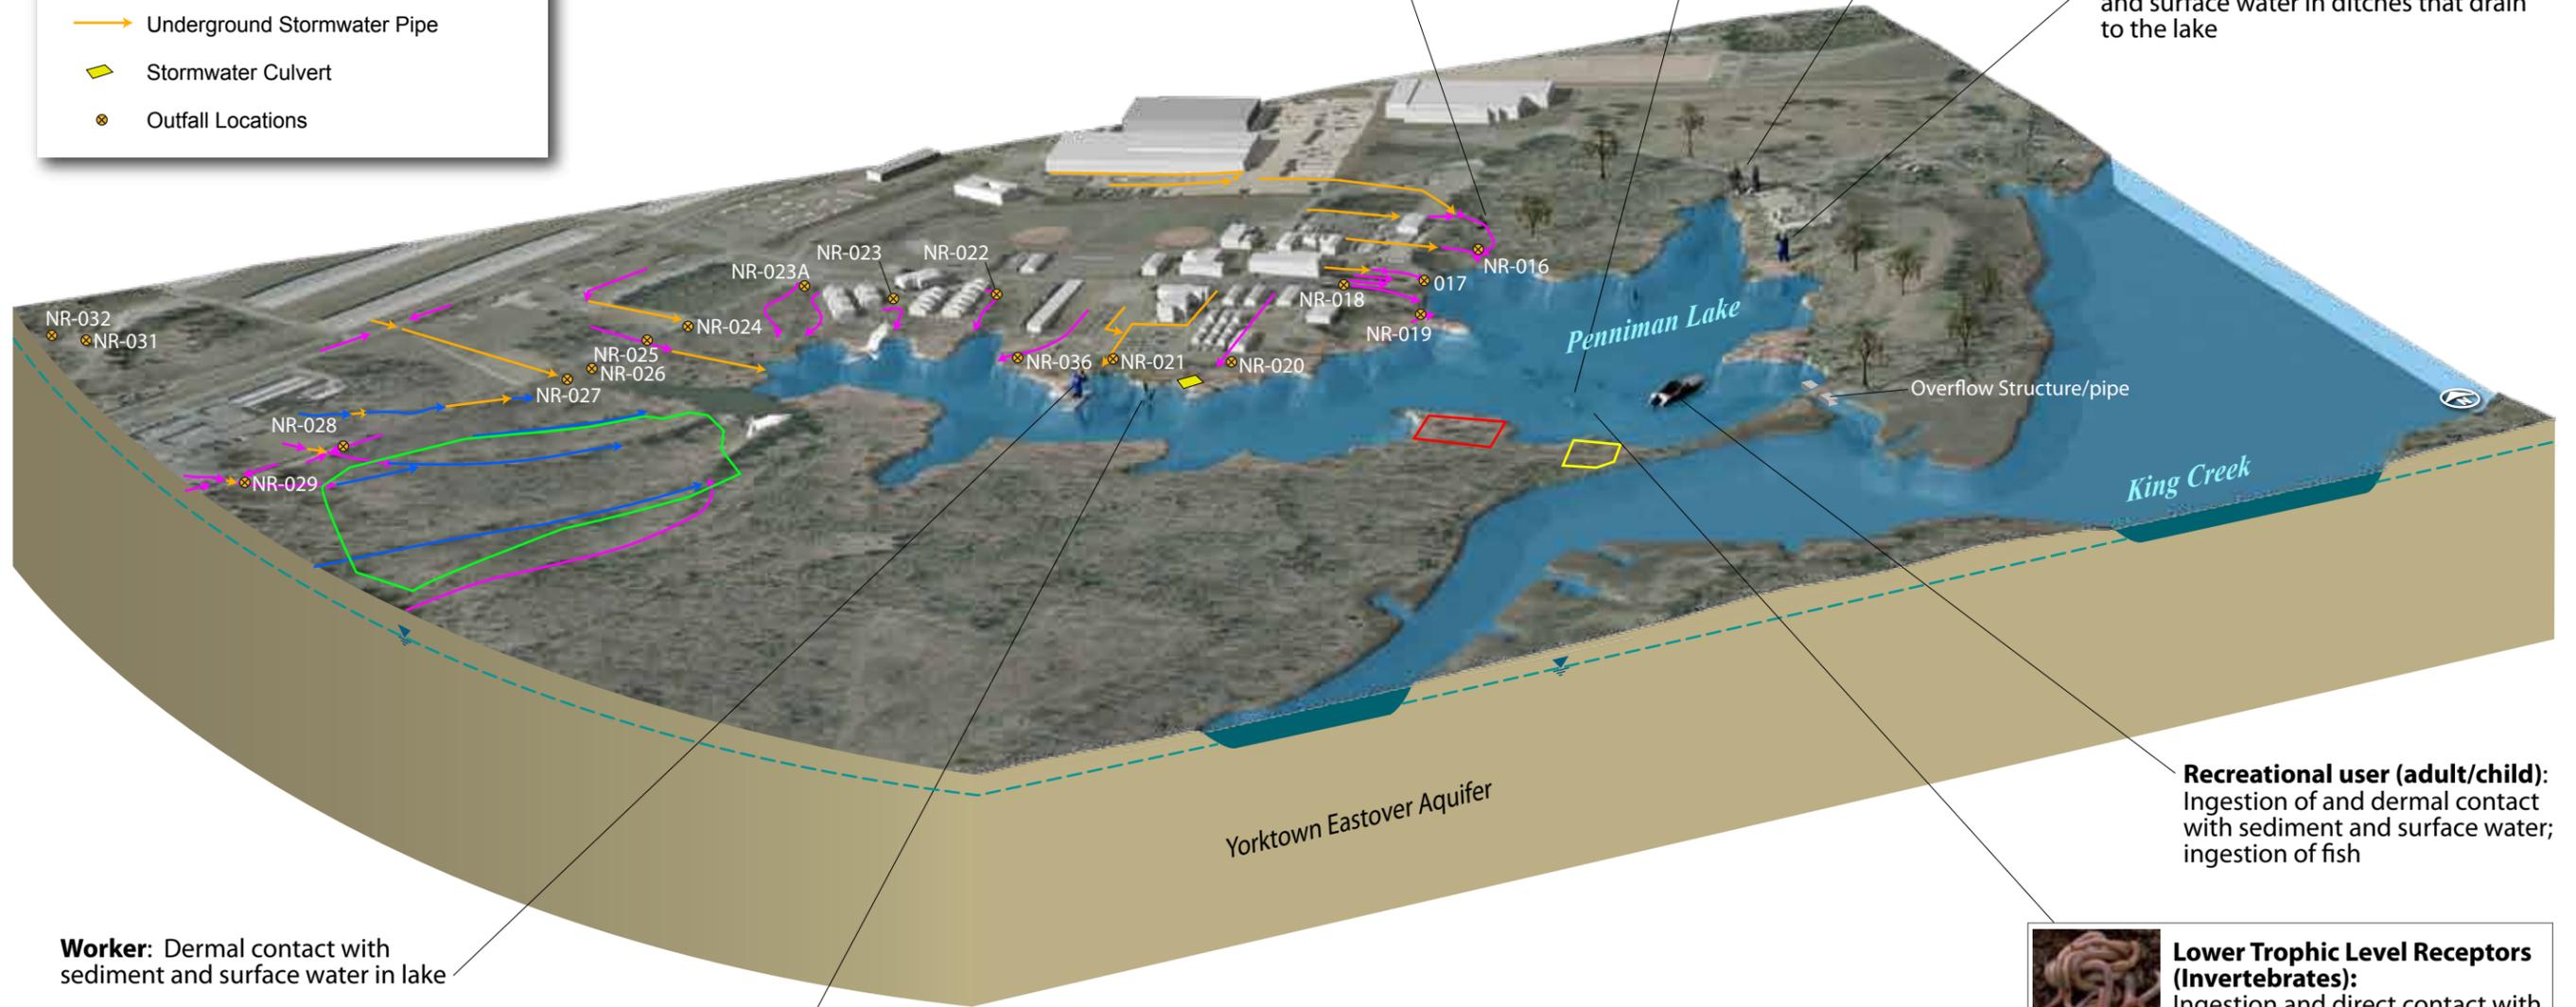
**FIGURE 2**  
Conceptual Site Model  
Penniman Lake  
Cheatham Annex  
Williamsburg, Virginia

The conceptual site model (CSM) for Penniman Lake is based on data collected as part of previous investigations. The CSM interprets the site background and history, physical setting, distribution of contamination, release history, potential contaminant sources and transport pathways, and the potential exposure and receptor pathways. Since the specific source or sources of contaminants to Penniman Lake have not been identified to date, the CSM remains incomplete. The current CSM for Penniman Lake is shown in **Figure 2**.

**Upper Trophic Level Receptors (birds, mammals)**  
Ingestion of contaminated plant and/or animal tissue; incidental ingestion of surface water, sediment, and/or soil.

**Lower Trophic Level Receptors (fish, reptiles, amphibians):**  
Direct contact with surface water/sediment, ingestion of sediment, other fish, plants, and invertebrates

**Recreational user (adult/child):** Dermal contact with sediment and surface water in ditches that drain to lake

**Worker:** Dermal contact with sediment and surface water in ditches that drain to the lake

**Worker:** Dermal contact with sediment and surface water in lake

**Aquatic/Wetland Plants**  
Direct contact with surface water and sediment; root uptake from sediment

**Lower Trophic Level Receptors (Invertebrates):**  
Ingestion and direct contact with soil, sediment, or surface water.

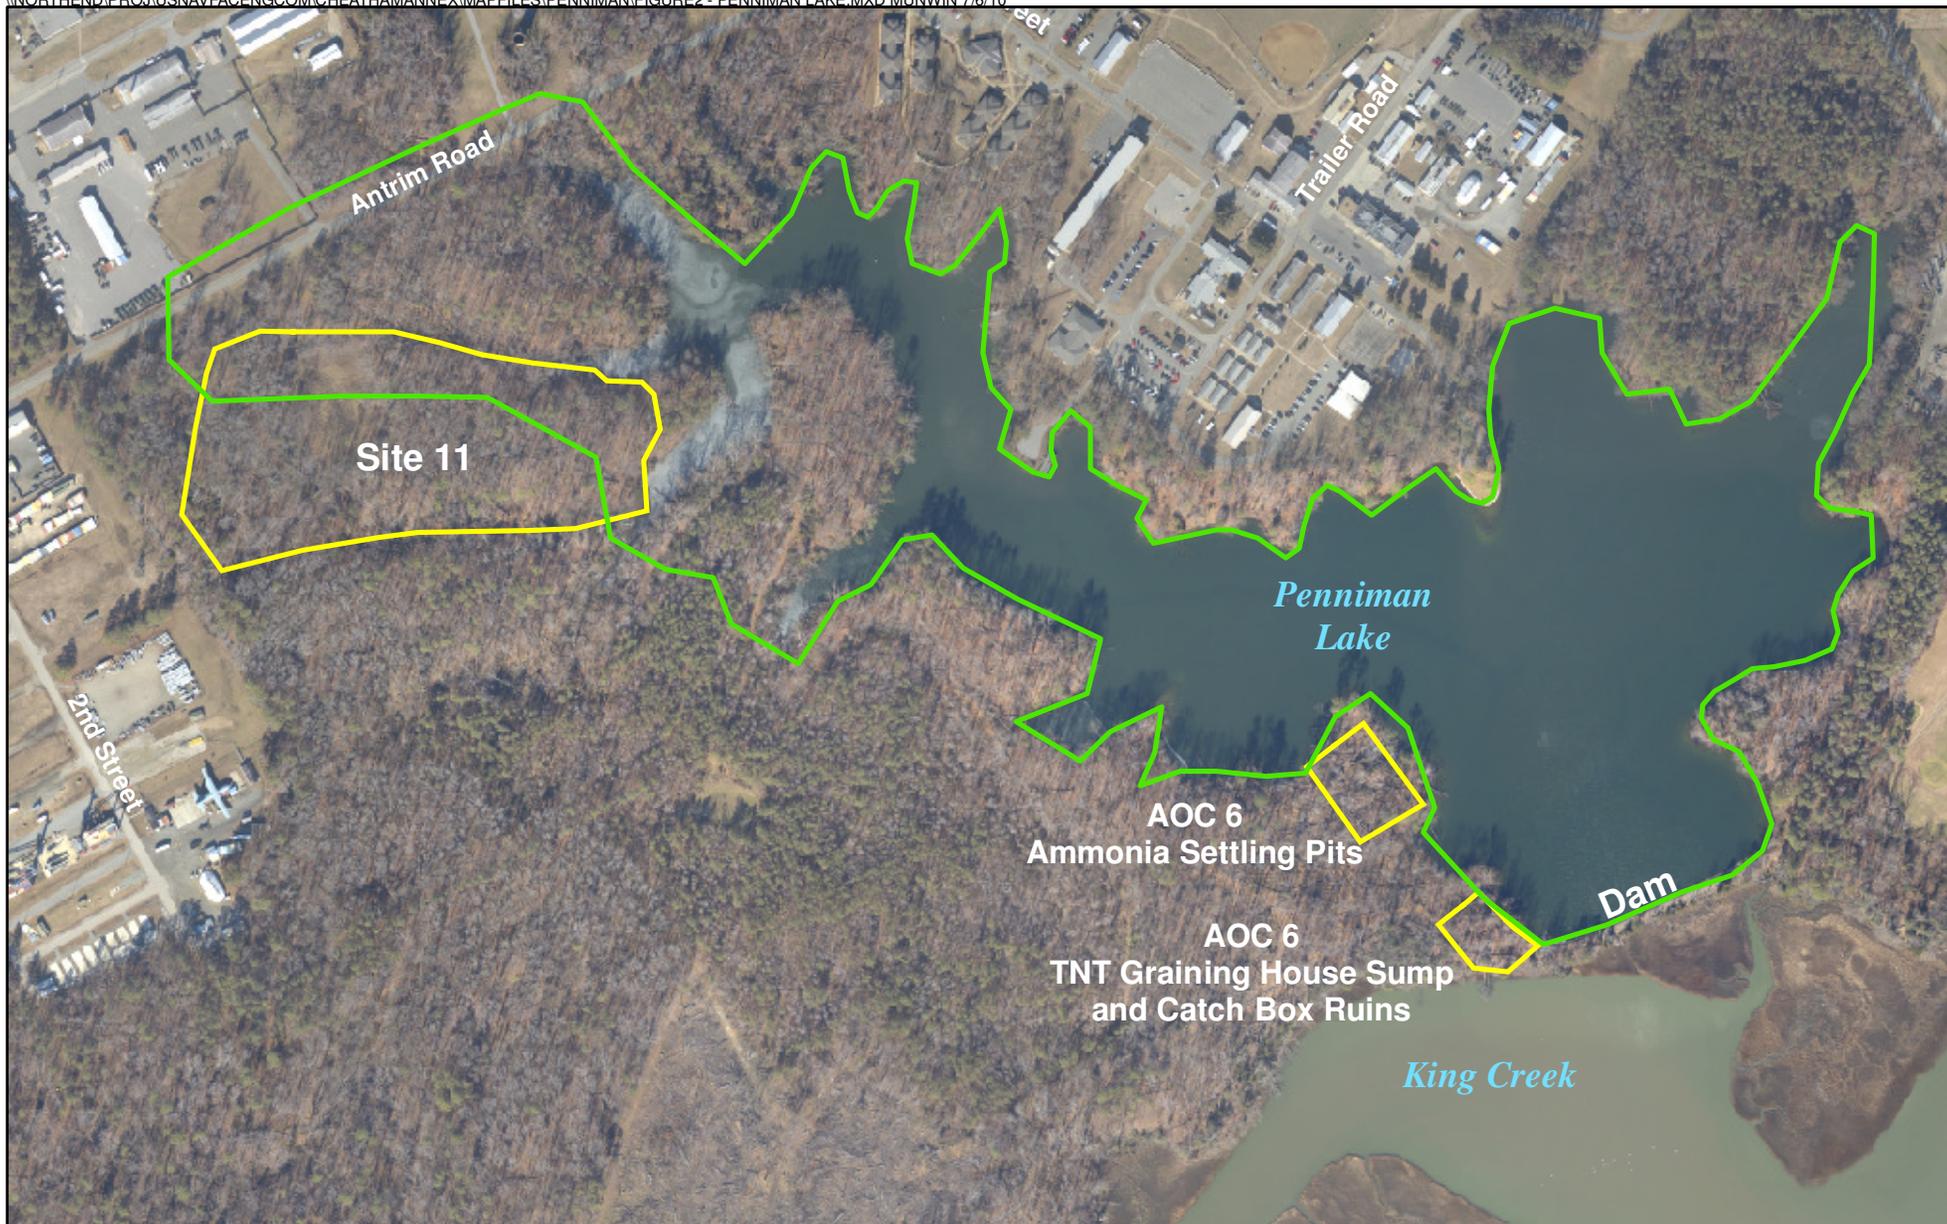
Figure 3  
Penniman Lake  
Layout Map  
Cheatham Annex  
Williamsburg, Virginia

Penniman Lake is a 48-acre fresh water surface water body located in the southeastern portion of CAX, created in 1943 when a portion of King Creek was dammed; it is not tidally influenced (**Figure 3**). Numerous drainage channels and stormwater outfalls discharge to the lake. There is an overflow structure adjacent to the dam (**Figure 4**) that discharges directly to King's Creek; other major outlets are evaporation and recharge to groundwater. The historical use of the lake is unknown; however, the lake is currently used by the Department of Defense (DoD) for recreational activities. The lake is not open to the general public. Catch-and-release fishing restrictions were implemented for the lake in 2000 following identification of PCBs within lake sediment.

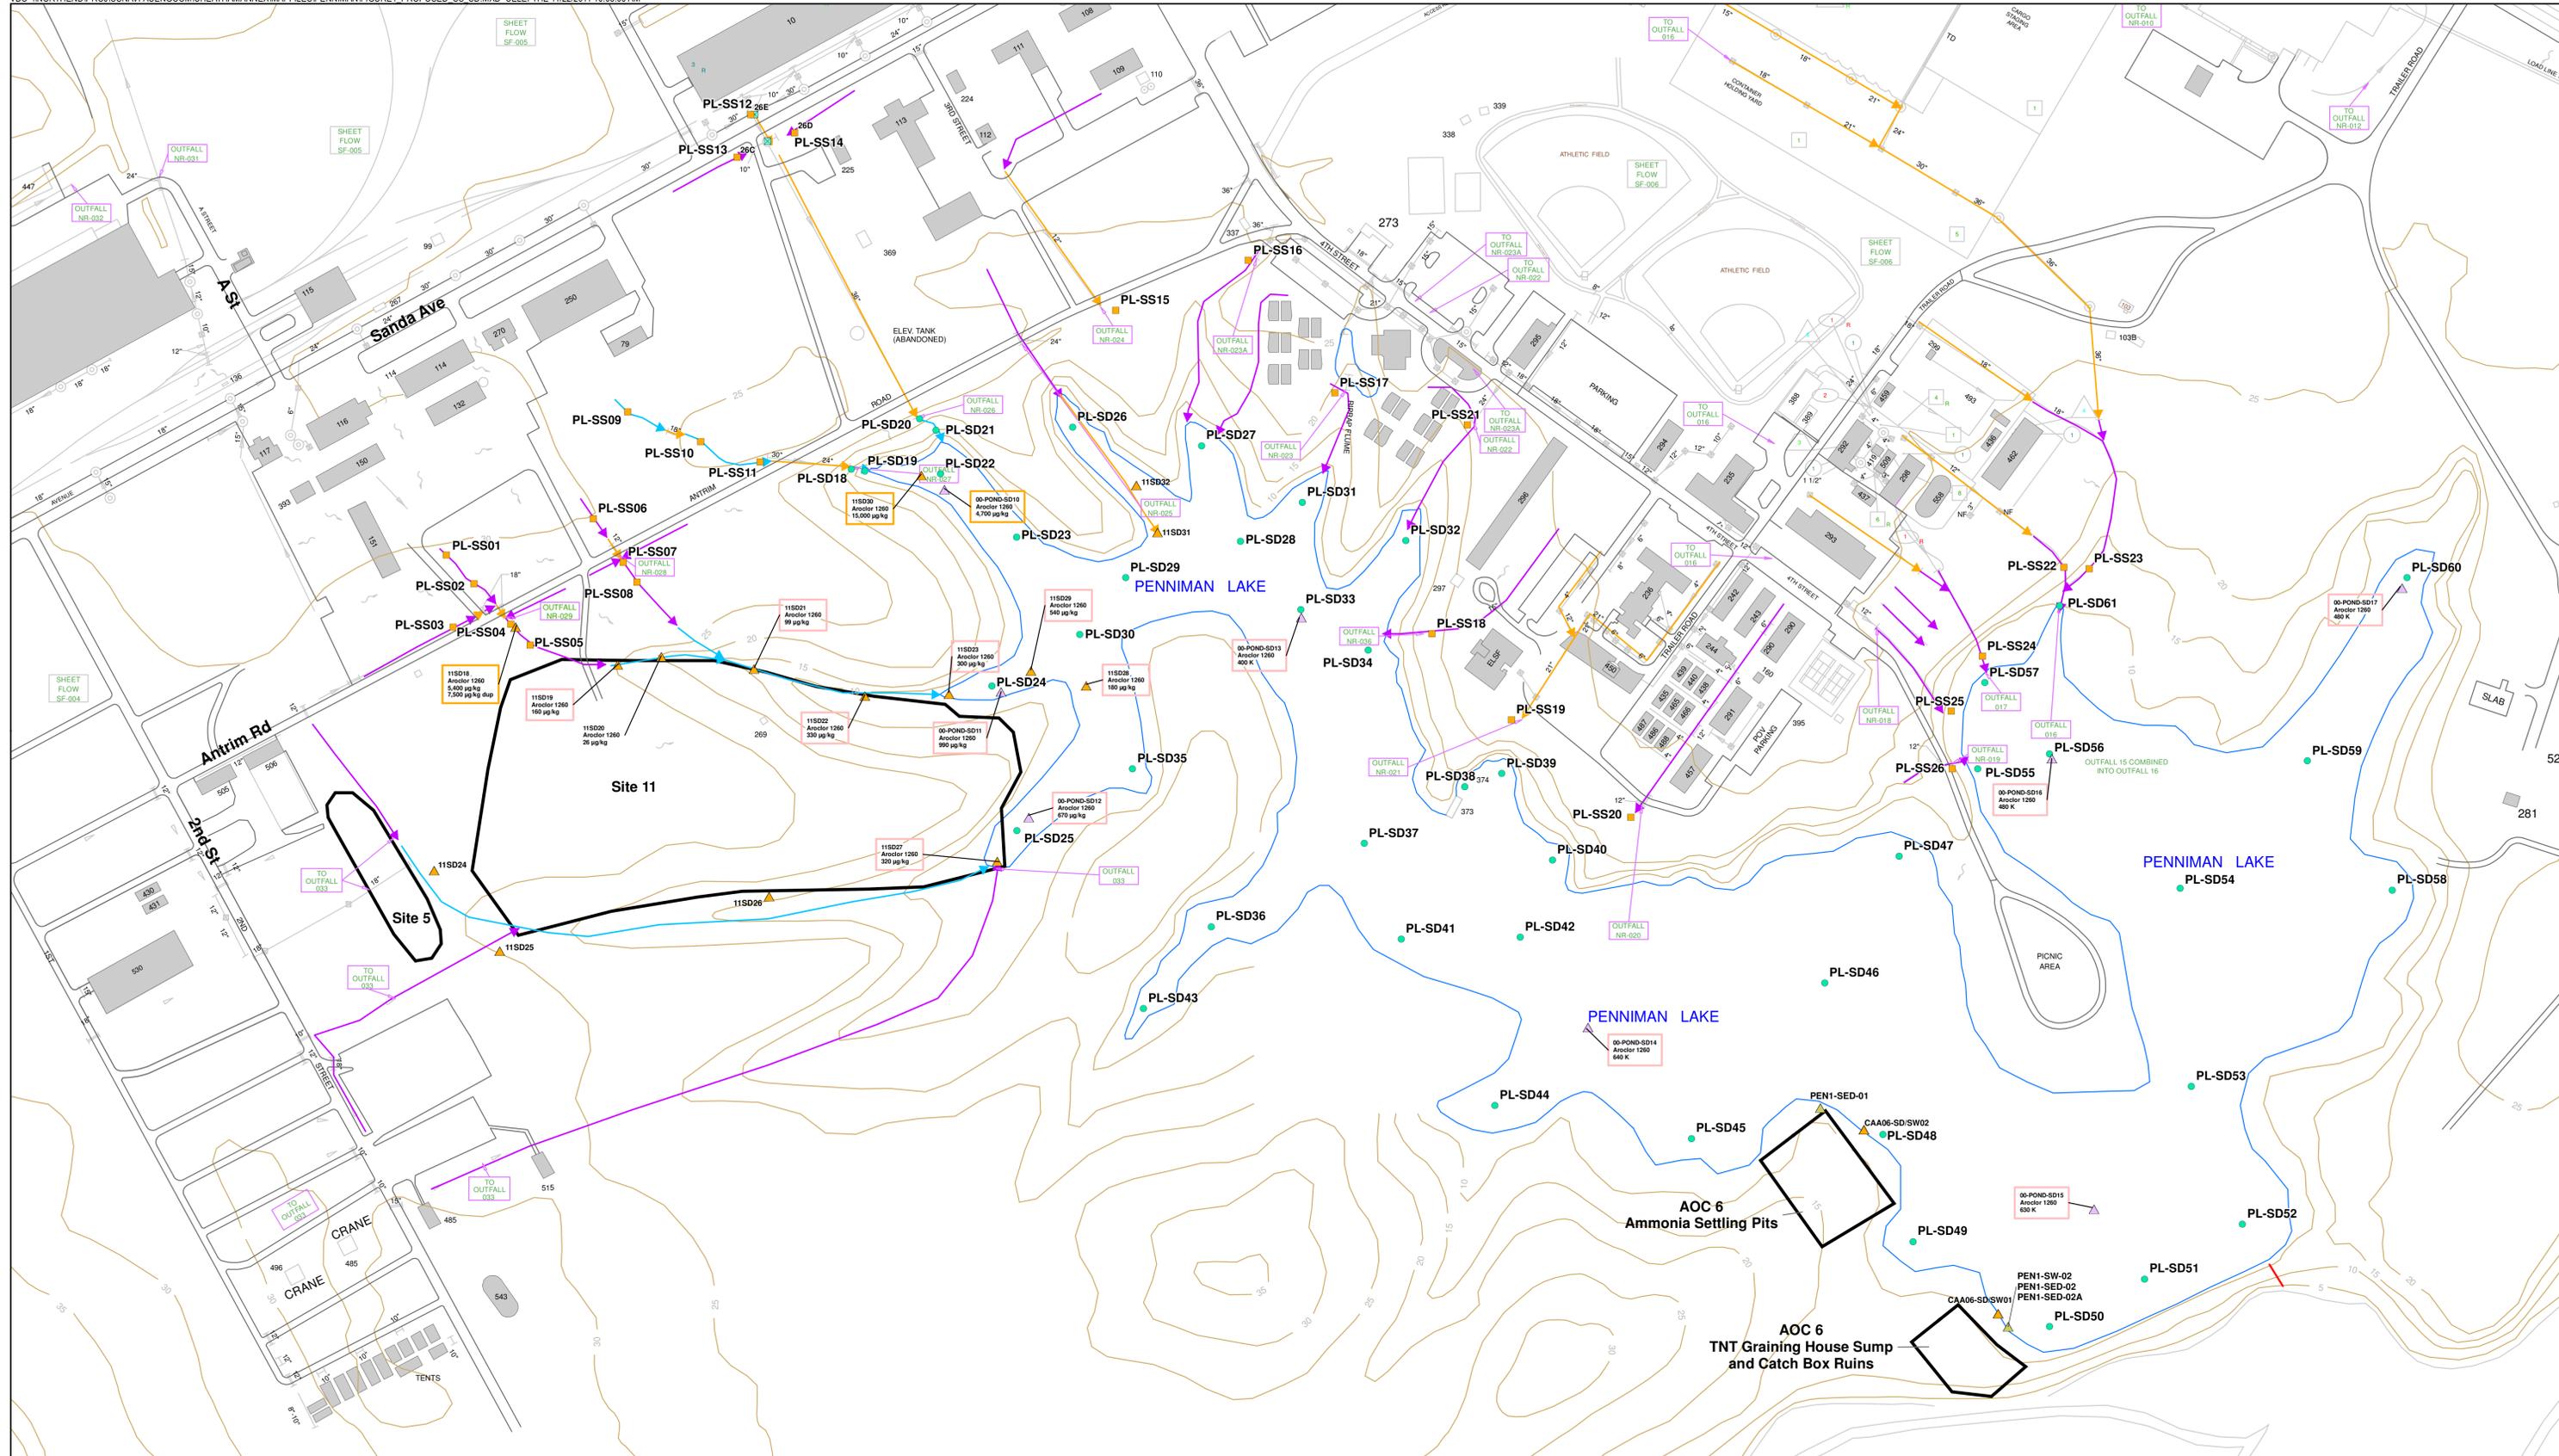
Figure 4  
Proposed Surface Soil and Surface Sediment Sample Locations  
and Previous Investigation Results  
Penniman Lake  
Cheatham Annex  
Williamsburg, Virginia  
**CH2MHILL**

this investigation, at locations shown on **Figure 4**. The sediment samples were analyzed for Target Compound List (TCL) organic compounds, Target Analyte List (TAL) inorganic constituents, and explosive compounds, while the surface water sample was analyzed for TCL organic compounds, and TAL inorganic constituents. The SI concluded that the activities at the former PSLP had not affected Penniman Lake.

In October 2008, samples of Penniman Lake surface water and sediment were collected from two locations adjacent to AOC 6 (CAA06-SD/SW01 and CAA06-SD/SW02 – **Figure 4**) to determine if AOC 6 has had an impact on the lake (CH2M HILL, 2011). Based on historic sample results and known site activities, the AOC 6 SI analytical parameters did not include PCBs. Thus, these samples do not contribute to the evaluation of Penniman Lake PCB contamination, but are mentioned here to complete the list of samples collected from the lake prior to the current Step 1 SI activities.

11SD18  
Aroclor 1260  
5,400 ppb

11SD21  
Aroclor 1260  
99 ppb

Detect Exceeds Human Health Risk Screening Level (2,200 ppb for sediment)

Detect Exceeds Ecological Risk Screening Level (59.8 ppb for sediment)

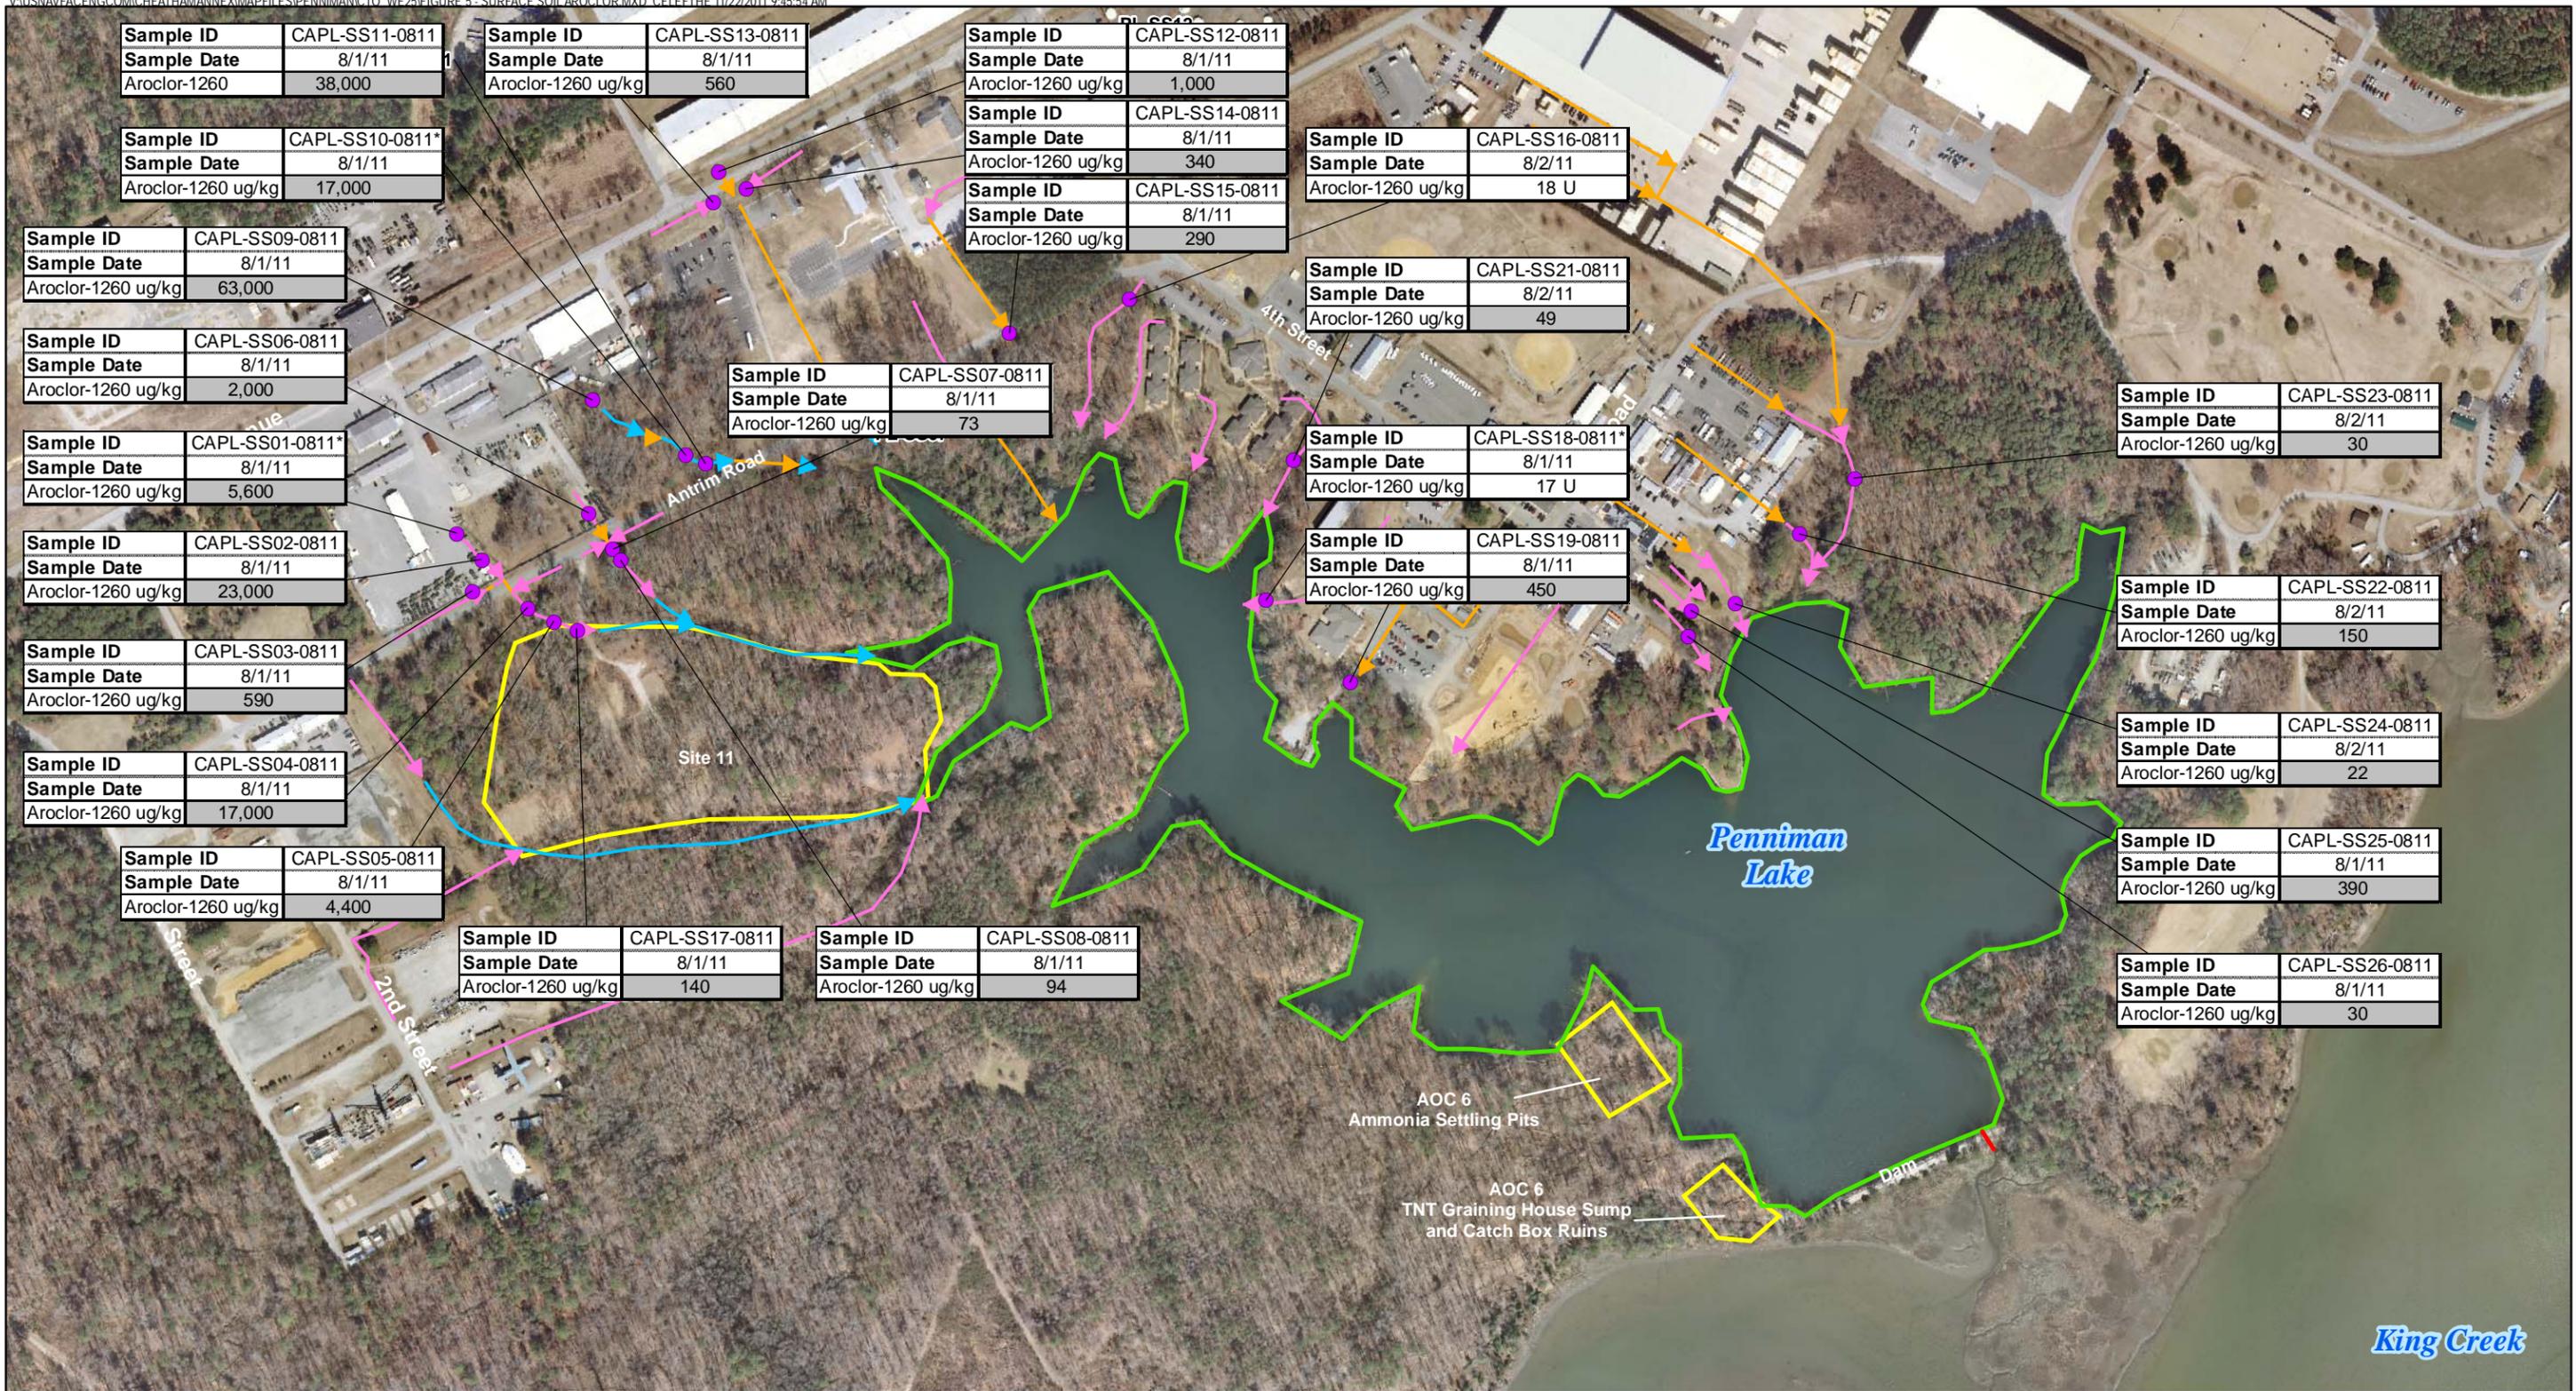
Figure 5  
Surface Soil Aroclor-1260 Results  
Penniman Lake  
Cheatham Annex  
Williamsburg, Virginia

The only PCB congener group that was detected in surface soil in the vicinity of Penniman Lake was Aroclor-1260. Aroclor-1260 concentrations ranged from below detection limits in surface soil samples SS16 and SS18 to a maximum of 63,000 µg/kg in surface soil sample SS09. The highest Aroclor-1260 surface soil concentrations were detected in the drainage ways leading to the northwest cove of Penniman Lake (**Figure 5**), including sample locations SS02 (23,000 µg/kg), SS04 (17,000 µg/kg), SS10 (17,000 µg/kg), and SS11 (30,000 µg/kg). The surface soil sample collected from immediately beneath the bucket-like container that was identified during the site reconnaissance of the wooded area (SS17) contained Aroclor-1260 at 140 µg/kg. Given this relatively low Aroclor-1260 concentration and the significantly higher concentrations in upstream samples, this container does not appear to represent a PCB source.

Sample ID	CAPL-SS11-0811
Sample Date	8/1/11
Aroclor-1260	38,000

Sample ID	CAPL-SS09-0811
Sample Date	8/1/11
Aroclor-1260 ug/kg	63,000

Sample ID	CAPL-SS02-0811
Sample Date	8/1/11
Aroclor-1260 ug/kg	23,000

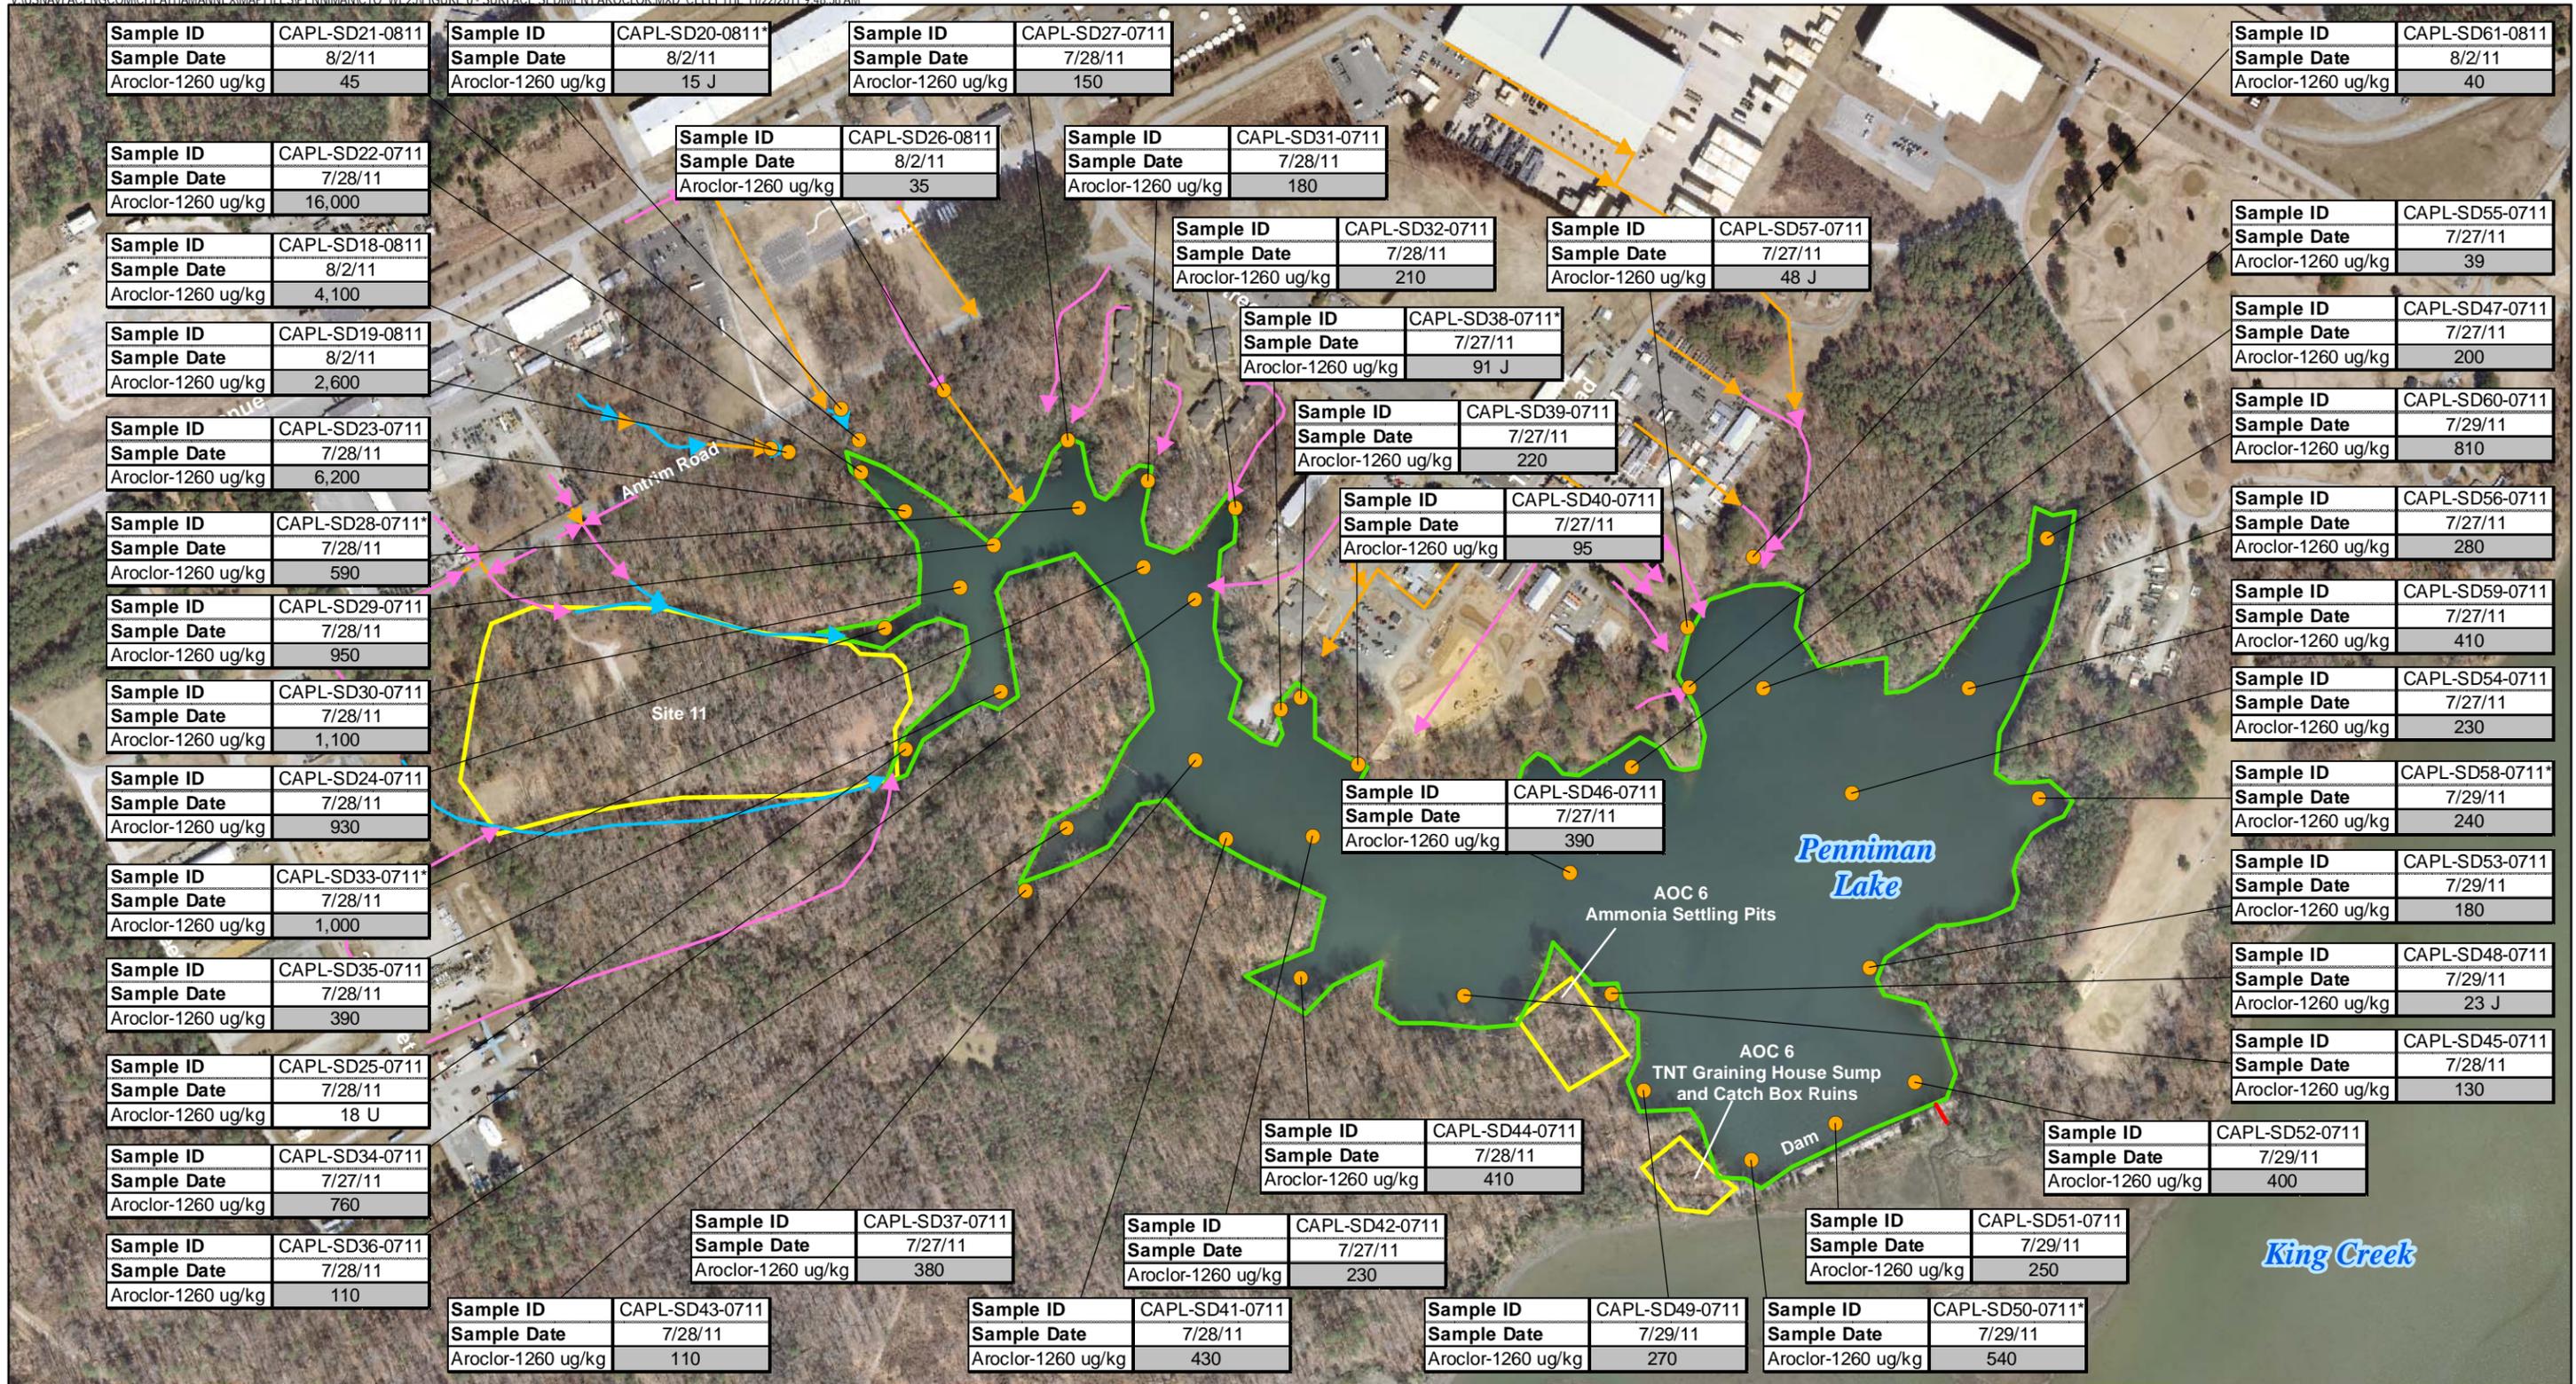
Figure 6  
Surface Sediment Aroclor-1260  
Penniman Lake  
Cheatham Annex  
Williamsburg, Virginia

The only PCB congener group that was detected in surface sediment samples in Penniman Lake was Aroclor-1260. Aroclor-1260 concentrations ranged from below the detection limit in surface sediment sample SD25 to a maximum of 16,000 µg/kg in sample SD22. The highest surface sediment concentrations were detected in the sediment samples collected in the northwest cove of Penniman Lake (**Figure 6**). Outside of the northwest cove area, the highest Aroclor-1260 concentration was 810 µg/kg in surface sediment sample SD60, located in the northeast finger of Penniman Lake.

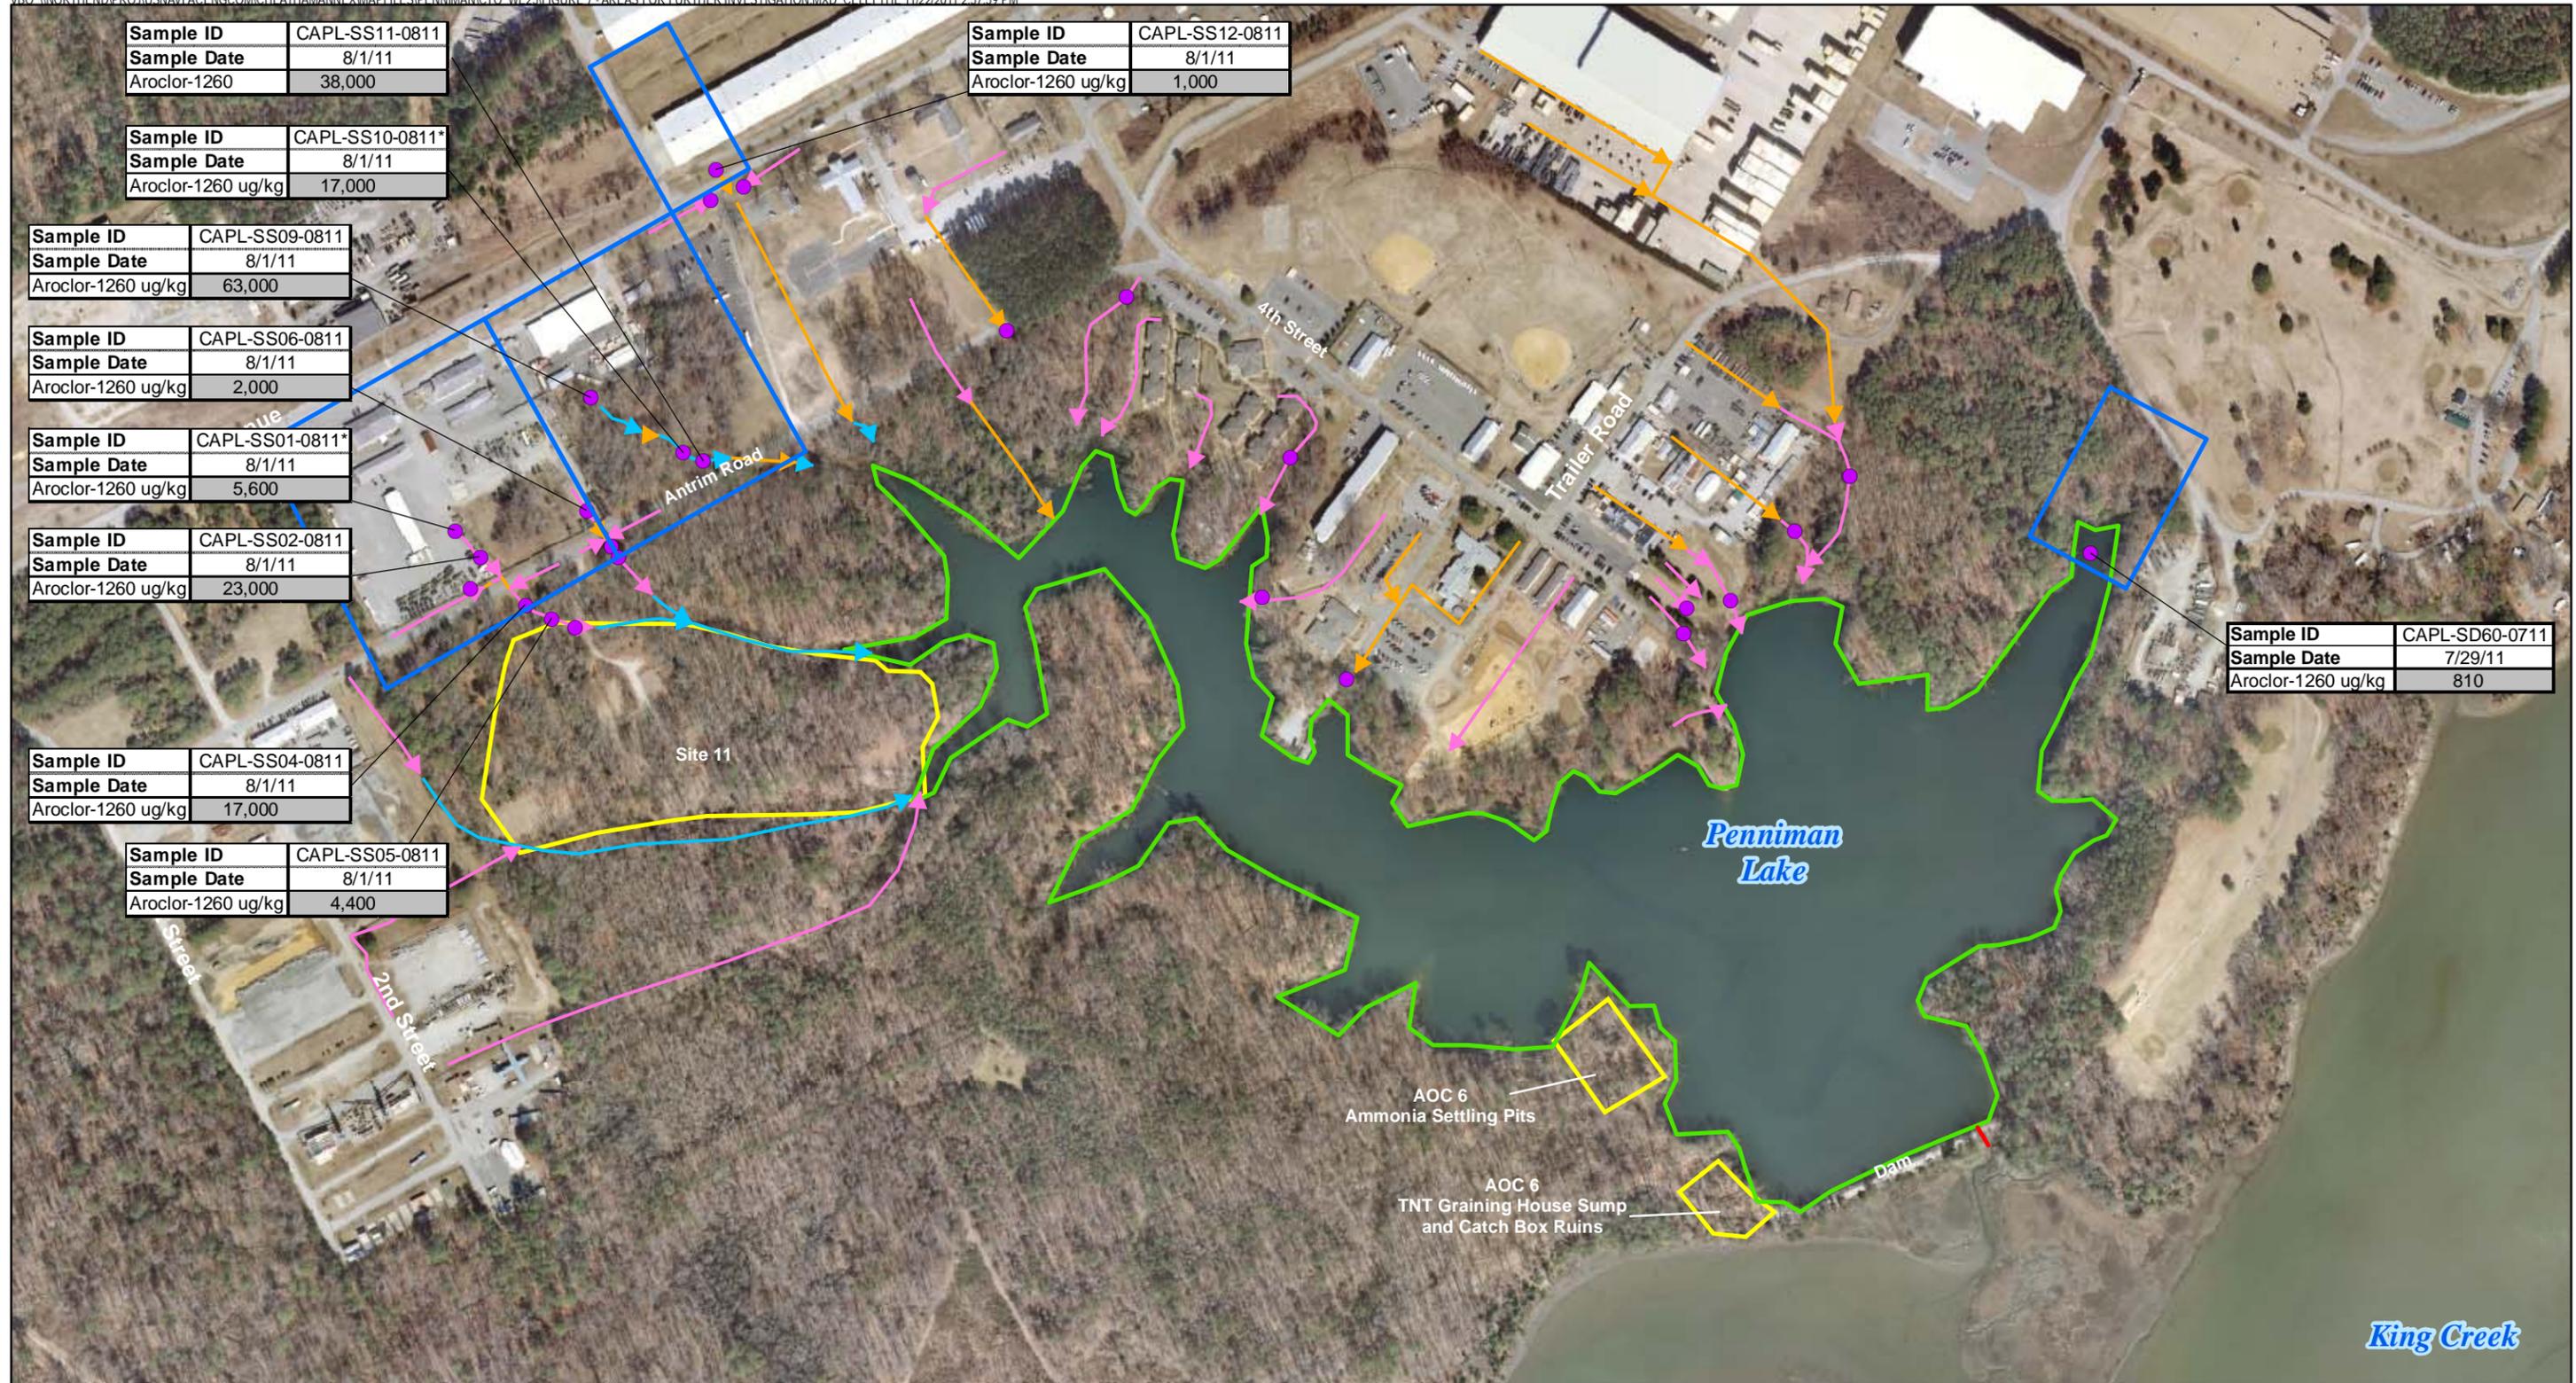
Figure 7  
Areas of Further Investigation  
Penniman Lake  
Cheatham Annex  
Williamsburg, Virginia

Results of the Step 1 PCB sampling indicate that PCBs are distributed throughout Penniman Lake, but the highest concentrations are found in the northwest cove area, nearest the outfalls of the stormwater drainage channels in which the highest concentrations of Aroclor-1260 were detected in upstream surface soil samples. In order to continue the investigation to locate potential sources for the PCBs detected in surface soil and sediment, four areas upstream of Penniman Lake are recommended for Step 2 investigation activities. These areas are shown in **Figure 7**, and include Step 1 sampling locations SS02, SS09, SS12, and SD60, which appear to be along potential migration pathways from a potential PCB source.

In addition, a review of available historical records and information on building usage will be conducted to gather additional information regarding the use of PCBs at the base, and specifically within the four areas recommended for further investigation activities. Lastly, the historic non-PCB data from the Pond Study (Baker 2001), Site 11 RI (Baker, 2007) and AOC 6 SI (CH2M HILL, 2011), will be reviewed to help identify constituents of potential concern that may need further evaluation. The sampling strategy and approach for Step 2 will be determined by the CAX Partnering Team and documented, under separate cover, in an addendum to the UFP-SAP *Site Inspection Sampling and Analysis Plan, Penniman Lake, June 2011*.
