REVISED FINAL SITE INSPECTION REPORT FOR MUNITIONS RESPONSE PROGRAM
SITE UNEXPLODED ORDNANCE 2 NWS YORKTOWN VA
06/01/2011
CH2M HILL

Revised Final
Site Inspection Report
Munitions Response Program Site UXO-2
Naval Weapons Station Yorktown
Yorktown, Virginia

**Site Inspection Report
Munitions Response Program Site UXO-2**

**Naval Weapons Station Yorktown
Yorktown, Virginia**

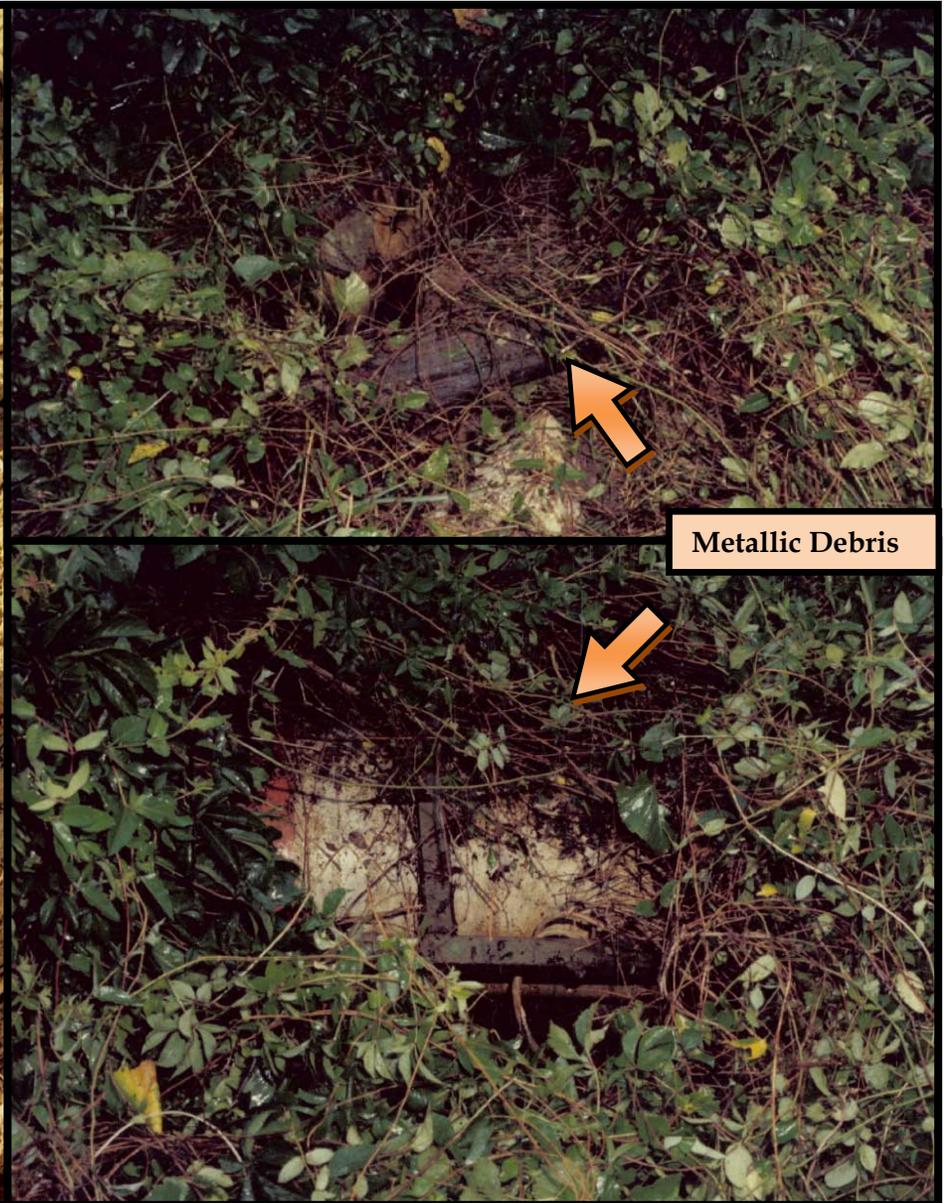
Metallic Debris
