SUMMARY OF REMEDIATION PROJECTS AT PLANT 4 VOLUME 2 OF 2 NAS FORT  
WORTH TX  
1/15/1994  
ENVIRONMENTAL SCIENCE AND ENGINEERING

## Summary of Remediation Projects at Air Force Plant 4 and Carswell Air Force Base

Volume 2

Environmental  
Science &  
Engineering, Inc.

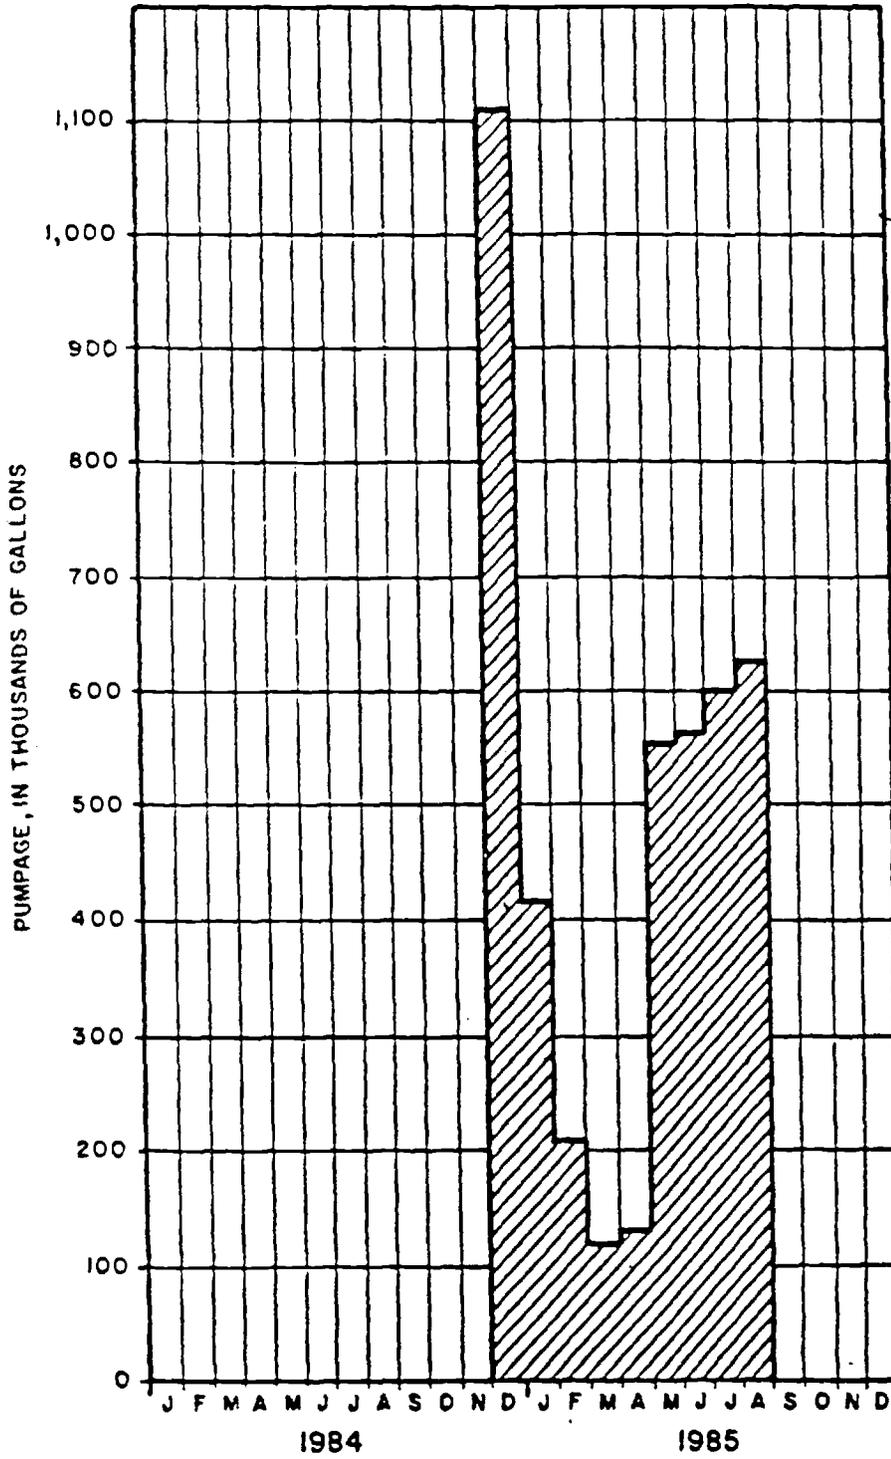
Figure A.2-2 ESTIMATED MONTHLY PUMPAGE FROM FRENCH DRAIN NO. 2  
SOURCES: HARGIS & ASSOCIATES, INC., 1985; ESE.

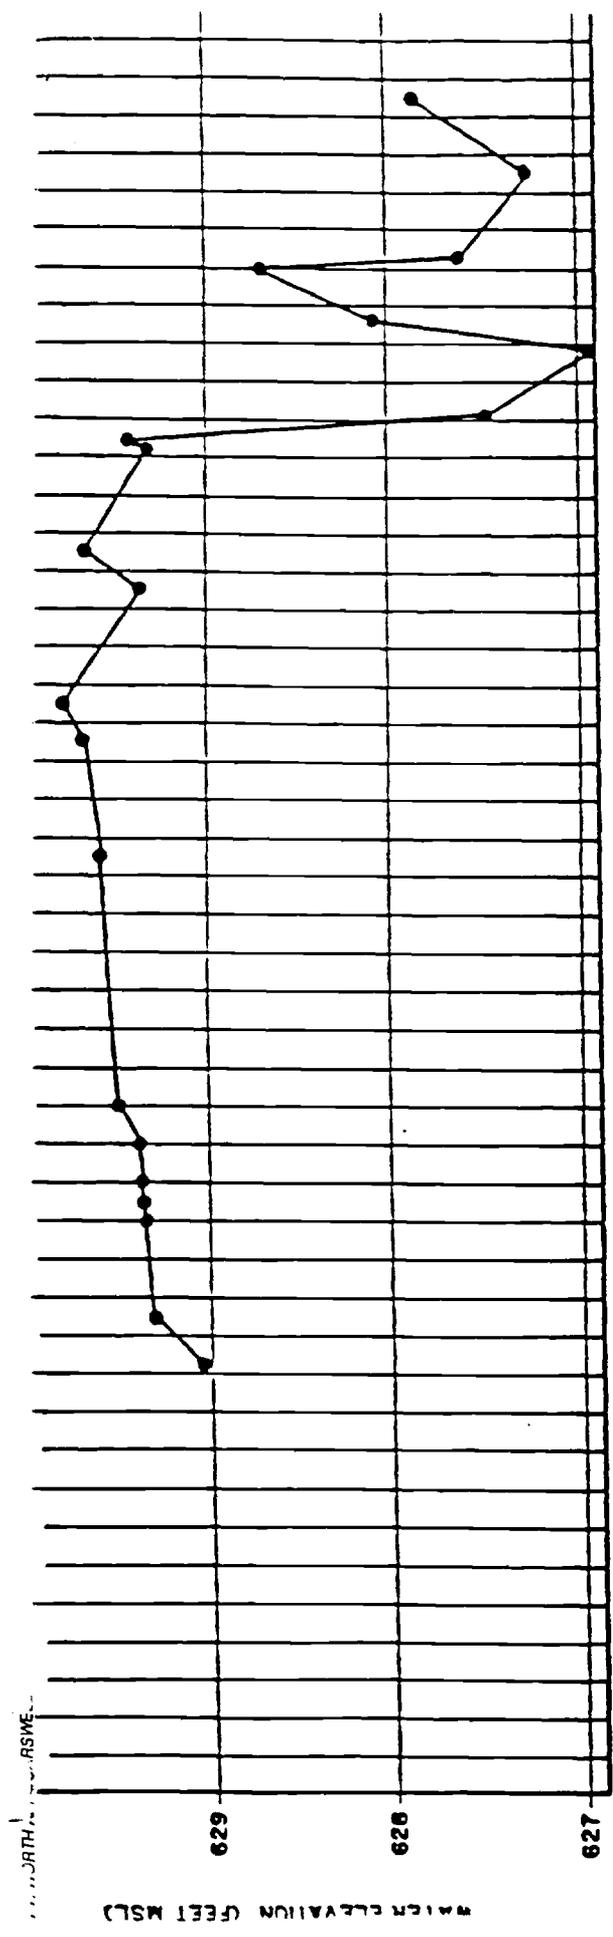
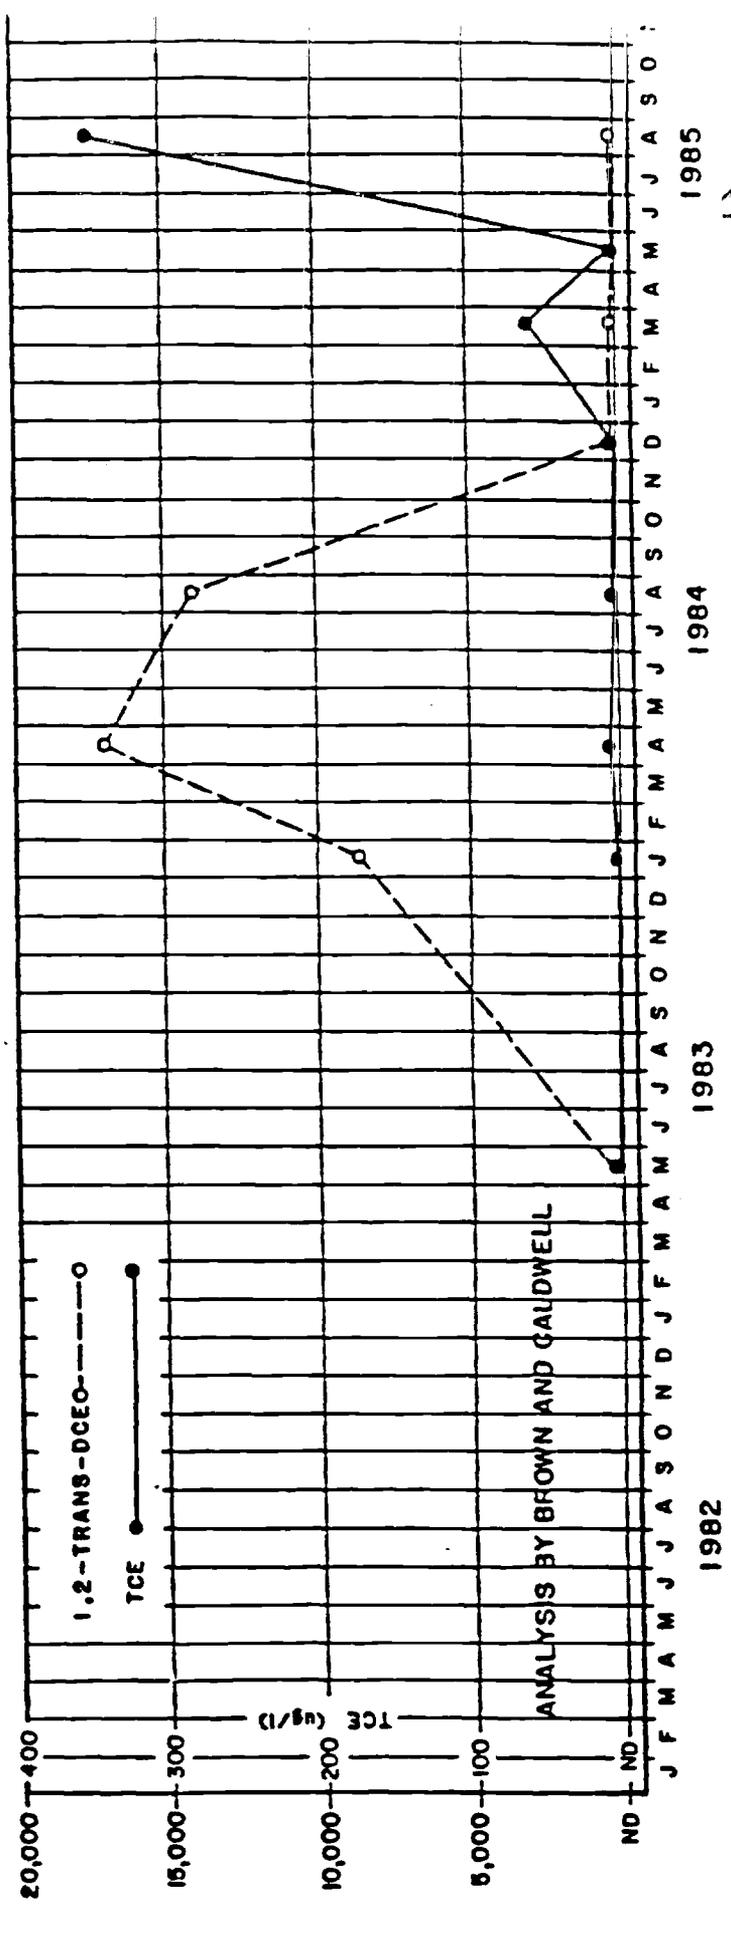
Figure A.2-3 WATER LEVEL AND WATER QUALITY HYDROGRAPH FOR MONITOR WELL HM-7

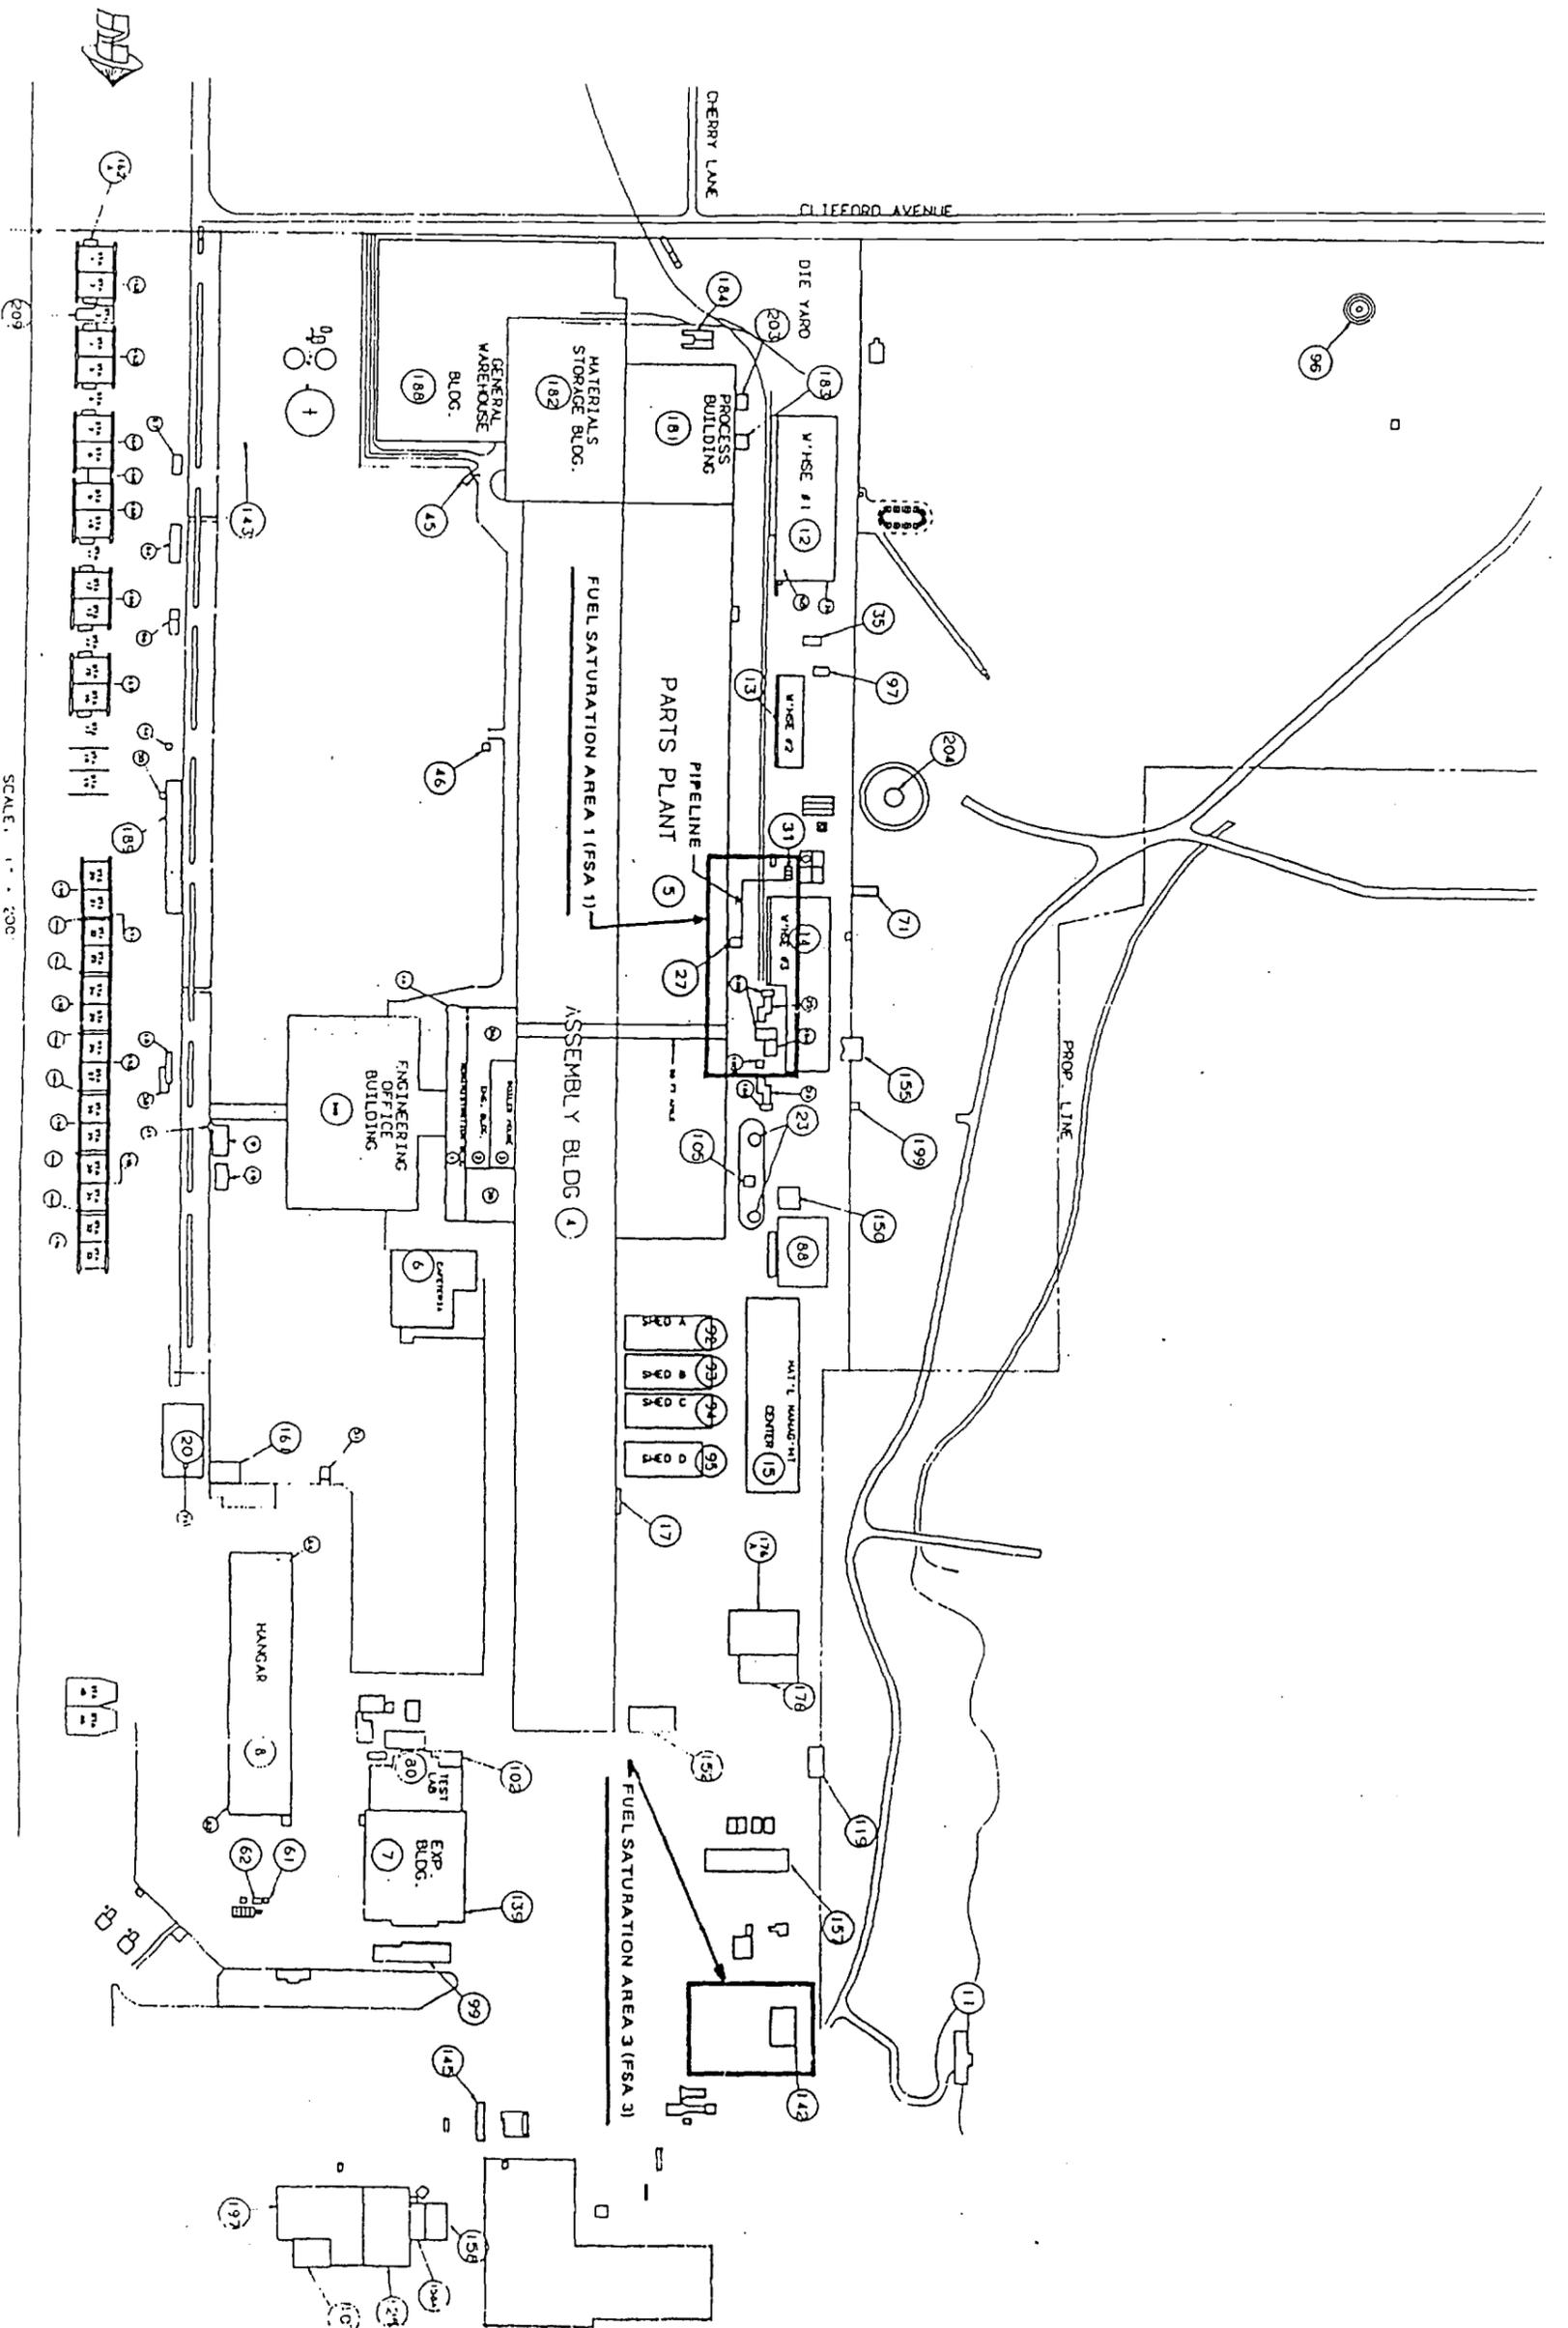
Figure A.3-1 FSA 1 AND FSA 3 LOCATION PLAN

During Phase II investigations, 8 of the 21 sites [Former Fuel Storage Site, Landfill No. 2 (LF02), Landfill No. 4 (LF04), Fire Department Training Area 3 (FDTA 3), FDTA 4, Solvent Lines, Nuclear Aerospace Research Facility (NARF) Area, and Jet Engine Test Stand) were recommended for no further action. One site (FSA-2) has been recommended for further investigation, and the remaining 12 sites have been recommended for remediation. FSA-1 and FSA-3 are depicted in Figure A.3-1.

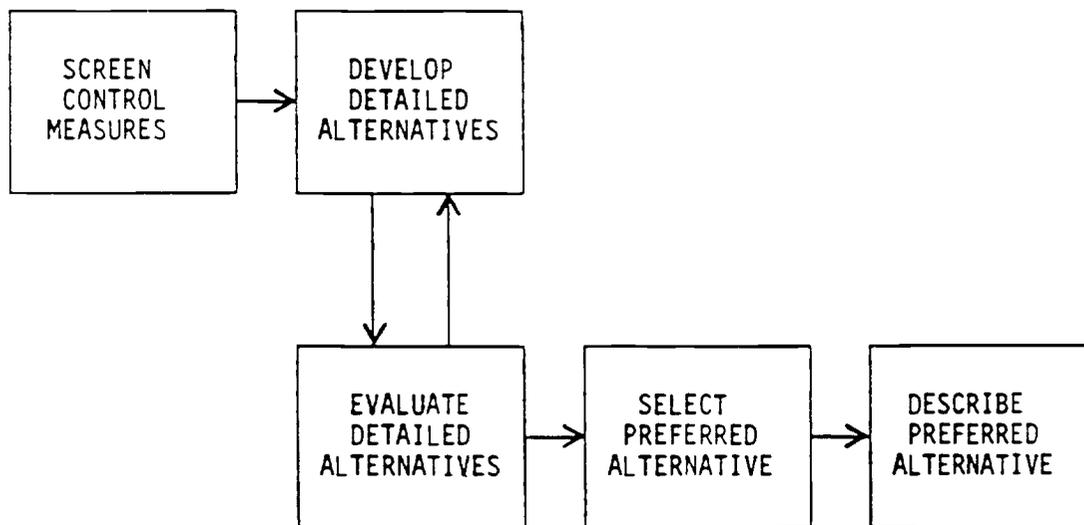
**Figure A.4-3 PREPARATION OF REMEDIAL ACTION PLAN**  
SOURCES: INTELLUS, 1986; ESE.

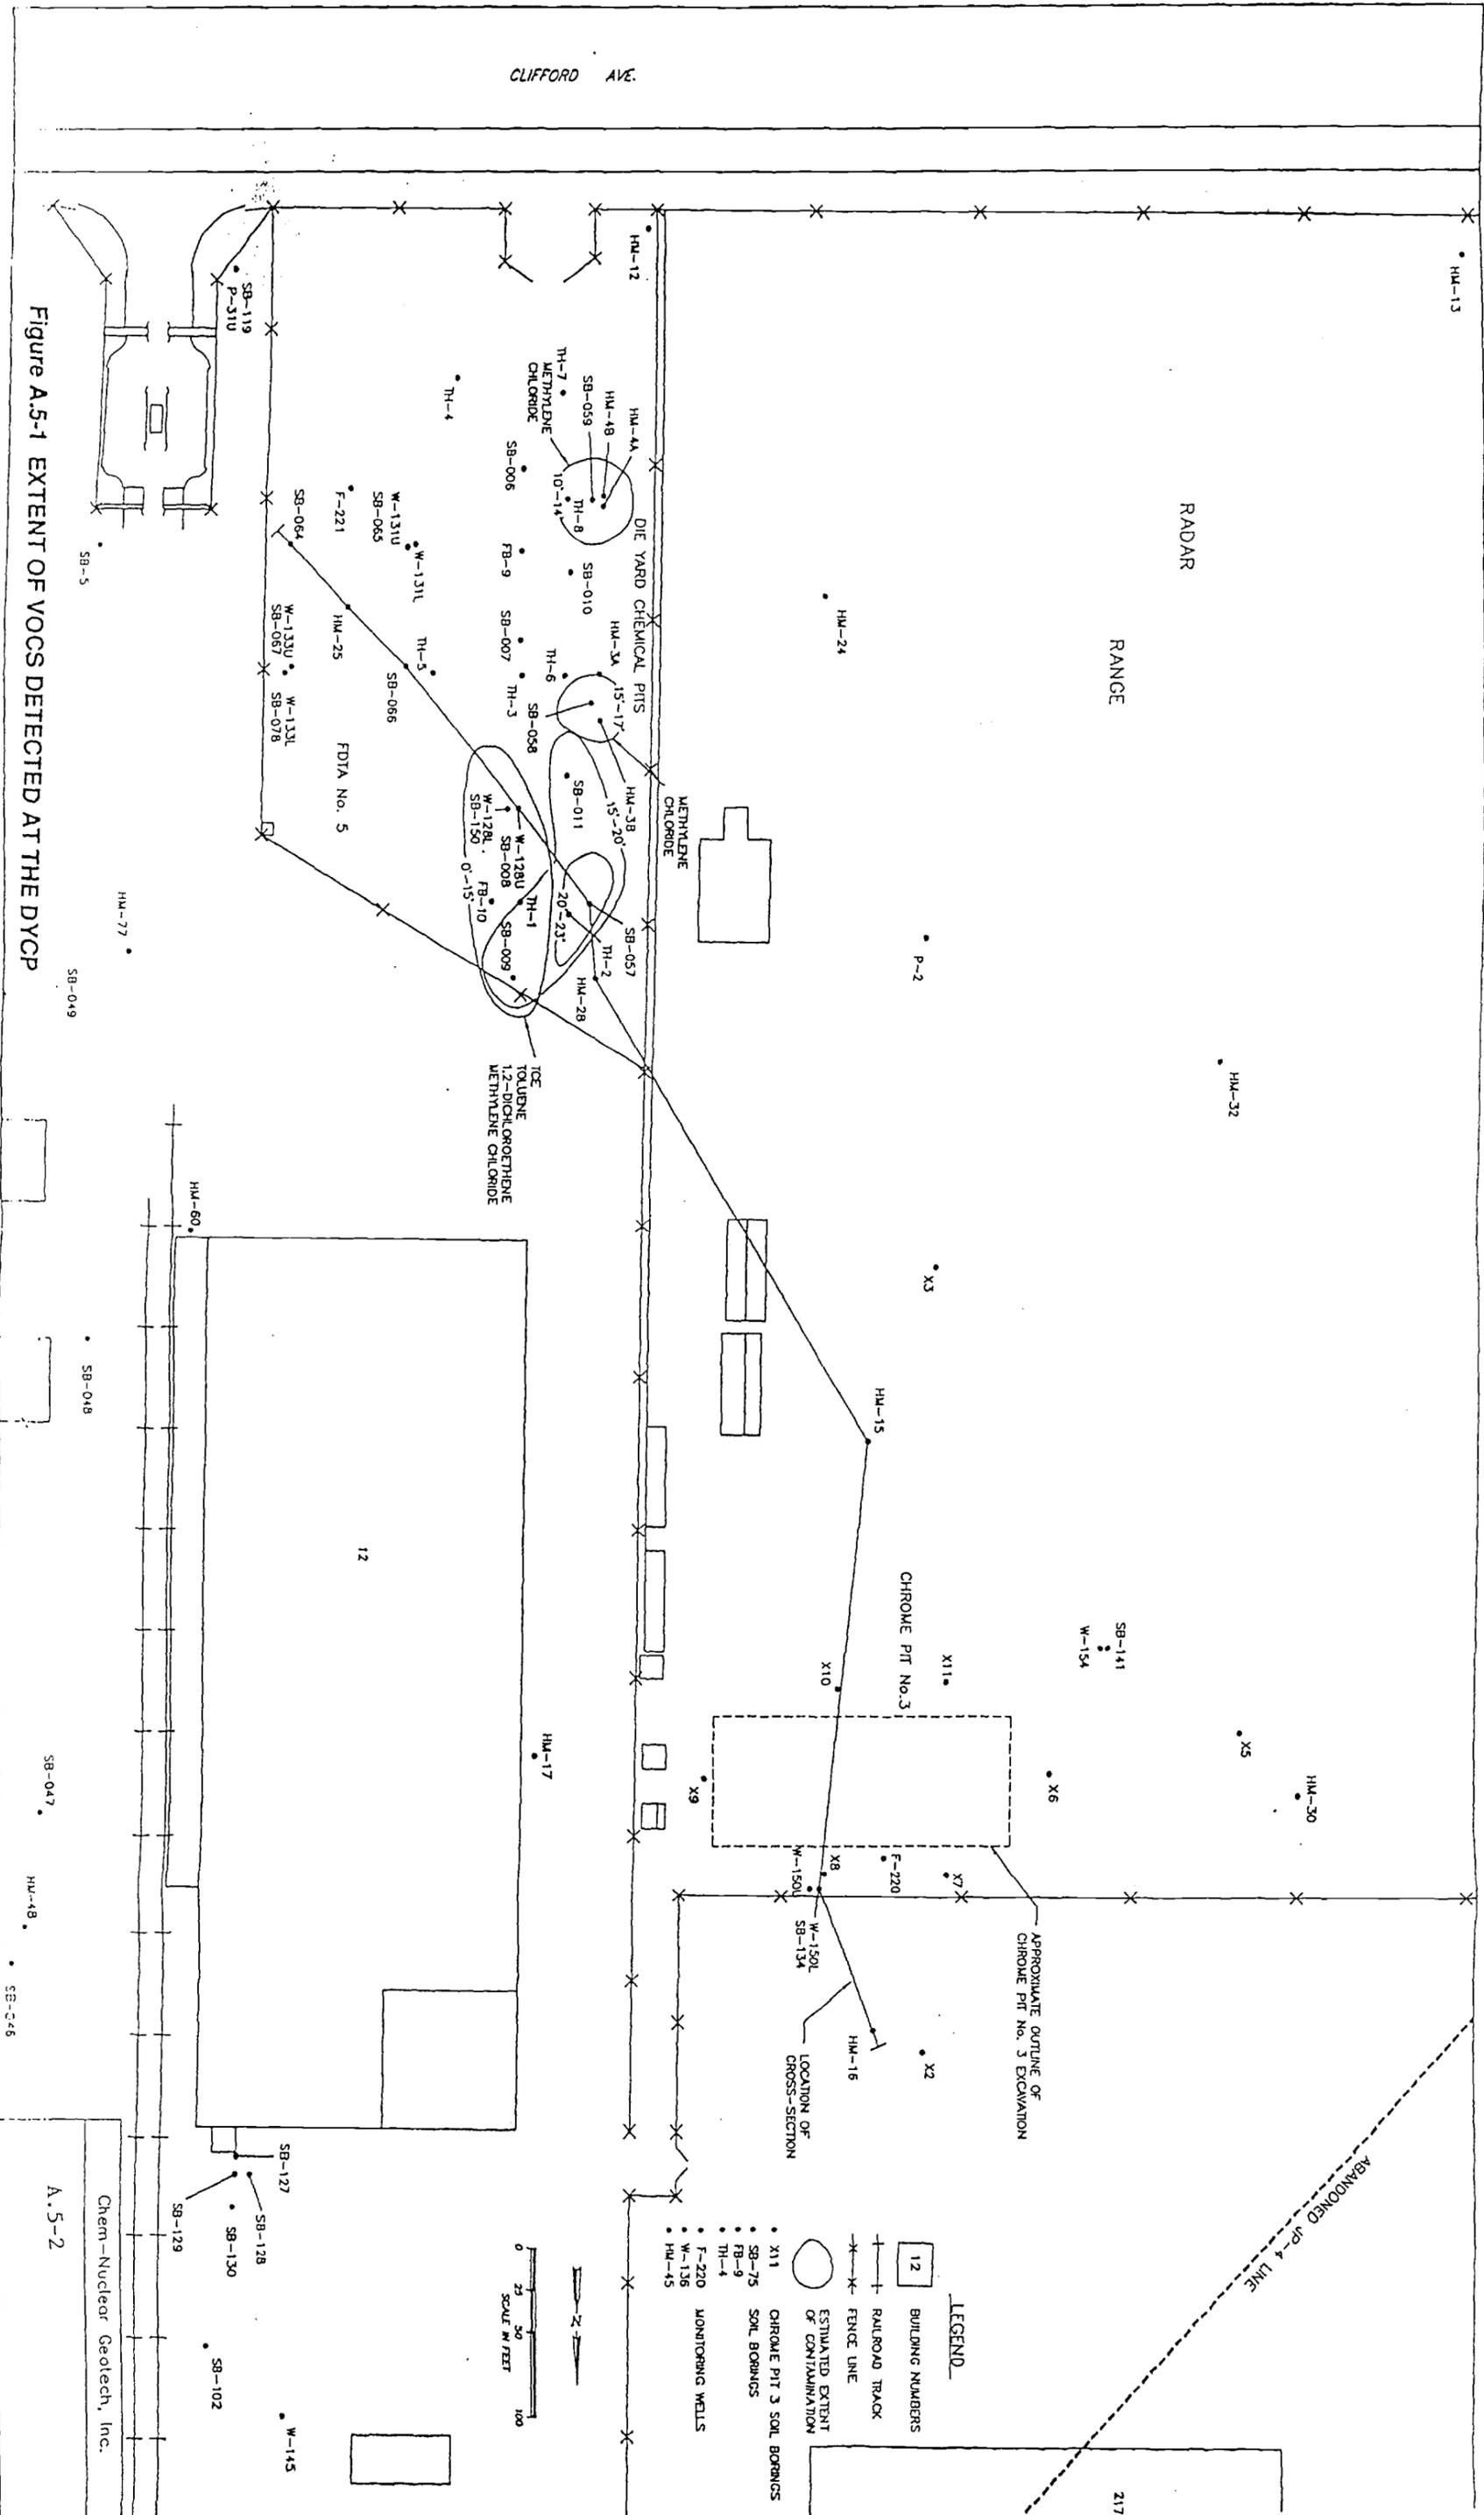
Figure A.5-1 EXTENT OF VOCS DETECTED AT THE DYCP

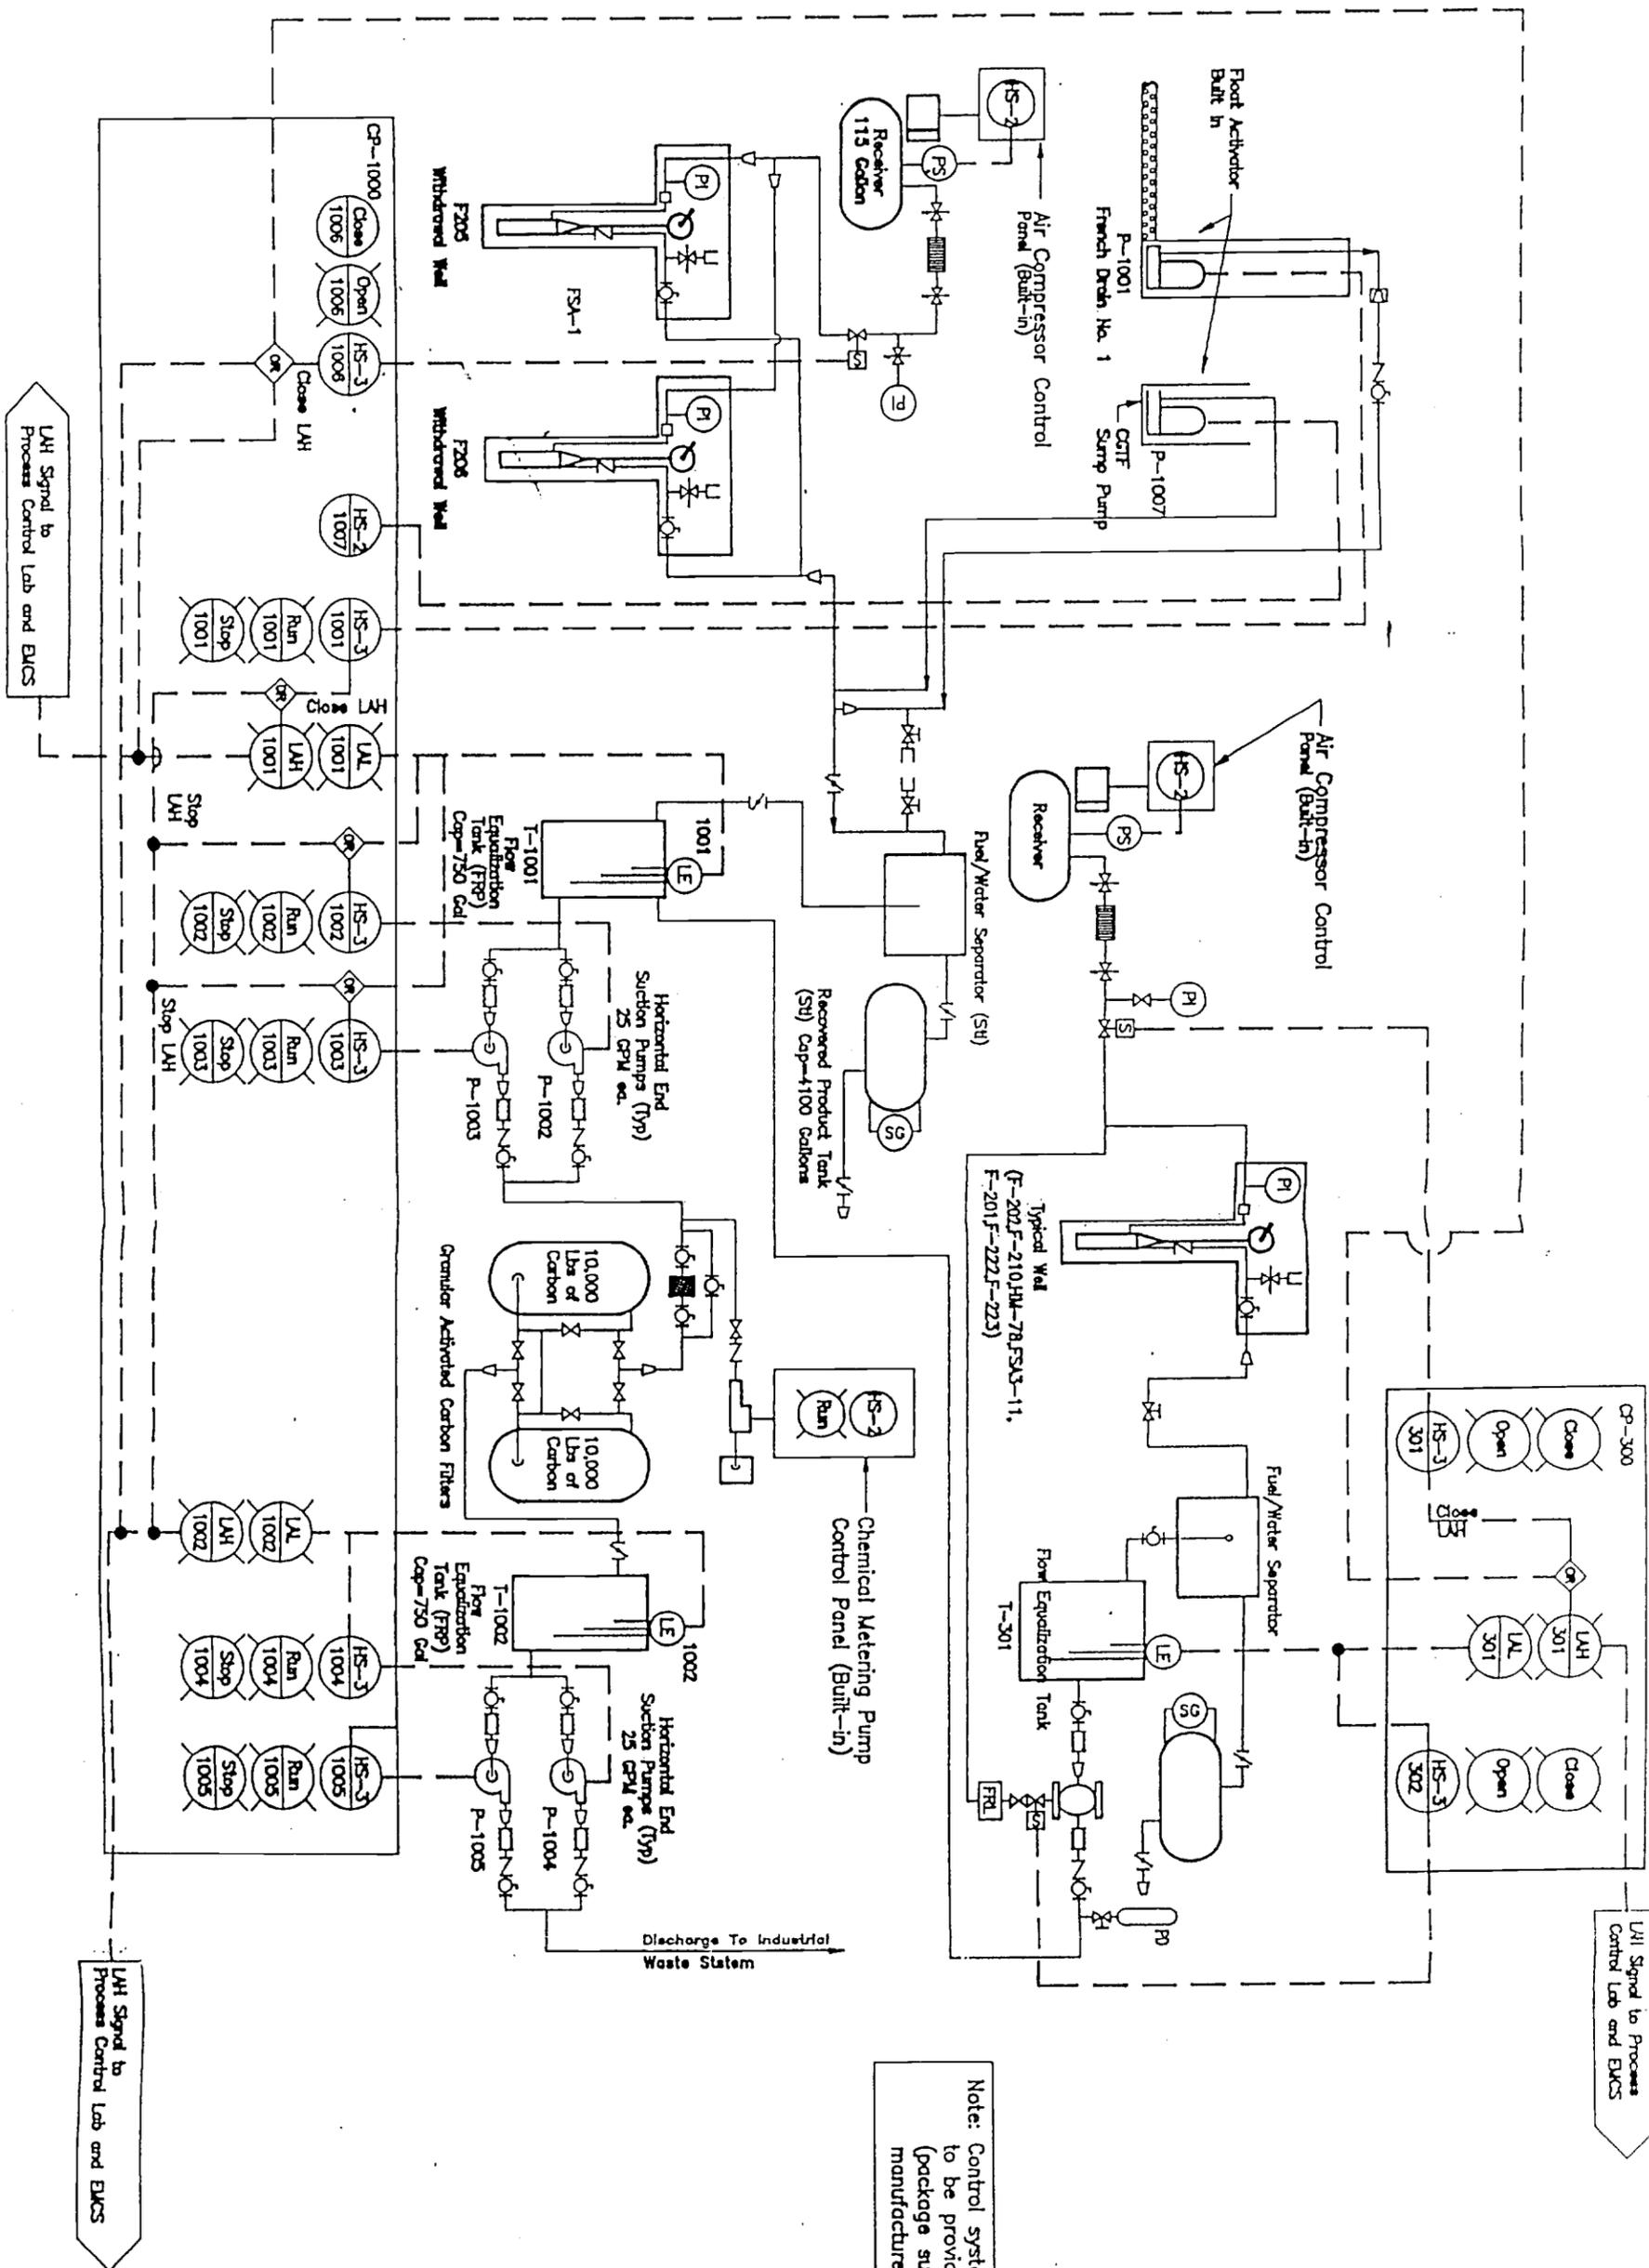
Figure A.7-2 PROCESS AND INSTRUMENTATION DIAGRAM PROJECT NO. G-0601  
 SOURCES: GENERAL DYNAMICS, 1989; ESE

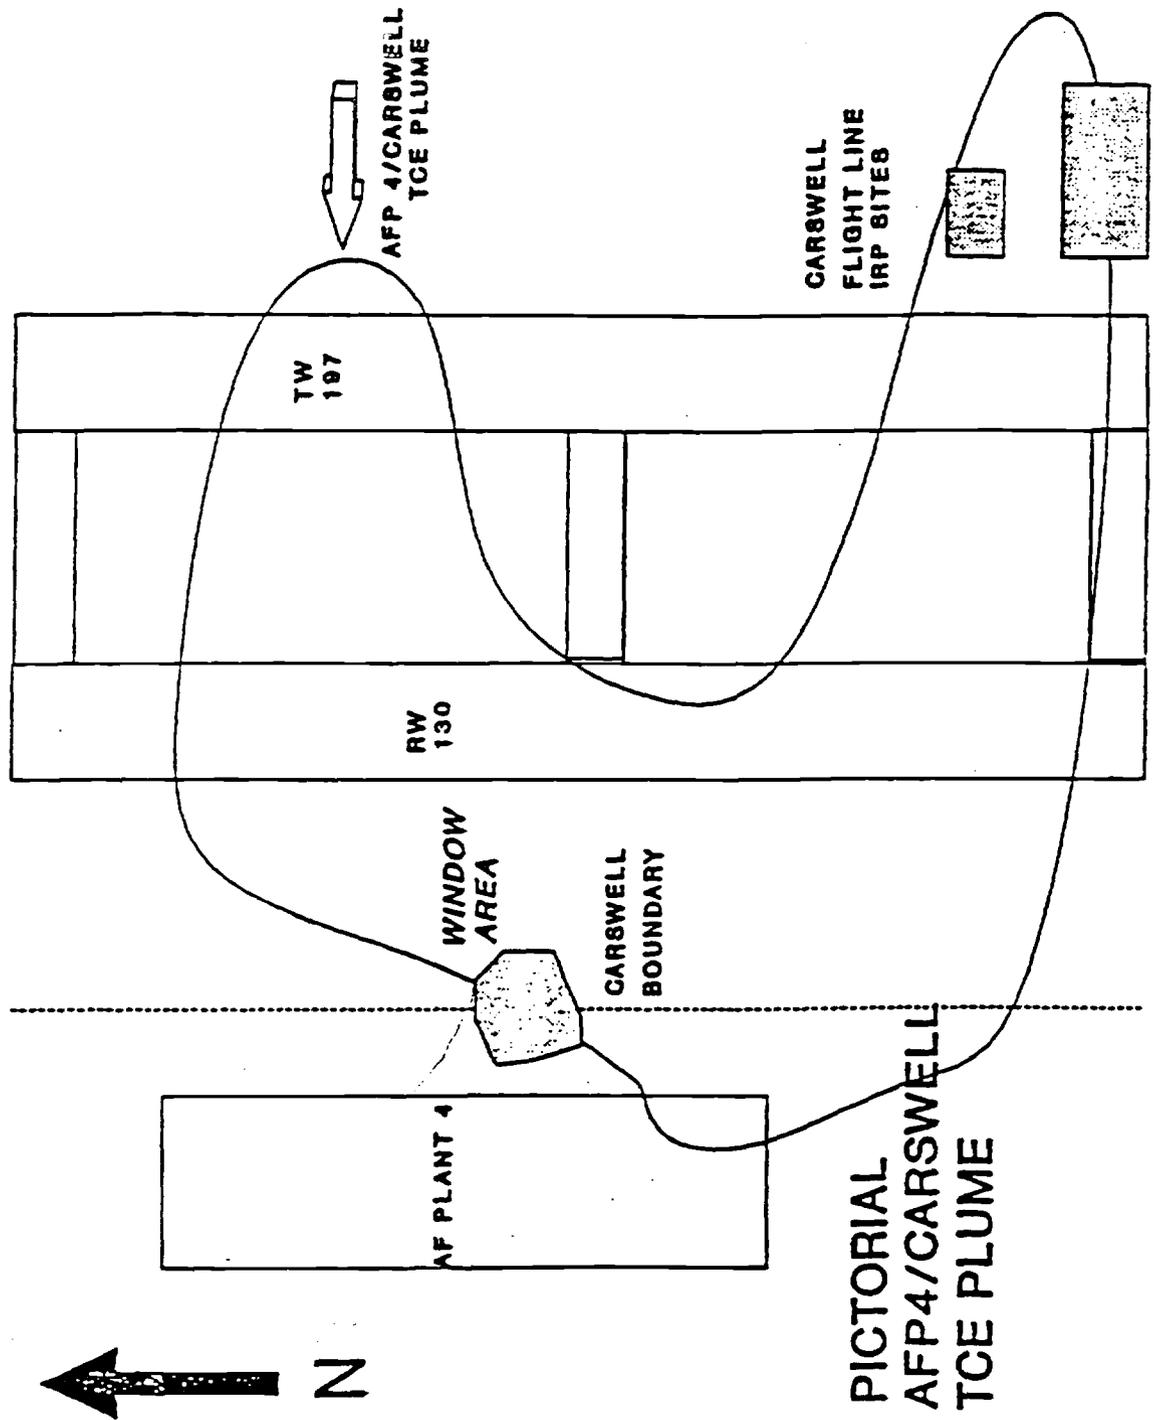
Figure A.9-2 THE EXTENT OF TCE CONTAMINATION

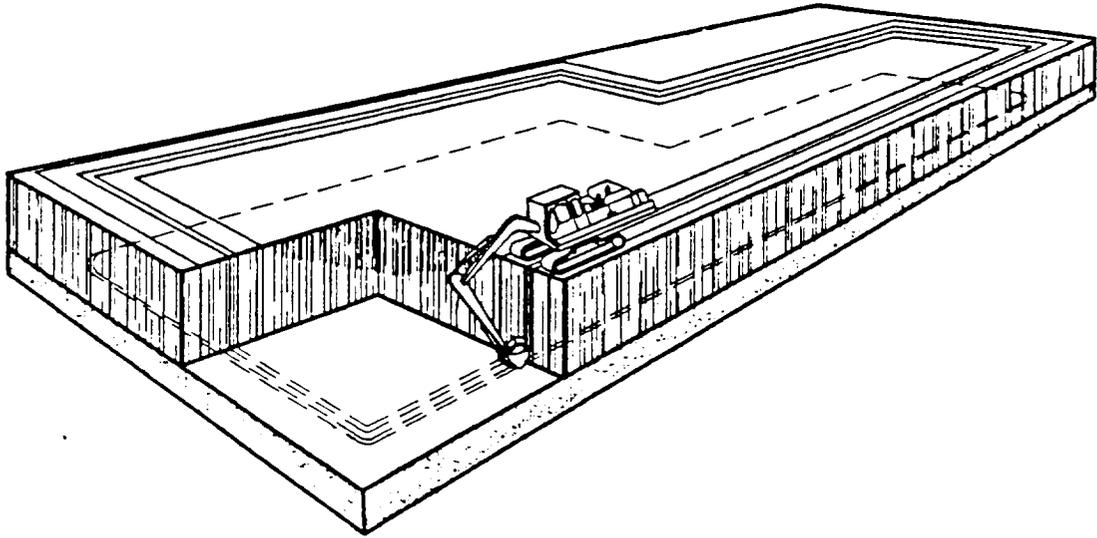
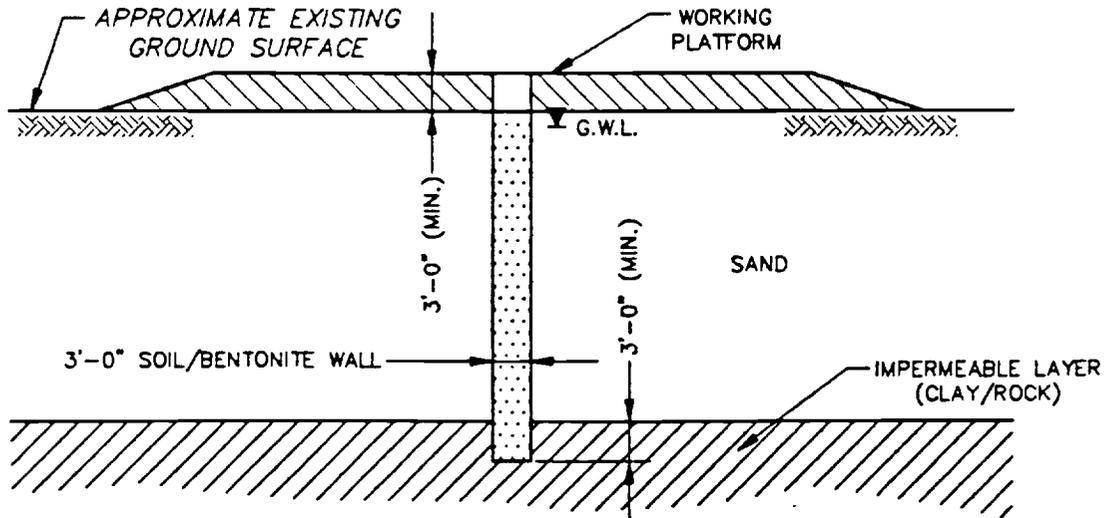
**Figure A.12-2**  
**SLURRY WALL**  
**SCHEMATIC AND CROSS-SECTION**  
**LANDFILL #3**  
SOURCES: IT CORP., 1993; ESE.

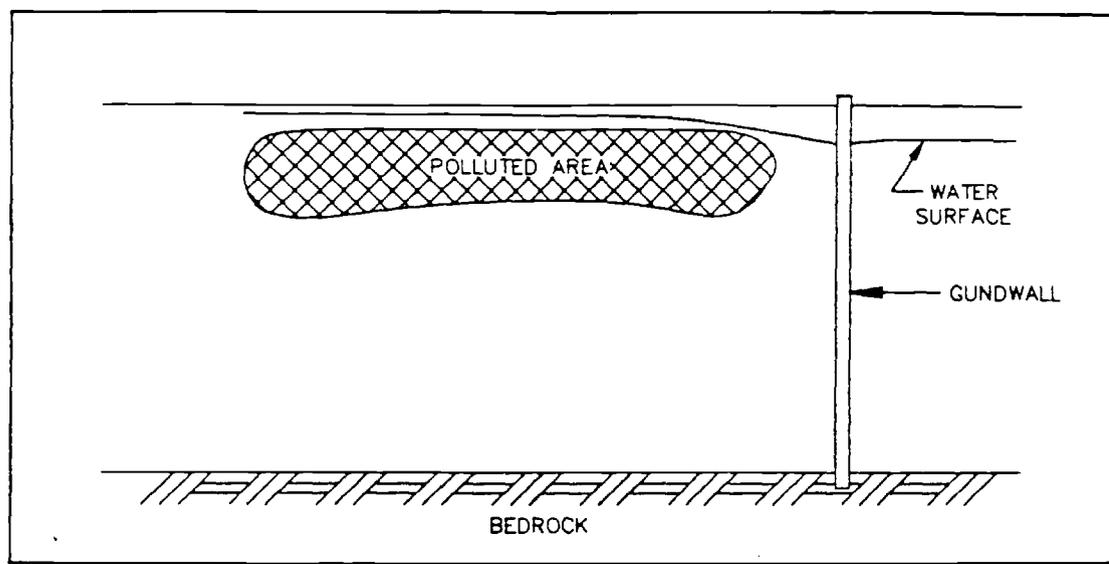
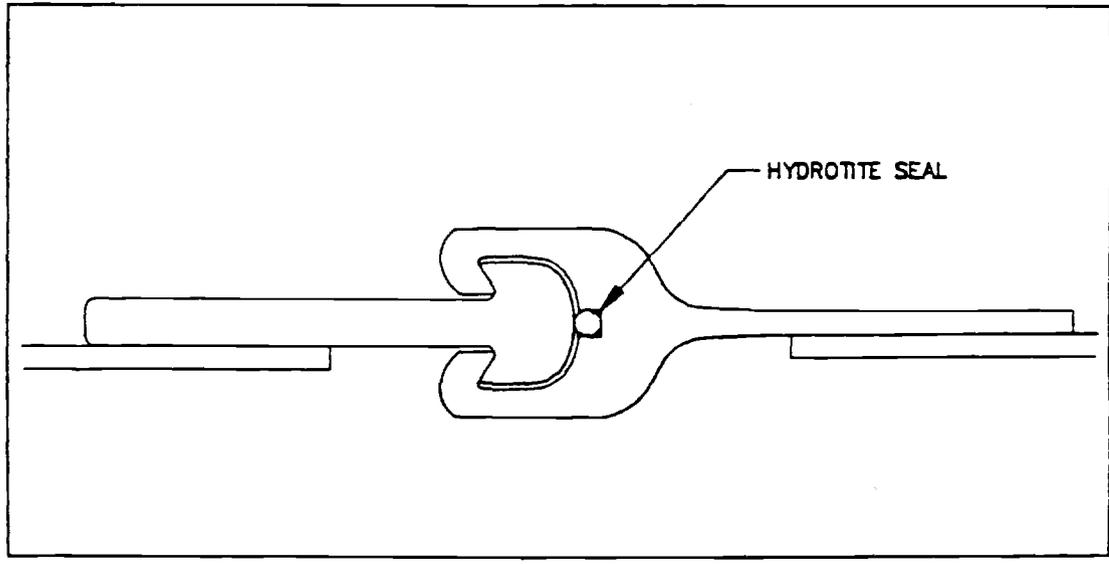
Figure A.12-3  
GUNDWALL CROSS-SECTION  
& INTERLOCK  
LANDFILL #3  
SOURCES: IT CORP., 1993; ESE.

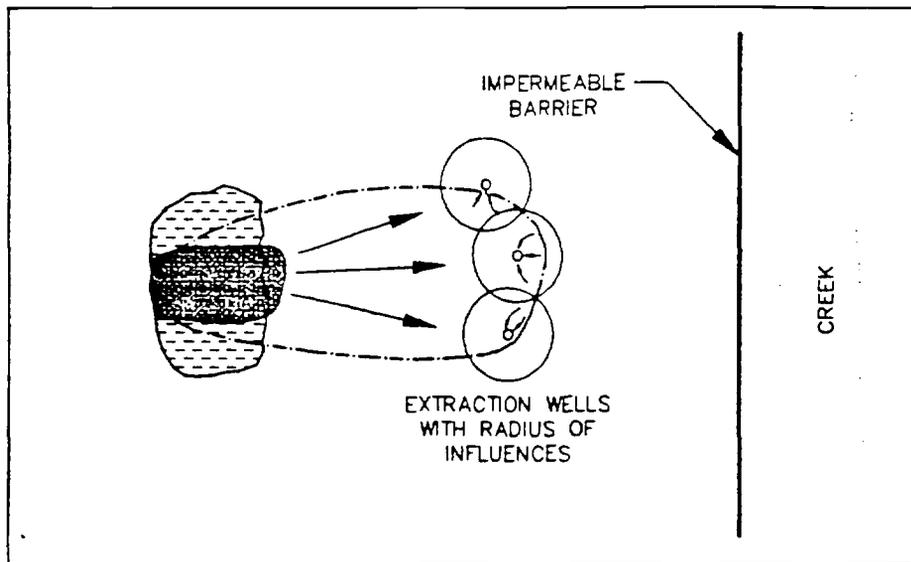
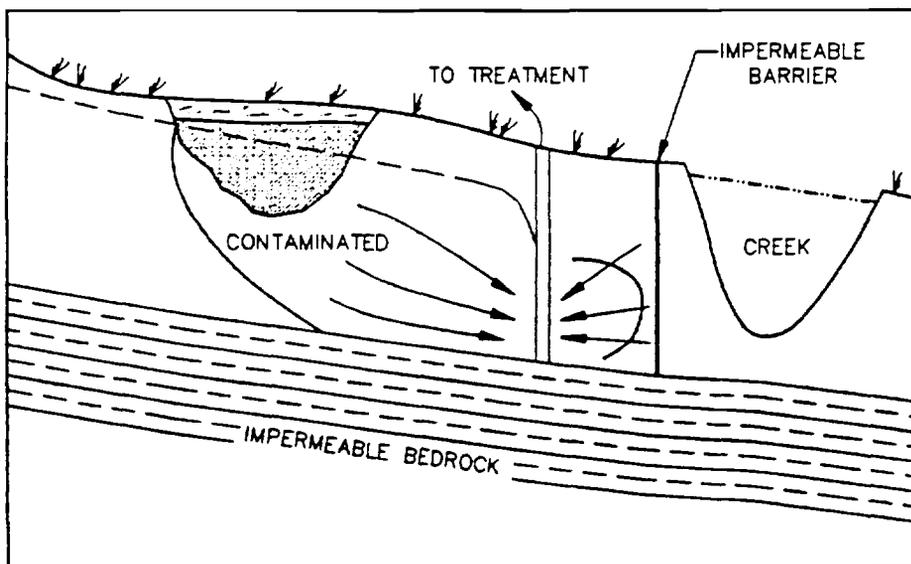
Figure A.12-4  
EXTRACTION WELLS  
AND IMPERMEABLE BARRIER  
PLAN VIEW AND CROSS-SECTION  
LANDFILL #3  
SOURCES: IT CORP., 1993; ESE.

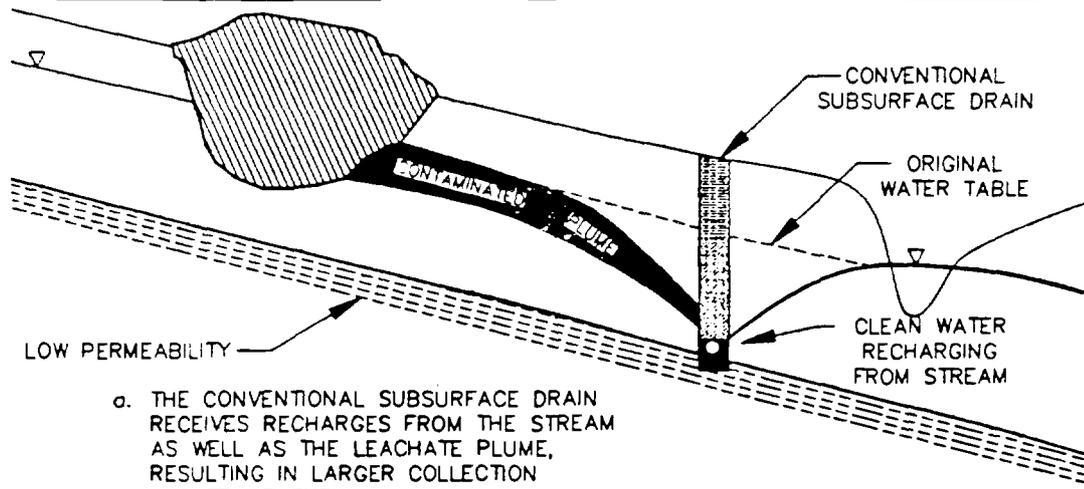
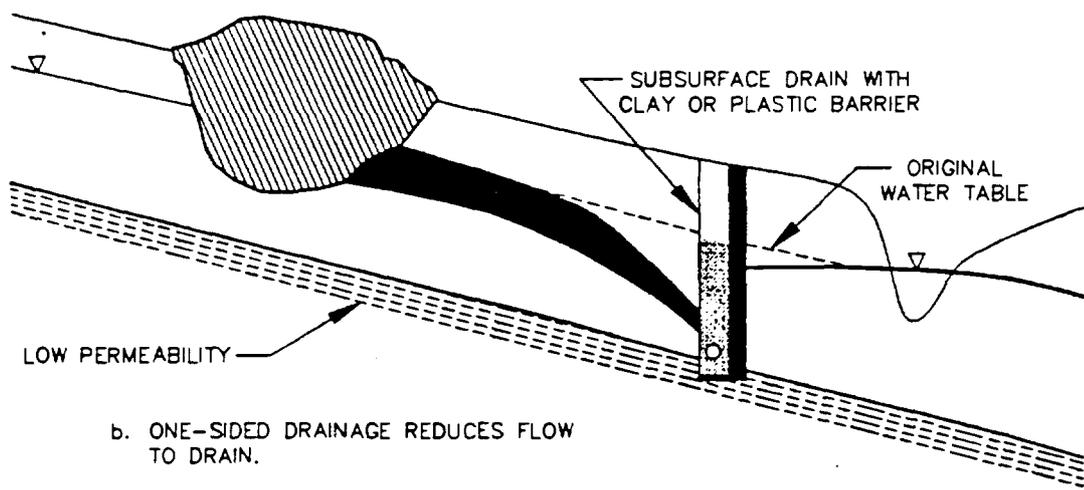
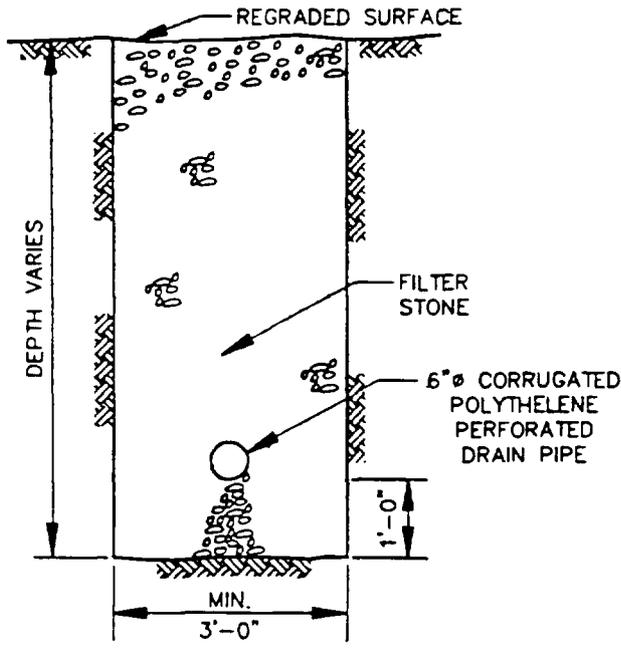
a. THE CONVENTIONAL SUBSURFACE DRAIN RECEIVES RECHARGES FROM THE STREAM AS WELL AS THE LEACHATE PLUME, RESULTING IN LARGER COLLECTION AND TREATMENT.

b. ONE-SIDED DRAINAGE REDUCES FLOW TO DRAIN.

Figure A.12-5  
LEACHATE COLLECTION  
TRENCH SECTIONS  
LANDFILL #3  
SOURCES: IT CORP., 1993; ESE.
