SUMMARY OF REMEDIATION PROJECTS AT PLANT 4 VOLUME 2 OF 2 NAS FORT  
WORTH TX  
1/15/1994  
ENVIRONMENTAL SCIENCE AND ENGINEERING

## Summary of Remediation Projects at Air Force Plant 4 and Carswell Air Force Base

Volume 2

Environmental  
Science &  
Engineering, Inc.

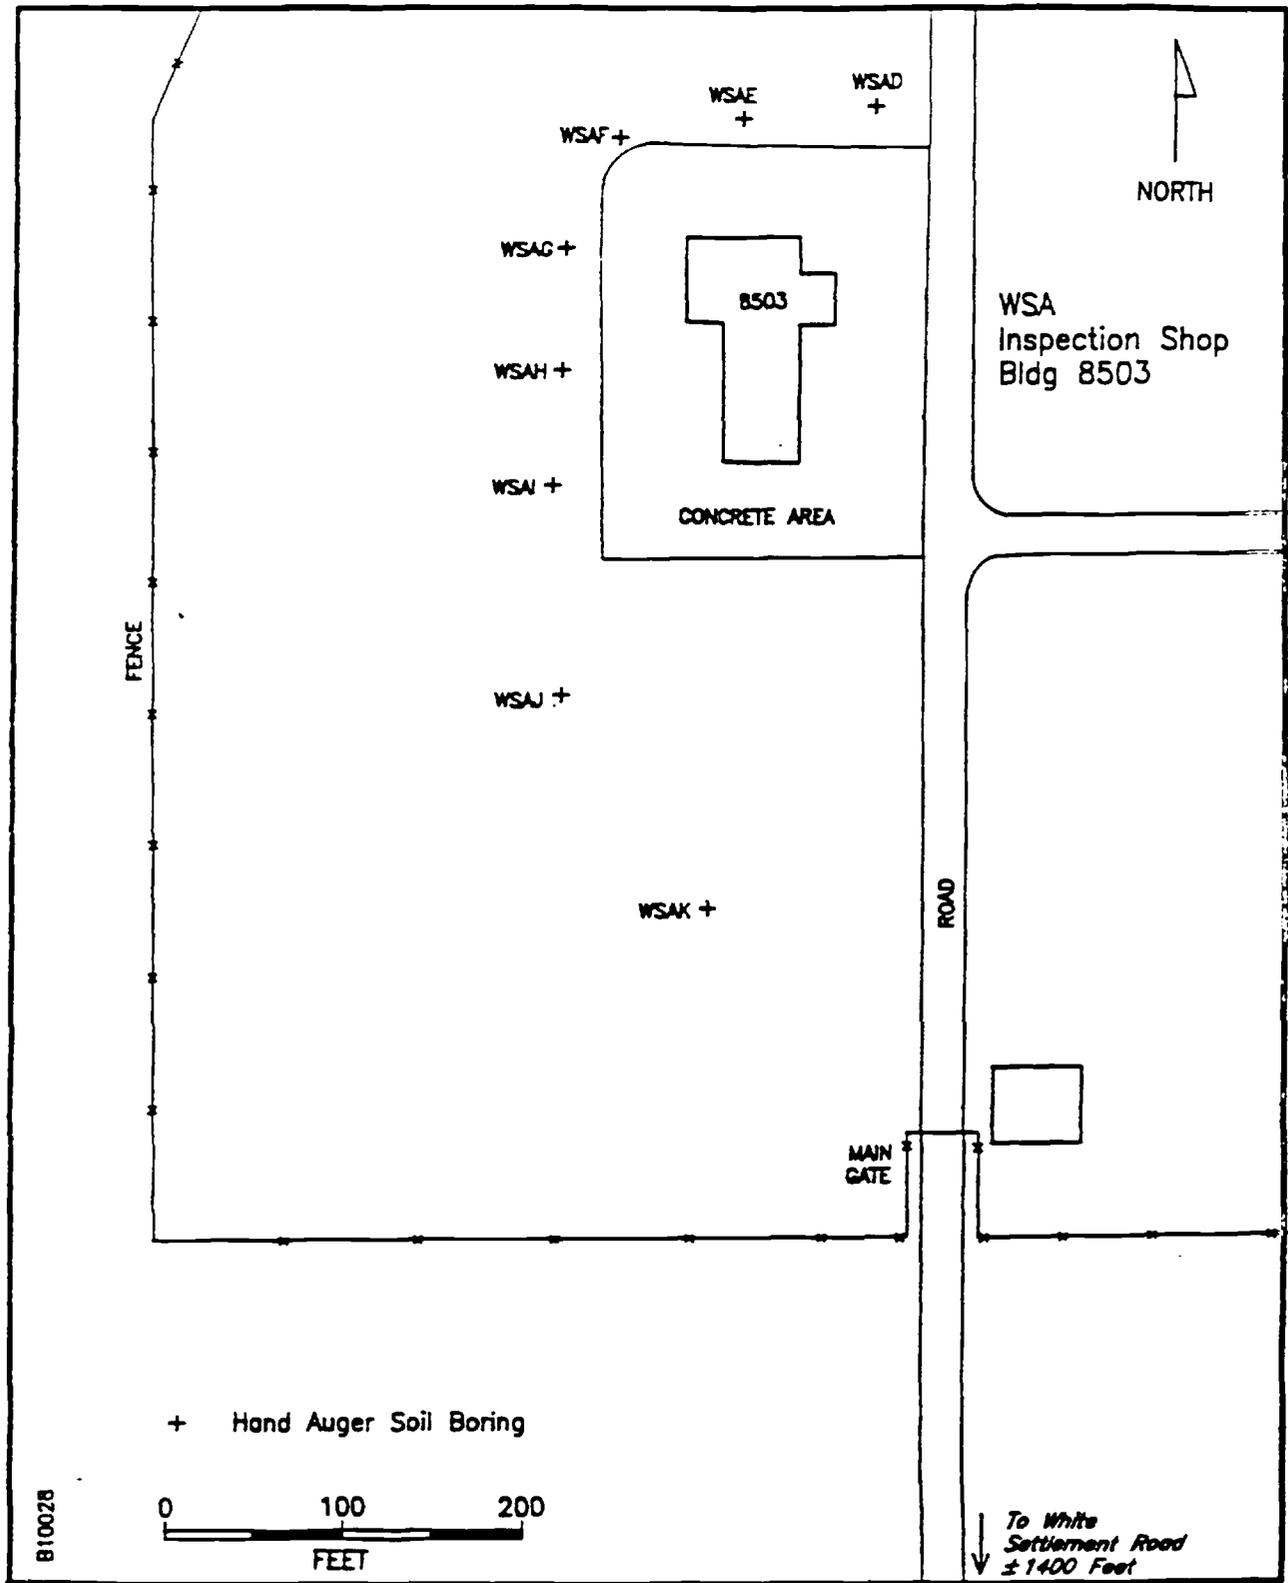
Figure B.2-1 Location of Sampling Points, Weapons Storage Area, Carswell AFB, Texas

The alternatives evaluation was conducted as part of the IRP RI/FS Stage 2 investigation at CAFB. Soil samples were collected from the ditch at the locations shown on Figure B.2-1 and were analyzed as part of the IRP RI/FS Stage 2 investigation. Tables B.2-1 and B.2-2 present the results of the soil

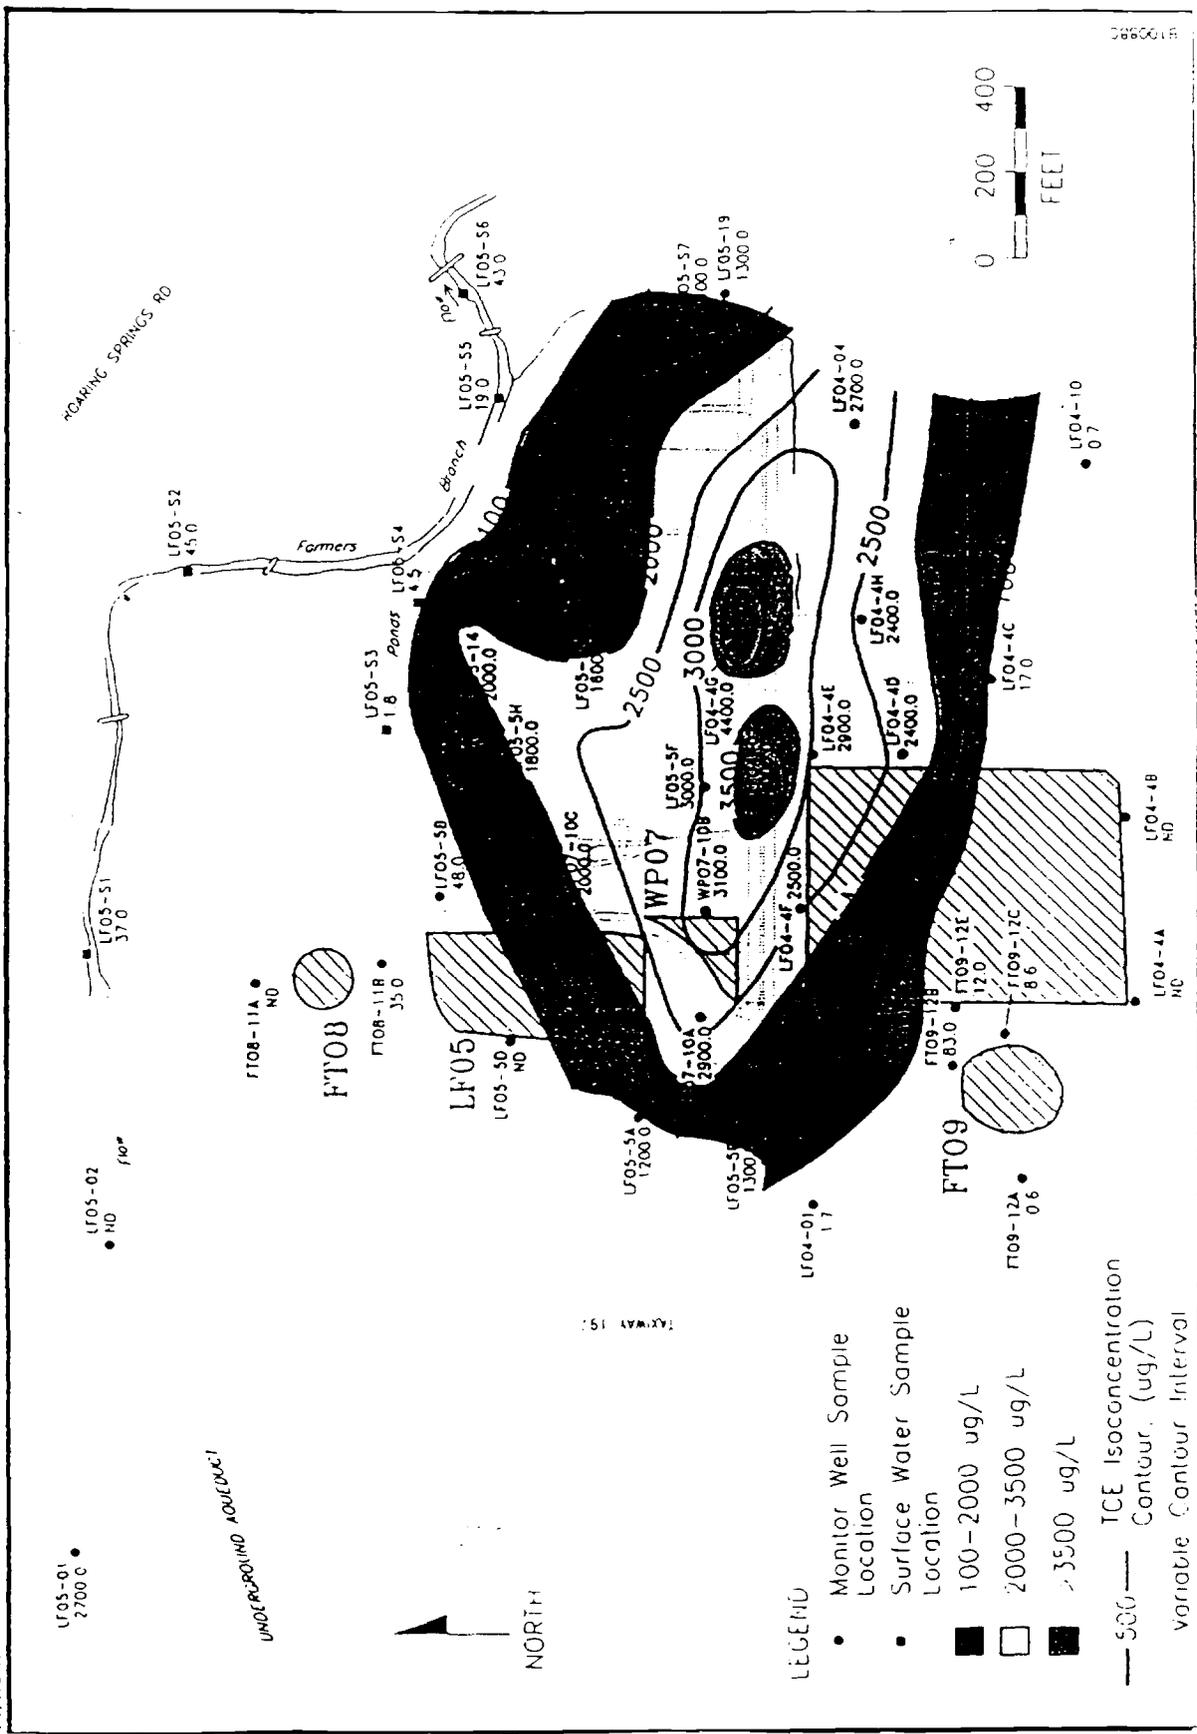
Figure B.11-2 TCE Isoconcentration Contour Map, Flightline Area, Carswell AFB, Texas (Based on Spring, 1990 Water Sampling) SOURCES: Radam, 1991; ESE.

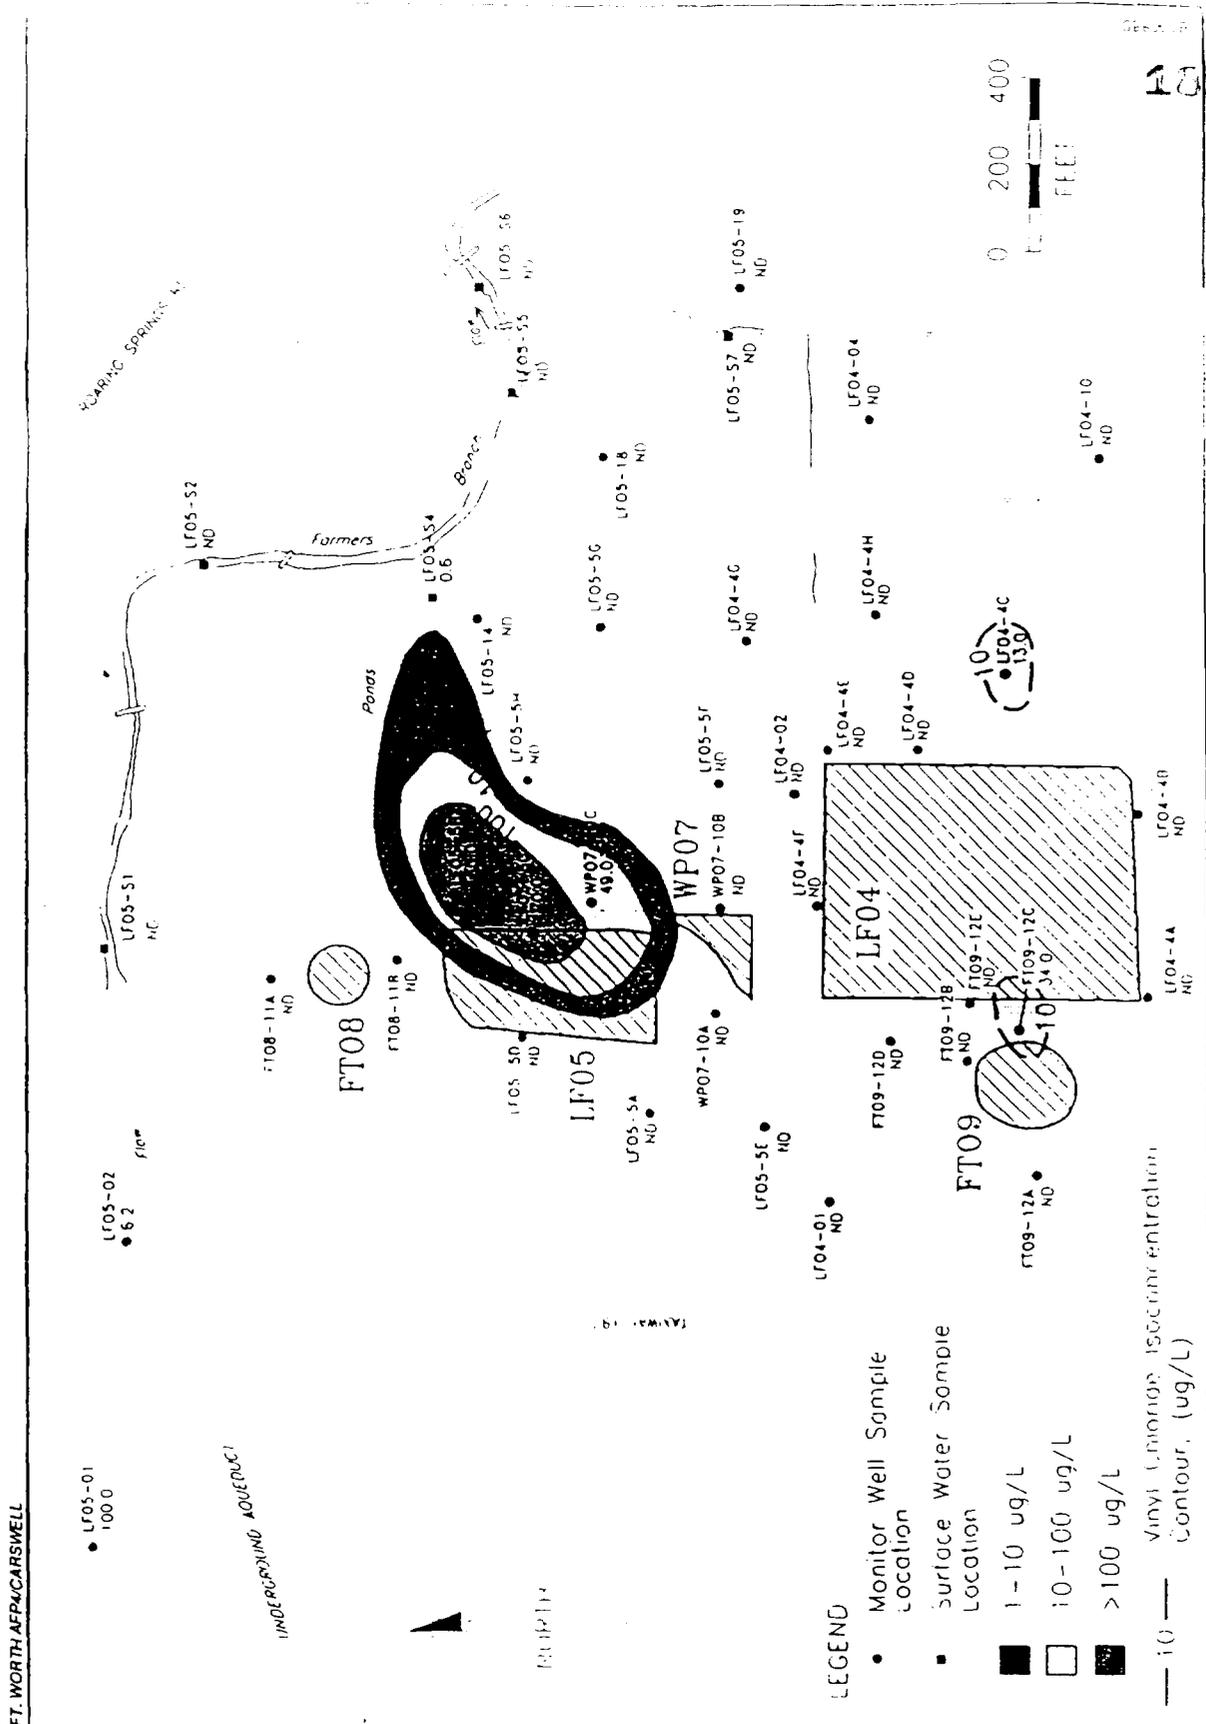
**Figure B.11-3 Vinyl Chloride Isoconcentration Contour Map, Flightline Area, Carswell AFB, Texas**  
 (Based on Spring, 1990 Water Sampling)

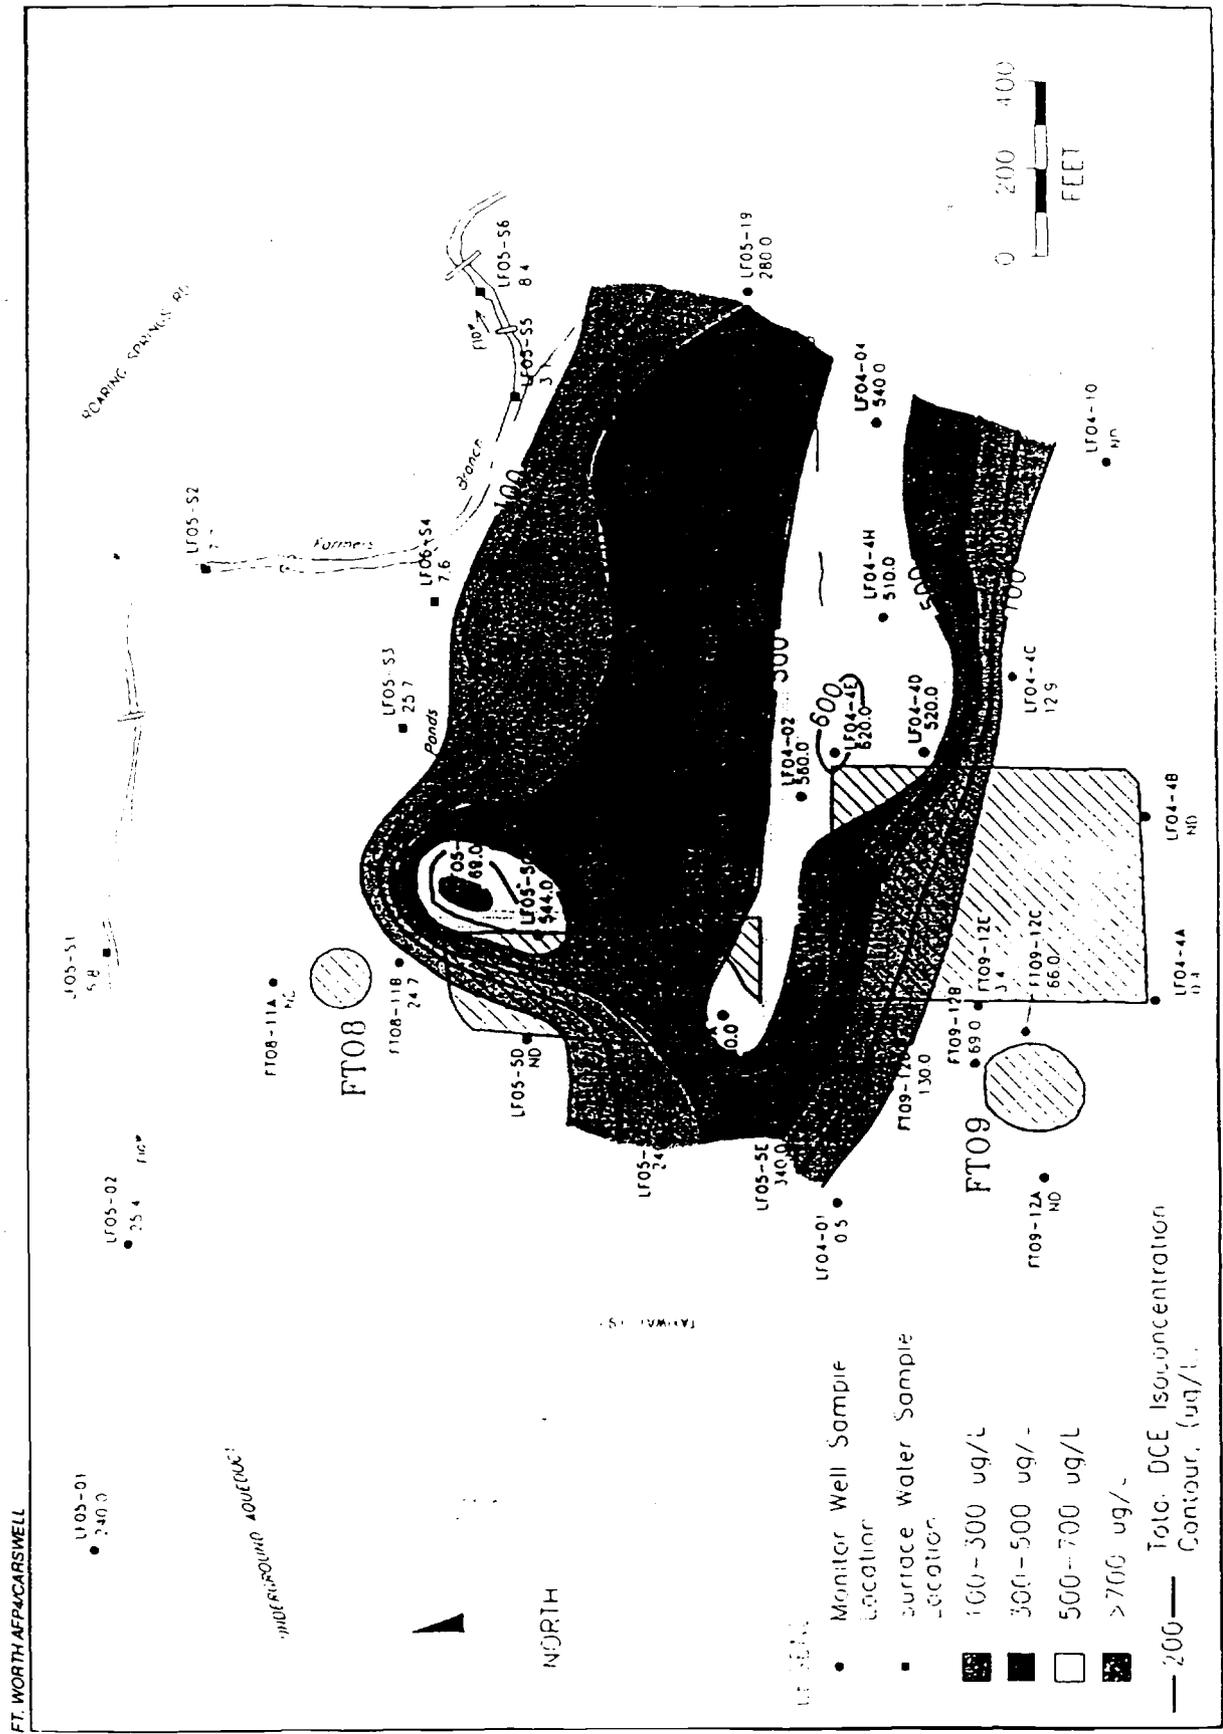
Figure B.11-4 Total 1,2-Dichloroethene Isoconcentration Contour Map, Flightline Area, Carswell AFB, Texas (Based on Spring, 1990 Water Sampling)
