INITIAL ASSESSMENT STUDY FOR NAS JACKSONVILLE FL
3/1/1983
FRED C. HART ASSOCIATES

INITIAL ASSESSMENT STUDY

NAVAL AIR STATION, JACKSONVILLE, FLORIDA

NAVAL FUEL DEPOT, JACKSONVILLE, FLORIDA

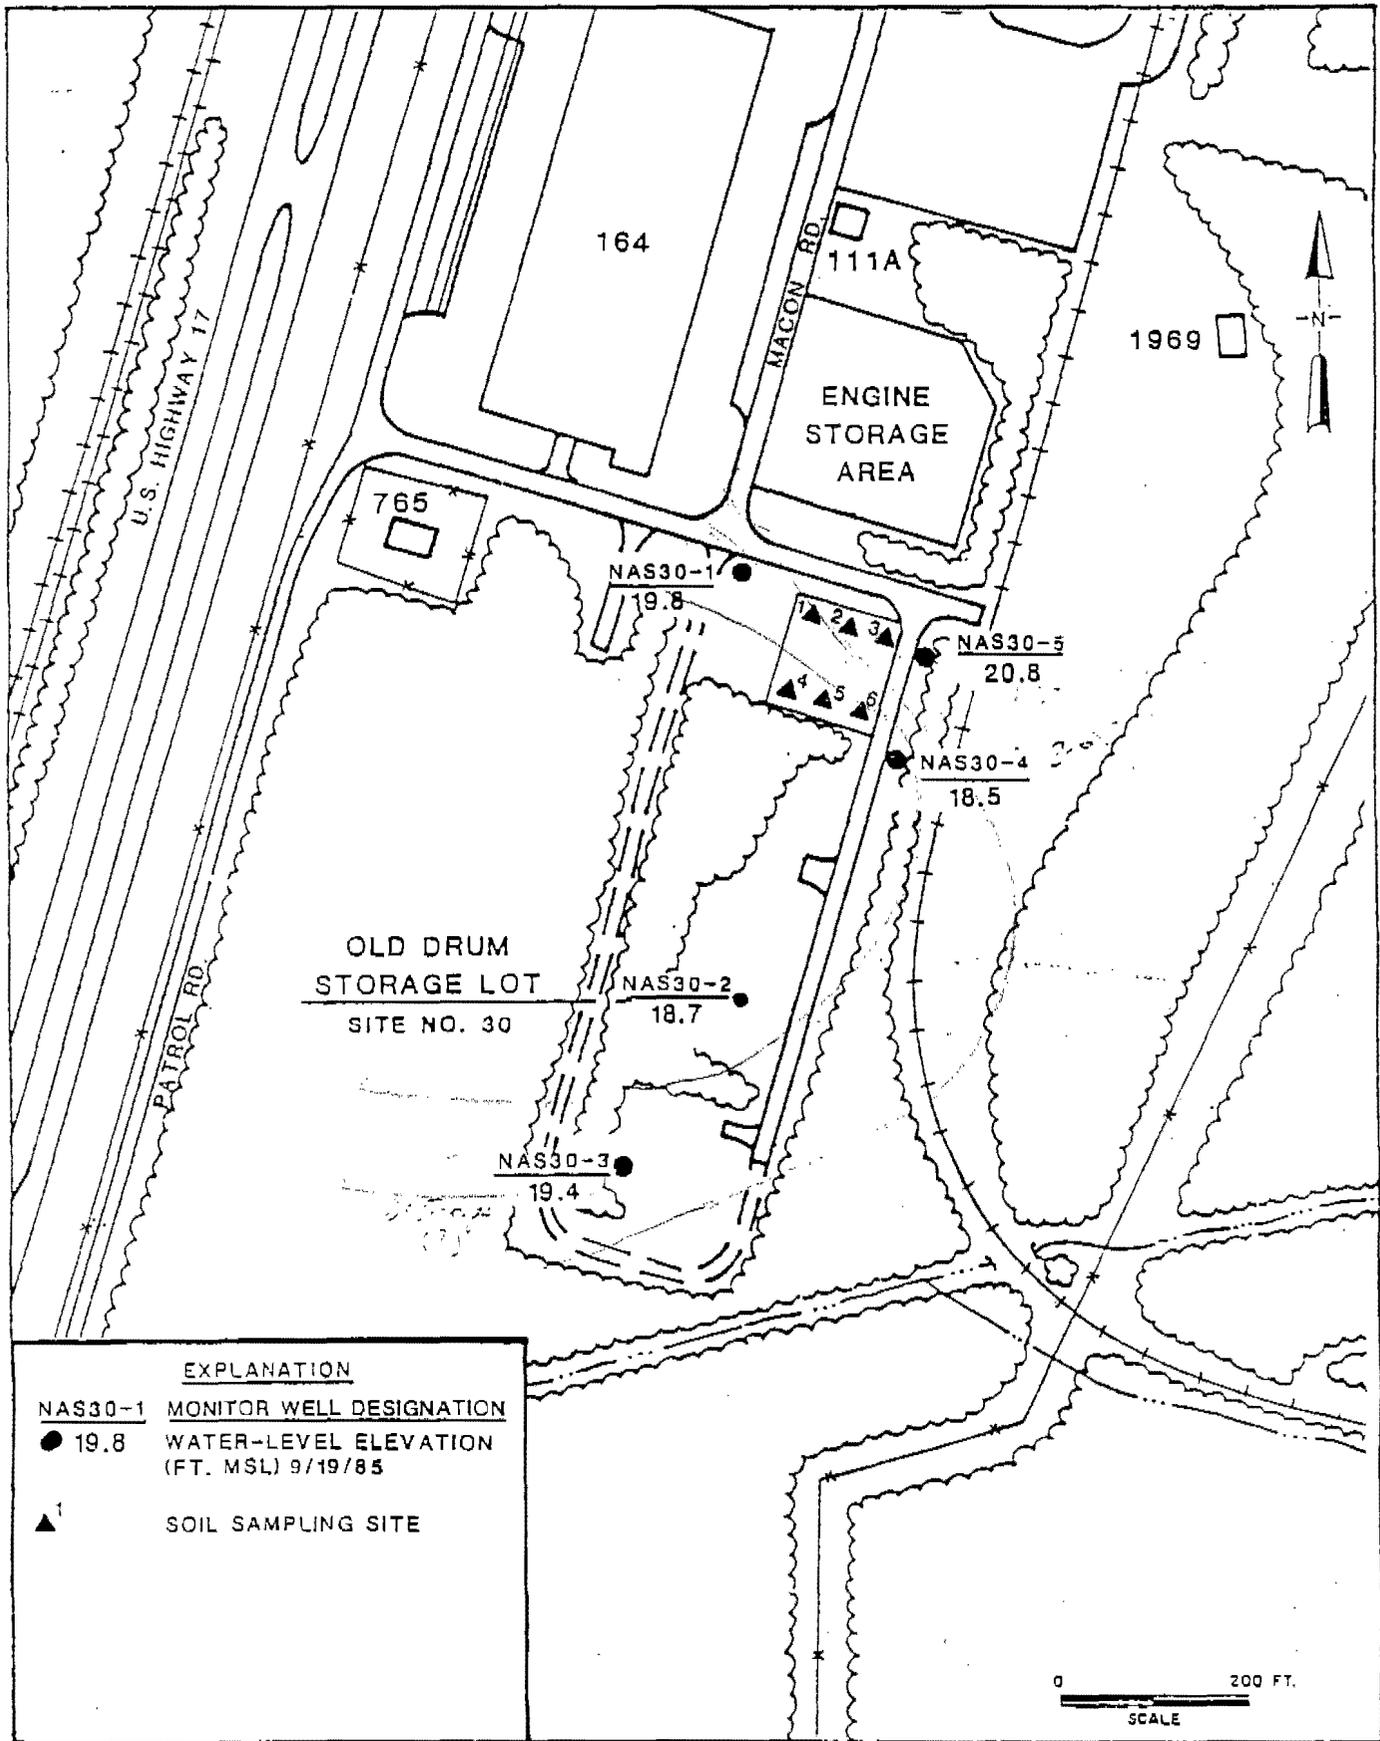
Figure 9. Location of Wells and Sampling Sites, NAS Site No. 30

Monitor well NAS 30-1 was resampled, as recommended, and found to be free of VOCs and heavy metals. Samples from the newly installed monitor well 30-4 were also free of VOCs and heavy metals. Well 30-5, however, contained a total of 29 ug/l VOCs, chiefly toluene (11 ug/l) and TCE (7 ug/l). The metal content of the sample was low and below drinking water standards.

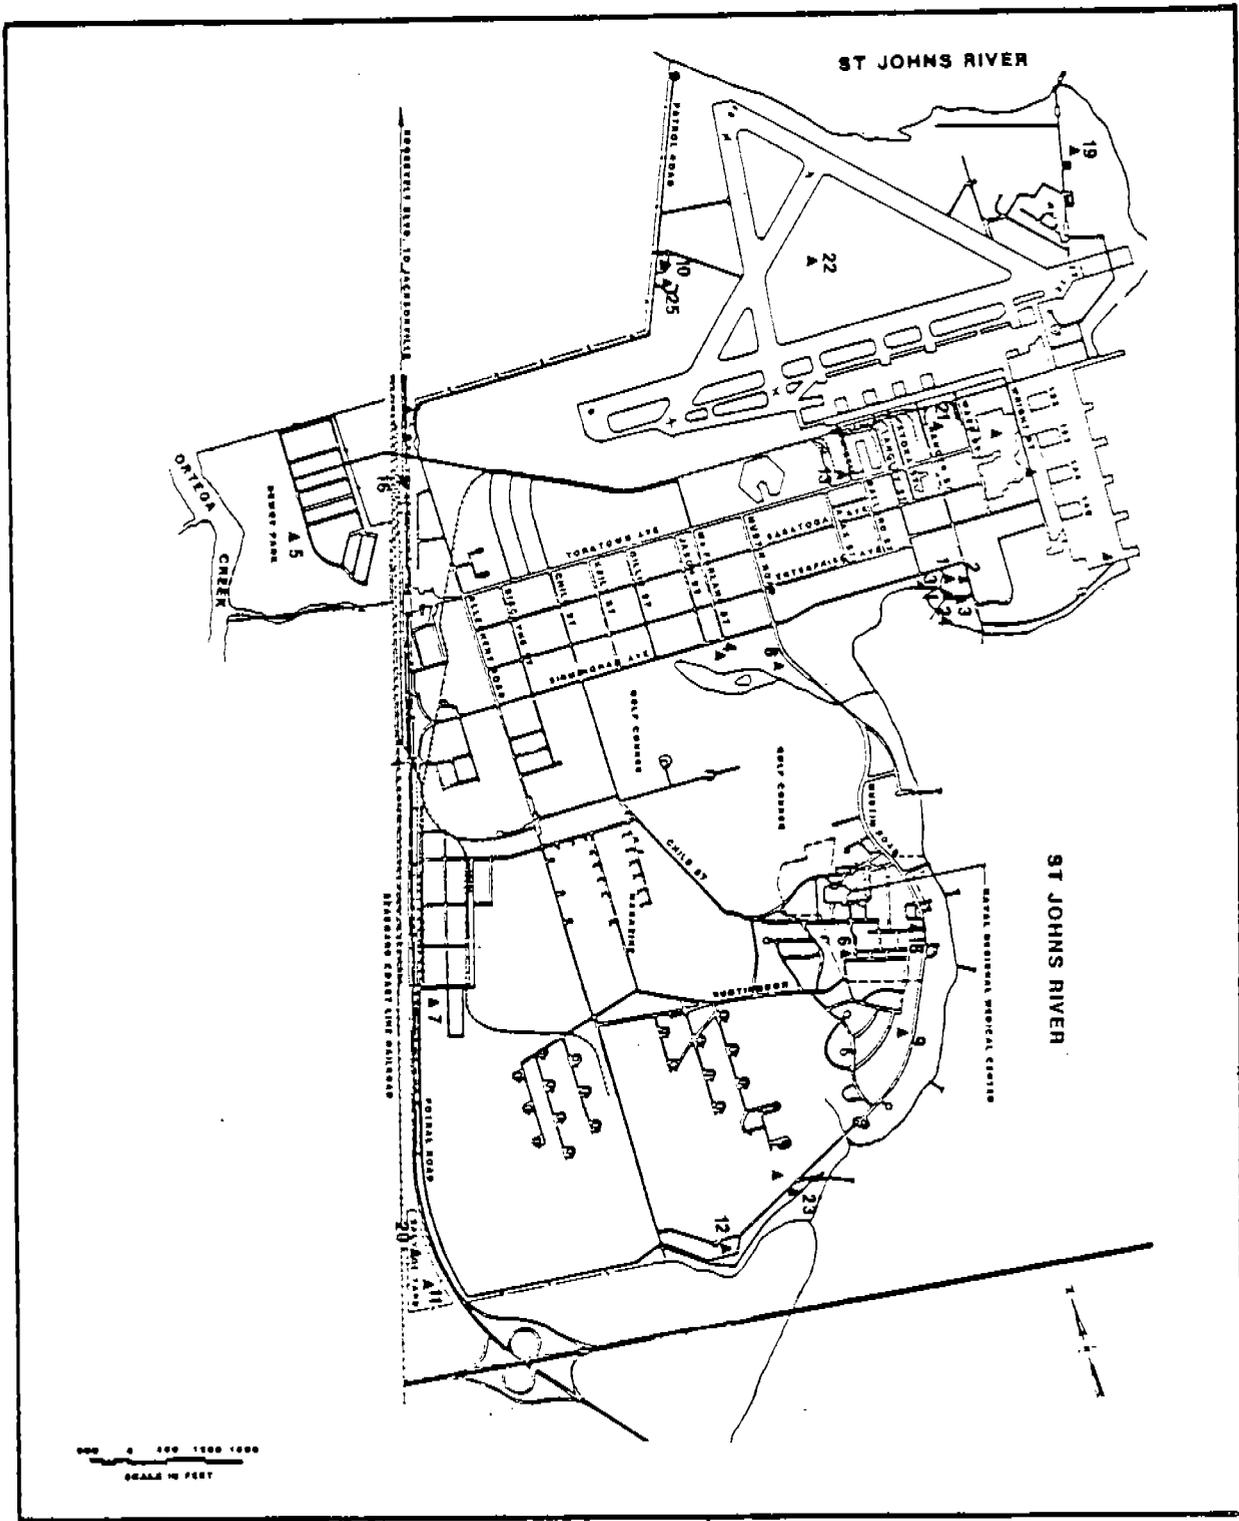
Figure 5.3-17 WELL LOCATIONS NAS JACKSONVILLE

The water supply system at the NAS Jacksonville utilizes ground-water as the source of supply. Currently, the water supply distribution network is fed from 5 deep wells, which are completed in the Floridan Aquifer beneath the site. Many more wells, however, have been drilled at the NAS over the stations' history and NAS personnel are in the process of locating and inventorying all wells located on base. To date 27 wells have been identified by NAS personnel, inclusive of the 5 major water supply wells that furnish water to the distribution network (Figure 5.3-17).

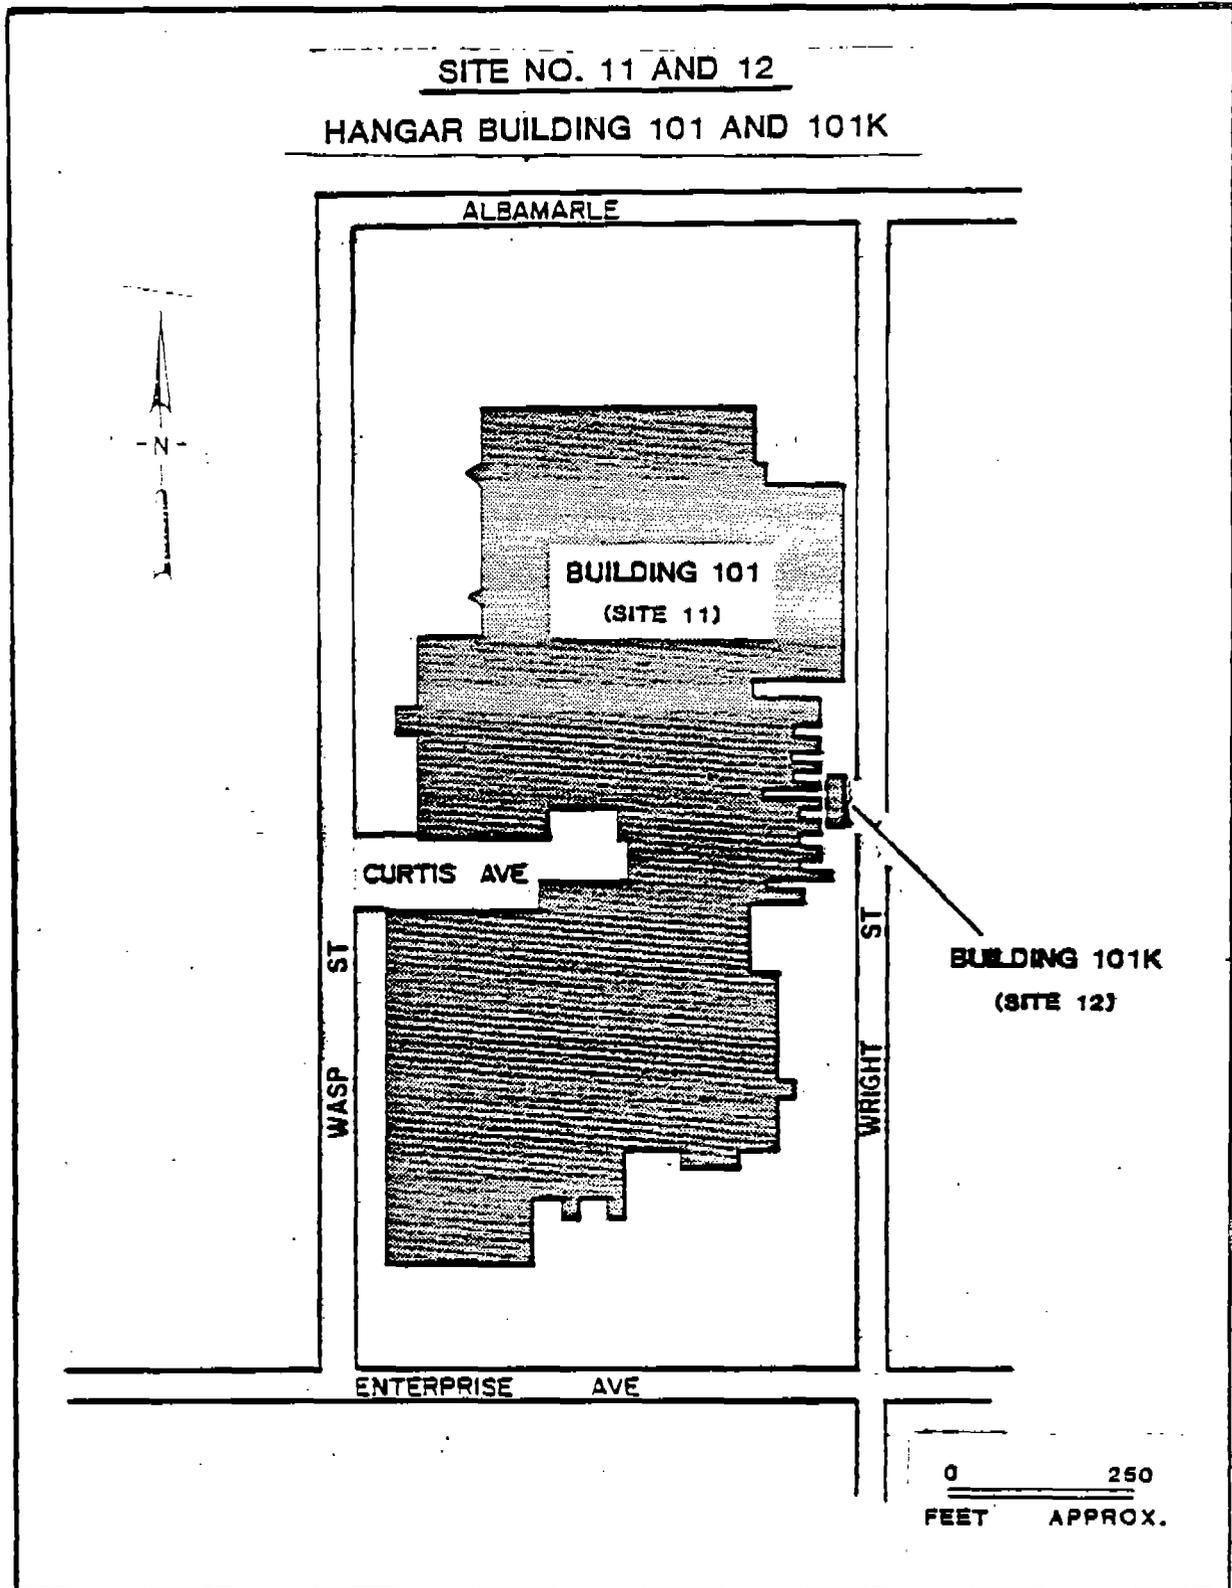
Figure 6.6-4 SITES 11 and 12 -
HANGAR BUILDING 101 AND BUILDING
101K

Reportedly, waste solvents, oils and fuels have leaked beneath the floor boards of Hangar Building 101 for many years. Infiltration of waste solvents and other flammable liquids to the soils has also occurred. The potential for an explosion or fire and migration of solvents to the St. Johns River via storm sewers are the concerns at this site.

Reportedly some interconnection of the storm, sanitary and industrial sewer system in the old test cell area, Building 101 k, has occurred. In addition, numerous spills (one 55-gallon drum per week) of chemicals (waste oil, fuel and solvents) from ruptured or rusted drums were reported at this site. The concern at this site is the potential contamination of the St. Johns River due to migration of these hazardous materials into the storm sewer via infiltration/inflow or faulty connections. Specifically, wastes containing heavy metals may possibly contaminate the St. Johns River.
