**RCRA FACILITY ASSESSMENT (RFA)  
NAS MEMPHIS  
MILLINGTON, TENNESSEE**

**Prepared For:  
Department of the Navy  
Southern Division  
Naval Facilities Engineering Command  
Charleston, South Carolina  
Contract No. N62467-88-C-0198**

**REVISED FINAL REPORT**

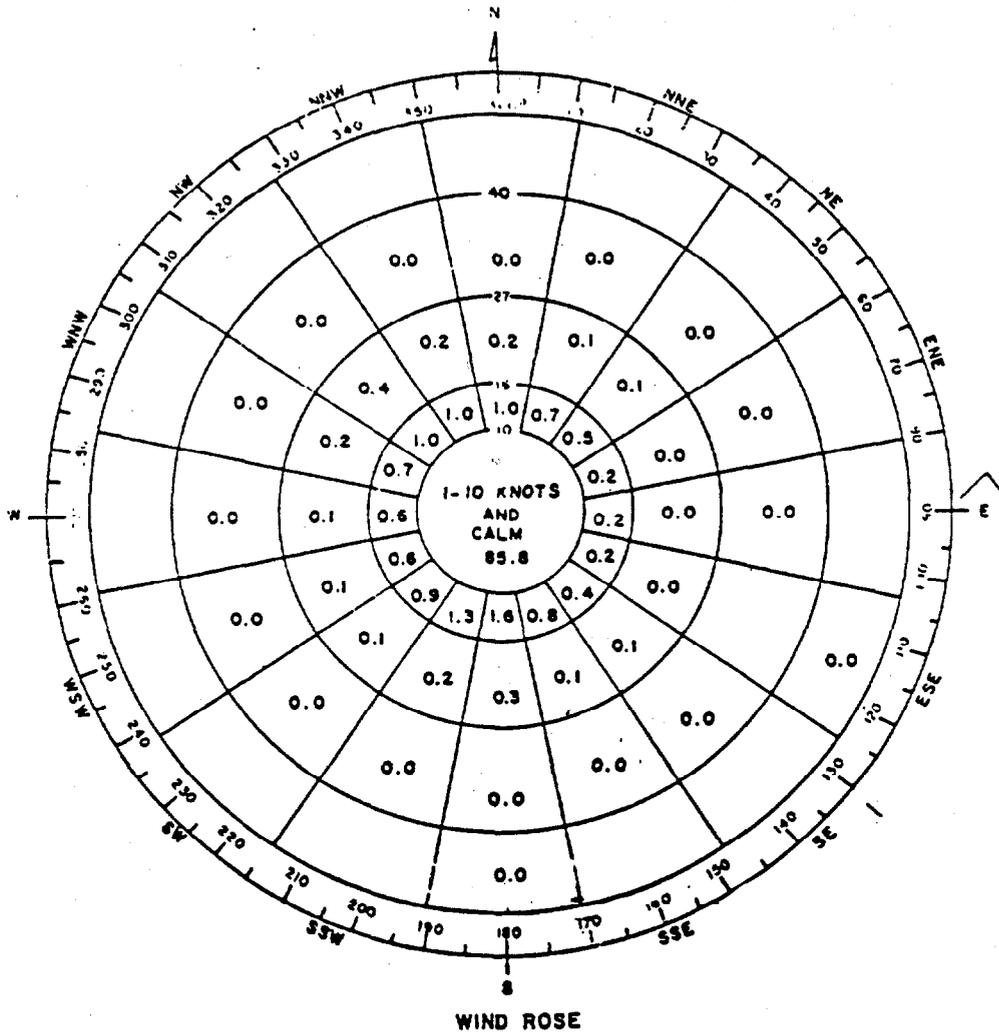
Figure 4-1. Wind Rose for NAS Memphis

Atmosphere conditions at NAS Memphis are well understood. Meteorological and climatological records for the area are readily available. The wind rose (Figure 4-1) for the facility showing prevailing wind directions follows. Exhibits 4-1 and 4-2 are the current Climatic Data Summaries for the Memphis area and NAS Memphis, respectively.
