**Comprehensive Long-Term
Environmental Action Navy
Naval Air Station
Memphis, Tennessee
CTO-0076**

**Final Report
Environmental Baseline Survey**

Volume I

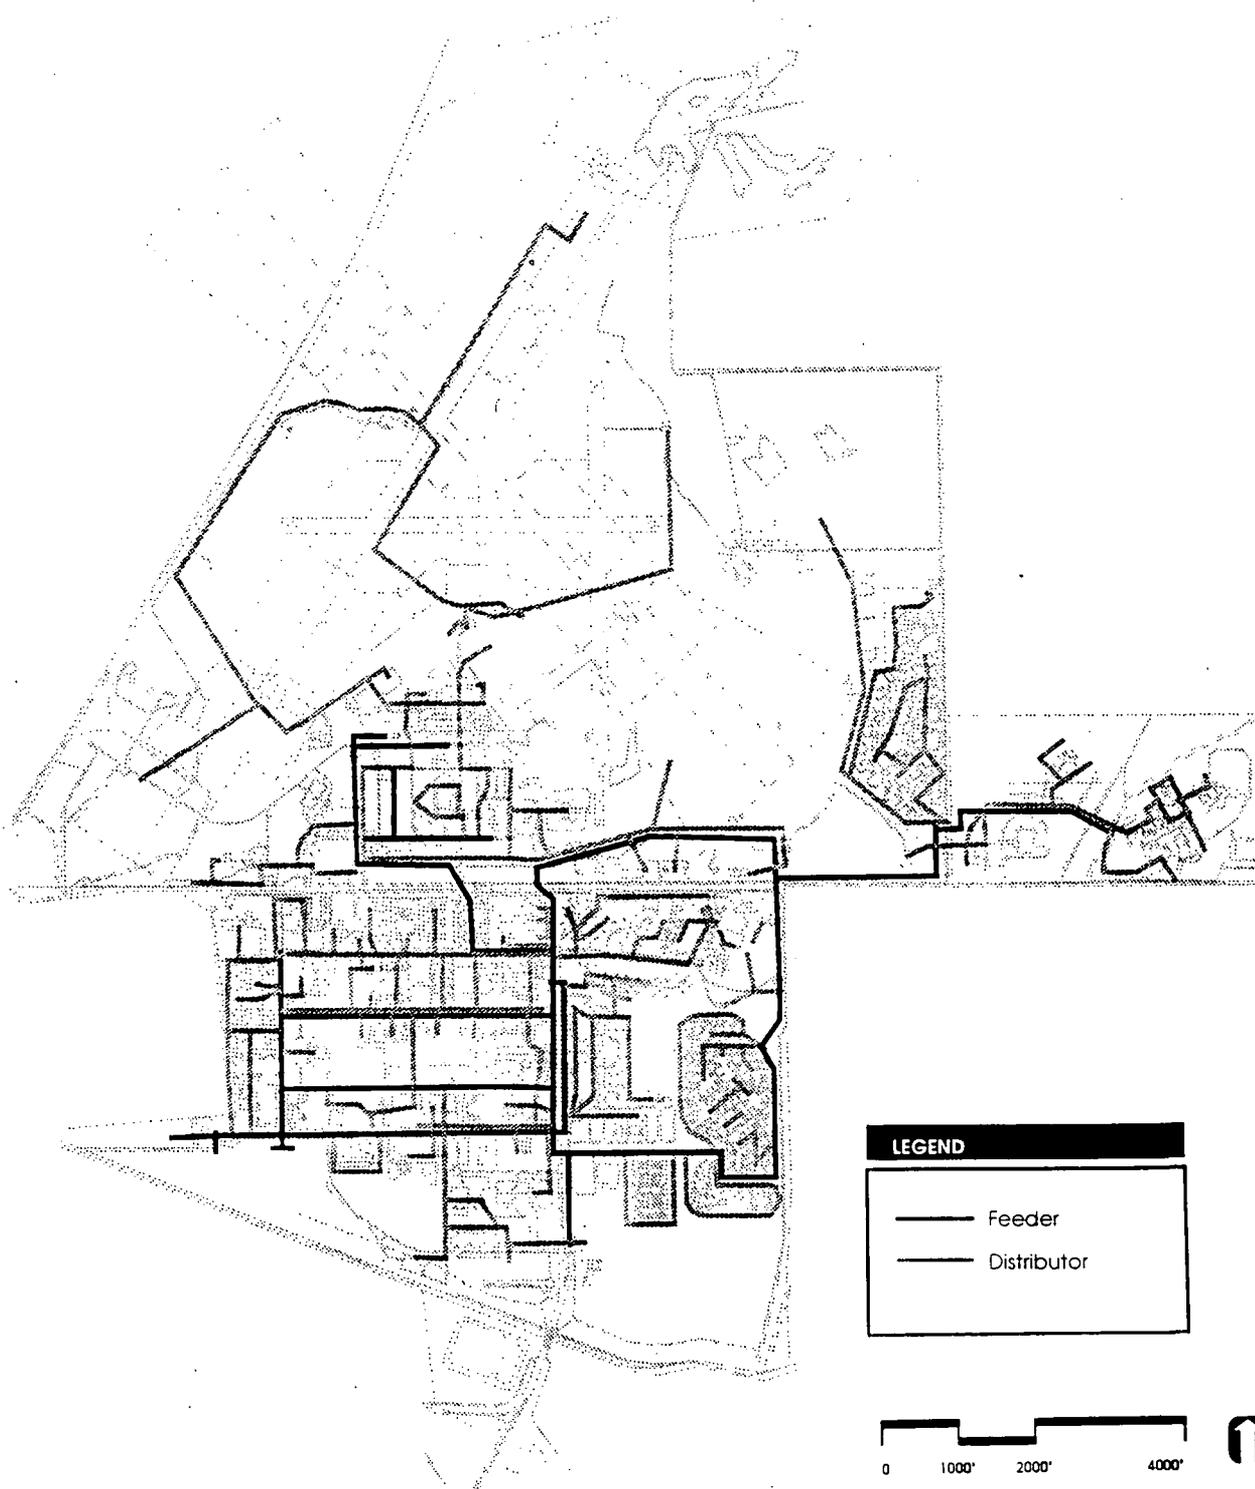
FIGURE 3-2

The electrical, storm water, potable water, sanitary sewer, steam and natural gas systems, and floodplain/wetlands are presented in Figures 3-2 through 3-8. The environmental condition of the base is summarized according to the following events that have occurred during the history of base operations. The environmental condition of property and current environmental concerns at each NAS Memphis facility are summarized in the Conclusion/Executive Summary page of each facility survey form (Appendix G).

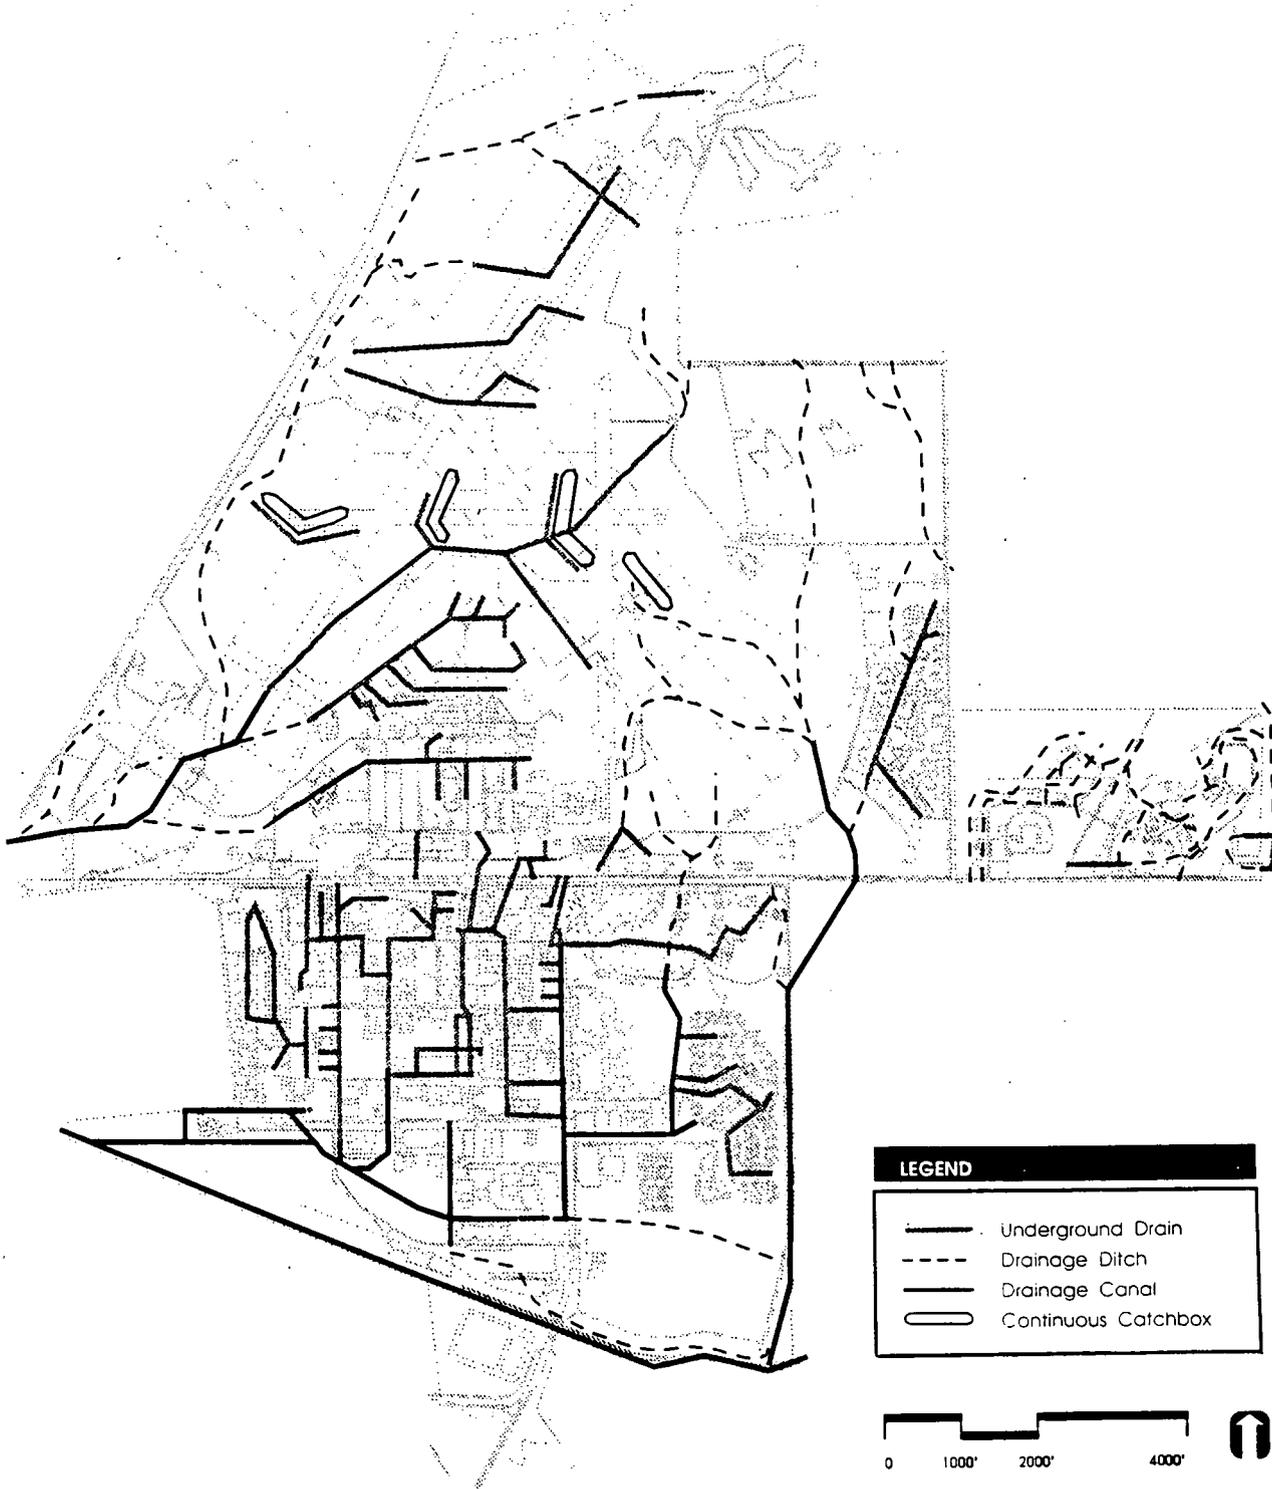
FIGURE 3-3
 EXISTING STORM
 DRAINAGE SYSTEM
 NAS Memphis

- Underground Drain
- - - Drainage Ditch
- Drainage Canal
- Continuous Catchbox

Storm drainage at NAS Memphis discharges into Big Creek via storm drains, ditches and canals (Figure 3-3). Surface drainage problems are associated with the topography and soil found at the base, and water may stand after moderate rainfall.
