**BUILDING N-121 SOIL REMOVAL AND SPILL
CLEANUP ACTIVITY REPORT
NAVAL SUPPORT ACTIVITY MEMPHIS
MILLINGTON, TENNESSEE**

CORRECTIVE ACTION
ACTIVITY REPORT
NSA MEMPHIS
MILLINGTON, TN

*Naval Support Activity Memphis
Building N-121 Soil Removal and Spill Cleanup Activity Report
Revision: 2
August 29, 1997*

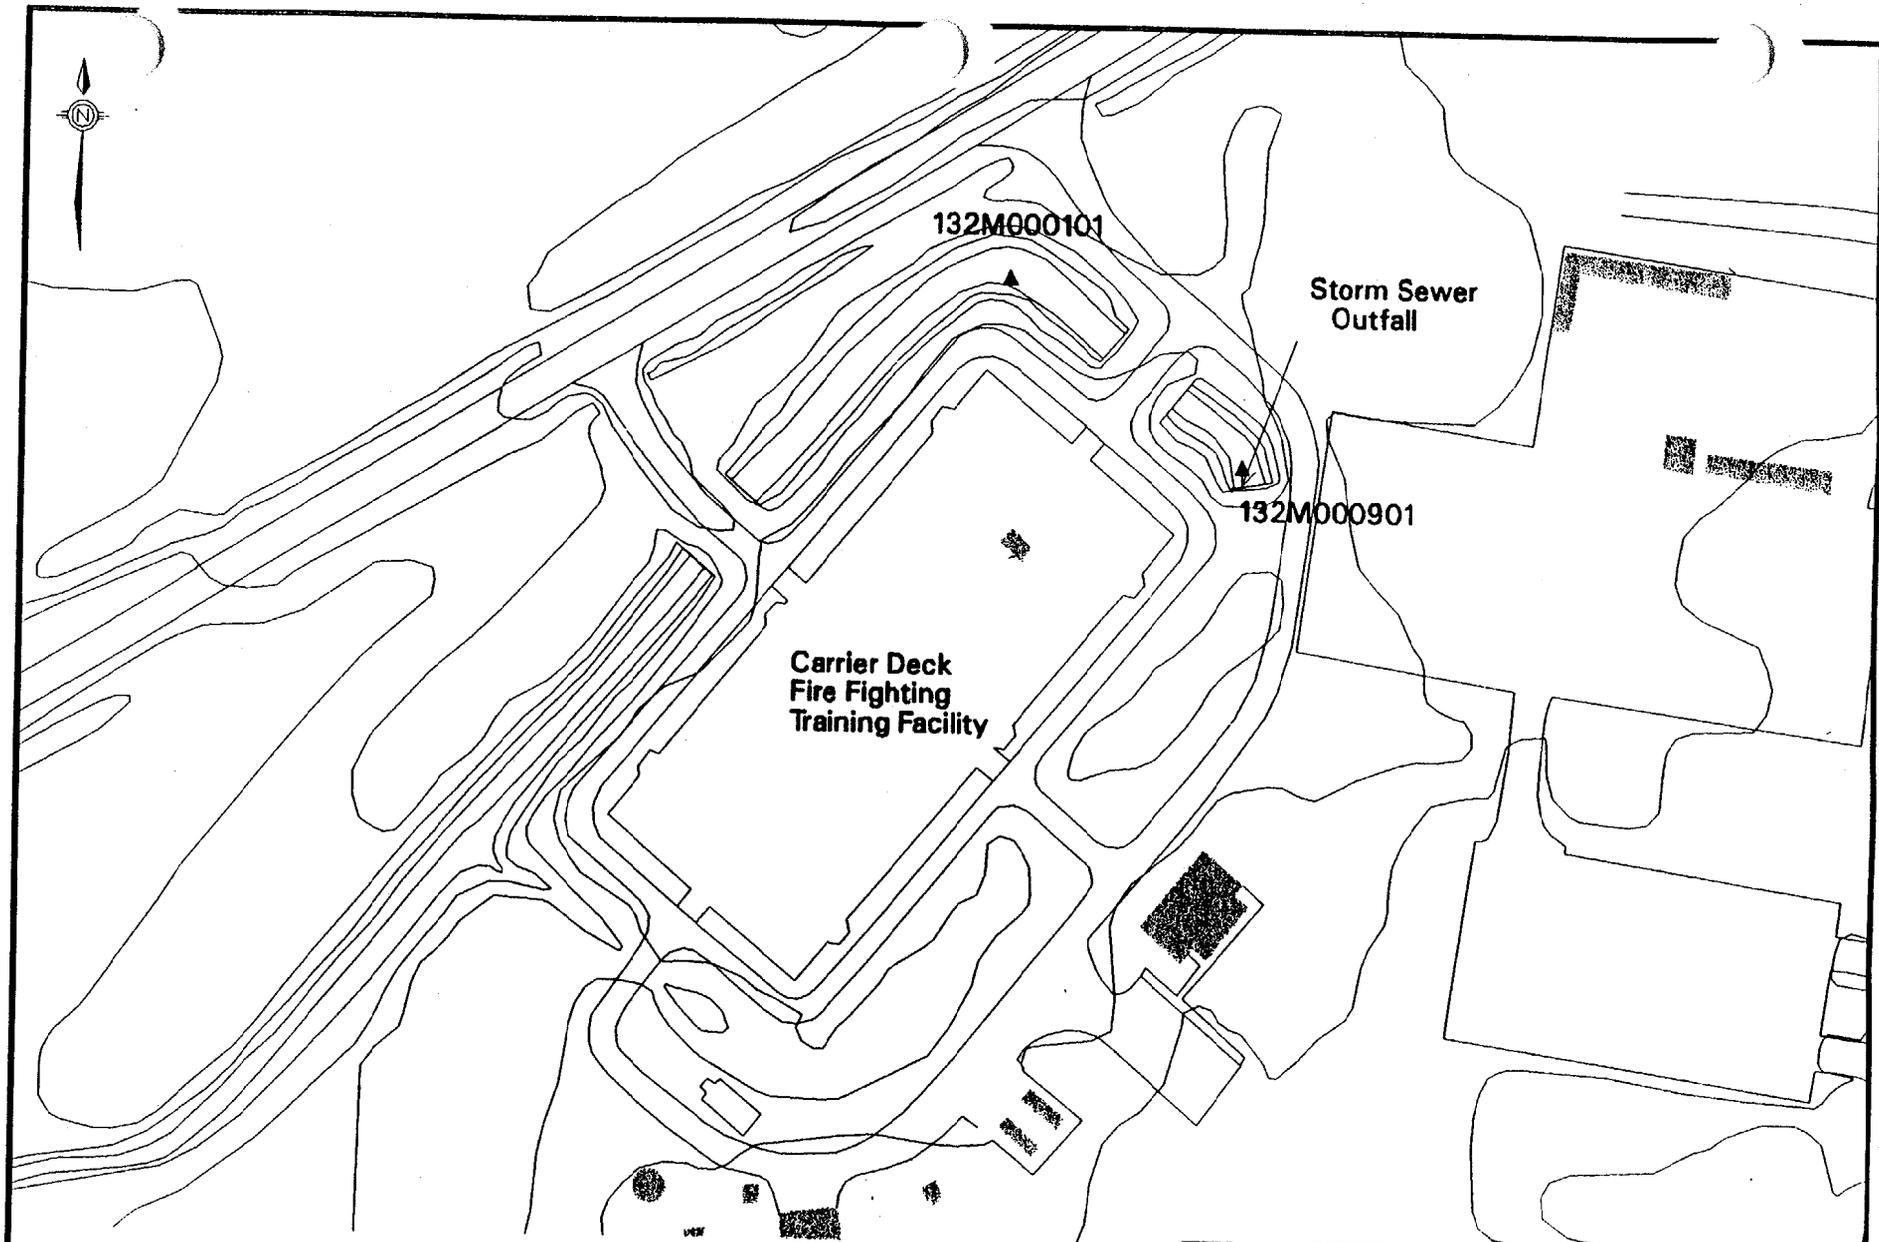
**FIGURE 4
SEDIMENT SAMPLING LOCATIONS**

In addition to the confirmation samples collected at N-121, sediment samples were collected on April 9, 1997, at the outfall of the storm sewer catch basin. These samples were collected to determine if the spill had impacted any areas downstream of the outfall. This outfall is just north of the Carrier Deck Fire Fighting Training Facility. Two samples were collected — one at the outfall (132M000901) and one downstream at the edge of the concrete ditch (132M001001) (Figure 4). The sample collected at the edge of the concrete ditch was chosen because the ditch was deeper at this point, indicating slower water velocities and the potential for heavier materials settling in this area. At the time of sampling, water in the ditch was stagnant. Results from these samples are listed in Table 4.

Based on these sediment sampling results, the BCT determined no further action related to sediments would be required.

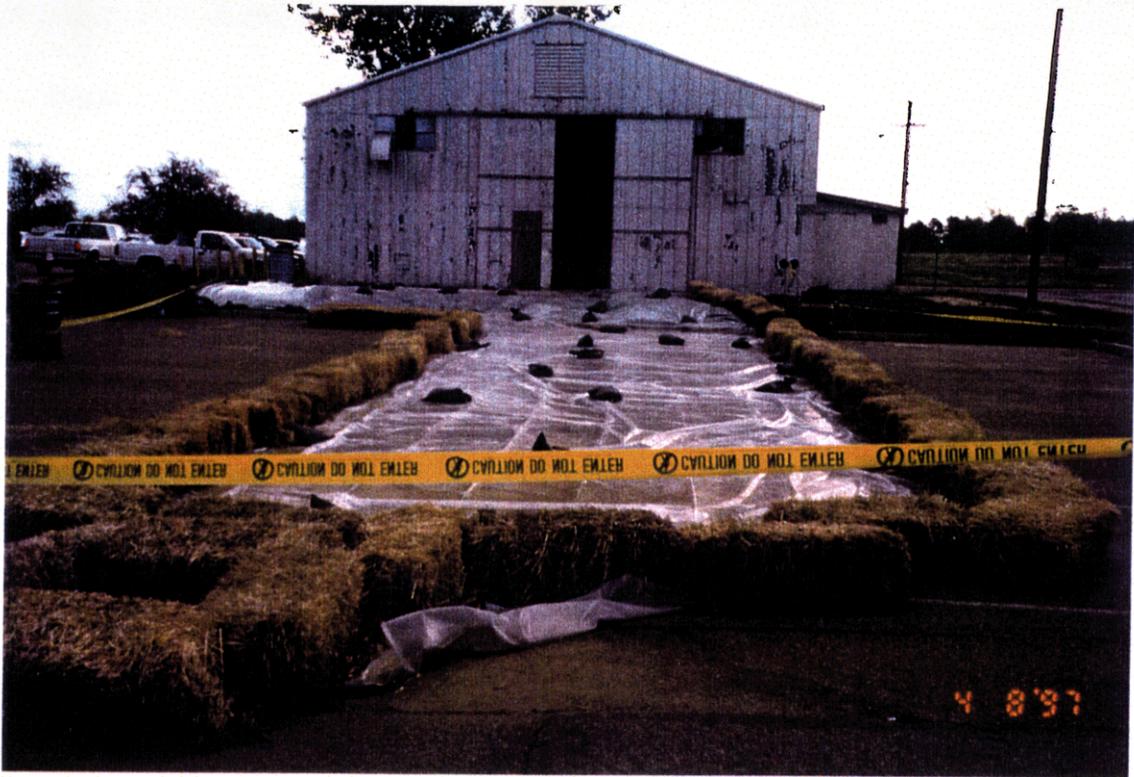
Site prior to any activities being performed.

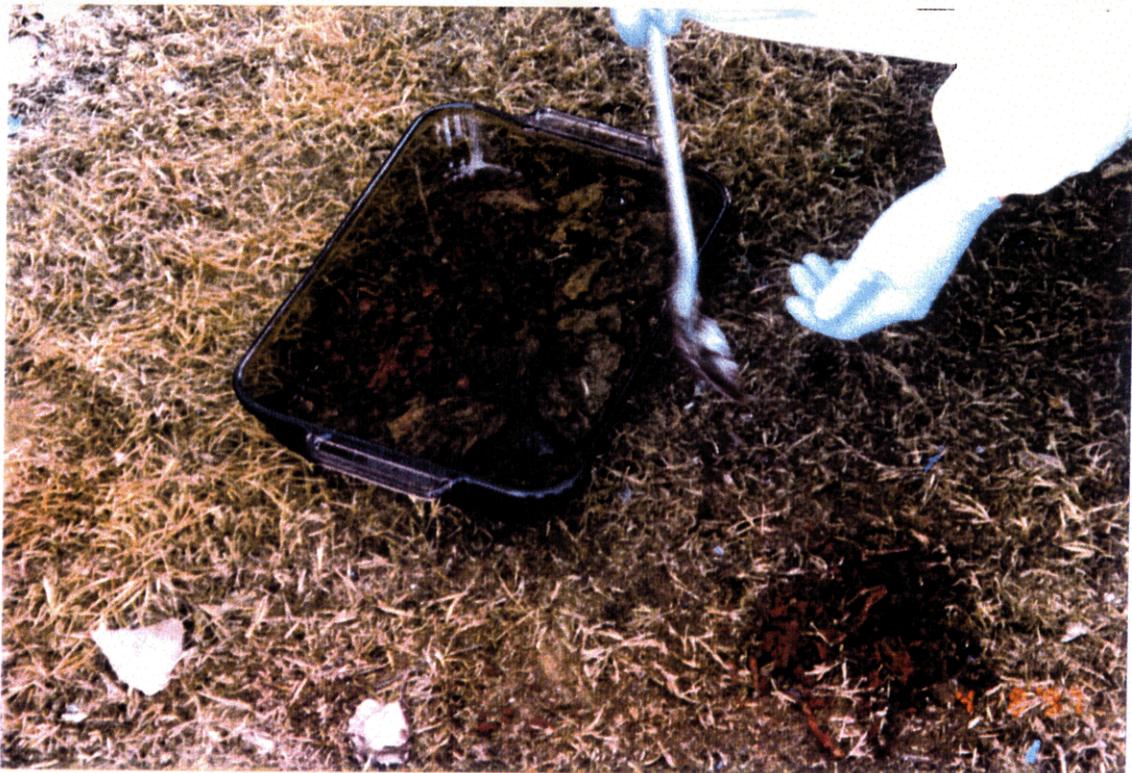
Collection of samples taken from surface soil in spill area.

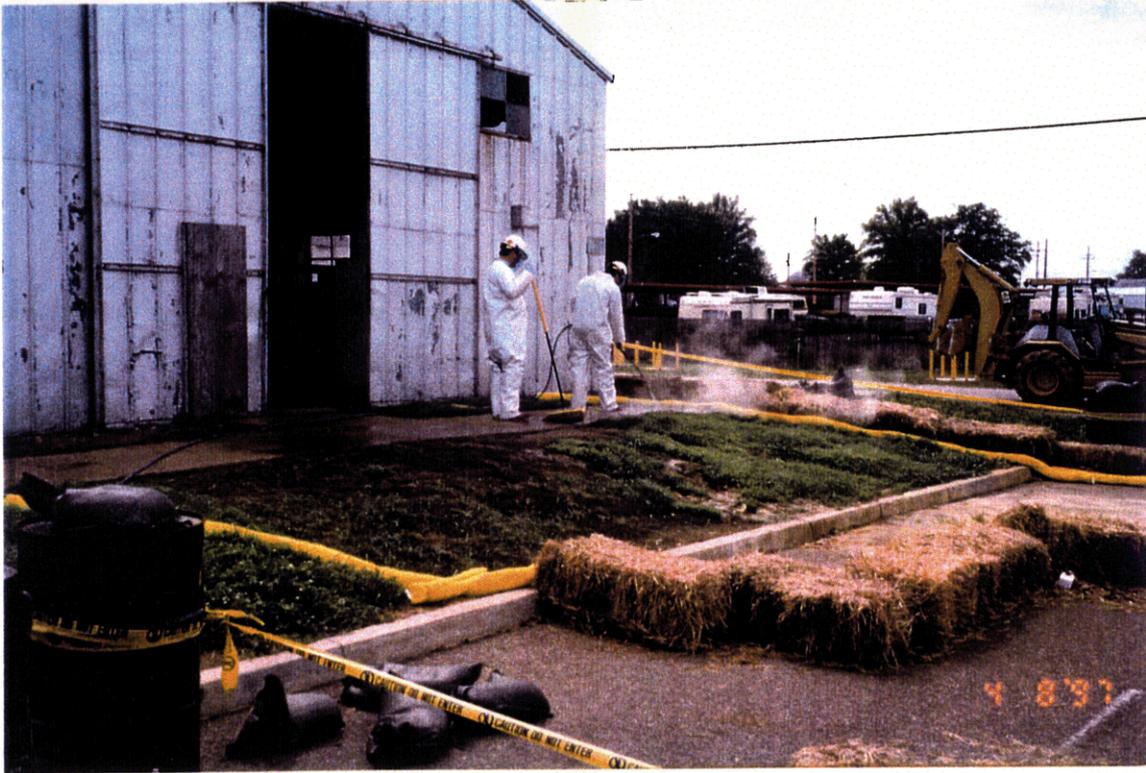
Pressure washing of paved sidewalk adjacent to N-121.

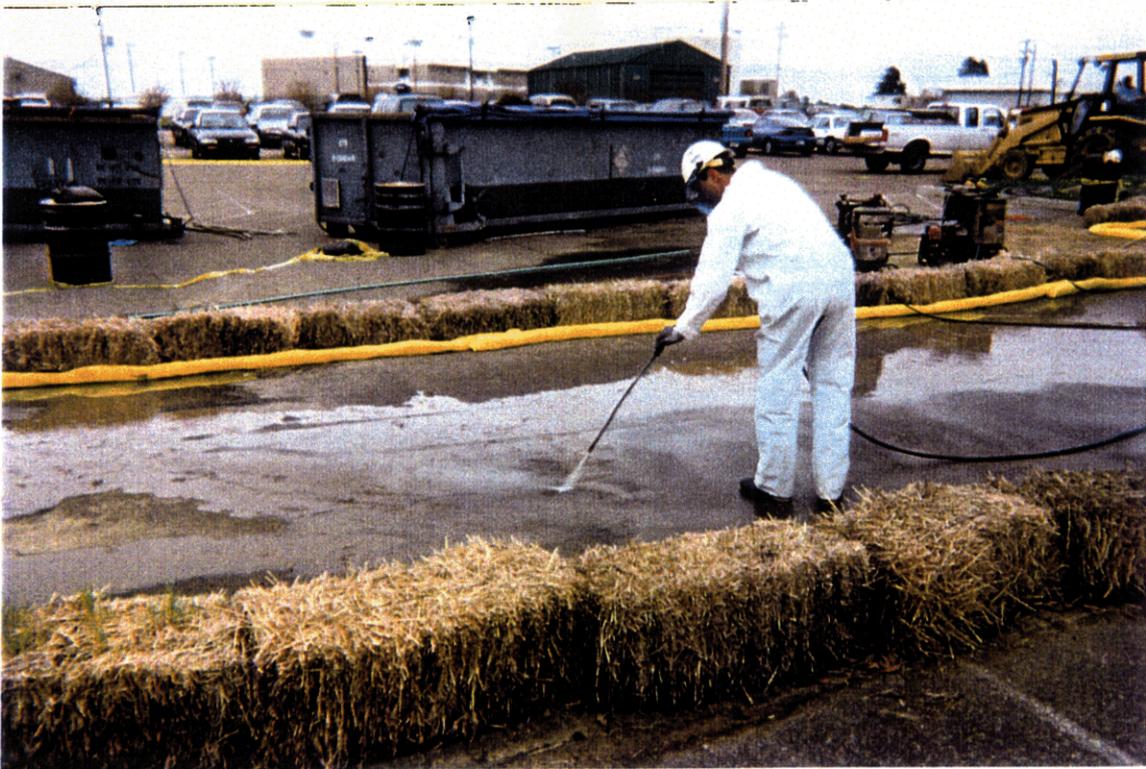
Pressure washing of pavement.

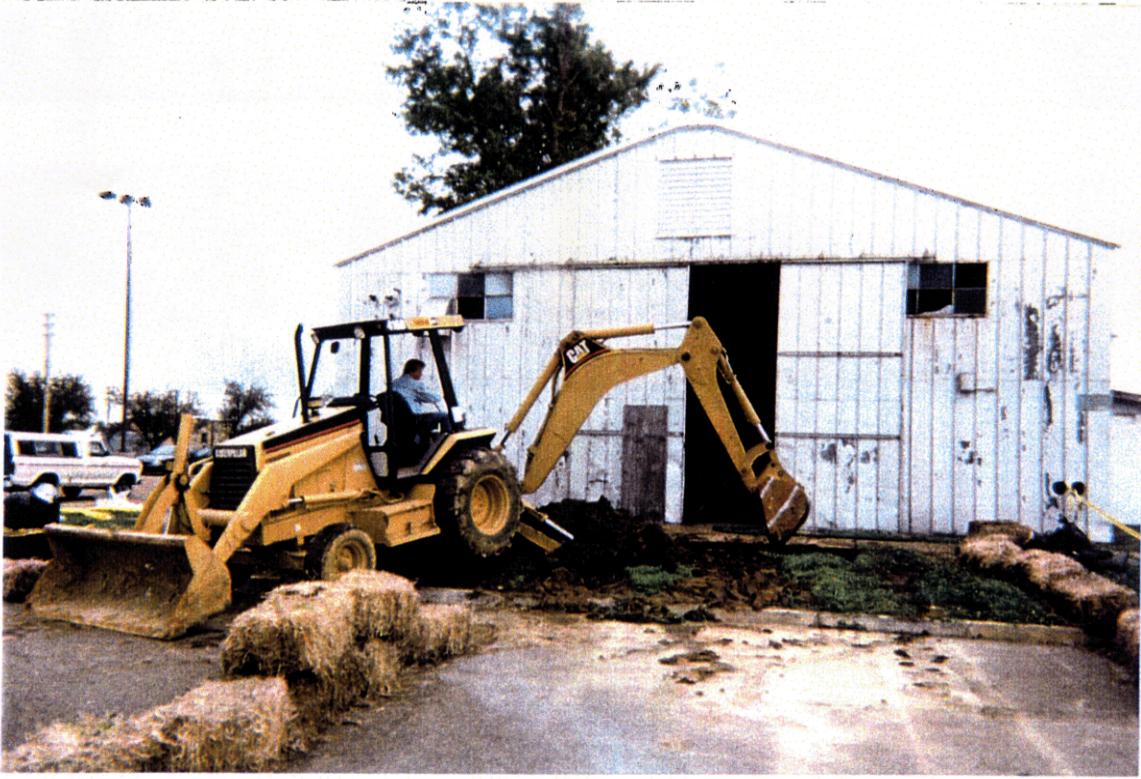
Excavation in Area 3 during Phase I.

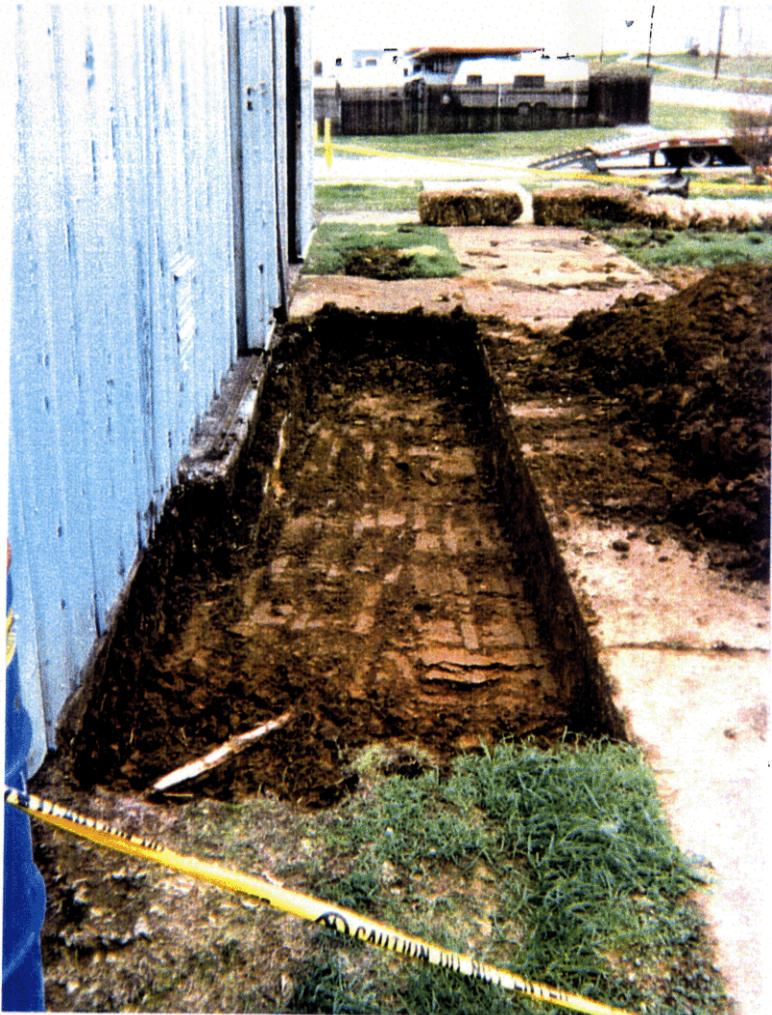
Area 1 after excavation during Phase I.

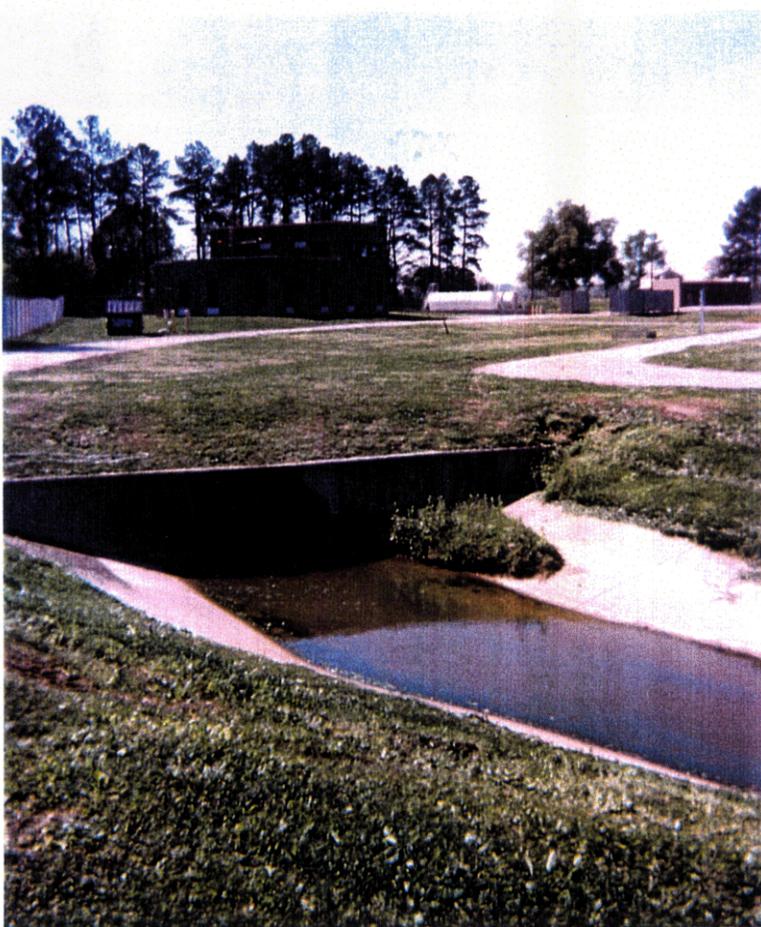
Location of sediment sample location 132M000901.

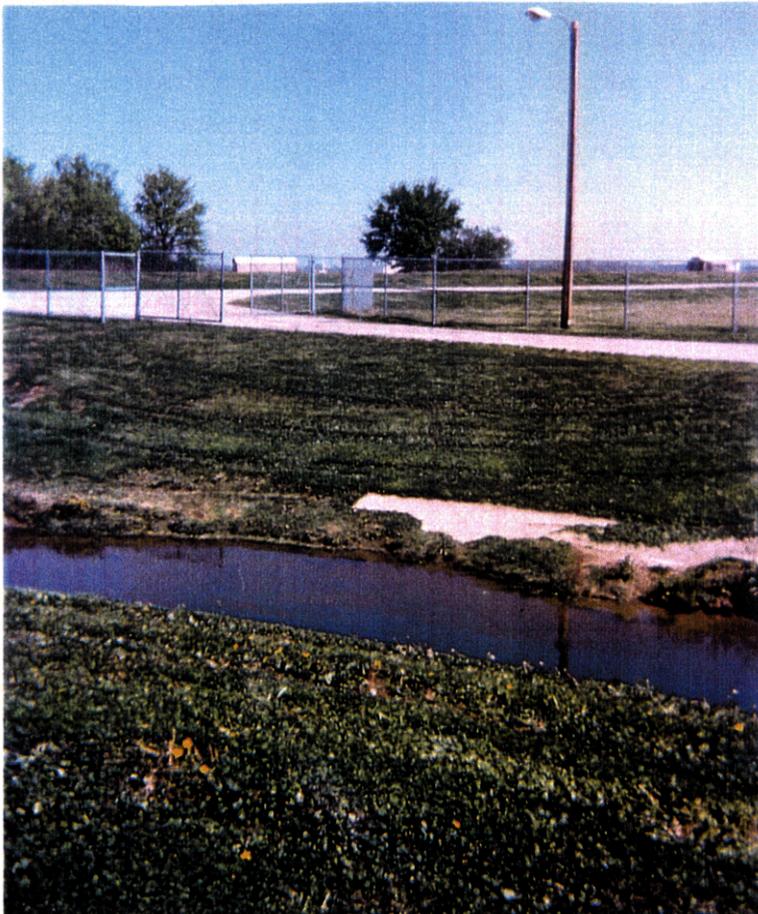
Location of sediment sample location 132M001001.

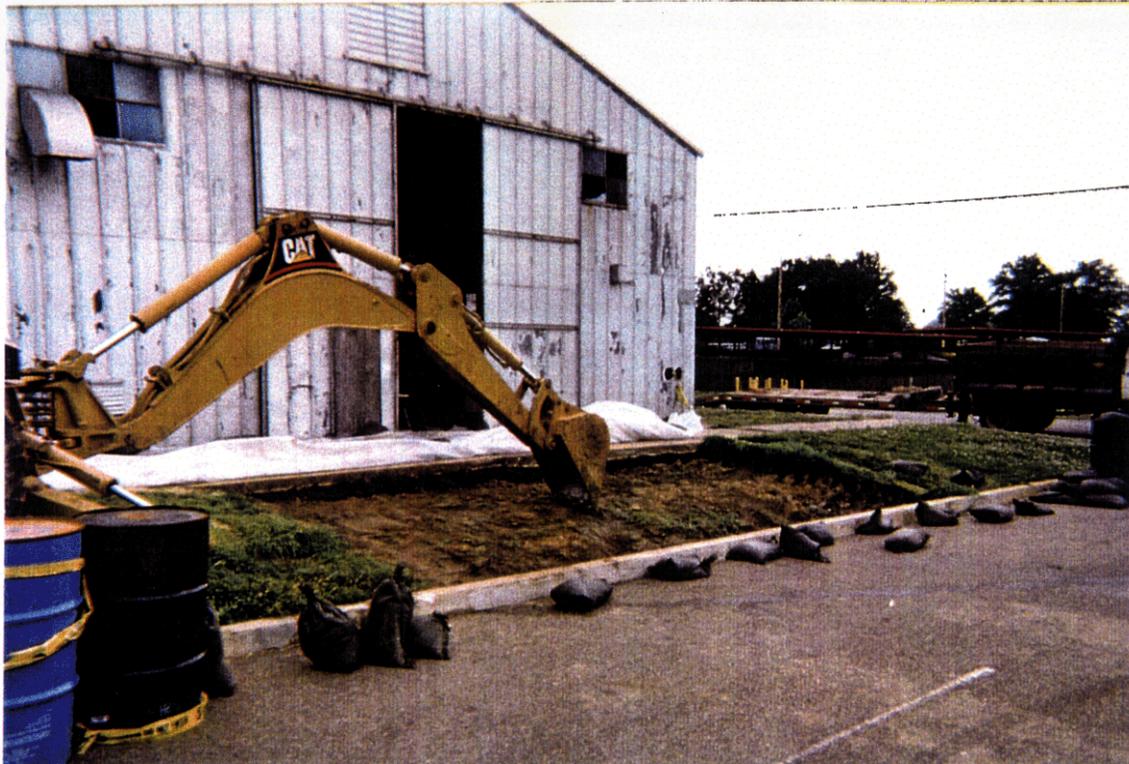
Beginning excavation of Area 2 during Phase II activities.

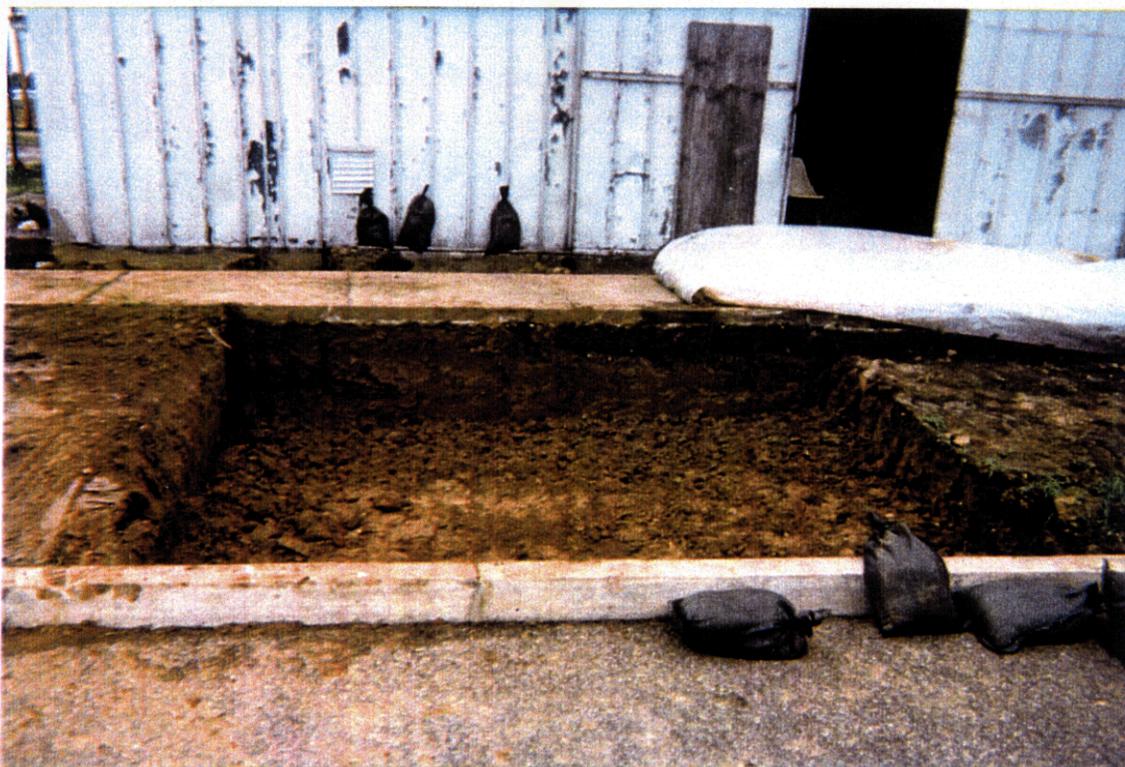
Excavation of Area 2 completed.

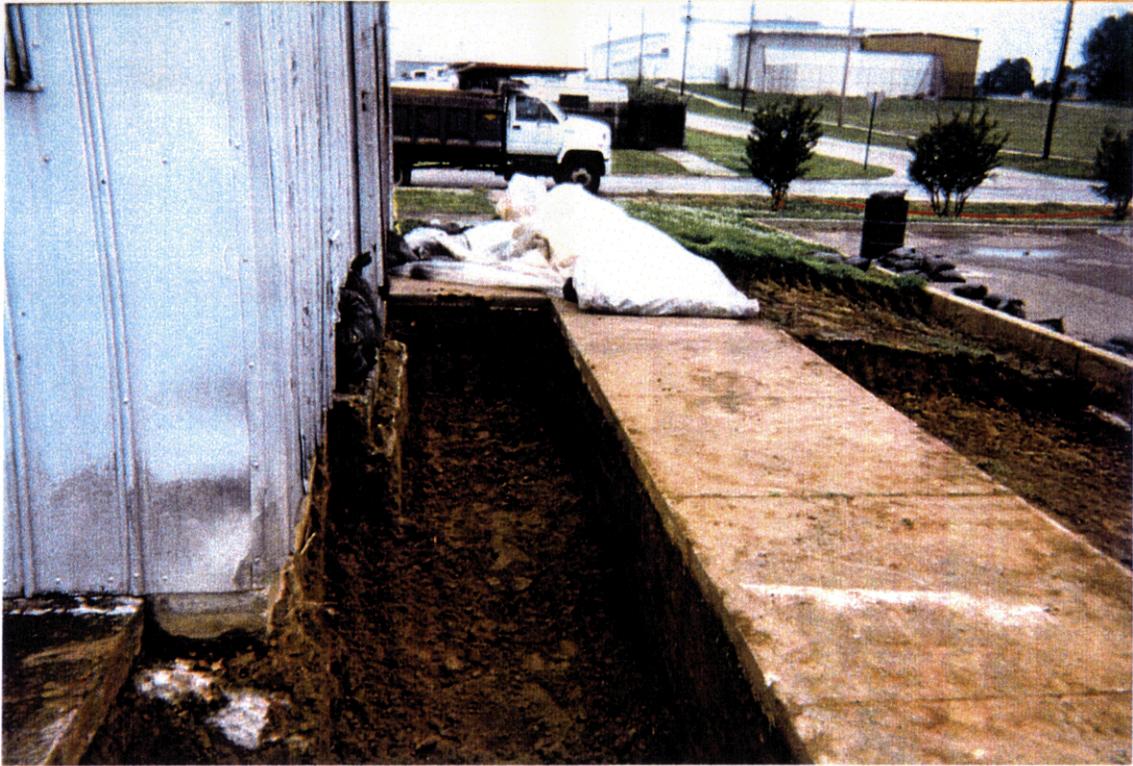
Area 1 excavation complete after Phase II operations.

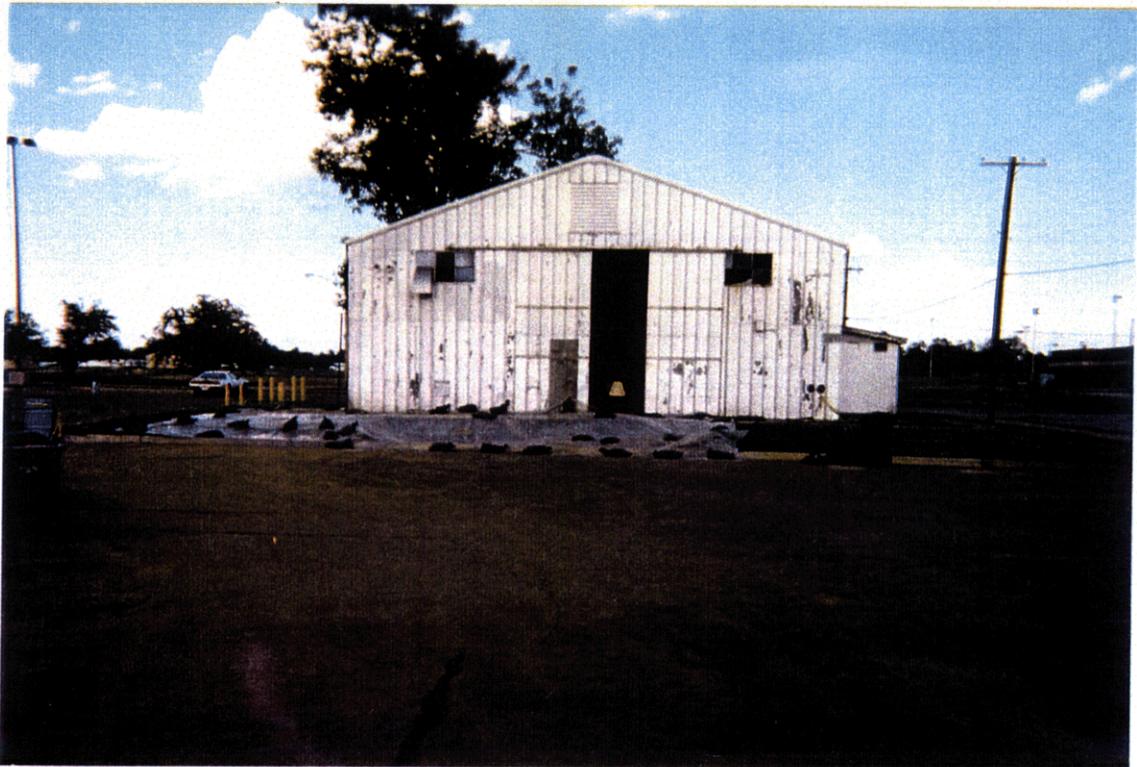
Site covered and secured after Phase II operation.

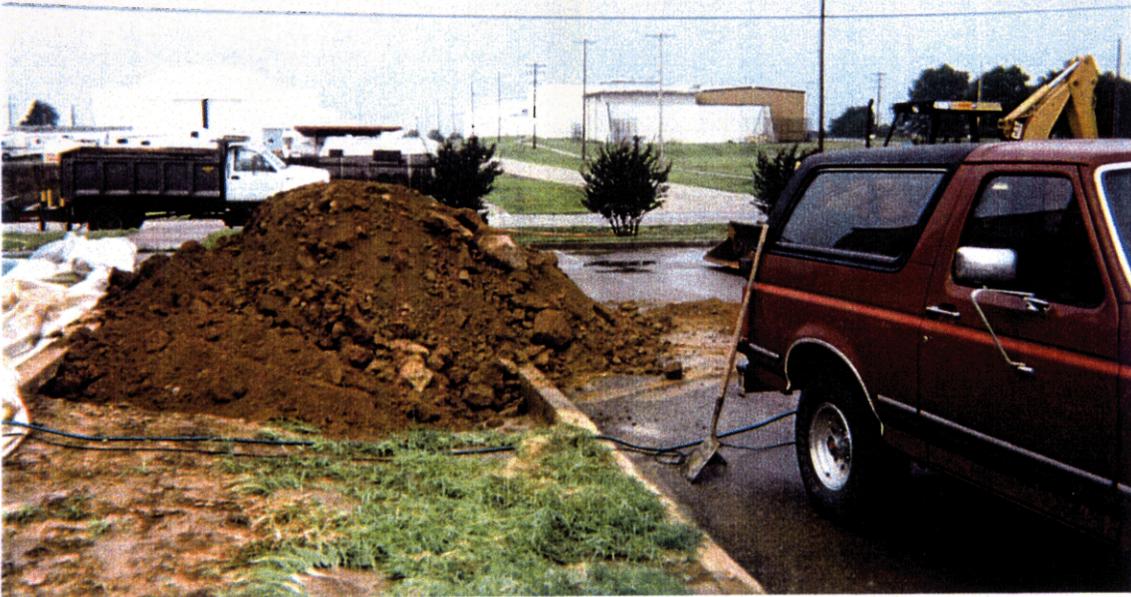
Backfill delivered to site for Phase III operations.

On June 16, 1997, the site was backfilled with approximately 30 cubic yards of clean soil. The soil was lightly compacted with the backhoe bucket and graded to match the existing soil profiles. After the site was graded, all disturbed portions were seeded with bermuda grass and fertilized with a commercial lawn fertilizer. The seeded area was then covered with approximately 6 inches of straw mulch to prevent excessive erosion and retain moisture while the seed germinated.

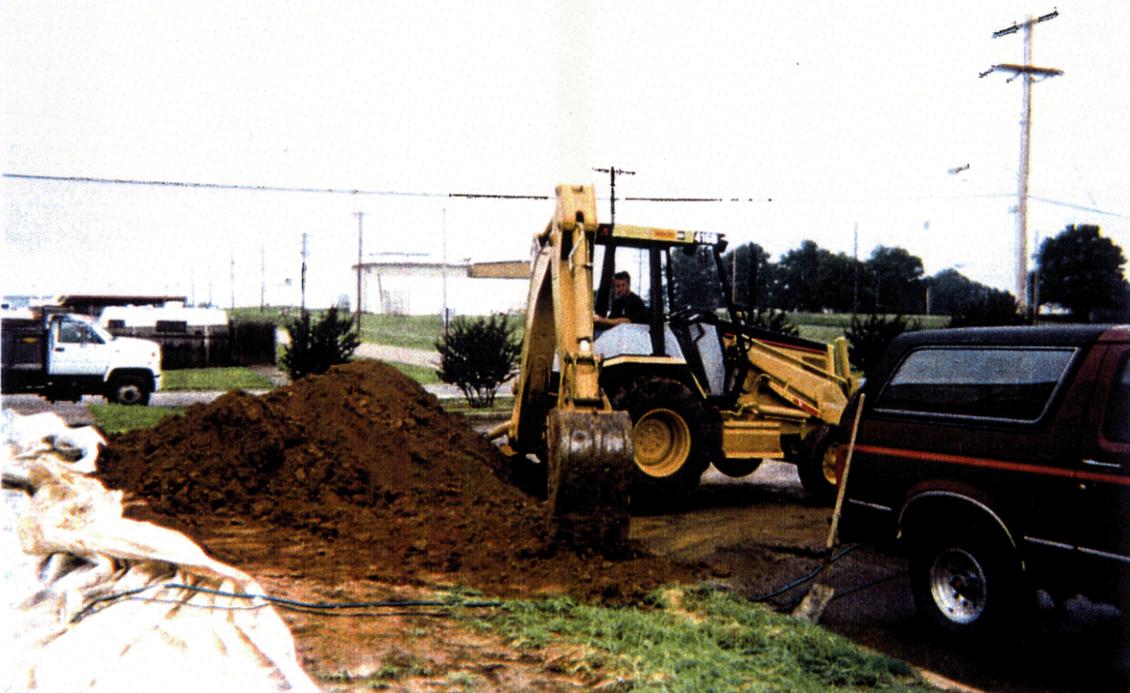
Spreading backfill material.

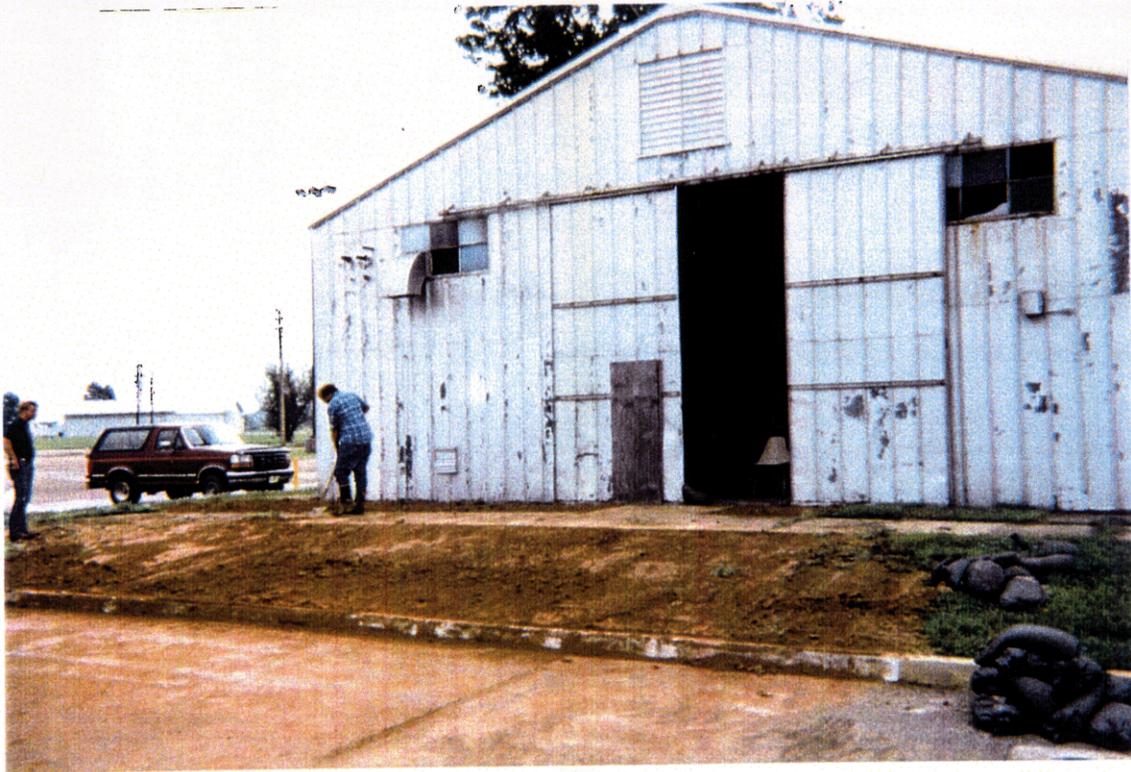
Final touch up of grading activities.

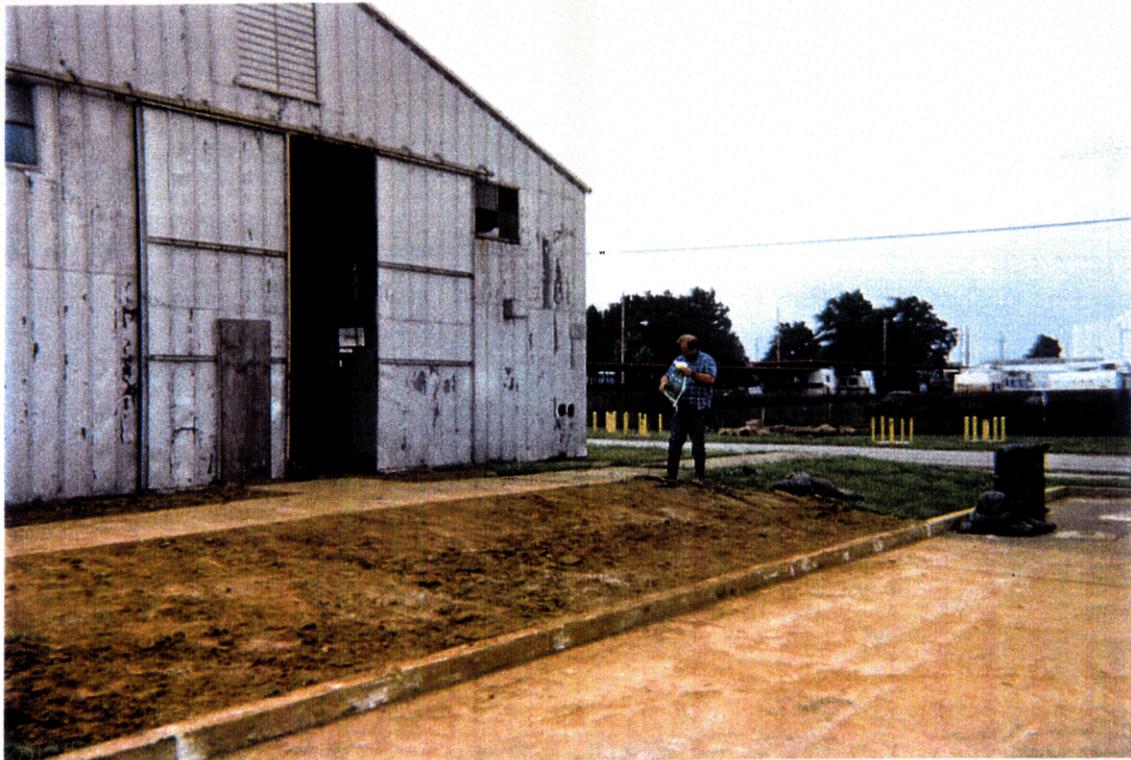
Seeding and fertilizing of the site.

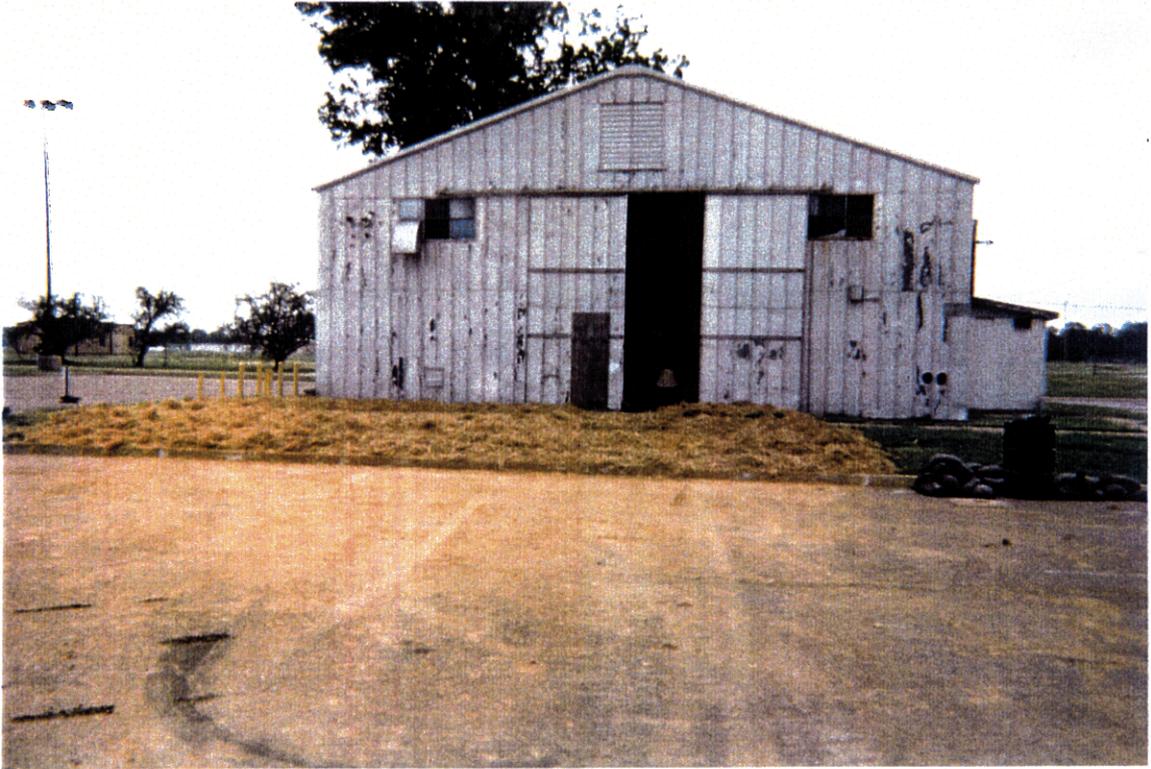
Site with completed straw mulch cover.

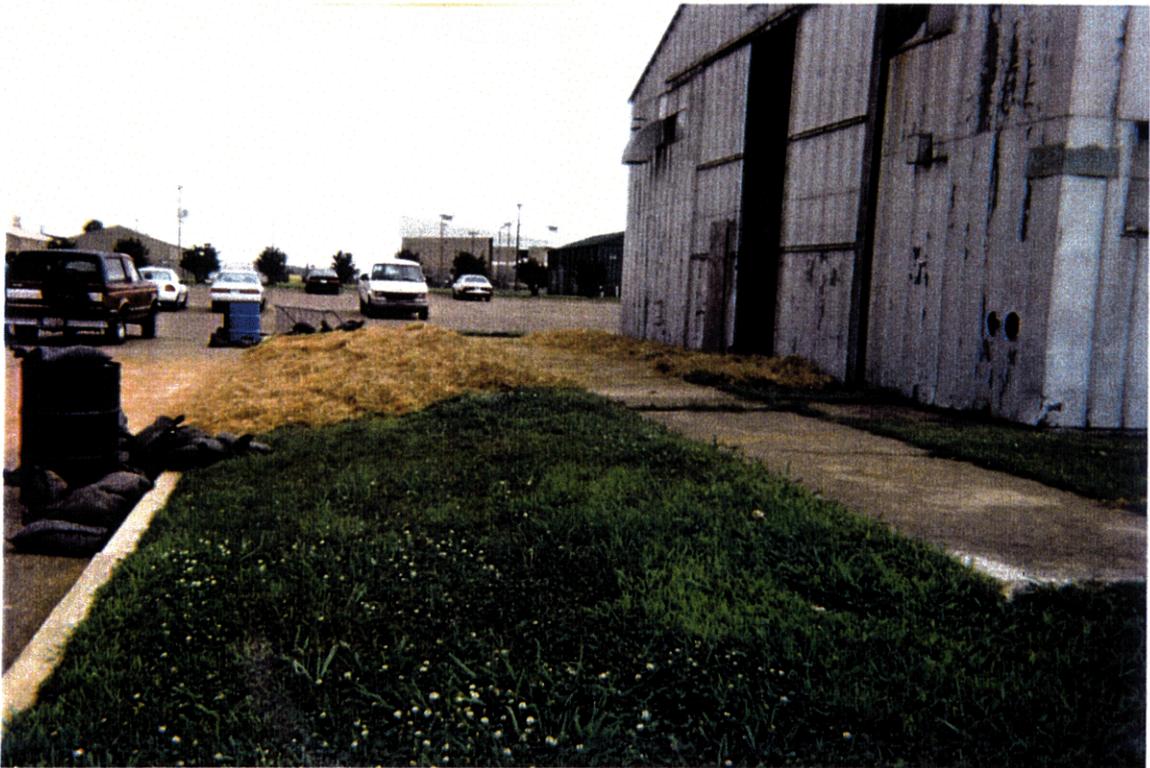
View from Casablanca Street of straw mulch cover.
