FINAL BASE REALIGNMENT AND CLOSURE ENVIRONMENTAL SITE SCREENING  
REPORT STUDY AREA 22 NTC ORLANDO FL  
5/1/1997  
ABB ENVIRONMENTAL

**BASE REALIGNMENT AND CLOSURE  
ENVIRONMENTAL SITE SCREENING REPORT**

**STUDY AREA 22  
FORMER GOLF COURSE (UNF-1)**

**NAVAL TRAINING CENTER  
ORLANDO, FLORIDA**

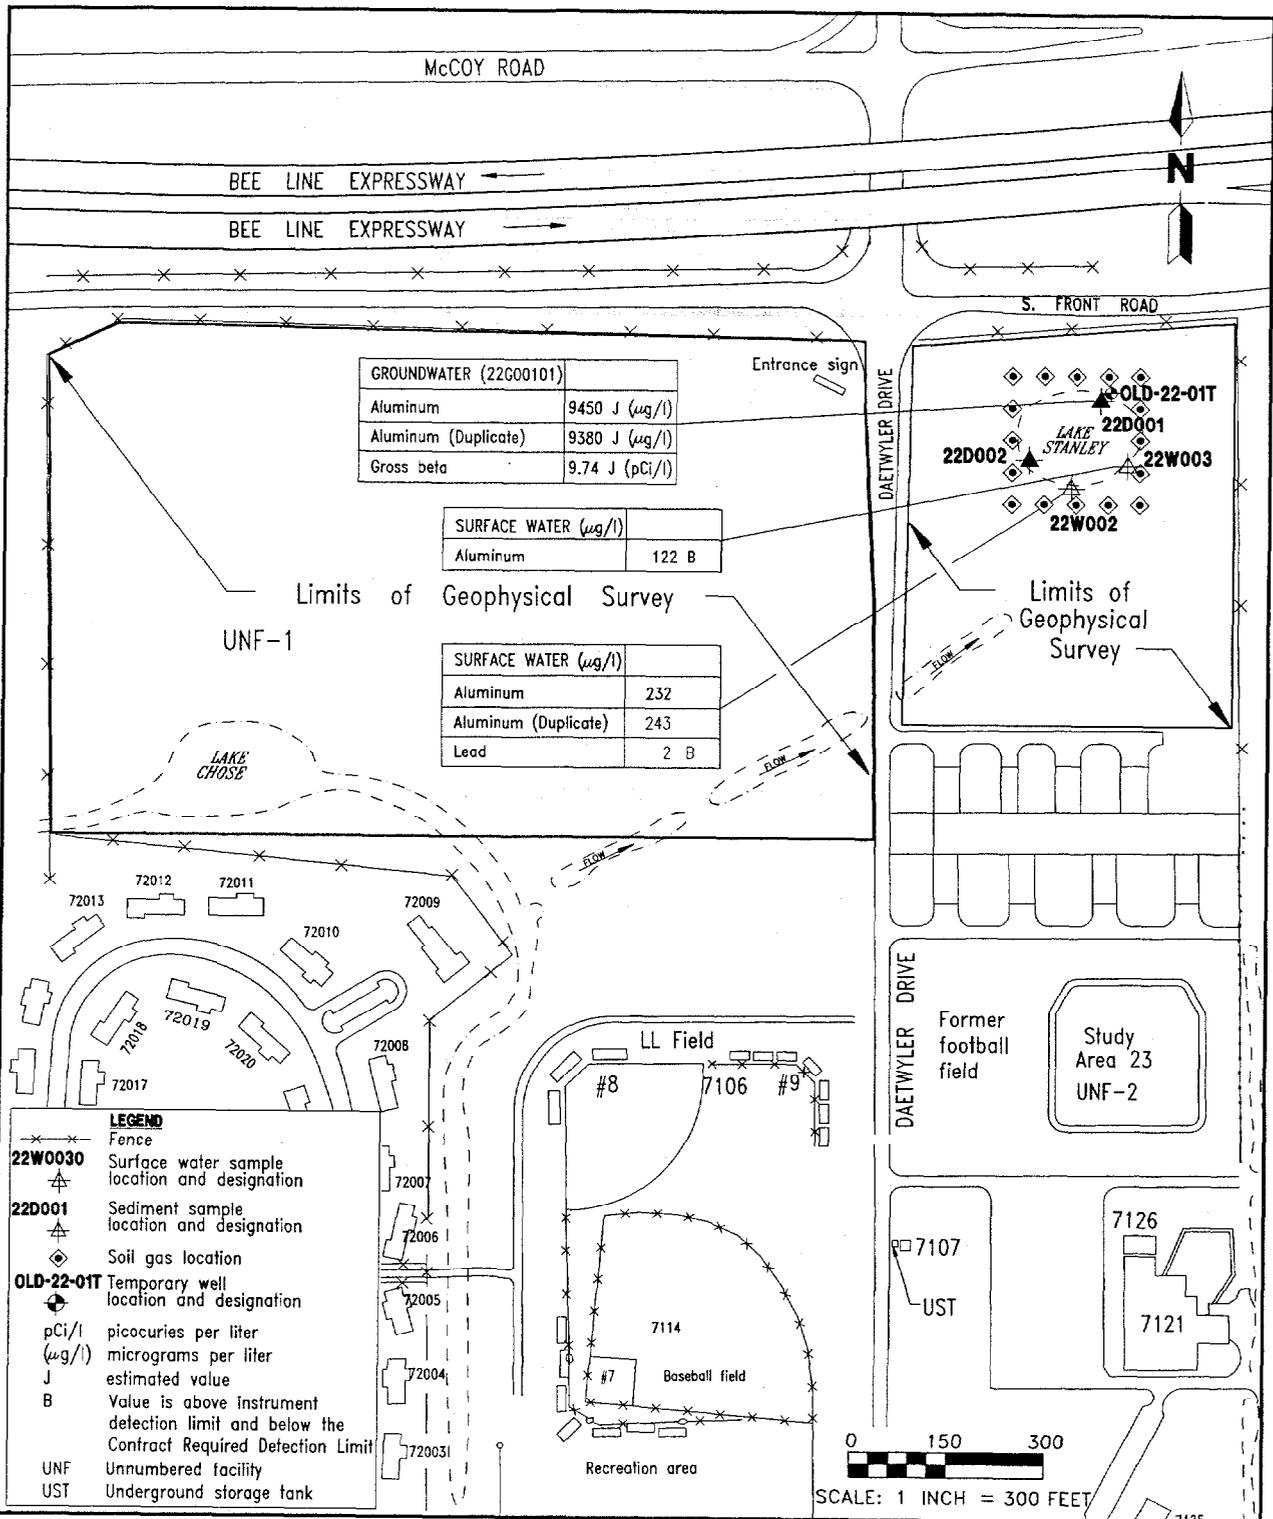
**FIGURE 2**  
**SEDIMENT, GROUNDWATER AND SURFACE**  
**WATER SAMPLE LOCATIONS,**  
**GEOPHYSICAL SURVEY AREAS**  
**AND SOIL GAS LOCATIONS, MCCOY ANNEX UNF-1,**  
**FORMER GOLF COURSE, STUDY AREA 22**

1.1 SA 22 UNNUMBERED FACILITY (UNF-1), BACKGROUND AND CONDITIONS. UNF-1 is a 30-acre open grass field with scattered trees divided by Daetwyler Drive (Figures 1 and 2). Prior to 1975, it was part of the McCoy Annex golf course. Two ponds and at least one surface drainage feature are present in the study area and may have served as water traps and/or provided drainage control while the golf course was active. One of the ponds, Lake Stanley, may have received spent engines, bomb shells, and ordnance in 1945 and 1946. An UXO and geophysical survey was conducted in this area in 1994 to confirm allegations of UXO disposal. At that time, a number of magnetic and ground penetrating radar (GPR) anomalies were delineated and the area was posted with signs warning of potential UXO.

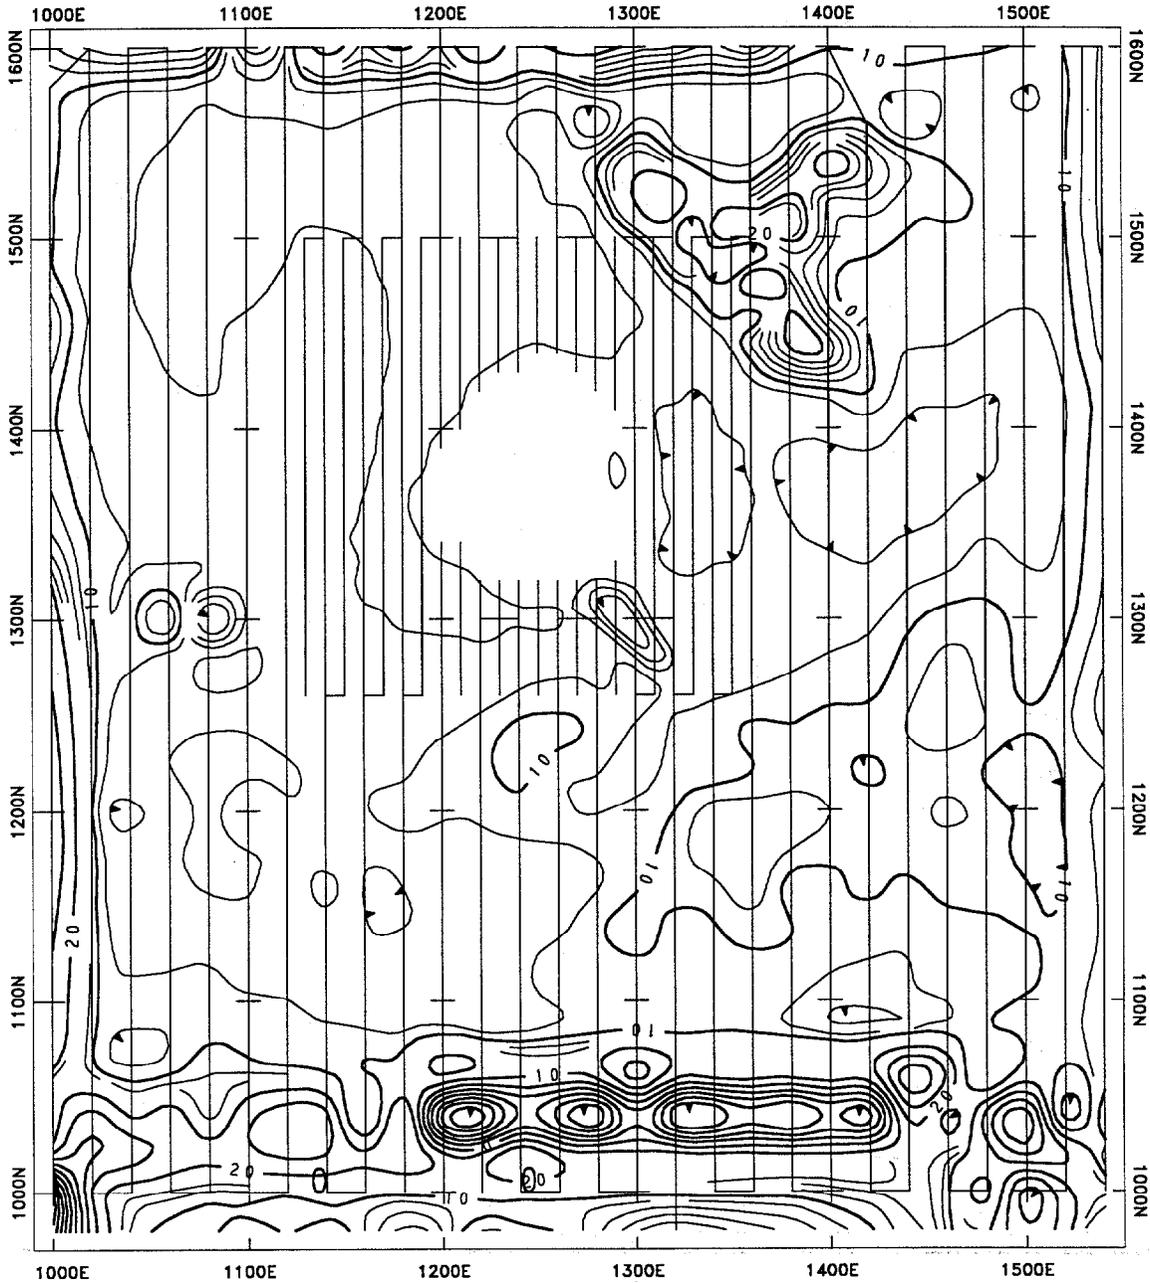
FIGURE 7

Most of the features can be explained by comparing the contours to existing site and utility maps. For example, a water main can be clearly noted as a prominent east-west lineament on Figures 7 and 8 at approximately 1040N. A second east-west feature, a sewer main, is discernible on Figure 8 at approximately 1215N.

<p>SOUTHERN DIVISION</p> <p>TERRAIN CONDUCTIVITY CONTOURS</p> <p>STUDY AREA 22 - EASTERN PORTION</p> <p>LAKE STANLEY</p> <p>ABB ENVIRONMENTAL SERVICES, INC.</p>
--

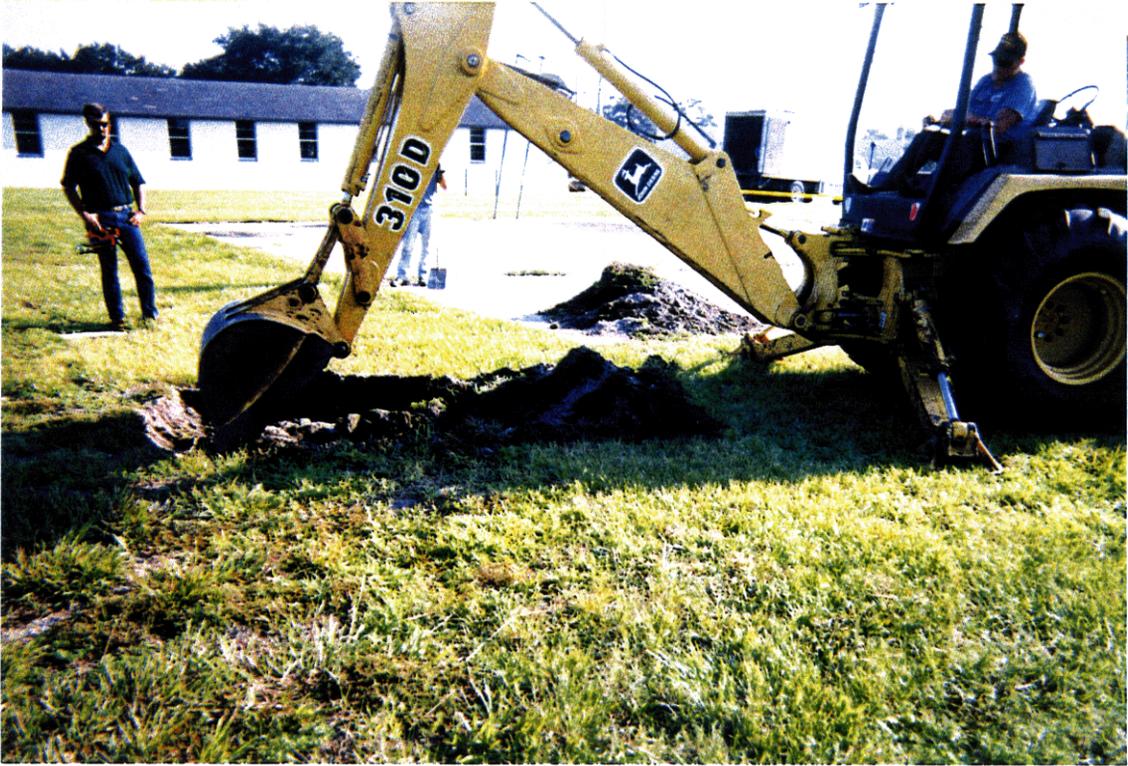
Photograph # 3: Backhoe taking 6-inch buckets of soil at a time.

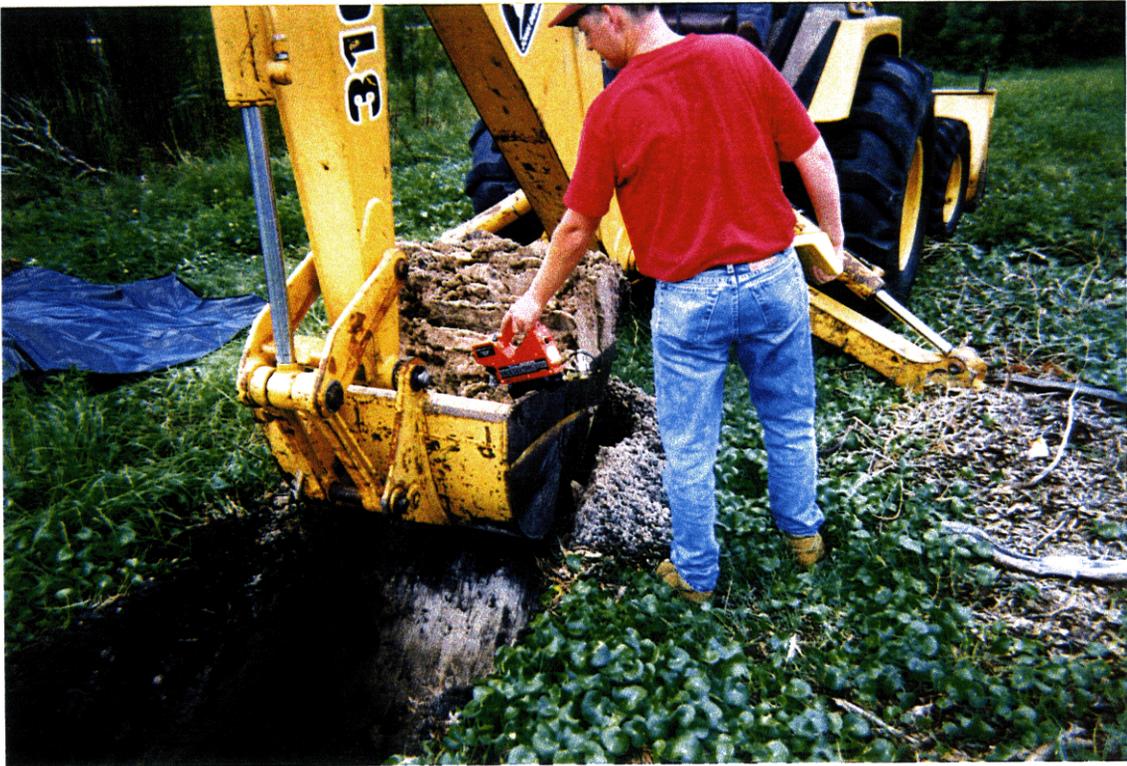
A decontamination pad was built for decontaminating the back hoe and Investigative Derived Waste (IDW) was contained in 55-gallon drums (Photographs 1 & 2). All personnel on site were 40-hour OSHA 29 CFR 1910.120 certified and were given a health and safety briefing. At each location, the back hoe operator was instructed to remove a trench of 6 inches of soil at a time (Photograph 3). Each bucket of soil was analyzed for volatile organic vapors with a flame-ionization detector and the results recorded in a logbook (Photograph 4).

Photograph # 4: Monitoring each bucket for volatile organic vapors with a flame-ionization detector and recording any readings.

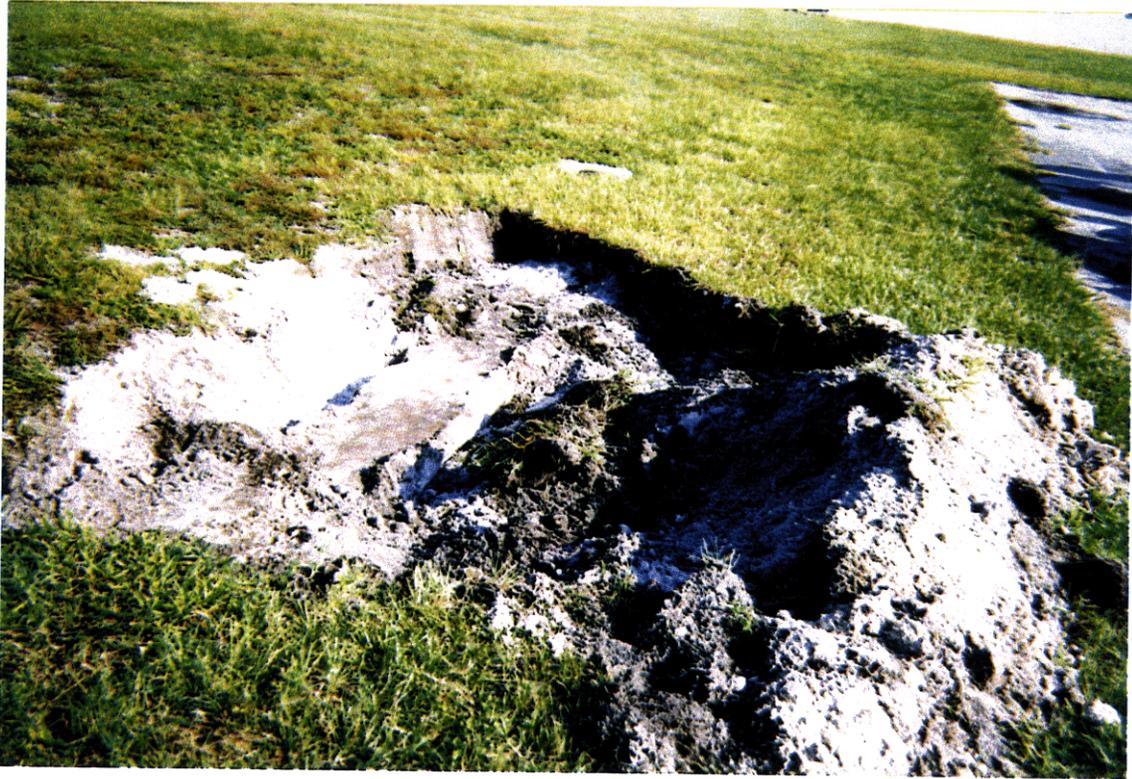
The first anomaly, 44TP1 was located approximately 4 feet from the southwest corner of the existing basketball court and 6 feet south of monitoring well, OLD-44-07 (Figure 1). A concrete pad was located 1 foot below level surface (bls). The pad was approximately 18 inches wide by 8 inches thick. The length of the concrete pad was not determined. The size of the excavation was approximately 8 feet wide by 10 feet long by 1 foot deep (Photographs 5). No volatile organic vapors were detected and the anomaly was identified as non-hazardous. The test pit was backfilled with the original soil (Photograph 6).

Photograph # 5: Excavation 44TP1 facing North.

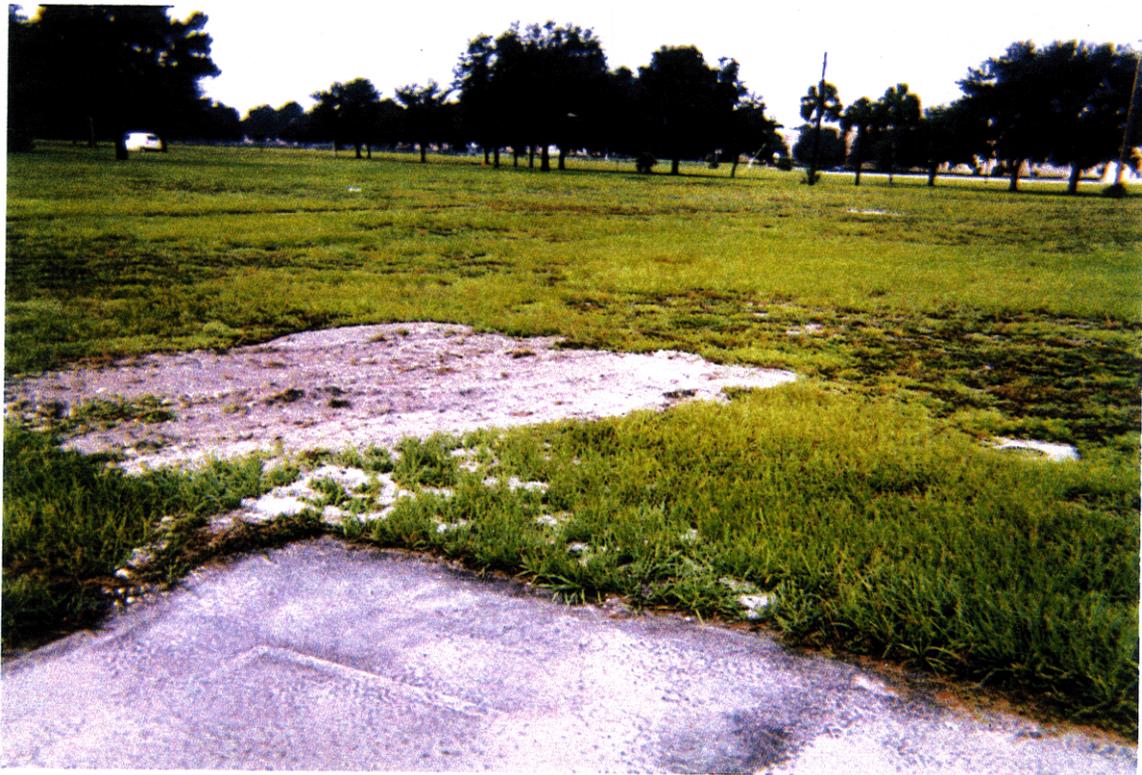
Photograph # 6: Excavation 44TP1 backfilled with original soil.

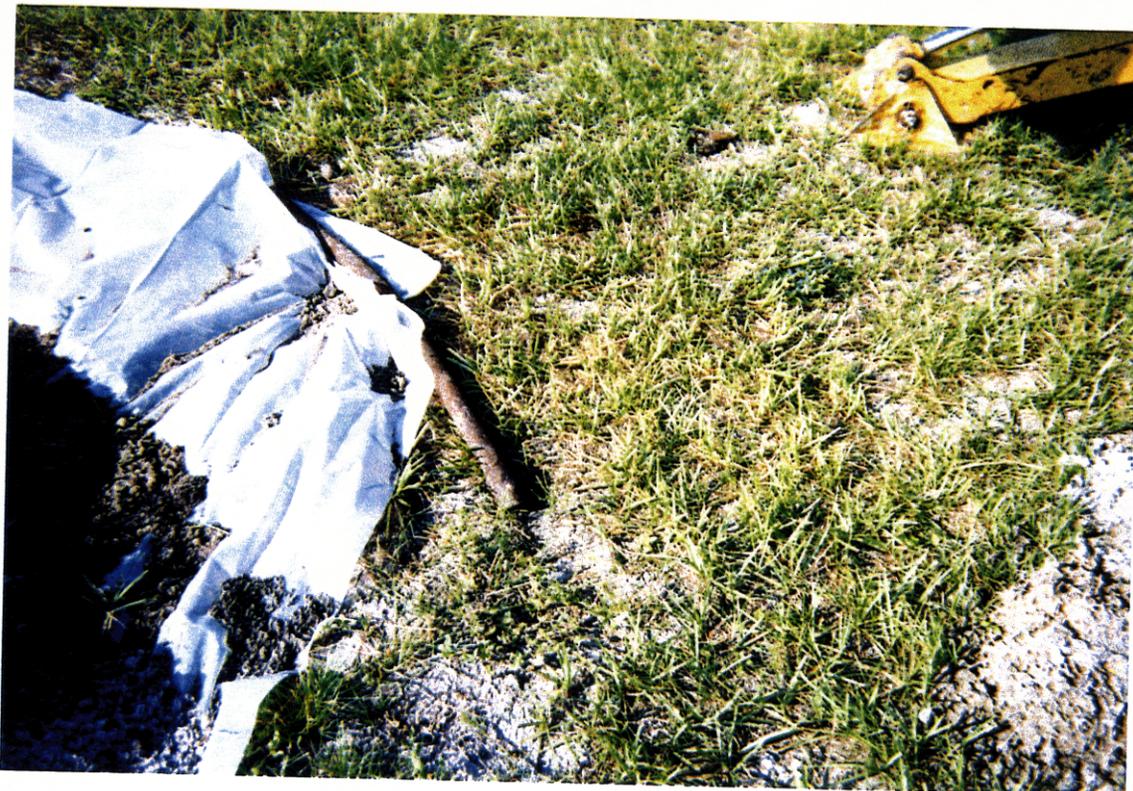
The second anomaly, 44TP2 was located approximately 10 feet southeast of monitoring well OLD-44-07 and 22 feet south of the basketball court (Figure 1). Within the first 6 inches of trenching, a three foot metal pipe, 2-inches in diameter was located (Photograph 7). The excavation continued and a concrete pad was found at 1 foot bls, resembling the concrete pad found at 44TP1. The length of the pad was not determined. The size of the excavation was approximately 5 feet by 5 feet by 1 foot deep (Photograph 8). No volatile organic vapors were detected and the anomalies were identified as non-hazardous. The test pit was backfilled with the original soil. The metal pipe was removed from the test pit, set aside and reported to the NTC Orlando Environmental Coordinator at the Public Works office.

Photograph # 7: Metal pipe found at 44TP2.

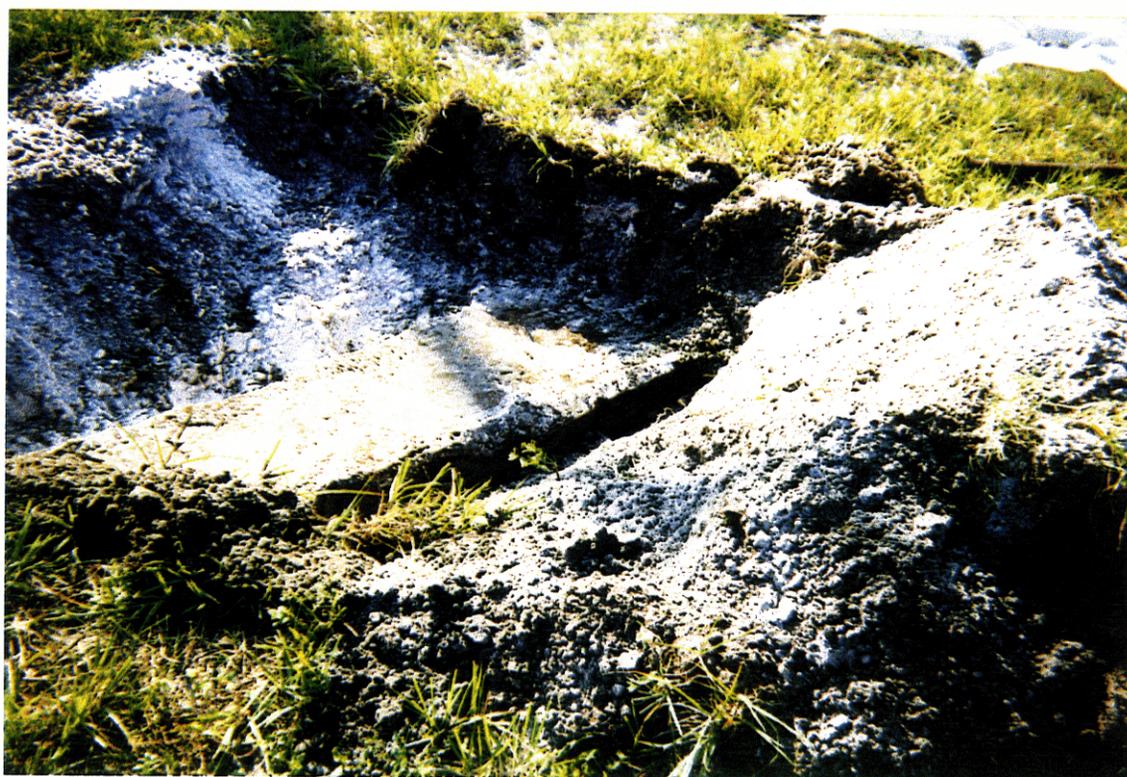
Photograph # 8: Concrete pad found at 44TP2.

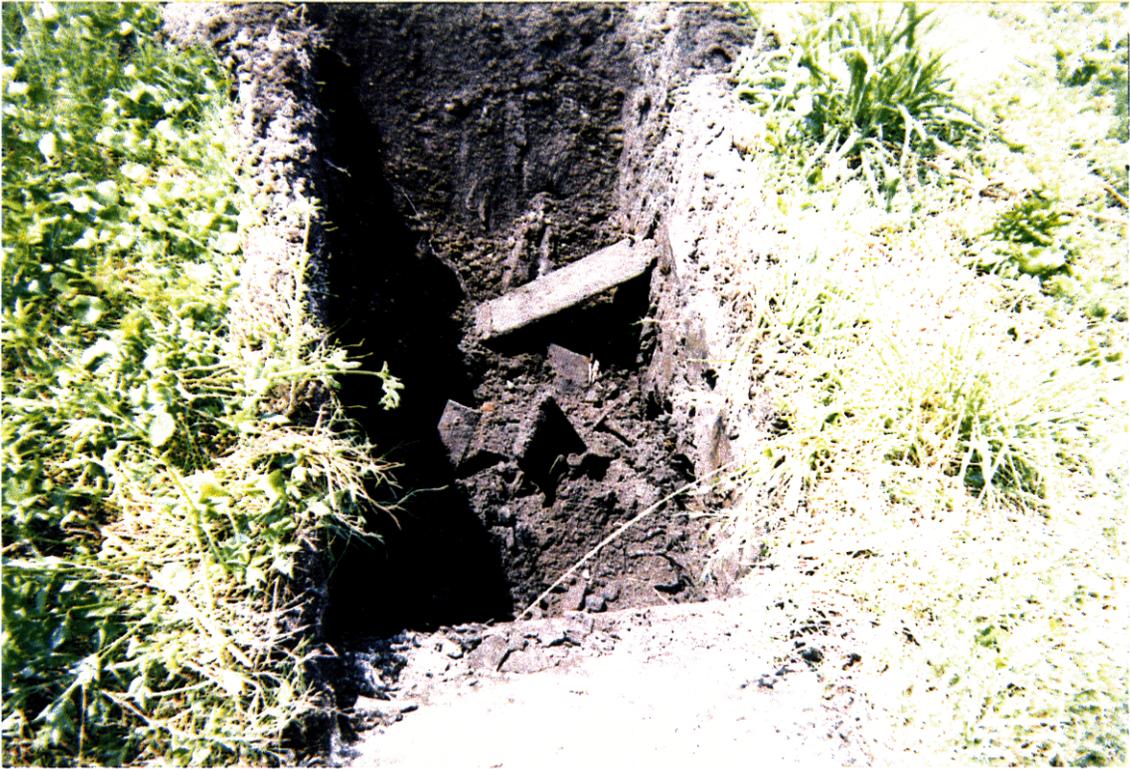
Photograph # 9: Wood & metal debris found at SA-17.

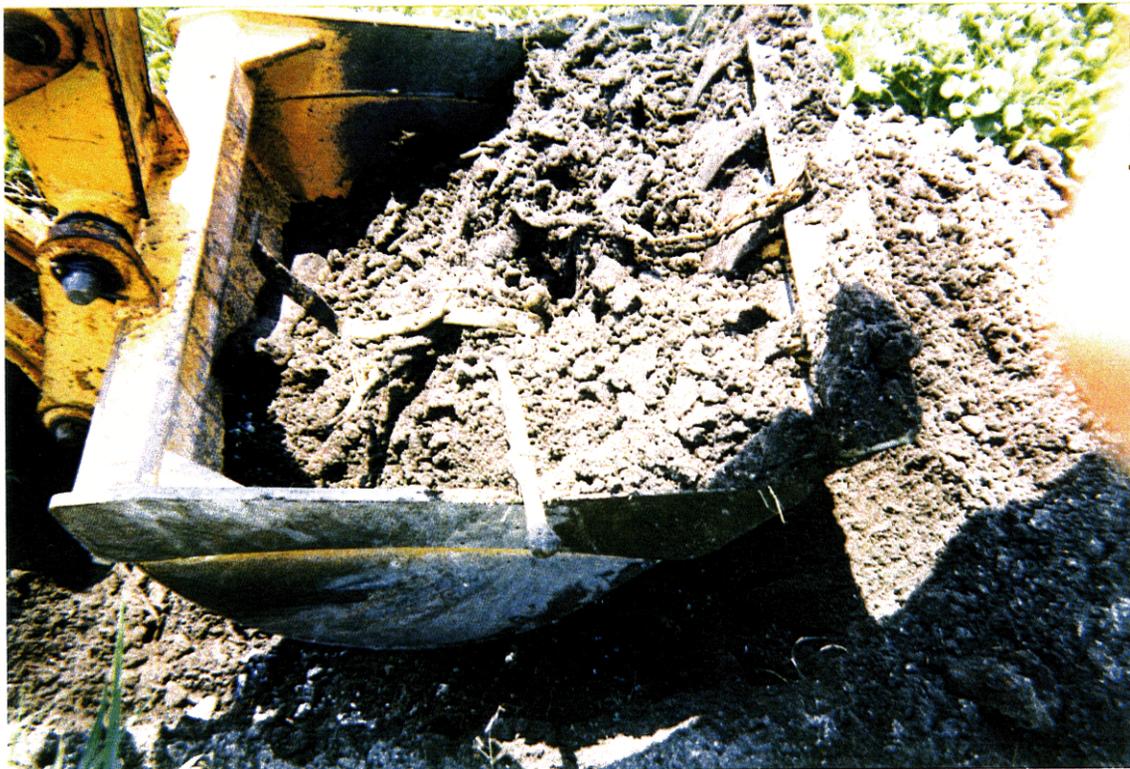
Photograph # 10: Wood and metal debris found at SA-17.

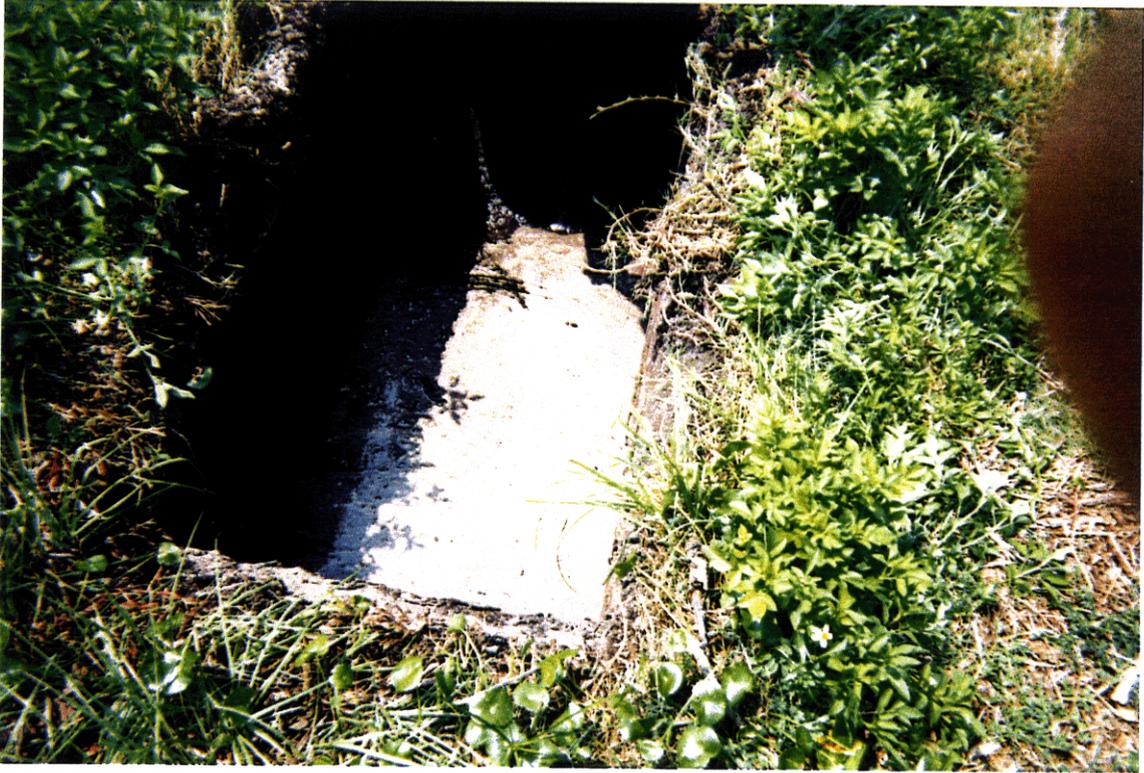
Photograph # 11: Trench 17TP1c.

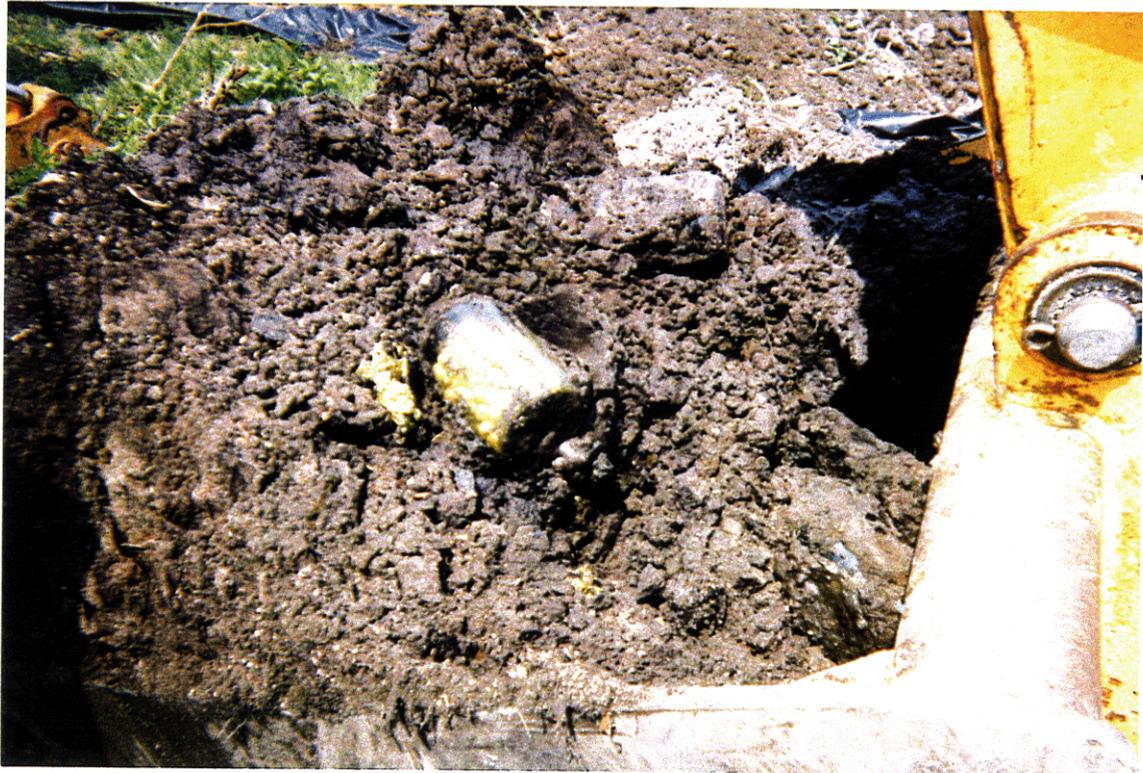
Two more trenches, 17TP1d and 17TP1e, were excavated parallel to 17TP1c, four feet on center from one another (Figure 2). At location 17TP1d and 17TP1e and at a depth of 3 feet, yellow, elliptical, 1/2 inch to 3/4 inch diameter objects were encountered in mason jars (Photograph 12 & 13). The jars appeared to be 3/4 filled and unopened. Only methane was encountered with the flame-ionization detector. Five jars were found. One jar was broken and the objects were smeared together with a clayey texture. All objects were noted and not removed from the excavation. The water table was encountered at 3 feet. All trenches were backfilled (Photograph 14) and the back hoe was decontaminated.

Photograph # 12: Yellow, elliptical, 1/2 inch to 3/4 inch diameter objects encountered in mason jars.

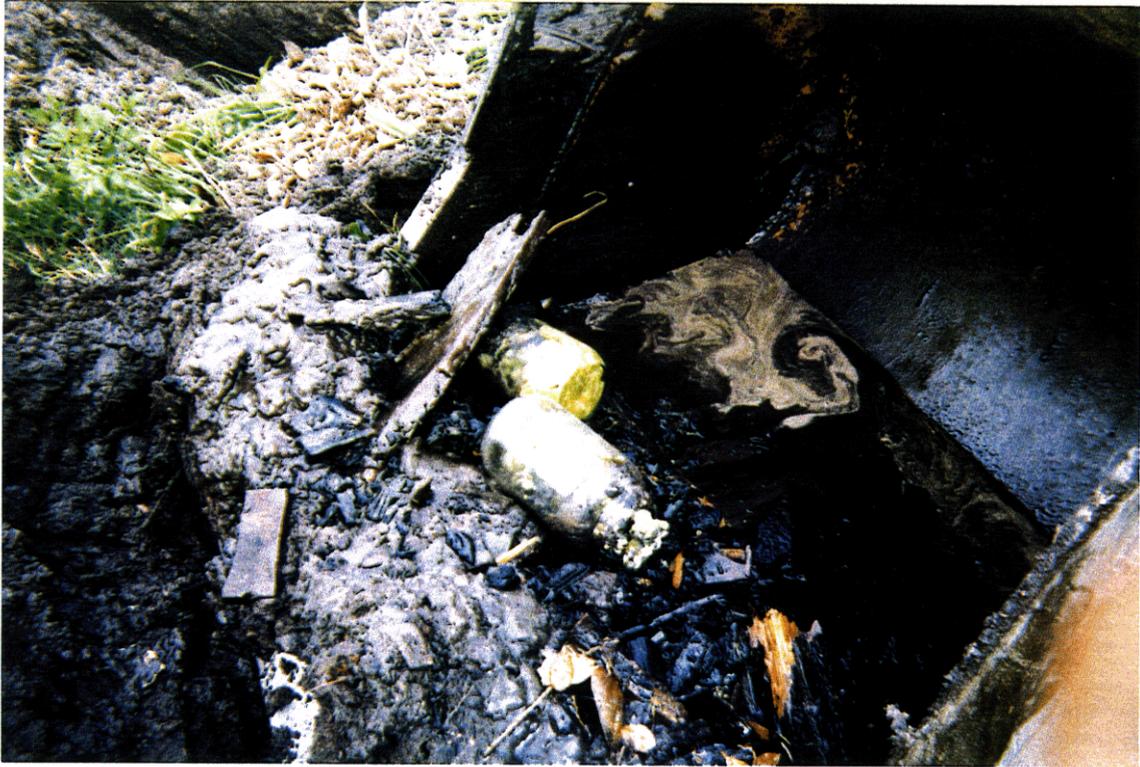
Photograph # 13: Yellow, elliptical, 1/2 inch to 3/4 inch diameter objects encountered in mason jars.

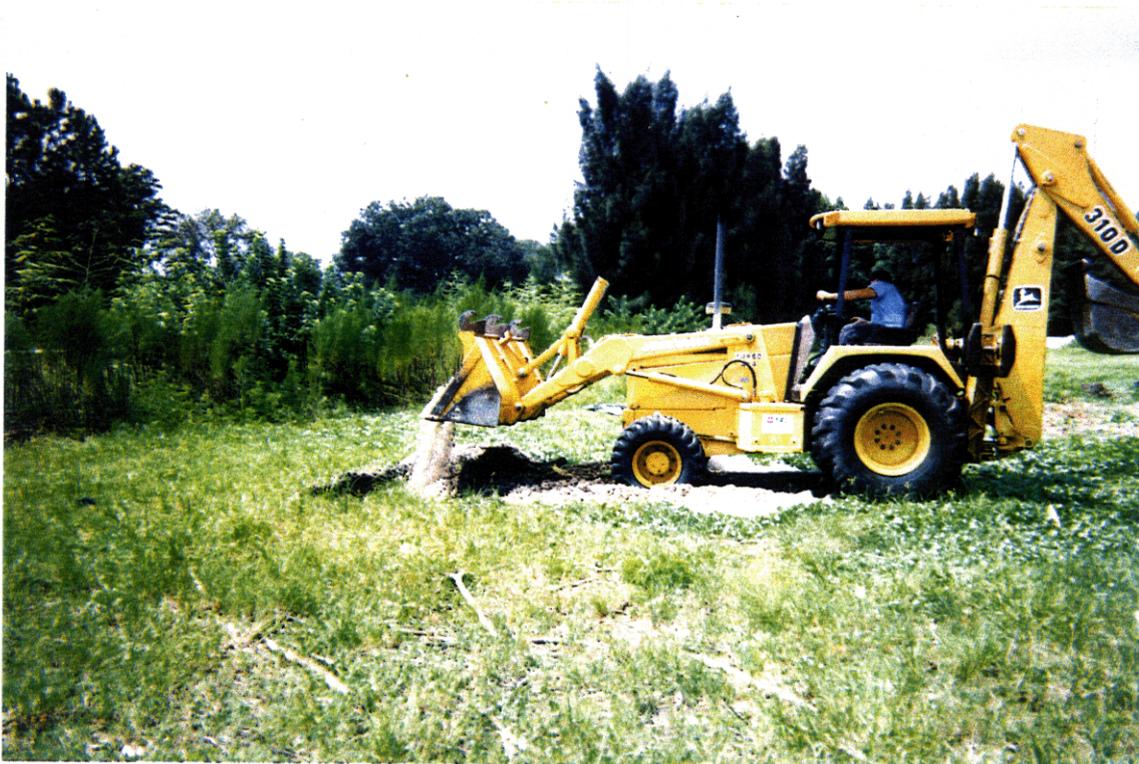
Photograph # 14: Backfilling trenches at SA-17.

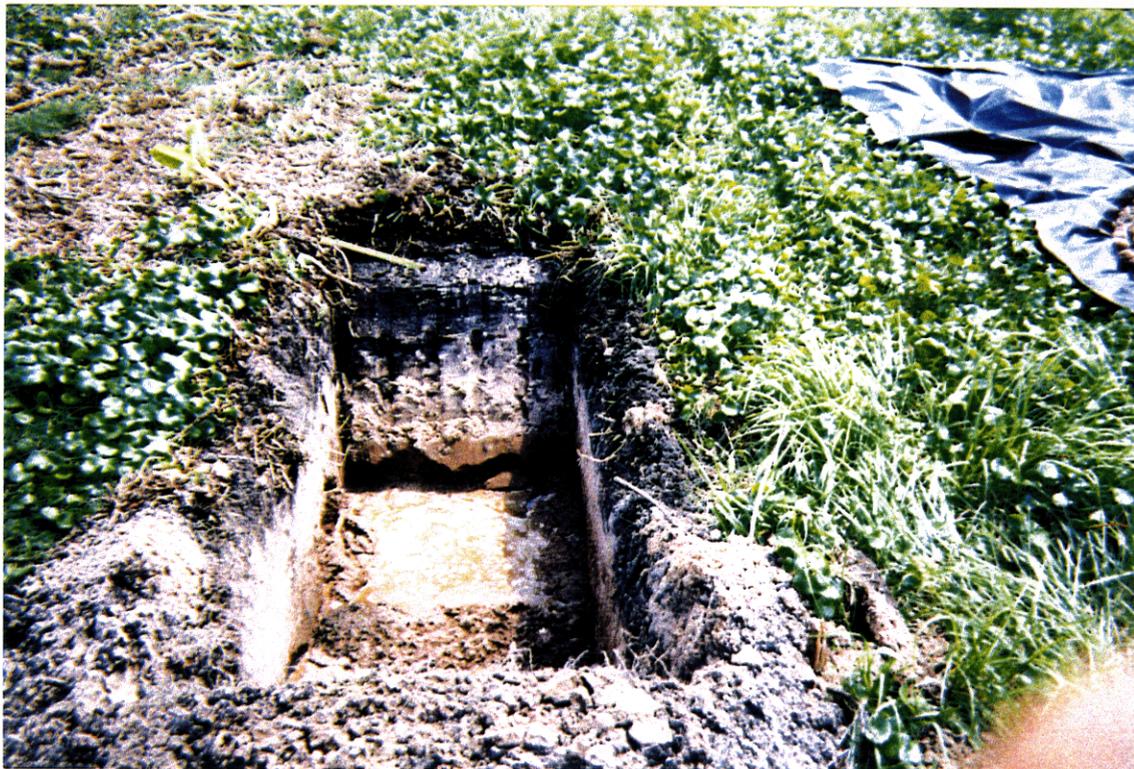
The first anomaly, 22TP1, was excavated at 1070E - 1075E and 1300N from a previous geophysical investigation grid (Figure 3). The trench was 4 feet wide by 5 feet long and 4.5 feet deep (Photograph 15). The water table was encountered at approximately four feet. Remnants of an old tree were found. No volatile organic vapors were encountered and the anomaly was identified as not hazardous. Due to time restraints and dark clouds, the old tree was assumed to be the anomaly in question and the excavation was backfilled.

Photograph # 15: Excavation at 22TP1.

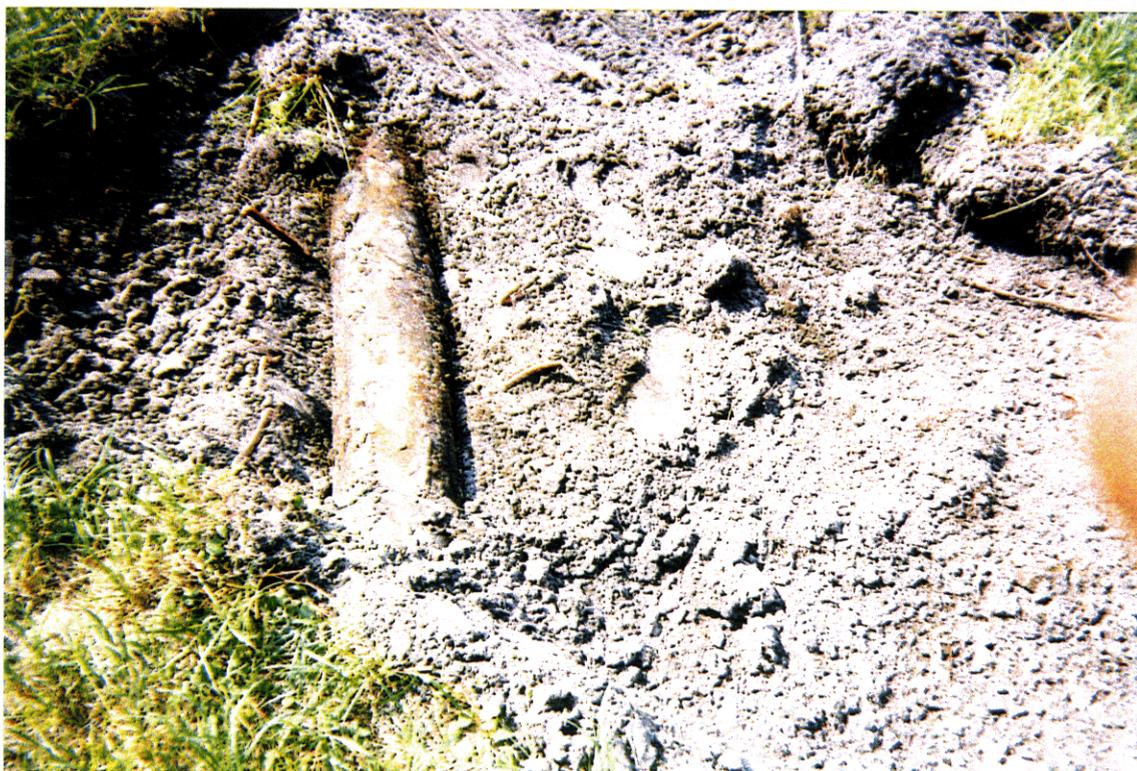
The second anomaly, 22TP2, was excavated at 1300E and 1300N (Figure 3). The anomaly was identified as an 8-inch diameter metal pipe (Photograph 16). The start of the pipe was at 1310E, 1280N and ran northwest into the lake edge at 1270E, 1310N. No volatile organic vapors were encountered and the anomaly was identified as not hazardous. The excavation was backfilled.

Photograph # 16: Anomaly at 22TP2.
