PHASE II
RCRA FACILITY ASSESSMENT
OF THE
NAVAL AMMUNITION FACILITY
VIEQUES ISLAND, PUERTO RICO
EPA I.D. No. PRD980536189

prepared for
U.S. Environmental Protection Agency
Region II
26 Federal Plaza
New York, New York 10278

A. T. Kearney, Inc.
225 Reinekers Lane
Alexandria, Virginia 22313

October, 1988

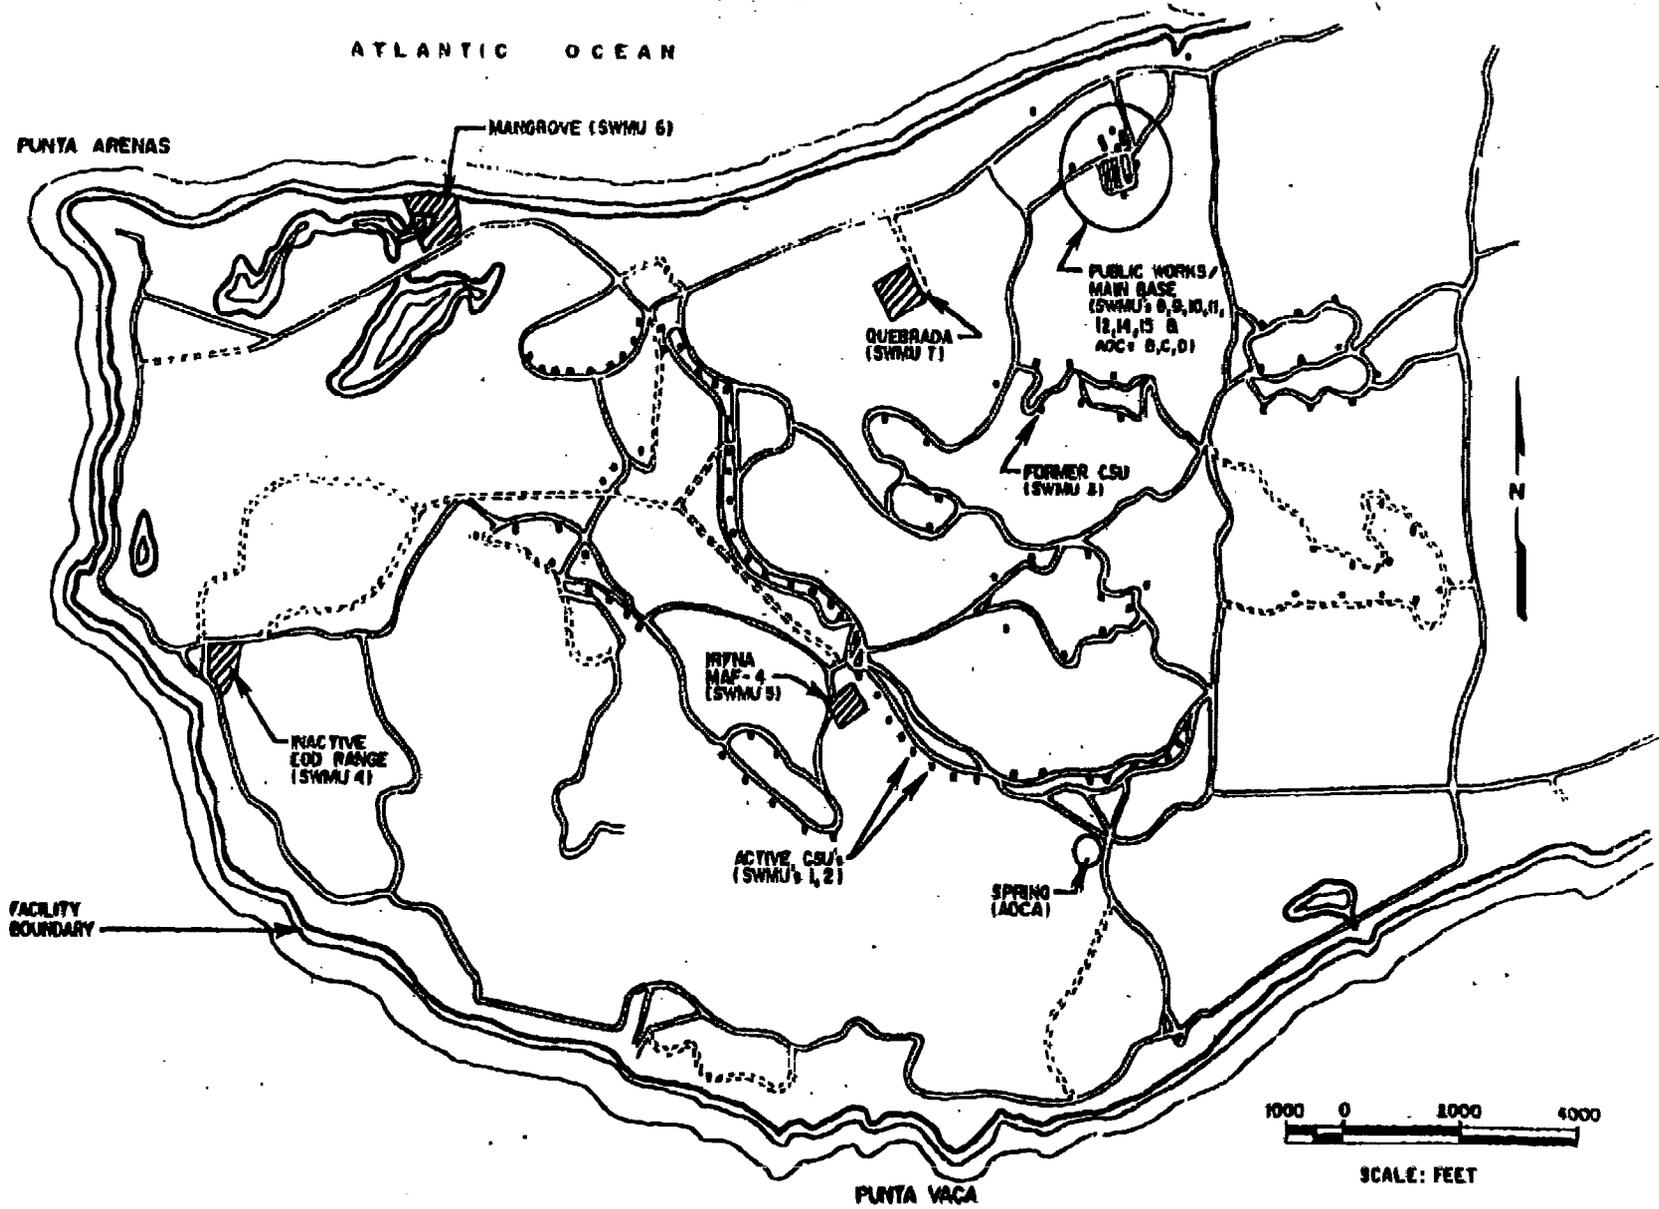
The preliminary review of file material resulted in the identification of 6 SWMUs and 6 AOCs. Following the VSI, a total of 15 solid waste management units and 4 areas of concern were identified (Table 1, Figure 1). Although the facility occupies 8,000 acres, the majority of the property is undeveloped. The primary purpose for the facility is the storage and transfer of munitions for the U. S. Navy Atlantic Fleet. The facility, therefore, maintains and manages numerous magazines for storage of these munitions. Wastes generated at the facility include waste munitions, wastes generated during maintenance of equipment used in transfer and storage of munitions (e.g., vehicles), and sanitary wastes. The final identification of units as SWMUs and AOCs is based upon the preliminary review, observations made during the VSI, and conclusions made concerning the types of wastes managed and the potential for a release from the units.

FIGURE I. SWMU s AND AOC s AT THE NAVAL AMMUNITION FACILITY.

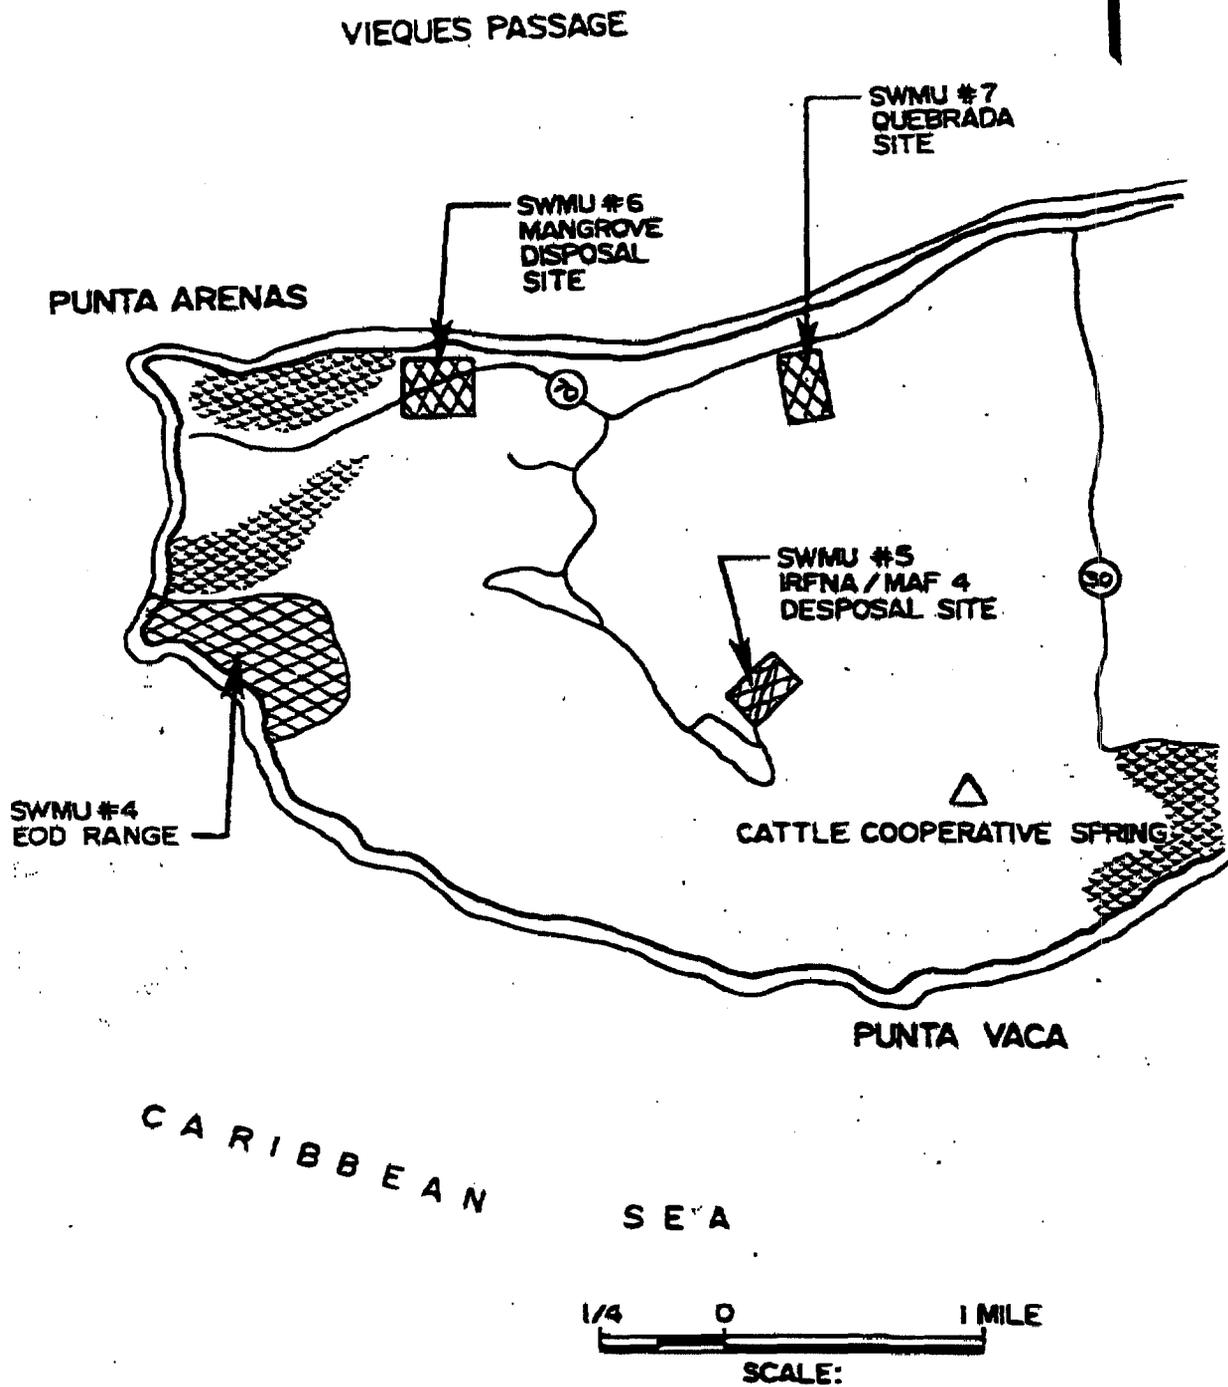
The Navy Assessment and Control of Installation Pollutants (NACIP) Initial Assessment Study (IAS) (Ref. 2) suggested a Confirmation Study for four sites on NAF property (Figure 3). The sites include the Inactive Waste Explosive Open Burn/Detonation Range (SWMU #4), the IRFNA/MAF-4 Disposal Site (SWMU #5), the Mangrove Disposal Site (SWMU #6), and the Quebrada Disposal Site (SWMU #7). A site inspection conducted in 1986 observed rusted 1-gallon paint cans and 55-gallon drums situated on coarse sand at the Mangrove Disposal Site (SWMU #6) (Ref. 6). In addition, some of the waste material was standing in the water of Laguna El Pobre (Ref. 6). Although no additional information was obtained from file information available at the time of the PR and VSI to characterize releases from units at the NAF, a 1986 reference indicates that a Confirmation Study was in progress (Ref. 5). Waste material was observed during the 1988 VSI at both the Mangrove Disposal Site (SWMU #6) and the Quebrada Disposal Site (SWMU #7). At both of these sites, waste materials were placed in a location that would be subject to transport of wastes by surface runoff during the characteristic high intensity, short-duration rainfalls that occur on Vieques Island. Confirmation studies were recommended at all of the land disposal sites (Ref. 2).

FIGURE 3. SITES RECOMMENDED FOR CONFIRMATION STUDIES IN THE NACIP IAS REPORT (REF. 2).
