Re: Contract N62470-07-D-0502  
IQC for A/E Services for Multi-Media  
Environmental Compliance Engineering Support  
Delivery Order (DO) 0002  
Final Pico Del Este Site Investigation Report

# **FINAL SITE INVESTIGATION REPORT PICO DEL ESTE RADAR FACILITY**

## **CARIBBEAN NATIONAL FOREST LUQUILLO, PUERTO RICO**

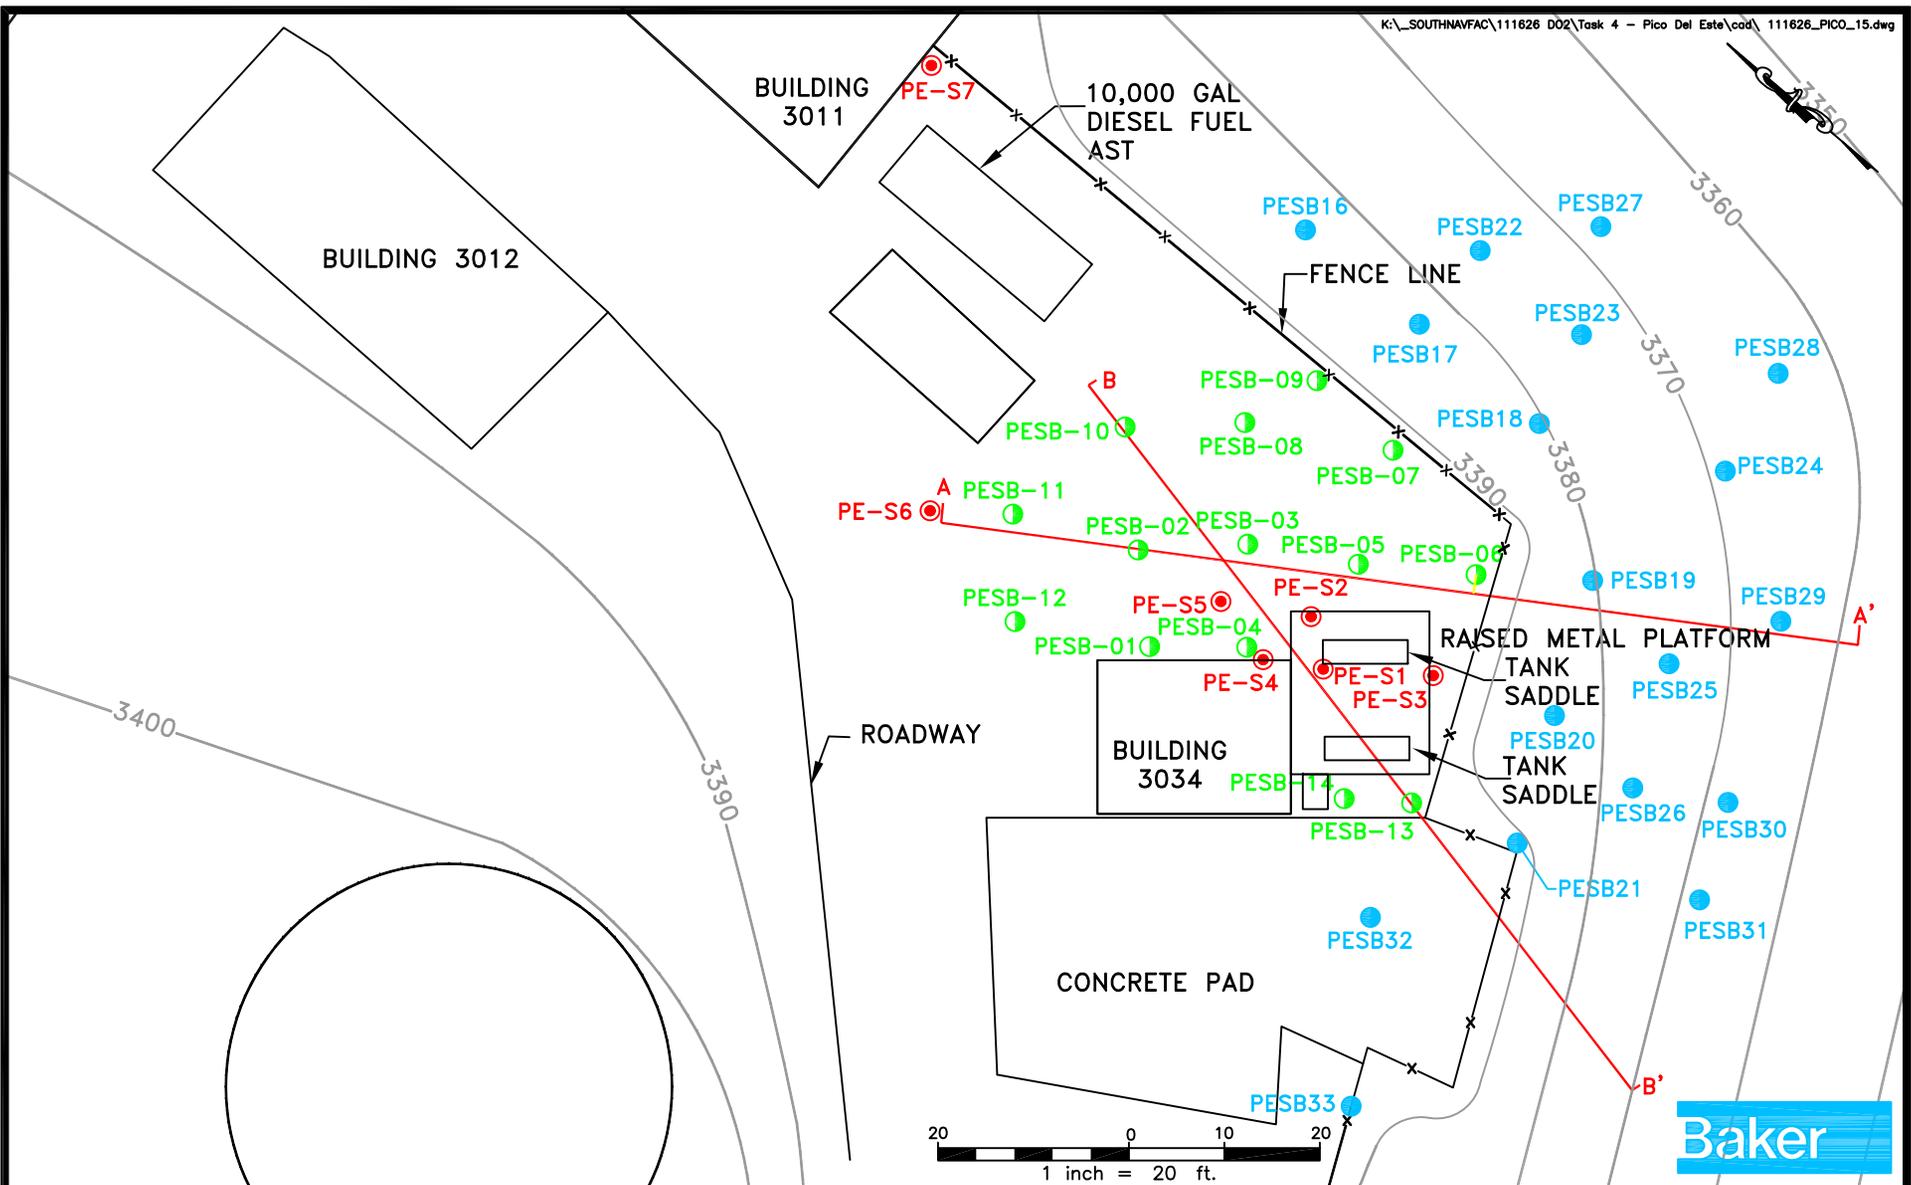
**FIGURE 2-1**  
**SITE PLAN**  
**SITE INVESTIGATION**

LEGEND	
	- PREVIOUS EBS BORING LOCATIONS 2003
	- NEWLY INSTALLED SI BORING LOCATIONS 2007
	- SI SURFACE SOIL LOCATIONS 2008
	- CROSS SECTION LOCATION

7. *Page 2-1, Section 2.2, Paragraph 2. The text refers to the collection of seven soil samples as part of the Environmental Baseline Survey. However, only six locations are shown on the corresponding Figure 2-1. Location PE-S2 appears to be missing from the figure. Revise the text or the figure accordingly.*

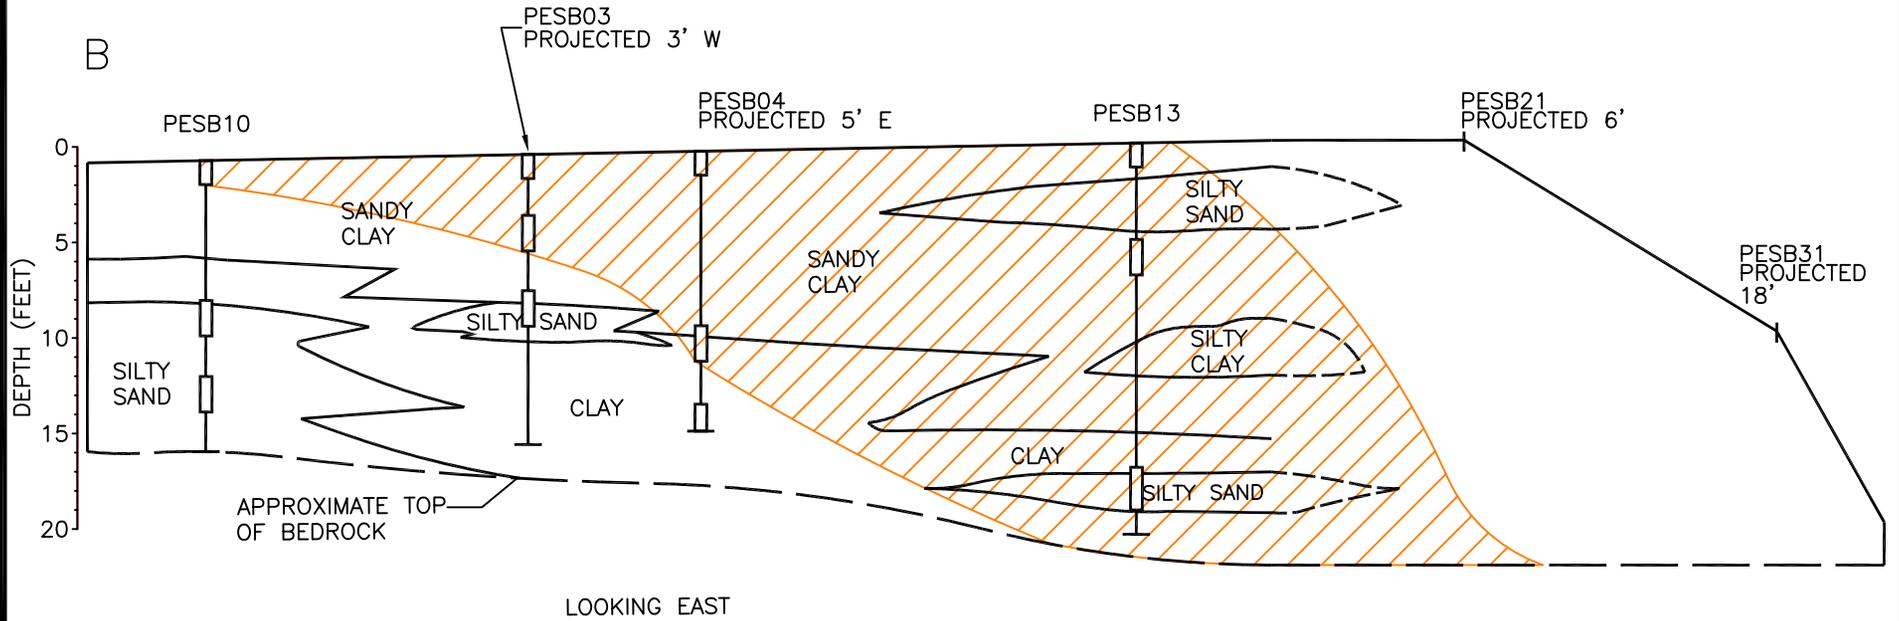
FIGURE 2-3  
 GEOLOGIC CROSS-SECTION B-B'  
 SITE INVESTIGATION

NOTE: GROUND SURFACE WAS ASSUMED RELATIVELY FLAT WITH A SLIGHT GRADE WEST TO EAST.

- *Figures 2-2 and 2-3 indicate that TPH-DRO contamination exists down to bedrock. The hydrogeology of the site should be documented. Although groundwater was not encountered in the vadose zone, the depth to bedrock groundwater should be discussed and groundwater discharge points should be investigated. Surface water features that could be a repository for contamination carried from the site via overland flow or via infiltration and subsurface migration should be discussed in the report.*

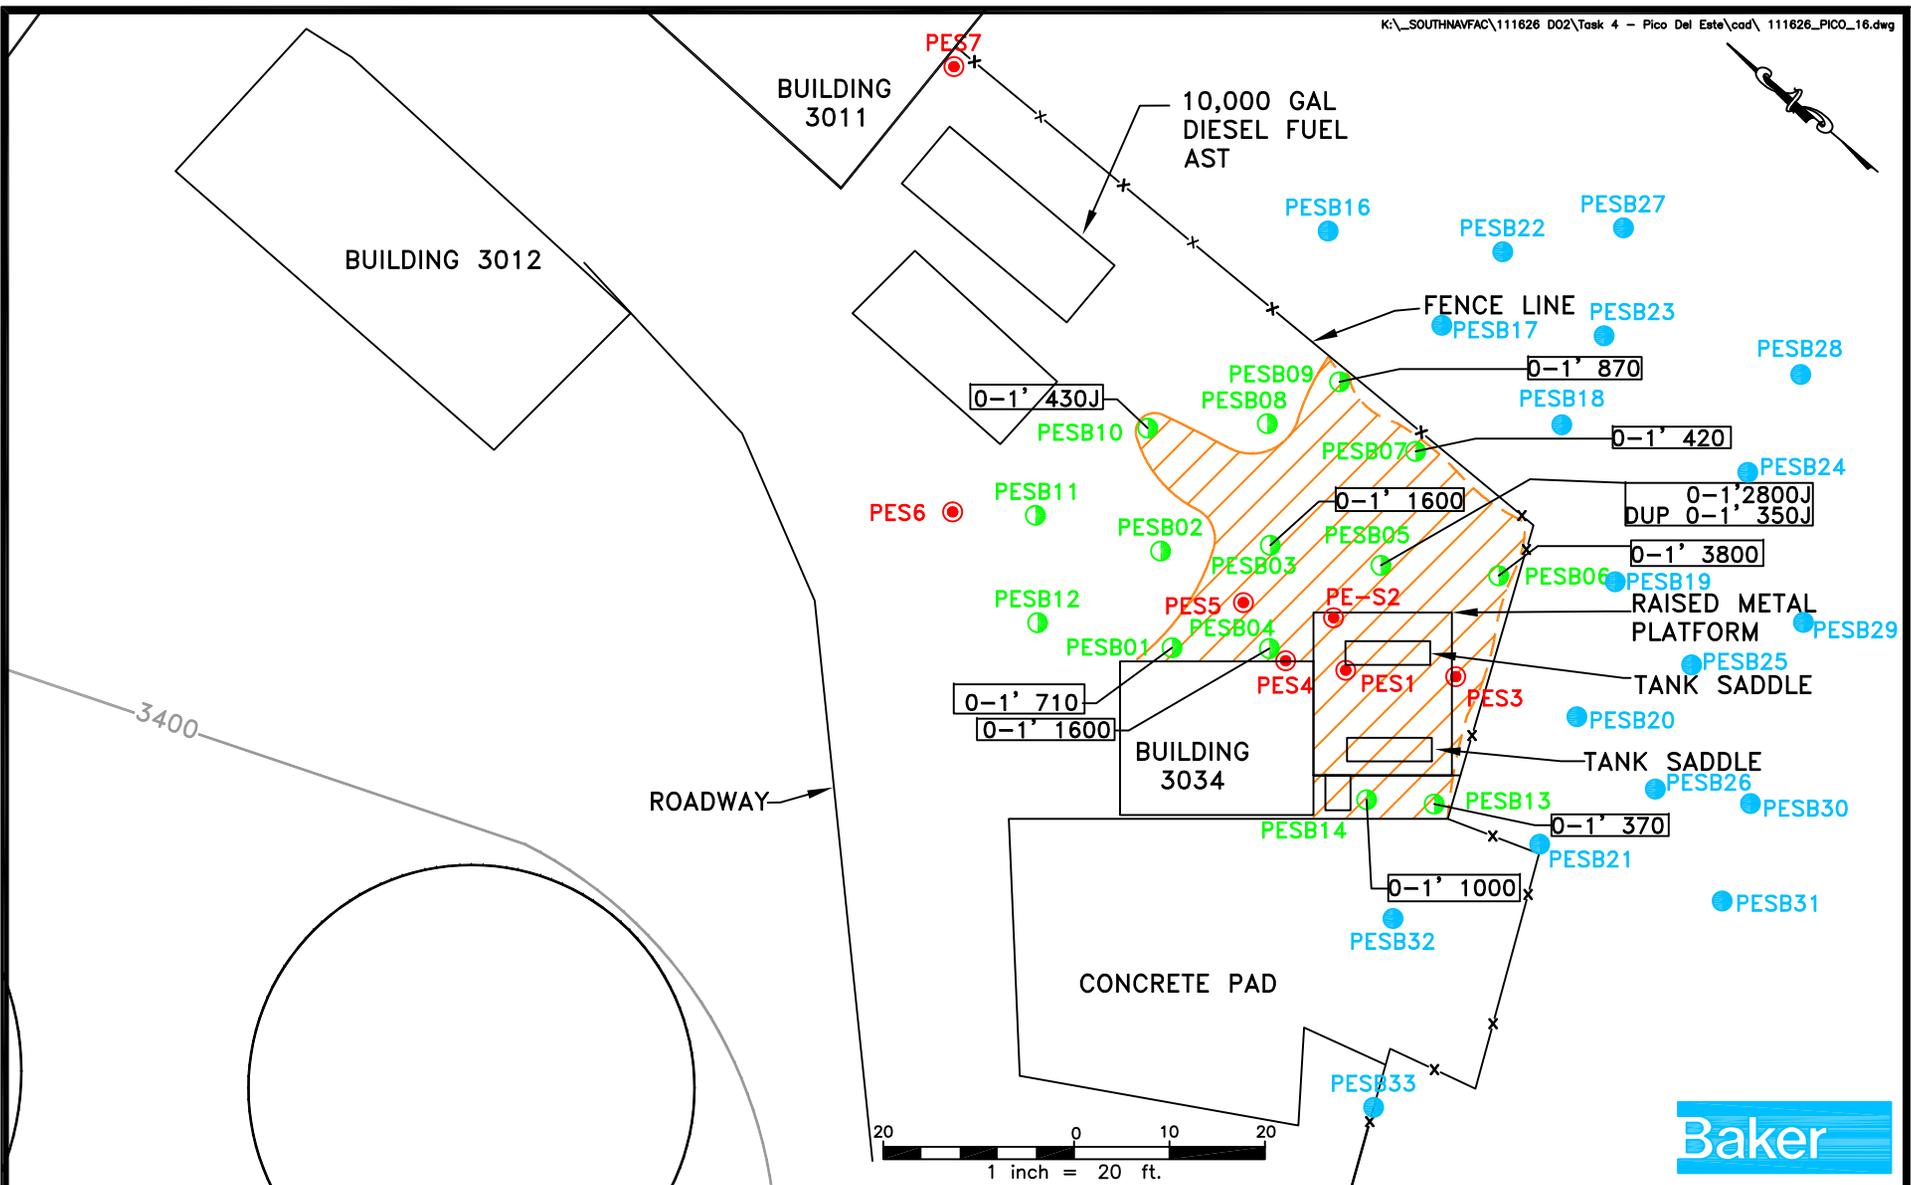
**FIGURE 4-1**  
**DRO ABOVE EQB CRITERIA, SURFACE SOIL**  
**SITE INVESTIGATION**

LEGEND	
<span style="color: red;">●</span>	- PREVIOUS EBS BORING LOCATIONS 2003
<span style="color: green;">●</span>	- EXISTING SI BORING LOCATIONS 2007
<span style="color: blue;">●</span>	- SI SURFACE SOIL LOCATIONS 2008
1-3'	- DEPTH OF SAMPLE
<span style="border: 1px solid orange; display: inline-block; width: 10px; height: 10px; background: repeating-linear-gradient(45deg, transparent, transparent 2px, orange 2px, orange 4px);"></span>	- AREA WITH TPH-DRO ABOVE 100 mg/Kg ALL CONCENTRATIONS IN mg/Kg

DRO was found at concentrations exceeding the EQB DRO soil screening criteria in both surface and subsurface soil. The delineation of DRO results indicated subsurface soil with levels higher than the EQB criteria are extending outside the perimeter fence, while the additional sample collection in January 2008 confirms surface soil is not impacted at levels above the EQB screening criteria outside the fence line. Due to the extremely sensitive ecosystem in the rainforest, it is not advisable to perform soil removal activities outside the fence line to remove potentially DRO-impacted subsurface soil. No individual VOC or PAH parameters exceed the EPA PRGs and DRO will biodegrade over time, especially if the point source area in the surface soil is removed within the fence line. The Navy proposes to conduct surface soil removal activities within the fence line to a depth of no more than two feet below ground surface in the area delineated on Figure 4-1.

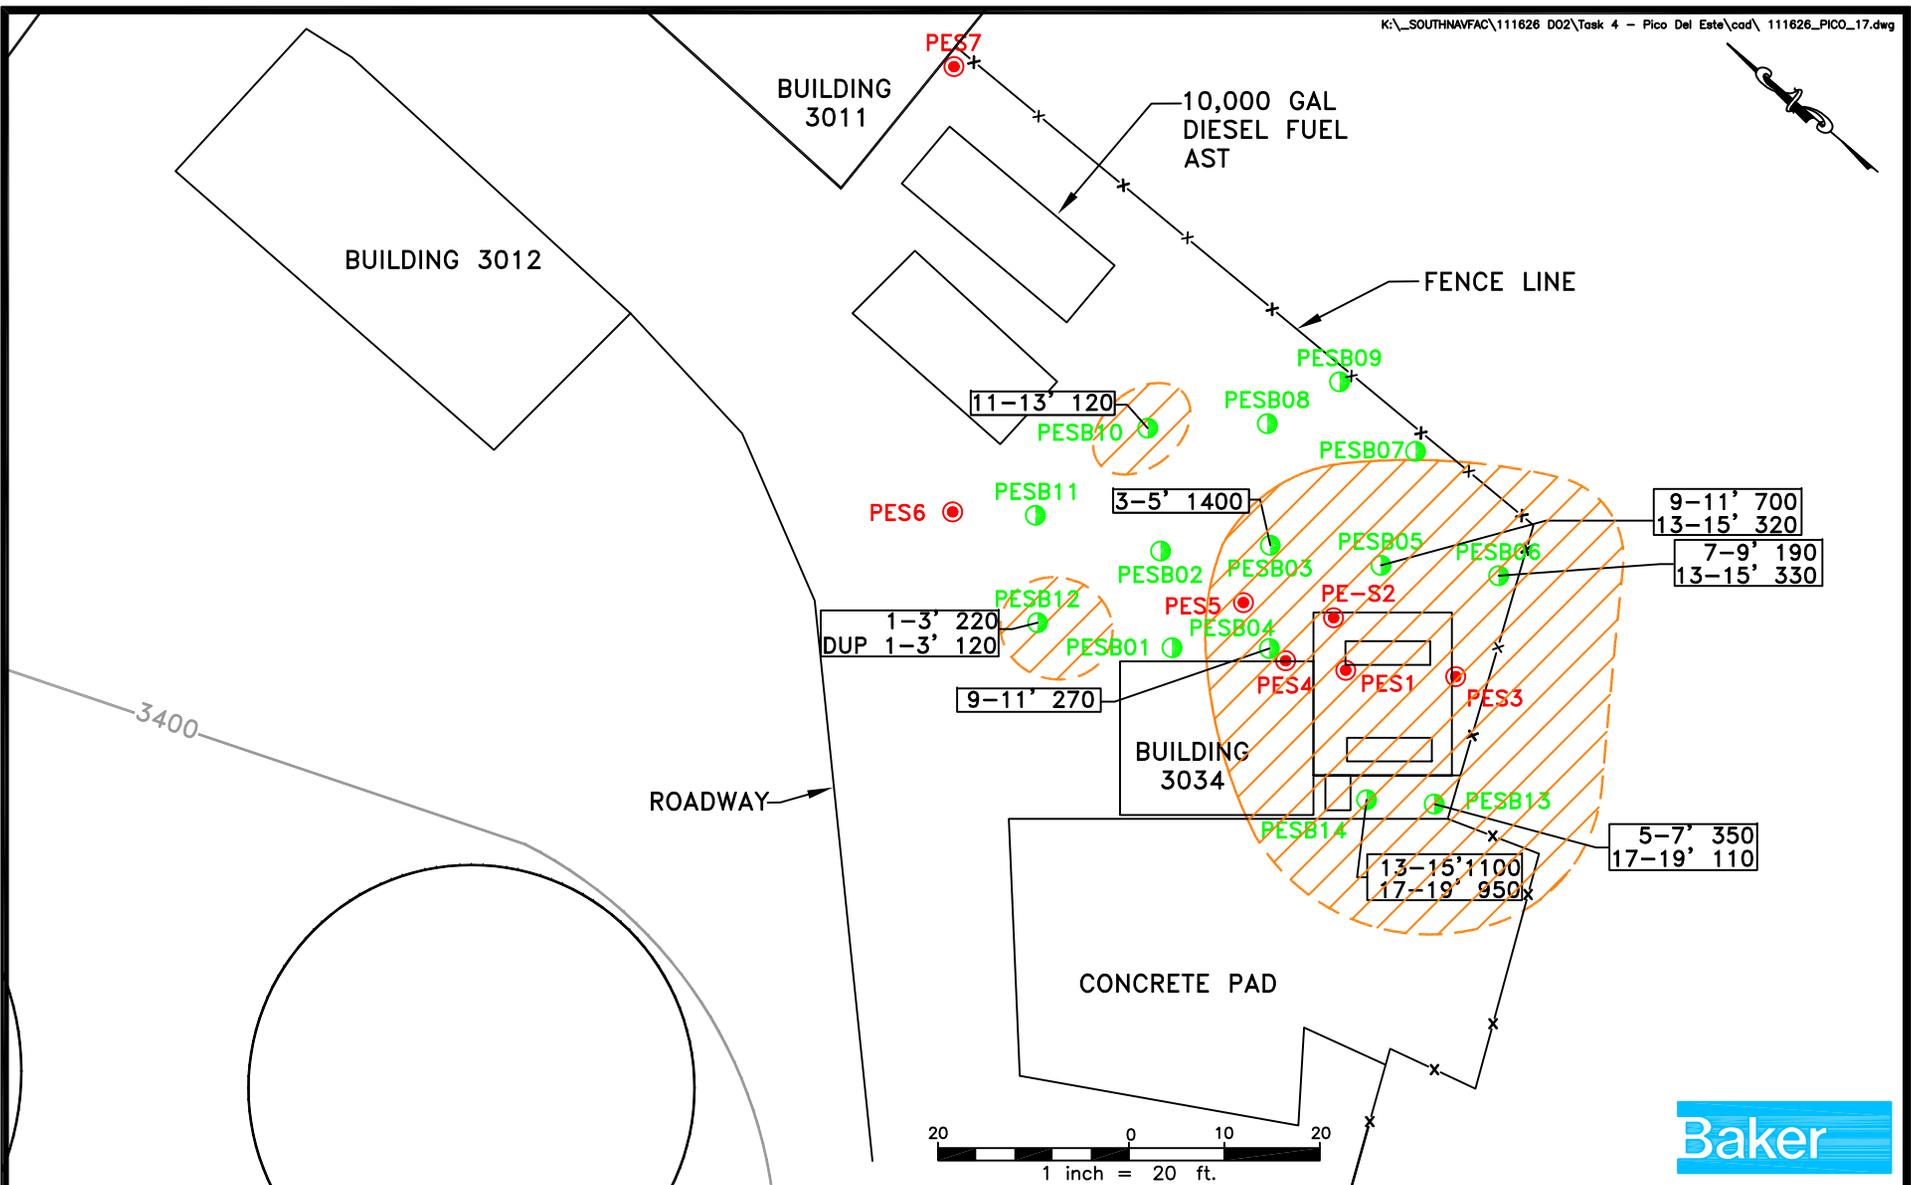
- - PREVIOUS EBS BORING LOCATIONS 2003
- - SI BORING LOCATIONS 2007
- 1-3'- DEPTH OF SAMPLE
- ▨ - AREA WITH TPH-DRO ABOVE 100 mg/Kg

21. Figure 4-2. *Figure 4-2 indicates that the eastern, southern, and western boundaries of the area of TPH contamination exceeding 100 mg/kg is inferred. This indicates that the objective of determining the horizontal extent of contamination has not been achieved; the report should be revised to identify this deficiency and present corrective action.*
- 22.

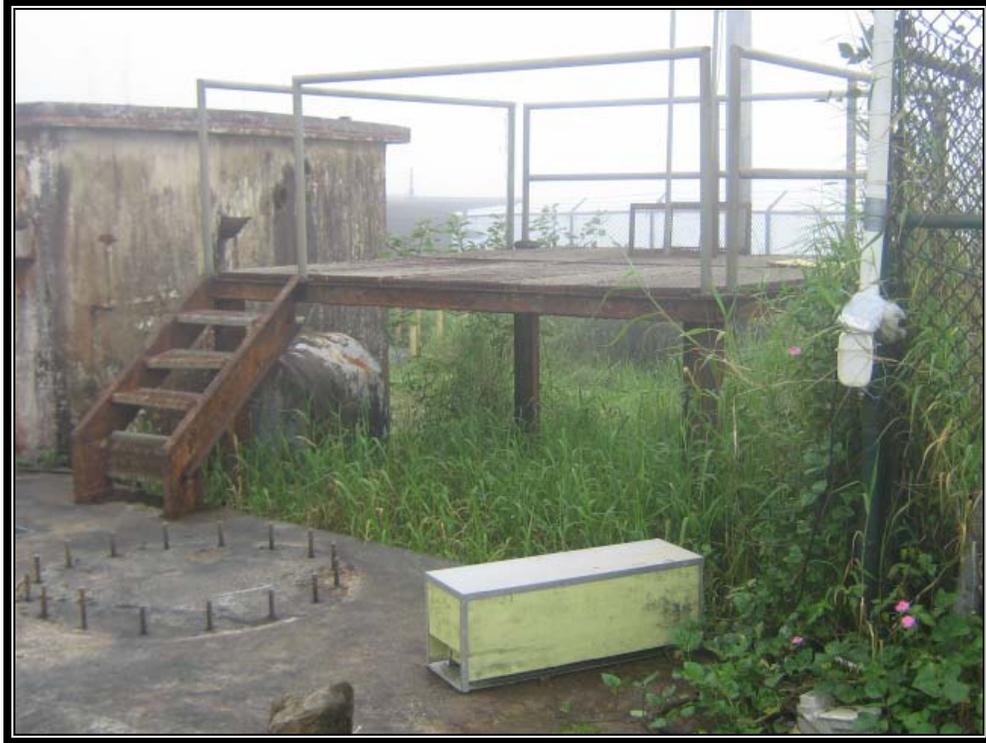
**Photo 5**

East side of Building 3034 – previous diesel fuel spill area

The 2003 EBS report indicates a records search uncovered a spill of diesel fuel occurring at the Pico del Este Radar Facility in April 2002. The spill record indicates that a broken seal on a fuel feed pump caused a release of diesel fuel from the emergency generator formerly housed in Building 3034. An area of approximately 116 square feet of soil was contaminated during this release according to the report. The record also indicates that the contaminated soil was removed and properly disposed off site, while the affected areas were restored with clean topsoil (NAVFAC, 2003).
