SUMMARY REPORT OF ENVIRONMENTAL ACTIVITIES AT HOSPITAL SITE NAVAL
ACTIVITY PUERTO RICO
11/1/1996
BLASLAND, BOUCK AND LEE, INC.

*Summary of
Environmental Activities at
the Hospital Site*

U.S. Naval Facilities
Ceiba, Puerto Rico

November 1996

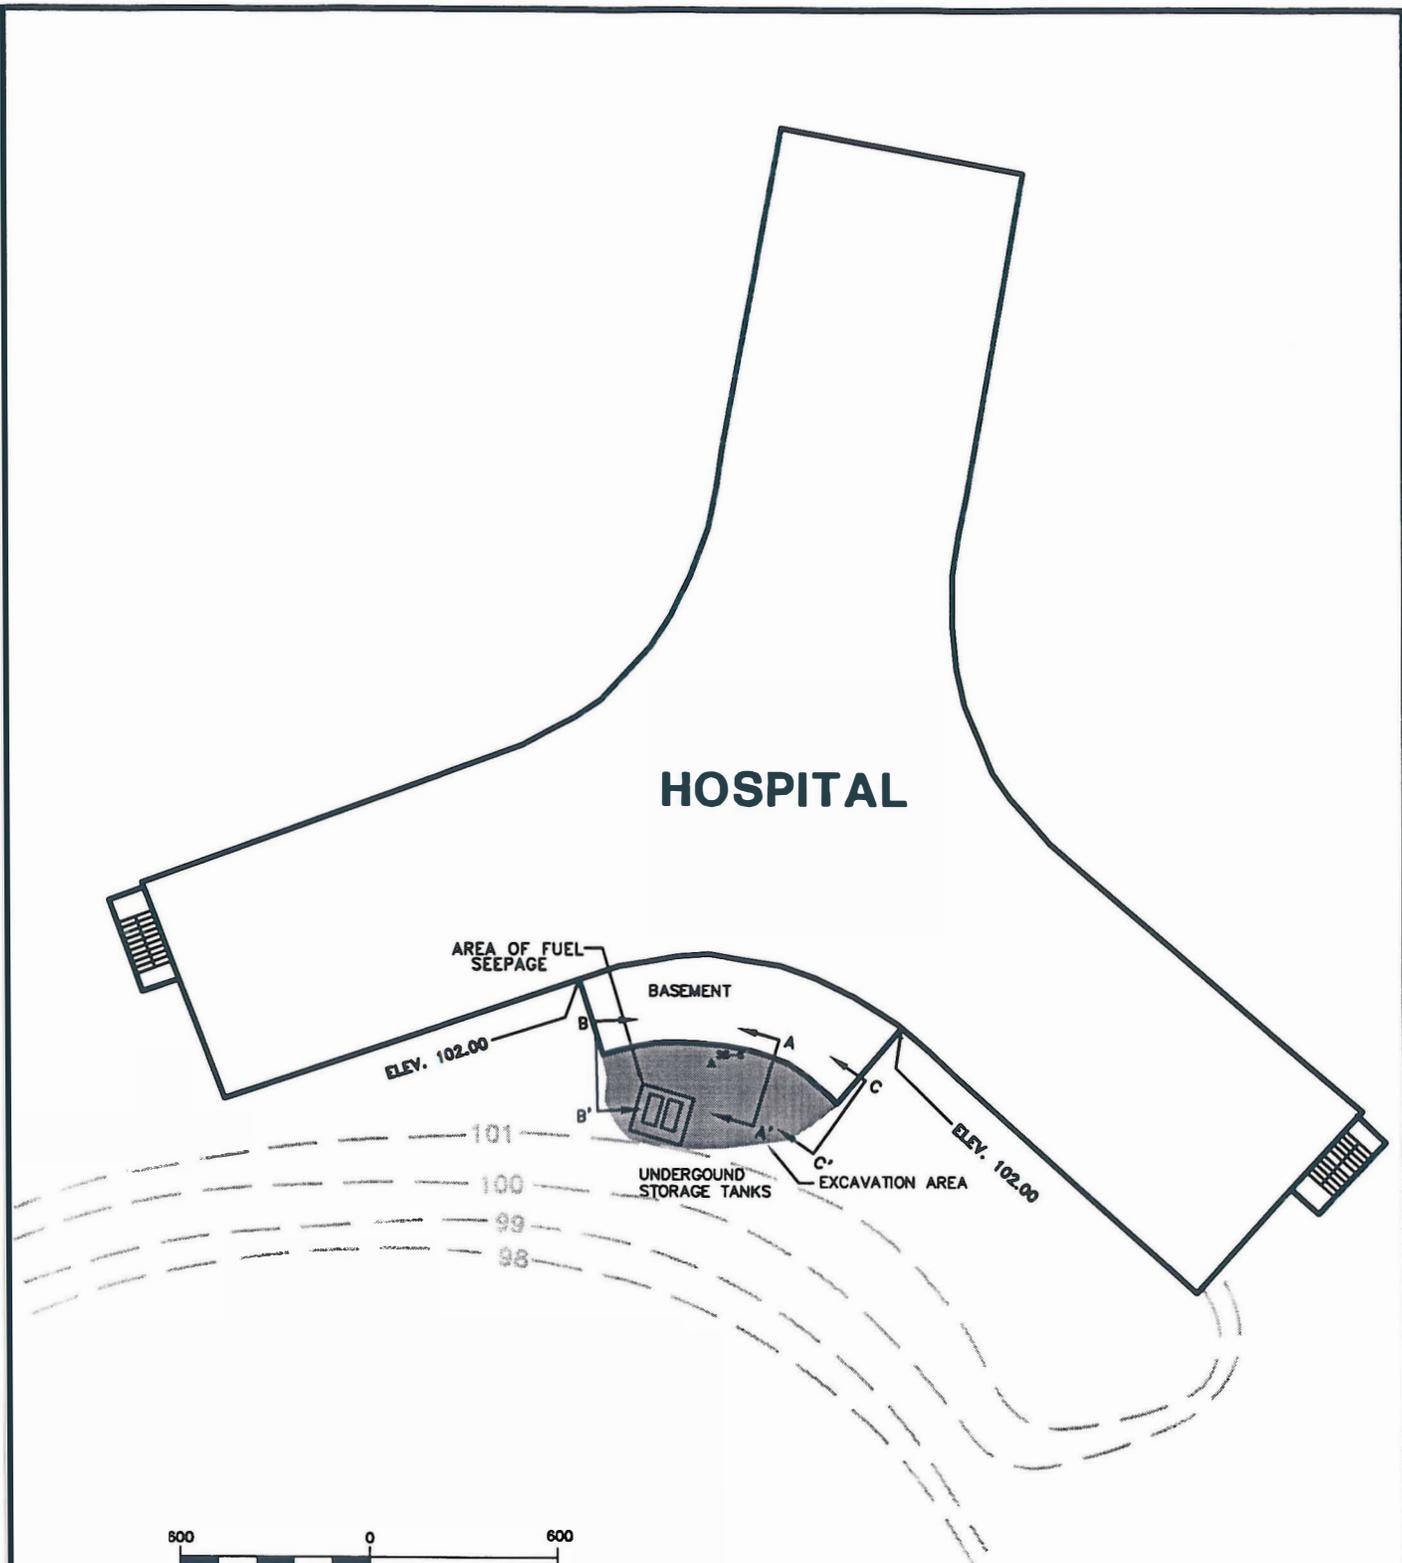
AREA OF FUEL SEEPAGE

BASEMENT

Overfill of two fuel tanks used for hospital generators, (located approximately 15' south of the basement wall approximately 10 feet below land surface) was the suspected source of petroleum (see attached, Figure 1). Excess rainwater percolating into the ground during the storm events in November of 1994 and August of 1995 is believed to have forced both water and fuel into the basement floor, through a weak or cracked joint.

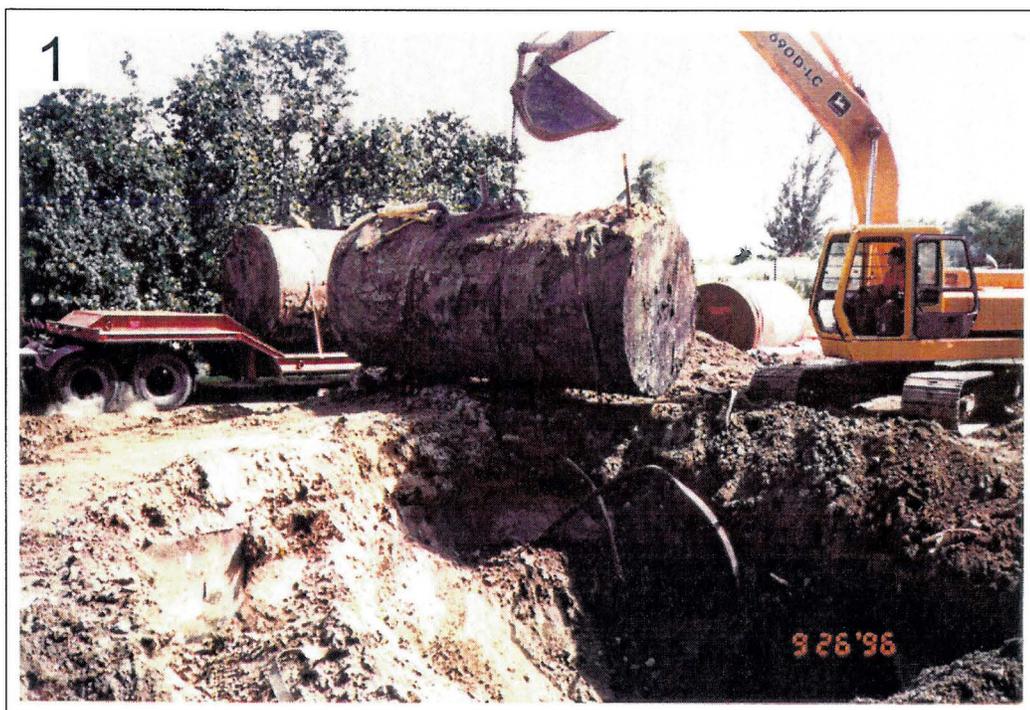
Excavation and removal of UST's.

The two 6,000-gallon, JP-5 USTs were excavated on September 26, 1996. The USTs were loaded onto a trailer and transported off-site for disposal. The USTs were in good condition with no visible pits, holes, or rust (Photographs 1 and 2). However, the area around the UST fill ports was stained and the soil extending from the fill ports toward the hospital and underneath the USTs was greenish/grey in color and had a strong petroleum odor. OVA screening of the soil confirmed that the soil was contaminated. In addition, the soil under the fuel piping entry points into the basement was also contaminated. All soil determined to be contaminated was loaded onto dump trucks, hauled to a holding area where it was stockpiled on plastic sheeting, and later transported to the BFI landfill in Ponce, Puerto Rico.

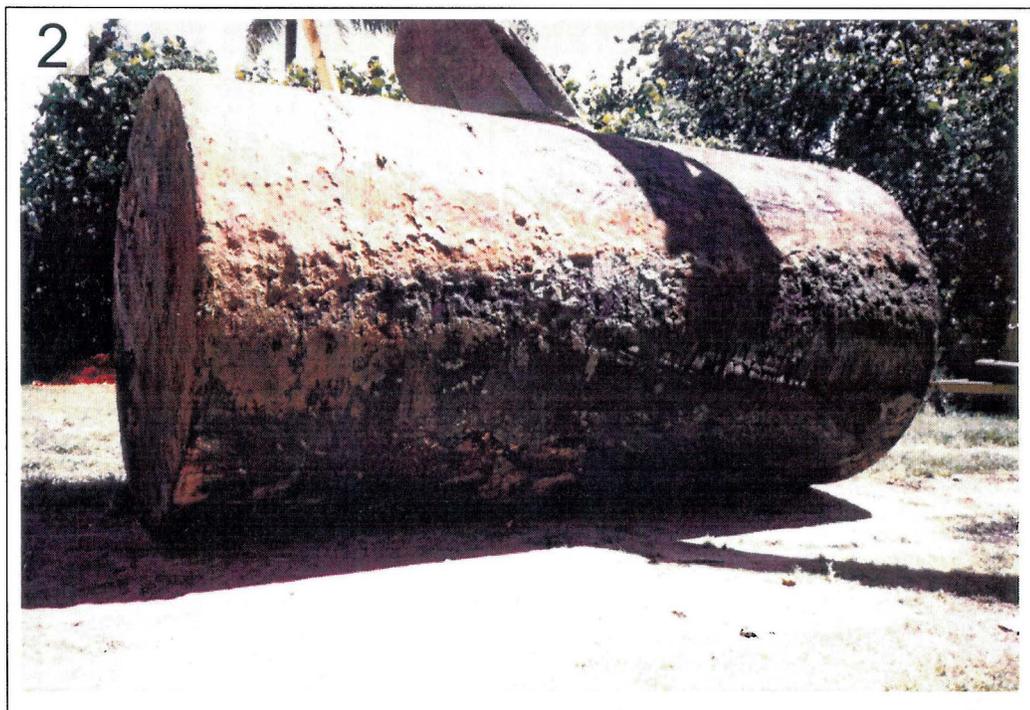
View of UST after removal (note no pits holes or rust.)

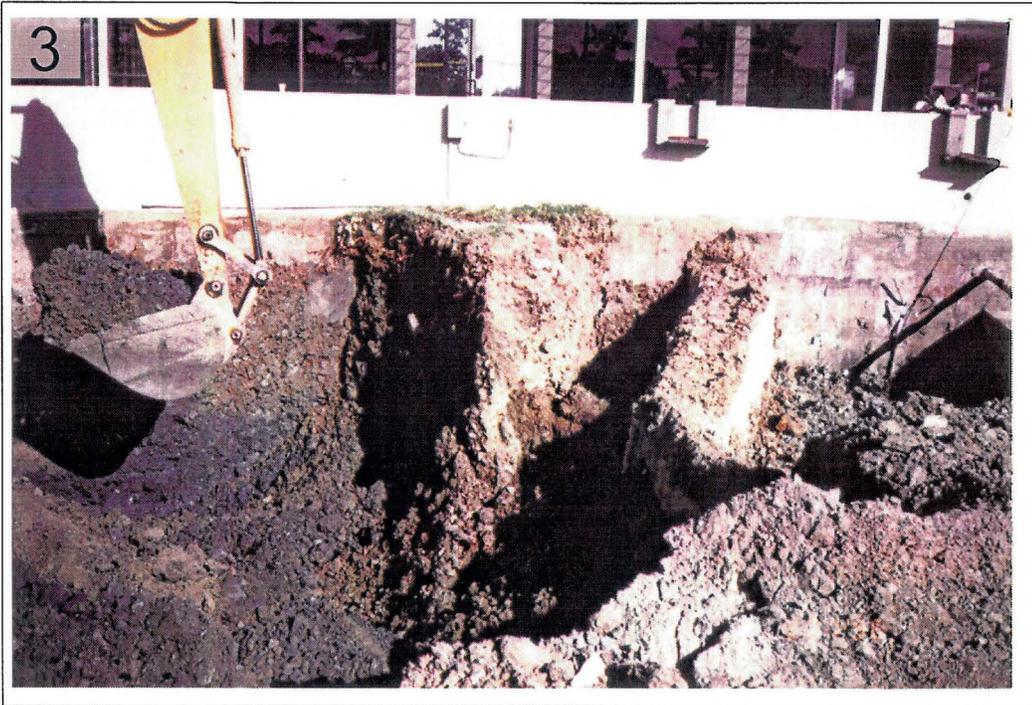
Excavation between UST's and basement wall. Note: Clean brown to tan colored soil on top and contaminated greenish/gray colored soils below.

used as backfill. The soil, between the USTs and the hospital, excavated below 5 feet was greenish/grey in color (Photographs 3 through 5) and had a strong petroleum odor. OVA screening of the soil confirmed that it was contaminated, requiring disposal.

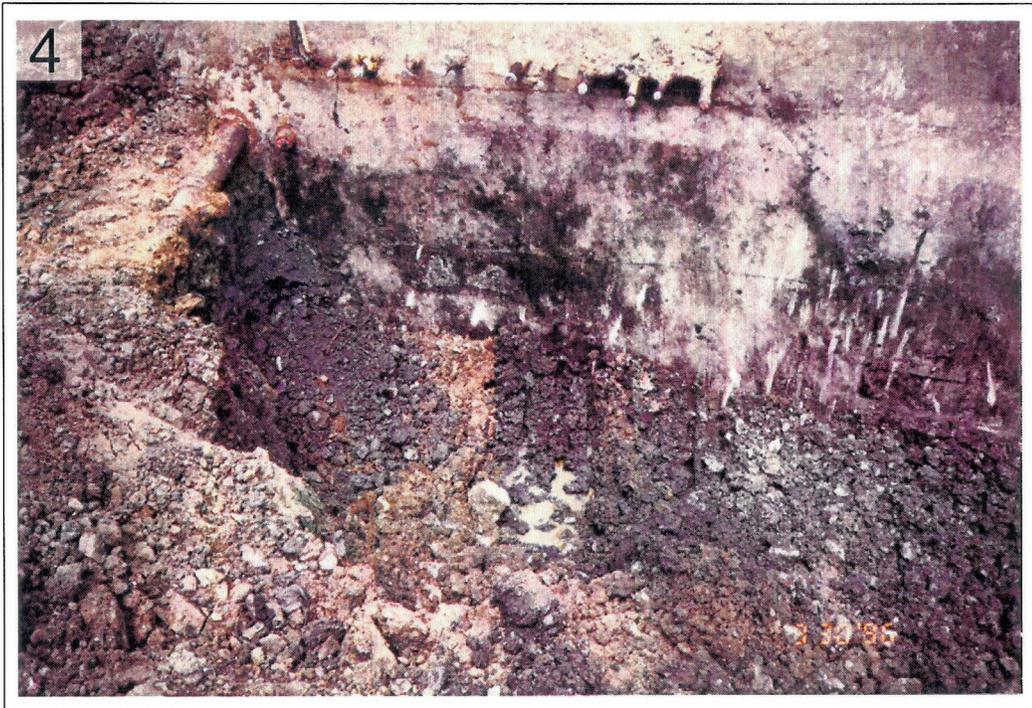
Western end of basement wall. Note: contaminated soils below fuel pipes.

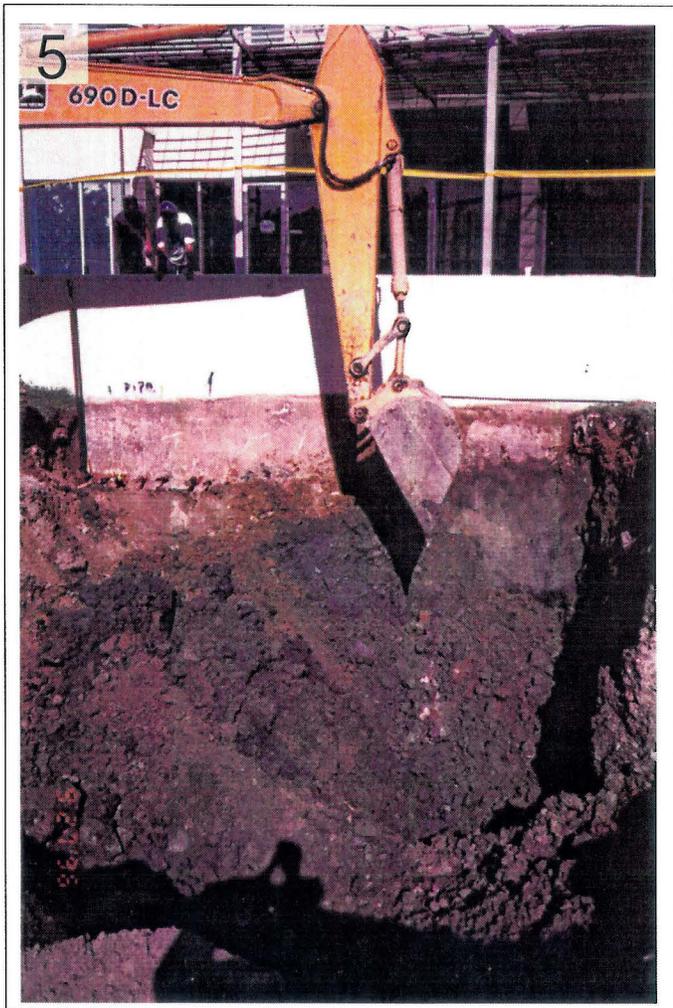
Excavation near the western end at Basement wall.
Note: fuel pipes on left side.

As the excavation started on the western end and moved eastward along the hospital wall, the depth of soil contamination encountered increased from west to east. Contaminated soil was encountered at approximately 4 feet bls on the west end of the hospital basement wall under the fuel pipes (Figure 3 and Photographs 4 and 5), and at approximately 13 feet bls on the east end of the basement wall (Figure 4). Excavation along the east end of the basement wall was complicated by the presence of two concrete encased electrical conduits. The conduits had to be supported to prevent collapse and a potentially hazardous situation. It was determined by the ROICC that the conduits could be supported from above using a heavy gauge steel pipe and support straps (Photograph 6 through 9).

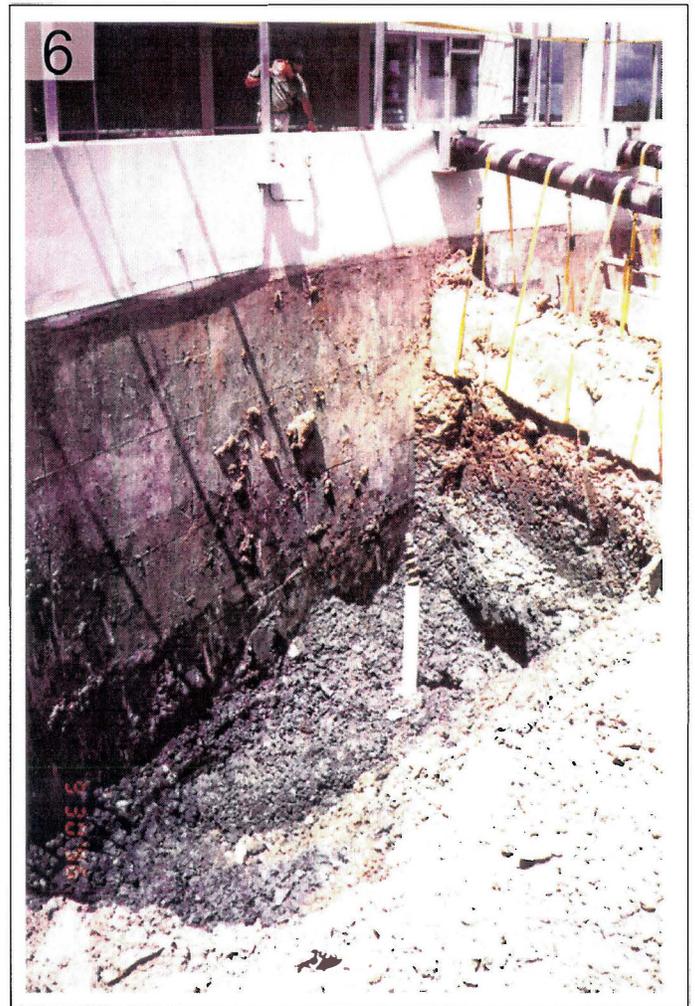
Excavation on western end and the support structure used for the electrical conduits. Note: auger and casing in middle of photograph is the location of soil boring SB-8.

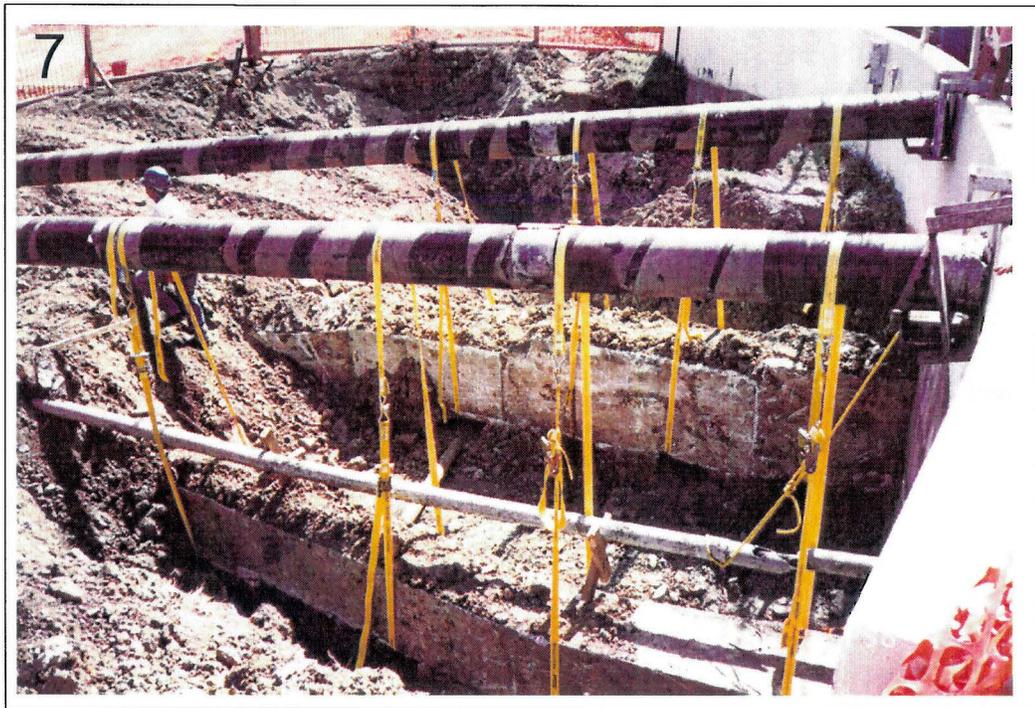
Support structures used for the electrical conduits

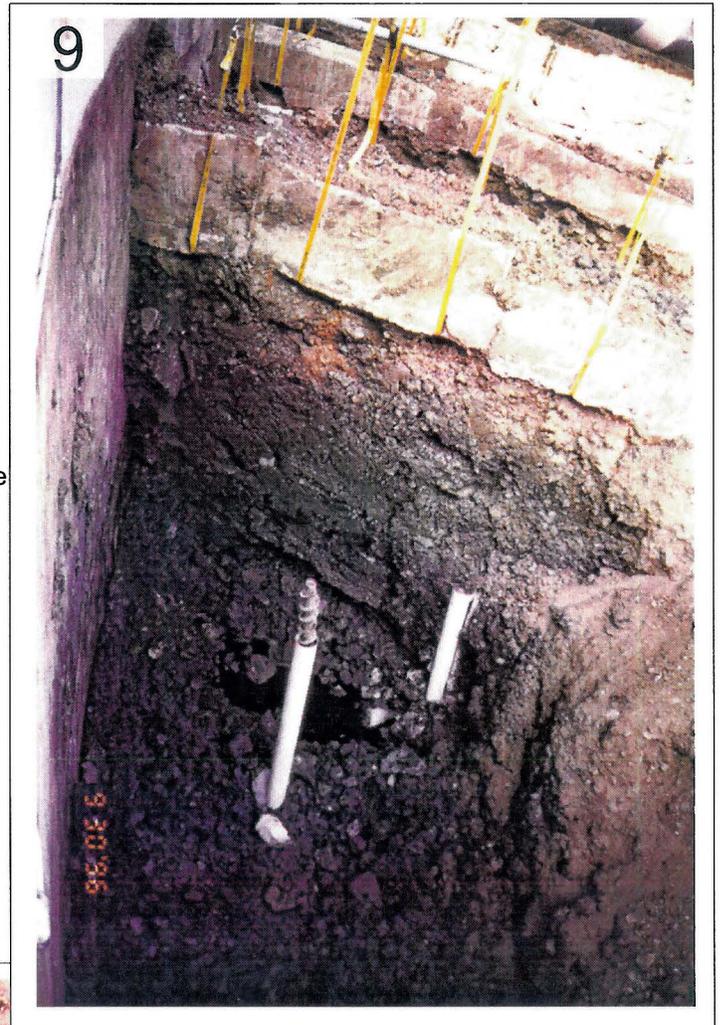
Support structures used for the electrical conduits. Note location of SB-8 (white PVC casing) and pools of water and fuel (sheen).

Once the engineering controls were in place to support the electrical conduits, the excavation continued to base of the foundation (16 feet bls). Small pockets or pools of water and fuel (sheen) were observed at the base of the excavation (Photograph 9). The entire basement wall was exposed to the foundation (Photographs 10 through 12). The foundation is 18 inches thick and extends out approximately 6 inches from the basement wall joint. It is through this joint that water and fuel are assumed to enter the basement.

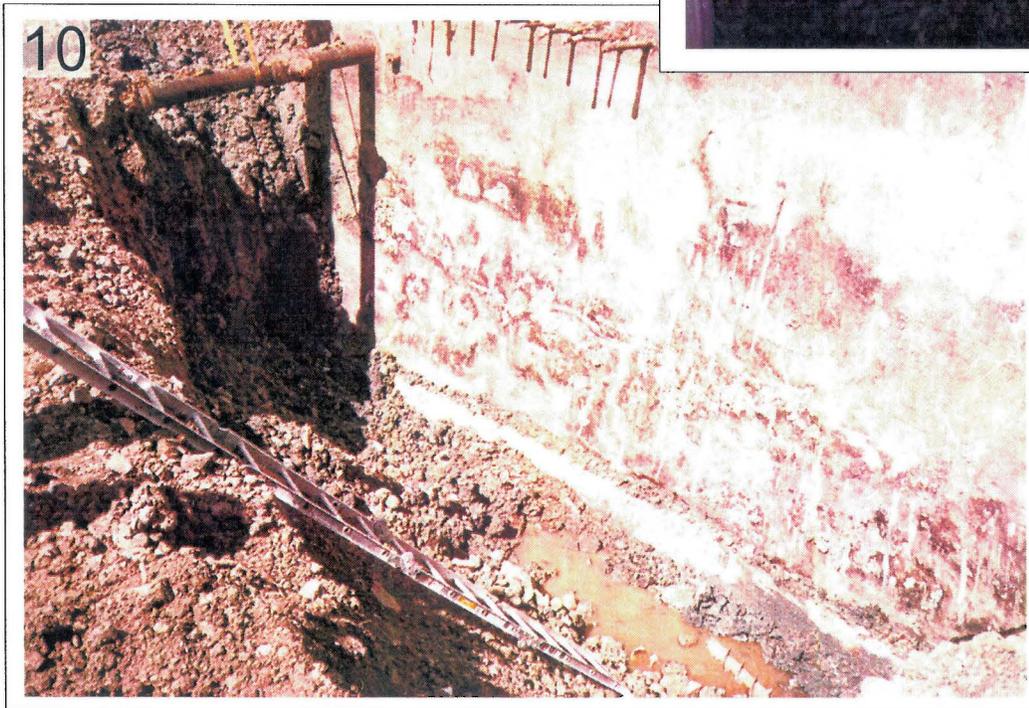
Western end of basement wall exposed to the foundation.

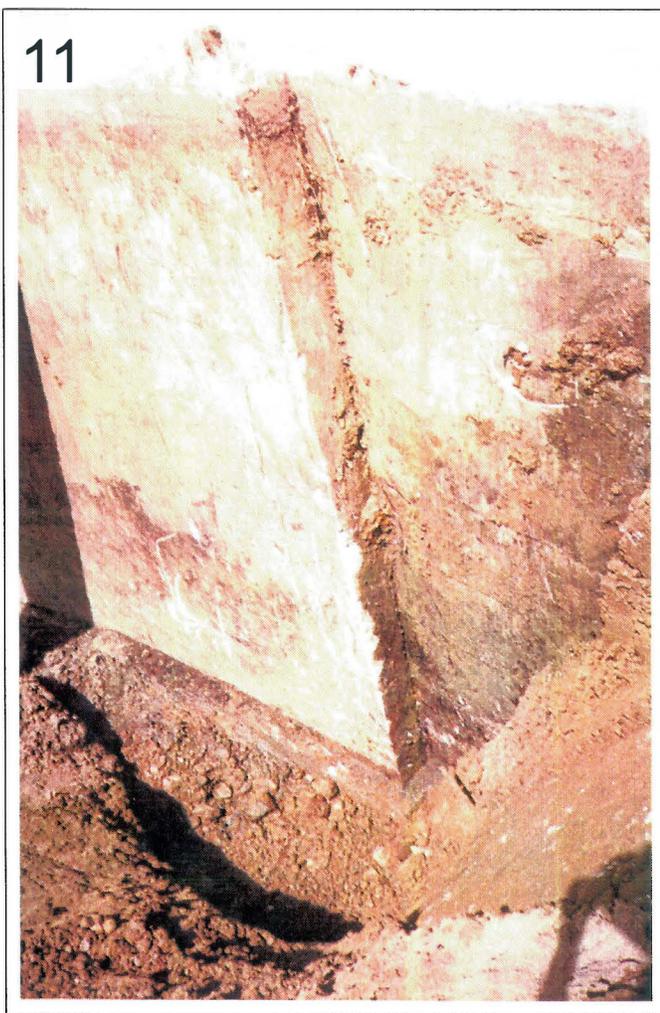
Eastern end (corner) of basement wall exposed to the foundation.

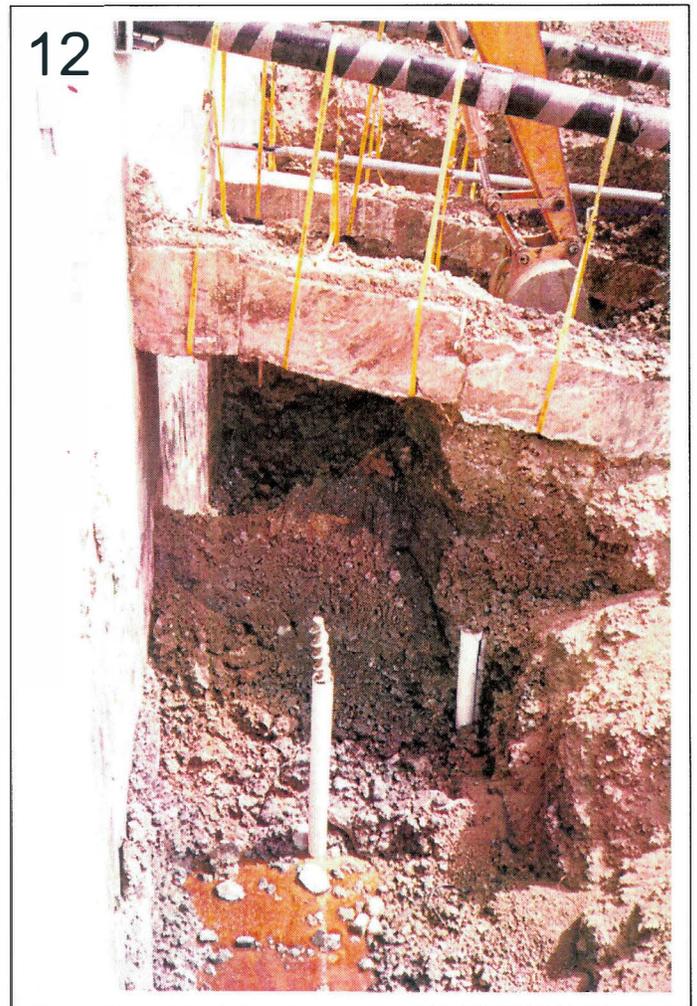
Excavation below the electrical conduits.

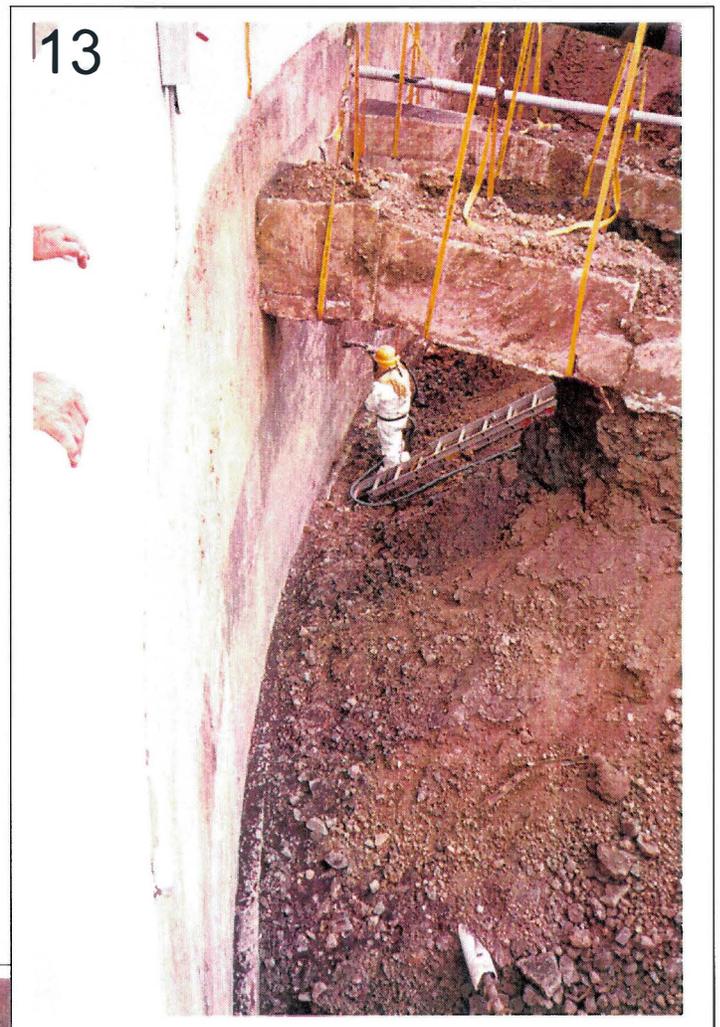
Sandblasting at bottom 8 feet of basement wall.

Subsequent to the soil excavation and prior to backfilling, the basement wall was sandblasted (Photographs 13 through 17) and sealed (Photographs 18 through 20). The bottom 8 feet of the basement wall was sandblasted using a black silica sand. The sandblasting was performed by Caribe Hidroblasting Environmental Division (CHED). The wall was sandblasted to remove all loose dirt, grit, and oil contaminants, to prepare the surface for sealing. Sandblasting ensured that the surface would be clean allowing a better bonding of the sealants to the concrete wall. The sealing process consisted of applying four different coating materials (see Attachment A) to the wall. The four different sealing materials were applied and allowed to dry before backfilling.

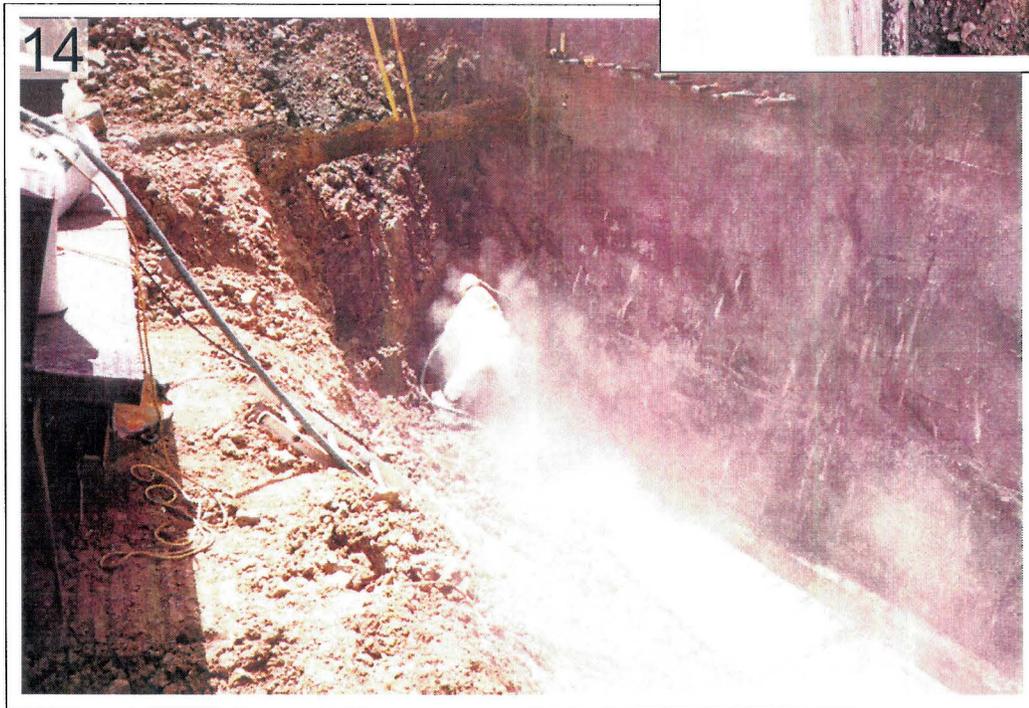
Sandblasting at bottom 8 feet of basement wall.

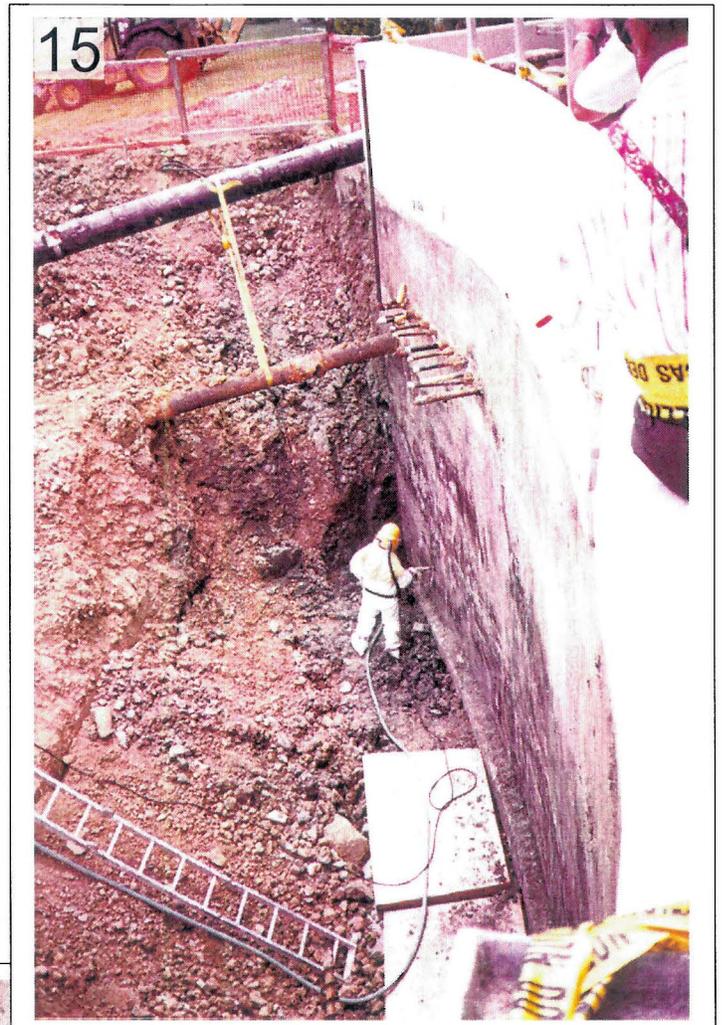
Sandblasting at bottom 8 feet of basement wall.

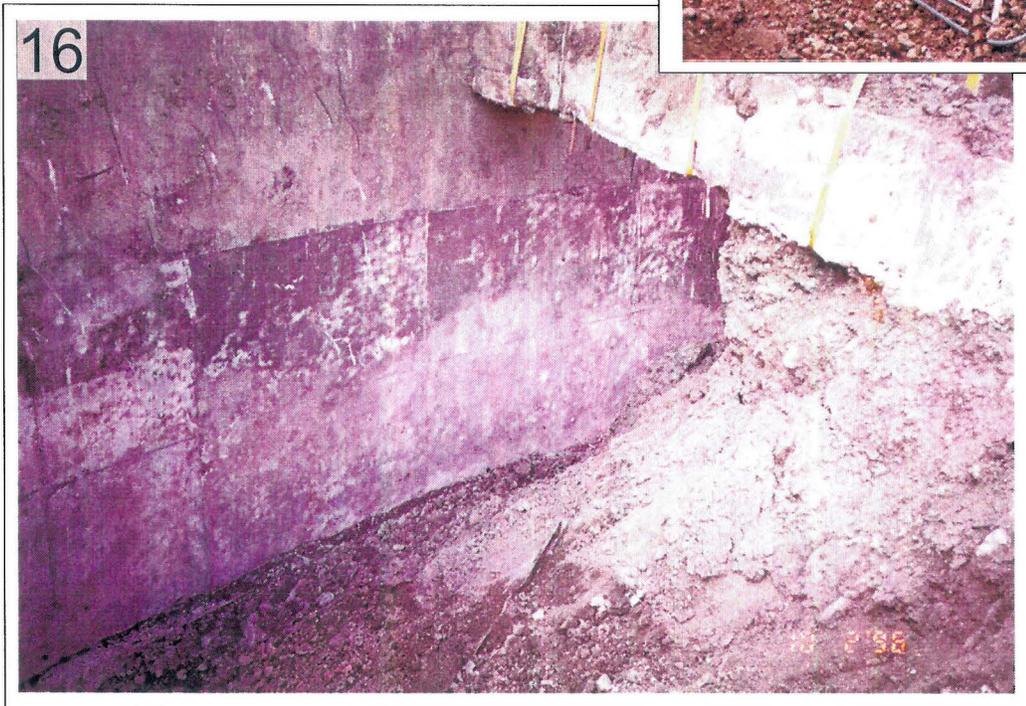
Wall after sandblasting.

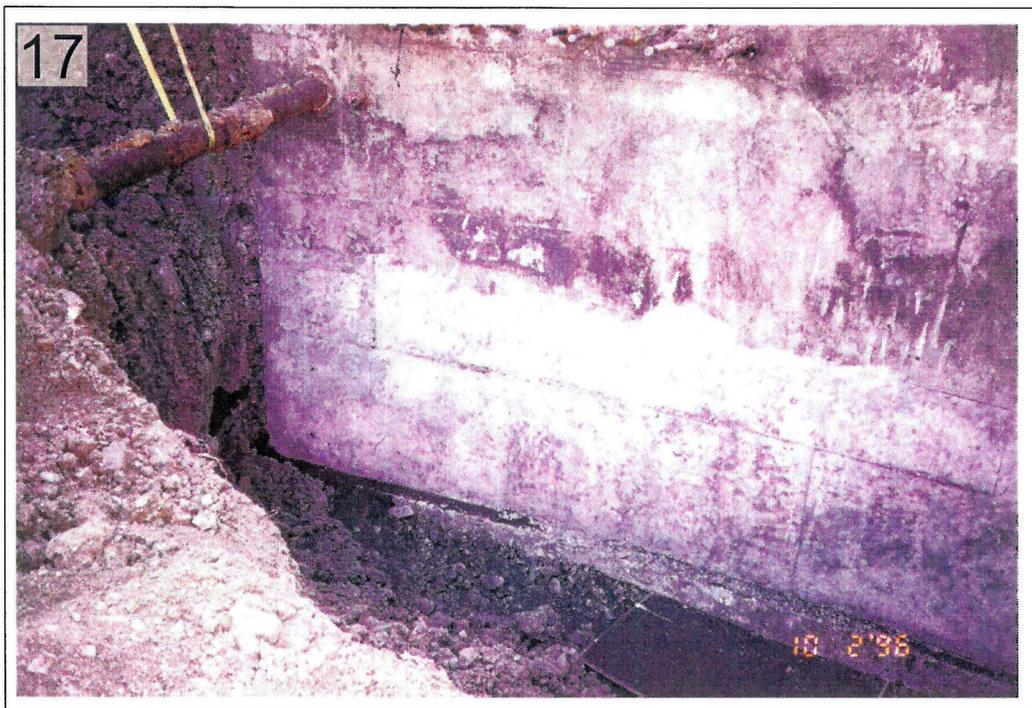
Wall after sandblasting.

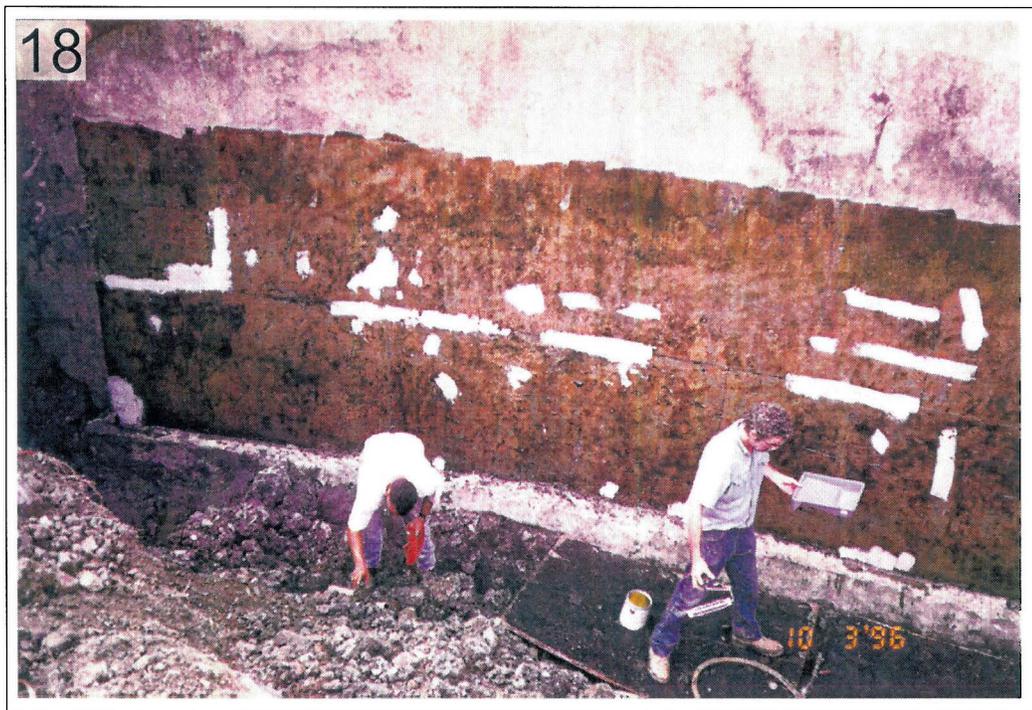
Sealing of basement wall.

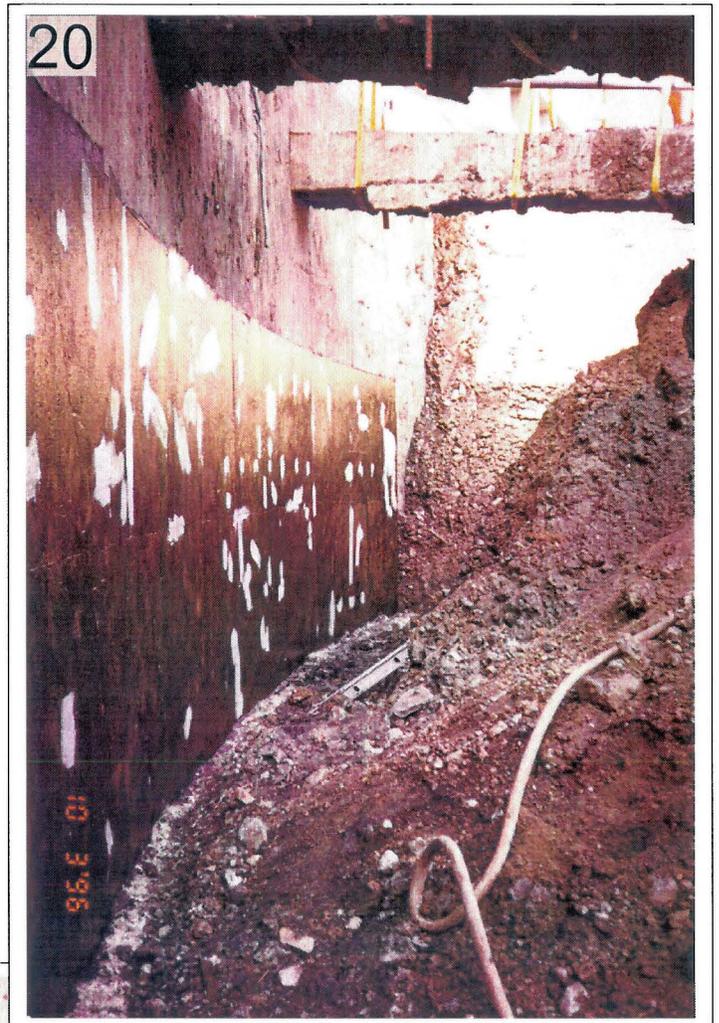
Sealing of basement wall.

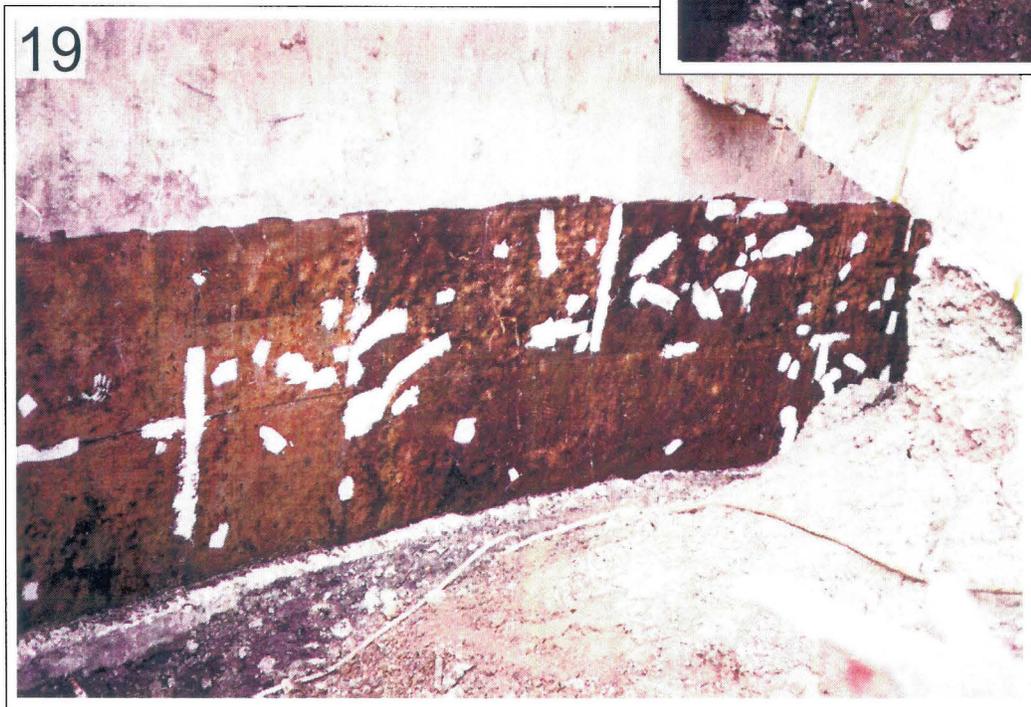
Sealing of basement wall.
