Site Management Plan for Installation Restoration Program

Naval Support Facility Indian Head
Indian Head, Maryland

October 2009

**Tetra Tech NUS, Inc.
234 Mall Boulevard, Suite 260
King of Prussia, Pennsylvania 19406**

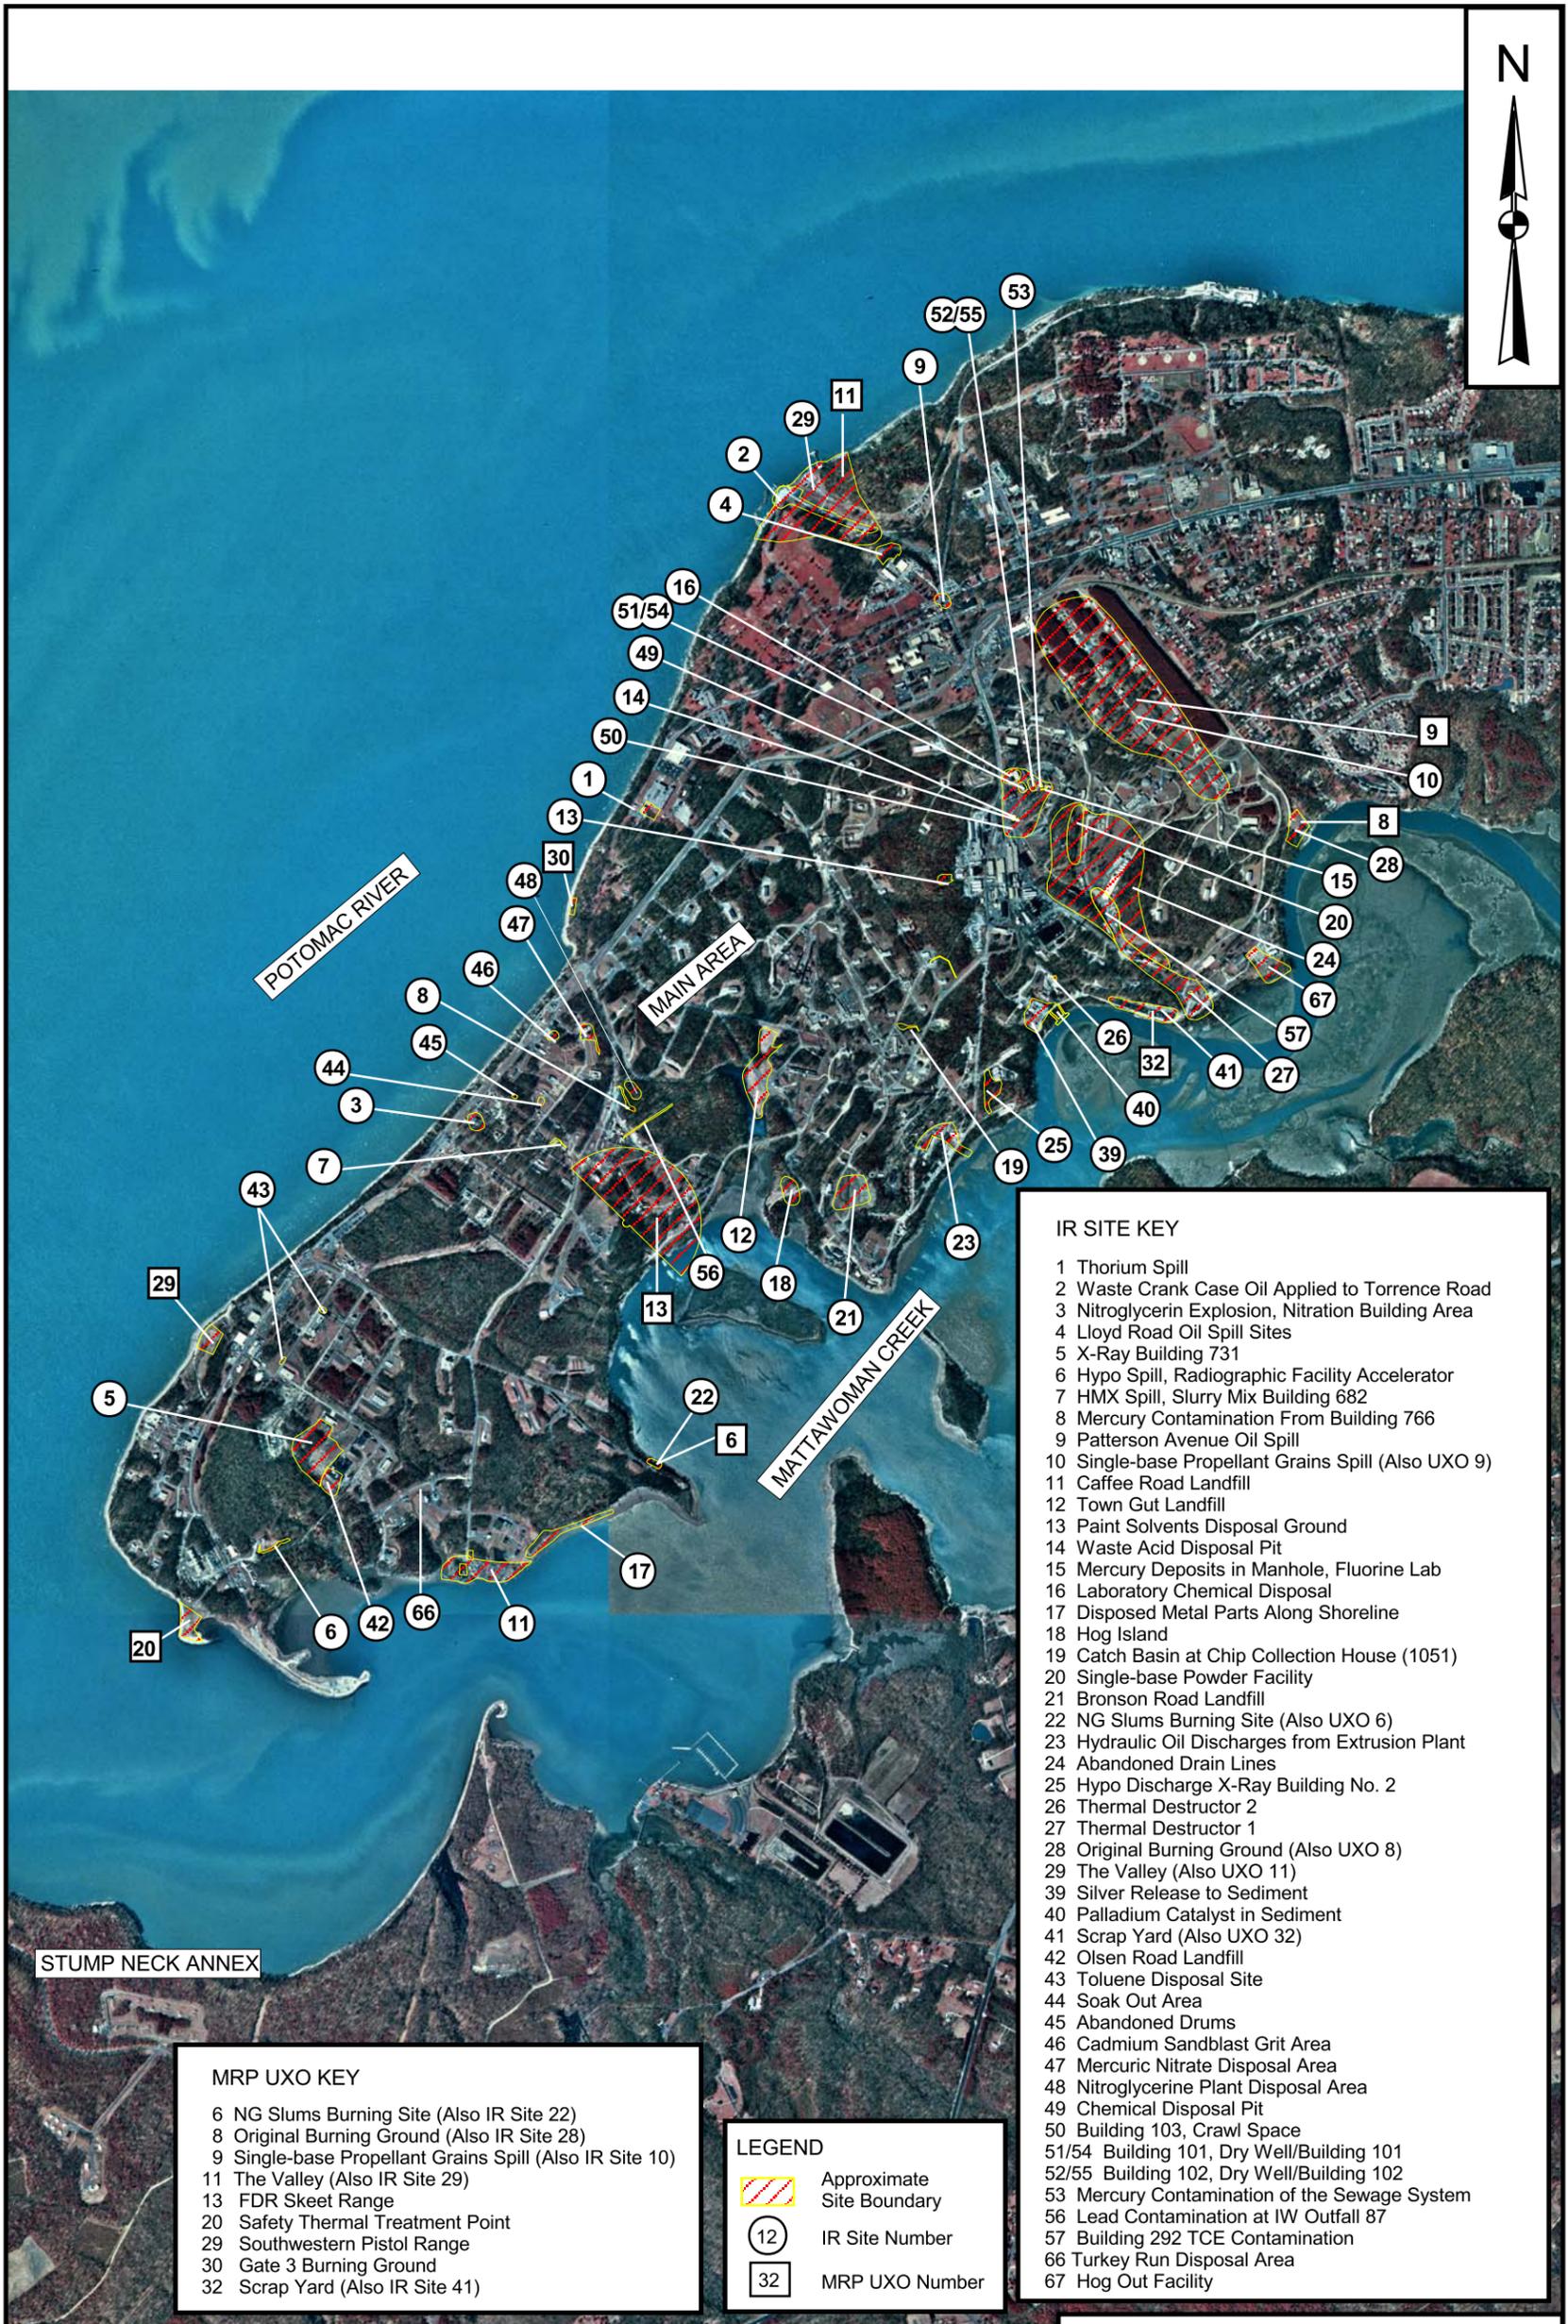
The locations of all the sites and AOCs identified in the previous sections of this Site Management Plan are illustrated in Figure 3-1 and 3-2. Figure 3-1 identifies the locations of the NSF-IH Main Area sites and AOCs, and Figure 3-2 identifies the locations for the NSF-IH Stump Neck Annex sites and AOCs.

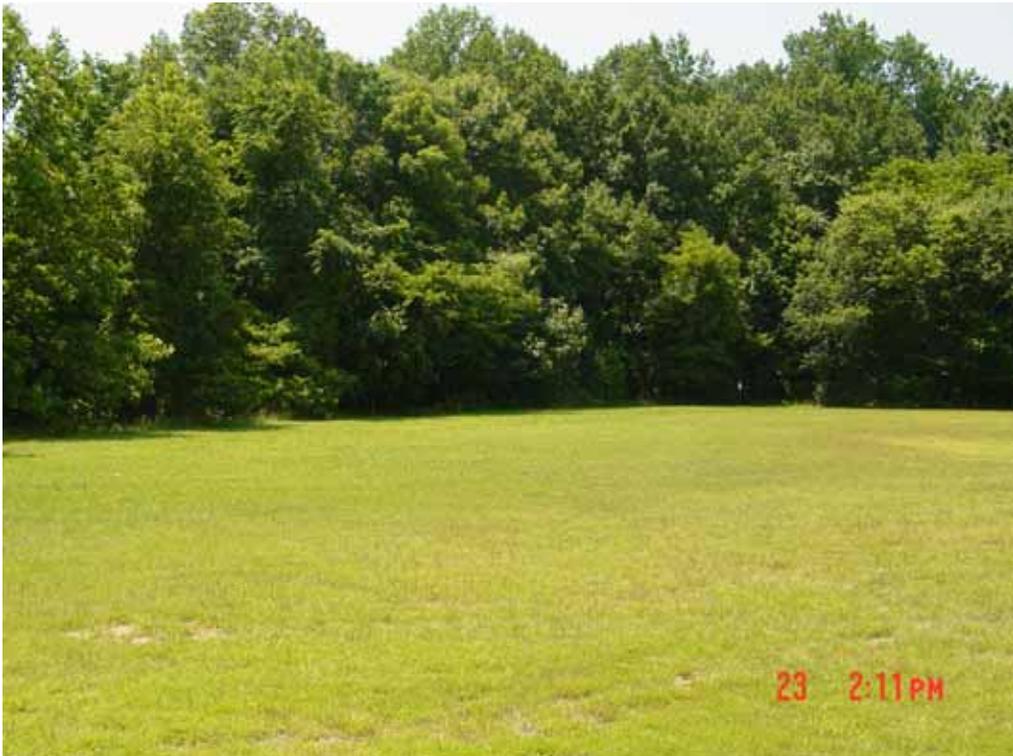
UXO 7 – Current conditions at the Old Demolition Range. (2003)

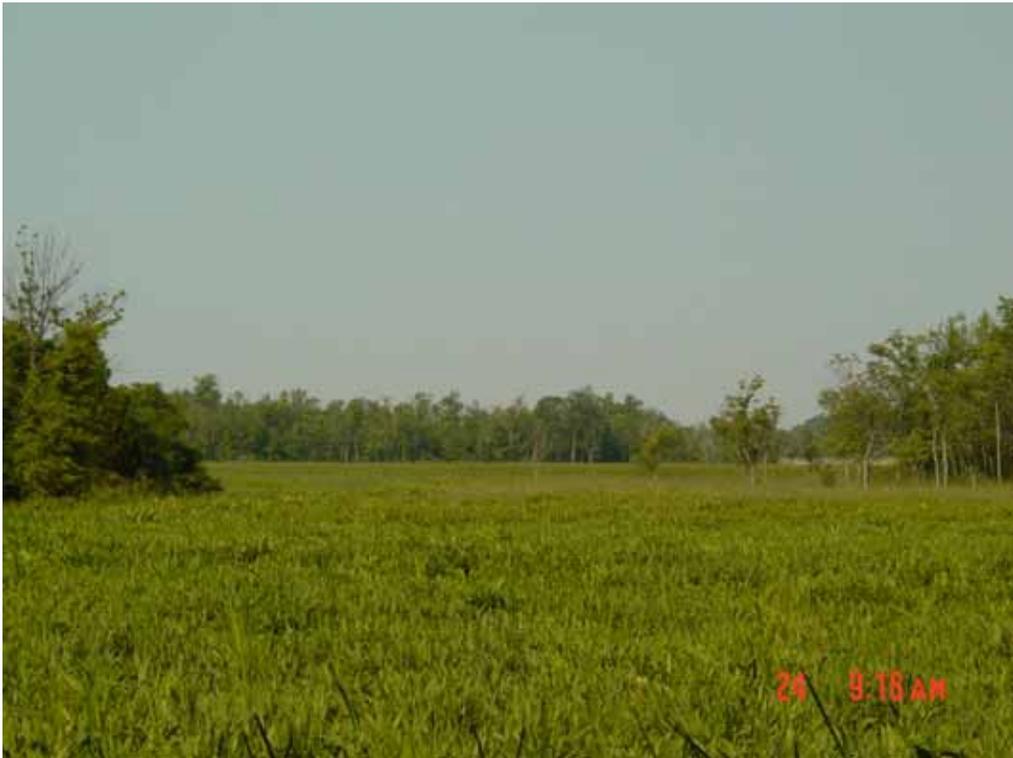
UXO 10 – Heavy shrubs observed from the periphery of the impact area. (2003)

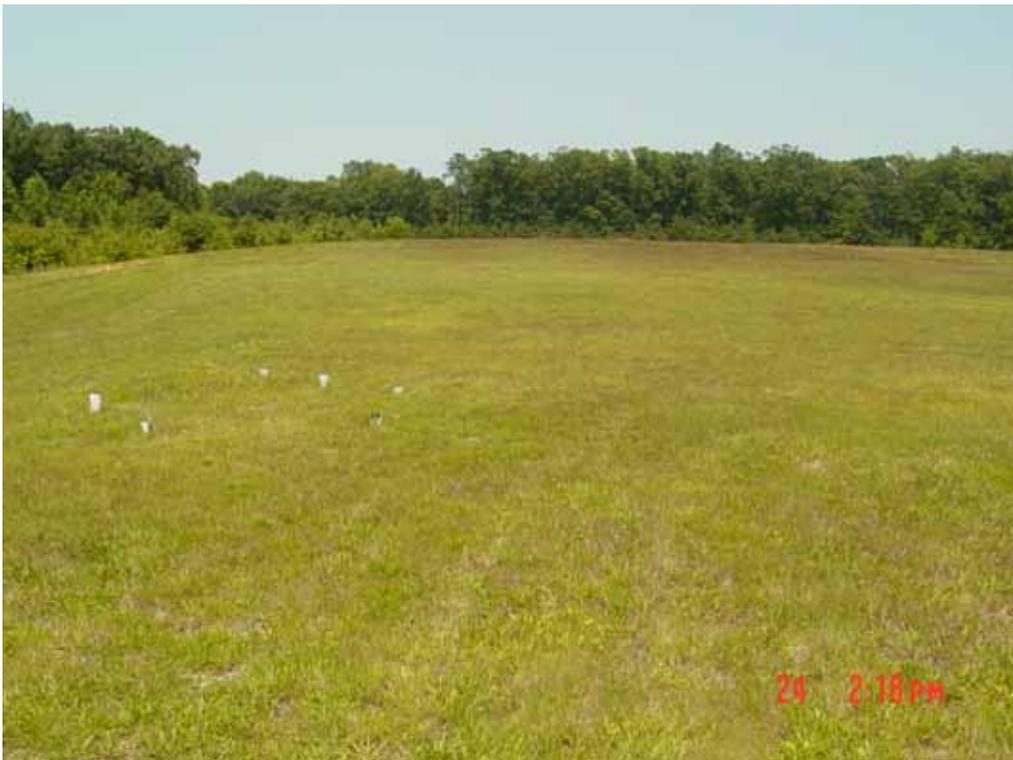
UXO 22 – Current conditions at Test Area 2 – off-set PVC test ports. (2003)

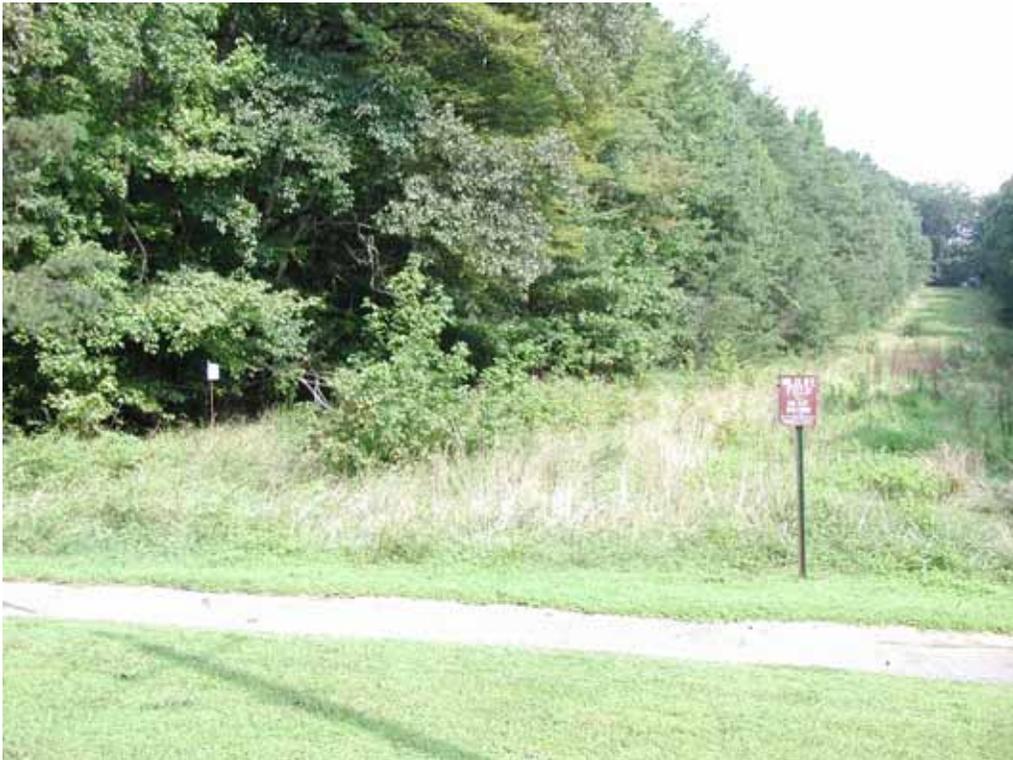
UXO 23 – The Torpedo Casing Disposal Area and wildlife protection area. (2003)
